# HEDGE MANAGEMENT PLAN FOR SAINT-GAUDENS NATIONAL HISTORIC SITE

CORNISH, NEW HAMPSHIRE

Olmsted Center for Landscape Preservation  
National Park Service, Boston, Massachusetts, 2008

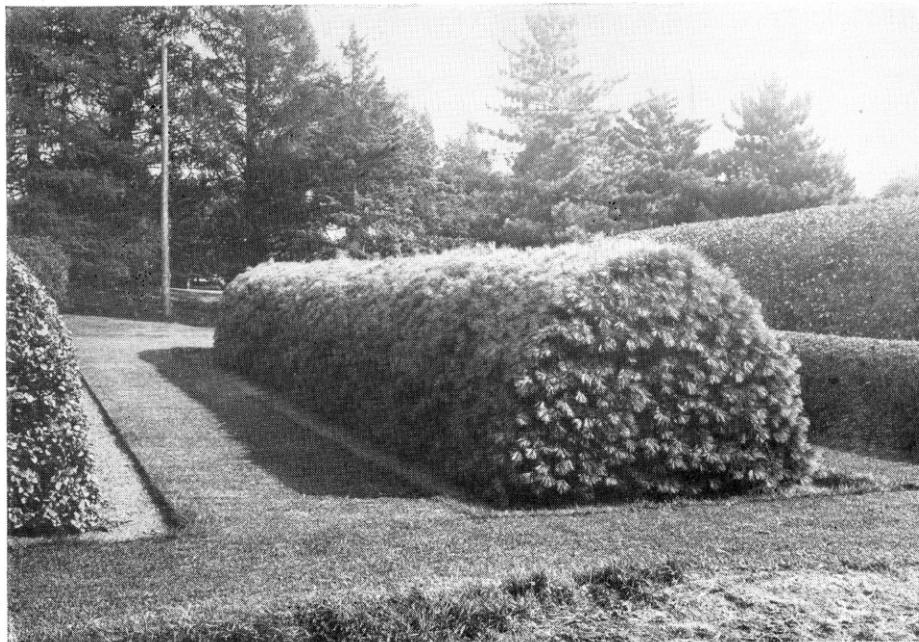
**Figure 0.3:** Mature white pine hedge at the Canadian Central Experimental Farm in Ottawa forty years after planting, c.1931 (W. T. Macoun, *Hedges and their Uses* [Ottawa: Dominion of Canada Department of Agriculture, Bulletin No. 142, 1931], 22).

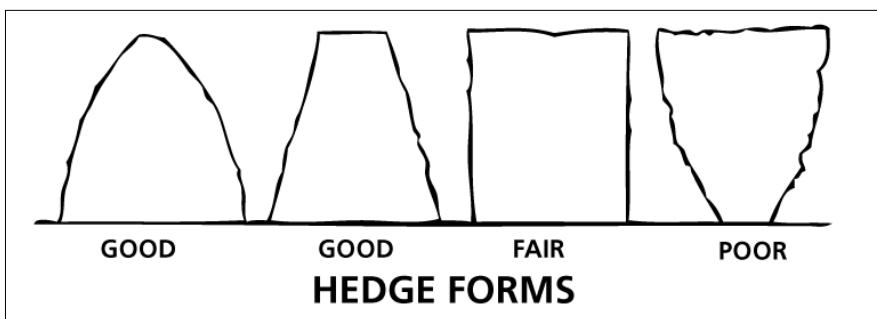
**Figure 0.7:** Rating of common hedge forms based on health of hedge. The good forms have a substantial batter outward toward the base, which allows sunshine to reach the lower branches (SUNY ESF sketch based on Donald Wyman, *Hedges, Screens & Windbreaks* [New York: Whittlesey House, 1938], 41).

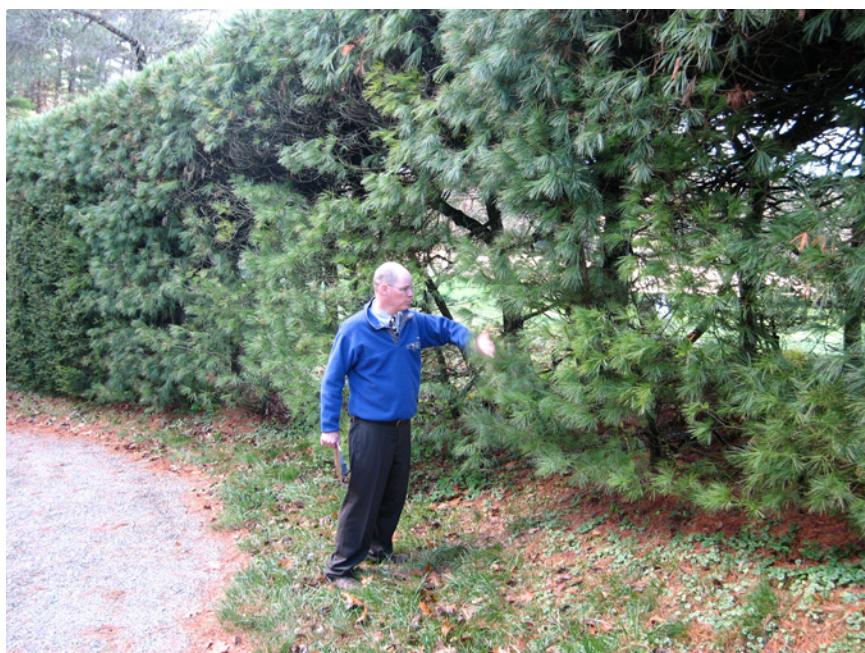
**Figure 1.1:** Example of interplanting in the horseshoe hedge, 2006. At right next to Superintendent BJ Dunn are white pine interplantings made in the late 1980s, and on the far left are older examples of hemlock infill within the original white pine hedge (SUNY ESF).

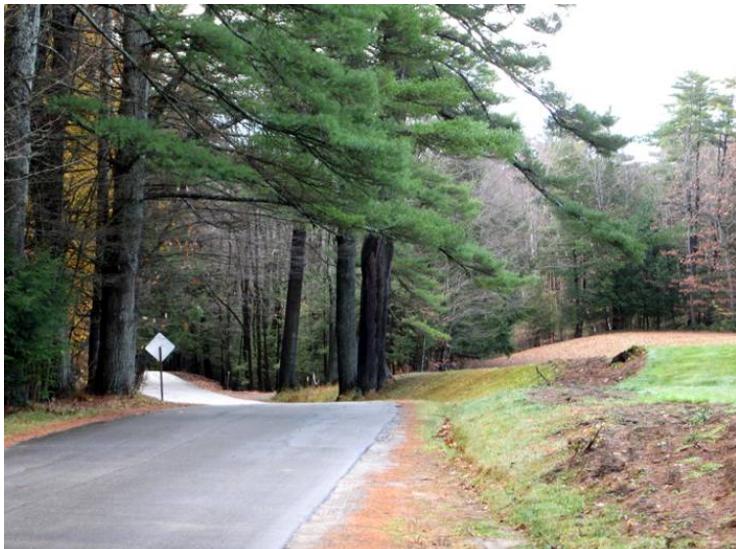
**Figure 3.2:** View looking west along Saint Gaudens Road showing site of west meadow hedge, 2006. The uphill alignment most likely dates to the c.1970 replanting. The mature white pines in the background are probably remnants of the original (c.1893-94) hedge (SUNY ESF).

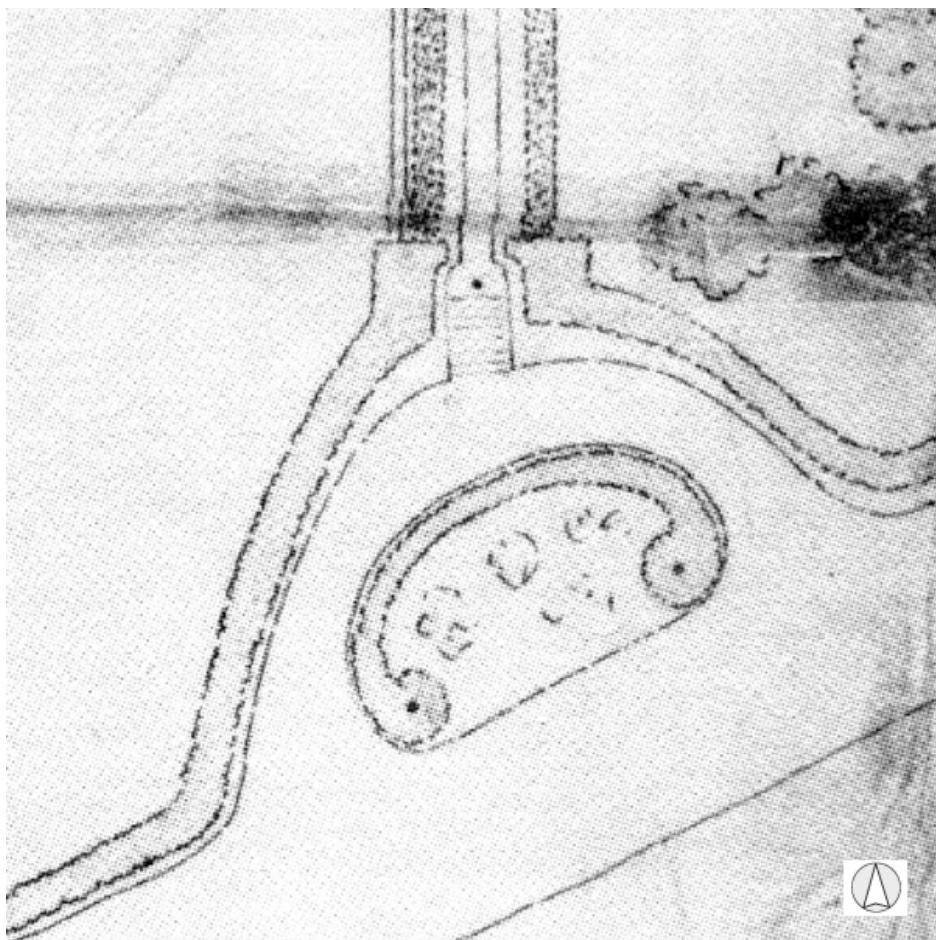
**Figure 3.4:** Detail of a 1904 plan of the grounds showing original design intent of the horseshoe hedge, showing scrolls on inner hedge and semi-rectangular termini of outer hedges at walk to Aspet. These details were apparently unintentionally lost as the hedge grew in width in later years (Saint-Gaudens National Historic Site).

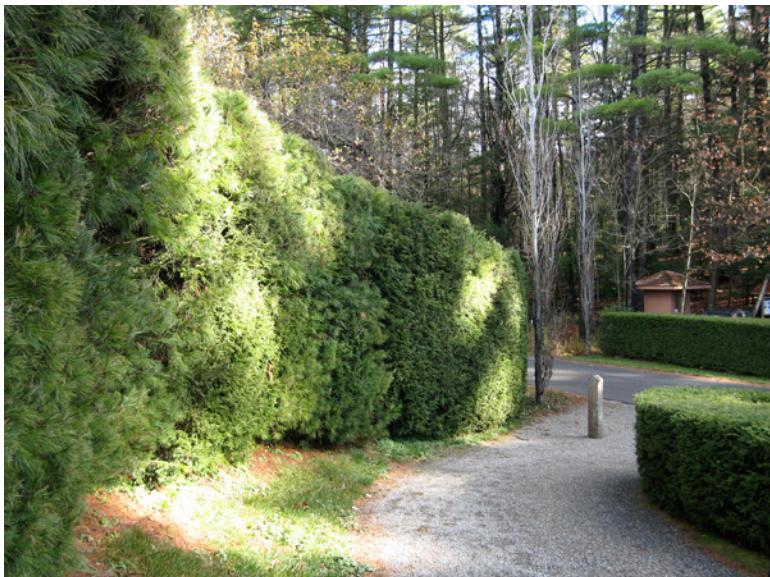
Figure 3.6: Horseshoe hedge, detail of east side of outer section (H-3) showing tapestry of white pine and hemlock, 2007 (SUNY ESF).

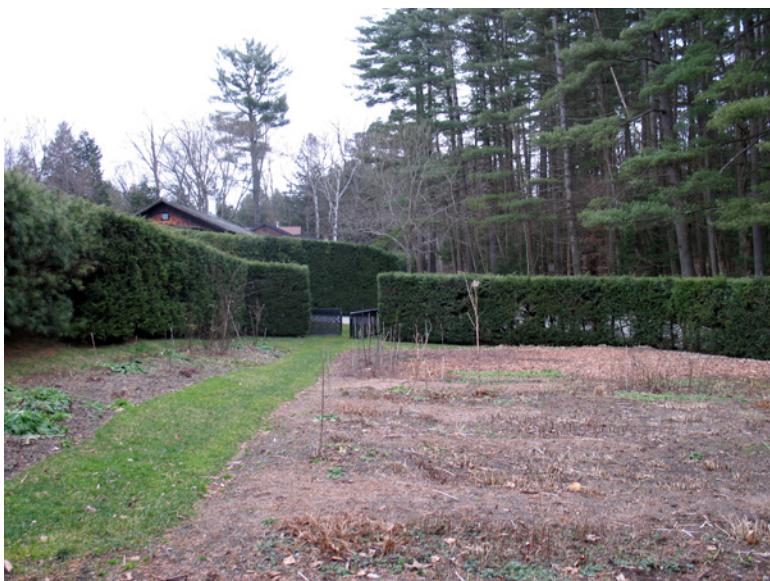
Figure 3.8: The cutting garden hedge, view looking east showing the opening at the service drive and the change from hemlock to white pine in section H-6 (left), 2006 (Olmsted Center for Landscape Preservation).

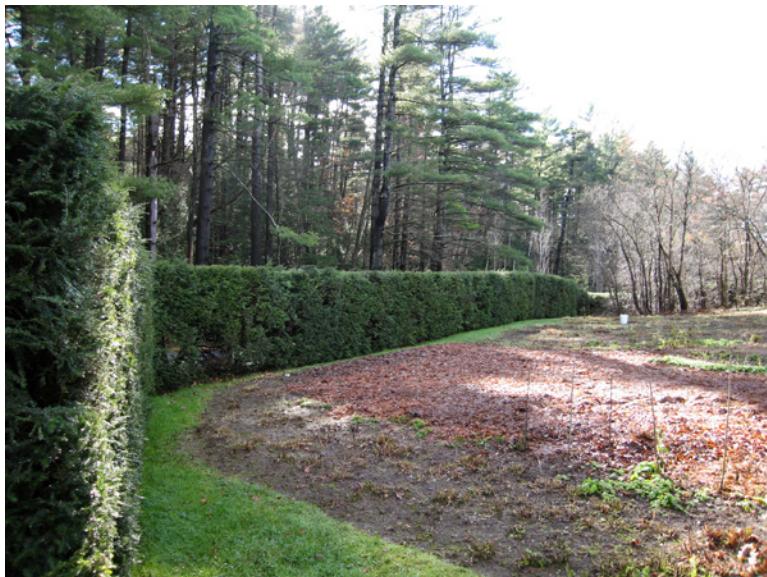
**Figure 3.9:** The cutting garden hedge, view looking west showing generally full side canopy on garden side of section H-5, with Japanese tree lilac grove in the background, 2006 (SUNY ESF).

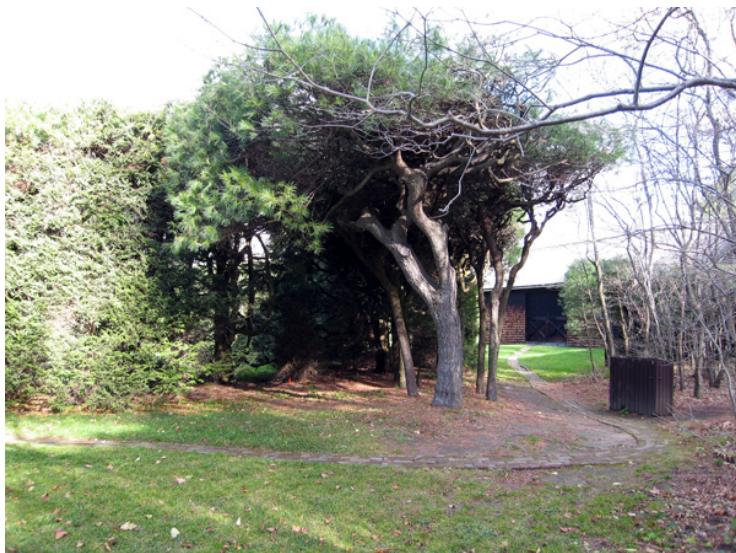
Figure 3.15: The kitchen hedge, view looking northeast at the dogleg portion of H-7, 2006 (SUNY ESF).

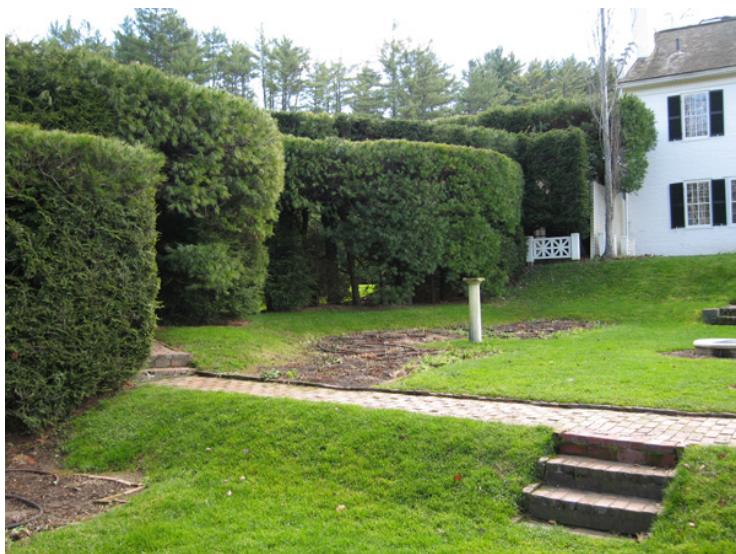
which is approximately 3 to 5 feet taller (see Figure 3.16). At the north end, this hedge is contiguous with H-14 (east side of lower terrace) and H-16 (Adams hedge). H-13 engages these hedges by extending over the brick walkway, forming an arched opening. It is approximately 3 feet taller than H-14, but is level with H-16. Section H-13 is weak where the two convex curves meet; recent hemlock interplanting here has failed in part.

Figure 3.16: The kitchen hedge, view looking southeast at section H-8 extending above the terrace garden hedge (H-13) and stepping up adjacent to Aspet on the upper terrace, 2006 (SUNY ESF).

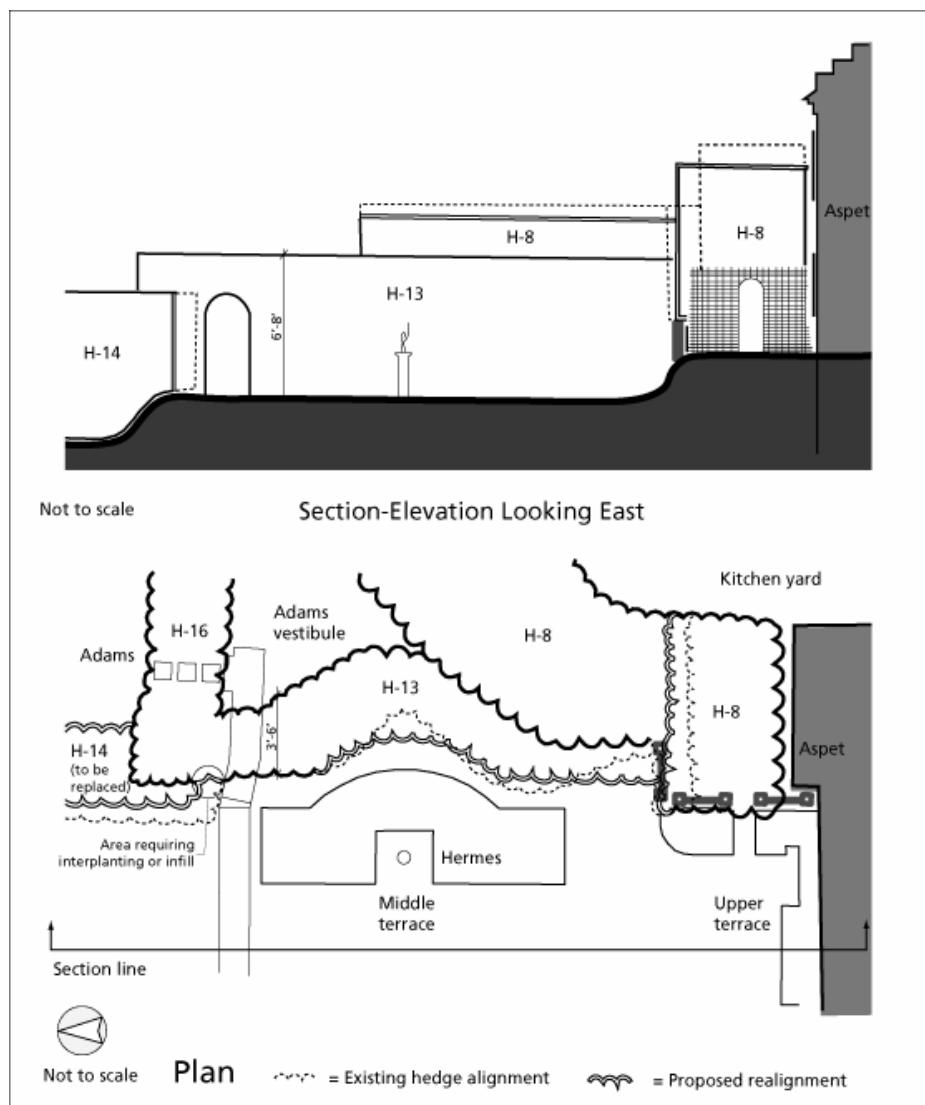
Figure 3.17: Plan and section-elevation detail of intersection of kitchen and terrace garden hedges showing proportional relationships (SUNY ESF).

flanked by straight sections (rather than the existing double convex form) that mirrors the shape of the flowerbed in front, with Hermes as the center point (see Figure 3.17). The hedge should extend to the base of the upper terrace, as it does now.

Renovation is not recommended for sections H-11 and 14 of the lower terrace garden hedge given the need for replacement in the short term. Due to the extent of overgrowth in width (approximately 2 to 6 feet), renovation is not feasible for these sections because pruning would extend into deadwood where new growth would not be possible. Section H-12 is in good condition in the projections around the curved bench and warrants renovation in the short term through interplanting on the front (south) side. Interplanting on the north side may not be successful due to the shade from the birch allee. Renovation is also warranted for section H-13 on the middle terrace to return its historic alignment and fill in weak areas of its canopy. This hedge should be renovated through interplanting of white pine and/or hemlock depending on available light to maintain it as a tapestry. The south front of the hedge should be gradually returned to its rectangular profile and concave alignment, following the outline of the adjoining flowerbed (see Figure 3.17).

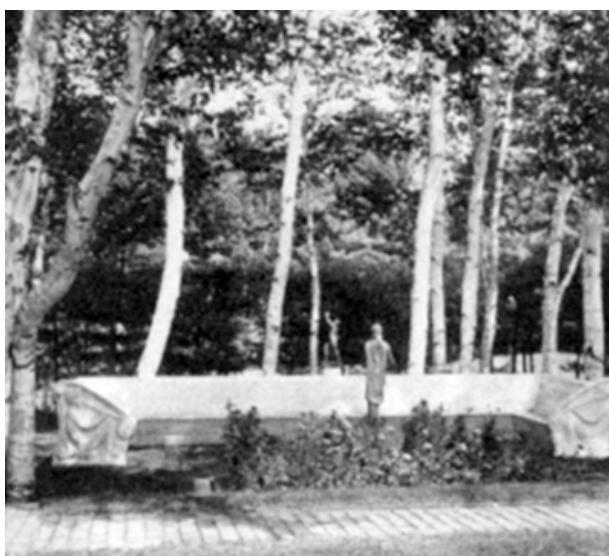
Figure 3.21: The Pan grove, view looking north showing thinning white pine hedge in background, 1924. These hedges were replaced with hemlock shortly after this photograph was taken (From *House and Garden*, June 1924, reproduced in CLR volume 1, page 99).

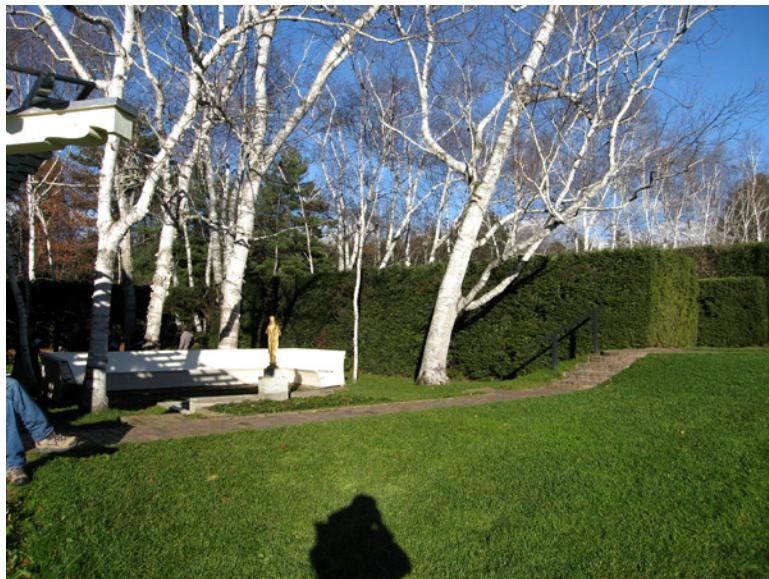
The Pan grove hedge consists of two hedge sections (H-10, H-11) of pure hemlock that together with the Little Studio enclose a garden room that is open to the south (Figure 3.22, Drawing 1). It is clipped in a rectangular profile. Most of the hedge is heavily shaded by the mature birch in the Pan grove and by the non-historic birch allee extension to the rear (north). The hedge is planted in a single row with variable spacing of between 2 and 5 feet.

Section H-11, on the east side of the Pan grove, is 7 to 10 feet tall (the shorter section due to rise in grade at the south end) and 13 feet wide, and aligns in height with sections H-11 and H-12. It is full on the Pan grove side because it receives ample light through the high understory of the birch trees (see Figure 3.22). It is overgrown to the south, where it extends over the brick walk, as well as on the east side in the terrace garden.

Figure 3.22: The Pan grove hedge, view looking northeast at section H-11 that forms the divide with the terrace garden, 2006 (SUNY ESF).

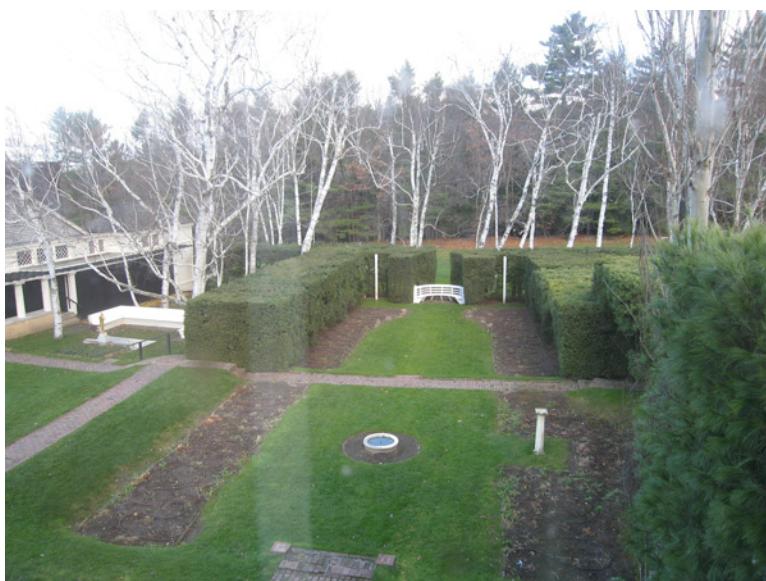
Section H-11, framing the west side of the lower terrace, is pure hemlock planted in c.1930, measuring 7 to 10 feet tall (the shorter section due to rise in grade at the south end) and 13 feet wide, with a single row and 1 to 4 feet between plants (Figure 3.27). The hedge aligns in height with adjoining sections H-10 and H-12. It is overgrown in width, extending over the adjoining flowerbed and brick walk to the south. The hedge is full on top but weak on the terrace garden side.

Figure 3.27: Overview of the terrace garden hedge on the lower terrace looking north form the second floor of Aspet, 2006. Note the Pan grove hedge to the left and Adams hedge to the right (SUNY ESF).

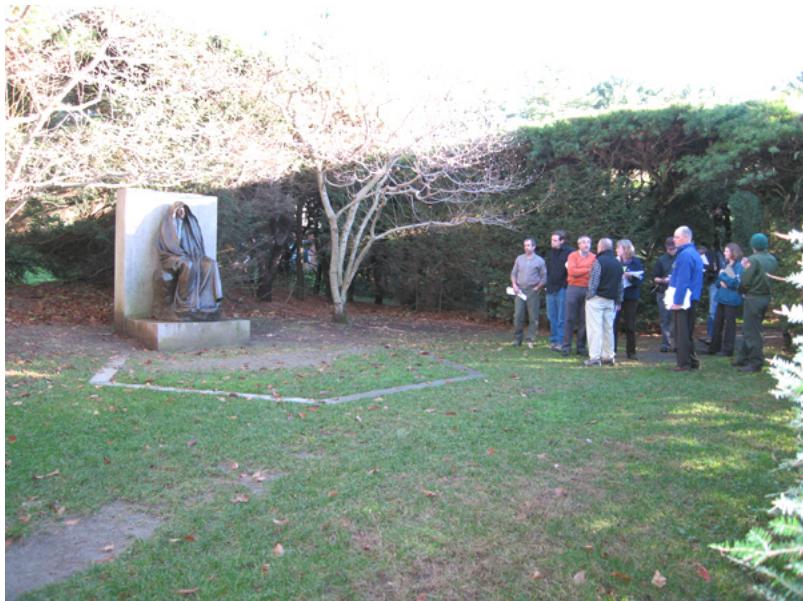
**Figure 3.32:** The Adams hedge, view looking southeast at sections H-16 and 17, 2006 (SUNY ESF).

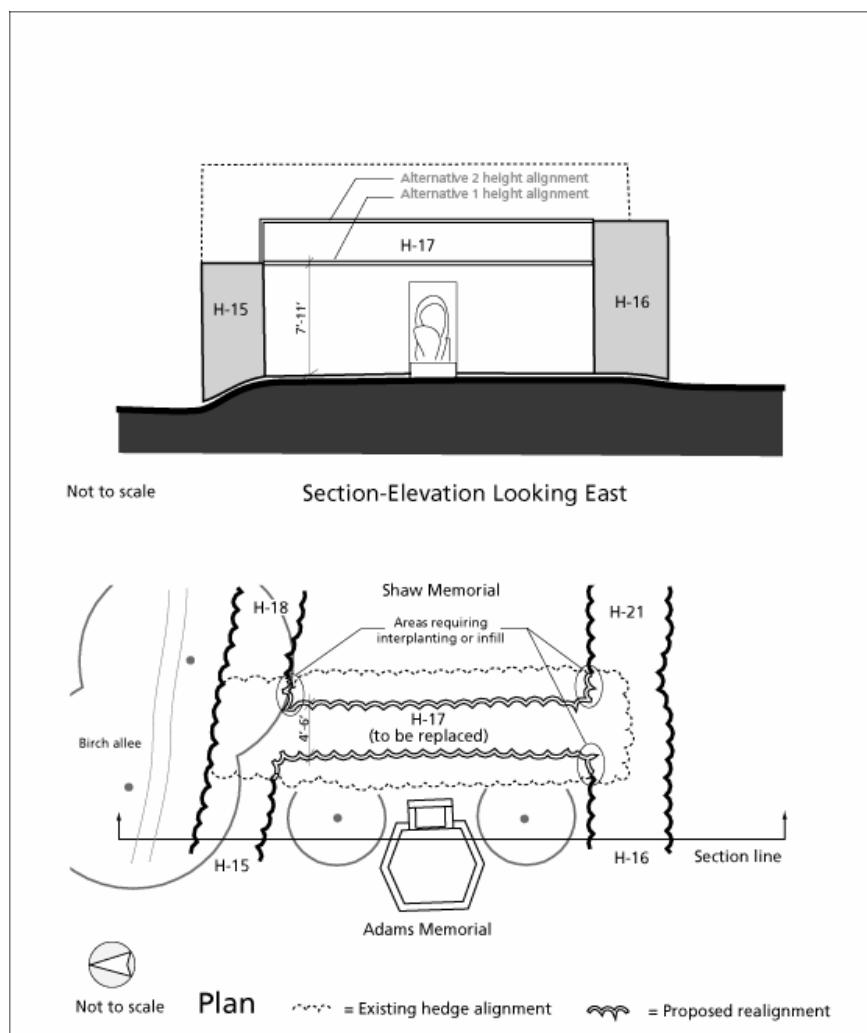
Figure 3.33: Plan and section-elevation detail of H-17 and adjoining sections in the Adams and Shaw hedges showing proportional relationships (SUNY ESF).

extensions should be removed and the hedge kept to the interior face of the adjoining hedges (see Figure 3.33).

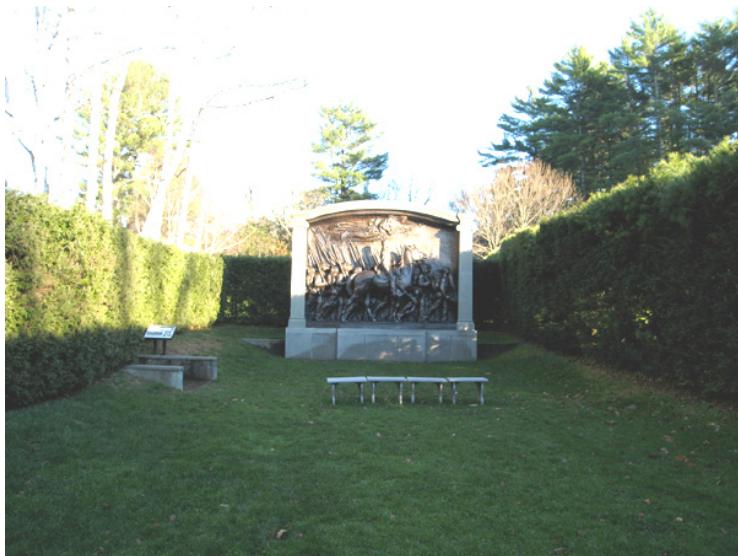
**Figure 3.36:** The Shaw hedge, view looking east showing H-18 and 19 to the left and background, and H-21 to the right, 2006 (SUNY ESF).

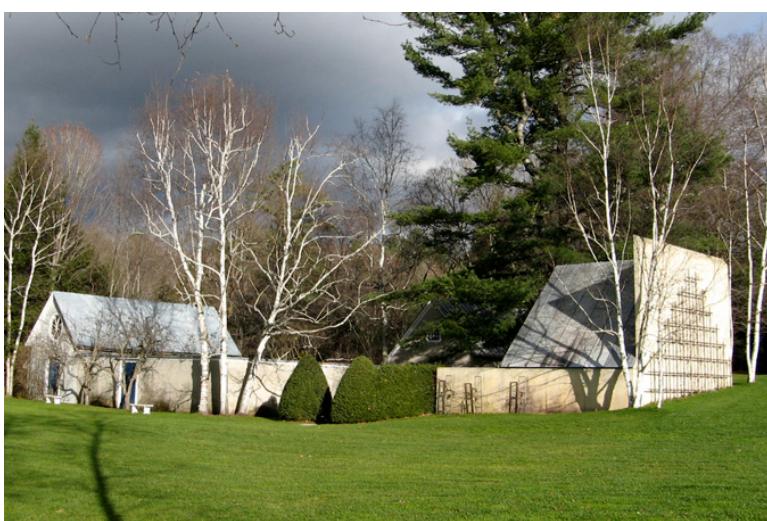
Figure 3.40: The galleries entrance hedge, view looking northeast with Farragut pavilion at right, 2006. Note height of linear section compared with cones. (SUNY ESF).

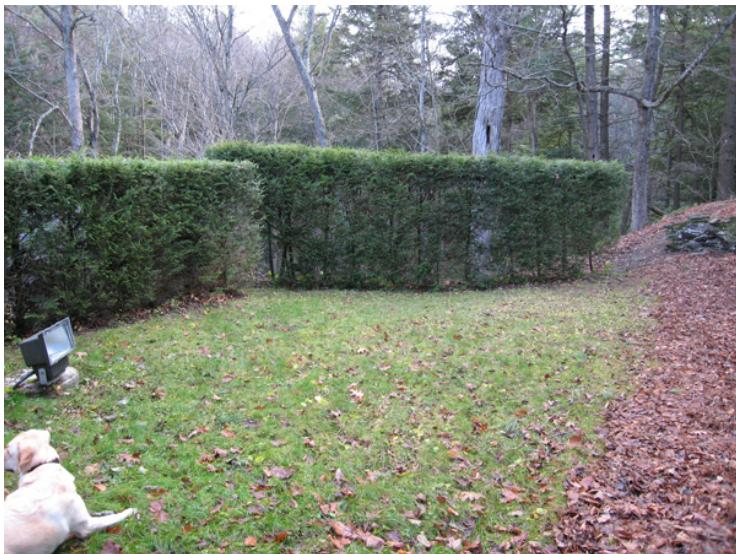
The Lincoln bust hedge is comprised of two adjoining sections of hemlock hedge (H\_24, 25) clipped in a rectangular profile (Figure 3.43, Drawing 1). The hedge is situated in a triangular space between the buildings and mature woods that extend across the steep bank that leads to Blow-Me-Down Brook. Section H-24 is 'U'-shaped and frames the narrow 20 foot-long walk leading from the Atrium to the Lincoln bust. Replaced in c.1998, it is 5 feet tall (matching the height of the sculpture pedestal) and 2 feet wide, with a single row and 2 feet spacing between plants. It has a full but thin canopy facing the walk. The north and east (exterior) sides, which are not visible to the public, are mostly bare. These sides of the hedge apparently died off due to shade created by overgrowth of successional trees, vines, and shrubs (grape, honeysuckle, and walnut), which are now cut back from the hedge. Section H-25 frames the east side of the adjoining room to the south, between the Atrium and the Picture Gallery (Figure 3.44). It is 6 feet tall and 4 feet wide, with a single row and 2 foot-spacing between plants. It has a full but thin canopy except on the north side, which is not visible to the public. This side may have died back from competing vegetation, or from shade.

**Figure 3.44:** The Lincoln bust hedge, view looking east at sections H-25 and 26, 2006. The site of the south leg of H-26 removed in 2006 is the bed at right (SUNY ESF).

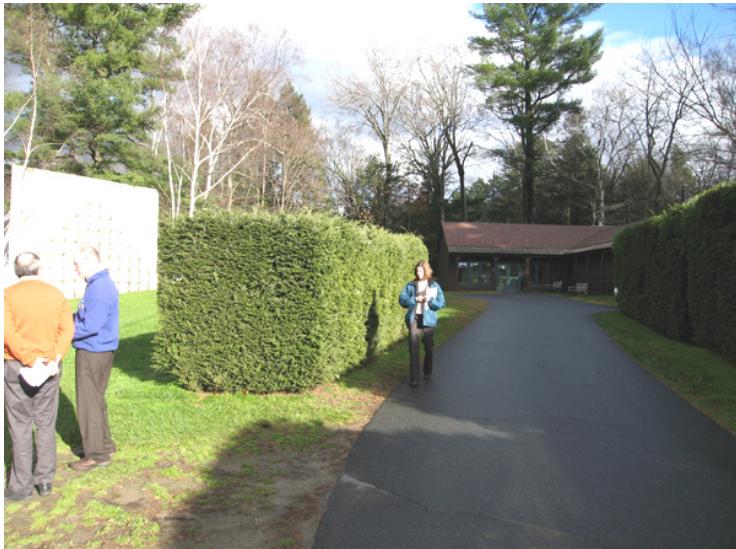
plants (Figure 3.45). It is in excellent condition, with a compact, full canopy. The hedge screens views from the visitor center (former maintenance building) to the north and west.

**Figure 3.45:** The visitor center hedge, view looking east with visitor center in the right background and Farragut pavilion to the left, 2006 (SUNY ESF).

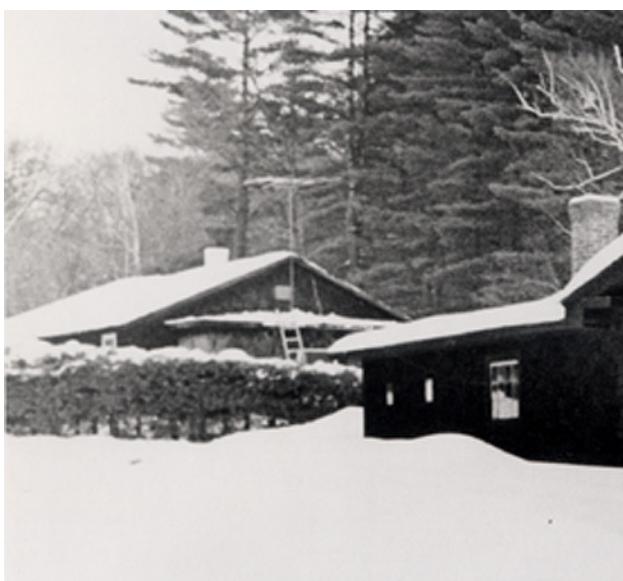
By the mid-1960s, the older section of the hedge extending along the service drive was being maintained at about the height of the eaves of the Caretaker's Cottage (Figure 3.46). In later years, this section grew upwards of 12 feet, concealing all but the upper gable of the cottage when looking from the exterior of the hedge. In c.1980, the section along the road (all or part of H-28) was replanted in hemlock.<sup>82</sup> This section did not develop strongly most likely due to shade from the woods across the road. In c.2000, a small section of the hedge near the curve along the service drive was replaced due to snow damage.

**Figure 3.46:** The Caretaker's Cottage hedge, view looking east from the stable showing height after the historic period, c.1970. Note that the hedge was lower than the eaves of the cottage (Saint-Gaudens National Historic Site, photograph 20).

- Lower Caretaker's Cottage hedge (H-27) to height below eaves of cottage
- Lower Galleries entrance hedge and extend missing part (H-22, 23)
- Lower height of kitchen hedge and address bare understory of dogleg (H-7, 8)

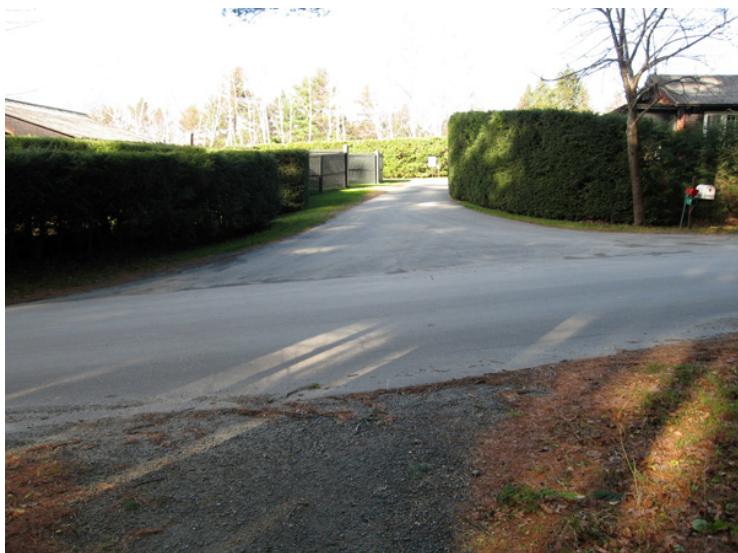
Section H-27, forming the north and west sides of the hedge extending around the curve at the corner of the service drive and Saint Gaudens Road, is mixed white pine and hemlock planted between c.1917 and 1927 with later infill (Figures. 3.47, 3.48). It is 10-12 feet tall and 10 feet wide, planted in a single row with 1 to 3 feet spacing between plants. It is taller than the companion cutting garden hedge on the opposite side of the service drive (see Figure 3.48). The section has three openings: one at the entrance walk to the Caretaker's Cottage, a second to the north of the cottage that is closed by a gate, and a third non-historic narrow arched opening near the east end of the hedge. It has a dense canopy that is mostly full but has some bare spots between the hemlock and white pine. The southeast end of the section, adjoining H-28, was replanted in hemlock in c.2000 as a result of damage from snow.

Figure 3.48: The Caretaker's Cottage hedge, view looking north up the service drive, 2006. Note difference in height compared to cutting garden hedge to left of drive (SUNY ESF).

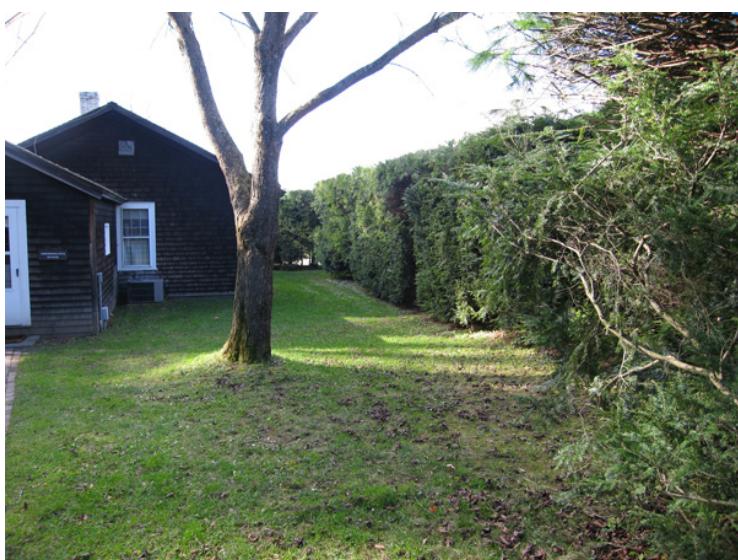
Figure 3.49: The Caretaker's Cottage hedge, view looking west of interior of H-27 showing relationship to scale of cottage, 2006 (SUNY ESF).

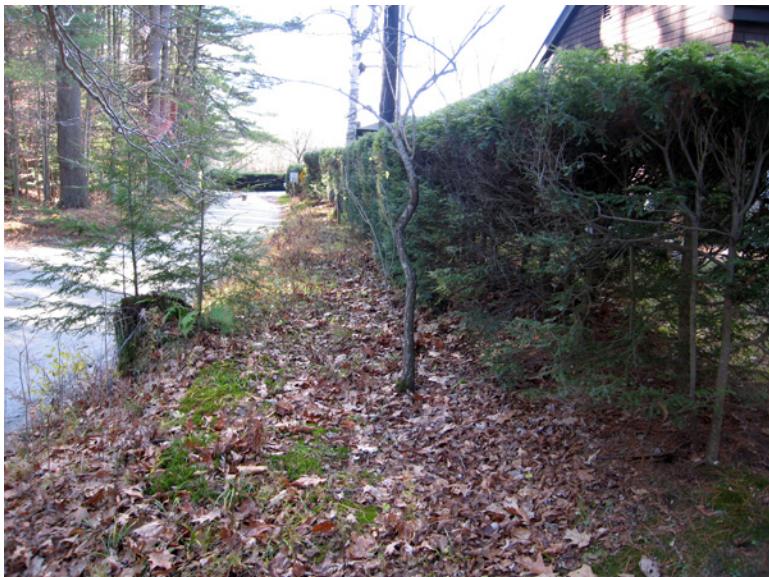
Section H-28, extending along Saint Gaudens Road, is pure hemlock replanted in c.1980 (Figure 3.50). It ranges from 8 feet tall at section H-27 to 5 feet tall to the rear of the garage and visitor center, and averages 4 feet wide. The hedge is full facing the Caretaker's Cottage yard, but is weak on the remainder of the hedge, with gaps and bare areas. The hedge is heavily shaded from the woods south of the road as well as several adjoining trees on the north side, and is situated at the top of a steep bank that is eroding.

**Figure 3.50:** The Caretaker's Cottage hedge, view looking west from the east end of the hedge along Saint Gaudens Road, 2006 (SUNY ESF).

- Replace roadside hedges when the woods south of Saint Gaudens Road are cleared back to increase light levels (H-2, 3, 5, 28)
