THE FARM BUILDINGS at SAGAMORE HILL

Sagamore Hill National Historic Site
Oyster Bay, New York

HISTORIC STRUCTURES REPORT

James J. Lee III
Architectural Conservator

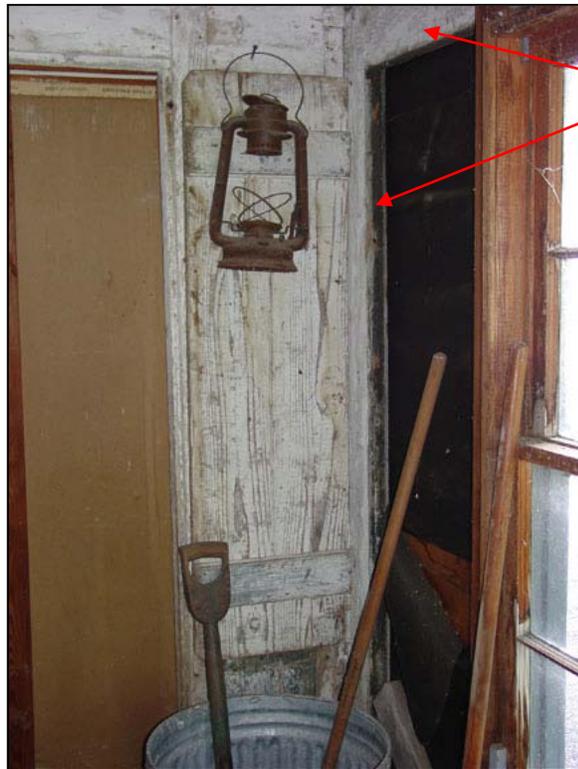
Evidence of earlier opening:
2" by 6" header
2" by 6" stud

Figure 64. Chicken House: Room 102, looking southeast. Note framing of south wall, 2007.

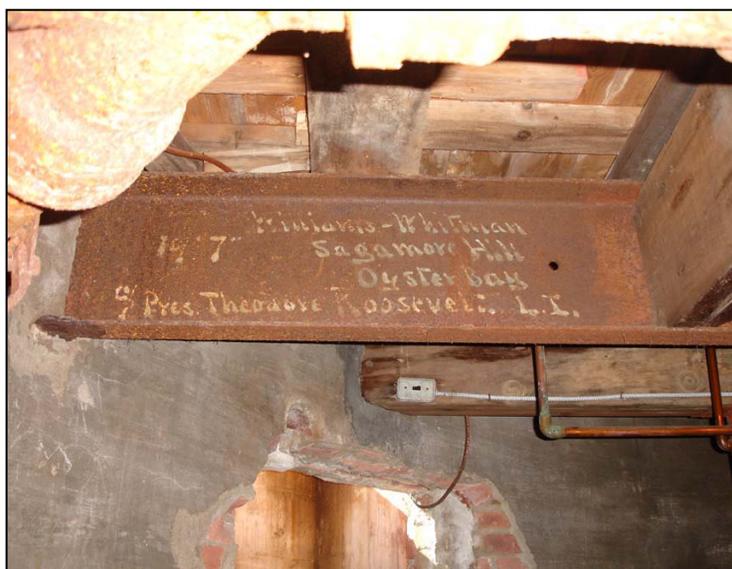
The documentation examined for this report suggested that there were no other significant changes to the Ice House during the Roosevelt period. Historic photographs of the building appeared to confirm this. However, it appears that some large steel beams supporting the floor of the Ice House were added by Williams, Whitman, plumbers for the site during Theodore Roosevelt’s residency. The beams are extant and could be seen from inside the cistern. There was one center 12 inch I-beam spanning the Ice House from east – west, and there was a half I-beam (or E-shaped beam) installed about three feet to either side of the center beam. Writing on one of the beams showed that it was delivered to “Williams – Whitman, Sagamore Hill, Oyster Bay, LI” in care of “Pres. Theodore Roosevelt.” The beam was also dated and, although one of the numbers was faint, it appeared to read “1917”, indicating the date of installation (fig. 72). When the beams were installed sections of the floor may have been replaced, but this could not be determined from the physical evidence on site.

Figure 72. Steel beam in the basement/cistern of the Ice House, inscribed with the address and date, 2007.

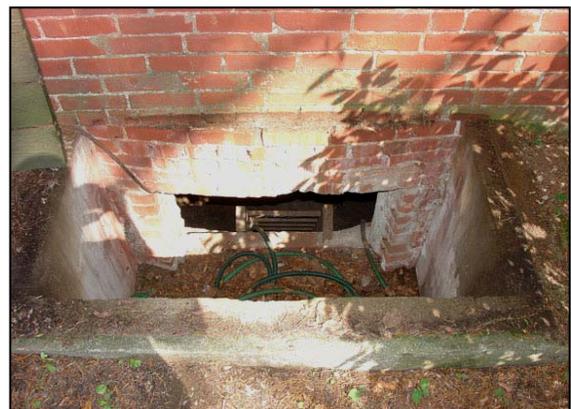
The only opening at the foundation level is a window opening on the southeast side of the building (fig 76). The window frame and sash were removed during alterations to the building.

Figure 76. Ice House: Window well on southeast elevation, 2007.

described. The window is currently open to the cistern and the window well is protected by a wooden cover constructed with pressure-treated lumber.

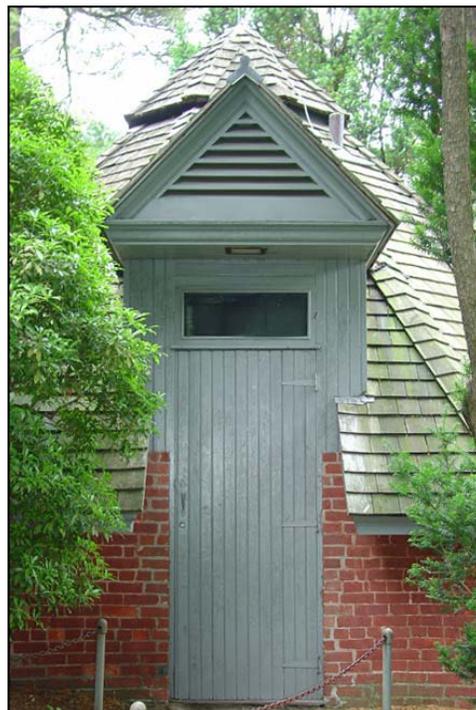
The south entry doorway was installed by the TRA when the Ice House was converted to restrooms in 1951 (fig. 78). The entry is similar to the north entry doorway but there are some differences. The opening in the brick wall for the south entry doorway is 2 feet 11½ inches wide, which is about a foot narrower than the north side. Above the main roof line the entry doorway is wider, measuring 4 feet 9 inches wide. Examination of the masonry around the opening indicates that both have been altered, further indicating that this was a later alteration.

Certain elements common to both entries indicate that those materials were installed by the TRA during the initial renovation or during later repairs. The façade of the south entry doorway is clad with tongue-and-groove vertical boards and the sidewalls of the dormer are sided with wood shingles. The door and transom window elements of the south entry are similar to those of the north entry. Examination of paint samples from similar elements on both the north and south entry doorways determined that they had comparable paint layering and were installed at the same time. With the exception of the sidewall shingles, which were a later repair, these elements were installed during the TRA restroom renovations.

Figure 78. Ice House: South Entry Doorway, 2007.

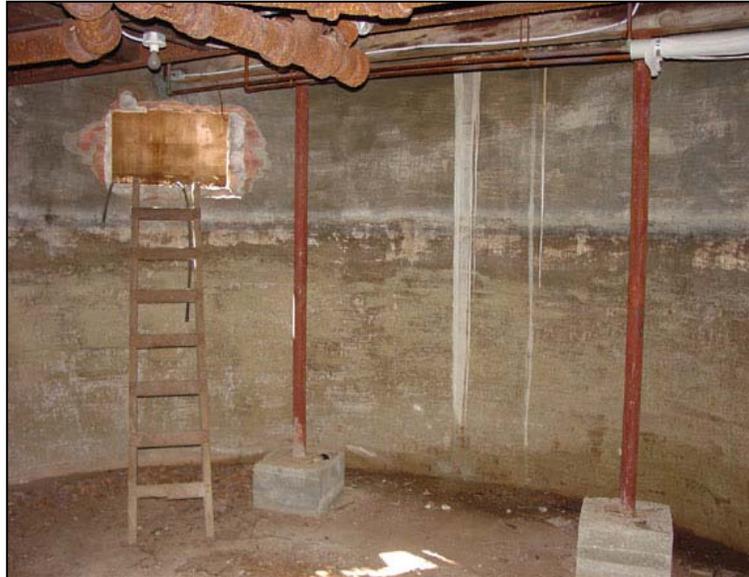
Figure 79. Ice House: Cistern, looking southeast toward window opening, 2007.

The cistern forms the basement of the Ice House (fig. 79). The floor and walls of the cistern are lined with concrete. The floor is solid concrete with no visible drains. Four concrete piers rest on the floor of the cistern and support lally columns that were added either by the TRA or NPS for additional floor support.

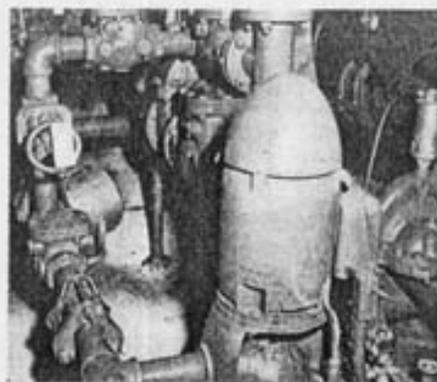
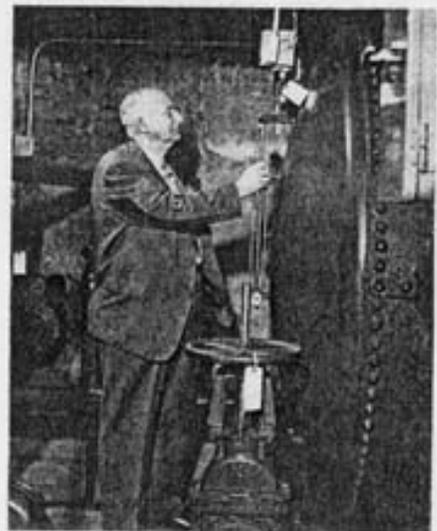
Interior of Pump House

Above: Deep well pump is in center foreground with fire pump and water pressure tank to the right. Below: Pressure tank is at right and fire pump at left. Flow switch on fire main at rear left with mercurial pressure switch at top of tank. Both are used for automatic operation of fire pump.

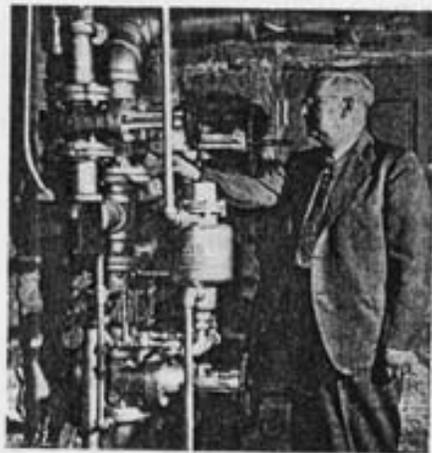
Control and Alarm Equipment in Basement of Dwelling

Automatic sprinkler and standpipe and hose systems are included. Water for both systems passes through the sprinkler alarm valve.

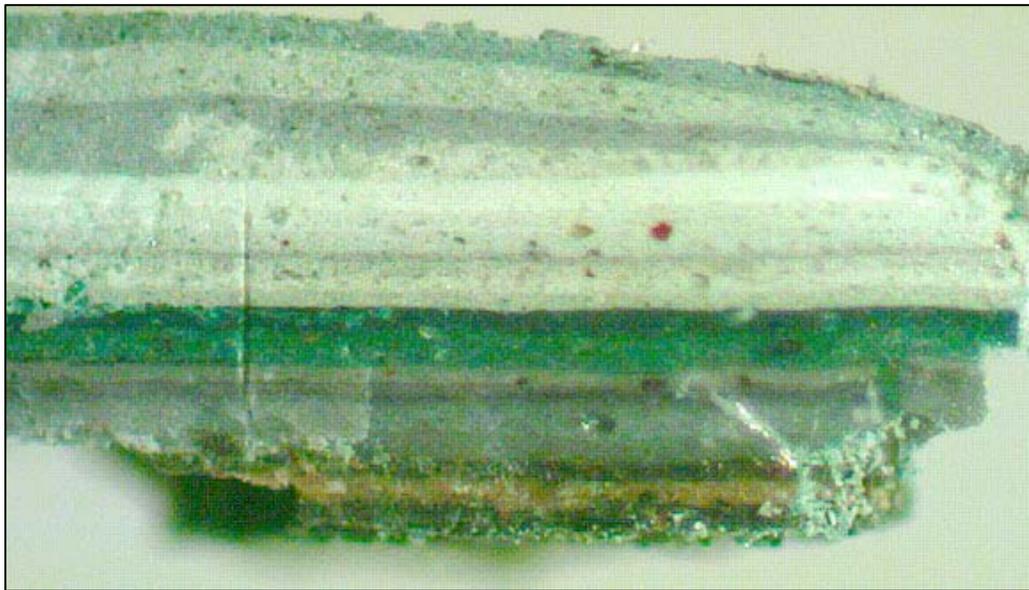
The earliest paint colors found on the Gardener's Shed helped establish the period of construction of the building and set it apart from other farm buildings. Analysis of the paint samples determined that the earliest paint colors applied to the Gardener's Shed were similar to paint colors found on the Main house at Sagamore Hill.² The first of these was a dark green paint layer, which was found on both the original siding and the original trim. Though there was no documentation of when this paint was applied, a similar dark green paint was present on both the Ice House and the Main house (see "Ice House Exterior Paint Analysis"). The presence of a similar paint color on these three buildings suggested that the Gardener's Shed was constructed in circa 1885, which coincided with the construction of the other two buildings. The paint evidence suggested that all three buildings were painted at the same time, presumably soon after construction. The dark green paint and the Victorian era elements of the Gardener's Shed were important in establishing the buildings date and differentiating it from the other farm buildings. The dark green paint color has been matched to Munsell Color Notation System 5G 2/1.

The analysis of the paint samples from the Gardener's Shed suggested that the first application of gray, above the green paint layer, would be representative of the paint color present during Theodore Roosevelt's life time. The gray paint color has been matched to Munsell Color Notation System 5PB 5/1. It should be noted that this gray color is similar to the gray paint used on the wood shingles of the Main house but that the trim of the Main

Figure 99. Gardener’s Shed paint sample from vertical board siding (P004).

The current paint analysis determined that the exterior of the Gardener's Shed was finished with a gray paint color during the Roosevelt period. It is recommended that the rehabilitation of the exterior elements of the Gardener's Shed should include the application of the exterior gray paint color that is specified in Table II.

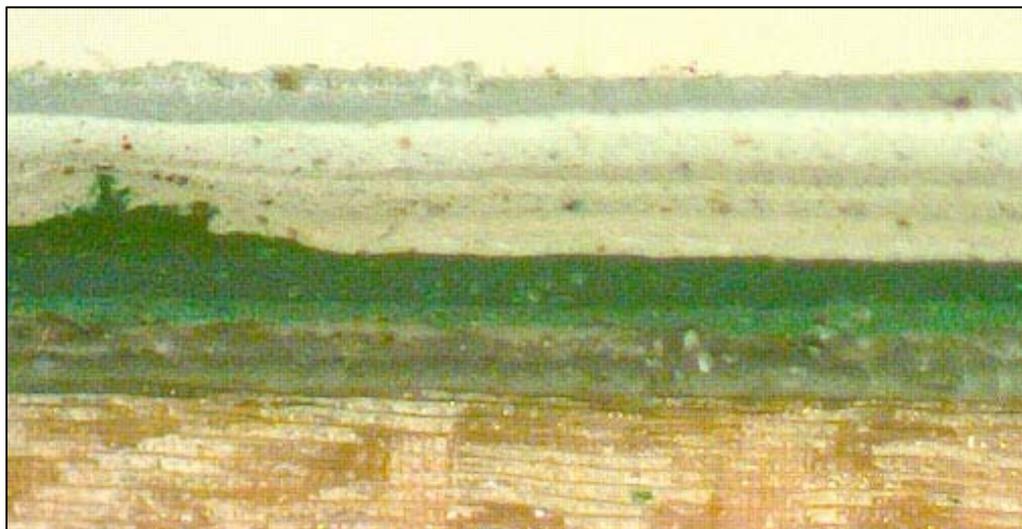
The first layer of paint found on many of the representative samples was an off-white color. Certain paint samples had two or more layers of off-white paint. The paint evidence indicated that the off-white color was not a primer layer but was the first finish of the Farm Shed. Given the paint stratigraphy above the first layer, it appeared that the off-white paint color was present on the building from the time of construction in circa 1900 to circa 1907.

The paint layer above the off-white was a blue-gray color and appeared to be applied during an extensive painting project that unified the exterior colors of the farm buildings. As previously described, the blue-gray paint layer appeared to date from the circa 1907 painting campaign at Sagamore Hill. The blue-gray color was similar to the exterior paint color found on all the farm buildings, as well as the wood shingles of the Main house. Examination of paint samples from the trim elements of the Farm Shed indicated that they were also finished with the same blue-gray paint color. The paint evidence further indicated that all the farm buildings were painted the same exterior color from the circa 1907 paint application to the present.

Figure 100. Farm Shed paint sample from horizontal drop siding (P011).

The current paint analysis determined that the exterior of the Farm Shed was finished with a gray paint color during the Roosevelt period. It is recommended that the rehabilitation of the exterior elements of the Farm Shed should include the application of the exterior gray paint color that is specified in Table IV.

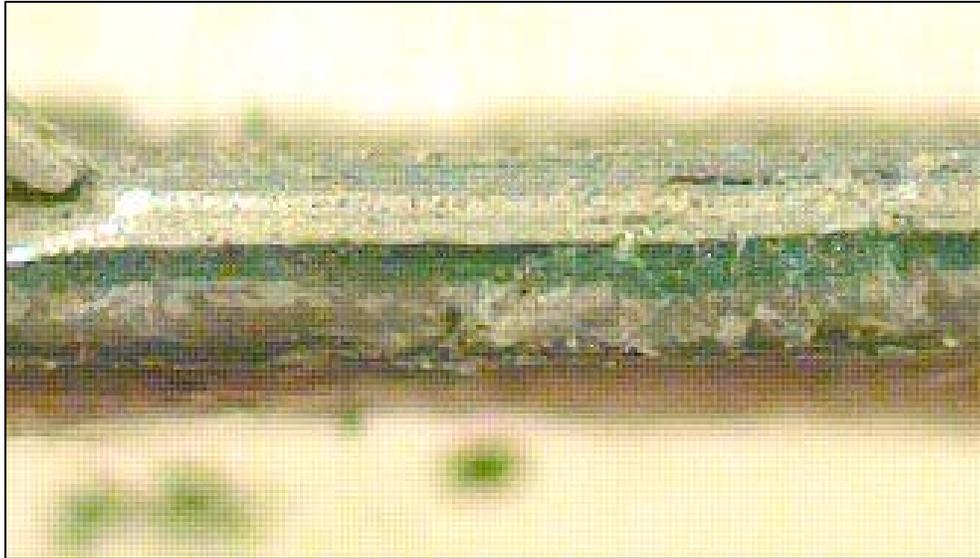
Figure 101. Chicken House horizontal drop siding (P014).

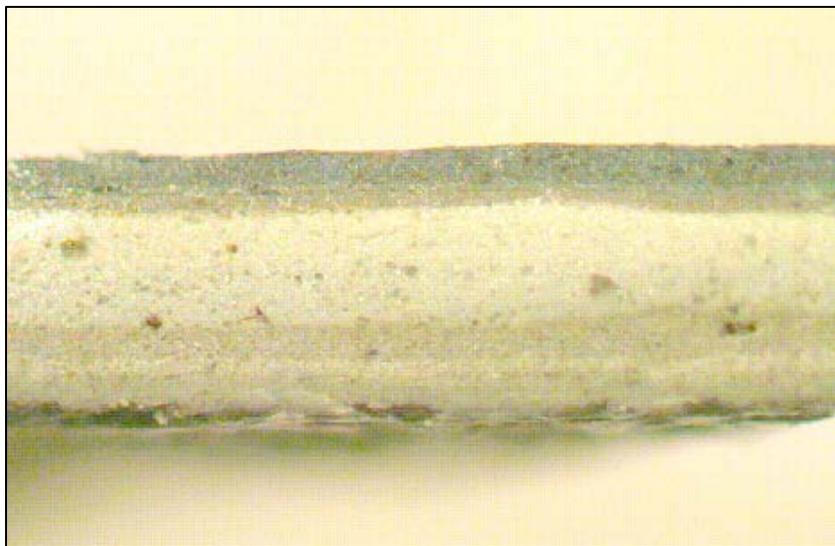
Figure 102. Chicken House replacement horizontal drop siding (P007).

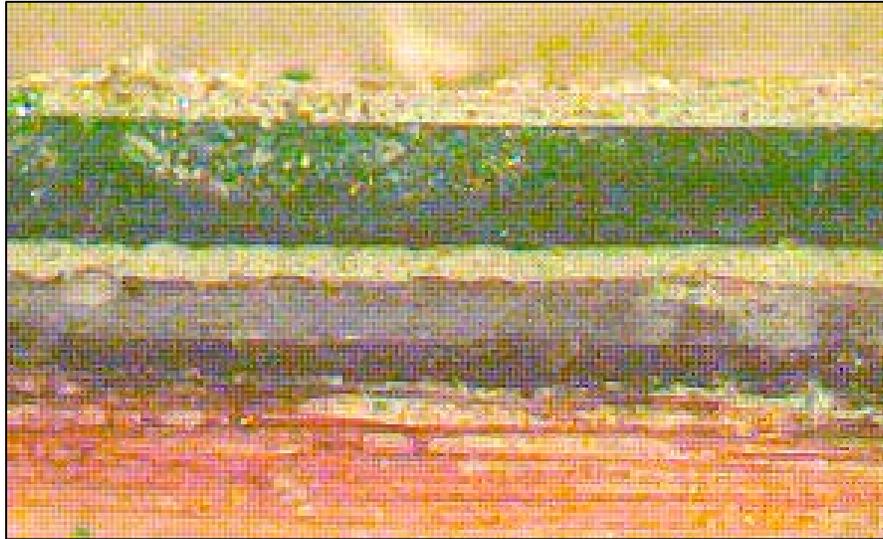
Figure 103. Ice House north entry doorway portico, pediment molding (P001).

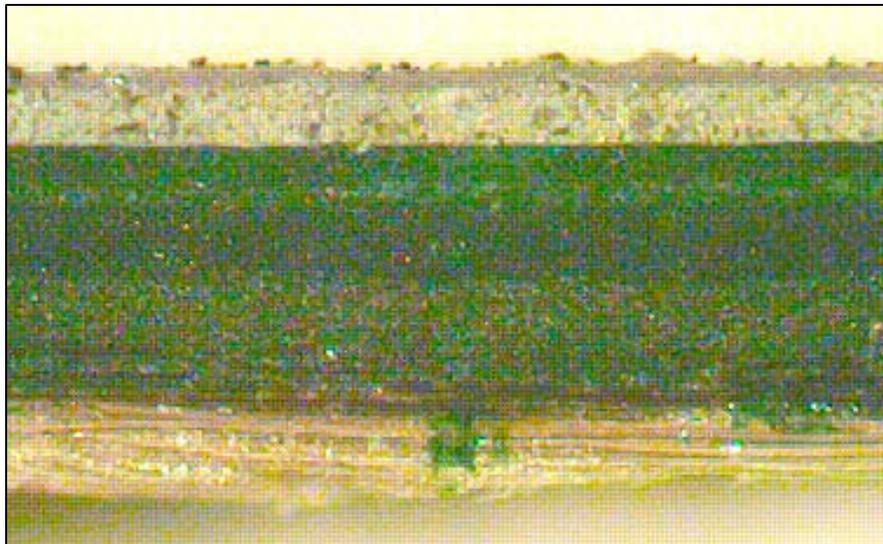
Figure 104. Ice House south entry doorway portico, pediment molding (P013).

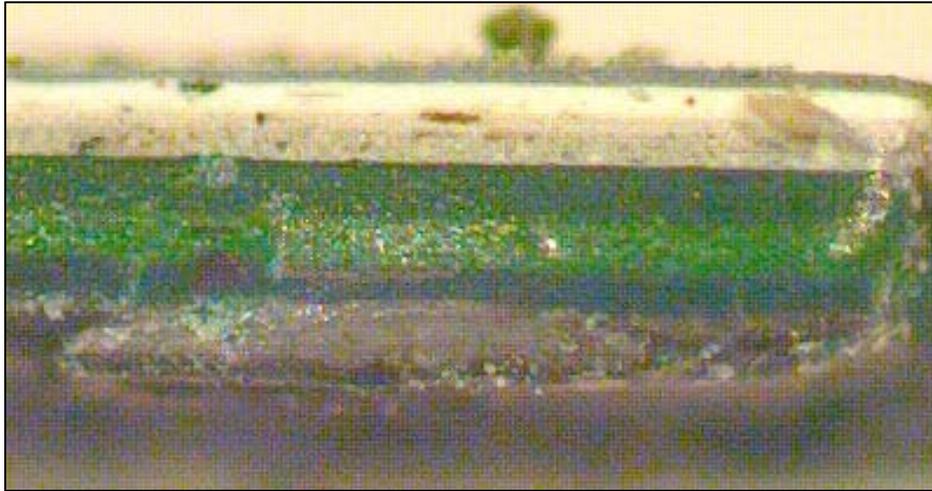
Figure 105. Pump House south gable-end rake (P001).

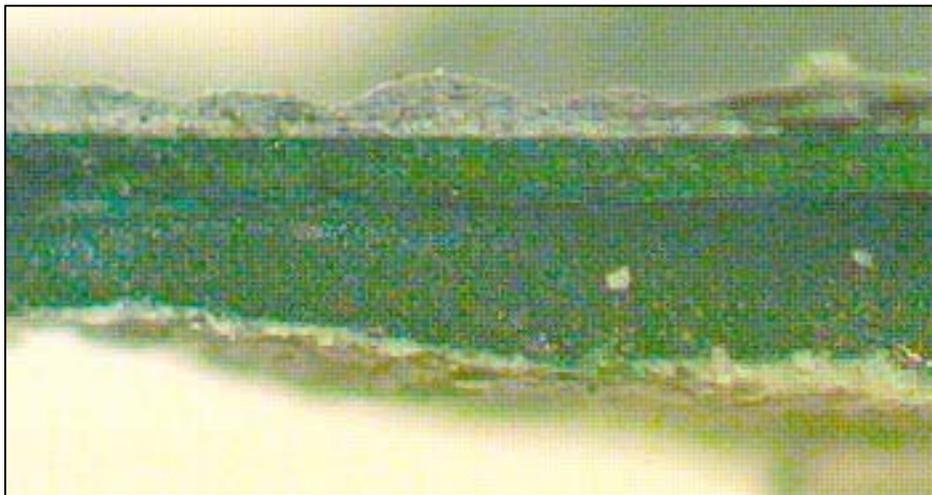
Figure 106. Hose Reel House at north end of Pump House,
north gable-end rake (P004).
