**A STUDY OF THE PROBABLE ORIGINAL LAYOUTS,
USES, AND INTERIOR APPEARANCE OF THE
OFFICERS' QUARTERS (HS-11)
AT AMERICAN CAMP**

San Juan Island National Historical Park

Prepared by: Kingston Heath, Fred Walters and Aaron Lemchen
Historic Preservation Program
School of Architecture and Allied Arts
University of Oregon

FINAL REPORT: AUGUST 15 , 2005

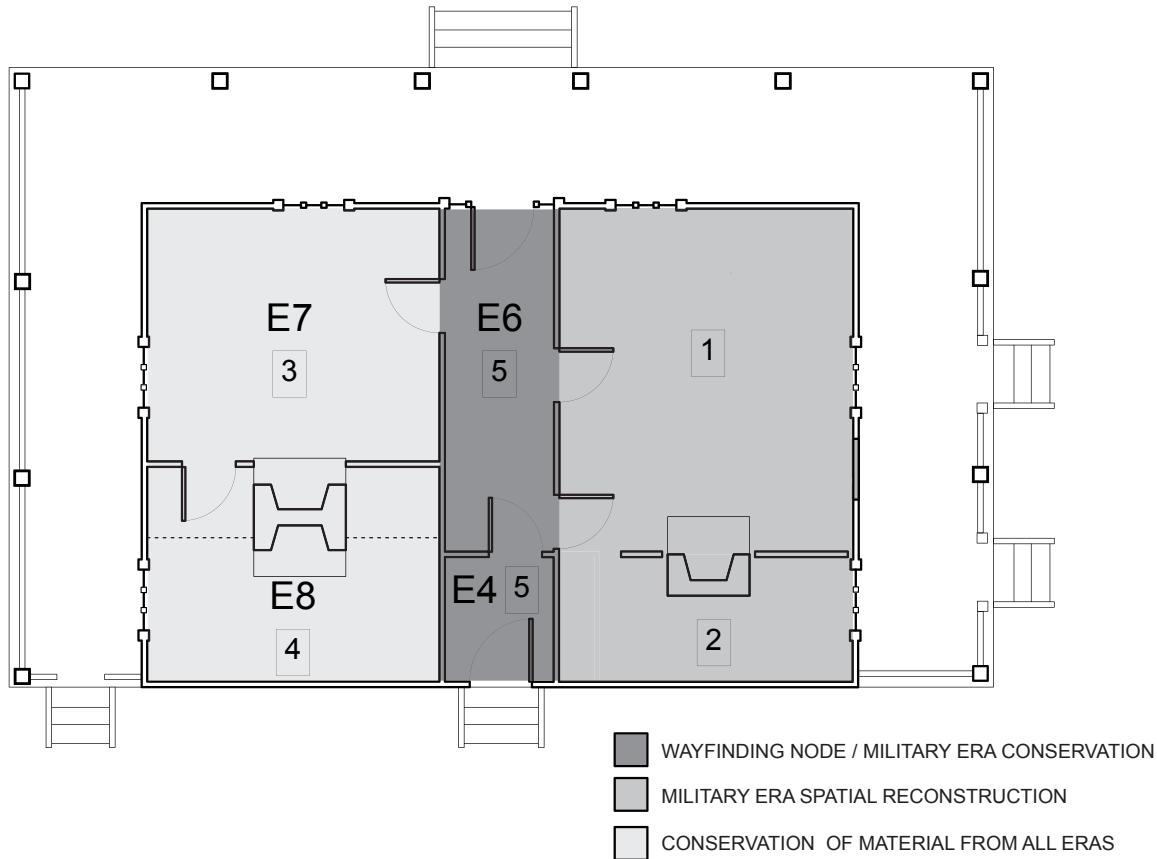
Fig. VII-2. Diagram of proposed hybrid interpretation plan with aspects of a study house (conservation) and the restoration of Room 1 and 2 spatially to their military era configuration. Note the restoration of the wall between Rooms 2 and 5 (E6). Interpretive scheme drawing by A. Lemchen, 2005.

This approach could take advantage of the inherent conceptual symmetry of the building with its central hall. The east side of the building would be carefully restored to a spatial configuration reflecting its status during the Military era and the west side rooms would be left, more or less in their current condition under a study house type of treatment. Figure VII-2 shows a conceptual diagram related to the proposed interpretation of the building. The rooms to the east of the central hall would be restored in a manner that recalls their spatial configuration to the best of our knowledge during the Military era. Any new walls would clearly be of modern construction. The current wall between Rooms 1 and 2 would be removed along with the Beaver Board and batten finish in Room 2 and replaced by a wall in alignment with the location evidence in the floor, walls and ceiling.

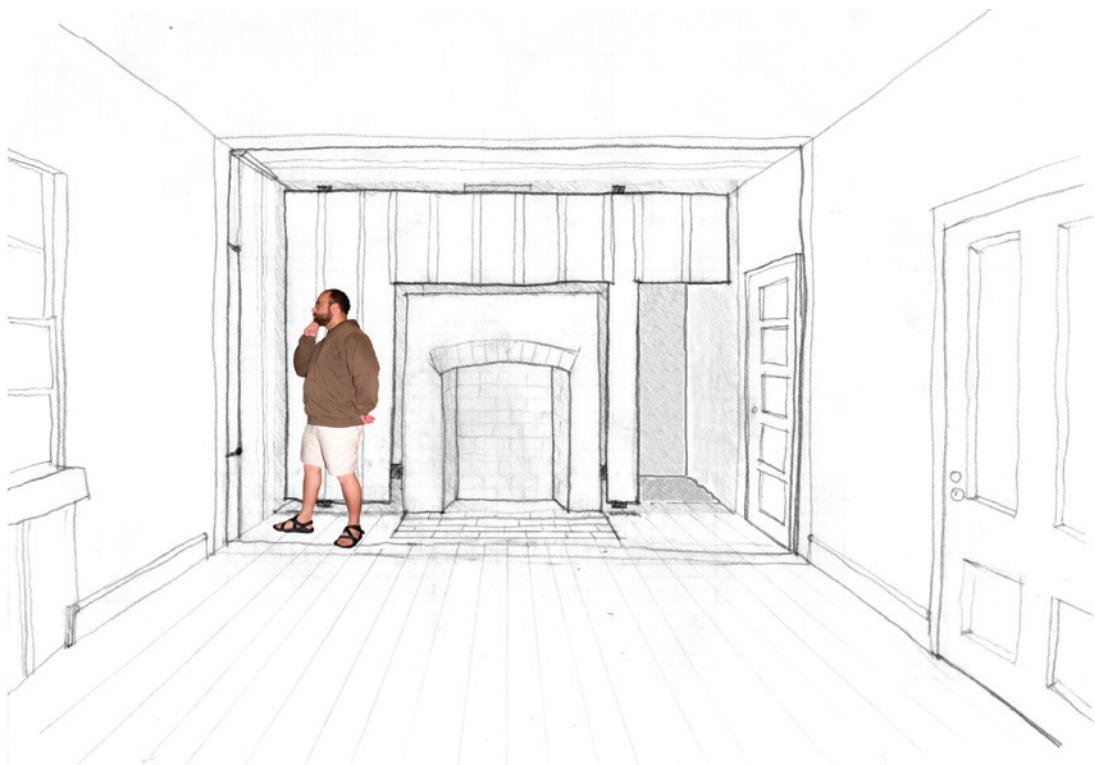
Fig. VII-3. Perspective drawing showing the interior of the proposed spatially-restored Room 1 looking south. Looking through the doorway to the right of the hearth, the intrusion of the walls from the twentieth century restroom can be seen. Beaver Board is depicted as partially removed in the current Room 2 (E5).

the same structural load bearing capacity as the previous wall. (3) The construction of extant walls, the application of finishes, and their relationship with other wall, floor and ceiling surfaces should be carefully documented as it is disassembled or demolished. The proposed reconstructed wall would leave voids where there may not be enough current evidence to show the exact design of various details including molding. The wall facing would not contact any of the planar surfaces adjacent to it including the ceiling, walls or floor. Instead, the wall plane would be several inches short of contacting these planes. The wall facing would be of the same dimension lumber in a vertical orientation as those found in the wall between Rooms 3 and 4: Figure V-9. This plane of lumber would be covered by battens at the joints and be supported by a steel framework that discretely contacts the floor, ceiling and hearth on both sides to transfer both vertical and lateral loads to the foundation. The structural system would be demountable should future developments demand alterations, and it would clearly be identified as a twenty-first century intervention: Figure VII-3.

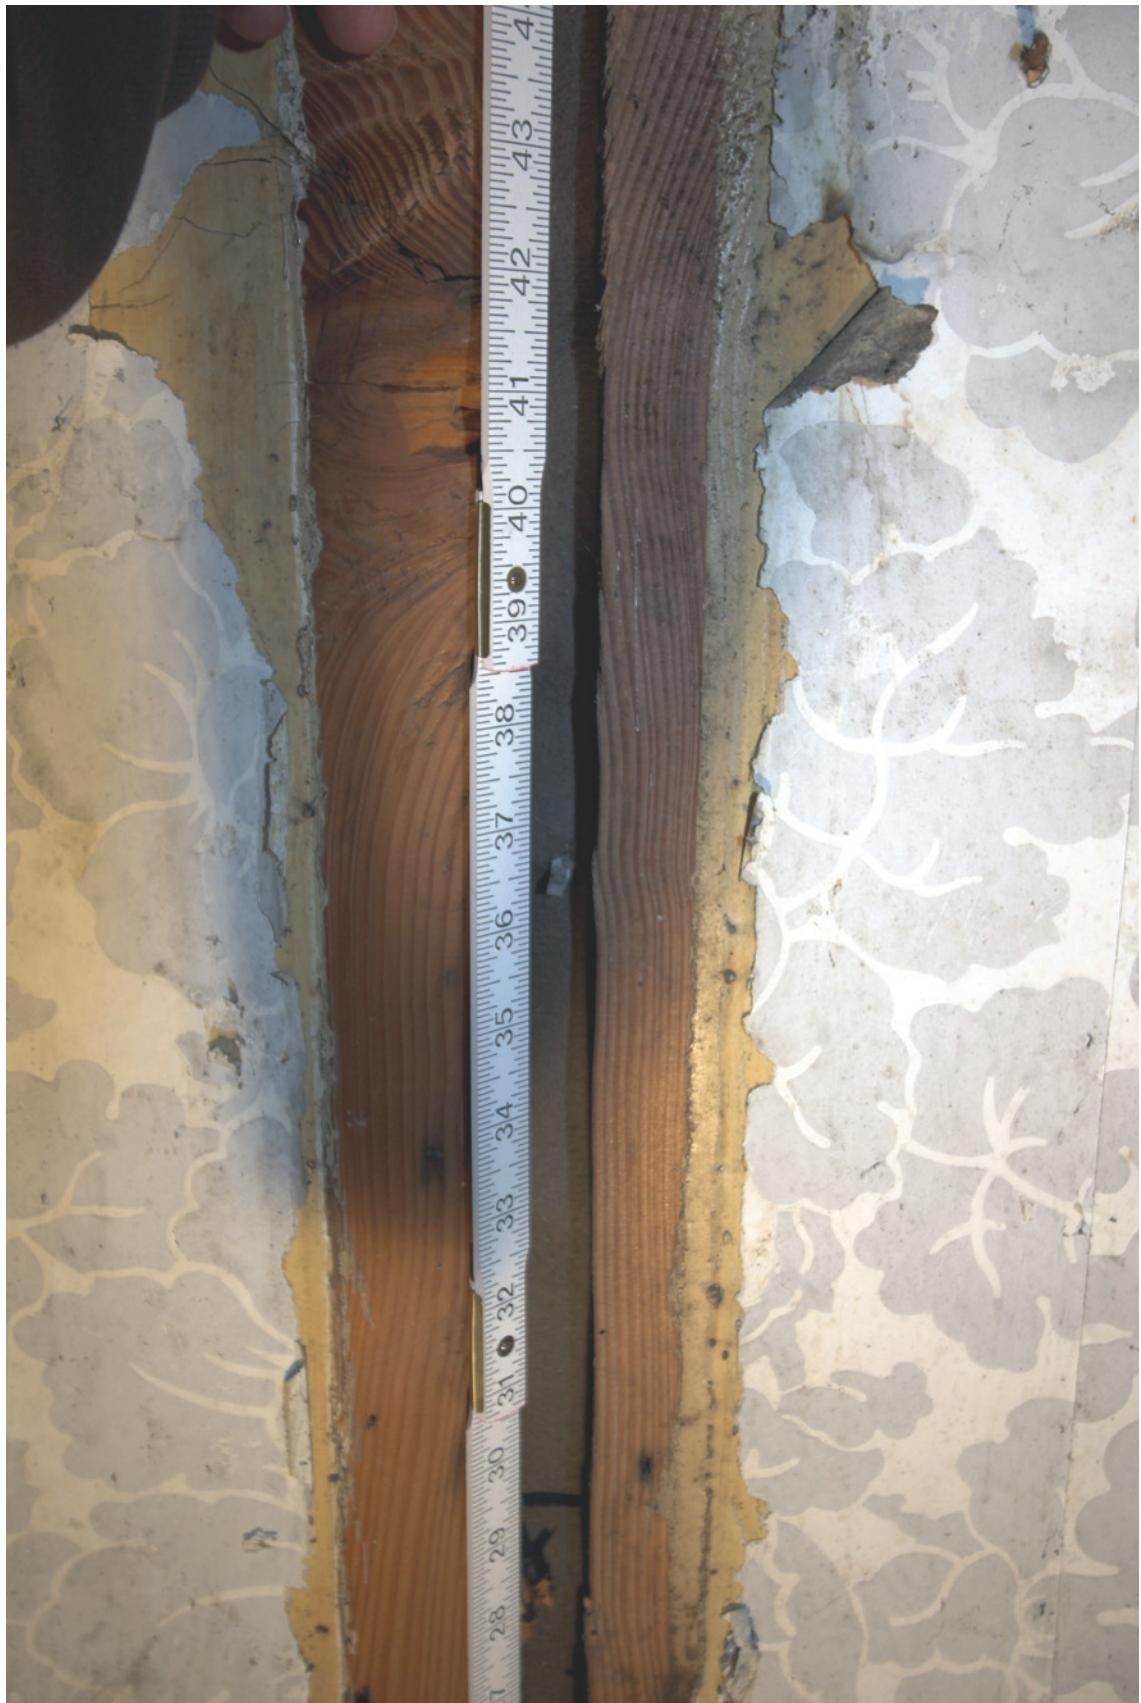
APPENDIX II-3

Right. Photo of remnant wallpaper on the South Wall of Room 2 (E5).

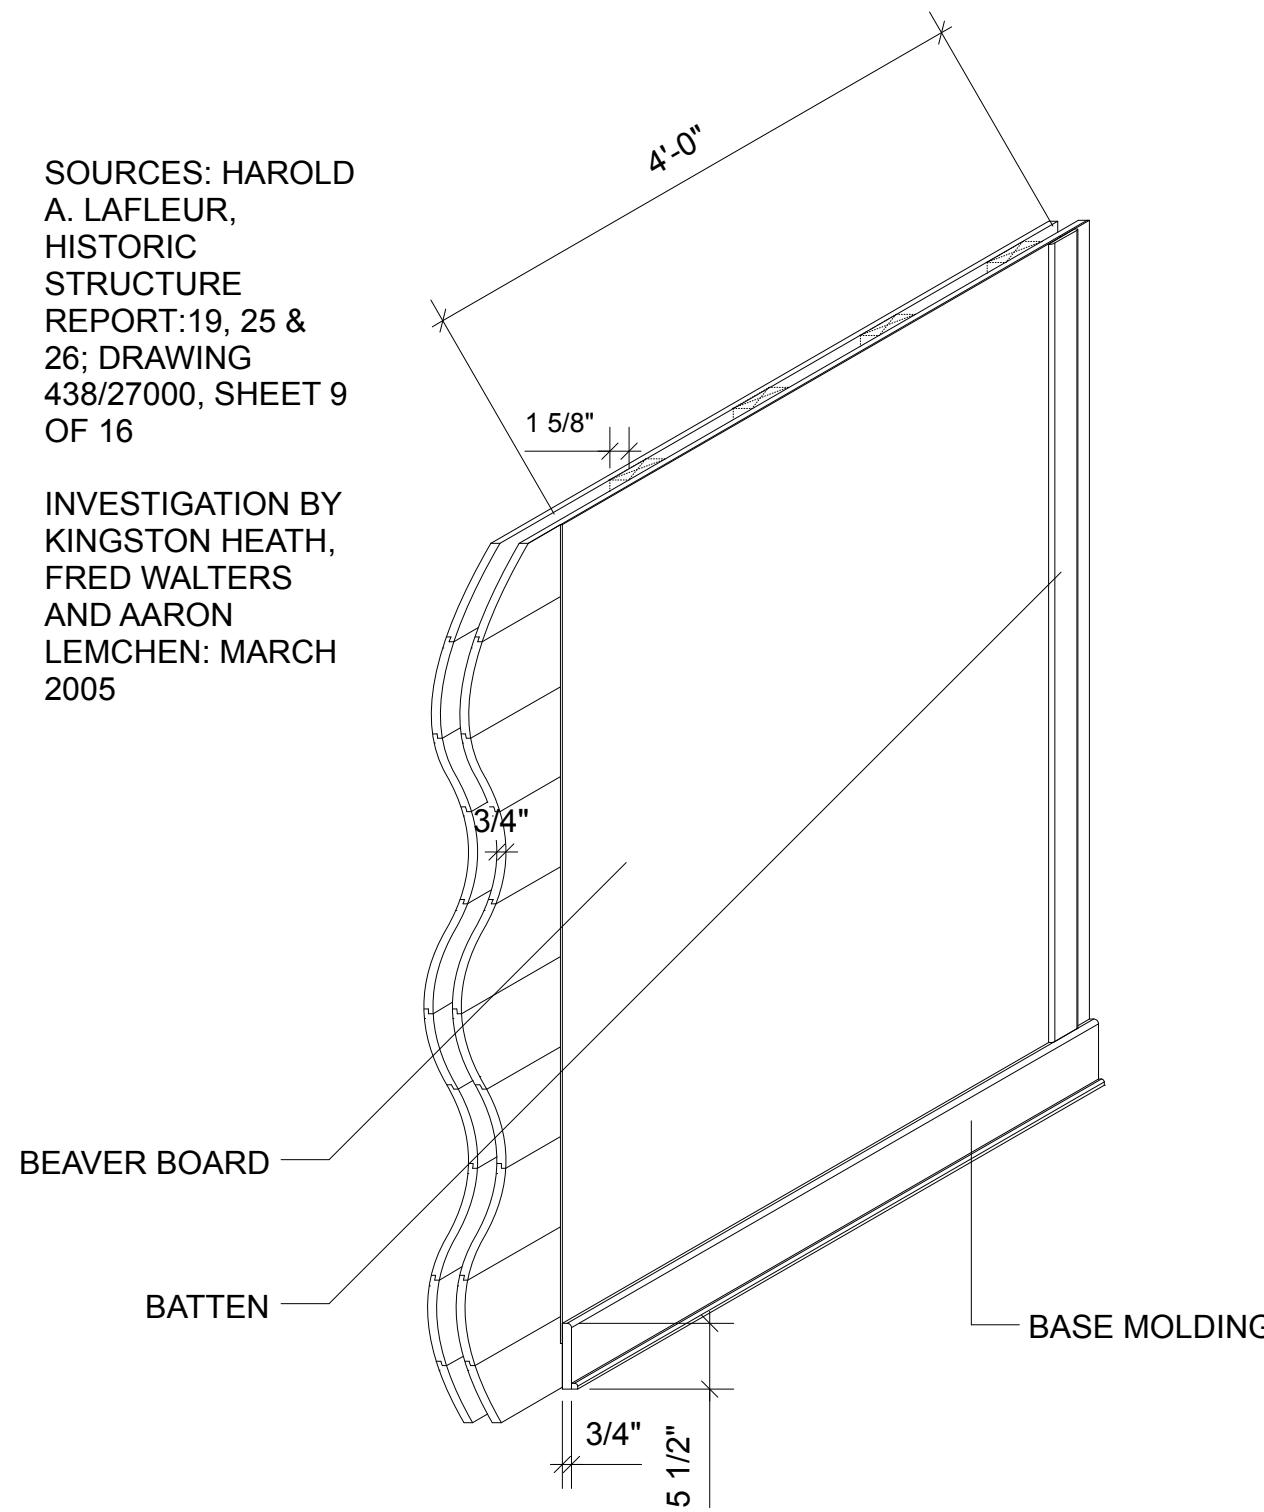
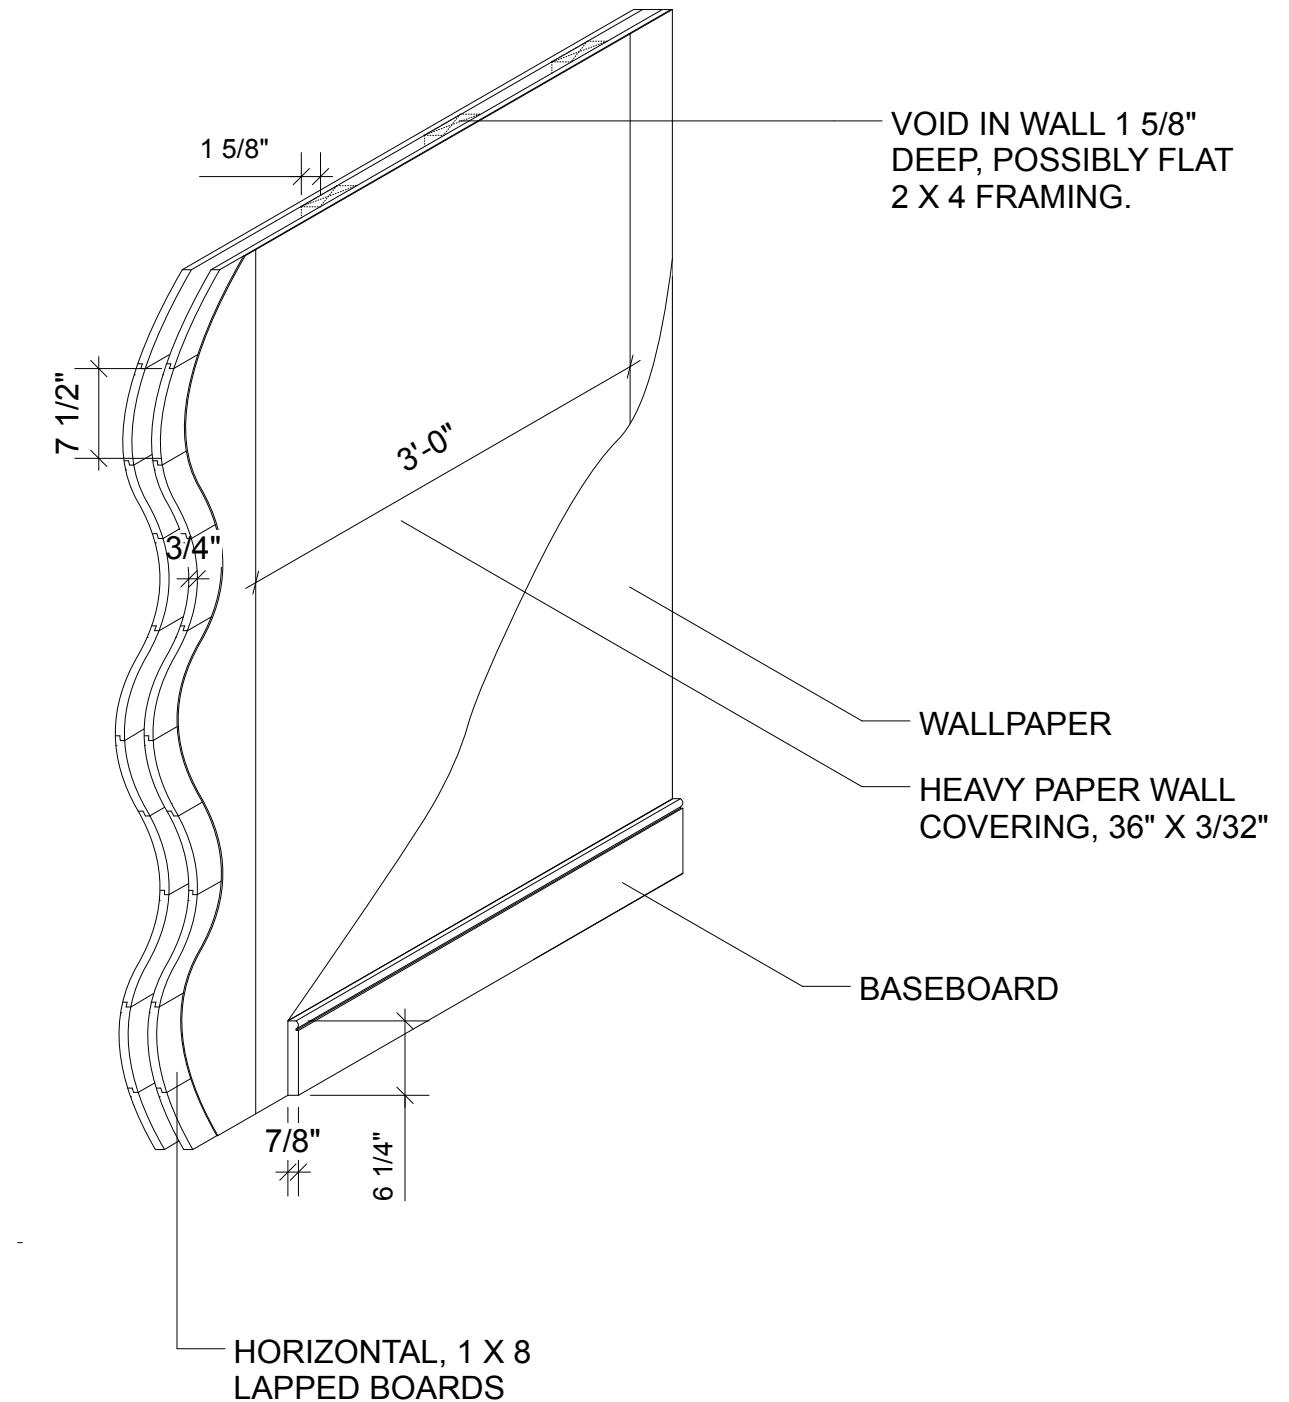
HS-11, OFFICERS' QUARTERS
DETAIL 4: WALL BETWEEN ROOM 1 (E2) AND ROOM 2 (E5)

A: SOUTH SIDE OF THE WALL

B: NORTH SIDE OF THE WALL

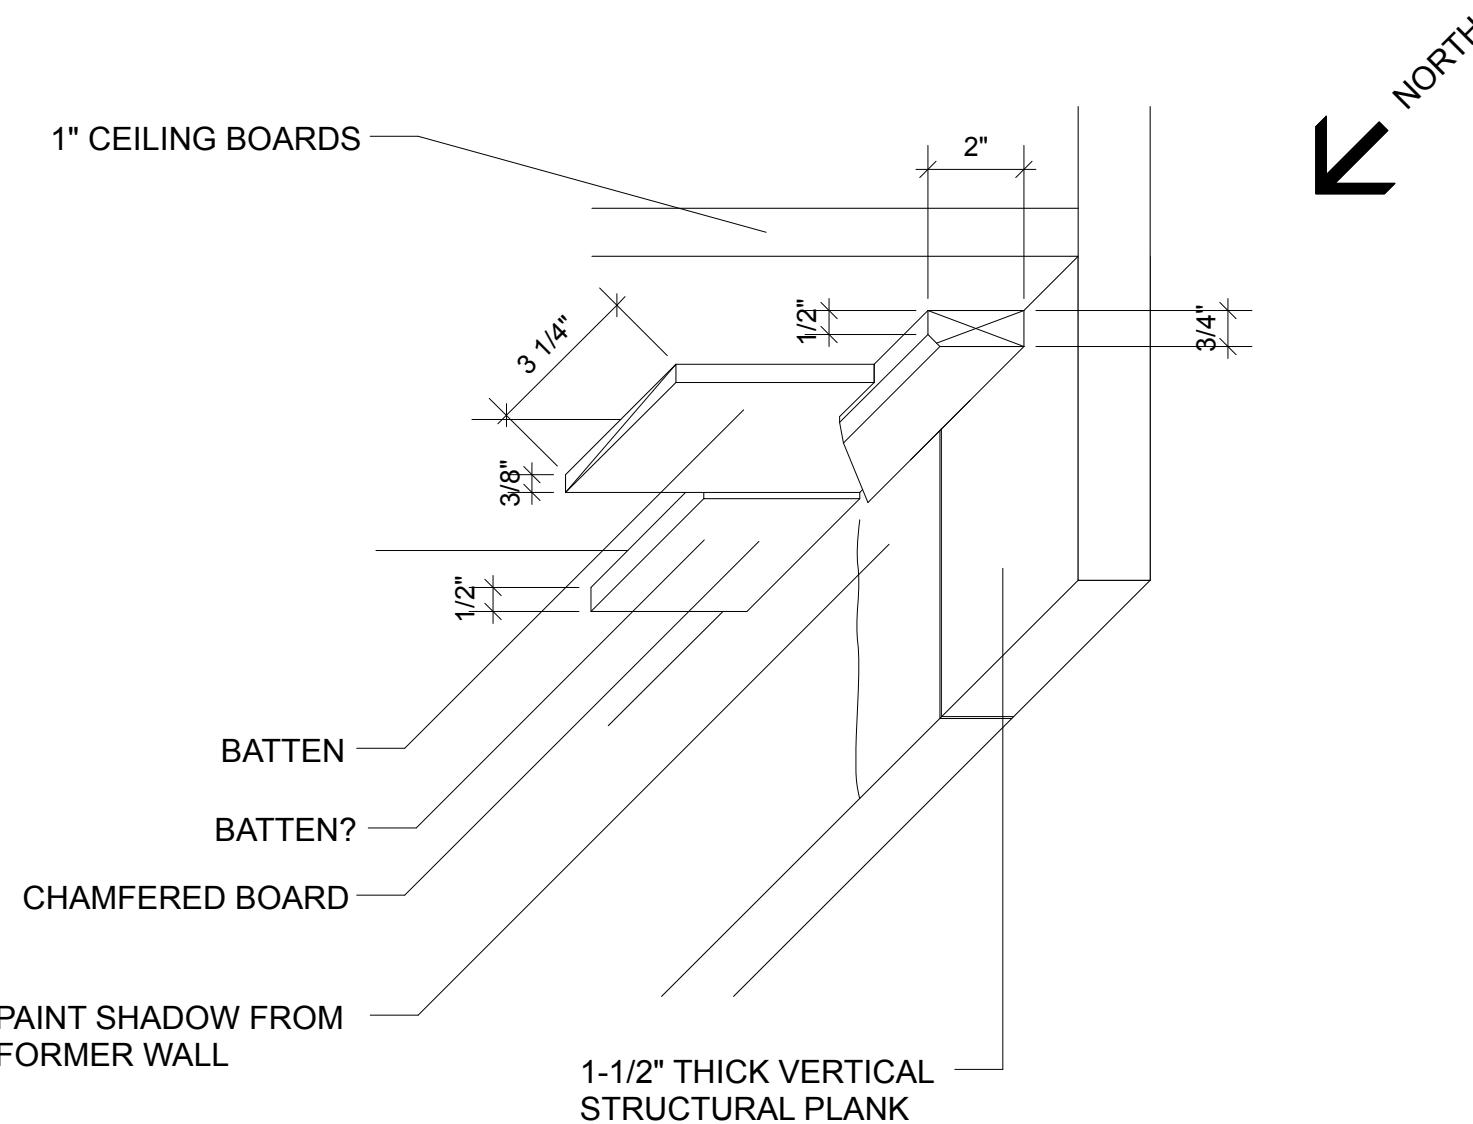
HS-11, OFFICERS' QUARTERS
DETAIL 6: ROOM 2 (E5) EAST WALL

EAST WALL: The aligned butt joints running east to west in the second layer of wooden flooring appear to match evidence of a former wall location according to evidence found in the crawlspace. This also matches the evidence found behind the east wall's Beaver Board finish layer as illustrated in Figure V-7; here, a paint shadow 2 inches wide (with its thickness to the north of the butt joint in the floor) was found. Faint stains left by former plaster keys stop at the edge of the former wall location along with the wallpaper finish. A small block of wood is located between two planks and 75-1/2 inches off the ground on center. It is located on the south side of the plank abutting the window in-fill described in the following paragraph. The face appears to have been split off it and clearly visible are two machine cut nails toe nailed into the block from the adjoining vertical planks on either side: Figure V-8. It appears this could suggest the placement of a former cabinet, closet or related feature: see entry "West Wall" under the heading "Room 4 (E8) for a similar feature.
