Quarters 208

Historic Structure Report

San Juan National Historic Site, Puerto Rico

Prepared by:
Panamerican Consultants, Inc.
2390 Clinton Street
Buffalo, New York 14227

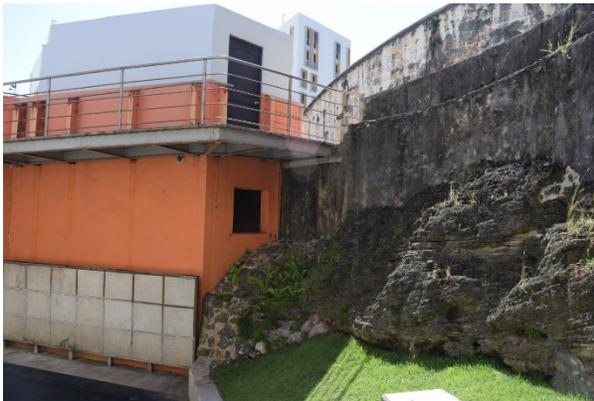
FIGURE 26. The retaining wall and embankment where they meet the east elevation of Quarters 208 in 2018.

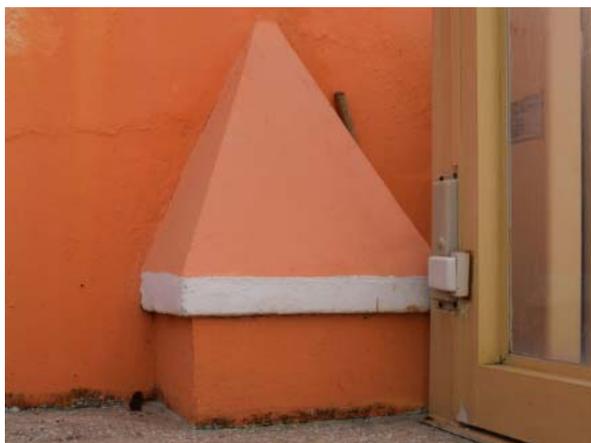
FIGURE 38. Easternmost pier at south elevation. Note that pier is concealed by concrete stair and only the cap is visible.

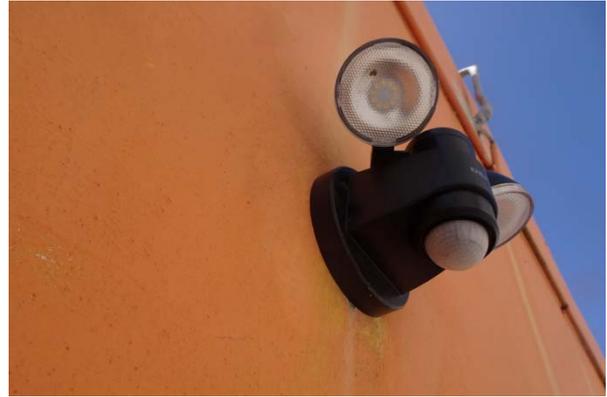
Electrical conduit is surface mounted to the upper portion of both the east and west sections of the wall, and penetrates the wall at three locations. The wall penetrations have been filled with grout. There is also a non-original floodlight over the door opening and a motion sensor mounted to the wall (Figure 41).

FIGURE 41. Non-original flood light over door opening.

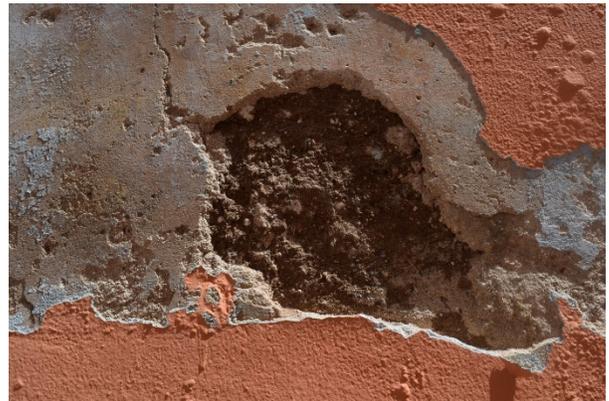
While exploratory openings were not included in the scope of this project, observations at areas of distress conditions on the south and west walls indicate that the exterior walls were constructed of rubble masonry. The rubble masonry consists of brown-colored matrix containing some white aggregate (Figure 50). At some locations, specifically adjacent to door openings and projecting decorative elements, brick units with similar brown-colored mortar with white stone

FIGURE 50. Wall construction at the west half of the building. Note underlying mortar and stucco visible at one area of distress.

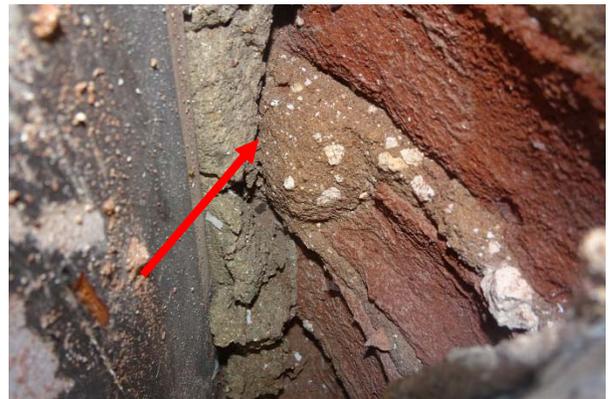
aggregate were observed (Figure 51 and Figure 52). Decorative elements such as cornice units were observed to have a corbelled brick masonry back-up. The decorative features therefore typically follow a module consisting of 1-1/2-inch projections and 2-inch bands. Exterior window and door openings have chamfered corners at the interior edge.

FIGURE 51. Wall construction at west half of building. Note brick and mortar at perimeter of door opening.

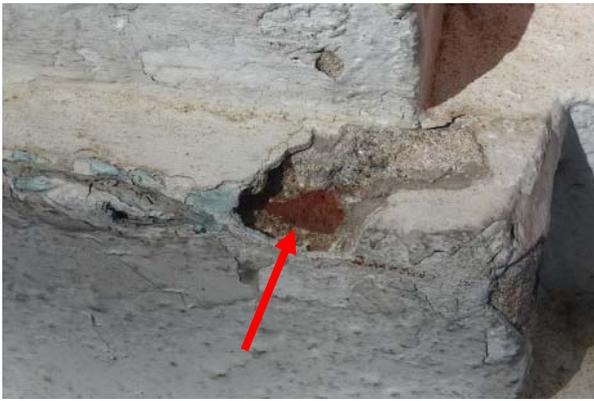
FIGURE 52. Wall construction at the projecting decorative elements on the west half of the building. Note underlying brick.

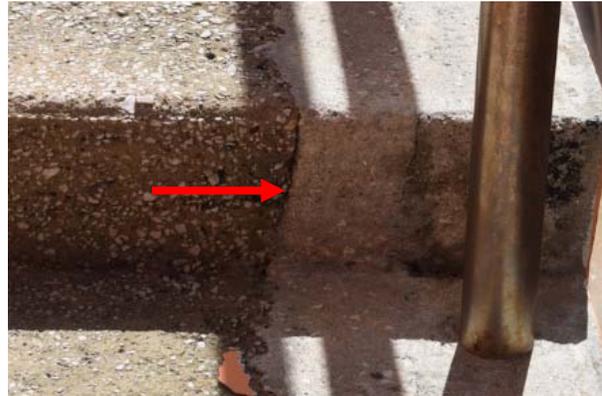
Physical evidence suggests that the stair and landing were modified since construction. Cold joints in the concrete and the appearance of the concrete indicate that the original stair was 4 feet wide and the landing was 4 feet square (Figure 91 and Figure 92).

FIGURE 91. Concrete at stair with cold joint between original concrete (arrow side) and concrete addition.

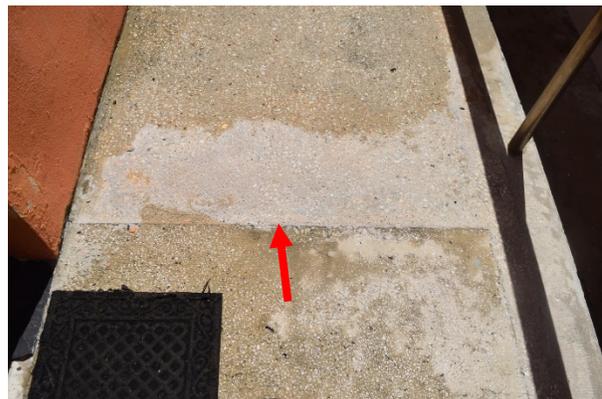
FIGURE 92. Concrete at landing with cold joint between original concrete (arrow side) and concrete addition.

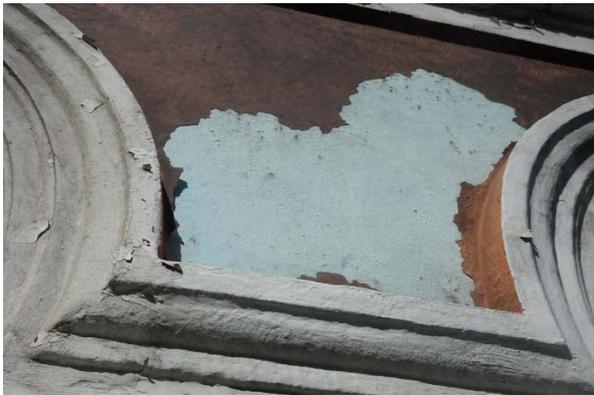
- Bubbling and peeling paint was observed at the stucco (Figure 110). At the time of the survey, loose and deteriorated paint was being scraped off and removed in preparation for repainting. Areas of bubbling paint were typically in close proximity to areas of observed debonding of the stucco.

FIGURE 110. Peeling paint at the west elevation.

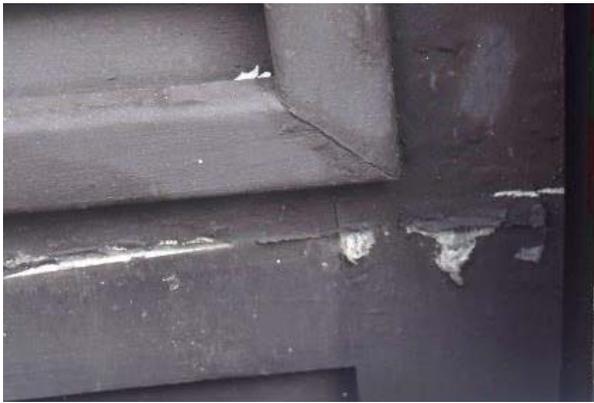
- Peeling and bubbling paint was observed at the exterior face of the doors on the west elevation (Figure 117 and Figure 118). Peeling paint was typically located near edges and at joints between wood members. Bubbling typically consisted of 3/8-inch diameter bulges in the surface coating.

FIGURE 118. Peeling paint along joints of door framing.

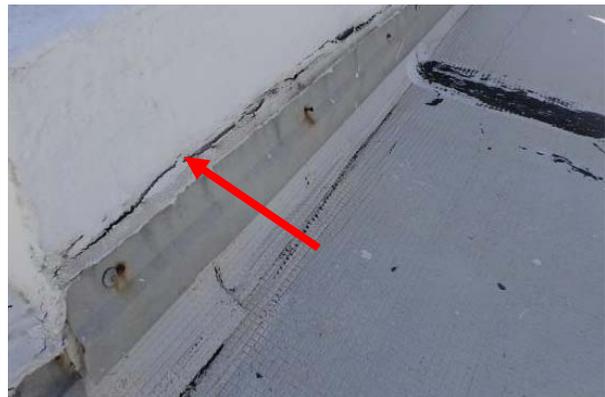
- Failed sealant was observed along roof flashings and at edges (Figure 125). The sealant had failed adhesively and cohesively. Nearly all sealant along the top edge of the sheet-metal flashing on the west elevation parapet had failed.

FIGURE 125. Open and debonded sealant joint along top edge of sheet-metal flashing.

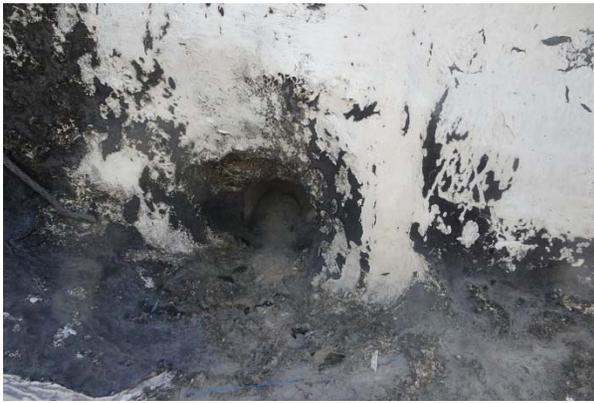
- Roof scupper drains lack proper flashing and detailing (Figure 126). Each existing scupper drain consists of a pipe penetration without a drain strainer, flashed with modified bitumen roofing membrane and roofing mastic that wrap the edge of the drain. At the main roof, the drain is obstructed and partially concealed by bundles of roof-mounted pipes and conduits that may inhibit drainage of the roof (Figure 127).

FIGURE 126. Existing roof scupper. Note that the drain does not have a strainer or typical flashing details.

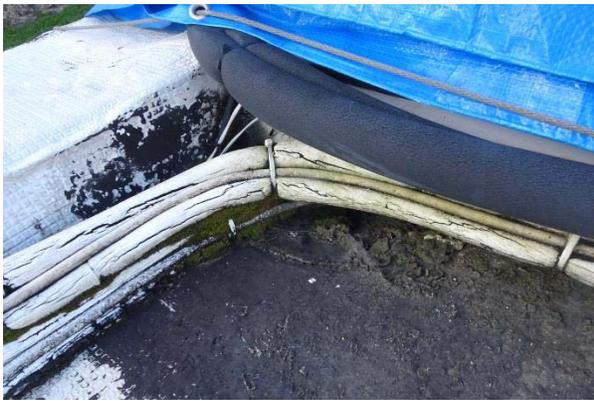
FIGURE 127. The roof scupper at the main roof is obstructed by bundles of conduit and insulated piping.

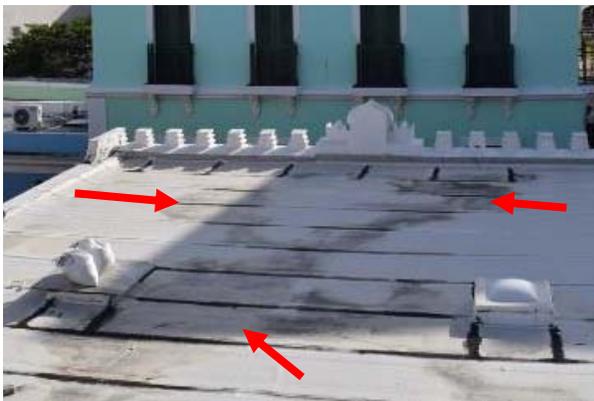
- Evidence of ponding water including staining of the roof membrane was observed at the roof (Figure 128). The staining was most pronounced along the center of the roof area. Drains are located at the east end of the roof.

FIGURE 128. Numerous areas of ponding water at the center of the roof.

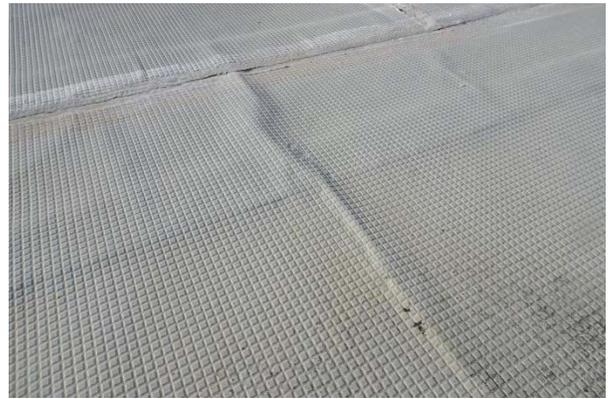
- Bubbling and blistering was observed in the field of the roof at the second-floor addition roof (Figure 129). The blistering typically extended north–south, across the width of the roof sheets.

FIGURE 129. Puckering and bubbling of the roof membrane.

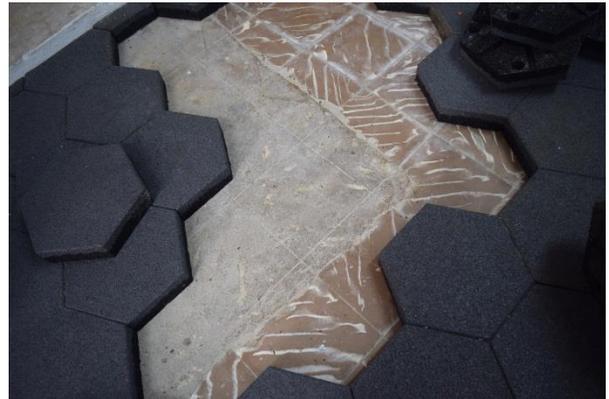
The second-floor storage room has interlocking hexagonal rubber tile flooring with each tile measuring 2 inches thick and 9 inches wide. The tiles are laid loose on a substrate of terra cotta-colored ceramic tiles, each measuring 8 inches square. Ghosting and residue from previous adhesives indicate that an adhered tile flooring was previously applied over the ceramic tile. A section of the floor tile measuring approximately 6 feet by 3 feet has been removed and replaced with concrete (Figure 153). The concrete section of the flooring is adjacent to a landing at the south side of the roof that is raised 4 inches above the slab. The landing is located at the point where the wall transitions from running diagonal to parallel with the south elevation. Thus, the landing is polygonal in plan. The landing floor finish consists of beige ceramic tile measuring 8 inches square. At the east end of the landing is an infilled toilet bowl ring, indicating that the landing, and likely the adjacent concrete section of the flooring, were previously part of a restroom.

FIGURE 153. Floor at storage room includes rubber tile flooring over previously existing ceramic tile and concrete patch repair.

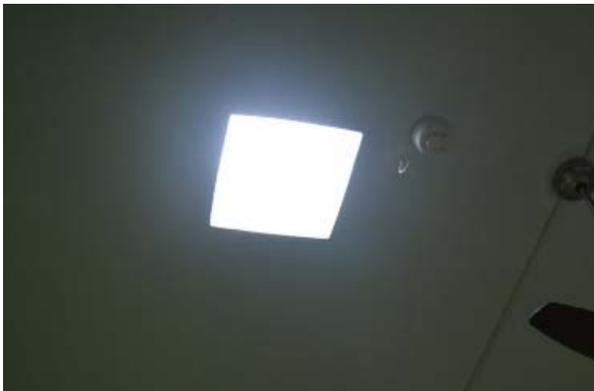
Ceilings at Quarters 208 are painted white. At the west half of the building, which includes four rooms, ceiling heights are 13 feet 10 inches from finished floor. The ranger's office and south entrance room each have a skylight opening, measuring 18 inches square at the west end of the ceiling (Figure 181). The skylight at the south entrance room has been removed and the opening covered with sheet metal. The ranger's support room and adjacent classroom have ceiling heights of approximately 12 feet 7 inches. The east portion of the courtyard, under the second-floor addition, has a ceiling height of 8 feet 9 inches. A soffit, measuring 24 inches wide and 12 inches deep, extends north-south across the west end of the courtyard ceiling. The restrooms at the east end of the building plan have ceiling heights of 9 feet 5 inches.

FIGURE 181. Skylight opening as observed from the ranger's office.

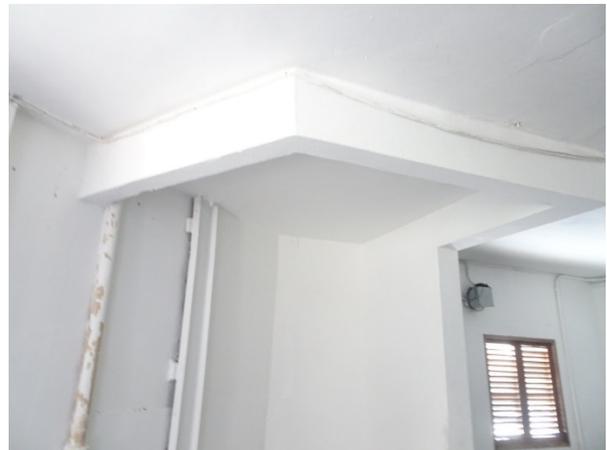
The second-floor addition has a ceiling height of approximately 9 feet. It has two fluorescent light fixtures oriented east-west across the center of the ceiling with surface-mounted conduit. The ceiling also has a soffit, measuring 8 inches wide and approximately 16 inches deep (Figure 184). The soffit outlines a polygonal-shaped area that appears to denote the location of a previous bathroom.

FIGURE 184. Soffit at storage room ceiling.

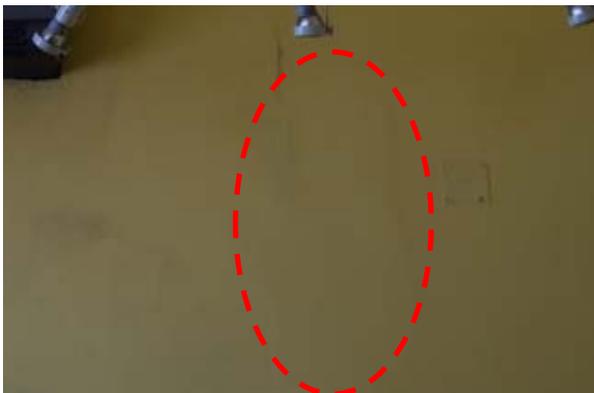
- Bubbling and blistering paint was observed at interior face of the north and south exterior walls as well as at some interior walls (Figure 187 and Figure 188). At a few locations where distress was observed, the paint was observed to be debonded, and the underlying substrate exhibited efflorescence (Figure 189). Conditions observed included small raised bubbles measuring approximately 1/4 inch in diameter as well as larger blisters measuring anywhere from a few inches to few feet in length. Bubbling was usually concentrated in small clusters on the wall. Blisters located at the interior face of exterior walls sometimes corresponded to wall penetrations at the exterior wall.

FIGURE 188. Bubbling paint at the top of the wall at the main entrance room, opposite a conduit penetration at the exterior face of the wall (within dashed area).

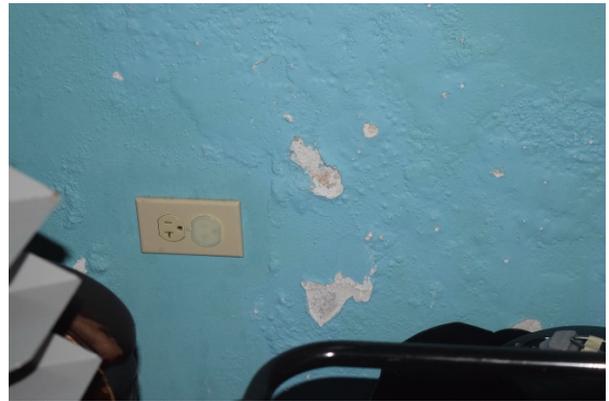
FIGURE 189. Bubbling paint at the south entrance room. Portions of the paint has peeled away and the underlying plaster is exposed to view.

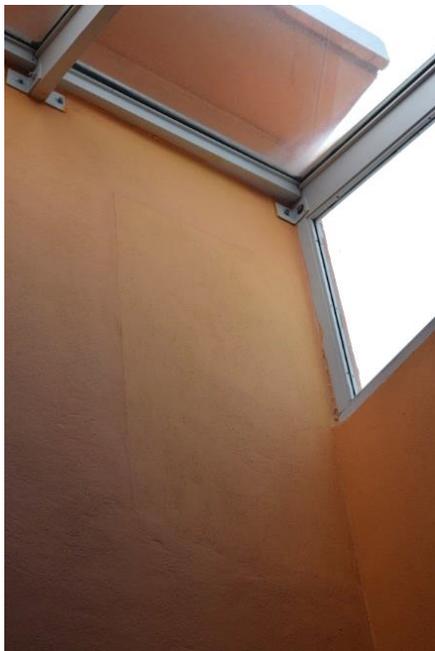
- Cracks were observed in the plaster at the subframe adjacent to some doors (Figure 191). The cracking was typically located near door hinges.
- Physical evidence of previous alterations was observed at walls, specifically at the covered courtyard. Alterations included removal and infill of some doors, windows, and stairs at the second-floor addition; installation of conduit, light fixtures, outlets, and junction boxes; and localized infill where previous repairs or alterations had been performed, such as at door heads (Figure 192 through Figure 194).

FIGURE 193. Evidence of previously infilled door opening at the south end of the east interior elevation of the covered courtyard.

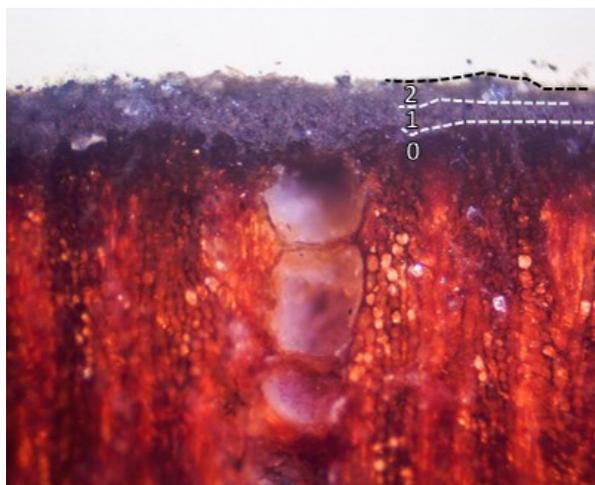
Sample number: 15

The substrate for this sample is wood. The lowest layer (1, Gray) makes up the first generation of coatings; this layer may be original.

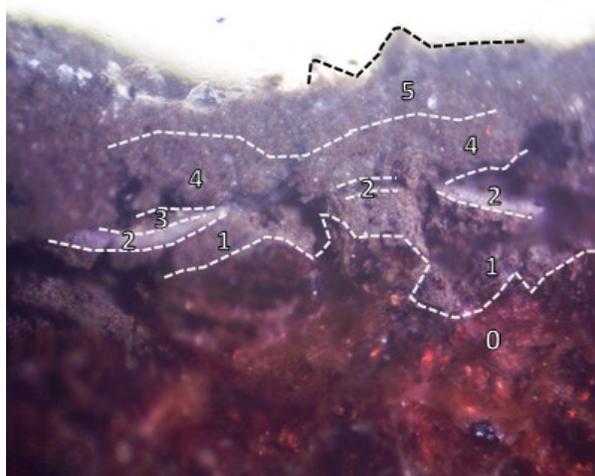
Sample number: 16

The substrate for this sample is wood. The lowest layer (1, Gray) makes up the first generation of coatings; this layer may be original.

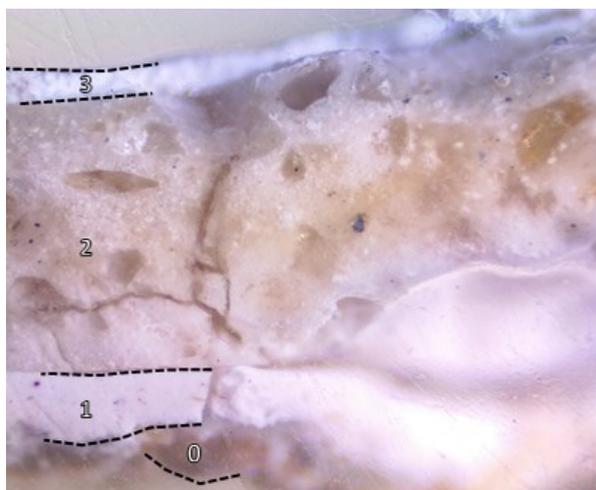
Sample number: G

The substrate for this sample is stucco. The lowest layer (1, White) makes up the first generation of coatings; this layer may be original.

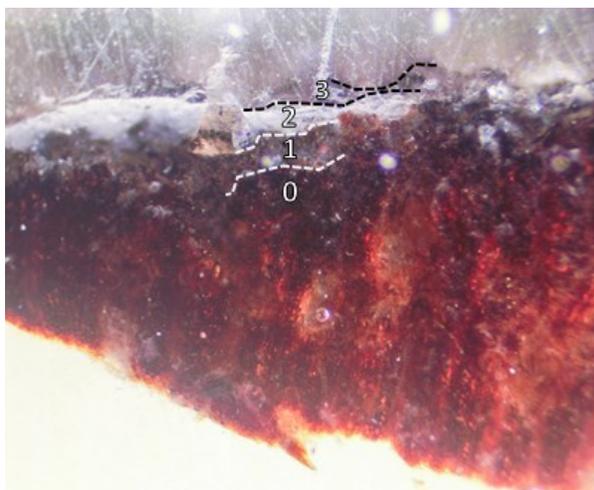
Sample number: I

The substrate for this sample is wood. The lowest layer (1, Gray) makes up the first generation of coatings; this layer may be original.

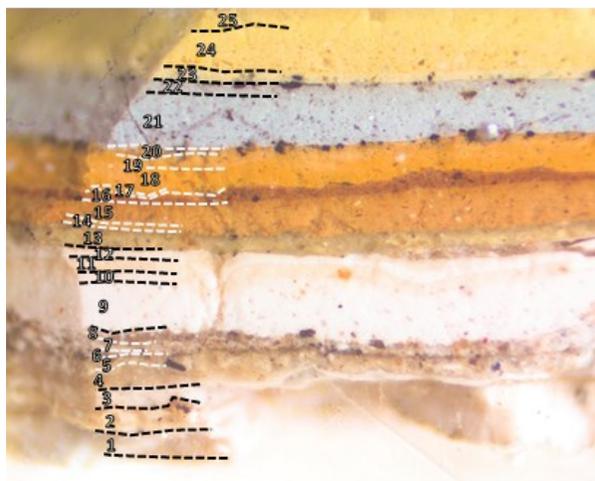
Sample number: J

The substrate for this sample is stucco (not visible in cross-section diagram). The lowest layer (1, Ivory) makes up the first generation of coatings; this layer may be original. See layers 26-34 in Appendix II.

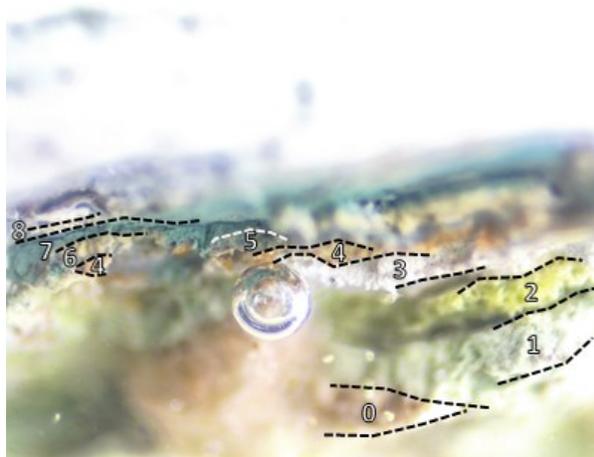
Sample number: P

The substrate for this sample is stucco. The lowest layer (1, Light green) makes up the first generation of coatings; this layer may be original.

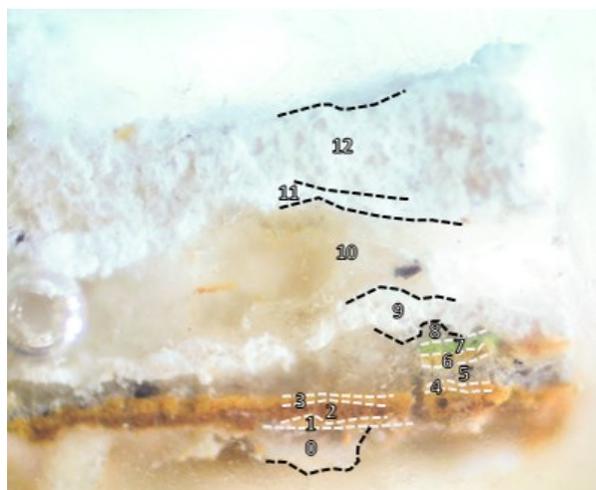
Sample number: Q

The substrate for this sample is stucco. The lowest layer (1, Buff) makes up the first generation of coatings; this layer may be original.

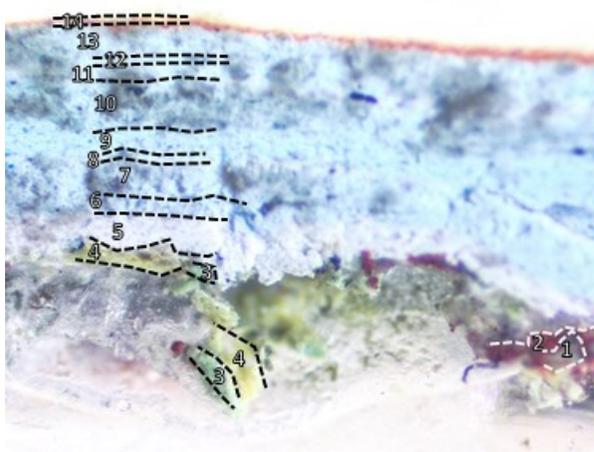
Sample number: R

The substrate for this sample is stucco (not visible in cross-section diagram). The lowest layer (1, Gray) makes up the first generation of coatings; it is unclear if this layer is historic. A darker blue paint was observed on the sample during microexposure but, because of the extent of deterioration, the chronological position could not be determined and has been excluded from reporting.

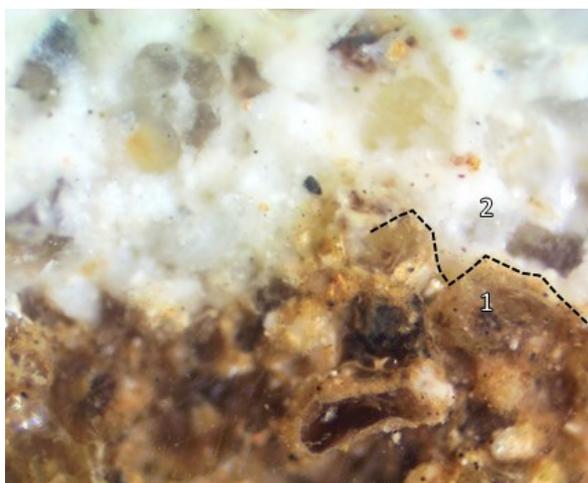
Sample number: M1

The substrate for this sample is stucco. The lowest layer (1, Brown) makes up the first generation of stucco; this layer may be original.
