HISTORIC STRUCTURES REPORT
ARCHITECTURAL DATA SECTION
ON
NARBONNE HOUSE
SALEM, MASSACHUSETTS

Prepared by
The Society for the Preservation of New England Antiquities
141 Cambridge Street
Boston, Massachusetts 02114

December 1972
for

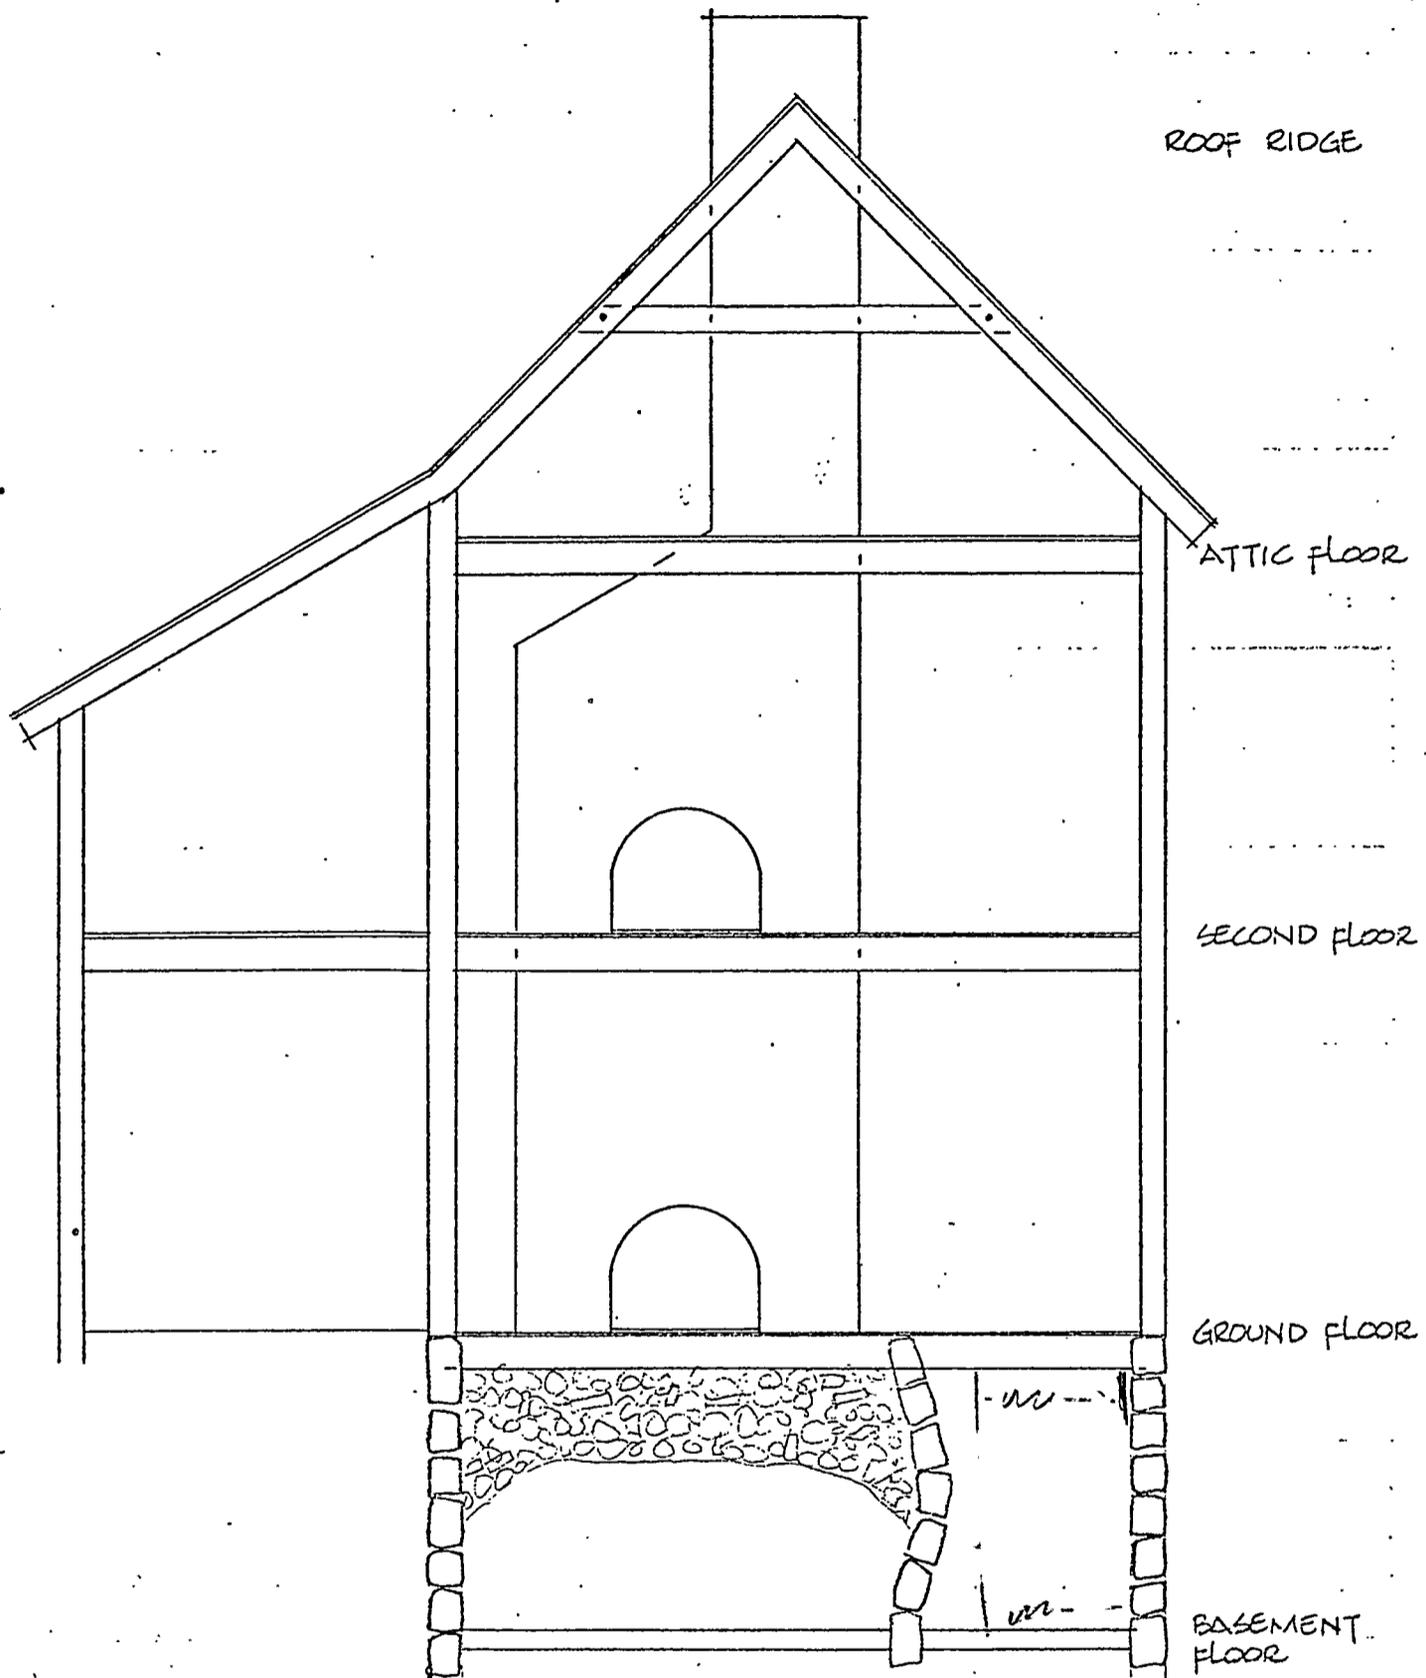
CROSS-SECTION AT FACE OF CHIMNEY
IN FRONT ROOM LOOKING
TOWARDS BACK ROOM.

The main problem: the right hand stone wall at the chimney foundation has bulged by several inches as indicated in the two attached sketches; as a consequence, the chimney itself has been structurally affected by the partial failure of its foundation up to the second floor level. The structural problems have been compounded by the changes made through the years to the hearths and lower sections of the flues. However the chimney seems to have remained in fairly good condition from the second floor level up to the roof ridge.

The suggested remedy, in Mr. Olsen's letter, of simply using a cement grout to stabilize the chimney foundation does not appear quite feasible because, - as shown in the cross-section - the base of the chimney has a great percentage of its volume made up of soil which would prevent setting of the cement grout assuming that the soil could be penetrated by the grout.

The remedy recommended here is more complex and conditional upon a few simple tests; it seems that some temporary supports could be installed to prevent additional damage to the chimney while the work is being carried out at the foundation level. Mr. Phillips can describe ways and means of supporting the chimney.

- a) The soil within the chimney foundation should be stabilized by chemical grouting; the first chemicals to consider are AM-9 and Cyanaloc-62, sold this side of the border by Cyanamid of Canada Ltd.; these products are manufactured and distributed by the parent company in the U.S.A. It must be ascertained by easy testing how far the chemical penetration will reach into the soil to determine how many injection points will be needed. (It must be remembered that chemically stabilized soil should not freeze, should remain damp and that a leakage of the chemicals may affect adversely a well for drinking water.)
- b) The layer of loose rock/brick/soil near the top of the chimney foundation should then be also stabilized. Because

of the high content of soil in the layer, the grouting should be made with a chemical "paste" which will react favourably with the soil. (It seems that Cyanamid can also provide appropriate formulae but they have been very secretive about revealing their composition.) Assuming that no chemical "paste" can be found, it may be possible to try cement grout in order to fill the bigger voids but it must be remembered that the cement will set very poorly and will have very little strength.

- c) Because the stabilization of the soil may not be permanent, it is recommended that a few steel rods be driven between the stones of the foundation wall near the basement stairs clear across the full width of the house and tied to a deadman beyond the house itself if the foundation wall of chimney at the left does not prevent the operation; if the left wall is too much in the way, then a trench may have to be dug up under the "lean to" and a few holes made in the left wall to permit the rods to come out through the wall and then anchored to an anchor plate on the face of the walls.

After the chimney foundation has been made structurally safe, repairs can probably be carried out on the chimney itself. There is no need to insist upon the importance of going at it slowly and of leaving most of the chimney well supported while only a small area is worked on at a time. Mr. Phillips is well aware of the difficulties and he can describe a technique or combination of techniques for that particular phase.

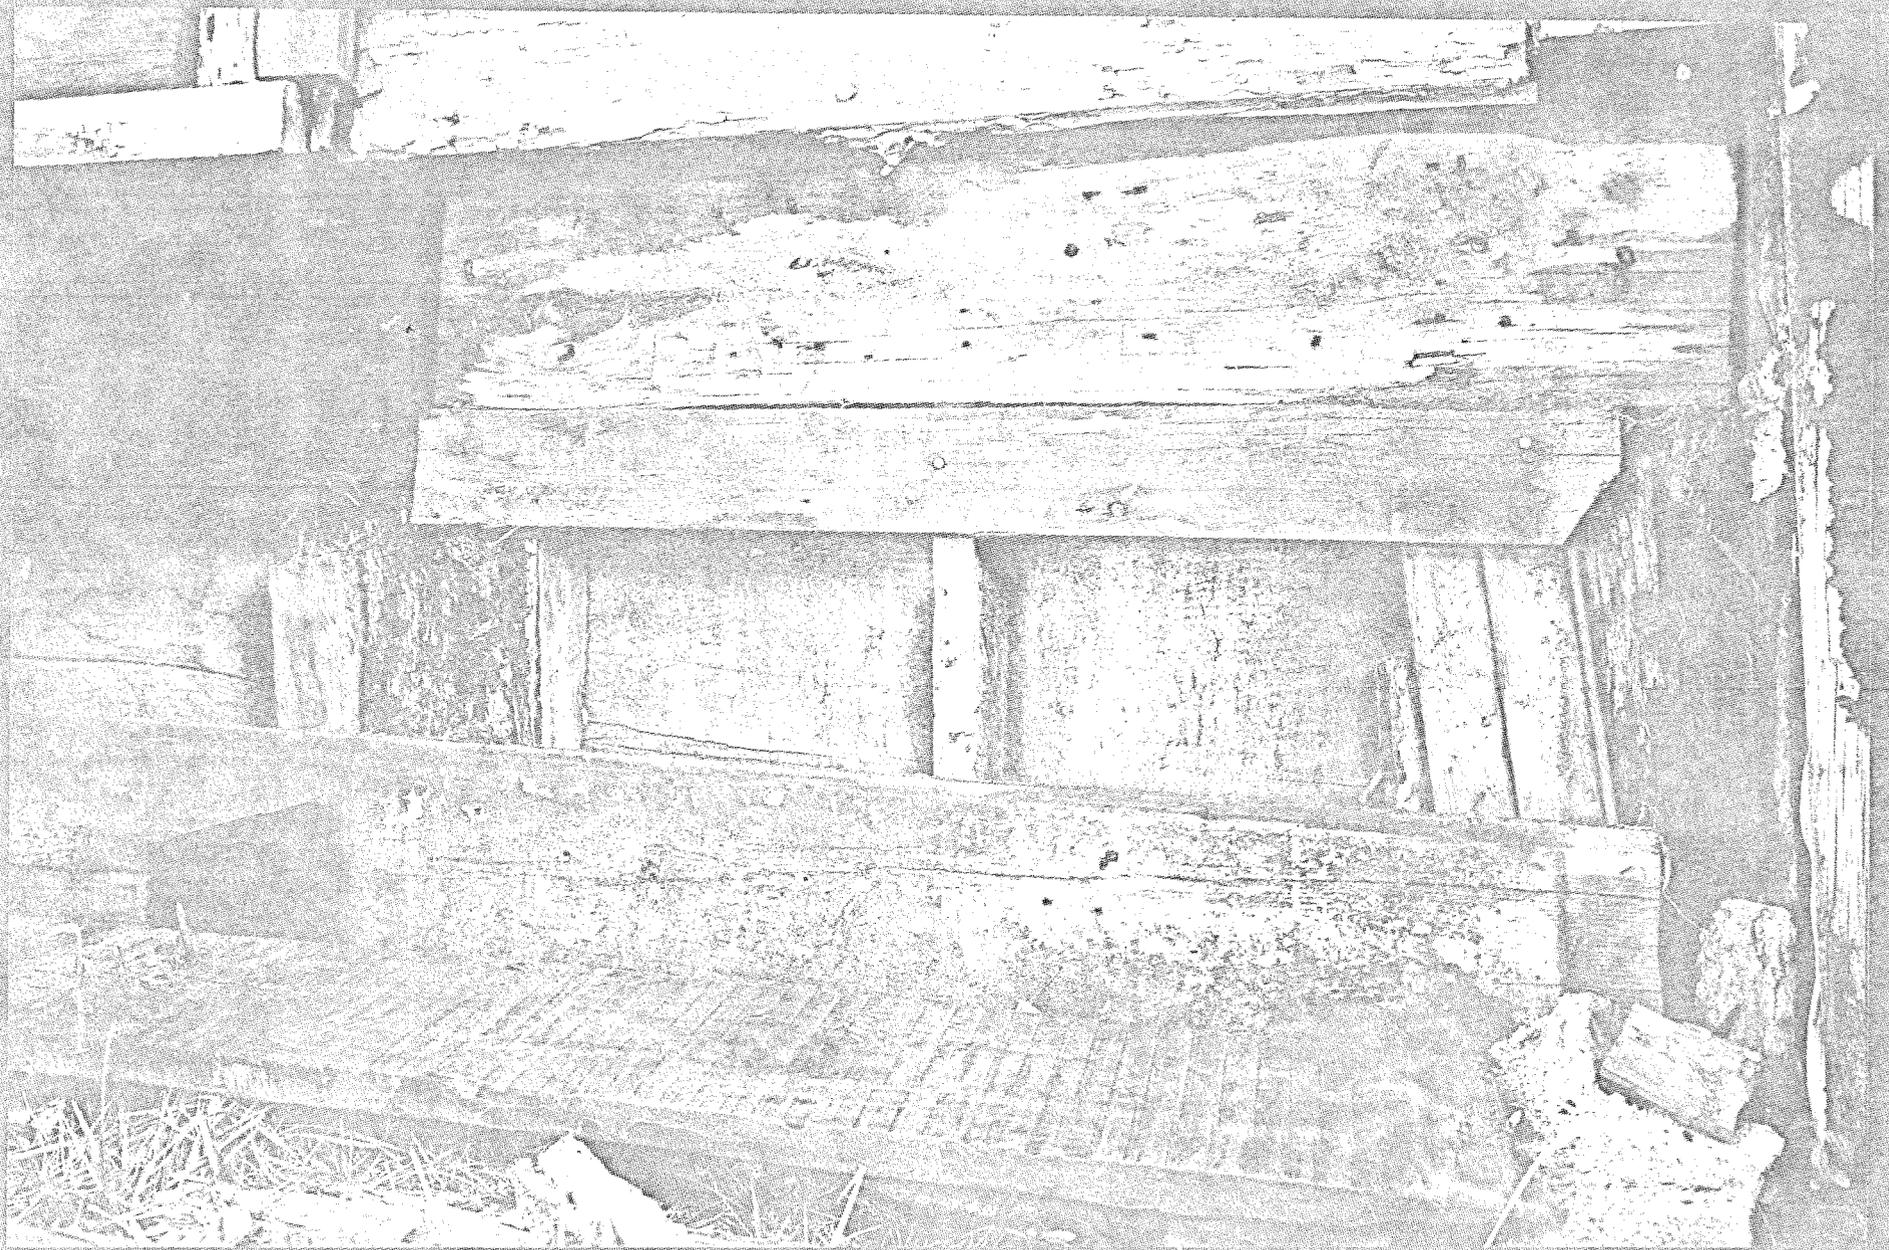
11. Narbonne House, Salem, Mass. Detail of east wall.

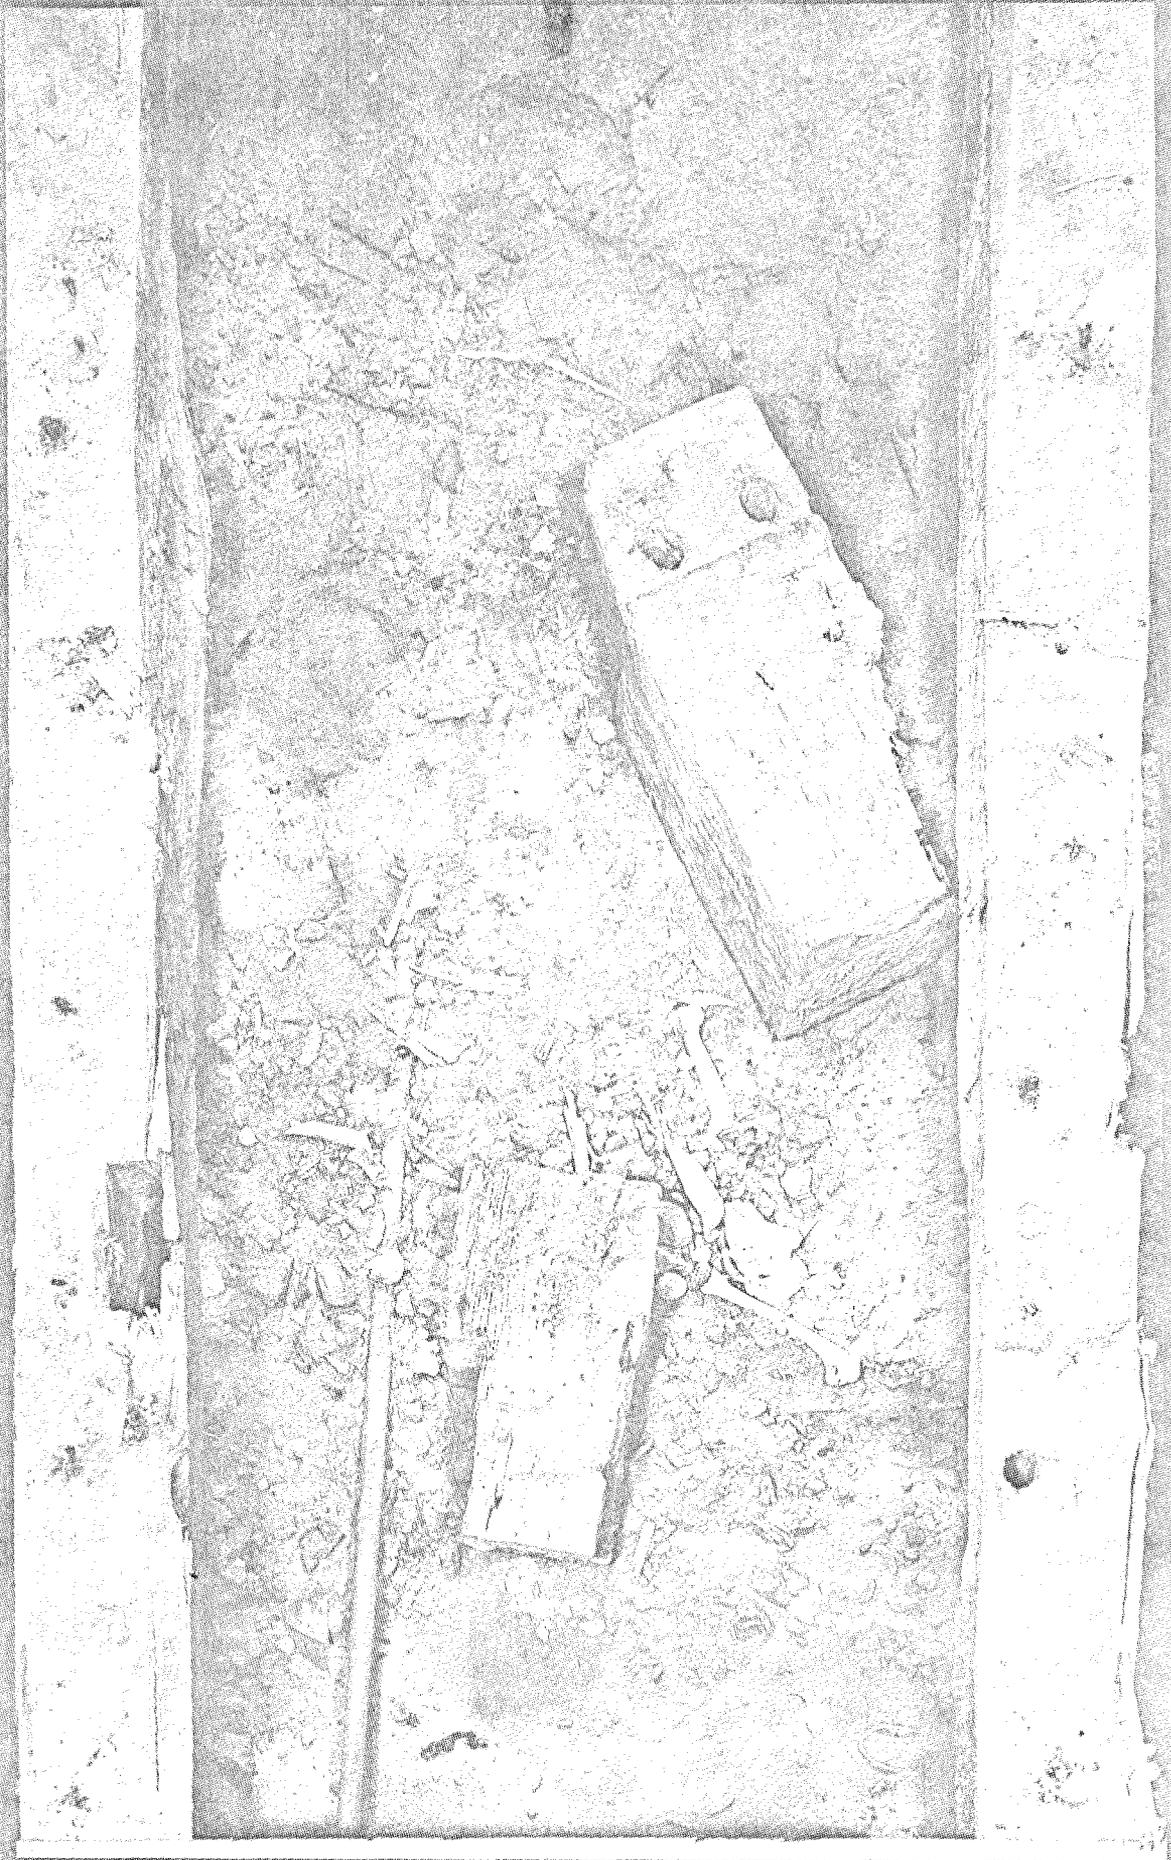
13. Narbonne House, Salem, Mass. Detail of first floor joists in ell. Mortises and pins indicate the reuse of old material.

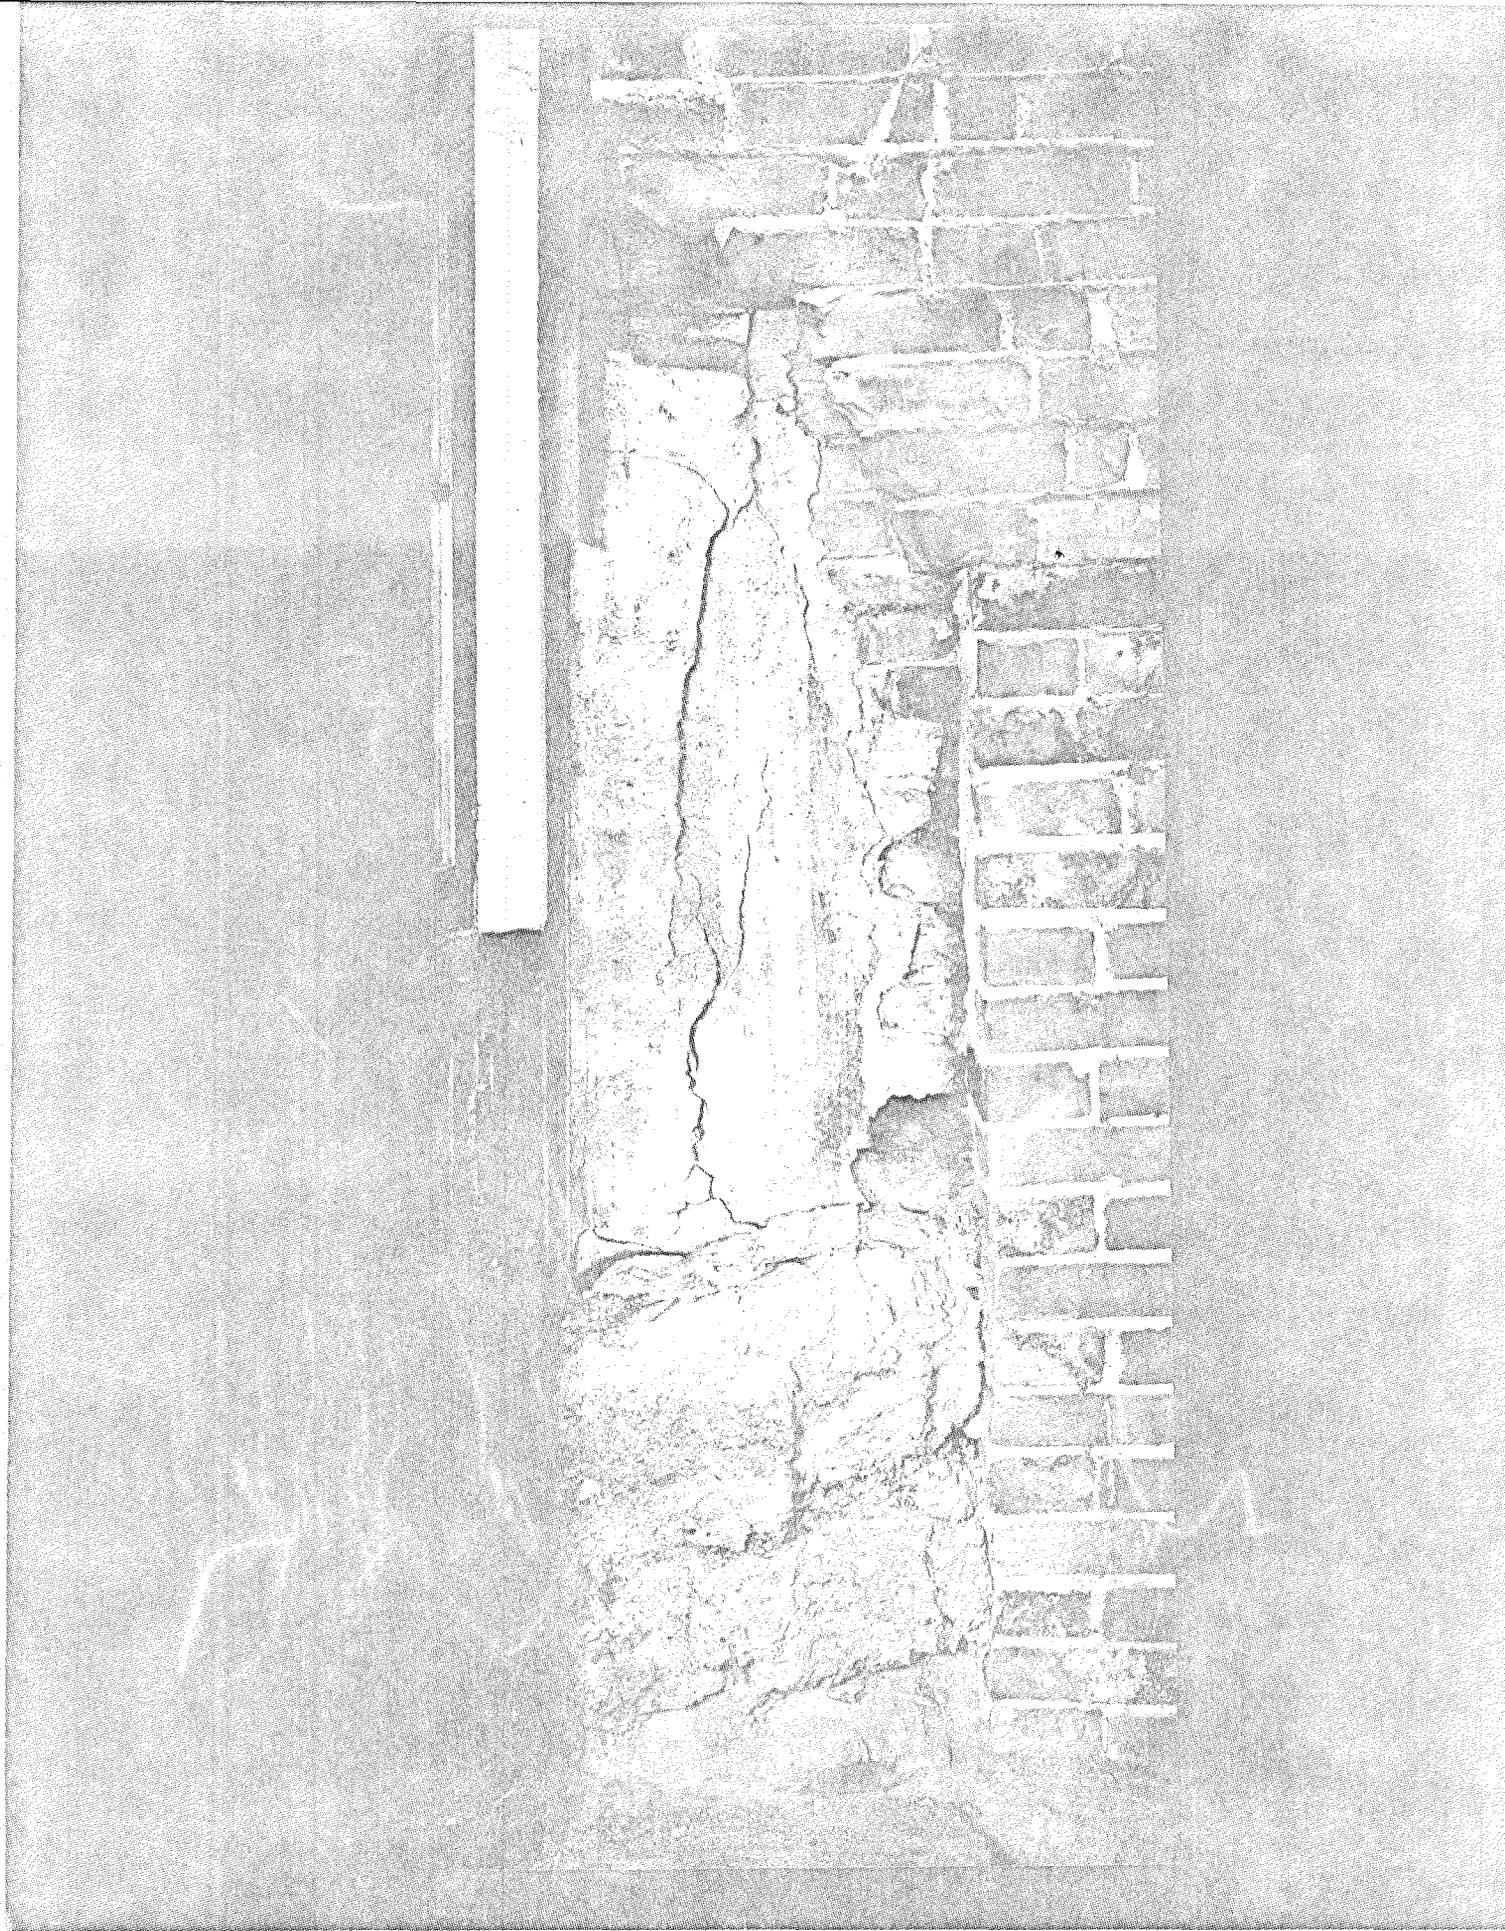
16. Narbonne House, Salem, Mass. Detail of fireplace in north room. Note old plaster which pertains to an earlier fireplace.

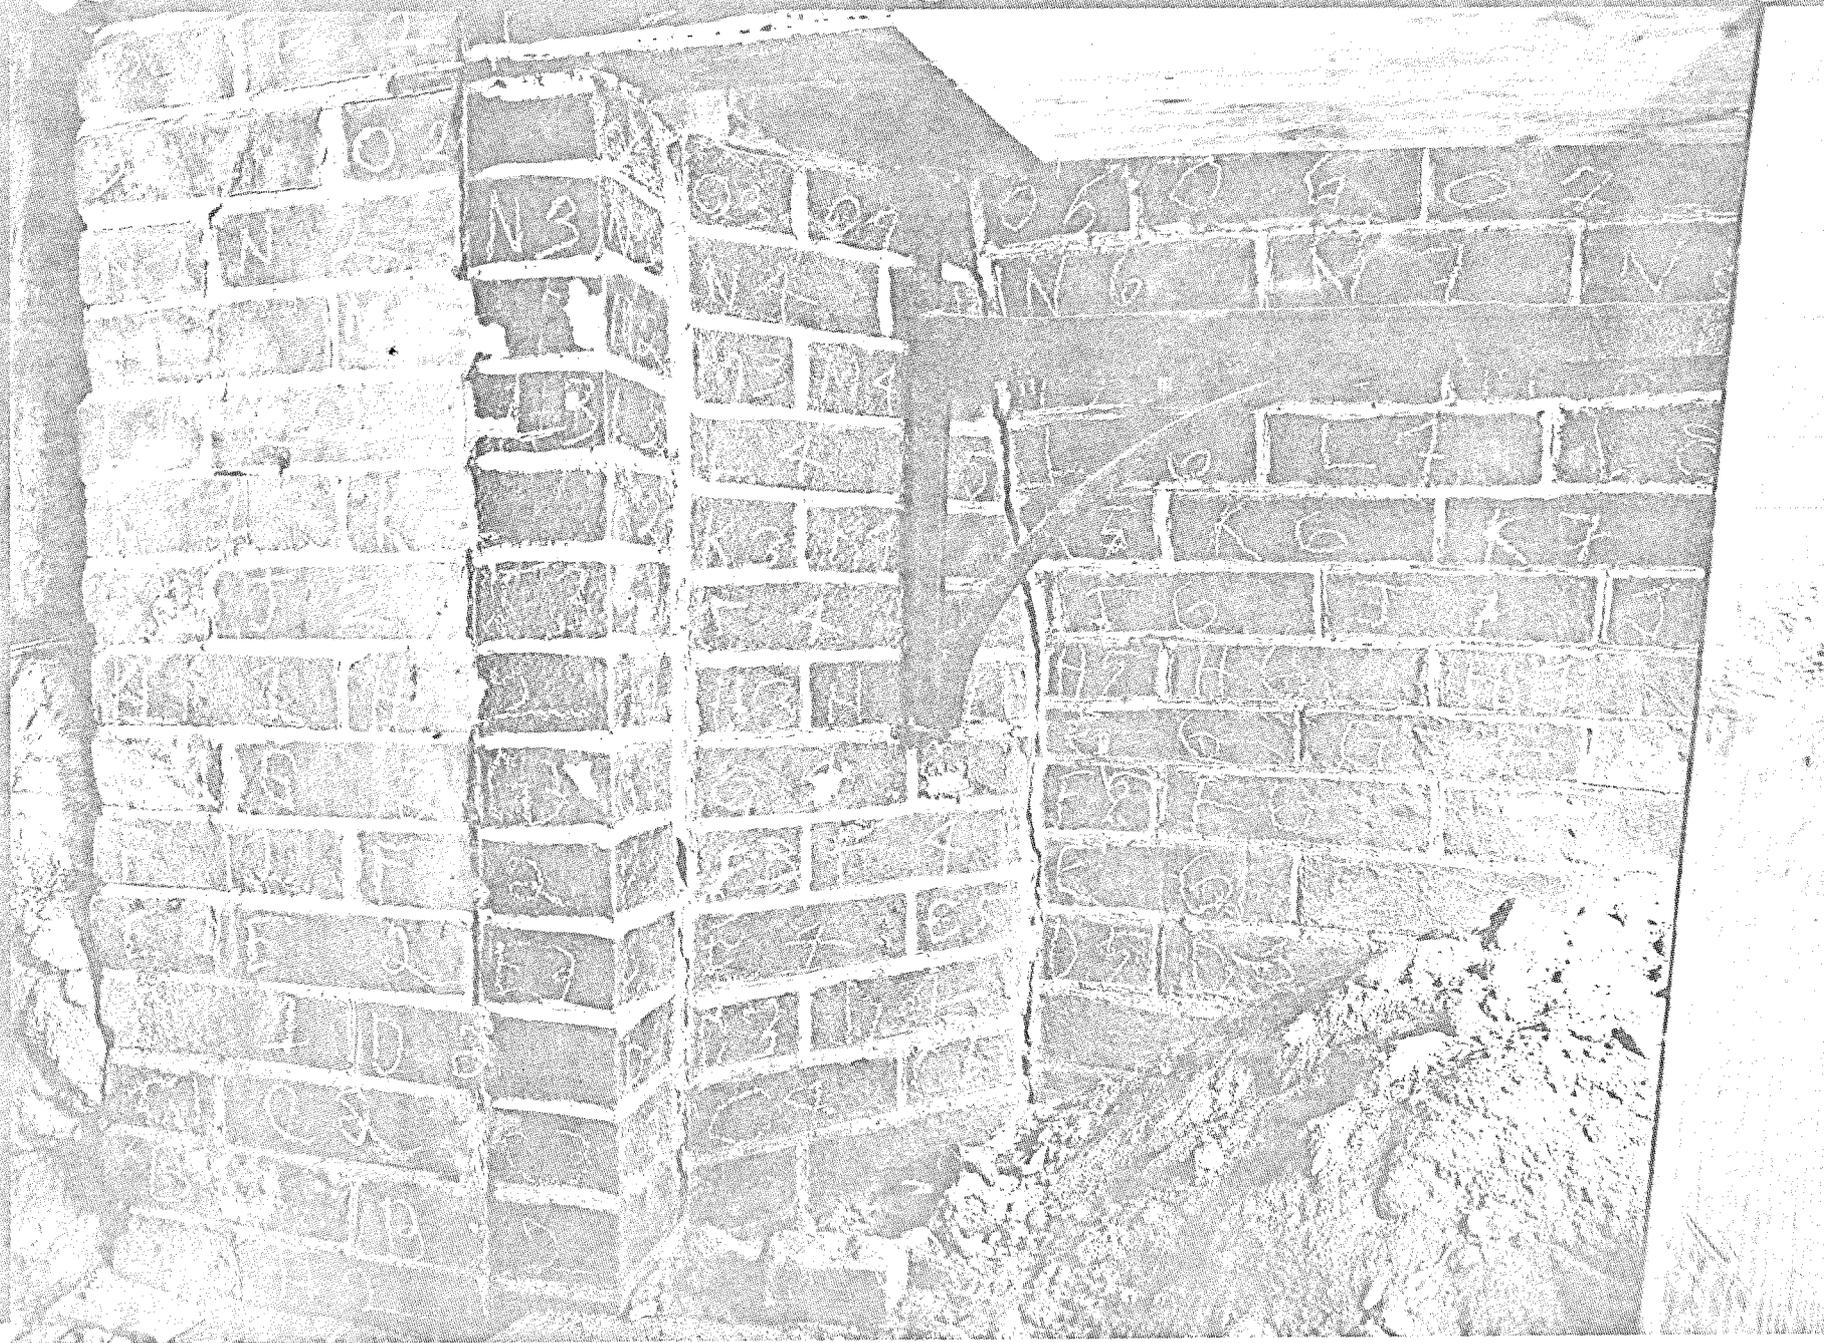
17. Narbonne House, Salem, Mass. Detail of fireplace in north room showing bricks numbered for record purposes.

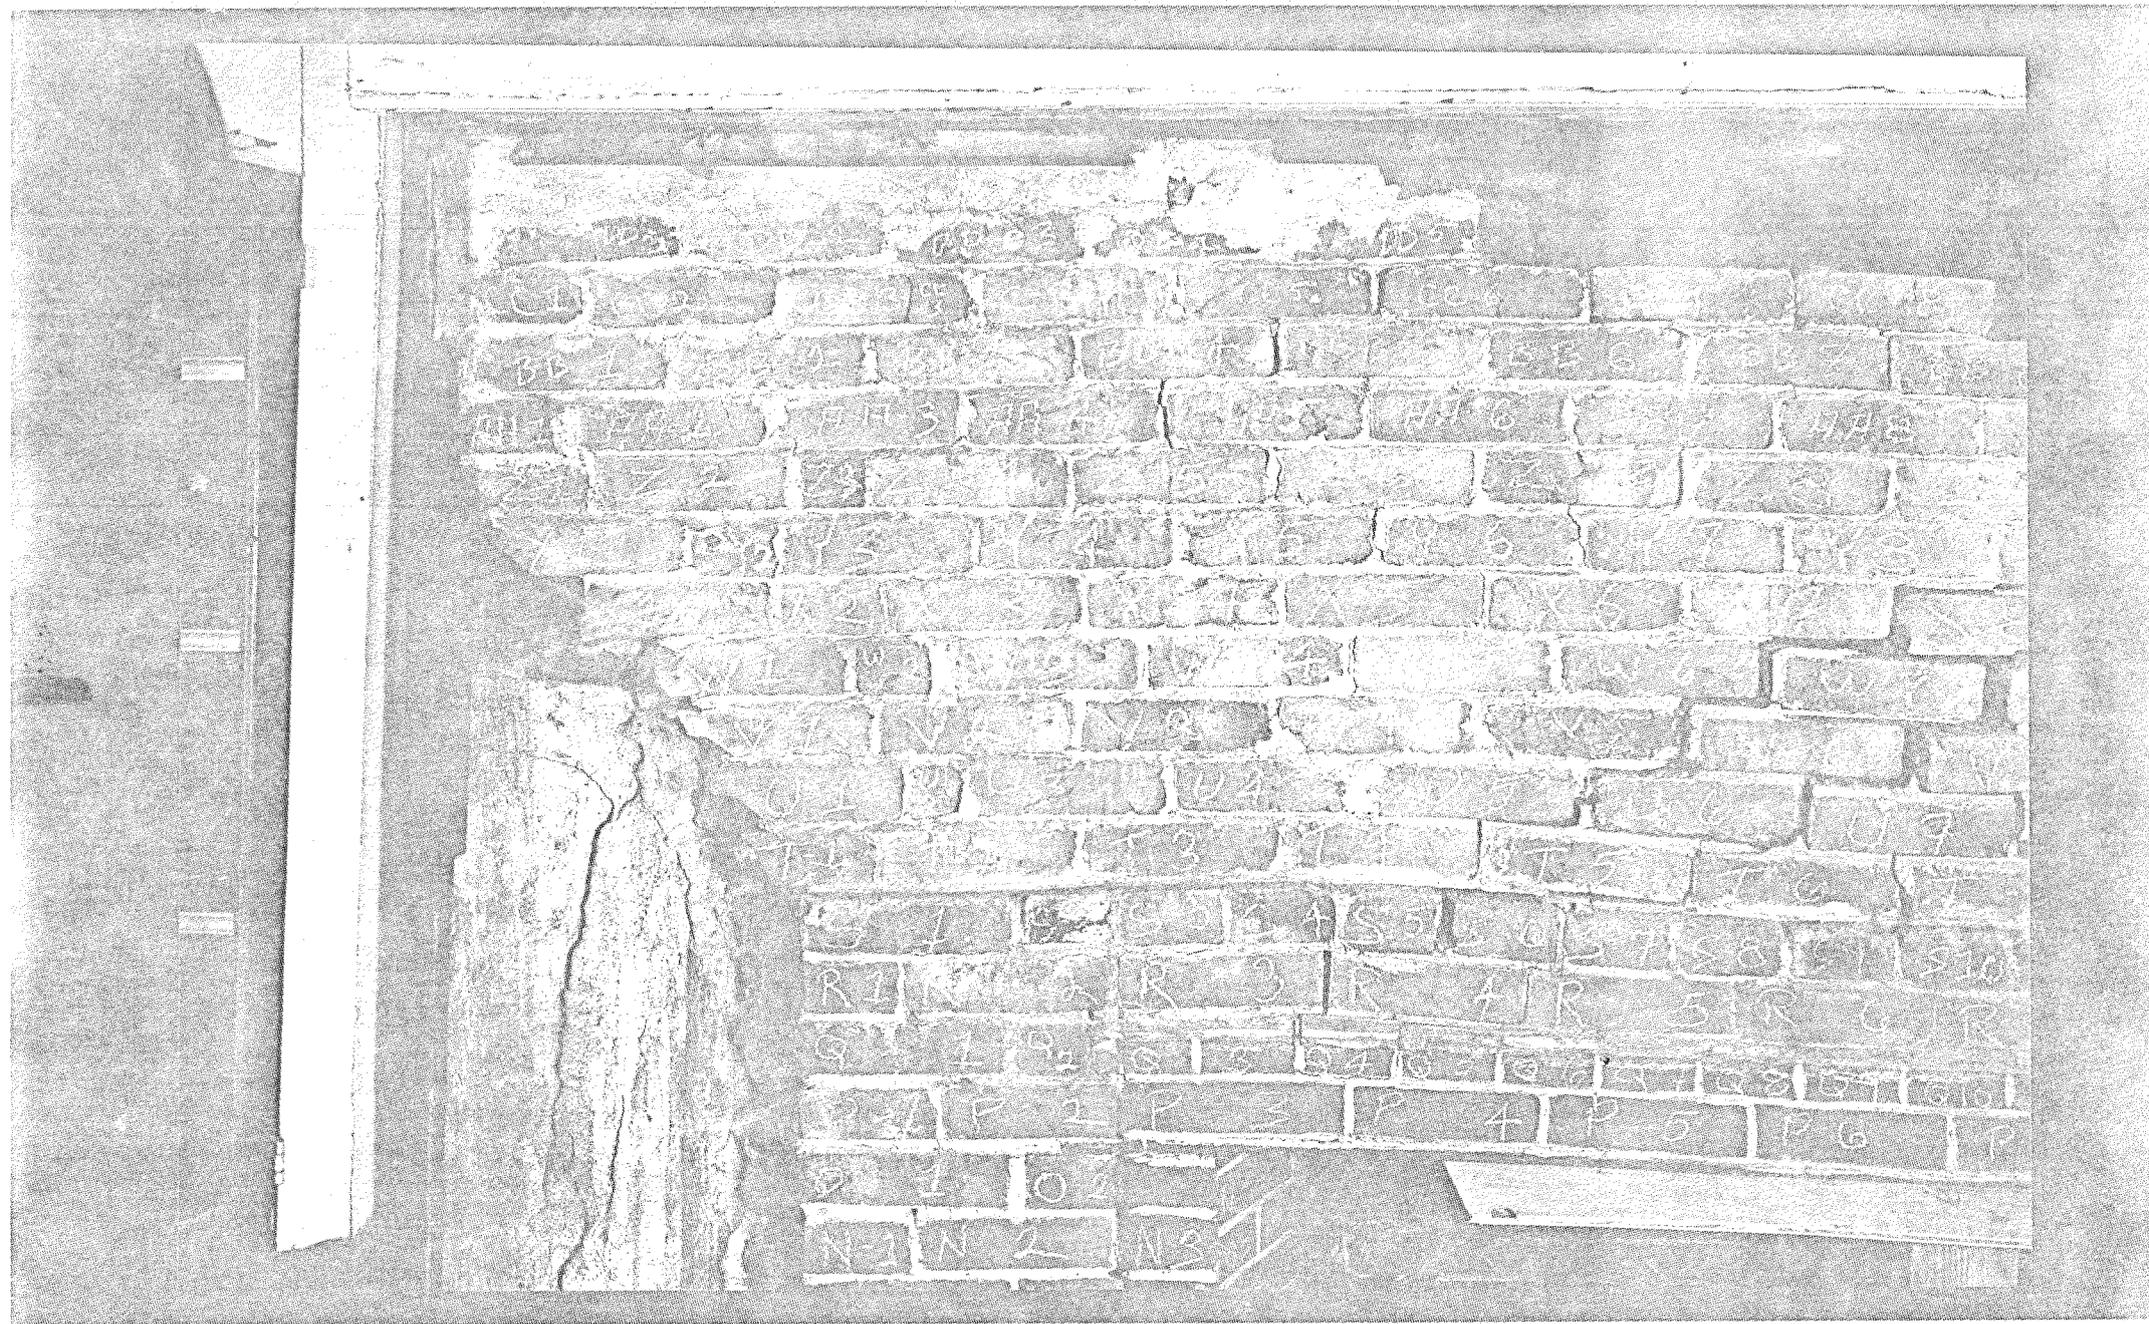
18. Narbonne House, Salem, Mass. Detail of fireplace in north room. Record photograph of numbered bricks in upper left corner before their removal.

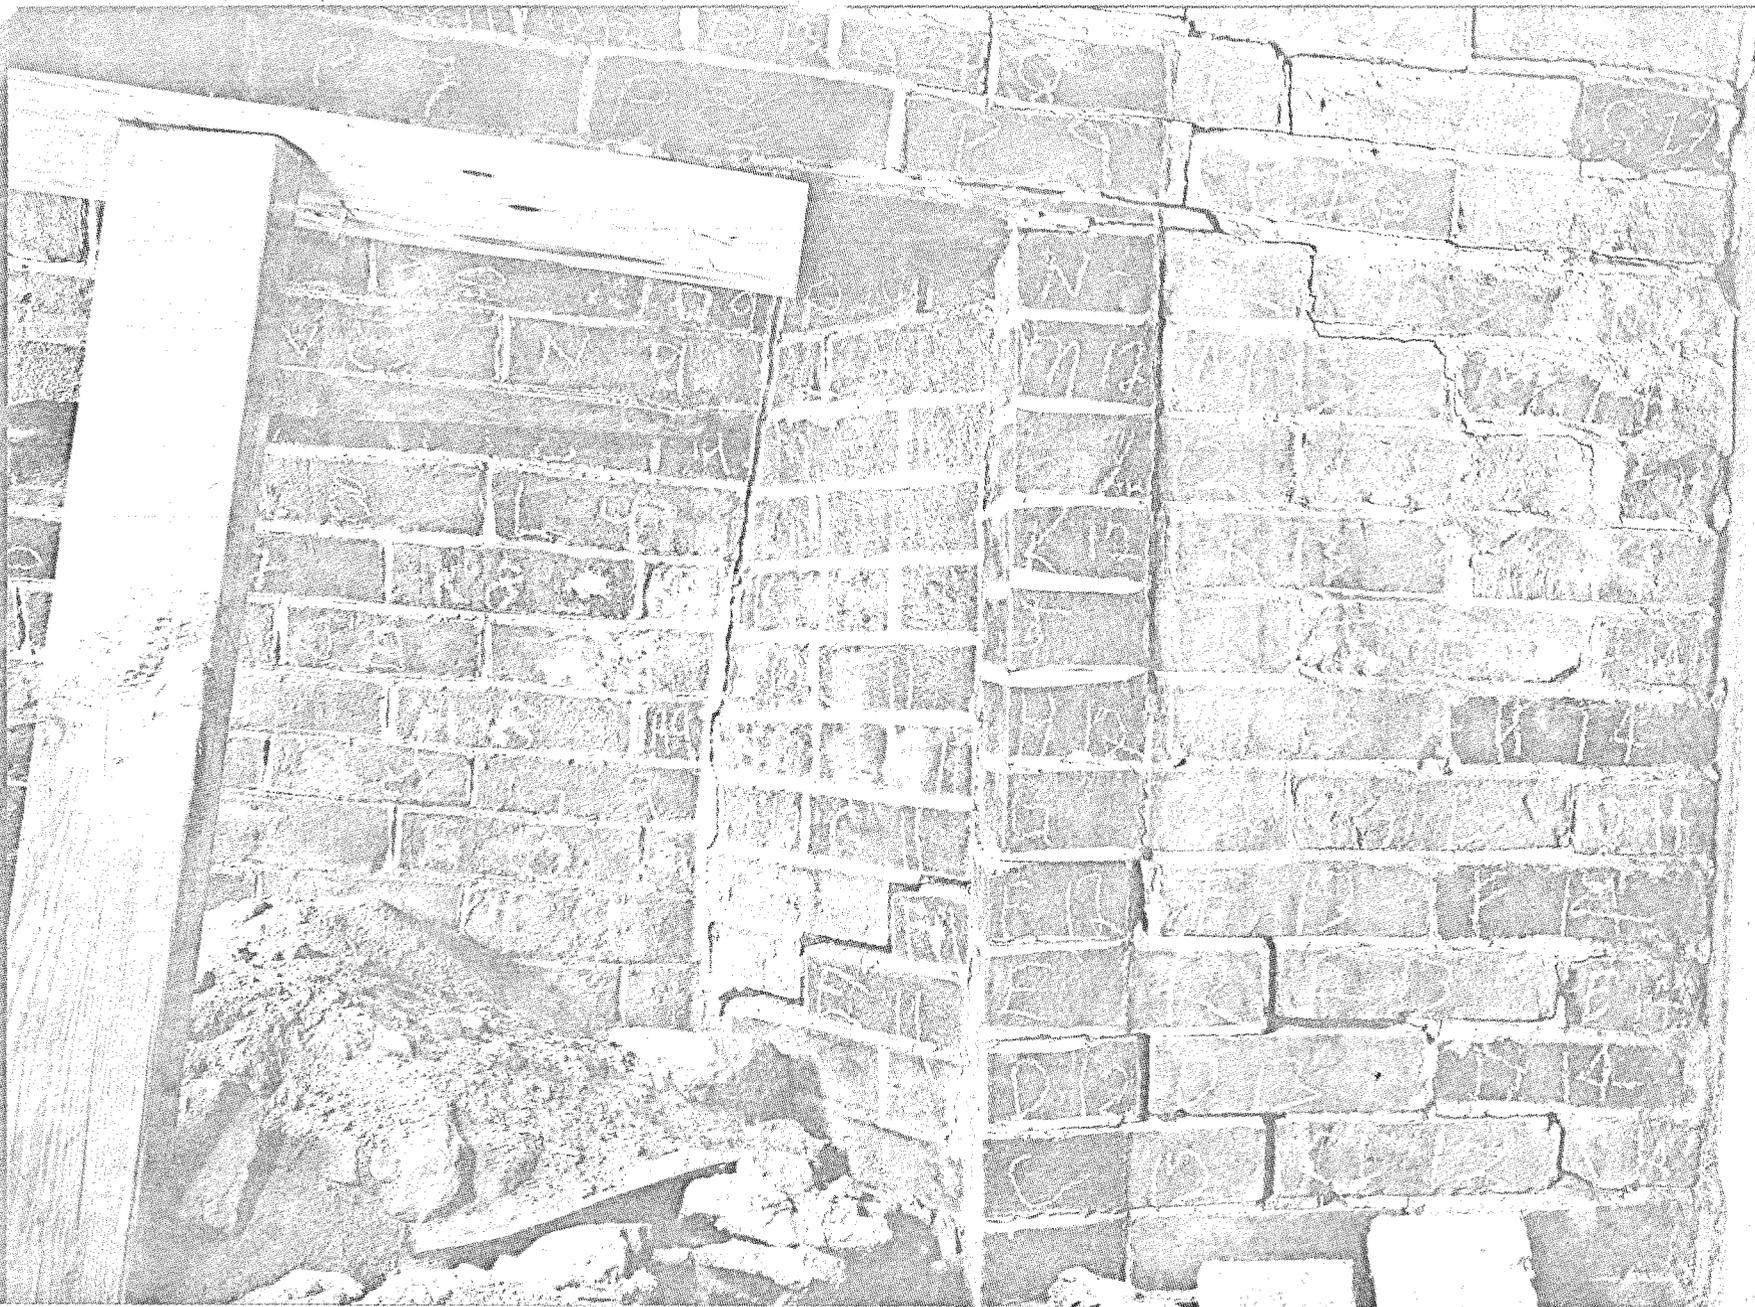
20. Narbonne House, Salem, Mass. Detail of fireplace in north room. Record photograph of bricks in lower right corner.

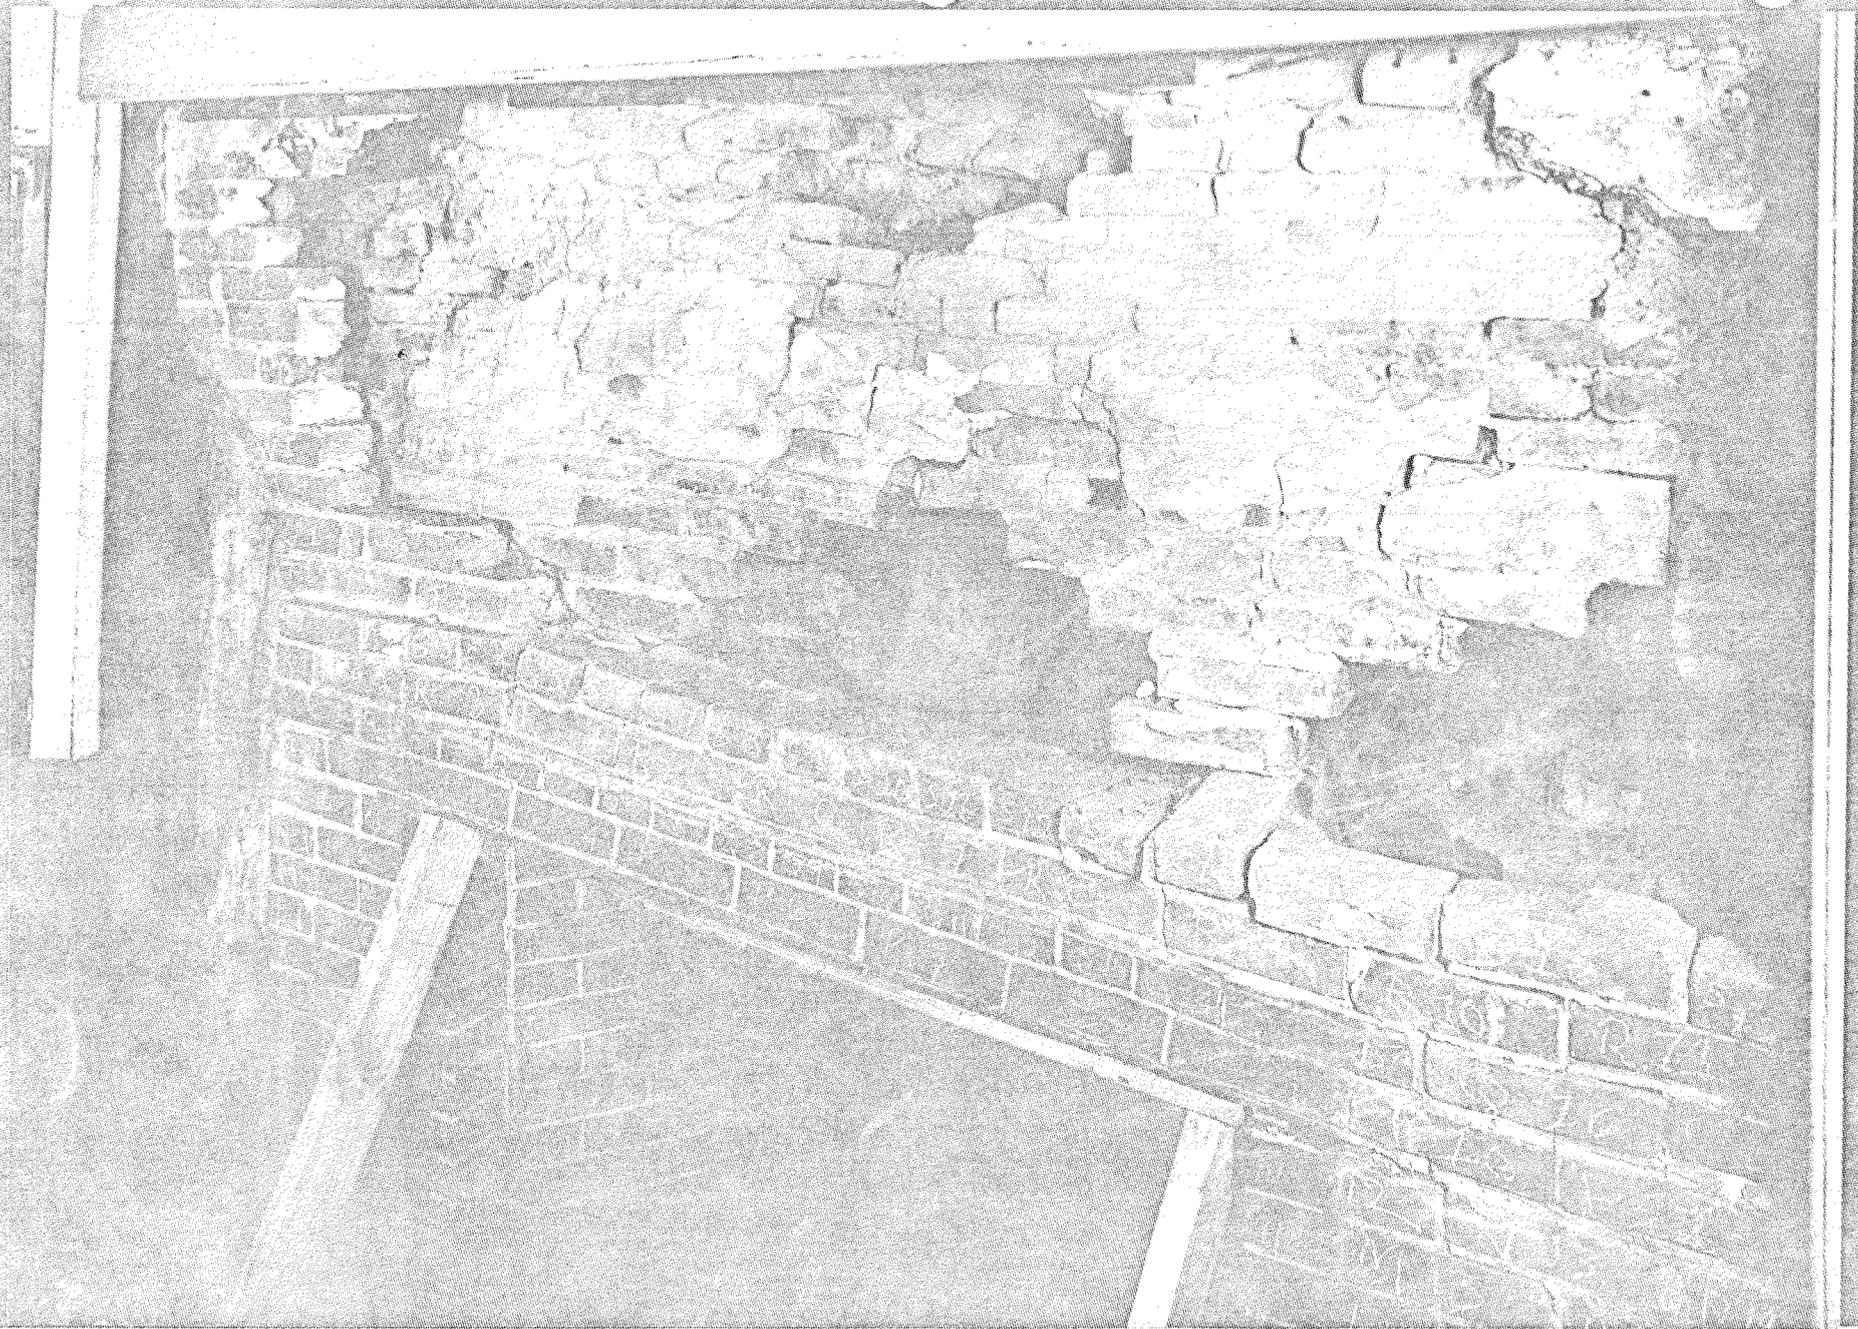
21. Narbonne House, Salem, Mass. Detail of fireplace in north room. Condition upon removal of bricks showing evidence of earlier fireplace.

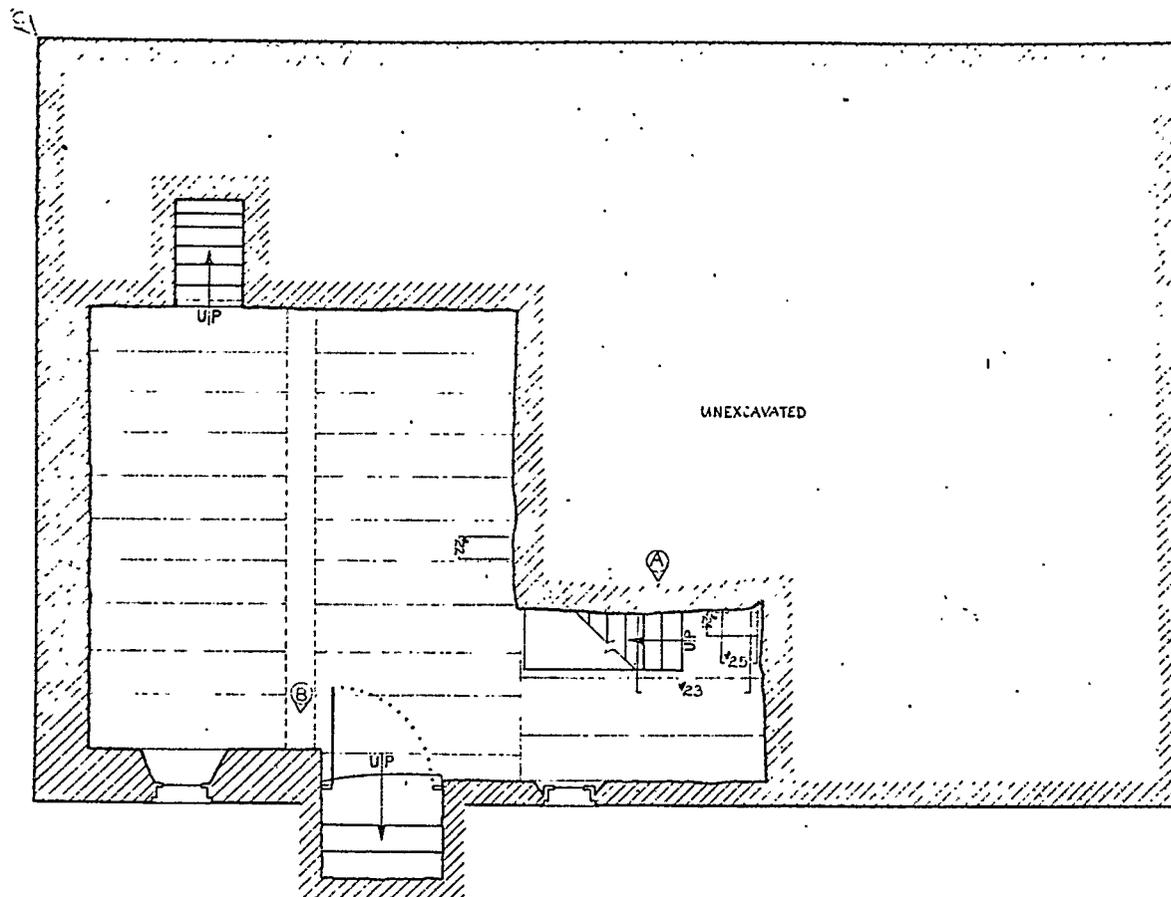
- (A) BULGING FOUNDATION WALL
- (B) TIMBER PARTIALLY ROTTED
- (C) FOUNDATION SETTLING
