HISTORIC STRUCTURES REPORT
PART II
ARCHITECTURAL DATA SECTION
ON
THE RUM SHOP
Salem Maritime National Historic Site

Prepared by
Norman M. Souder
Architect
October 1964

United States Department of the Interior, National Park Service
Eastern Office, Design and Construction
Division of Architecture

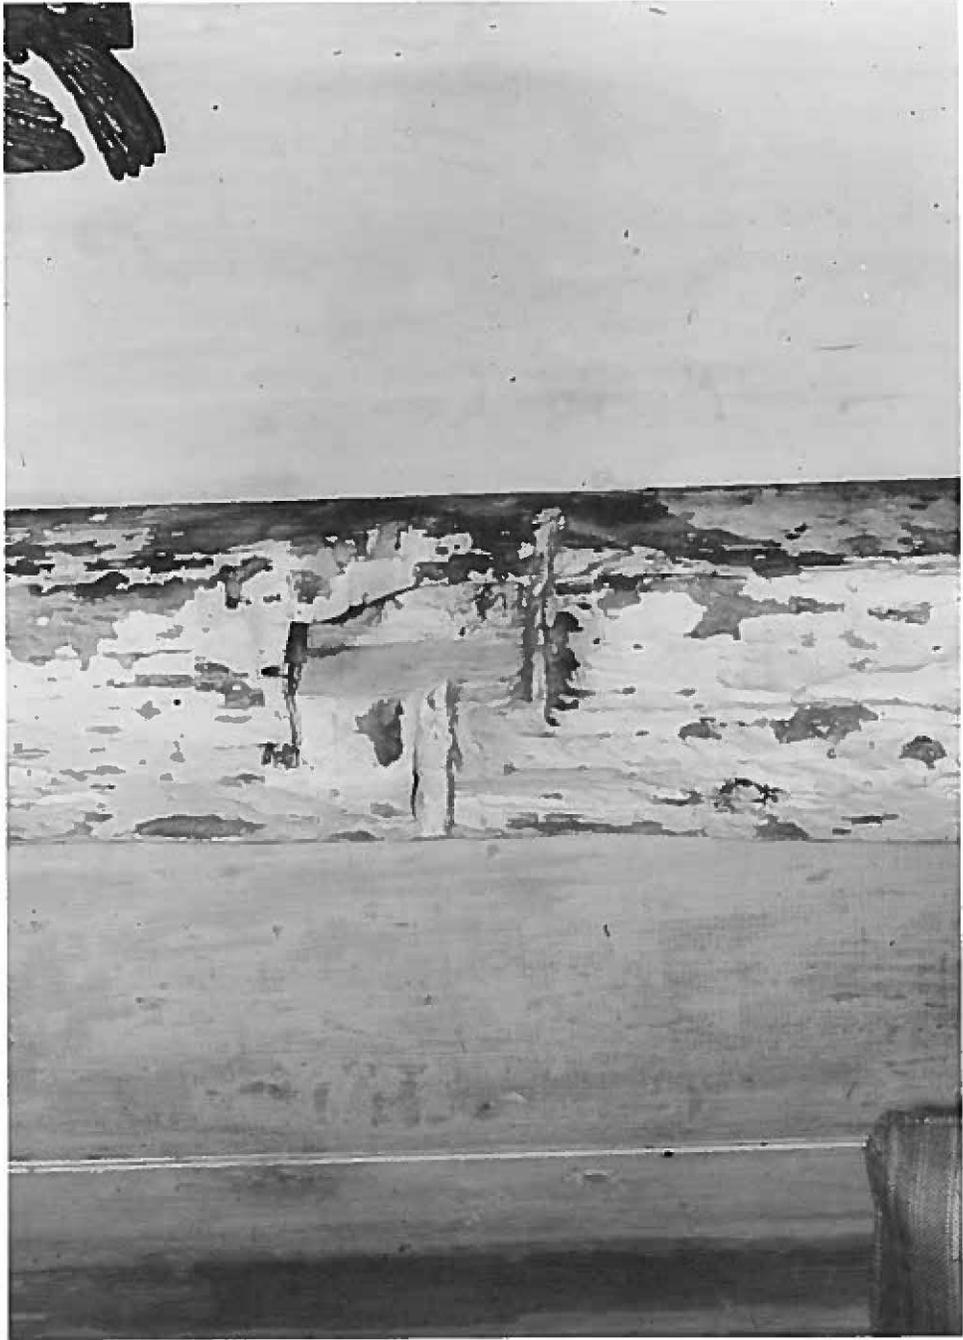
ILLUSTRATION NO. 4

A detail photograph of the west wall of the Rum Shop. The photograph shows the condition of the peeling clapboard siding and the window frame. The window frame is one of the few remaining original features of the building. Most of the existing frames are replacements.
