HISTORIC STRUCTURES REPORT

NARBONNE HOUSE

Salem Maritime National Historic Site

Salem, Massachusetts

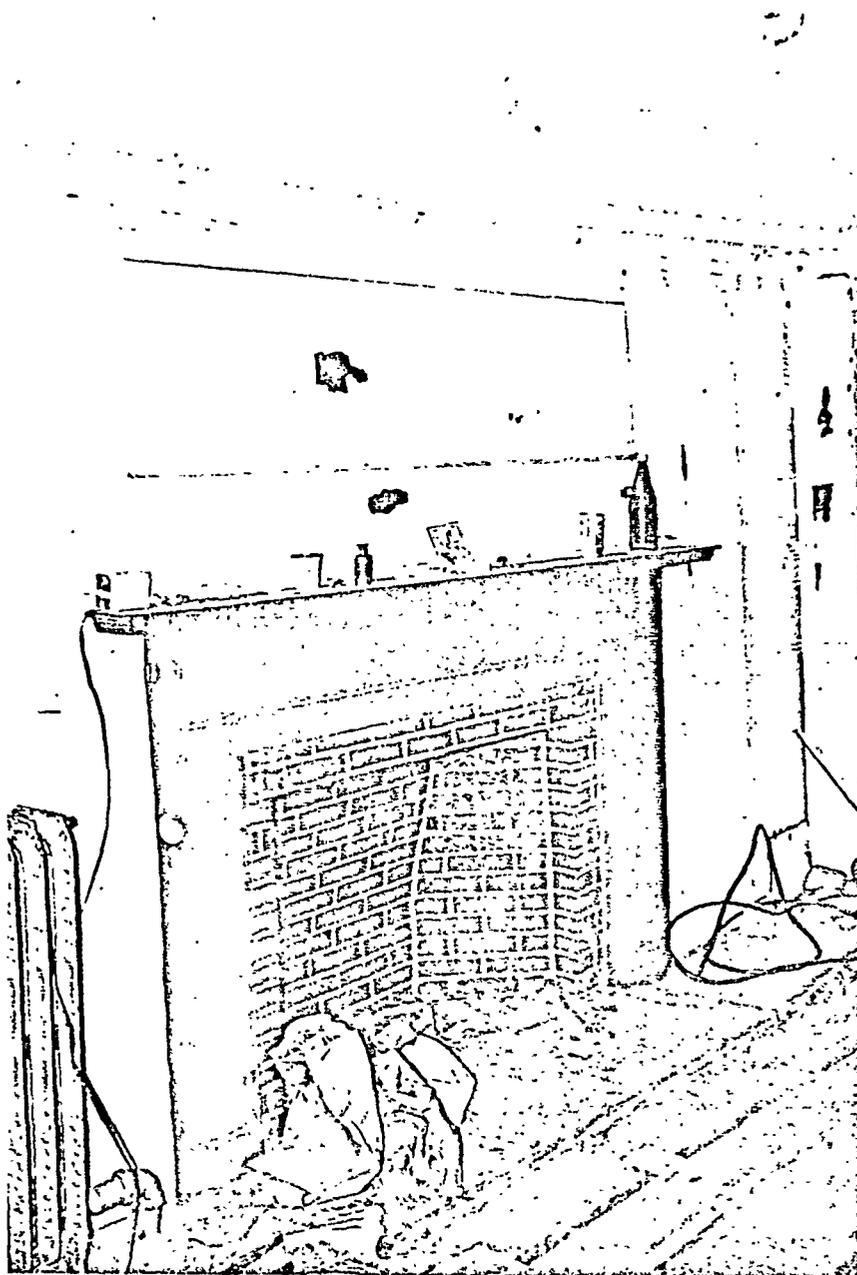
beams seen throughout, most notably the posts in the large first floor room with their chevron ornamentation, (Photograph 29).

Photograph 29: East wall of first floor north room showing Federal mantel temporarily detached from fireplace. Decoratively carved summer beam and post are important seventeenth century features of the house.

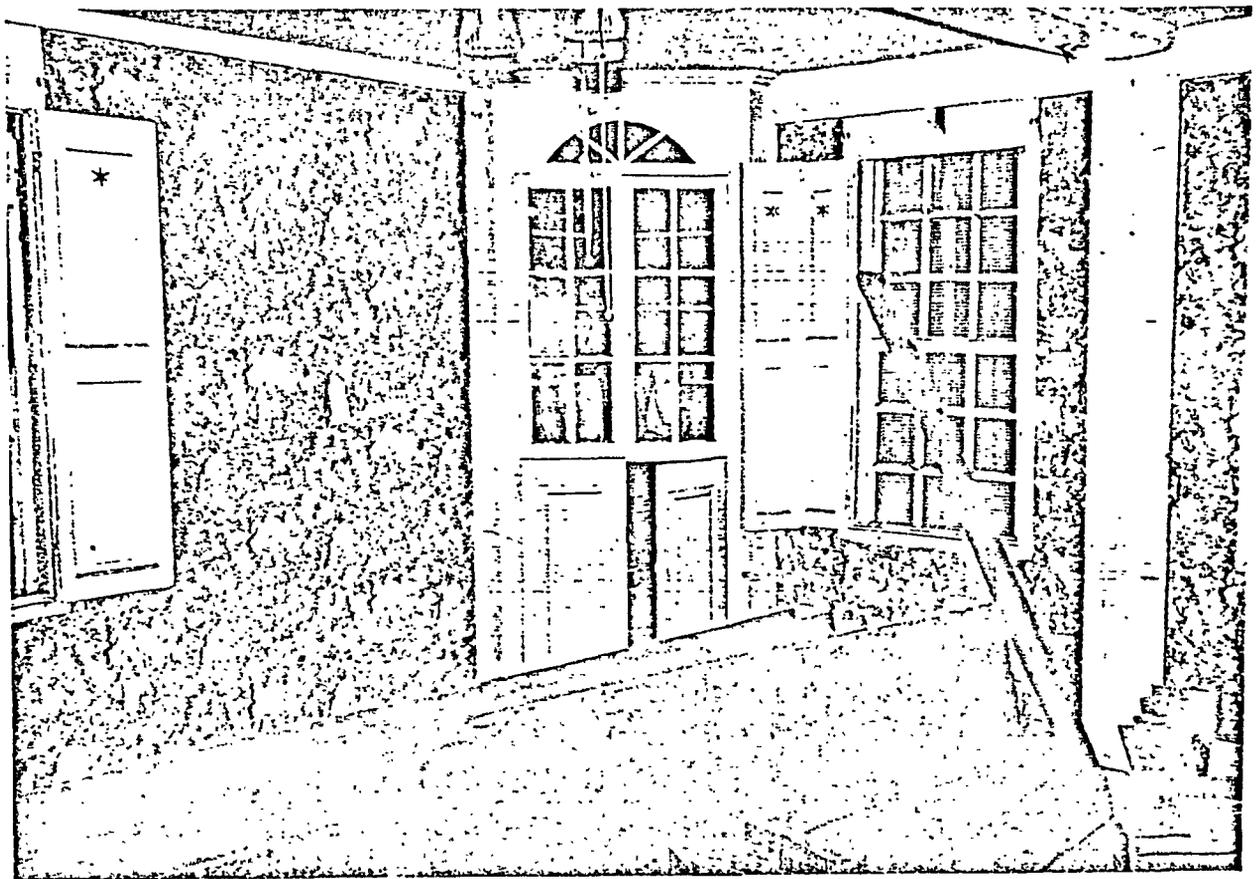
of the added room (Dwg. 4,c). Since the panelling (except for the Federal mantel) is of a relatively early character, this change probably dates back to the addition of the ell, (Photograph 30).

Photograph 30: North wall of first floor south room (in gambrel ell). Federal period mantel is filled against eighteenth century sheathing, which, in turn, covers earlier lath.

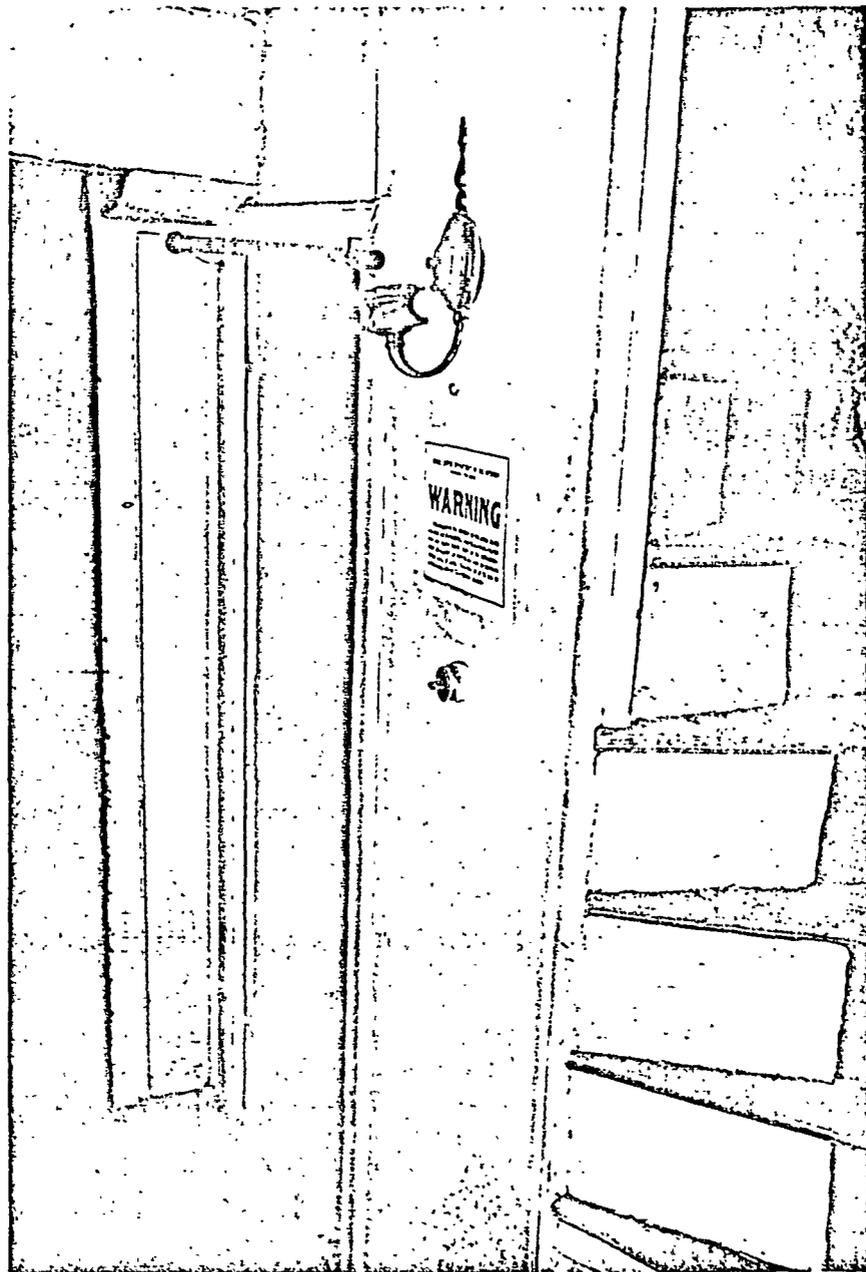
Photograph 32: View toward south in first floor front (west) entrance hall. Chimney girt has been substantially cut to make headroom for door.

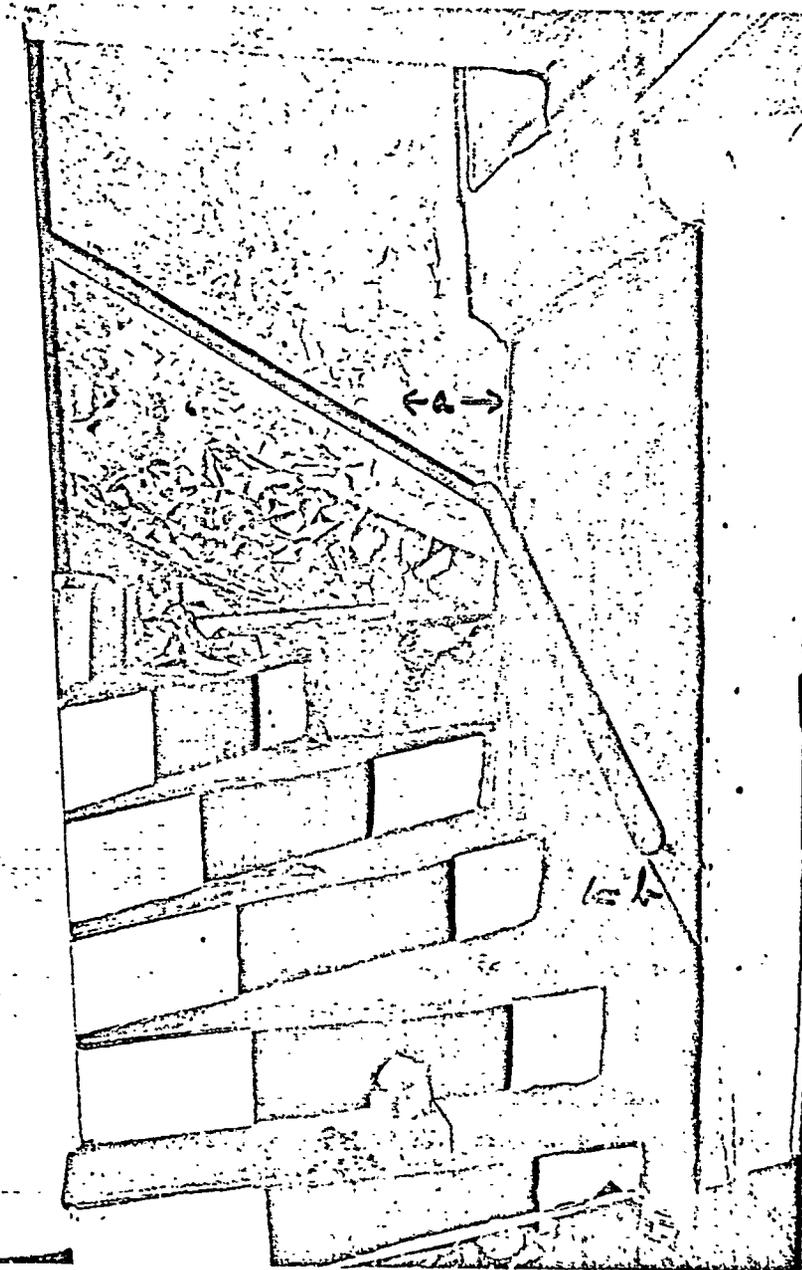
The present front staircase clearly dates from long after the construction of the original house, probably from the date the gambrel ell was added. The sheathing which encloses the stair at first floor level is not of a seventeenth century character (Photograph 33), although at second floor level one sheathing board, possibly re-used, is of the first period (Photograph 35,a). Further evidence of the altered character of the stairs is the existence of a seventeenth-century-type shadow-moulded door at the top of the stairs, (Dwg. 3,d). This door is covered on its north side by the eighteenth century fireplace wall panelling of the north second floor room (Dwg. 3,e). The door does not fit the present stairs but may have fit the earlier ones. In addition, the staircase as a whole extends too far south to have fitted against the west face of the chimney as

Photograph 33: View toward northeast in first floor front (west) entrance hall. Sheathing is not of a seventeenth century character.

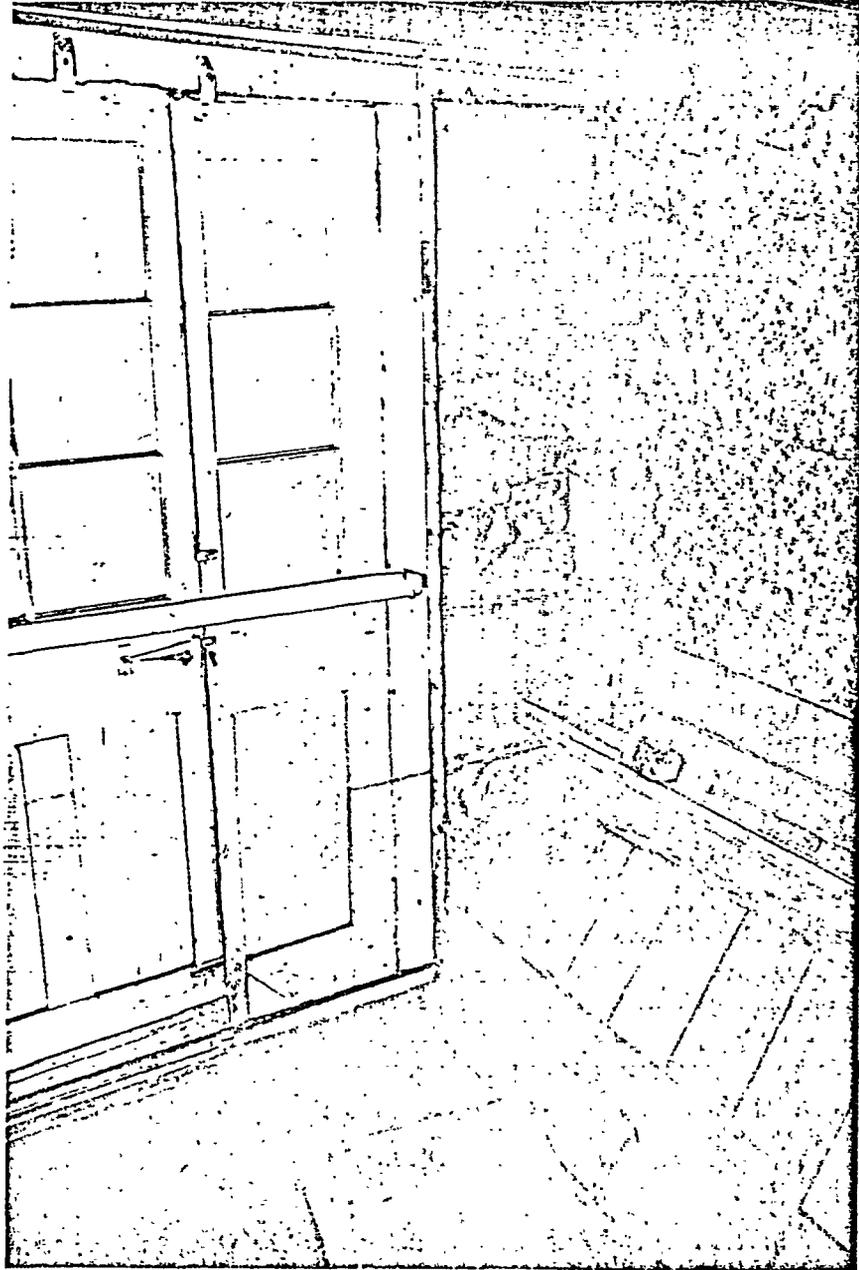
That the earliest portion of the present leanto did not extend all the way across the rear east wall of the house is indicated by many items of evidence, of which only the most obvious and conclusive need be mentioned here. The northern limit of the earliest portion (about 6' south of the present north end of the leanto) is clearly shown by the survival of early clapboarding now covered in by the short addition made toward the north. At second floor level (in the leanto attic) this clapboarding exists on what had been the north end wall of the leanto (Dwg. 3,g) and on what had been a 6' length of the east wall of the original main body of the house (Dwg. 3,h). At first floor level, only the eastward-facing clapboards survive (Dwg. 3,i; Photograph 40), the former northward facing end wall of the leanto having been removed, but the scribe marks for the missing end wall clapboards are clearly seen where they had joined those on the main house (Dwg. 3,j; Photograph 40).

Photograph 40: Clapboards on east wall of main house now enclosed by northern extension of leanto. Clapboards are secured with handmade nails.
