COMMANDING OFFICER'S QUARTERS (Building 1)

Springfield Armory National Historic Site
Springfield, Massachusetts

Historic Structure Report

James J. Lee III
Architectural Conservator
and
Marilou Ehrler
Historical Architect

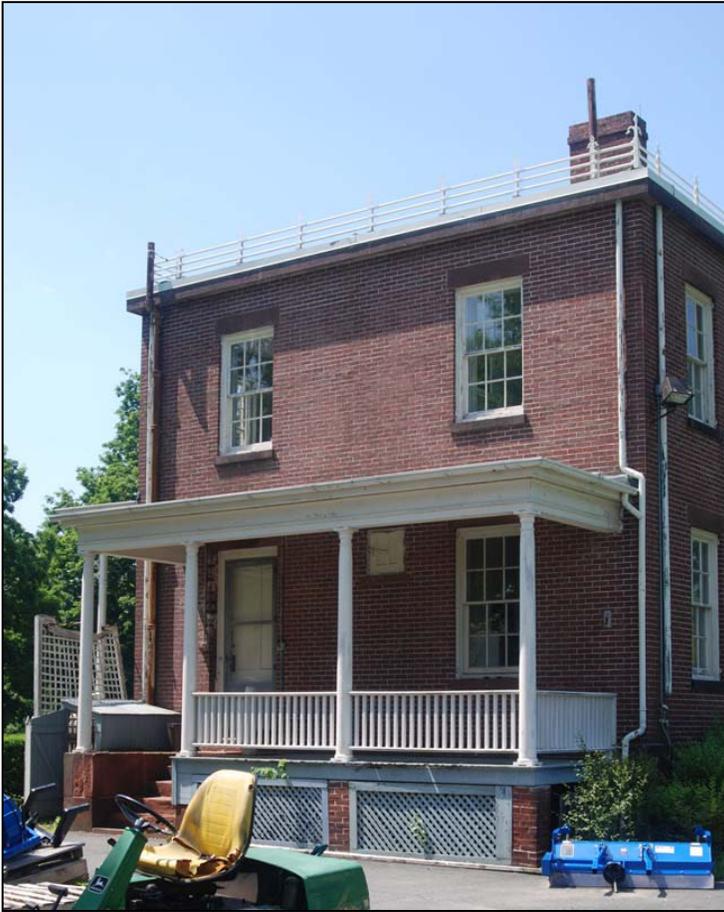
The east porch is again single-story and runs the width of the elevation (fig. 75). At the south end, a brownstone wall and steps form the edge of the porch. Masonry piers encased in

Figure 75. Commanding Officer's Quarters, Ell, east elevation, 2008.

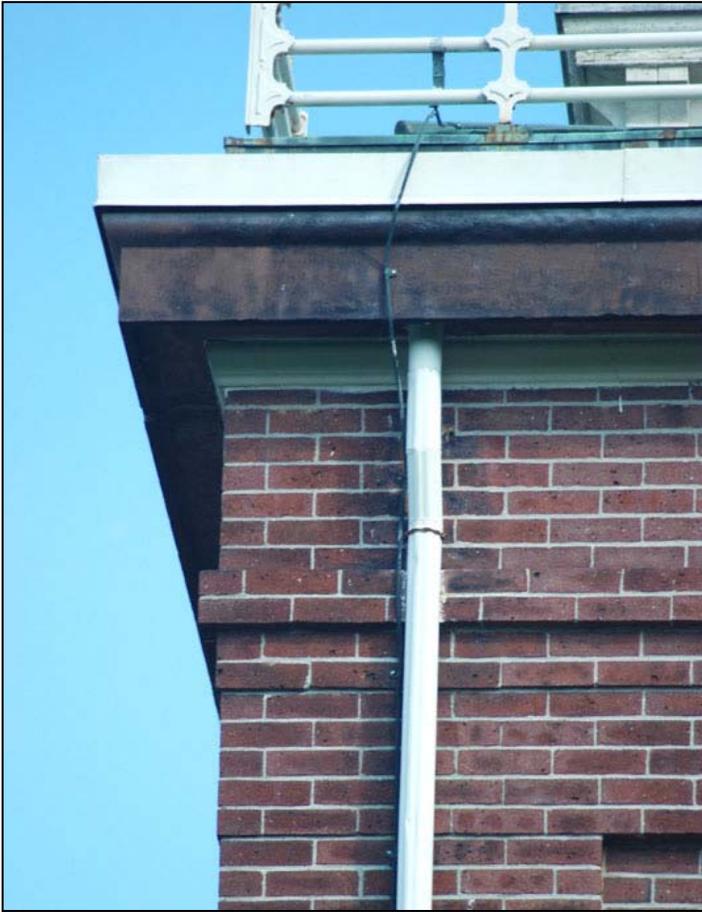
Figure 79. Commanding Officer's Quarters, Main Block, cornice and brownstone gutter, 2008.

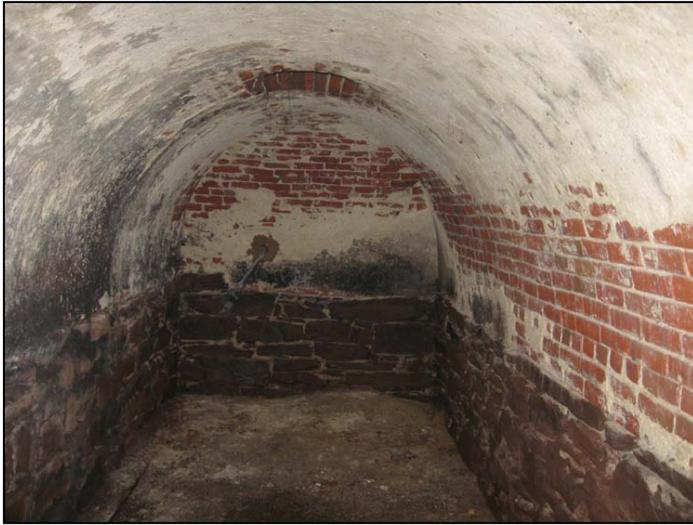
Ceilings: Room B01A has a brick barrel-vaulted ceiling with parging (fig. 94). Two octagonal openings, located on either side of D17A, are set into the center of the vault; both have rusted metal covers. Two courses of brownstone are set on top of the brick arch to support the covers (fig. 95).

Figure 94. Basement, Room B01A, barrel vaulted brick ceiling with brick walls and brownstone foundation, 2008.

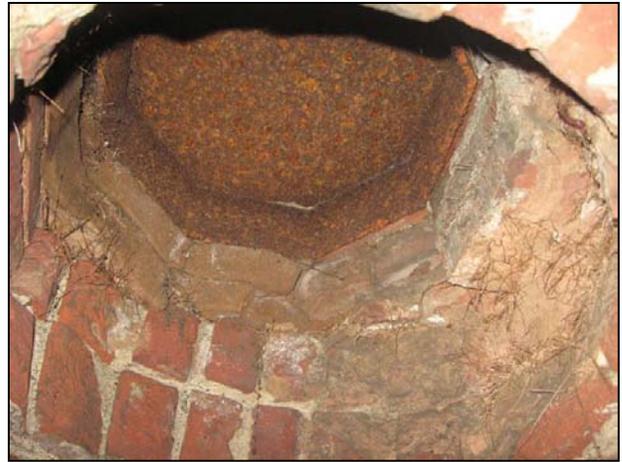
Figure 95. Basement, Room B01A, octagonal shaft in barrel vaulted ceiling with rusted cover, 2008. The 1876 historic plans indicated that the shaft was historically used for coal delivery.

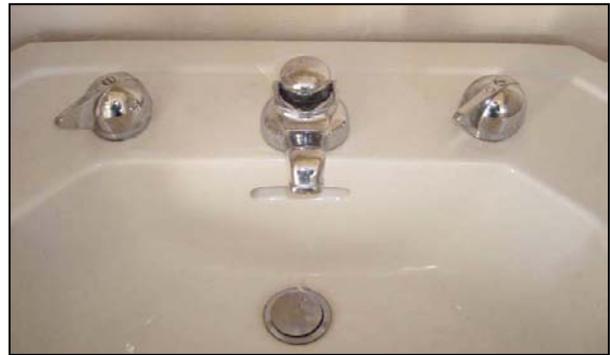
Plumbing: There is a single white porcelain sink set on chrome legs, on the north wall. The faucet is by Crane; the drain pull has a lever handle (fig. 99). A floor-mounted flush-valve toilet is located at the south end beneath the window.

Figure 99. Room 109A, Crane lavatory fixtures, 2008.

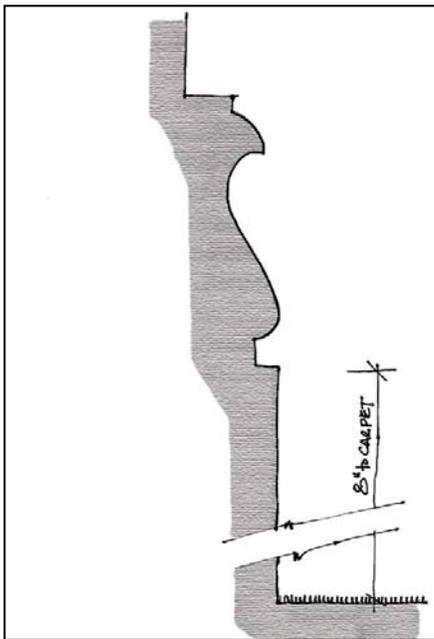
Figure 117. Room 201 baseboard.

Trim: The baseboard trim is visible adjacent to D211; the remaining baseboard, if it is in place, is hidden behind the built-in cabinets (fig. 117). The wooden baseboard has a beak molding set on a cyma reversa on an 8-inch-tall flat plinth. The cabinets are scribed to the wall.

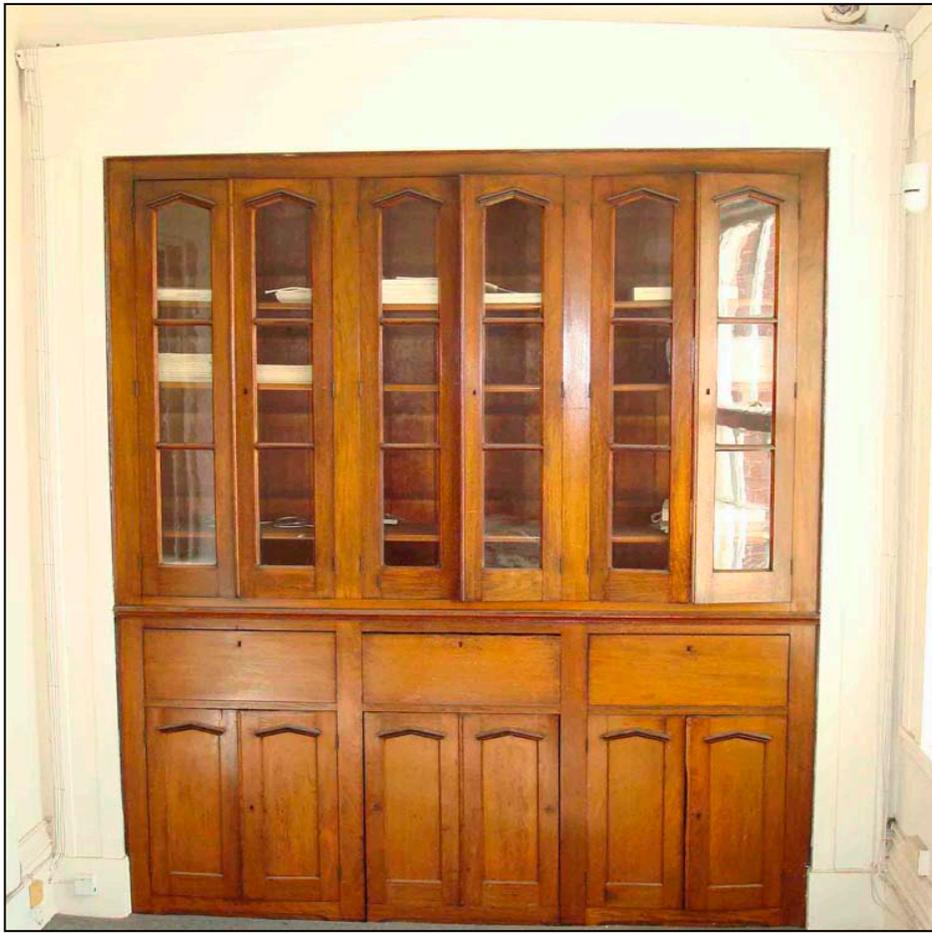
Built-ins: There is a built-in cabinet along the east wall (fig. 118). Three paired three-light sashes, the top light with a pedimented head, set atop flat-panel drawers, above three paired flat-panel cabinet doors; the panels have pedimented heads. Three wooden shelves continue behind all three pairs of doors; the wall behind the shelves is bead-board. The center cabinet has a gas light fixture mounting bracket with a decorative escutcheon plate on the rear wall (fig. 119). The center drawer is actually a fold-out writing desk, and the lower cabinet conceals a roll-out seat. The cabinet is stained a natural wood finish. The entire cabinet is set within a wooden casing with decorated pilaster jambs with plinths and a stepped-pedimented head with a cornice.

Figure 118. Room 217, built-in cabinets on east wall.

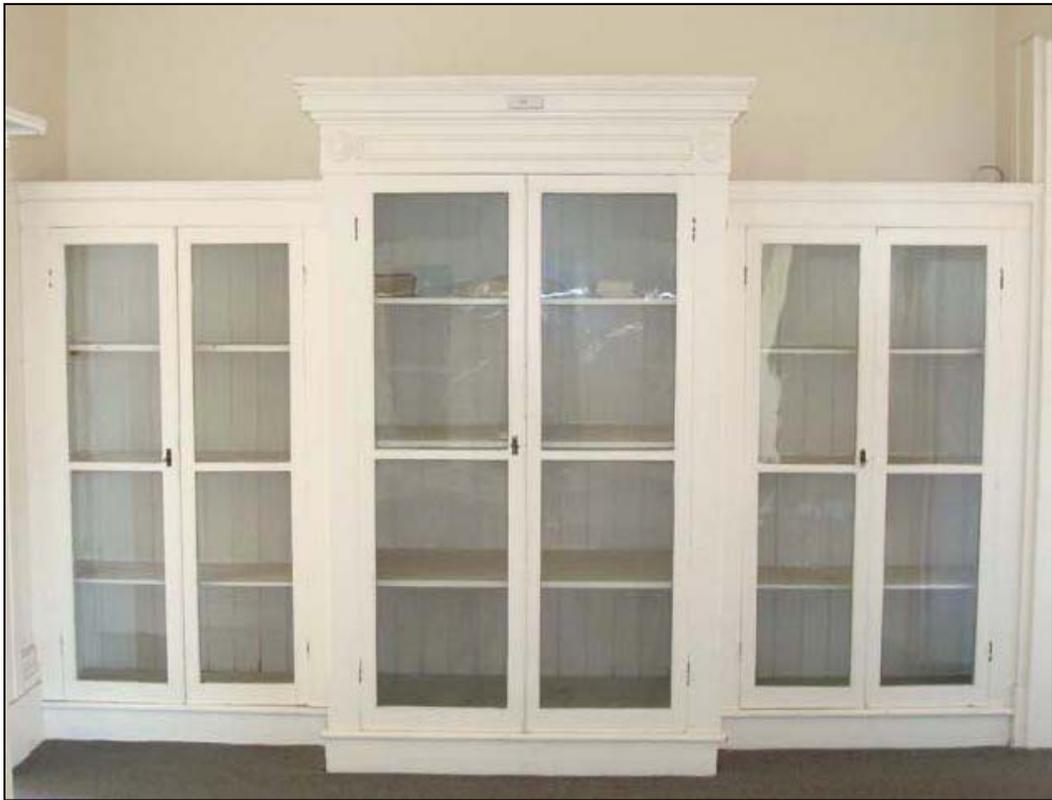
Built-ins: Cabinets along the north, south, and west walls. The cabinets at the north and south ends are similar with a three-part design (fig. 122). The central section is taller, stands above, and projects farther out from the wall than the flanking side cabinets. The center cabinet has a pair of one-over-one-light doors hung on a pair of three-knuckle cabinet hinges with an architrave with bull's-eye corner blocks finished with a detailed cornice above. The side cabinets have a single pair of one-over-one-light doors hung on a pair of three-knuckle

Figure 122. Second story, Main Block, Room 201, built-in cabinets on north wall, 2008.

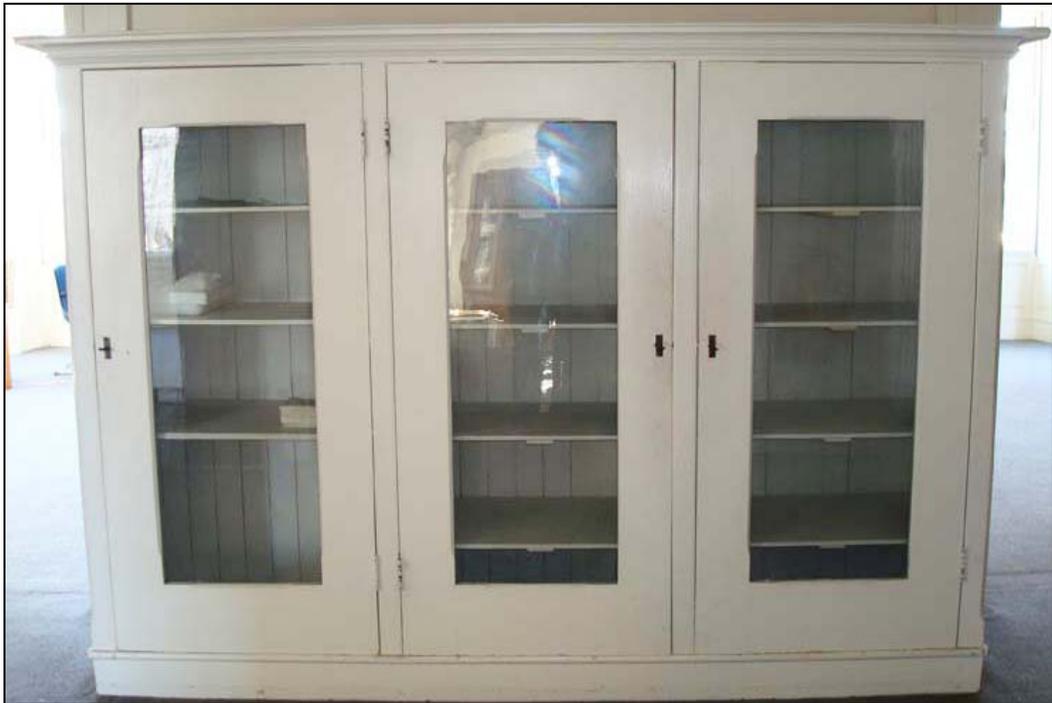
The cabinet along the west wall has three single-light glass doors, each hung on a pair of bronze five-knuckle cabinet hinges, capped by a single crown molding (fig. 123). Each door has a bronze turnbuckle cabinet knob. The interior back wall is bead-board, and the wooden shelves are all painted.

Figure 123. Second story, Main Block, Room 201, built-in cabinets on west wall, 2008.

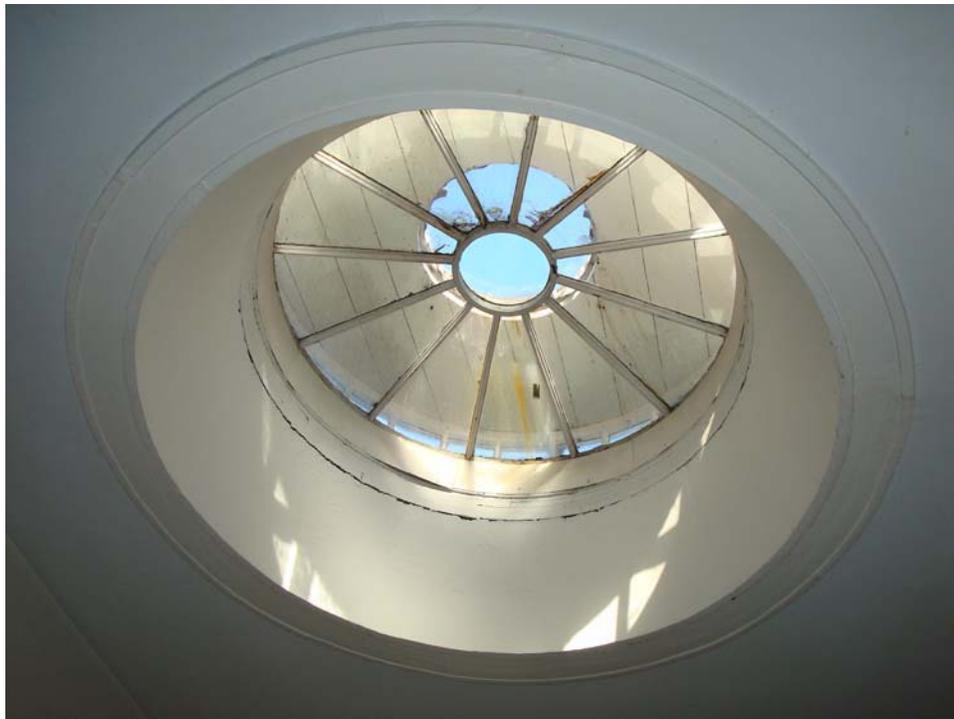
Figure 131. Circular laylight over main staircase to attic story, 2008.

Windows: Above the staircase landing at the east end of the room is a round laylight with twelve light divisions around a center circular light. An articulated plaster casing encircles the laylight. On the exterior the laylight is covered by a protective roof/light structure, visible from below (fig. 131).

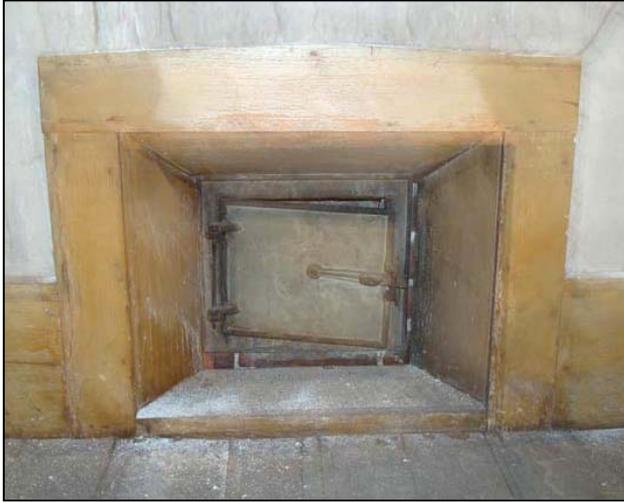
Figure 133. Attic, Main Block, Room 304, small doorway with metal door and grained wood casings, 2008.

There are two flat metal doors set in the short knee walls at the exterior north and south walls. The doors open to ventilation shafts. The doors are set into grained wooden casings with pedimented heads and cased splayed walls. The doors are 12 inches wide by 11 inches tall, hung on a single hinge with a latch (fig. 133).
