# **BUILDING No. 5 & 6**

## **HISTORIC STRUCTURE REPORT**

**Springfield Armory National Historic Site  
Springfield, Massachusetts**

2012

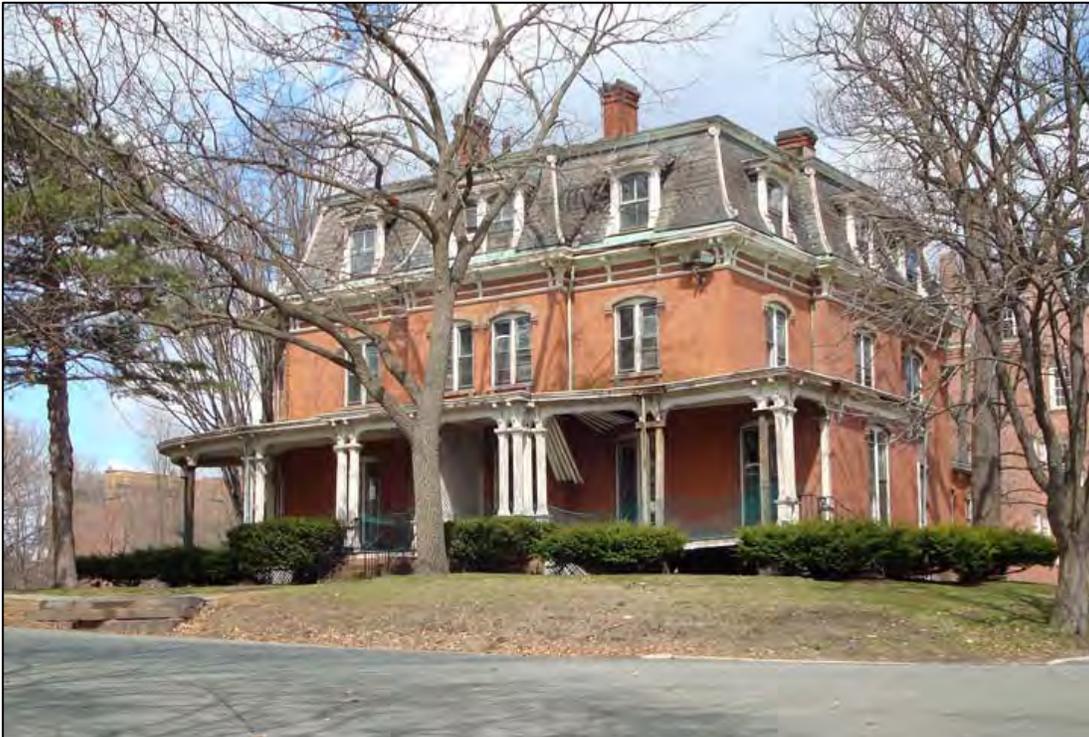
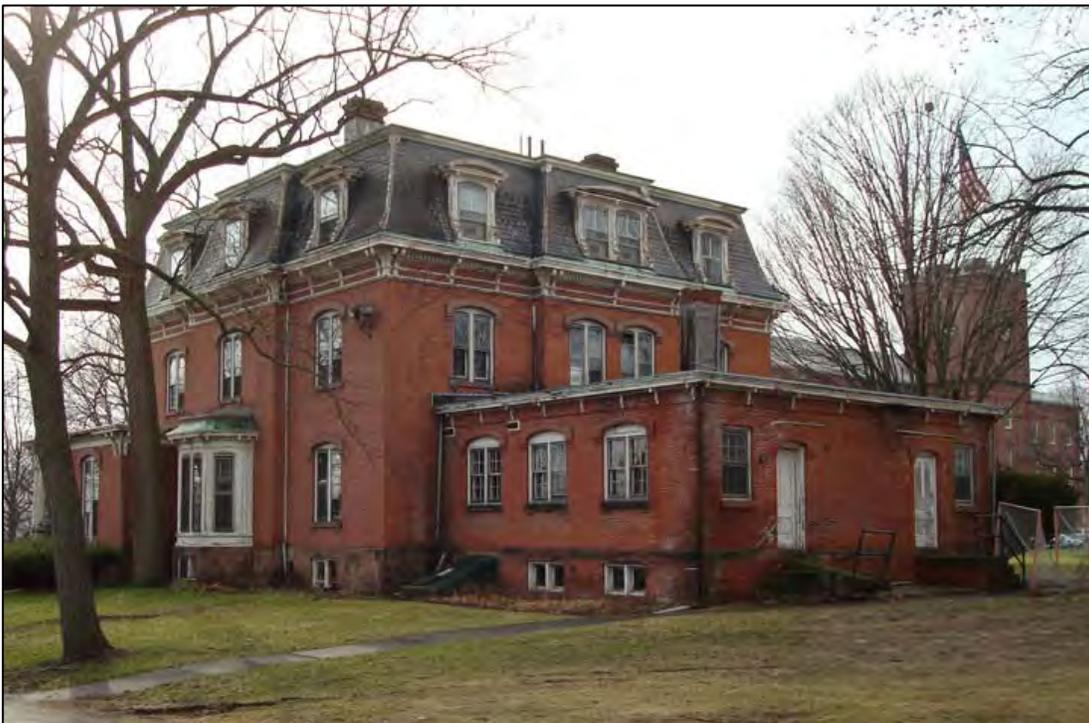
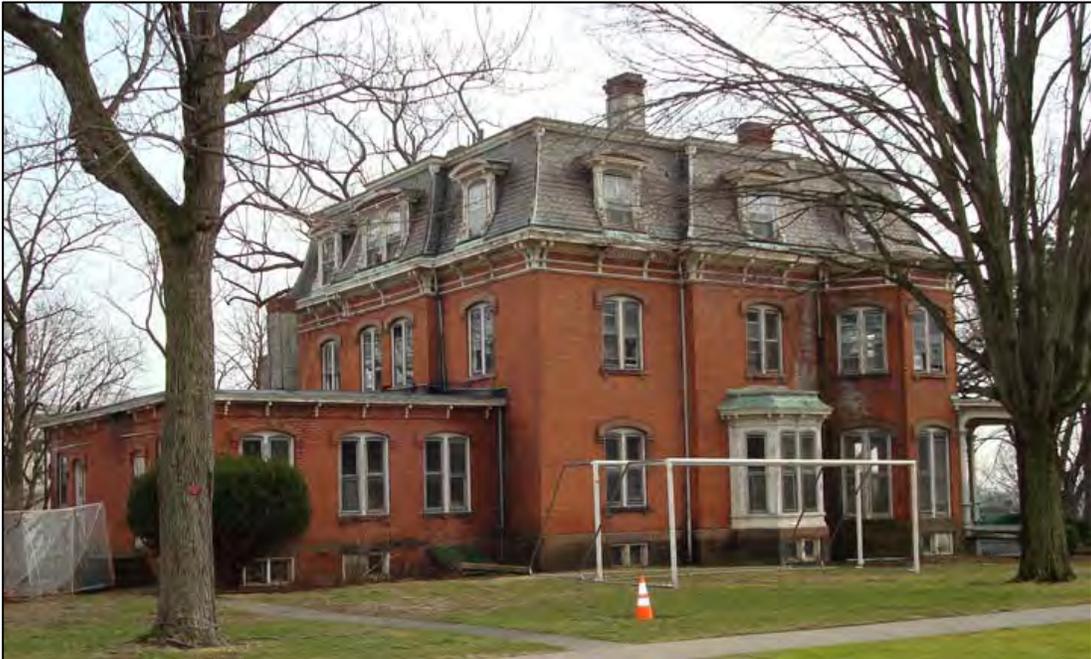
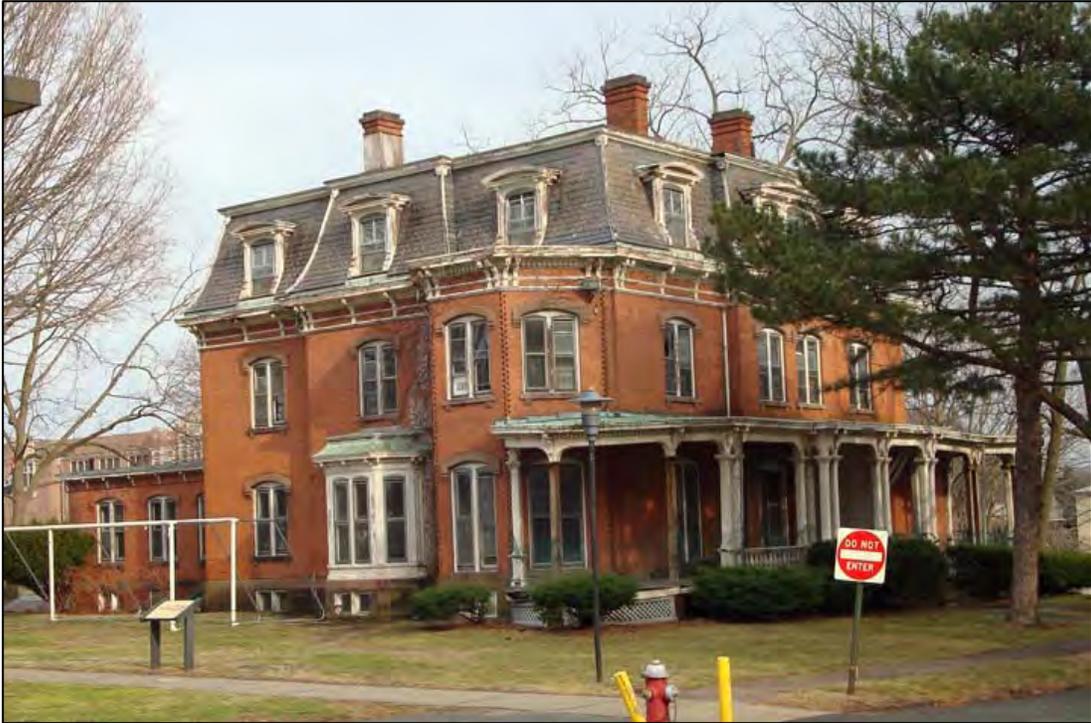
The exterior and interior of Building No. 5 & 6 retain historic elements that convey its historic appearance, but the building is in overall poor condition and some of the historic elements may be deteriorated beyond repair (figs. 93–96).

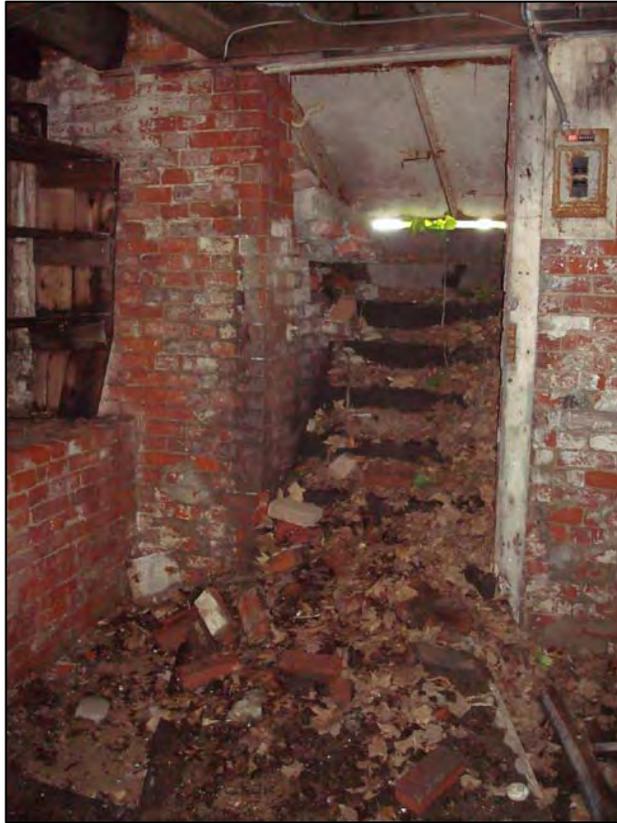
The brick retaining wall of the bulkhead entrance has buckled and partially collapsed (fig. 99). This is due to water infiltration and poor drainage on the exterior of the building. The bulkhead wall is in poor condition, and the water infiltration could cause further damage to historic materials.

Figure 99. Building No. 5 & 6, Quarters No. 5, bulkhead walls and steps showing collapsed wall on left side of bulkhead steps, 2011.

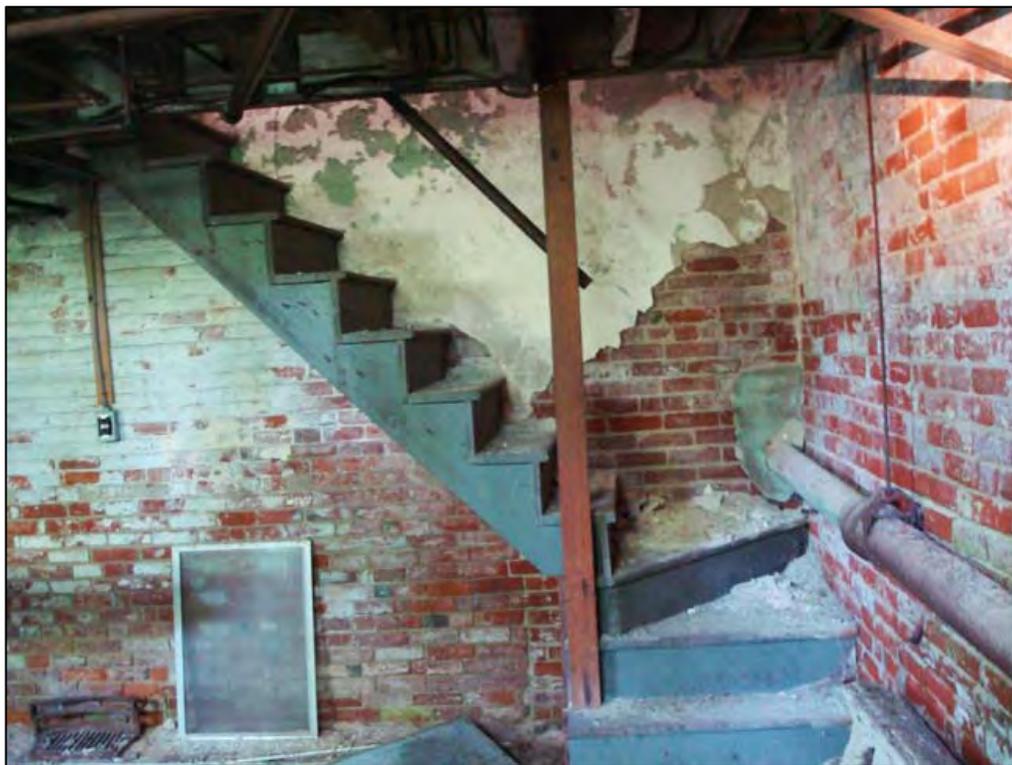
The staircase in the Kitchen ell leads down to the basement of Quarters No. 6. On the first story the staircase is enclosed by plaster walls, and in the basement it is an open-stringer staircase (fig. 100). It has wooden treads and risers with a winder tread near the bottom of the stairs. There is a wooden handrail on the south side of the staircase. This is currently the only interior staircase to the basement. The original staircase is extant in Room 6/007, but has been blocked off at the top the stairs (fig. 45). This staircase has wooden bullnose treads and wooden risers. The wooden stair stringer has the same profile as the adjacent baseboard in Room 6/007.

Figure 100. Building No. 5 & 6, Quarters No. 6, Room 6/005, basement stairs in Kitchen ell, 2011.

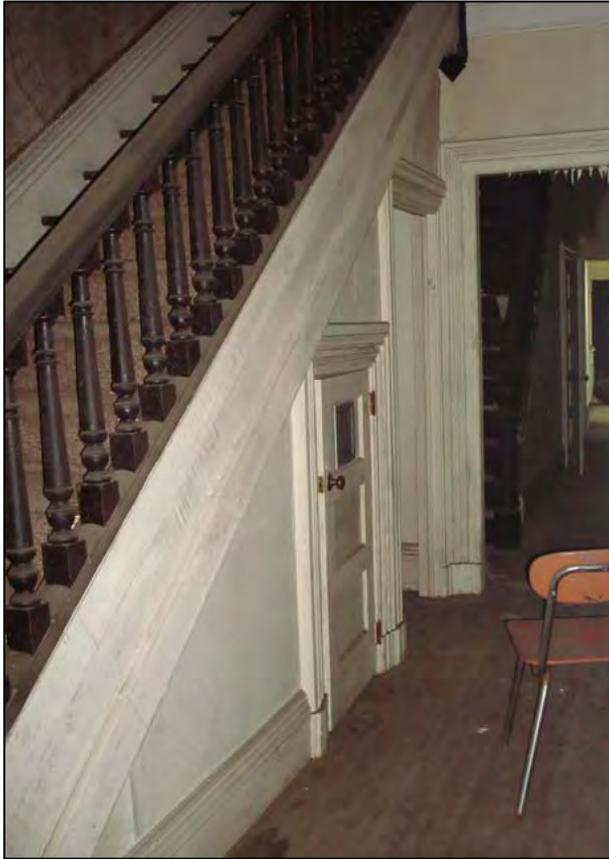
The doorways under the front hall stairs were added during the 1960 alterations (fig. 105). There is a low doorway to a small closet and a doorway to the larger closet that in turn leads to the doorway connecting to Quarters No. 5. The doorways casings are similar to the historic casings, and the door to the small closet is a three-panel door with butt hinges and a brass knob. The larger closet door is missing. The connecting doorway has the historic casings and four-panel door.

**Figure 105.** Building No. 5 & 6, Quarters No. 6, Room 6/101 wall under front stairs with added closet doorways, 2011.

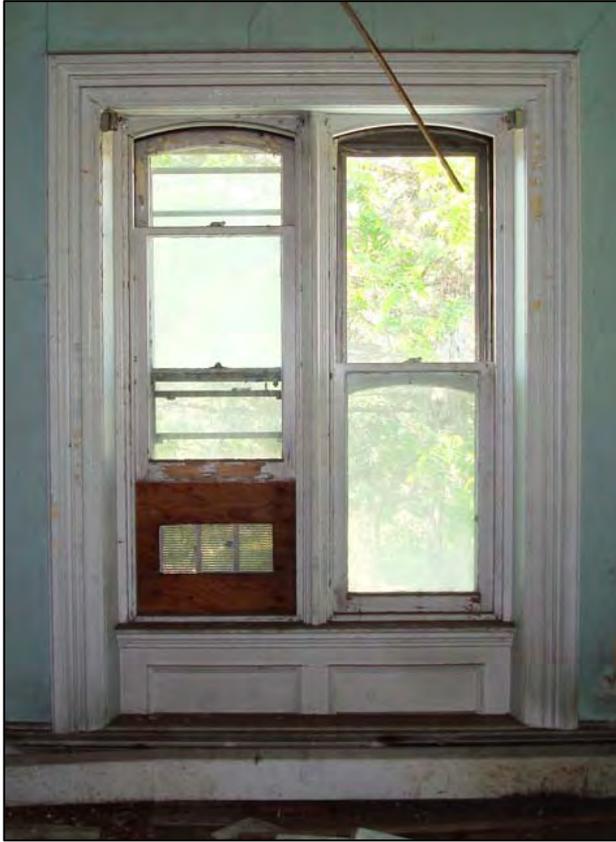
The window elements on the second story including the bay in Room 5/202 have not been significantly changed since the historic period. The double windows are set in shallow niches surrounded by wooden casings (fig. 107). The historic casings in the front rooms are more elaborate than those in the back rooms. The windows retain the historic double sash sets, molded panels, and casings. However, part of the panels below the windows, the base of the window casings, and the baseboards were removed when baseboard radiators were installed. The double window in Room 5/205 has been covered with glass blocks and the interior elements could not be assessed.

**Figure 107.** Building No. 5 & 6, Quarters No. 5, Room 5/202, W201 typical interior window in second-story bedrooms at the front of the building, 2011.

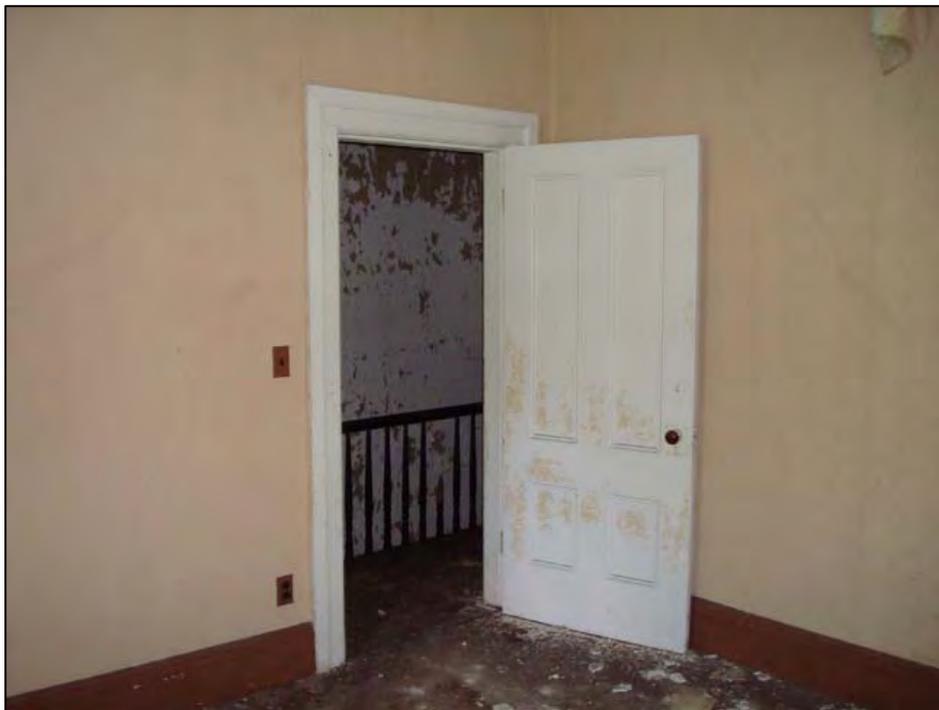
The attic doorways in the rooms and closets have wooden casings and doors. The casings have two boards with quarter-round edges, and the doors are four-panel doors with lift-off hinges and porcelain knobs (fig. 114). The doorway in Room 5/303 has a two-light transom. All of these elements are historic and retain a high degree of historic integrity.

**Figure 114.** Building No. 5 & 6, Quarters No. 5, Room 5/304, typical attic doorway, 2011.

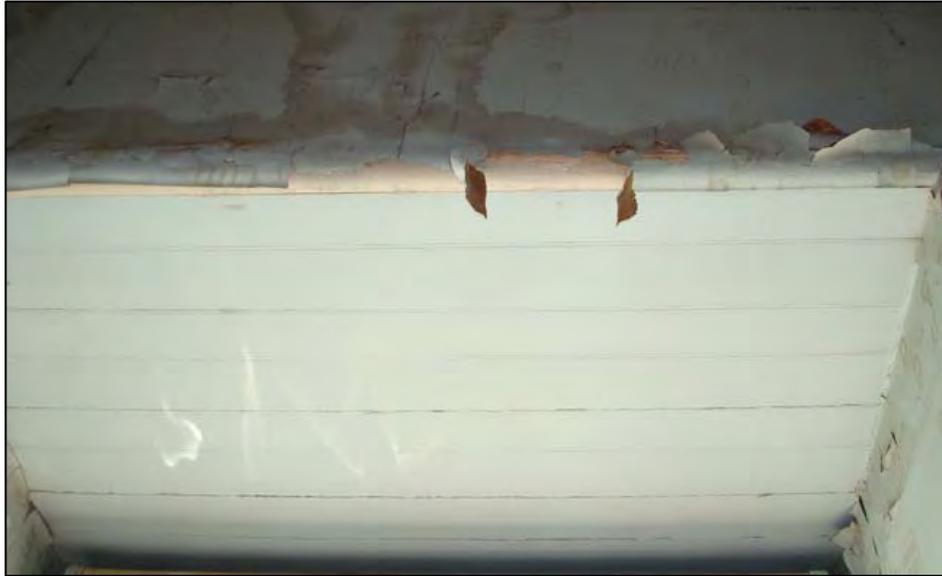
The attic windows in Quarters No. 5 have double-hung, two-over-two sashes, and are set in deep niches formed by the framed walls. The windows have plain casings and windowsills with molded aprons below the sills. Some of the window niches have tongue-and-groove boards on the ceiling (fig. 115). The window elements are in fair condition and retain a high degree of historic integrity.

**Figure 115.** Building No. 5 & 6, Quarters No. 5, Room 5/302, tongue-and-groove board ceiling in window niche, 2011.

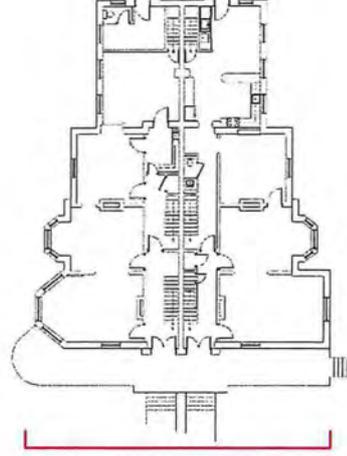
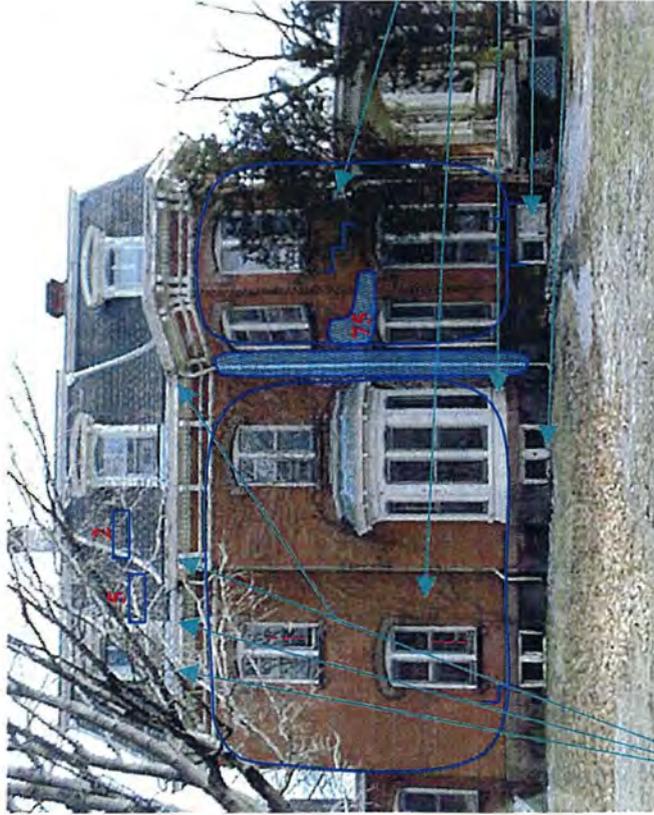
# Building #5/6 North Façade: West End

- Re-grout around all stone window sills and windows
- Damaged/missing slate roof tiles
- Severe rot at roof ridge
- Aluminum storm system at all windows (except at basement)

Significant weathering; soffit rot severe

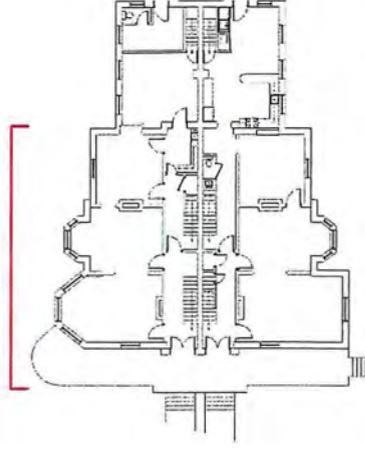
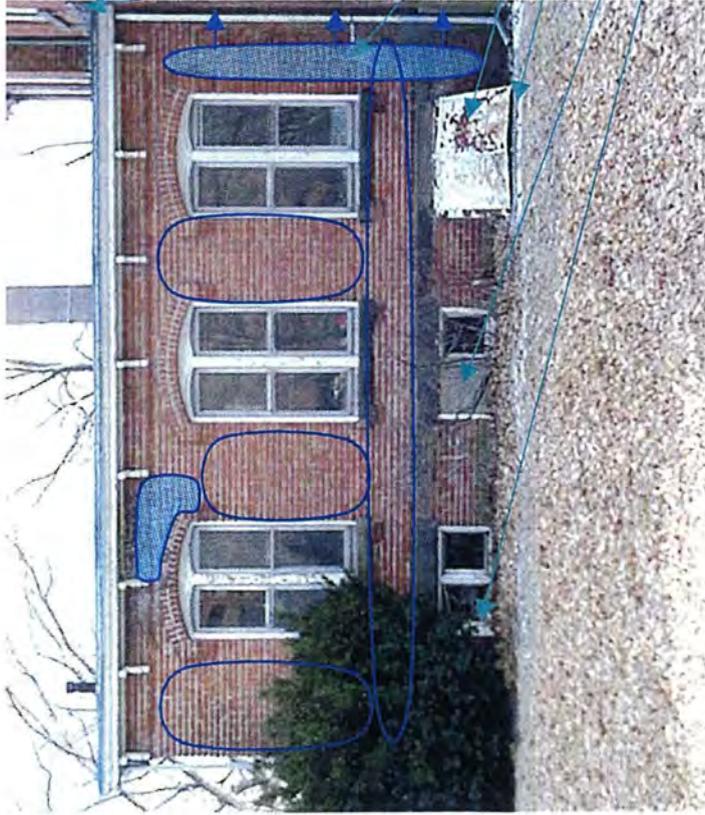
# Building #5/6 North Façade: East End

- Rotting wood at soffits
- Rubber roof needs replacement
- Aluminum storm system at all windows (except at basement)

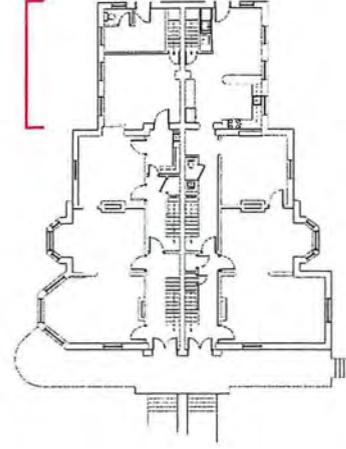
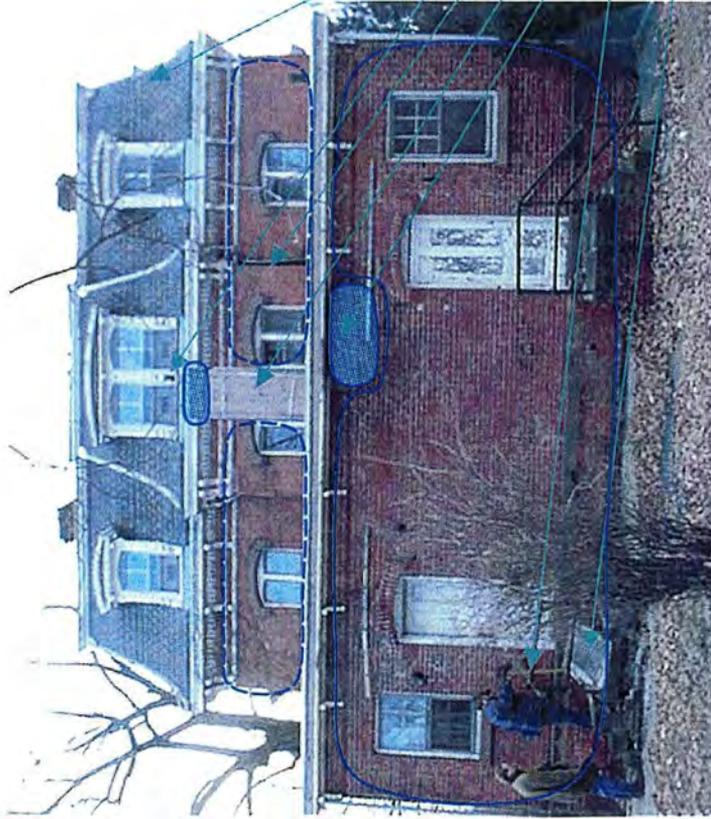
# Building #5/6 East Façade

- Severely weathered doors
- Missing light fixtures
- Rotted and weathered soffits
- Wood window frames generally salvageable
- Copper flashing in good condition
- Aluminum storm system at all windows

- 4 or 5 slipping slate tiles
- Missing wood trim
- Copper downspout missing brackets
- Plywood strapped chimney
- Missing bracket
- Wood rail is rotted; metal brackets are corroded but intact
- Displaced Stair

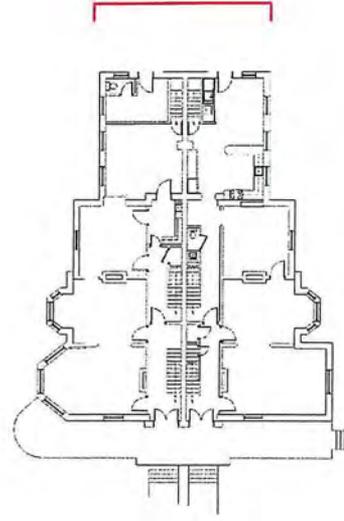
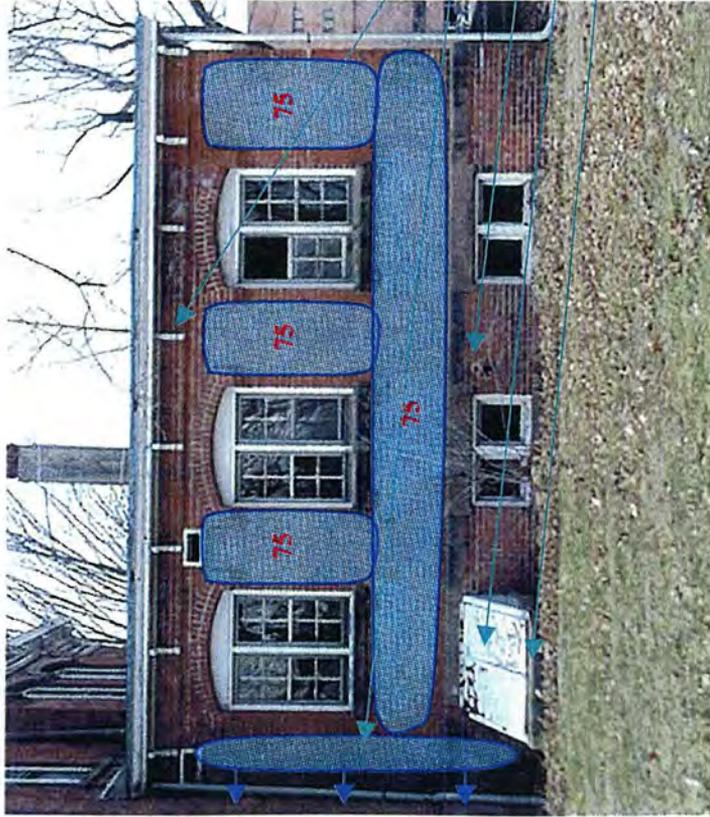
# Building #5/6 South Façade: East End

- Rotting wood at soffits
- Rubber roof needs replacement
- Aluminum storm system at all windows (except at basement)
- Metal pipe straps at aluminum downspout)

- Most brackets rotted or broken
- 100% repointing at indicated area of East face
- Opening for pipe
- Severely rusted bulkhead door
- Concrete repairs to original stone at bulkhead are deteriorating

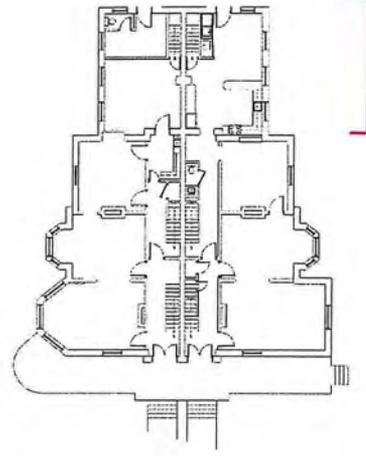
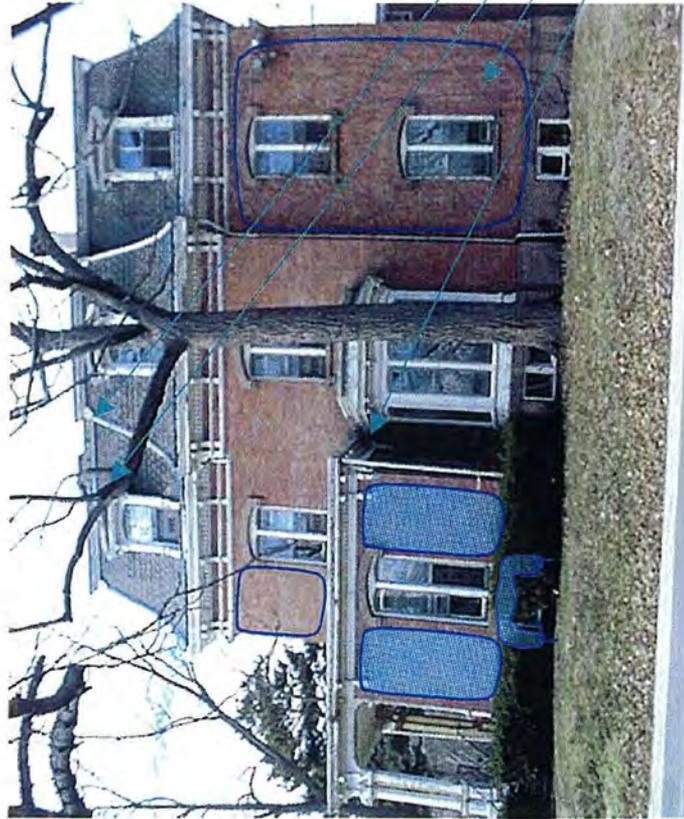
# Building #5/6 South Façade: West End

- Significant rot of soffits and gutters
- Wood window frames generally salvageable
- Remaining columns may be salvaged, with significant repair
- Copper flashing in good condition
- Porch floor has some buckling, significant weathering
- Lifting/damaged slate tiles
- Aluminum storm system at all windows (except at basement)

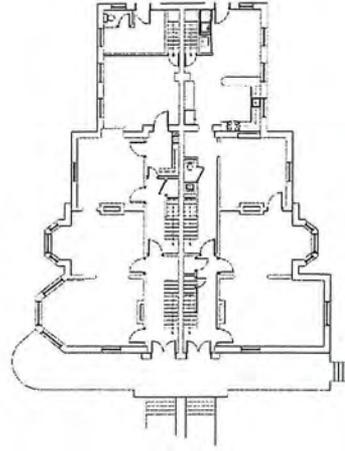
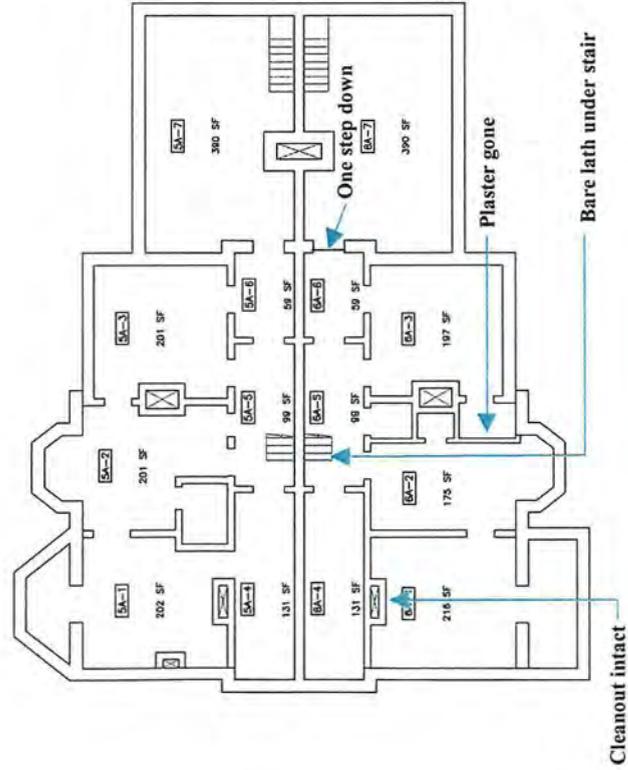
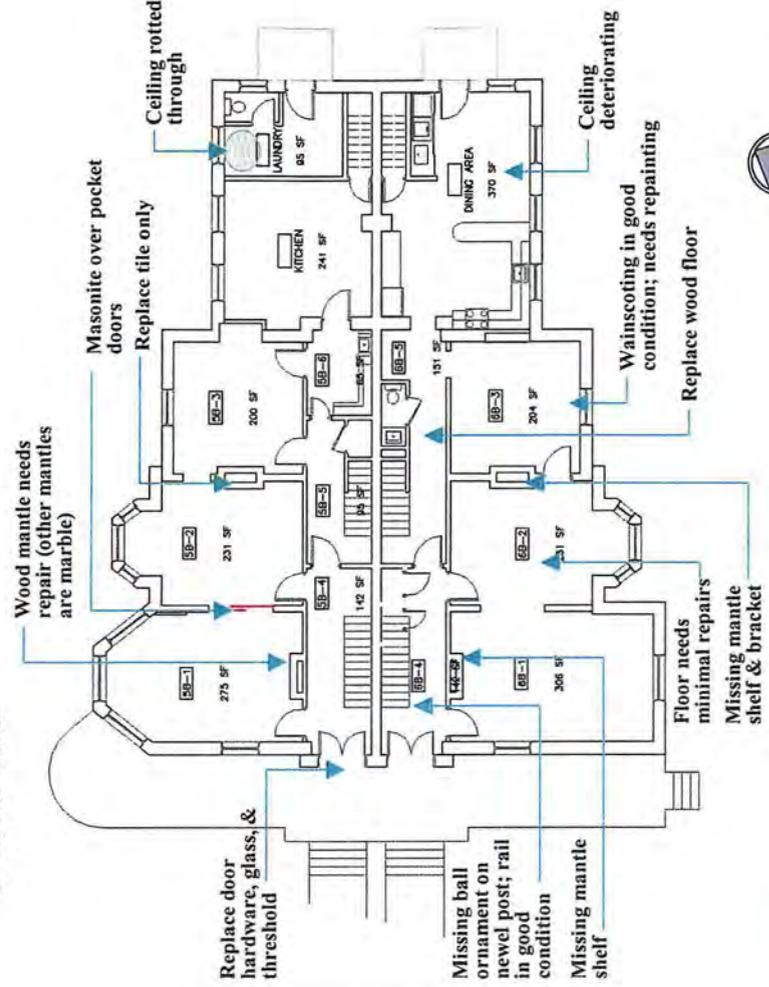
# Building #5/6 Floor Plans

- No ceilings in basement
- Brick floor in basement
- All new plaster needed
- Ceilings are panel on furring in lath (bare)

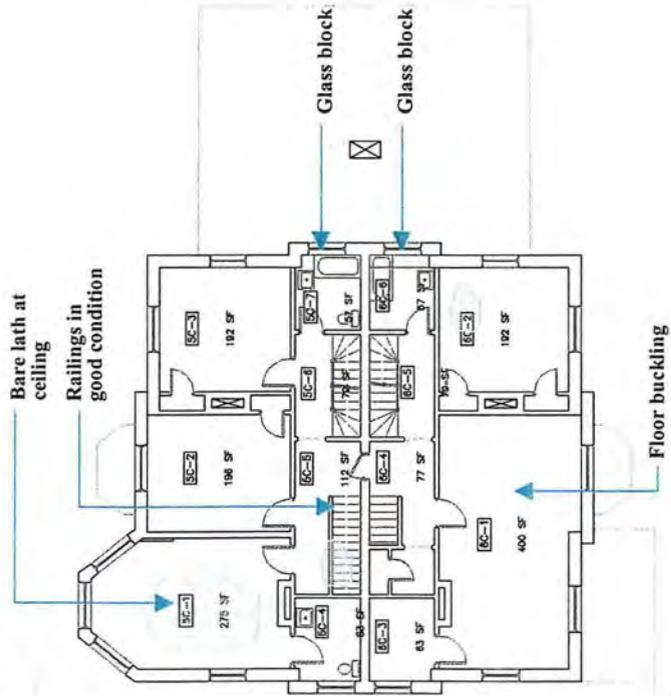
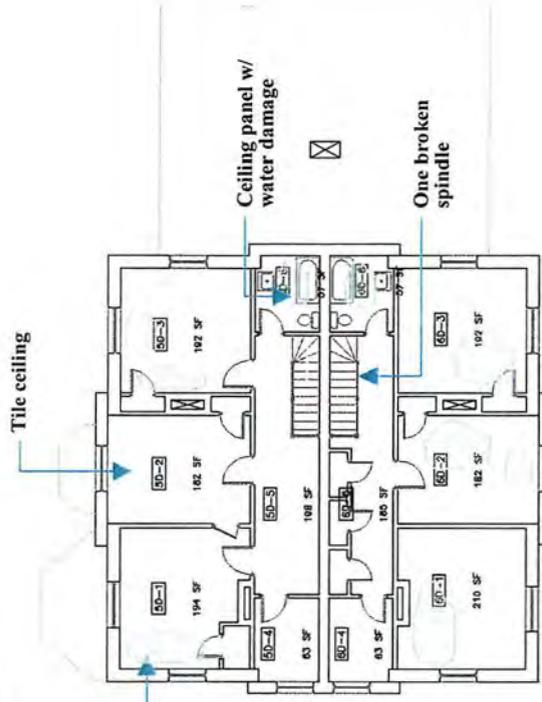
# Building #5/6 Floor Plans

- Wood at mantles generally in good condition
- Large areas of ceiling decay
- Stair railings generally in good condition
