100% SUBMITTAL
November, 1995

HISTORIC STRUCTURES REPORT

LACKAWANNA HERITAGE VALLEY TROLLEY MUSEUM

Silk Mill Building
Steamtown National Historic Site

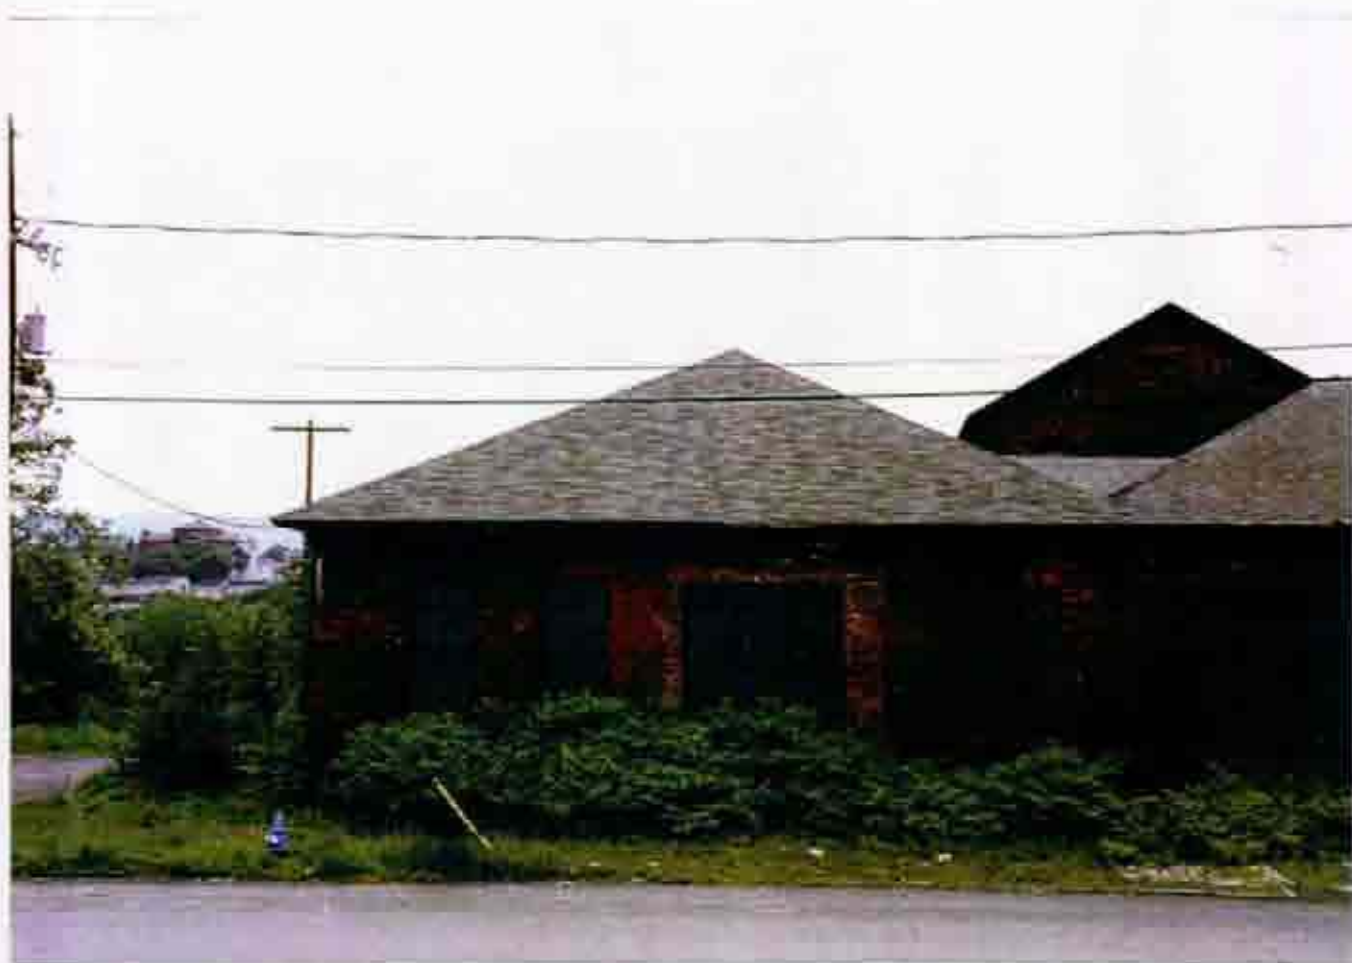
Figure 3.3

Curiously, the second floor masonry openings of Bays 2 and 4 contain wood double hung windows, which suggests that the steel windows of the first floor are later alterations. See Figure 3.14. The flat arch head types appear in the perimeter walls of Bays 1, 2 and 4, while the flat head type are confined to east elevation of Bays 2 and 3 where clear signs that the original flat arch masonry openings were changed to accommodate flat head window units are visible. The east elevations of Bays 1 and 2 contain later alterations, but with a slight variation - two/three flat head steel units tied together with steel mullions to form larger masonry openings. See Figure 3.3. The units in the masonry openings along the south, west and north

Detail of east elevation of Machine Shop (Bay 1), showing original large door opening that has since been partially closed in.

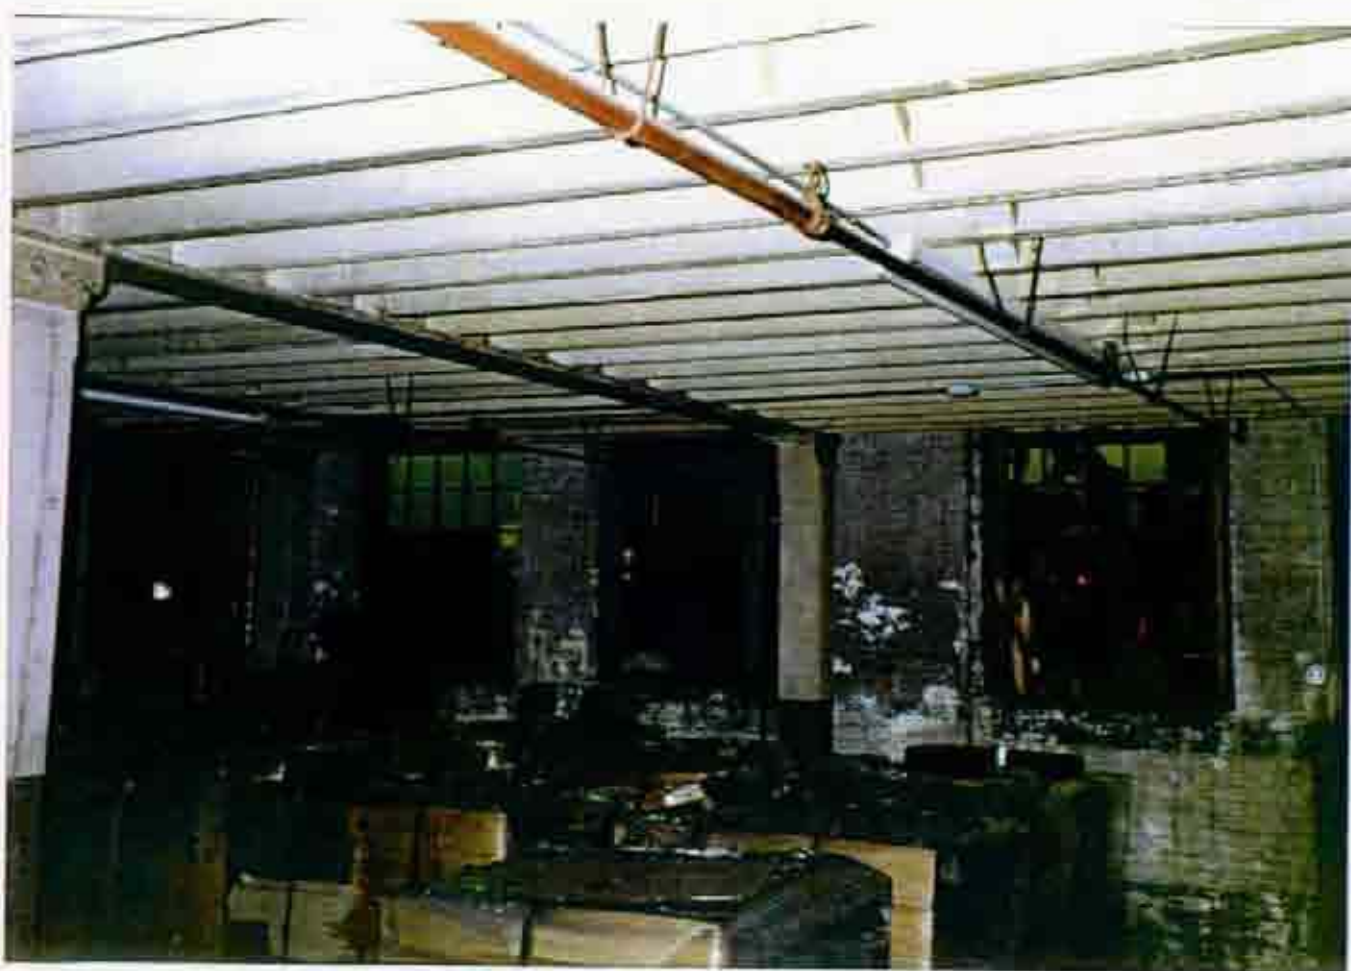
Figure 3.16

A mezzanine level at 9'-10" above first floor level was added inside the structure in Bays 1 and 2. This framing is composed of 3x12 wood joists at 16" centers spanning to steel beams. These beams are supported by wood posts, independent of the brick columns supporting the roof trusses above. See Figure 3.16. A ramp up to this level starts in Bay 3 and finishes in Bay 2. See Figure 3.17.

Detail of the mezzanine installed in Bay 1; this view looks north at windows that once looked out toward Bay 4, but were closed in when Bay 2 was added.

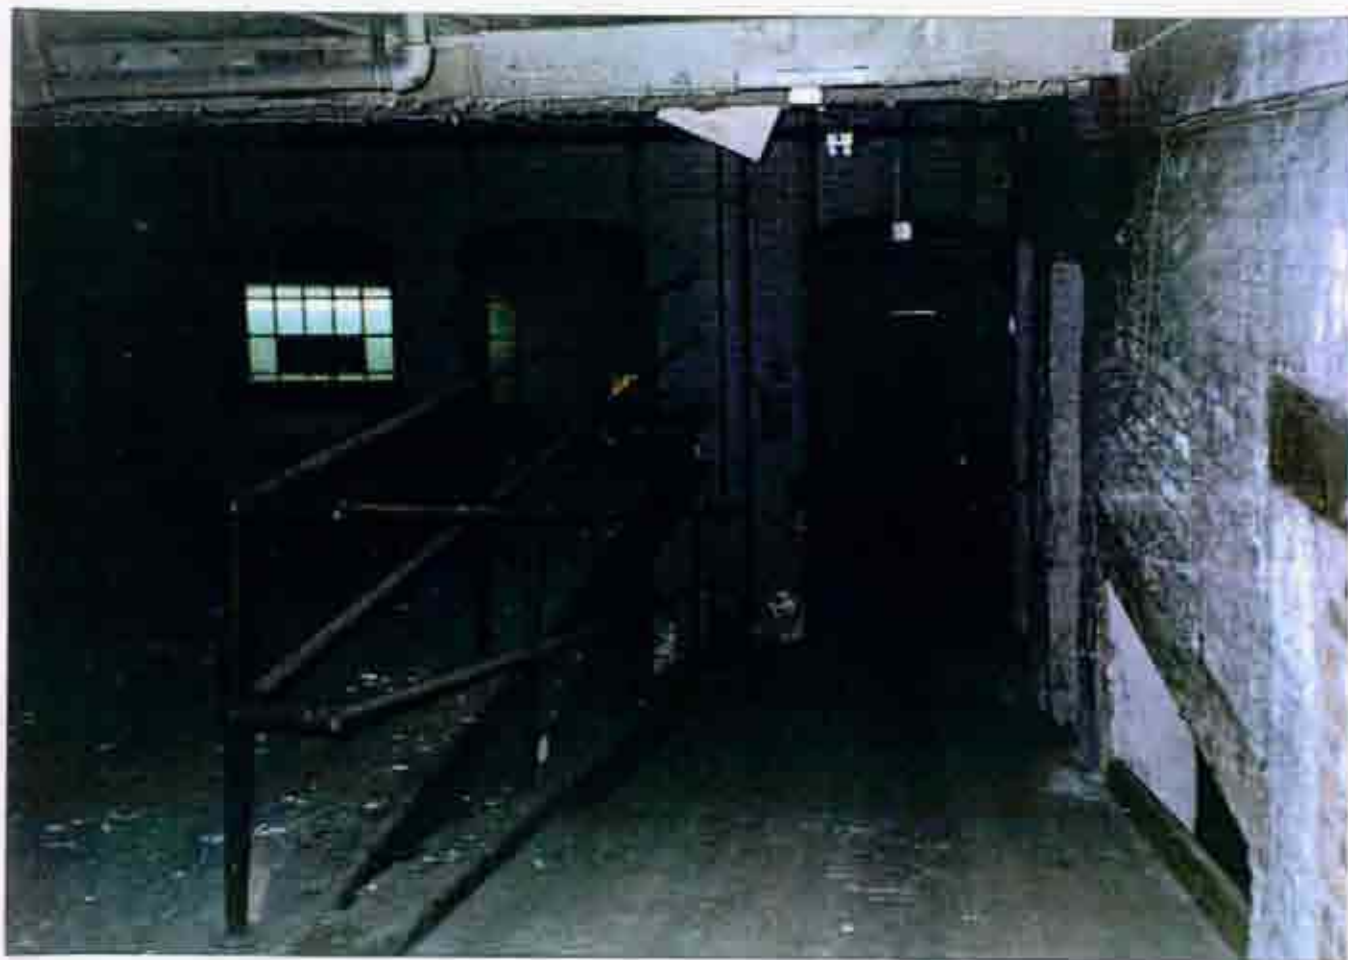
Figure 3.17

Detail, looking down the ramp, from the mezzanine past the windows at Bay 2, into Bay 3.
