# George Washington Carver Museum Historic Structure Report

# George Washington Carver Museum Tuskegee Institute National Historic Site

## Historic Structure Report

Prepared by:  
Panamerican Consultants, Inc.  
2390 Clinton Street  
Buffalo, New York 14227

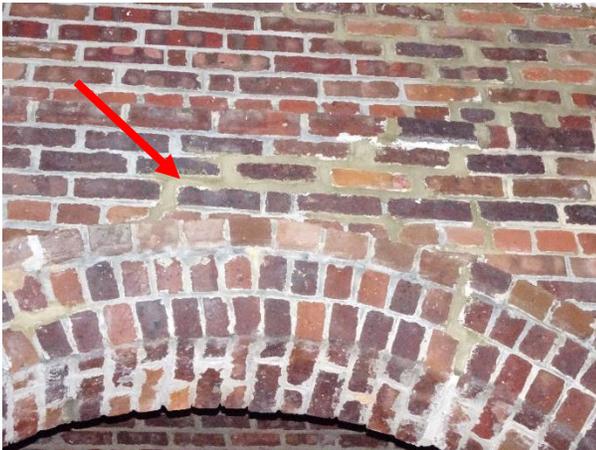
- Step cracking was observed at arched openings at the south portico (Figure 62). The cracking included open mortar joints, eroded mortar, and vertical cracking through some brick units at locations aligned with head joints. The cracking was also associated with portions of masonry that were displaced approximately 3/4 inch from the natural curve of the arch (Figure 63). At some locations, the deteriorated mortar and cracked brick had been repaired with replacement mortar. The replacement mortar was typically cracked and

deteriorated as well, indicating that the cracking is still active.

**FIGURE 62.** Step cracking at semi circular arched opening. Note that the joints have replacement mortar.

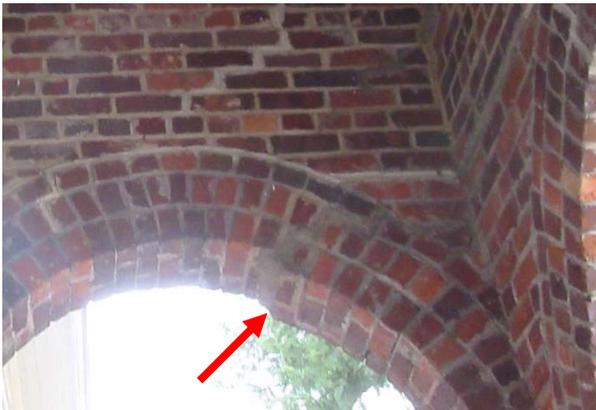
**FIGURE 63.** Displaced masonry at arched opening.

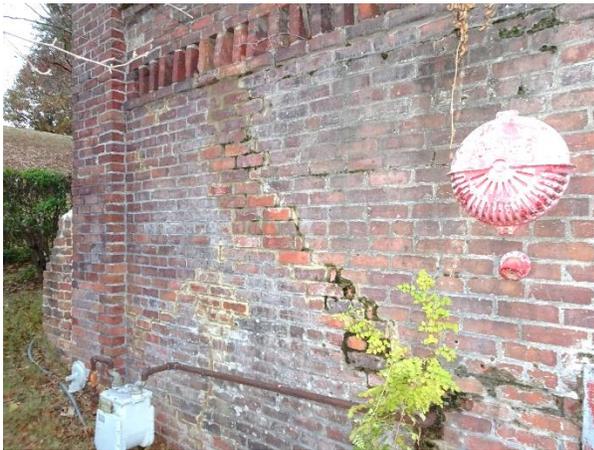
- Step cracking was observed at the east terrace wall (Figure 67 and Figure 68). The cracking extended from the terrace balustrade to the base of the wall. It appeared that the cracked

mortar joints had been previous repaired. The area around the cracking appeared damp and had biological growth at the joints.

**FIGURE 67.** Step cracking at east elevations of terrace wall.

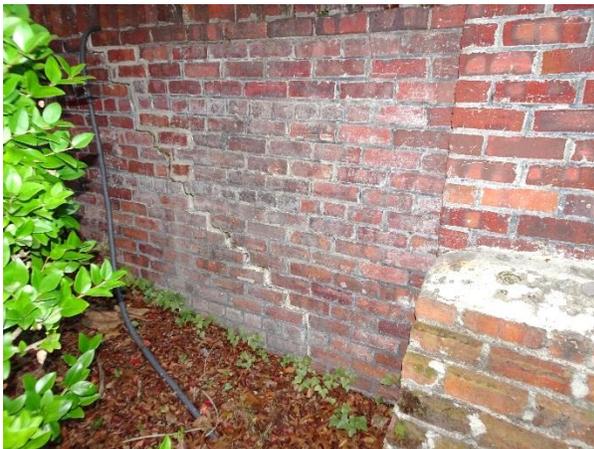
**FIGURE 68.** Step cracking at north elevations of terrace wall.

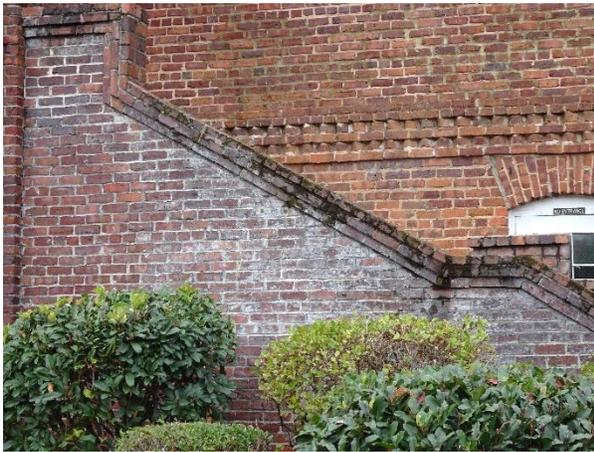
- Efflorescence was observed at the brick masonry walls at the south portico, the stair cheek walls, the underside of brick arch openings, and the north addition. At the south portico, the efflorescence was primarily located at the masonry below planter boxes and appeared to be associated with the moisture expelled from these boxes (Figure 74). Efflorescence at stair cheek walls was most pronounced immediately below the coping of the cheek wall (Figure 75). Efflorescence at arched openings was typically located at the face of the brick on the underside of the arch (Figure 76). At the north addition, efflorescence was extensive throughout the east and north elevations but was most concentrated at the top of the wall, along a horizontal line approximately five courses below the coping (Figure 77). The efflorescence aligns with the bottom of the roof scuppers and is located at the approximate height of the roof.

**FIGURE 75.** Efflorescence at retaining walls is located primarily below the coping.

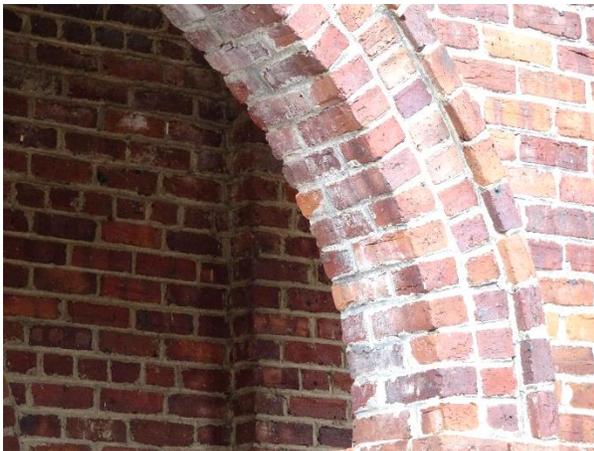
**FIGURE 76.** Efflorescence at underside of arched openings

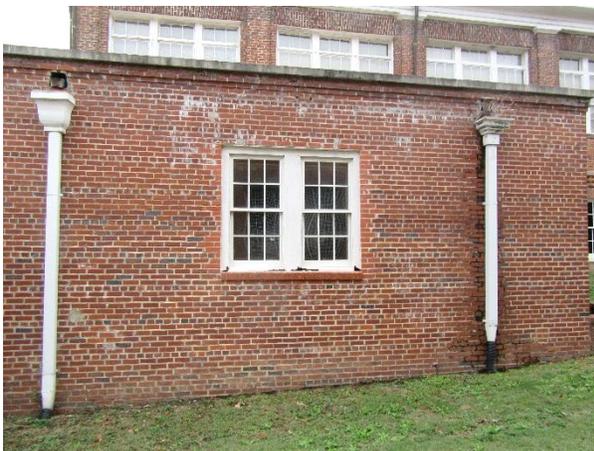
**FIGURE 77.** Efflorescence extends horizontally across the top of the wall at the north addition.

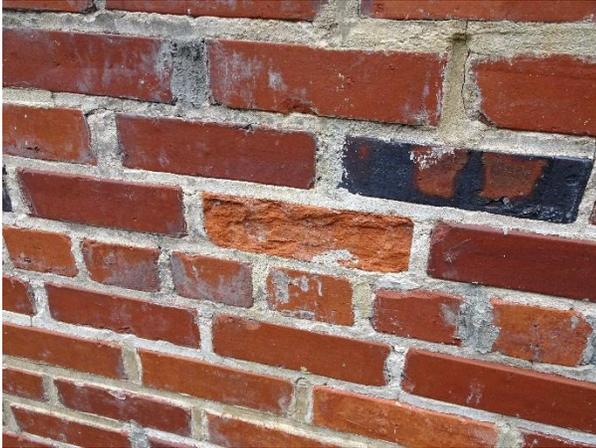
- Spalled brick was located at localized areas at the main portion of the building as well as at the north addition. At the main portion of the building, the spalls were small and were typically localized at corners and along edges (Figure 79). Spalls at the north addition were

located in the field of wall and consisted of loss of the entire fired face, which comprises the outer 1/8 inch of the brick (Figure 80). The deterioration was typically associated with other distress conditions such as cracked mortar joints.

**FIGURE 80.** Face spalls of brick are located at the north addition.

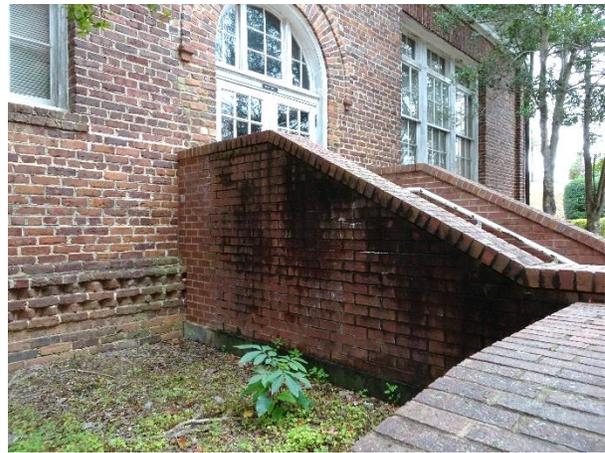
- Biological growth was observed at the brick throughout the building including at areas below window openings, adjacent to downspouts, at stair cheek walls, and at terrace walls (Figure 81 through Figure 84). The observed growth included green and black-colored growth on the brick and mortar joints. The growth was most pronounced near cracked and deteriorated mortar joints and at cheek and terrace wall copings, and was often associated with areas of visible moisture or moisture staining.

**FIGURE 82.** Biological growth at cheek walls.

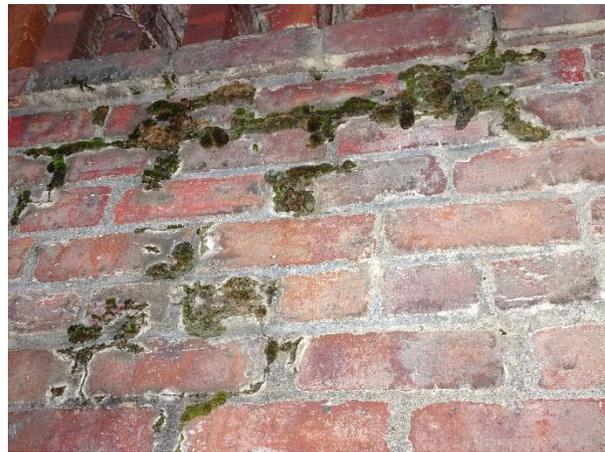
**FIGURE 83.** Biological growth at mortar joints.

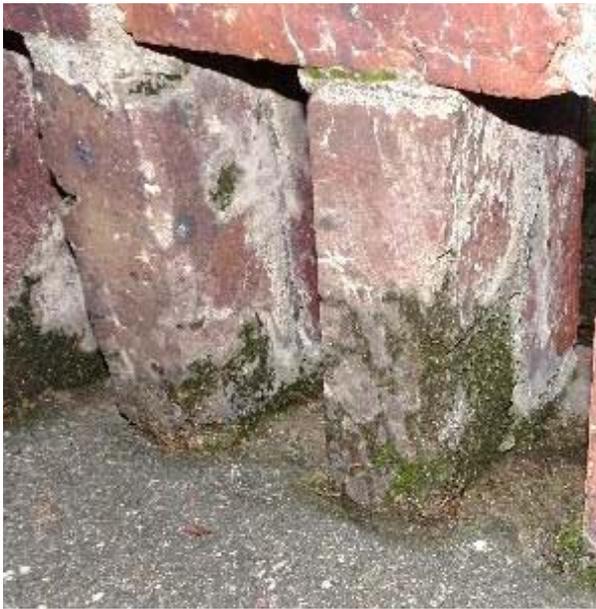
- Craze cracking was observed on many clay brick masonry units at the base of the terrace balustrade (refer to Figure 84). The bricks are set in a soldier course and bear directly on the terrace paving. The distress consisted of a network of micro cracks on the face of the brick. At the base of the terrace wall, the paving was wet and had biological growth. The pattern of cracking was characteristic of moisture-related deterioration.

**FIGURE 84.** Crazing and microcracks at bottom course of brick at terrace balustrade.

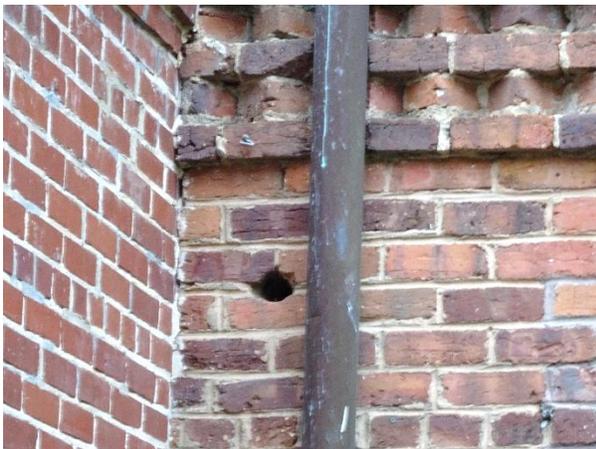
- A large hole is located at the basement level of the north elevation, adjacent to the north addition (Figure 85). The hole appears to have been associated with a pipe penetration or large anchor in the masonry wall and has since been removed.

**FIGURE 85.** Hole in masonry wall.

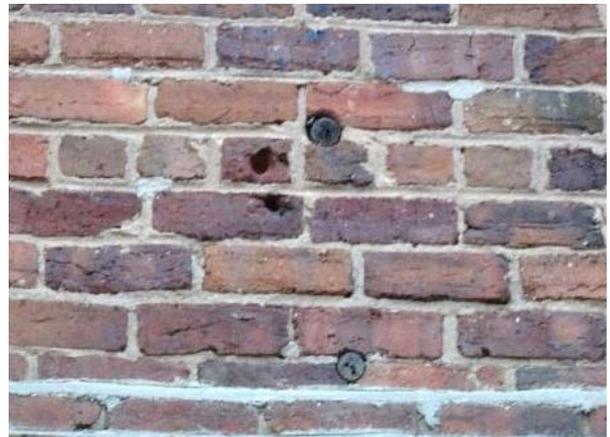
- Abandoned anchors were observed in the masonry above the basement door opening on the north elevation (Figure 87). The anchor holes are typically centered on mortar joints but extend into and notch the adjacent brick units. It is unclear what the anchors were associated with; however, the anchors appear to be wood and have been cut flush with the brick.

**FIGURE 87.** Abandoned anchors in field of wall.

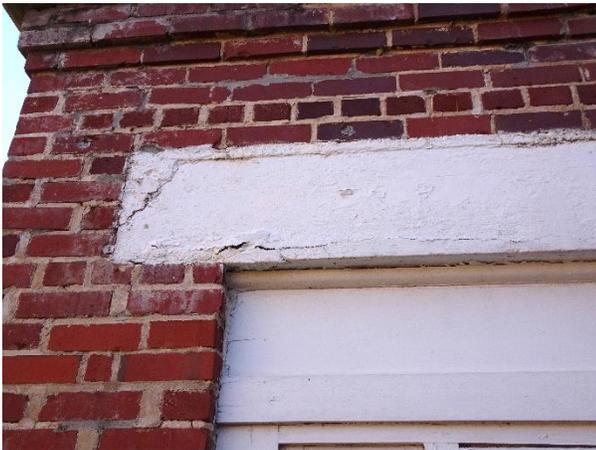
- Spalling was observed at the concrete lintel above the exterior entrance door to the north addition (Figure 89). The spalling consisted of cracking at the upper corner of the lintel and included continuous crack spanning horizontally across the opening, approximately 1 inch above the bottom edge. The brick masonry around the lintel had step cracking and evidence of water infiltration.

**FIGURE 89.** Spalled concrete lintel at north addition entrance.

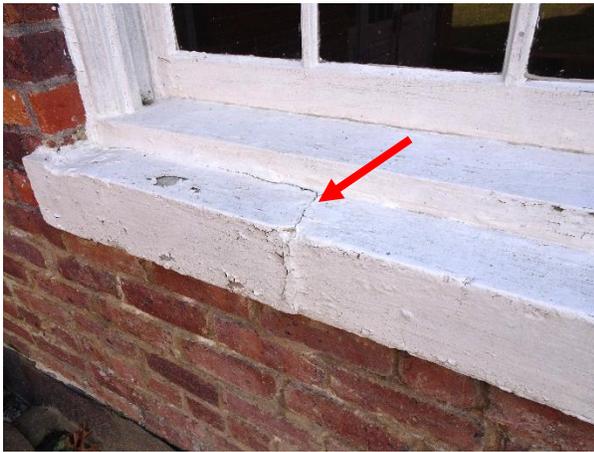
- Cracking was observed at three concrete sills at basement windows on the north elevation (Figure 92). Where located, the sections of the sill were slightly displaced and had been painted over. The paint coating over the cracked sill had also cracked.

**FIGURE 92.** Crack and displacement at concrete window sill.

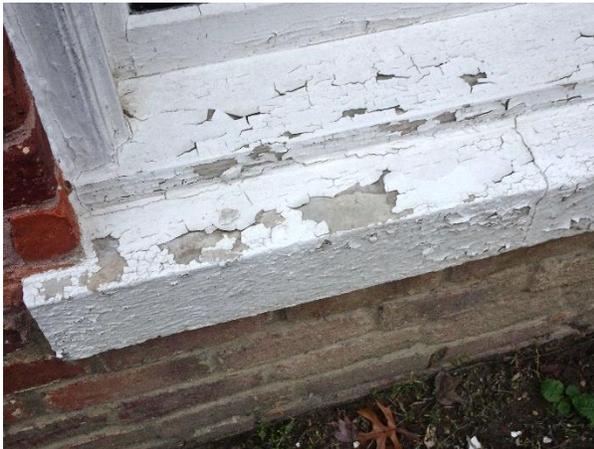
- Deteriorated paint was observed at concrete sills at the basement level of the north elevation (Figure 93). The deterioration consisted of alligatoring and debonding of the paint. The concrete is exposed at areas where the paint has peeled away.

**FIGURE 93.** Peeling paint at concrete window sills.

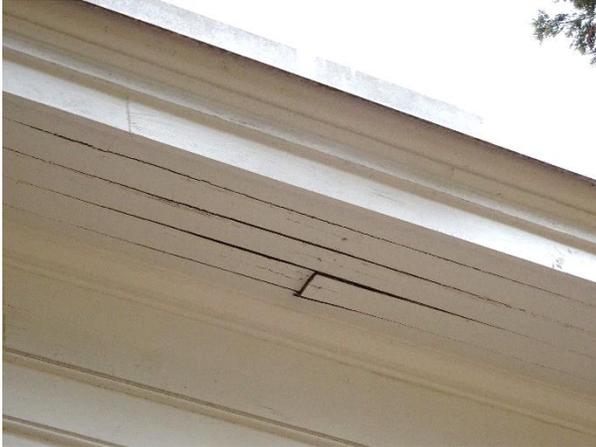
- Checked and split boards were observed at a few locations on the soffit as well as at the lower cornice band above the soffit (Figure 96 and Figure 97). Large checks in the lower cornice band were typically located near the ends of board or were associated with areas where moisture-related distress was observed. Splits in the wood were typically located at the ends of soffit boards. At these locations, the

boards had come free of the nail and were loose.

**FIGURE 96.** Displaced wood boards at soffit.

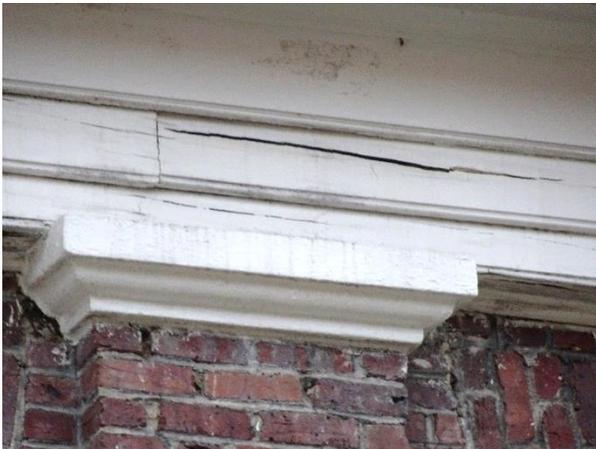
**FIGURE 97.** Checked and split boards at lower cornice.

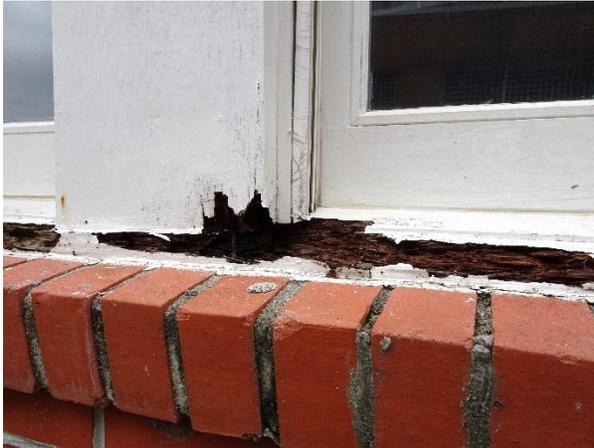
- Deteriorated wood was observed at window and door mullions, jambs, and sills at the north addition (Figure 100). The wood appeared wet and was friable when probed. At some areas, over half of the cross-sectional areas of the wood were lost.
- Deteriorated glazing putty was observed at some window locations (Figure 101). Large sections of putty had come loose and fallen out at localized areas of first floor windows on the south and west elevations. Where the glazing putty had fallen out, there were no

**FIGURE 100.** Deteriorated wood at window frames.

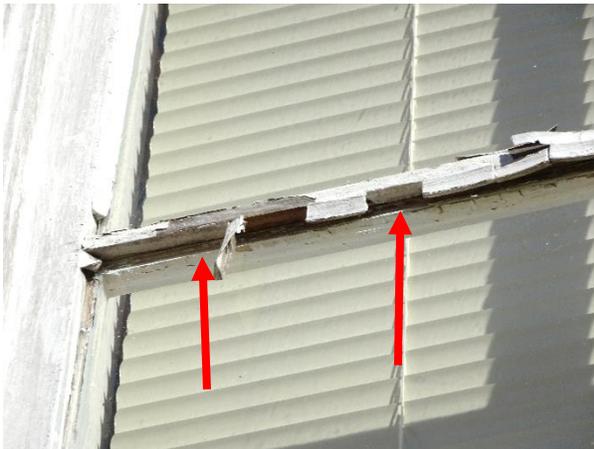
glazing points observed, and the edge of the glass was visible.

**FIGURE 101.** Deteriorated and missing window glazing.

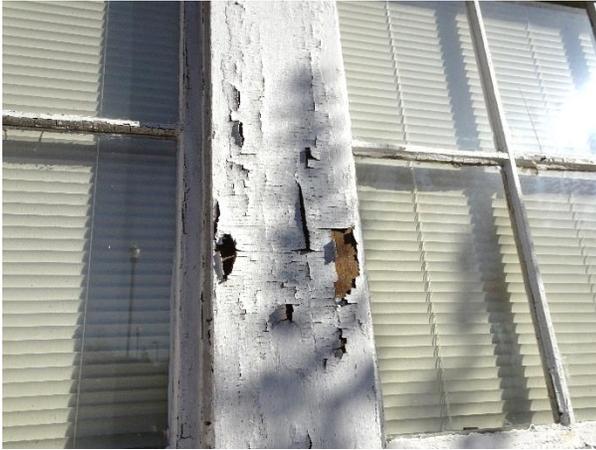
- Peeling paint was observed at exterior entrance doors and at window frames (Figure 103 and Figure 104). At many locations, the paint had failed and fallen away, and the bare wood was exposed to view. There was no primer coating observed on the wood.
- Biological growth was observed at the underside of the main floor window opening lintels (Figure 105). The growth consisted of dark-colored spots on the painted lintel. Window openings where biological growth was observed were typically located near downspouts and below soffits with evidence of moisture-related damage.
- Evidence of previous repairs was observed at the east basement door (Figure 106). It appears that portions of the east door frame were repaired with wood dutchman. The

**FIGURE 104.** Peeling paint at door framing.

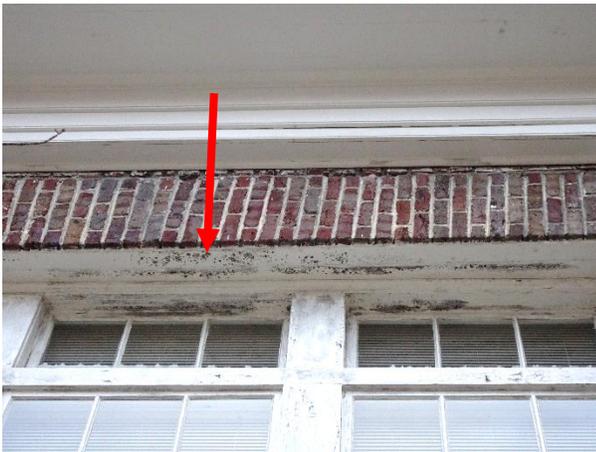
**FIGURE 105.** Biological growth at underside of lintel.

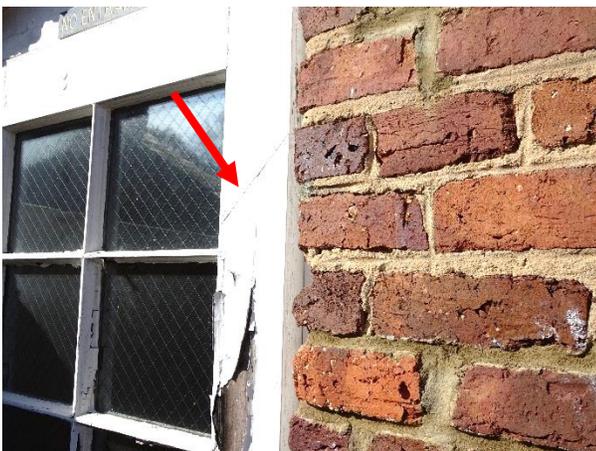
repair was painted white to match the adjacent framing.

**FIGURE 106.** Evidence of previous dutchman repair at door frame.

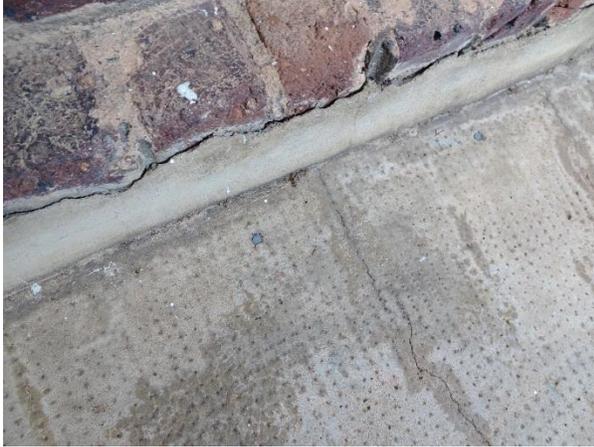
- Evidence of ponding was observed at the partially enclosed south portico. The concrete at the portico was damp, and the bottom courses of brick at the portico wall appeared

wet. Furthermore, there is no drainage or slope to the concrete to assist in directing water that entered the enclosure. As a result, water that enters the portico ponds along the portico wall (Figure 109).

**FIGURE 109.** The concrete at the south portico appeared wet and does not provide drainage.

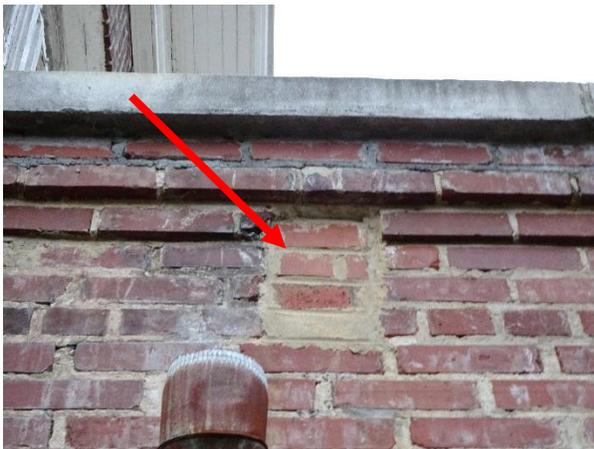
- One roof scupper at the south end of the north addition was observed to be infilled with brick and was no longer in use (Figure 110). The infill brick had a distinctly different appearance than the adjacent brick.

**FIGURE 110.** Infilled scupper opening.

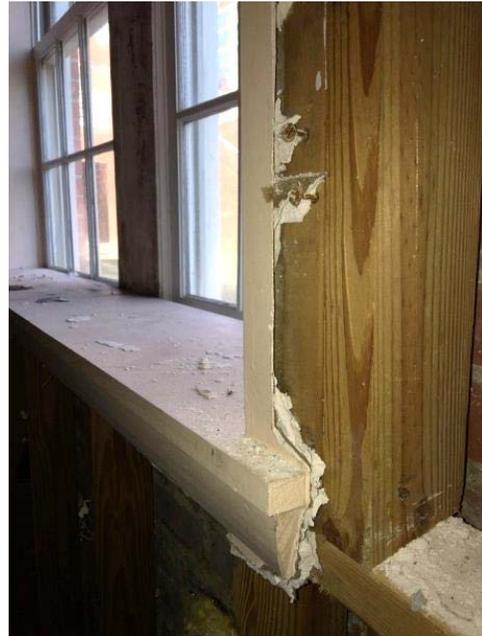
According to the 2011 CAR, the gypsum board at the interior of the library exhibited signs of mold growth and was recommended to be replaced.<sup>220</sup> Gypsum board finishes have been removed from the wood stud framing at the perimeter of the exterior wall to approximately the face of the window jamb returns and the wood stool and

apron at the paired windows (Figure 161). Documents detailing the proposed restoration were not available at the time of the site visit.

**FIGURE 161.** Detail of termination of gypsum board removal at window return and sill.

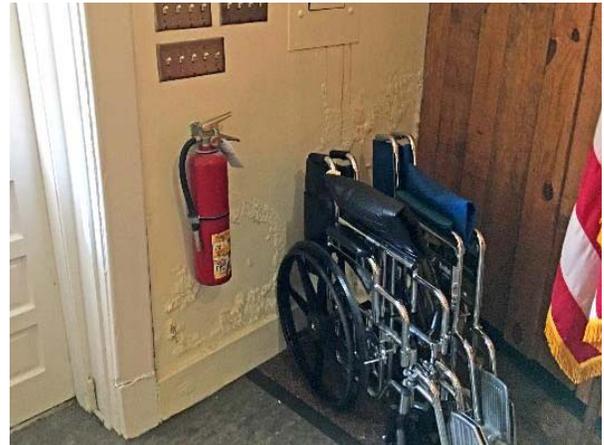
- Blistering paint and plaster were observed at several locations below the window sill height, at exterior walls at the upper level (Figure 166). In several locations the condition was observed below windows (Figure 167).

**FIGURE 166.** Blistering paint and plaster at south entry.

recessed cabinet may be exposed to moisture within the wall (refer to Figure 166).

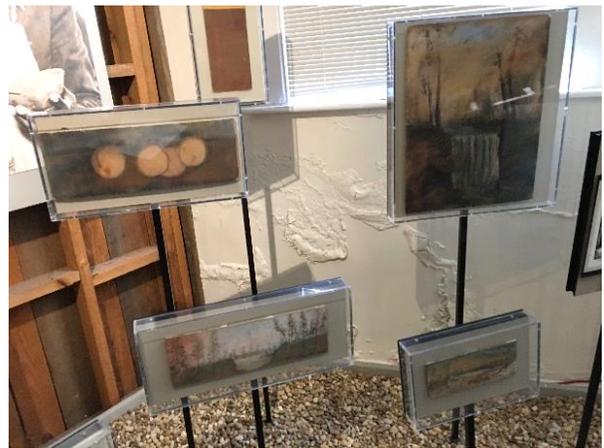
**FIGURE 167.** Blistering paint and plaster below window.

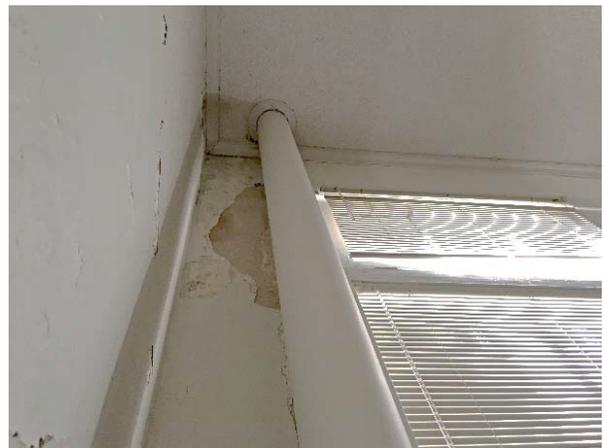
- Delamination of the plaster finish coat was observed at several locations near the top of windows at the upper floor (Figure 168 and Figure 169). As these locations occur at the narrow masonry pilasters, the moisture in the

wall is present near the bearing condition of the trusses.

**FIGURE 168.** Delamination of finish plaster coat at exterior wall.

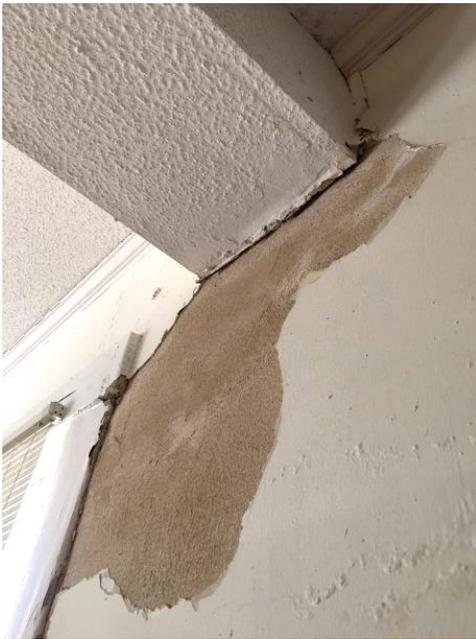
**FIGURE 169.** Delamination of finish plaster coat at exterior wall.

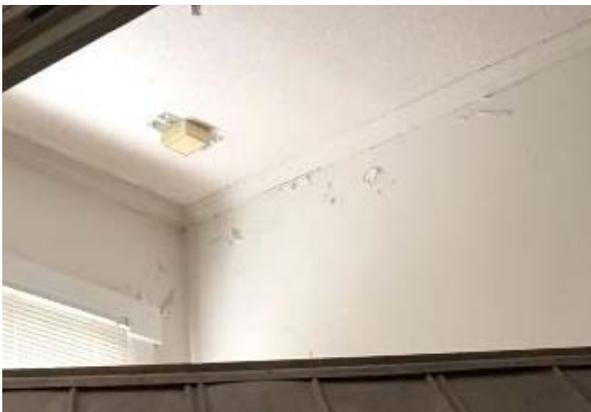
**FIGURE 170.** Blistering of plaster and paint and debonding of sealant at crown molding.

- Blistering and peeling paint was observed near the ceiling at some plaster walls on the upper floor (Figure 170). At some locations sealant installed at the bottom of the crown molding was observed to be debonded from the wood trim.

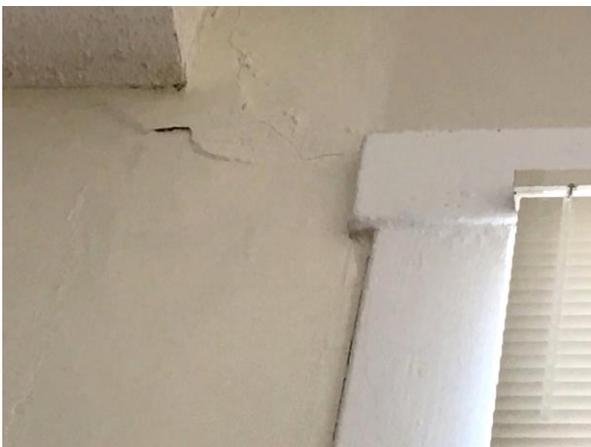
**FIGURE 171.** Crack in plaster at truss bearing.

- Cracks were observed in the plaster, typically radiating from the beam bearing points outward toward the heads of the window (Figure 171) or originating at the head of the window and traveling vertically (Figure 172).

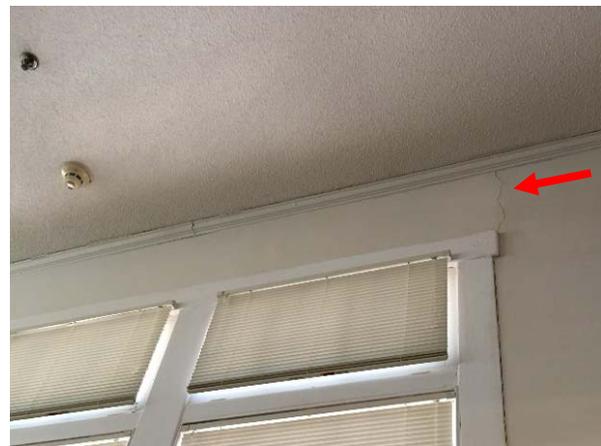
**FIGURE 172.** Crack in plaster extending from window head to ceiling above.

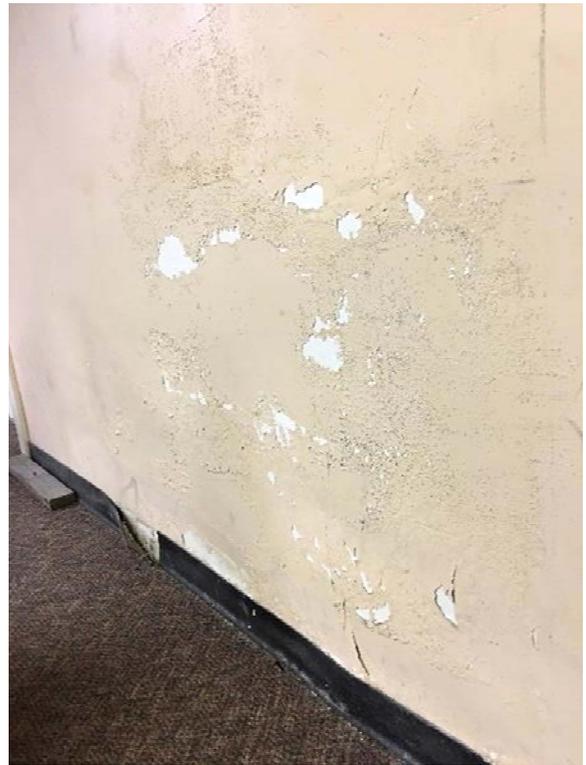
- Blistering paint and plaster at exterior walls were observed at several locations in the lower level. The most severe conditions were observed at the north wall of the curator's office (Figure 174) and assembly room (Figure 175). Rubber base was observed to be delaminating at these areas. Minor blistering of paint was observed at the exterior east wall of the restrooms (Figure 176) and the chair storage closet.

**FIGURE 175.** Blistering of plaster and paint and debonding of rubber base.

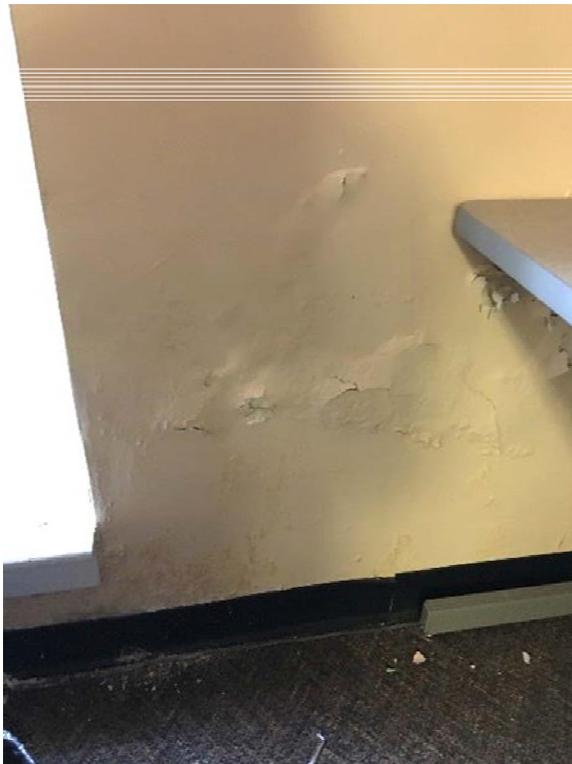
**FIGURE 174.** Blistering of plaster and paint and debonding of rubber base.

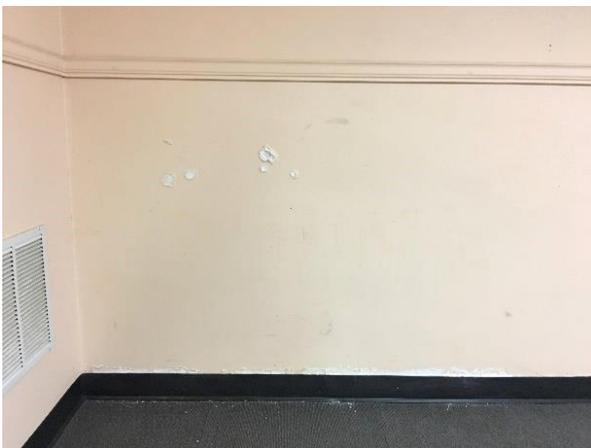
- Blistering paint and plaster were noted at the exterior wall at the east end of the assembly room (Figure 177) and at the north end of the corridor (Figure 178). Both conditions occur in portions of the masonry wall associated with the single-story addition on the northeast corner of the building. The condition at the assembly room continues at the plaster jamb return of the window.

**FIGURE 178.** Blistering paint and plaster on masonry wall adjoining the single-story addition.

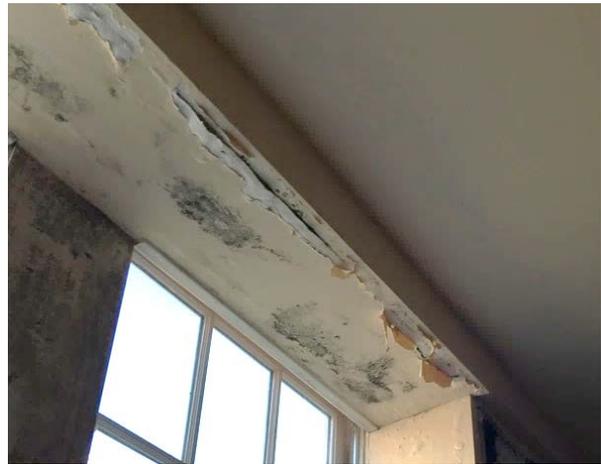
- Mold and mildew was observed at the gypsum board head return at the paired window in the single-story addition (Figure 179). Gypsum finishes had been removed from the walls but remained at window returns and interior finishes.
- A daylight gap was observed from the interior at the intersection of the single-story addition wall with the wall of the main building.

**FIGURE 179.** Mold and mildew on gypsum return at head of window, single-story addition.

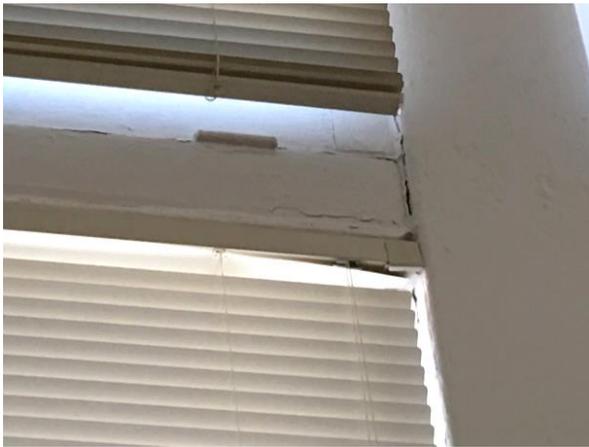
- Paint was observed to be delaminating at interior trim elements, such as mull covers and jamb casings (Figure 180; refer to Figure 173).
- Separations due to moisture infiltration of the window frame members were observed at joints between horizontal mullions and vertical casing trim (Figure 181 and Figure 182).

**FIGURE 181.** Moisture damage at horizontal mullion trim.

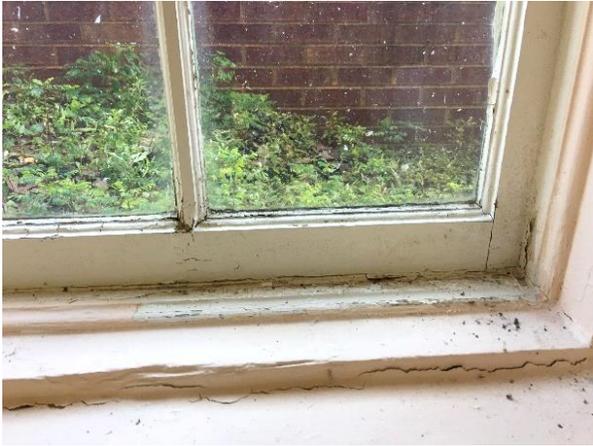
- Separation of sill members due to moisture infiltration was observed at the fixed sash window located in the curator's work room (Figure 185).
- Paint was observed to be blistering and delaminated at the interior panels of entry doors on the upper floor level (Figure 186).

**FIGURE 185.** Delamination of paint and possible moisture damage to sill frame members at fixed sash window.

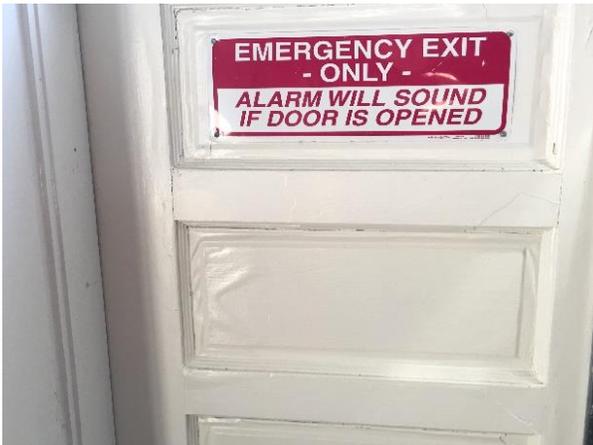
**FIGURE 186.** Blistering and delamination of paint at interior face of door panels.

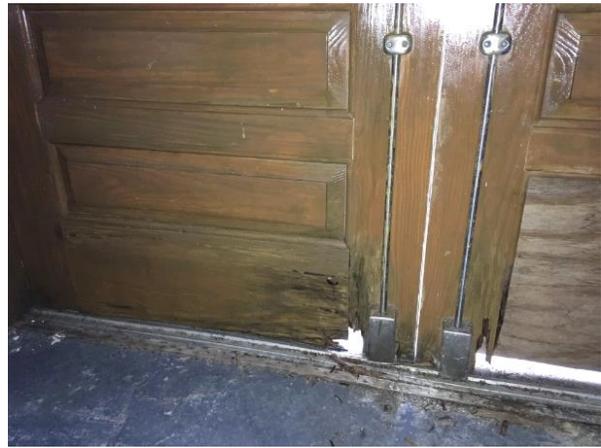
- Severe moisture damage was observed at the lower rail of the paired entry doors on the west side of the single-story addition (Figure 187). The lower rail of the north door was missing. The lower rail of the south door showed significant loss of material. Stiles, panels, and rails at multiple locations on the unit exhibit similar deterioration. Moisture damage was also observed at the interior sill members of the sidelights frames (Figure 188).

**FIGURE 187.** Severe moisture damage at paired doors of single-story addition.

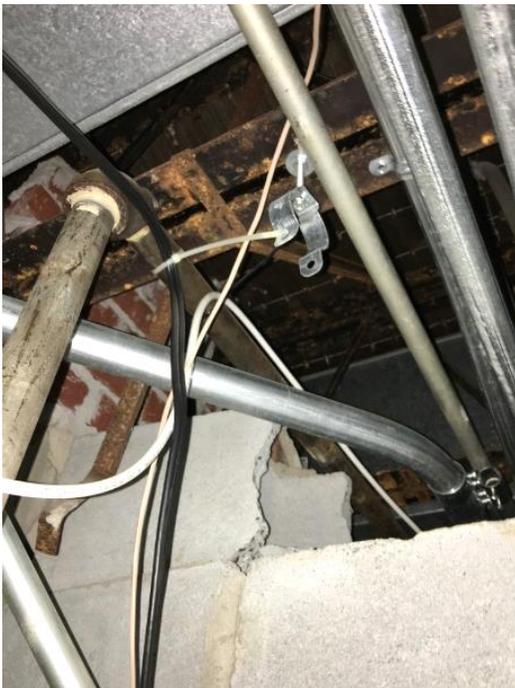
- The floor-ceiling space is open at the perimeter to areas such as the crawl space and boiler room, where penetrations have been infilled with concrete masonry units (CMU; Figure 189 and Figure 190). Where the brick wall has been extended to the underside of the deck, it does not appear to be sealed or fire-stopped (Figure 191) as may be required for completeness of the floor-ceiling assembly, separation of rated spaces such as the boiler room, or air-seal at the return air plenum. Negative pressure at these areas could result in moisture from damp areas, such as the crawl space, to be drawn into the return plenum, increasing the dew point and potential for condensation at interior surfaces.

**FIGURE 189.** CMU infill at masonry wall terminates below deck at mechanical crawl space boiler room. Partition does not provide fire seal at deck and penetrations.

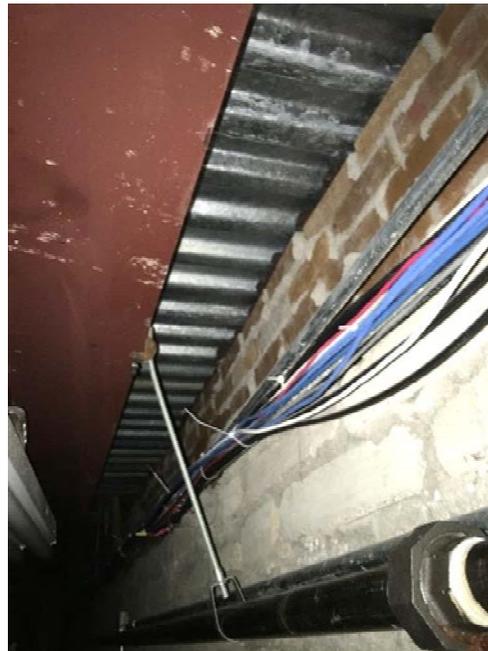
**FIGURE 191.** Brick masonry infill parallel to joists terminated at deck. No firecaulk or air seal was evident at top of wall.

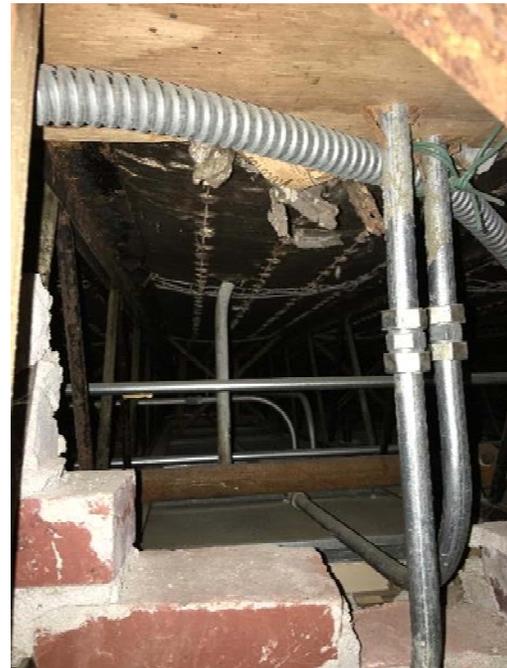
- Several deck infill patches were observed to be supported by plywood fastened to the underside of the concrete deck (Figure 193). The use of combustible materials may be prohibited depending on the floor-ceiling assembly requirements and under IBC for the return air plenum.
- The penetration of the supply duct through the floor deck was observed to be sealed with expansive foam-type filler (Figure 194). The shaft walls were not noted to be fire rated in the 1979 documents. Penetrations through the floor-ceiling assembly may require a fire-stop system and a fire or smoke damper.

**FIGURE 193.** Deck patch supported by plywood. Combustible materials not allowed in plenum return.

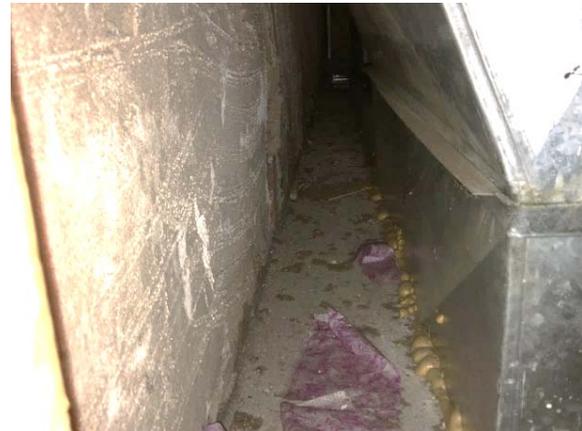
**FIGURE 194.** Duct penetration of floor assembly sealed with expansive foam sealant. If chase is not constructed as a fire-rated partition, the floor penetration should be firestopped.

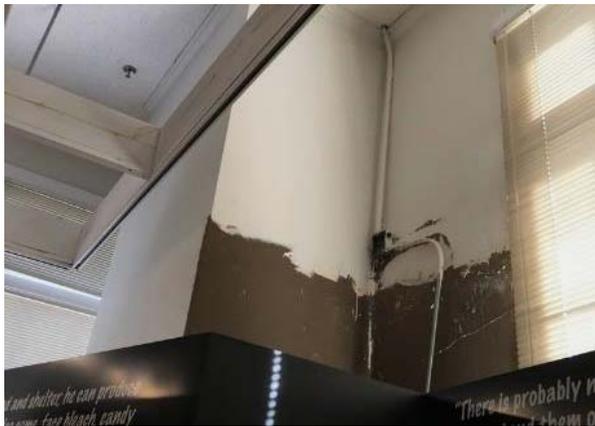
- An open junction box was observed in the museum space adjacent to the northeast chimney (Figure 195).
- Gypsum board was observed to be removed above the electrical panel in the mechanical room.
- Copper hydronic piping serving the HVAC units was observed to be uninsulated (Figure 196).

**FIGURE 195.** Open junction box at northeast chimney.

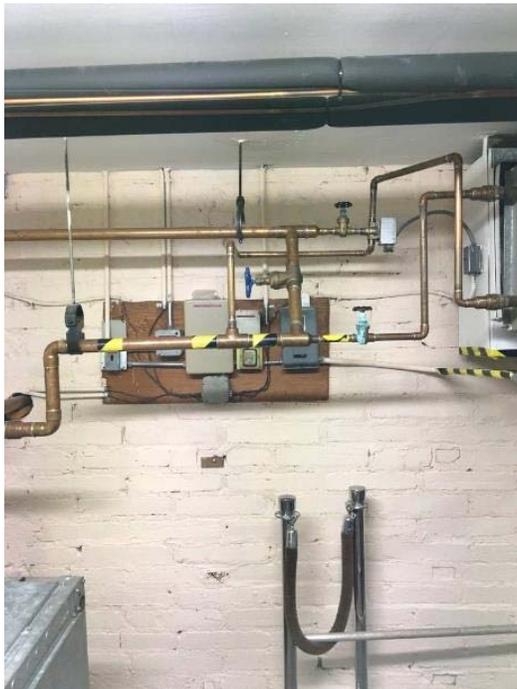
**FIGURE 196.** Hot water hydronic pipe and controls.

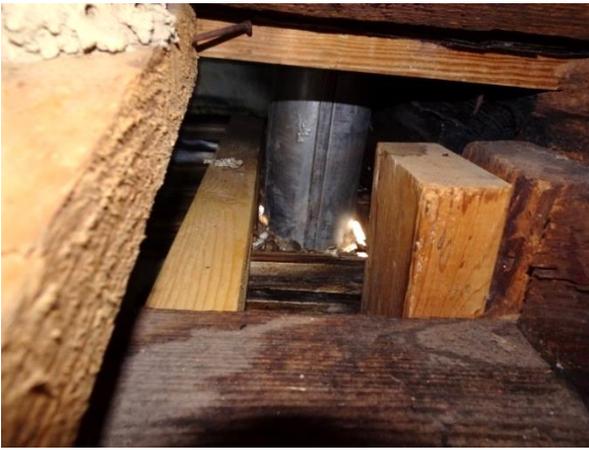
**FIGURE 202.** Water staining was observed on wood framing members in the attic.

- After the temporary bracing of trusses is completed, longer term repairs and straightening of the structure will be necessary. As part of this work, a review of purlin assemblies and their supports (some of which have been affected by the truss leans discussed above) will need to be conducted and any problems corrected.
- Active moisture infiltration was observed at perimeter gutter locations, with associated water staining and apparent rot (Figure 202).
- Plank decking is damaged at some locations (Figure 203).
- Damage from a previous fire was observed at truss framing members in the attic (Figure 204 and Figure 205).
- No visible means of wind uplift resistance are present within the existing roof framing.

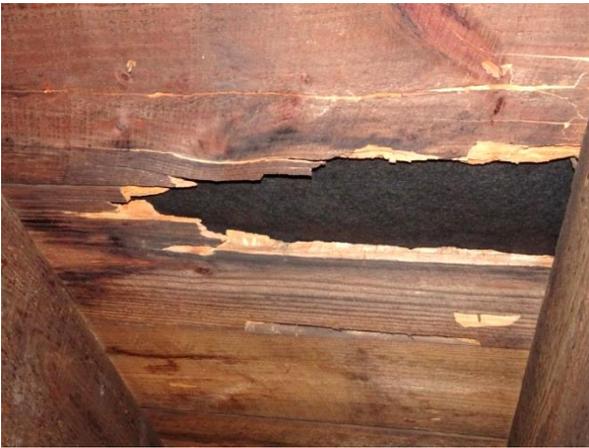
**FIGURE 203.** Areas of damage plank decking were observed.

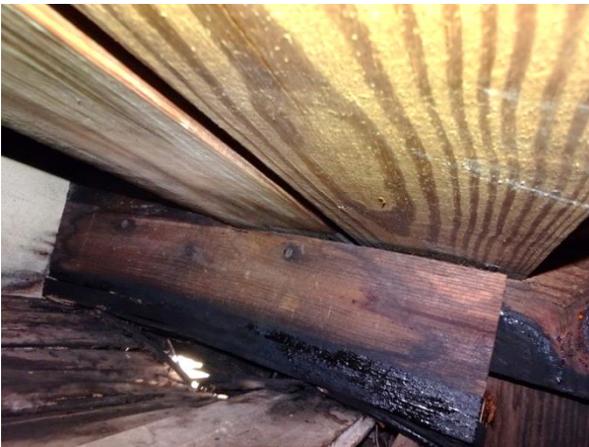
**FIGURE 204.** Example of previous fire damage observed in the attic.

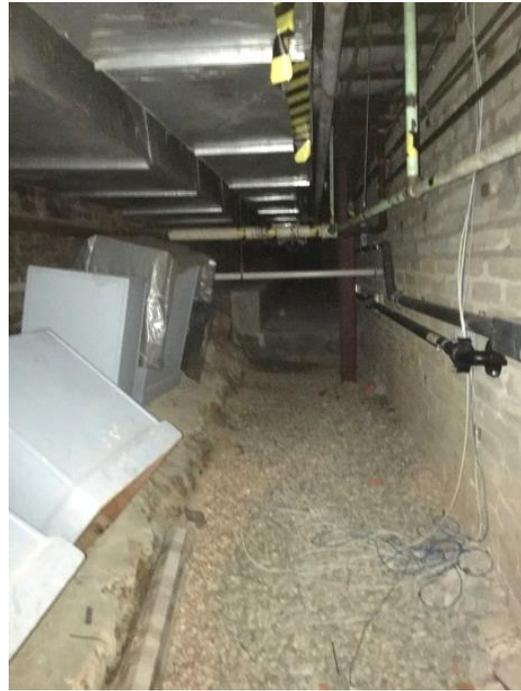
**FIGURE 208.** Ductwork serving the upper floor. Refrigerant lines penetrate the enclosure between the ducts.
