STIRLING'S QUARTERS AT VALLEY FORGE NATIONAL HISTORICAL PARK  
HISTORIC STRUCTURE REPORT

PREPARED BY:  
JOHN MILNER ARCHITECTS, INC.  
104 LAKEVIEW DRIVE, CHADDS FORD, PA 19317

JANUARY 2006

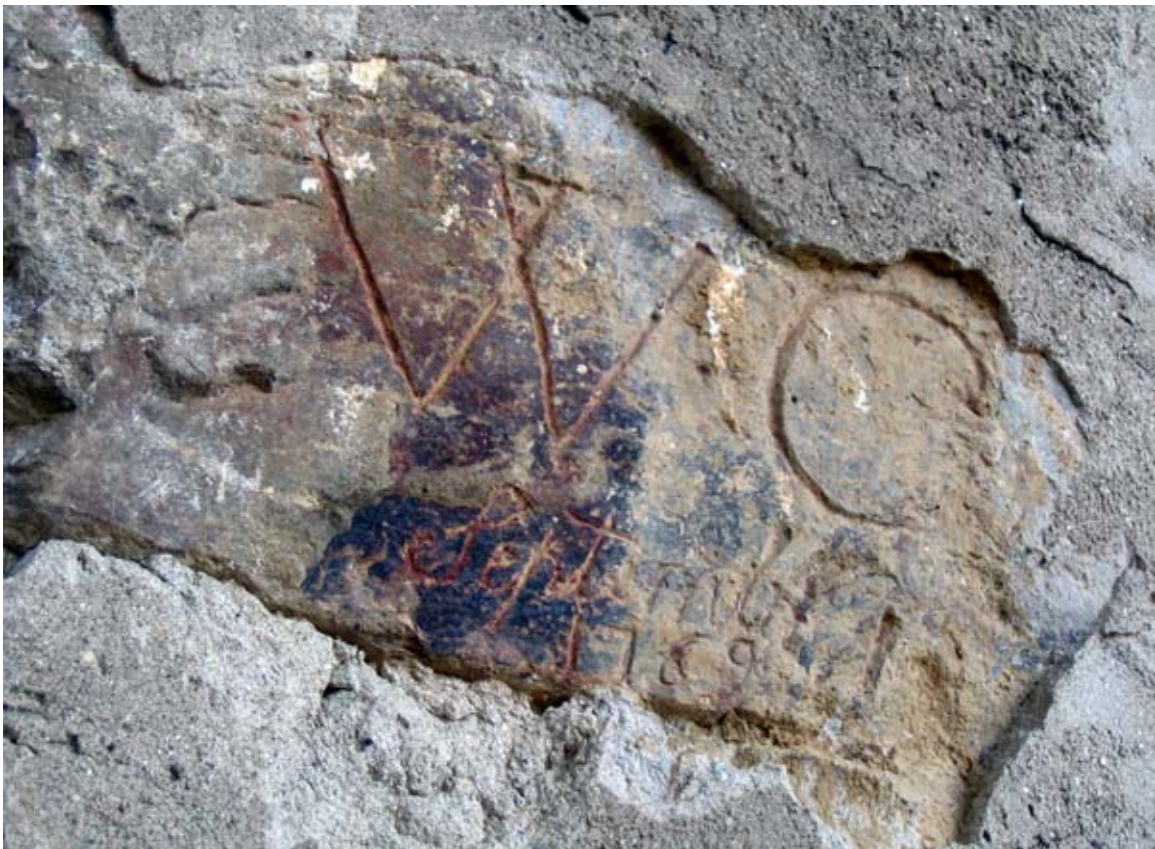
**Figure 6:** Detail view of one of the corner stones at the southwest corner of original kitchen block with the inscription, "W C September 1769."

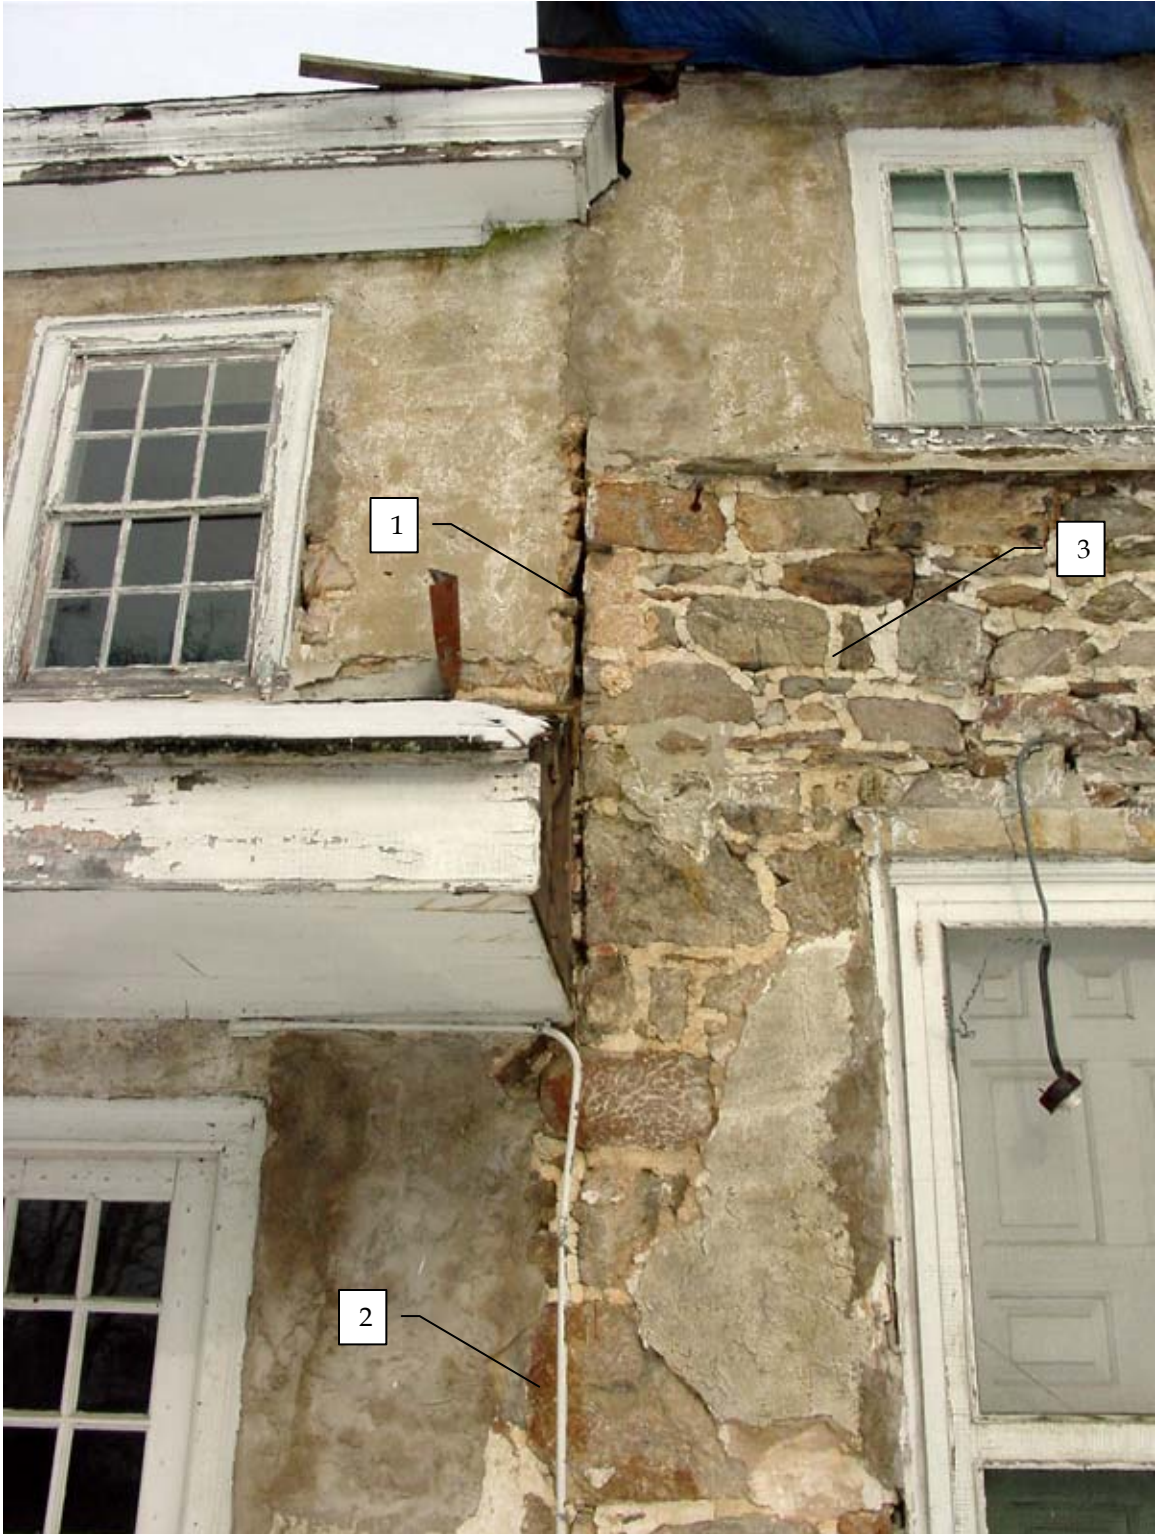
**Photo SEb** - Partial view of south elevation masonry at juncture of main block and west block, looking north.

1. Seam in masonry at 2<sup>nd</sup>-floor level between west block and main block.
2. No seam in masonry at 1<sup>st</sup>-floor level between west block and main block.
3. Rubble fieldstone with lime-based pointing mortar is typical at main block and original kitchen block.

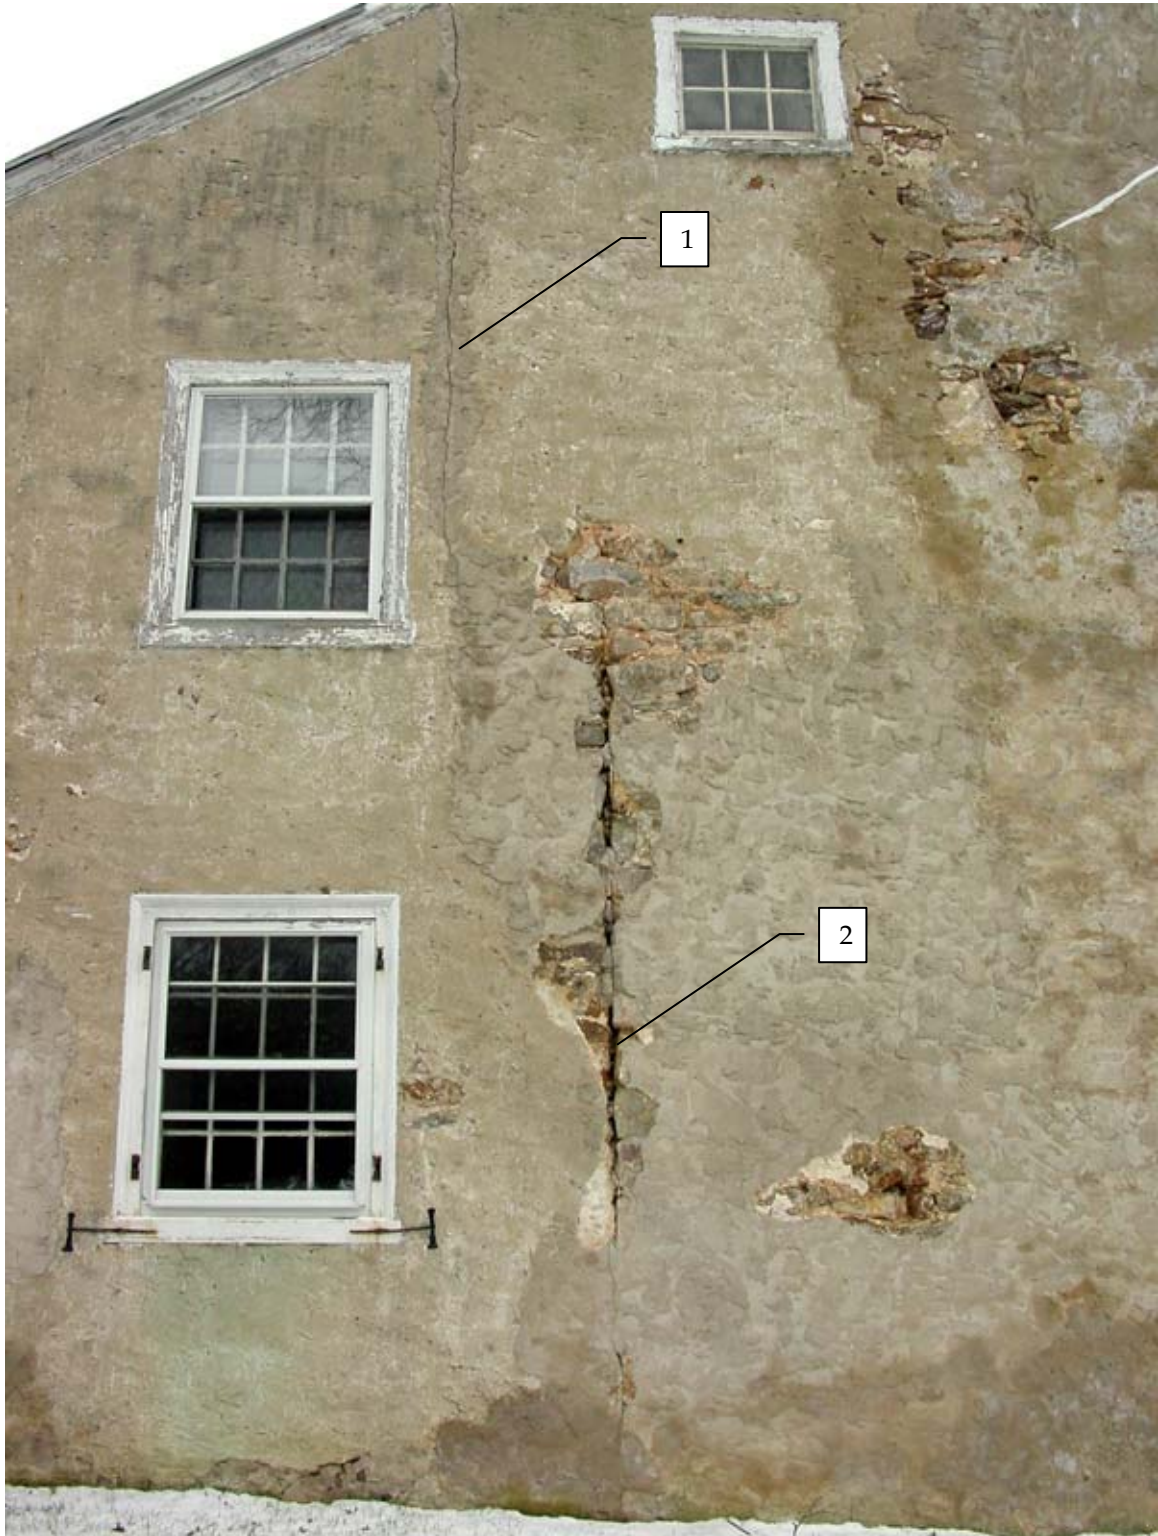
**Photo WEB** – Partial view of west elevation of west block, looking east.

- There is a single chimney mass projecting from the south roof of the west block. The location of the chimney is consistent with the location of the original kitchen fireplace. The original chimney has been extended in height, however, as part of the various renovations to the house.
- A vertical crack to the south of Window 208 represents the location of a former chimney that was added when the west block was expanded to the north c. 1810. An archival photograph shows the chimney in place in 1902. The chimney was removed as part of the 1926 renovations. (Photo WEB, Note 5/WE) (Archive Photo 3)

1. Seam in masonry where c. 1810 chimney was removed during the c. 1926 renovations to the house. The first- and second-story windows (left) were added when the chimney and interior fireplace were removed, c. 1926.
2. Seam between original c. 1769 kitchen block (right) and c. 1810 addition to the north (left).

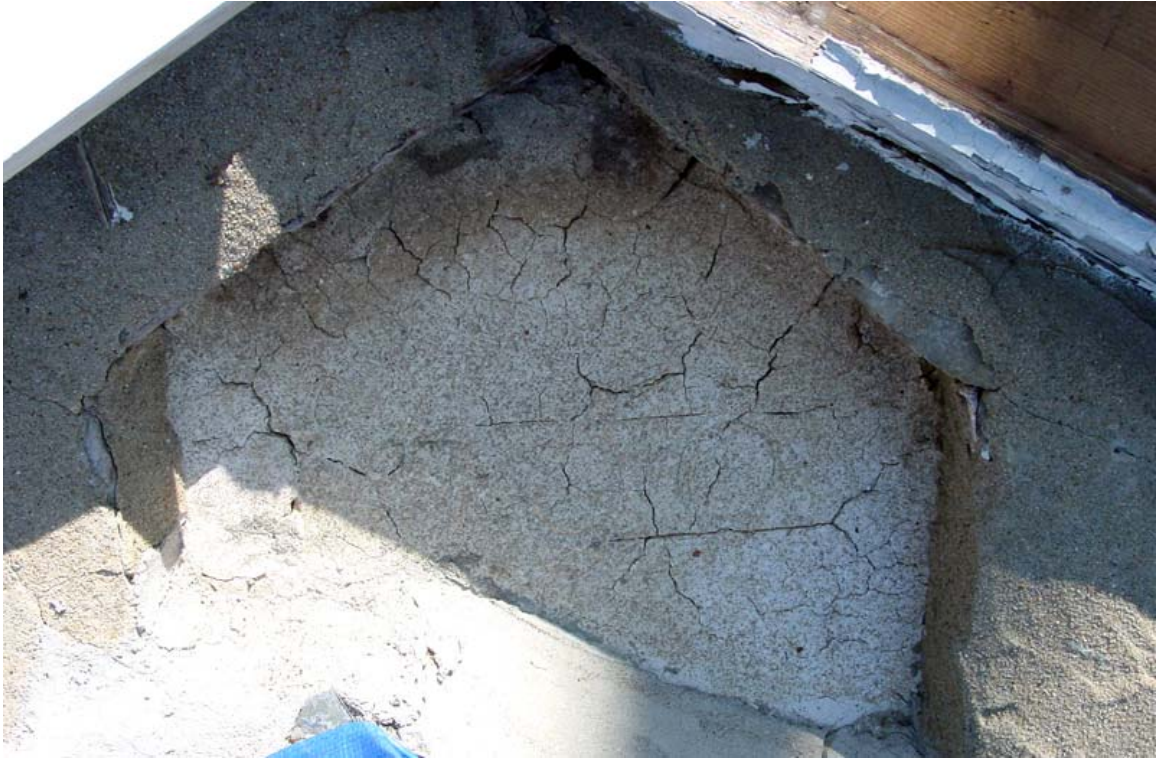
**Photo WEc** - Detail view of recessed stucco panel at west gable peak of main block, looking east. The inscription "1769" is faintly visible.

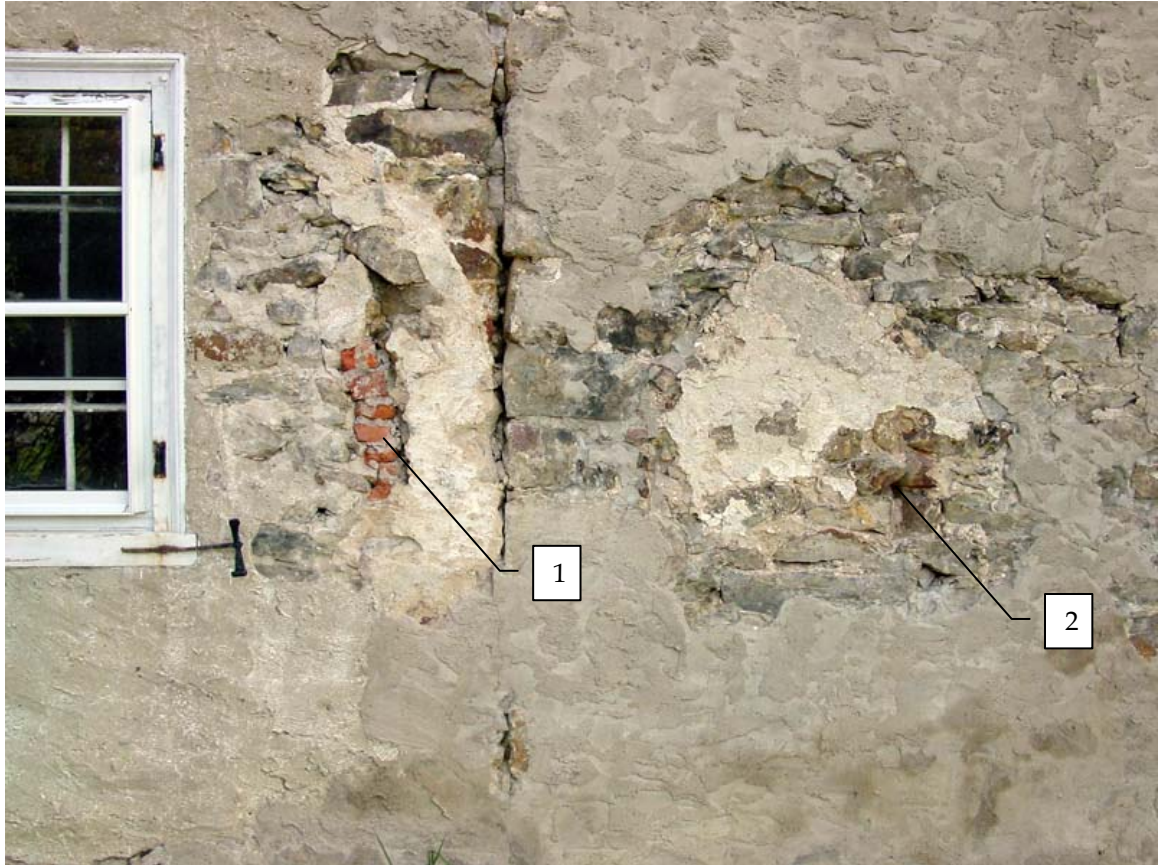
**Photo WEf** - Detail view of seam between original c. 1769 kitchen block (right) and c. 1810 addition to the north (left), looking east.

1. Brick infill at location of former bake oven.
2. Masonry infill at location of former bake oven.

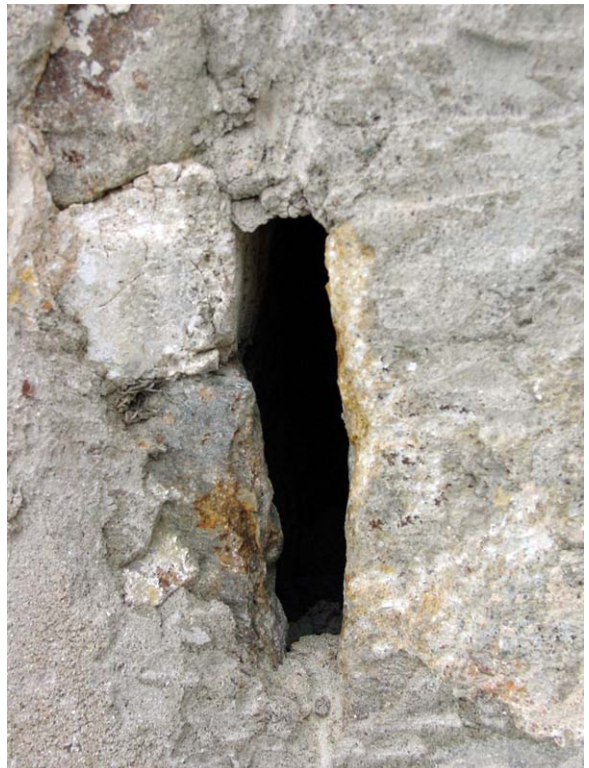
**Photo NEc** -  
Detail view of seam in masonry between main block (left) and west block (right). The pointing mortar of west block extends into the seam along west side of the masonry wall. There is no evidence of stucco at the west side of the main block. View represents the general location of Material Sample 32.

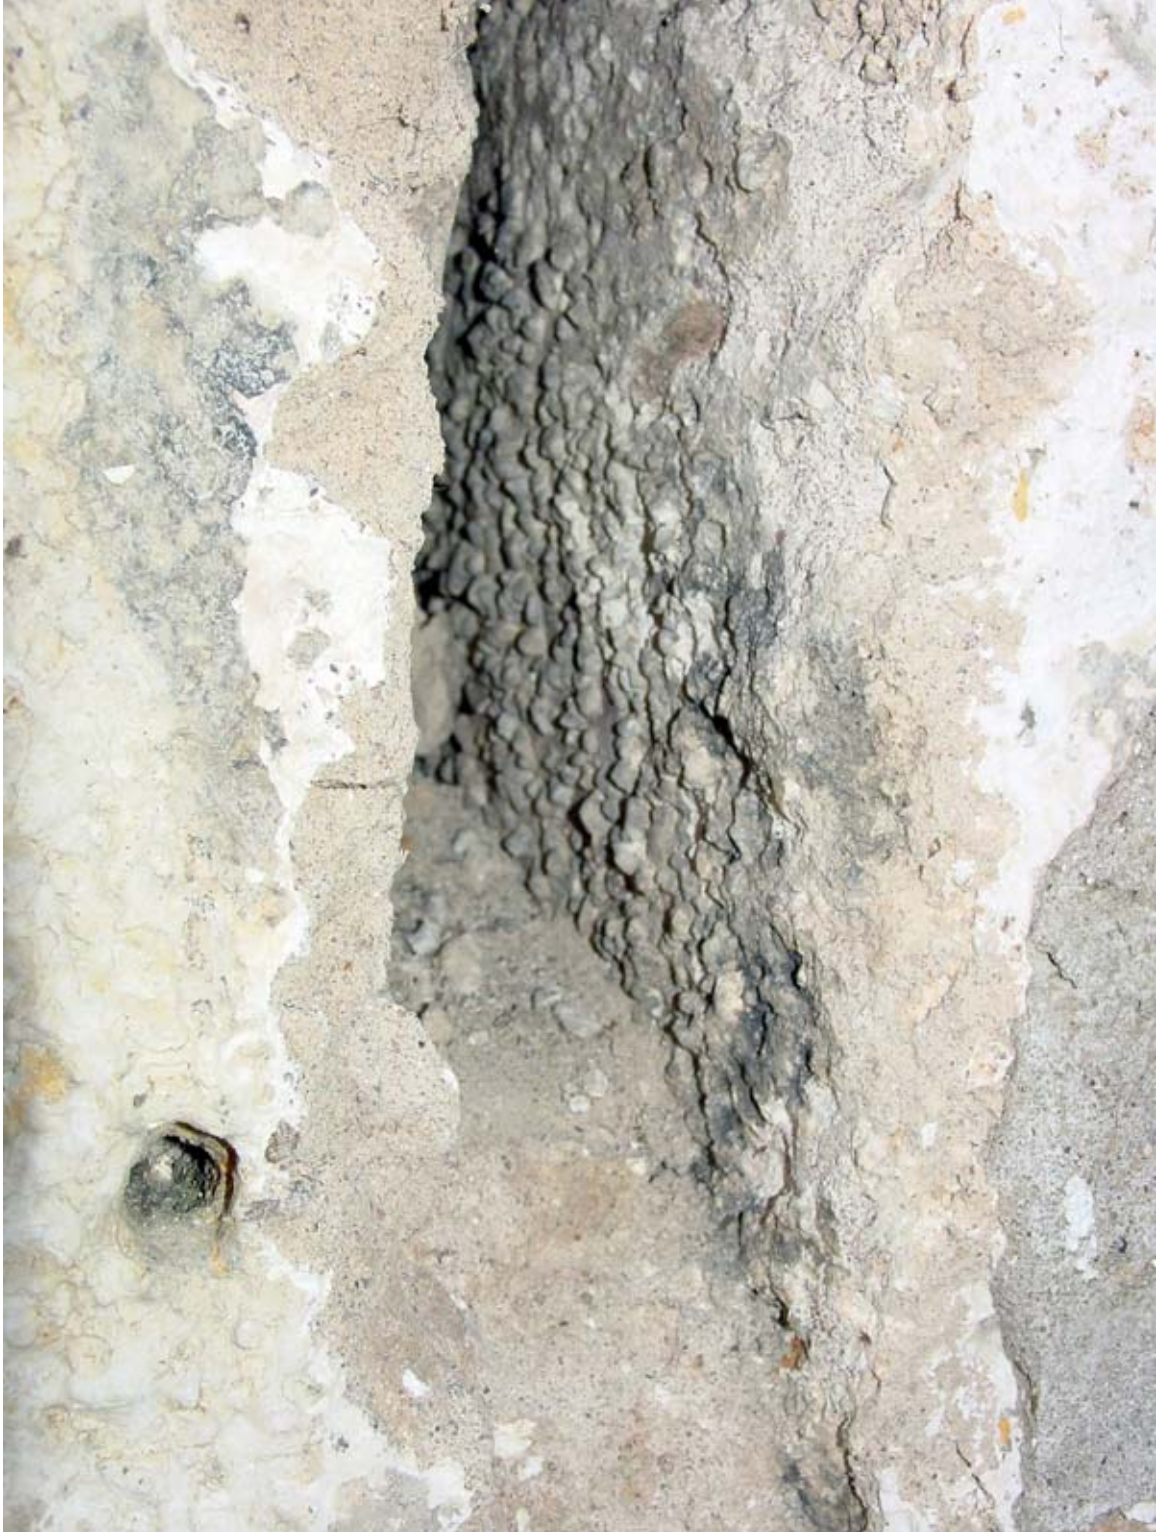
**Photo NEd** - Detail view of seam at north elevation between main block (right) and east addition (left), looking south. Note textured surface of stucco and that stucco wraps around east side of the main block. View represents the general location of Material Sample 26.

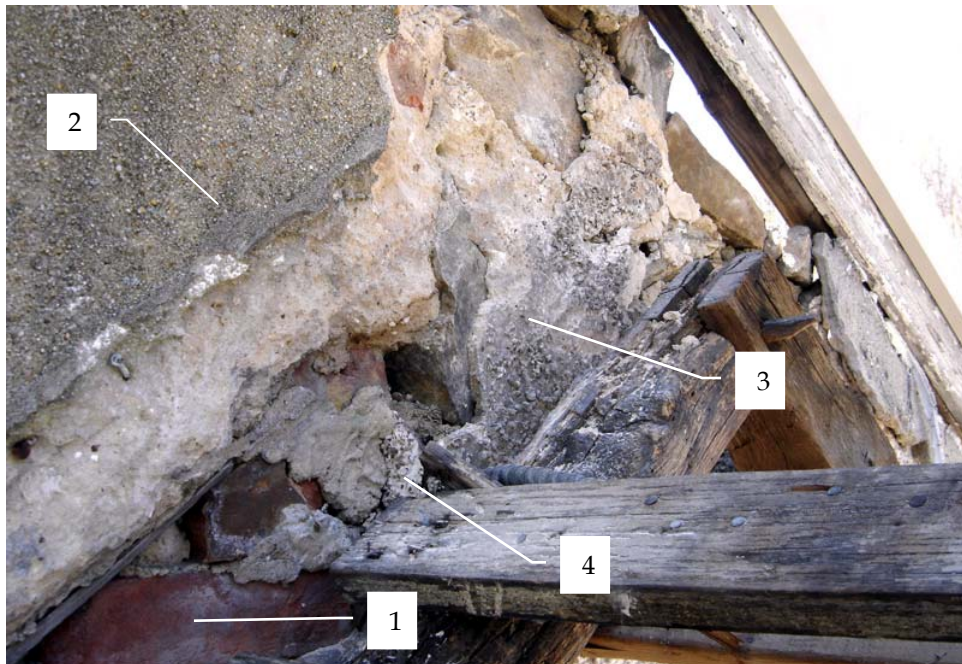
**Photo EEc** – Detail view of portion of former masonry opening at east exterior wall of main block, north end behind existing roof rafter, looking west. (East roof was removed at the time of this photo.)

1. Former masonry opening infilled with brick.
2. Cement-based, 20<sup>th</sup>-century exterior stucco application.
3. Early lime-based stucco application on masonry wall.
4. Early lime-based stucco application at north jamb of former opening.

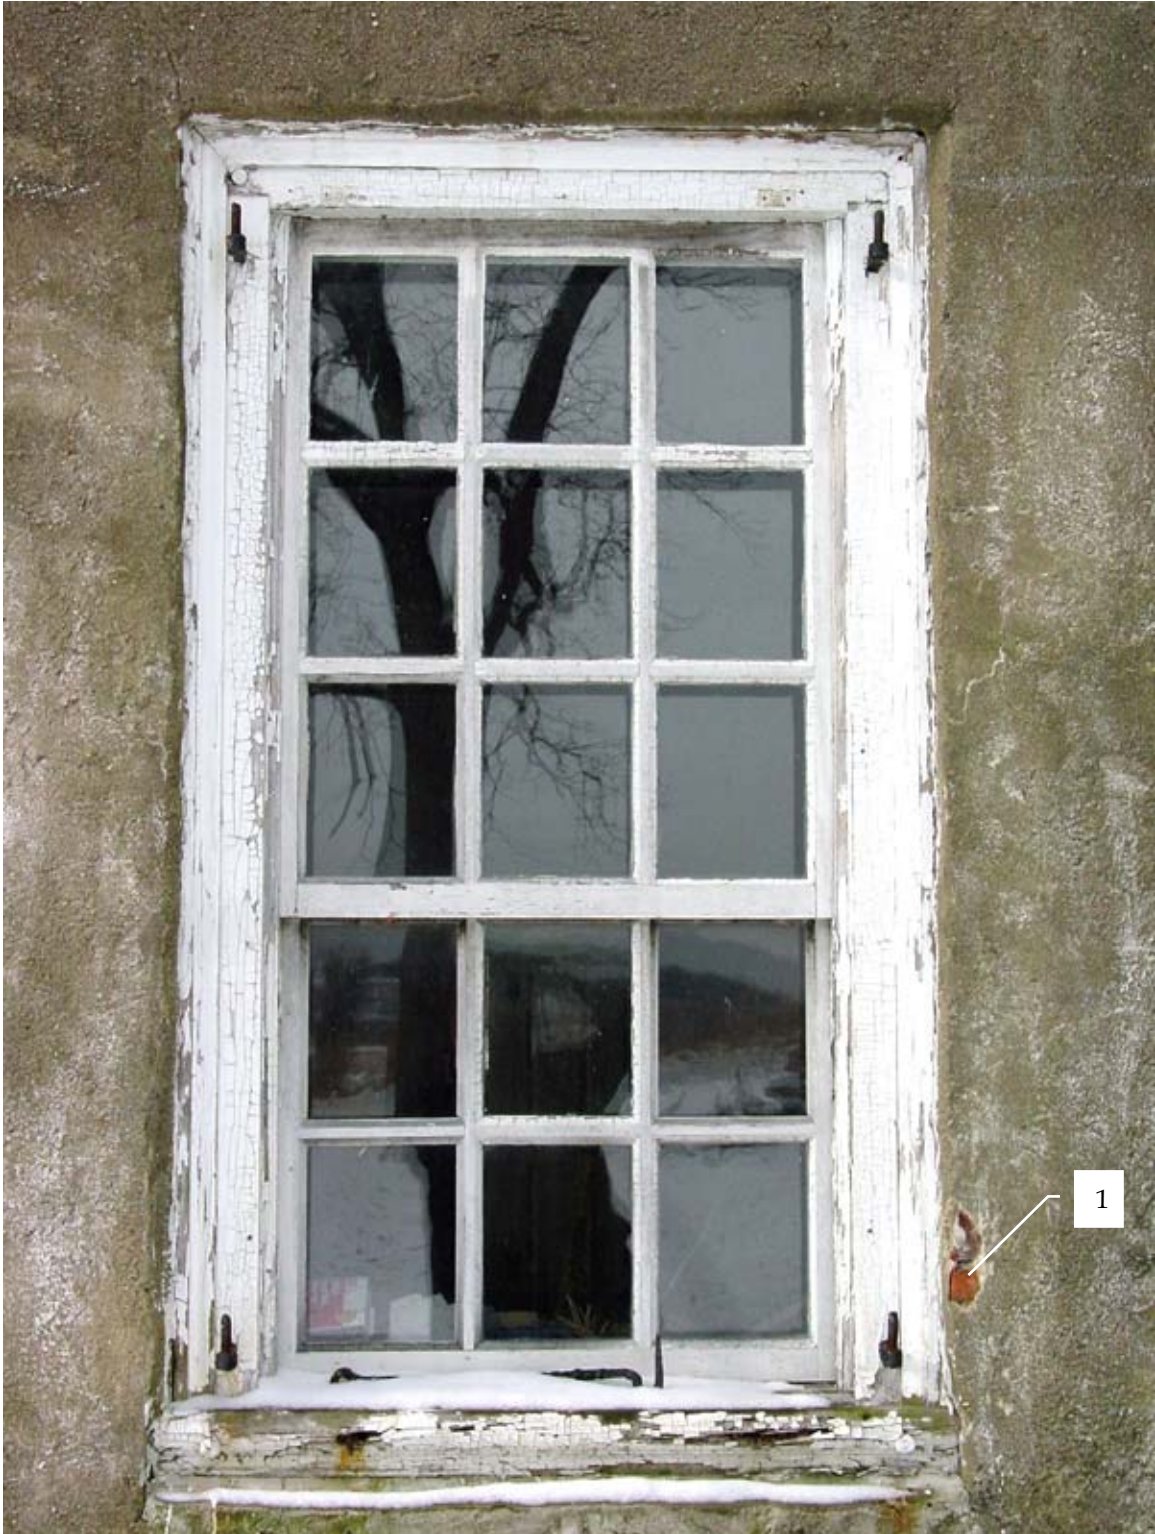
**Photo EEd** - Exterior view of Window 102, looking west.

- Window 102: 9/6 single-hung wood window. Based on the molding profiles and the construction of the window, Window 102 does not appear to be original to the main block. Archival photographs do not show a window at this location. Window 102 was likely added as part of the 1926 renovations to replicate the existing windows at the south façade of the main block (Windows 103 and 104). (Photo EEd, Note 3/EE) (Archive Photos 2 & 4)
- Window 301: 4-light wood window. This window appears to be original to the east addition (c. 1830).

1. Brick infill at north jamb.

- Windows 103 & 104: Two windows on the south wall are 6/6 single-hung, wood windows. The detailing and profiles of the windows are consistent with 18<sup>th</sup>-century characteristics and are likely original.
- Window 102: Investigation at the east window exterior jamb revealed brick infill and indicates that this window opening is not original. Archive photographs show the east façade without the window which further corroborates that it is not original. The addition of this window is attributed to the Ligget family. There is also a seam in the chair rail cap and window sill where the sill for the new window would have been inserted. (Archive Photos 2 & 4)

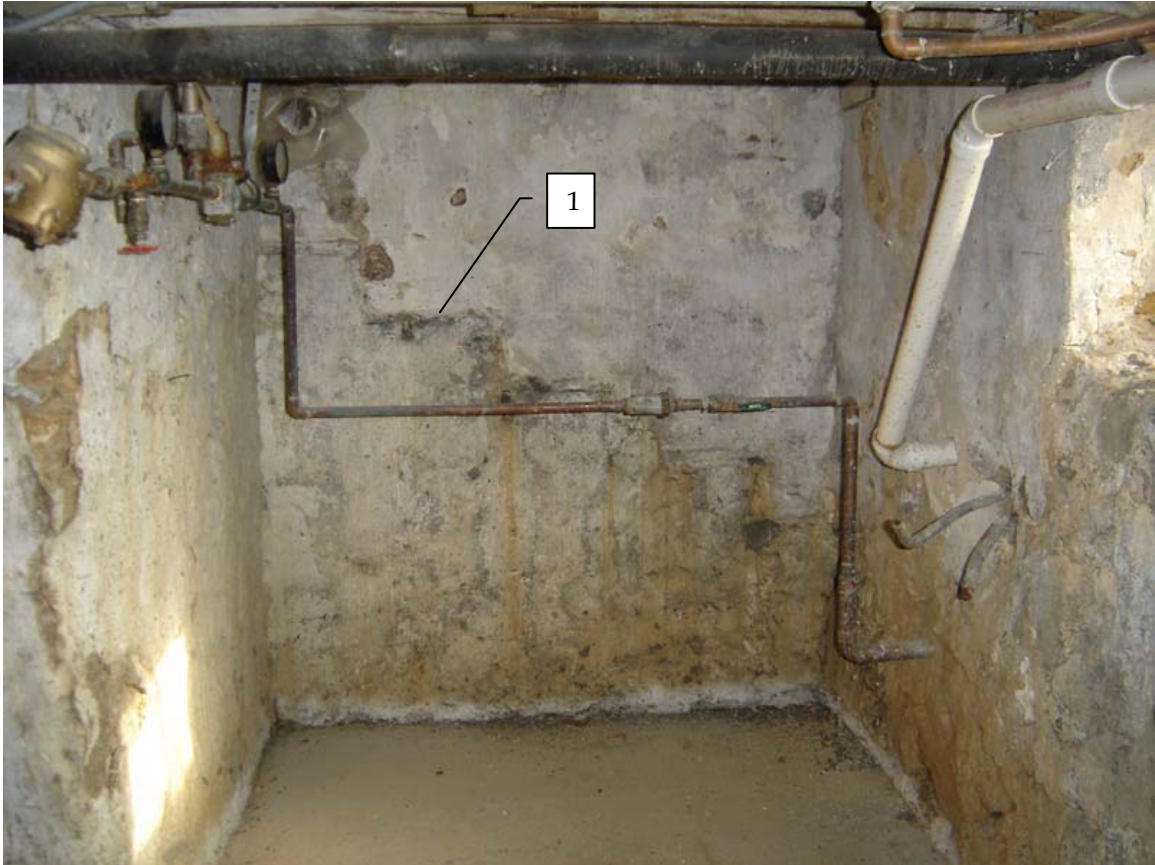
- The impression from the original winder stair to the first floor can be seen to the south of the fireplace vault and on the south wall of the vault. (Photo 001a, Note 1/001)
- There is a 20<sup>th</sup>-century concrete lintel to support the fireplace hearth. The original hearth support was most likely stone.

**Photo 001a** - View of segment of east wall to the south of the chimney vault, Room 001, looking east.

1. Evidence in plaster of former winder stair.

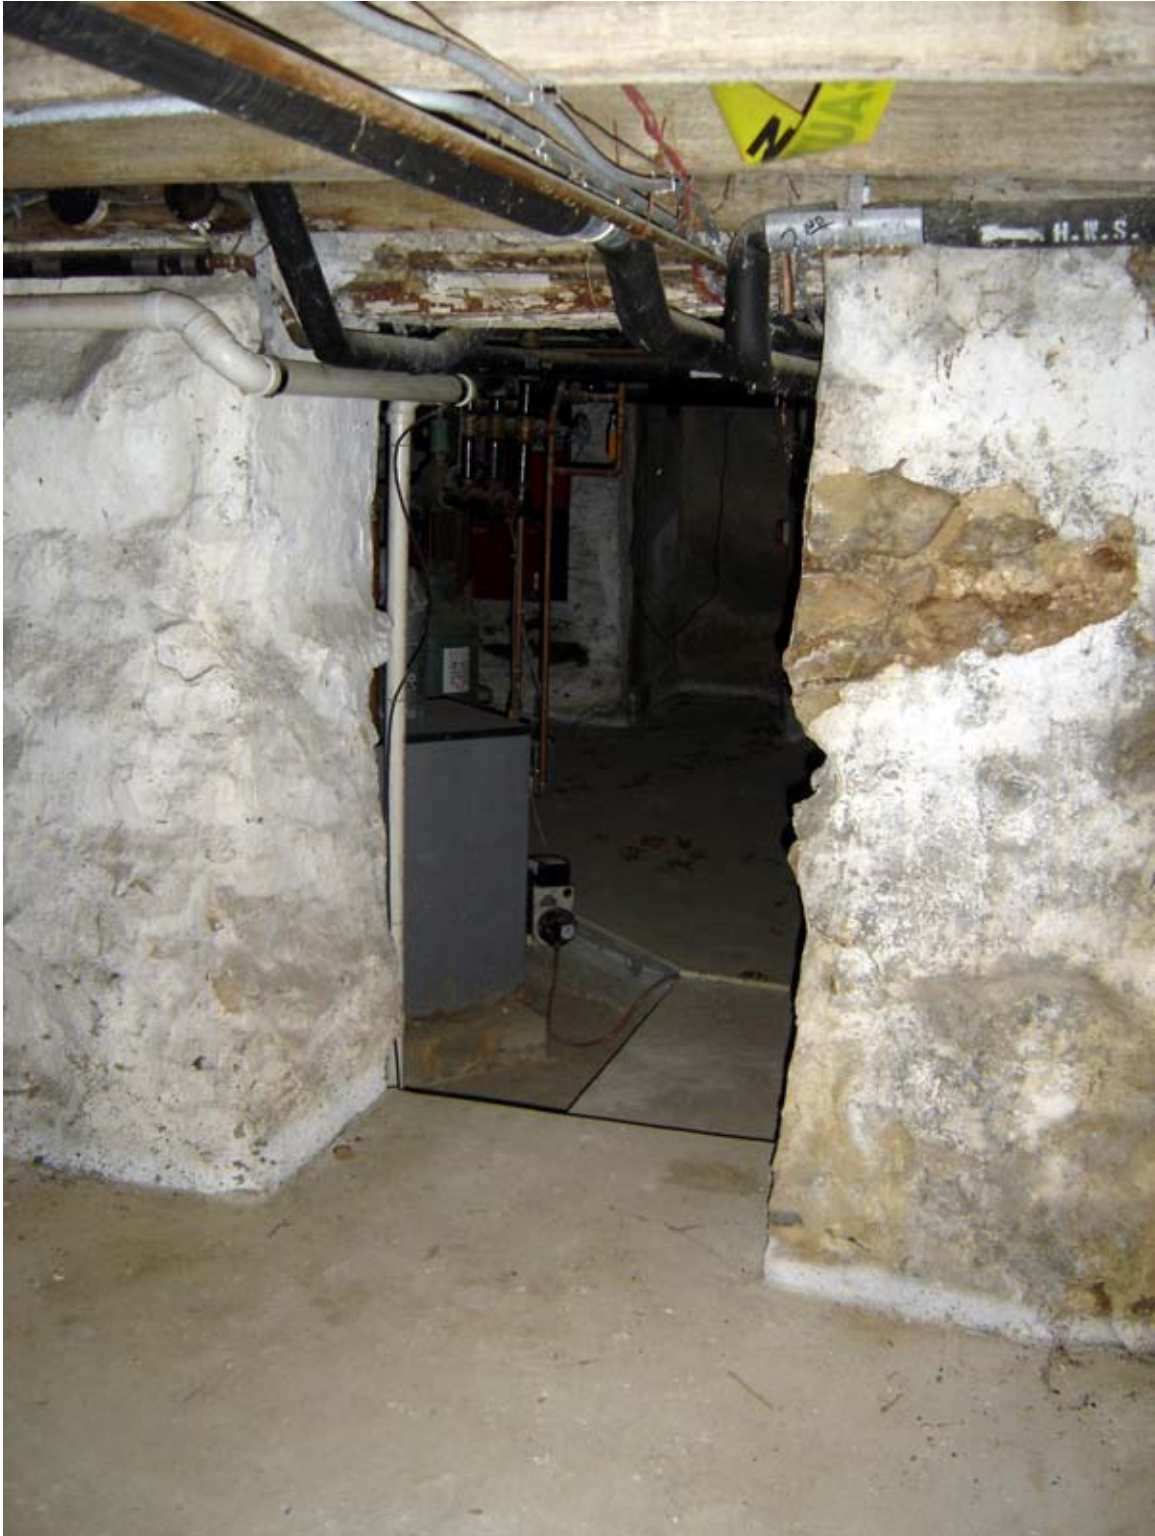
- Similar to what can be seen from the main block basement, the rough character of the stonework at the passageway to the basement of the main block suggests that the opening was introduced after the original foundation construction of 1769; most likely at the time of the c. 1830 addition. (Photo 001b, Note 3/001)

**Photo 001b** - Masonry opening between Rooms 001 and 002, looking west. Rough character of stonework suggests that the opening was added after original construction. This opening was likely formed at the time of the east addition, c.1830.

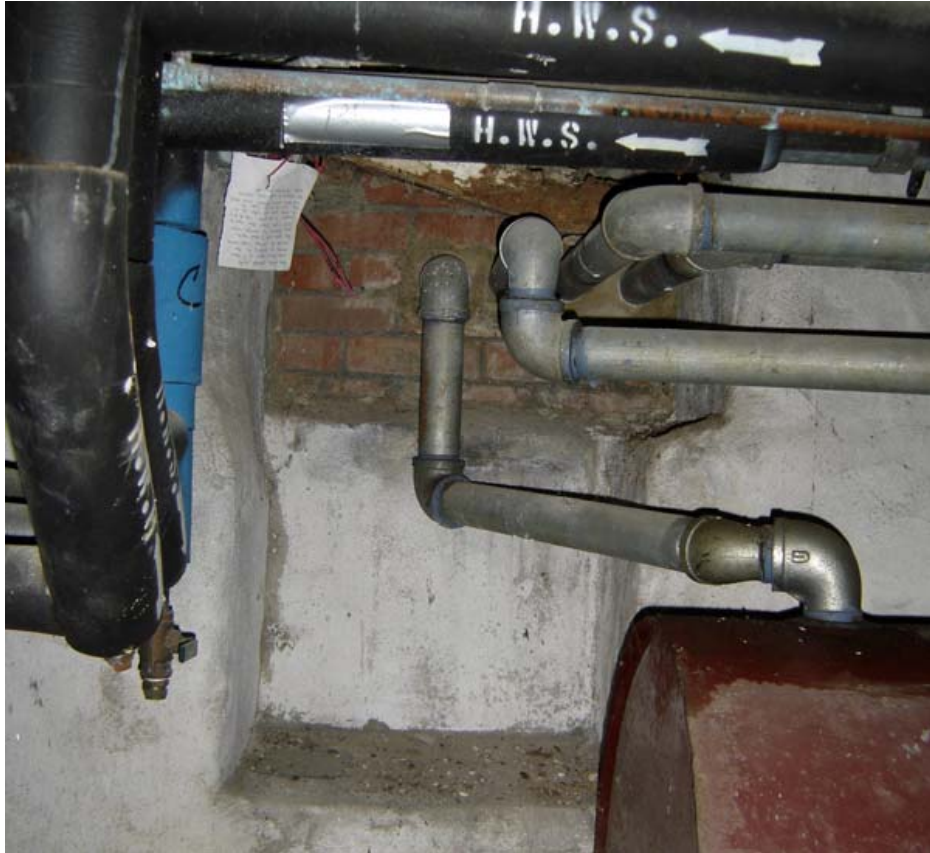
- An opening on the north wall has been infilled with brick around several mechanical pipes. The jagged edges of the opening suggest that it was not original to the building (c. 1769) but cut into the wall at a later date. The area below this infill appears to be an early wall niche and the ledge on the right and left may have supported a wood lintel. (Photo 002b, Note 2/002)

**Photo 002b** - Former masonry opening and niche at north wall, Room 002, looking north.

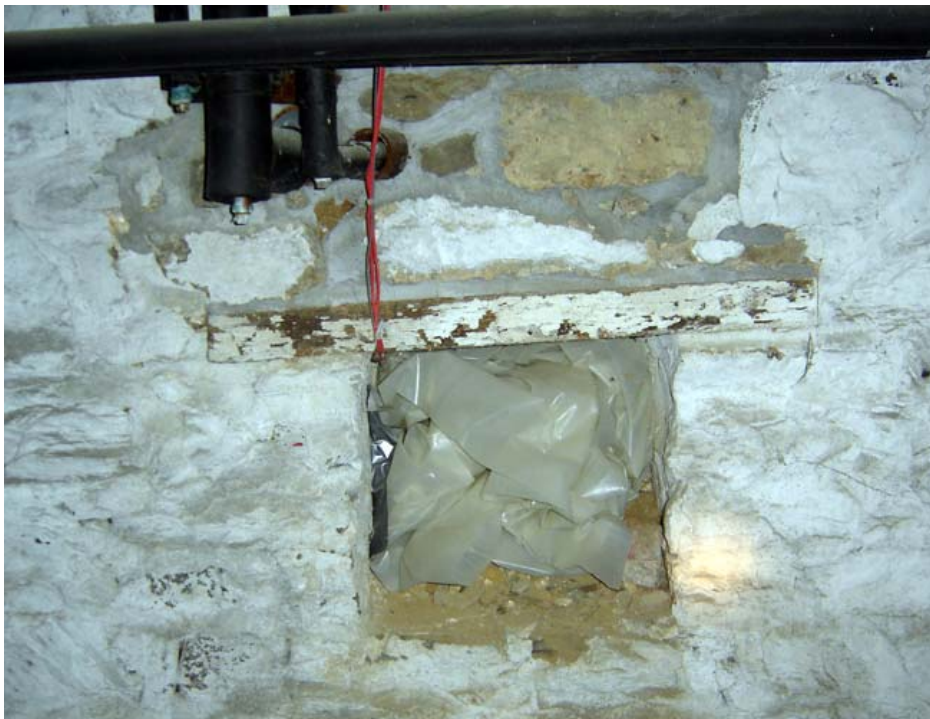
**Photo 002c** - Former masonry opening at west wall, Room 002, looking west.

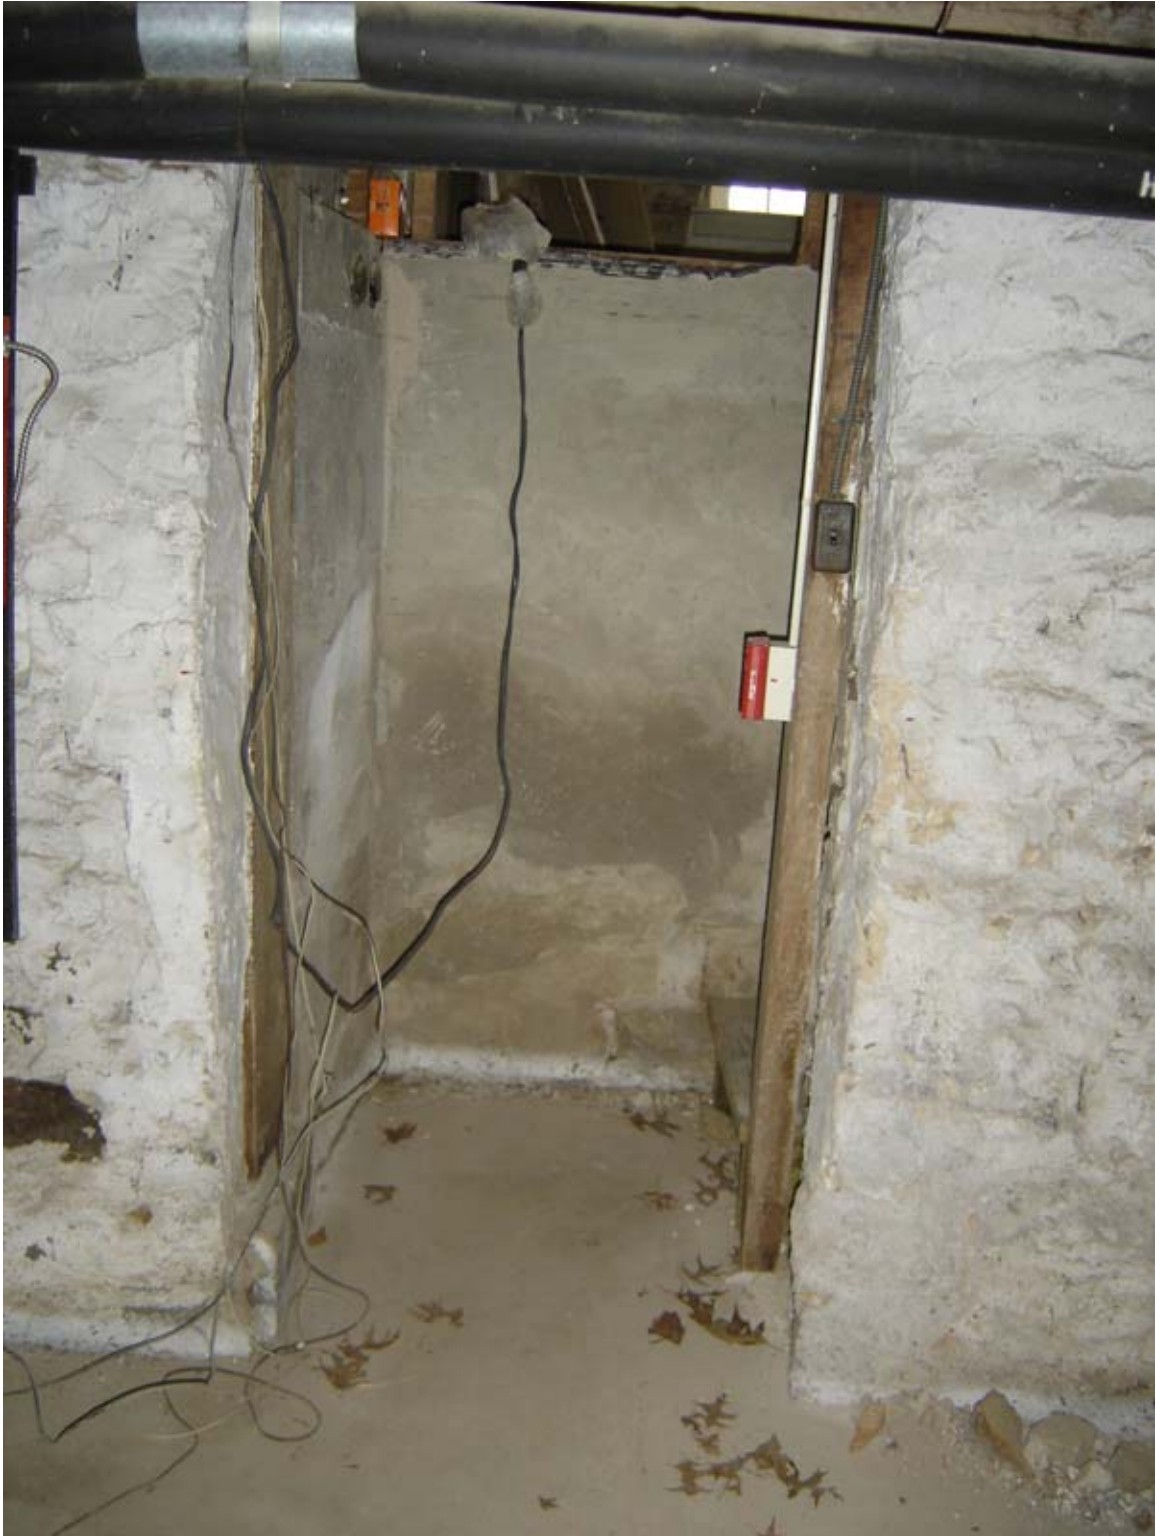
**Photo 002d** - Masonry opening at west wall, Room 002, looking west, into areaway for stair to Room 106. This opening was likely added as part of the c. 1926 alterations to the house to enable access to the basement from the first-floor kitchen.

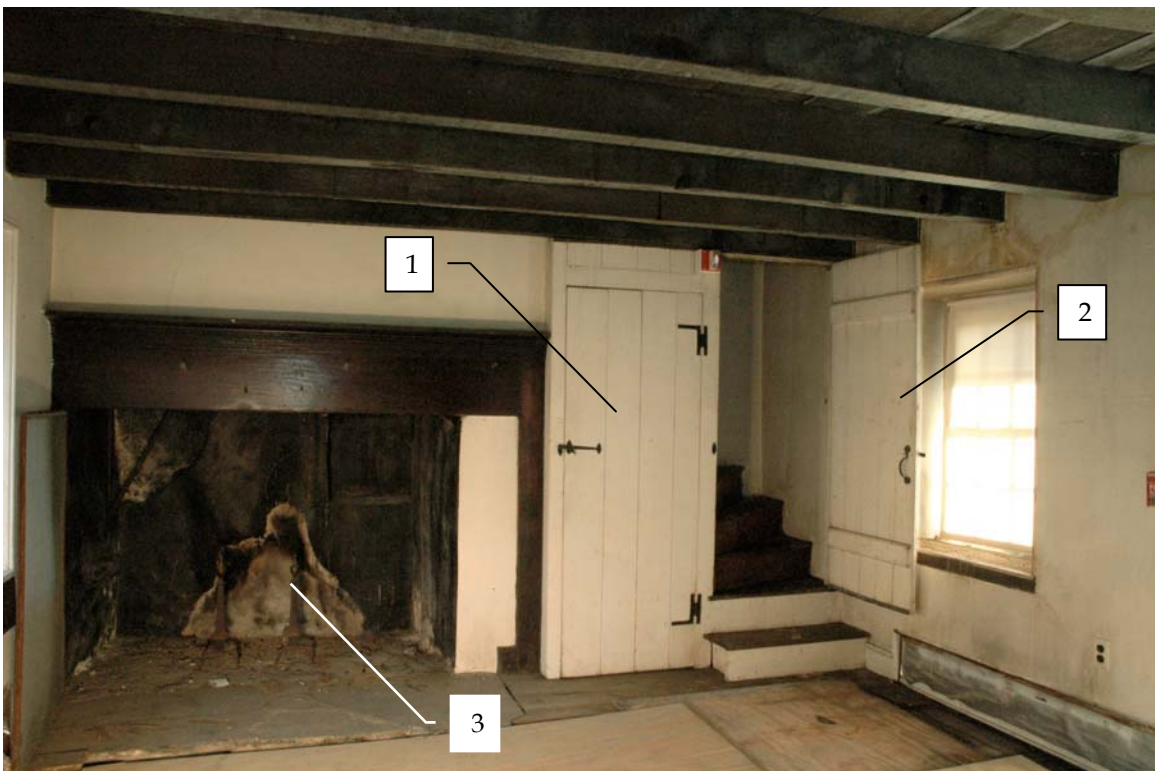
**Photo 101b** – Interior view of Room 101, looking east.

1. Original door to former winder stair to basement.
2. Original door to existing winder stair to 2<sup>nd</sup> floor.
3. Original cooking fireplace.

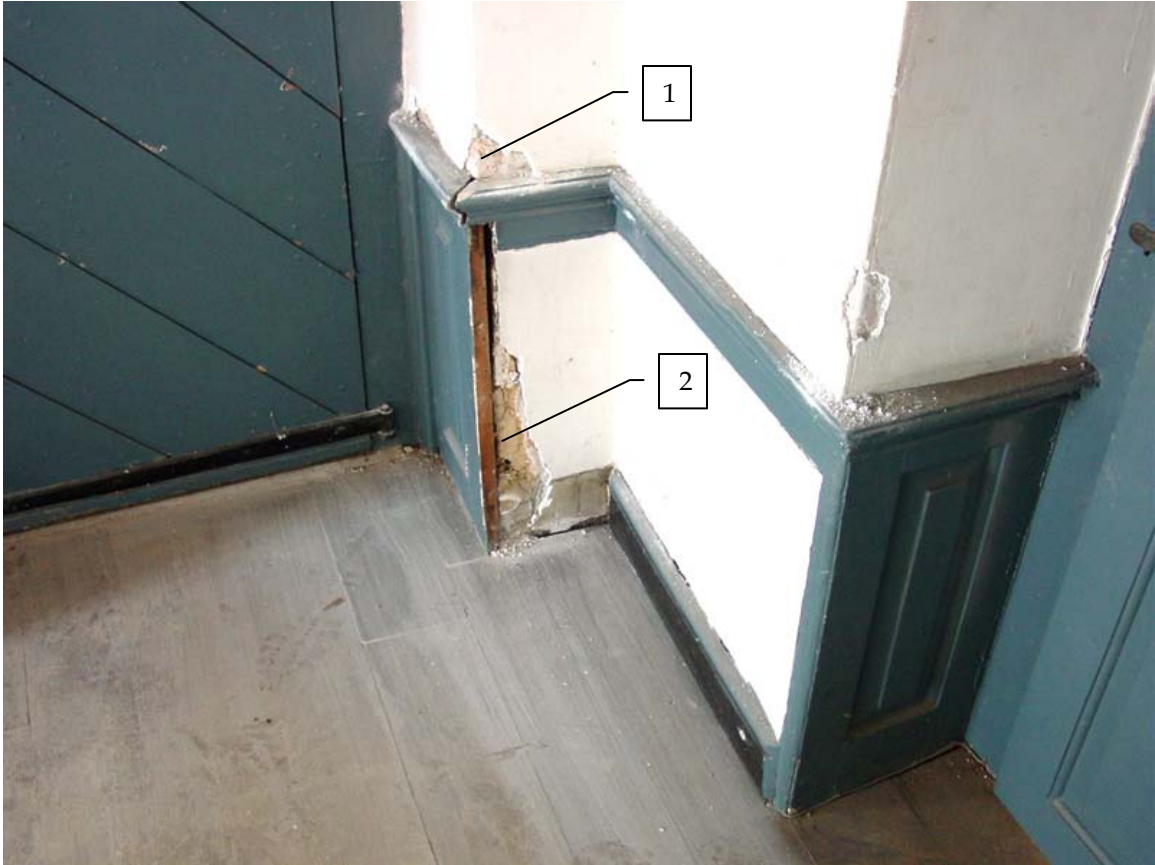
- Chair rail appears to be original to the 1769 construction period. The first plaster layer abuts the top and bottom of the chair rail. (Photo 103a)
- Investigations at the raised panel door jambs indicate that the detail is original at both doorways. There is no 1769 plaster behind the panels and the edge molding is applied with hand-wrought brads. (Photo 103b, Note 1/103)

**Photo 103b** – Oblique view of paneled jambs at south door (left) and west door to original c. 1769 kitchen (right), looking south.

1. Original first-layer plaster turns corner above chair rail.
2. Original first-layer plaster abuts original wood framing for raised panel jamb below chair rail.

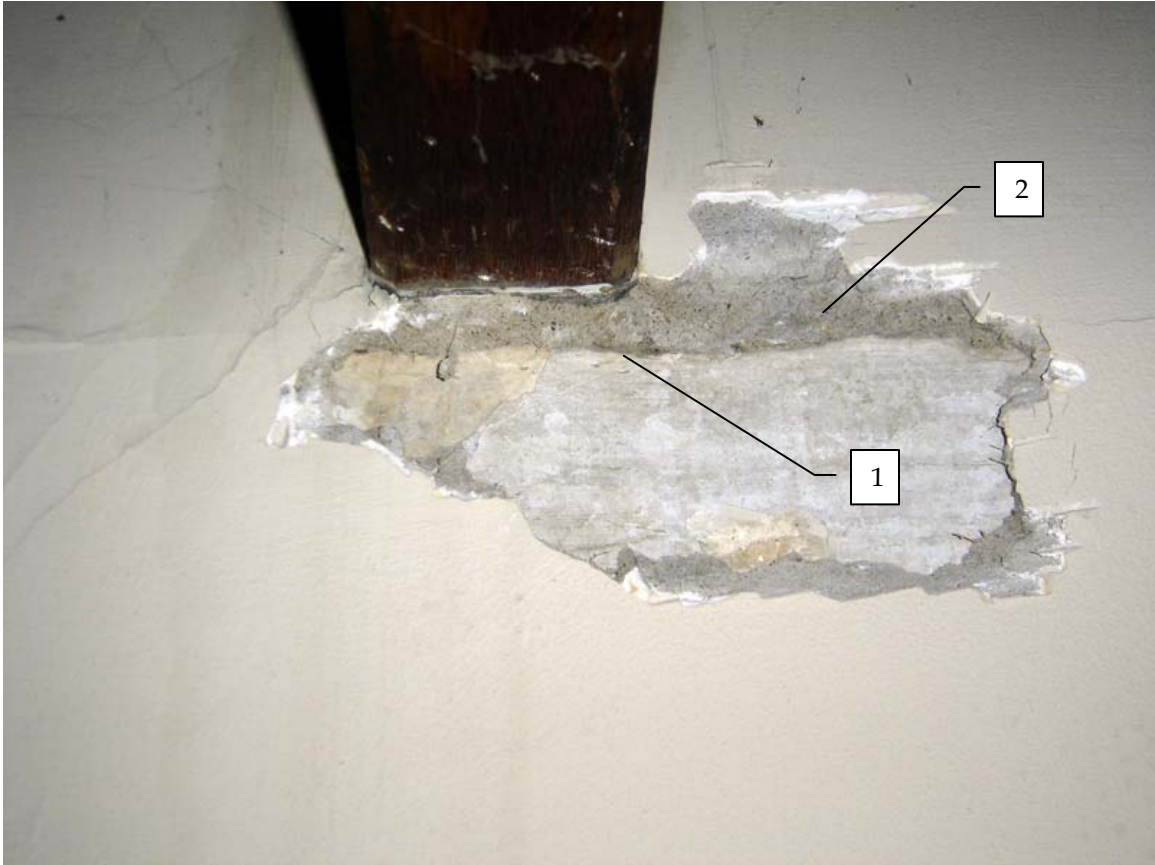
- Ceiling joists are exposed. Joists do not have nail holes for lath boards, yet the wall evidence indicates that there was a ceiling in 1769. It is believed that the floor joists were replaced. This is further evidenced by the presence of the top plaster layer around the sides and bottoms of the joists. This work was most likely part of the 1926 renovations. (Photo 103c)

**Photo 103c** - Detail of plaster evidence below ceiling joist, south wall, Room 103, looking south.  
1. Line of original c. 1769 plaster indicating intersection of wall and former ceiling plaster.  
2. Early 20<sup>th</sup>-century cement-based plaster infill.

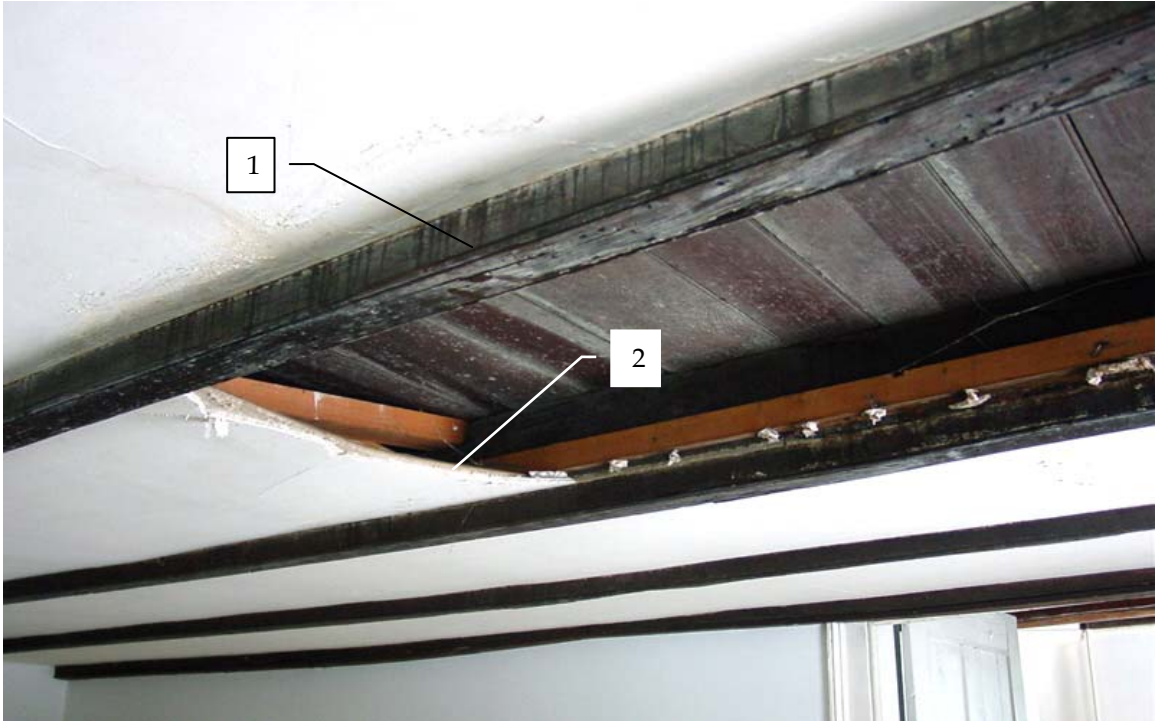
**Photo 104b** – View of ceiling, Room 104, looking northeast.

1. Original beaded wood joists.
2. Plaster ceiling installed between joists.
