STIRLING'S QUARTERS AT VALLEY FORGE NATIONAL HISTORICAL PARK  
HISTORIC STRUCTURE REPORT

PREPARED BY:  
JOHN MILNER ARCHITECTS, INC.  
104 LAKEVIEW DRIVE, CHADDS FORD, PA 19317

JANUARY 2006

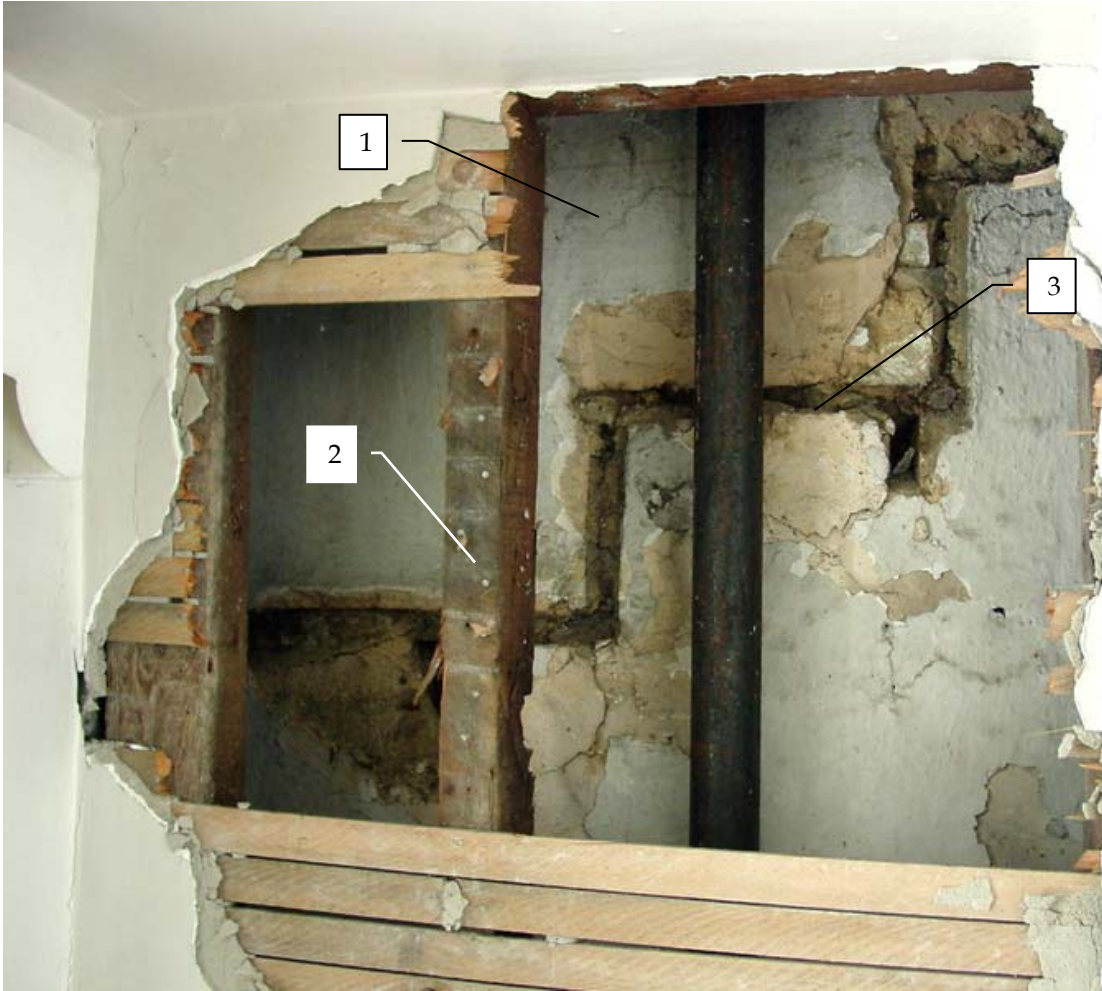
**Photo 105a** - Detail view of north wall, Room 105, looking north.

- Tile wainscot installed c. 1926.
- North wall, against chimney, has been furred out with 20<sup>th</sup>-century studs and drywall to form a plumbing chase. (Photo 105a)
- Traces of winder stair treads to second floor are evident behind 20<sup>th</sup>-century north wall and in earlier plaster layer. (Photo 105a, Note 1/105)
- East wall, door, and cabinet added c. 1926.

1. Original cooking fireplace cheek wall.
2. 20<sup>th</sup>-century stud wall furring with lath and plaster.
3. Evidence of winder stair in early plaster.

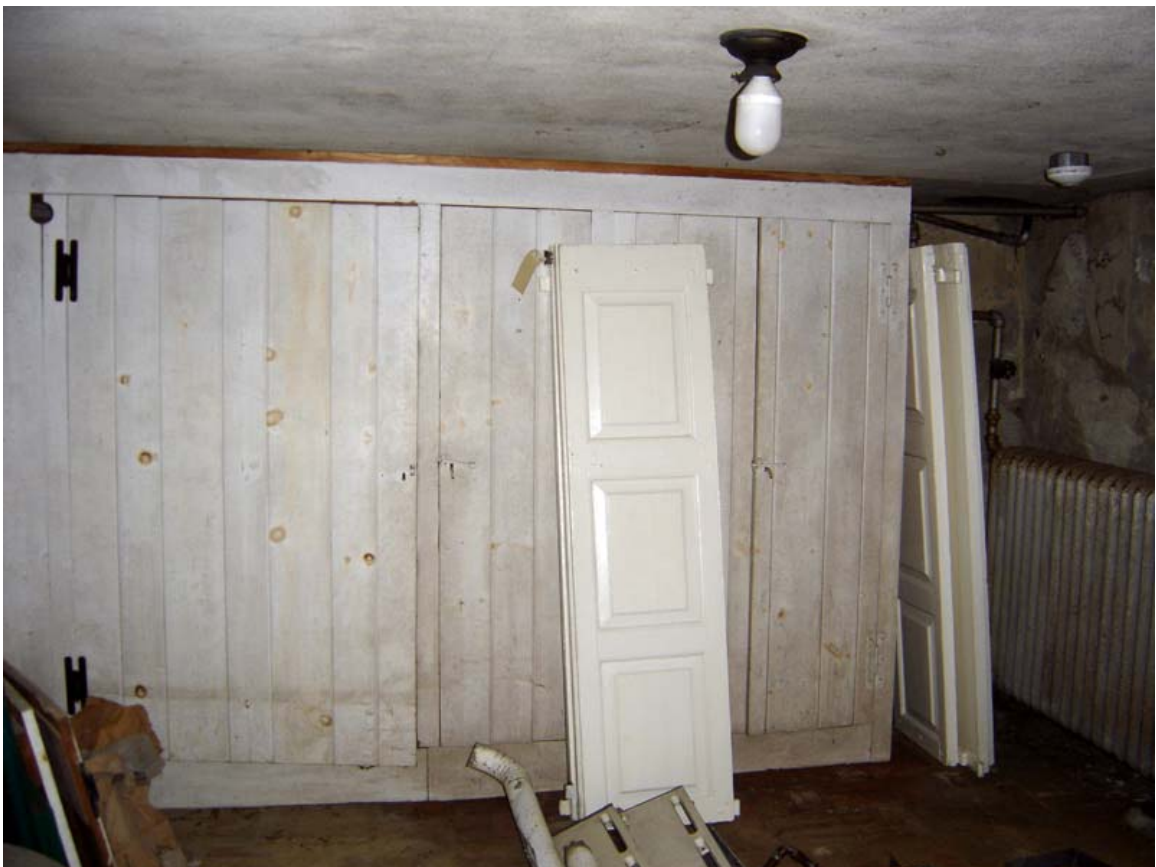
- Built-in cabinets/closets along west wall were installed by the Ligget family in 1926. The doors are fabricated with reproduction nails. (Photo 108b, Note 4/108)

**Photo 108b** - 20<sup>th</sup>-century cabinetry at west wall of bakehouse, Room 108, looking west.

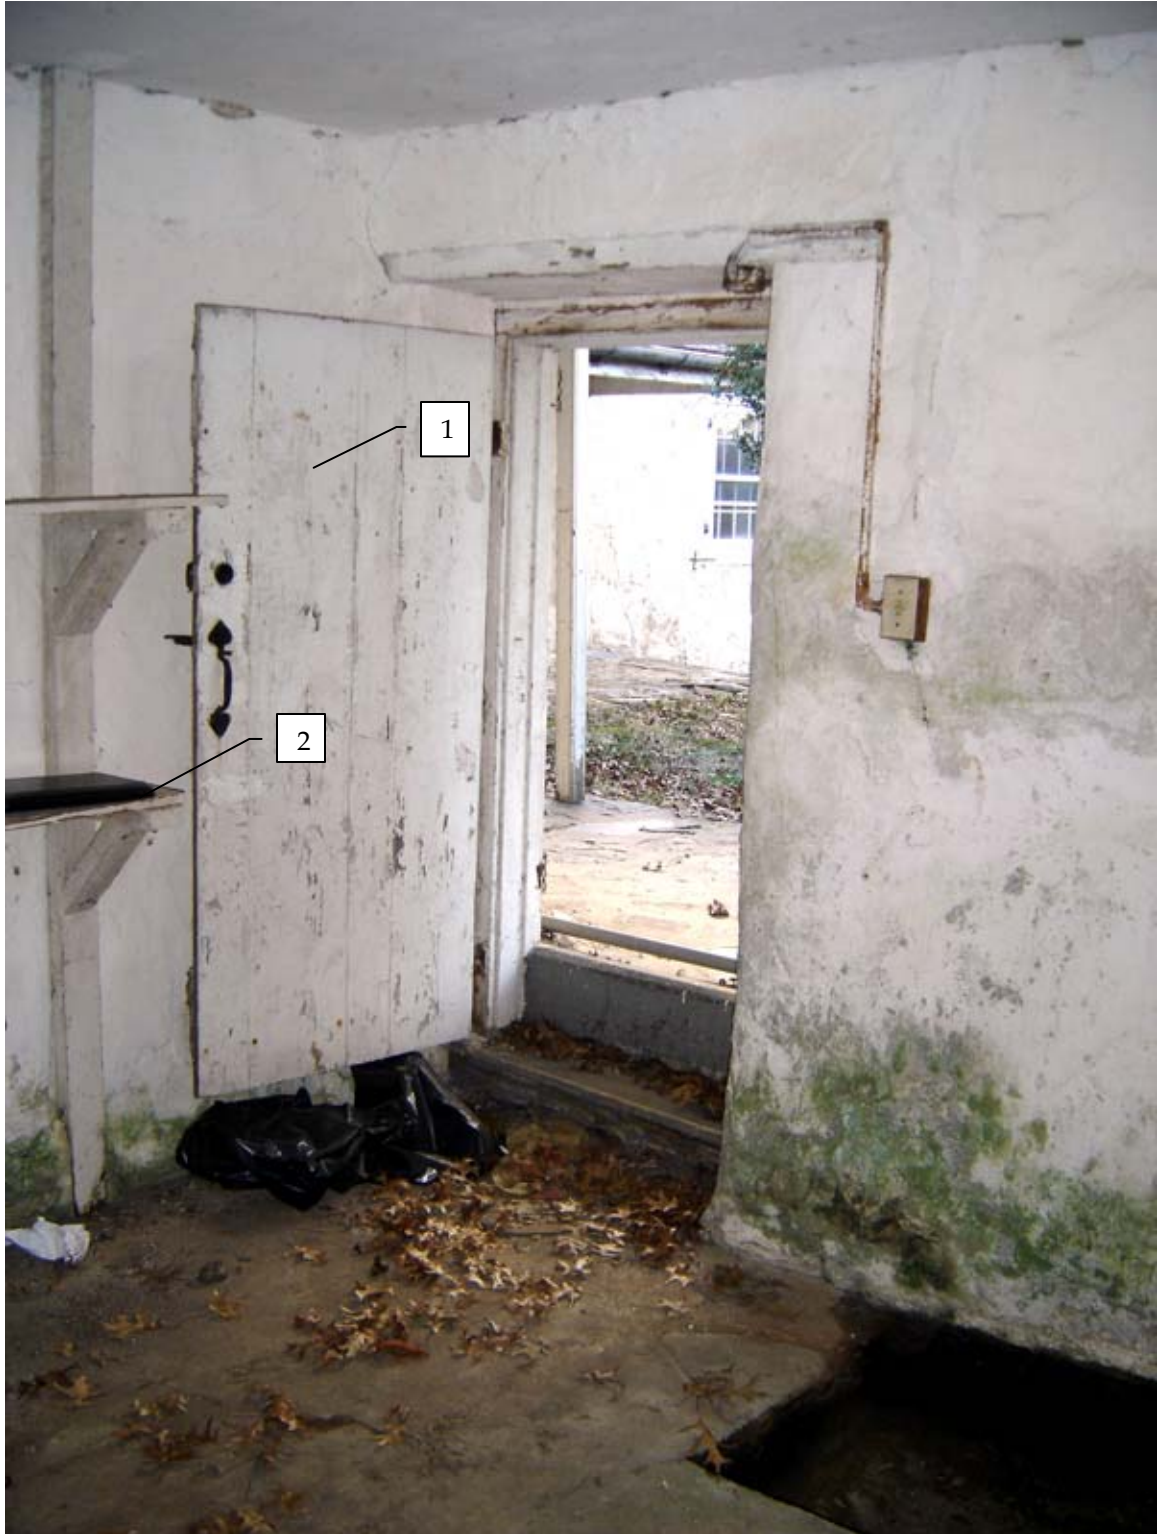
- The only door into the spring house is a vertical board and batten door. This door is a 20<sup>th</sup>-century replacement. The door frame is not as recent as the door but also appears to be a non-original frame. (Photo 109c, Note 4/109)

- Shelving on the east wall is not original. It consists of nominal 2x4 vertical supports and brackets and nominal 1x10 shelves. (Photo 109c, Note 7/109)

**Photo 109c** - Segment of springhouse interior, Room 109, looking southeast.

1. 20<sup>th</sup>-century board-and-batten door.
2. 20<sup>th</sup>-century shelving.

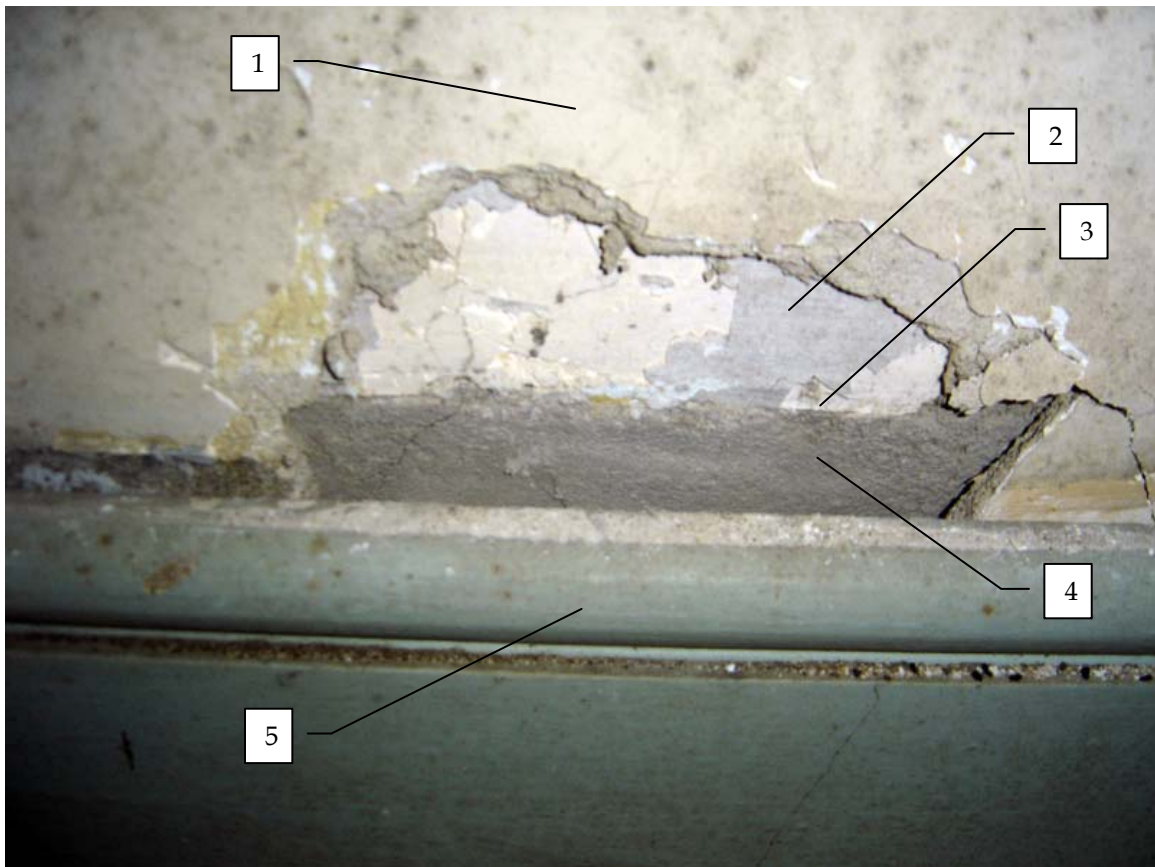
**Photo 204a** - Detail of plaster wall and baseboard at back of chimney mass, south wall, Room 204A, looking south.

- At the base of the chimney flue, there is a line in the bottom plaster layer where the plaster abutted the original baseboard. The original baseboard has been removed and the space filled with a 20<sup>th</sup>-century plaster that matches the top layer of plaster. This is strong evidence that there was never a corner fireplace in the northeast room. (Photo 204a, Note 7/204)

1. Cement-based, 20<sup>th</sup>-century plaster application.
2. Original first-layer plaster.
3. Line in original first-layer plaster indicates where original baseboard was removed.
4. Cement-based, 20<sup>th</sup>-century plaster infill.
5. Replacement baseboard installed over cement-based plaster.

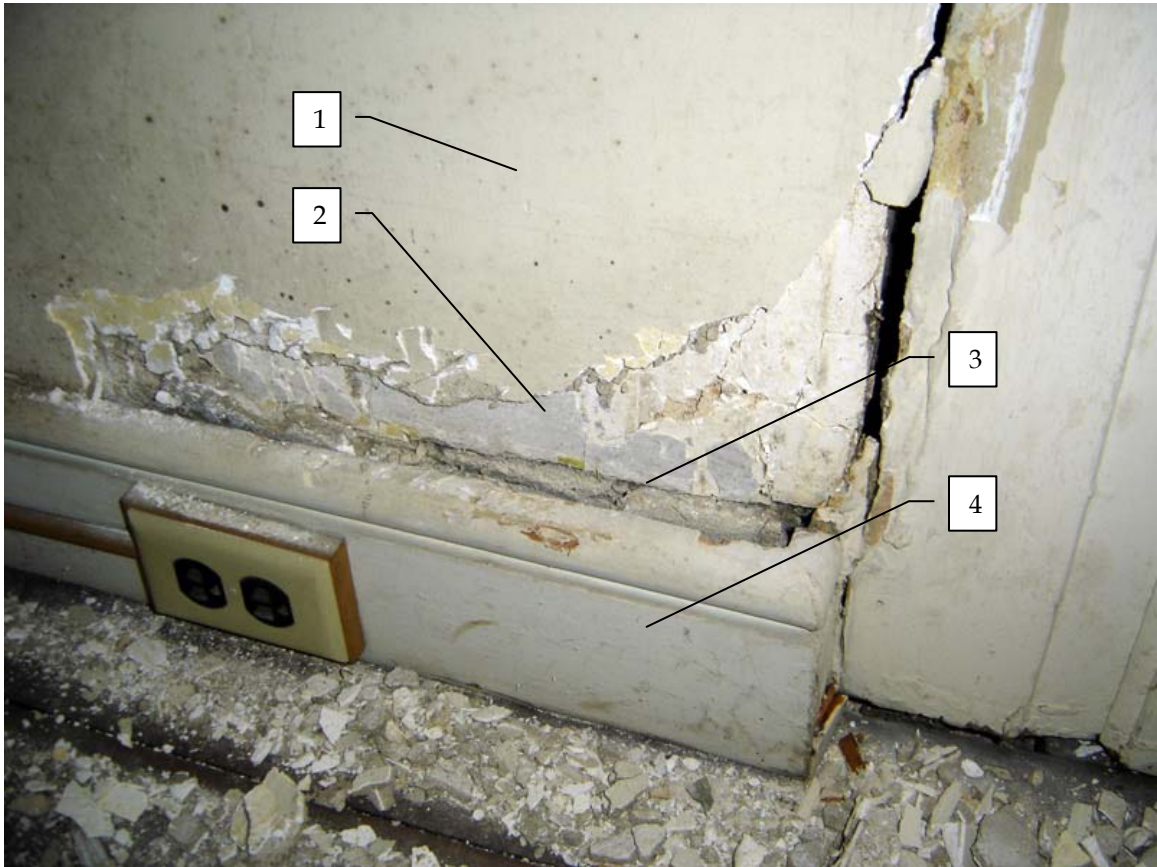
**Photo 205e** – Detail view of plaster and baseboard at south wall of closet in Room 205, looking south.

1. Cement-based, 20<sup>th</sup>-century plaster application.
2. Original first-layer plaster.
3. Line in original first-layer plaster indicates where original baseboard was removed.
4. Replacement baseboard installed over cement-based plaster.

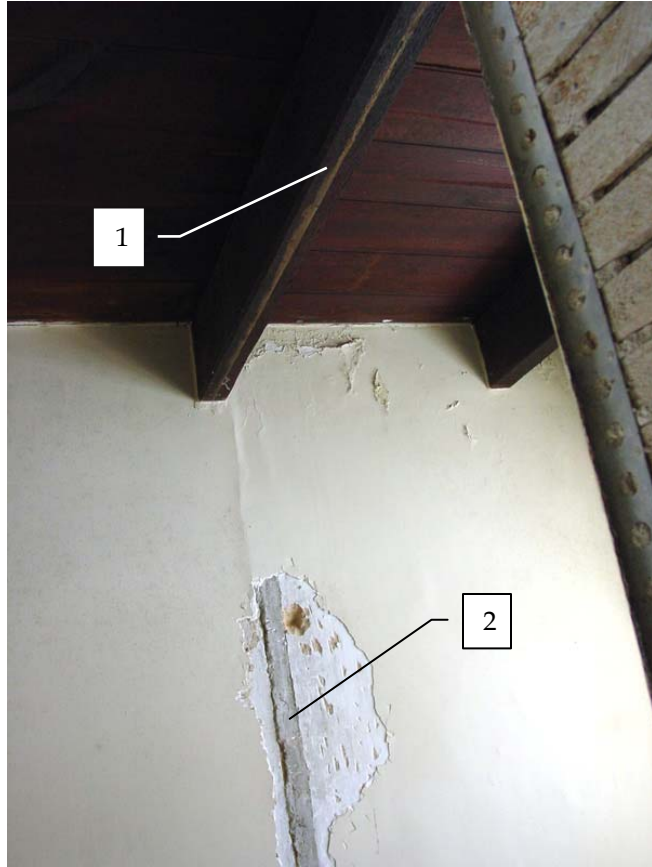
**Photo 206b -**

- Vertical line in plaster on south wall corresponds to paint line on ceiling joists and ceiling boards. Line is from a board partition wall which formed a hallway at the winder stair. (Photos 206b & 206c, Note 4/206)

Detail view of portion of south wall and ceiling, Room 206, looking south.

1. Paint line along wood joist.
2. Plaster patch in south wall likely corresponding to former board partition around former winder stair.

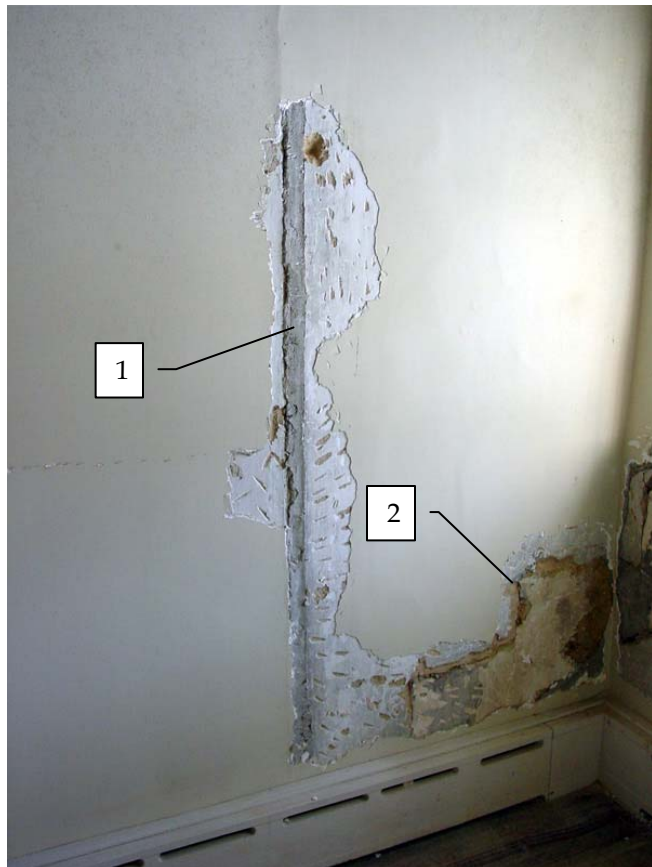
**Photo 206c -**

- Winder stair tread evidence on south, west and north walls indicates there was a stair to the attic. Winder added c. 1790 when roof was raised to 1½ stories or c. 1810 when larger expansion occurred. (Photo 206c, Note 1/206)

Detail view of portion of south wall, Room 206, looking south.

1. Plaster patch in south wall likely corresponding to former board partition around former winder stair.
2. Evidence in plaster of former winder stair.

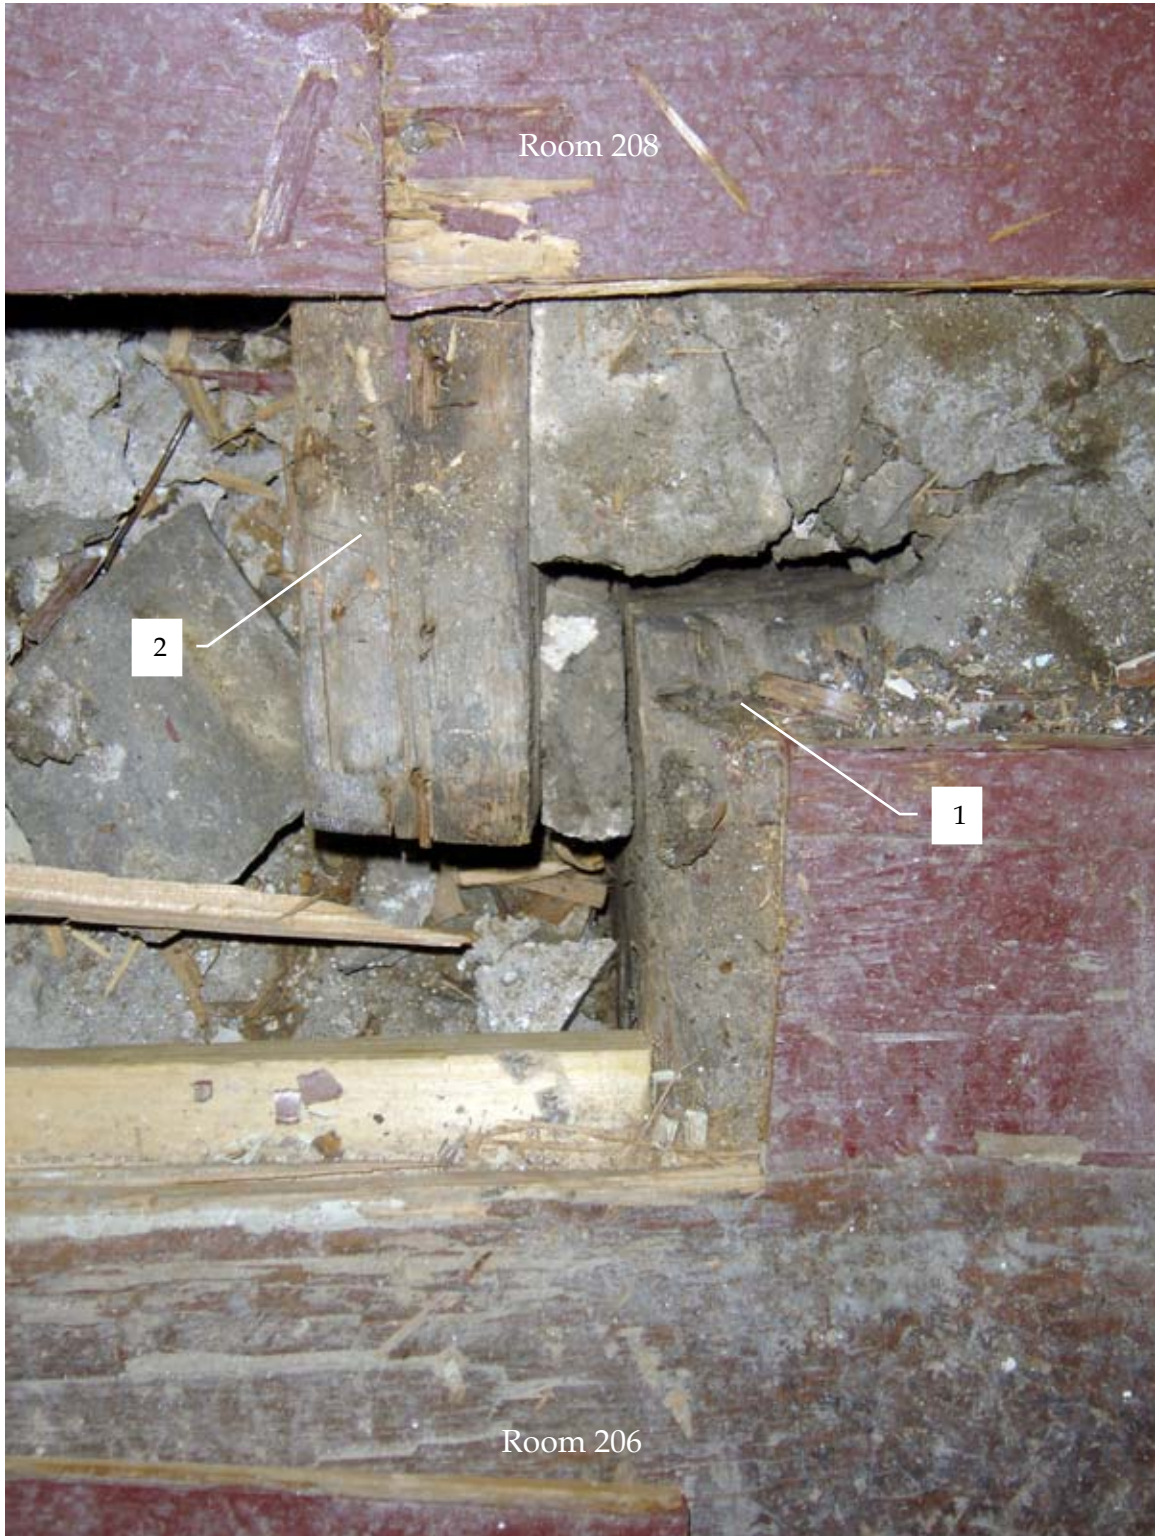
- Random-width floorboards installed in 1926 when the corner winder stair was removed.
- The floor joists between Room 206 and Room 208 appear to have been cut off in-situ. These floor joists originally projected beyond the face of the original north kitchen wall to support the rafter plate and rafters of the original roof of the 1-story kitchen. When the original kitchen was raised to 1½ stories, circa 1790, the roof and cornice were removed, the projecting joists were chiseled back behind the north face of the wall, and new stonework was constructed to elevate the wall by ½ story. The floor joists of Room 208 were inserted next to the existing joists circa 1810 when the kitchen wing was expanded to the north. This detail supports the idea that the original west kitchen wing was first (c. 1790) expanded in height and then later (c. 1810) was expanded to the north and up to the full two stories. (Photo 206d, Figure 206a)

**Photo 206d** – Detail view of floor and framing (over masonry wall), between Room 206 (bottom) & Room 208 (top), looking down.

1. Original joist over c. 1769 kitchen has been chiseled back to accommodate elevation of the walls by  $\frac{1}{2}$  story.
2. Adjacent floor joist for Room 208 added at the time of the c. 1810 expansion to the north.

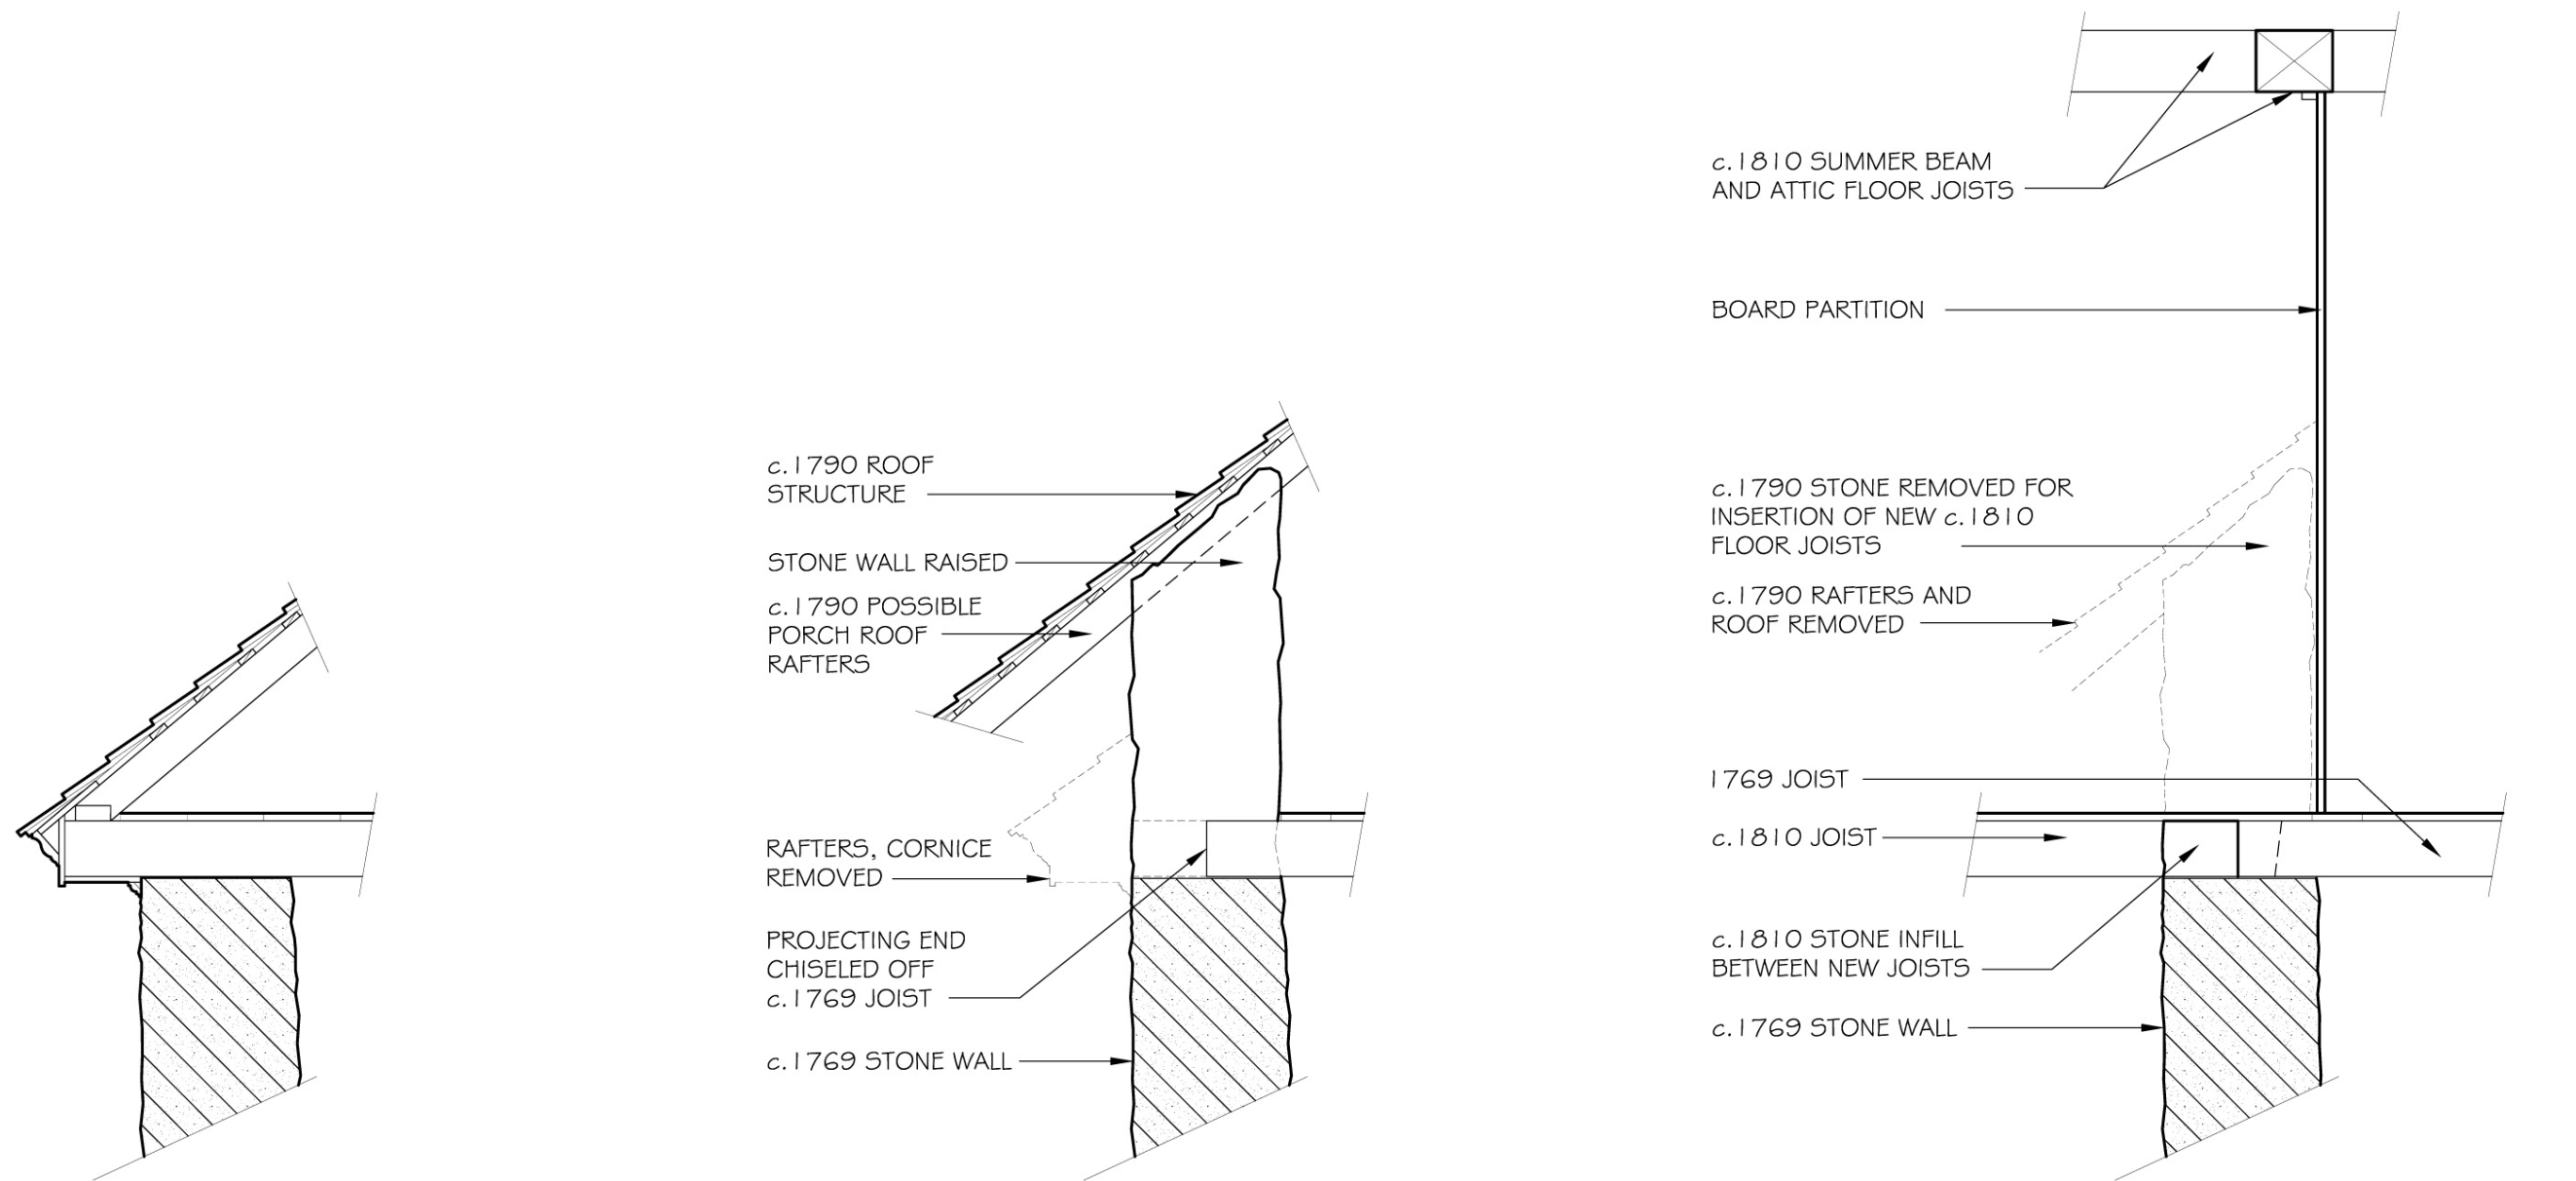
ORIGINAL EAVE CONFIGURATION AT NORTH WALL OF 1-STORY KITCHEN BLOCK, c. 1769

ORIGINAL KITCHEN BLOCK RAISED TO 1½ STORIES, c. 1790

ORIGINAL KITCHEN BLOCK EXPANDED TO NORTH AND RAISED TO 2 STORIES, c. 1810

Figure 206a: Details of modifications to north wall of original kitchen block from c. 1769 - c. 1810.

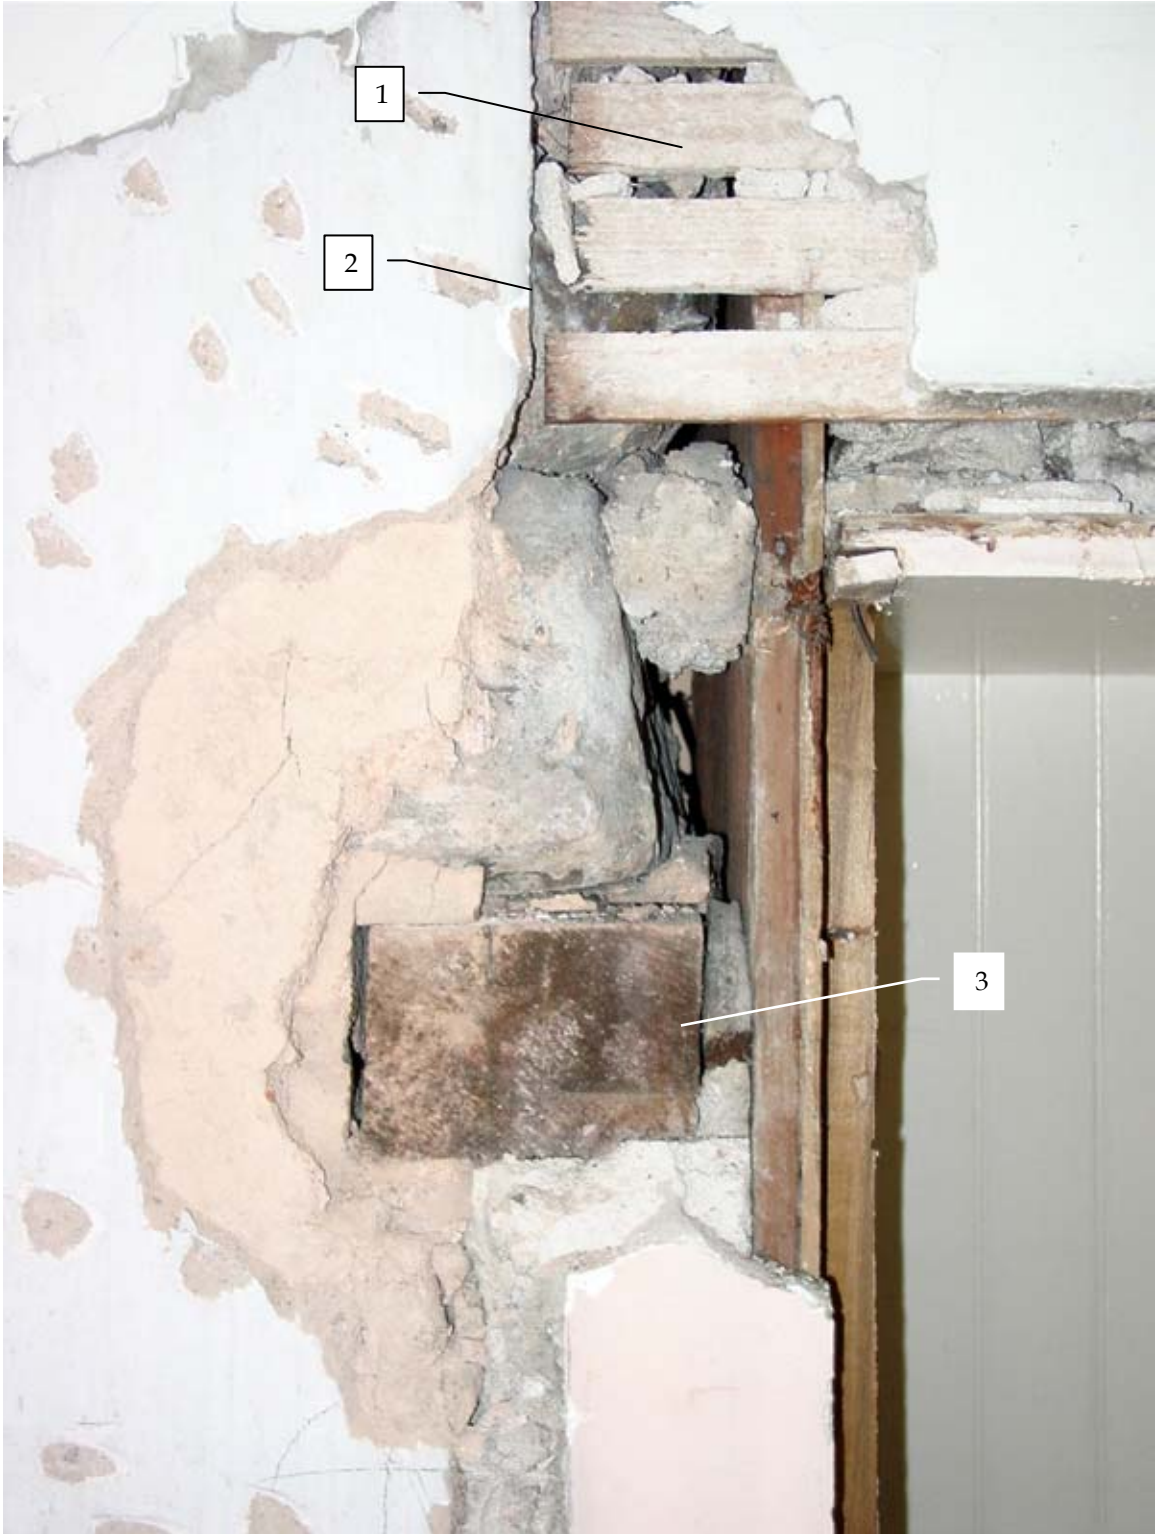
- Removal of the recessed medicine cabinet and plaster above the sink revealed the same doorway seen from Room 203. (Photo 207a, Note 1/207,)
- Closet on east wall is a 20<sup>th</sup>-century addition.
- South wall partition is a 2x4 stud wall with vertical boards. The current wall was installed in the 1920s. There may have been a wall in this location as early as c. 1810 when the building was expanded to its full two-story height. (Note 2/207)
- West wall is largely covered by an existing bathtub and shower surround.
- A plumbing chase was added in the northeast corner.

**Photo 207a** – Detail view of north jamb of former doorway between Rooms 203 and 207, looking east.

1. 20<sup>th</sup>-century lath and plaster.
2. Line where former door trim abutted plaster.
3. Wood nailer set in masonry to attach door frame.

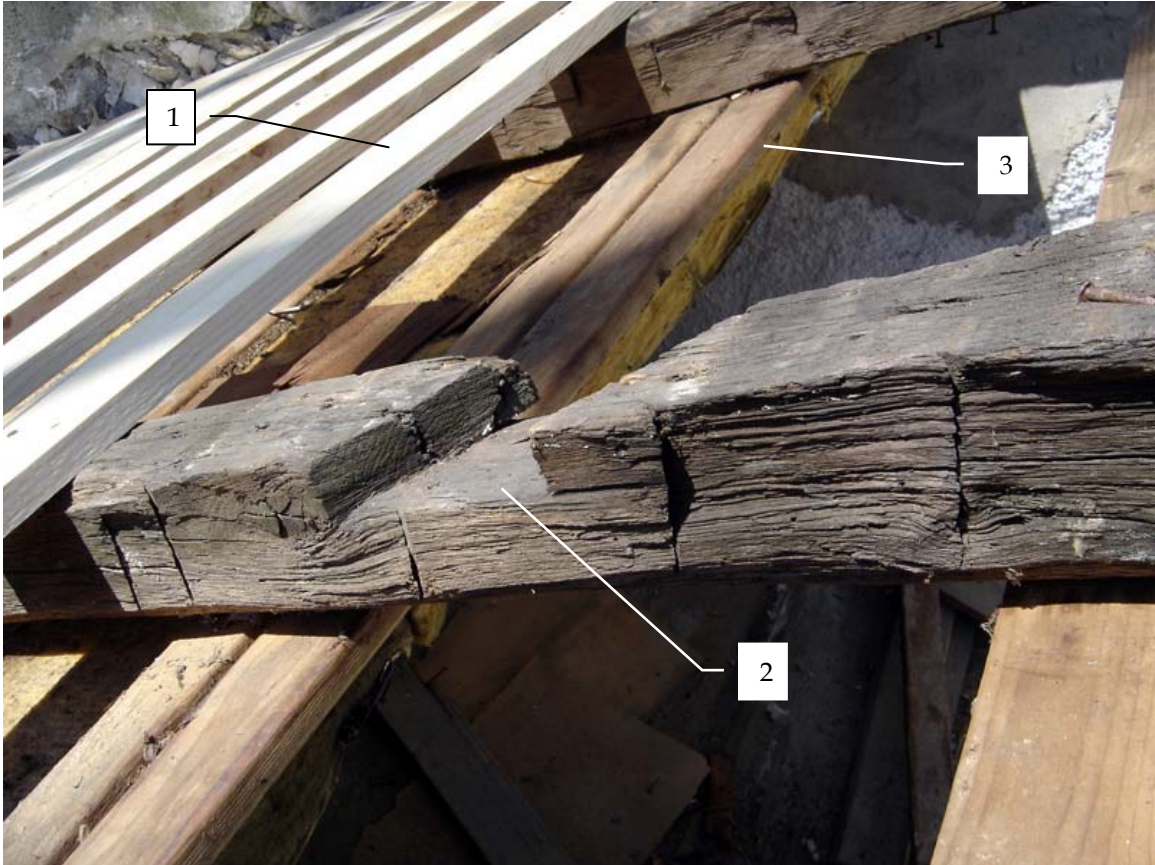
- Recent framing reinforcements are evident in the rafter framing.
- Many of the rafters have been reused from other locations. Several rafters are cut for half-lap collar tie connections, but there is no corresponding connection on the opposite rafter. Several other rafters are cut on top which has no correlation to existing conditions. (Photo 301a)

**Photo 301a** – Detail of east roof rafter. Note: Shingles were removed at the time this photograph was taken.

1. Lath for replacement shingle roof.
2. Reused roof rafter with notch for half-lap joint from former use.
3. Lath at underside of roof used to hold insulation in place. Date of installation is unknown.

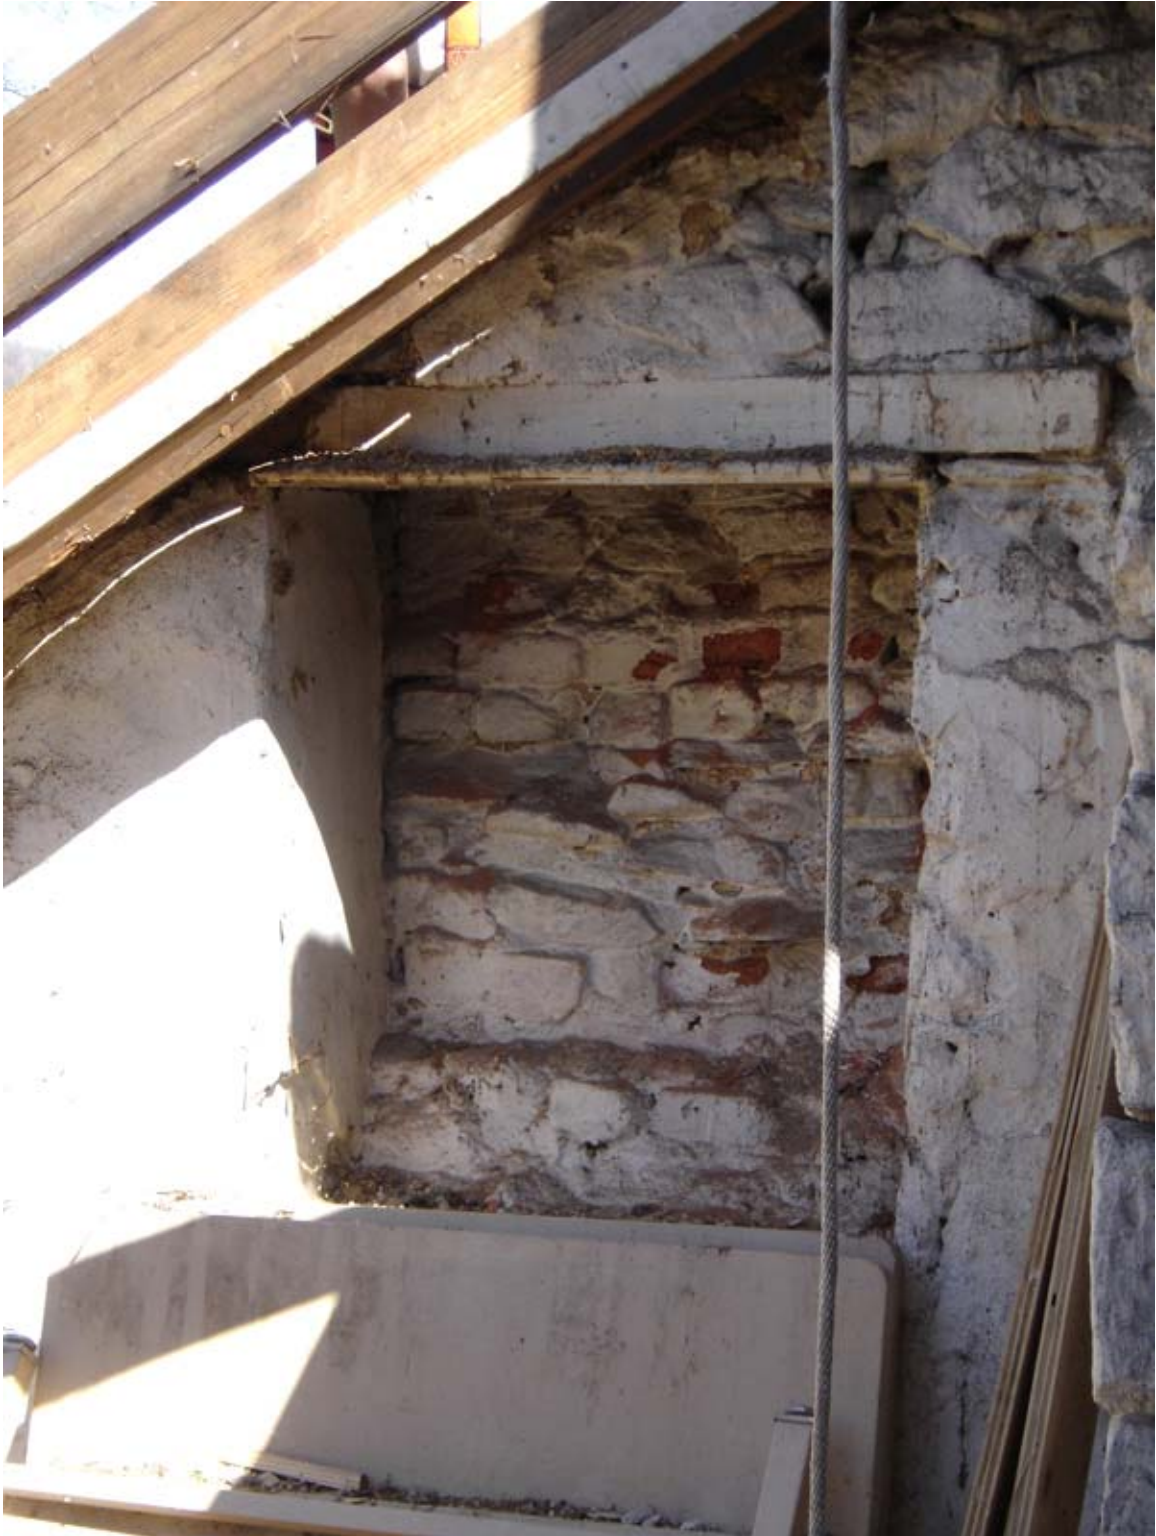
- The east wall originally had two (2) four-light windows flanking the chimney. The north window has been removed though the plastered recess and lintel remain. The opening was blocked in by the c. 1830 east addition. (Photo 302b, Note 3/302)
- Window 302: There are indentations in the frame of the east wall window indicating the possibility of louver slats instead of glazed sashes. However, if this is the case, this would contradict the Glass Tax (i.e., the 1798 U. S. Direct Tax) which indicated two (2) four-light windows on the original main dwelling unit. (Photo 302a, Note 4/302)

**Photo 302b** - Interior view of former window opening at east wall, north side of chimney, Room 302, looking east. Opening was in-filled c. 1830 during construction of the east addition.

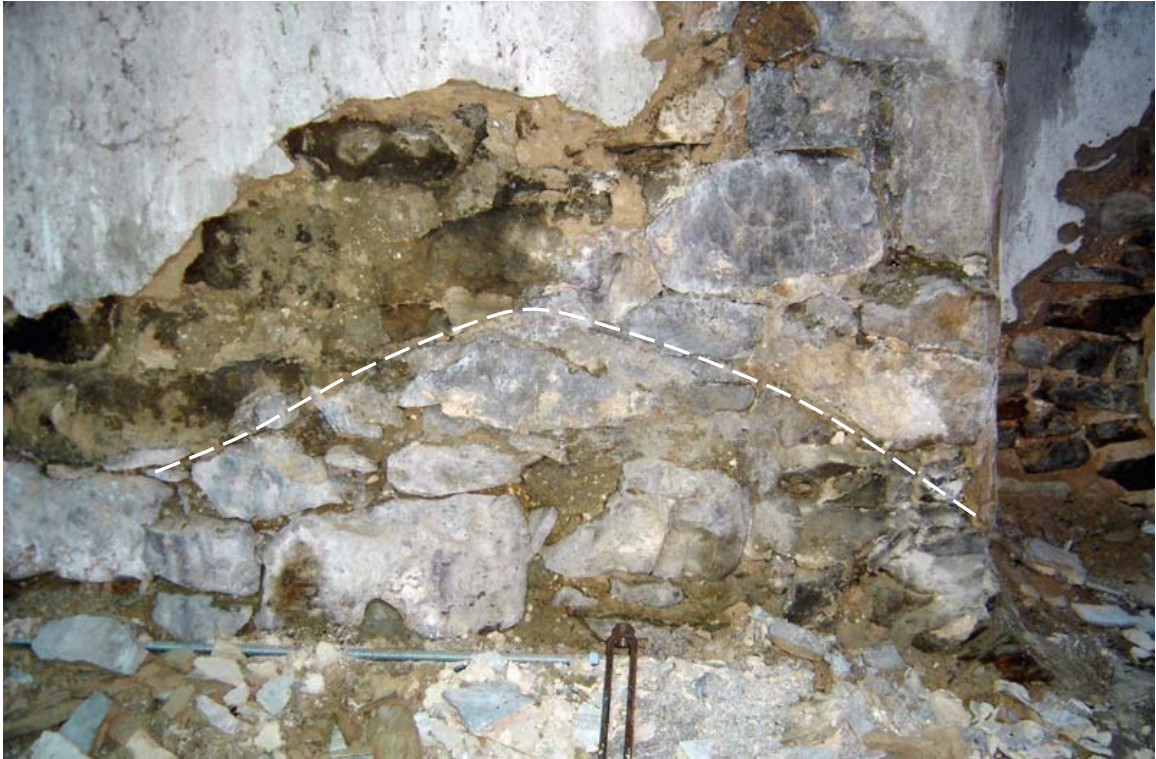
- On the west wall, beneath the plaster on the chimney mass, is a rough stone peak corresponding to the peaked ledge at the exterior. In addition, a very small piece of sloped mortar is present on the chimney which appears to be a remnant of mortar "flashing" from the earlier, 1½-story roof line (c. 1790). (Photos 303b & 303c, Note 4/303)

**Photo 303b** - Chimney mass at west wall, Room 303, looking west. Outline indicates masonry peak corresponding to the peaked ledge at the exterior west elevation of the building.

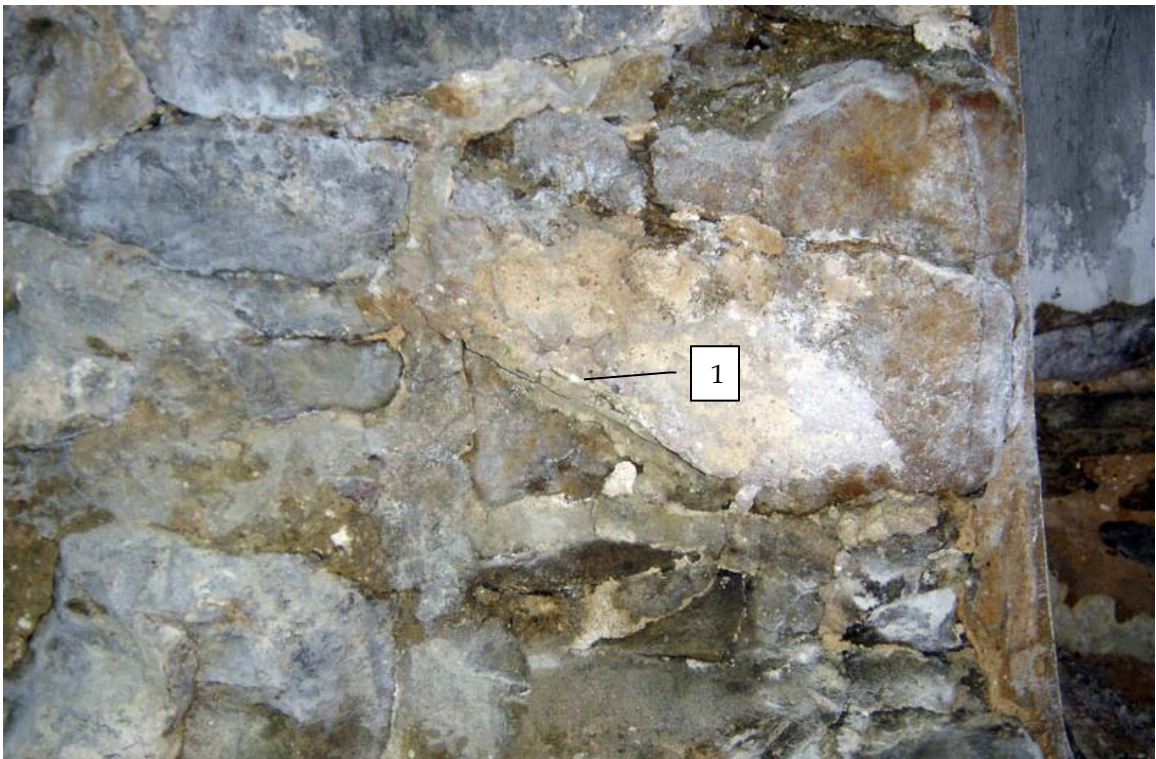
**Photo 303c** - Detail view of north half of chimney mass at west wall, Room 303, looking west.  
1. Remnant of mortar "flashing" from previous c. 1790 roof location.

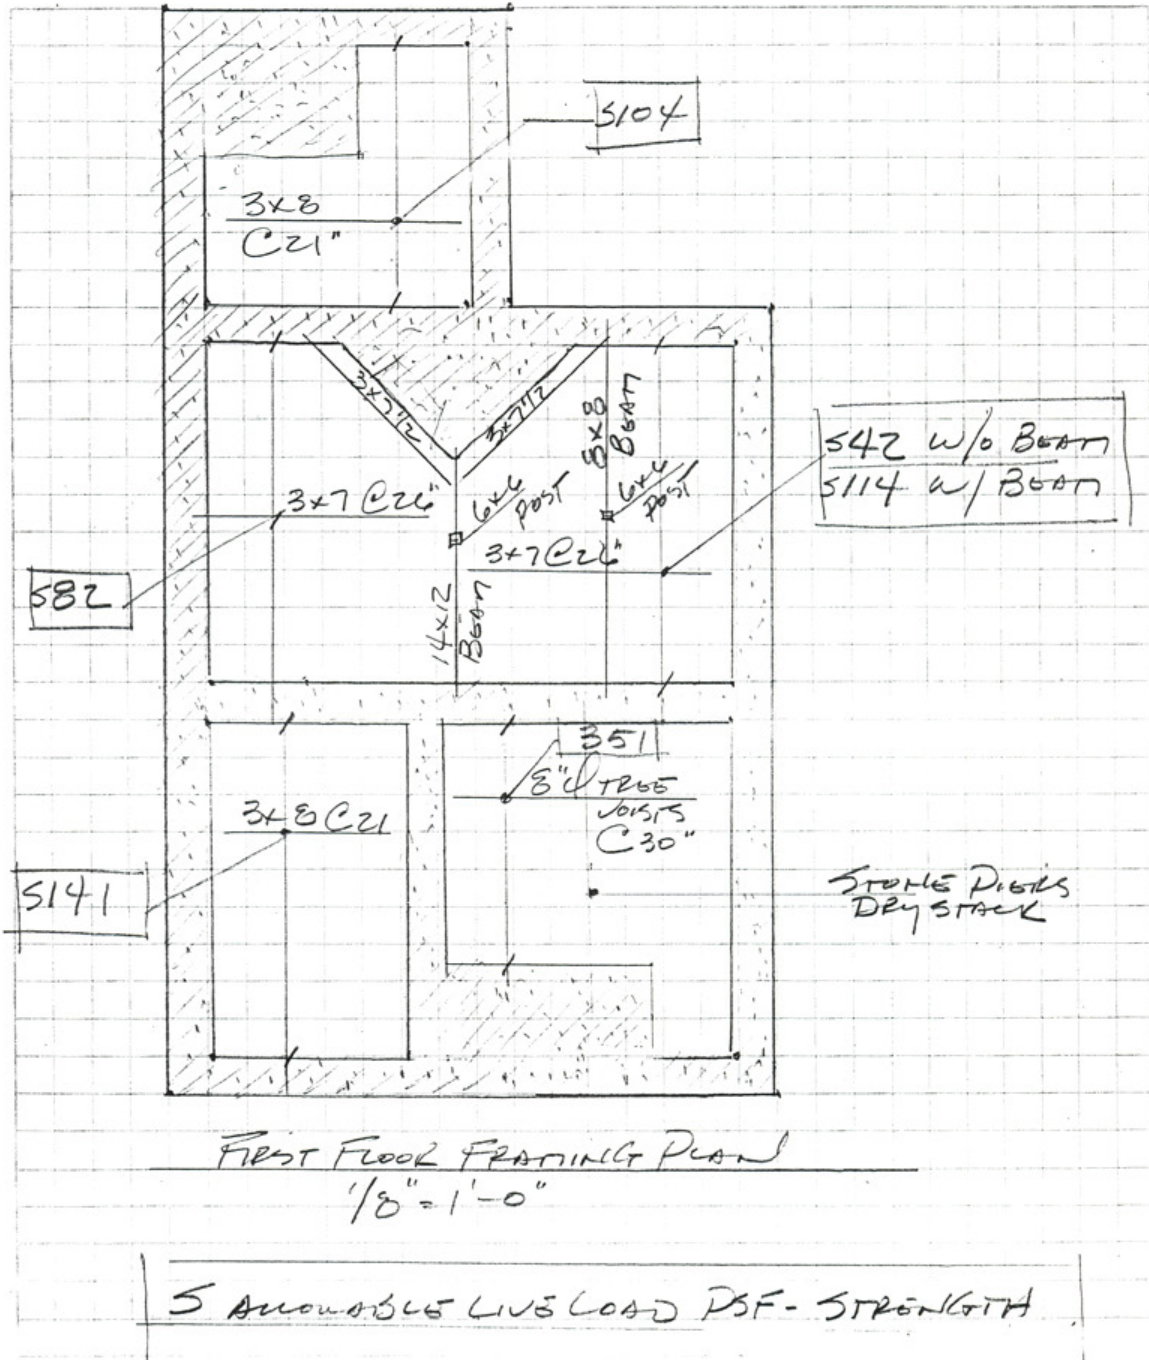
Figure S-1: Sketch of First Floor Framing Plan. (Note: Image is not to scale).

For the longer span, a more recent 8x8 timber beam (east-west) underframes the floor joists; halving the spans and thereby stiffening the floor. The primary central beam is supported by the foundation for the corner fireplaces and chimney mass (east), a central 6x6 post, and the exterior west wall of the block. The first floor farming is in poor condition with approximately half the joists partially consumed by termite infestation. Both of the diagonally running hearth headers are in poor condition. The central summer beam is severely checked exhibiting cracks parallel to the grain. The central post is set into the concrete floor where damp is a concern with regard to serviceability. In addition, the timber lintel at the passage to the east addition is rotten and requires replacement.

**Recommendations:** At the first floor, carefully remove the flooring, rotten joists and diagonal hearth headers. Replace the members in kind or reframe the floor with double 2x8 pressure-treated, "select structural" members set into the original wall pockets and supported by metal framing connectors. Repair the severe check in the summer beam with a combination of epoxy and bolting. Damp-proof the bottom of the central post that is currently set into the concrete basement floor. Replace the timber lintel at the passage to the east addition basement.
