STIRLING'S QUARTERS AT VALLEY FORGE NATIONAL HISTORICAL PARK  
HISTORIC STRUCTURE REPORT

PREPARED BY:  
JOHN MILNER ARCHITECTS, INC.  
104 LAKEVIEW DRIVE, CHADDS FORD, PA 19317

JANUARY 2006

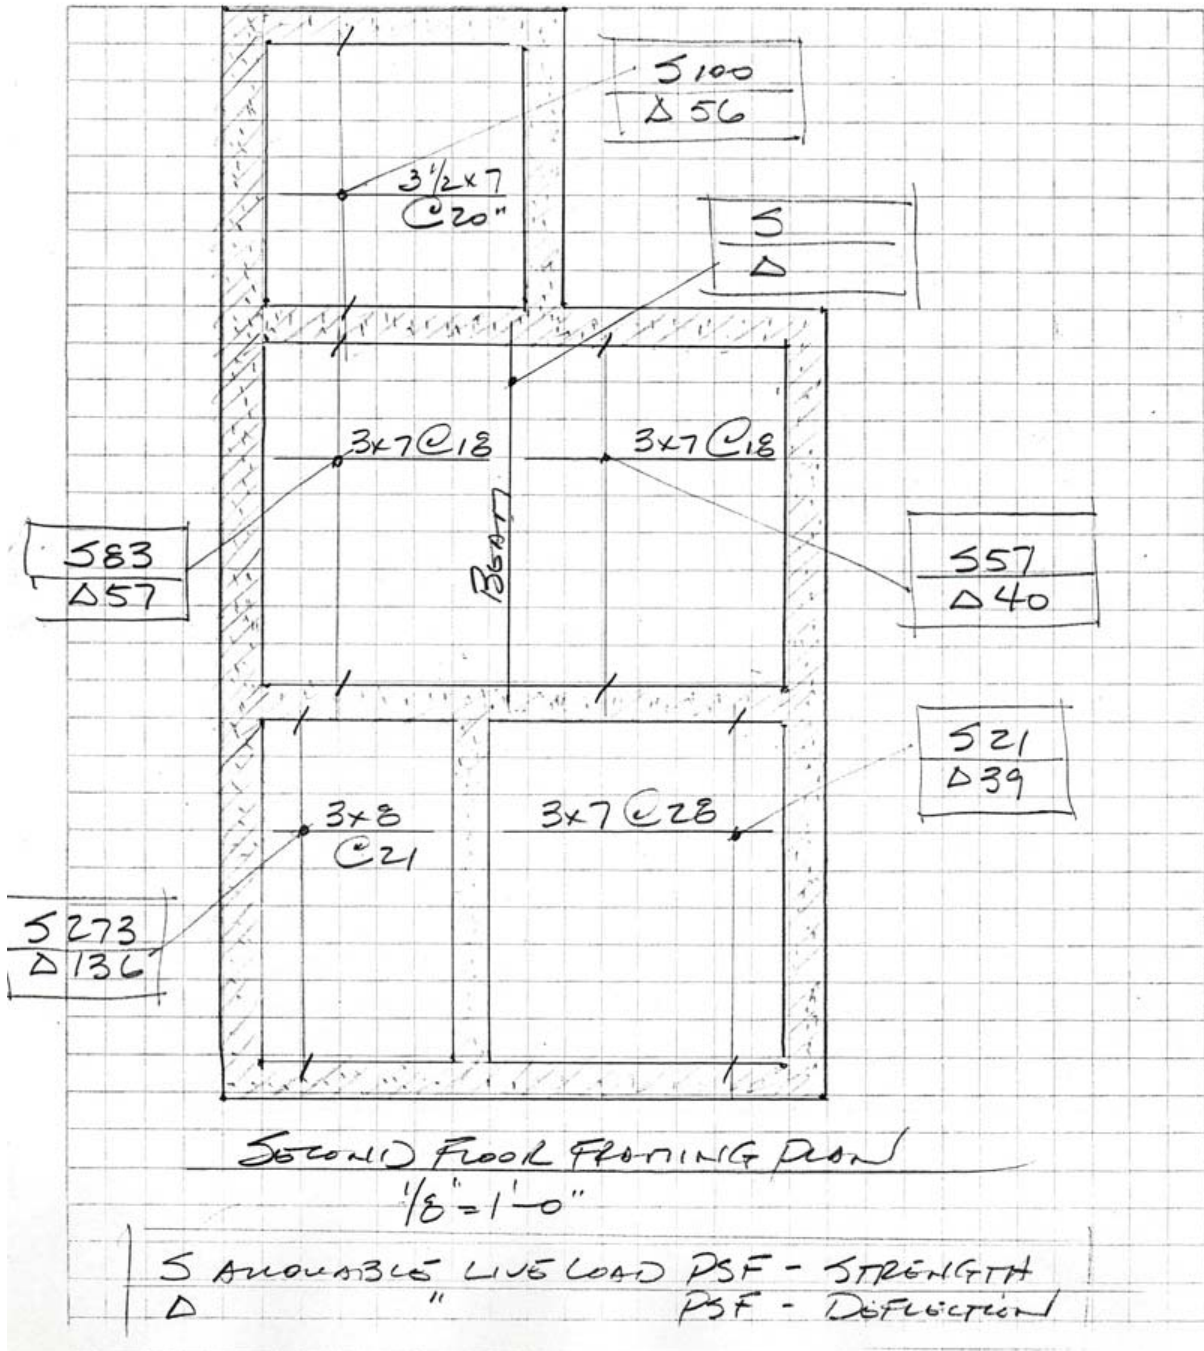
Figure S-2: Sketch of Second Floor Framing Plan. (Note: Image is not to scale).

The framing of the second and attic floors is provided by 3x7 joists set at approximately 20" centers spanning north-south. An east-west running summer beam, positioned 2' north of the geometric center of the building, is concealed at both levels. At the attic floor on the south side, the joists are dressed with chamfered corners. The framing appears to be in good structural condition. The allowable tributary live loading for the floor is limited by the deflection of the joists on the south side to 36 PSF. This is without consideration of the summer beam, since it is concealed and its capacity is unknown.

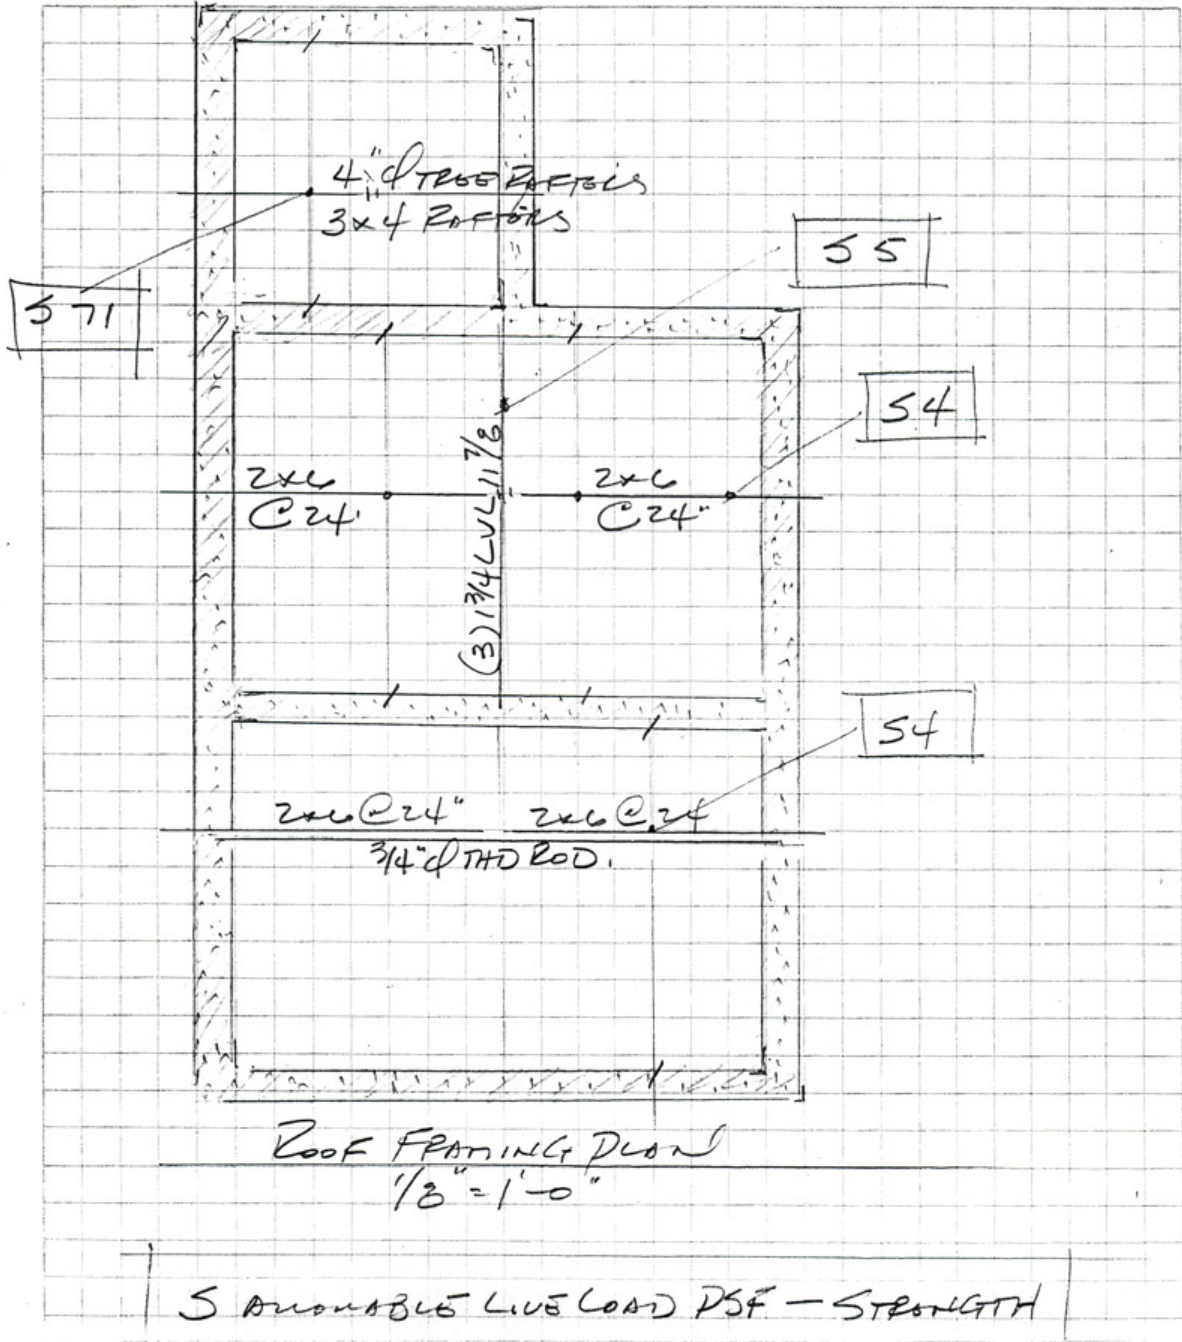
Figure S-4: Sketch of Roof Framing Plan. (Note: Image is not to scale).

The gable form roof structure of the main block has been reframed with 2x6 rafters set at 2' centers supported by collar members bearing on a manufactured timber beam (3) 1¾ LVL 11⅞ spanning east-west. The allowable uniformly distributed live loading on this reframed roof is only 5 PSF, which is considerably less than the minimum loading recommended by the building code of 15 PSF.

Except for the original roof framing of the east addition, the current roof framing of the main building as a whole is typically undersized with only 1/3 the recommended capacity for snow loading. It is recommended that these members be reinforced by sistering. Reinforcement of the peculiar splicing observed at the roof of the north block of the 1926 addition is also recommended; otherwise, the load capacity of the existing gable roof framing of the 1926 addition should be adequate.

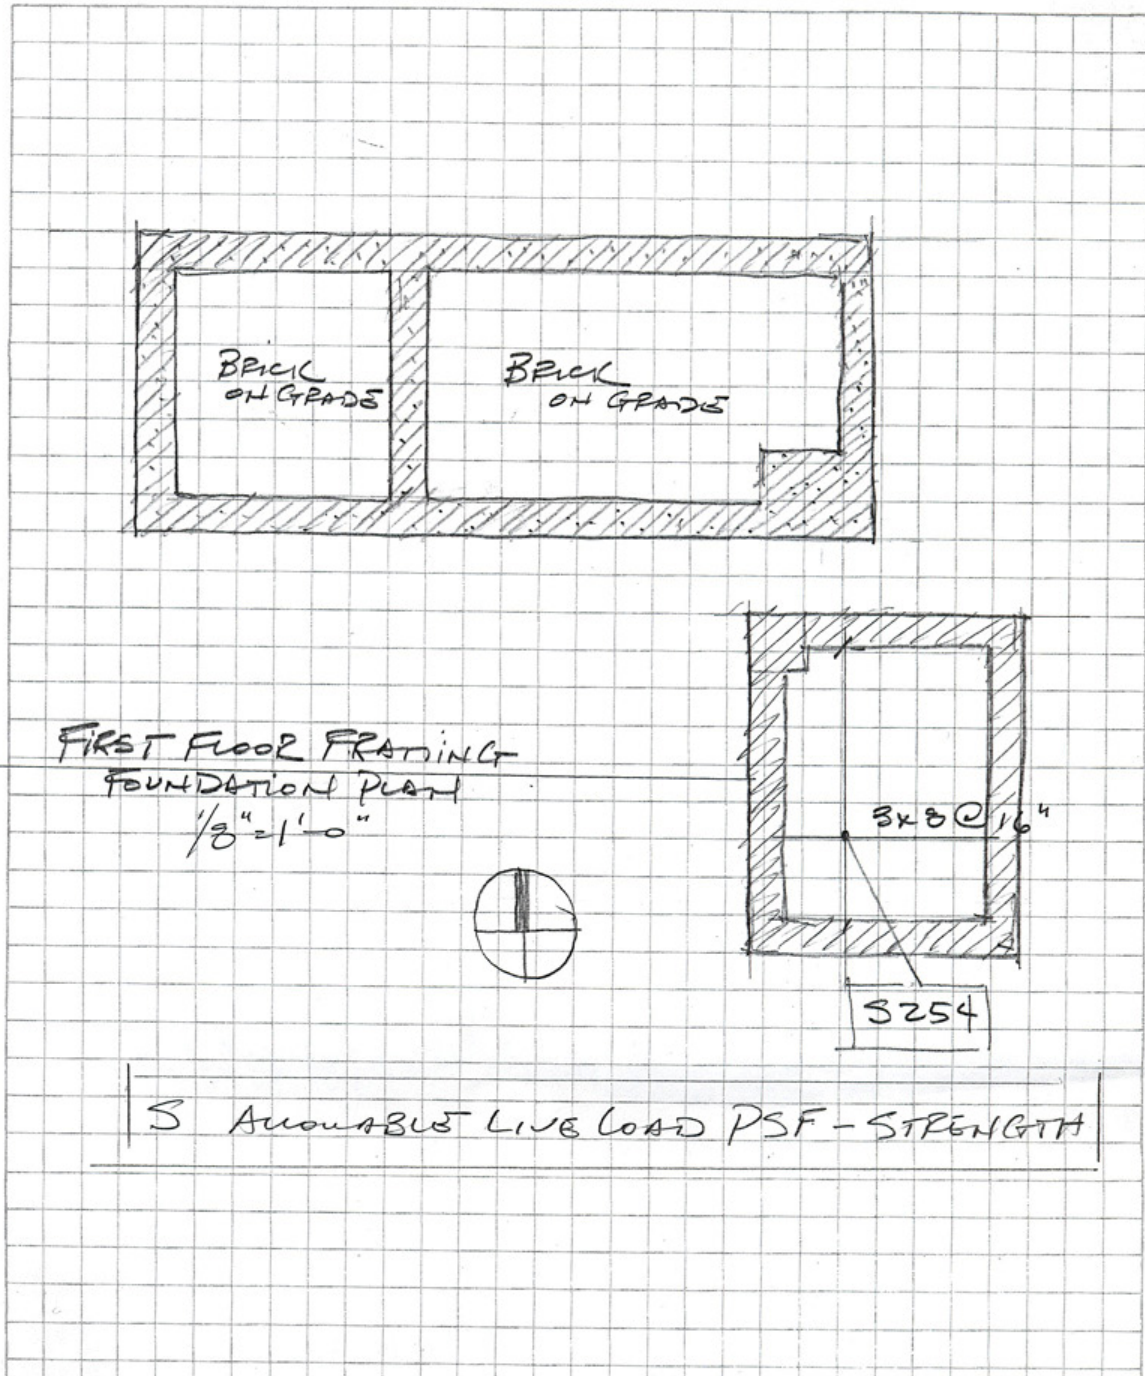
Figure S-5: Sketch of First Floor Framing Plan at 1926 northwest addition. (Note: Image is not to scale).

The plan of the northwest addition to the original kitchen measures about 12' north-south by 20' east-west. All of the first-floor joists have been removed. Based on some remaining evidence at the northwest corner, it appears that the framing consisted of 3x8 joists spanning north-south and bearing on the masonry walls. These members could safely support a tributary live loading of 140 PSF.

Recommendations: Provide ventilation and damp proofing of the crawl space. Replace the stone piers with concrete masonry set on new footings and reframe the floor with pressure treated timber of similar section to the tree joists so that masonry bearings can be reused. Since it would be difficult to provide adequate ventilation in this area without excavating, which would cause concern regarding the undermining of the exterior wall foundation, damp-proofing and subsequently casting a slab on grade with wood sleepers and wood deck may be the best approach for restoring the floor structure in this addition. It should be noted that further archeological investigation and documentation of the space would be necessary as a mitigation measure for either approach.

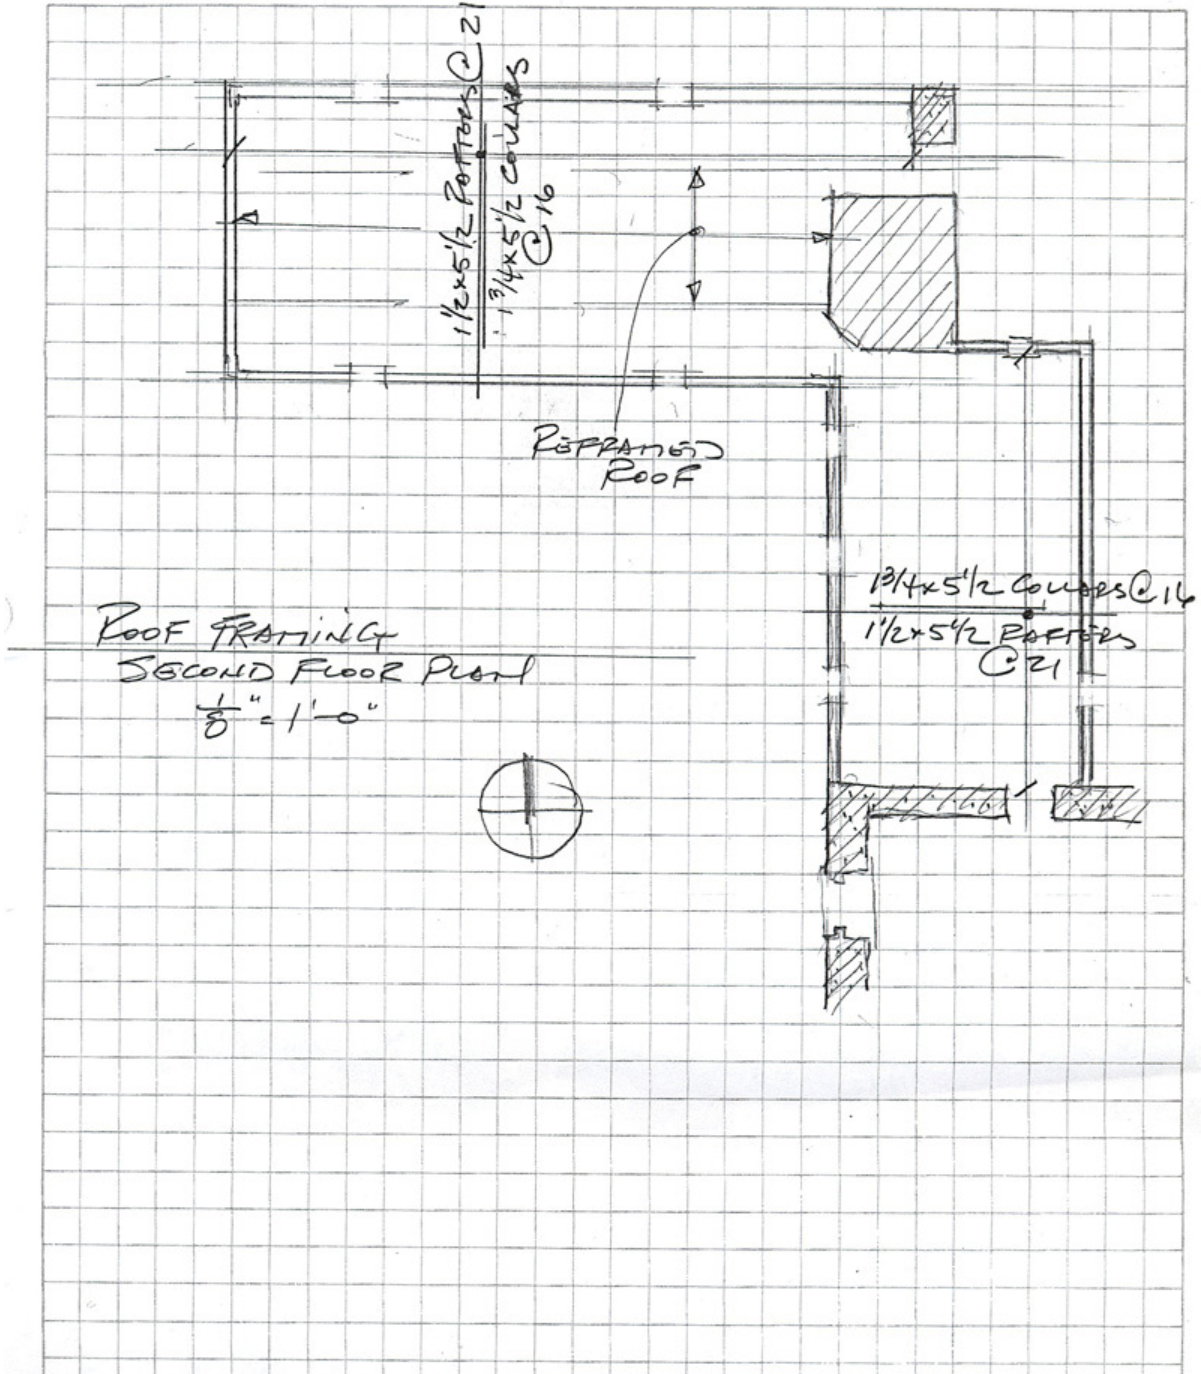
Figure S-7: Sketch of Roof Framing Plan at 1926 northwest addition. (Note: Image is not to scale).

In the north block of the addition, the upper portions of the roof framing have been replaced. The char that can be observed on some of the members is witness to a fire, which probably started in the chimney located at the east end of the north block. The subsequent repair of the roof structure involved removal of the damaged upper half of the roof, including the ridge, and then splicing on a replacement roof. The approach allowed the eave and attic section to remain intact, which simplified the repair.

Unfortunately, the method of splicing the rafters was poorly conceived. The damaged rafters were square cut and the ridge section of the roof was removed. Then a 2x6 wood plate purlin was end nailed to the cut rafters. This provided a means for toe-nailing the replacement rafters that form the ridge of the roof. The connection has no bending strength and as a result has separated due to the tension at the bottom of the splice, causing noticeable sag in the member.

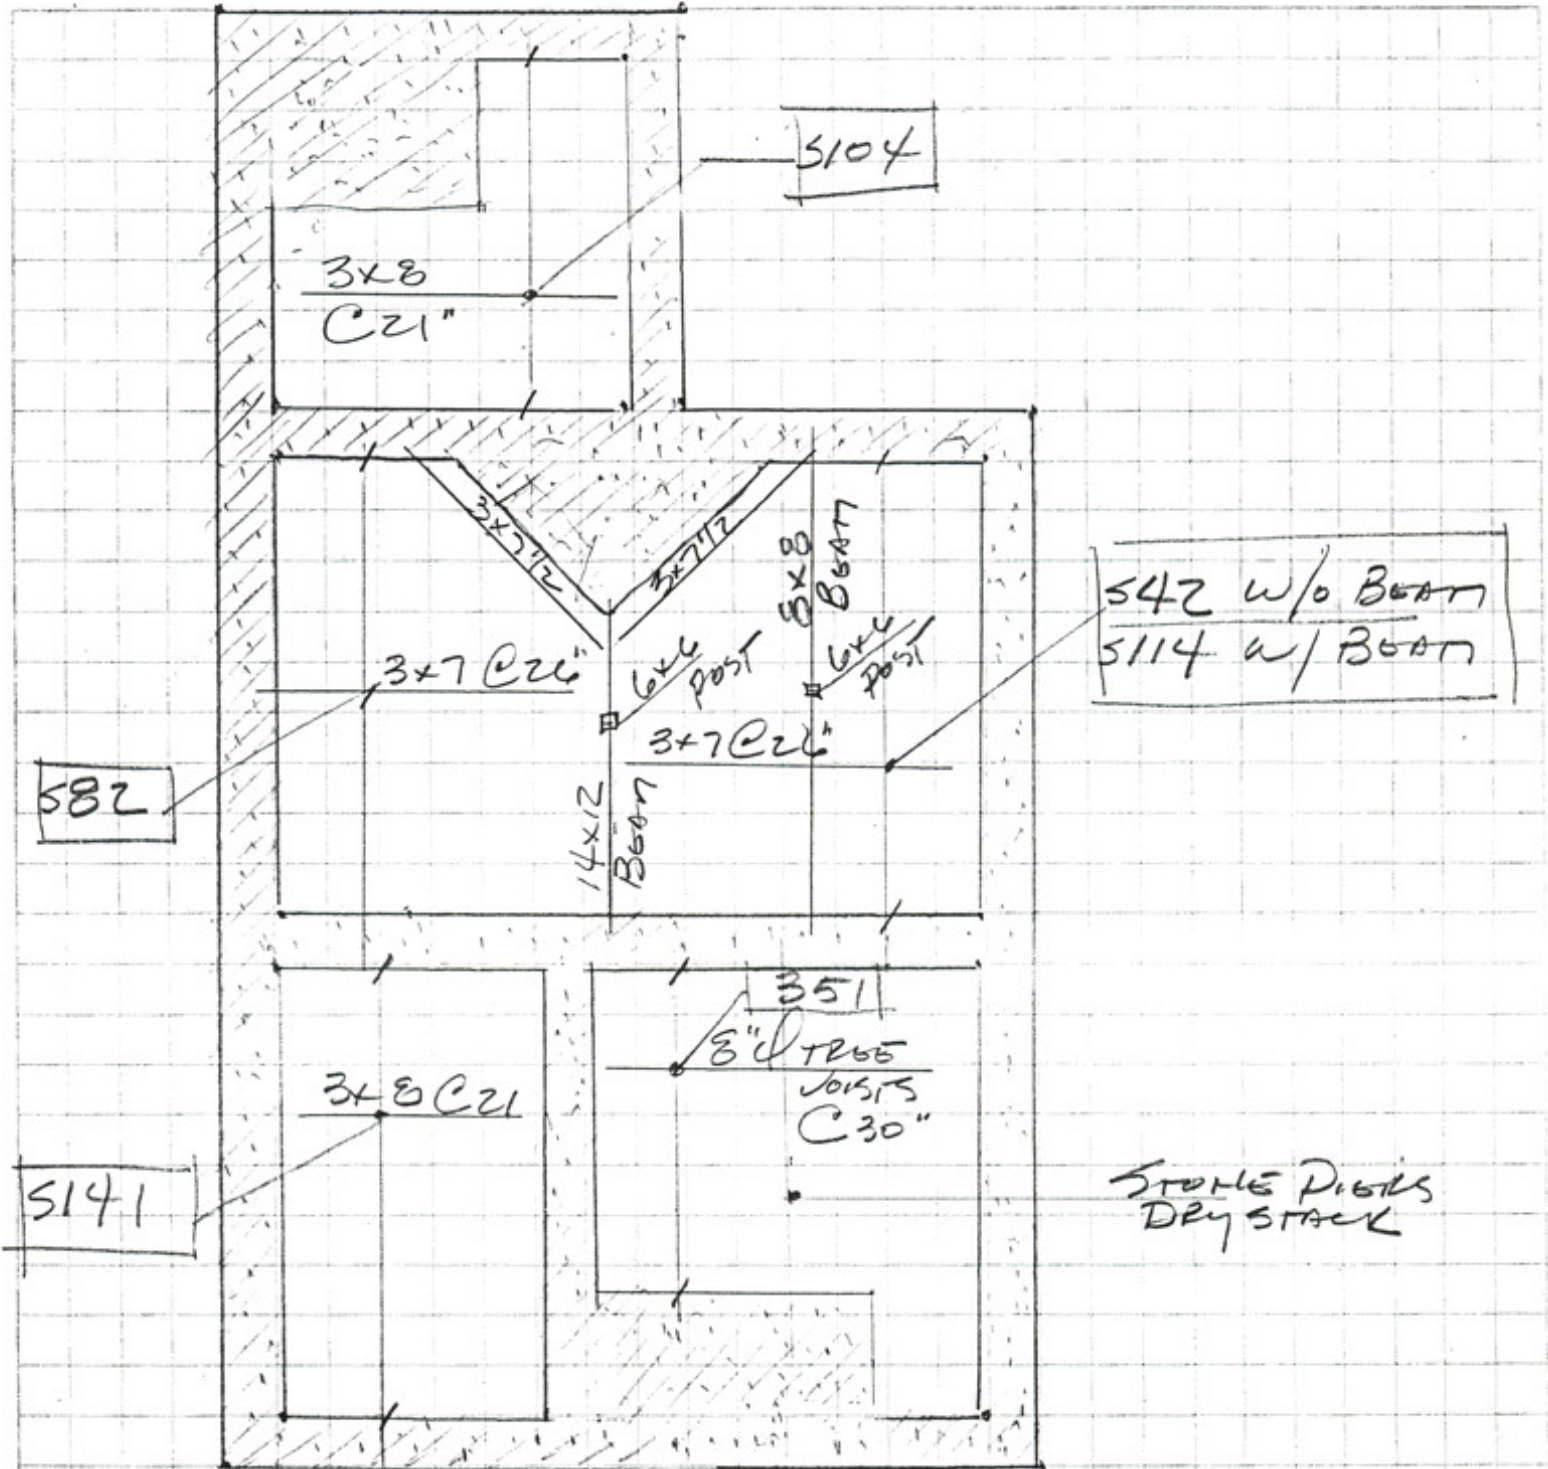
FIRST FLOOR FRAMING PLAN

The building which measures in plan approximately 32' north-south by 24' east-west is built over a full basement and rises on uncoursed, rubble stone walls 2 ½ stories to a gable form roof. The first floor is framed with 3x7 joists set at 26" centers and spanning north-south, bearing on the exterior masonry walls and flush framed to a central timber summer beam spanning east-west. The joist spans are asymmetric; 13' north and 15'

south. For the longer span a more recent 8x8 timber beam (east-west) underframes the floor joists; halving the spans and therefore stiffening the floor. The primary, central beam is supported by the foundation for the corner fireplaces and chimney mass (east) a central 6x6 post and the exterior west wall of the block. The first floor farming is in poor condition with approximately half the joists partially consumed by termite infestation. Both the diagonal running hearth headers are in poor condition. The central summer beam is severely checked and the central post is set into the concrete floor where damp is a concern with regard to serviceability.

The first floor framing installed over a shallow crawl space is comprised of 8" diameter tree joists spanning north-south and bearing on the exterior masonry walls and an interior row of central piers formed from dry stack stones. The joists are in poor condition with extensive termite damage; especially at the south end adjacent to the bearings. The 9x8 hearth header has very little section remaining due to the extent of the infestation. The original framing configuration with the piers in place provided enough strength

to support a uniformly distributed live load of approximately 300PSF. There is no need to provide for such a high loading in the repaired structure.

*Carefully remove the flooring, rotten joists and diagonal hearth headers. Consider two options: replacing the members in kind or reframe the floor with double 2x8 pressure treated, "select structural" members set into the original wall pockets and supported by metal framing connectors. Repair the severe check in the summer beam with a combination of epoxy and stitch bolting. Damp proof the bottom of the post. In addition, the timber lintel at the passage to the east addition is rotten and requires replacement.*

*Provide ventilation and damp proofing of the crawl space. Replace the stone piers with concrete masonry set on new footings and reframe the floor with pressure treated timber of similar section to the tree joists so that masonry bearings can be reused.*

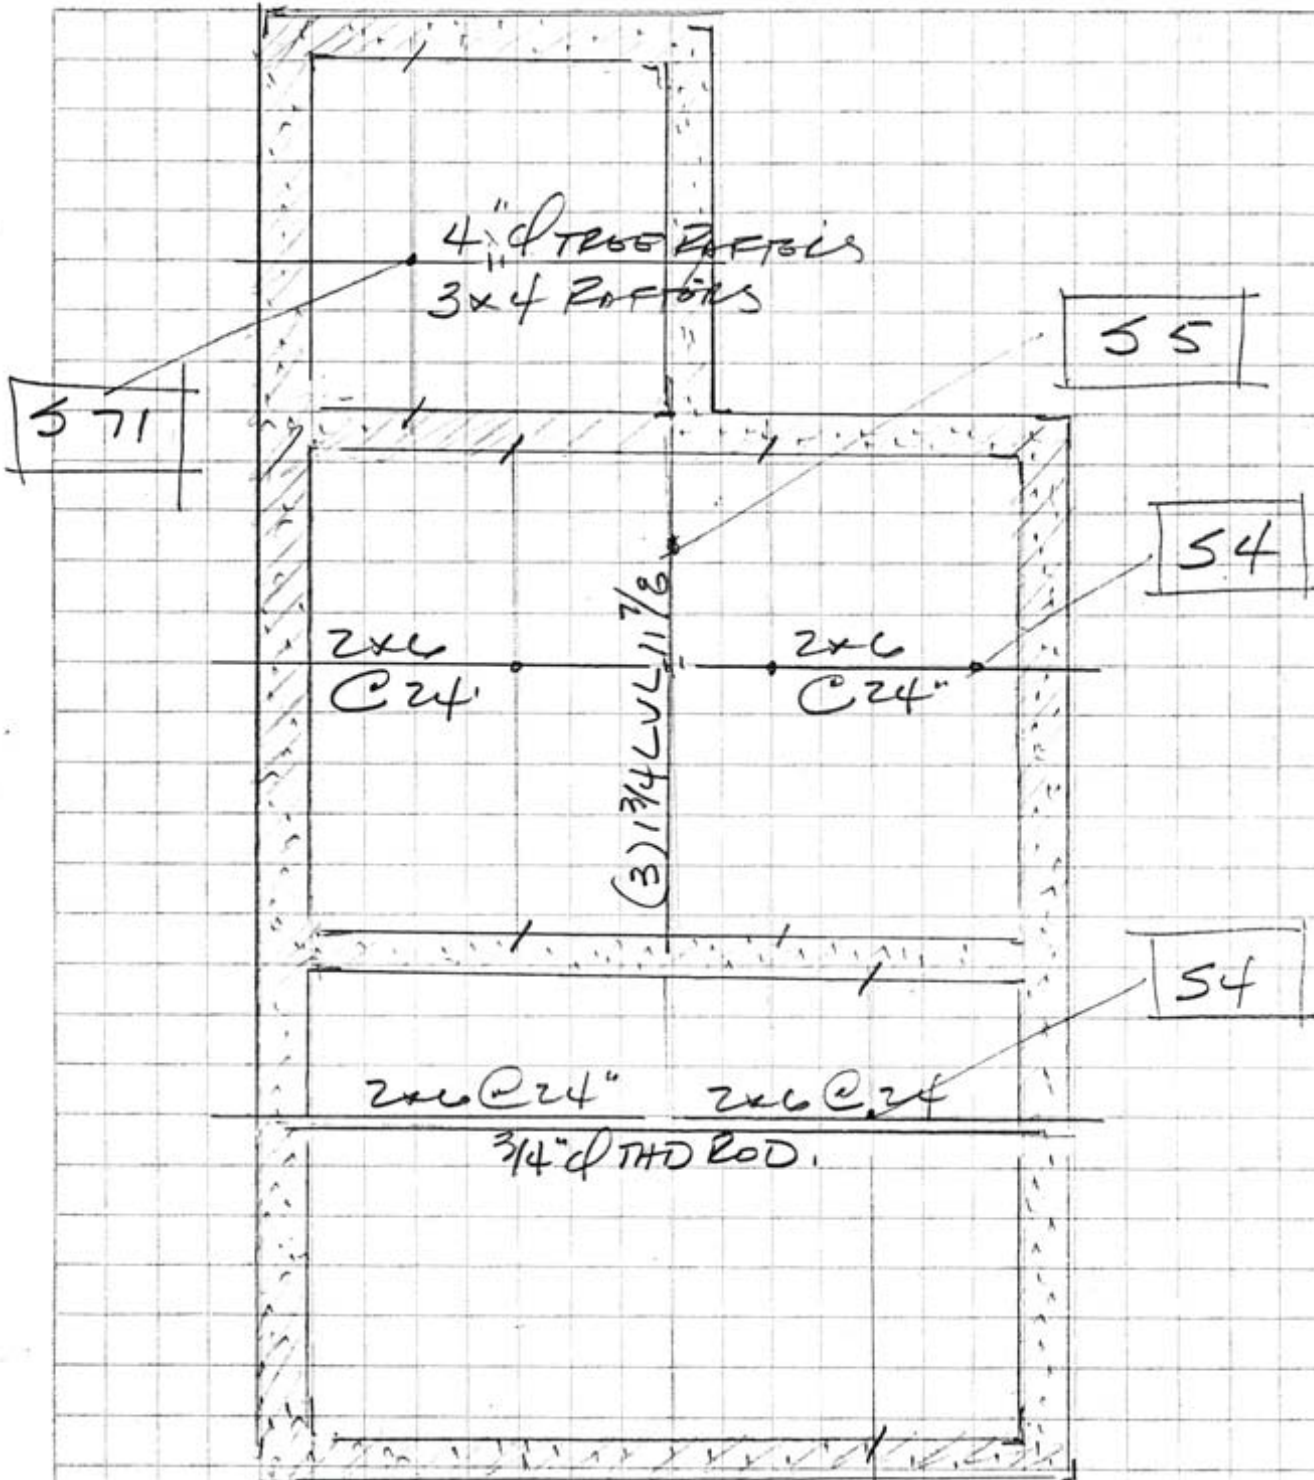
ROOF FRAMING PLAN  
1/8" = 1'-0"

The gable form roof structure of the block has been reframed with 2x6 rafters set at 2' centers supported by collar members bearing on a manufactured timber beam (3) 1<sup>3</sup>/<sub>4</sub> LVL 11 7/8 spanning east-west. The allowable uniformly distributed live loading on this reframed roof is only 5 PSF, which is considerably less than the minimum loading recommended by the building code of 15 PSF.

The roof of this addition has been reframed with 2x6 rafters placed at 24" centers; tied at the bottom by a 3/4" diameter threaded rod and coupled to the base of the rafter with a bolted steel plate connector. The allowable uniformly distributed live (snow) load capacity of the roof structure is 4 PSF. This matches the allowable loading of the original block which is considered not adequate; meeting only 1/3 of the minimum recommended by the

Except for the original roof framing of the 1830 addition located to the east of the original block, the roof framing is undersized with only 1/3 the recommended capacity for snow loading. We recommend that these members be reinforced by sistering prior to shingling the roof.

building code. The threaded rod tie and connector assembly is sufficiently strong enough to address the thrusting at the base of the rafter under code recommended snow loading. *Sister the rafters in order to provide the required strength. As an option to the threaded rod ties, a structural ridge could be provided by a lightweight east-west attic truss.*

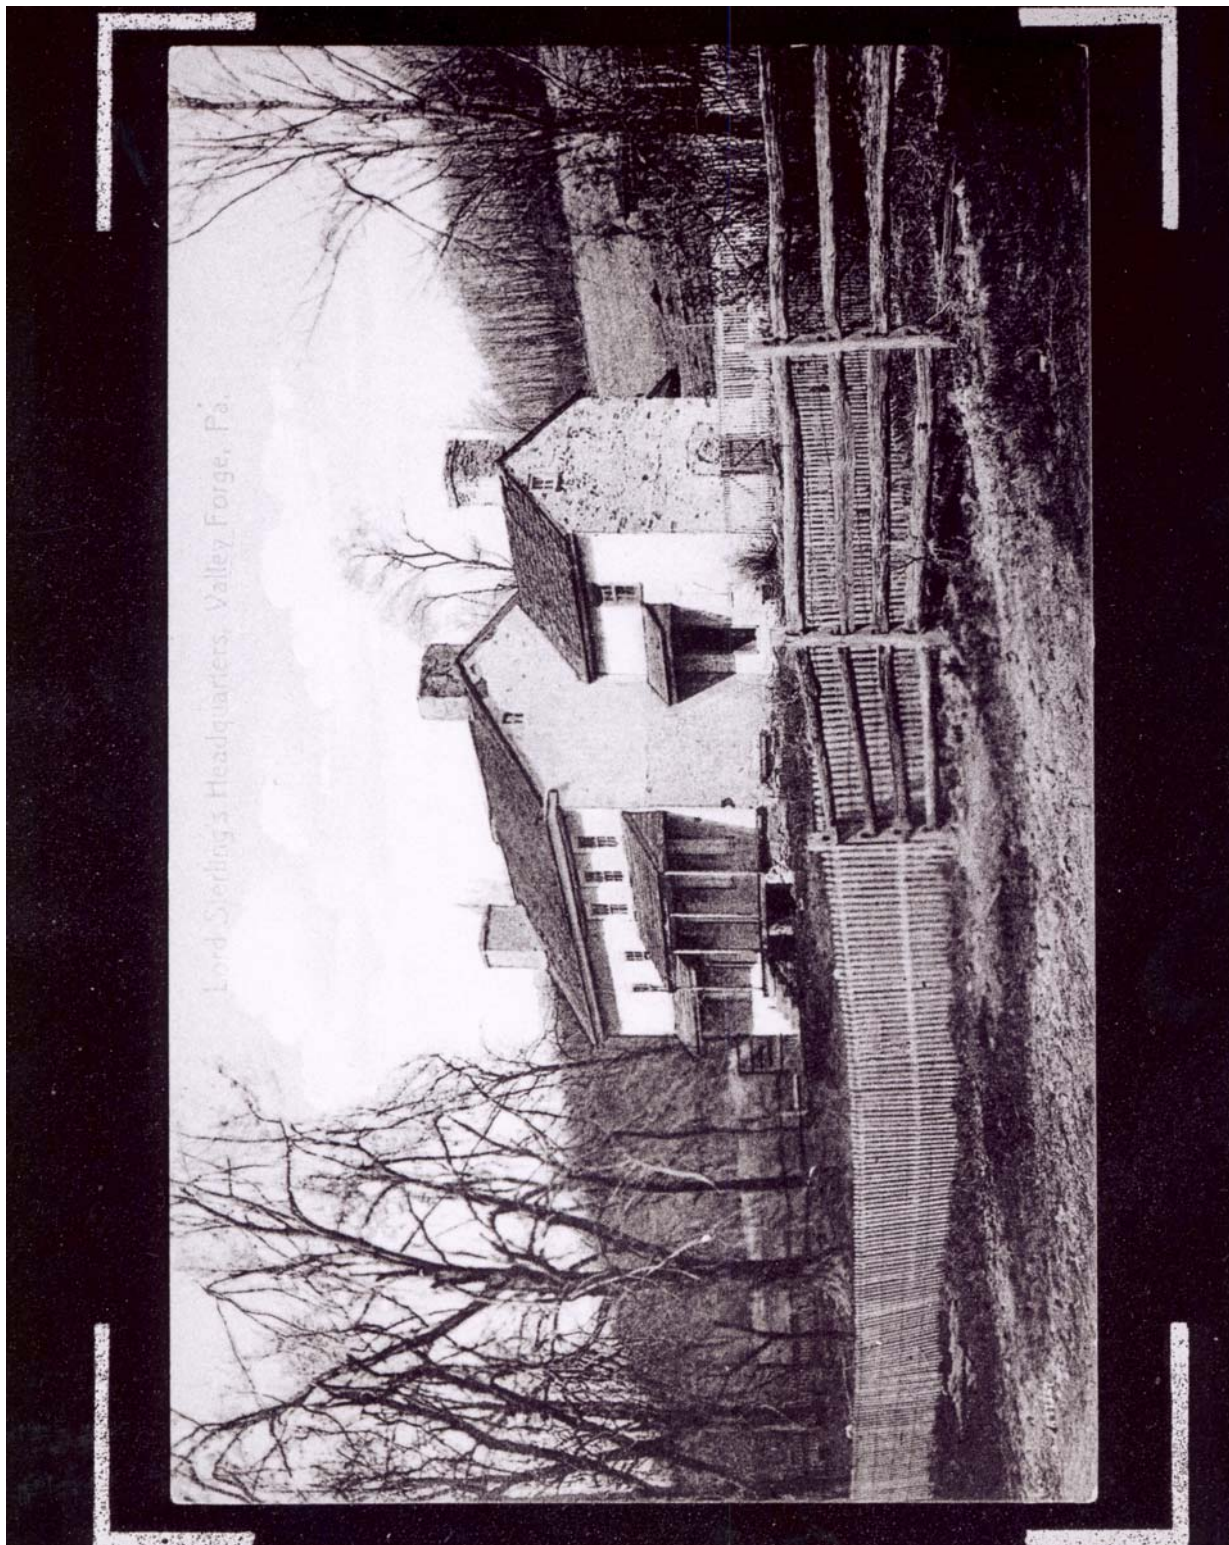
**Archive Photo 2**  
Postcard - "Lord Stirling's  
Headquarters, Valley Forge, Pa."

renovations. Part of the pent was removed during architectural investigations of the building. (Archive Photos 2 - 4)

- Windows 103 & 104: Two windows on the south wall are 6/6 single-hung, wood windows. The detailing and profiles of the windows are consistent with 18<sup>th</sup>-century characteristics and are likely original.
- Window 102: Investigation at the east window exterior jamb revealed brick infill and indicates that this window opening is not original. Archive photographs show the east façade without the window which further corroborates that it is not original. The addition of this window is attributed to the Ligget family. There is also a seam in the chair rail cap and window sill where the sill for the new window would have been inserted. (Archive Photos 2 & 4)

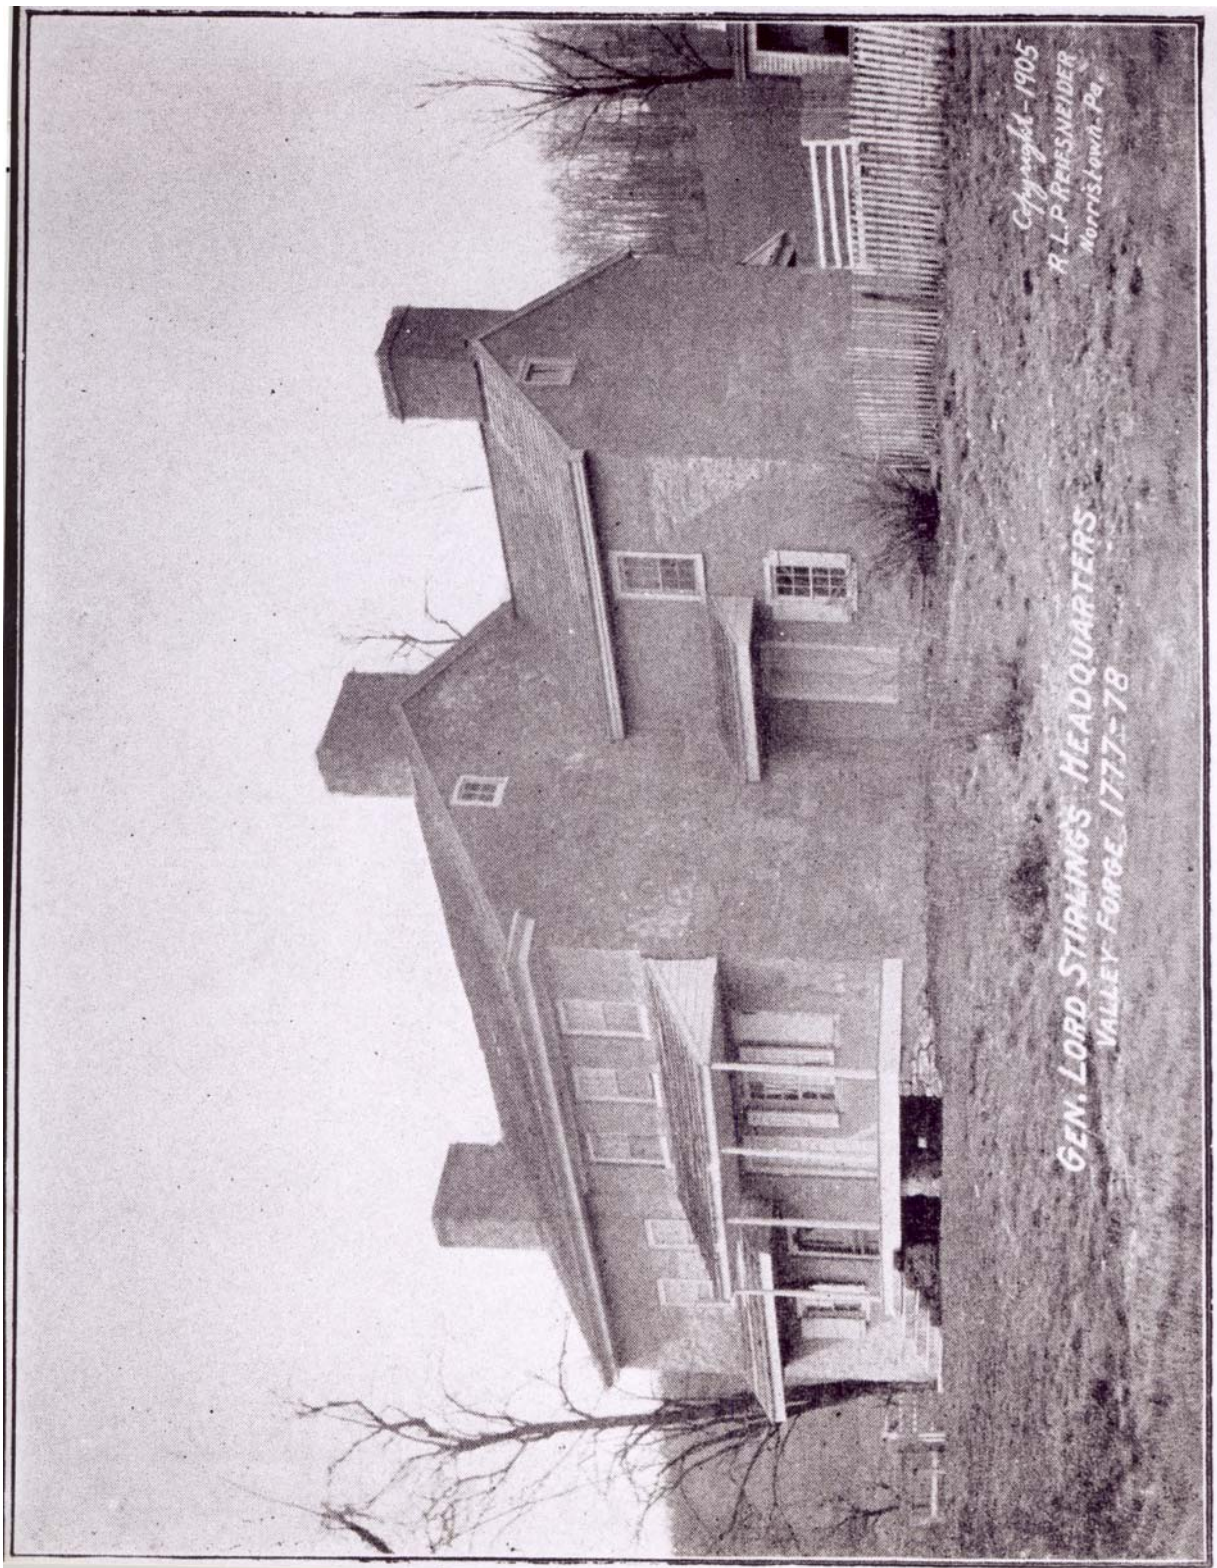
**Archive Photo 3**  
Oblique view of main house,  
looking northeast.

- There is a single chimney mass projecting from the south roof of the west block. The location of the chimney is consistent with the location of the original kitchen fireplace. The original chimney has been extended in height, however, as part of the various renovations to the house.
- A vertical crack to the south of Window 208 represents the location of a former chimney that was added when the west block was expanded to the north c. 1810. An archival photograph shows the chimney in place in 1902. The chimney was removed as part of the 1926 renovations. (Photo WEB, Note 5/WE) (Archive Photo 3)

- Double casement window on west wall was added in 1926. Archive photos show a four-light casement window on this wall up until the 1926 renovations. (Note 3/206) (Archive Photos 3 & 7)
- 6/6 single-hung, wood windows on south wall appear to date to c. 1810 when this wing was raised to a full two stories.

- The roof framing is not original (see Structural Evaluation). A 1902 photo shows that the roof height was originally the same as the main block. The Liggets lowered the roof during their renovations of the building c. 1926. (Archive Photos 3 & 6)
- Plaster on the east wall runs above the existing collar ties to a straight horizontal line. This line was probably the underside of the collar ties of the higher roof. Without the earlier collar ties, it is difficult to tell if the ceiling was plastered, but there is a slight curve at the top of the plaster which suggests a plaster ceiling. (Note 6/303)

- Window 303: six-light wood sash window set in a modified wood frame. Archive photos of the west gable show that this opening was previously a 6/6 window before the roof was lowered. (Archive Photos 3 & 7)
- The six-light window surround is also patched with gray cement which is likely related to the roof lowering and the changing of the 6/6 window.

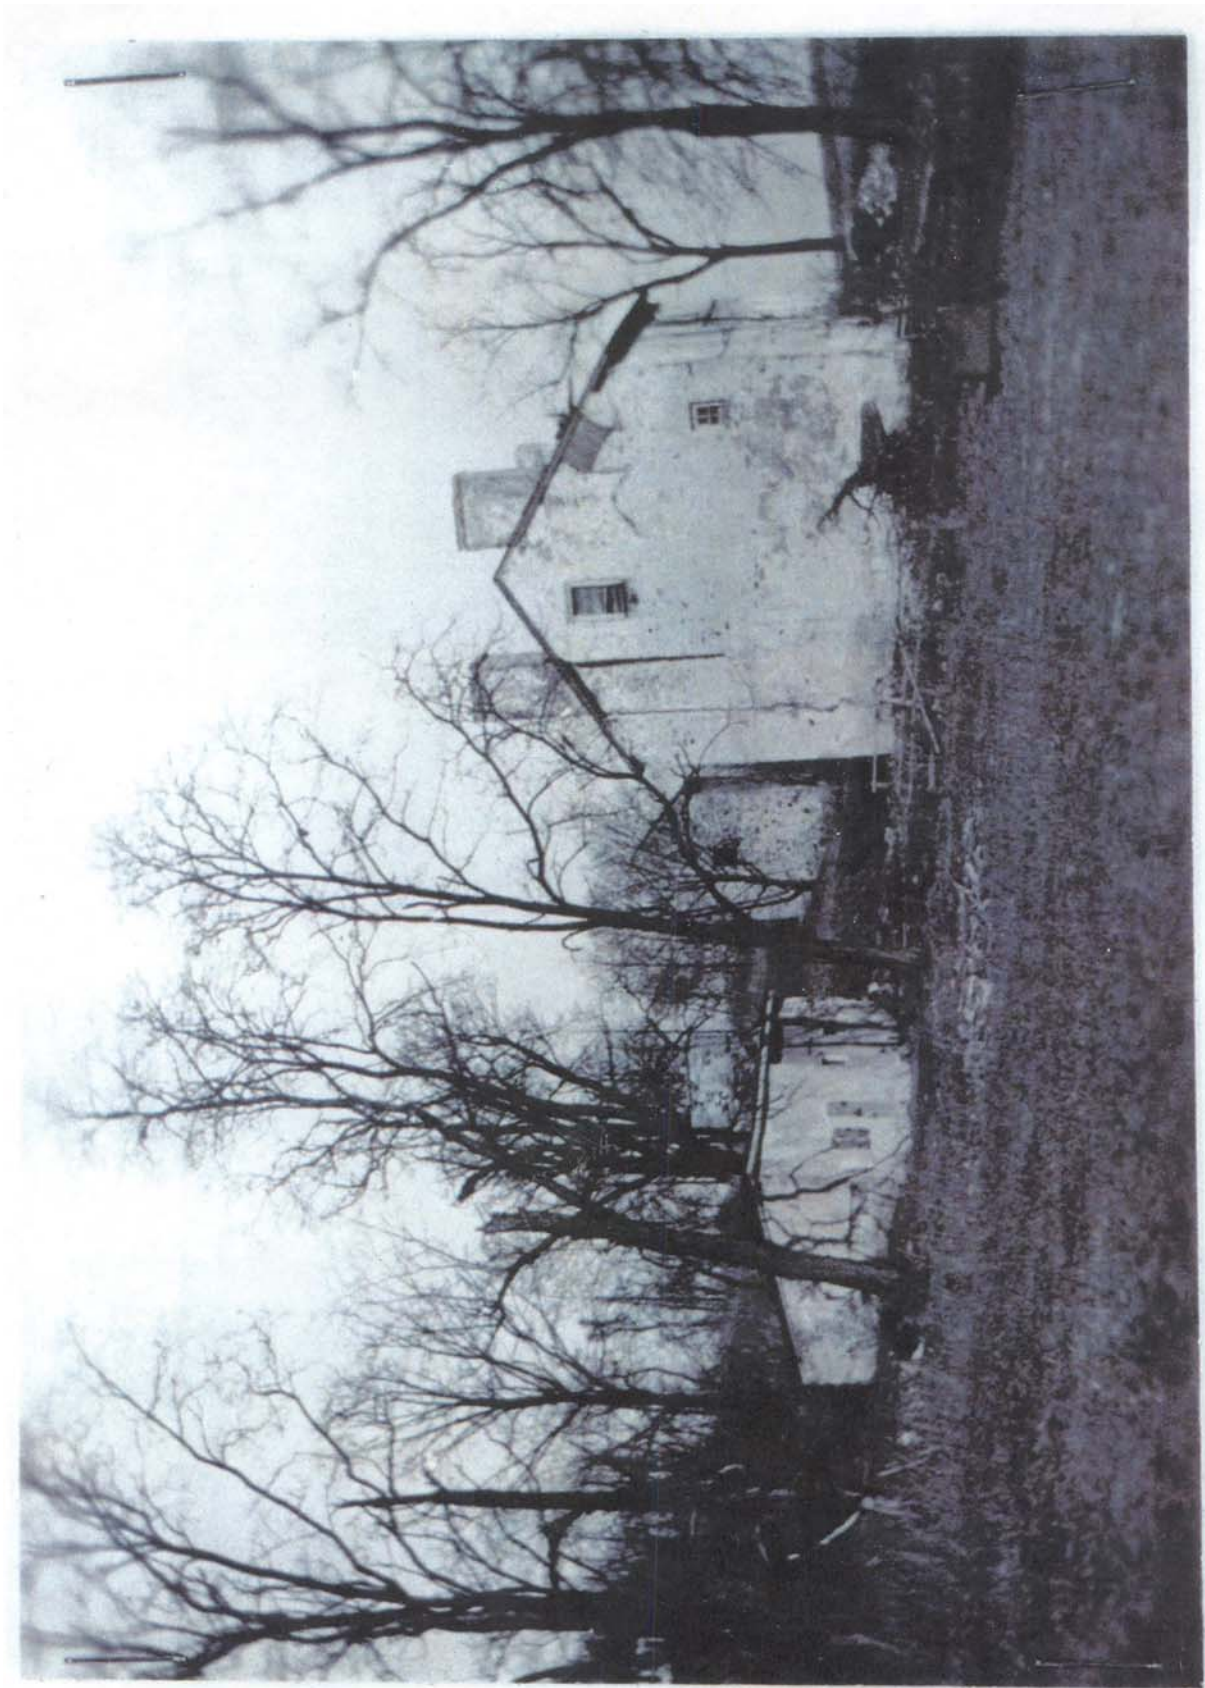
**Archive Photo 6**  
 South elevation of main house  
 and small barn, looking north.  
 (Captions are attached to photo.)

- The south entrance door appears to be a new masonry opening. The door and frame appear to be 20<sup>th</sup>-century. Archive photographs from c. 1925 do not show a door in this location. Instead, a door is located more in the center of this south wall. (Note 2/108) (Archive Photos 6 & 7)
