VICKSBURG NATIONAL MILITARY PARK

PEMBERTON'S HEADQUARTERS

(WILLIS-COWAN HOUSE)

HISTORIC STRUCTURE REPORT

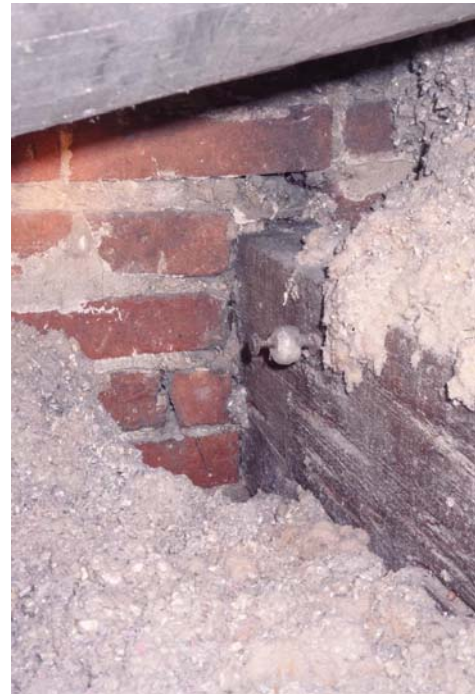
Figure B - 3 Ceiling joists above the original L-shaped porch are resting in formed joist pockets in the brick wall, indicating they are an original feature

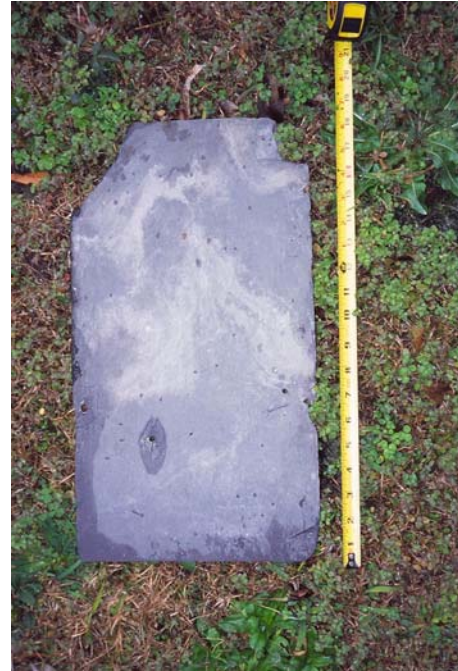
Roof & Rainwater Collection/Dispersal: The pitched roofs are covered with a dark purple slate, 10" x 18," with square edge and 8" weather exposure. The ridges are covered with a clay tile, 6" x 18," with dark brown glazing. The low-sloped, side sections of the main entrance portico (north elevation) are covered with flat-seamed, terne-metal roofing.

Figure C – 4 Roofing slate

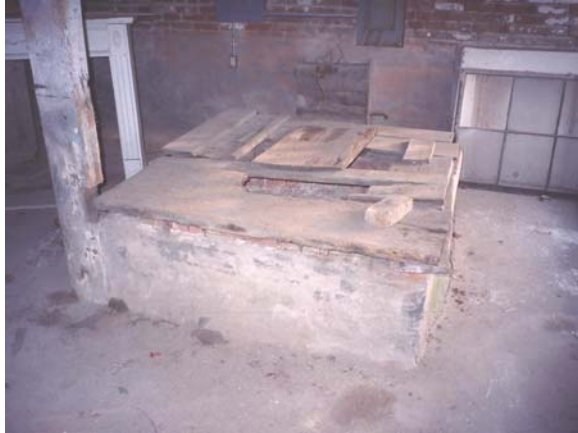
Figure C – 5 Cistern

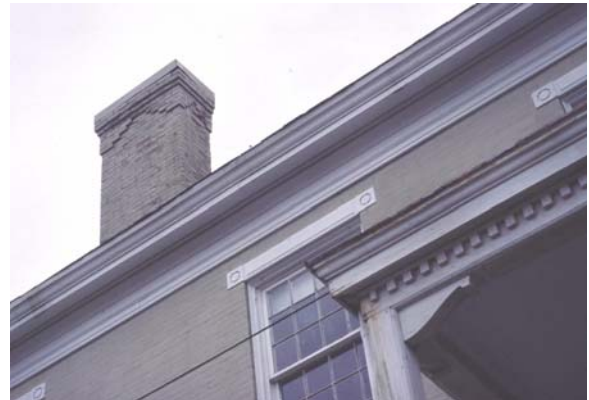
Roof Cornice: A large, Greek Revival style cornice, constructed in wood, spans the north and west elevations. At the gables of the east and south elevations, simple, unadorned rake boards trim out the roof edge.

Figure C – 6 Cornice of west porch and original house, and corbelled chimney

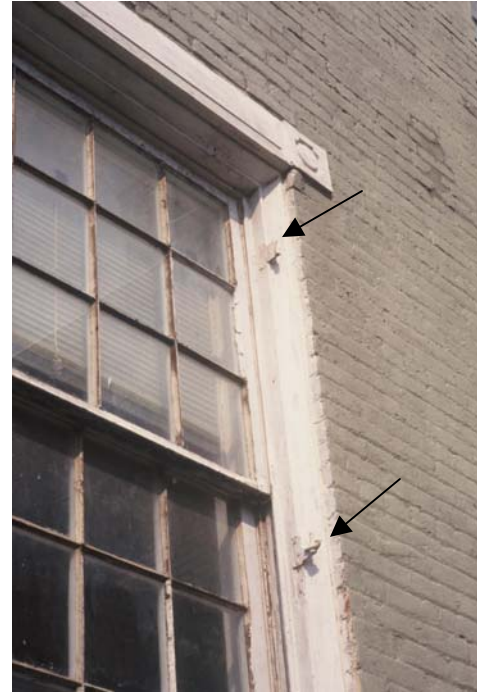
All these window units either contain portions of a two-knuckle shutter hinge that was popular in the second quarter of the nineteenth century, or ghost marks of that hinge. There are also a few cast shutter hinges dating to the late nineteenth century that were added as replacement to the early hinges.

Figure C – 10 Shutter hinges; the upper hinge dating from the second quarter of the nineteenth century, the lower dating from the third or fourth quarter or the nineteenth century

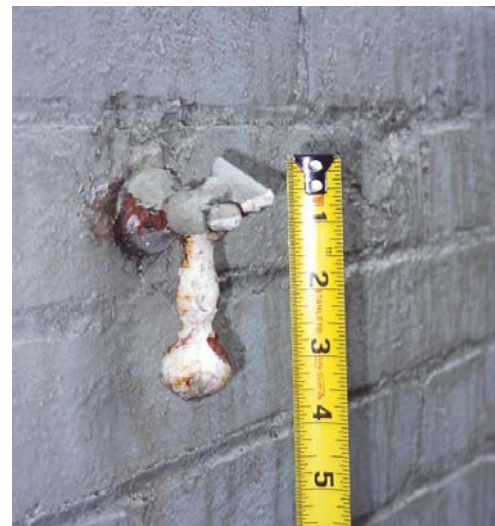
Also in the masonry flanking the windows of the north, east, and west elevations of the 1835-36 house, are remnants and ghost marks of a shutter dog design popular in the second and third quarters of the nineteenth century.

Figure C – 11 Shutter dog

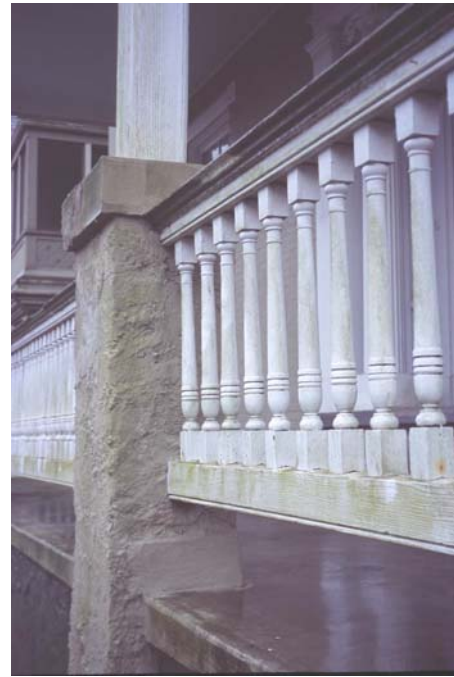
Figure C – 13 Front porch balustrade

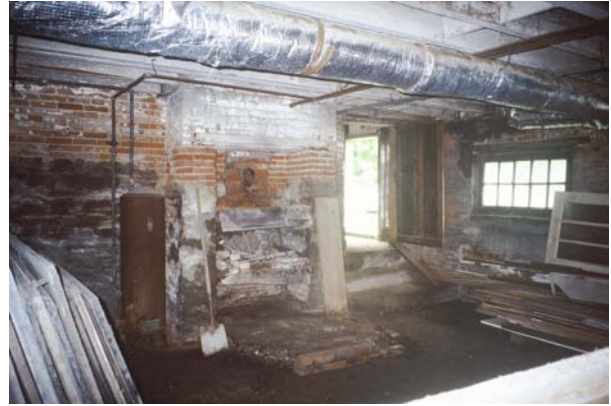
Figure C – 15 Room 001

is not keyed to the house foundation. The corner beaded posts, scroll brackets, handrail, and beaded bottom rail match. The side porch now has a modern, 1½" x 1½," replacement balustrade; the remnants of the original are in storage in Room 001. Both porches were likely constructed to complement one another during the same 1850-51 construction campaign.

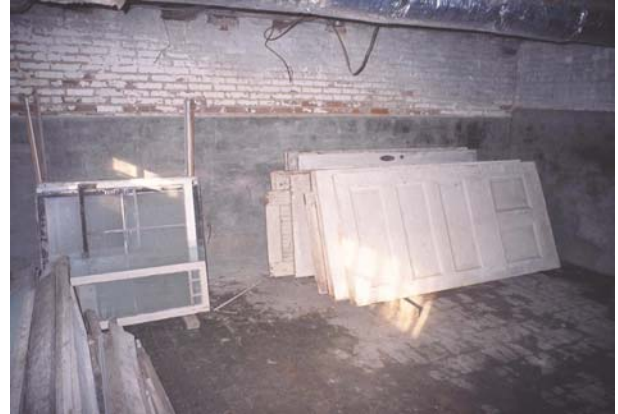
Figure C – 16 Original doors in storage in Room 001

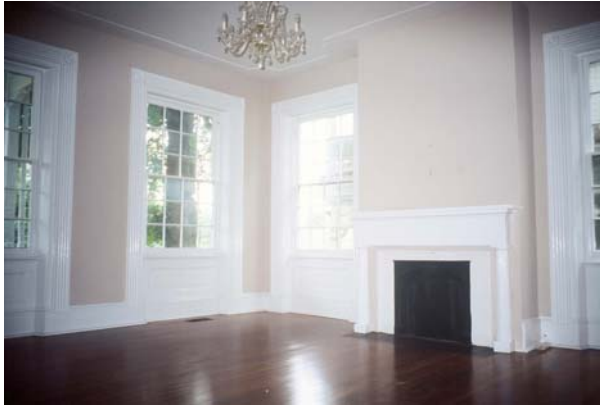
Figure C – 17 Room 101

- *Flooring:* The 1919 era, tongue-and-groove, 3¼” pine flooring is laid east-to-west on top of the original random width flooring.
- *Walls:* Early lime plaster, perhaps original, was patched in 1997-99.

- *Windows:* Four, 1835-36 vintage, floor-to-lintel window units have splayed paneled jambs and heads, fluted floor to lintel casings, recessed panels, and 12-over-12 light, double-hung, window sash. All sash are the original 1835-36 Type A. Three of the sashes, however, and the muntins of the lower sash of the two north windows and the lower of the southeast window, have been replaced with Type C muntins, probably a Civil War era repair.

- *Ceiling:* The flat plaster ceiling was replaced in the 1997-99 repair effort with the current double layer of gypsum board ceiling with top layer cut to form a border. A synthetic center medallion was also installed at that time.

- *Other Features:* A plexiglass panel in the ceiling provides a view to a shattered joist reportedly damaged during the Siege of Vicksburg. A built-in bookcase was installed in a door opening in the south wall in 1997-99. According to the owner who made the change, Andrew Johnson, the Victorian 4-panel door and flat board door casing matched that of the doorway that leads from Room 108 to Room 110, as well as the doorways of the Kitchen, Room 109.

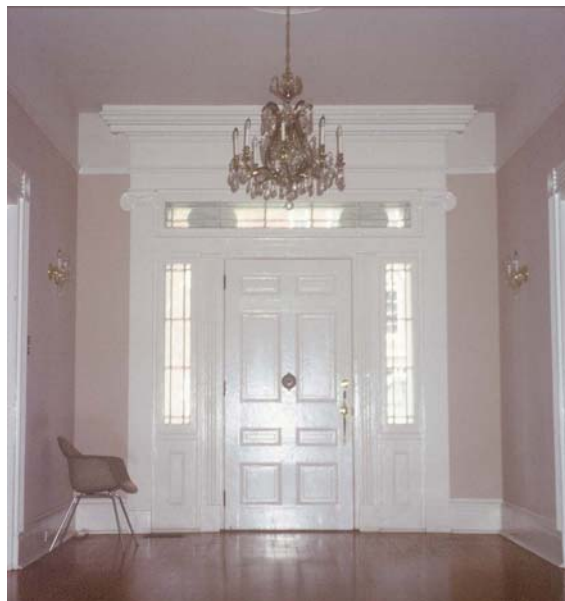
Figure C – 18 Room 102

- *Flooring:* The 1919 era, tongue-and-groove, 3¼” pine flooring was laid north-to-south on top of the original random width flooring.
- *Walls:* The early lime plaster, perhaps original, was patched in the late 1990s.
- *Doors:* The house’s main entrance doorway is located at the north end of the room. Most of the component parts are probably original, dating to the 1835-36 construction period, and are a spectacular example of Greek Revival style design and craftsmanship. The eight-panel door is attached with three, 5-knuckle, 4½,” iron, butt hinges with the manufacturer’s stamp: PERKS. The original and early rim locks

are missing. Immediately opposite, a complimentary composition of fluted pilasters, architrave, and transom frame a double doorway with paneled jambs and head and fluted surrounds; here the doors are missing but are presumed to be among those stored in Room 001. The doorways to the two Parlors, Rooms 101 and 103, opposite each other to the east and west, retain their 1835-36 vintage, Greek Revival style, paneled jambs and head, fluted surrounds and trim.

- *Windows:* None are present.
- *Ceiling:* The original, lime, flat, plaster ceiling was repaired and the synthetic center medallion was added in the 1997-99 repair effort. This room probably never had a three dimensional cornice because of the height of the entrance doorway enframing, though it may have had a wallpaper cornice, which was popular at that time.
- *Baseboards:* The tall, 1835-36 vintage, Greek Revival style baseboards with beveled caps are intact.
- *Fireplace & Mantel:* None are present.
- *Finishes:* The floor is varnished. Walls, ceilings, door, transom, sidelight and trim are painted. The woodwork was stripped in the 1997-99 repairs.
- *Mechanical & Electrical Systems:* A modern metal floor register adjoining the

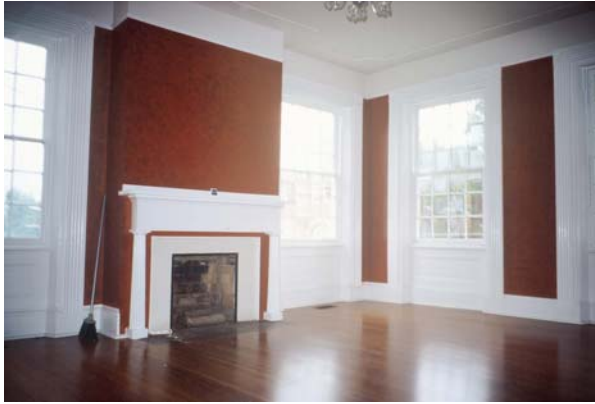
Figure C – 19 Room 103

- *Flooring:* The 1919 era, tongue-and-groove, 3¼" pine flooring is laid east-to-west on top of the original random width flooring.
- *Walls:* Early lime plaster, perhaps original, was patched in the late 1990s.

- *Doors:* The original five-panel doors to the Entrance Hall, Room 102, and the Stair Hall, Room 104, are now missing and presumably are among the doors stored in Room 002. Both doorways retain their 1835-36 vintage, Greek Revival style, paneled jambs and heads, fluted surrounds and trim.

- *Ceiling:* The flat plaster ceiling was replaced in the 1997-99 repair effort with the current double layer of gypsum board ceiling with top layer cut to form a border. A synthetic center medallion was also installed at that time.

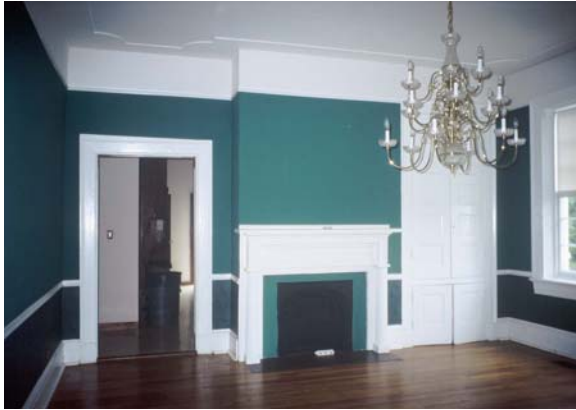
Figure C – 23 Room 105

Room 105: In the early nineteenth century, this room, the Dining Room, was a less public room. The architectural elements of the original 1835-36 construction period reflect this secondary importance. The windows, for example, while still splayed to display craftsmanship and flood the room with natural light, do not extend all the way to the floor as they do in the two, more public rooms that also have windows, the parlors. The door surrounds are not fluted as they are in the public rooms, nor are the window surrounds fluted as they are in the two parlors. In 1850-51, a portion of the original porch was enclosed and the east exterior wall of the Dining Room was demolished, thus creating an enlarged dining area of the combined Rooms 105 and 106. By the late 1990s, pronounced structural problems had resulted from the diminished support and the wall was partially rebuilt.

- *Flooring:* The 1970s, tongue-and-groove, 2¼” red oak flooring was laid east-to-west here and in Room 106 into which this room opened.
- *Walls:* Early lime plaster, perhaps original, was patched in the late 1990s.
- *Doors:* The doorway to the Stair Hall, Room 104, dates to 1835-36; the original five-panel door is now absent but presumably is among the doors stored in Room 001. The doorway to the Kitchen, Room 109A, was added, probably in 1850-51, when enclosing the east side porch would have necessitated another route to the Kitchen Building. The door, probably a reused 1835-36 era, five-panel door or a 1850-51 reproduction, is now absent but presumably is among the doors stored in Room 001. It is noteworthy that the Greek Revival style casing of this doorway, while appearing to be identical to the other 1835-36 and 1850-51 door

casings, is the only example in the house joined on the diagonal. The cased, paneled doorway to Room 106 was constructed in 1997-99; the pattern of casing and paneled jamb are very poor replications of the Greek Revival style detailing found elsewhere in the house.

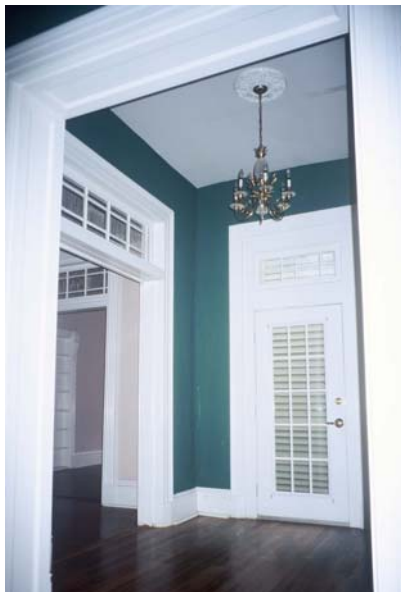
Figure C – 26 Room 106A

- *Flooring:* The 1970s, tongue-and-groove, 2¼” red oak flooring was laid east-to-west here and in Room 105 into which Room 106 opened. By the 1990s, there was termite damage throughout the red oak flooring of Rooms 105 and 106. During the remodeling of 1997-99, the perimeter of the original Dining Room, Room 105, was re-established, and the Dining Room Extension, Room 106, was subdivided. Red oak flooring was salvaged from the area that became Room Section 106B, and used to patch the flooring of 106A and 105. In its place, a plywood subfloor with carpet was installed in the resultant bathroom of Room 106B.

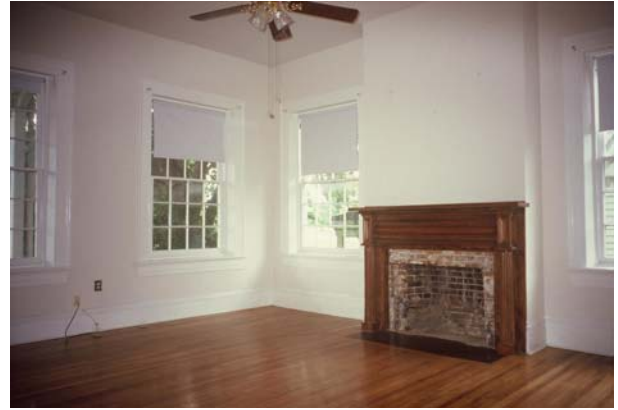
Figure C – 29 Room 201

- *Flooring:* The 1970s, tongue-and-groove, 2¼” red oak flooring is laid east-to-west on top of the original random width flooring.
- *Walls:* Early lime plaster, probably original, was patched during the 1997-99 remodeling.

- *Ceiling:* The flat plaster was replaced in the 1997-99 repairs with gypsum board.
- *Baseboards:* The tall, 1835-36 vintage, Greek Revival style baseboards with beveled caps are largely intact, except for a missing section where the 1850-51 doorway was added to access ancillary space of Room 208.

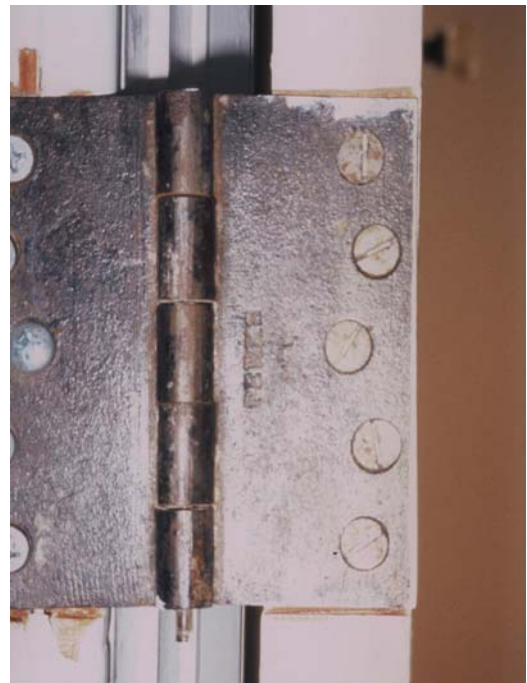
Figure C – 30 “PERKS” Hinge

- *Doors:* In the doorway to the Hall, Room 202, an original five-panel door is hung with two early, 4½", 5-knuckle, iron butt hinges with the fabricator's mark: "PERKS;" a modern, 5-knuckle hinge has been added at mid-section of the door. This doorway retains its original 1835-36 vintage, Greek Revival style, paneled jambs and head, and door casing. A second doorway, also with paneled jambs and header, opens to Room 208, a section of the original open porch that was enclosed to be a secondary space in 1850-51. The door is a five-panel door hung with two modern 5-knuckle butt hinges. This doorway has Greek Revival style trim, probably dating to 1850-51, mimicking the 1835-36 trim found elsewhere.

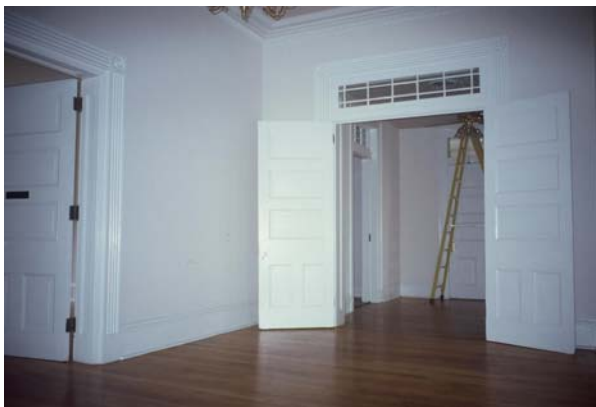
Figure C – 31 Room 202

- *Doors:* The doorway to the upper level of the front entrance porch is located at the north end of the room. Most of the component parts are probably original, dating to the 1835-36 construction period. Like its match at first level, it is a spectacular example of Greek Revival

style design and craftsmanship. The eight-panel door is secured with three 5-knuckle, 4½," iron, butt hinges. The original and early rim locks are missing. Immediately opposite, a complimentary composition of fluted pilasters, architrave, and transom frame a double doorway; here there is a pair of five-panel doors, each with two, 5-knuckle, 4" iron butt hinges labeled "PERKS." The doorways to the two large bedrooms, Rooms 201 and 203, opposite each other to the east and west, retain their 1835-36 vintage, Greek Revival style, paneled jambs and head, and fluted casing.

- *Windows:* None are present.
- *Ceiling:* The early lime plaster ceiling was patched and the synthetic center medallion was added in the 1997-99 repair effort.
- *Baseboards:* The tall, 1835-36 vintage, Greek Revival style baseboards with beveled caps are intact.
- *Fireplace & Mantel:* None are present.
- *Finishes:* The floor is varnished. Walls, ceilings, door, transom, sidelight, and trim are painted. The woodwork was stripped in the 1997-99.
- *Mechanical & Electrical Systems:* A modern circular ceiling register supplies the heating and cooling. An electrical, pseudo-historical chandelier hangs from the center of the ceiling. Modern, pseudo-

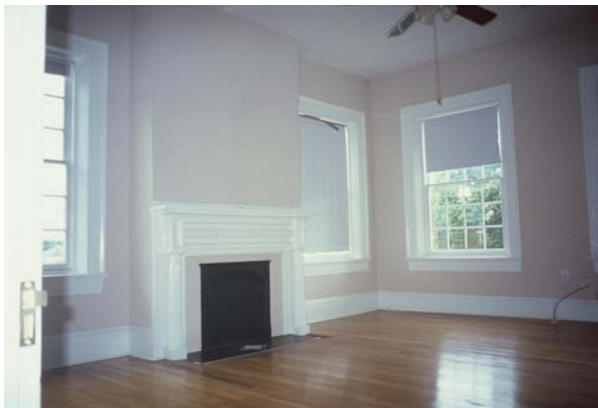
Figure C – 32 Room 203

- *Flooring:* The 1970s, tongue-and-groove, 2¼” red oak flooring was laid east-to-west on top of the original random width flooring.
- *Walls:* Early lime plaster, probably original, was patched in the 1997-99 repairs.
- *Doors:* The doorway to the Entrance Hall, Room 202, and the one to the Stair Hall,

- *Windows:* Four 1835-36 window units contain 12-over-12 light, double-hung, window sash. All sashes but one are Type A; one sash is Type B.
- *Ceiling:* The flat plaster ceiling was replaced in the 1997-99 repairs with gypsum board.

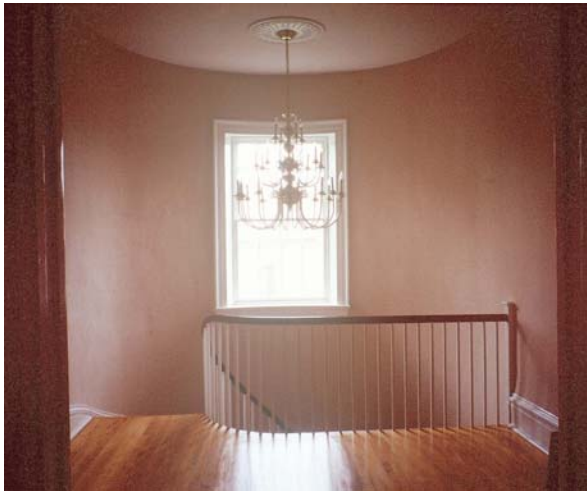
Figure C – 33 Room 204

- *Walls:* Early lime plaster, probably original, was patched in the 1997-99 repair effort.
 - *Doors:* A double doorway with a transom matching that of the Hall, Room 202, opens to the east; the doors are now missing but presumably are among those stored in Room 001. A doorway for a single-leaf door leads to the Northwest Bedroom, Room 203, and another to the Southwest Bedroom, Room 205. All three doorways have 1835-36 vintage, Greek Revival style, paneled jambs and heads, and fluted door casing.

- *Windows:* A single window unit with double-hung, 12-over-12 light sash is centered on the west wall. One sash is 1835-36 era Type B and the other is Type C and a Civil War era repair.

- *Ceiling:* The flat plaster ceiling was replaced with gypsum board in 1997-99.
 - *Baseboards:* The tall, 1835-36 vintage, Greek Revival style baseboards with beveled cap are intact.

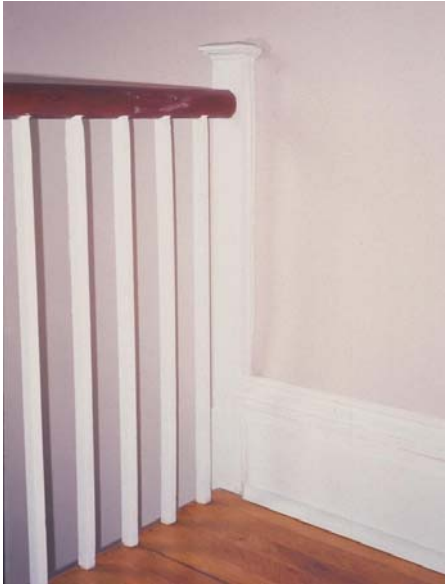
- *Fireplace & Mantel:* None are present.
 - *Staircase:* An elegant, curving, Greek Revival style staircase to the first floor level is positioned along the west wall. The handrail height is now, with added flooring, 3'-0½" above the floor at second level where it terminates into a 3¼" wide square cut pilaster with simple cap.

Figure C – 34 Top stair post

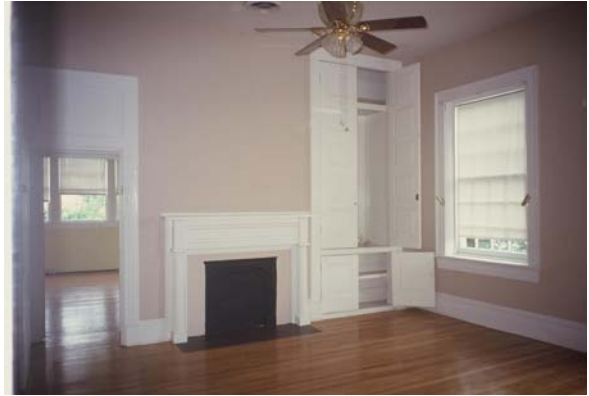
Figure C – 35 Room 205

Room 205: This, the Southwest Bedroom, is smaller than the other two original 1835-36 bedrooms, Rooms 201 and 203 at the front of the house.

- *Windows:* Two window units of 1835-36 vintage, Greek Revival style design are located on the west wall. Each is a 12-over-12 light, double-hung, window sash. All four sashes are Type B. The remnants of two matching windows are immediately opposite on the east wall. Both have had their sashes removed. The north window of the east wall retains its original sill and stool, and has a poorly copied, 1997-99 vintage reproduction of a 1835-36 Greek Revival style window surround. The south window of the east wall has been stripped of its original trim and modified for a doorway.

- *Ceiling:* The plaster ceiling was replaced with gypsum board in the 1997-99 repair effort.
- *Baseboards:* The tall, 1835-36 vintage, Greek Revival style baseboards with beveled caps are largely intact along the north and west walls. Portions have been rearranged and patched along the east and south walls where doorways have created and a cupboard has been installed.

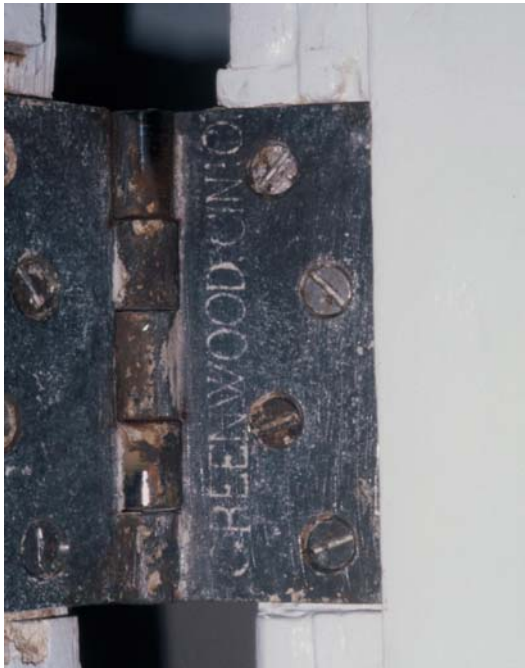
doorway has a three-light transom matching the one leading to the Sleeping Porch, suggesting that the doorway may date to 1919; the door surround was reworked, and a resin door cast in an historical six-panel design was installed in 1997-99.

Figure C - 36 "GREENWOOD CINO" Hinge

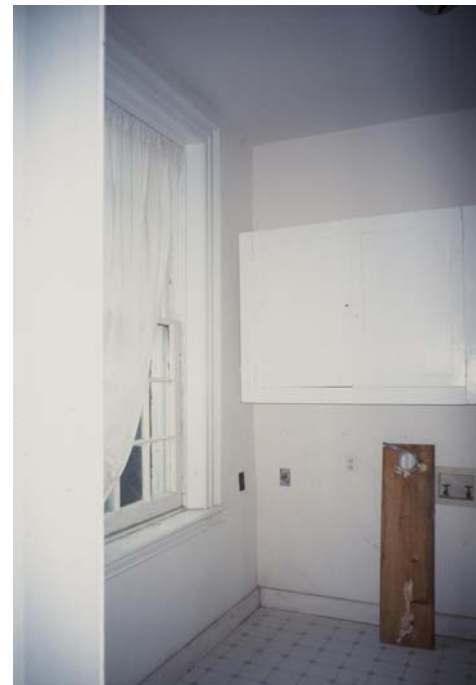
Figure C – 37 Room 206A

- *Walls:* In 1997-99, the early lime plaster, perhaps the original dating to 1850-51, of the north, east, and west walls was patched. The south wall, containing the remnants of a small firebox added in 1850-51, was furred out with gypsum board to create a plumbing chase. A new gypsum board on stud, cross wall running east-west, was constructed to divide the room into two sections.

- *Ceiling:* The early lime plaster ceiling, probably original, was replaced with gypsum board in 1997-99.
- *Baseboards:* The room was stripped of most early baseboard elements in 1997-99. A few elements were reused in the Bathroom, Room 206B, but none in the Laundry Room, Room 206A.

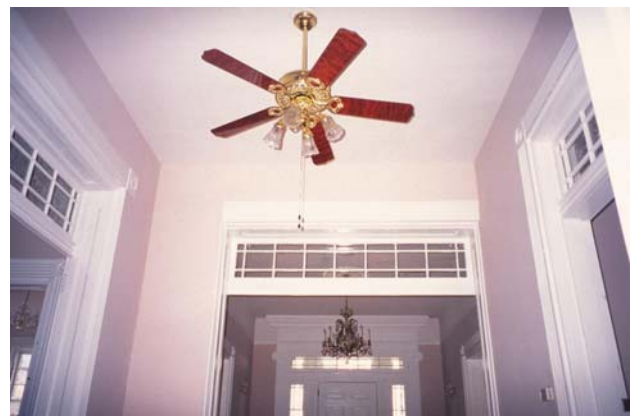
Figure C – 38 Room 207, looking into Room 202

- *Flooring:* The 1970s, 2¼" tongue-and-groove, red oak flooring was laid east-west on top of the 1850-51 flooring.
 - *Walls:* In 1997-99, the early lime plaster, presumably the original dating to 1850-51, was patched.

- *Doors:* The openings to the Hall, Room 202, and the Upper Stair Hall, Room 204, apparently date to 1835-36 as indicated by the decorative lintel panels. Either opening could have been a doorway or a window, originally. After 1850-51, both were doorways with transom. Both have paneled jambs and heads, and no trim on this side of the openings, except for the original paneled lintel. The doorway to Room 206 was constructed in 1850-51. It was constructed for a pocket door with transom; the transom is missing and a five-panel door of 1835-36 design is now hung as a swinging door with early, 5¾" iron butt hinges. The door trim is Greek Revival style dating to 1850-51. The doorway with transom to Room 208 was constructed as a pocket door in 1850-51, and the pocket door is still in place. The door trim is Greek Revival style dating to 1850-51.

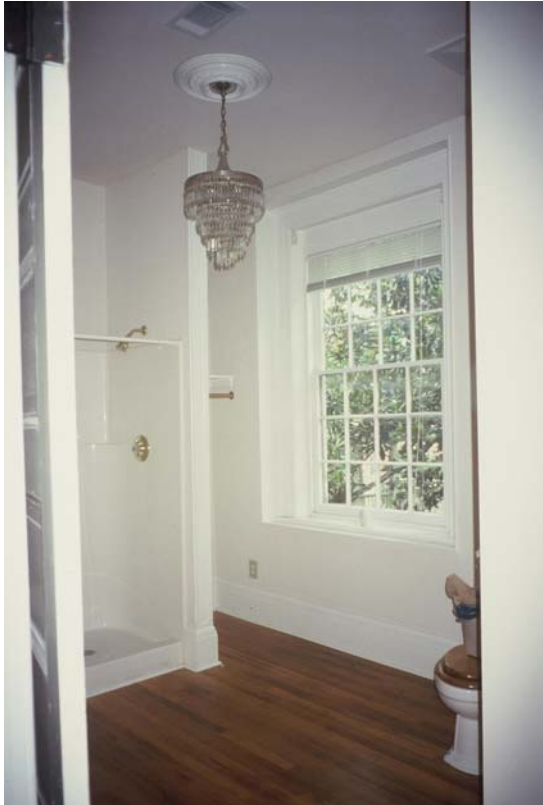
Figure C – 39 Room 208A

- *Flooring:* The 1970s, 2¼" tongue-and-groove, red oak flooring was laid east-west on top of the 1850-51 flooring.
- *Walls:* In 1997-99, the early lime plaster, presumably the original dating to 1850-51, of the north and west walls was patched; the east and south walls were furred out with gypsum board for plumbing chases. At the same time, a gypsum board on stud cross wall was constructed to subdivide the room into two bathrooms.

- *Doors:* The doorways to the Hall Extension, Room 207, and to the Northeast Bedroom, Room 201, retain 1850-51 vintage, Greek Revival style trim.
- *Windows:* There are two window openings for double-hung window units, both in Room 208A. Both conform to the 1835-36 design features found in the earliest part of the house. They were moved to their current locations during the 1850-51 remodeling. Their places of origin are not known, but they would likely be along the south wall of the Northeast Bedroom, Room 201. The window unit now on the east wall is blocked in. The window unit now on the south wall has two Type A sashes. A third double-hung window unit was removed from the south wall of Room 208B during the 1997-99 remodeling.

- *Ceiling:* The early lime plaster ceiling was replaced with gypsum board in 1997-99.
- *Baseboards:* The baseboards of both 208A and 208B are modern, dating to the 1997-99 remodeling.

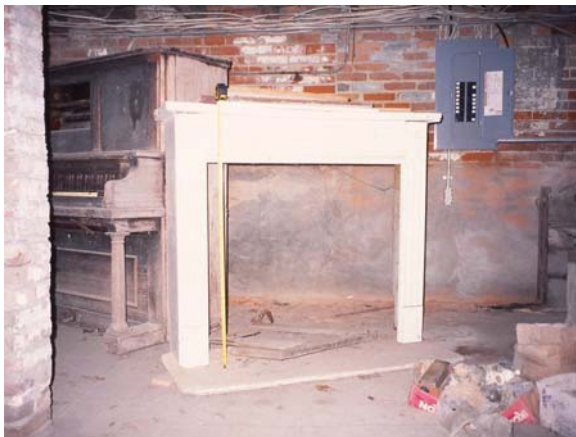
- *Fireplace & Mantel:* A small, corner fireplace was installed in 1850-51. In 1997-99, the firebox was blocked off and the mantel placed in storage in Room 002. The mantel is made of painted wood. Its most distinctive feature is the decorated frieze containing a classical urn at the center flanked by a garland on either side.

Figure C – 40 Room 208 mantel

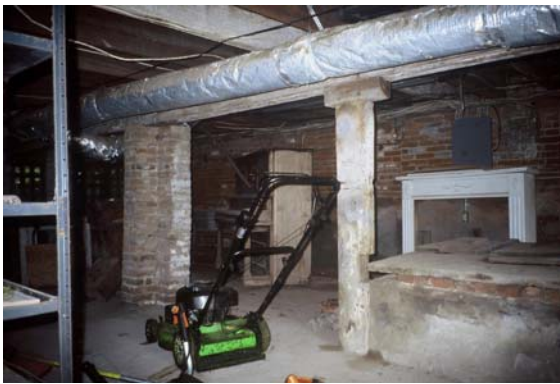
Figure C - 41 Room 002

- *Flooring:* Poured cement, set at grade, forms the flooring. This cement was poured after the brick piers were constructed. An earlier flooring of brick or even dirt may be below the current cement flooring.
- *Walls:* The 1835-36 south foundation wall of the house ell and porch forms the north wall of this space. The east one-half of the south wall is the remnant wall of the Kitchen Building, now demolished; the

west one-half of this wall was constructed in 1919. From grade up to a height of about 3'-3", the brickwork has been parged with a Portland cement-rich stucco, undoubtedly an attempt to stem rising damp. The east and west ends are enclosed with lattice work also dating, probably, to 1919.

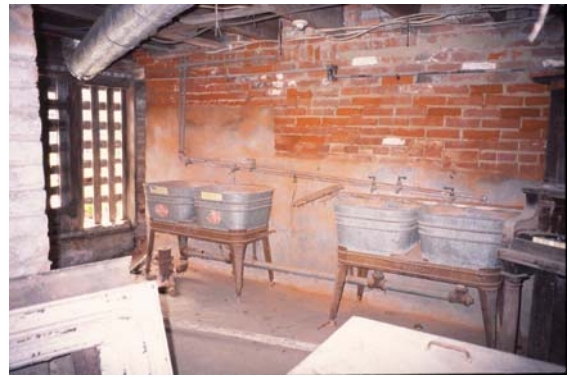
Figure C - 42 Remnant of Kitchen Building wall

- The slate roof over the 1835-36 and 1850-51 construction periods is close to the end of its projected life and will need to be replaced soon.
- The brick chimneys and associated roof parapets are in need of repointing.
- Site drainage is poor. The positive slope away from the house has been lost through erosion at downspouts. Water pools at the base of the house.
- Sections of the brickwork, particularly at the base of the building from grade up to about four feet, have been repointed with a Portland cement-rich mortar. In the basement rooms, 001 and 002, a Portland cement-rich stucco has been applied to the lower sections of the interior surfaces of the brick walls. Though done in response to rising damp, the Portland cement mortar

- and stucco further contribute to the moisture problem: they force groundwater higher up the walls to escape, causing brick to spall along the way and keeping the building wet.

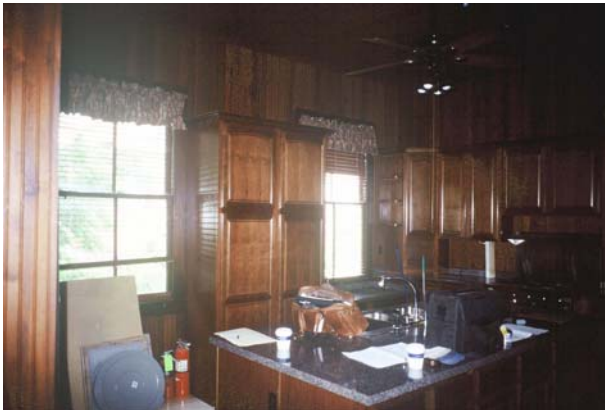
Figure C - 43 Room 109A

- *Flooring:* The flooring of the Kitchen (Room 109A) is 1997-99 vintage sheet vinyl, while that of the Bedroom (Room 109B) is similar vintage carpet.

- *Walls:* Except for the gypsum board on studs partition wall installed in 1997-99 to subdivide the room, the walls retain their 1919 vintage 3¼" beaded boards applied on the vertical.

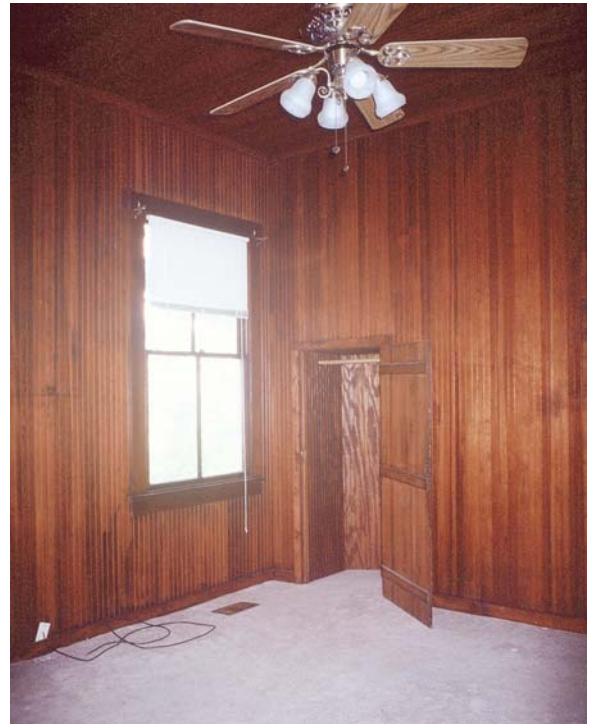
Figure C - 44 Room 109B

- *Doors:* Throughout the first level, the door casings are formed by simple, 1" x 4" plank pine boards of nominal dimensions. The doors in the openings between Rooms 109A and 109B, between Room 109B and its adjoining bathroom (Room 106B) and between 109A and the porch, are all cast resin, six-panel doors of a historic design installed in the 1997-99 remodeling. The door to the closet beneath the stairs is

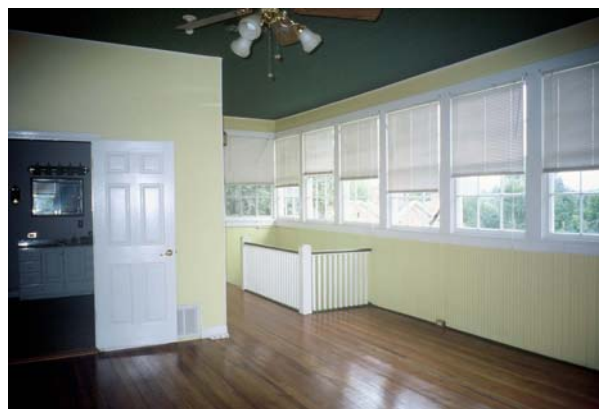
Figure C – 45 Room 209A

- *Flooring:* The tongue-and-groove, 3/4" pine flooring, running east-to-west, remains from the original construction of 1919. This flooring is exposed in Room

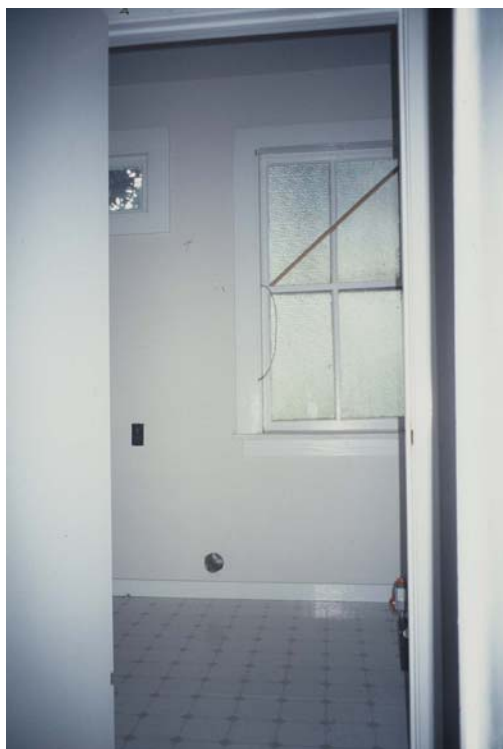
Figure C – 46 Room 110B

- *Flooring:* Sheet vinyl flooring was installed throughout during the repairs of 1997-99.
- *Walls:* Gypsum board was installed on the walls during the repairs of 1997-99.

- *Ceilings:* Gypsum board was installed during the 1997-99 repairs.
- *Baseboards:* Modern baseboards of nominal 1" x 4" plank boards were installed in the 1997-99 repairs.

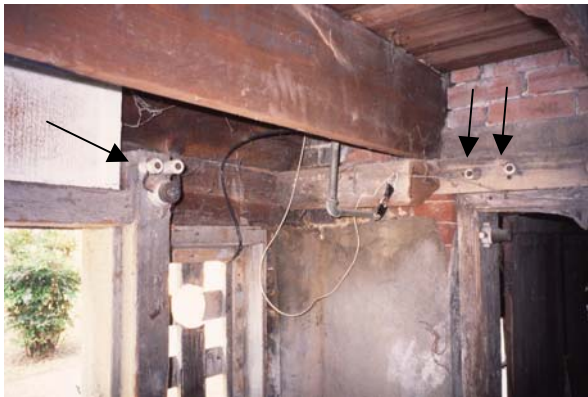
Electricity came to Vicksburg in 1886. The earliest evidence of electricity in the house is the late-nineteenth century/early-twentieth century ceramic insulators found in the

basement, Room 002, of the frame addition and in the attic of the original house. The previous owner reported that the house was largely rewired in the 1970s and completed in 1997-99 when the current lighting fixtures were installed. Nothing was observed to contradict those statements.

Figure C – 50 Knob and tubing

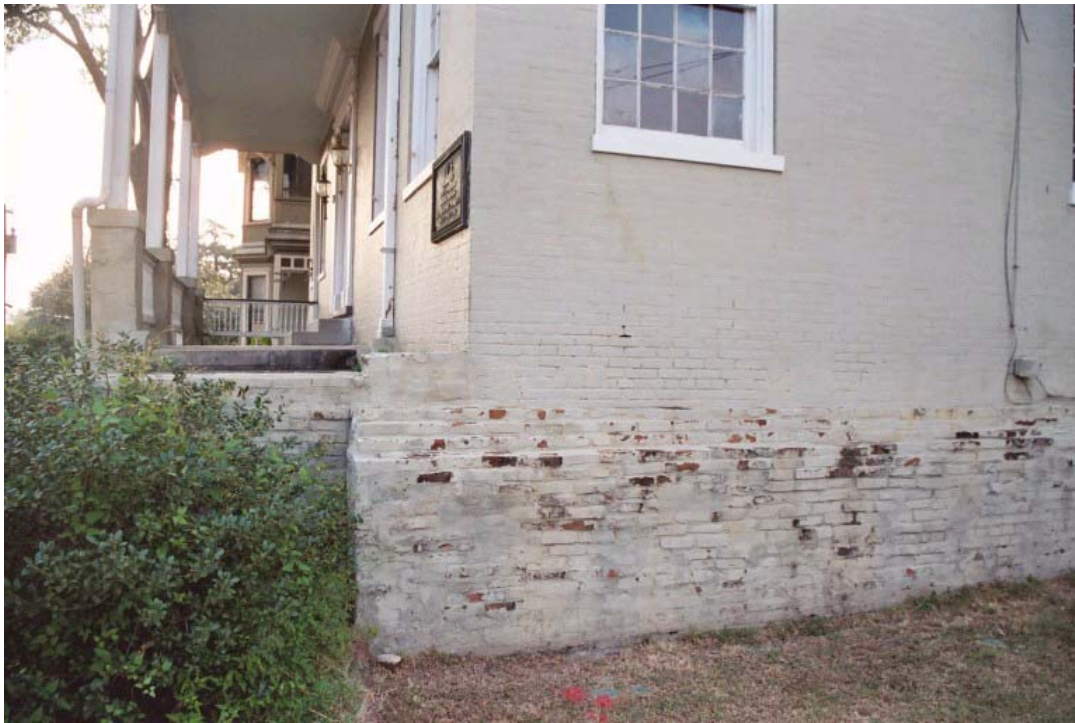
Figure 3 Retaining wall at northwest corner

It appears that some differential settlement has occurred in the northeast corner of the building due to the instability of earth cuts and slopes in this area. A brick retaining wall apparently contains the exterior wall on two sides of this corner of the house. It appears that the retaining wall on the side was constructed first. Bricks were laid up in stair step fashion to protect the top surface of the earth between the face of the house and the inside face of the retaining wall. Without exploratory excavation, we do not know the configuration of the retaining walls or the bottom of the wall elevation relative to grade in this area. (Fig. 3, 4)

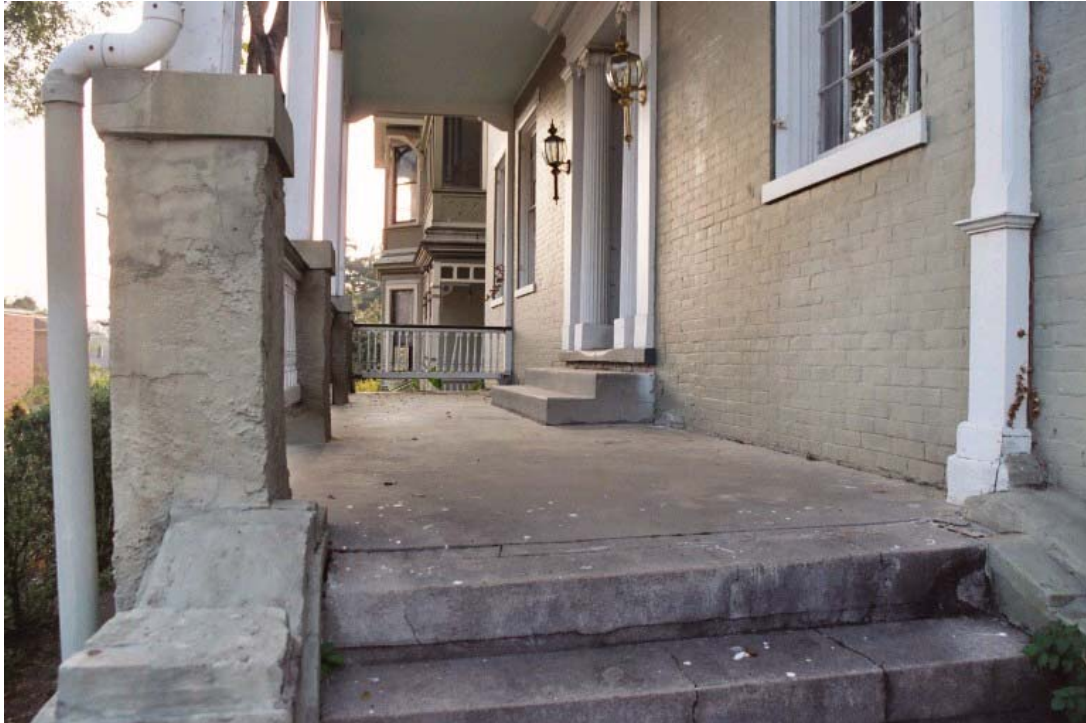
Figure 5

The concrete front porch, on the street side of the house, appears to be cast on earth fill. Any repairs to the steps or the porch will have to consider this. (Fig. 5)

Concrete front porch

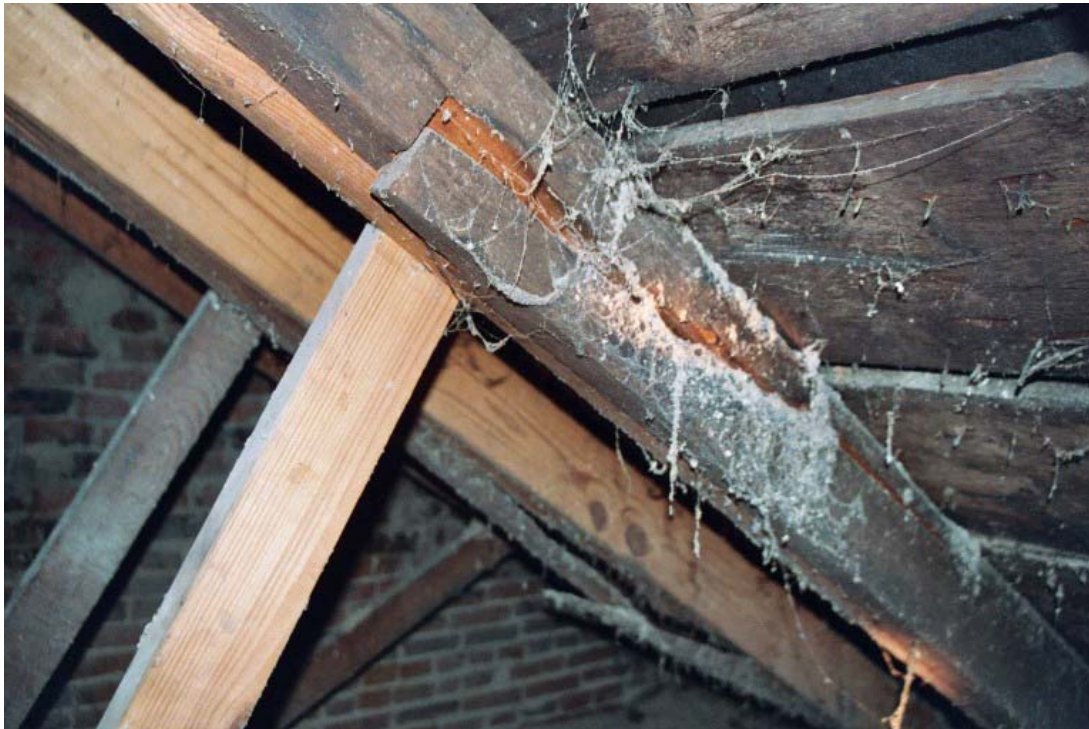
Figure 6

The roof framing consists of 2 ¾" x 5" to 2 7/8" x 4 ½" rafters spaced approximately at 24 inches on center. Ceiling joists are approximately 3" x 8 ½" in size. There are at least four fractured rafters which can be observed in the attic in the vicinity of the southwest chimney. They have been scabbed and propped up with 2x braces from the ceiling joists below. (Fig. 6)

Fractured rafters near southwest chimney

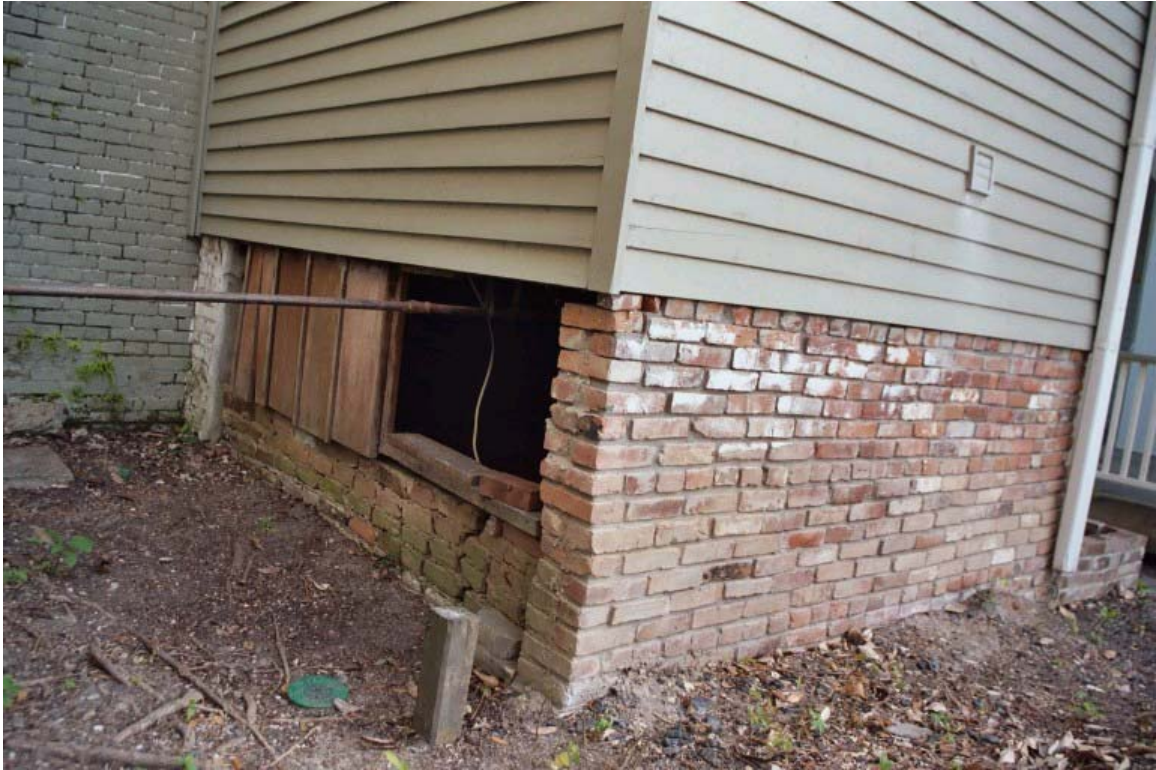
Figure 7

Southeast addition

Masonry restoration and repairs are recommended at several exterior locations including around lintels, at the front porch, and in the southeast and northeast corners of the building. The small, c. 1913 southeast frame addition is in poor condition with regards to masonry and framing. Consideration should be given to rebuilding or removing this portion of the building. (Fig. 7)
