HISTORIC STRUCTURE REPORT

FINAL REPORT

WASHINGTON MONUMENT AND
ASSOCIATED STRUCTURES

VOLUME III - SURVEY LODGE

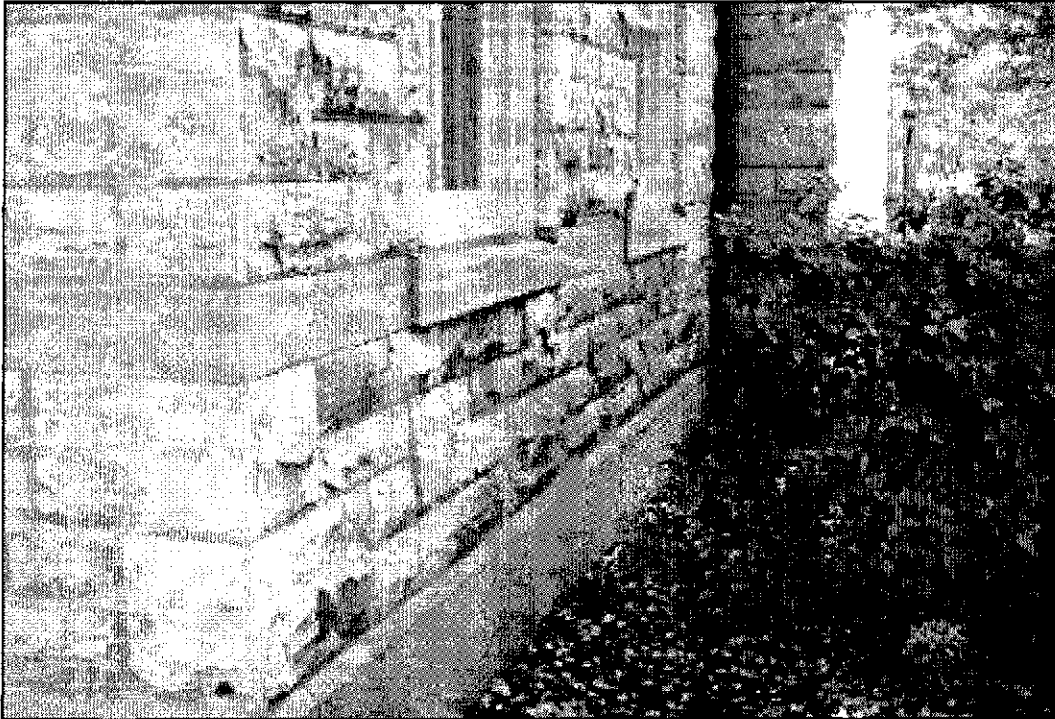
underside of projecting surfaces of the marble masonry on the lower half of the building wall and on the granite water table along the entire length of the northeast elevation. It is particularly severe under the western window where an air conditioning unit was previously removed (see figure 5.12). All areas of biological growth should be treated with a non-acidic biocidal cleaner to prevent masonry deterioration. The concrete sill below the door opening in the north bay of the northeast elevation is heavily soiled, covered in biological growth, and should be thoroughly cleaned.

Figure 5.12: Northeast elevation with significant biological growth on underside of rock-faced finish marble and granite water table.

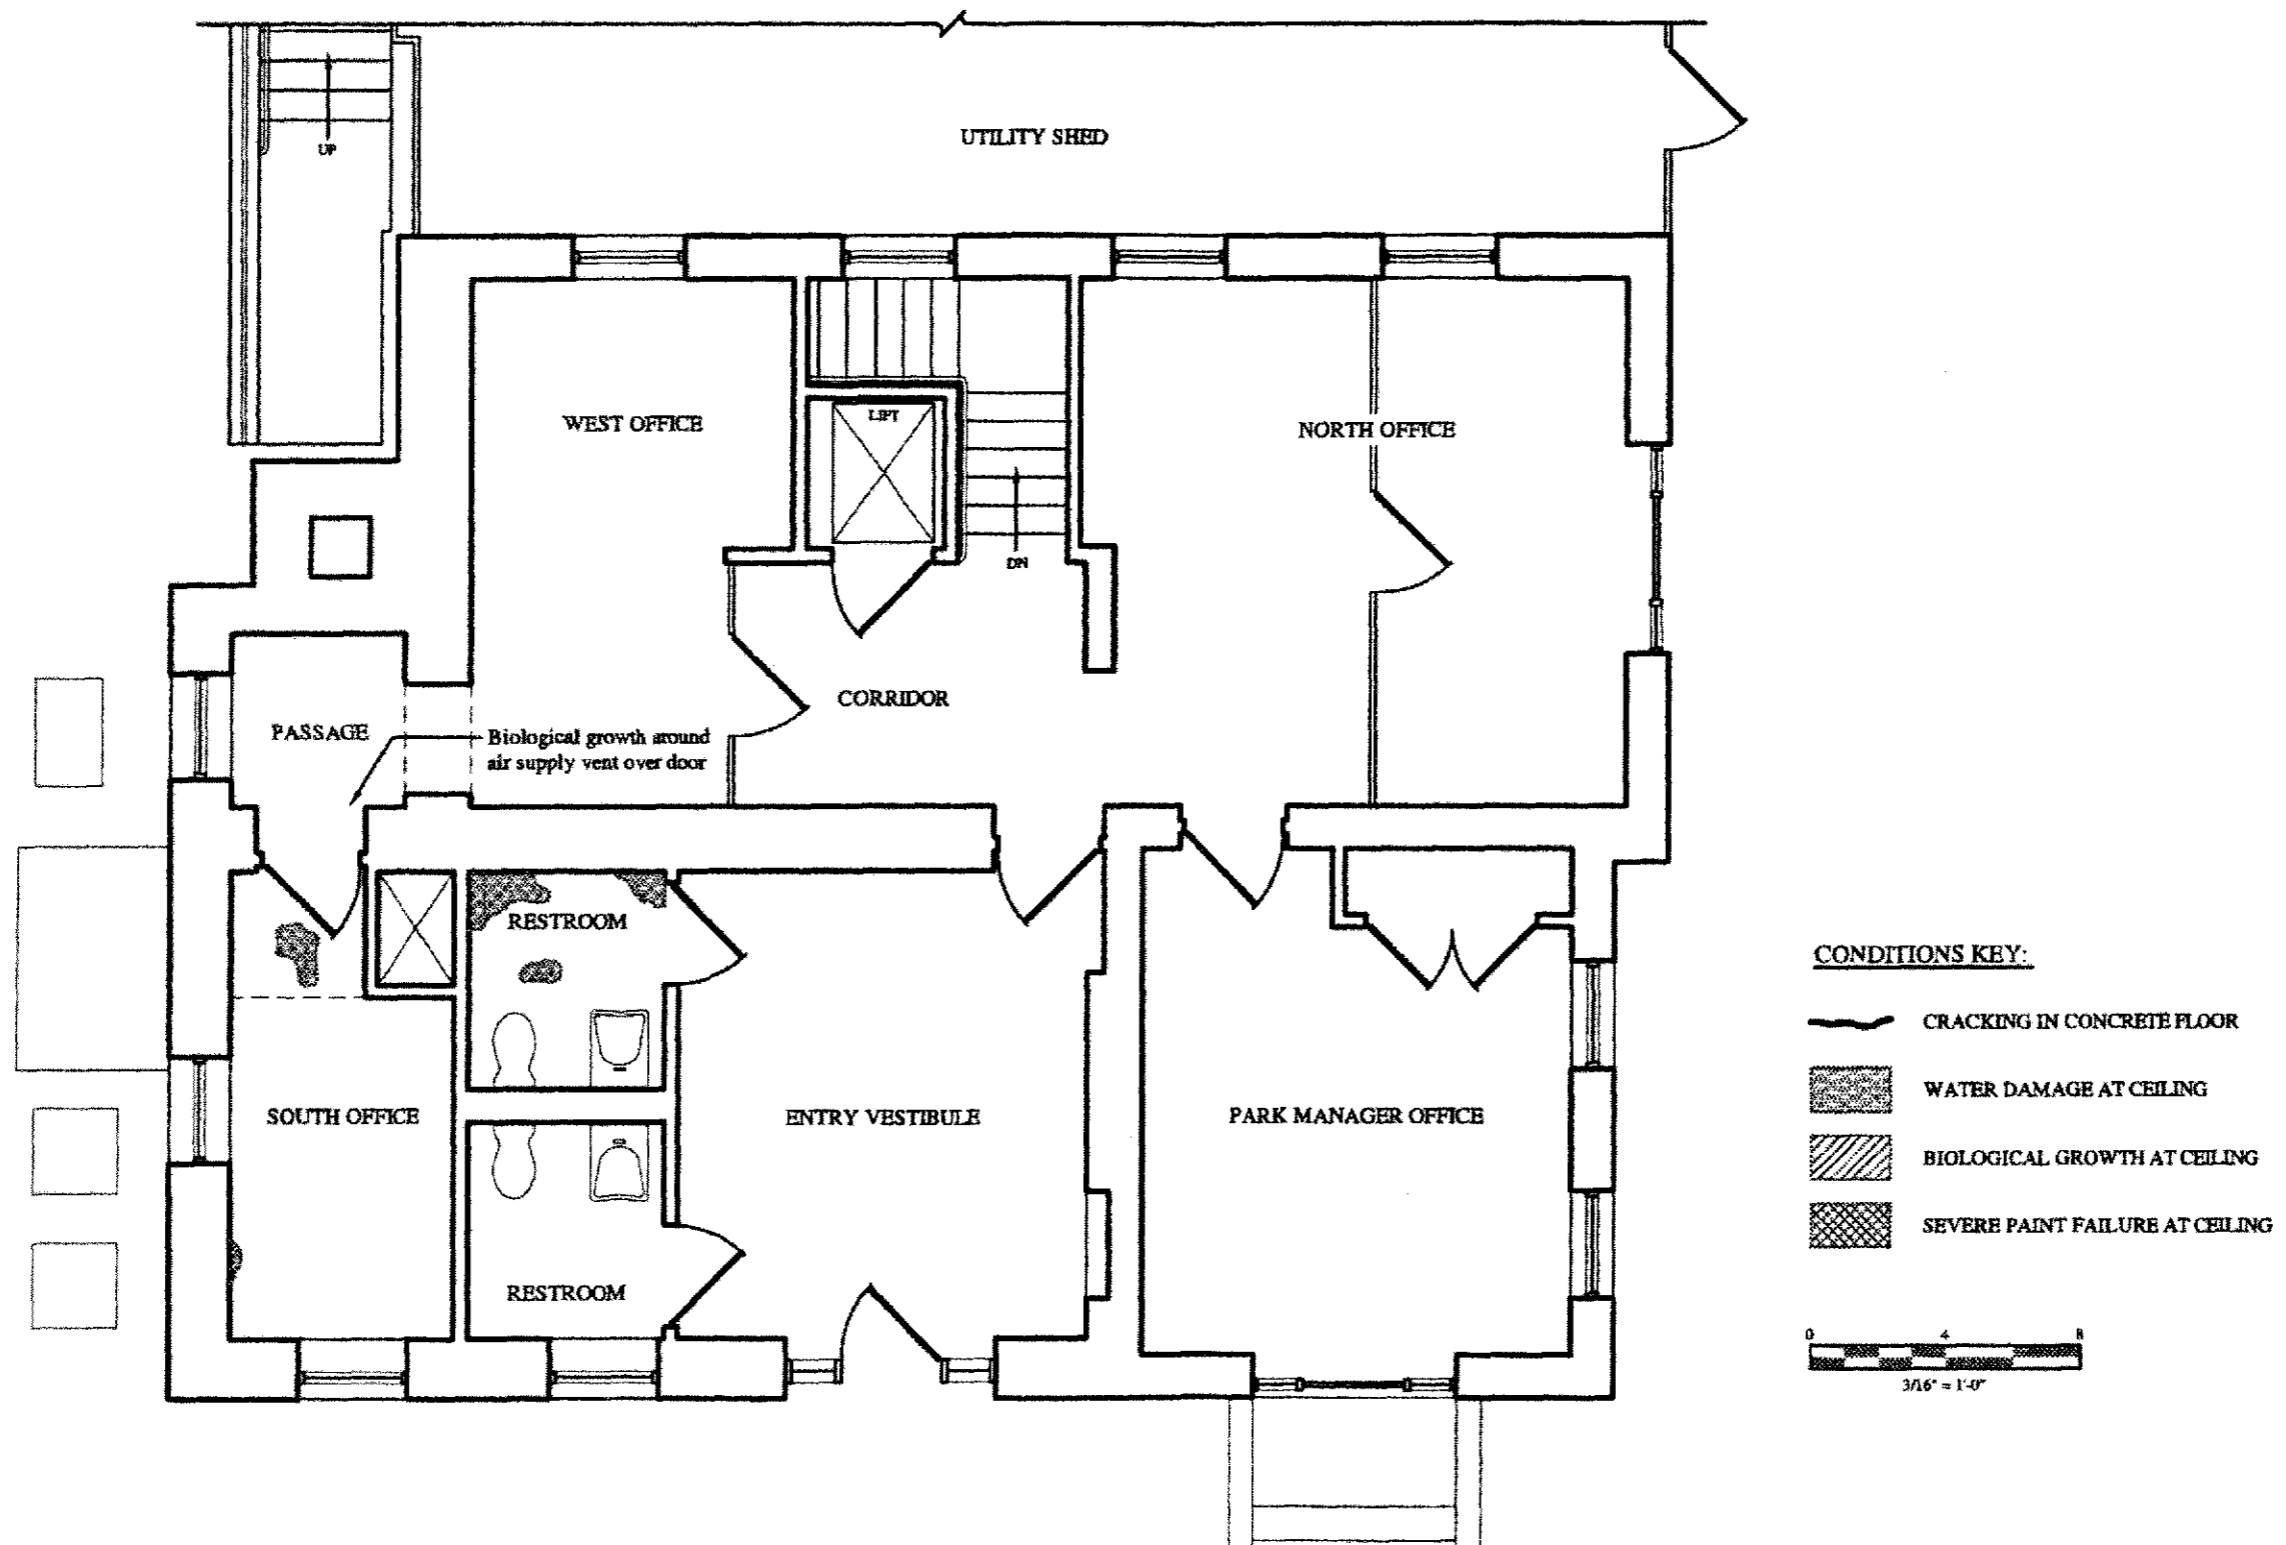
Condition assessment drawings for the first floor and basement have been prepared to visually represent areas of more serious damage (see figures 5.17 and 5.18). Damage represented on these drawings includes severe paint failure, biological growth, and water damage on ceiling surfaces, as well as concrete cracking in walls and floors. Water damage shown may be the result of active leaks in the building envelope or condensation on hidden pipes or ducts (see figure 5.19). Severe paint deterioration on ceiling surfaces, such as flaking or bubbling, may also be a direct result of water infiltration (see figure 5.20). All of these areas should be

Figure 5.17: First floor plan conditions. Drawing is provided for conditions assessment information only and should not be considered an accurate measured drawing.

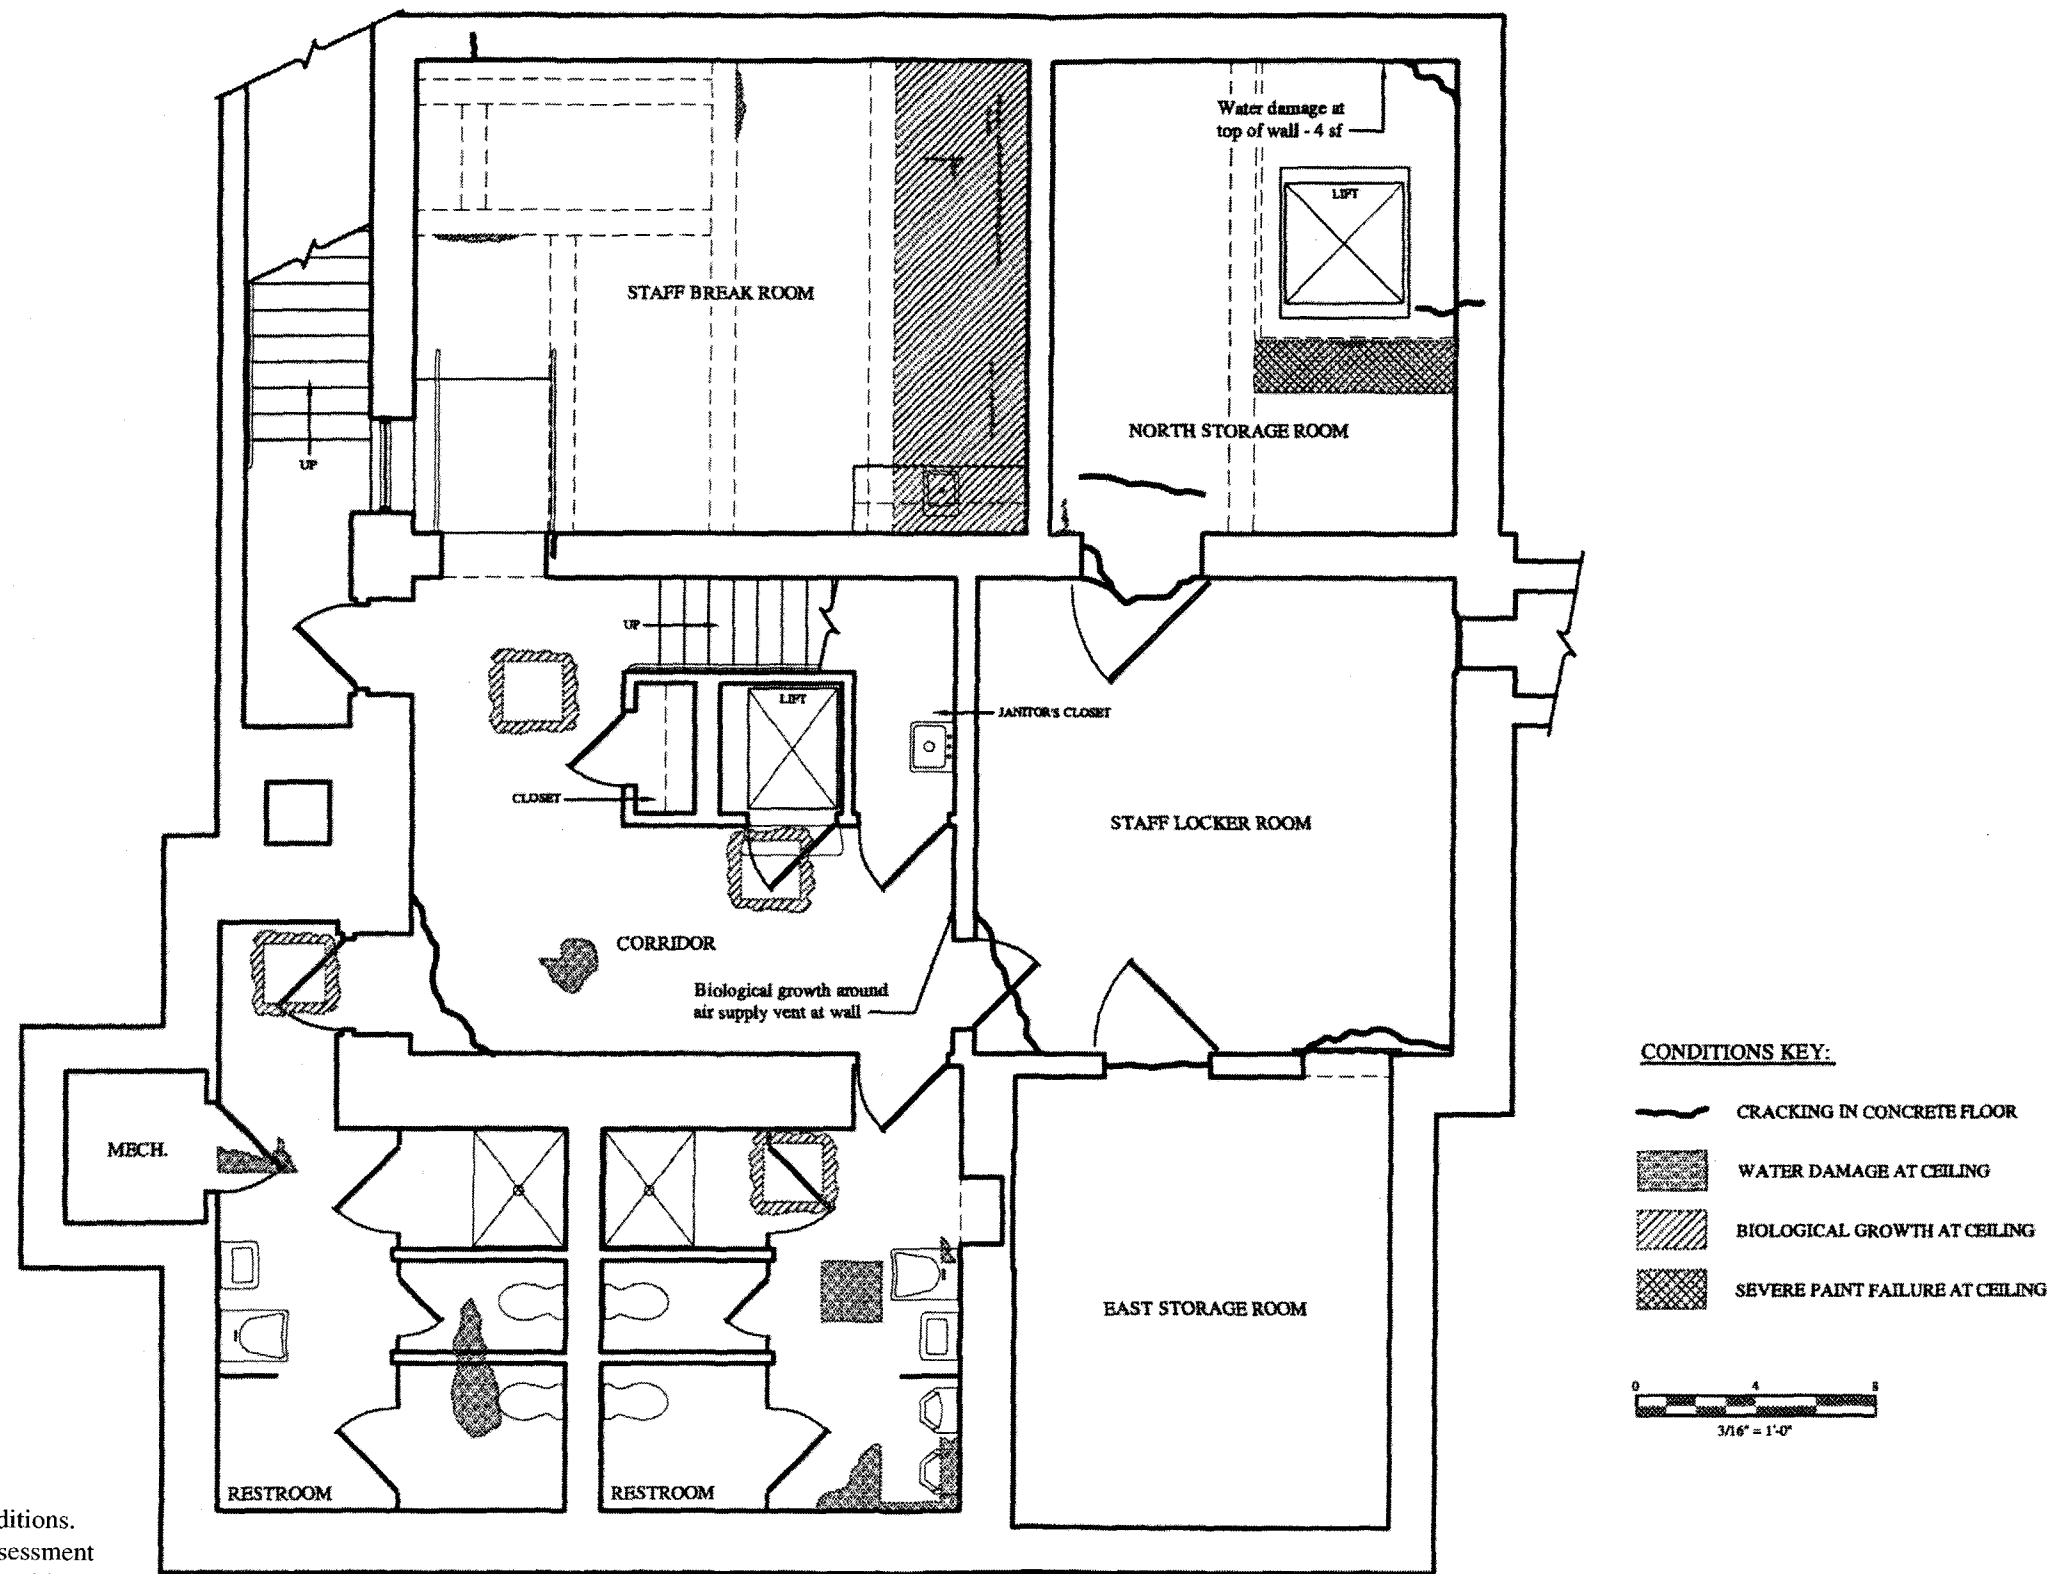
Figure 5.18: Basement floor plan conditions. Drawing is provided for conditions assessment information only and should not be considered an accurate measured drawing.
