National Park Service
U.S. Department of Interior
Northeast Region
Historic Architecture, Conservation, and Engineering Center

**Weir Farm National Historic Site
Weir Studio
Record of Findings: History of the Interior Appearance**

Judith M. Jacob, Senior Conservator
2013

Record of Findings: History of the Interior Appearance

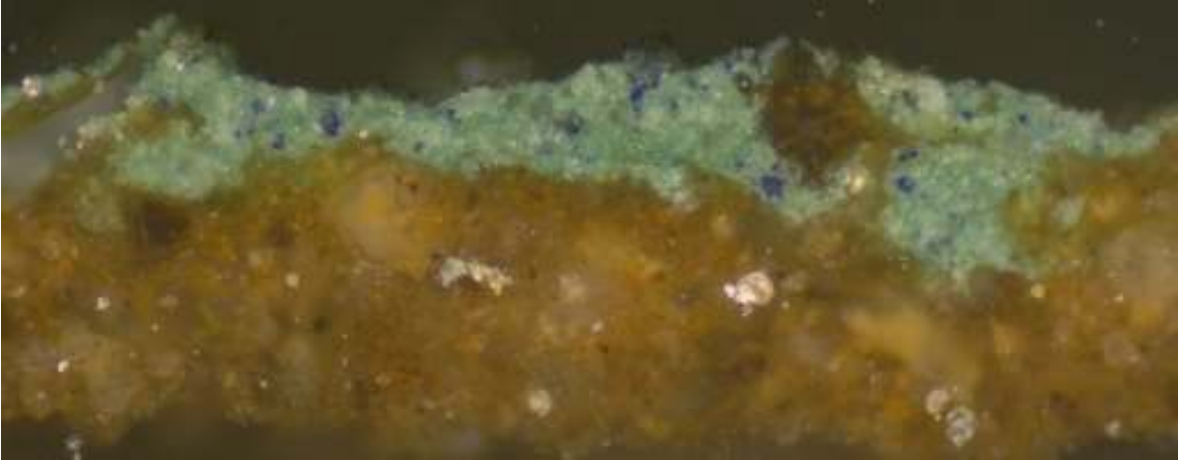
Sample 2. Top of the west plaster eave, edge of ceiling and eave, above E-W beam, with overlap of green ceiling paint.

Plaster Eaves. The first layer in cross-section sample 2 from the plaster eave is a coarse brown paint/plaster layer that was also found in samples 5 and 6, from the west and east walls. There is a thin, resinous layer on top of the brown plaster which may be remnants of a plant resin varnish (based on its characteristic bright white autofluorescence). It is not possible to determine whether this varnish was a finish coating for the first brown layer, or a sealant applied to the porous, coarse brown layer just before the blue-green paint was applied. The second generation is the eroded, uneven blue-green paint layer that can be seen below the gray paint on the ceiling; this is the paint from the adjacent wood ceiling that was lapped over onto the plaster of the eave.

200X image expanded to show the surface of the blue-green paint layer more clearly.

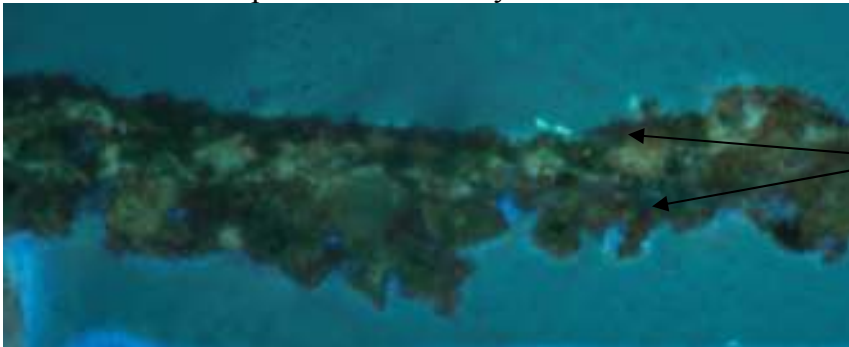
UV & TTC for the presence of carbohydrates 200X

Binding media analysis with biological fluorochrome stains shows that there are strong positive reactions for the presence of carbohydrates (starches, sugars, or the sugar component of milk and casein) in both paint layers. There is a strong positive reaction for proteins in the blue-green layer and a weak positive reaction for proteins in the brown wall paint layer. There is also a spotty positive reaction for the presence of unsaturated lipids on the surface of the blue-green layer, but this appears to be more like a deposit on the surface rather than a component of the binding media. These binder reactions suggest the possibility that these are emulsion paints, or possibly limewash or calcimine layers that have additional organic amendments. A whitewash, or “colourwash” recipe published in 1878 in *Workshop Receipts, for the Use of Manufacturers, Mechanics and Scientific Amateurs* shows that a variety of organic additives, such as hide glue, potato starch, rice flour and milk, were added to change the working properties of traditional washes for plaster and brick.

Positive reactions in both layers

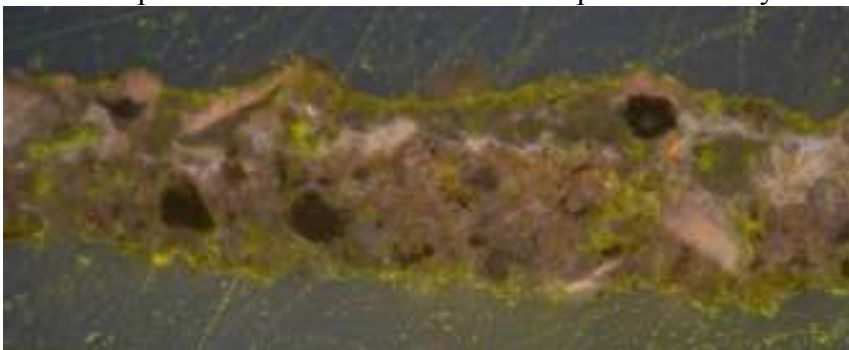
UV & DCF for the presence of saturated and unsaturated lipids 200X

There is a positive reaction for unsaturated lipids in both layers

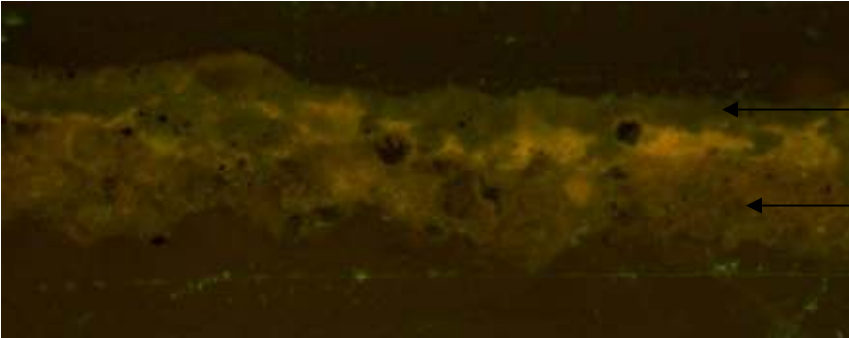
B-2a filter and Alexafluor 488 for the presence of proteins

Strong positive reaction

Weak positive reaction

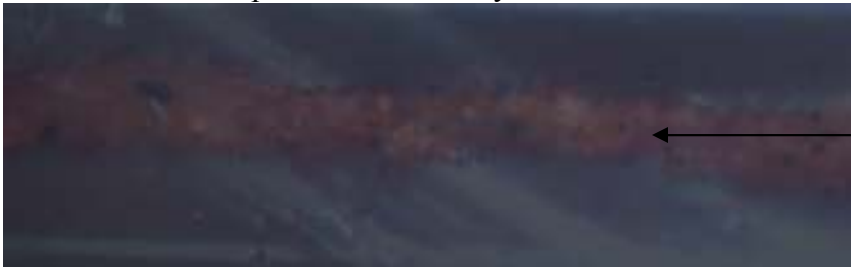
UV & TTC for the presence of carbohydrates 400X

Strong positive reaction

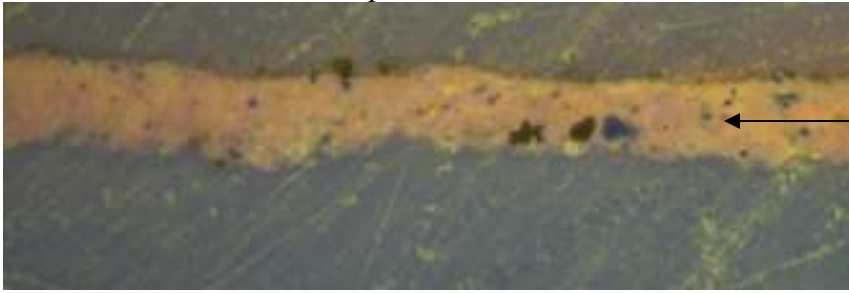
Sample 4. Flakes of gray paint from ceiling, above E-W beam.
UV & Rhodamine B for the presence of oils 400X

No reaction, it is simply a deposit of the stain on the surface

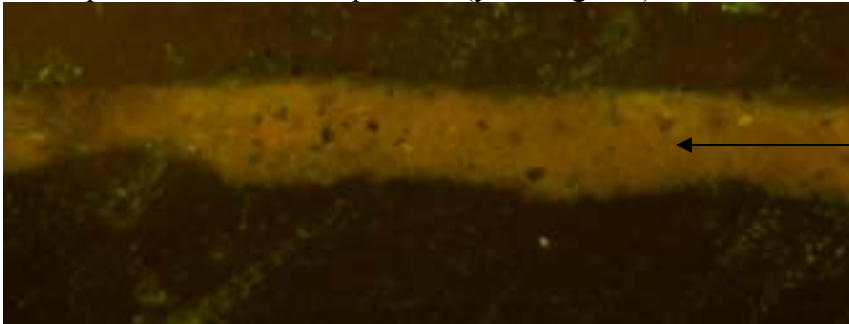
B-2a filter & Alexafluor 488 for the presence of proteins
Weak positive reaction for proteins (yellow-green)

Color change throughout the layer suggests the protein component is distributed throughout the layer

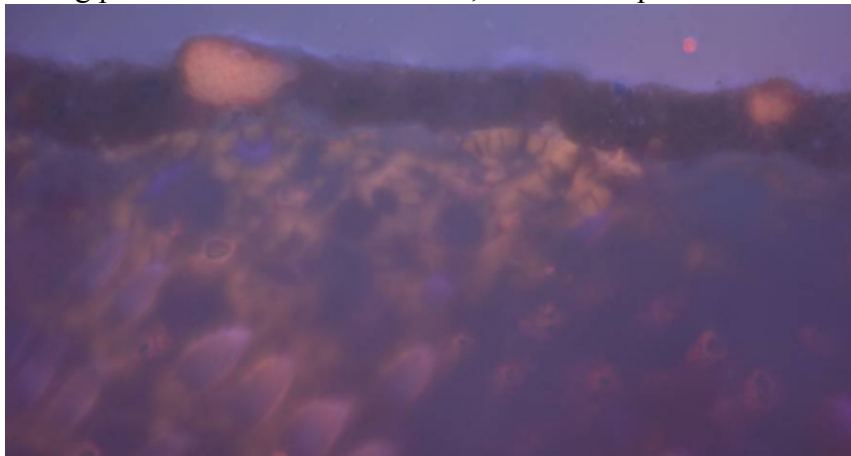
UV Light & TTC for the presence of carbohydrates 400X
Strong positive reaction in the wood, sealant and paint

One additional finding from this second set of wooden ceiling cross-sections is that there is a thin pigmented varnish on the surface of the wood substrate. This could have been the original translucent finish coat on the wood, or it could have been intended to seal the wood prior to painting.

← Clean, bright surface
← Thin layer of pigmented varnish or sealant

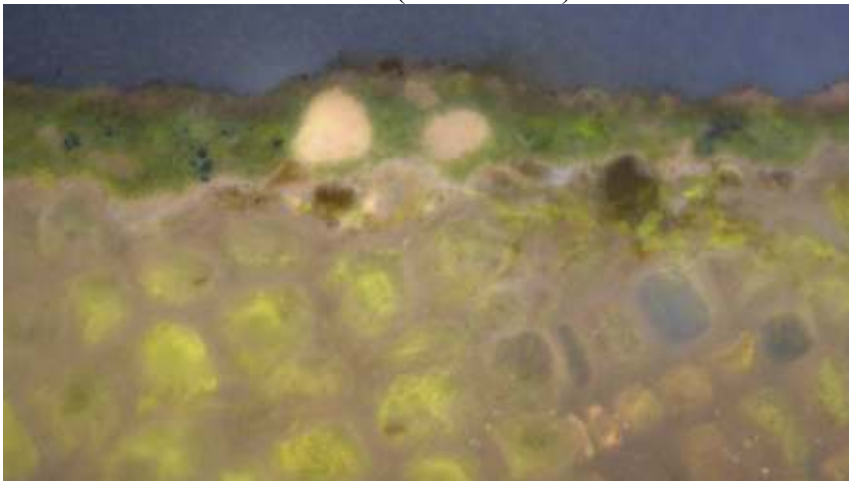
UV Light & DCF for the presence of oils 400X

Positive reaction for saturated (cross-linked) oils in the wood and in the paint

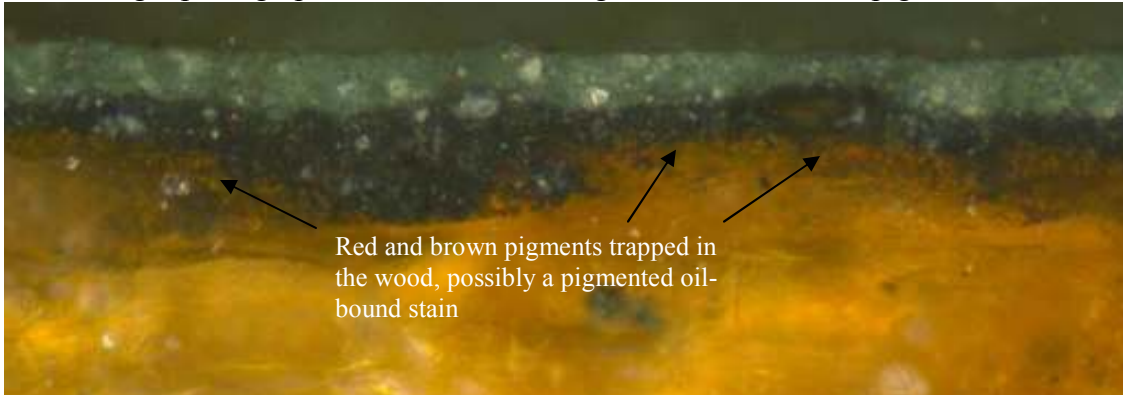
Sample 1. D1, door, north side.

Door. One key question about the green paint on the door was whether it is the original color and if so, if it has changed over time. The cross-section shows that the green paint is the third generation on the door. The first generation is a deep red-brown stain (the pigments are trapped in the wood fibers), the second generation is black, and the third generation is a finely ground deep green which does not resemble the green paints found on the ceiling. The surface of this uppermost green door paint does not appear particularly blanched, but it does seem slightly darkened and dirty. It is finely ground and still slightly glossy.

Visible Light photographed at 200X and enlarged to show the stain pigments in the wood

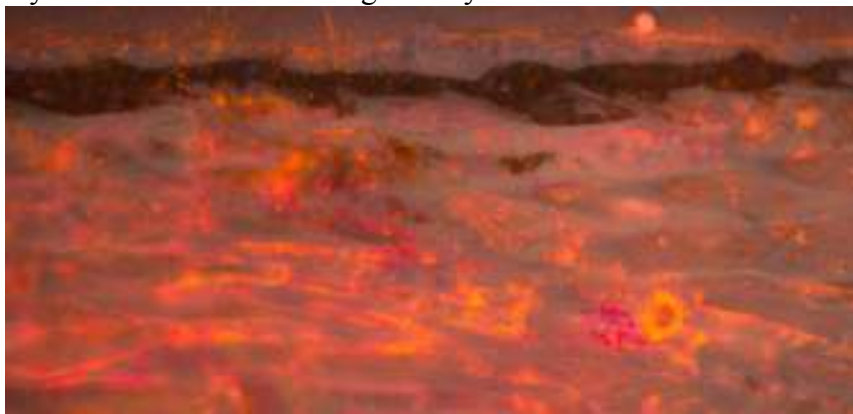
UV & RHOB for the presence of oils 200X

Binding media analysis with biological fluorochrome stains suggests that all the layers in this paint sequence are oil-bound. There is also oil trapped deep in the wood fibers (see the staining reaction with the fluorochrome Rhodamine B) which suggests the first pigmented stain layer was applied as a low viscosity, oil-based layer. There are no varnish coatings present in this cross-section sample, but the oil binding component has contributed to the slight glossiness remaining in the uppermost green paint layer.

Strong positive reaction in the wood, positive reaction in the pigmented stain, the black layer and the surface of the green layer

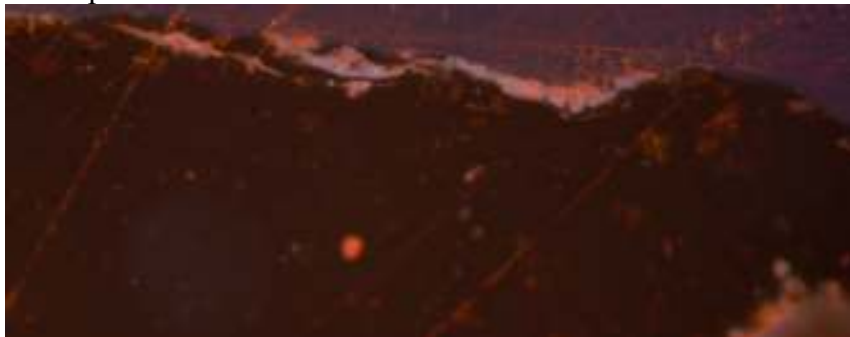
UV & RHOB for the presence of oils 200X

Black drips on southernmost west window. This is an interesting material as it appears dark brown and glossy in uncast form, but there are suspended red and yellow pigments discernible in the brownish material when viewed in the cross-section. There are also remnants of a yellowish paint-gray paint on the surface that could be an accidental overlap of gray paint from the wall which are now discolored. This somewhat amorphous brown material is slightly translucent (unlike an oil-bound paint) and it most resembles natural pine tar with some pigments to add opacity, durability, and to contribute to drying. This type of material was a byproduct of turpentine production and was a typical waterproofing material in the 18th and 19th centuries, primarily before the Civil War. The precise nature of this coating would have to be determined with other analytical methods such as FTIR and/or GC-MS, but it does seem to have an oil component, based on the weak positive reaction with the fluorochrome Rhodamine B.

Weak positive reaction for oils
