Yosemite National Park
California

Historic Structure Report

Yosemite Museum

Yosemite National Park
Yosemite Valley, California

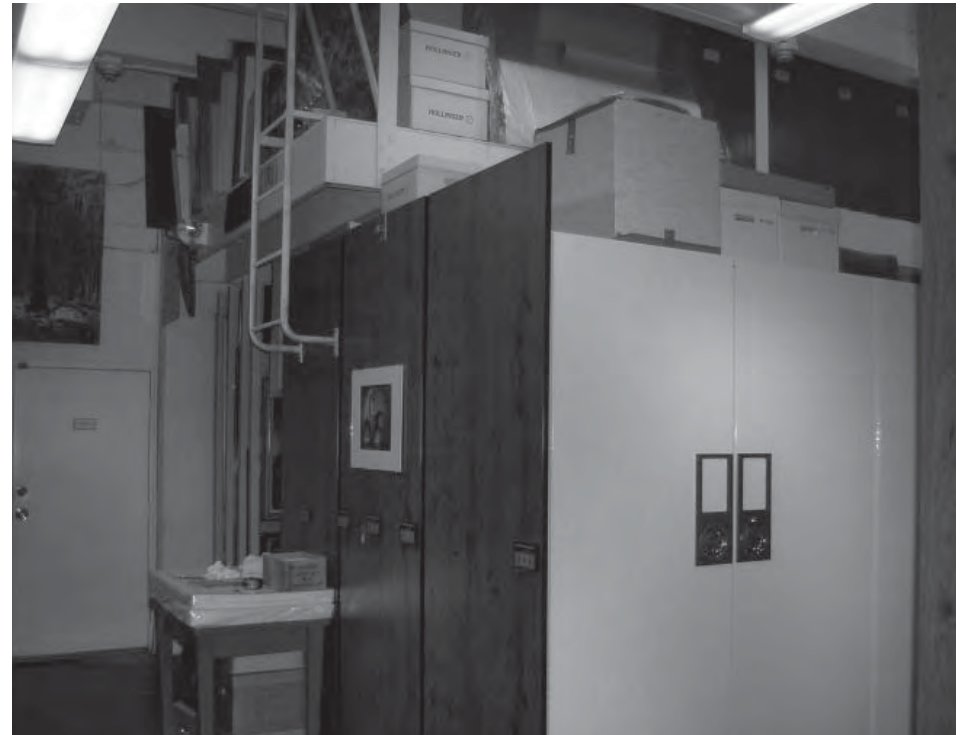
Storage in former library, 2006.

The doorway leading to the former library is now covered on the lobby side by the shelving in the gift shop. The outer edges of the original doorframe are visible at the intersection of the gift shop wall. A single flush metal door just past the gift shop now leads into the former library space, which is now used for archival storage for the museum. The south wall has been furred out and covered with sheetrock, blocking the window openings. The fireplace remains and appears to be intact, obscured by storage cabinets placed on a platform over the hearth. The double doorway leading to the Mather room has been blocked. A single heavy steel door now connects these two former library rooms.

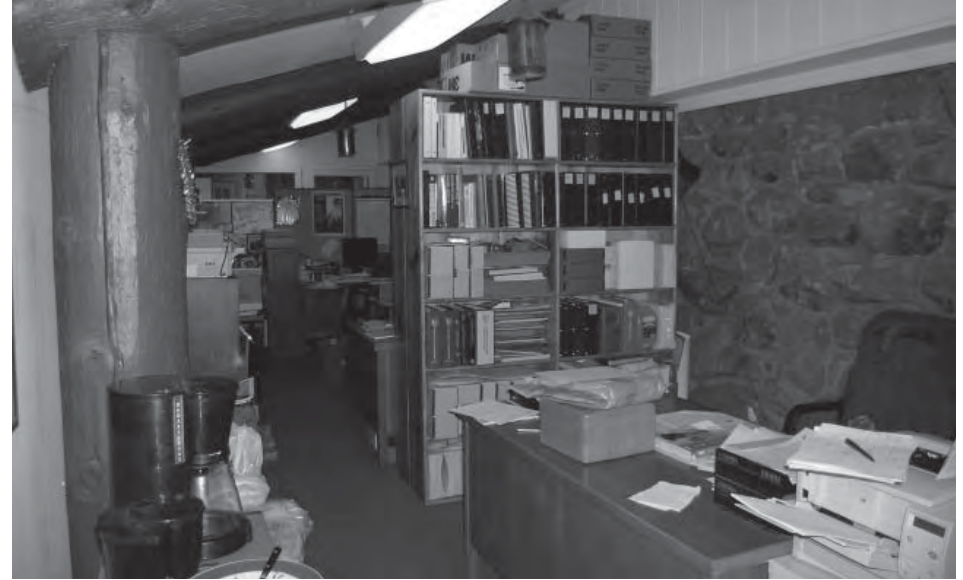
Museum Offices, 2006.

Most of the back porch has now been enclosed and contains offices for museum staff. The log posts of the original porch are still evident within this space and the former exterior stone wall is exposed. The backyard north of the building has continued to be used to exhibit reconstructed Indian dwellings. A number of structures have been added and now serve both educational purposes for visitors and ceremonial purposes for local tribes.

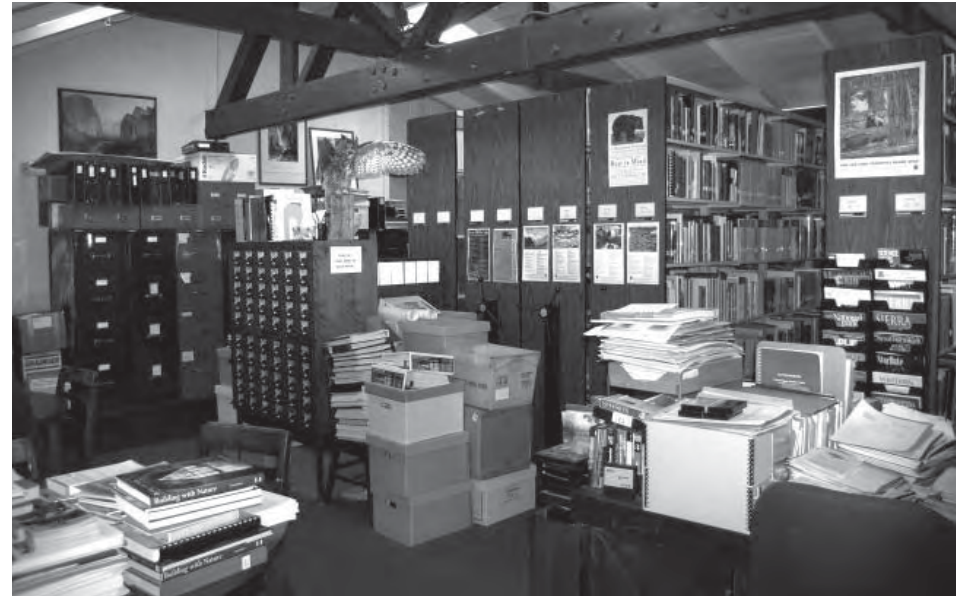
The room that was originally used as a Club Room now houses the Yosemite Research Library. The fireplace still exists but is hidden behind file cabinets placed on a platform built over the stone hearth. The space is quite cramped, with rolling stacks required to accommodate the library collections. The heavy wood roof truss and rafters remain exposed as shown in early photos.

Research Library in former Club Room, 2006.

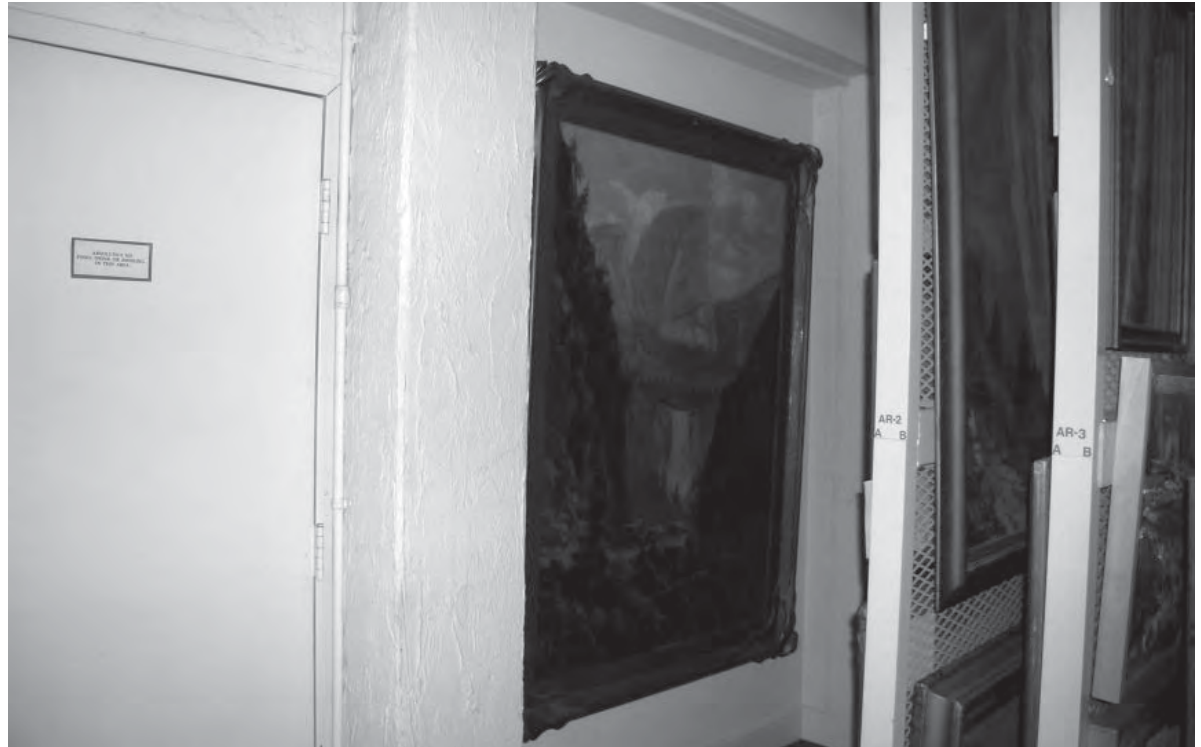
Former doorway from library to lobby (center of photo, new door on left), 2006.

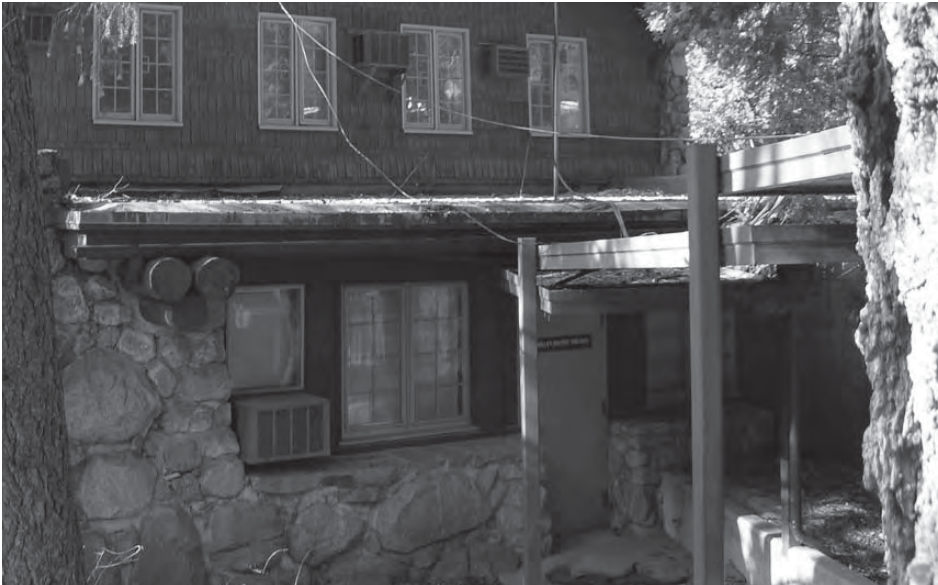
Museum East Entrance, 2006.

The sidewalk at the east elevation under the covered walkway slopes directly into the building and requires sand bags to divert water from entering the building in the winter months. This presents not only a maintenance issue but also a safety issue as the sand bags create a tripping hazard. The ground at the north side of the building is sloping toward the structure causing moisture accumulation along the north wall. Drainage problems are exacerbated by missing downspout sections at a number of locations around the building.

1. Trim trees that are touching or are in close proximity to the roof and exterior walls.
2. Repaint benches at north entry.
3. Replace missing downspout sections
4. Re-grade the east elevation and install french drains as needed to correct the drainage problems associated with the sidewalk and ground slope.
5. Provide screening around the propane tank at the west end of the building

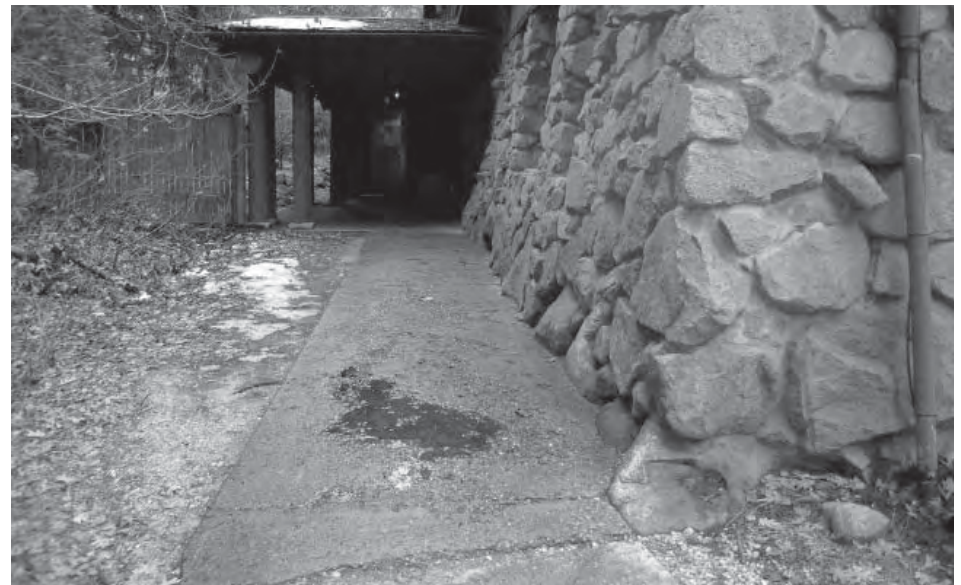
Museum North Entrance, 2006.

The museum site, in general, is in fair condition. Site components such as the benches at the north elevation, exterior post lighting, signs, garbage cans and utility equipment are not compatible with the historic character of the site. Deferred maintenance is also apparent with overgrown trees, poorly maintained landscaping and visible broken drain piping near the entry. Branches of trees growing near the building are resting on the roof and siding, causing damage to the shakes and creating pathway for the spread of fire. The concrete sidewalk along the north elevation is pitted from moisture damage, creating a potential tripping hazard.

1. Repair pitted sidewalk at north elevation.
2. Design and construct benches compatible with the rustic style for the north entry.
3. Remove trees which are too close to the building potentially damaging the structure due to root systems undermining the foundation or branches growing too close the building.
4. Design and install site lighting compatible with the historic character of the building and the Village.
5. The sidewalk at the east elevation is non-historic and could be removed to reduce drainage problems.

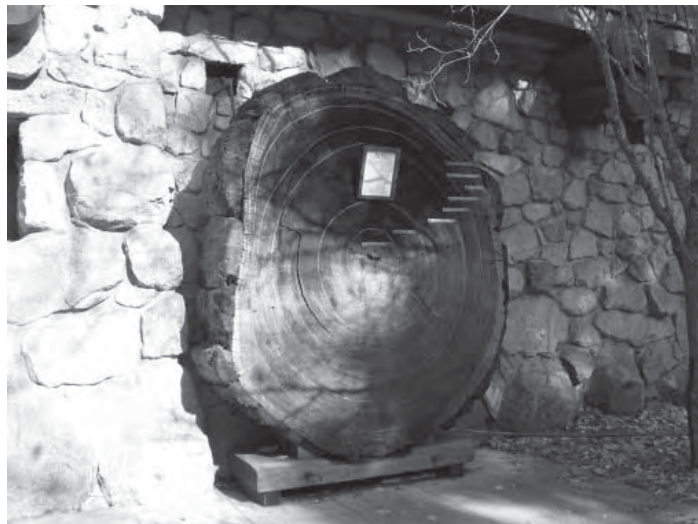
Sequoia Section at Museum Entrance, 2006.

The log round is in fair condition. Perpetual exposure and contact from curious visitors have contributed to its wear over years. Metal fasteners now hold some of the outer bark in place. A window air-conditioner is located directly above the log section, creating a potential for condensation dripping from the unit onto the log section. A gutter directly above is filled with leaves, creating another potential concentrated moisture source.

1. Remove the air-conditioner above the log.
2. Clean out the gutters, divert rainwater away from log.

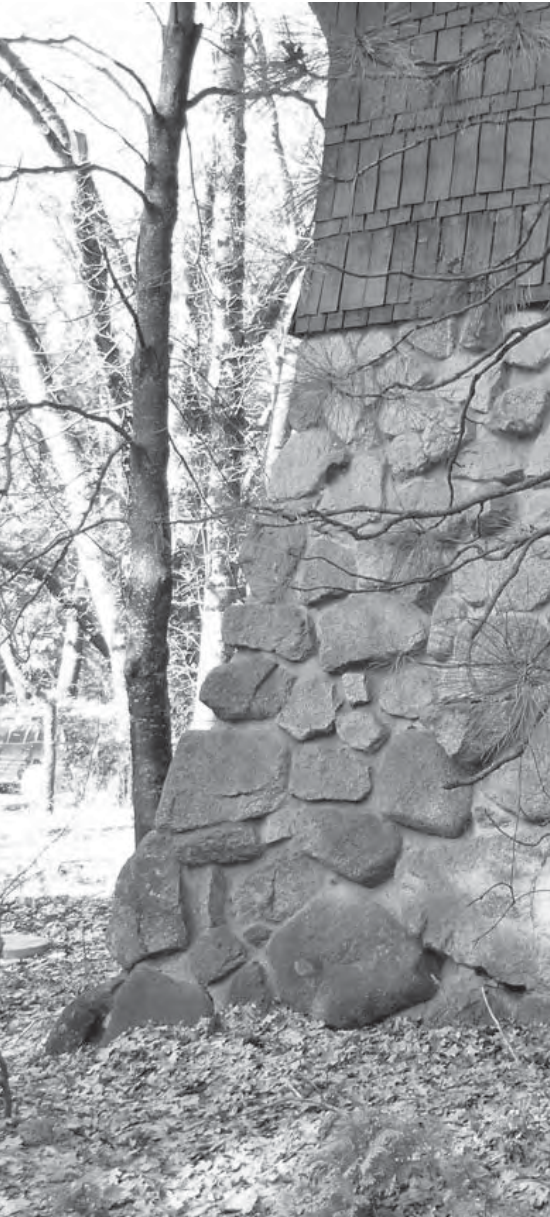
Museum SE corner, 2006.

Overall, the stone is in very good condition. There is some efflorescence at the southeast corner. This efflorescence is present on both the interior and exterior of the east wing. There is a missing downspout beside the projecting log roof supports, causing runoff from the roof to concentrate at this point on the stone wall. In addition, the ground at the east end of the building slopes toward the building causing moisture to

accumulate at the base of the wall. Significant moisture penetration is evident on the interior face of this wall.

1. The east wing roof and downspouts leaks and site drainage should be corrected as soon as possible to prevent further damage to the interior spaces and stonework.
2. Resolve the moisture related issue at the northwest corner of the north elevation, to include repair of the flashing at the parapet wall and installation of a downspout.
3. After correcting the sources of moisture, carefully clean the efflorescence using the gentlest means possible.

1. After correcting the sources of moisture, carefully clean off only the heavy build up of moss. One of the basic principles of rustic architecture is that the structures should blend in with the surrounding landscape. To achieve this, it was the designers' intention that natural materials be used and allowed to age and weather, so it is not necessary to aggressively clean the structure. A small amount of moss and lichen build up on the stonework is acceptable, even desirable. This should be monitored however, as excessive growth can be an indicator of moisture problems.
2. Mortar joints should be monitored as a part of the cyclic maintenance plan and should be re-pointed by qualified personnel as required. Ensure that the proper mortar mix is used that is compatible with the existing stone work and the color, texture and detailing of new mortar matches the existing.

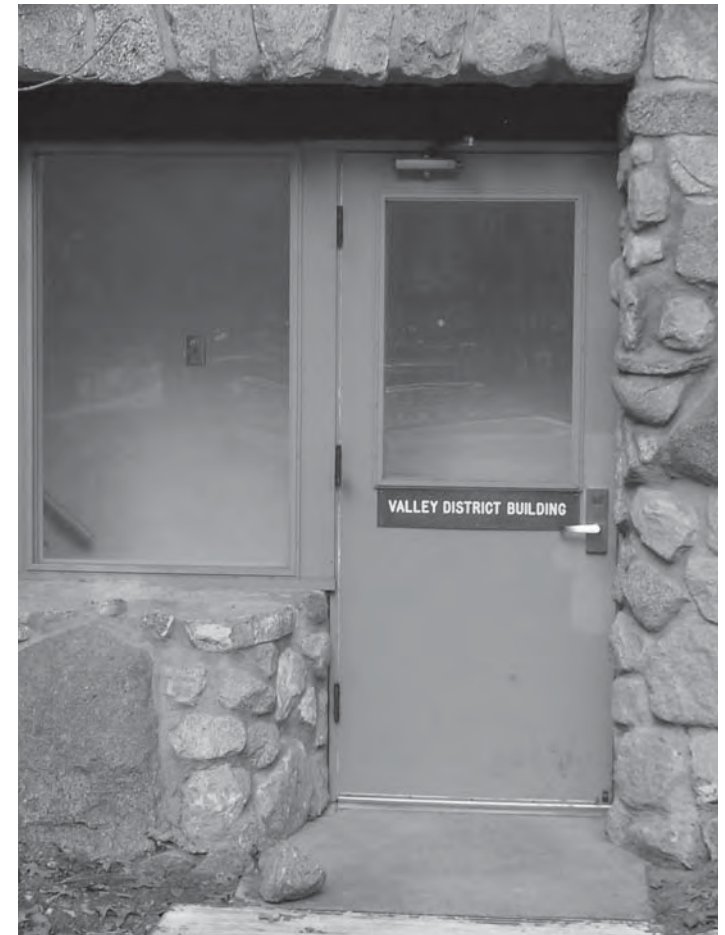
Ranger Entry door at south elevation, 2006.

The doors are in good condition. The door to the mechanical room has been notched to accommodate a pipe at the ground. The opening may permit rodents to enter the building.

1. Inspect and oil the doors as needed prior to and after each summer season. The doors get heavy use and the hinges will wear without appropriate maintenance.
2. Consider an alternative for the mechanical room door notch to prevent rodents from entering the building.

1. Research the appearance of the original doors to the museum lobby and consider replacing when full treatment plan is established.
2. The other doors on the building have been installed in locations where doors did not exist. If these doorways are to remain, consider replacing the doors with more compatible styles.
3. Consider restoring doorways in original locations on the east wing and north elevations.

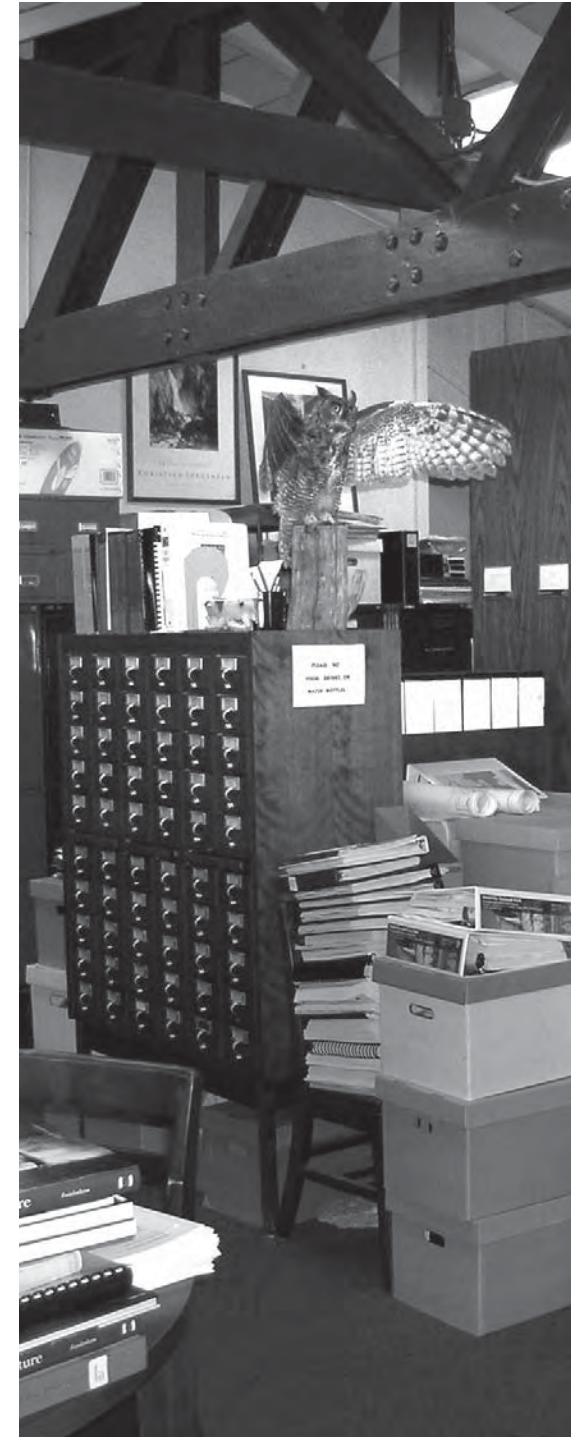
Research Library in former Club Room, 2006.

1. Restoring this space to its original configuration should be considered in future planning efforts. Particular attention should be given to the fireplace on the west interior elevation.
2. Restoring the Club Room to its original appearance will require additional studies to determine the historic finishes and fixtures. Future planning efforts should anticipate additional time for this effort.
3. Conduct a paint analysis of the library to determine the original color scheme and repaint to match.
4. Determine if a structural engineer was consulted to determine the loading requirements could be adequately supported by the existing structure.
5. Ensure that occupants and users are aware of and familiar with the operation of the collapsible fire escape ladder outside the north window on the west elevation.

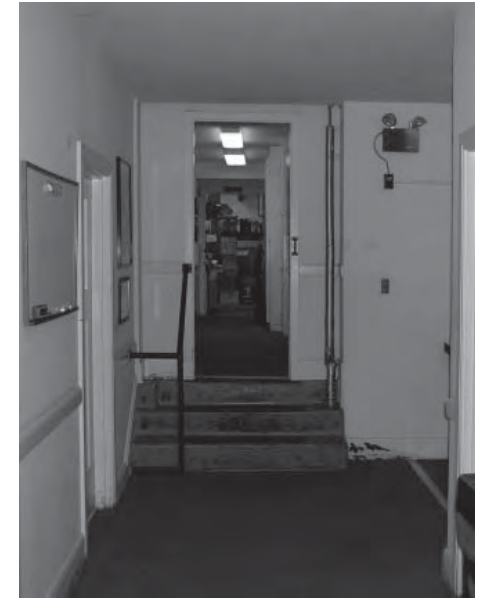
The hallway is in good condition, with the exception of damage to the paint on the baseboards.

Second floor hall, looking west, 2006.

1. Paint the baseboards that were damaged during carpet installation.

1. Conduct a paint analysis to determine the original paint scheme in the hall and repaint based on the findings.
2. Consider removing the carpet and restoring the exposed concrete floors.

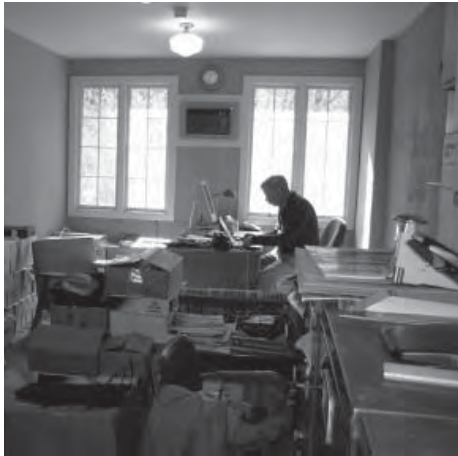
Offices in former caretakers apartment, 2006.

Operationally, the offices are in good condition. However, the use of window or wall air-conditioner units detracts from the exterior and interior appearance of the building and creates potential for damage due to condensation runoff. Hot water radiators heat some of the offices. The occupant's inability to control the temperature is evident in the high percentage of windows left open in the winter.

1. See mechanical section regarding heating and cooling issues. Providing alternatives to the wall and window mounted air-conditioners will be important to restoring the building to its original appearance.
2. An effort should be made by all building occupants to remove clutter and unofficial postings from all windows visible to the public from the exterior.

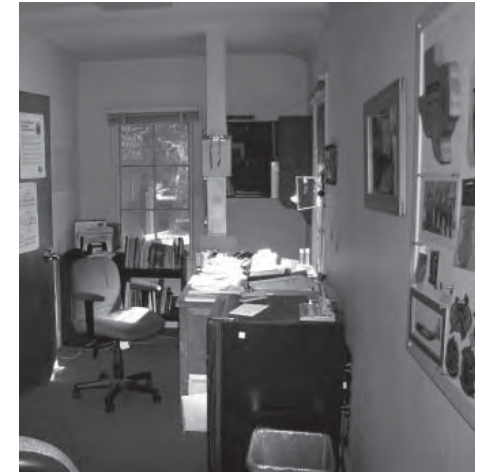
The majority of the original exterior wall surfaces retain their original sand finished plaster treatment. Minor cracks are present in the ceiling, apparently the result of heavy items previously stored in the attic above.

Offices in former lecture hall stage area, 2006.

1. Restore the lecture hall to its original configuration and finishes.

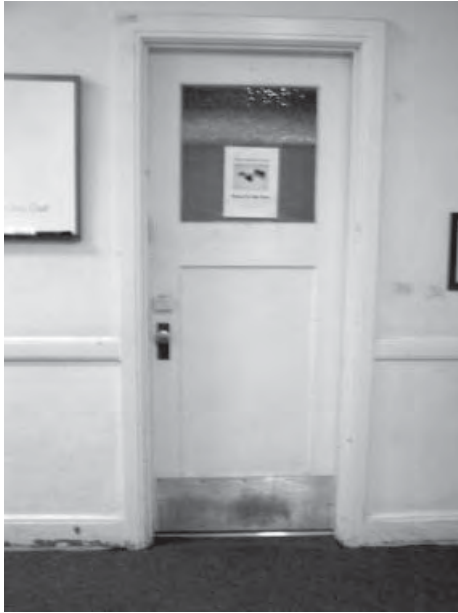
Typical door, second floor hall, 2006.

The interior doors and moldings are generally in good condition. Some of the doors have been retrofitted with modern locksets and deadbolt locks. Paint is peeling in some areas, notably in the second floor hallway and office areas where carpet installation impacted the surfaces.

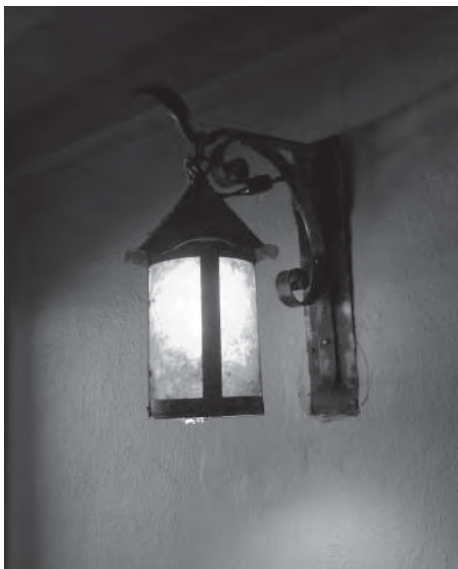
Light fixture in lobby below mezzanine

The light fixtures are in good working condition. The historic exterior fixtures are covered with dust and cobwebs.

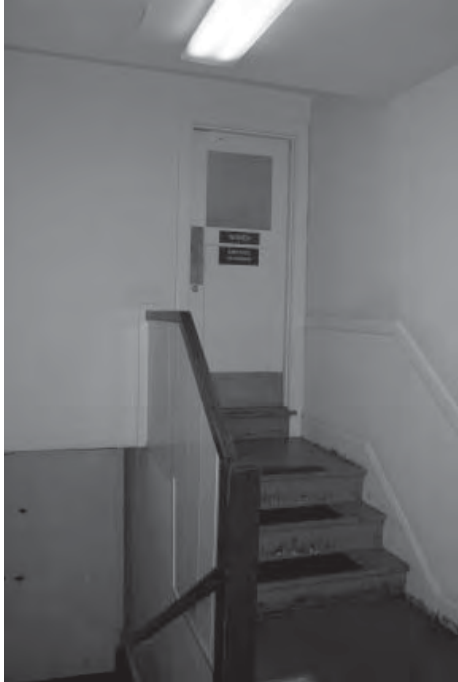
Example of inaccessible bathrooms, 2006.

1. Elevator locations proposed in the WJE report negatively impact significant spaces in the building. Further study is required if an elevator is determined to be needed.
2. Consider a Limited Use Limited Access (LULA) lift instead of a commercial grade elevator. LULAs meet the IBC and the ADA and require less space and alterations to the historic building, minimizing the impact to the structure.

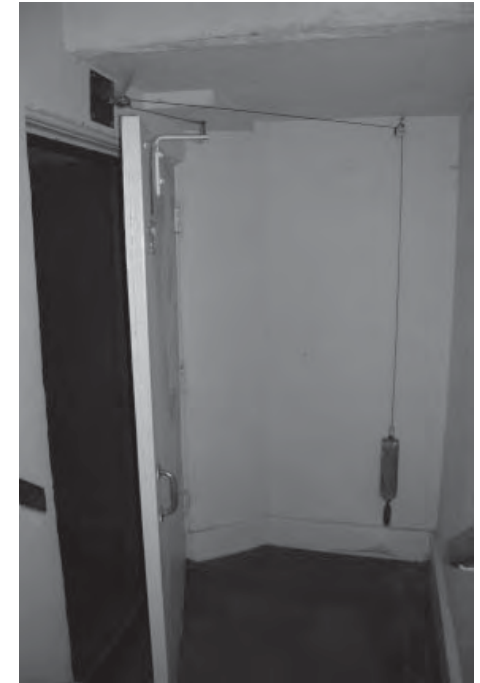
There are no fire doors on the exit stairways. Exit signage throughout the building is currently inadequate. Placement of the signs makes them difficult to see and some are not lighted. A Fire Protection Condition Assessment is currently being done by Carter Burgess that will enumerate the existing deficiencies in greater detail.

Fire door, 2006.

1. Review Carter Burgess report when it becomes available. If urgent conditions must be addressed prior to preparing a full protection plan, consult with the Park Historical Architect to determine appropriate means of implementing report recommendations with minimal impact to the historic character of the building.

1. Hire a specialist in fire protection with expertise in museum collections and historic structures to evaluate the building and make recommendations for appropriate fire protection systems, including compliance with recent NPS mandated sprinkler requirements.
