Acadia National Park

Accessibility Assessment

FINAL REPORT

Findings and Recommendations

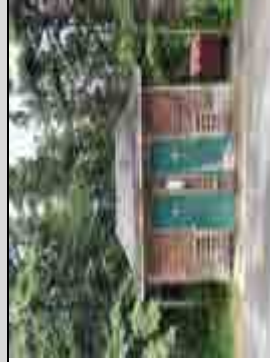
NPS_ACAD_KGP_174

<p><u>Deficiency</u> The thresholds at the entrance to each single-user vault toilet room (2) exceed maximum height requirements at greater than ½ inch.</p>	<p><u>Solution</u> Replace the thresholds at the entrances to ensure a maximum change in level of ¼ inch.</p> <p><u>Alternative Solution</u> Where a higher threshold is desirable to account for weather extremes and other maintenance factors, the threshold shall be ½ inch high maximum with a beveled edge on each side. The beveled edges shall have a slope not steeper than 1:2.</p>
	<p><u>Criticality</u> Serious</p> <p><u>Timeframe</u> Immediate</p>
<p>Reference Standards and Guidelines: ABAAS 404.2.5</p>

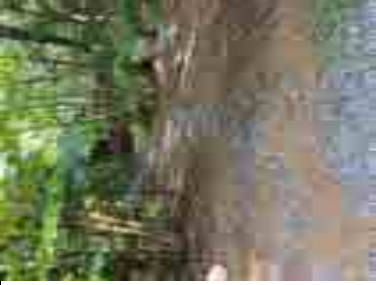
<p>Location: Campground paths Corrective Action: Reconstruct paths to adhere to ORAR standards</p>		
<p><u>Deficiency</u> The ground of the campground paths is not firm or stable.</p>	<p><u>Solution</u> Ensure paths between campground features (including between campsites and the restrooms and between the road and the restrooms) meet the Outdoor Recreation Access Route standards including a firm, stable ground surface, 36 inches minimum width, passing spaces every 200 ft when the width is <60 inches, obstacles <1inch high, openings <½ inches wide, a running slope of 5% maximum or up to 10% if segment is short and resting intervals are provided, and a cross slope <5%. These requirements are in reference to paths that have a surface material other than concrete, asphalt, or boards. Recommend using the same ground material as the campsites, like that used on the carriage roads.</p>	<p><u>Criticality</u> Critical</p> <p><u>Timeframe</u> Short-term</p> <p style="text-align: right;">ACAD_KGP_177</p>

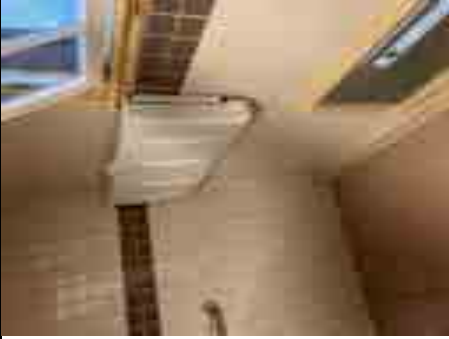
<p>Location: Restrooms Corrective Action: Move all features within the restroom to be within reach range</p>			
<p><u>Deficiency</u> The features within the restrooms are inconsistently positioned within reach range for all individuals.</p>	<p><u>Solution</u> Ensure the operable parts of all soap dispensers, hooks, outlets, changing stations, and shelves are positioned at a maximum of 48 inches above the ground and are not blocked by other objects either on the wall or on the ground.</p>	<p><u>Criticality</u> Serious</p> <p><u>Timeframe</u> Immediate</p>

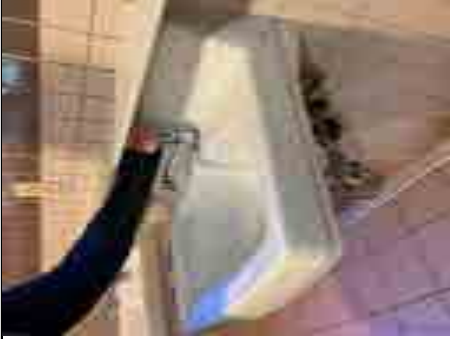
<p>Location: Restrooms Corrective Action: Increase the time the faucets are open to at least 10 sec.</p>			
<p><u>Deficiency</u> The hand-operated metering faucets do not stay on long enough.</p>	<p><u>Solution</u> Ensure the hand-operated metering faucets shall remain open for 10 seconds minimum for individuals to be able to wash their hands successfully. Ensure the hand-operated faucets are not blocked by the countertop above the sinks.</p>	<p><u>Criticality</u> Critical <u>Timeframe</u> Immediate</p>

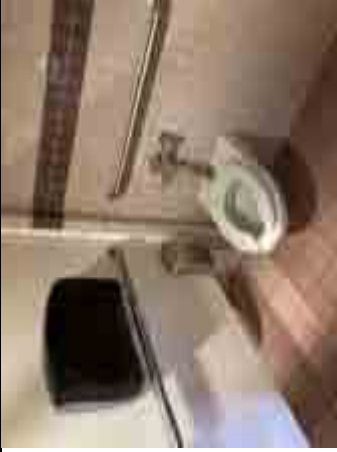
<p>ACAD_KGP_182</p>

<p>Reference Standards and Guidelines: ABA</p>			
<p>Location: Restrooms</p> <p>Corrective Action: Ensure flush controls are located on the open side of the toilet</p>			
<p><u>Deficiency</u></p> <p>The flush controls are inconsistently positioned correctly throughout the park.</p>	<p><u>Solution</u></p> <p>Ensure the flush controls are located on the open side of the toilet in the accessible water closets to be within reach range for individuals with disabilities.</p>	<p><u>Criticality</u></p> <p>Critical</p> <p><u>Timeframe</u></p> <p>Short-term</p>

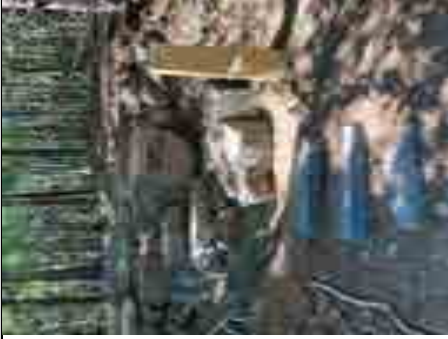
<p>NPS ACAD_KGP_459</p>
<p>Reference Standards and Guidelines: Programmatic Accessibility Guidelines for NPS Interpretive Media; Rehabilitation Act of 1973, as amended, Section 504; ABAAS 703.5</p>

<p>Location: Start of Trail</p> <p>Corrective Action: Color lettering to increase color contrast between lettering and wooden post</p>		
<p><u>Deficiency</u> The trailhead signage is difficult to read.</p>	<p><u>Solution</u> Recommend increasing the color contrast between the lettering and the wooden post to improve readability for individuals with low vision.</p>	<p><u>Criticality</u> Serious</p> <p><u>Timeframe</u> Short-term</p>

Recommendation #1: Recommend improving the color contrast between the lettering and the wooden post to improve readability.

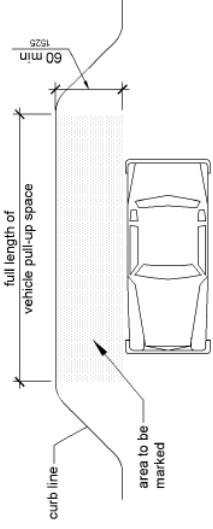
<p>Location: Lower Summit Parking Lot - Bus Parking and Taxi Stand Corrective Action: Add passenger loading zones</p>			
<p><u>Deficiency</u> The bus and taxi parking areas do not have designated passenger loading zones. The correction may include adding curbcuts and clear ground space; a short-term solution should be put in place in the form of marked, level zones for passengers to access these "specified public transportation vehicles."</p>	<p><u>Solution</u> Long term goal: add zero change-in-level spaces that meet ABA standards for loading and unloading passengers from tour buses and taxis:</p>

<p>Recommended in the interim: identify and mark clear space for a passenger loading zone that connects to an access aisle with a curb cut. Instruct vendors on using this space.</p>	<p><u>Criticality</u> Serious</p> <p><u>Timeframe</u> Immediate</p>

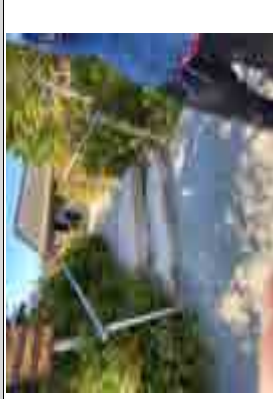
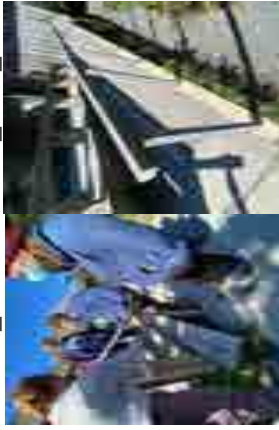
Handrails do not return and are loose (in need of maintenance). Ramp has only one handrail.

At the ramp, deck stairs, and steps from sidewalk at parking lot, replace existing railings with compliant handrails with returns and tighten loose components. Add a handrail to the ramp so that there is one on both sides.

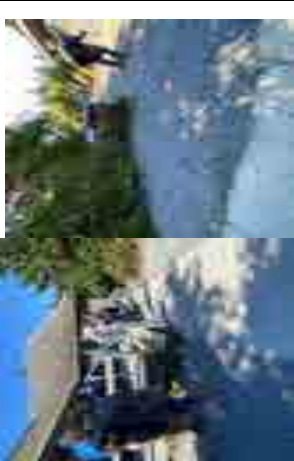
</div> <p>ACAD_Cadillac Mtn_LKW_035 ACAD_Cadillac Mtn_LKW_037</p>

Location: Ground surfaces at Cadillac Summit Center Corrective Action: Replace with firm and stable surface		
<p><u>Deficiency</u></p> <p>The gravel surface surrounding the giftshop/restroom building is loose and in places where it meets the ramp, asphalt, concrete path, and other surfaces, there are changes in level up to 1 inch. In addition, the trash bins do not have clear ground space.</p>	<p><u>Solution</u></p> <p>Replace surfacing throughout with firm and stable composite and correct change in level at based of ramp. Ensure that where different surface types meet (at trail and clear space around trash, drinking fountain, kiosk, steps, and ramp) a smooth transition is maintained without changes in level.</p>	<p><u>Criticality</u></p> <p>Serious</p> <p><u>Timeframe</u></p> <p>Short-term</p> <div data-bbox="402 147 662 556">

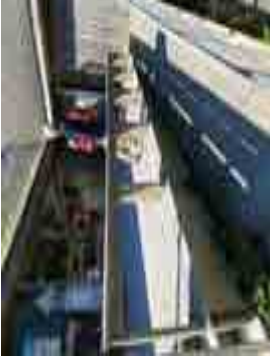
<p>Location: Gift Shop – Deck Area Corrective Action: Add back and arm rests to bench seating</p>			
<p><u>Deficiency</u> Existing railing is used as a bench seat by visitors. This railing does not meet the standards for bench seating, including height, depth, or back/arm support</p>	<p><u>Solution</u> Replace the existing railing with bench seating that meets ABA standards.</p>	<p><u>Criticality</u> Serious</p> <p><u>Timeframe</u> Short-term</p>

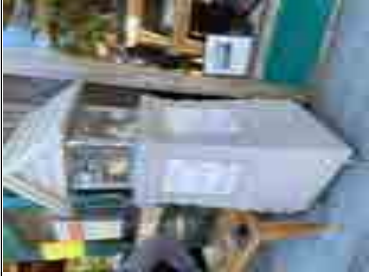
<p>ACAD_Cadillac Mtn_LKW_058</p>

<p>ACAD_Cadillac Mtn_LKW_041</p>
<p>Reference Standards and Guidelines: ABAAS 903 Benches</p>			
<p>Location: Gift Shop – Deck Area Corrective Action: Add accessible donation box</p>			
<p><u>Deficiency</u> The opening on the donation box on the deck is 57" from the ground, making it out of reach for someone using a wheelchair or a person of short stature.</p>	<p><u>Solution</u> Add an opening below 48 inches or add a lower donation box.</p>	<p><u>Criticality</u> Minor</p> <p><u>Timeframe</u> Short-term</p>

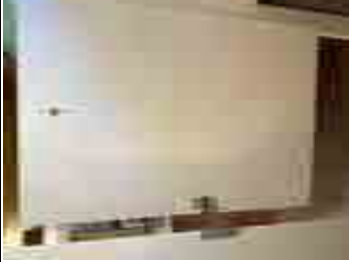
<p>Reference Standards and Guidelines: ABAAS 308.2 Reach Ranges; 604.5 Grab Bars</p>			
<p>Location: Restrooms – stall doors Corrective Action: lower hooks and add handles</p>			
<p><u>Deficiency</u> The doors to the accessible stalls have a hook on the inside that is out of reach range. Also, the doors do not have handles that permit easy opening and closing per ABA standards.</p>	<p><u>Solution</u> Lower hoods to at or below 48 inches. Add D-shaped handles to the inside of the doors.</p>	<p><u>Criticality</u> Serious</p> <p><u>Timeframe</u> Immediate</p>

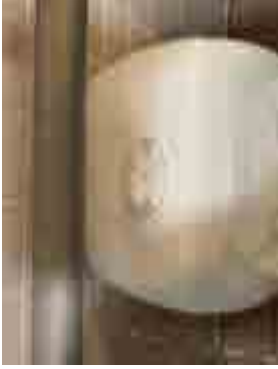
<p>ACAD_Cadillac Mfn_LKW_048</p>

Location: Restrooms – toilet Corrective Action: replace flushing mechanism			
<p><u>Deficiency</u> Standards related to button-operated flushing mechanisms for toilets are not specific. However, the flush controls should be both within reach range and operable with minimum dexterity. The button flush control mechanism may not meet the standard for operable parts.</p>	<p><u>Solution</u> Replace tank/flush control or add side-mounted lever flushing mechanism that is easily operable with a closed fist, or confirm and document that the existing system meets the standard for operable parts.</p> <p>From the ABA Technical Guide: <u>Manual flush controls, including push buttons, must be usable from a point between the centerline and the open side of the fixture. A portion of the control can be outside the range if it is usable without having to reach beyond the water closet centerline from the open side.</u></p>	<p><u>Criticality</u> Serious</p> <p><u>Timeframe</u> Immediate</p>

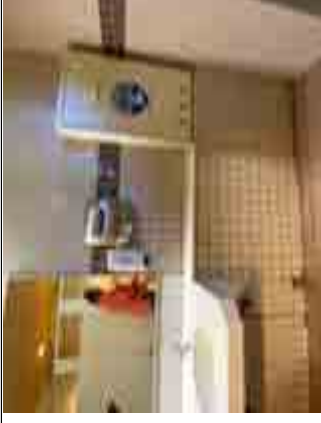
<p>Reference Standards and Guidelines: ABAAS 309 Operable Parts</p>			
Location: Restrooms – hand dryers Corrective Action: adjust or replace high intensity dryers			
<p><u>Deficiency</u> The loud hand dryers are not addressed by the standards; however, some models can produce sound greater than 100 decibels and they are disturbing to individuals with sensory processing disorder and other cognitive disabilities.</p>	<p><u>Solution</u> Some dryers can be adjusted to lower the speed and sound. However, the noise would be eliminated by using a non-electric or quieter model dryer.</p> <p><u>Alternative Solution:</u> Offering a non-electric (paper towel dispenser) hand drying option provides an option for lower sensory stimuli.</p>	<p><u>Criticality</u> Serious</p> <p><u>Timeframe</u> Immediate</p>

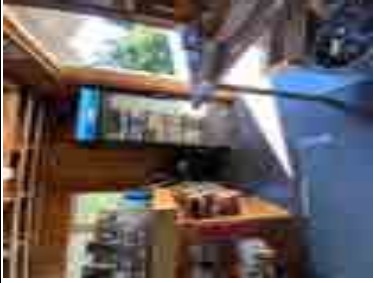
Location: Gift Shop - Interior			
Corrective Action: Rearrange display units to allow clear width			
<u>Deficiency</u> A few spots within the store allowed only 29.25" between displays. The space between the counter and a table narrows the route to the emergency exit to 22" .	<u>Solution</u> Move fixtures (tables, racks) within the store to allow for a minimum accessible route width of 32" (for runs less than two feet).	<u>Criticality</u> Serious <u>Timeframe</u> Immediate

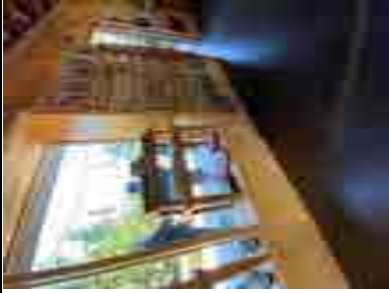
ACAD_Cadillac Mtn_LKW_063

ACAD_Cadillac Mtn_LKW_070
Reference Standards and Guidelines: ABAAS 403.5.1 Accessible Routes Clear Width			
Location: Gift Shop - interior			
Corrective Action: Stock items vertically			
<u>Deficiency*</u> * Not a deficiency, but a best practice Items on higher shelves are beyond the reach range for someone using a wheelchair, making the items unavailable without assistance.	<u>Solution</u> On displays that have components beyond reach of 48" from the floor, use vertical stocking. Rather than placing like items at the same level, distribute them at different for easier access by shoppers who are unable to reach higher shelves.	<u>Criticality</u> Minor <u>Timeframe</u> Short-term

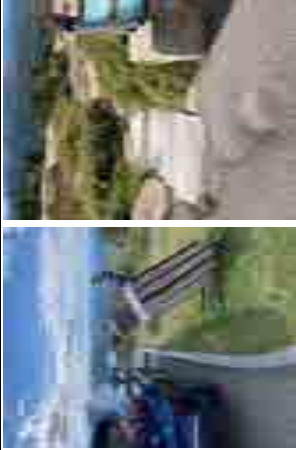
Location: Blue Hill Overlook Corrective Action: Create clear space at trash bins and wayside			
<u>Deficiency</u> The ground at the trash receptacles and the wayside does not provide enough clear ground space for access by individuals with disabilities.	<u>Solution</u> Improve the surfacing at the top of the stairs and in front of the wayside and trash bins to eliminate changes in level and slope across this area.	<u>Criticality</u> Serious <u>Timeframe</u> Short-term

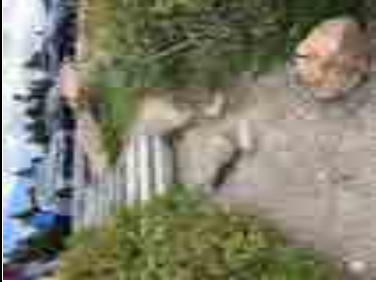
<p>ACAD_Cadillac Mtn_KGP_142</p>

<p>ACAD_Cadillac Mtn_KGP_129 ACAD_Cadillac Mtn_KGP_134</p>
Reference Standards and Guidelines: ABAAS 1011.2 Recreational Facilities Clear Ground Space; 1015 Viewing Areas			
Location: Blue Hill Overlook Corrective Action: Add handrails to steps			
<u>Deficiency</u> The steps to the viewing area are hazardous and uneven and lack handrails. There are boulders in the path from steps to viewing area.	<u>Solution</u> While working toward an accessible solution for this area, an immediate need for handrails exists at this location. Adding compliant railings to both sides of the steps, a sign warning of the sloping stairs, and removal of the largest rocks at the bottom of the steps is needed to make this area safe for any but the most agile of visitors.	<u>Criticality</u> Critical <u>Timeframe</u> Immediate

Recommendation #3: Improve access to the viewing area at Blue Hill Overlook. Multiple visitors were seen stumbling on the stairs that lead to the outcropping/viewing area. Adding a concrete pad at the top and bottom, as well as handrails, and constructing stable steps is necessary to provide safe access for people with mobility concerns.

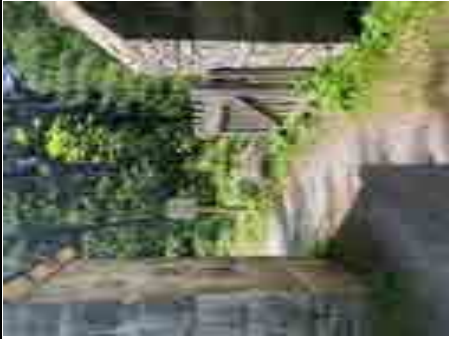
<p>Location: Carriage roads close to Jordan Pond Area Corrective Action: Provide standardized accessibility information at the trailheads</p>			
<p><u>Deficiency</u> There are no signs at the entrances to the Carriage Roads.</p>	<p><u>Solution</u> For best practice, at the start of each carriage road, recommend including a sign indicating destination, length of road, surface type, typical and minimum tread width, typical and maximum running slope, typical and maximum cross slope, and a note regarding the condition of the trail.</p>	<p><u>Criticality</u> Critical</p> <p><u>Timeframe</u> Immediate</p>

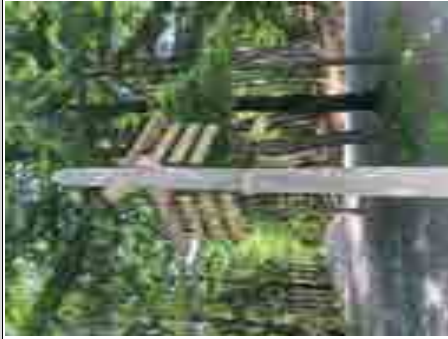
<p>NPS_ACAD_KGP_024</p>

<p>NPS_ACAD_KGP_026</p>
<p>Reference Standards and Guidelines: Public Rights-of-Way Accessibility Guidelines R211.2, R410</p>			
<p>Location: Junction 15 Corrective Action: Change directional signs at trail junctions to increase readability of writing</p>			
<p><u>Deficiency</u> The directional signs at carriage road junctions are outside of readable range.</p>	<p><u>Solution</u> Change trail signs at trail junctions to comply with the technical requirements for visual characters including the provisions for contrast of the characters and their background, and character size and style</p>	<p><u>Criticality</u> Serious</p> <p><u>Timeframe</u> Short-term</p>

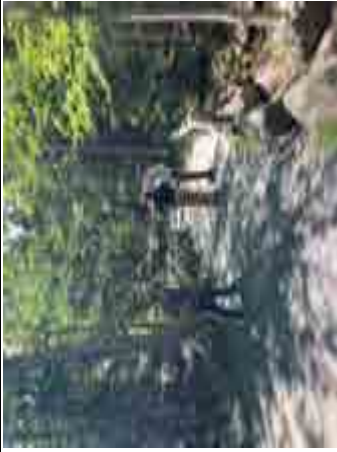
Location: Bridal Path close to Junction 15			
Corrective Action: Reconstruct the wooden bridge near Junction 15			
<u>Deficiency</u> The bridal path branching off the road at Intersection-15 has a bridge with one-inch gaps between wooden slats.	<u>Solution</u> Reconstruct the wooden bridge to decrease the gaps between the wooden slats to 1/2-inch max.	<u>Criticality</u> Serious <u>Timeframe</u> Short-term

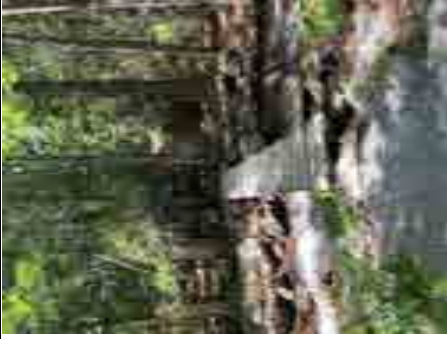
NPS_ACAD_KGP_31
Reference Standards and Guidelines: ABA 403.5.1

NPS_ACAD_KGP_032
Reference Standards and Guidelines: ABA 302.3			
Location: Hiking Path close to Junction 15			
Corrective Action: Reconstruct footbridge near Junction 15			
<u>Deficiency</u> The footbridge at the beginning of a hiking path that branches off the road at Junction 15 is too narrow at 30 inches.	<u>Solution</u> Reconstruct the footbridge to be a minimum width of 36 inches.	<u>Criticality</u> Serious <u>Timeframe</u> Short-term

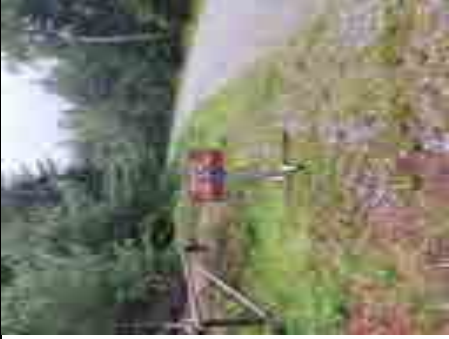
<p>Location: Parking Lot Corrective Action: Replace sign</p>			
<p><u>Deficiency</u> The sign, "Handicapped Access Only Beyond This Point" directing individuals to the accessible lot uses the outdated term, "handicapped."</p>	<p><u>Solution</u> Replace current sign with a new sign that directs cars to the Accessible Parking Lot.</p>	<p><u>Criticality</u> Critical</p> <p><u>Timeframe</u> Immediate</p>

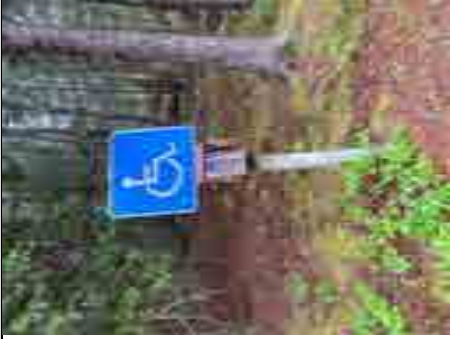
<p>Location: Parking Lot Corrective Action: Replace parking lot ground material and stripe parking spaces</p>		
<p><u>Deficiency</u> The parking lot where the accessible parking spaces are located does not have a firm, stable surface and it is not lined.</p>	<p><u>Solution</u> Replace parking lot closest to the site with a ground material that is firm, stable, and slip resistant. Line the accessible parking lot with at least two van-accessible parking spaces. These spaces should be a minimum of 132" wide with an access aisle of a minimum of 60" wide or a parking space 96" wide minimum where the access aisle is 96" wide minimum.</p>	<p><u>Criticality</u> Critical</p> <p><u>Timeframe</u> Short-term</p>

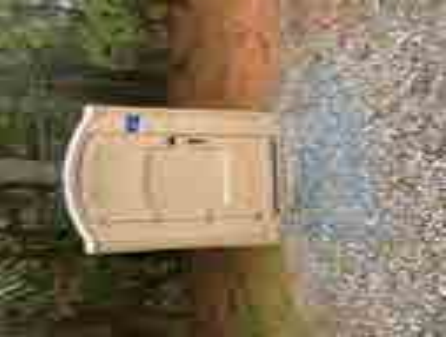
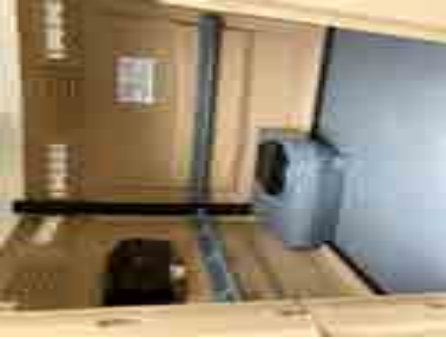
<p>Location: Parking Lot Corrective Action: Replace porta potty and add accessible route</p>		
<p><u>Deficiency</u> The porta potty is not accessible.</p>	<p><u>Solution</u> Replace porta-potty with one that fully complies with ABA Standards and is placed along an accessible route.</p>	<p><u>Criticality</u> Critical</p> <p><u>Timeframe</u> Immediate</p>

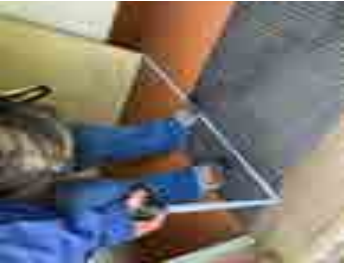
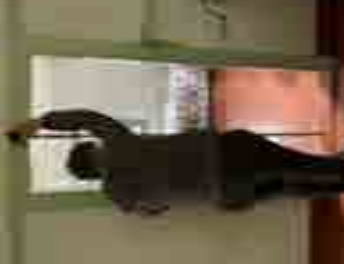
<p>Location: The Mountain House Corrective Action: Provide information about the interior of the house on the website and on a sign outside of the house</p>	
<p>Deficiency The interior of The Mountain House has decreased maneuvering clearing through the entrance, too-high thresholds, too-low door frame heights, and protruding objects.</p>	<p>Solution As this is an historic site, it is not expected that historical elements are modified. However, any new modifications made to the interior of the house should adhere to ABA standards. It is important to provide a realistic account of the accessibility of the interior of the homestead on the site website and an exterior sign to provide people with disabilities with the information they need to make an informed decision regarding their ability to safely navigate The Mountain House.</p>
<p>Criticality Serious Timeframe Immediate</p>

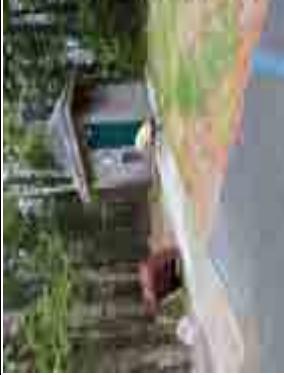
<p>Location: Parking Lot Corrective Action: Add sign to identify accessible parking</p>			
<p><u>Deficiency</u> There are no signs at the two accessible parking spaces.</p>	<p><u>Solution</u> Add appropriate signage and raise the sign marking the van accessible parking space to >60". Signs identifying van parking spaces shall contain the designation "van accessible." Signs shall be 60" minimum above the finish floor or ground surface measured to the bottom of the sign.</p>	<p><u>Criticality</u> Serious</p> <p><u>Timeframe</u> Immediate</p>

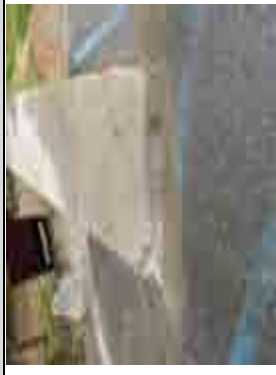
<p>ACAD_Eagle Lake_LKW_019</p>

<p>ACAD_Eagle Lake_LKW_018</p>
<p>Reference Standards and Guidelines: ABAAS 502.6 Parking Spaces-Identification</p>			
<p>Location: Parking lot at restroom Corrective Action: Regrade and restripe</p>			
<p><u>Deficiency</u> ORAR extends into access aisle (slope in aisle is 4.7%). Waste receptacles are not placed along ORAR and do not have clear ground space.</p>	<p><u>Solution</u> Regrade and surface the access aisle and route to/around trash cans to eliminate slope and allow loading/unloading at accessible parking spaces. Restripe parking lot to accommodate an access aisle next to, but separate from, the accessible route.</p>	<p><u>Criticality</u> Serious</p> <p><u>Timeframe</u> Short-term</p>

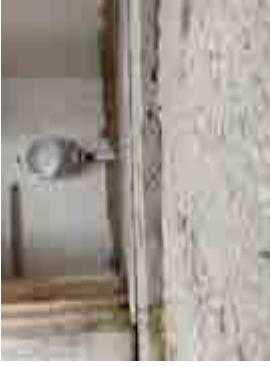
<p>Location: Restroom Building Corrective Action: Eliminate change in level</p>			
<p><u>Deficiency</u> Significant change in level (1.5") exists at the threshold to the restroom.</p>	<p><u>Solution</u> Add a concrete pad or similar clear space at the door exterior and grade to ORAR.</p>	<p><u>Criticality</u> Serious</p> <p><u>Timeframe</u> Short-term</p>

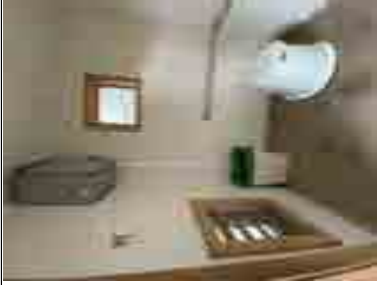
<p>ACAD_Eagle Lake_LKW_023</p>

<p>ACAD_Eagle Lake_LKW_021</p>
<p>Reference Standards and Guidelines: ABAAS 303 Changes in Level; 304 Turning Space</p>			
<p>Location: Restrooms Corrective Action: Add cane detection to protruding object, lower hook</p>			
<p><u>Deficiency</u> A large metal box is attached to the wall at 68.5" above the floor surface and protruding >9" from side wall. Also, an out of reach range hook is fixed to the same wall.</p>	<p><u>Solution</u> Ensure that maintenance staff are trained to place the trash can beneath the protruding metal box so that it acts as a cane-detectable barrier. Alternatively, install a more permanent trash can or another barrier. Lower the hook to below 48".</p>	<p><u>Criticality</u> Serious</p> <p><u>Timeframe</u> Short-term</p>

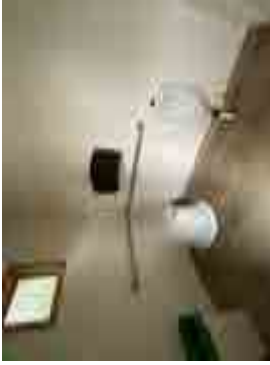
Location: Restroom Corrective Action: move toilet paper dispenser			
<u>Deficiency</u> Toilet paper dispenser is mounted 8" over the grab bar.	<u>Solution</u> Move the toilet paper dispenser out of the 12" clearance over the grab bar (but keep within reach range for height.)	<u>Criticality</u> Serious <u>Timeframe</u> Short-term

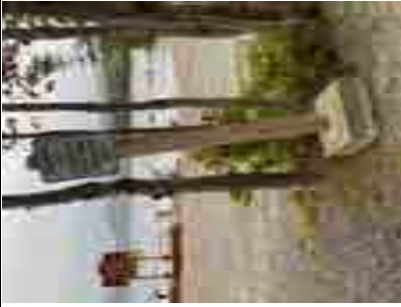
<p>ACAD_Eagle Lake_LKW_035</p>

<p>ACAD_Eagle Lake_LKW_024</p>
Reference Standards and Guidelines: Reference Standards and Guidelines: ABAAS 609 Grab bars			
Location: Parking area near Carriage Road Corrective Action: Identify vehicle parking and install permanent signage			
<u>Deficiency</u> Information about accessible parking for cars with trailers in unavailable. Sites are not marked.	<u>Solution</u> Place sign at parking area with clearly marked spaces for vehicles with trailers. Add accessible parking of this type and indicate with signage.	<u>Criticality</u> Serious <u>Timeframe</u> Short-term

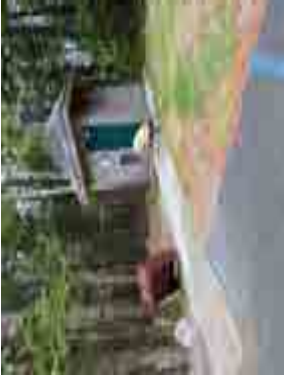
Location: Parking Lot Corrective Action: Add sign to identify accessible parking			
<u>Deficiency</u> There are no signs at the two accessible parking spaces.	<u>Solution</u> Add appropriate signage and raise the sign marking the van accessible parking space to >60". Signs identifying van parking spaces shall contain the designation "van accessible." Signs shall be 60" minimum above the finish floor or ground surface measured to the bottom of the sign.	<u>Criticality</u> Serious <u>Timeframe</u> Immediate

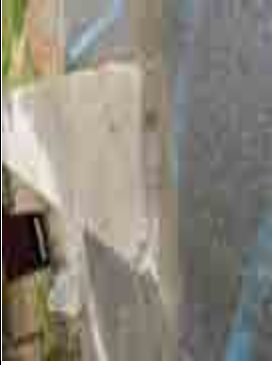
ACAD_Eagle Lake_LKW_019

ACAD_Eagle Lake_LKW_018
Reference Standards and Guidelines: ABAAS 502.6 Parking Spaces-Identification			
Location: Parking lot at restroom Corrective Action: Regrade and restripe			
<u>Deficiency</u> ORAR extends into access aisle (slope in aisle is 4.7%). Waste receptacles are not placed along ORAR and do not have clear ground space.	<u>Solution</u> Regrade and surface the access aisle and route to/around trash cans to eliminate slope and allow loading/unloading at accessible parking spaces. Restripe parking lot to accommodate an access aisle next to, but separate from, the accessible route.	<u>Criticality</u> Serious <u>Timeframe</u> Short-term

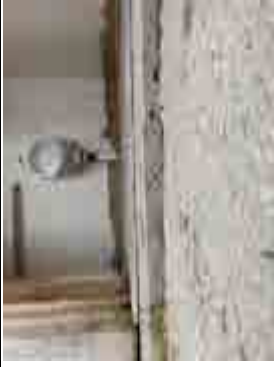
<p>Location: Restroom Building Corrective Action: Eliminate change in level</p>			
<p><u>Deficiency</u> Significant change in level (1.5") exists at the threshold to the restroom.</p>	<p><u>Solution</u> Add a concrete pad or similar clear space at the door exterior and grade to ORAR.</p>	<p><u>Criticality</u> Serious</p> <p><u>Timeframe</u> Short-term</p>

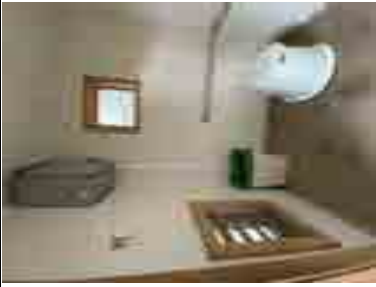
<p>ACAD_Eagle Lake_LKW_023</p>

<p>ACAD_Eagle Lake_LKW_021</p>
<p>Reference Standards and Guidelines: ABAAS 303 Changes in Level; 304 Turning Space</p>			
<p>Location: Restrooms Corrective Action: Add cane detection to protruding object, lower hook</p>			
<p><u>Deficiency</u> A large metal box is attached to the wall at 68.5" above the floor surface and protruding >9" from side wall. Also, an out of reach range hook is fixed to the same wall.</p>	<p><u>Solution</u> Ensure that maintenance staff are trained to place the trash can beneath the protruding metal box so that it acts as a cane-detectable barrier. Alternatively, install a more permanent trash can or another barrier. Lower the hook to below 48" .</p>	<p><u>Criticality</u> Serious</p> <p><u>Timeframe</u> Short-term</p>

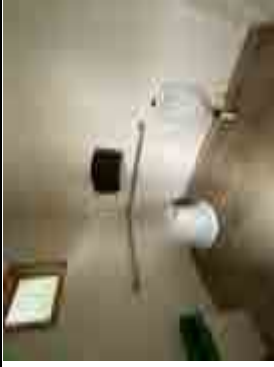
<p>Location: Restroom Corrective Action: move toilet paper dispenser</p>			
<p><u>Deficiency</u> Toilet paper dispenser is mounted 8" over the grab bar.</p>	<p><u>Solution</u> Move the toilet paper dispenser out of the 12" clearance over the grab bar (but keep within reach range for height.)</p>	<p><u>Criticality</u> Serious</p> <p><u>Timeframe</u> Short-term</p>

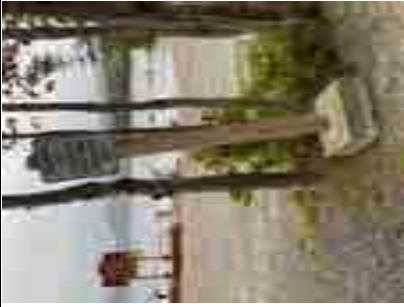
<p>ACAD_Eagle Lake_LKW_035</p>

<p>ACAD_Eagle Lake_LKW_024</p>
<p>Reference Standards and Guidelines: Reference Standards and Guidelines: ABAAS 609 Grab bars</p>			
<p>Location: Parking area near Carriage Road Corrective Action: Identify vehicle parking and install permanent signage</p>			
<p><u>Deficiency</u> Information about accessible parking for cars with trailers in unavailable. Sites are not marked.</p>	<p><u>Solution</u> Place sign at parking area with clearly marked spaces for vehicles with trailers. Add accessible parking of this type and indicate with signage.</p>	<p><u>Criticality</u> Serious</p> <p><u>Timeframe</u> Short-term</p>

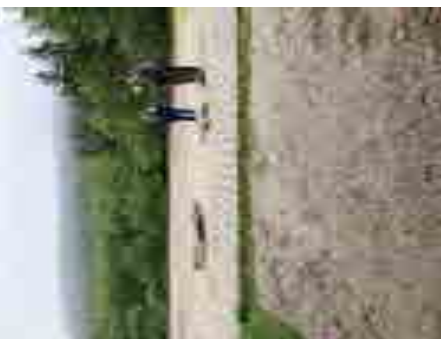
<p>NPS_ACAD_KGP_067</p>   <p>NPS_ACAD_KGP_066</p>
---	--	---	--

Location: Echo Lake Beach – Path from stairs to boardwalk Corrective Action: Replace path to decrease gaps in materials

<p>Deficiency The transitions from pavement to sand and sand to boardwalk at the bottom of the steps are too large (>1inch, >3inches).</p>	<p>Solution Extend the boardwalk laterally to the bottom of the steps or replace the sand with ground material extending from the pavement to the boardwalk that is stable, firm, and slip resistant and ensures no gaps between materials.</p>	<p>Criticality Serious Timeframe Immediate</p>

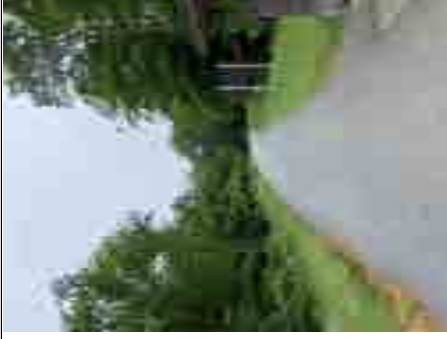
<p>Location: Echo Lake Beach - Paved Path Corrective Action: Decrease slope to <5% grade</p>			
<p><u>Deficiency</u> The paved trail down to Echo Beach has maximum slope grades of 5.4-5.8% with a 2.5% cross slope.</p>	<p><u>Solution</u> Ensure paved path has a grade of <5% when the path requires to be repaved.</p>	<p><u>Criticality</u> Minor</p> <p><u>Timeframe</u> Long -term</p>

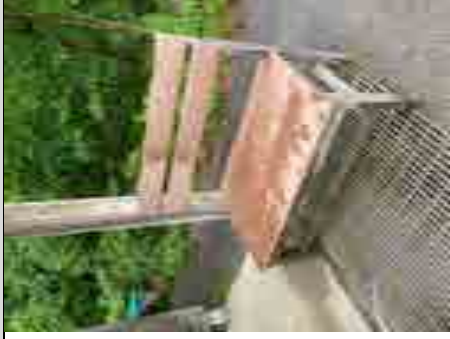
<p>NPS_ACAD_KGP_074</p>

<p>NPS_ACAD_KGP_094</p>
<p>Reference Standards and Guidelines: ABA 403.3</p>			
<p>Location: Echo Lake Beach Corrective Action: Replace current grating under washing station</p>			
<p><u>Deficiency</u> The grates underneath the two foot-washing stations have openings that are too large (4.5 inches x 1 inches).</p>	<p><u>Solution</u> Replace current grates with grates that have openings of <1/2 inch x 1/2 inch.</p>	<p><u>Criticality</u> Serious</p> <p><u>Timeframe</u> Short-term</p>

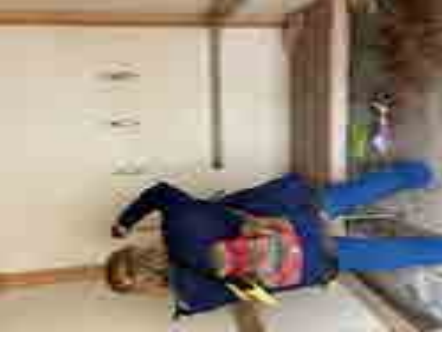
</div> <p>NPS_ACAD_KGP_081</p> <p>NPS_ACAD_KGP_083 NPS_ACAD_KGP_084</p>
<p>Reference Standards and Guidelines: ABA 308, 803.5</p>

Location: Echo Lake Beach – Changing Rooms Corrective Action: Lower coat hooks and perform maintenance on lock mechanisms		
<p><u>Deficiency</u></p> <p>The hooks inside the accessible changing rooms are too high (59 inches).</p> <p>The lock mechanism is difficult to operate.</p>	<p><u>Solution</u></p> <p>Lower hooks to <48 inches to be within reach range (not on wall behind bench) for individuals using wheelchairs or who have a short stature.</p> <p>Perform maintenance on the lock mechanism to improve the ability for individuals with impaired hand function to be able to operate the lock mechanism.</p>	<p><u>Criticality</u></p> <p>Serious</p> <p><u>Timeframe</u></p> <p>Immediate</p> <div style="display: flex; justify-content: space-around;">

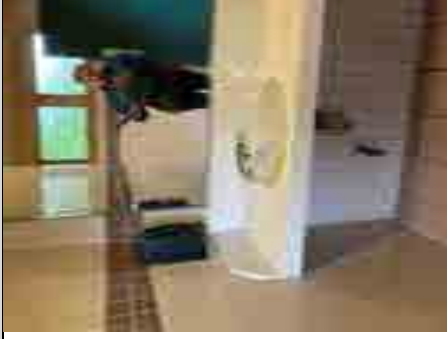
Location: Echo Lake Beach – Men’s and Women’s Restrooms			
Corrective Action: Wrap pipes under sink			
<u>Deficiency</u> The pipes are not wrapped under the sink.	<u>Solution</u> Wrap pipes under sink to prevent injury from hot/cold and sharp edges for someone who uses a wheelchair and positions their legs under the sink while washing their hands.	<u>Criticality</u> Critical <u>Timeframe</u> Immediate

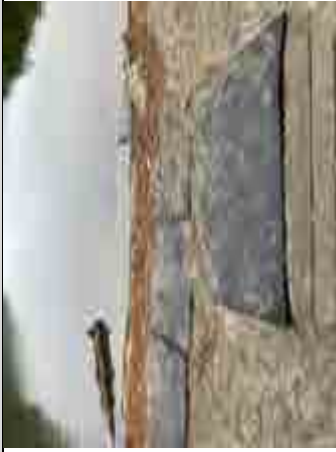
<p>NPS_ACAD_KGP_071</p>
<p>Reference Standards and Guidelines: ABAAS 302.3, 1018</p>

<p>Location: Echo Lake Beach - Boardwalk Corrective Action: Replace rubber mats with Mobi-Mat</p>			
<p><u>Deficiency</u> The transition from the boardwalk to the rubber mat has a 4-inch gap. There are large gaps between each square of the rubber mat.</p>	<p><u>Solution</u> Replace rubber mats with a Mobi-Mat that attaches to the boardwalk (with a gap <1/2 inch) that is removable to allow for ground maintenance that extends into the water.</p>	<p><u>Criticality</u> Critical</p> <p><u>Timeframe</u> Immediate</p>

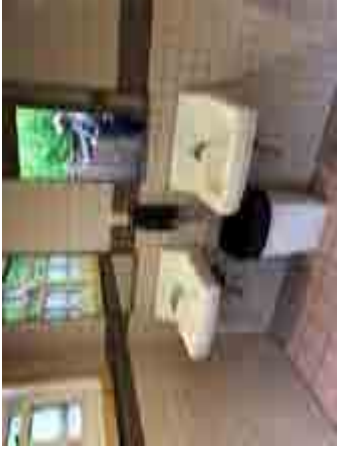
Location: Family, Men's, Women's restroom			
Corrective Action: Wrap pipes under sink			
<p><u>Deficiency</u> The pipes are exposed underneath the sink.</p>	<p><u>Solution</u> Wrap the pipes under the sinks in the Restrooms to prevent injury from hot/cold and sharp edges for someone who uses a wheelchair and positions their legs under the sink while washing their hands.</p>	<p><u>Criticality</u> Critical</p> <p><u>Timeframe</u> Immediate</p>

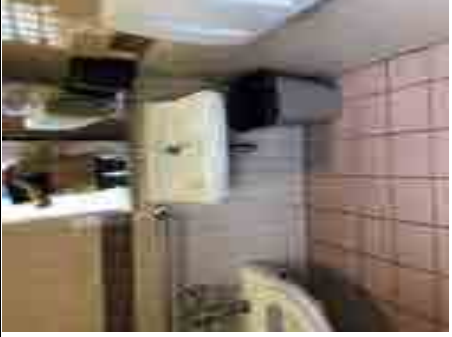
<p>ACAD_Fabbri_LMK_077</p>

<p>ACAD_Fabbri_LMK_088</p>
Reference Standards and Guidelines: ABBAS 606.5			
Location: Women's, Men's, Family Restrooms			
Corrective Action: Lower mirrors and hooks			
<p><u>Deficiency</u> The mirrors and clothing hooks are all too high.</p>	<p><u>Solution</u> Mirrors located above countertops shall be installed with the bottom edge of the reflecting surface 40" maximum from the floor. Lower hooks to be <48 within reach range.</p>	<p><u>Criticality</u> Serious</p> <p><u>Timeframe</u> Immediate</p>

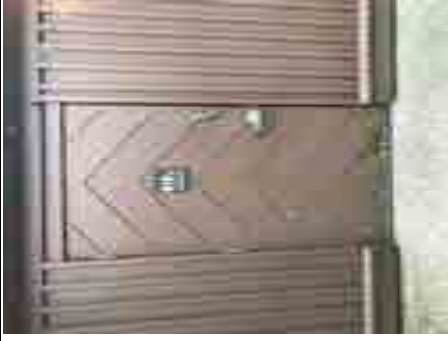
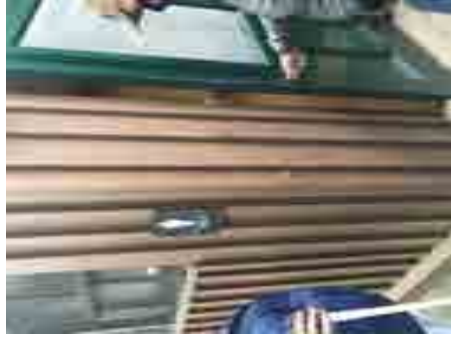
Deficiency
 Restroom signs are placed incorrectly.

Criticality
 Critical

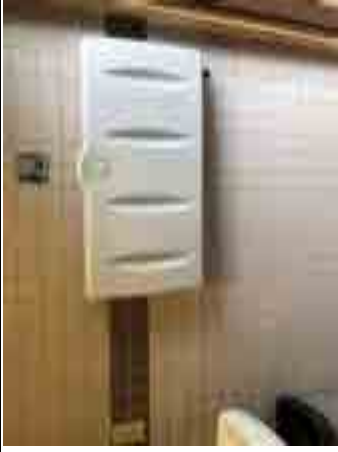
Location: Family Restroom			
Corrective Action: Lower baby changing station			
<p><u>Deficiency</u> The baby changing station is too high outside of reach range.</p>	<p><u>Solution</u> Lower the baby changing station so that the height of the opening mechanism is <48" to be within reach range.</p>	<p><u>Criticality</u> Serious</p> <p><u>Timeframe</u> Short-term</p>

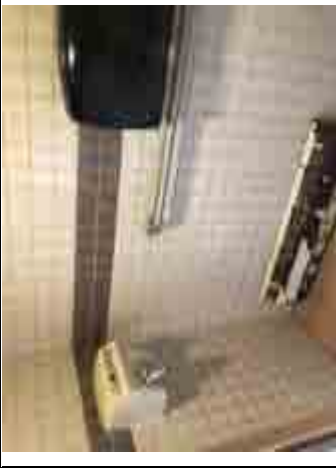
<p>ACAD_Fabbri_LMK_080</p>
<p>Reference Standards and Guidelines: ABBAS 604.9.6</p>

<p>Location: Family Restroom Corrective Action: Reinstall toilet paper dispenser</p>			
<p><u>Deficiency</u> There is currently not enough space between the toilet paper dispenser and side grab bar.</p>	<p><u>Solution</u> Move the toilet paper dispenser to 7" minimum and 9" maximum in front of the center of the toilet. The outlet of the dispenser shall be 15" minimum and 48" maximum above the floor and shall not be located behind grab bars. If toilet paper dispensers are installed above the side wall grab bar, the outlet of the toilet paper dispenser must be 48" maximum above the finish floor and the top of the gripping surface of the grab bar must be 33" minimum and 36" maximum above the floor.</p>	<p><u>Criticality</u> Serious</p> <p><u>Timeframe</u> Immediate</p>

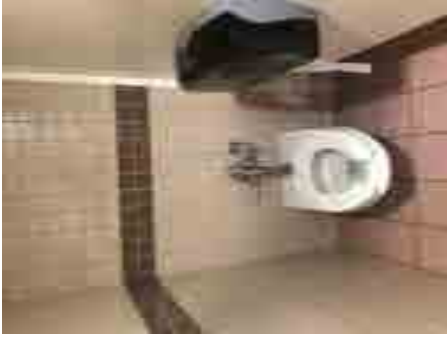
<p>ACAD_Fabbri_LMK_091</p>	
<p>Reference Standards and Guidelines: ABAS 604.3.1, 604.6, 609.1, 309.4</p>

Location: Women's Restroom Corrective Action: Increase the accessibility of features within the accessible rest room stalls	
<p><u>Deficiency</u></p> <p>Width of accessible stall does not meet standards.</p> <p>Toilet flusher is on the wrong side.</p> <p>Grab bars are not installed.</p> <p>The door is difficult to open from the inside using the lock mechanism.</p>	<p><u>Solution</u></p> <p>Recommend redesigning stall to meet accessibility standards. Stall dimensions should be 60" minimum measured perpendicular from the side wall and 56" minimum measured perpendicular from the rear wall.</p> <p>Replace the toilet with one that has the flush control on the open side of the toilet to be within reach range, so individuals may be able to flush.</p> <p>The side wall grab bar shall be 42" long minimum, located 12" maximum from the rear wall and extending 54" minimum from the rear wall. The rear wall grab bar shall be 36" long minimum and extend from the centerline of the water closet 12" minimum on one side and 24" minimum on the other side.</p> <p>Add a D-ring handle to the inside of the stall door to improve the ability to open the door from the inside for those that have decreased hand function.</p>

<p><u>Criticality</u></p> <p>Critical</p> <p><u>Timeframe</u></p> <p>Short-term</p>

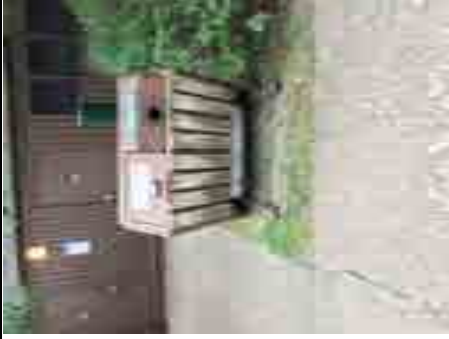
<p>ACAD_Fabbri_LMK_072</p>

<p>Location: Fabbri Picnic Area Corrective Action: Provide clear ground space for trash receptacles</p>		
<p><u>Deficiency</u> There are three trash receptacles that do not have appropriate clear ground space.</p>	<p><u>Solution</u> Trash and recycling receptacles must include a 36 by 48" clear ground space positioned for a forward approach to the receptacle opening or a 30 by 60" clear ground space positioned for a parallel approach to the receptacle opening.</p>	<p><u>Criticality</u> Serious</p> <p><u>Timeframe</u> Short-term</p>
<p>Reference Standards and Guidelines: ABBAS 305.7</p>

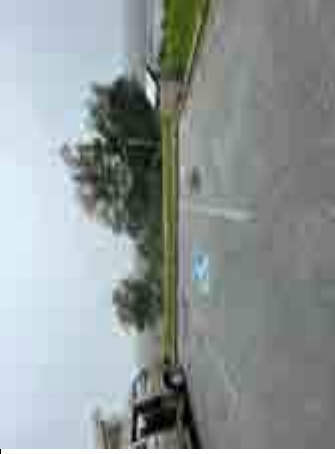
<p>ACAD_Fabbri_LMK_063</p>

<p>Location: Scenic overlook Corrective Action: Improve accessible parking area</p>		
<p><u>Deficiency</u> The parking lot does not include required features of accessibility.</p>	<p><u>Solution</u> Provide one van-accessible parking space in the parking lot. The space shall be 11ft wide with an adjoining 5 ft wide access aisle. The access aisle shall be striped or otherwise marked to discourage parking in it. Install vertical signage at the front, center of the space including the International Symbol for Accessibility and the designation "van accessible." Ensure that the signage is installed a minimum of 60" above the ground surface, measured to the bottom of the lowest sign.</p>	<p><u>Criticality</u> Serious</p> <p><u>Timeframe</u> Immediate</p>
<p>Reference Standards and Guidelines: ABBAS F205.2, 502</p>

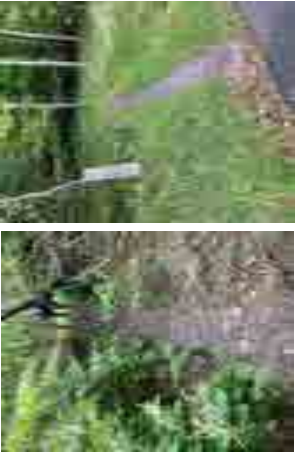
<p>ACAD_Grt Meadow Loop_KGO_292 ACAD_Grt Meadow Loop_KGO_311</p>

<p>Location: Great Meadow Loop Corrective Action: Widen trail and provide passing spaces</p>			
<p><u>Deficiency</u> Tread width of trail is as narrow as 10" in various areas.</p>	<p><u>Solution</u> Recommend widening trail so clear tread width meets minimum standard of 36". Where the tread width is less than 60", passing spaces must be provided at intervals of at least 1000 feet.</p>	<p><u>Criticality</u> Serious</p> <p><u>Timeframe</u> Short-term</p>

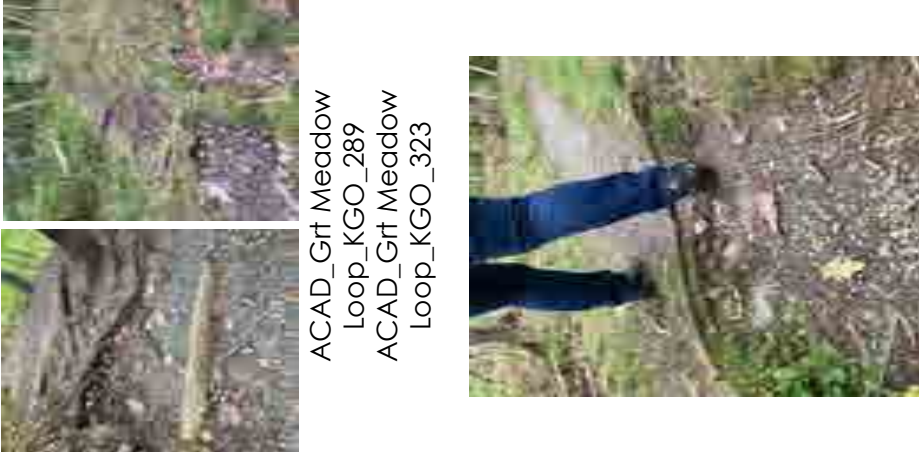
<p>ACAD_Grt Meadow Loop_KGO_289 ACAD_Grt Meadow Loop_KGO_323</p> <p>ACAD_Grt Meadow Loop_KGO_383</p>
<p>Reference Standards and Guidelines: ABBAS 1017.5</p>

<p>Location: Great Meadow Loop Corrective Action: Reduce tread obstacles</p>	
<p><u>Deficiency</u> There are various tread obstacles such as tree roots throughout the trail that are higher than the 2" maximum allowed.</p>	<p><u>Solution</u> The limit on the height of tread obstacles on trails, passing spaces, and resting intervals is based on the surface material used. When the trail surface is constructed of materials other than concrete, asphalt, or boards, tread obstacles are permitted to be a maximum of 2 inches high. Use fill materials to level out the surface and reduce tread obstacle height to 2" or less.</p>
<p><u>Criticality</u> Serious</p> <p><u>Timeframe</u> Interim</p>

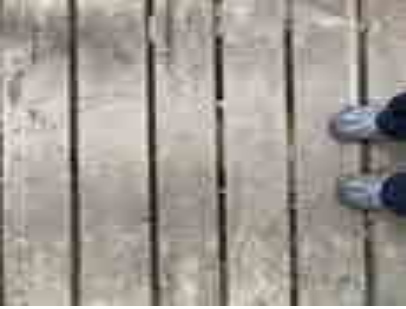
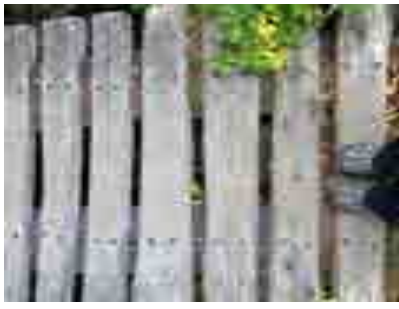
<p>ACAD_Grt Meadow Loop_KGO_299</p>

<p>Location: Great Meadow Loop Corrective Action: Fill gaps on bridges</p>			
<p><u>Deficiency</u> Two bridges on the trail have openings ranging from 1-3"</p>	<p><u>Solution</u> Fill gaps or rebuild bridges so that gaps are a maximum of 1/2".</p>	<p><u>Criticality</u> Serious</p> <p><u>Timeframe</u> Interim</p>

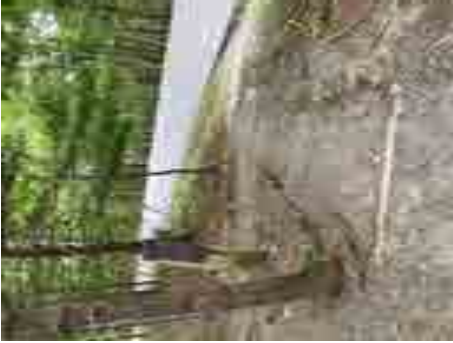
<p>ACAD_Grt Meadow Loop_KGO_361</p>
---	--	---	---

Corrective Action: Reduce running slope of trail

<p><u>Deficiency</u> Numerous sections of the trail exceed the allowable running slope for accessible trail segments.</p>	<p><u>Solution</u> Regrade sections of trail to ensure the running slopes adhere to ABA standards. Trail segments of any length may be constructed with running slopes up to 5%. To accommodate steep terrain, trails may be designed with shorter segments that have a running slope and length, as shown in the table below, with resting intervals at the top and bottom of each segment.</p>	<p><u>Criticality</u> Serious</p> <p><u>Timeframe</u> Interim</p>

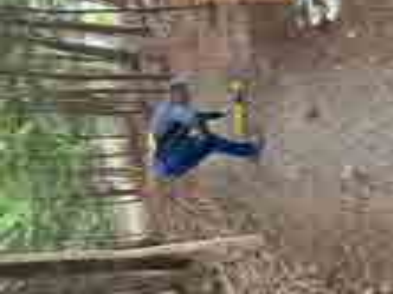
<p>Location: Great Meadow Loop Corrective Action: Reduce cross slope</p>			
<p><u>Deficiency</u> Sections of trail have high cross slope due to natural erosion.</p>	<p><u>Solution</u> Recommend cribbing to avoid erosion of trail causing cross slope greater than 5%.</p>	<p><u>Criticality</u> Serious</p> <p><u>Timeframe</u> Interim</p>

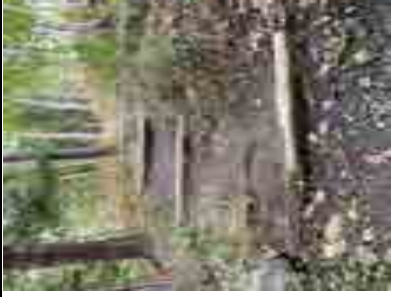
<p>ACAD_Grt Meadow Loop_KGO_284</p>
<p>Reference Standards and Guidelines: 1017.5</p>

<p>ACAD_Grt Meadow Loop_KGO_275</p>
<p>Reference Standards and Guidelines: ABBAS 1017.7.2</p>			
<p>Location: Great Meadow Loop Corrective Action: Remove water bars</p>			
<p><u>Deficiency</u> Water bars throughout trail create tread obstacles.</p>	<p><u>Solution</u> Recommend removing water bars and implementing grade reversals.</p>	<p><u>Criticality</u> Serious</p> <p><u>Timeframe</u> Interim</p>

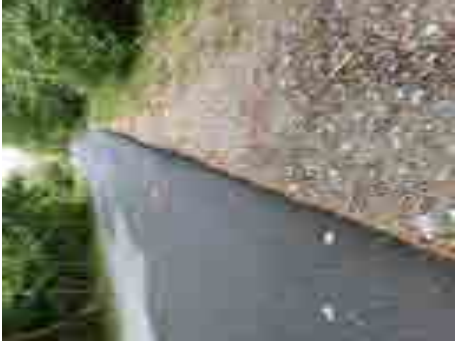
<p>ACAD_Grt Meadow Loop_KGO_303</p>
Reference Standards and Guidelines: ABBAS 1017.2

Location: Great Meadow Loop Corrective Action: Improve surface material of trail			
<u>Deficiency</u> Loose surface material is used in sections of trail	<u>Solution</u> The surfaces of trails, passing spaces, and resting intervals must be firm and stable. Paving with concrete or asphalt may be appropriate for highly developed areas. For less developed areas, crushed stone, fine crusher rejects, packed soil, soil stabilizers, and other natural materials may provide a firm and stable surface. Natural materials also can be combined with synthetic bonding materials to provide greater stability and firmness.	<u>Criticality</u> Serious <u>Timeframe</u> Short-term

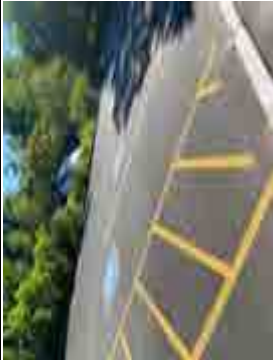
Location: Main Visitor Parking Lot Corrective Action: Rescope and restripe the accessible parking and access aisles			
<u>Deficiency</u> Accessible parking spaces are not properly marked for angled parking. Some van accessible spaces do not have an access aisle on the passenger side, which is required for angled spaces.	<u>Solution</u> As part of the upcoming restriping project, rescope the parking lot to determine required minimum number of accessible spaces. Then, either stripe the lot and mark accessible spaces vertically (which can have shared access aisles) or maintain angled parking and add access aisles as required. Additionally, ensure that each aisle is met by a curb cut at the sidewalk.	<u>Criticality</u> Serious <u>Timeframe</u> Immediate

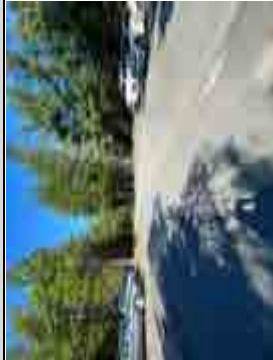
<p>NPS_ACAD_LKW_306</p>
Reference Standards and Guidelines: ABAAS 502.3 and 502.4

<p>NPS_ACAD_LKW_292</p>
Reference Standards and Guidelines: ABAAS 502.3.4			
Location: Employee Parking lot Corrective Action: Regrade lot surface and add access aisle

<u>Deficiency</u> The slope in the employee lot exceeds the maximum of 2% around the accessible space. In addition, there is not a marked access aisle for the space.	<u>Solution</u> Regrade and level the employee lot to meet the standard. Add an access aisle to the accessible parking space.	<u>Criticality</u> Serious <u>Timeframe</u> Short-term

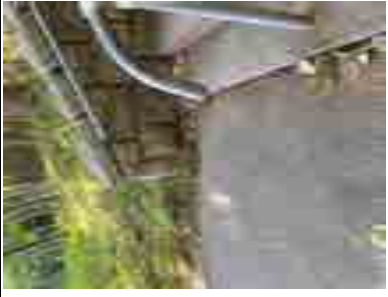
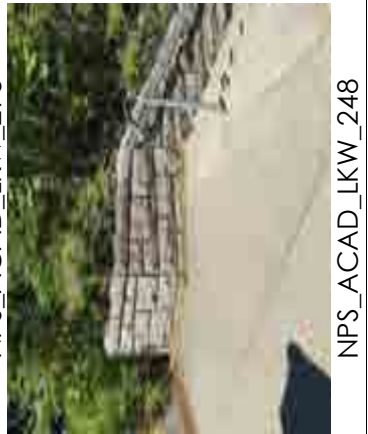
Location: Route from parking to visitor center - stairs Corrective Action: Replace handrails		
<p><u>Deficiency</u> Handrails on the stairs leading to the visitor center are open on the ends and could catch loose clothing or accessories. This poses a hazard, particularly for people who are unsteady on their feet.</p>	<p><u>Solution</u> Replace the handrails with continuous, closed rails that extend 12 inches beyond the top and bottom of each flight and meet ABA standards for height and dimensions.</p>	<p><u>Criticality</u> Critical</p> <p><u>Timeframe</u> Short-term</p> <div style="display: flex; justify-content: space-around;"> <div data-bbox="402 241 787 535">

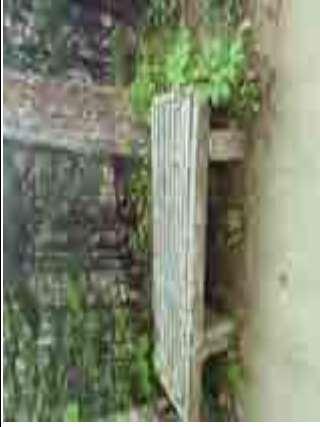
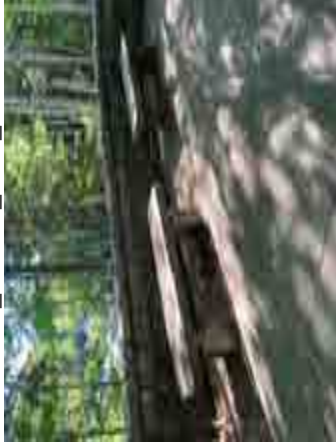
<p>NPS_ACAD_LKW_299</p>

<p>Location: Route from parking to visitor center – benches Corrective Action: Replace/add accessible seating</p>	
<p><u>Deficiency</u> The benches placed at landings along the route do not have back or arm rests.</p>	<p><u>Solution</u> Add accessible bench seating with back and armrests. Include areas for companion seating for those needing an adapted chair. Benches should meet standards for height and placement.</p>
<p><u>Criticality</u> Serious</p> <p><u>Timeframe</u> Immediate</p>

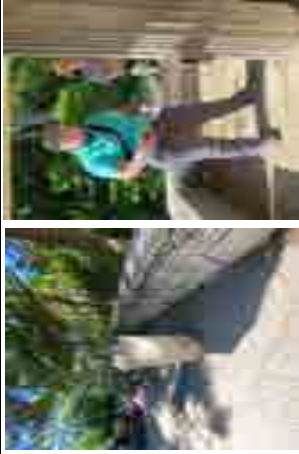
<p>NPS_ACAD_LKW_307 NPS_ACAD_LKW_287</p>

Location: Route from parking to visitor center – water fountain			
Corrective Action: add dual level accessible fountain			
<p><u>Deficiency</u> Drinking fountains do not provide knee and toe clearance or meet height standards for use in a seated position. The fountain at the parking lot pavilion is a protruding object.</p>	<p><u>Solution</u> Replace existing outdoor drinking fountains with fountains that allow for clear ground space and clearance as well as spout height. Provide two spouts at different heights to accommodate the widest range of users. *Because the pillar-mounted fountain protrudes into the accessible route and is not cane detectable, it poses a hazard for visitors who are blind or have low vision. Add a detectable barrier beneath the fountain to bring it to standard.</p>	<p><u>Criticality</u> Serious</p> <p><u>Timeframe</u> Short-term</p>

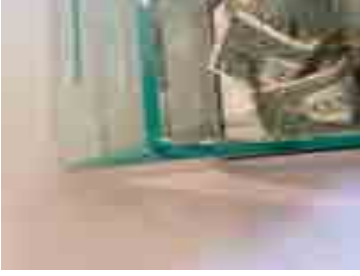
<p>NPS_ACAD_LKW_322</p>
Reference Standards and Guidelines: Section 504 of the Rehabilitation Act of 1973, as amended

Reference Standards and Guidelines: ABAAS 602 and 307			
Location: Visitor Center			
Corrective Action: Bevel display case edges			
<p><u>Deficiency</u> Clear plexiglass displays with sharp edges are particularly hazardous for people with low vision.</p>	<p><u>Solution</u> Bevel and smooth edges of the plexiglass display cases. Marking the edges with colored tape can also improve their visibility and prevent injury. (photo shows the collection box with properly smoothed edges)</p>	<p><u>Criticality</u> Serious</p> <p><u>Timeframe</u> Immediate</p>

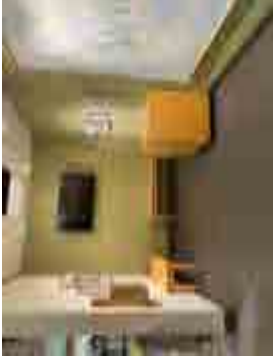
<p>Location: Visitor Center Corrective Action: Add accessible seating</p>			
<p><u>Deficiency</u> Seating does not meet standards for back and arm rests, making it difficult for some users to sit or stand from the benches.</p>	<p><u>Solution</u> Add or replace with seating that has back and arm rests and meets standard for height. Back rests may not be necessary when the bench is affixed to the wall, but arm rests or grab bars are still necessary.</p>	<p><u>Criticality</u> Serious</p> <p><u>Timeframe</u> Immediate</p>

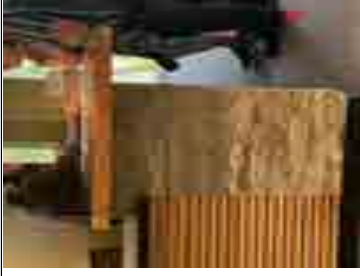
<p>NPS_ACAD_LKW_337</p>

<p>NPS_ACAD_LKW_323</p>
<p>Reference Standards and Guidelines: ABAAS 903.4</p>			
<p>Location: Visitor Center Corrective Action: Add cane detection to counters and wall mounted objects</p>			
<p><u>Deficiency</u> The countertop at the information desk in the visitor center protrudes into the accessible route and is not detectable by someone using a white cane. The "ask an artist" box also exceeds the limits for protrusion from the wall.</p>	<p><u>Solution</u> Both the countertop and the mounted box can be brought to standard by adding either a lip to hang below 27 inches from the ground or placing a fixture on the floor below. Evaluate the wall mounted drinking fountain for compliance with standard as well.</p>	<p><u>Criticality</u> Serious</p> <p><u>Timeframe</u> Short-term</p>

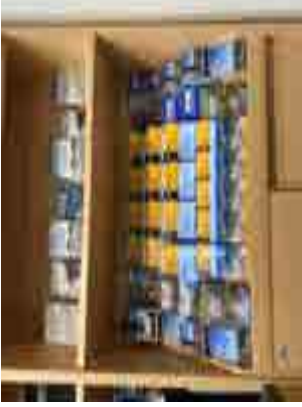
<p>Location: Gift Shop Corrective Action: Train staff; arrange stock</p>			
<p><u>Deficiency</u> Some items in the gift shop are beyond the reach range of someone using a wheelchair.</p>	<p><u>Solution</u> Work with the gift shop concessionaire to stock inventory vertically whenever possible. When similar items are stocked on shelves vertically rather than horizontally, they are reachable by visitors using a wheelchair and others with a shorter reach range.</p>	<p><u>Criticality</u> Serious</p> <p><u>Timeframe</u> Immediate</p>

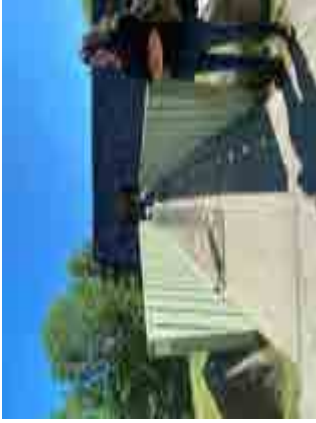
<p>NPS_ACAD_LKW_339</p>

<p>NPS_ACAD_LKW_341</p>
<p>Reference Standards and Guidelines: ABAAS 308; Section 504 of the Rehabilitation Act of 1973, as amended</p>			
<p>Location: Bridge to VC – gift shop entrance Corrective Action: Remove sign; train staff</p>			
<p><u>Deficiency</u> Signs are placed in the accessible route and do not leave adequate clear width of 36 inches on either side.</p>	<p><u>Solution</u> Remove the temporary signs and train staff on proper clear width needed for accessible routes.</p>	<p><u>Criticality</u> Critical</p> <p><u>Timeframe</u> Immediate</p>
