Acadia National Park

Accessibility Assessment

FINAL REPORT

Findings and Recommendations

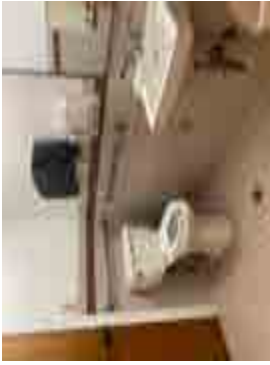
Location: Restroom on lower floor			
Corrective Action: Reposition toilet			
<p><u>Deficiency</u> The grab bar behind the toilet is too short and does not extend far enough past the tank to be used for a side transfer onto the toilet.</p>	<p><u>Solution</u> Reposition the toilet to allow for enough space for back and side grab bars. (Ensure that the flush handle is on the side away from the wall.)</p>	<p><u>Criticality</u> Serious</p> <p><u>Timeframe</u> Short-term</p>

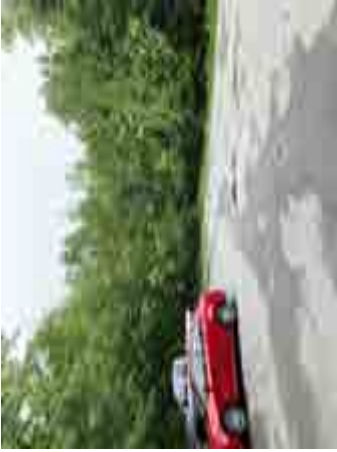
<p>Location: Ike's Point – Parking Lot Corrective Action: Re-line parking lot to add a van accessible parking space</p>			
<p><u>Deficiency</u> There are no accessible parking spaces in the parking lot.</p>	<p><u>Solution</u> Re-line parking lot to add a van-accessible parking space that is a minimum of 132" wide with an access aisle of a minimum of 60" wide or a parking space 96" wide minimum where the access aisle is 96" wide minimum.</p>	<p><u>Criticality</u> Serious</p> <p><u>Timeframe</u> Immediate</p>

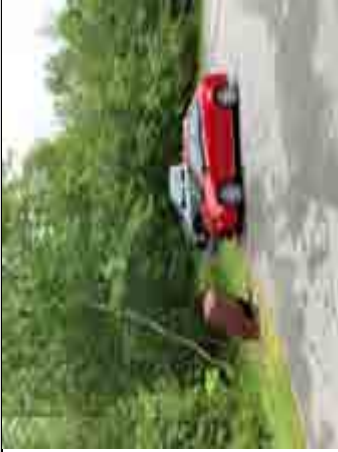
<p>NPS_ACAD_KGP_106</p>

<p>NPS_ACAD_KGP_105</p>
<p>Reference Standards and Guidelines: ABAAS 502</p>			
<p>Location: Ike's Point – Parking Lot Corrective Action: Move the trash and recycling receptacle closer to the pavement</p>			
<p><u>Deficiency</u> The trash and recycling receptacle is outside of reach range.</p>	<p><u>Solution</u> Move the trash and recycling receptacle within reach range of the pavement.</p>	<p><u>Criticality</u> Serious</p> <p><u>Timeframe</u> Immediate</p>

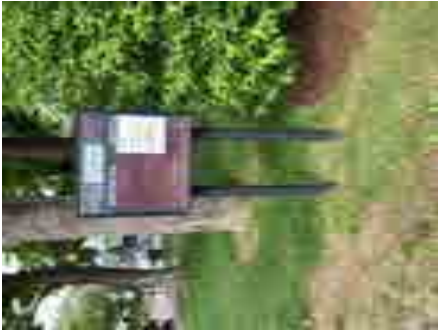
<p>NPS_ACAD_KGP_053</p>

<p>Location: Village Green Shuttle Stop Corrective Action: Ensure there is an audio component for any electronic signs</p>			
<p><u>Deficiency</u> Important information on the shuttle route and arrival/departure is conveyed only visually. (The electronic sign was not in service during the assessment period.)</p>	<p><u>Solution</u> Ensure there is an audio component for any information provided by the electronic signs. Real-time arrival displays with mobile app integration improve rider satisfaction and can increase ridership. Real-time displays should be accompanied by audible announcements. For riders with visual disabilities, provide an alternative to visual display boards; audible announcements are preferred over braille and other methods that require finding the display. Consider station/street noise and environmental characteristics during implementation.</p>	<p><u>Criticality</u> Serious</p> <p><u>Timeframe</u> Short-term</p>

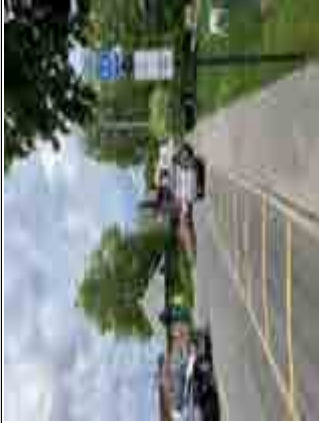
<p>NPS_ACAD_KGP_050</p>
<p>Reference Standards and Guidelines: ABA F209, 810.2</p>

<p>Reference Standards and Guidelines: Rehabilitation Act of 1973, as amended, Section 504 and Section 508 (402.5 and Functional Performance Criteria 302)</p>			
<p>Location: Village Green Shuttle Stop Corrective Action: Ensure ALL shuttle stops have accessible loading zones and clearly mark them</p>			
<p><u>Deficiency</u> The sidewalk at the Kennebec St. bus stop is sloped (the sidewalk at the Firefly St. bus stop appears to be level) and the accessible bus boarding area is not identified.</p>	<p><u>Solution</u> Ensure there is a level area of sidewalk (slope < 1:48) of 96 inches (measured perpendicular to the curb or vehicle roadway edge) and a clear width of 60 inches (measured parallel to the roadway) that is clearly marked as the accessible loading zone at all bus stops.</p>	<p><u>Criticality</u> Critical</p> <p><u>Timeframe</u> Immediate</p>

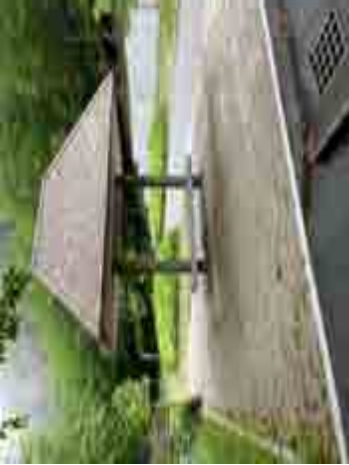
<p>NPS_ACAD_KGP_099</p>

<p>Location: Village Green, Echo Lake, Hulls Cove VC, Sand Beach, Jordan Pond and other Shuttle Stops Corrective Action: Replace benches without back support with benches that have back support</p>	
<p><u>Deficiency</u> The benches at the shuttle stops that were evaluated during this site visit do not have backrests.</p>	<p><u>Solution</u> Replace the current benches with benches that have back support (at least 42 inches long and extend from a point of two inches maximum above the seat surface to a point of 18 inches minimum above the seat surface. The back support should be 2.5 inches maximum from the rear edge of the seat measured horizontally. The benches should be 42 inches long minimum, 20-24 inches deep, and 17-19 inches above the sidewalk.</p>
<p><u>Criticality</u> Serious</p> <p><u>Timeframe</u> Short-Term</p>

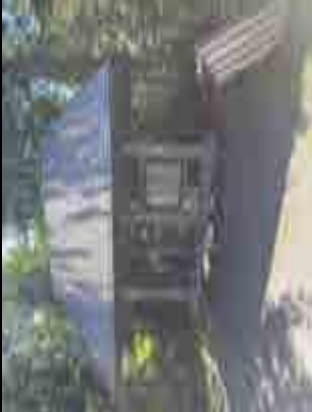
ACAD_KGP_018
Reference Standards and Guidelines: 302.1

ACAD_KGP_216
Reference Standards and Guidelines: ABA F206, 402, 1016			
Location: Seawall Campground Shuttle Stop			
Corrective Action: Replace ground material with material that is firm and stable			
<u>Deficiency</u> The ground at this shuttle stop is too loose and too steep of a grade.	<u>Solution</u> Resurface with ground material that is firm and stable and level grade to <1:48.	<u>Criticality</u> Serious <u>Timeframe</u> Short-term

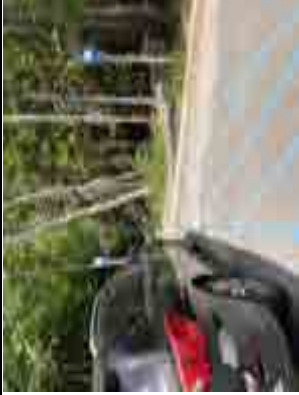
<p>Location: Parking lots Corrective Action: Rescope and add accessible parking</p>			
<p><u>Deficiency</u> Accessible parking spaces are inadequate for the lot size and not located at nearest route to amenities.</p>	<p><u>Solution</u> Rescope accessible parking for each lot and disperse spaces for better access to trails, Jordan Pond House, and boat launch.</p>	<p><u>Criticality</u> Serious</p> <p><u>Timeframe</u> Immediate</p>

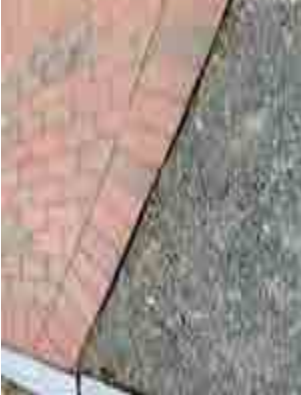
<p>NPS_ACAD_LKW_095</p>

<p>NPS_ACAD_KGP_013</p>
<p>Reference Standards and Guidelines: ABAAS 208</p>			
<p>Location: Accessible routes Corrective Action: Grade and fill surfacing at transitions</p>			
<p><u>Deficiency</u> Changes in level throughout area, particularly where different surfacing types meet.</p>	<p><u>Solution</u> Fill, pack, and grade to achieve acceptable changes in level on accessible routes (to facilities).</p>	<p><u>Criticality</u> Serious</p> <p><u>Timeframe</u> Short-term</p>

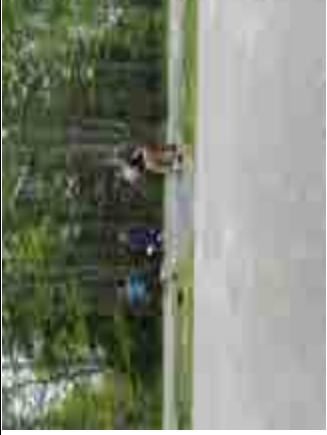
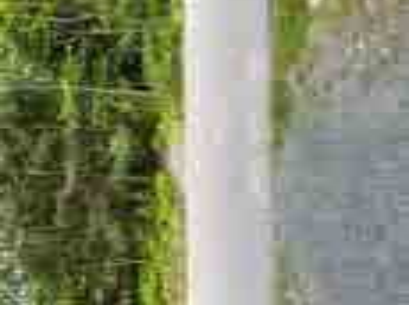
</div> <p style="text-align: center;">NPS_ACAD_LKW_049</p> <p style="text-align: center;">NPS_ACAD_LKW_046</p>

Location: Ocean Path at Old Soaker Parking lot Corrective Action: Add signs to indicate accessibility of Ocean Path and route from accessible parking		
<p><u>Deficiency</u> There is no information on where and how to find accessible parking, routes, amenities, and trails.</p>	<p><u>Solution</u> Add simple signs with the international accessibility symbol (ISO) to identify routes to accessible features. Add directional signs, using accessible fonts and contrast with the ISO symbol for indicating the distance to points of interest, e.g. Sand Beach. Clearly identify road crossing from parking lot to trail with "no parking" signs and striping.</p>	<p><u>Criticality</u> Serious</p> <p><u>Timeframe</u> Immediate</p> <div style="display: flex; justify-content: space-around;">

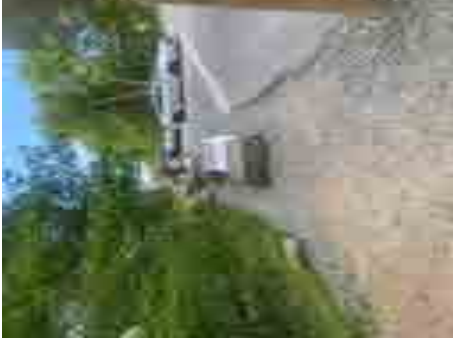
<p>NPS_ACAD_LKW_053</p>
<p>Reference Standards and Guidelines: ABAAS 703</p>

<p>Location: Ocean Path at Sand Beach Parking Area Corrective Action: Add accessibility directional signs</p>			
<p><u>Deficiency</u> Accessible facilities are not identified, and directional signs are missing.</p>	<p><u>Solution</u> Add signage to roadway, trail intersections, entrance and exit multi-use paths and driveways to identify points of interest. Include ISO symbol wherever accessible parking, facilities or routes are available.</p>	<p><u>Criticality</u> Serious</p> <p><u>Timeframe</u> Short-term</p>

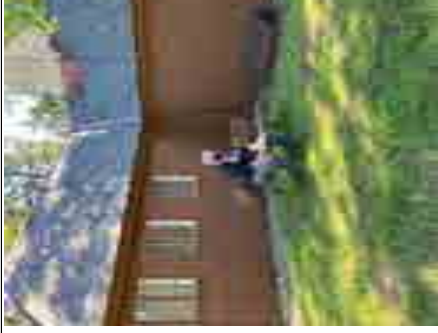
<p>ACAD_KGP_015</p>

<p>ACAD_KGP_002</p>
Reference Standards and Guidelines: ABA 305			
Location: Ranger's Station			
Corrective Action: Relocate bench			
<p><u>Deficiency</u> The bench is not along an accessible route.</p>	<p><u>Solution</u> Relocate the bench along an accessible route to improve access for all individuals.</p>	<p><u>Criticality</u> Minor</p> <p><u>Timeframe</u> Immediate</p>

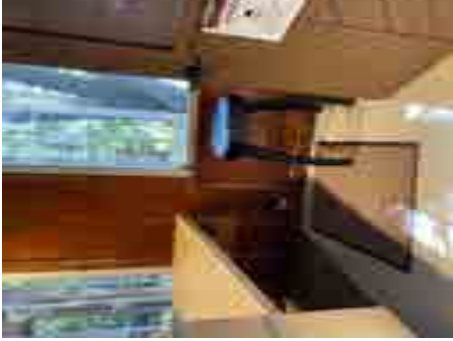
<p>ACAD_KGP_010</p>

<p>Location: Ranger's Station Corrective Action: Increase the space for individuals to turn inside the ranger's station to facilitate a front approach to the low countertop.</p>			
<p><u>Deficiency</u> The lower section of countertop in the Ranger Station is placed in the corner and blocked by the open door, so it is difficult for people using wheelchairs to be able to turn to access the space. (33.5" from edge of open door to lower counter). Individuals do not have the space to perform a front approach the low counter as intended.</p>	<p><u>Solution</u> Provide enough space to accommodate a circular or "T" turning space to allow for a front approach to the low countertop for individuals with mobility devices. This can be achieved by relocating the lower section of countertop to the middle or changing the swing of door to outside instead of inside to increase turning space to improve ease of use.</p>	<p><u>Criticality</u> Serious</p> <p><u>Timeframe</u> Short-term</p>

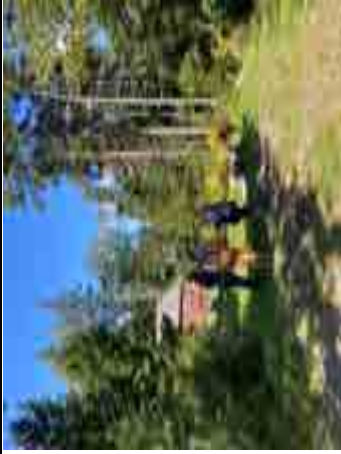
<p>Reference Standards and Guidelines: ABA 304</p>			
<p>Location: Accessible Campsites Corrective Action: Resurface accessible campsites with ground material that is firm and stable.</p>			
<p><u>Deficiency</u> The surface of the accessible campsites is not firm and stable.</p>	<p><u>Solution</u> Resurface accessible campsites with ground material that is firm and stable.</p>	<p><u>Criticality</u> Critical</p> <p><u>Timeframe</u> Short-term</p>

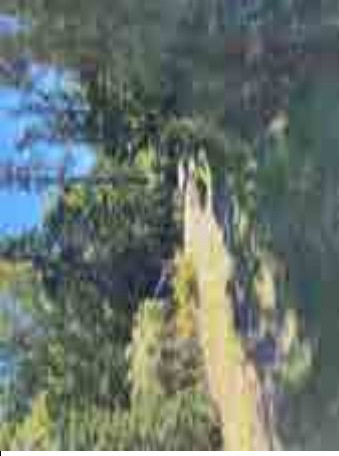
<p>Location: Accessible Campsites Corrective Action: Ensure picnic table has the appropriate group space around it before visitors check into the site.</p>			
<p><u>Deficiency</u> The accessible picnic tables are regularly moved to inaccessible areas that do not have enough clear space for someone with a disability to safely navigate around.</p>	<p><u>Solution</u> Park Rangers should check each accessible campsite prior to new visitors checking in to ensure the picnic tables are in an accessible location with at least 36" of clear space around the entire picnic table.</p>	<p><u>Criticality</u> Serious</p> <p><u>Timeframe</u> Immediate</p>

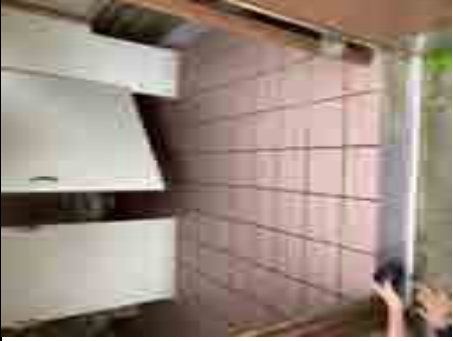
<p>Location: Restrooms Corrective Action: Install transition plates at the door thresholds.</p>			
<p><u>Deficiency</u> The change in surface height at some of the restroom thresholds is too large.</p>	<p><u>Solution</u> Install transition plates at the door thresholds or perform more regular door maintenance to decrease the change in surface height.</p>	<p><u>Criticality</u> Serious</p> <p><u>Timeframe</u> Immediate</p>

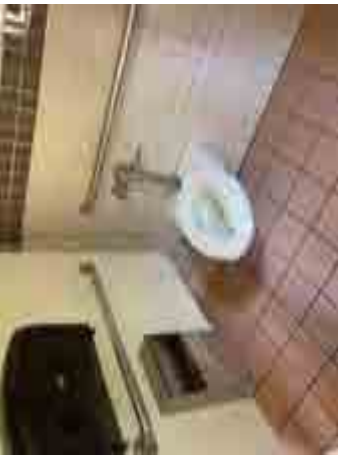
</div> <p>ACAD_KGP_038</p>

Location: Restrooms' Accessible Water Closets Corrective Action: Change placement of side and rear wall grab bars to adhere to standards. Ensure flush controls are on the open side of the toilet. Add D-rings to the interior accessible stall door.		
<p><u>Deficiency</u></p> <p>Rear and side wall grab bars are not in the correct locations.</p> <p>Some toilet paper dispensers and sanitary baskets interfere with the use of the grab bars.</p> <p>Some flush controls are located on the closed side of the toilet.</p> <p>The door of the accessible stall is difficult to close for individuals with impaired hand function.</p>	<p><u>Solution</u></p> <p>Change the placement of the side and rear wall grab bars to adhere to standards: The side wall grab bar shall be 42" long minimum, located 12" maximum from the rear wall and extending 54" minimum from the rear wall. The rear wall grab bar shall be 36" long minimum and extend from the centerline of the water closet 12" minimum on one side and 24" minimum on the other side.</p> <p>Ensure the toilet paper dispensers and sanitary baskets are within reach range and do not interfere with the use of the grab bars per standards in the accessible water closets.</p> <p>Ensure the flush controls are located on the open side of the toilet in the accessible water closets.</p> <p>Add D-rings to the inside door of the accessible stalls to facilitate door closing for people with impaired hand function.</p>	<p><u>Criticality</u></p> <p>Serious</p> <p><u>Timeframe</u></p> <p>Immediate</p> <div data-bbox="402 157 738 619">

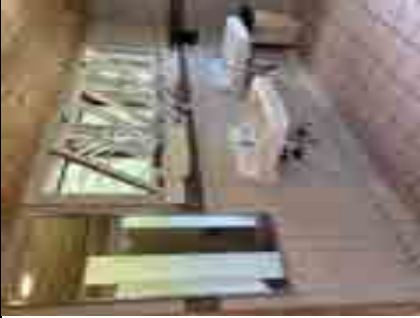
Location: Restrooms			
Corrective Action: Lower the shelf over the sinks.			
<p><u>Deficiency</u> The counter/shelf over the sink is too high (50.25").</p> <p>Some operable parts of restroom features are positioned too high outside of reach range.</p>	<p><u>Solution</u> Lower the shelf over the sink to a height of 40"- 48" maximum above the floor for individuals to be able to successfully reach and use the surface.</p> <p>Ensure the operable parts of all soap dispensers, hooks, outlets, baby changing stations are 48" maximum height above the floor and not blocked by other objects.</p>	<p><u>Criticality</u> Serious</p> <p><u>Timeframe</u> Short-term</p>

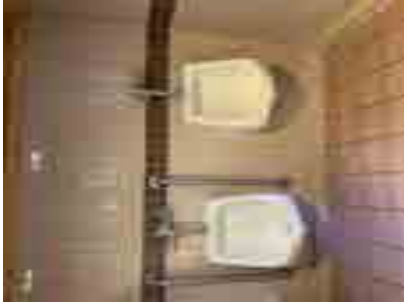
<p style="text-align: right;">ACAD_KGP_197</p>

<p style="text-align: right;">ACAD_KGP_039</p>
Reference Standards and Guidelines: ABA 603.4			
Location: Men's Restrooms			
Corrective Action: Lower the urinal.			
<p><u>Deficiency</u> The urinal is positioned too high (18").</p>	<p><u>Solution</u> Lower the position of the urinal to 17" maximum. Ensure wall hung urinals are positioned where the rim is 17" maximum above the finish floor or ground and 13.5" deep minimum measured from the outer face of the urinal rim to the back of the fixture. In addition, ensure appropriate clear space to facilitate a forward approach to the urinal.</p>	<p><u>Criticality</u> Serious</p> <p><u>Timeframe</u> Short-term</p>

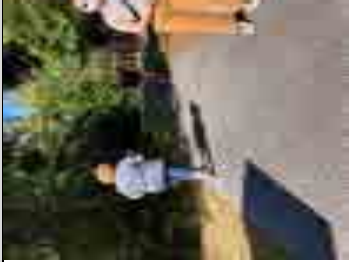
<p>Location: Amphitheater Corrective Action: Regrade and resurface path from parking lot to amphitheater area.</p>			
<p><u>Deficiency</u> The path from the parking lot to the amphitheater and to the kiosks is slippery, its gaps are too wide, and it has too steep of a cross slope (5.8%) and running slope (6.7%).</p>	<p><u>Solution</u> Regrade and resurface path to the amphitheater and kiosks to be firm, stable, and sleep resistant, with grades of <1:48, and without gaps of >1/2".</p>	<p><u>Criticality</u> Serious</p> <p><u>Timeframe</u> Short-term</p>

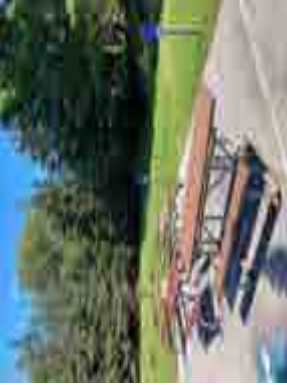
<p>ACAD_KGP_074</p>

<p>ACAD_KGP_064</p>
<p>Reference Standards and Guidelines: ABA 403</p>			
<p>Location: Group Campsites Corrective Action: Add 1 accessible picnic table to the current accessible group site and at least two accessible fire rings.</p>			
<p><u>Deficiency</u> There is only one accessible picnic table and no accessible fire rings in the accessible group campsite.</p>	<p><u>Solution</u> Ensure at least 20%, but no less than 2, picnic tables, fire rings, and pedestal grills are accessible at each of the accessible group sites.</p>	<p><u>Criticality</u> Serious</p> <p><u>Timeframe</u> Short-term</p>

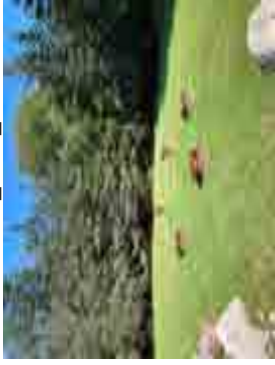
<p>ACAD_KGP_075</p>

Location: Group Campsites Corrective Action: Replace ground material and mark accessible group site on the map.		
<p><u>Deficiency</u> The group campsite's surface and the path leading to the restrooms is grass.</p> <p>The accessible group campsite is not marked on the campground map.</p>	<p><u>Solution</u> Replace surfaces with ground material that is firm and stable, like the material on the carriage roads.</p> <p>Ensure the accessible group campsites are marked on the campground map.</p>	<p><u>Criticality</u> Critical</p> <p><u>Timeframe</u> Short-term</p>
<p>Reference Standards and Guidelines: ABA 1013.2.2</p>		
Location: Dump Station Corrective Action: Widen the road through the dump station and ensure clear ground space at the dump station features.		
<p><u>Deficiency</u> There is no clear ground space around the dump station features and the road is too narrow.</p>	<p><u>Solution</u> Ensure there is a minimum of 30"x60" of clear ground space (with the long side of the space adjoining or overlapping the pull-up space for campers) around the waterspout and sewage hatch at the dump station for individuals who use mobility devices.</p> <p>Ensure the road at the dump site is at least 20 feet wide to provide appropriate clear space for individuals who use mobility devices.</p>	<p><u>Criticality</u> Serious</p> <p><u>Timeframe</u> Short-term</p>

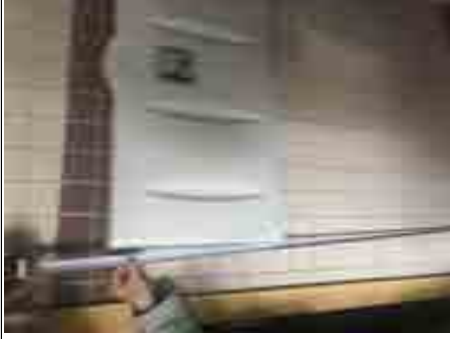
Location: Family Restroom			
Corrective Action: Lower baby changing station			
<p><u>Deficiency</u> The baby changing station is too high outside of reach range.</p>	<p><u>Solution</u> Lower the baby changing station so that the height of the opening mechanism is <48" to be within reach range.</p>	<p><u>Criticality</u> Serious</p> <p><u>Timeframe</u> Short-term</p>

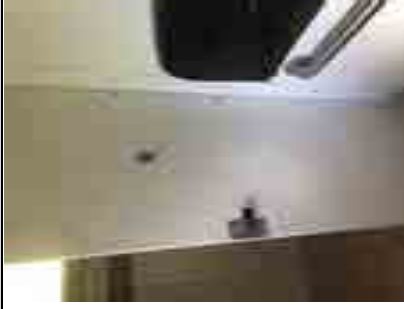
<p>Location: Women's, Men's, Family Restrooms Corrective Action: Lower clothing hook</p>			
<p><u>Deficiency</u> Clothing hook on wall is too high outside of reach range.</p>	<p><u>Solution</u> Lower the clothing hook so that it is <48" to be within reach range.</p>	<p><u>Criticality</u> Serious</p> <p><u>Timeframe</u> Immediate</p>

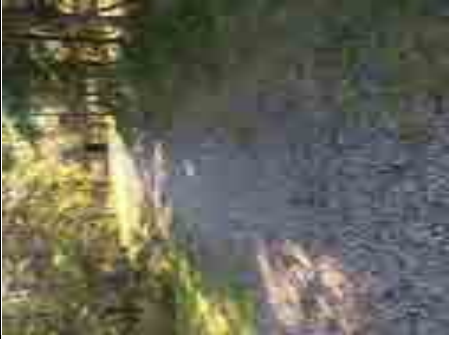
<p>Location: Family Restroom Corrective Action: Lower baby changing station and hook</p>			
<p><u>Deficiency</u> Path to restroom building is too narrow and has slope grades up to 9%.</p>	<p><u>Solution</u> Trim overgrown vegetation to ensure packed gravel paths are a minimum of 36" wide (paths may be reduced to 32" for a length of 24", but these reductions must be separated by segments that are a minimum of 48" long and 36" wide). Regrade path so path has a grade of <5%.</p>	<p><u>Criticality</u> Serious</p> <p><u>Timeframe</u> Short-term</p>

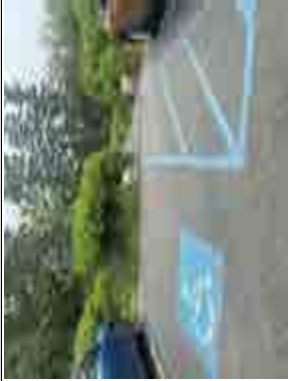
<p>Location: Parking lot Corrective Action: Install accessible parking sign</p>			
<p><u>Deficiency</u> There is no sign identifying the accessible parking space at the trail entrance. The sign at the space near the toilet says, "Handicapped Parking."</p>	<p><u>Solution</u> Install a sign indicating the accessibility of the space (van-accessible, if wide enough) and containing the International Symbol of Accessibility (ISA). Ensure that the sign is 60 inches minimum from the ground to the bottom edge. Replace the sign at the accessible space near the toilet with one that uses the more up-to-date term "accessible" rather than "handicapped," which is not favored.</p>	<p><u>Criticality</u> Serious</p> <p><u>Timeframe</u> Immediate</p>

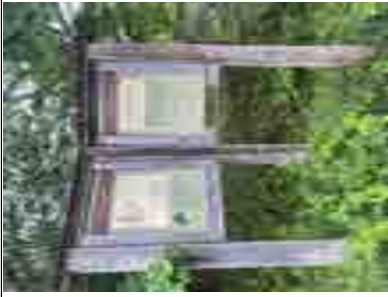
<p>NPS_ACAD_LKW_176</p>
<p>Reference Standards and Guidelines: ABAAS 1017.10</p>

<p><u>Deficiency</u> Visitors do not have access to the information needed to determine their use of the trail.</p>	<p><u>Solution</u> Move the existing two-panel kiosk close to the parking lot and add trail segment information including slope, surfacing and distance.</p>	<p><u>Criticality</u> Serious</p> <p><u>Timeframe</u> Short-term</p>

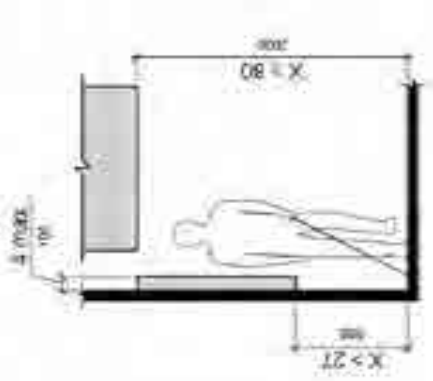
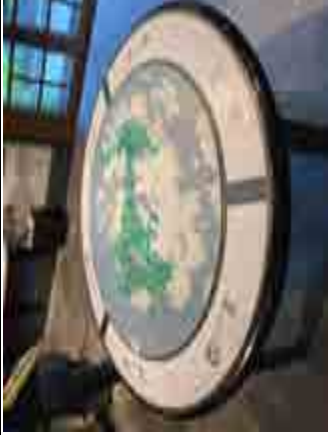
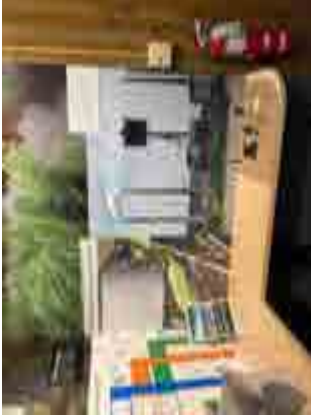
<p>Location: Nature Center Corrective Action: Install cane detection at exhibits</p>	
<p><u>Deficiency</u> The exhibit shelf along the wall at the exhibits protrudes into the pedestrian route and is too high for cane detection by visitors who are blind.</p>	<p><u>Solution</u> Install a lip that brings the outside edge of shelves, tables, and other features that are deeper than four inches down to the standard height for cane detectability (27 inches from floor); or install a barrier on the ground below.</p>

<p><u>Criticality</u> Critical</p> <p><u>Timeframe</u> Immediate</p>

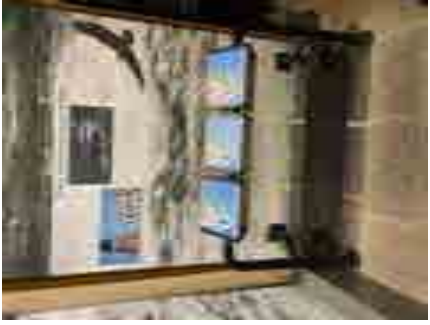
<p>Location: Nature Center Corrective Action: Reduce pressure necessary to operate moveable components</p>			
<p><u>Deficiency</u> The hurricanes exhibit has an operable component that requires excessive pressure to manipulate. It was measured at 9 psi. (This display is also not cane detectable – see above.)</p>	<p><u>Solution</u> Reduce the pressure necessary to move the display components to less than or equal to five pounds.</p>	<p><u>Criticality</u> Serious</p> <p><u>Timeframe</u> Immediate</p>

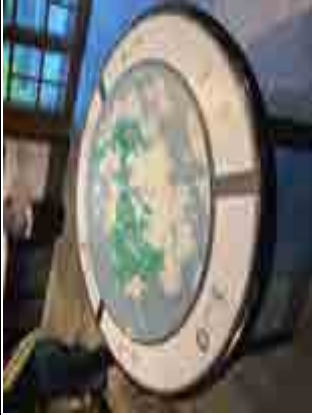
<p>NPS_ACAD_KGP_246</p>

<p>Location: Nature Center Corrective Action: Provide meaningful and accessible tactile exhibits</p>		
<p><u>Deficiency</u> The topographic map is too wide to be reached by someone using a wheelchair and the key is only provided visually. In addition, tactile objects in the wall panel displays do not offer a full or equivalent experience related to the objects behind the plexiglass barrier.</p>	<p><u>Solution</u> Provide replicas or duplicates of key meaningful artifacts for tactile displays. Choose items that are unique or outside the range of typical visitor experience, for example the woven basket as opposed to maple syrup jug. Consider adding additional tactile features to existing exhibits, for example tree bark samples.</p>	<p><u>Criticality</u> Critical</p> <p><u>Timeframe</u> Immediate</p>

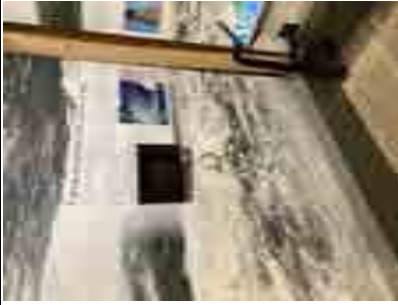
Location: Nature Center			
Corrective Action: Add audio description to video components of exhibits			
<p><u>Deficiency</u> The interpretive videos (provided via exhibit-embedded tablets) are not audio described.</p>	<p><u>Solution</u> Record and add to existing videos an introduction that describes the setting and context for the video.</p>	<p><u>Criticality</u> Critical</p> <p><u>Timeframe</u> Immediate</p>

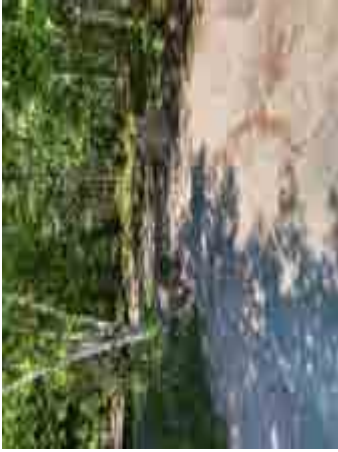
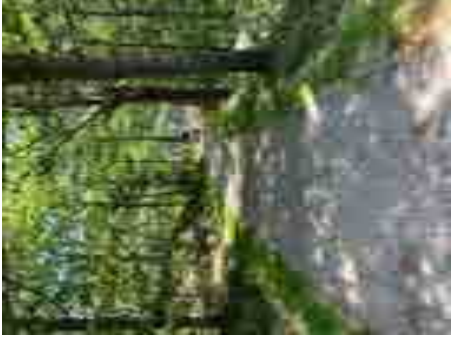
Location: The Beachcroft Path	
<p>Corrective Action: Change the ground material on the Beachcroft Path</p>	
<p><u>Deficiency</u> The Beachcroft Path has rocks of >2 inches in size and ends at an area of loose gravel that is unstable.</p>	<p><u>Solution</u> Recommend removing rocks that are 2+ inches large and confining the packed ground material all the way to the historic rock bridge at the end of the accessible trail.</p>
<p><u>Criticality</u> Serious</p> <p><u>Timeframe</u> Short-Term</p>

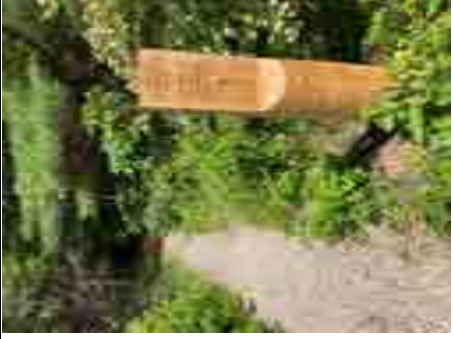
Location: Directional Trail Signs			
Corrective Action: Increase lettering contrast			
<p><u>Deficiency</u> There is not enough contrast between trail name lettering and the wooden post.</p>	<p><u>Solution</u> Recommend making the directional signs more easily readable by individuals who have low vision by increasing the color contrast between the lettering and the wooden post.</p>	<p><u>Criticality</u> Serious</p> <p><u>Timeframe</u> Short-Term</p>

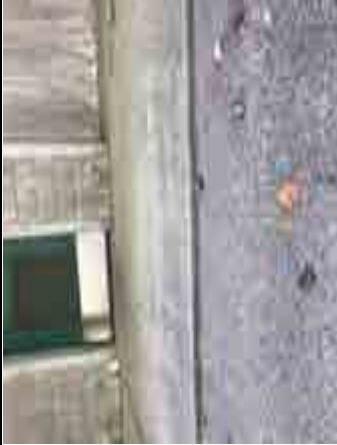
<p>Location: Restroom building Corrective Action: Repair change in level</p>			
<p><u>Deficiency</u> There is a 1.5" change in level at the front of the restroom building.</p>	<p><u>Solution</u> Relay the concrete of the path to ensure a maximum change in level of ¼ inch.</p>	<p><u>Criticality</u> Serious</p> <p><u>Timeframe</u> Short-term</p>

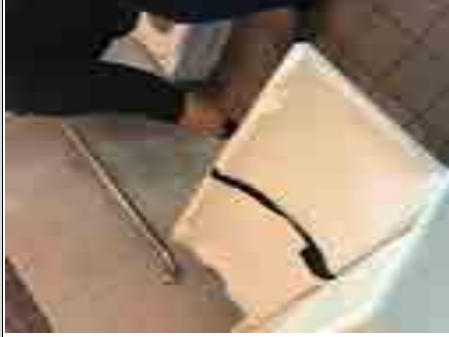
<p>ACAD_Thompson Picnic_LMK_022</p>
Reference Standards and Guidelines: ABBAS 604.8.1.1,

Location: Family Restroom Corrective Action: Reduce the amount of force needed on door			
<u>Deficiency</u> The entry door requires excessive force to open.	<u>Solution</u> Reduce the amount of force needed to open the door to 5 pounds maximum.	<u>Criticality</u> Critical <u>Timeframe</u> Immediate	No photo
Reference Standards and Guidelines: ABBAS 604.5, 604.7, 609.3, 609.4			
Location: Family Restroom Corrective Action: Reposition changing table			
<u>Deficiency</u> The placement of the changing table does not allow for maneuvering into position.	<u>Solution</u> Reposition the changing table so that it folds down from the rear wall.	<u>Criticality</u> Serious <u>Timeframe</u> Immediate

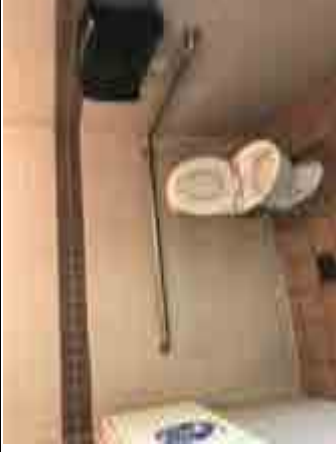
Location: Family Restroom			
Corrective Action: Re-install grab bars			
<p><u>Deficiency</u> Grab bars are incorrectly installed, and the side wall is too short for correct installation at 52.75".</p>	<p><u>Solution</u> The side wall should be built out so it measures 54" in length. Reinstall new grab bars where the side wall grab bar is 42" long minimum, located 12" maximum from the rear wall and extending 54" minimum from the rear wall and the rear wall grab bar is 36" long minimum and extend from the centerline of the water closet 12" minimum on one side and 24" minimum on the other side.</p>	<p><u>Criticality</u> Serious</p> <p><u>Timeframe</u> Short-term</p>

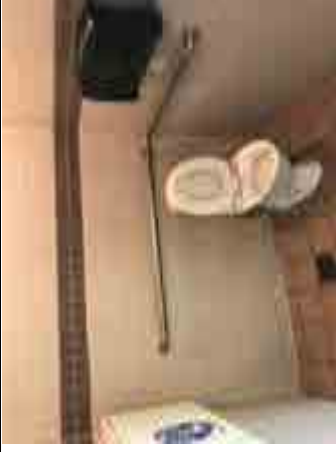
<p>ACAD_Thompson Picnic_LMK_020</p>
Reference Standards and Guidelines: ABBAS 604.5.1, 604.5.2			
Location: Family Restrooms			
Corrective Action: Relocate toilet paper dispenser			
<p><u>Deficiency</u> The space between the toilet paper dispenser and grab bars is not sufficient.</p>	<p><u>Solution</u> Reinstall the toilet paper dispenser 7" minimum and 9" maximum in front of the toilet measured to the centerline of the dispenser. The outlet of the dispenser shall be 15" minimum and 48" maximum above the finish floor and shall not be located behind grab bars.</p>	<p><u>Criticality</u> Serious</p> <p><u>Timeframe</u> Immediate</p>

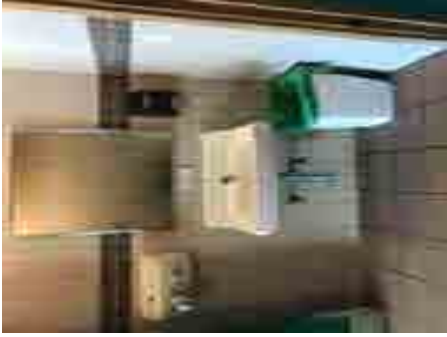
<p>Location: Family Restroom Corrective Action: Wrap pipes under sink</p>			
<p><u>Deficiency</u> Pipes under sink are exposed.</p>	<p><u>Solution</u> Wrap the pipes under the sinks in the Restrooms to prevent injury from hot/cold and sharp edges for someone who uses a wheelchair and positions their legs under the sink while washing their hands.</p>	<p><u>Criticality</u> Critical</p> <p><u>Timeframe</u> Immediate</p>

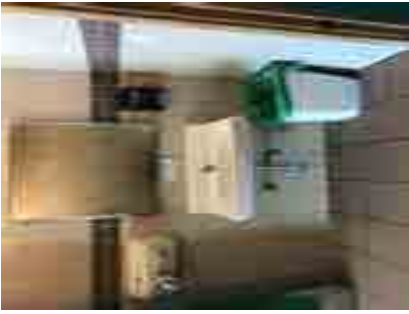
<p>ACAD_Thompson Picnic_LMK_019</p>
<p>Reference Standards and Guidelines: ABBAS 603.3</p>

<p>ACAD_Thompson Picnic_LMK_019</p>
<p>Reference Standards and Guidelines: ABBAS 606.5</p>			
<p>Location: Family Restroom Corrective Action: Lower mirror</p>			
<p><u>Deficiency</u> The mirror is currently too high at 43.5".</p>	<p><u>Solution</u> Lower the mirror to 40" above the finish floor.</p>	<p><u>Criticality</u> Serious</p> <p><u>Timeframe</u> Immediate</p>

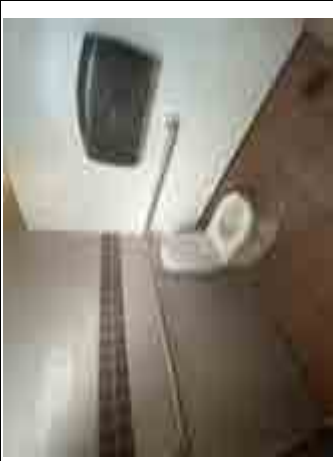
<p>ACAD_Thompson Picnic_LKW_006</p>

Location: Women's Restroom Corrective Action: Re-install grab bars and toilet paper dispenser		
<p><u>Deficiency</u> Grab bars are incorrectly installed.</p> <p>The space between the toilet paper dispenser and grab bars is not sufficient.</p>	<p><u>Solution</u> Flip and reinstall grab bars so the side wall grab bar is 42" long minimum, located 12" maximum from the rear wall and extending 54" minimum from the rear wall and the rear wall grab bar is 36" long minimum and extend from the centerline of the water closet 12" minimum on one side and 24" minimum on the other side.</p> <p>Reinstall the toilet paper dispenser 7" minimum and 9" maximum in front of the toilet measured to the centerline of the dispenser. The outlet of the dispenser shall be 15" minimum and 48" maximum above the finish floor and shall not be located behind grab bars.</p>	<p><u>Criticality</u> Serious</p> <p><u>Timeframe</u> Immediate</p>

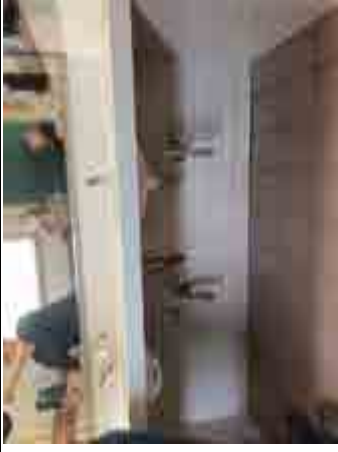
<p>Location: Women's Restroom</p> <p>Corrective Action: Wrap pipes under sink</p>			
<p><u>Deficiency</u> Pipes under sink are exposed.</p>	<p><u>Solution</u> Wrap the pipes under the sinks in the Restrooms to prevent injury from hot/cold and sharp edges for someone who uses a wheelchair and positions their legs under the sink while washing their hands.</p>	<p><u>Criticality</u> Critical</p> <p><u>Timeframe</u> Immediate</p>

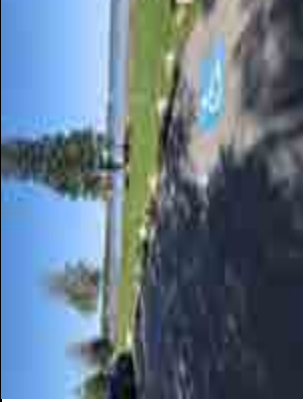
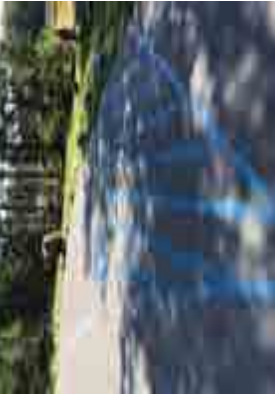
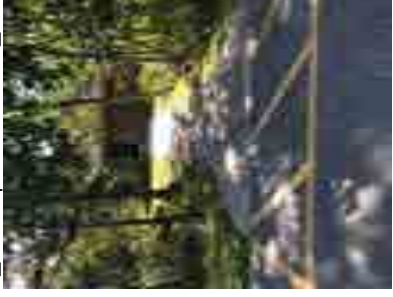
<p>Location: Parking Lot Corrective Action: Rescope and restripe the accessible parking and access aisles</p>	
<p>Deficiency Accessible parking spaces are not properly marked. Accessible space in front lot on the right does not have an access aisle on the passenger side, which is required for angled spaces.</p>	<p>Solution Add appropriate signage and raise the sign marking the van-accessible parking space to >60". Signs identifying van parking spaces shall contain the designation "van accessible." Signs shall be 60" minimum above the finish floor or ground surface measured to the bottom of the sign. Maintain angled parking in front lot and add access aisles as required or relocate one accessible space closer to restroom building and add access aisle. Ensure that access aisle is met by a curb cut at the sidewalk or is connected to a crosswalk leading to accessible route to restroom building.</p>

<p>Criticality Serious</p> <p>Timeframe Short-term</p>

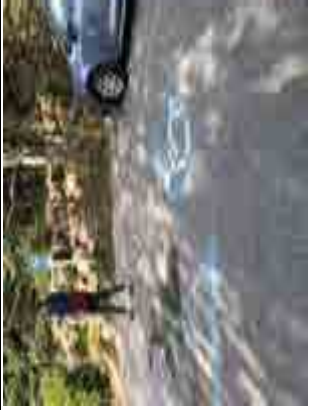
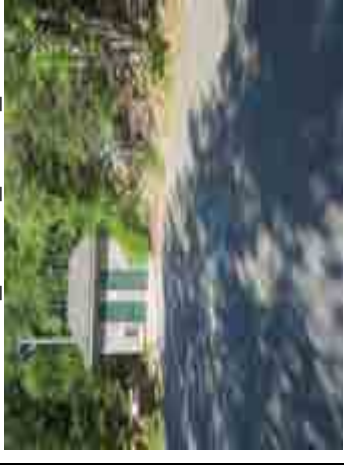
<p>Location: Parking Lot Corrective Action: Rescope and restripe the accessible parking and access aisles</p>			
<p><u>Deficiency</u> Accessible parking spaces are not properly marked for angled parking. Some van accessible spaces do not have an access aisle on the passenger side, which is required for angled spaces.</p>	<p><u>Solution</u> Maintain angled parking and add access aisles as required. Ensure that aisle is met by a curb cut at the sidewalk. Recommend adding appropriate signage raising the sign marking the van accessible parking space to >60".</p>	<p><u>Criticality</u> Serious</p> <p><u>Timeframe</u> Short-term</p>

Recommendation #2: Improve the accessible parking area by installing vertical signage at the front, center of each parking space including the International Symbol for Accessibility and ensure appropriate access aisles are implemented to comply with ABA standards.

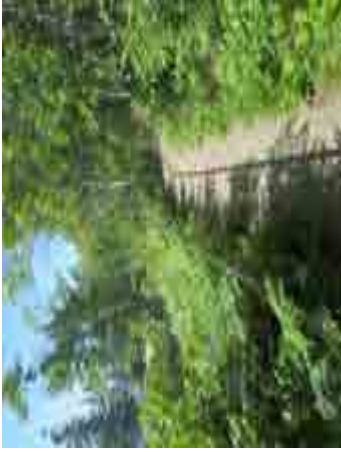
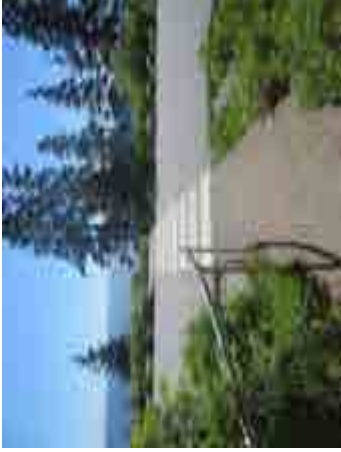
<p>Location: Parking lot Corrective Action: Add handrails and edge protection to accessible route</p>			
<p><u>Deficiency</u> Accessible route from parking lot to viewing area has high cross slope with no edge protection and handrails only on one side.</p>	<p><u>Solution</u> Add handrails and edge protection to full length of route, on both sides. Ensure end of handrails fully return. Handrails should be continuous, closed, and meet ABA standards for height and dimensions.</p>	<p><u>Criticality</u> Serious</p> <p><u>Timeframe</u> Short-term</p>

Recommendation #5: Due to accessible route slope, handrails should be placed on both sides of route and edge protection should be implemented.

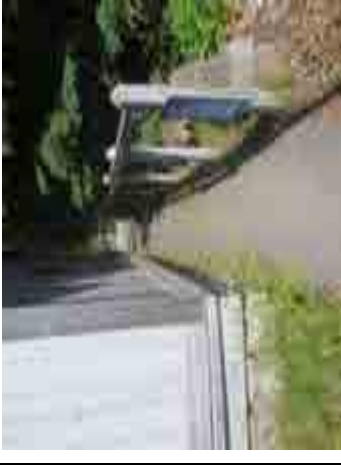
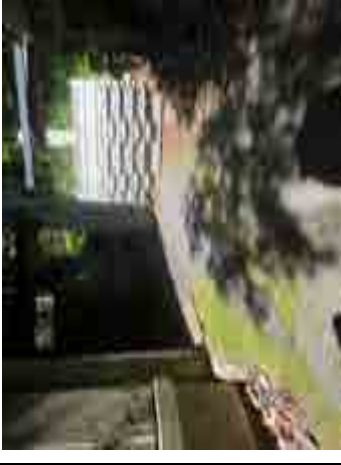
Location: Parking lot – Gift Shop Corrective Action: Improve accessible entrance ramp			
<p><u>Deficiency</u></p> <p>Current ramp has non-grippable handrail only on one side with open ends. Landing at the rear accessible entrance is not level and ground space is not clear.</p>	<p><u>Solution</u></p> <p>Replace handrails with grippable rails that fully return on both ends. Handrails should be on both sides of ramp. Landing at rear entrance should be made level. Implement staff training to ensure route is kept clear of obstructions.</p>	<p><u>Criticality</u></p> <p>Serious</p> <p><u>Timeframe</u></p> <p>Immediate</p>

Recommendation #4: Improve entrance to gift shop by replacing handrails on stairs, implementing grippable handrails on both sides of accessible route, leveling the landing on accessible route and improving slope to be in compliance with ABA standards.

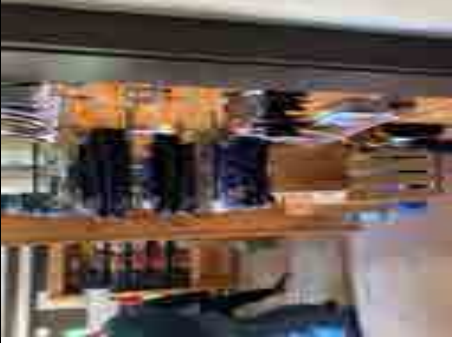
<p>Location: Parking lot – Gift Shop</p> <p>Corrective Action: Remove Protruding Object</p>			
<p><u>Deficiency</u></p> <p>The clear width for one interior doorway is currently obstructed by protruding shelf.</p>	<p><u>Solution</u></p> <p>Remove glass shelf near doorway to provide appropriate clear width of 32".</p>	<p><u>Criticality</u></p> <p>Minor</p> <p><u>Timeframe</u></p> <p>Immediate</p>

Recommendation #2: There is one glass shelf inside the gift shop that reduces the clear width of a doorway. This shelf should be removed to provide 32" of clear width.

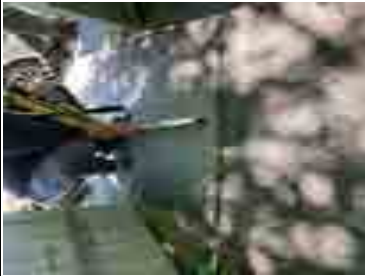
<p>Location: Entrance/Exit Gate</p> <p>Corrective Action: Remove slope</p>			
<p><u>Deficiency</u></p> <p>Slope at the exit gate to the parking lot is >17% and has a change in level of 1 inch.</p>	<p><u>Solution</u></p> <p>Extend the sloped path from the exit gate to lessen the slope.</p>	<p><u>Criticality</u></p> <p>Serious</p> <p><u>Timeframe</u></p> <p>Short-term</p>

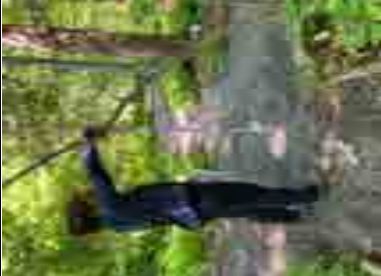
<p>NPS_ACAD_KGP_338</p>

<p>NPS_ACAD_KGP_360</p>
<p>Reference Standards and Guidelines: ABAAS 303 Changes in Level; 1016 Outdoor Recreation Access Routes</p>			
<p>Location: Garden paths</p> <p>Corrective Action: Pruning branches and other vegetation</p>			
<p><u>Deficiency</u></p> <p>There are points along the garden paths where branches protrude into the pedestrian route, between 27 and 80 inches.</p>	<p><u>Solution</u></p> <p>Prune or trim branches out of the paths.</p>	<p><u>Criticality</u></p> <p>Critical</p> <p><u>Timeframe</u></p> <p>Immediate</p>

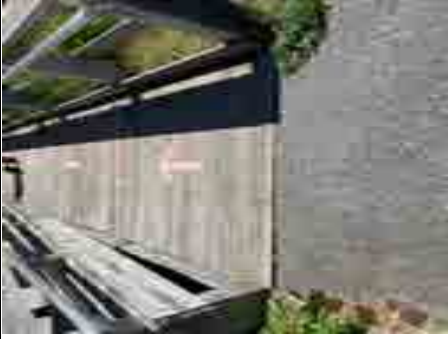
<p>Location: Path from Parking Lot to Main Building Corrective Action: Remove gap between change in surfaces.</p>			
<p><u>Deficiency</u> There is a gap between the paved path from the parking lot to the ramp.</p>	<p><u>Solution</u> Install a transitional plate between the paved path and the ramp to remove the gap in surfaces and improve the accessible route.</p>	<p><u>Criticality</u> Serious</p> <p><u>Timeframe</u> Immediate</p>

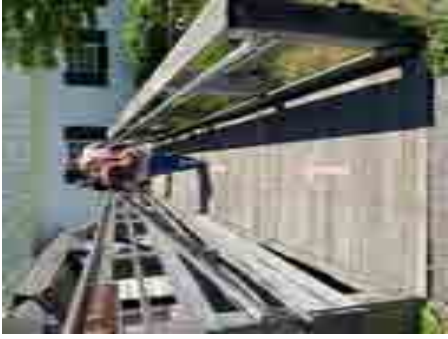
<p>NPS_ACAD_KGP_388</p>

<p>NPS_ACAD_KGP_389</p>
<p>Reference Standards and Guidelines: ABAAS 302.3, 303</p>			
<p>Location: Main Building - Ramp Corrective Action: Extend bilateral hand railings at the top and bottom of the ramp</p>			
<p><u>Deficiency</u> The ramp's bilateral handrails do not extend far enough at the top and bottom of the ramp.</p>	<p><u>Solution</u> Extending the ramp's hand rails bilaterally by a minimum of 12" in the same direction of travel at the top and bottom of the ramp.</p>	<p><u>Criticality</u> Serious</p> <p><u>Timeframe</u> Short-term</p>

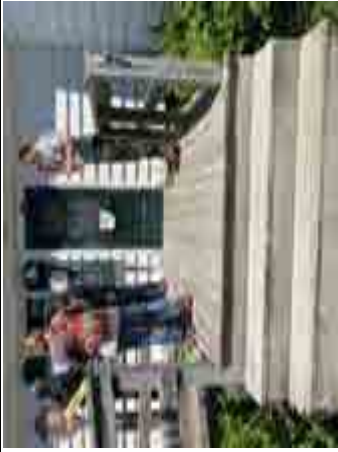
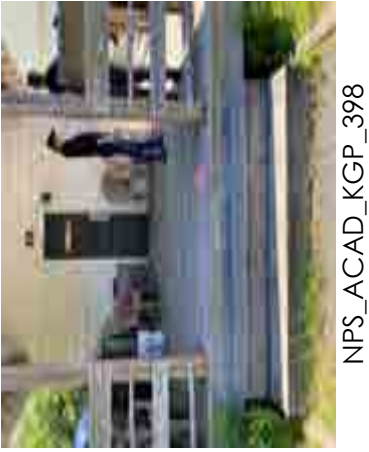
<p>Location: Main Building – front and side steps Corrective Action: Rebuild steps and add railings</p>		
<p><u>Deficiency</u> The front and side steps do not have uniform height and depth and they do not have handrails.</p>	<p><u>Solution</u> Rebuild the front and side steps with a uniform height between 4"-7" and a uniform depth of 11" and add bilateral handrails to both sets of stairs.</p>	<p><u>Criticality</u> Critical</p> <p><u>Timeframe</u> Short-term</p> <div data-bbox="321 163 656 611">

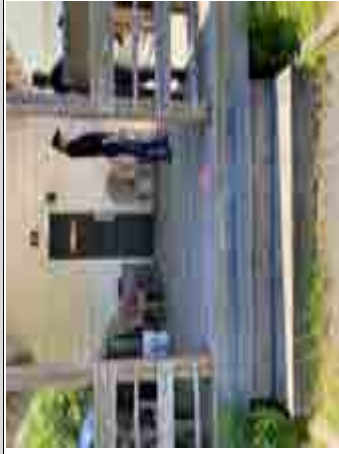
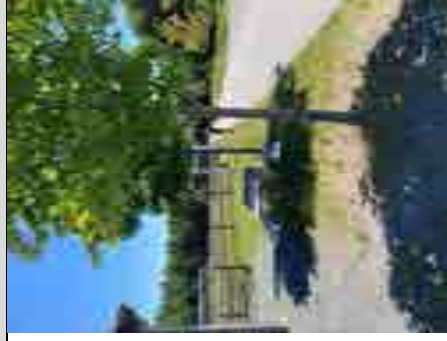
Location: Main Building - Porch Corrective Action: Add edge protection around the perimeter of the porch		
<u>Deficiency</u> There is no edge protection around the perimeter of the porch	<u>Solution</u> Add edge protection around the perimeter of the porch.	<u>Criticality</u> Critical <u>Timeframe</u> Short-Term
Reference Standards and Guidelines: ABAAS 405.9		
Location: Sitting Area around Main Building Corrective Action: Add accessible picnic tables		
<u>Deficiency</u> There is one picnic table that is not accessible.	<u>Solution</u> If picnic tables are available for use by the public, at least 20%, but no less than one, must comply with ABA standards (at least one wheelchair space positioned for a forward approach must be provided for each 24 ft of usable table surface and shall be a minimum of 30" by 48" with knee and toe clearance).	<u>Criticality</u> Serious <u>Timeframe</u> Short-term

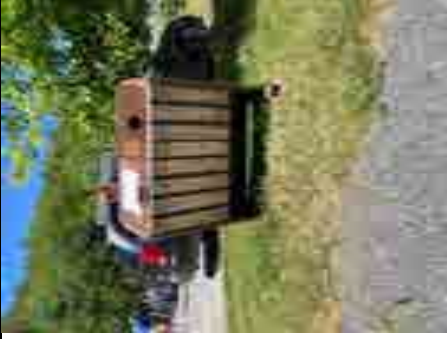
Location: Trash and Recycling Receptacles			
Corrective Action: Move receptacles closer to accessible path.			
<p><u>Deficiency</u> The trash and recycling receptacles are too far off the accessible path.</p>	<p><u>Solution</u> Move the trash and recycling receptacles closer to the accessible path to be within reach range.</p>	<p><u>Criticality</u> Serious</p> <p><u>Timeframe</u> Immediate</p>

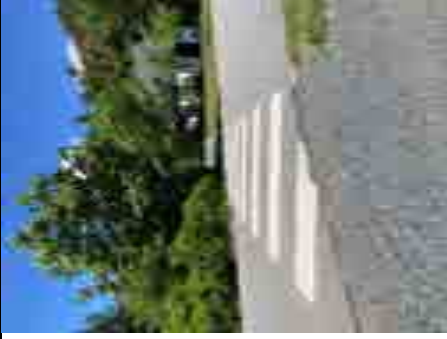
<p style="text-align: right;">NPS_ACAD_KGP_435</p>

<p style="text-align: right;">NPS_ACAD_KGP_399</p>
Reference Standards and Guidelines: ABAAS 308			
Location: Crosswalk			
Corrective Action: Add packed gravel to smooth transition from path to sidewalk.			
<p><u>Deficiency</u> There is a gap between the packed gravel path and pavement at the crosswalk.</p>	<p><u>Solution</u> Smooth the transition between the packed gravel path and pavement to remove the gap by adding packed gravel to the path to improve the accessible route.</p>	<p><u>Criticality</u> Critical</p> <p><u>Timeframe</u> Immediate</p>

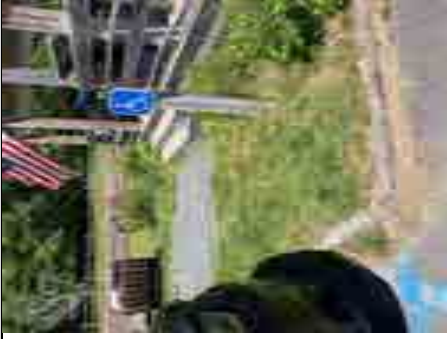
Location: Van Accessible Parking Space (in front of ramp)			
Corrective Action: Replace and raise sign			
<p>Deficiency The van-accessible parking space is not identified correctly, and the sign is too low.</p>	<p>Solution Improve accessible parking by identifying the accessible parking space closest to the ramp with the International Symbol of Accessibility and the designation "van accessible" on a sign that is a minimum of 60" above the ground to the bottom of the sign.</p>	<p>Criticality Serious</p> <p>Timeframe Short-term</p>

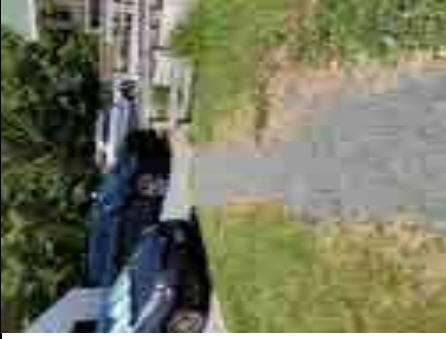
<p style="text-align: right;">NPS_ACAD_KGP_443</p>

<p style="text-align: right;">NPS_ACAD_KGP_445</p>
Reference Standards and Guidelines: ABAAS 502.6, 703.7.2.1			
Location: Packed gravel paths outside main building			
Corrective Action: Trim back vegetation			
<p>Deficiency The vegetation is overgrown at some areas of the gravel paths outside of the main building making the accessible routes too narrow.</p>	<p>Solution Trim overgrown vegetation to ensure packed gravel paths are a minimum of 36" wide (paths may be reduced to 32" for a length of 24", but these reductions must be separated by segments that are a minimum of 48" long and 36" wide).</p>	<p>Criticality Critical</p> <p>Timeframe Immediate</p>

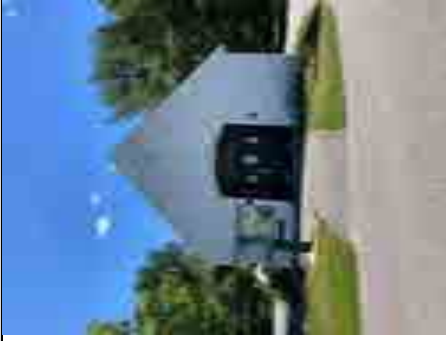
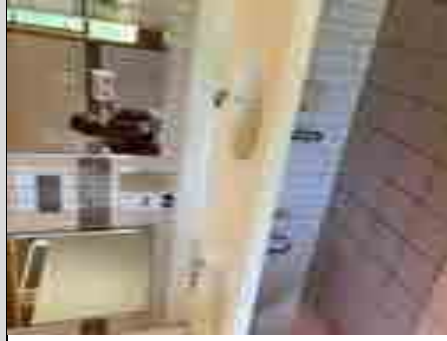
<p>Location: Outside restroom building Corrective Action: Install transitional plate between paved path and restroom concrete surface</p>		
<p><u>Deficiency</u> The change in level between the paved path leading to the restrooms and the concrete alcove floor of the restrooms is too large (1.5 inches).</p>	<p><u>Solution</u> Install a transitional plate between the paved path and concrete restroom floor to ramp the change in levels (grade can be steeper than 1:10 but not steeper than 1:8).</p>	<p><u>Criticality</u> Critical</p> <p><u>Timeframe</u> Immediate</p>
<p>Reference Standards and Guidelines: ABA AS 303, 405.2</p>		
<p>Location: Men's and Women's Restrooms Corrective Action: Wrap pipes under sinks.</p>		
<p><u>Deficiency</u> The pipes are exposed underneath the sink.</p>	<p><u>Solution</u> Wrap the pipes under the sinks in the Men's and Women's Restrooms to prevent injury from hot/cold and sharp edges for someone who uses a wheelchair and positions their legs under the sink while washing their hands.</p>	<p><u>Criticality</u> Critical</p> <p><u>Timeframe</u> Immediate</p>

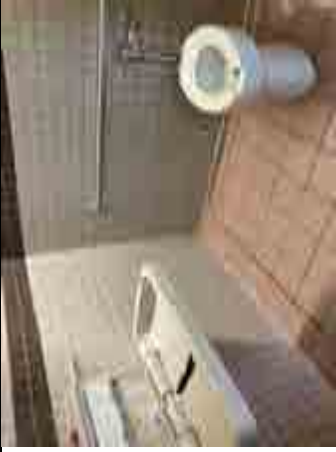
Location: Men's and Women's Restrooms			
Corrective Action: Lower the baby changing station			
<p><u>Deficiency</u> The baby changing station is too high outside of reach range.</p>	<p><u>Solution</u> Lower the baby changing station so that the height of the opening mechanism is <48" to be within reach range.</p>	<p><u>Criticality</u> Serious</p> <p><u>Timeframe</u> Short-term</p>
