COLORADO CULTURAL RESOURCE SURVEY

# Architectural Inventory Form

1. Resource number: 5OT.1728
2. Temporary resource number: N/A
3. County: Otero
4. City: La Junta
5. Historic building name: Bent's Old Fort (Reconstructed)
6. Current building name: Bent's Old Fort (Reconstructed)
7. Building address: 35100 State Highway 194 East, La Junta, CO 81050
8. Owner name and address: National Park Service, Intermountain Region, P.O. Box 25287, Denver, CO 80225

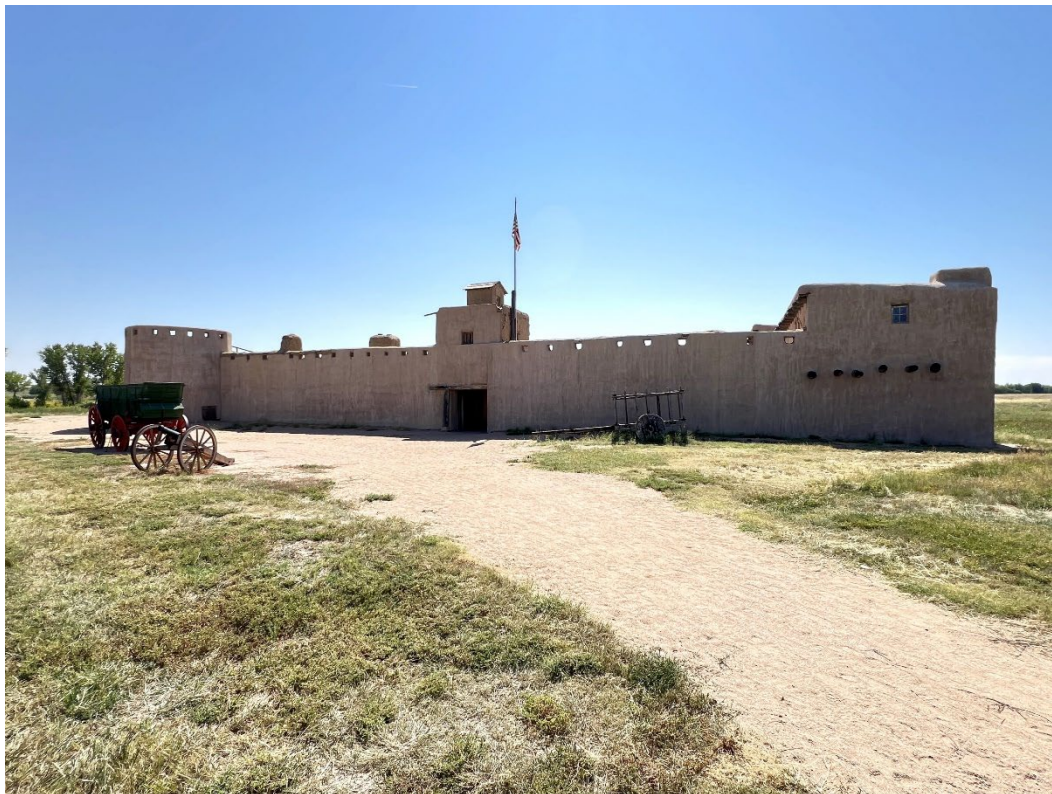
**Photo Number:** 50T.1728\_1

**Description:** Looking at the primary (north) elevation of the resource.

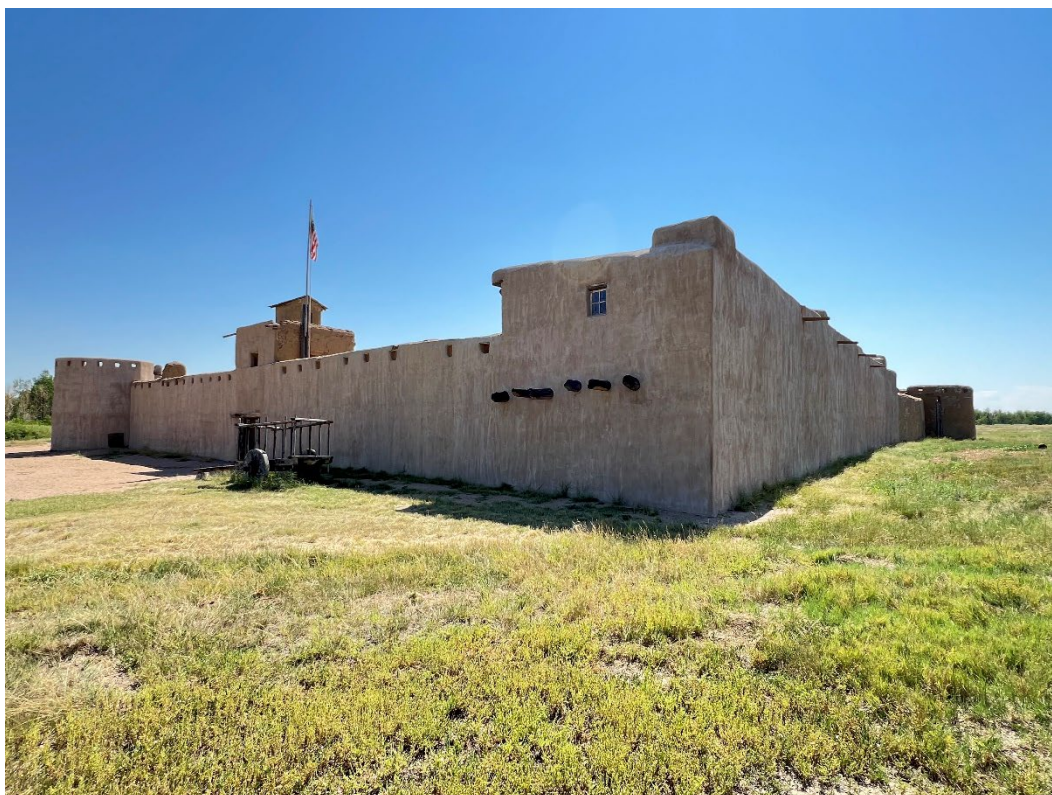
**Photo Number:** 50T.1728\_2

**Description:** View of the primary (north) and west elevations of the resource.

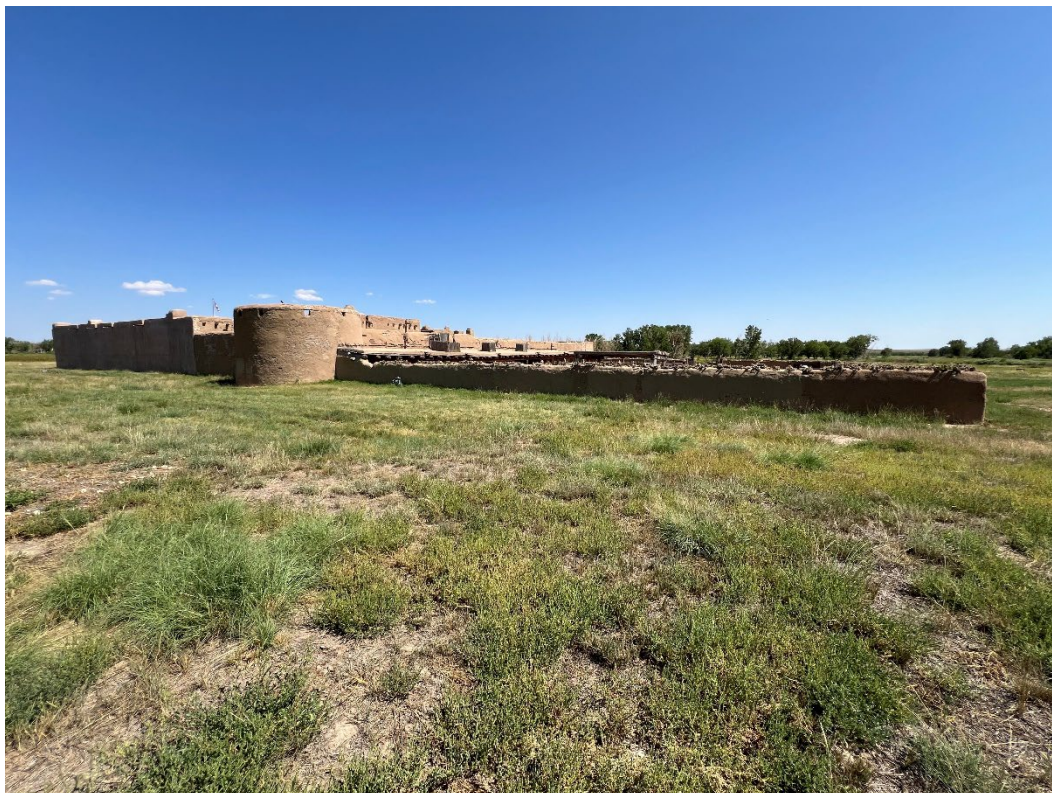
**Photo Number:** 5OT.1728\_5

**Description:** Looking at the far-right side of the west elevation.

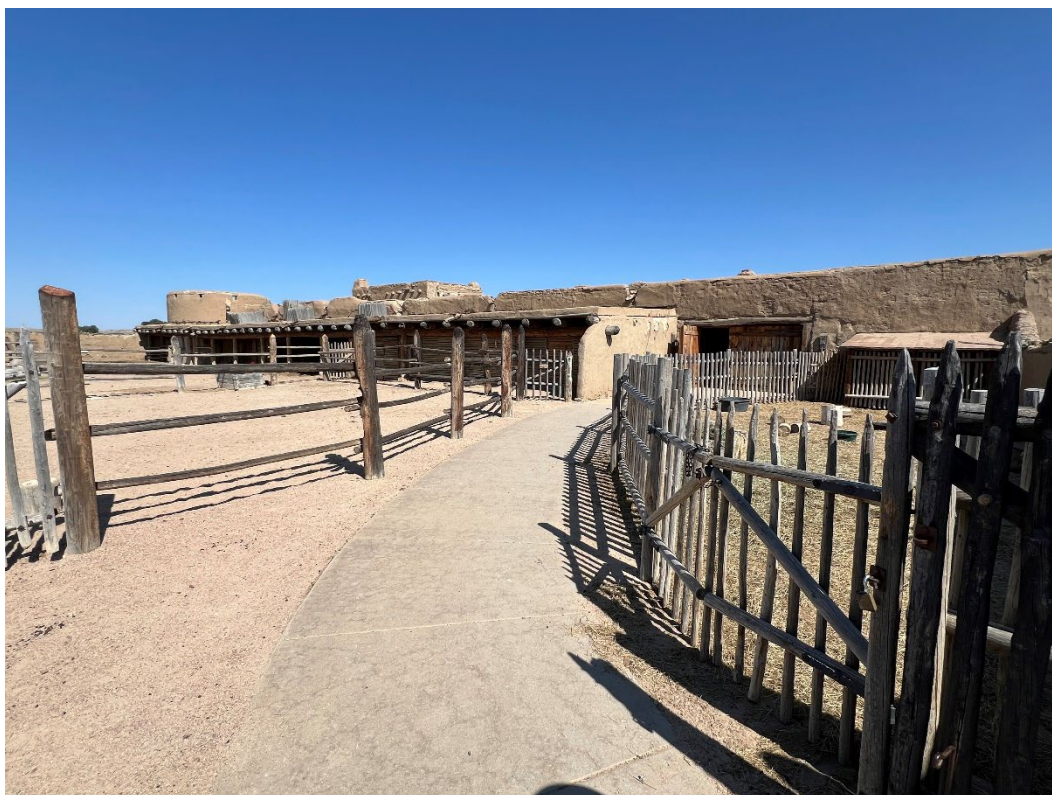
**Photo Number:** 5OT.1728\_6

**Description:** Detail view of the Main Corral space.

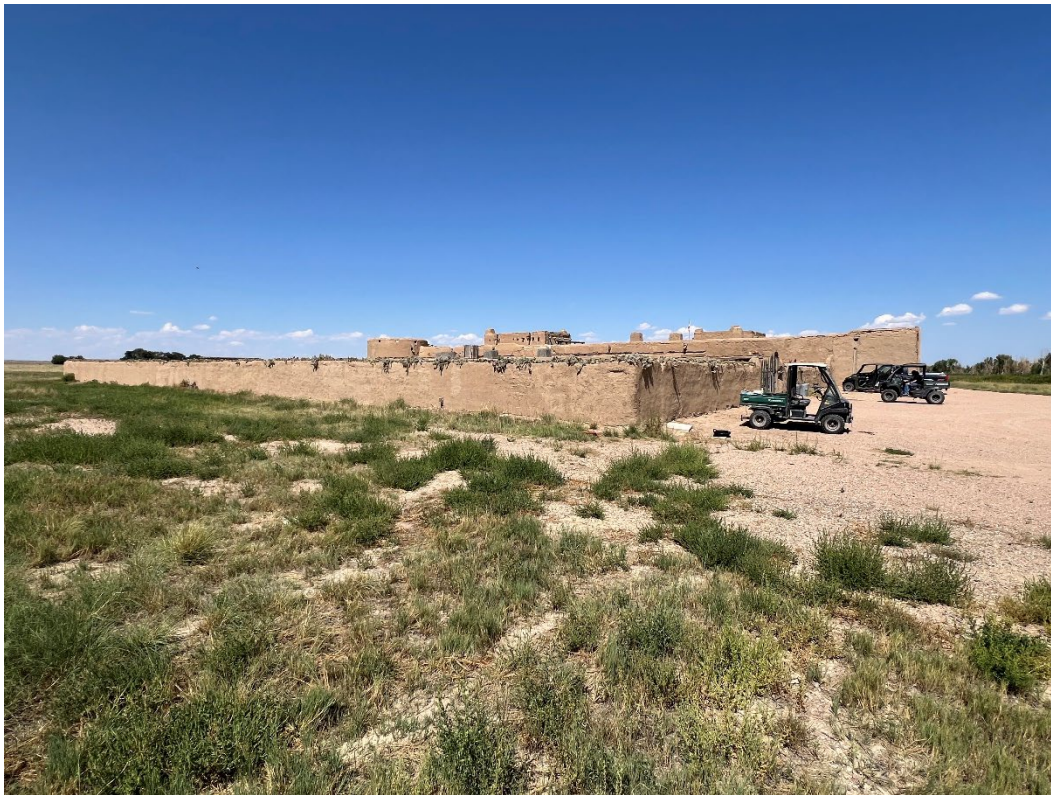
**Photo Number:** 5OT.1728\_7

**Description:** Looking at the south and east elevations of the resource. Note that the Main Corral is located behind the exterior wall.

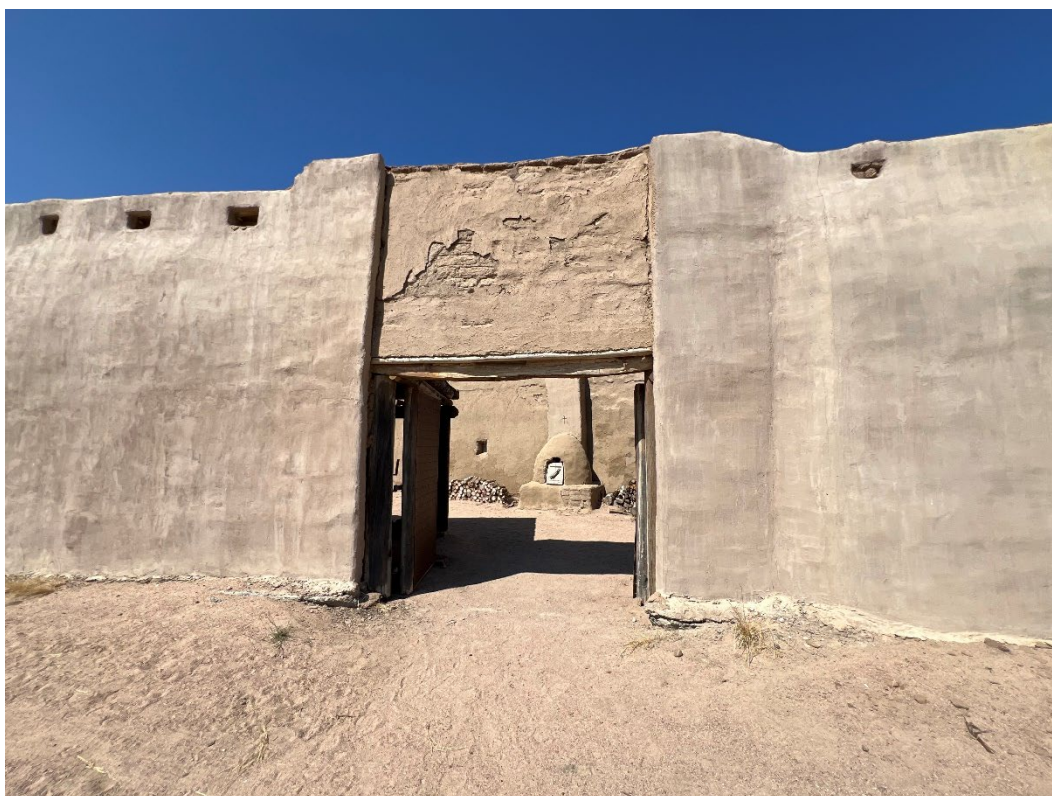
**Photo Number:** 5OT.1728\_9

**Description:** View of the auxiliary entrance to the Inner Carrol. The main entrance features identical doors.

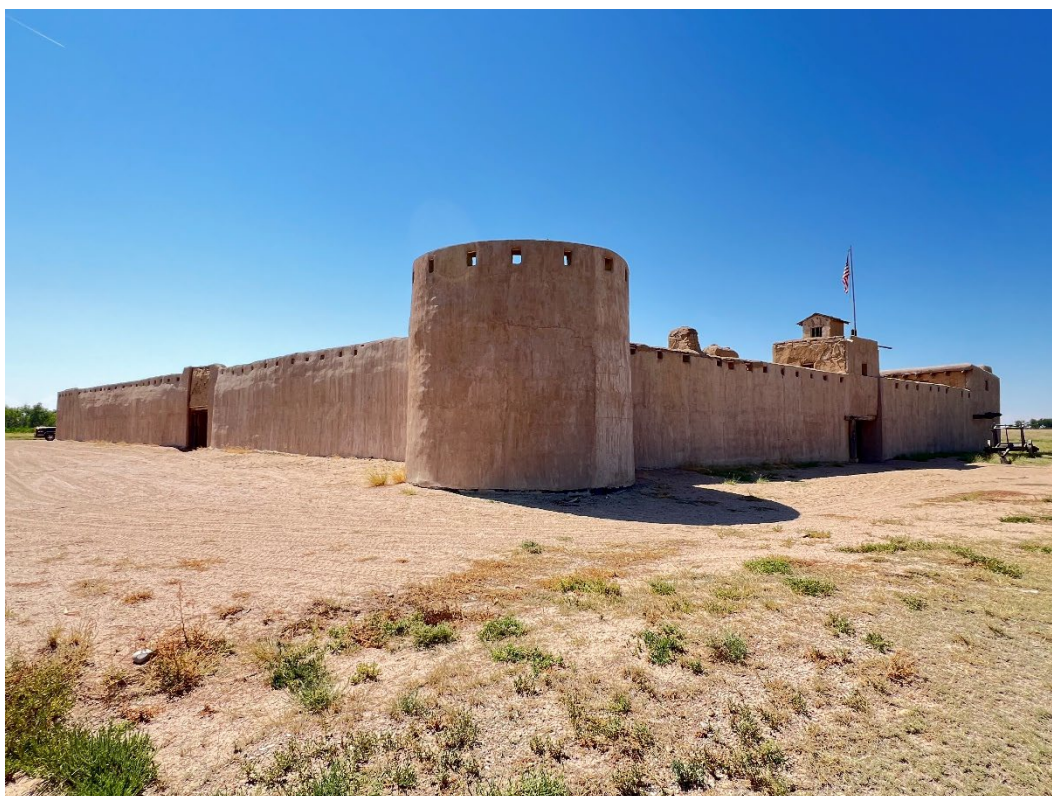
**Photo Number:** 50T.1728\_11

**Description:** View of the east and primary (north) elevations of the resource.

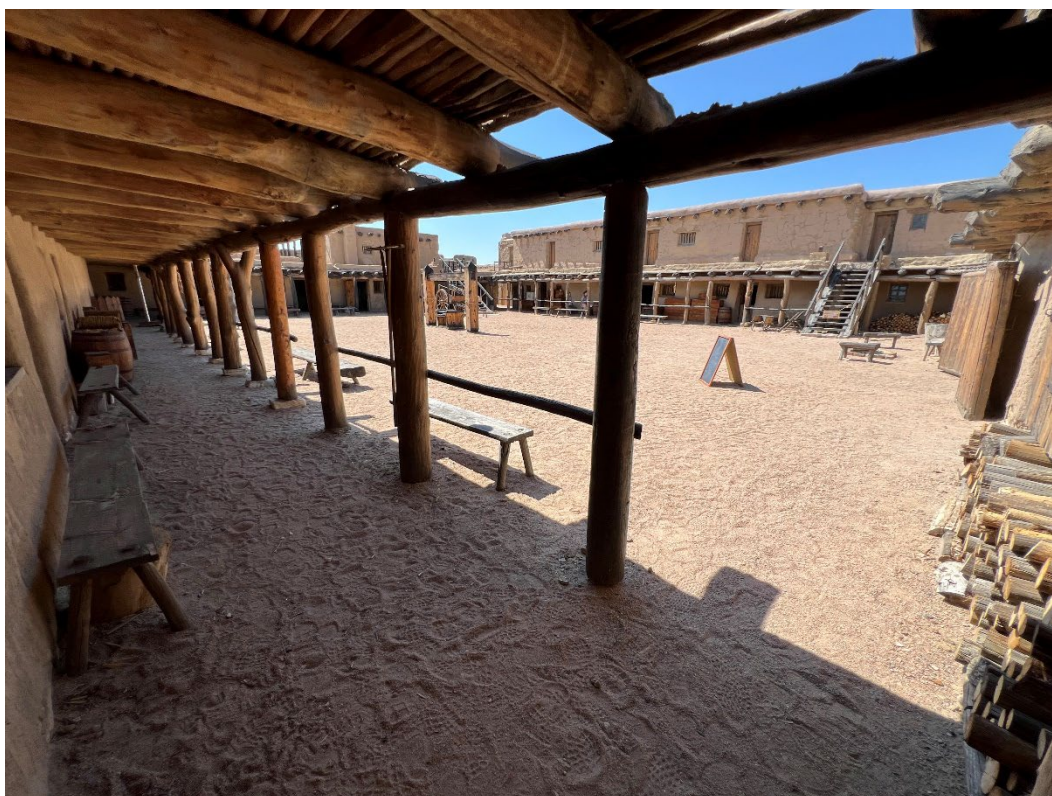
**Photo Number:** 50T.1728\_13  
**Description:** Looking at the interior of the plaza from the lower level of the resource.  
**View:** Southwest

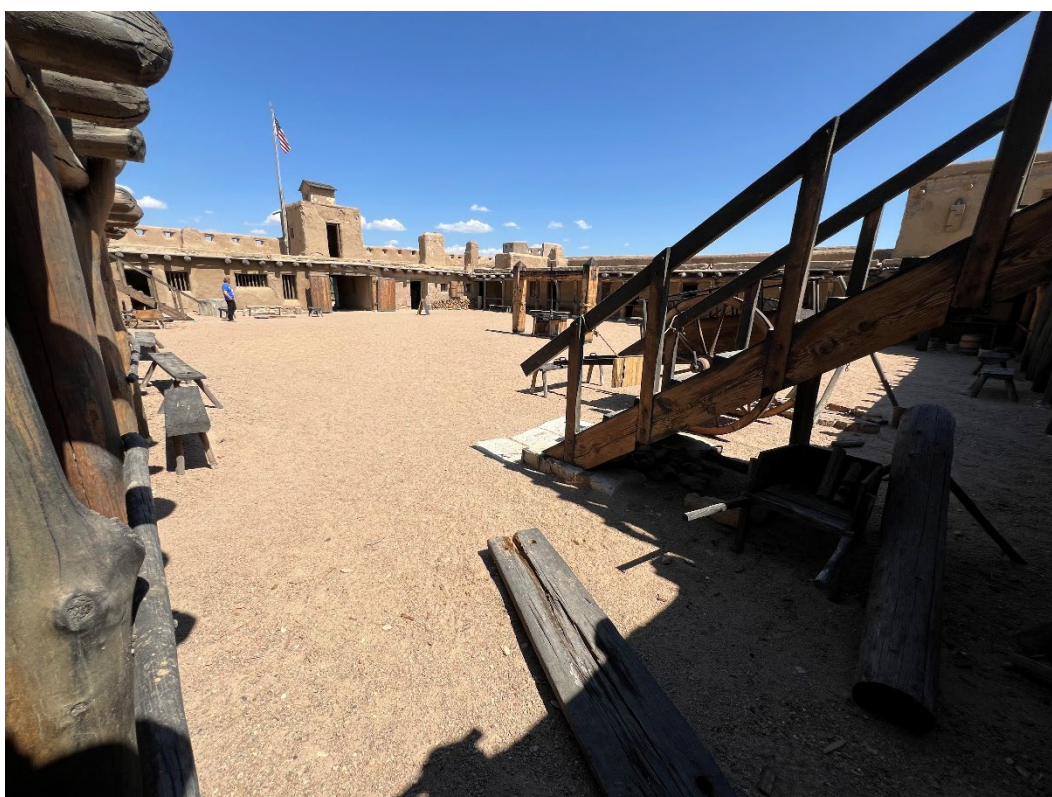
**Photo Number:** 50T.1728\_14  
**Description:** View of the interior plaza from the lower level.  
**View:** East

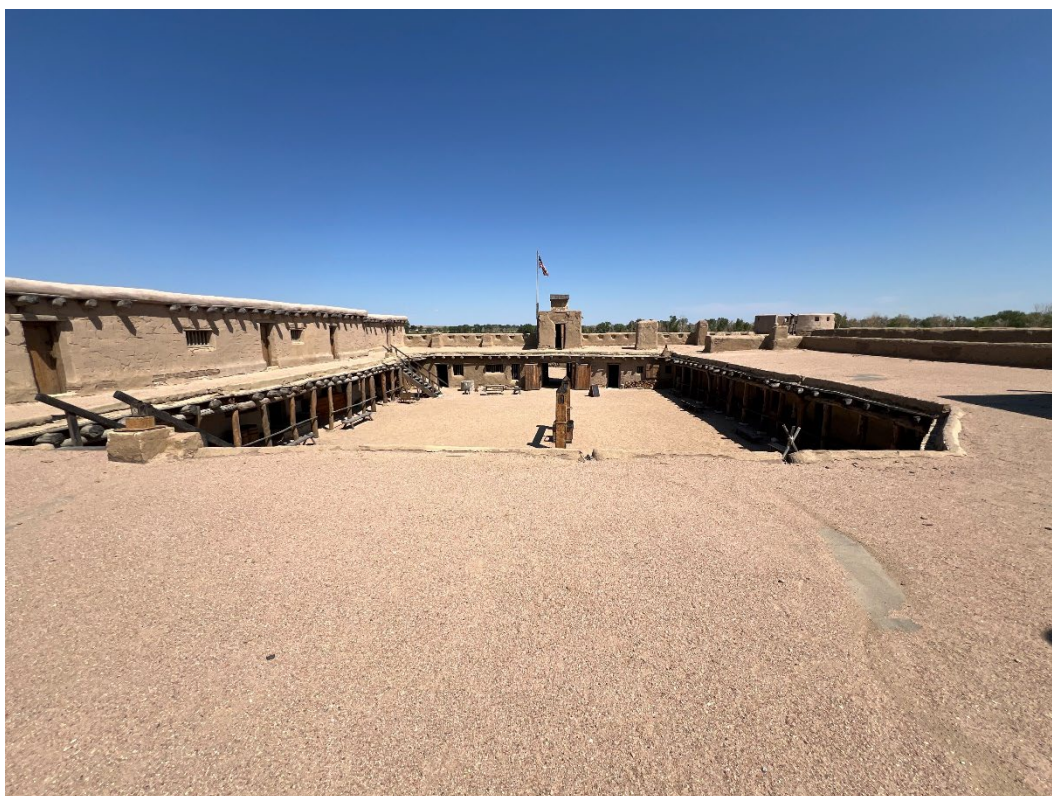
**Photo Number:** 5OT.1728\_15  
**Description:** Looking in toward the plaza from the second floor.  
**View:** Northeast

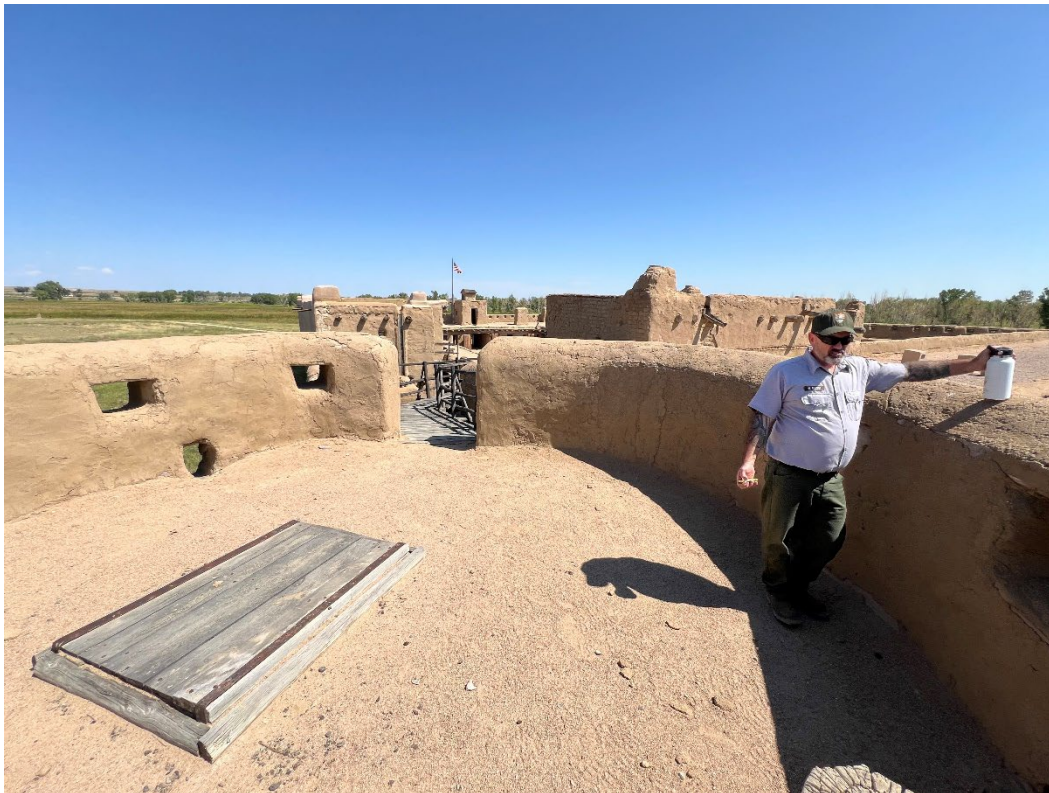
**Photo Number:** 5OT.1728\_18

**Description:** Context view of the resource from the upper level of the southwest bastion.

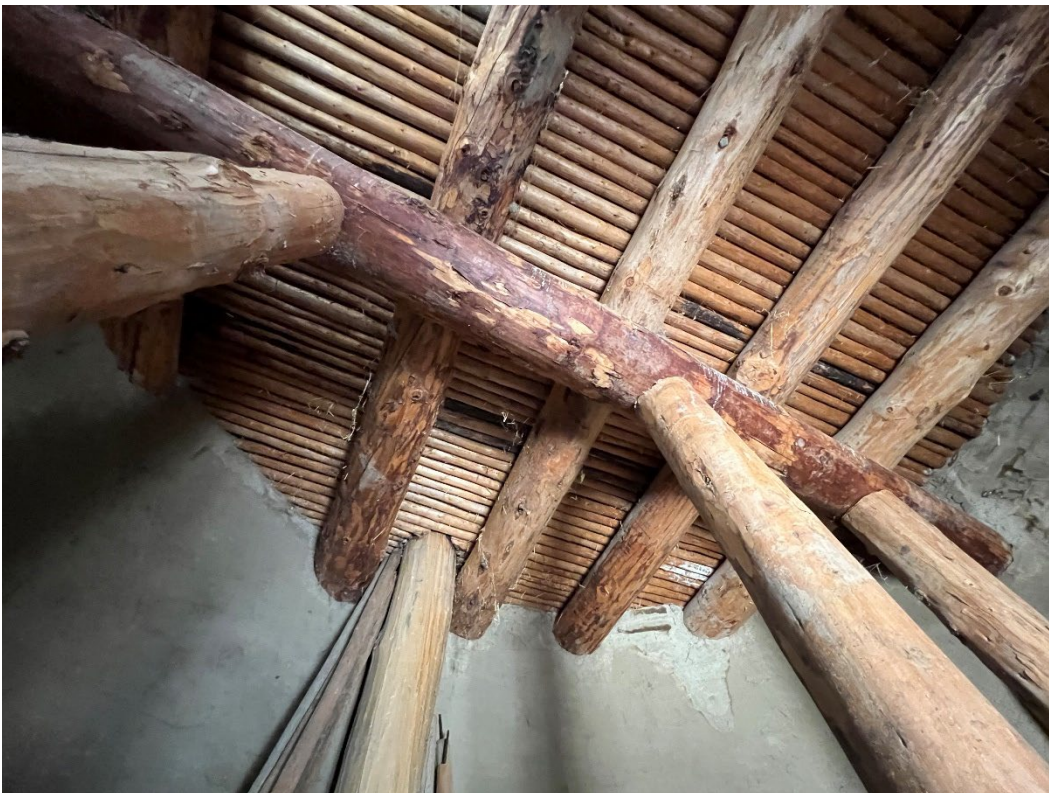
**Photo Number:** 5OT.1728\_20

**Description:** Detail photo showing vigas and latias in the ceiling construction.

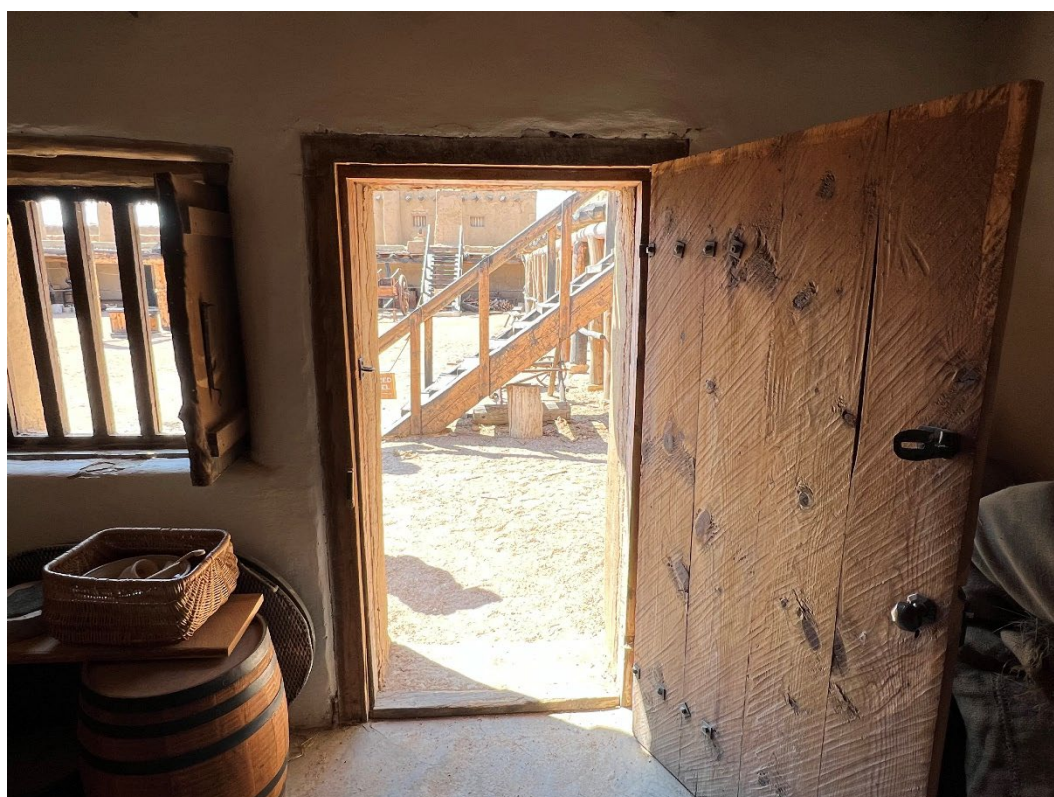
**Photo Number:** 5OT.1728\_22

**Description:** Sample interior entryway and door.

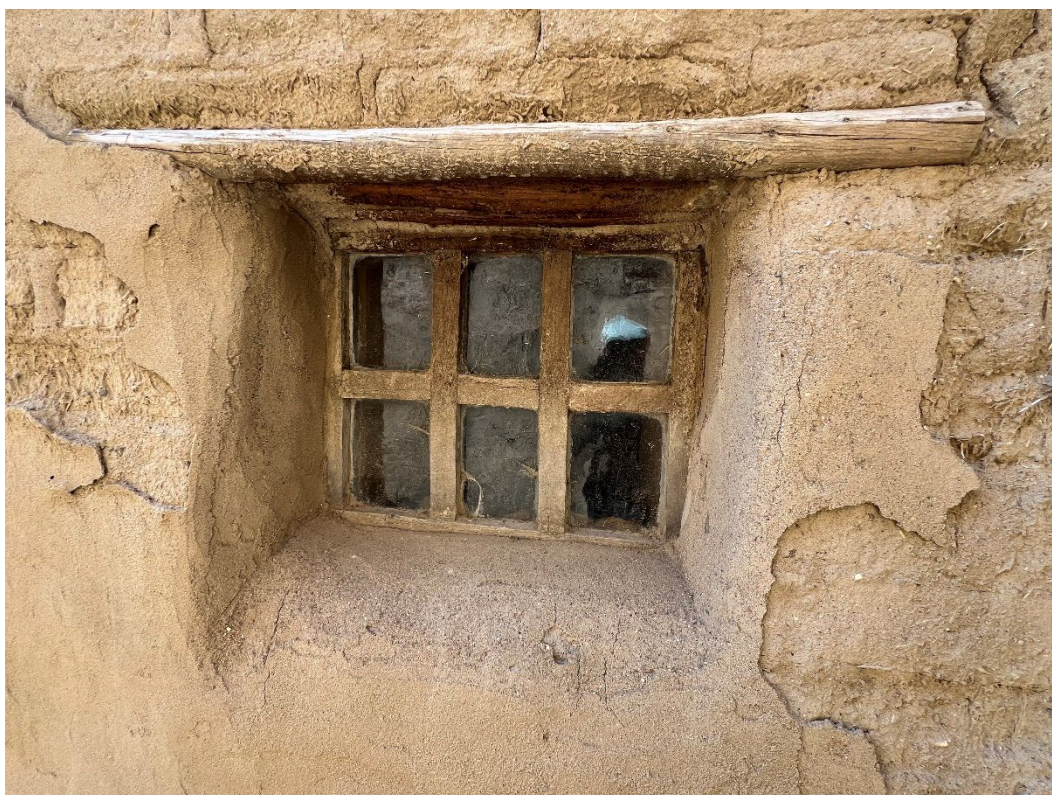
**Photo Number:** 50T.1728\_24  
**Description:** Another example of window showing a six-lite window.  
**View:** Detail

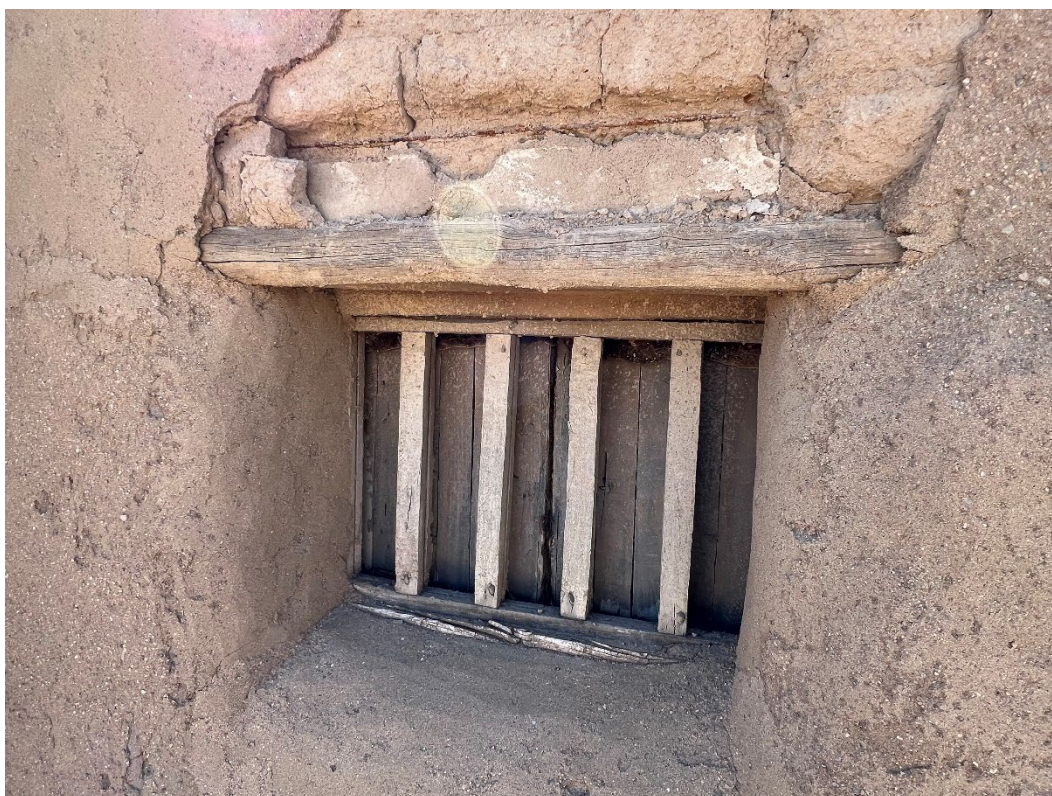
**Photo Number:** 50T.1728\_25

**Description:** A third window example without lites.

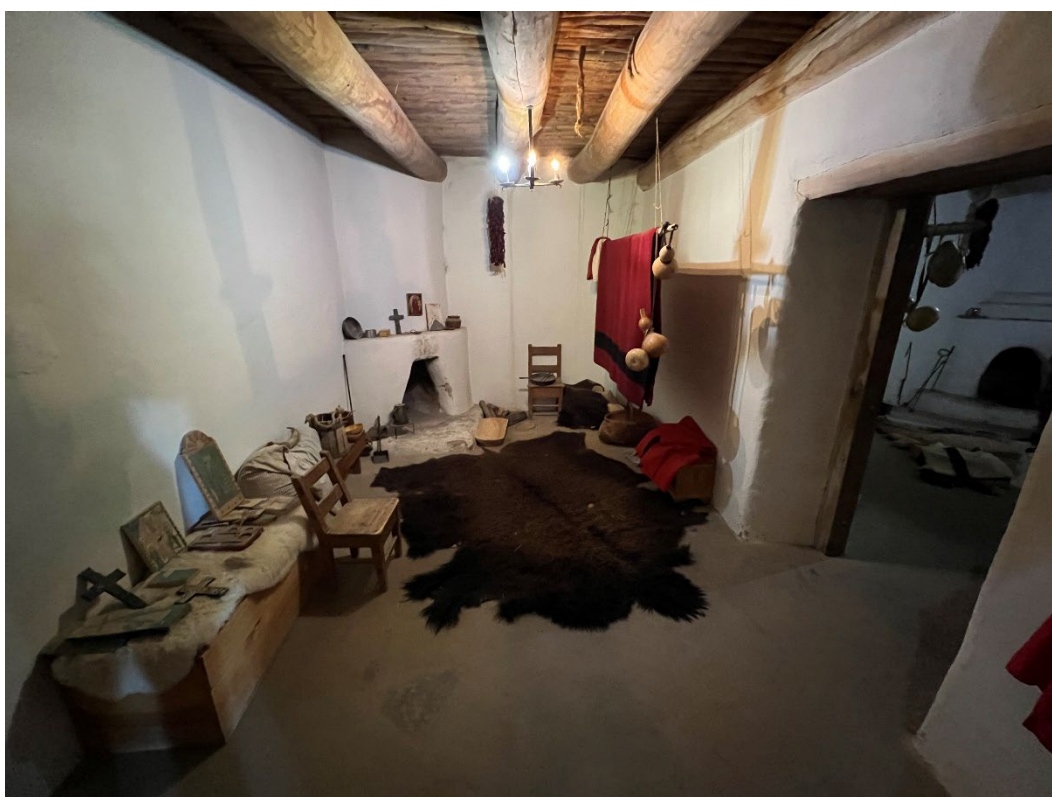
**Photo Number:** 50T.1728\_26

**Description:** Interior exhibit example of resource.

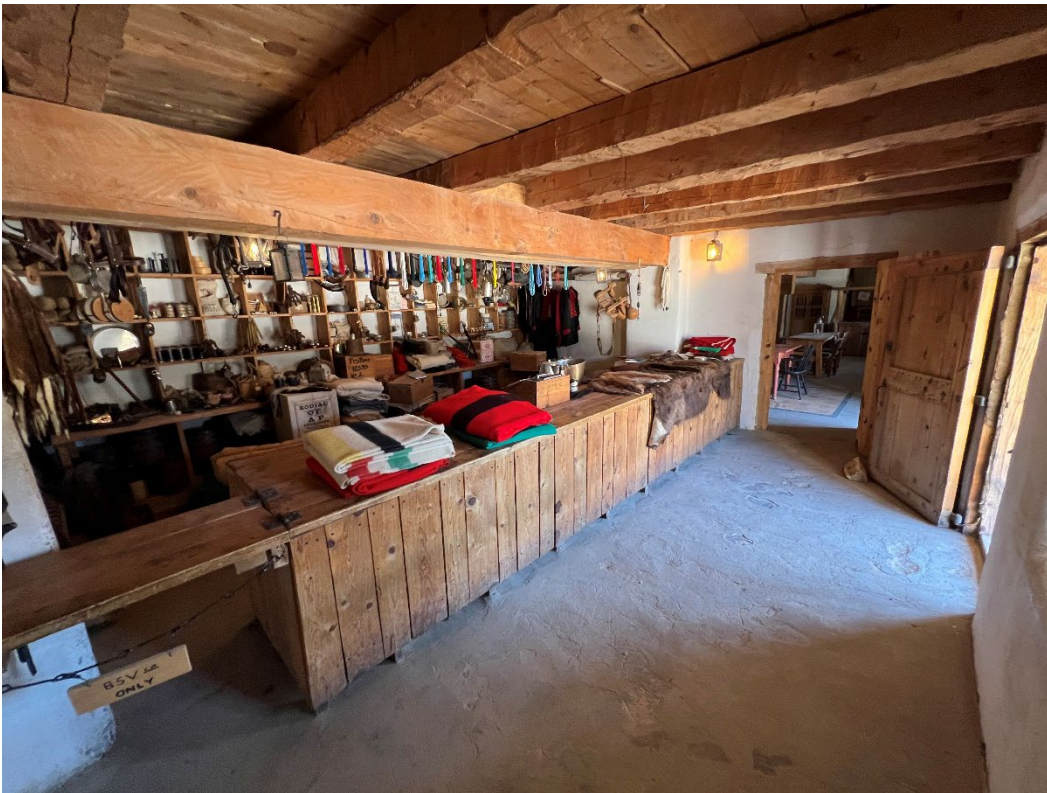
**Photo Number:** 5OT.1728\_27

**Description:** Interior space of the trade room.

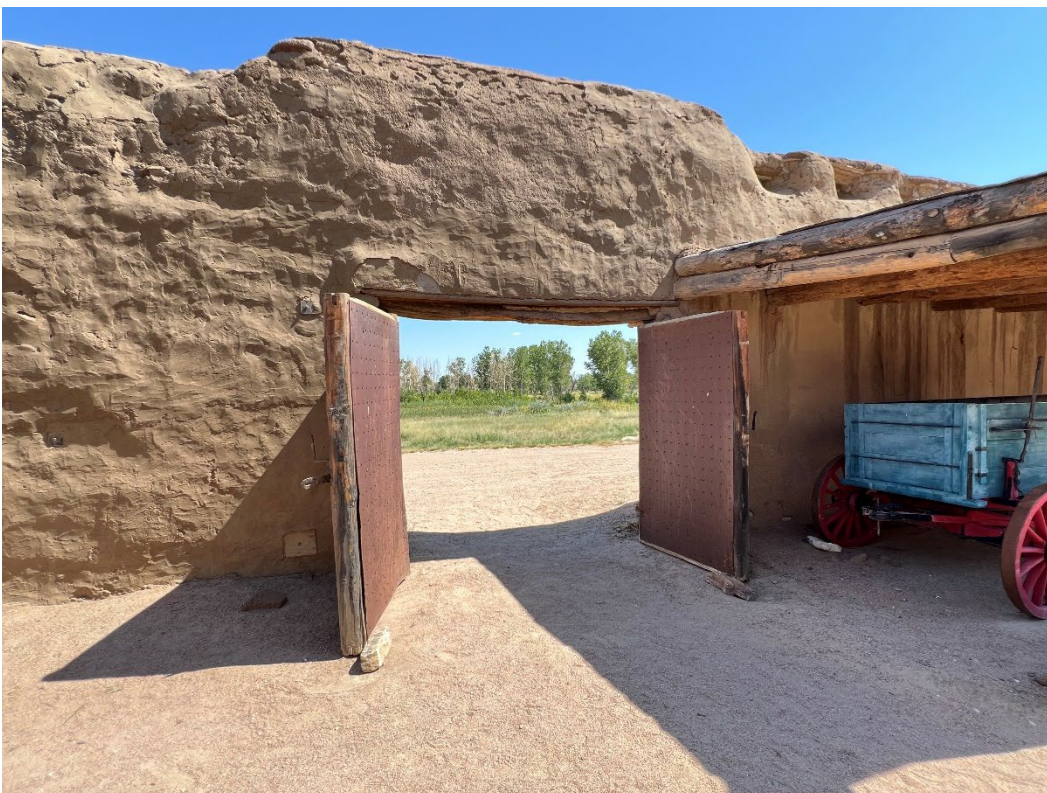
**Photo Number:** 5OT.1728\_28

**Description:** An interior view of the auxiliary entrance to the Inner Carrol. The main entrance features identical doors.

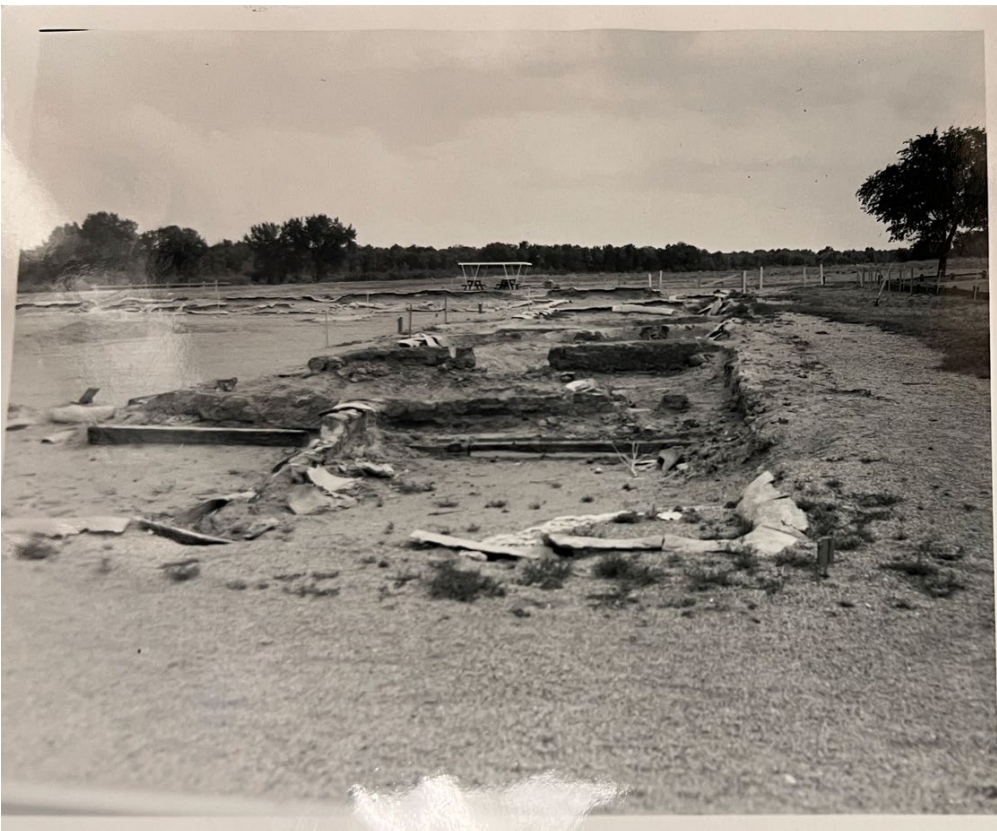
#### **Reference Photo 1**

**Description:** Historical photo of the original foundation of the 1833 fort before the reconstructed fort was erected. Photograph states, "Ruins of fort before reconstruction. NW side, quarters, well room, storage rooms, and shops in background." Photo dated May 30, 1975

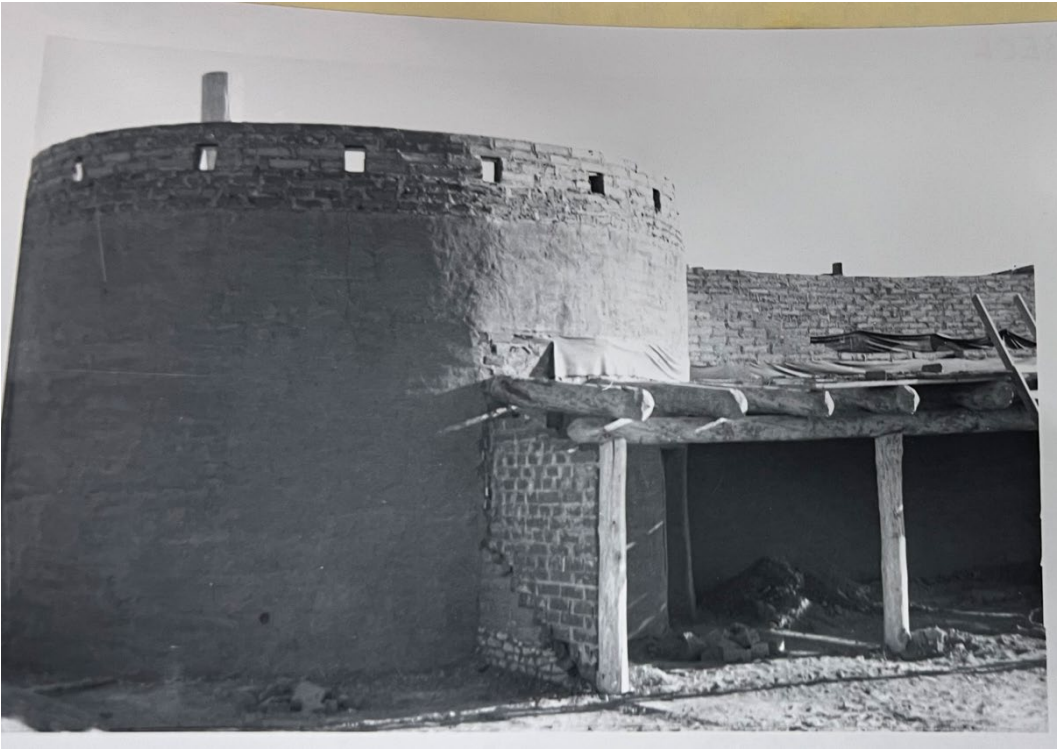
**Reference Photo 2**

**Description:** Historical photo of the southwest bastion under construction. Note the exposed adobe bricks. Photo dated: 11/5/1975.

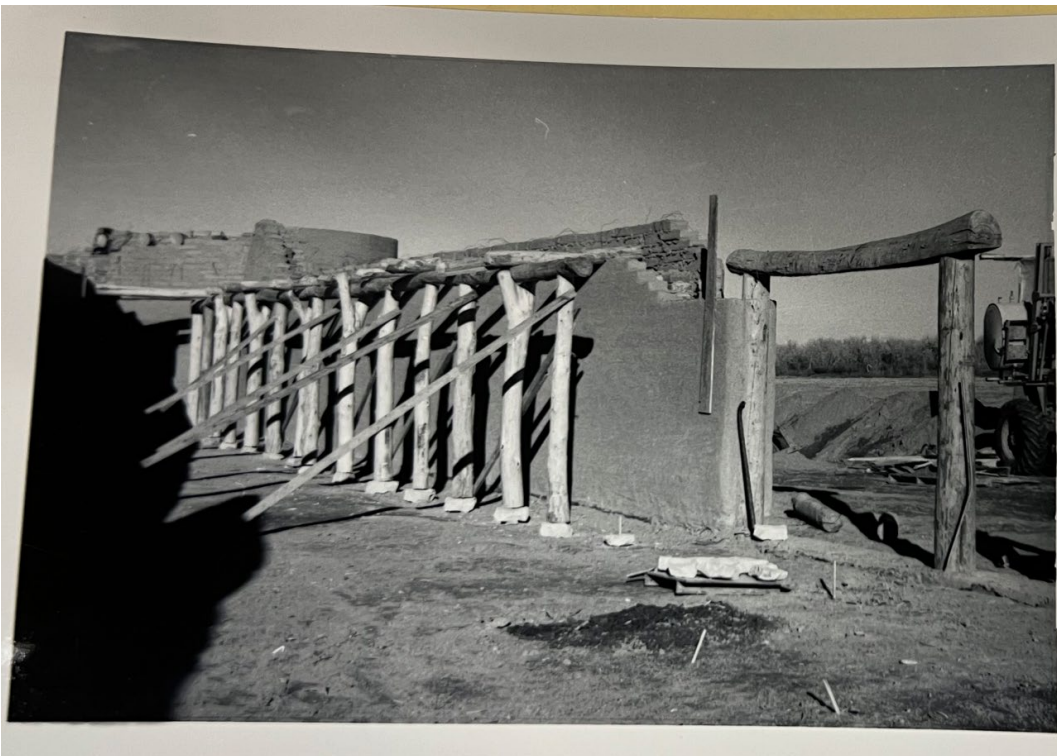
**Reference Photo 3**

**Description:** Historical photograph illustrating the construction of the southeast inner corral and entrance gate with catwalk. Photo dated: 12/18/1975 Note that this catwalk was later removed.

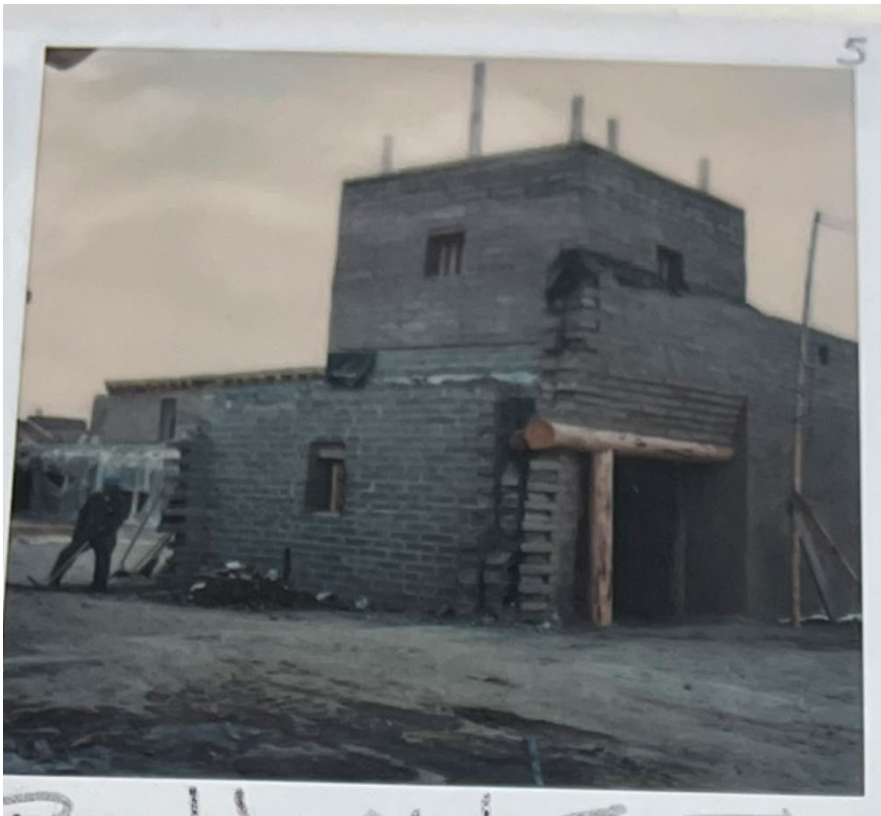
**Reference Photo 4**

**Description:** Historical photograph dated 1/15/1976. Photograph states, "Belfry to the right of the main entrance."

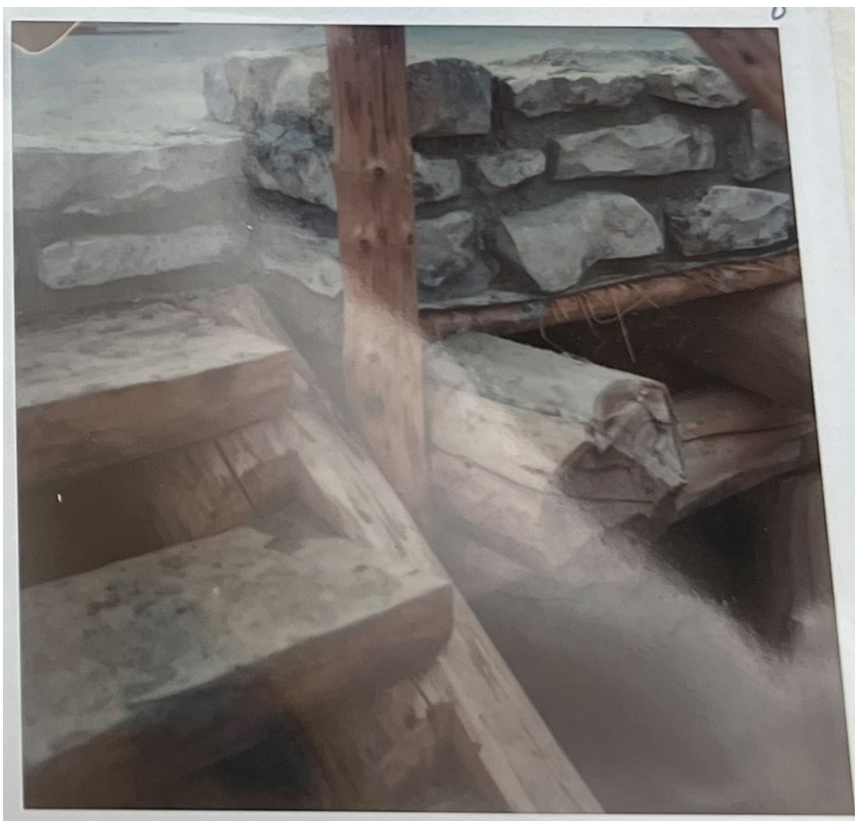
**Reference Photo 5**

**Description:** Detail photograph illustrating the staircase joining the promenade roof. Photo dated 1/15/1976 Note that the stone above vigas has since been removed.
