CAPE HATTERAS NATIONAL SEASHORE

BODIE ISLAND
LIGHTHOUSE & OIL HOUSE

HISTORIC STRUCTURE REPORT

**Cultural Resources Division
Southeast Regional Office
National Park Service
December 2004**

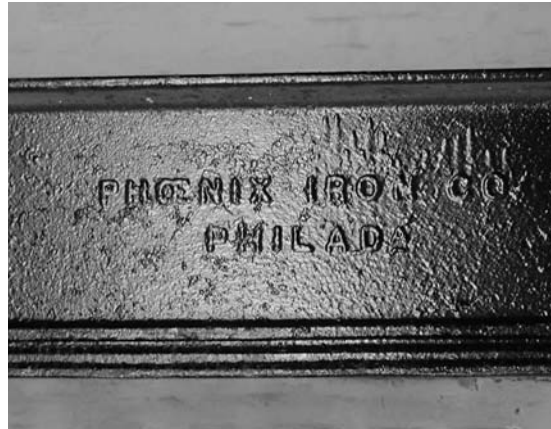
Figure 4 Landing support beams in Tower. Beams were actually installed with manufacturer's stamp upside down. Photo courtesy of Jack McCombs.

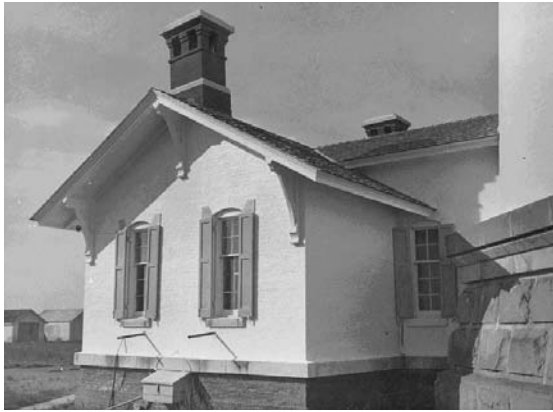
South Elevation: The south elevation is a mirror of the north elevation in composition. Like the north elevation, the south elevation exhibits a dormant and repaired crack from the west corner of the east window downward and to the east. In addition, there appear to be several patches in the elevation that have repaired brick damage, likely spalling. One patch is over the head of the east window, and one is at the east side and below the sill of the west window. Evidence of spalled brick can be seen on the lower east corner of the elevation below the water table.

Figure 19 Photo of south elevation by U.S. Coast Guard, 1948.

There are two patched holes in the center of the elevation below the water table and above the inset in the wall. Earlier photos suggest these patches mark the location of what appear to be drain outfalls from the Oil Room. Mid-20th century photos also indicate the location of a box mounted to the south wall below the water table. The brick shelf defining the inset brick panel below the water table was partly removed to accommodate the box sometime between 1930 and 1948. A portion of a bracket, likely part of the anchorage system for the box, remains attached to the wall. The windows on this elevation are 4/6 like those on the north elevation. However, the east window on the south elevation has a metal screen on a wood frame attached to the window frame. Also present are five brackets for shutters that no longer exist.

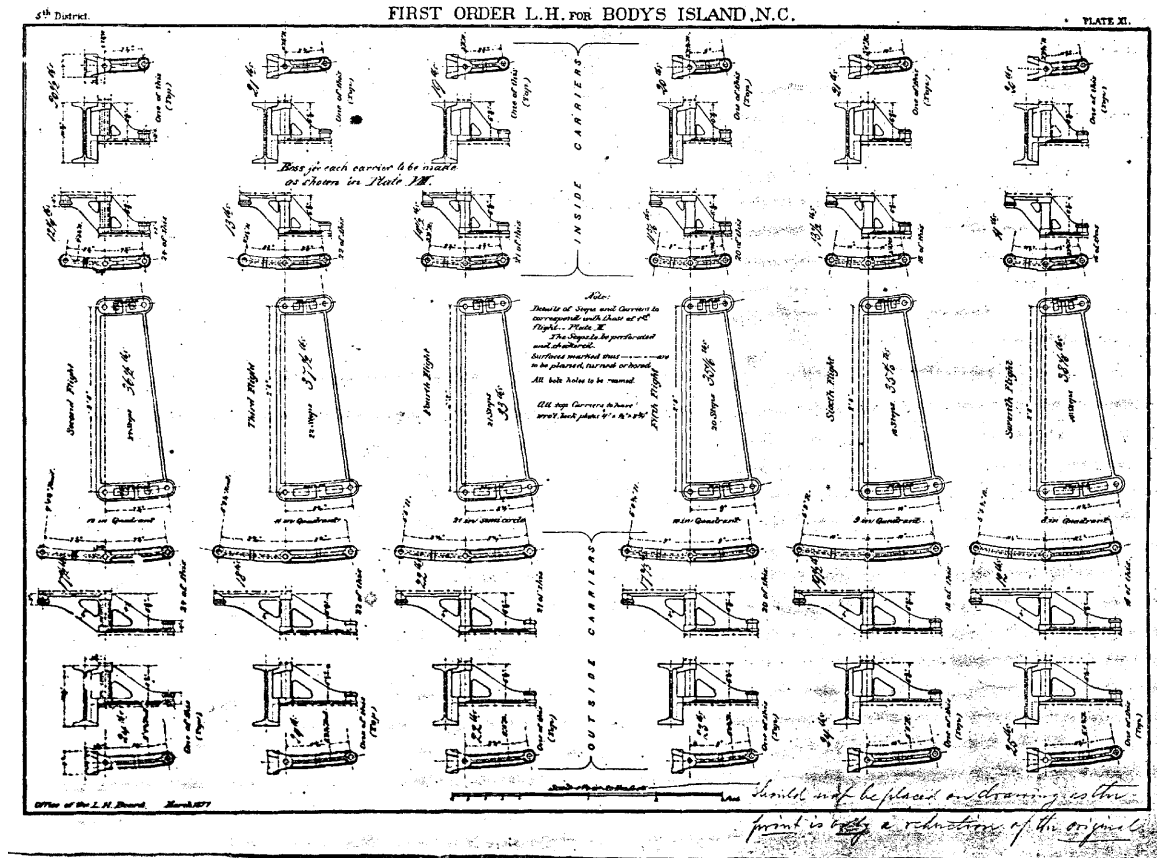
Stairs: Since the stairs are common to all levels of the Tower, they are addressed here to best present their condition and characteristics. The original drawings document the characteristics of the stairs in great detail. The Tower stairs and landings (except for the first level which is on fill with marble and stone flooring) are cast iron. There are five cast iron components associated with each tread (see Plate XI. of the 1871 construction documents), which are cast iron with an open-checked plate walking surface.

Figure 22 Plate XI, 1871 Drawings.

The landings are cast iron plate with diamond pattern on the walking surface and an integral reinforcing grid on the underside and are supported by a cast iron I- beam at the diameter edge of the landing.

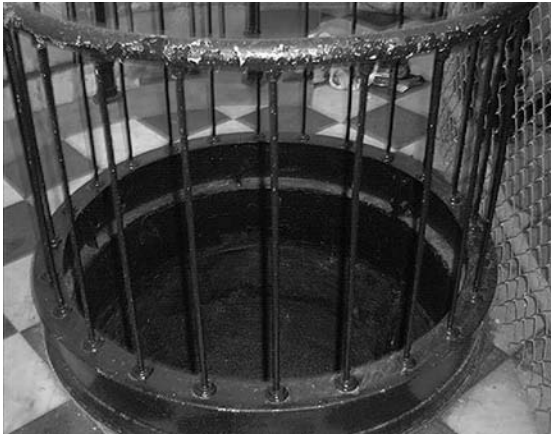
Well: In the center of the ground level is a depressed well approximately 30" deep protected by an original cast iron railing 38" high. The well is constructed of cast iron, with a cast iron wall and cast iron floor, the entire assembly being painted black. The well and railing are in sound condition. The well was reportedly constructed to receive weights used in the operation of a mechanism that would allow the

Figure 23 Well.

light to “flash.” However, the mechanism was never installed, and, thus, the well was never used as intended in the original design.

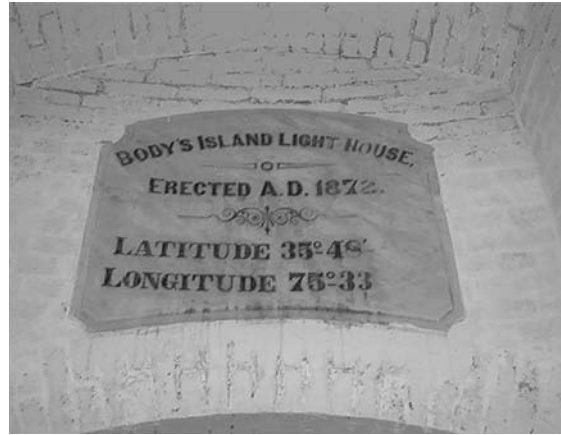
Dedication Plaque: A marble dedication plaque is mounted on the archway facing the center of the Tower (see picture). There are three points of note regarding this plaque. First, the spelling of “Body” is an early spelling of the name, thus suggesting an early fabrication and installation

Figure 24 Dedication Plaque.

of the plaque. The second point of note is that the 1871 construction documents do not show a plaque, suggesting one was designed, fabricated, and installed in an exercise separate from the original construction. Thirdly, this is not the first plaque erected. The original plaque listed the members of the Lighthouse Board and the date at the time the construction of the Bodie Island Lighthouse was begun. An image of the drawing for the original plaque is found in the Chronology of Development and Use portion of this report. The drawing indicates that the location of this plaque is also the location of the installation of the first plaque. The current plaque is in excellent condition, but has some overpainting of white, the result of applications of paint to the wall to which it is affixed, that should be removed.

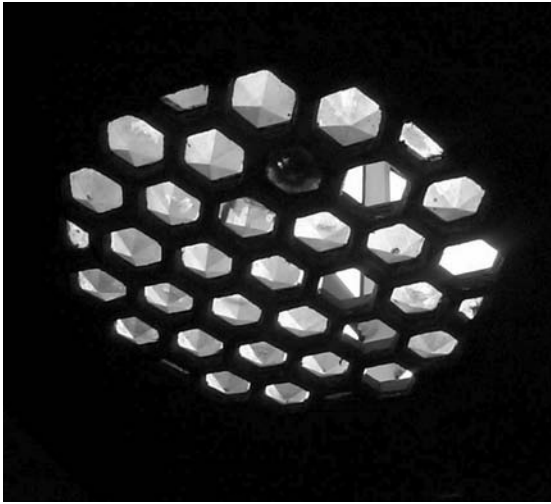
Figure 25 Watch Room ceiling insert made of prismatic glass.

Watch Room level below the lantern, much like the deck prisms of ships. A number of the glass prisms are missing. The cast iron grating and lens pedestal appear in sound condition. On the southwest side of the Watch Room is a penetration in the ceiling for a vent for earlier coal heat at that level. This source of heat has been abandoned.

The grating that serves as both the ceiling of the Watch Room and the floor of the lamp level is missing several of the glass prisms installed in the inserts to provide light to the Watch Room below. This grating and the interior of the muntins in the lamp should be stripped of paint, inspected for defects, and repaired as necessary. Replacement prisms should be fabricated and securely installed in the grating. (It is entirely possible that some of them have been removed in the past as souvenirs.) The grating and the muntins should be repainted as appropriate, consulting the 2002 paint analysis for guidance on paint colors.

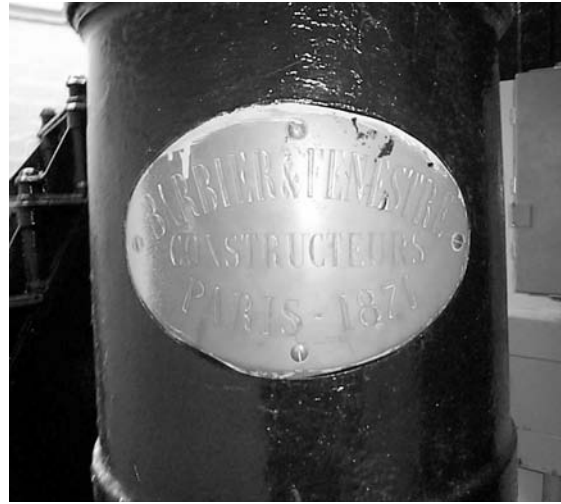
Figure 26 Lens pedestal, original manufacturer's brass plaque.

of the pedestal. The pedestal is in good condition.

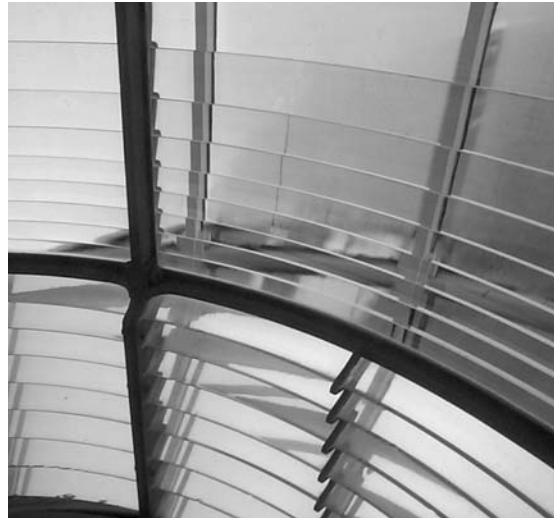
Lens: The lens is a first order Fresnel lens held in position by a brass and iron frame. There are five distinct sections of the lens defined by the position and configuration of the prisms. Except for a few chipped prisms and one missing prism in the second tier from the top of the southeast quadrant of the lens, the lens appears

Figure 27 First order Fresnel lens.

in sound condition. The frame exhibits a limited amount of oxidation in some parts of the cast iron frame. The bronze components of the lens frame appear in good condition.

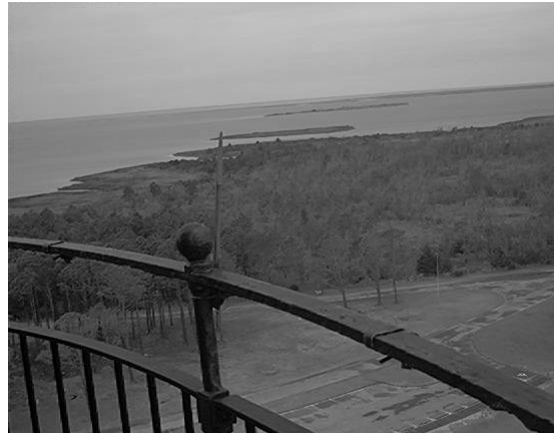
Figure 34 View from Lantern Gallery.

load mandated by current building codes. The top side of the floor plate shows some rusting but is adequate to support a man, though probably not the 100 pounds per square foot mandated by current building codes for public access areas. The brackets which support the gallery could not be closely inspected, due to lack of access, but at least a portion of one of the brackets has fallen to the ground. The condition of the gallery railing, installed in the 1960s, which is severely corroded, can give some indication of the condition of the support metal below the gallery, installed in 1872. It should be noted that these conditions have been in evidence since at least the 1989 structural evaluation performed by the U.S. Corps of Engineers for the Coast Guard, and have been repeatedly mentioned in subsequent reports. These reports and the warnings contained therein should be taken very seriously. Recommendations regarding these components may be found in the “Ultimate Treatment and Use” portion of this report.

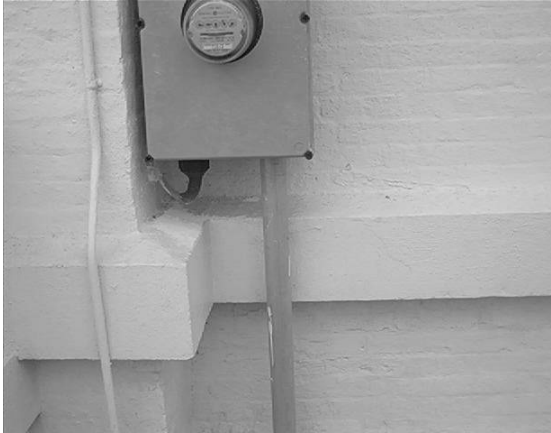
The electrical service entrance for the Bodie Island Lighthouse is provided via underground service. The utility meter is mounted on the west side of the entrance to the Oil House, and the meter indicates 120/240 V service (see Figure 36).

Figure 36 Detail of utility meter.

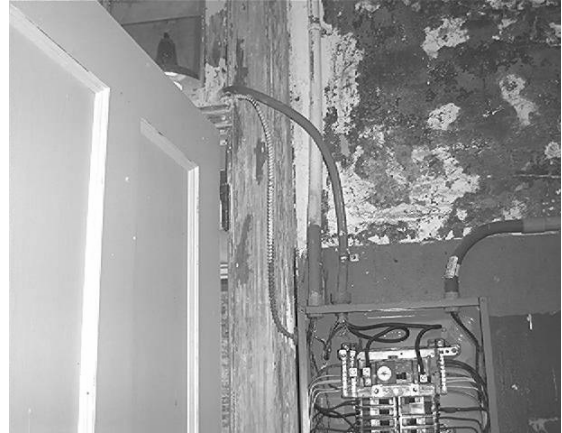
The routing of the service conductors and grounding cable runs from the utility meter to above the door of the Oil House entrance (see Figure 37), penetrates the door (Figure 38), is routed across the south wall of the Hall to above the Oil Room door, and penetrates the door to the distribution panel (see Figure 39).

Figure 39 Detail of electrical wiring access to distribution panel.

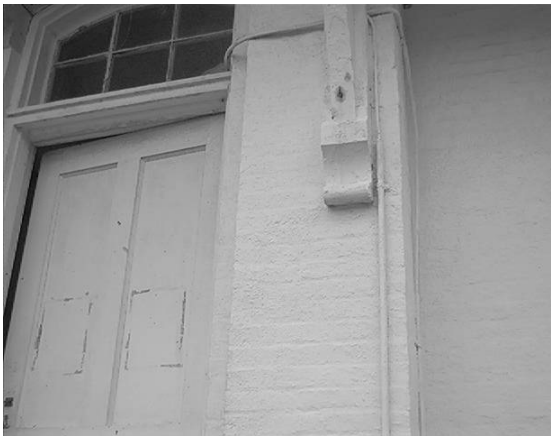
Figure 37 Detail of utility routing through door frame

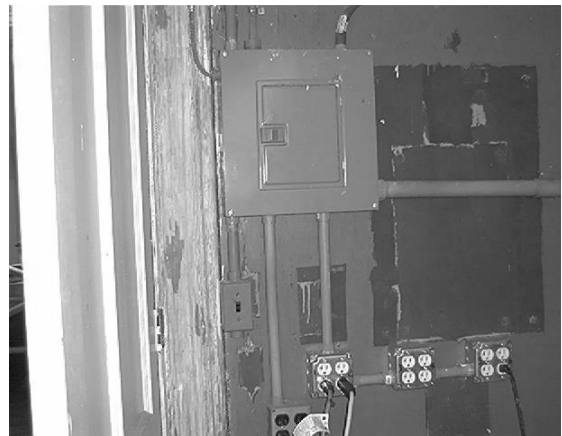
The distribution panel is a 12-circuit panel with a 100A main circuit breaker located in the north wall of the Oil Room (see Figure 40).

Figure 40 Detail of distribution panel.

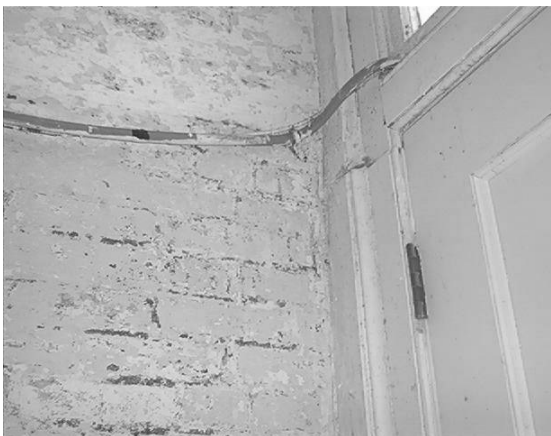
Figure 38 Detail of electrical line.

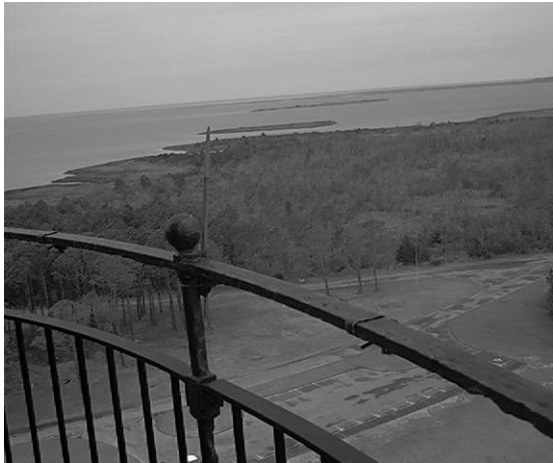
Figure 41 Lightning rod installed on gallery handrail.

There are number of lightning rods installed on the handrail of the gallery and supported by the handrail (see Figure 40) with two opposite down conductors (2/0) on the north and south side of the Lighthouse. The two down conductors are bare copper and are routed exposed to approximately 14' above ground, then routed to a 1/2" schedule 40 PVC conduit to the earth (see Figure 41). There was no indication of what the down conductors were connected to underground (ground rods, ground ring, or both). The original lightning rod at the top of the ventilator ball is no longer connected to any down conductors. However, a bare copper cable runs from a newel post at the base of the Tower stairs, along the perimeter of the ground floor of the Tower, through the window on the north side of the Hall Connection (H/100), and down the wall on the exterior into the ground. This

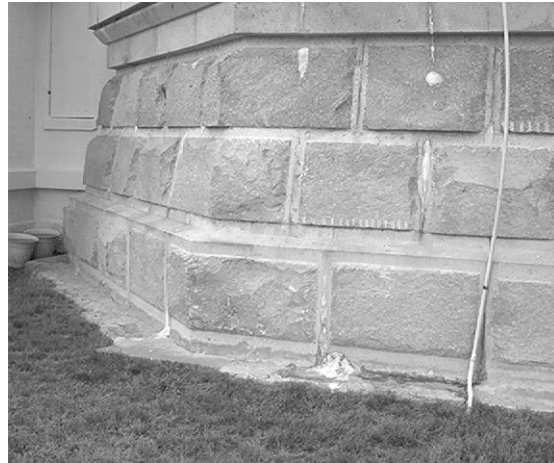
Figure 42 Conduit for lightning protection, located at tower base.

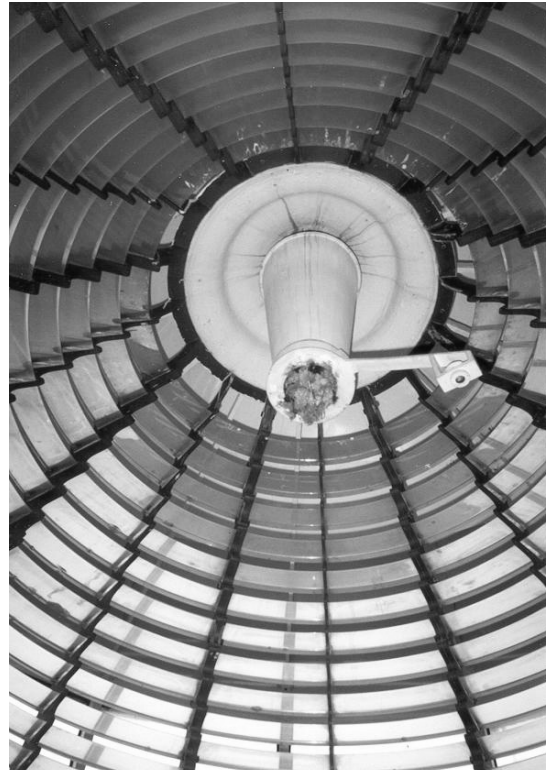
Figure 45 Detail of Fresnel lens.

The Fresnel lens and the light within are the property of the United States Coast Guard. It is not recommended that the Park Service undertake any repair activities on these features. The hood above the lens and the ventilation tube that connects to the ventilator ball are, however, features belonging to the Lighthouse structure. These should be cleaned, repaired if necessary, and painted if required. The ventilation tube is stopped up with some sort of fabric or paper. This should be removed. However, it is desirable to prevent insects, rain, or birds from accessing the interior of the Fresnel lens, so the tube should be stopped with caulk or other waterproof material at a distance inside
