**Cape Lookout**  
**Life-Saving Station**  
**HISTORIC STRUCTURE REPORT**

Historical Architecture, Cultural Resources Division

National Park Service

2004

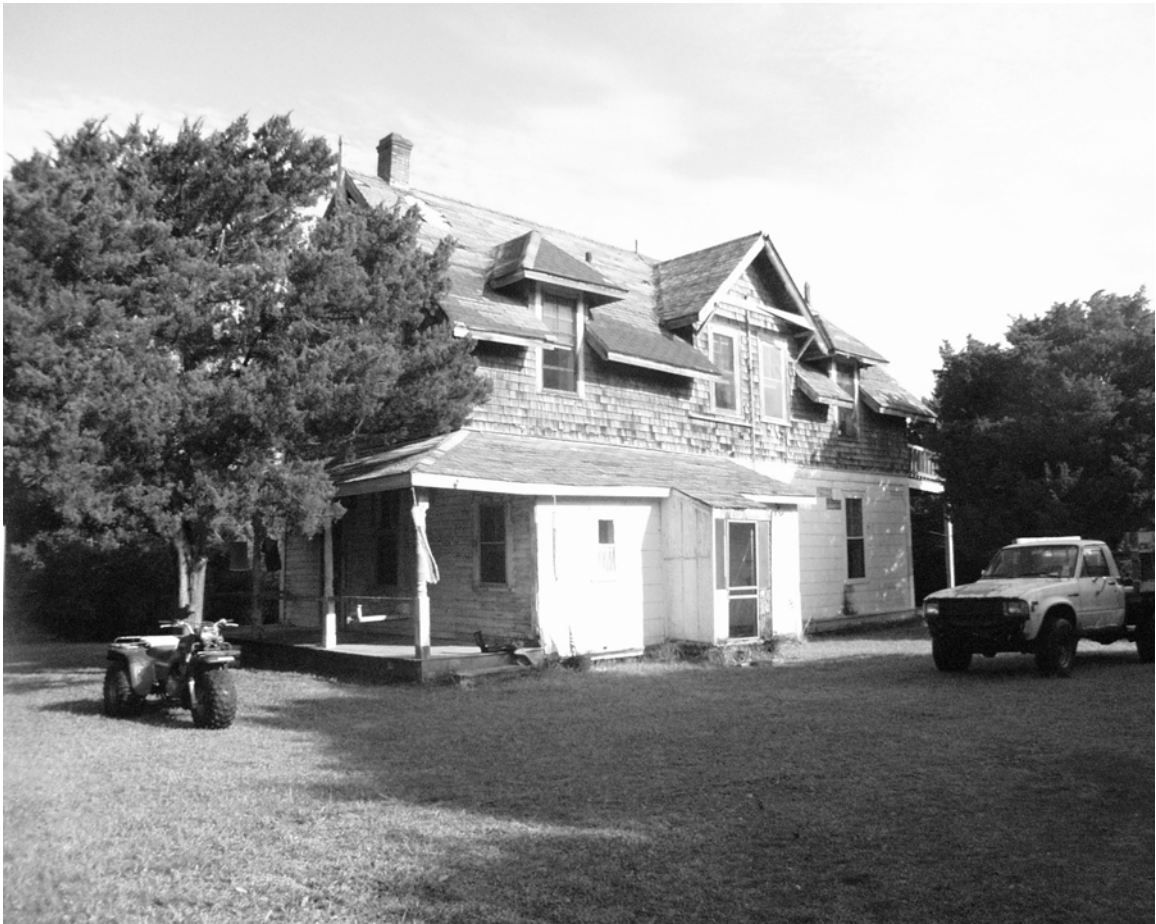
**Figure 42** Old Life-Saving Station,  
(NPS-SERO-CR, 2003)

With few exceptions, structural members are in generally excellent condition. There has been significant damage to the sills around the west corner of the building. Because of its proximity to the ground, the floor framing for Room 106 could not be directly examined, but interior conditions suggest that this framing is in very poor condition. The framing for the front porches is also in very poor condition (see below).

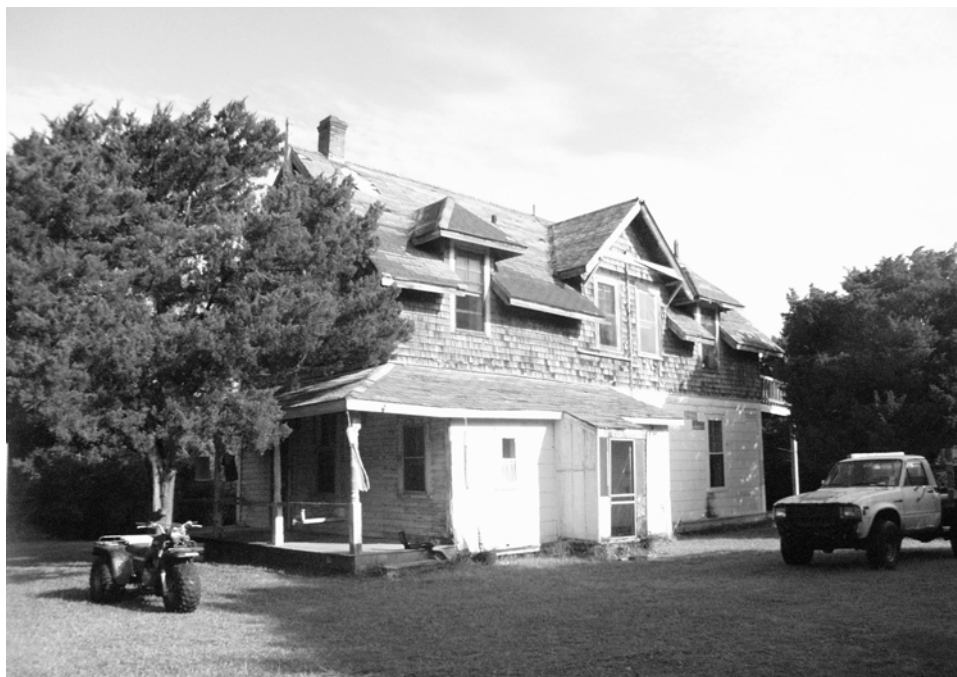
**Figure 44** View to north from road. (NPS-SERO-CRS, 2002)

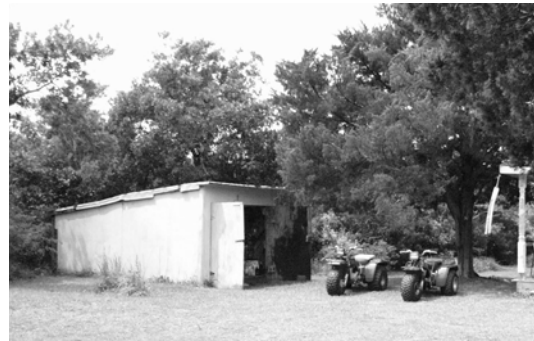
**Figure 46** View to west of modern garage; south corner of back porch is visible at right. (NPS-SERO-CRS, 2002)

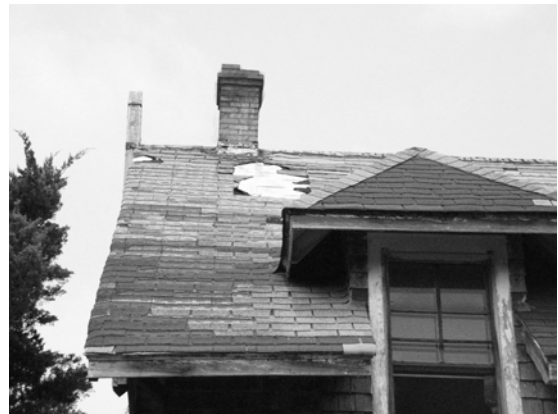
metal roof. Probably when the building was moved in 1958, asphalt “hurricane” shingles were installed over the metal roofing, except on the dormers. The entire roof, including the dormers, was overlaid with the present, three-tab, asphalt shingles in a variety of colors around 1970. These shingles are missing in several areas and in poor condition over the entire surface of the roof.

**Figure 49** View of existing roofing. White “hurricane” asphalt shingles installed in early 1950s are exposed just below the chimney. (NPS-SERO-CRS, 2002)

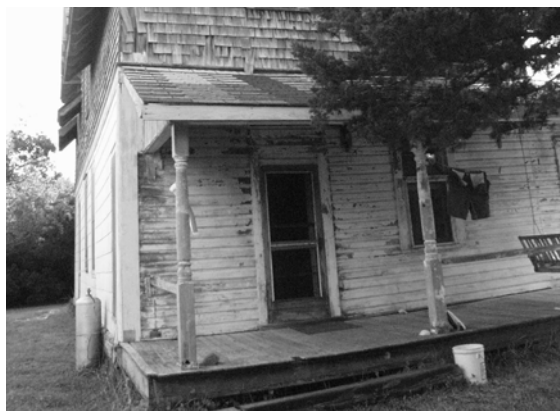
**Figure 57** View of back or south porch, added before 1905. The door was not present until the renovations in the 1920s. (NPS-SERO-CRS, 2002)

Floor framing for this porch is inaccessible and could not be examined. Flooring consists of 3/ 4" by 3- 1/2" boards in fair condition.

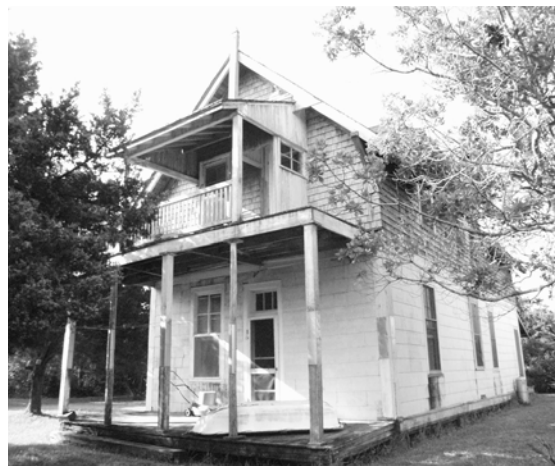
*Front Porch:* The front porch, located on the northeast end of the house, was added before World War II, but unlike the back porch, which is considerably older, is badly deteriorated and in unstable condition. Floor framing at the first floor level was inaccessible but the condition of the floor deck indicates serious problems with the underlying framing. Flooring, which appears to be mostly original, is 7/8" by 2- 1/2", tongue- and groove.

Deterioration, especially of the sills and floor framing at the first floor level, has allowed the roof of the upper porch to pull away from the building as much as 2", and the framing for the second floor is in very poor condition.

**Figure 59** View of front porches, added in 1920s. (NPS-SERO-CRS, 2002)

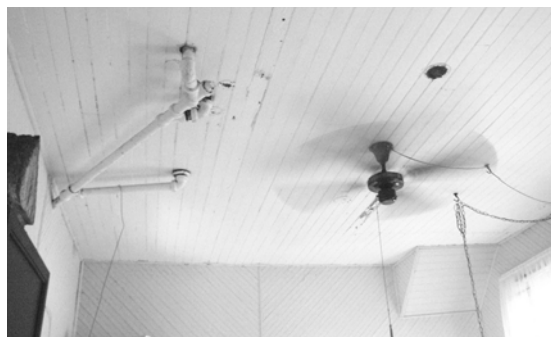
**Figure 70** View of ceiling in Room 102, showing cast-iron waste lines (c. 1920) from upstairs bathroom. (NPS-SERO-CRS, 2002)

Cast-iron waste and vent lines from the bathroom in Room 202 are exposed on the ceiling along the east side of the room. Because the upstairs sink was relocated, only the vent stacks are still in use. Other holes in the ceiling above the windows indicate the location of risers for the building's historic heating system.

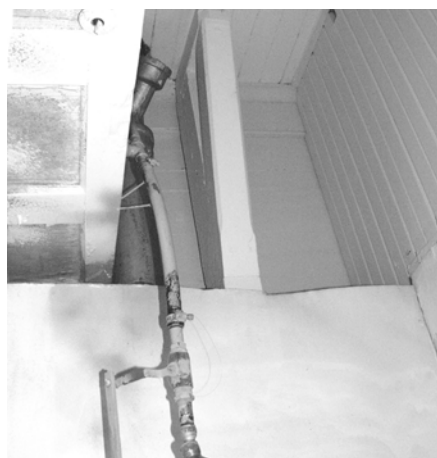
**Figure 73** View of large bracket behind and above shower, installed to support water tank at second floor. Note original cornice on rear wall. (NPS-SERO-CRS, 2002)

*Miscellaneous:* Next to the toilet is a large, cast- iron water tank set on wooden blocks and supported from below by a large bracket mounted against the ceiling below in Room 103. It was installed after 1969 to replace the original 1920s tank, which was moved but remains in the room after an unsuccessful attempt to saw it up and remove it.

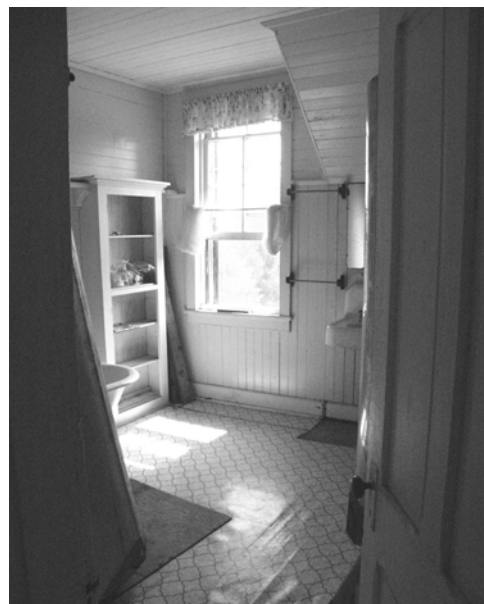
**Figure 79** View to east in Room 203. (NPS-SERO-CR, 2002)

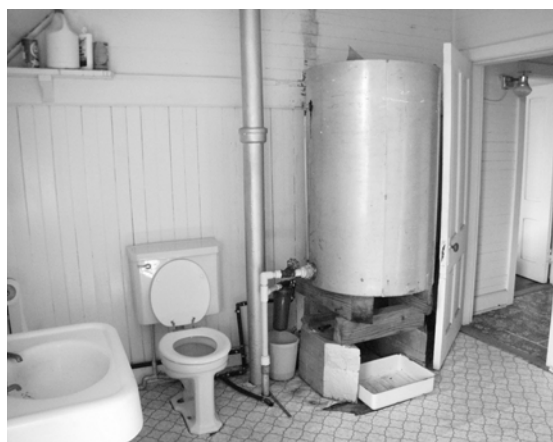
**Figure 80** View to west in Room 203. (NPS-SERO-CRS, 2002)

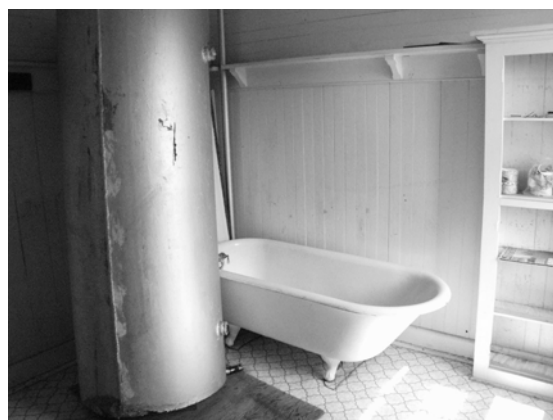
**Figure 81** View to north in Room 203, showing tub and original 1920s water tank. (NPS-SERO-CRS, 2002)

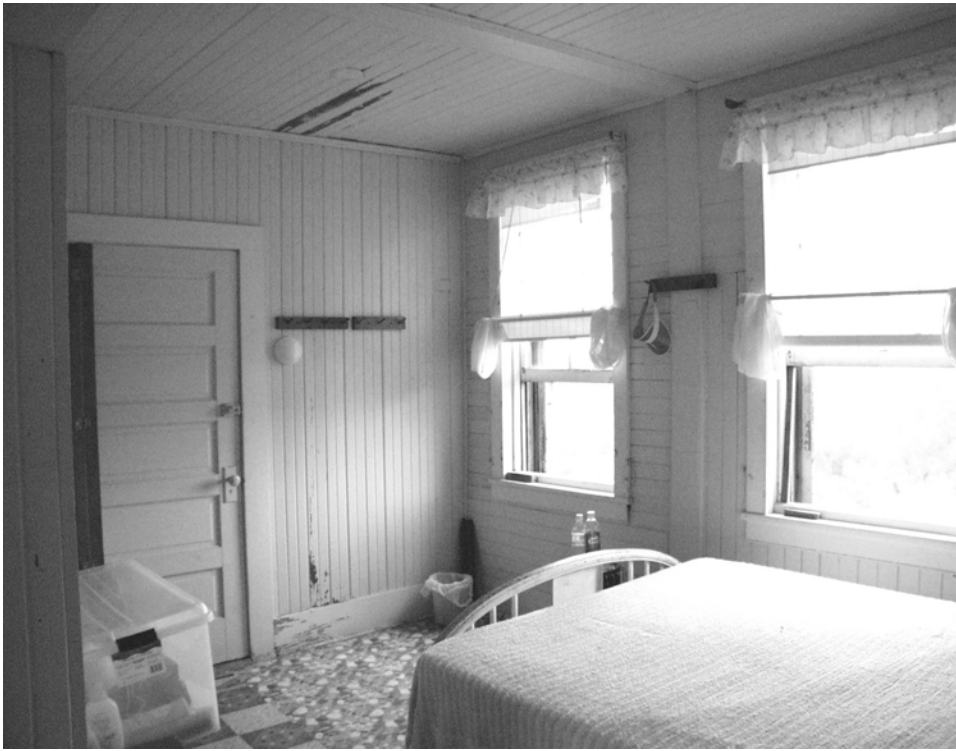
**Figure 82** View to west in Room 204. The wall that separated the original hall from the crews' quarters was located between the two windows. (NPS-SERO-CRS< 2002)

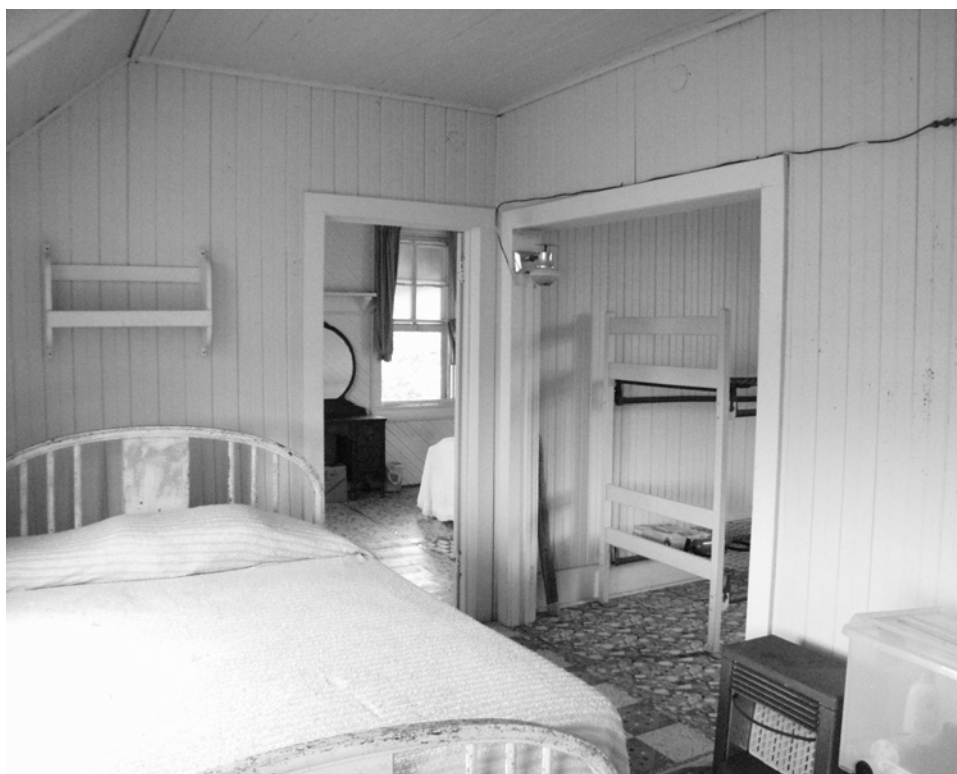
**Figure 83** View to northeast in Room 204. Large cased opening at right was created after the partitioning of the crews' quarters, probably after the building was moved. (NPS-SERO-CRS, 2002)

On the southeast wall a large cased opening, 5'- 2" by 6'- 7", opens into Room 205. About six feet of this wall was removed in the 1960s, but the ghost of an earlier header indicates that there was a door, which was presumably five- panel, at the northern end of this opening.

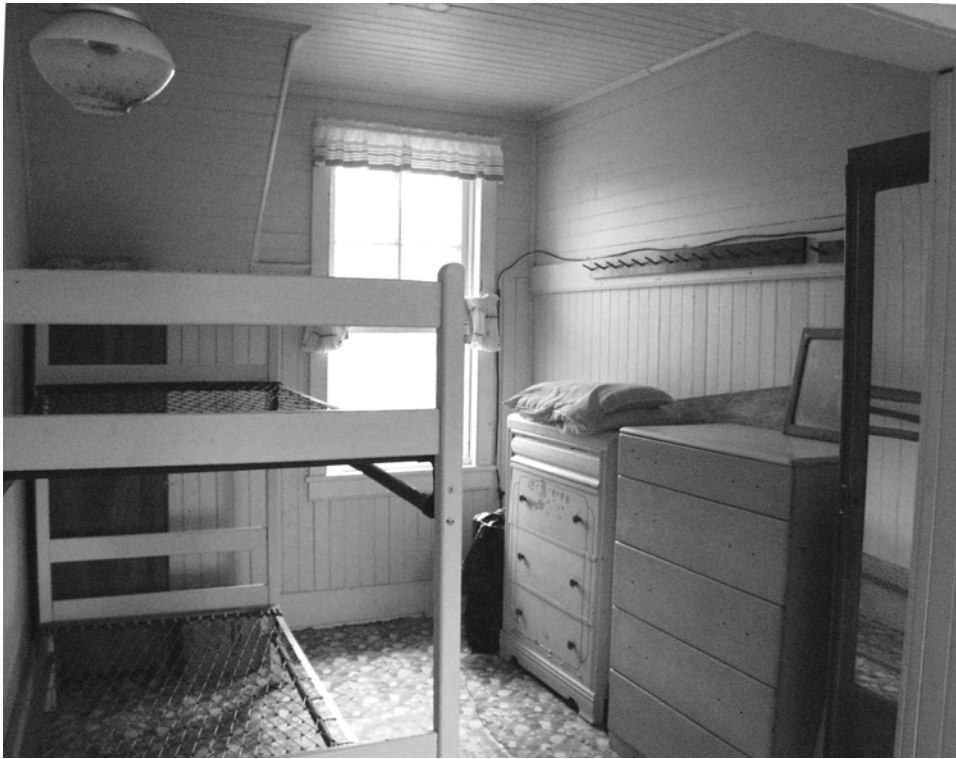
**Figure 84** View to south in Room 205. (NPS-SERO-CRS, 2002)

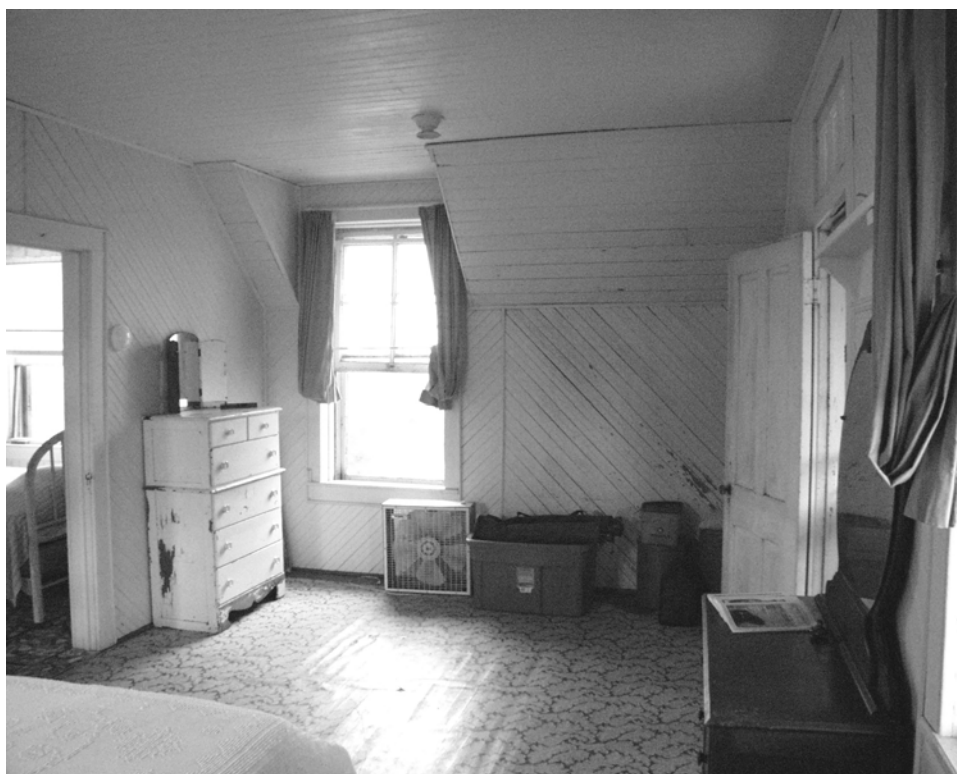
**Figure 85** View to west in Room 206, showing one of dormers added to second floor prior to World War II. (NPS-SERO-CRS, 2002)

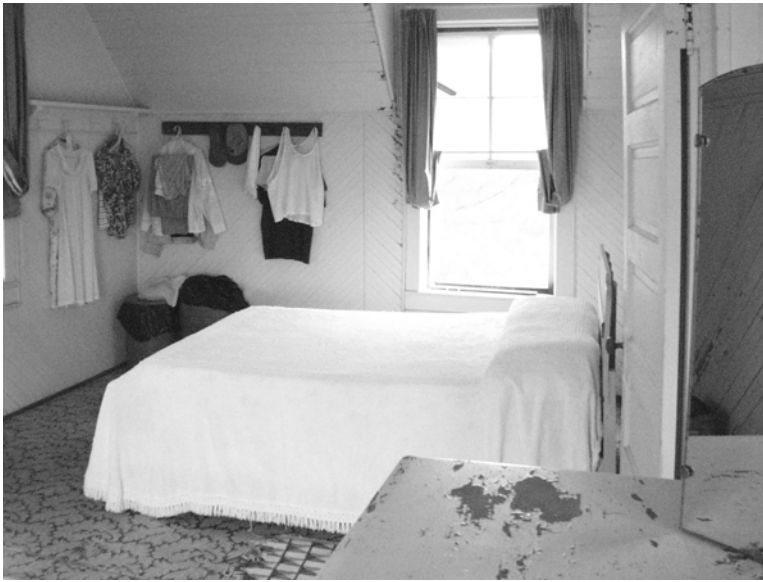
**Figure 86** View to northeast in Room 206. (NPS-SERO-CR, 2002)

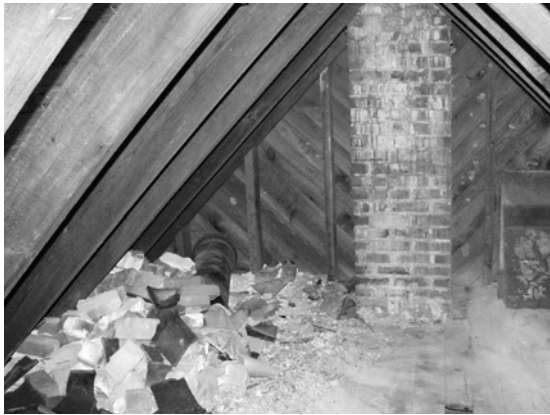
**Figure 87** View to south in attic showing chimney stack and unidentified brick rubble. (NPS-SERO-CRS, 2002)
