CAPE LOOKOUT NATIONAL SEASHORE  
Coast Guard Station Boat House  
**HISTORIC STRUCTURE  
REPORT**

**2004**

2004  
Historic Structure Report  
Coast Guard Station Boat House  
Cape Lookout National Seashore  
Cape Lookout Village  
LCS#: 091830

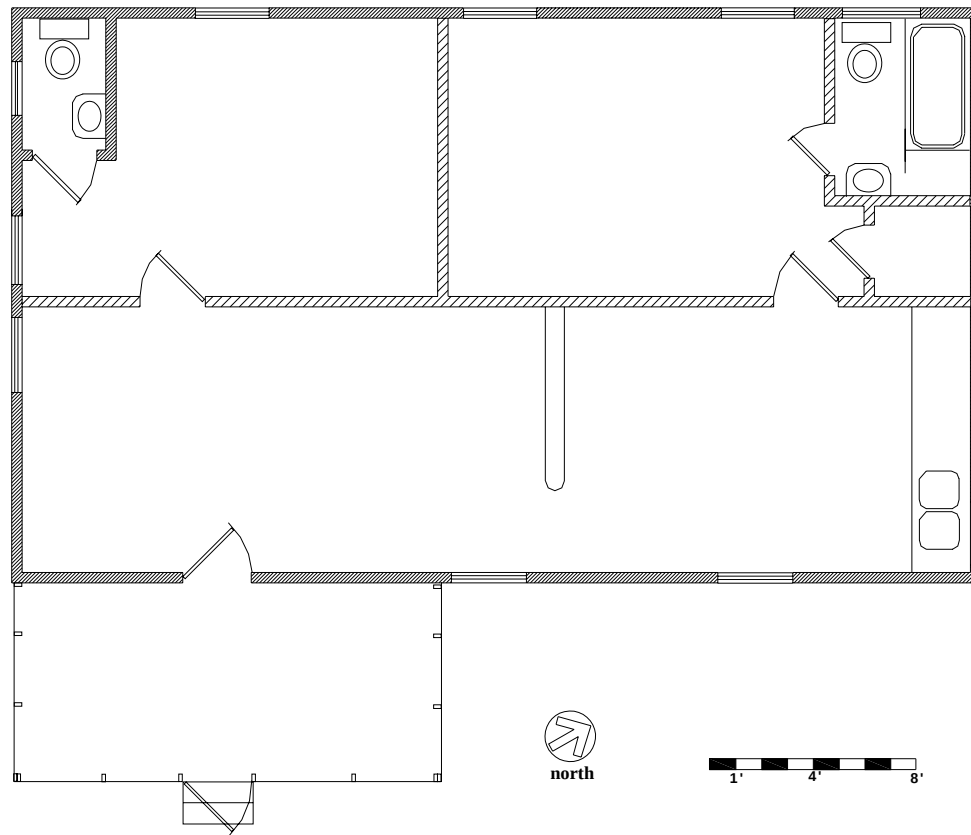
Alterations to the doors was the first major change. The single door on the southeast side of the building was removed and the opening closed by a wall and a conventional front door. The exterior of the wall was sided with drop

**Figure 22** Plan of Boat House showing alterations in the 1960s. (T. Jones, NPS-SERO-CR, 2003)

siding that matched the original siding, but it is not clear if the existing front door was installed at that time or if it is a later replacement. At the northeast end of the building, the old double doors were simply fixed in place and the exterior covered with drop siding. The roof was also shingled with wood at the same time.

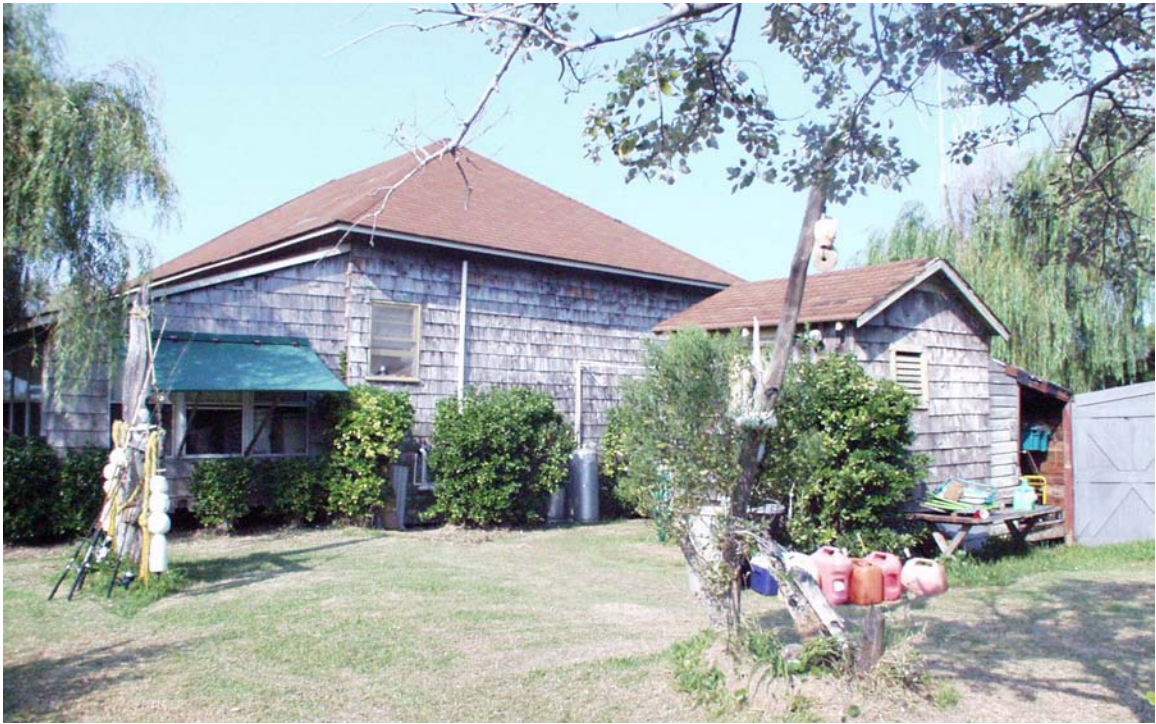
The building’s proximity to the ground, the modern finishes that cover most of the building, and lack of attic access prevent direct examination of most of the structure’s framing. Floor framing can be observed through the wire mesh that encloses the foundation and appears to be 2” by 8” joists on about 20” - 24” centers. Joists run parallel to the building’s long

**Figure 24** View west of L. S. S. Boat House. (NPS-SERO-CR, 2003)

side and are supported at mid-span by a 4" by 8" beam that runs the width of the structure.

There is evidence that termites have attacked the floor framing, but the damage may not be widespread. Walls are generally plumb, floors are level, and the roof shows no visible signs of structural deficiencies.

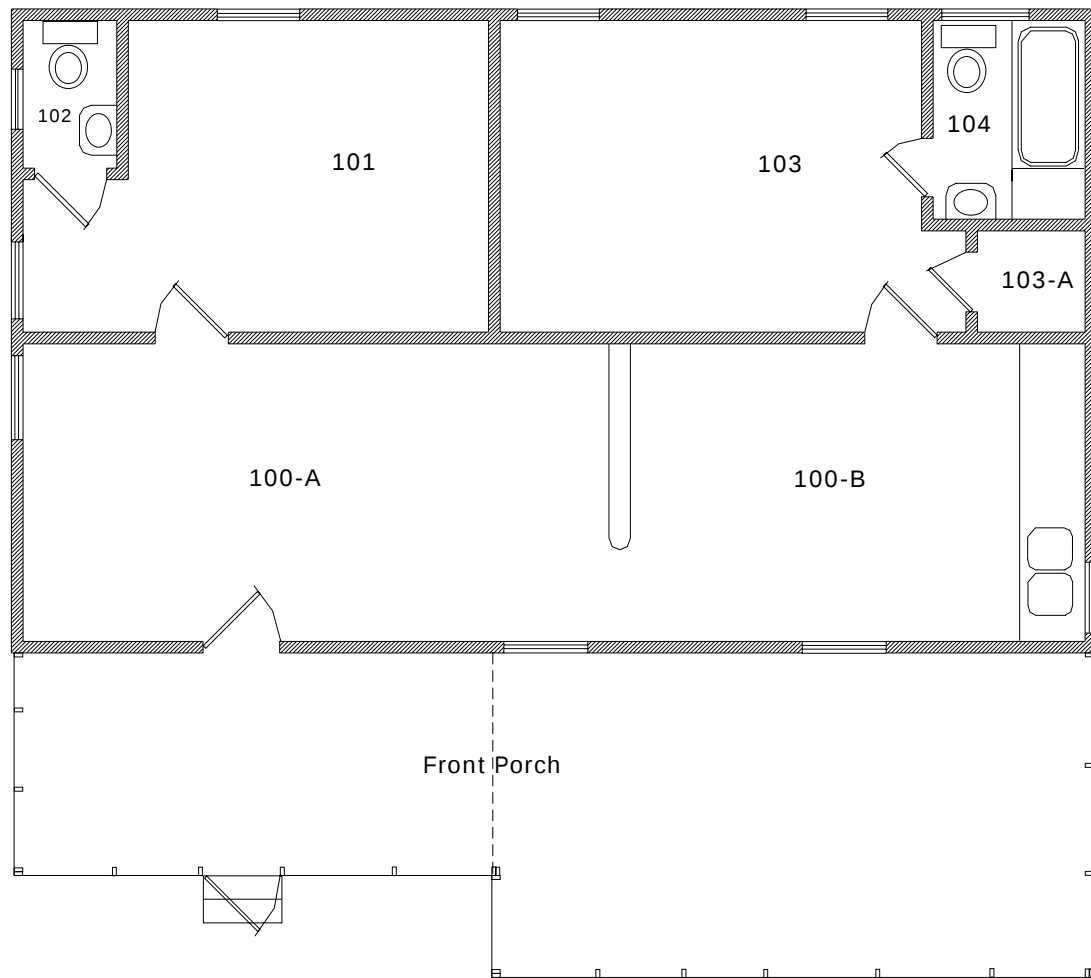
**Figure 40** Plan of existing building. (T. Jones, NPS-SERO-CR, 2003)
