Cape Lookout National Seashore  
**GASKILL - GUTHRIE HOUSE**  
**HISTORIC STRUCTURE**  
**REPORT**

2004  
Historic Structure Report  
Gaskill- Guthrie House  
Cape Lookout Village  
CAPE LOOKOUT NATIONAL SEASHORE  
Harker's Island, NC  
LCS#: 272049

## Gaskill-Guthrie House

### Historic Structure Report

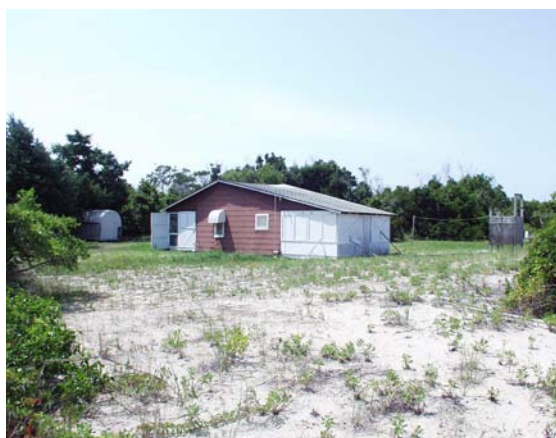
**Figure 19** View to south of Gaskill-Guthrie House. Modern metal building is at left, in front of the house; modern shower enclosure is at right, behind the house. (NPS-SERO-CRS,2002)

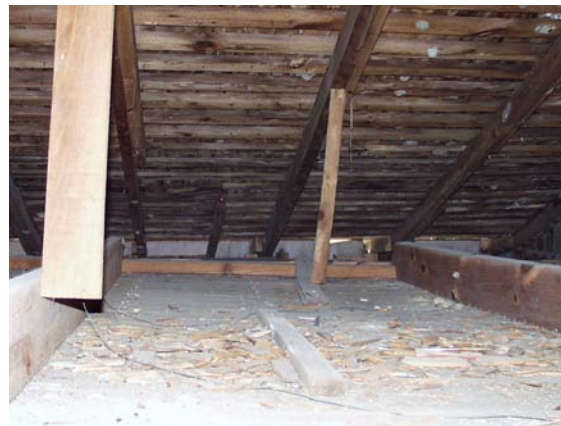
**Figure 22** View to southeast in attic of original house. (NPS-SERO-CRS, 2002)

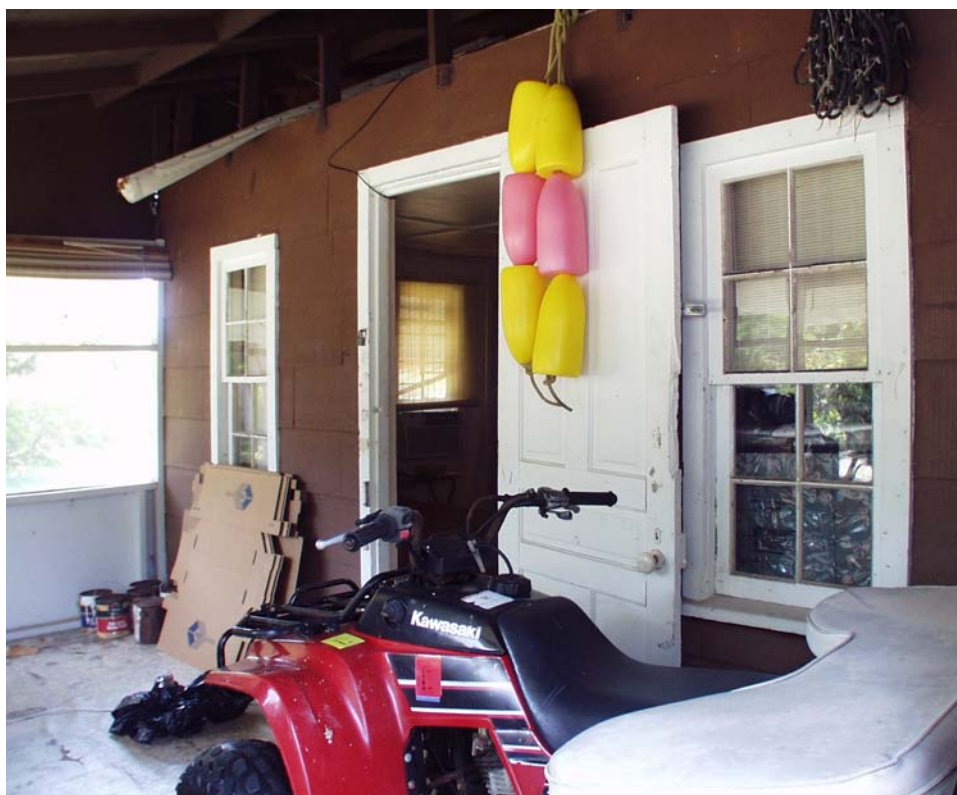
*W- 1:* Double- hung, four- over- four, wooden sash, 1'- 7" by 3'- 8", similar to the original windows at the Bryant House. Typical exterior casing, 2- 3/4" wide, no drip cap. A large, rounded, metal awning, added after 1976, covers the upper half of the window.

**Figure 25** View of front porch with original windows and door. (NPS- SERO- CRS, 2002)

- Repair and preserve existing windows.
- Remove metal awnings.

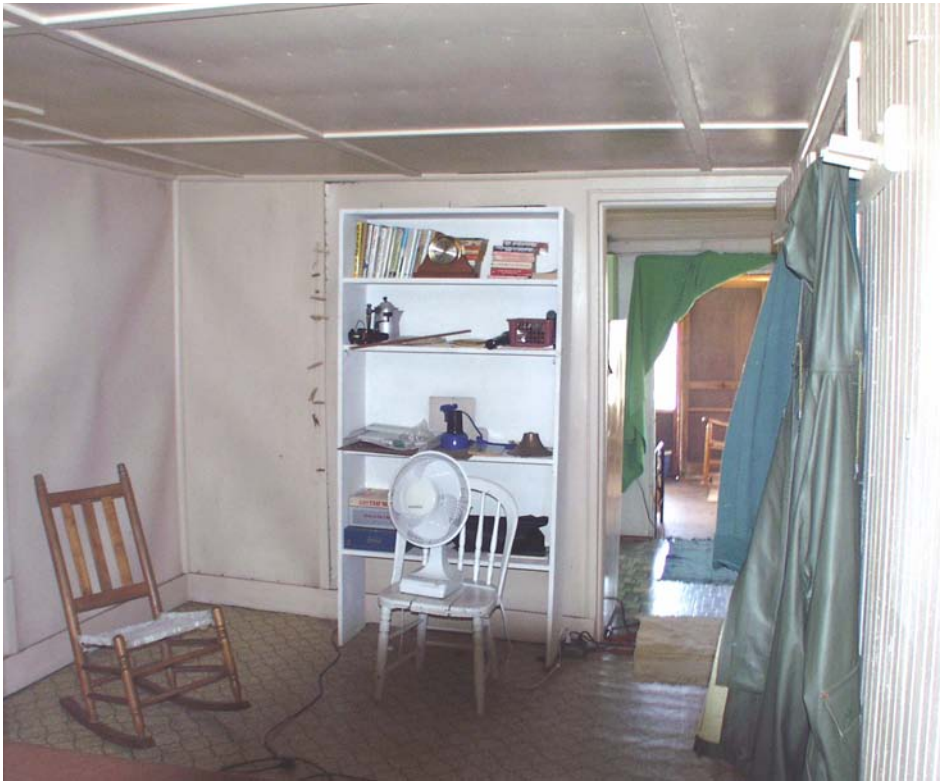
**Figure 26** View to west in living room, showing doorway to kitchen. (NPS-SERO-CRS, 2002)

*Ceiling:* The ceiling is set at 6'-8". The ceiling is only lightly framed, with 2" by 6" rafters on 48" centers and a 1" by 4" board laid flat half-way between the joists and helping to tie the ceiling boards together. The ceiling is finished with tongue-and-groove boards, 4-1/2" wide. These boards, which may be double-V-joint, are now covered with painted hardboard panels with battens at the seams.

- Remove existing hardboard and plywood paneling from walls and ceilings.
- Repair wall framing and install new 1/2" paneling.
- Repair existing flooring.
- Repaint all interior woodwork.

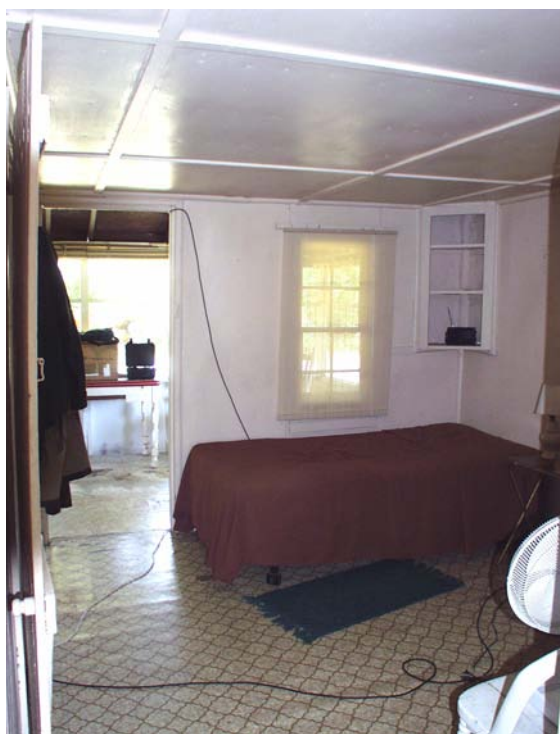
**Figure 27** View south in living room, showing door and window to front porch. (NPS-SERO- CRS, 2002)

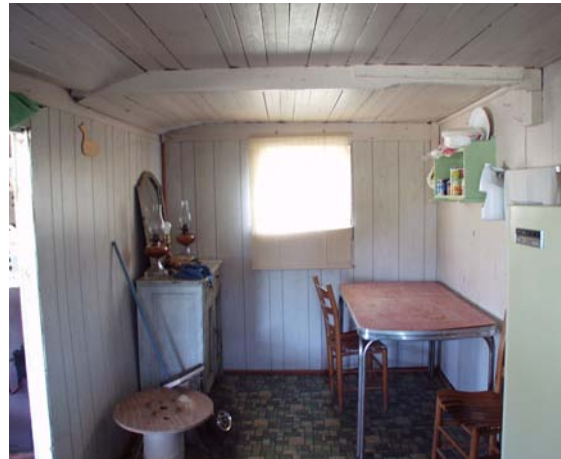
*Walls:* The front or southeast wall of this room, which may have originally been an exterior wall, is formed by vertical boards in random widths. The remainder of the walls are covered with modern plywood sheet paneling.

**Figure 28** View northeast in kitchen. (NPS-SERO-CRS, 2002)

- Install new electrical system.
- Install fire and smoke detection system.
- Do not install central heating or air-conditioning; install electric space heaters if necessary.
- Remove existing bathroom and install new bath at northeast end of Room 103.
- Rehabilitate existing kitchen.

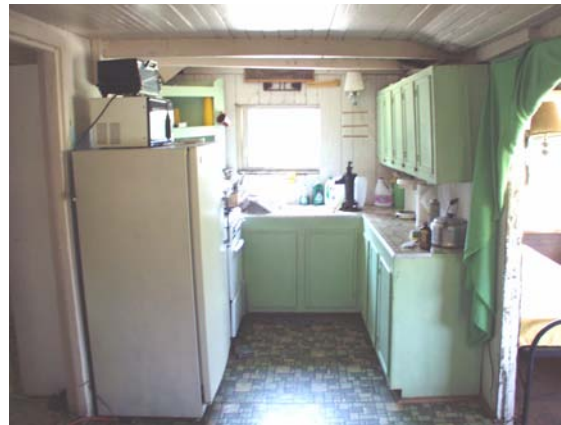
**Figure 29** View southwest in kitchen. (NPS-SERO-CRS, 2002)
