Cape Lookout National Seashore  
Portsmouth  
**GEORGE DIXON HOUSE**  
**HISTORIC STRUCTURE**  
**REPORT**

2004  
Historic Structure Report  
George Dixon House  
Cape Lookout National Seashore (CALO)  
Portsmouth, NC  
LCS#: 12519

## Historic Structure Report

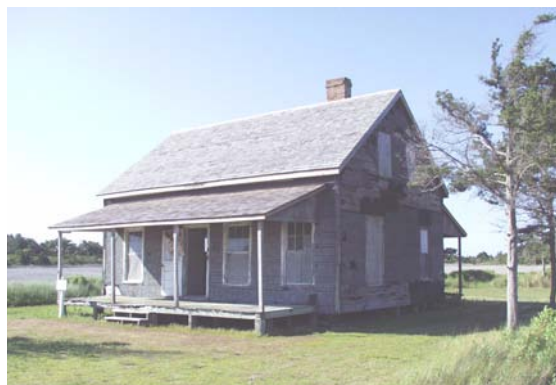
**Figure 9** View of front and north side of Dixon House. (NPS-SERO-CRS, 2002)

*Siding:* The house is presently finished with asphalt- composition panels installed after World War II. Measuring 16" by 36", these panels have a design meant to imitate random- range, dressed- face ashlar. On the southeast end of the house, all of the panels have been replaced by rolled asphalt roofing. On the northwest end, a quarter or more of the panels are missing, leaving the underlying wood sheathing exposed. Panels are badly damaged elsewhere.

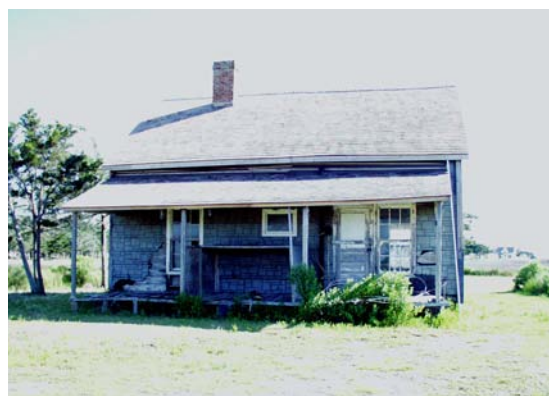
**Figure 10** View of rear or southwest side of Dixon House. (NPS-SERO-CRS, 2002)

*Sills and Plates:* Perimeter sills have undergone extensive repairs and modifications, especially on the southeast side of the house where the original sill has been replaced by a stacked trio of boards, 2" by 6-1/2". The 6" by 8" sill at the front wall of the house appears to be typical of the original sills. A beam, 6' by 7", runs through the house from end to end and supports the walls above that separate front from rear rooms. Support piers near the middle of this beam (under the central hall) appear to have been undermined and/or otherwise been displaced. As a result, the beam has broken and partially collapsed, causing nearby joists to split and allowing the center of the house to drop several inches.

*Joists:* First floor joists are about 1-7/8" by 7-3/4", set about 24" between centers. Joists run front to rear in the house and are notched and lapped over front and rear sills and over the collapsing center beam. Most are in good

condition; but at least one joist has split as a result of the collapsing beam.

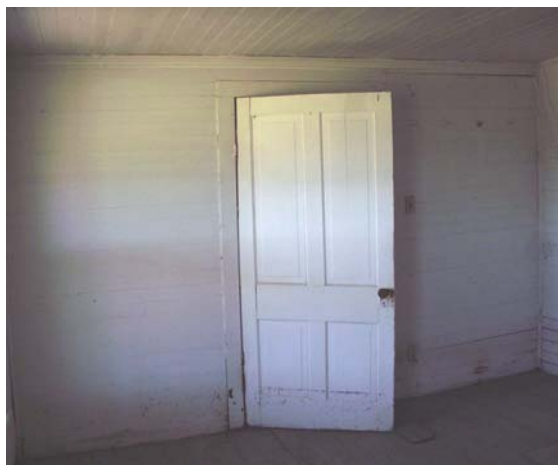
**Figure 17** View of south wall of Room 101, showing typical door in house. (NPS-SERO-CRS, 2002)

*Floors:* Flooring is 5"- wide, painted, tongue-and- groove boards. The collapsing sill that runs through the center of the house has

caused major deflection of the floor around the middle of the hall.

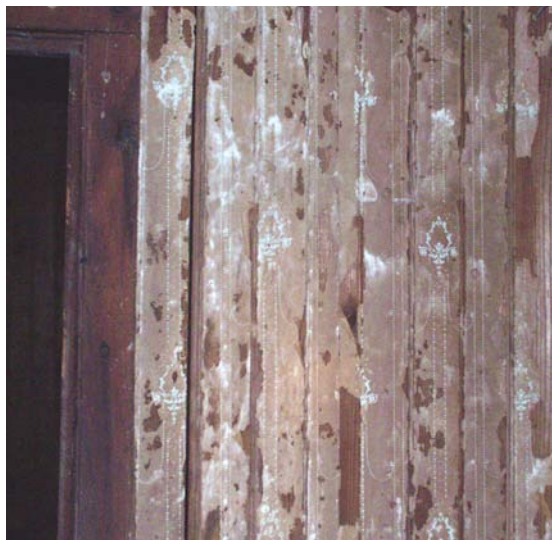
**Figure 25** View of wallpaper-covered paneling on north wall of Room 201. (NPS-SERO-CRS, 2002)

double- beaded, tongue- and- groove boards, thus creating Rooms 201 and 202 with a hall (Room 200) between the two. The layers of wallpaper on the walls in Room 201 indicate that this occurred as early as the 1890s or early 1900s.

- Preserve existing interior finishes, especially the original double-beaded tongue-and-groove boards that have survived.
- Remove existing bathroom.
- Install new bathroom in Room 202, avoiding alterations to the ceiling in Room 102.
- Install modern kitchen in Room 102.
- Rebuild wall between Rooms 103 and 104.
- Reconstruct ceiling in Room 202.
- Reconstruct missing walls and ceiling at front (east) end of center hall.
- Repair finishes in Room 201, preserving as much of the historic wallpaper as possible.
- Install modern electrical and plumbing systems.

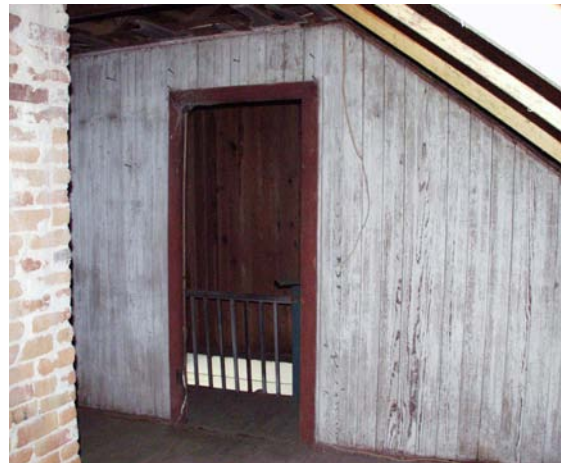
**Figure 27** View south in Room 202. (NPS-SERO-CRS, 2002)

*Windows:* There are two window openings on the south wall. Both are 2'- 4" by 3'- 10", originally fitted with six- over- six sash. The upper sash in the east window is missing.
