CAPE LOOKOUT NATIONAL SEASHORE  
GUTHRIE- OGILVIE HOUSE  
**HISTORIC STRUCTURE  
REPORT**

2004  
Historic Structure Report  
Cape Lookout National Seashore  
Guthrie- Ogilvie House  
LCS#: 09t829

# Guthrie-Ogilvie House

## Historic Structure Report

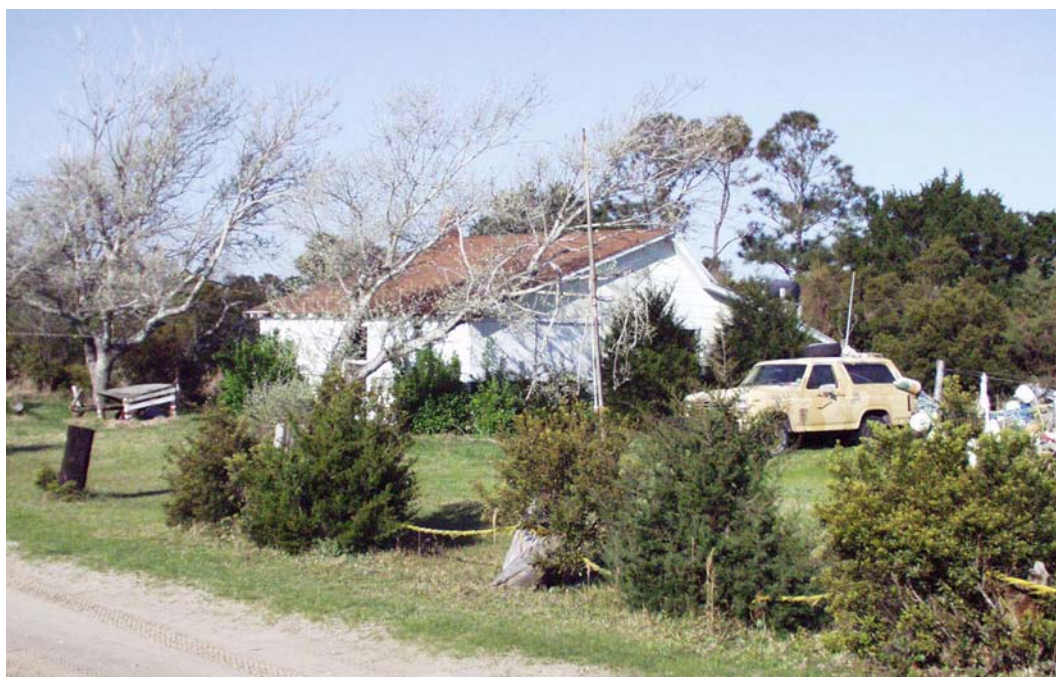
**Figure 15** View to west of Guthrie-Ogilvie House. (NPS-SERO-CR, 2003)

ing water to accumulate and remain standing under the house for extended periods of time.

with around 110 feet of frontage on the main road. The site is flat and very poorly drained. A slight depression has formed beneath the rear of the house, allowing large amounts of stand-

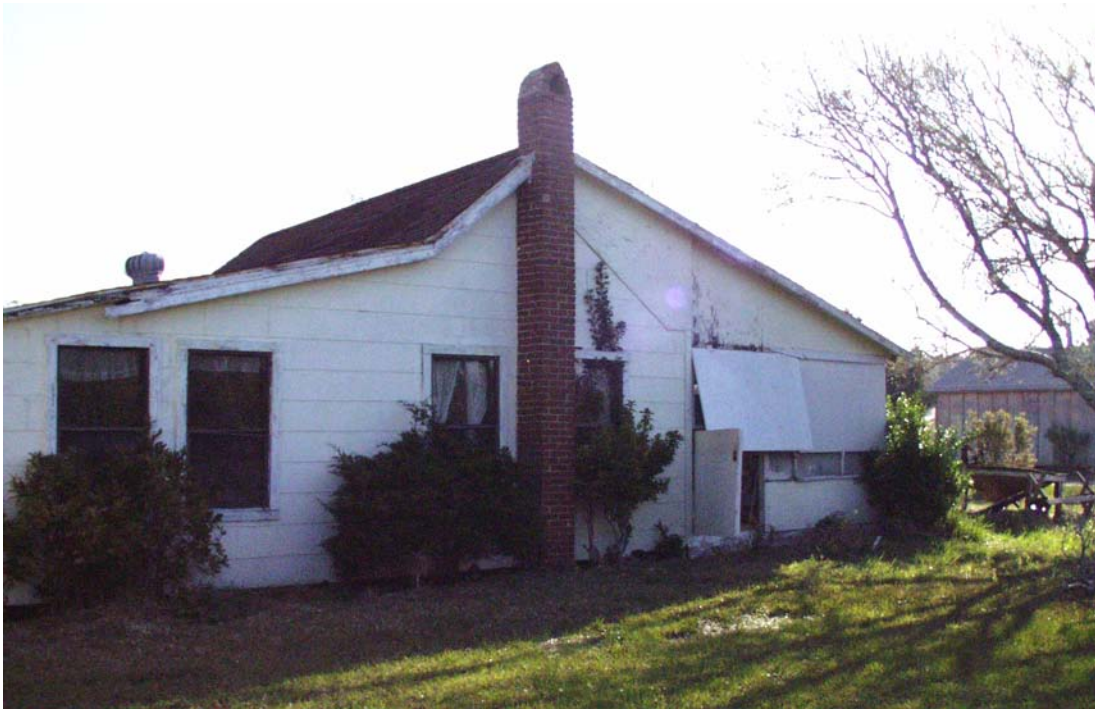
**Figure 17** View east of house.  
(NPS-SERO-CR, 2003)

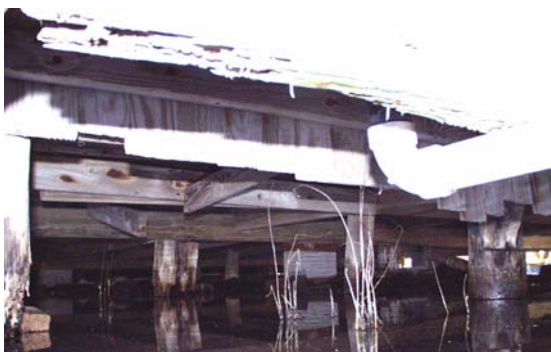
**Figure 21** View south under old porch, now a bathroom. Note original siding. (NPS-SERO-CR, 2003)

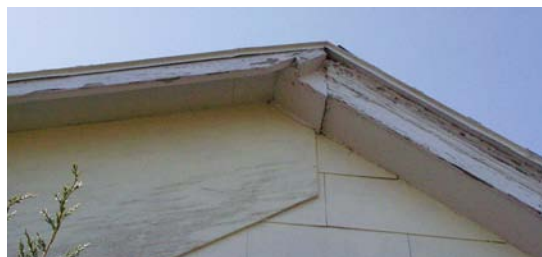
**Figure 25** View of typical boxed cornice at right and modern alteration to front shed of roof at left. (NPS-SERO-CR, 2003)

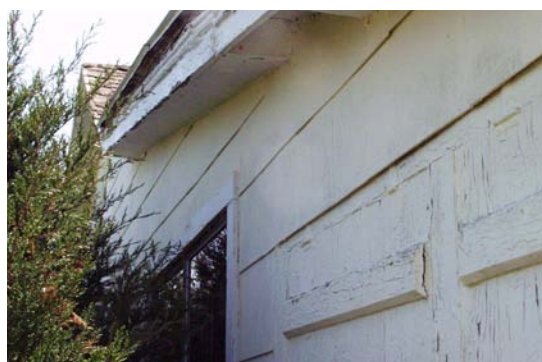
**Figure 26** View of typical exterior finishes including top-hinged shutters from original back porch. (NPS-SERO-CR, 2003)

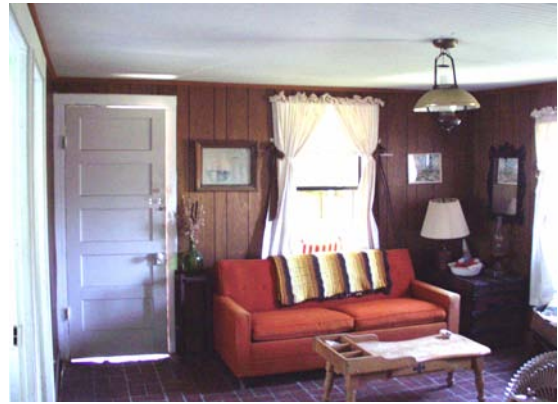
**Figure 27** View to southeast in living room or Room 100. (NPS-SERO-CR, 2003)

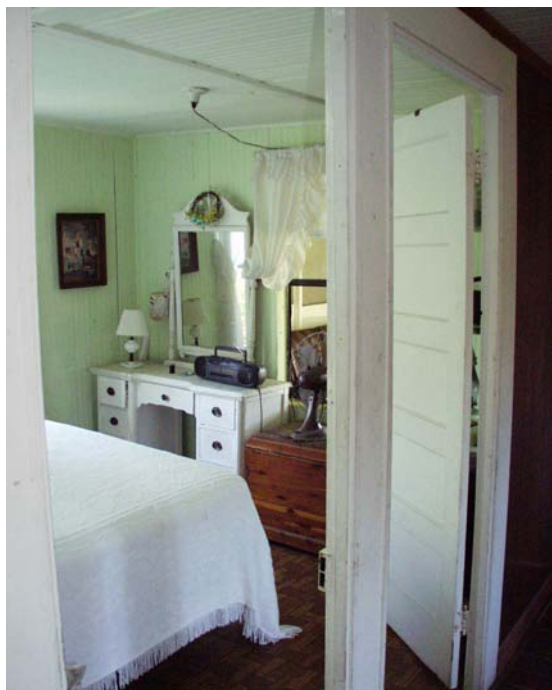
**Figure 29** View to east of Room 101, through double doors that originally opened into two separate rooms. (NPS-SERO-CR, 2003)

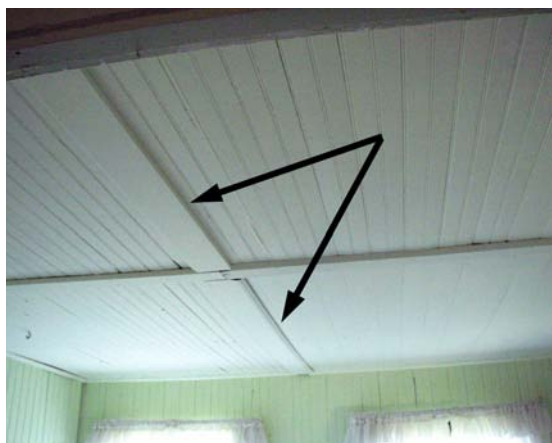
**Figure 30** View of ceiling in Room 101, with arrows indicating location of wall that originally divided the space. (NPS-SERO-CR, 2003)

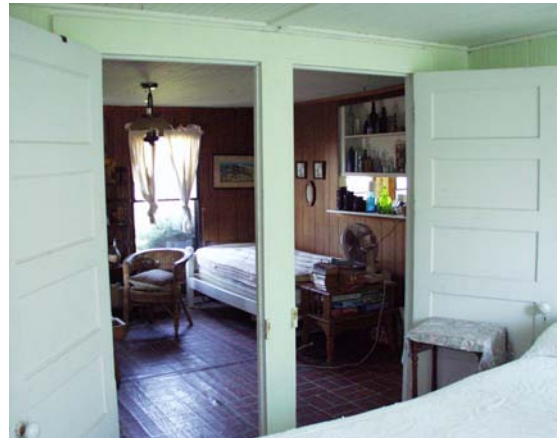
**Figure 31** View to west into Room 100, showing double doors opening into Room 101. (NPS-SERO-CR, 2003)

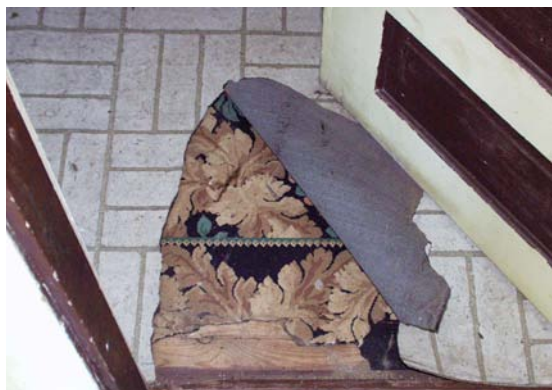
*Floor:* Flooring is typical 3- 1/2" tongue- and- groove boards covered with an early, floral- patterned, linoleum- type floor covering that itself is overlaid with modern, brick- patterned, sheet vinyl. The lack of discoloration and wear on

**Figure 33** View of linoleum-type floor-covering underneath modern vinyl in Room 102. (NPS-SERO-CR, 2003)

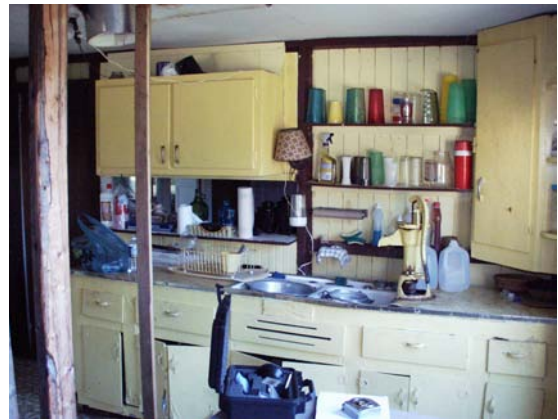
**Figure 36** View of kitchen counter and cabinets in Room 103. (NPS-SERO-CR, 2003)

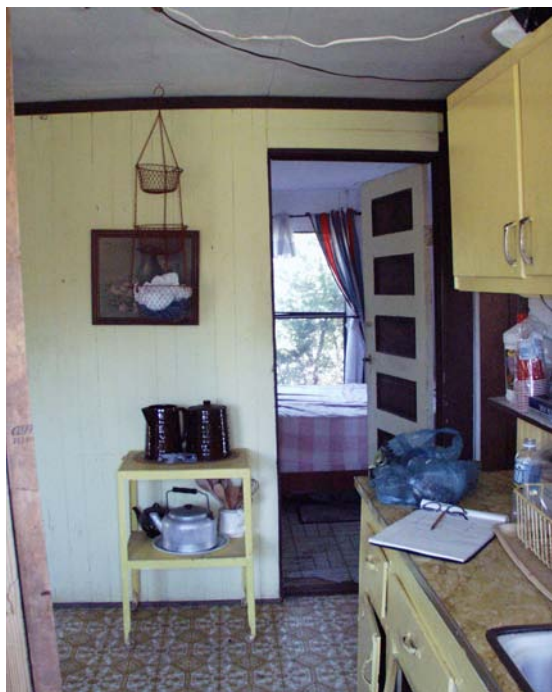
about 5'- 7" along the outside wall, there is no finish material on the ceiling at all. Significant water damage has occurred to the ceiling at the rear of the room, and removal of the separating wall between the two rooms weakened the

**Figure 37** View northeast in Room 103. (NPS-SERO-CR, 2003)

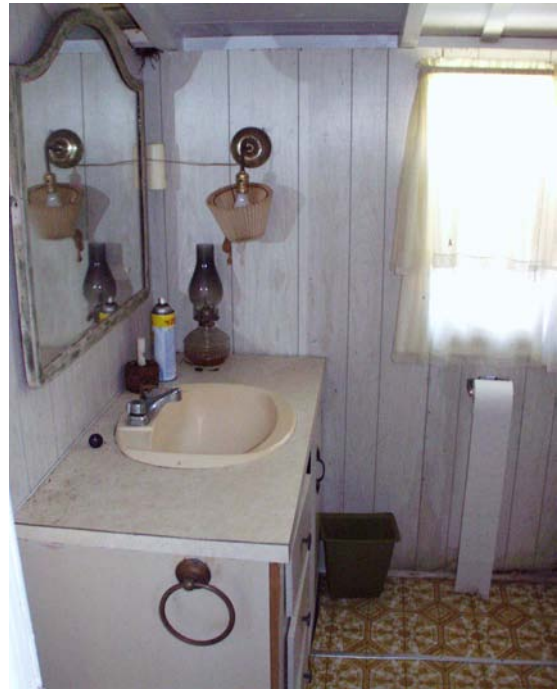
**Figure 39** View northwest of bathroom. (NPS-SERO-CR, 2003)

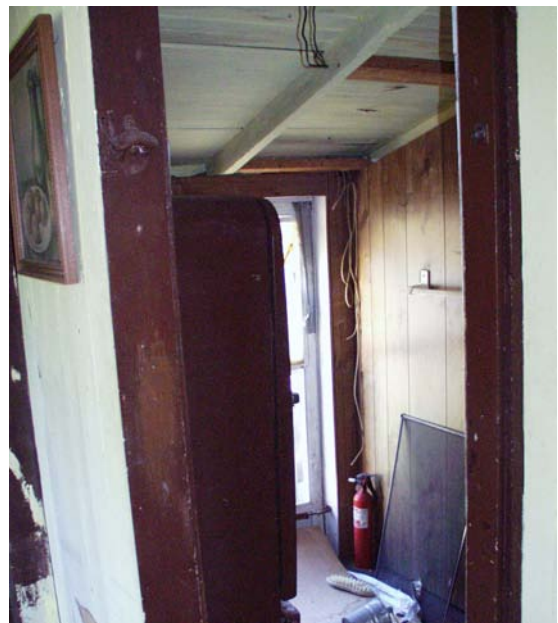
**Figure 40** View to north of Room 105. (NPS-SERO-CR, 2003)
