CAPE LOOKOUT NATIONAL SEASHORE  
Cape Lookout Lighthouse  
Keeper's Dwelling (1907)  
**HISTORIC STRUCTURE  
REPORT**

**2004**

2002  
Historic Structure Report  
Cape Lookout Lighthouse Keeper's Dwelling  
(1907)  
Cape Lookout National Seashore  
LCS#: 091838

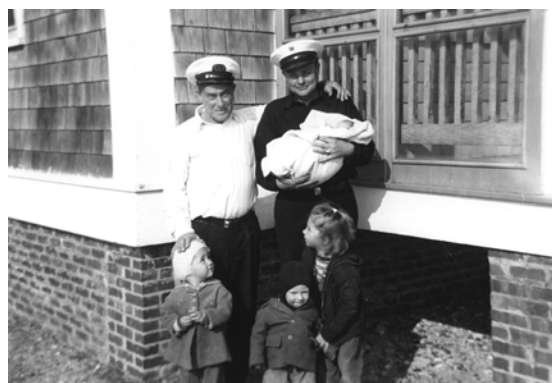
**Figure 12** Historic photograph, c. 1943, showing foundation of 1907 Keeper's Dwelling on its original site. (CALO Coll, Royer Photographs)

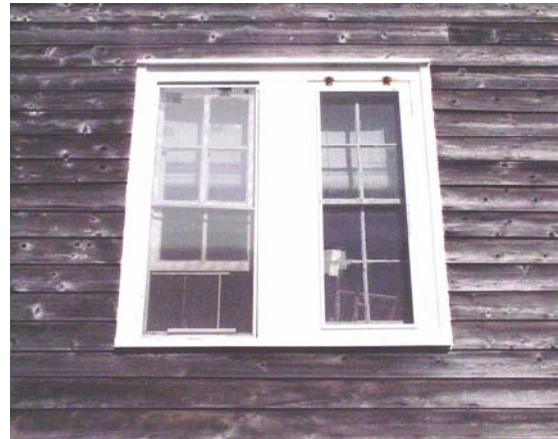
All of the present window and door openings on the house are historic, with all but two of those being a part of original construction. However, a number of the original sash have been replaced, although the original muntin pattern was maintained. Double windows are used on both stories of the three gable ends of the house, with single windows present elsewhere. Double window sash are four- over- four, 2'-1" by 5'-2" on the first floor and 2'-1" by 4'-6" on the second floor. Single window sash are six- over- six, 2'-10" by 5'-2", on the first floor and 2'-10" by 4'-6" on the second floor. Most of the sash are in generally good condition, except for paint, which is beginning to fail.

**Figure 9** View of typical double windows. (NPS-SERO-CR, 2002)

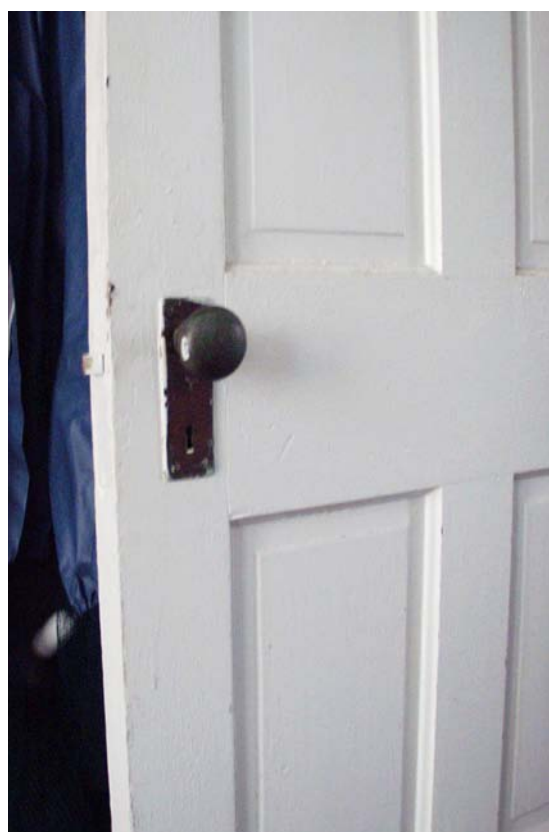
*Doors:* The door from the hall and the two closet doors are all 2'-6" by 7'-0" by 1-3/8" with four vertical panels. Mortise locks are present at all three doors, but the knob is missing from one of the closet doors. The closet door knob is plain metal while the hall door knob is also metal but has a design impressed in its face. The closet door knob is probably typical of the original hardware.

**Figure 21** Detail of closet door in Room 101. (NPS-SERO-CR, 2002)

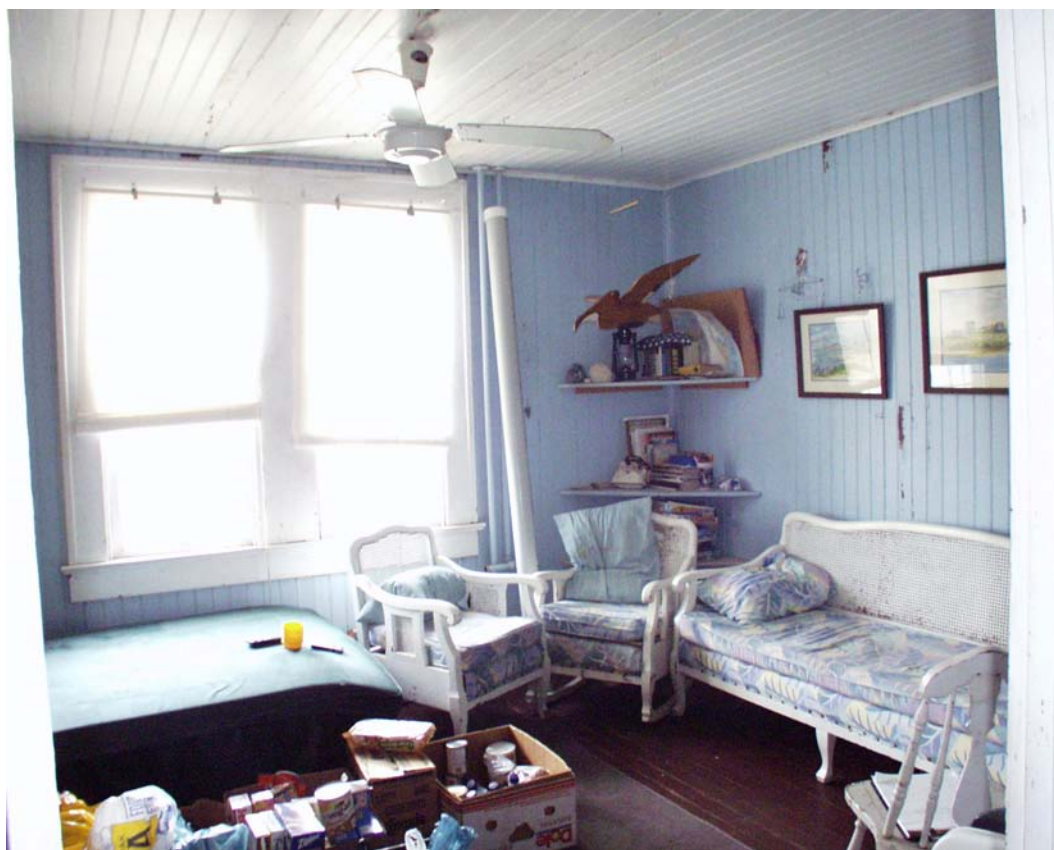
**Figure 22** View to east in Room 102. (NPS-SERO-CR, 2002)

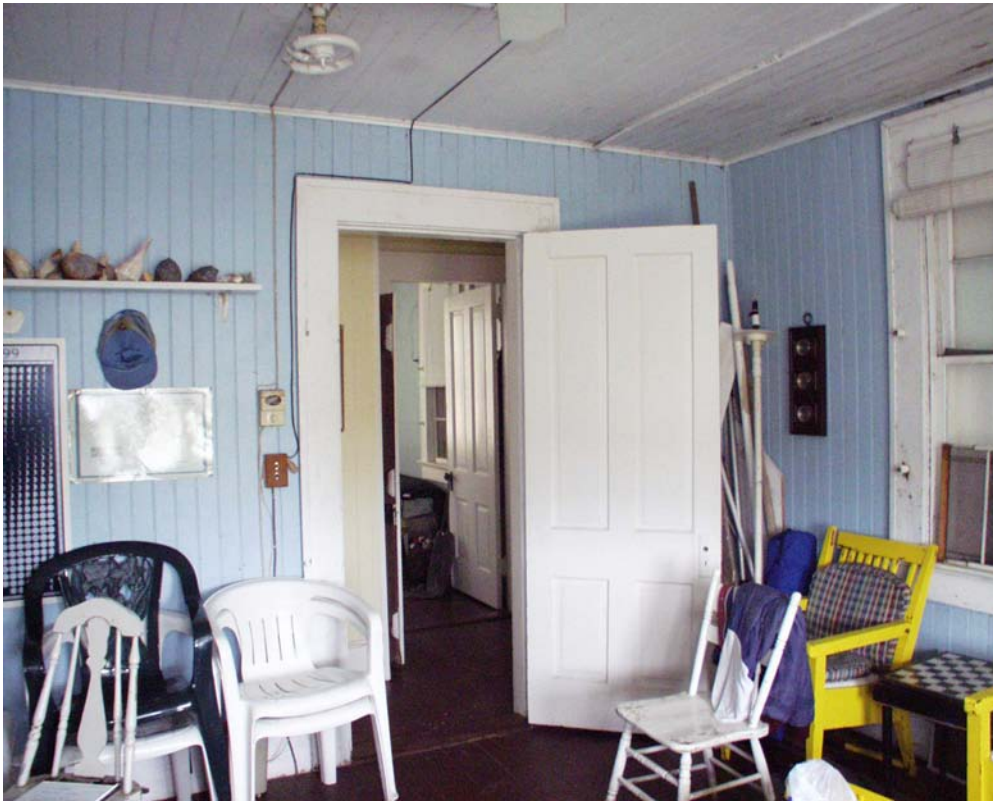
**Figure 23** View to west in Room 102. (NPS-SERO-CR, 2002)

tion, the door has been damaged and the hinges bent, with the damage only partially repaired.

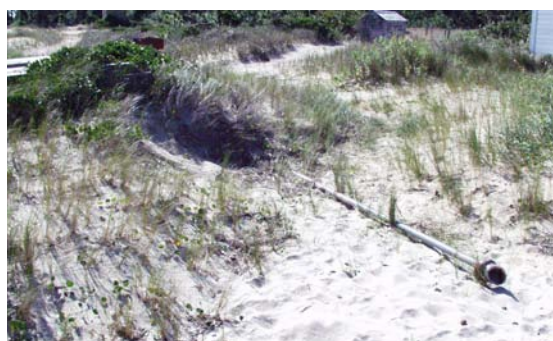
**Figure 38** Waste line from kitchen at original site. (NPS-SERO-CR, 2002)
