# Cape Lookout Village Lewis-Davis House Historic Structure Report

Cape Lookout National Seashore  
**LEWIS - DAVIS HOUSE**

# **HISTORIC STRUCTURE REPORT**

**2004**

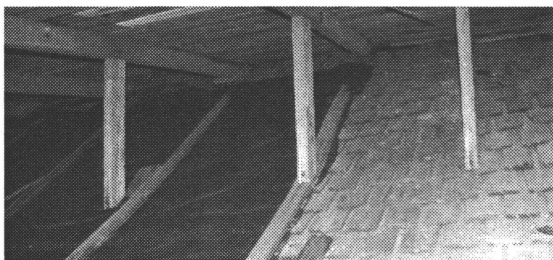
**Figure 27** View of wood shingle roof on original structure encompassing Rooms 100 and 101. (NPS-SERO-CR, 2002)

**Rafters:** There are three main rafter systems in the present structure: one over Rooms 100 and 101, which could not be examined, and another separate system over the rear rooms. When the two halves of the house were joined, a new roof structure was built to cover both of the earlier roofs (see Figure 10). Rafters of this third roof are around 1- 3/4" by 3- 3/4", on 30" centers, and woefully undersized for their span and pitch. Rafters at the rear of the house have been severely damaged by termites.

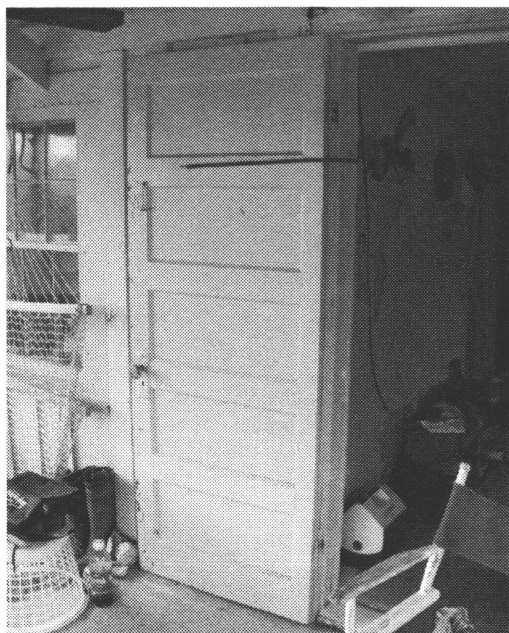
**Figure 30** View of front door D-1. (NPS-SERO-CR, 2002)

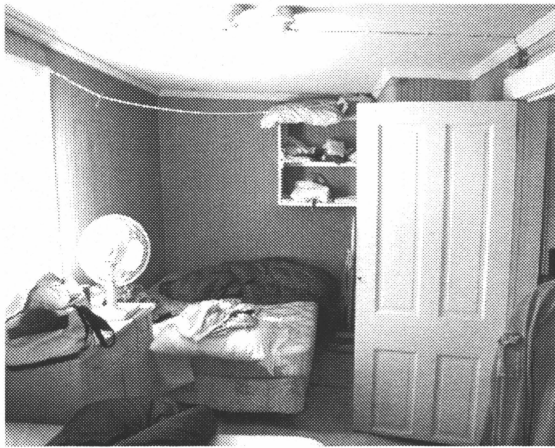
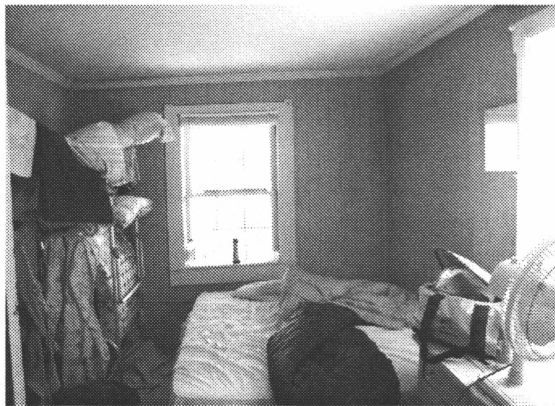
**Figure 34** View to west in Room 101. (NPS-SERO-CR, 2002)

**Figure 35** View to southeast in Room 101. (NPS-SERO-CR, 2002)

The floor is in dangerous condition and appears to be collapsing due to major deterioration of floor joists and/or piers under this part of the house.

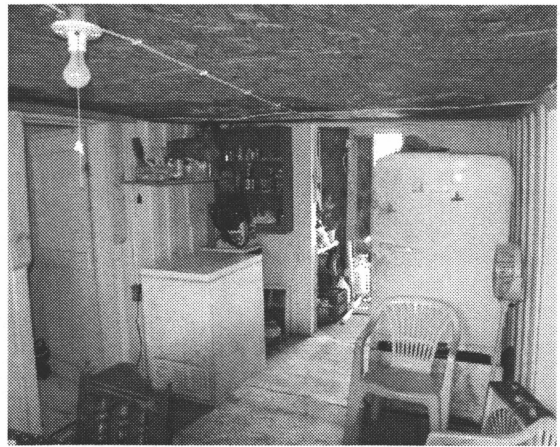
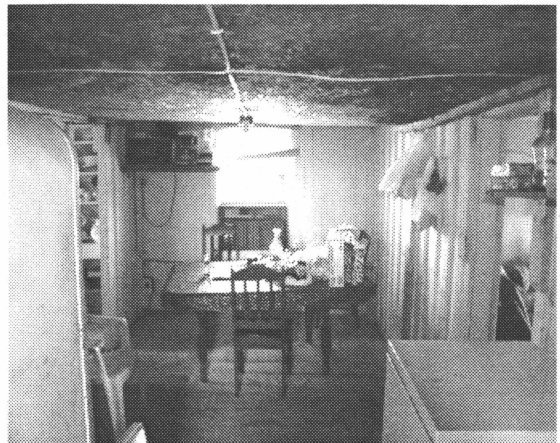
This room measures 8'-2" by about 15'. All of the rooms in the house except Room 101 open to this room. Major damage is ongoing where the roof is leaking along the wall adjoining Room 100.

*Ceiling:* The ceiling is set at about 7' and covered by sheets of wafer board. Original tongue- and-groove boards, 3-1/2" wide, probably V-joint, remain in place beneath the wafer board, but many are probably damaged or deteriorating due to water penetration. The ceiling has been braced along the middle of the

**Figure 36** View to south in Room 102. (NPS-SERO-CR, 2002)

**Figure 37** View to northeast in Room 102. (NPS-SERO-CR, 2002)

the east wall because water-damaged joists are collapsing in that area.

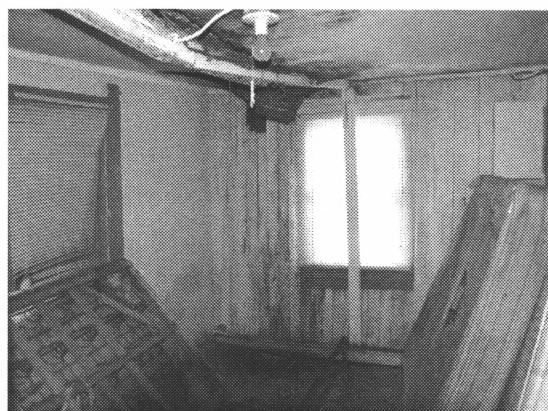
Measuring 8'- 4" by 11'- 6", this room is in extremely poor condition.

*Floors:* The floor is carpeted over plywood, although there appears to be an underlying layer of historic tongue- and- groove material. Water penetration and termites have destroyed the connection between the joists and the rear sill, allowing the entire floor to collapse at that end of the room.

*Ceiling:* The ceiling, like the floor, is on the verge of total collapse due to severe termite and water damage. It was originally finished with double- V- joint, tongue- and- groove boards, 3- 1/2" wide.

**Figure 40** View to west in Room 104. (NPS-SERO-CR, 2002)

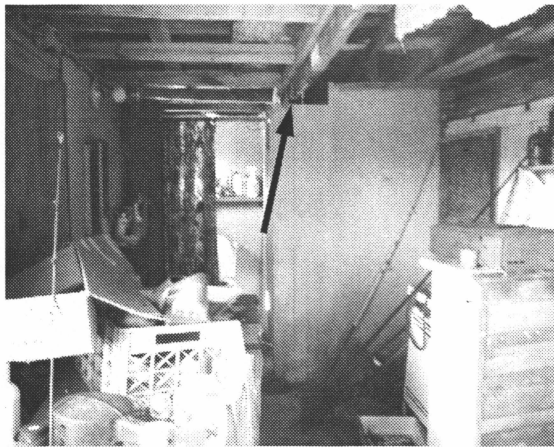
**Figure 42** View northwest in Room 105. Arrow marks header at outside of historic porch. (NPS-SERO-CR, 2002)

*Floor:* The floor is modern plywood and is suffering from severe water damage near the entrance to the bathroom area.

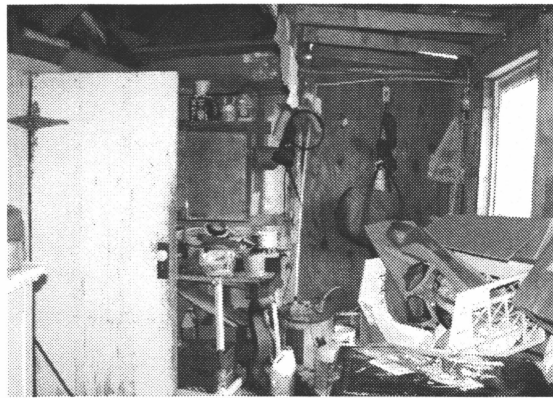
**Figure 43** View to southeast in Room 105. (NPS-SERO-CR, 2002)
