Buck House
Carl Sandburg Home National Historic Site
Historic Structure Report
Phase 1

December 2014

Cultural Resources Division
Southeast Region, National Park Service

JOSEPH K. OPPERMAN – ARCHITECT, P.A.

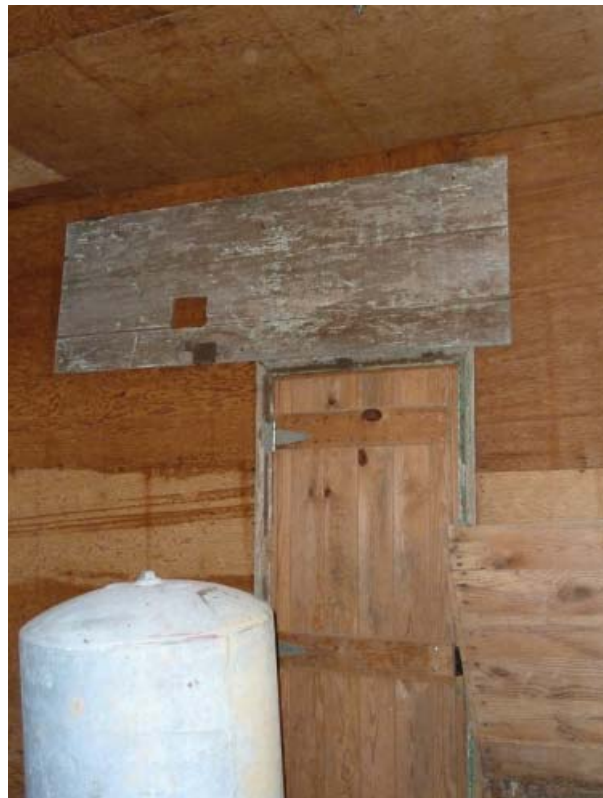
Figure 12. Modern board-and-batten door installed by Sandburg. Early door attached to wall above.

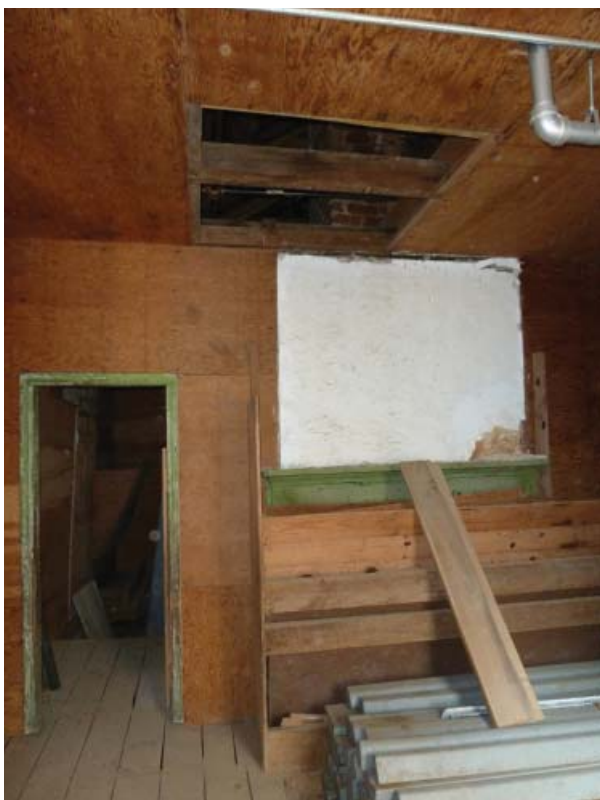
Figure 13. Doorway between north and south room as seen from south room. Note sheets of plywood on walls and ceiling.

Most walls and ceilings in both the front and the back sections of the house are covered with plywood sheets, presumably installed by NPS. The undersides of the ceiling joists retain lime stains from the original plaster ceilings.

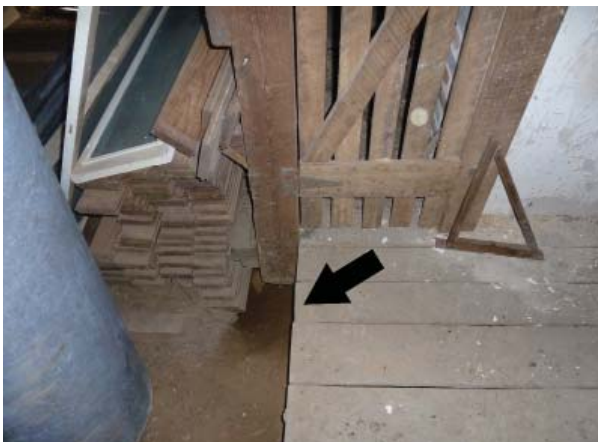
- Animals are burrowing under the house. The chimney has settled, forming cracks in the chimney stack both at first-floor level and attic level.

Figure 19. Animal burrows at north fireplace may be undermining chimney stack.

- Repair roof leak.
- Close off access by burrowing animals.
- Repair deteriorated elements of the building envelope such as roofs, flashing, windows, doors, and siding.
- Replace inferior materials, such as defective siding, which are prone to fail.
- Cap the chimney.
- Install wire mesh in north elevation vent.
- Consider installing gutters and downspouts.
- Establish positive drainage around the exterior perimeter of the house to drain water away from the house.
- Seasonally remove plants, fallen leaves, and other organic materials to prevent build up on and around the building.

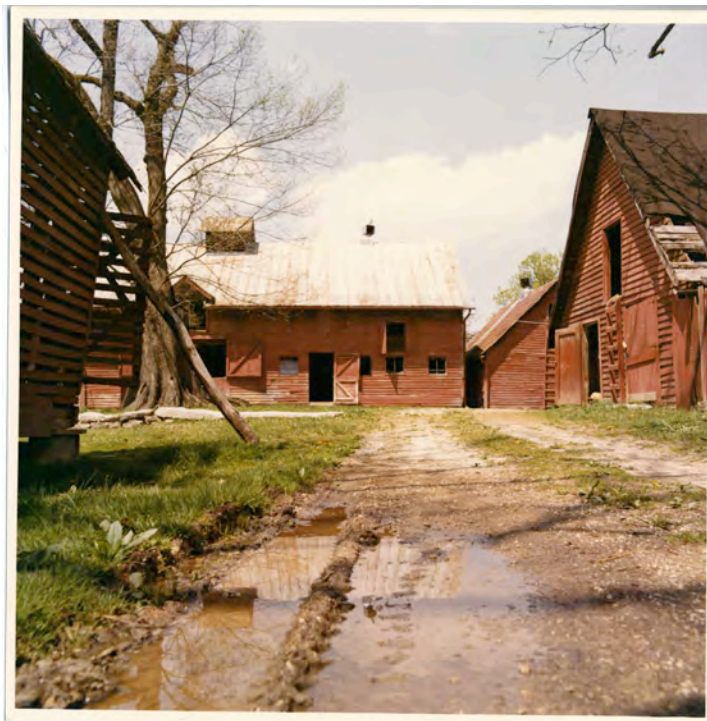
Image 12. The Goat Barn, circa 1971, once the NPS acquired the property. Note the red color on the barn and its deteriorated condition. (CARL 4009-2-1-G-84)

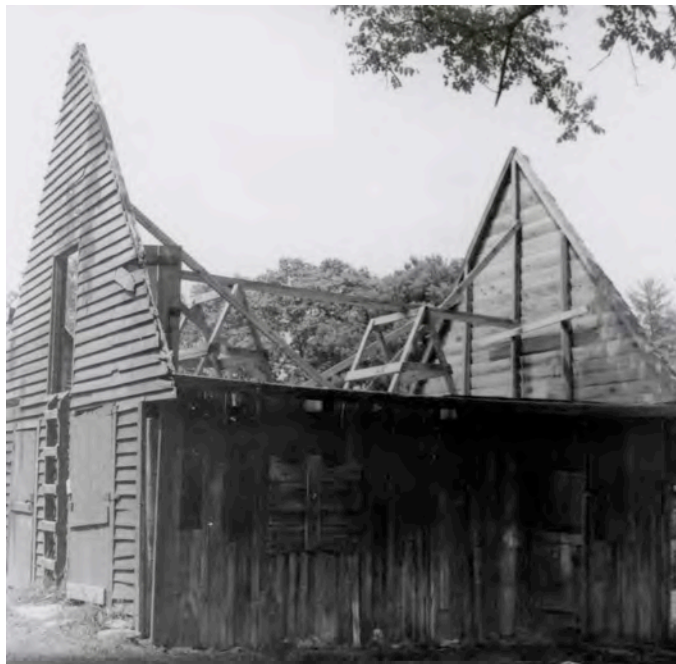
Photographic evidence shows that the Sandburgs modified this building by adding wide plank weatherboards to the west elevation to replace earlier slatted siding by 1952. They also enclosed the south elevation of the building with vertical siding. In a circa 1915 photograph, taken well before the Sandburg modifications, the siding of the west elevation appears unpainted or possibly with a weathered finish. (*Image 23*) In a photograph taken after the Sandburg changes, which may date to either 1948 or 1954, the siding appears unpainted while the rake boards appear to be painted a dark color. (*Image 24*) In the 1952 photograph, the building (including the weatherboards) appears dark and may be unpainted or painted a dark color. (*Image 25*) An undated photograph from the University of Illinois at Urbana-Champaign Library also shows a building that may or may not be painted. Because the image is taken from a distance and is black-and-white, it is difficult to discern the paint finish. (*Image 27*) By 1972, the building had fallen into a state of disrepair and was substantially rehabilitated by the NPS. Photographs from this year show total removal of the roof structure, but the weatherboards of the west and south elevation appear intact. (*Image 26*)

Image 26. The Buck Kid Quarters, 1972, when the NPS performed significant repairs on the building. (CARL 4008-16-13P)

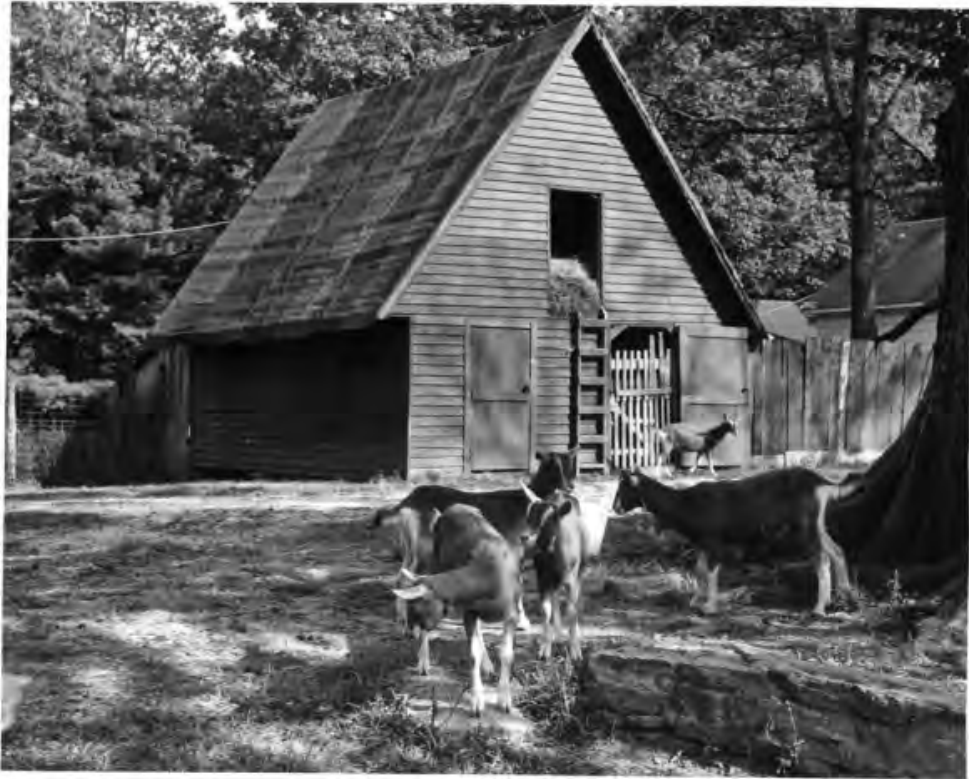
The 1952 photograph also shows white paint on the door surround of the west elevation. However, this door opening has been modified since the 1952 photograph, since it appears as a five-panel door in this photograph and a vertical-board door with a seemingly different surround in the later photograph in *Image 27*. Evidence of the white paint color on the door surround of the west

Image 27. An undated photograph from the *Carl Sandburg Collection Photographs* of the University of Illinois at Urbana-Champaign Library, shows the Buck Kid Quarters in active use during the Sandburg period. It is still unclear whether the weatherboards and trim are painted, however note the different door than in *Image 25* above. (Rare Book and Manuscript Library, University of Illinois at Urbana-Champaign, *Carl Sandburg Collection Photographs*, Inventory Number 014-028-008. www.library.illinois.edu/contentdm/cdm4/item_viewer.php?CISOROOT=/sandburg&CISOPTR=544&CISOBOX=1&REC=9; accessed 10 June 2012)

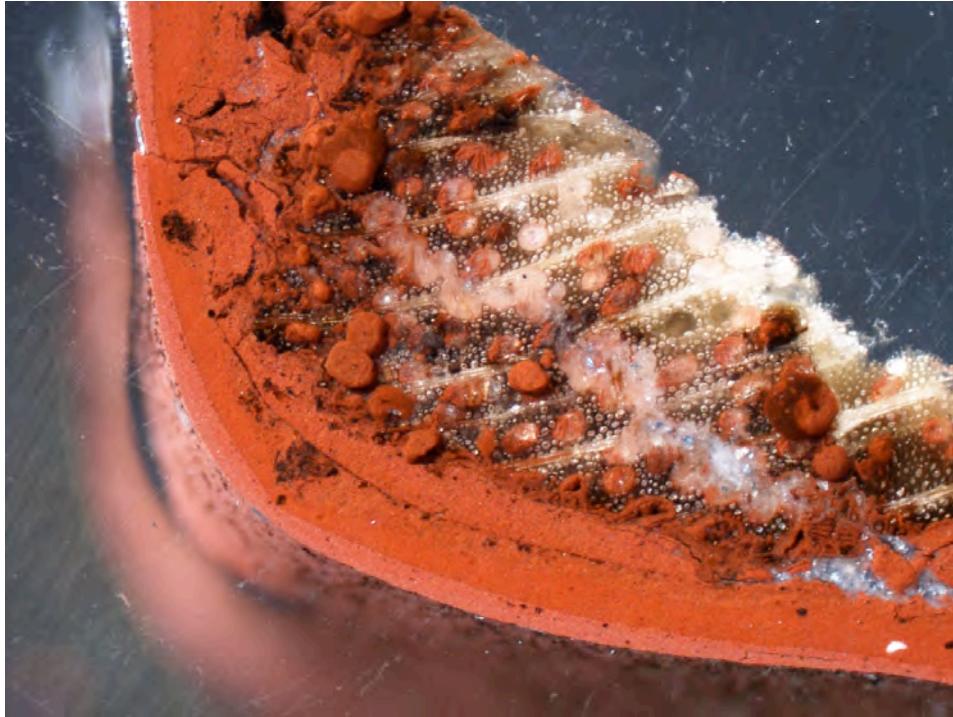
Four samples were removed from the Buck Kid Quarters, three from the exterior and one from the interior. The three exterior samples, removed from weatherboards on the north, west and east elevations, contain between three and six layers of dark red paint. The sample removed from the west elevation has the greatest number of paint layers (six), as well as the most disturbed substrate condition. This evidence suggests that these weatherboards were unpainted for a time prior to being painted with the red paint. (*Image 28*)

Image 28. Sample CSB.4, removed from a plank between joist ends on the north elevation of the Buck Kid Quarters, has only four layers of red paint. The wood substrate is highly weathered. (40x, Visible Light)

For the Buck Kid Quarters, based on the current evidence, it is not possible to know what year the building was first painted during the Sandburg period of occupancy, nor the colors employed when it was first painted. Photographic evidence suggests the building was painted by 1952; however, the photograph was taken some distance from the building and it is a black-and-white image, so this evidence is not conclusive. The undated University of Illinois photograph (*Image 27*), which dates to later in the Sandburg's period of ownership, may also show a painted building. The latter photograph also shows a different door than the one depicted in the 1952 photograph (*Image 25*) and the color of the door and trim is a dark color, most likely red. This color is different than the white that is visible on the door trim in the 1952 photograph. Additional research is necessary to determine exactly when the Buck Kid Quarters was painted by the Sandburgs and what colors they used. The 1952 photograph, as well as the University of Illinois photograph, should be further studied (at higher resolution, if possible) to determine if the building was painted at the time the photographs were taken, since both date to the Sandburg period (albeit beyond the 1950 period of interpretation). Additional paint samples could also be removed from protected locations of historic fabric to try to determine the early paint finishes on the building's trim.

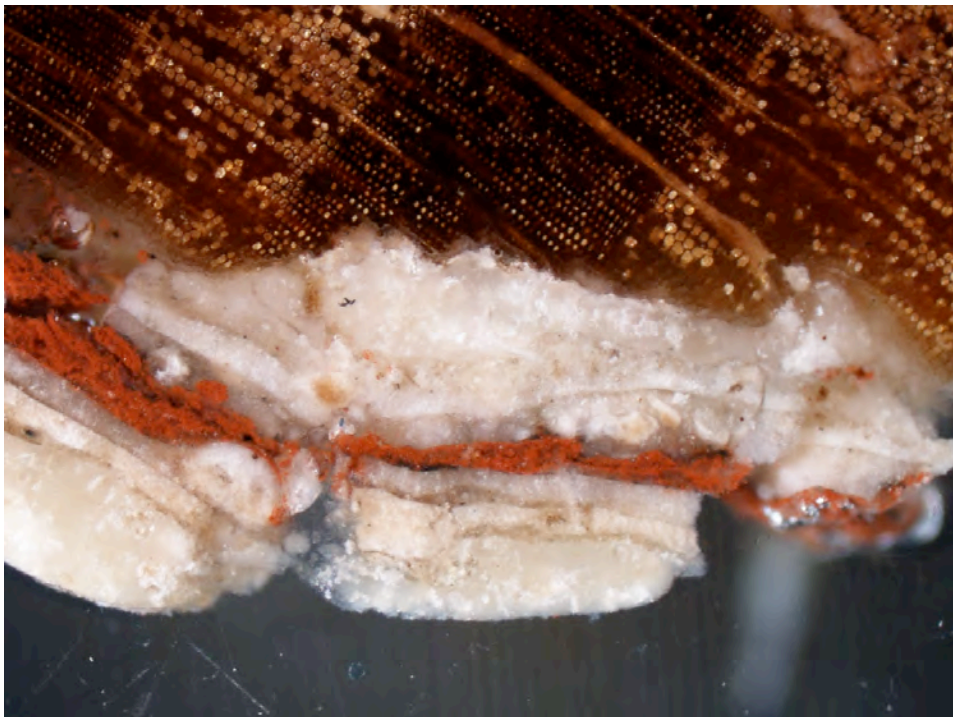
The sample removed from the interior of the building (CSB.6) has a different paint layering sequence. This sample, removed from a diagonal framing brace that was most likely exposed prior to the Sandburgs enclosing this elevation, contains six layers of white lime wash and one layer of red paint. (*Image 29*)

Image 29. Sample CSB.6, removed from a diagonal brace inside the Buck Kid Quarters, shows evidence of whitewash and a layer of later red paint. This element appears to be original to the building. (40x, Visible Light)

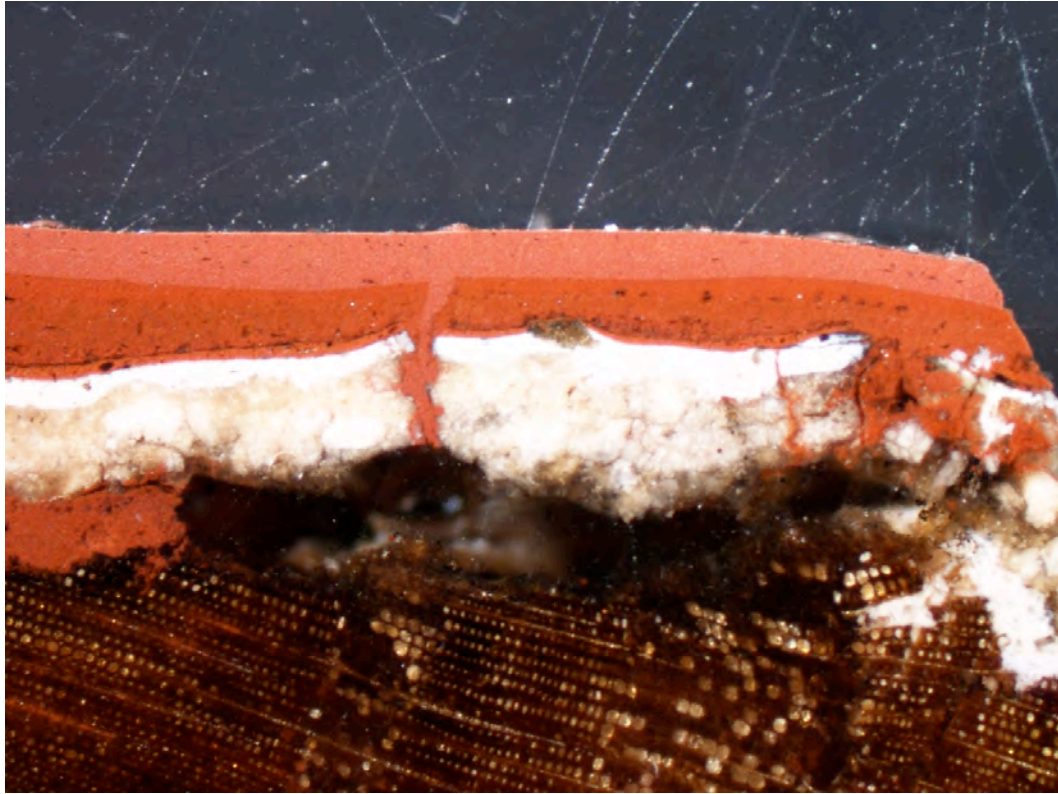
Two samples were removed from the exterior wide plank weatherboards of the Isolation Quarters, one from the north elevation and one from the west elevation. The latter sample was removed from a protected area and contained more layers of finishes, and was therefore examined in cross-section. In this location, a total of seven layers of finishes were documented, two layers of white lime wash, one layer of white paint and four layers of red paint. (*Image 30*)

Image 30. Sample CSB.44 was removed from the west elevation of the Isolation Barn and contains early lime wash and white paint finishes, as well as more recent reds. (40x, Visible Light)

For both the Isolation Barn and Corn Crib, there is neither solid photographic or physical evidence for their paint finish circa 1950. However, based on the findings for the other barn complex buildings, a paint scheme of dark red is recommended for these buildings as well.

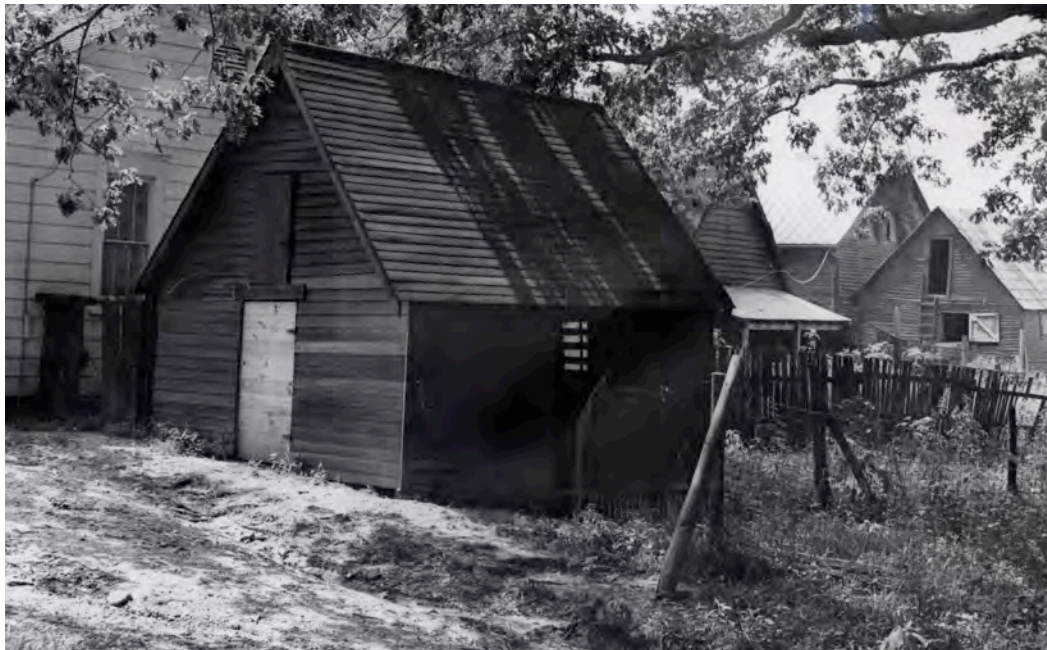
Historic photographs of the Isolation Barn are limited to those from the 1970s, once the NPS gained ownership of the property. These photographs show a dark-colored barn, presumably painted red, with some replacement boards and a new door that had not yet been painted. According to JKOA, there is documentation that the Sandburgs painted the Isolation Quarters red by the end of their period of occupancy, and this may be the paint color visible in the 1971 NPS photograph in *Image 30*. However, it is not possible to know if this building was painted red in 1950, the site's period of interpretation. (*Image 31*)

Image 31. The Isolation Barn, 1971. (CARL 4008-12-02P)

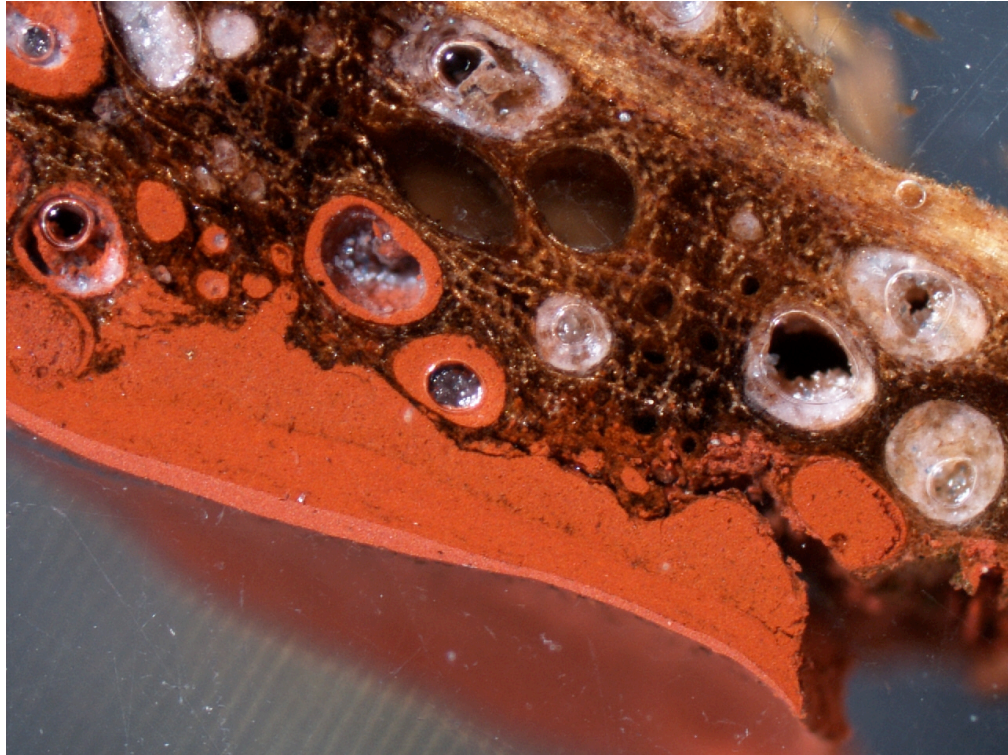
Samples were removed from protected areas of the building, under the roof overhang. One sample was removed from the wood slat above the door and the other from the uppermost piece of lath under the roofline. The door was also investigated in situ. In all of the locations that were examined, only recent campaigns of red paint were observed. In the samples viewed in cross section, five layers of red paint are present on top of a weathered wood substrate. (*Image 32*)

Image 32. Sample CSB.2 was removed from a slat above the door of the Corn Crib. Note highly weathered wood substrate. (40x, Visible Light)

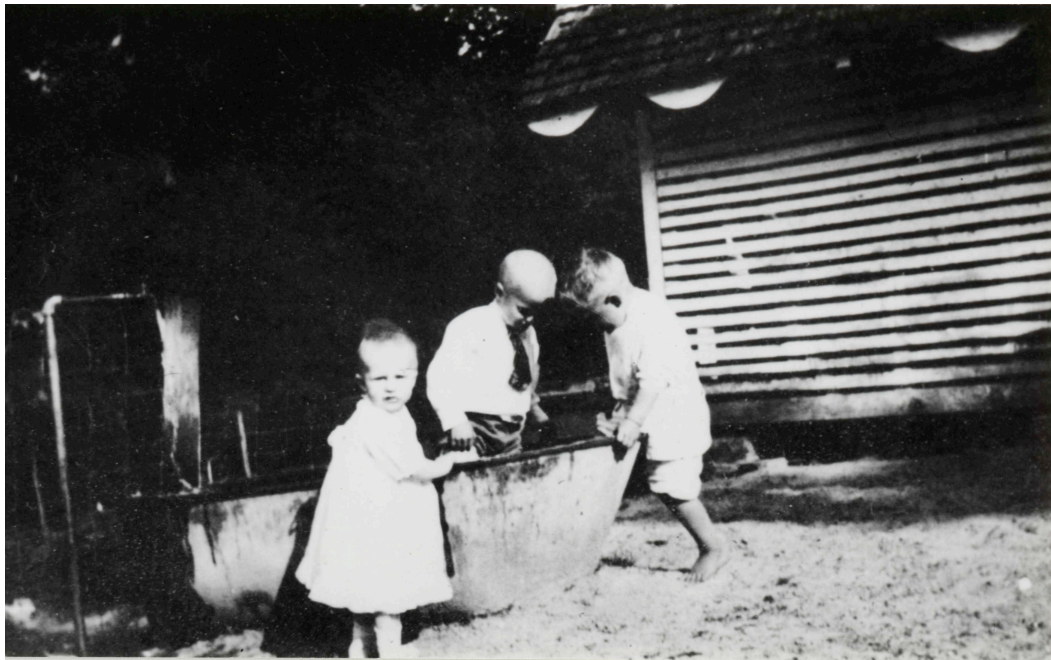
Historic images of the corn crib suggest its exterior was either unpainted or treated with a light colored finish, most likely lime wash. Two undated historic photographs from the Smyth era show this light colored appearance. No physical evidence of a light colored finish, such as a lime wash, was found during the current study. The lack of a light-colored finish does not provide conclusive evidence either way regarding the corn crib's early finish history, since it is possible that there was a light colored finish that weathered off but it is also possible that the wood was originally unpainted. Neither the photographic or physical evidence provides conclusive information on the corn crib's early finishes.

Image 33. The Corn Crib during the Smyth era. (CARL 3001-I6-22P, Smyth Family Photograph Collection)

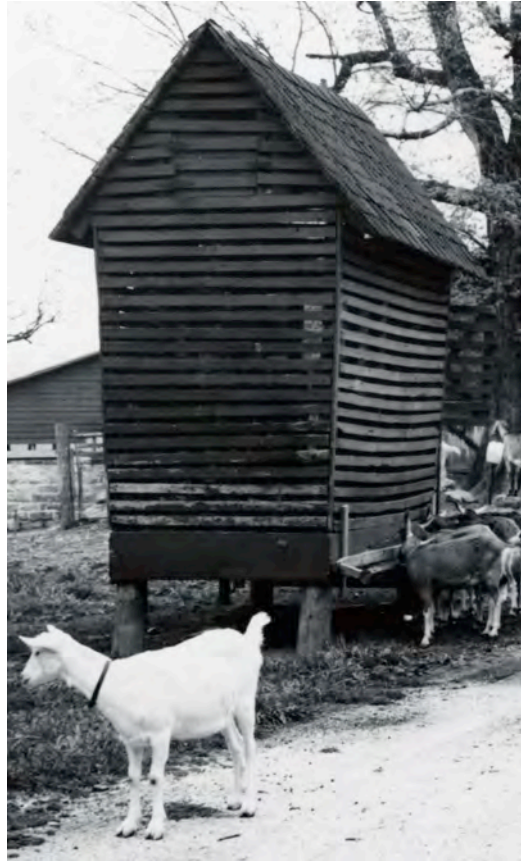
Photographs from 1956 and 1971 show a dark-colored, presumably painted, corn crib. It is unfortunately not possible to know if the existing paint on the corn crib dates back to the 1950s. It is also not possible to know if the color on the corn crib in the 1956 photograph is red, but it is very possible based on the paint evidence found on the other barn buildings. (*Images 33-35*)

Image 34. The Corn Crib, 1956. (CARL 3003-2.3-1)

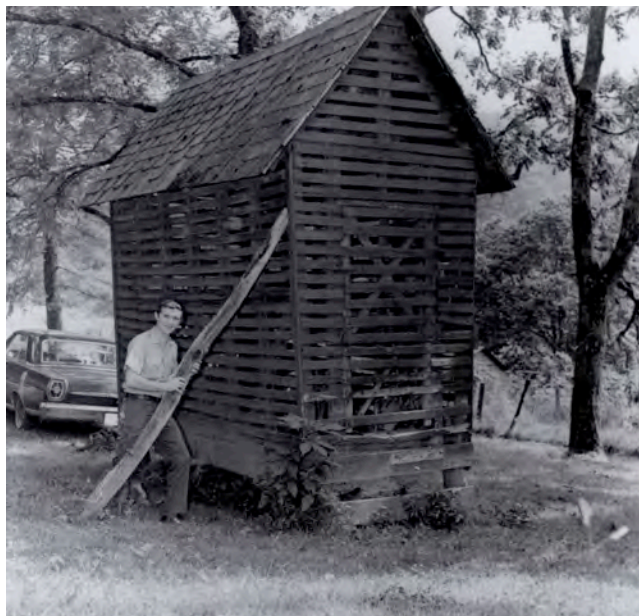
Image 35. The Corn Crib, 1971, under NPS stewardship. (CARL 4008-15-02P)

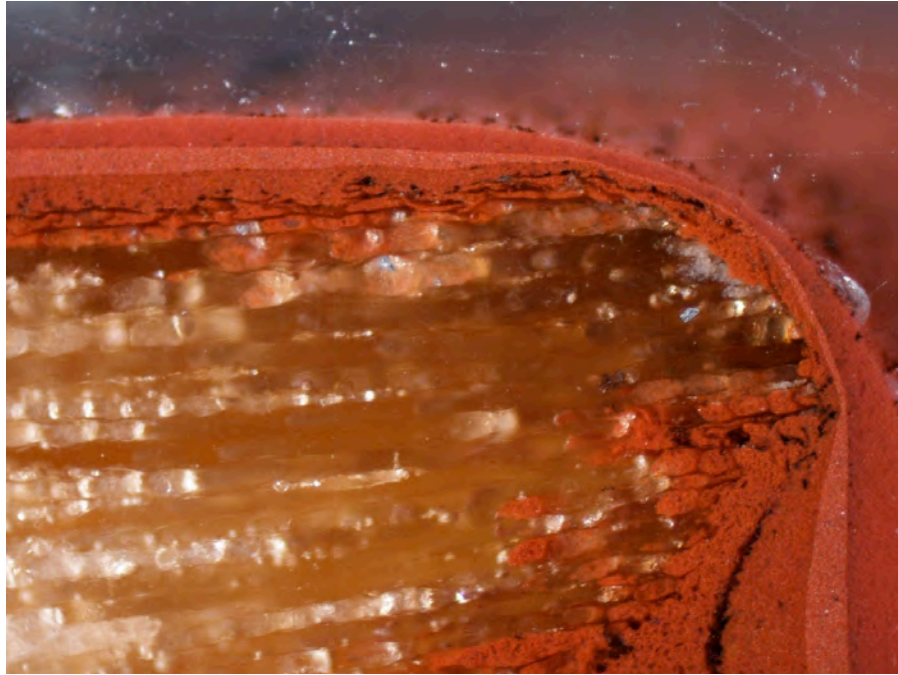
Paint samples were removed from five locations on the exterior of the Buck House, including four from the main building block and one from the enclosed rear shed. In all locations, the wood substrate appears rough and weathered, suggesting the earliest paint in these areas is most likely not original. Three of the five samples have the exact same paint layering sequence: four layers of dark red paint. The locations of these samples include the siding of the rear shed, the siding on the south elevation of the main portion of the building and the cornice on the south elevation of the main portion of the building. (*Image 36*)

Image 36. Sample CSB.47 was removed from the siding of the enclosed rear porch of the Buck House. (40x, Visible Light)

For the exterior of the Buck House, the same dark red can be applied to the weatherboards and cornice. While there is no way to determine if the earliest red paint layer dates to the NPS era or the Sandburg era, the only other choice would be to paint the Buck House the early pale yellow found on the protected front elevation. This paint color, however, is associated with the Smyth period and to re-instate it on the Buck House seems out of synch with the paint treatment for the rest of the buildings in the barn complex. Unfortunately, not enough information was gained from the

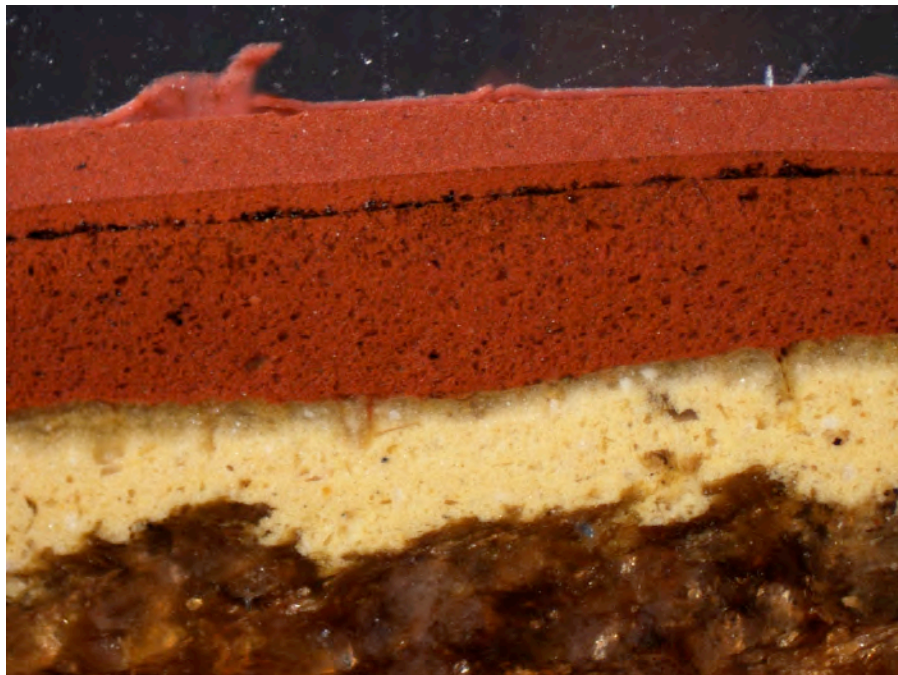
A sample removed from the front (east) elevation that is protected by a porch contains the same four layers of dark red paint. However, underneath the red paint is a pale yellow paint that looks very similar to the pale yellow found on the Goat Barn. As stated previously, this pale yellow is probably not the Buck House's original paint color, given the disturbed surface of the wood substrate on which it was applied, but it is still likely early. Although it is not known when it was applied, if it the same as the pale yellow on the Goat Barn, then it most likely dates to the Smyth period. (*Image 37*)

Image 37. Sample CSB.49 was removed from a protected area of the exterior siding of the Buck House, under the front porch. It contains earlier paint layers, including a yellowish-cream similar to that seen on the Goat Barn. (100x, Visible Light)

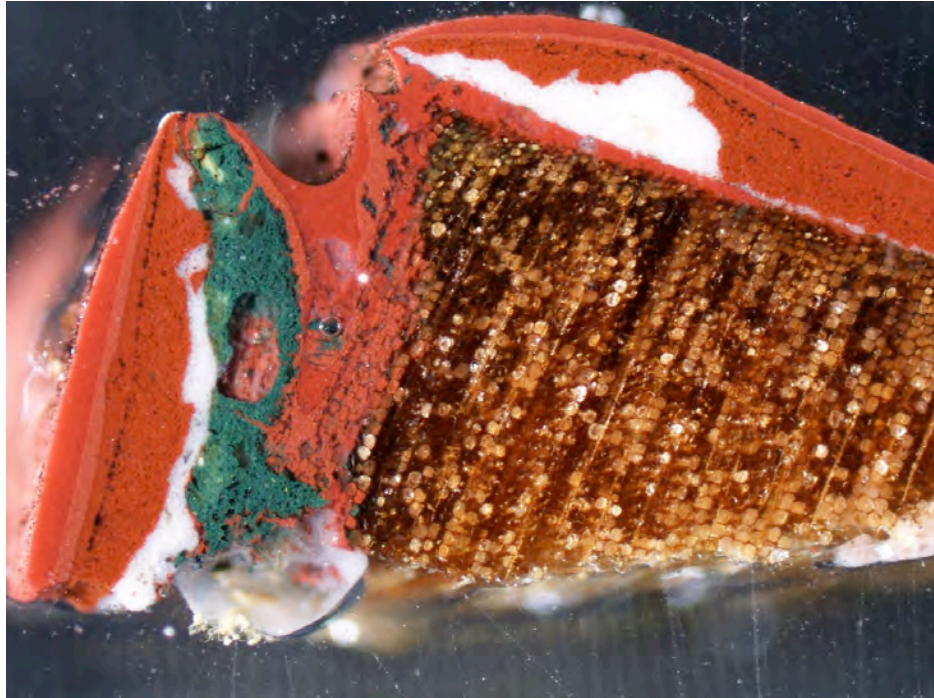
A sample removed from the corner trim of the main portion of the house (where it meets the enclosed rear porch) also has traces of earlier paint finishes. This trim piece contains evidence of dark green and white paint, suggesting the trim was treated differently from the weatherboards on the body of the house. The green was most likely applied to the house when the siding was pale yellow and the white when the first layer of dark red was applied. (*Image 38*)

Image 38. Sample CSB.48 was removed from the vertical corner trim of the main portion of the Buck House. Note the early dark green and white paint colors. (40x, Visible Light)

exterior trim sample (removed from the vertical corner piece on the west elevation of the building) to allow a paint color recommendation to be made for the trim. It is possible that the white paint color was applied to the trim when the red paint was applied to the body of the building, but more samples would need to be removed from the building in order to establish this. Additional samples should be removed from exterior window and door casings, and compared to the paint evidence on the corner piece, to try to identify the color of the trim during the red paint campaign. If historic photographs of the buildings are found that date to the Sandburg period, this would also be helpful in determining if the trim was a light (white) or dark color.

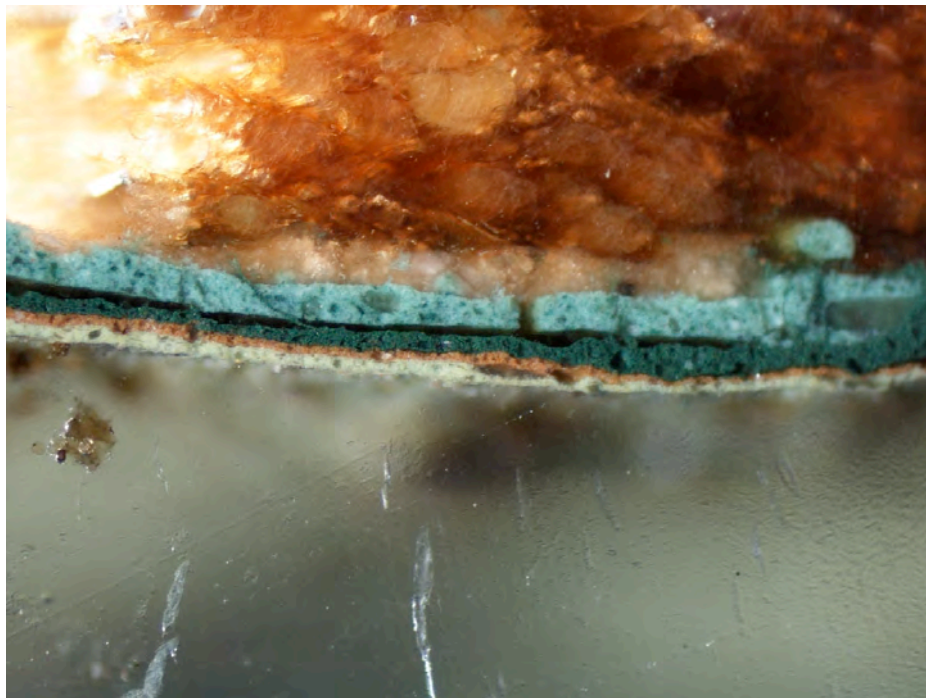
Image 39. Sample CSB.51, removed from a window casing in the south interior room of the Buck House, has four layers of paint, including an original pale blue-green. (100x, Visible Light)

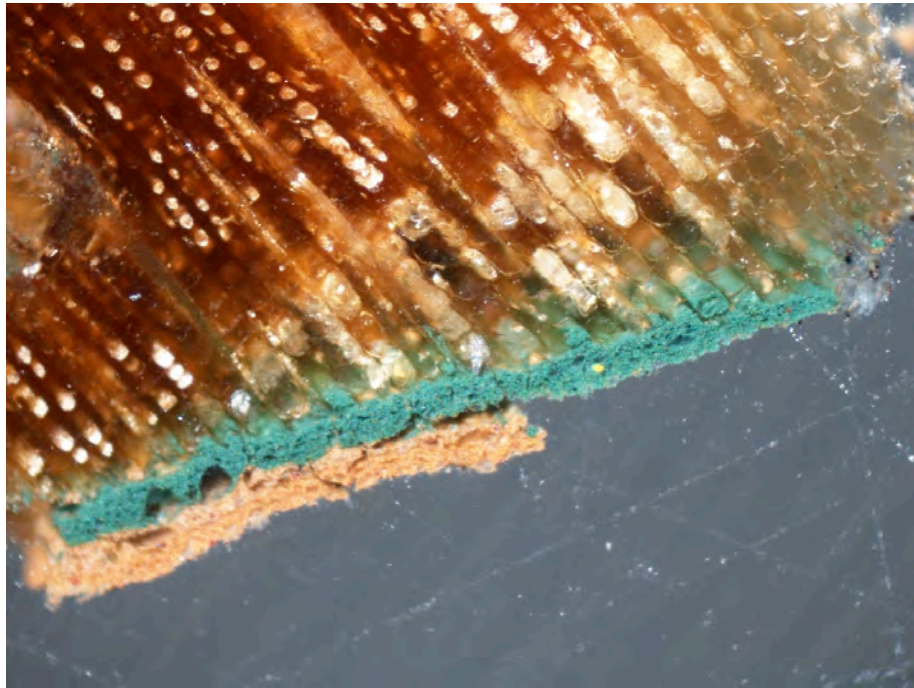
Image 40. Sample CSB.54, removed from a door casing in the north interior room of the Buck House, has only two layers of paint (which are the same as the later layers in Sample CSB.51 above). (100x, Visible Light)

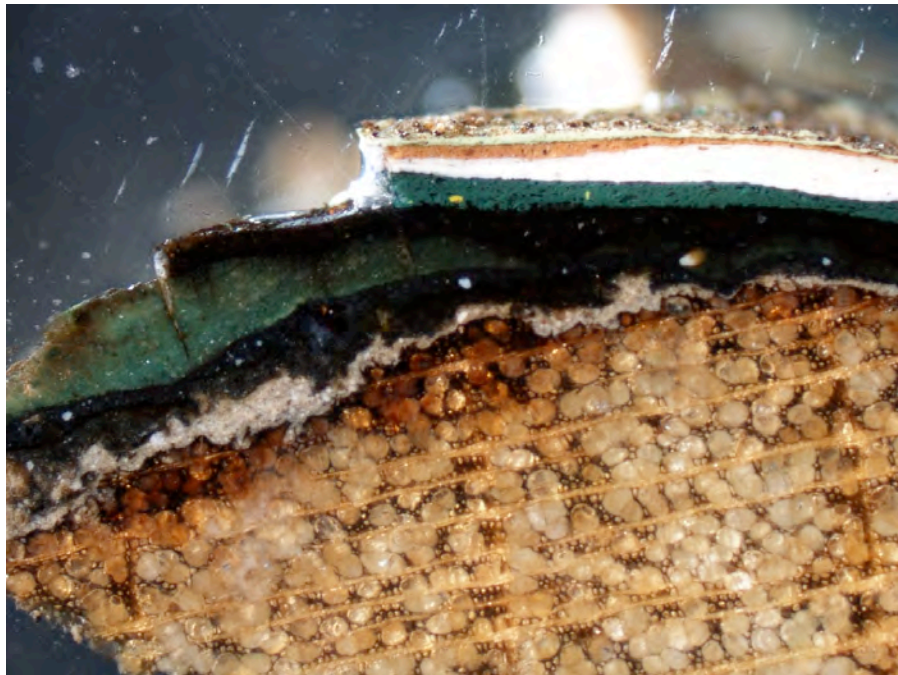
The mantelpiece (CSB.52) retains a good bit of paint evidence and appears to have been varnished originally. It is a hardwood, possibly mahogany, so a varnish treatment would not have been

surprising. After the varnish, the mantelpiece was painted dark gray twice, then dark green, dark orange and light green. The latter three colors directly relate to the window and door trim paint colors. (Image 41)

Image 41. Sample CSB.52, was removed from the mantelpiece of the Buck House. It contains an original varnish layer followed by dark grays and dark green, before being painted the same dark green and dark orange found on other trim inside the building. (40x, Visible Light)

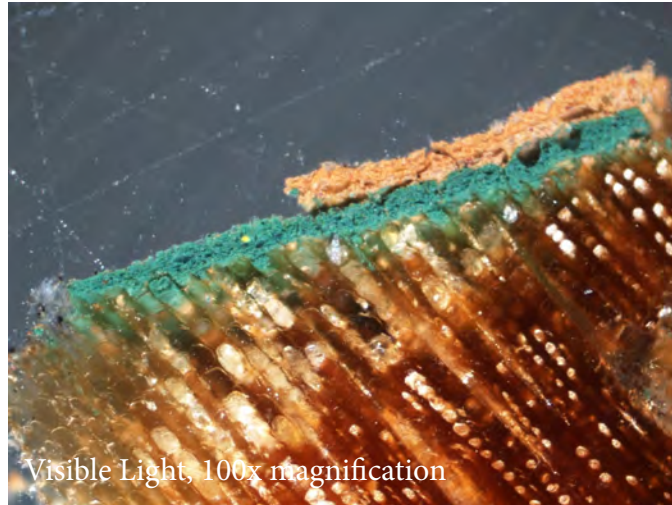
SAMPLE: CSB 54	LOCATION: Buck House
DESCRIPTION: Salvaged door hanging on wall above opening.

LAYER	REFLECTED LIGHT COLOR	NOTES
Wood		
1	Kelly Green	
2	Dark Orange	
3		
4		
5		
6		
7		
8		
9		
10		
11		
12		
13

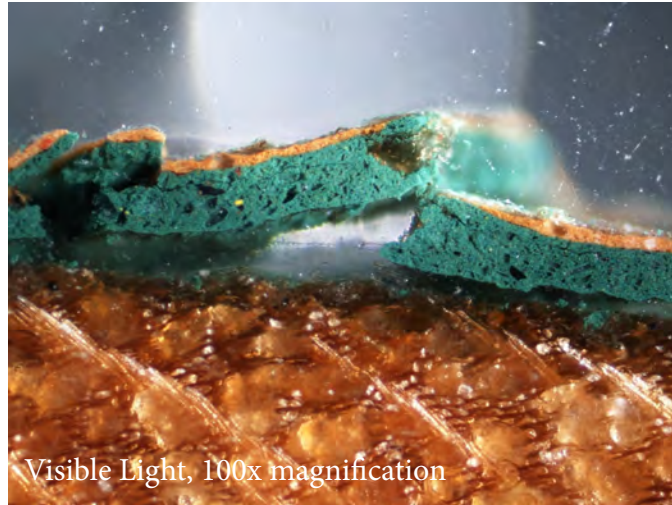
SAMPLE: CSB 55	LOCATION: Buck House
DESCRIPTION: Trim at jamb, south side of opening.

LAYER	REFLECTED LIGHT COLOR	NOTES
Wood		
1	Dark Green	
2	Dark Orange	
3		
4		
5		
6		
7		
8		
9		
10		
11		
12		
13

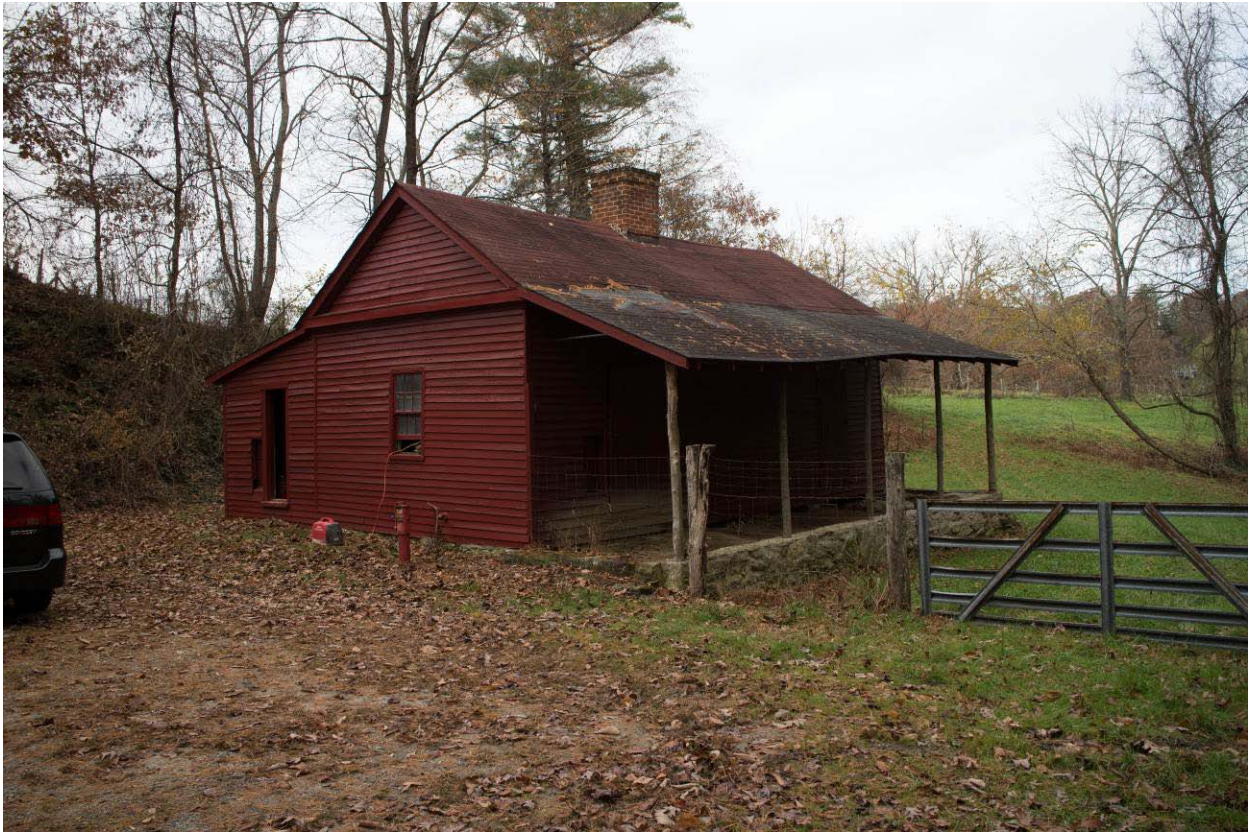
Figure 1. Buck House.

The Buck House is a two-level, wood-framed building with a central chimney stack, a porch on one side, and a lean-to addition on the back. It is situated several hundred yards to the northeast of the main farmyard, outside of the main farm complex.

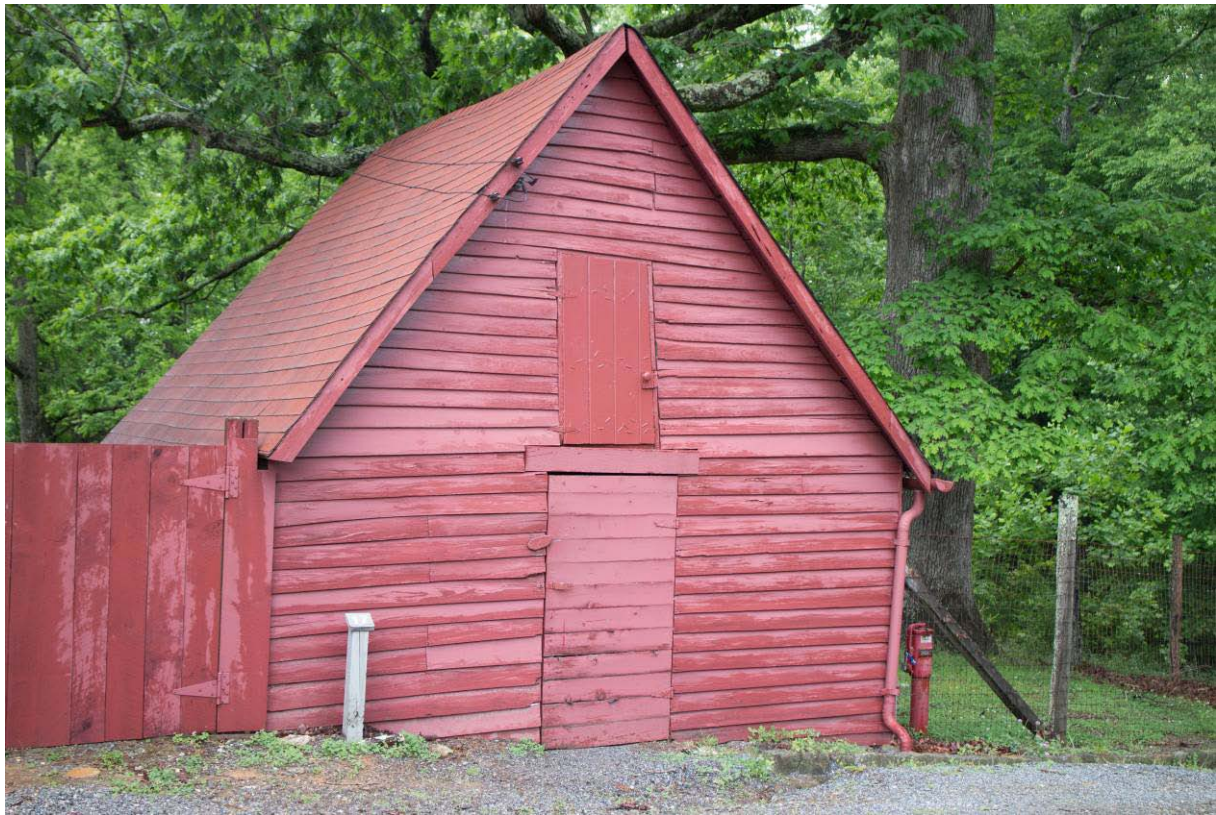
Figure 2. Isolation Quarters.

The Isolation Quarters is a small, wood-framed structure of two levels clad in red weatherboard. It is located a short distance away from the main farmyard to the east of the garage.

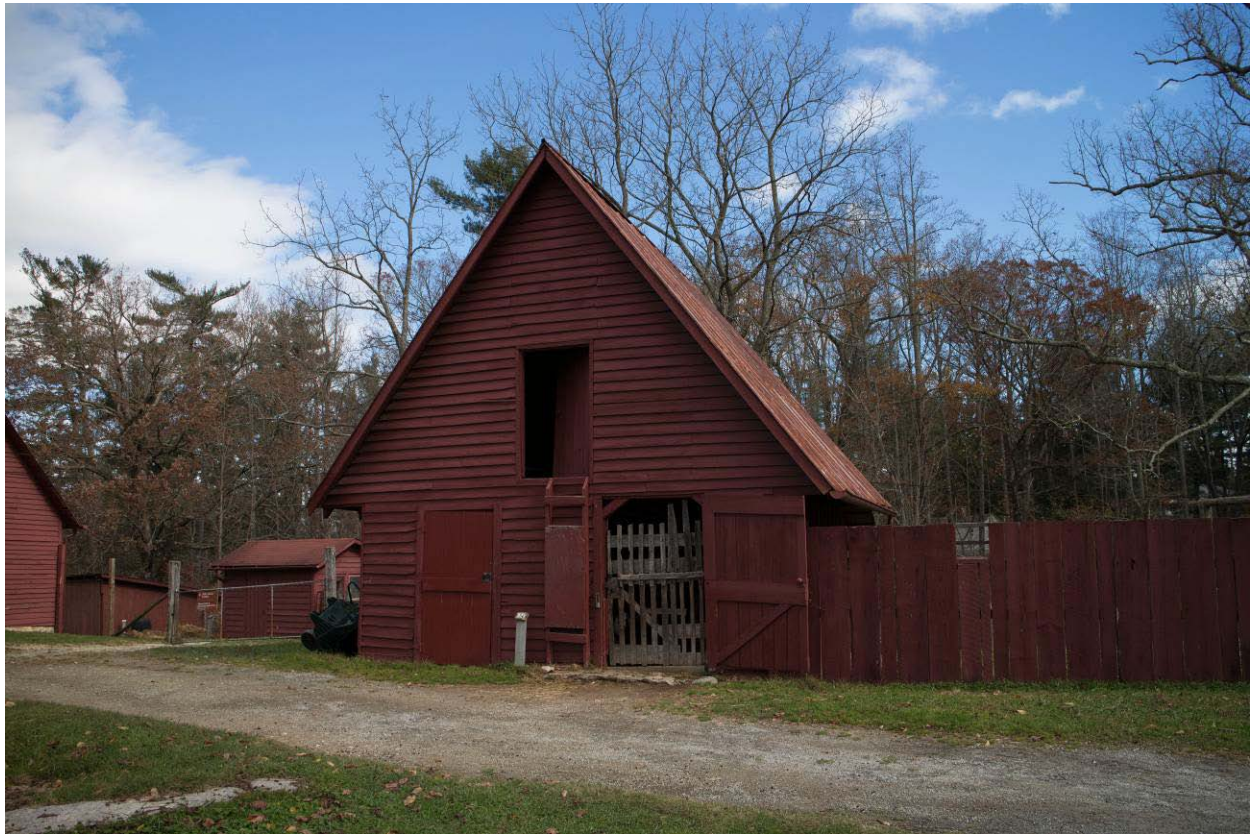
Figure 3. Buck Kid Quarters.

The Buck Kid Quarters is a small, wood-framed structure of two levels clad in red weatherboard. It is located to the southeast of the Horse Barn and faces west onto the main farmyard.

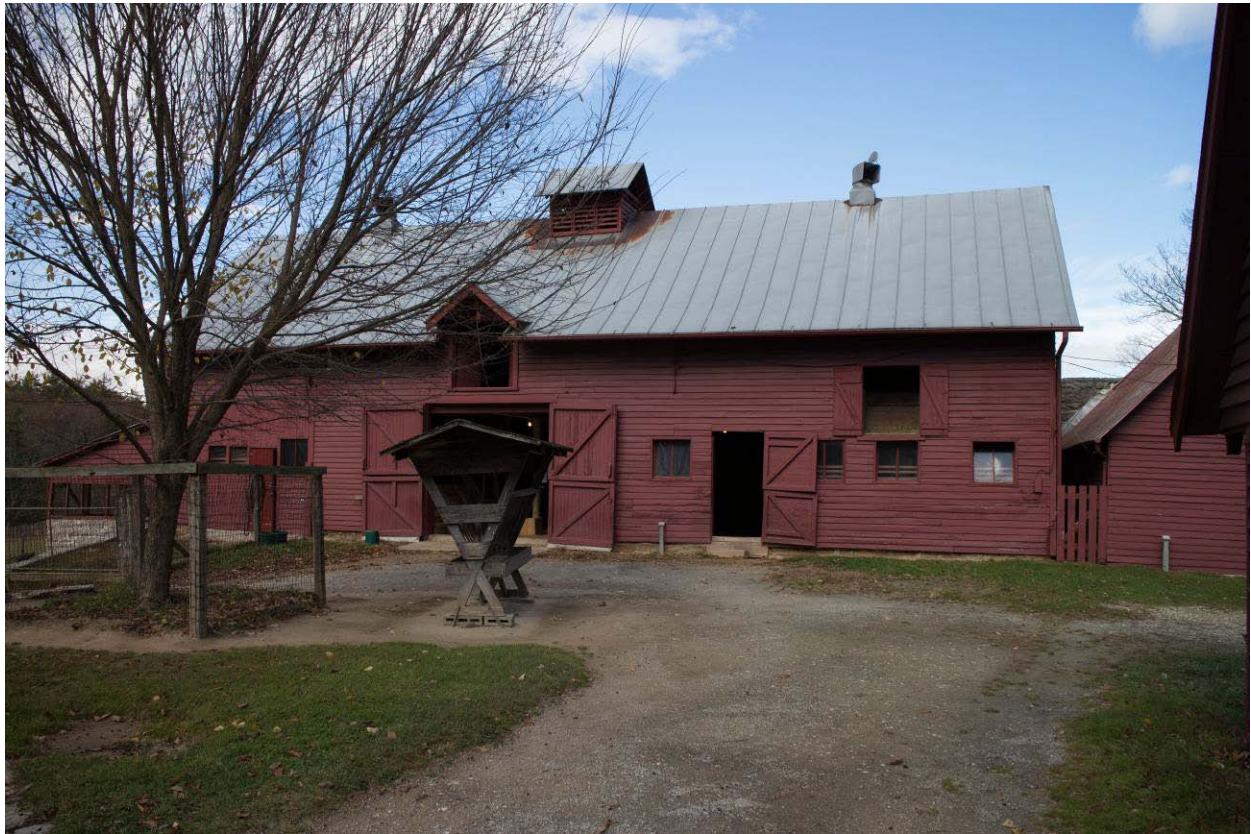
Figure 4. Main Barn.

The Main Barn is the largest structure in the Connemara farm complex. It is a two-story, wood-framed building clad in red weatherboard. It faces south onto the main farmyard and is located to the west of the Horse Barn.

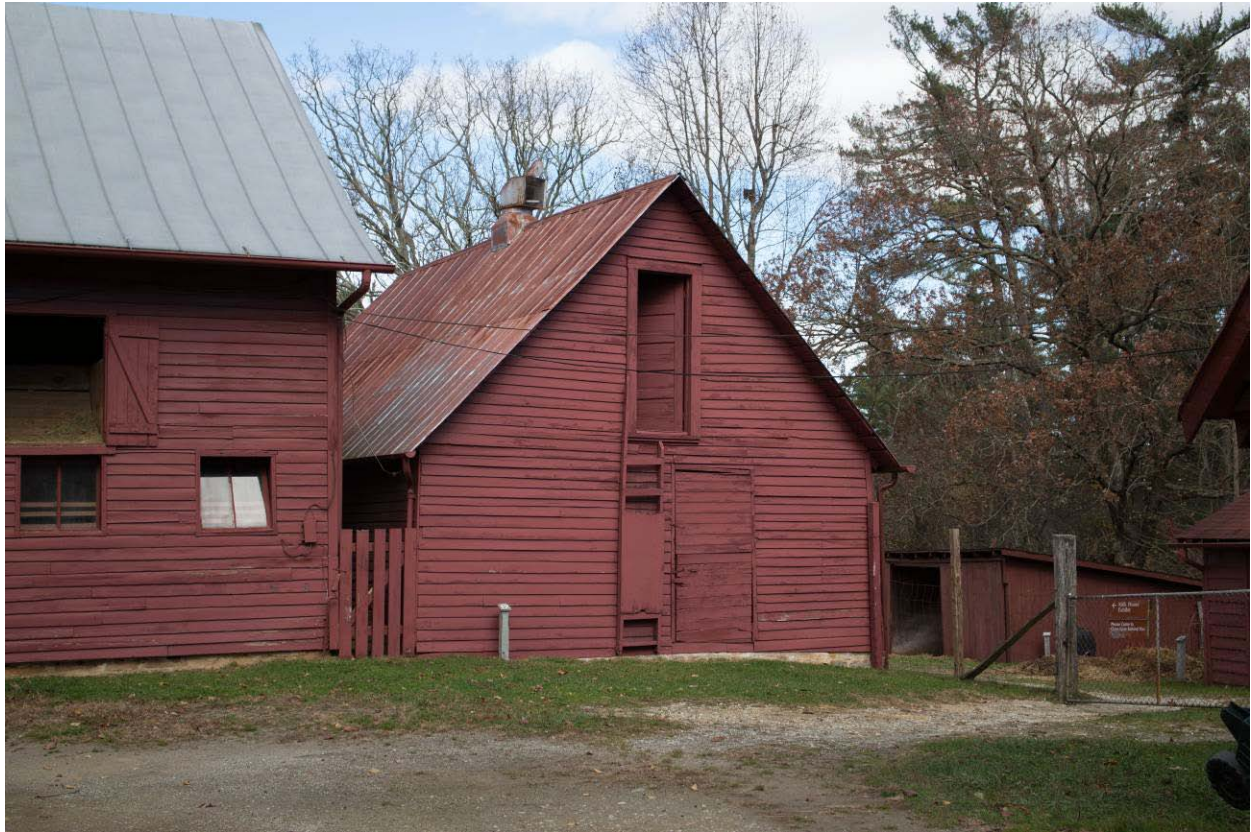
Figure 5. Horse Barn.

The Horse Barn is a wood-framed structure of two levels clad in red weatherboard. It is located to the east of the Main Barn, with its gable facing south onto the main farmyard.
