Buck House
Carl Sandburg Home National Historic Site
Historic Structure Report
Phase 1

December 2014

Cultural Resources Division
Southeast Region, National Park Service

JOSEPH K. OPPERMAN – ARCHITECT, P.A.

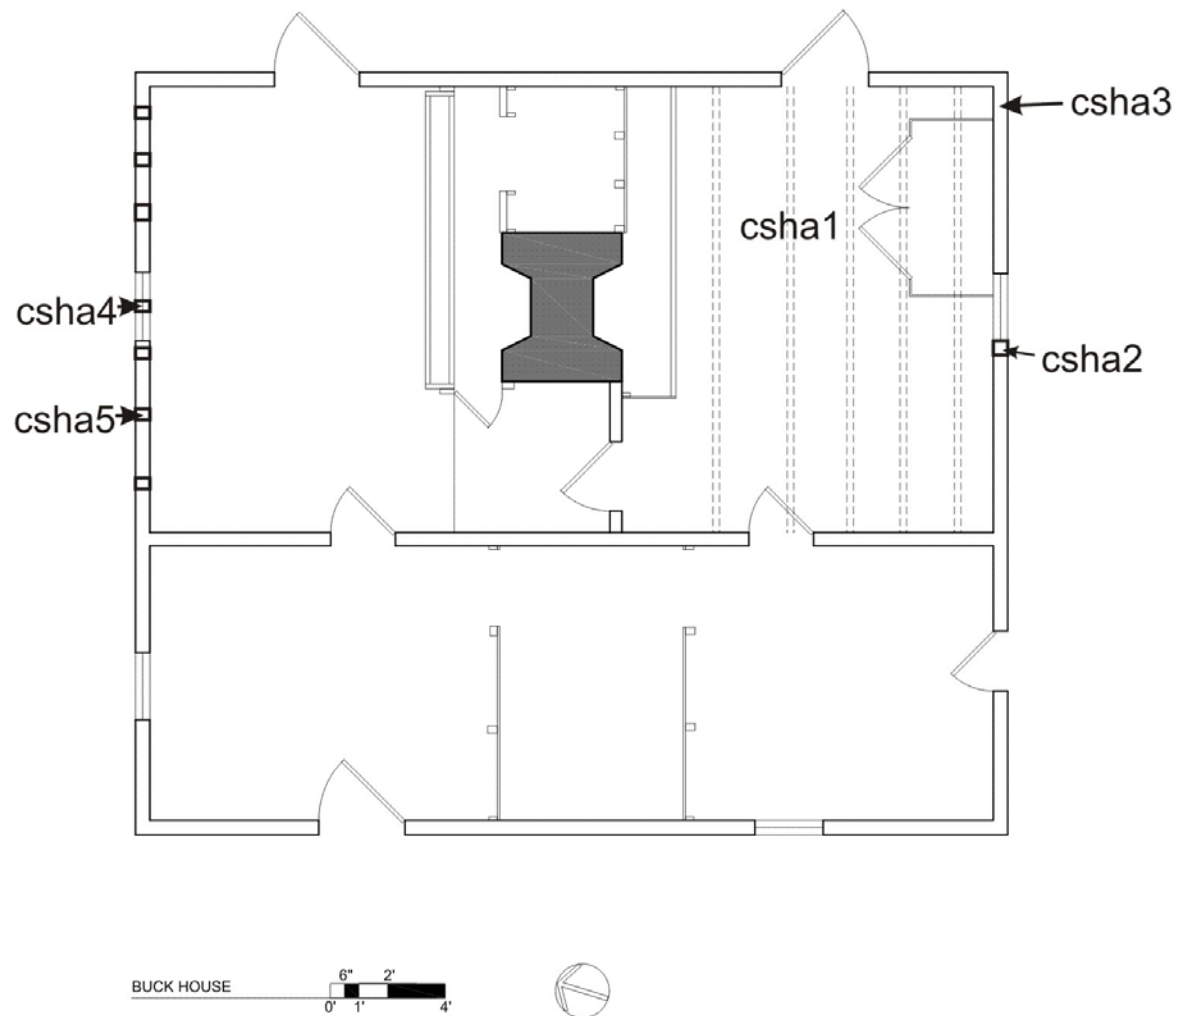
Five timbers were sampled from the first floor of the Buck House: three studs, one rafter, and one joist. All were of Southern yellow pine. Each timber sample was given the code **cs**ha (for Carl Sandburg Home, building a) and numbered 1 to 5 (see table 1a). The position of each sample was noted at the time of sampling (see figure 8).

Figure 8. Drawing showing location of samples taken from the first floor of the Buck House at the Carl Sandburg Home (after Joseph K. Oppermann - Architect 2011)

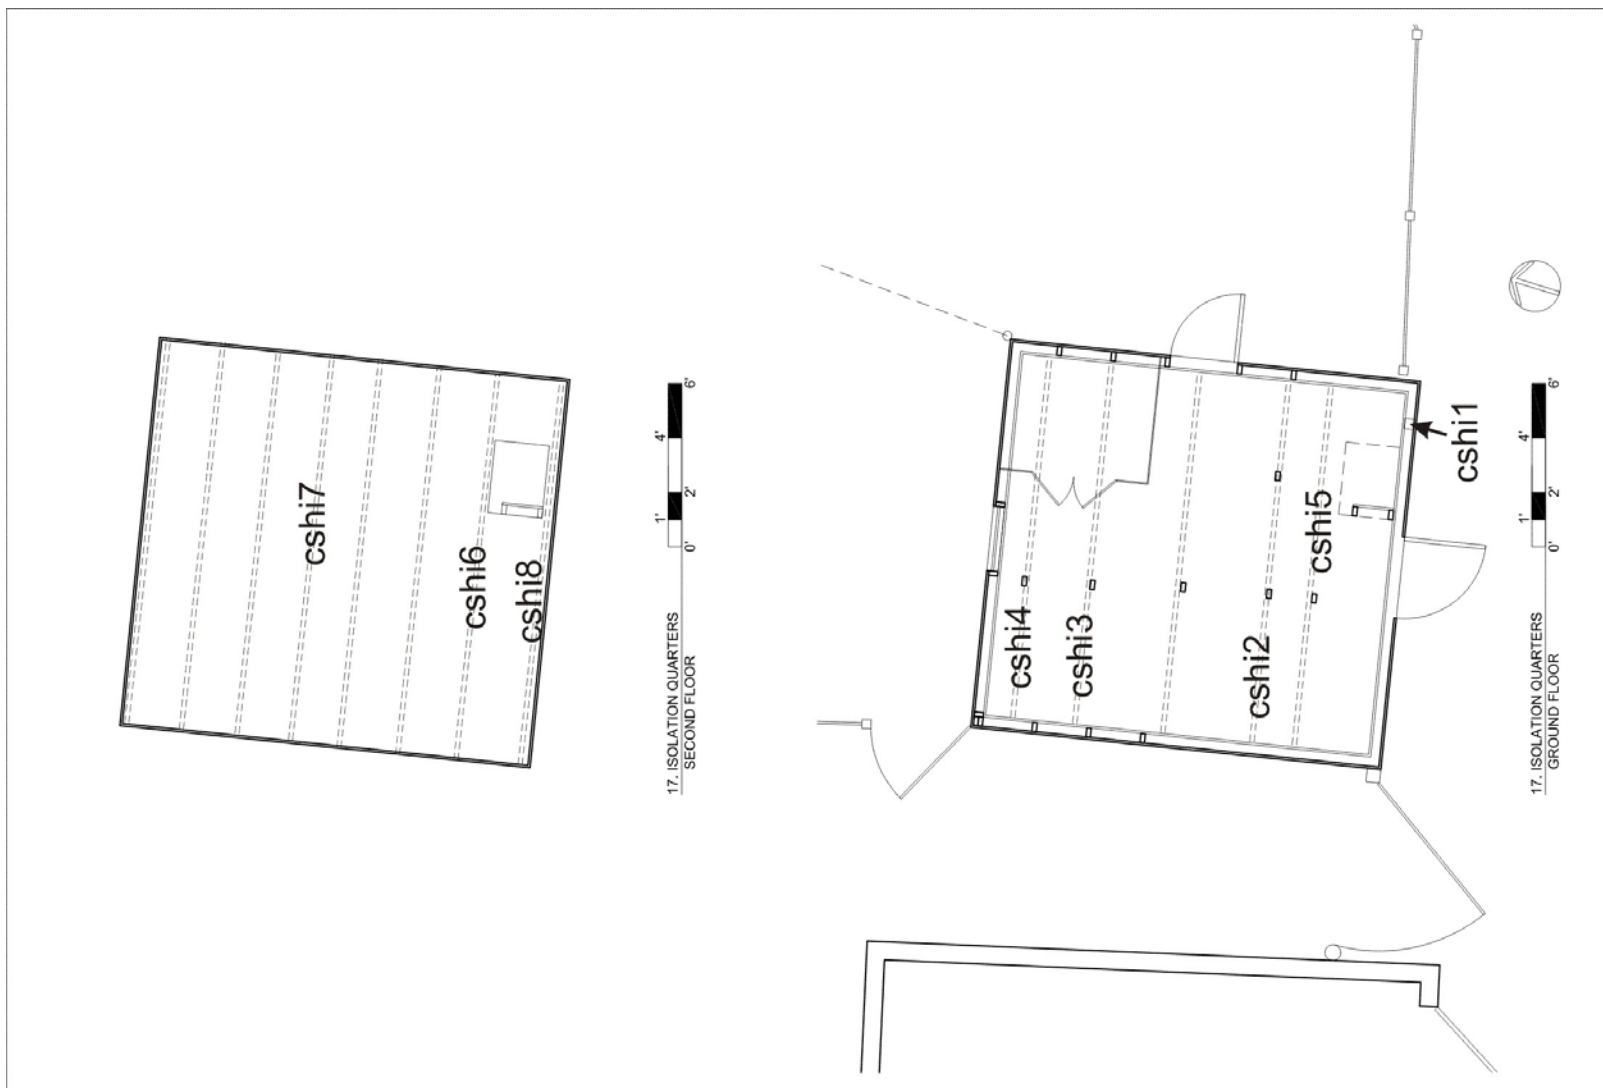
Eight timbers were sampled from the Isolation Quarters: four joists and one stud from the first floor and three rafters from the attic. The stud and all of the rafters were of Southern yellow pine. Two joists were of white oak, one was of American chestnut, and a fourth was of shagbark hickory. Each sample was given the code **cs**hi (for Carl Sandburg Home, Isolation Quarters) and numbered 1 to 8 (see table 1b). The position of each sample was noted at the time of sampling (see figure 9).

Figure 9. Drawing showing location of samples taken from the Isolation Quarters attic (left) and first floor (right) at the Carl Sandburg Home (after Joseph K. Oppermann - Architect 2011)

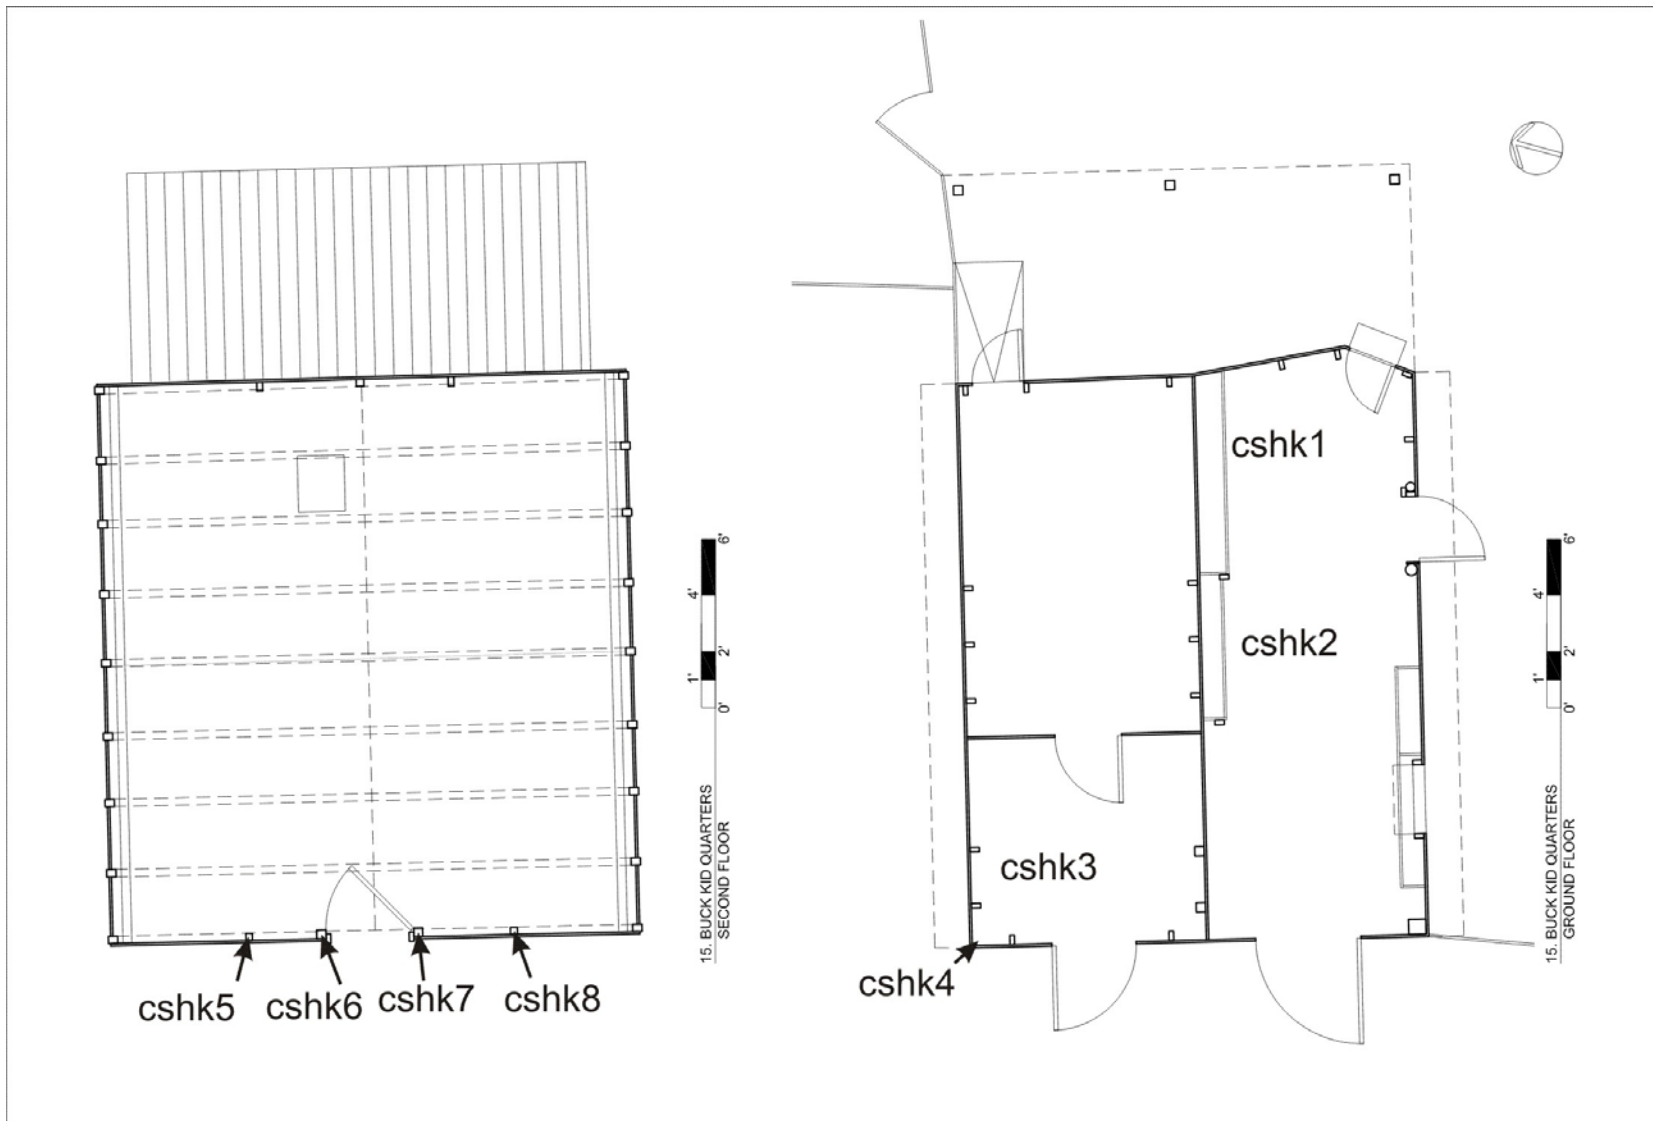
Eight timbers were sampled from the Buck Kid Quarters: three joists and one brace from the first floor and four studs from the attic. All of the timbers were of Southern yellow pine. Each sample was given the code **csHk** (for Carl Sandburg Home, Kid Quarters) and numbered 1 to 8 (see table 1c). The position of each sample was noted at the time of sampling (see figure 10).

Figure 10. Drawing showing location of samples taken from the Buck Kid Quarters attic (left) and first floor (right) at the Carl Sandburg Home (after Joseph K. Oppermann - Architect 2011)

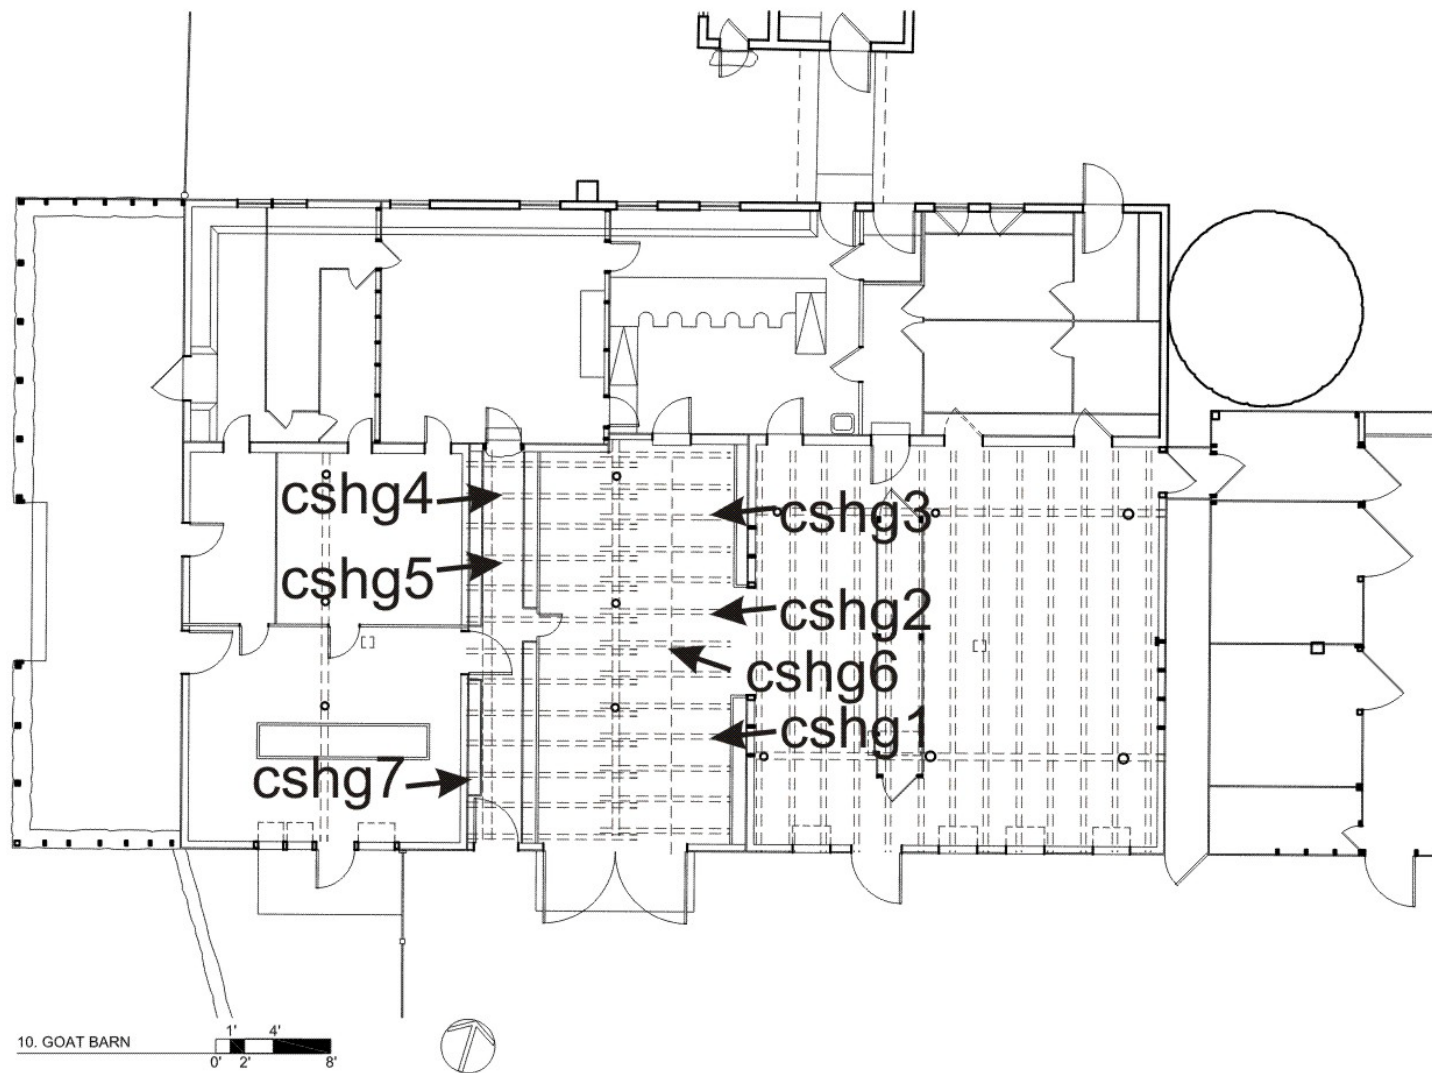
Seven timbers were sampled from first floor of the Main (or Goat) Barn: six joists and one stud. All were of Southern yellow pine, except for one of the joists, which was of white oak. Each sample was given the code **csHg** (for Carl Sandburg Home, Goat Barn) and numbered 1 to 7 (see table 1d). The position of each sample was noted at the time of sampling (see figure 11).

Figure 11. Drawing showing location of samples taken from the Main Barn at the Carl Sandburg Home (after Joseph K. Oppermann - Architect 2011)

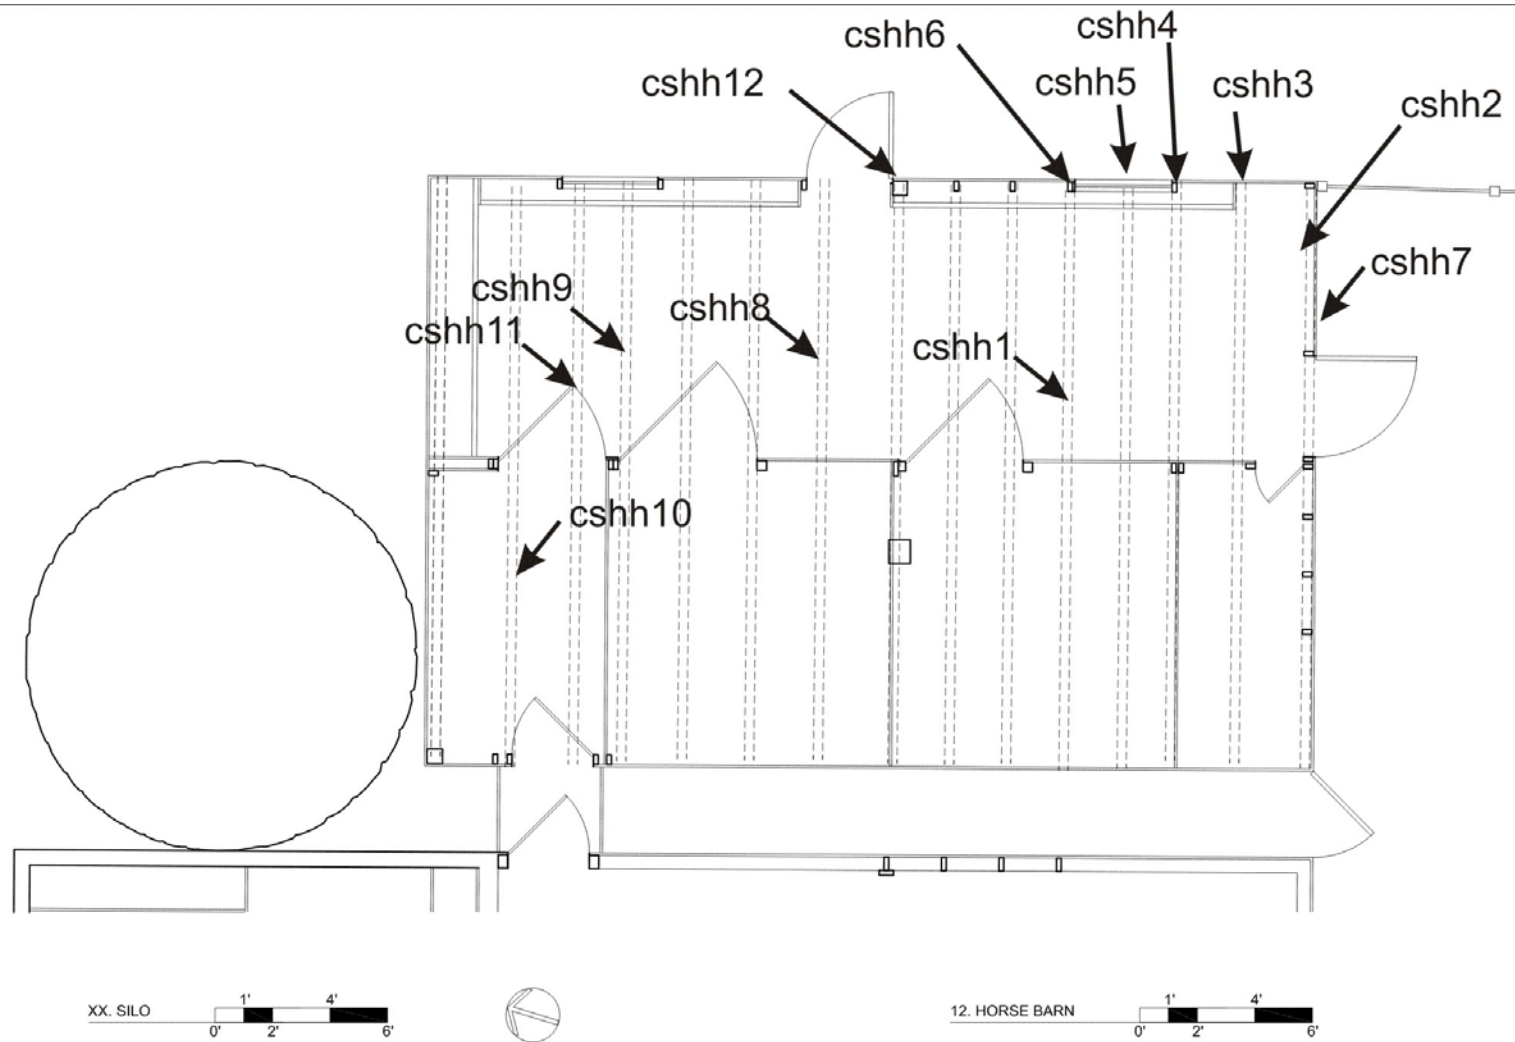
Twelve timbers were sampled from the first floor of the Horse Barn: five joists, five studs, one brace, and one door post. Four of the joists were of shagbark hickory while the rest of the timbers were of white oak. Each sample was given the code **csHh** (for Carl Sandburg Home, Horse Barn) and numbered 1 to 12 (see table 1e). The position of each sample was noted at the time of sampling (see figure 12).

Figure 12. Drawing showing location of samples taken from the Horse Barn at the Carl Sandburg Home (after Joseph K. Oppermann - Architect 2011)
