# historic structure report

## CRATER LAKE CRATER LAKE LODGE

HISTORIC STRUCTURE REPORT

CRATER LAKE LODGE  
CRATER LAKE NATIONAL PARK  
CRATER LAKE, OREGON

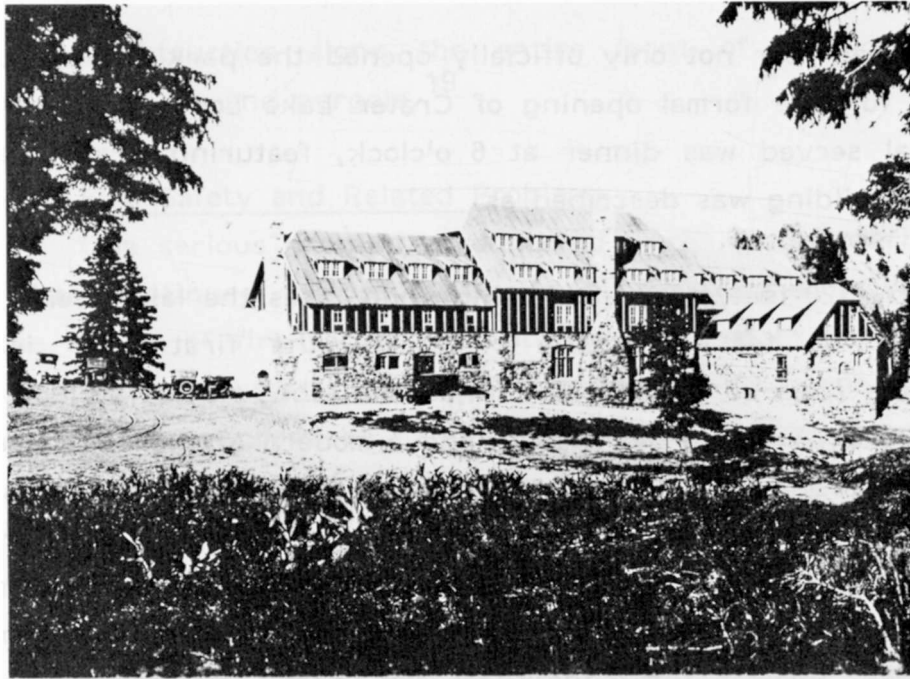
Illustration 10.

Crater Lake Lodge, south elevation, ca. 1915. The first-floor stonework is complete, but the second floor exterior is simply tarpapered. Shingles need to be added to the upper walls and roof. Courtesy Southern Oregon Historical Society.

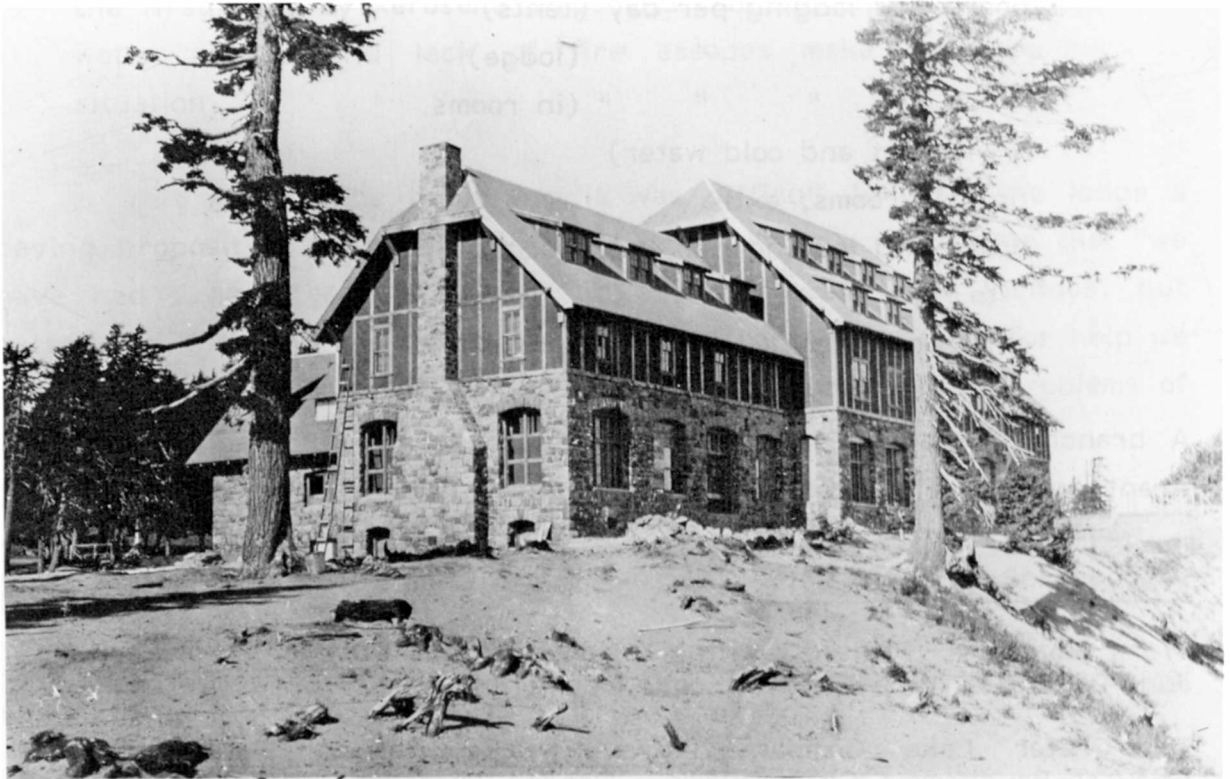
Illustration 11.

Crater Lake Lodge from northeast, ca. 1915-1917, showing still unfinished condition. Courtesy Oregon Historical Society

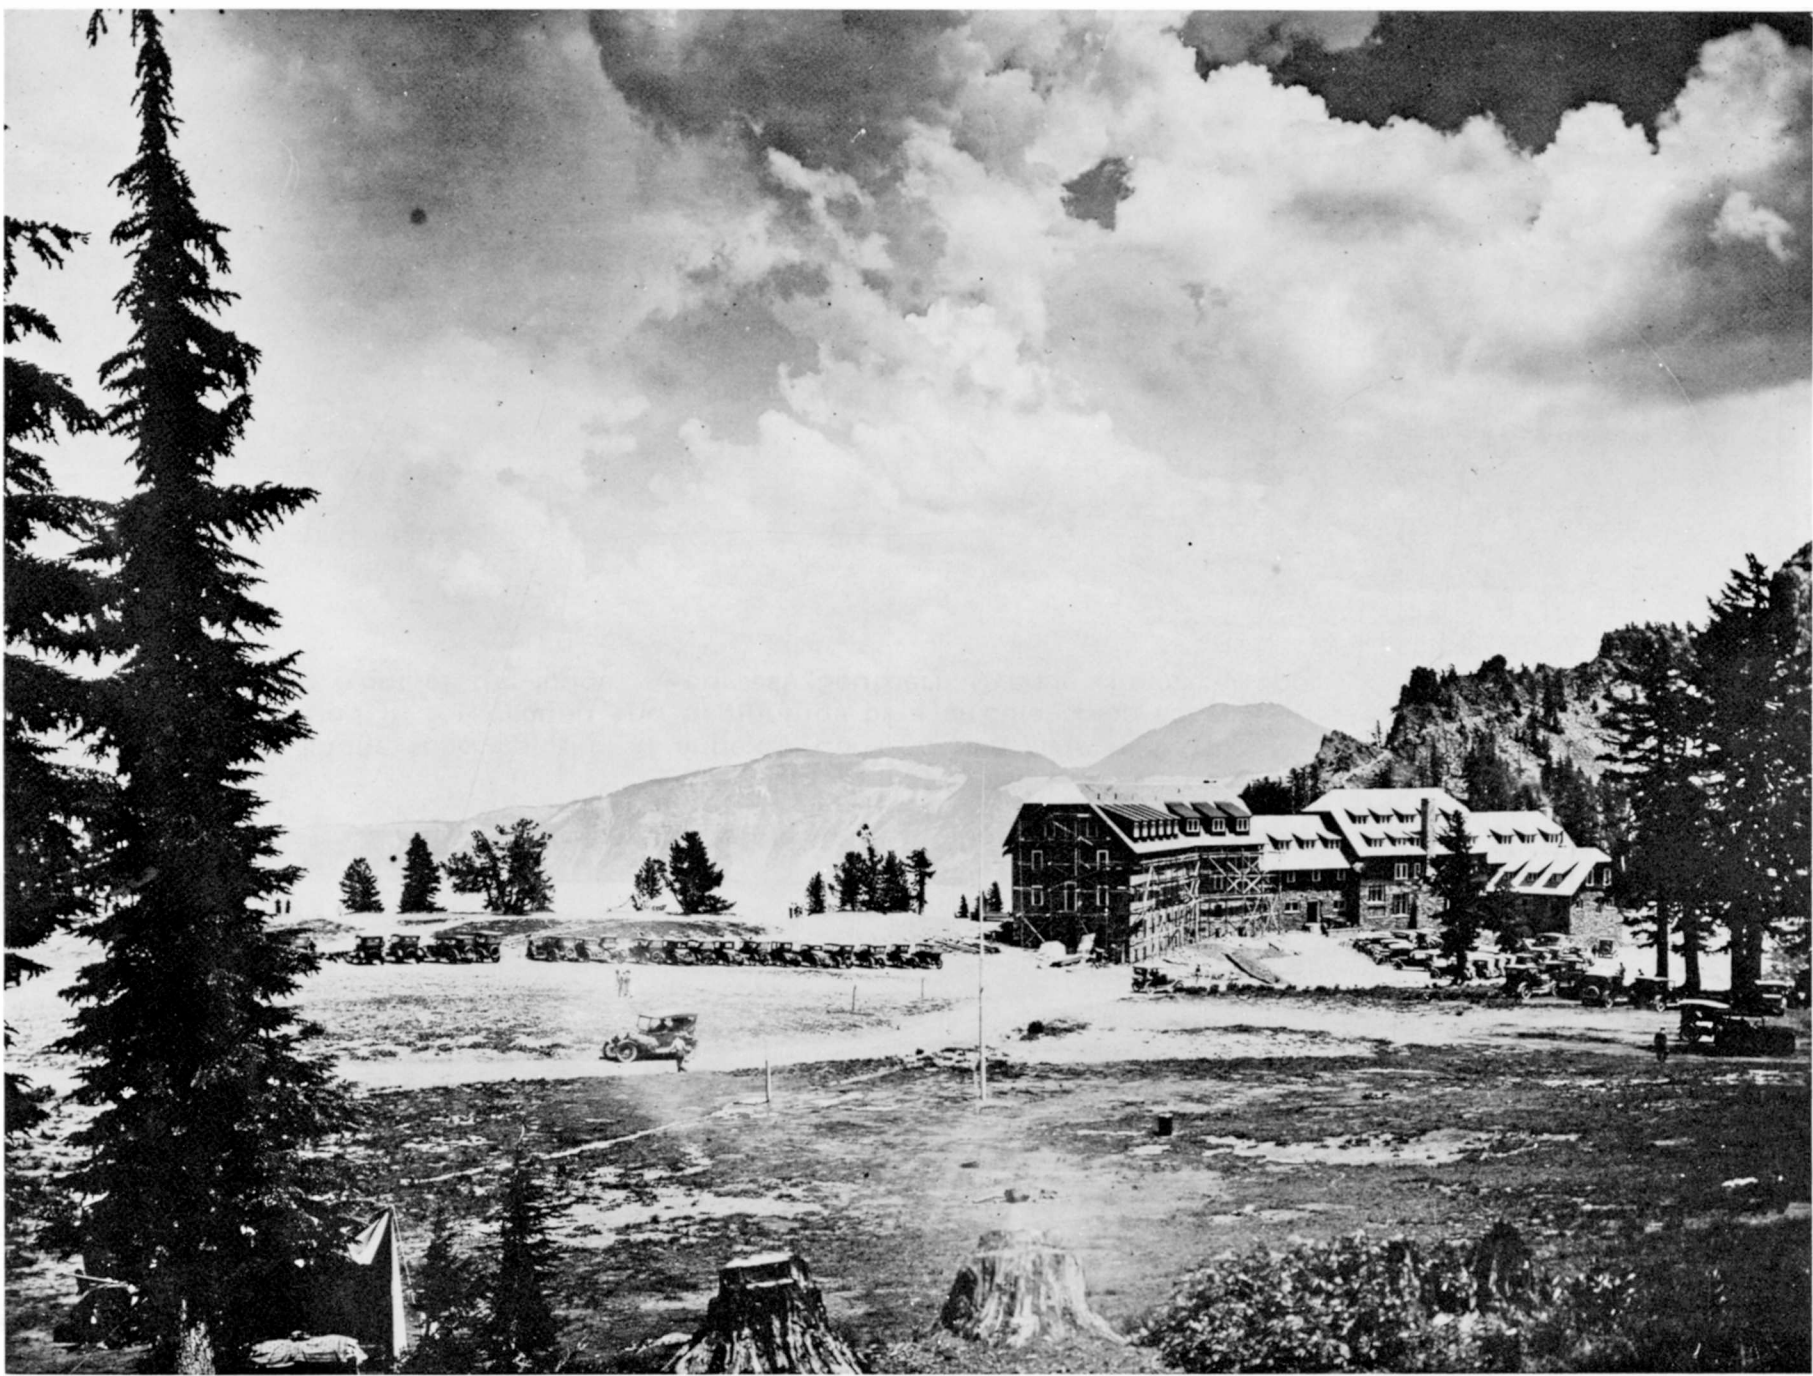
Illustration 20.

View of Crater Lake Lodge tract showing annex still under construction. Note vegetation has been destroyed by unrestricted parking and numerous footpaths. Crater Lake National Park scrapbook.

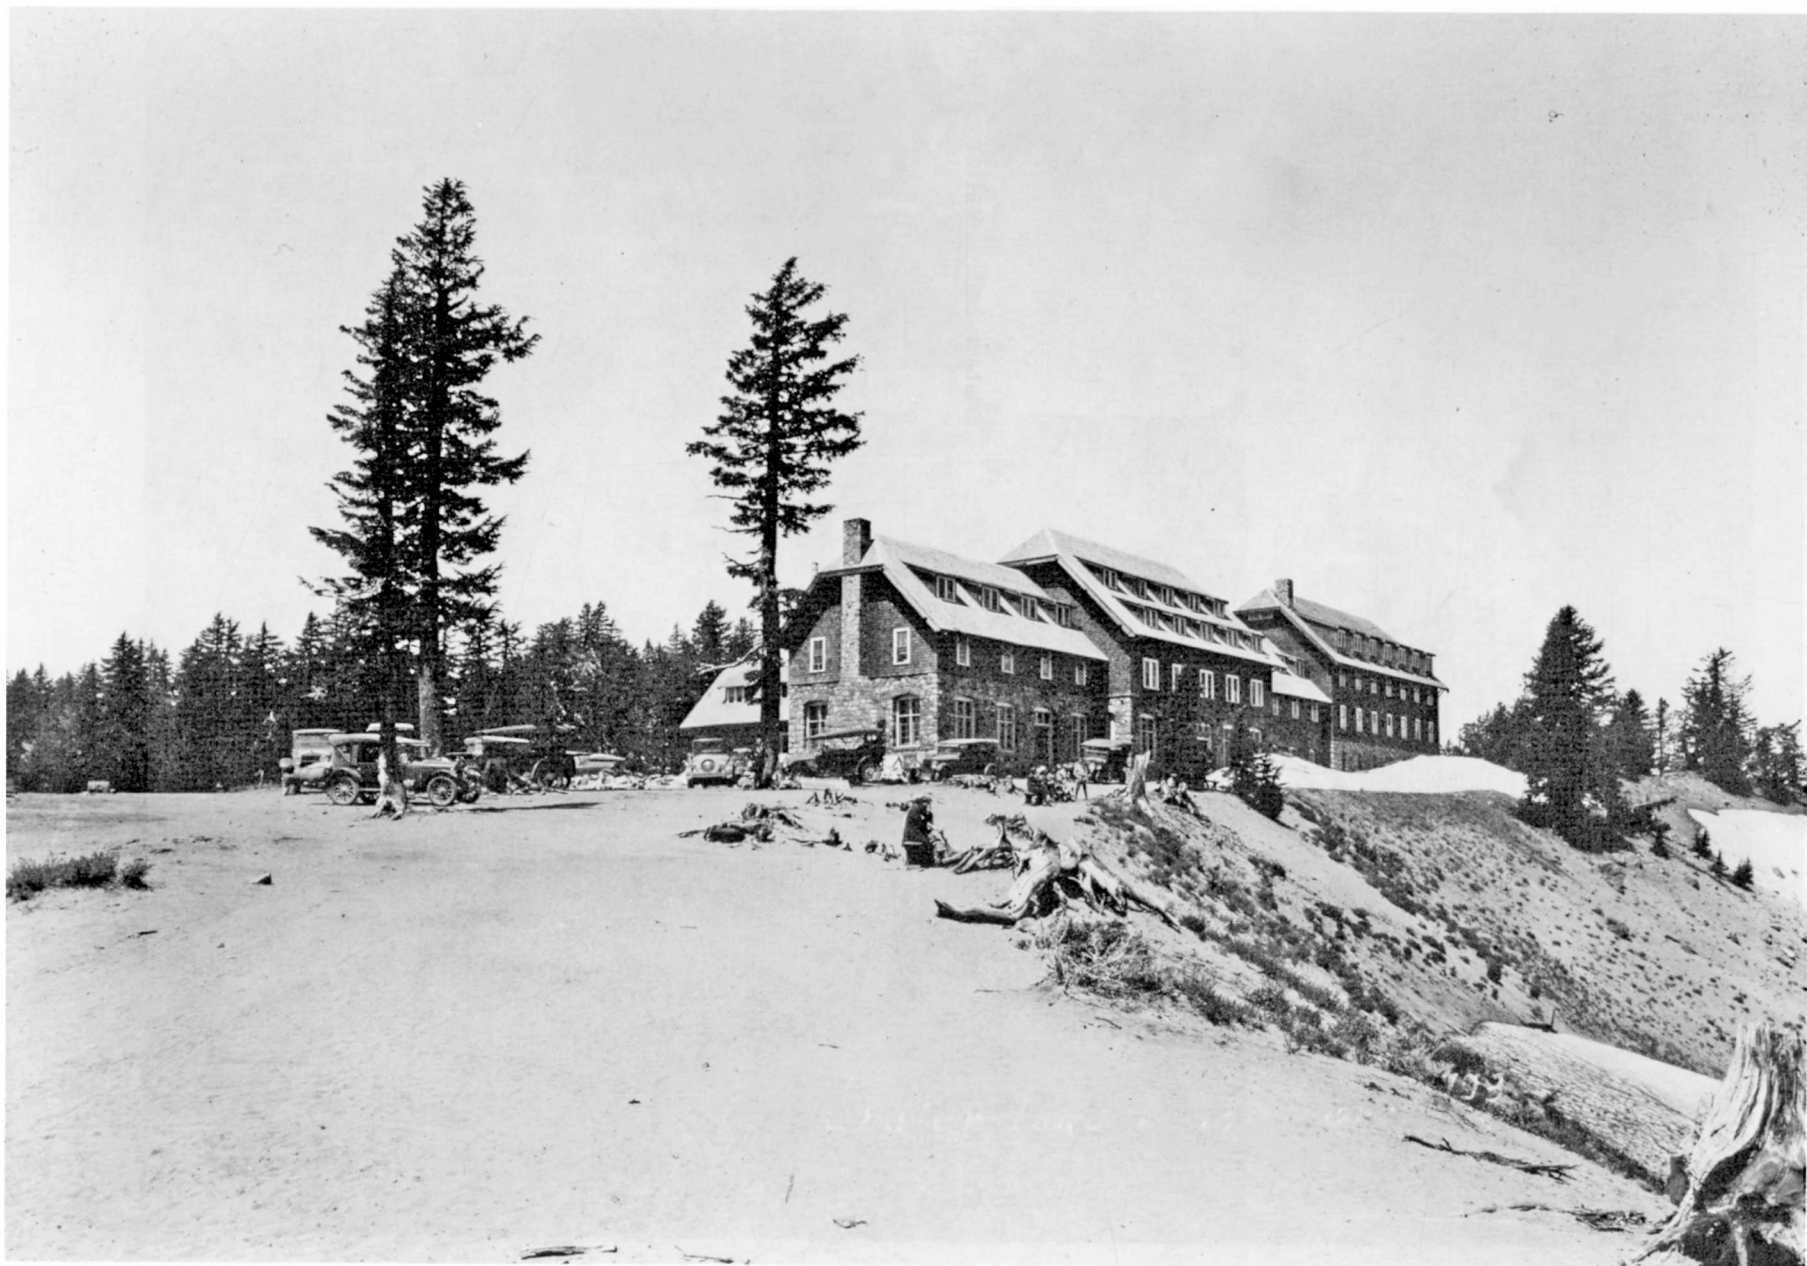
Illustration 24.

View of lodge from northeast, ca. late 1920s. Note lack of vegetation and sandy soil condition of rim area. Courtesy Oregon Historical Society.

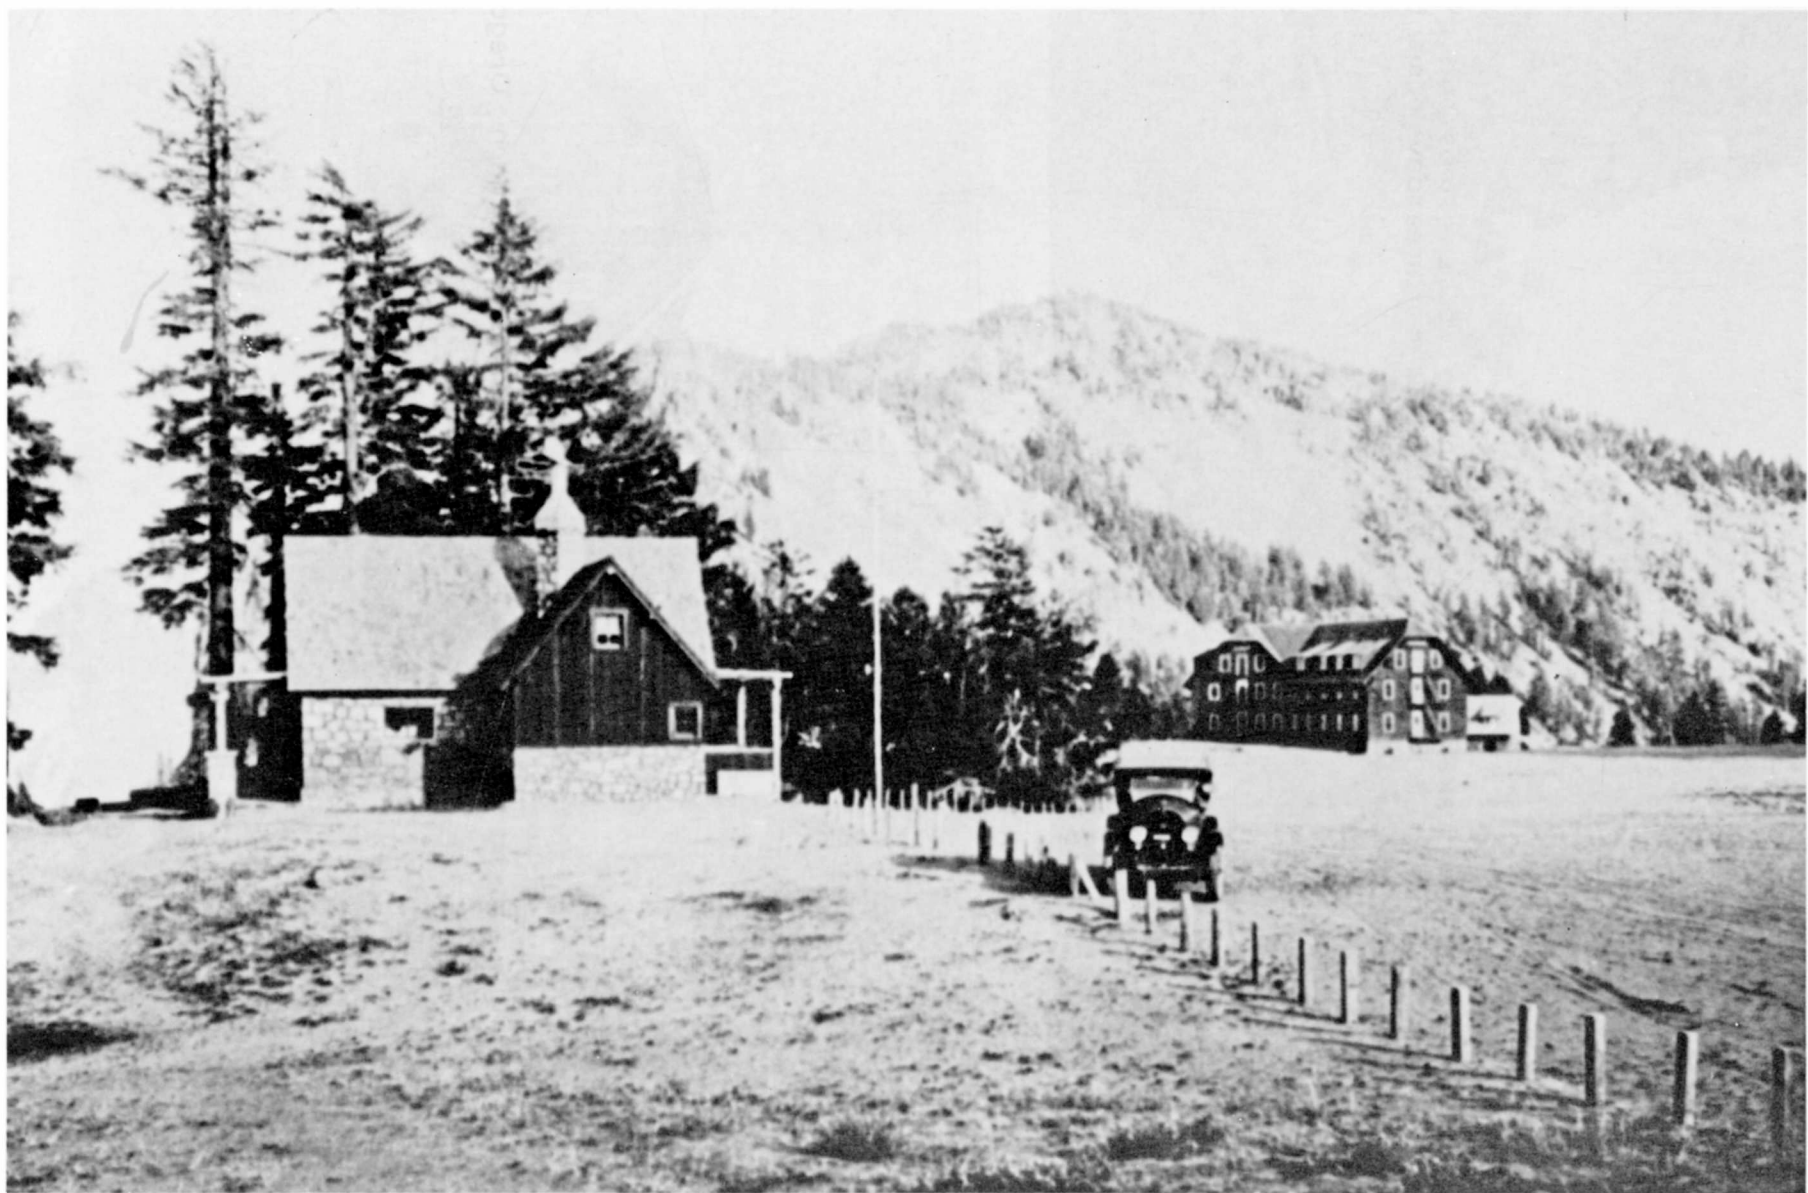
Illustration 26.

View of lodge area from vicinity of Kiser Studio, ca. late 1920s? Again note lack of landscaping.

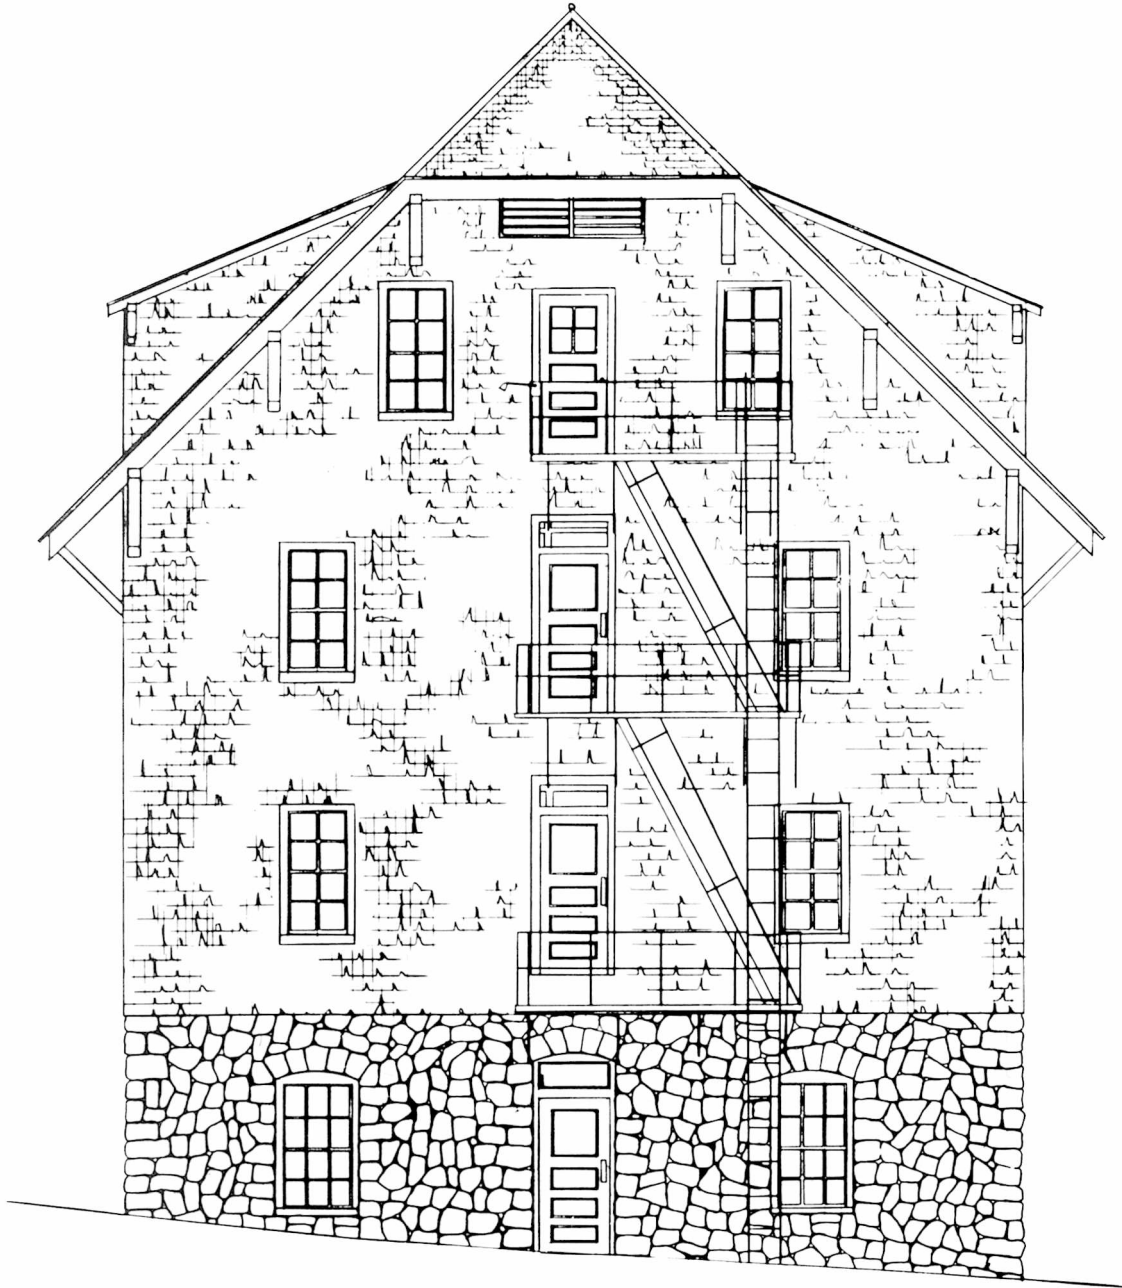
WEST ELEVATION - ANNEX WING

| EXISTING CONDITIONS | | | | | | | | RECOMMENDATIONS | | | | | | |
|---|---|---|---|---|---|---|---|---|---|---|---|---|---|---|
| Wall | Stone masonry<br>Window wells<br>Shingles | | x | x | | x | x | Three | | x | x | | | Repoint<br>Repoint |
| Roofs (3) | Shingles<br>Sheathing<br>Rafters<br>Flashing<br>Dormers (4)<br>Vent pipes(4)<br>Eaves braces | | x | | x | | x | Northeast dormer poor<br>One near ridge of connecting roof | | | x | | | x Additional framing as required<br><br>Reconstruct northeast dormer |
