HISTORIC STRUCTURE REPORT
1874 CAVALRY BARRACKS
ARCHITECTURAL DATA
FORT LARAMIE NATIONAL HISTORIC SITE
WYOMING

by
Frank Gerner

DENVER SERVICE CENTER
HISTORIC PRESERVATION TEAM
NATIONAL PARK SERVICE
UNITED STATES DEPARTMENT OF THE INTERIOR
DENVER, COLORADO

June 1975

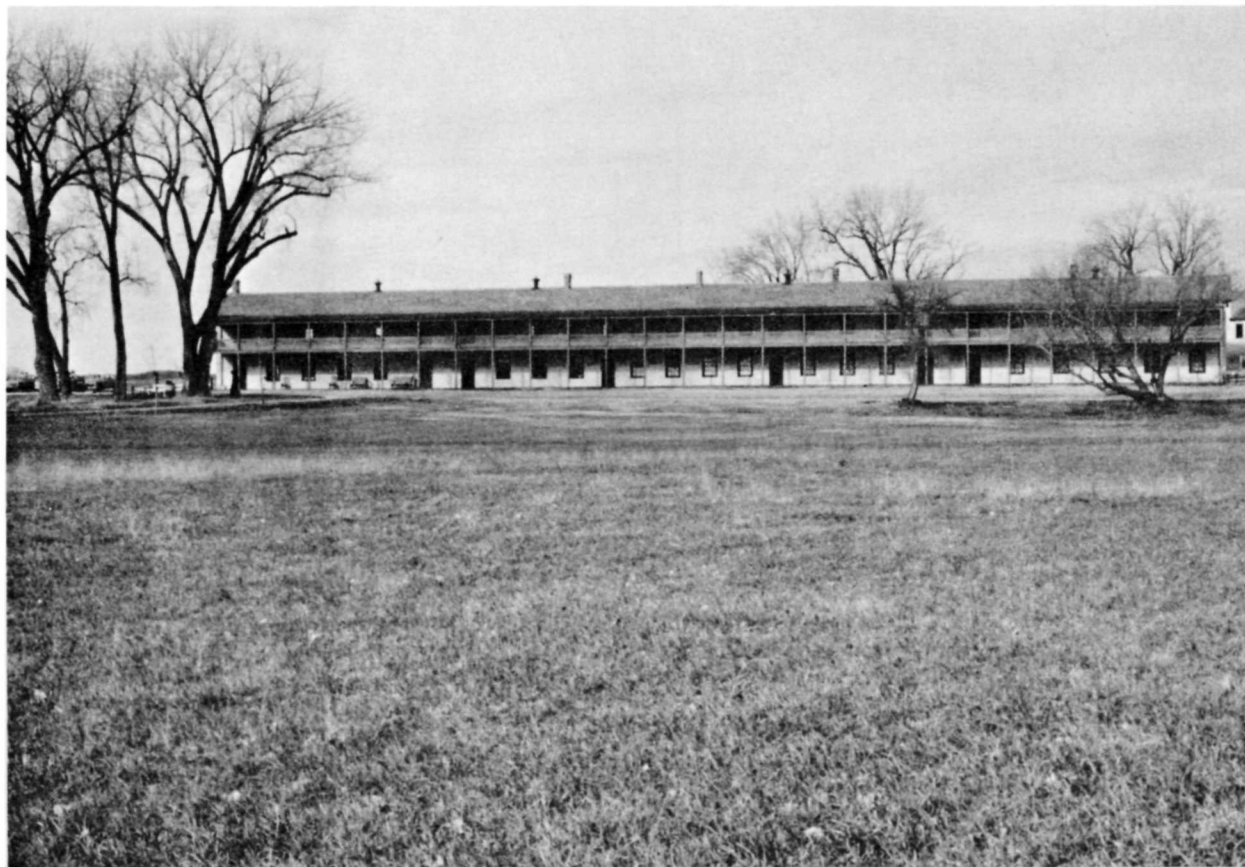
Illustration 1.

Southeast elevation, showing veranda and foreground.
A very impressive view of the 1874 barracks. This
picture shows the complete east elevation of the
building and its situation.

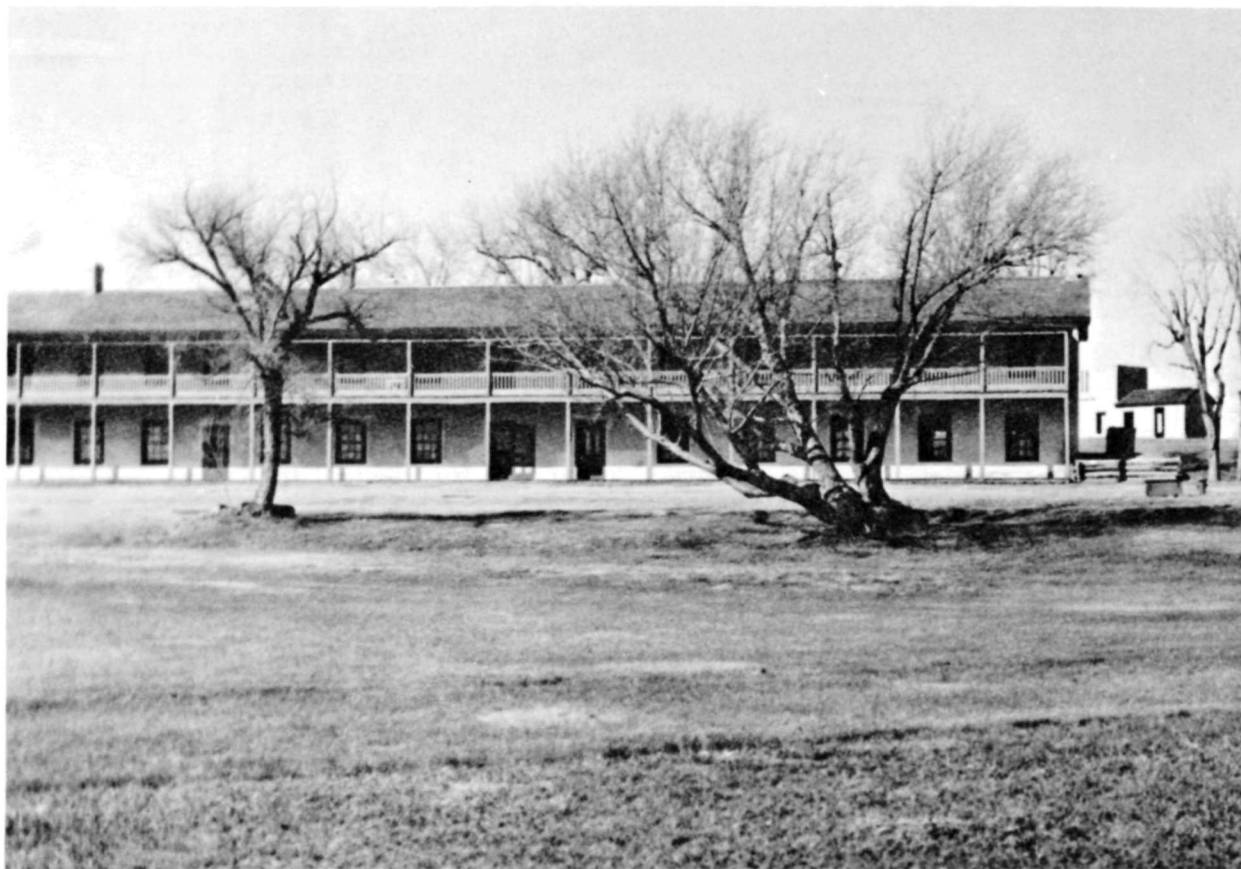
Illustration 2.

Southeast corner view of the 1874 barracks, providing a closer look at the building. This picture should give a more detailed picture of the veranda side or east elevation of the building.

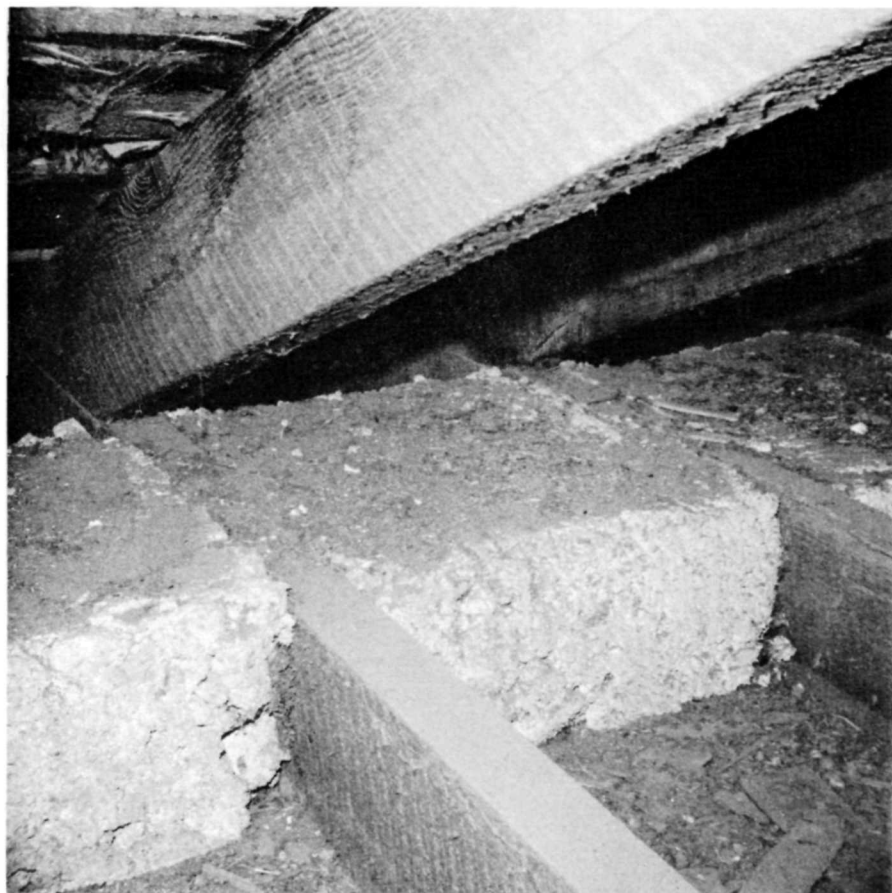
Illustration 13.

Shows ceiling joists running through the top of the lime concrete wall in the north squad room attic. This photo demonstrates how rafters at ceilings and floor joists went right through lime concrete wall in both north and south barracks.
