HISTORIC STRUCTURE REPORT

FORT POINT LIGHT

[ FORT POINT NATIONAL HISTORIC SITE

May, 1972

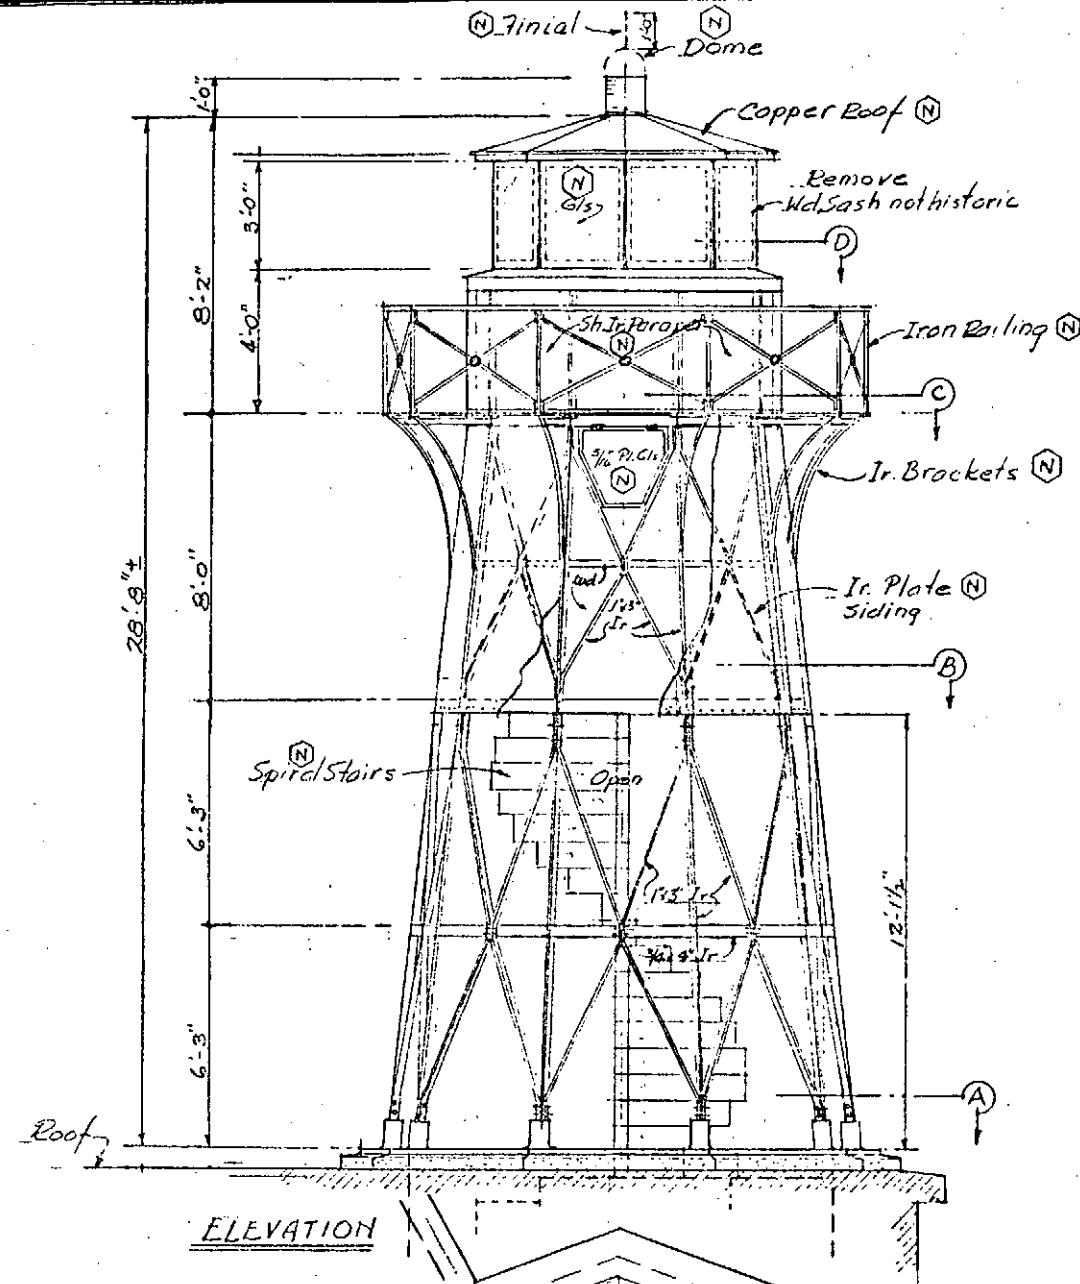
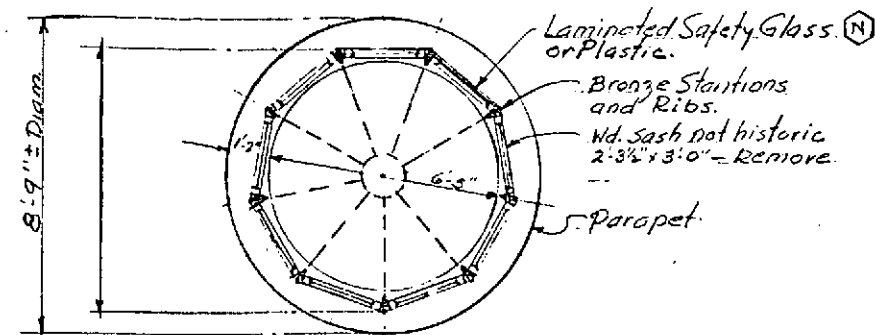
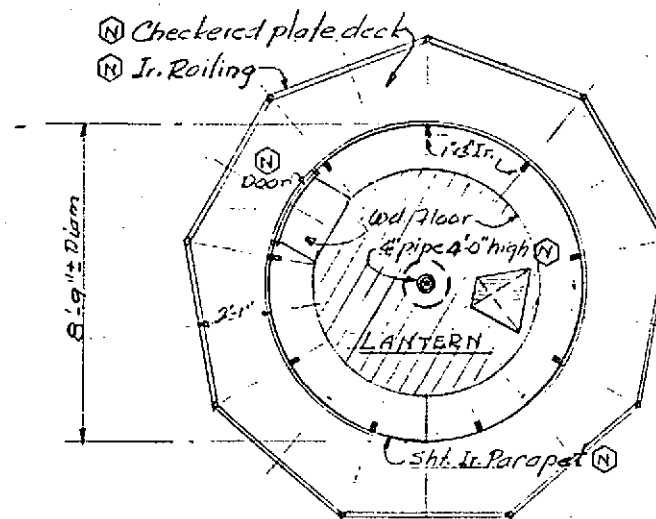
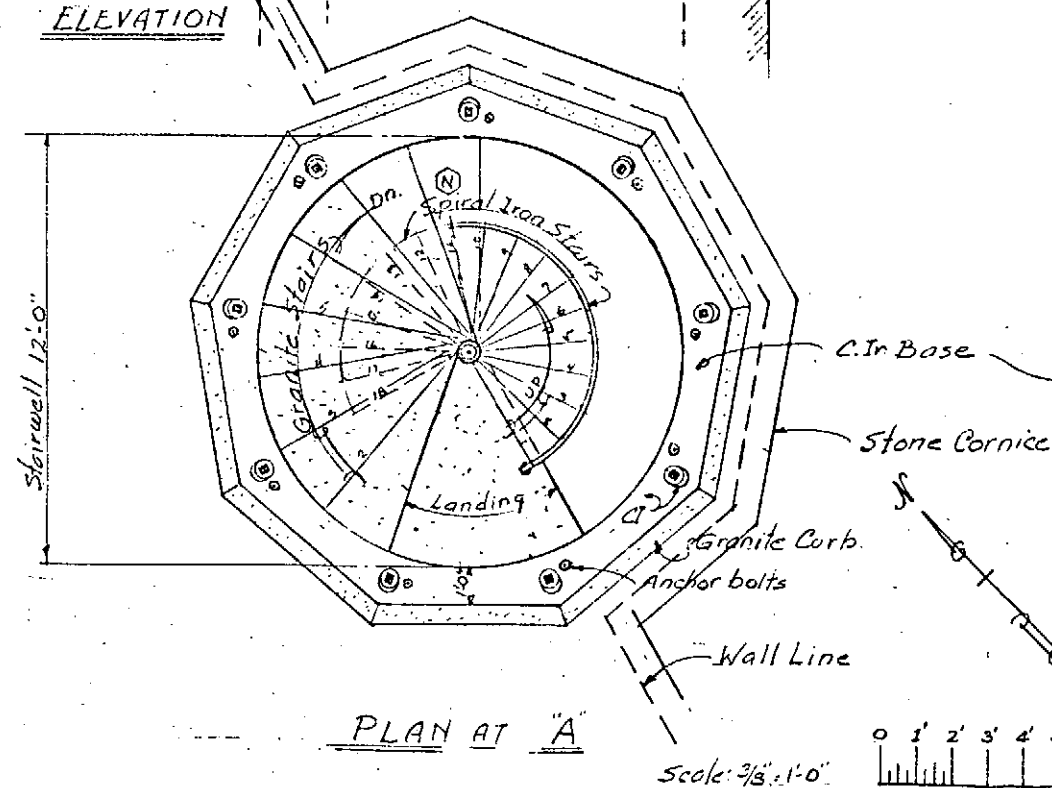
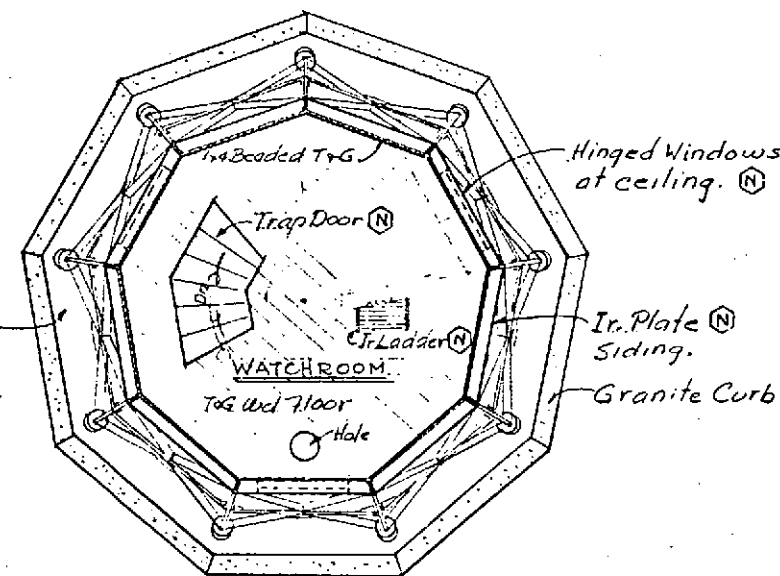
Ⓝ = New work or work to be replaced...

3. Sandblast all remaining metal and replace that which proves unsound.
4. All replacement parts shall match original as to size, shape and material unless otherwise specified.

5. All work shall be applied in place of the site, though parts may be prefabricated elsewhere.
6. Replace exterior sheet metal panels of level "B" with  $\frac{3}{16}$ " thick Boiler Plate, or equal, panels with pre-formed corner covers of same material.

9. Replace spiral iron stairway and railing of level "A" and ladder at level "B" with new to match original.
10. Replace gallery including railing and exterior brackets that support it with like material.

11. Repair copper roof at level "D".
12. Install new dome cap over vent stack at roof of level "D".
13. Remove wood sash of lantern and install  $\frac{1}{4}$ " thick laminated safety glass or plastic such as Lexan with neoprene gaskets or recommended sealant, and bronze strip.

14. Repair interior TAG wall lining and decking, and construct new hinged trap door at level "B".
15. Repair TAG decking at level "C".
16. Enclosed spaces shall be made weather tight.

17. All connections shall be made sturdy and in similar manner to original work.
18. All bolts and other fasteners shall be stainless steel.
19. All metal, except bronze and copper, shall be prime coated with a rust inhibitive paint of recommended formulation such as Rust-Oleum. Sandblasted surfaces shall be primed as soon as possible after cleaning; and shop work shall be primed at the shop.
