Fort Sumter
Fort Sumter National Monument
Historic Structure Report

Volume II
APPENDICES A-F

2015

JOSEPH K. OPPERMANN – ARCHITECT, P.A.

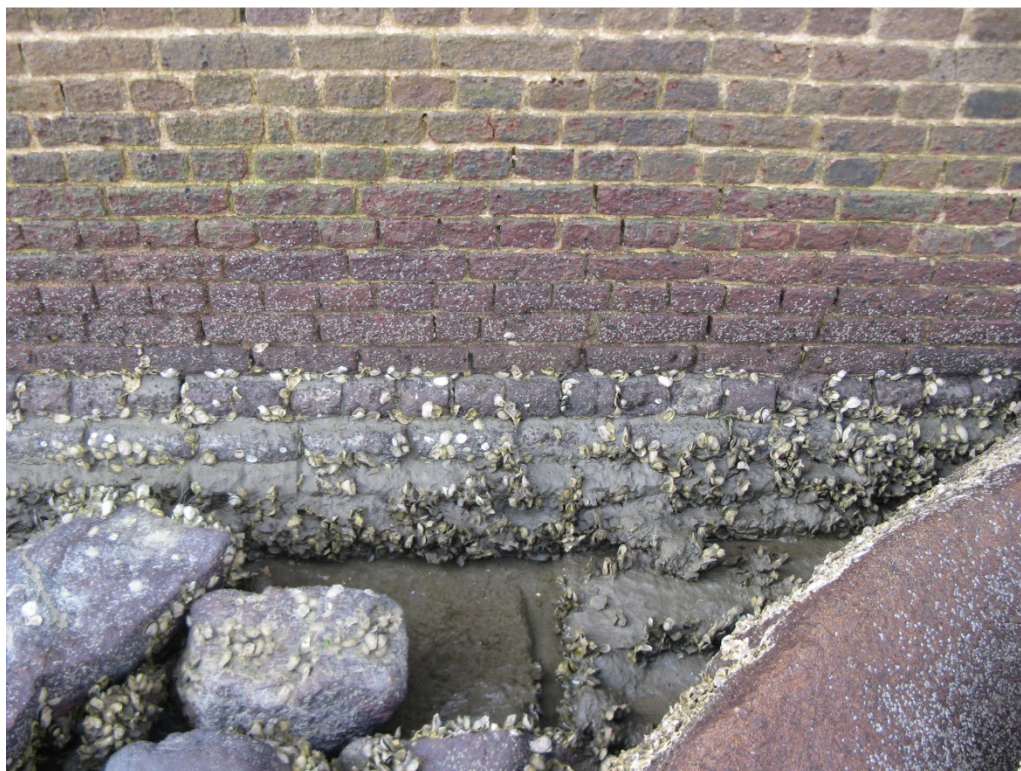
Erosion along the exterior scarp wall varies across the fort. Along the base of the wall, uniform softening and erosion of mortar has occurred below the high water mark (Figure 4). Erosion is most severe where granite revetment blocks rest against the wall (Figure 5). Above the high water mark, erosion of the face of the wall is most severe on the salient, right face, and right flank, areas which face the shipping channel (Figures 6 and 7). In some locations, previous repointing with a hard Portland cement has accelerated the loss of the brick face (Figure 8). Loose bricks along the cornice were also noted along the exterior (Figure 9).

Figure 4: Erosion of mortar below high water mark, Left Face, March 2009

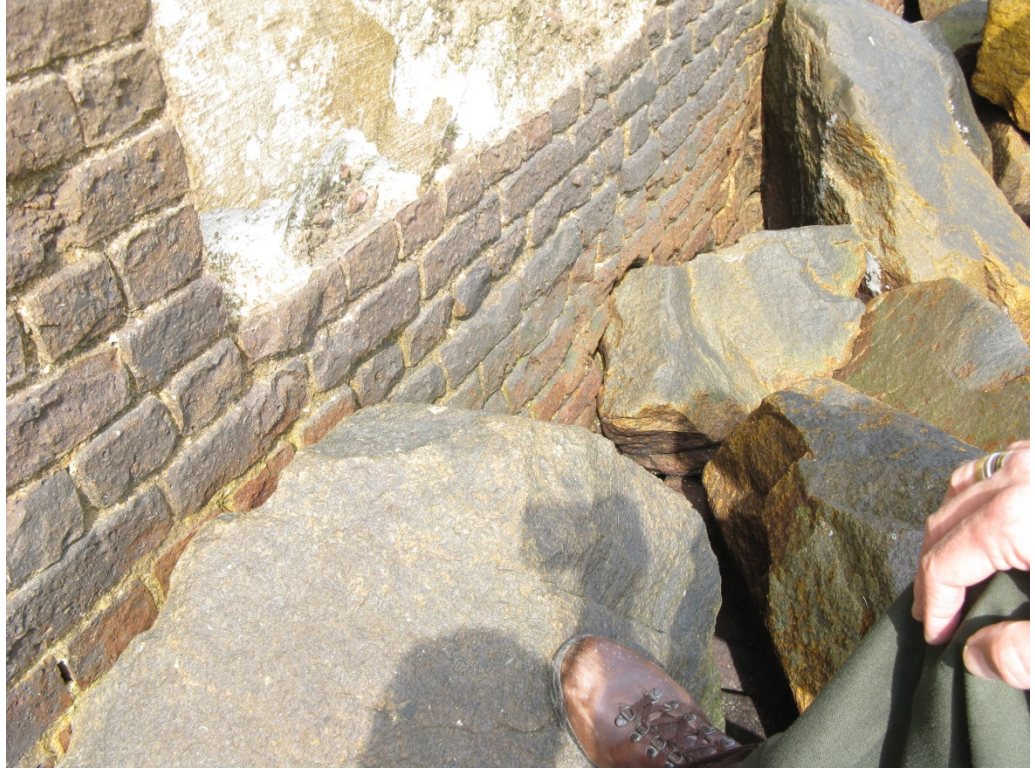
Figure 5: Accelerated erosion around granite blocks, Right Face, March 2009

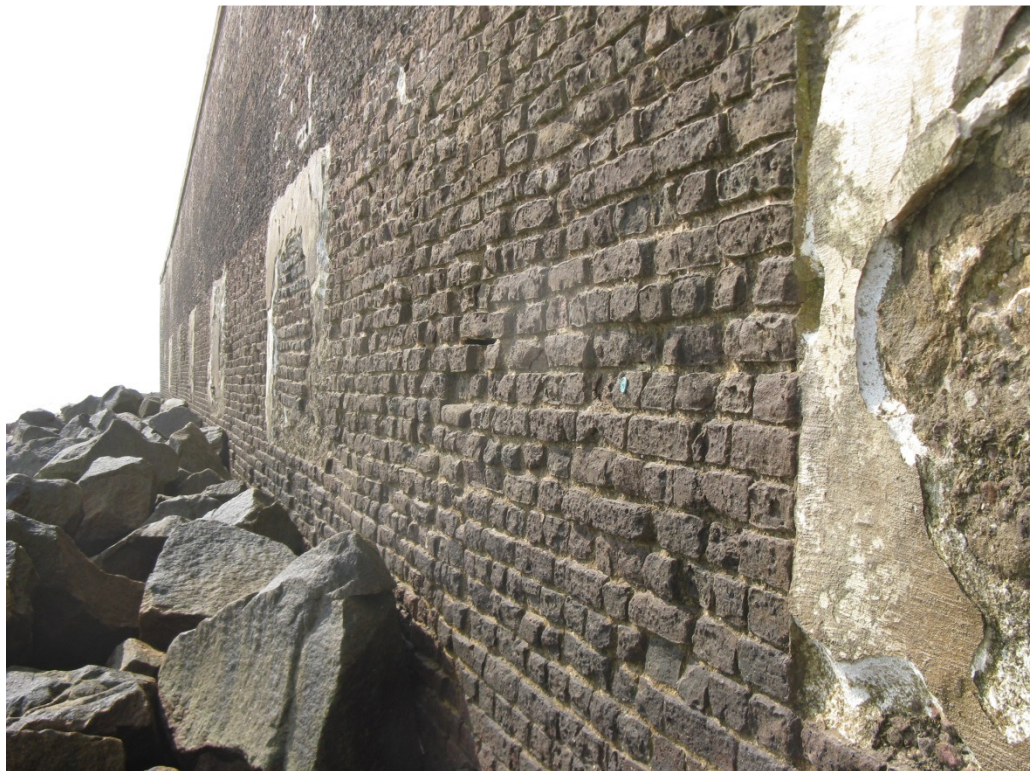
Figure 6: Erosion of wall surface, Right Face, March 2009

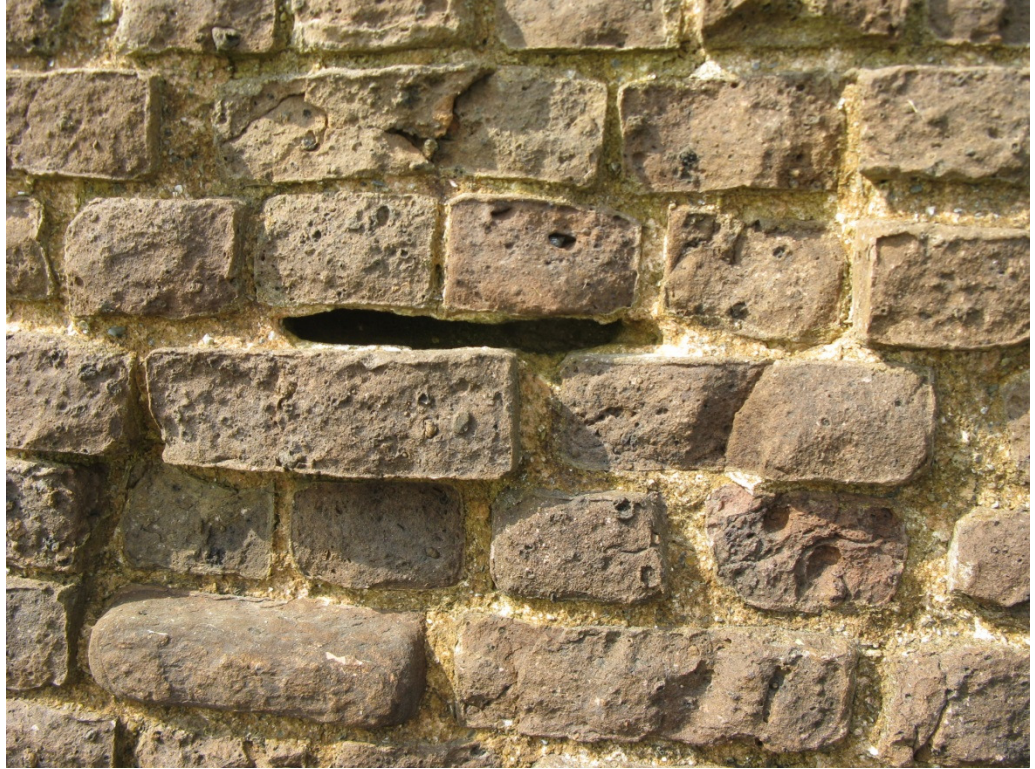
Figure 7: Erosion of wall surface and mortar, Right Face, March 2009

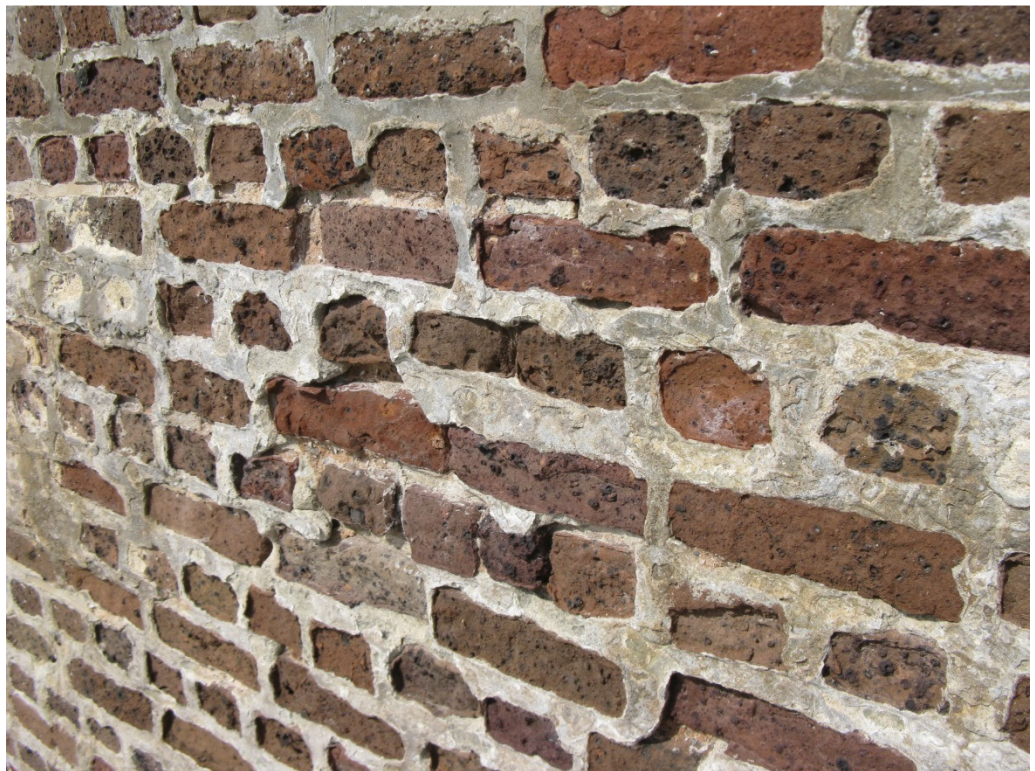
Figure 8: Portland cement used for repointing, Right Flank, March 2009

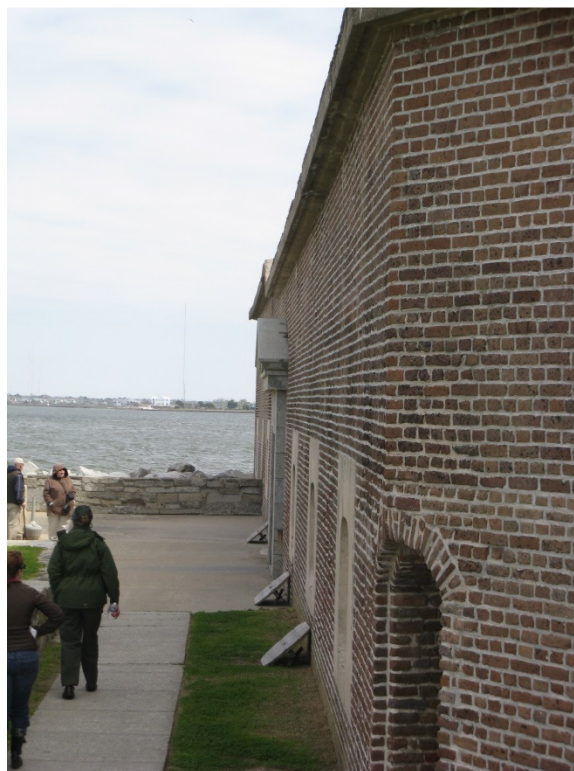
To varying degrees, the long walls of the fort bow out as they approach the shoulders, gorge angles, and salient. This is clearly discernible in Figures 10 through 14. In these photographs, there is an obvious curvature of the mortar lines between courses of brick, indicating that the walls themselves are bowing along that arc.

Figure 10: Bowing, Left Flank, March 2009

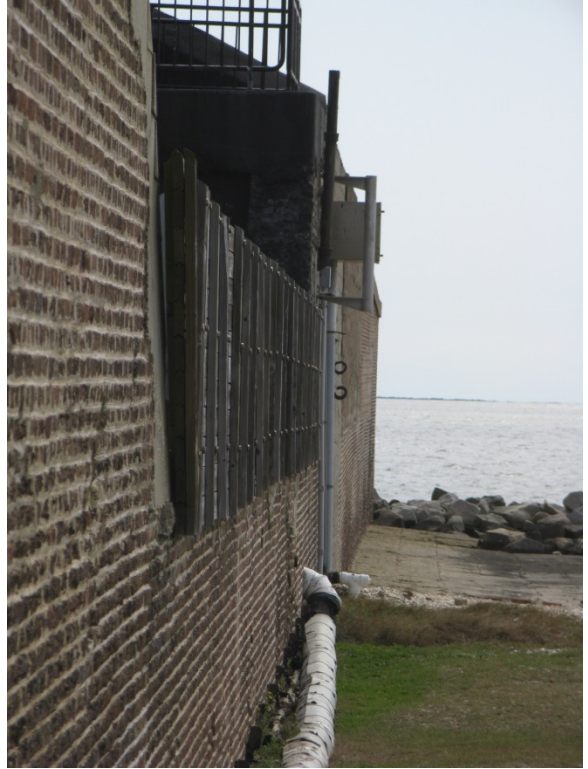
Figure 11: Bowing, Gorge Wall, March 2009

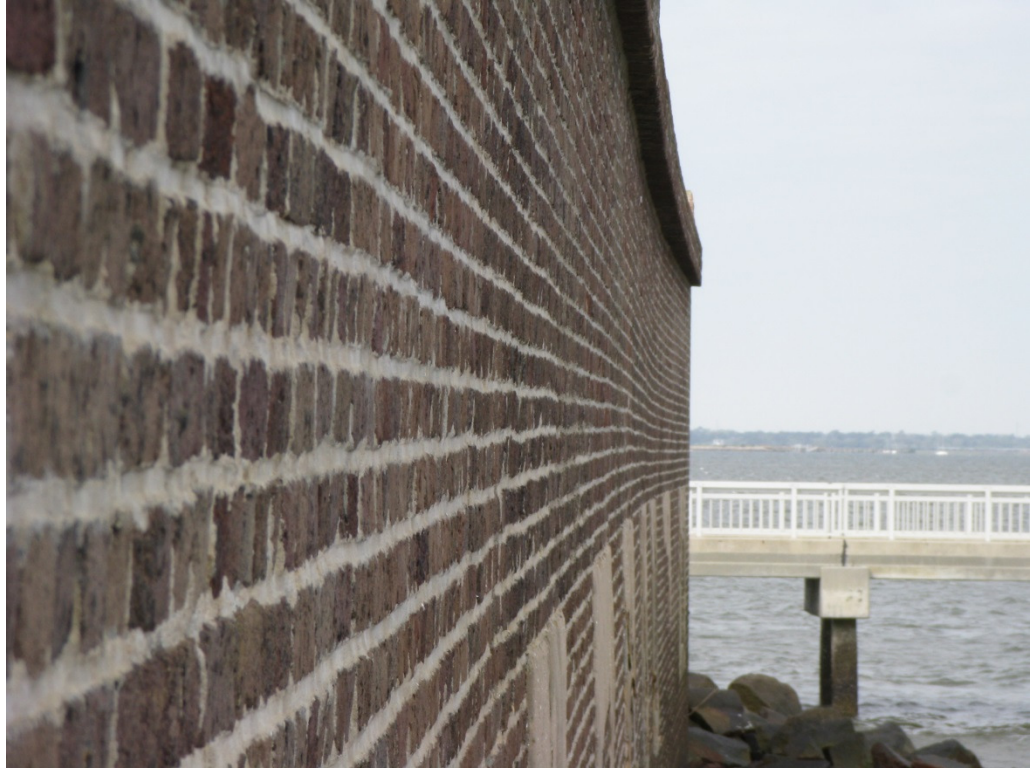
Figure 13: Bowing, Left Face, March 2009

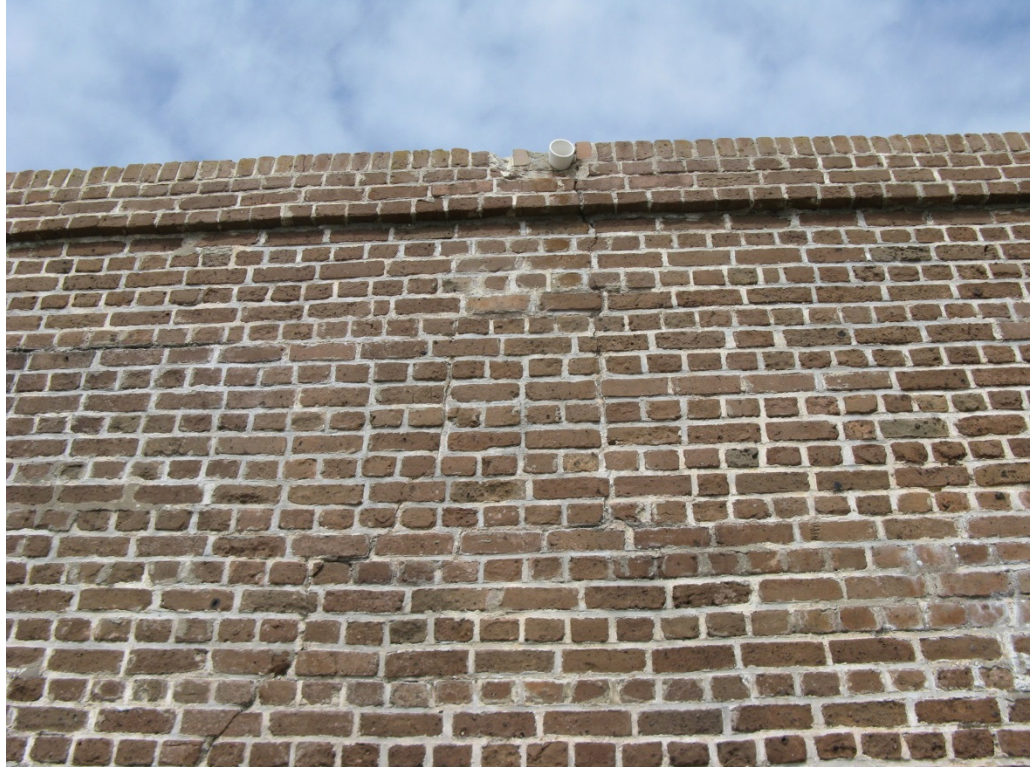
Figure 17: Masonry crack, Right Flank, March 2009

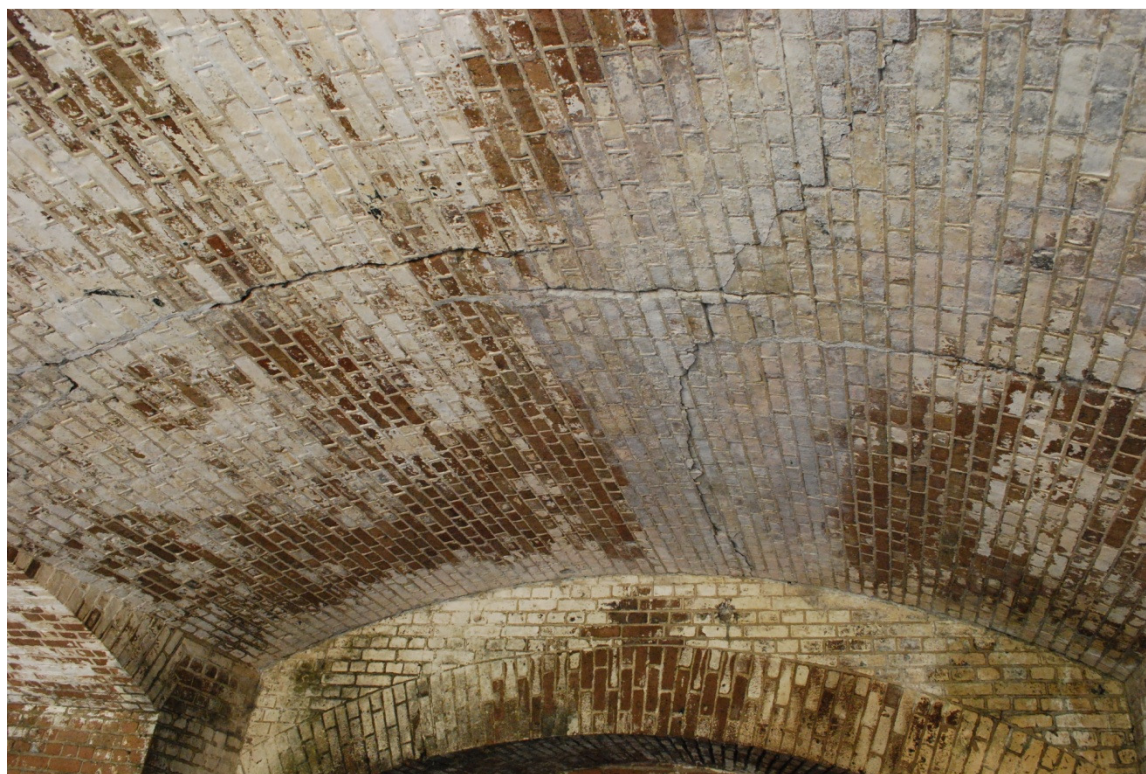
Figure 27: This vault has cracked in both directions, Right Face, March 2009

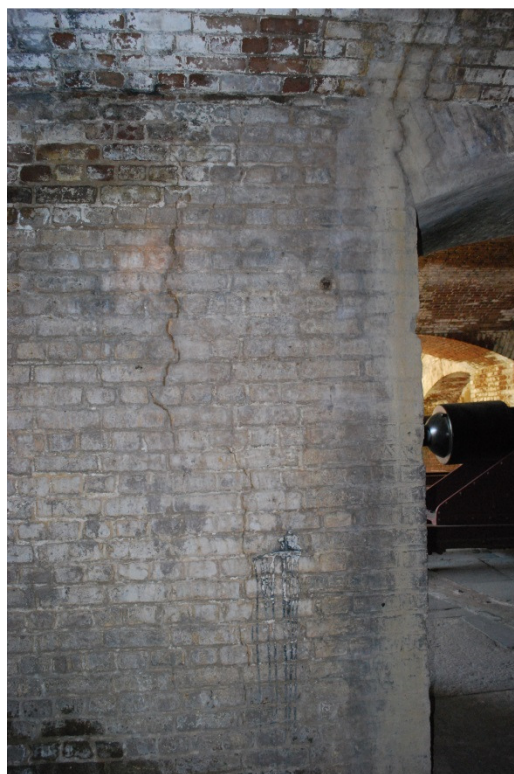
Other masonry cracks can be found throughout the fort (Figures 28 and 29). These will require evaluation individually to determine their cause and to determine whether the damage represents a common cause of structural distress.

Figure 28: Cracks caused by internal pipe, Right Face, March 2009

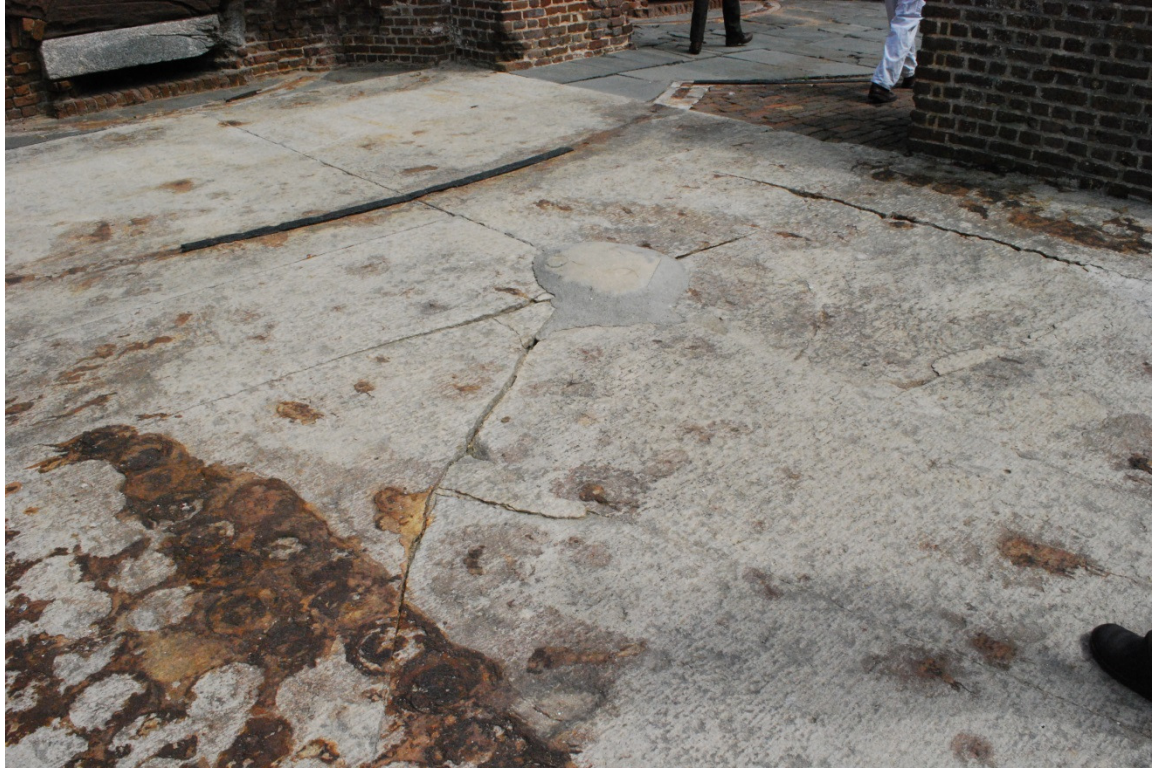
Figure 31: Cistern, March 2009

Also noted during the course of the field work were two issues that present life safety concerns. Loose bricks along the edges of broken vaults, arches, and the cornice can and regularly do fall, risking injury to a visitor or employee (Figures 9 and 30). Also, cracks in the granite over the cistern near the left face indicate that there is the possibility of localized catastrophic failure (Figure 31). Visitors are currently allowed to walk over and stand on this cistern, but should not be. These two issues are addressed in particular in the “Recommendations” section of this report.

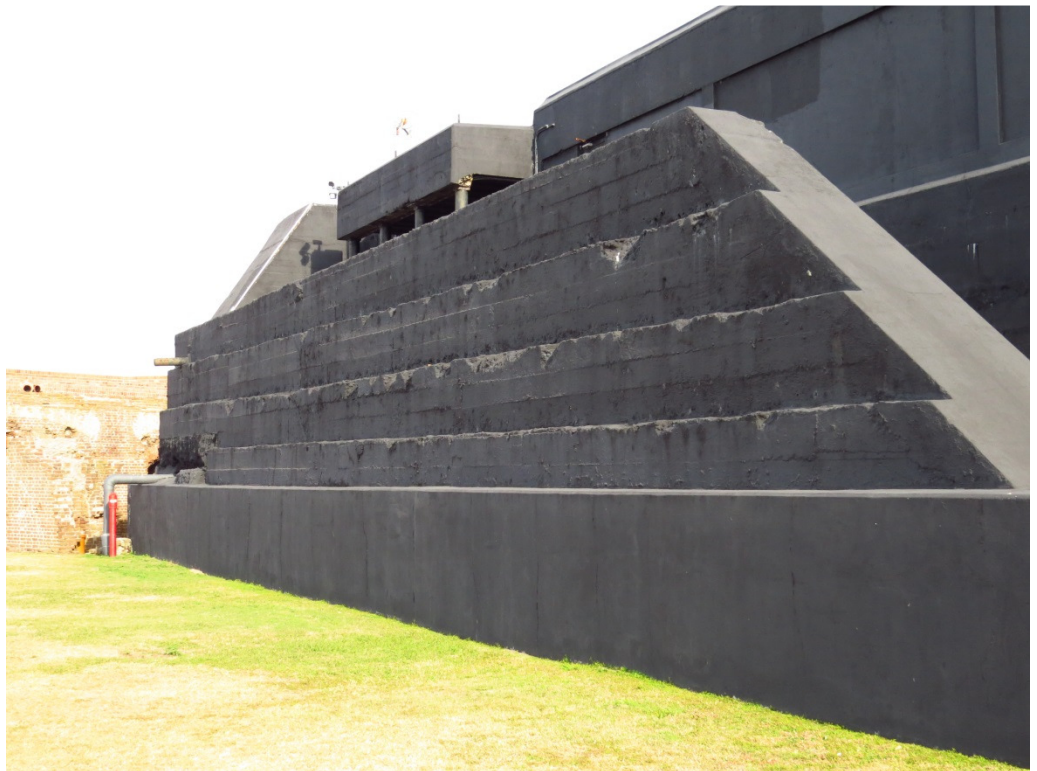
The fracture of the unreinforced concrete is most easily seen in the west wall of Battery Huger near ground level (Figures 34 through 41). Here one sees vertical fractures indicative of vertical movement of the middle portion of the walls relative to the north and south ends. Unfortunately, the 2006 Settlement Survey, comparing 1992 and 2006 settlements, was not able to confirm this behavior

Figure 34: West wall of Battery Huger, December 2013

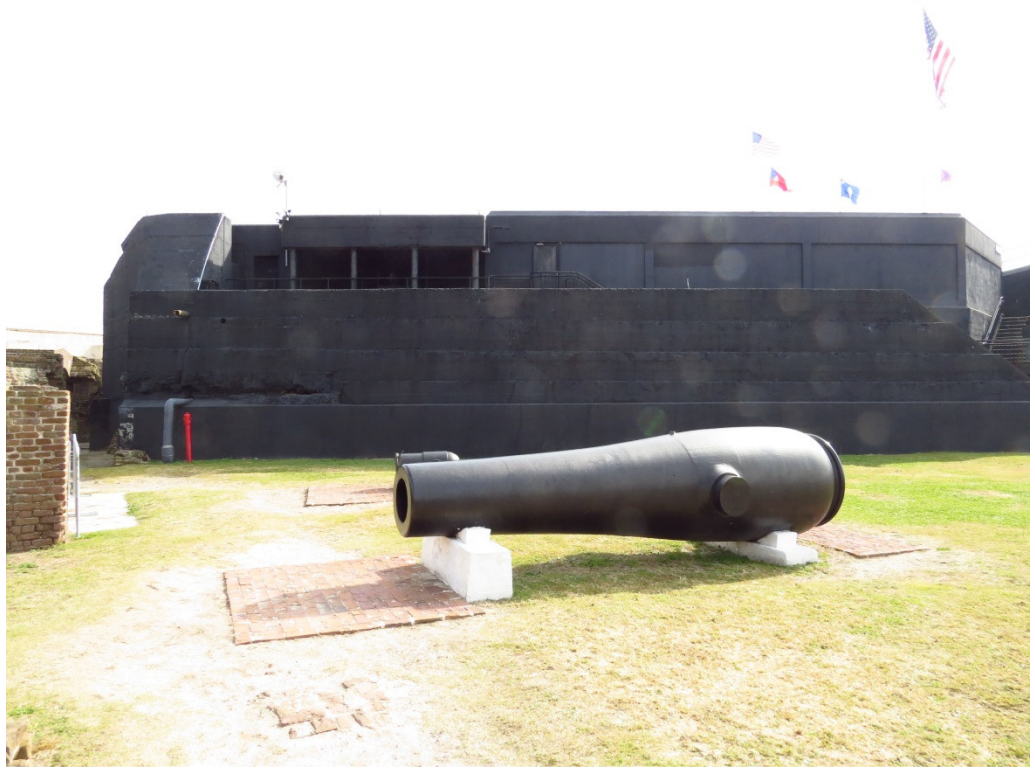
Figure 35: West wall of Battery Huger, December 2013

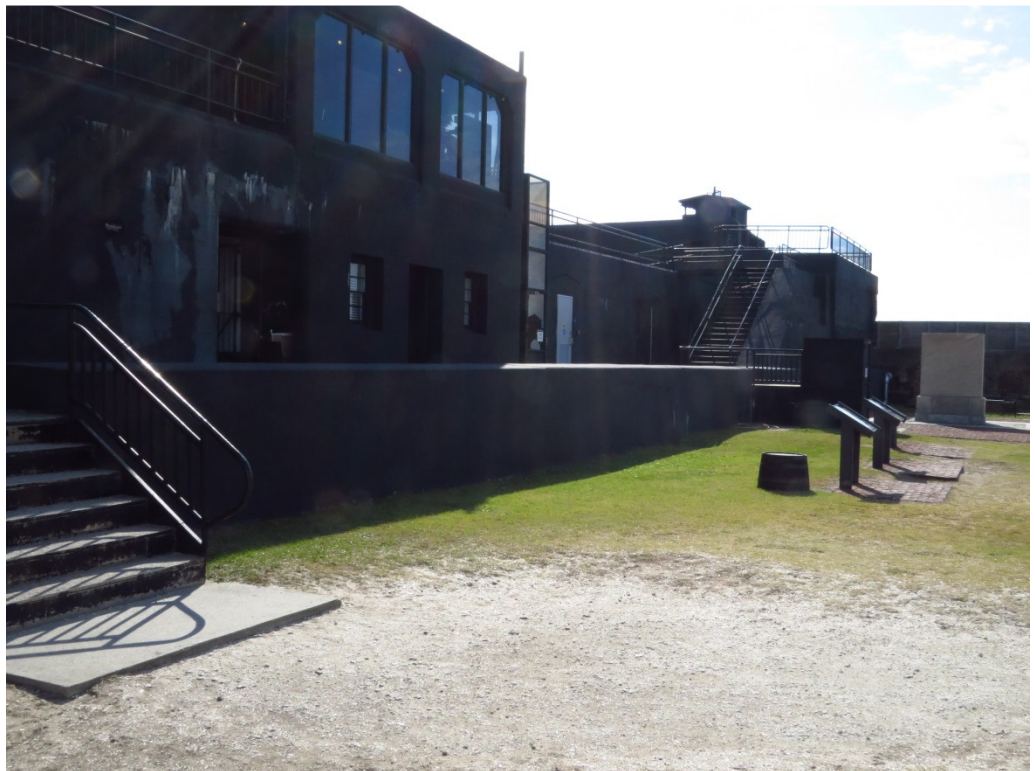
Figure 40: West Wall of Battery Huger, December 2013

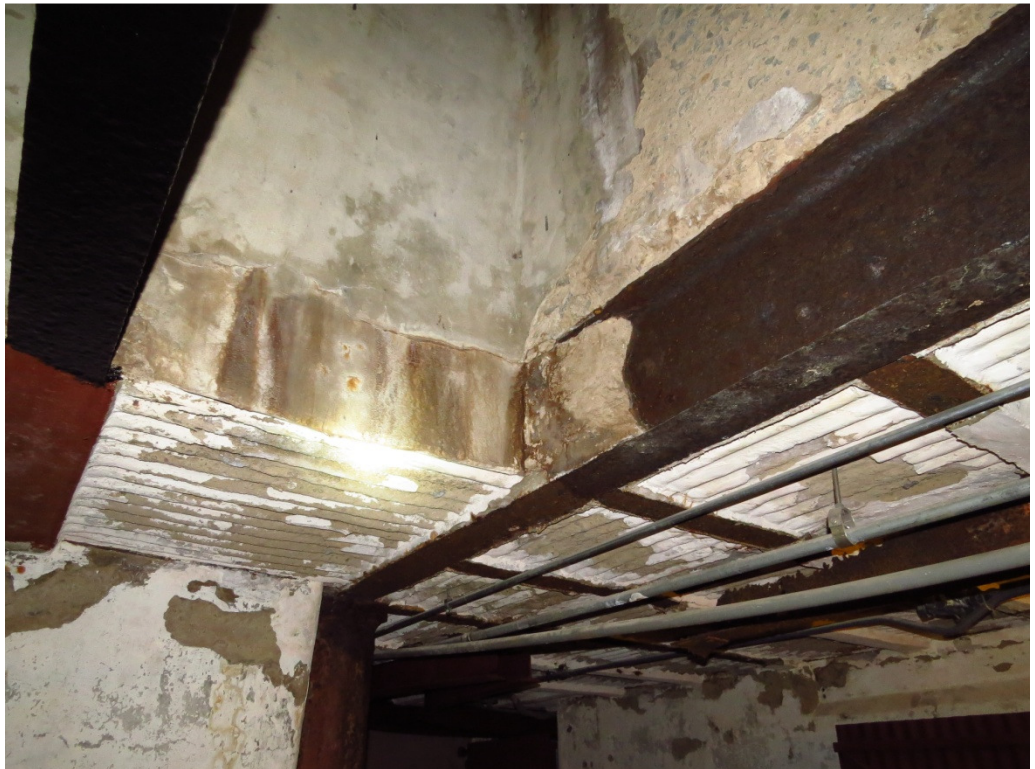
Corrosion of the supporting steel in Battery Huger is pervasive and, unfortunately, largely inaccessible. The columns generally are at least partially embedded in concrete and the girders and joists have significant portions embedded. Corrosion of the embedded portions is, in some areas, causing major damage to the concrete through corrosion jacking (Figures 42 through 47). It additionally suffers significant loss of section in the more exposed areas (Figures 50 through 52).

Figure 42: Corroding steel in joist system, December 2013

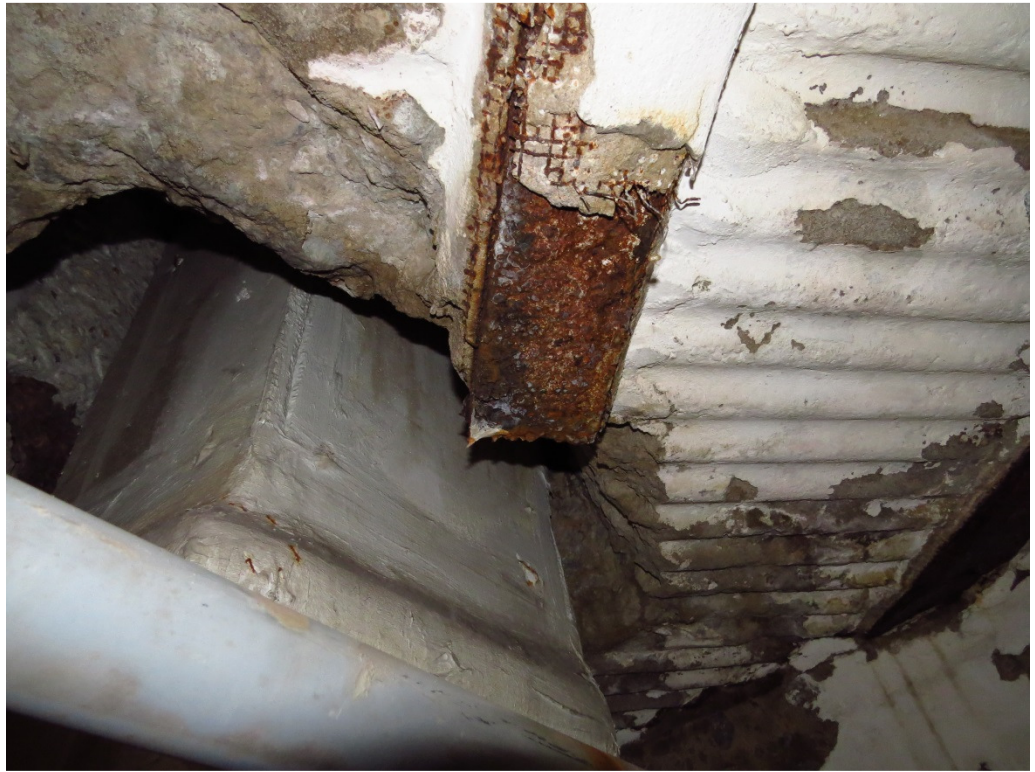
Figure 45: Corroding steel in joist system, December 2013

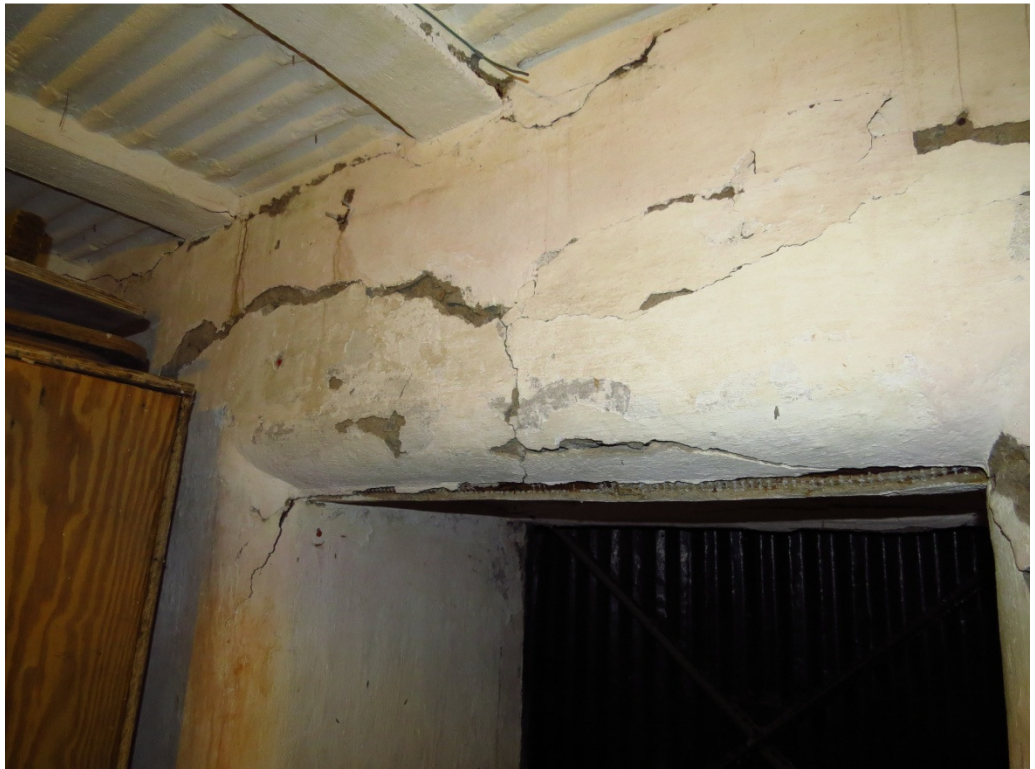
Figure 46: Corroding steel and jacking of concrete, December 2013

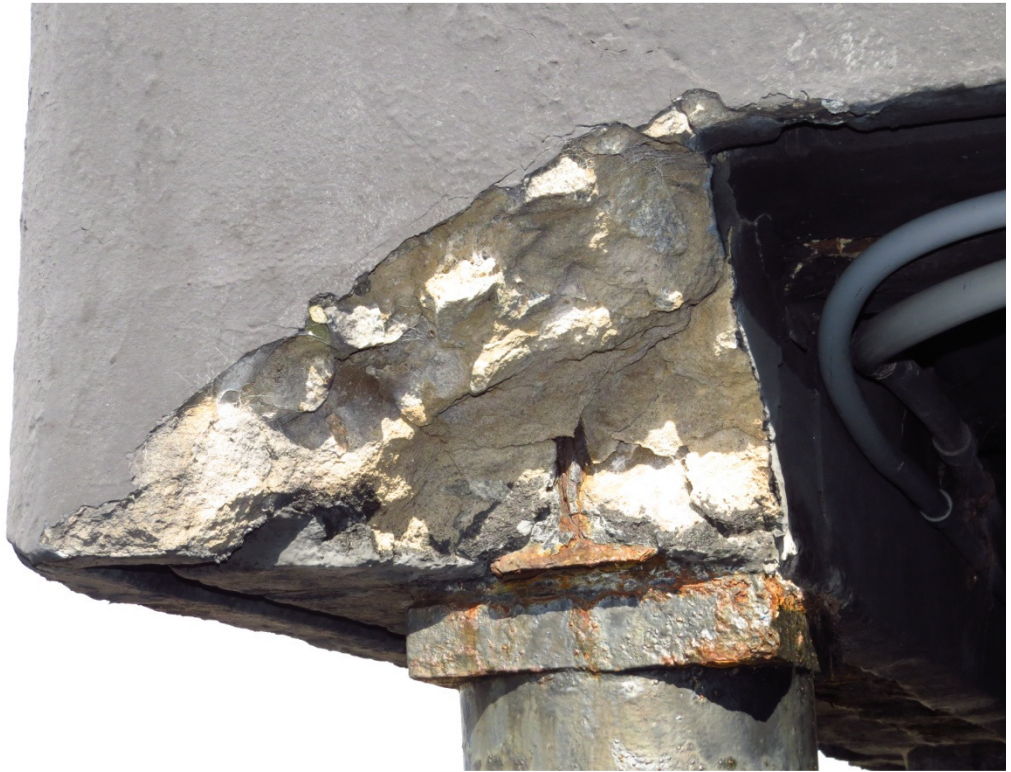
Figure 49: Corroding steel, December 2013

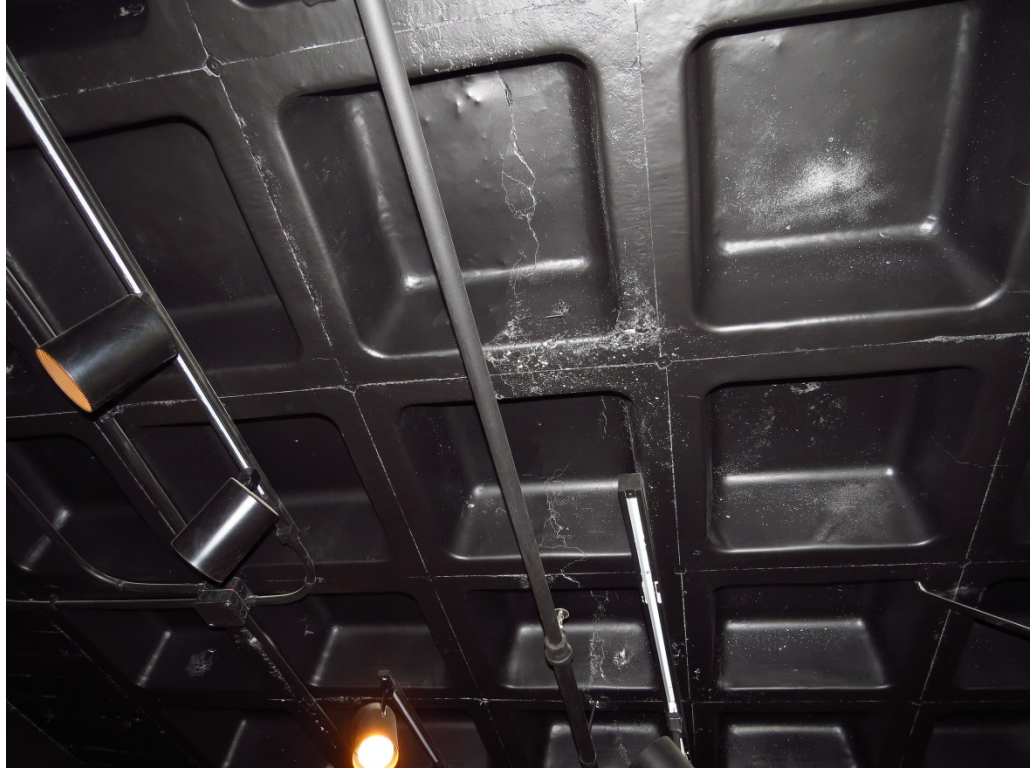
One final additional failure is seen in the two-way concrete pan joist system of the roof of the museum on top of Battery Huger. The two-way concrete pan joist system has fractured in the positive moment regions, in a manner consistent with structural overload. (Figure 53)

Figure 53: Structural fracture in the 2-way pan joist system of the museum ceiling, December 2013

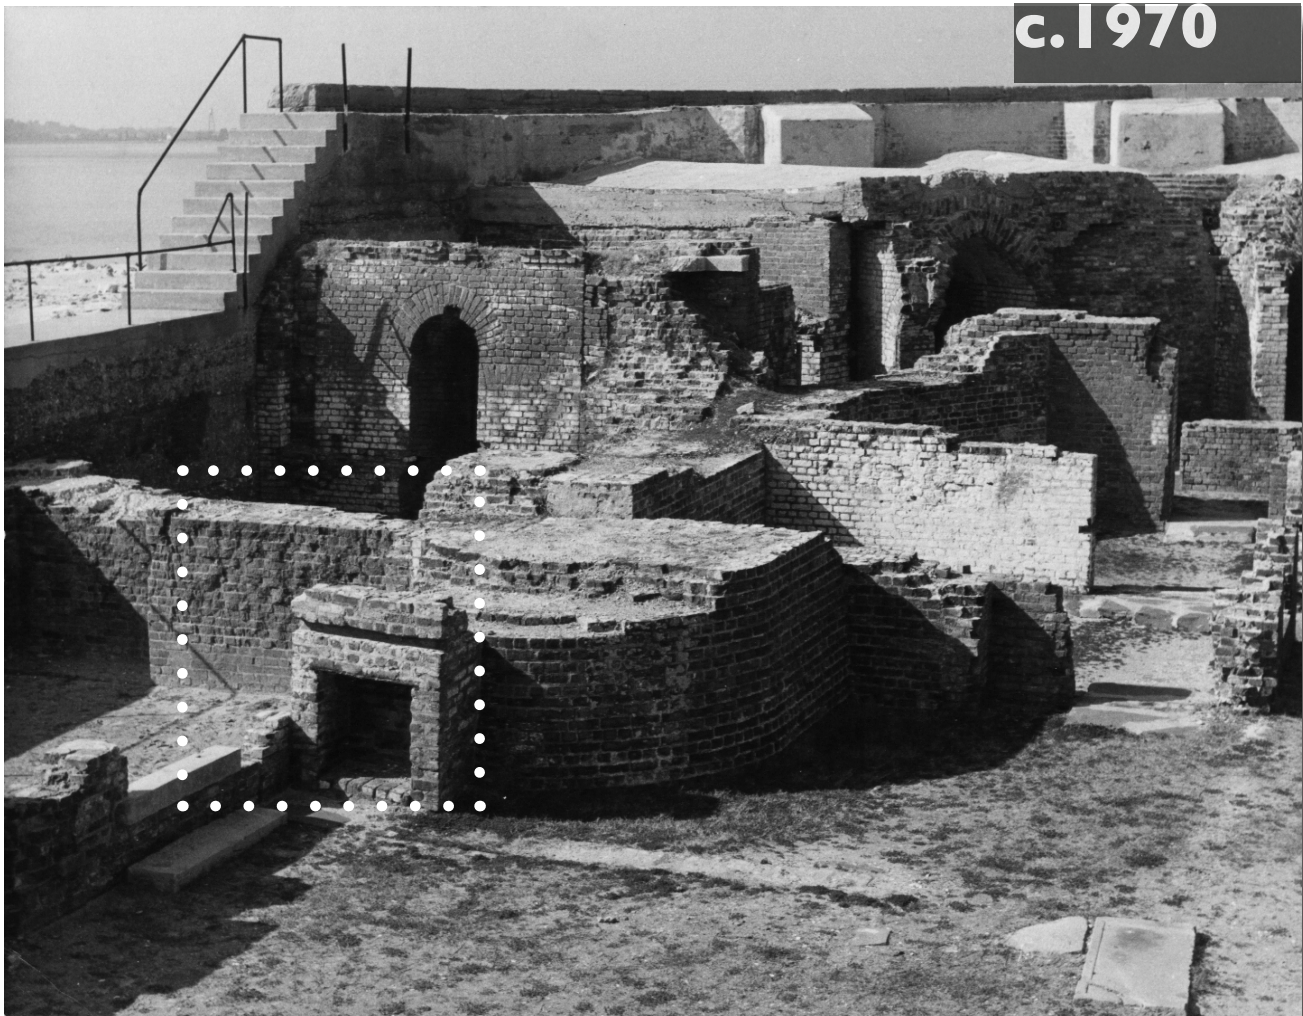
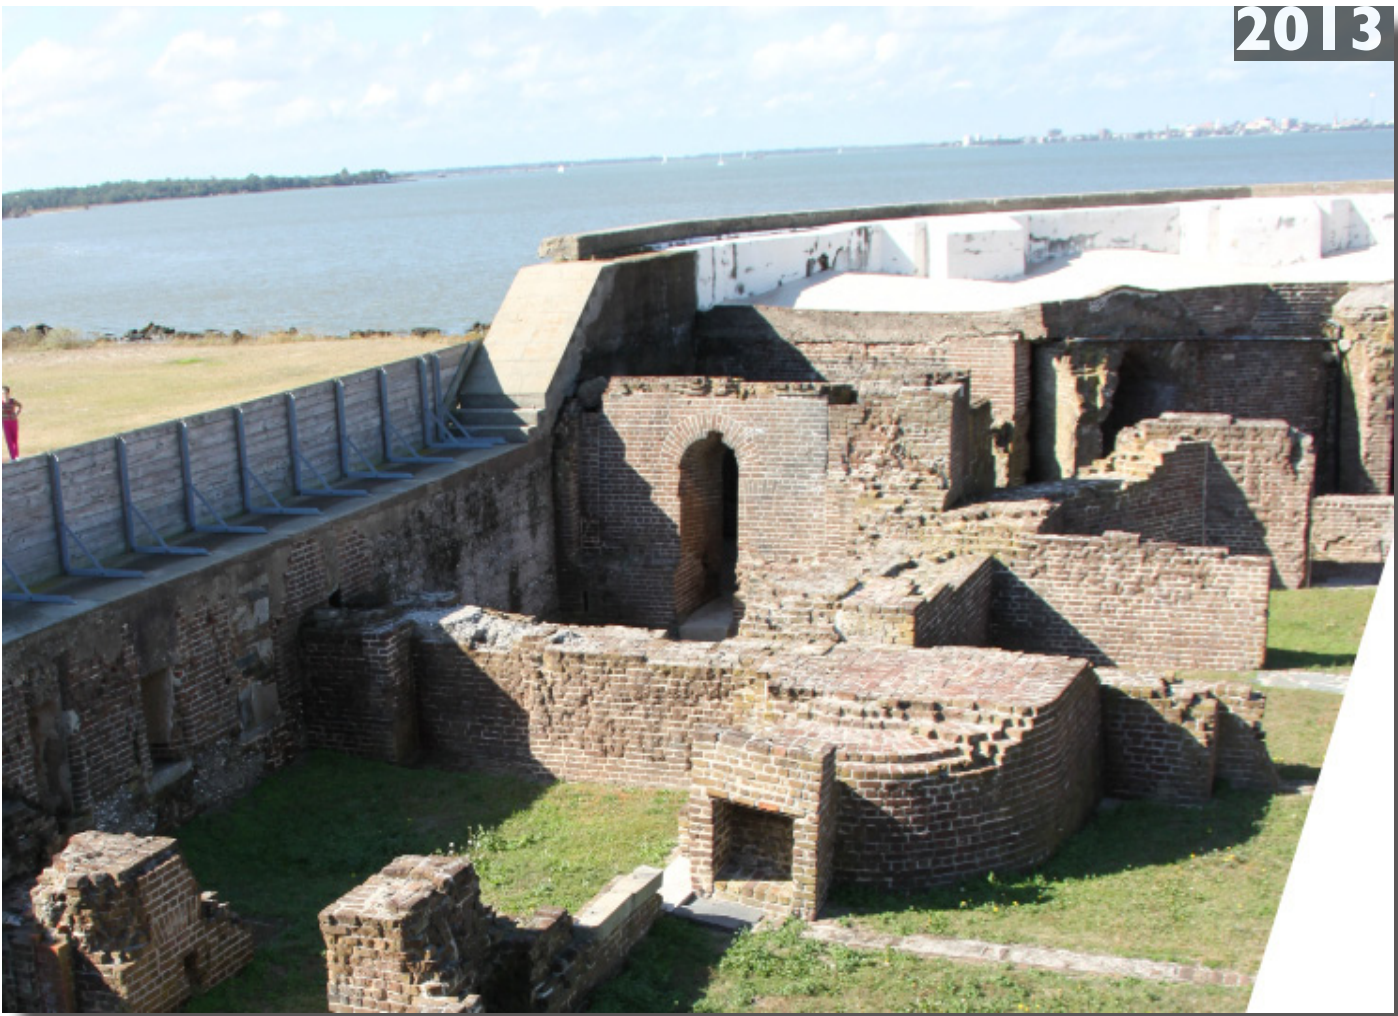
LOCATION

Gorge wall archeological ruins, looking west. [Credit: Fort Sumter Archives]

- The metal railing on the gorge wall that was present in c. 1970 was later replaced with the current wooden security wall.
- The traces of white finishes present in the c. 1970s are no longer extant.

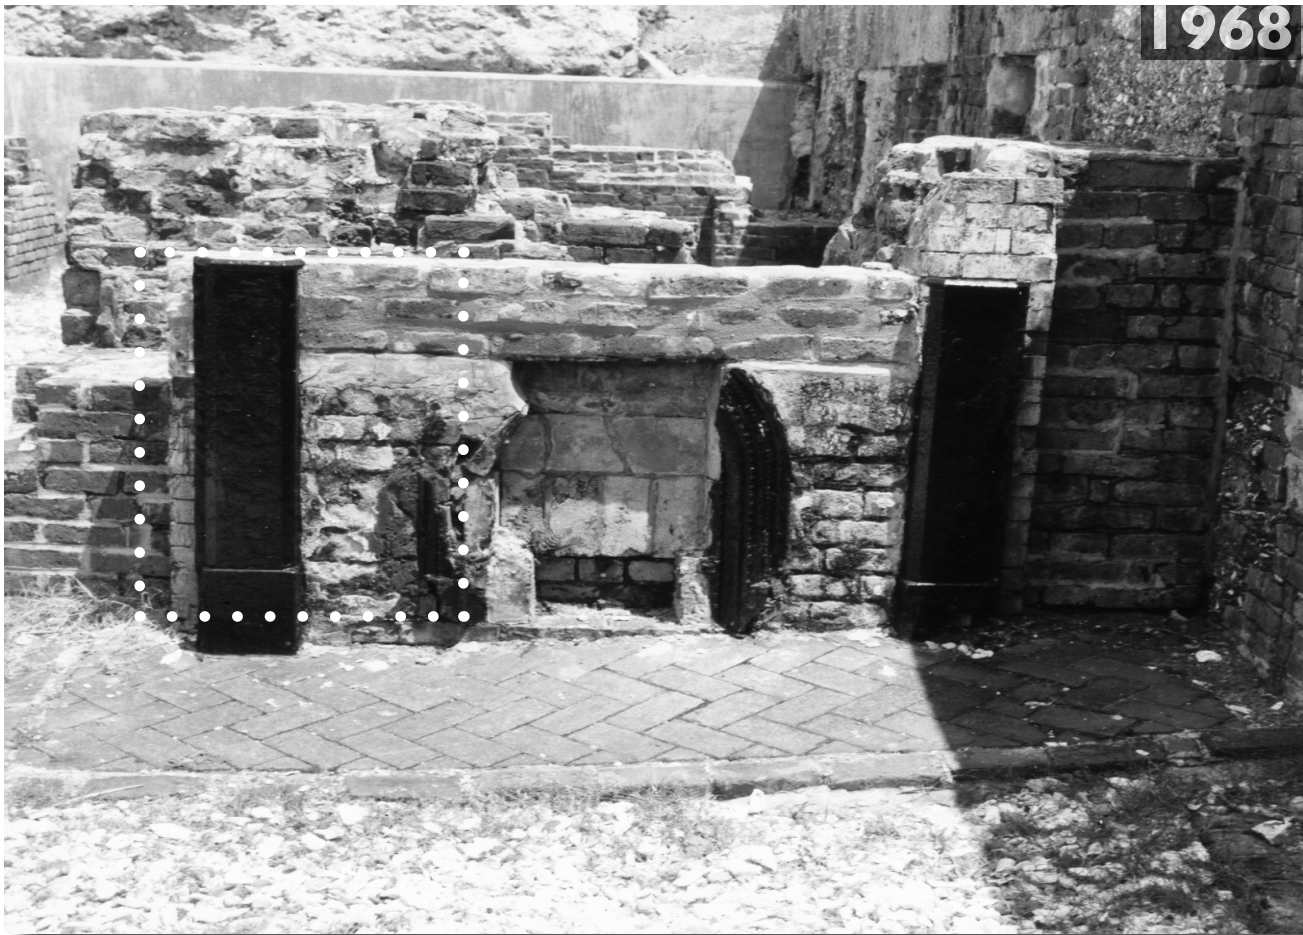
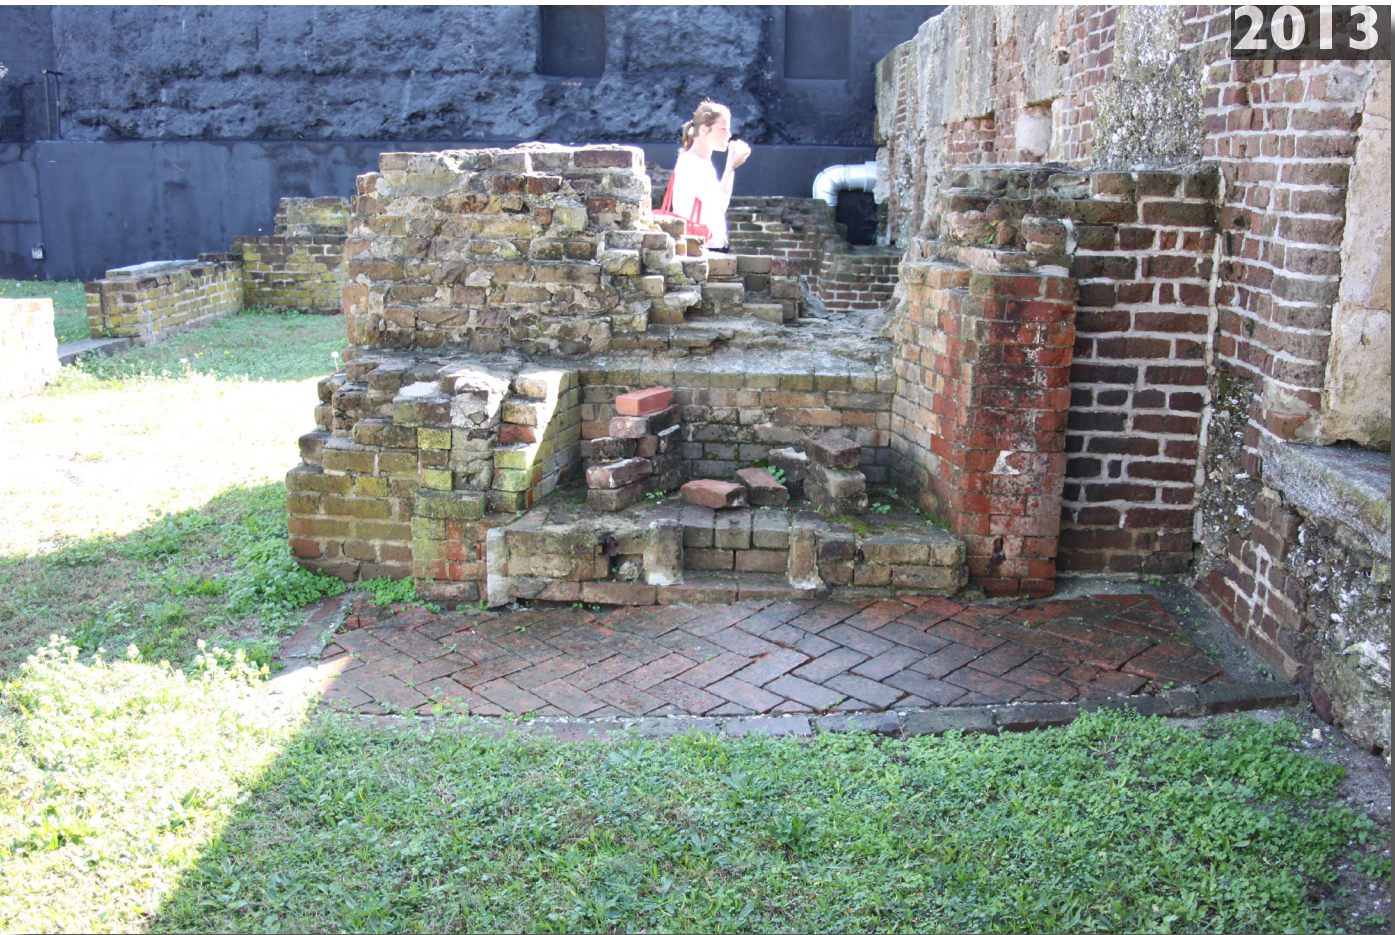
LOCATION

Gorge wall archeological ruins, herringbone brick hearth in the Kitchen area, looking east.
[Credit: Fort Sumter Archives]

- The fireplace surround is no longer intact.
