Fort Sumter
Fort Sumter National Monument
Historic Structure Report

Volume II
APPENDICES A-F

2015

JOSEPH K. OPPERMANN – ARCHITECT, P.A.

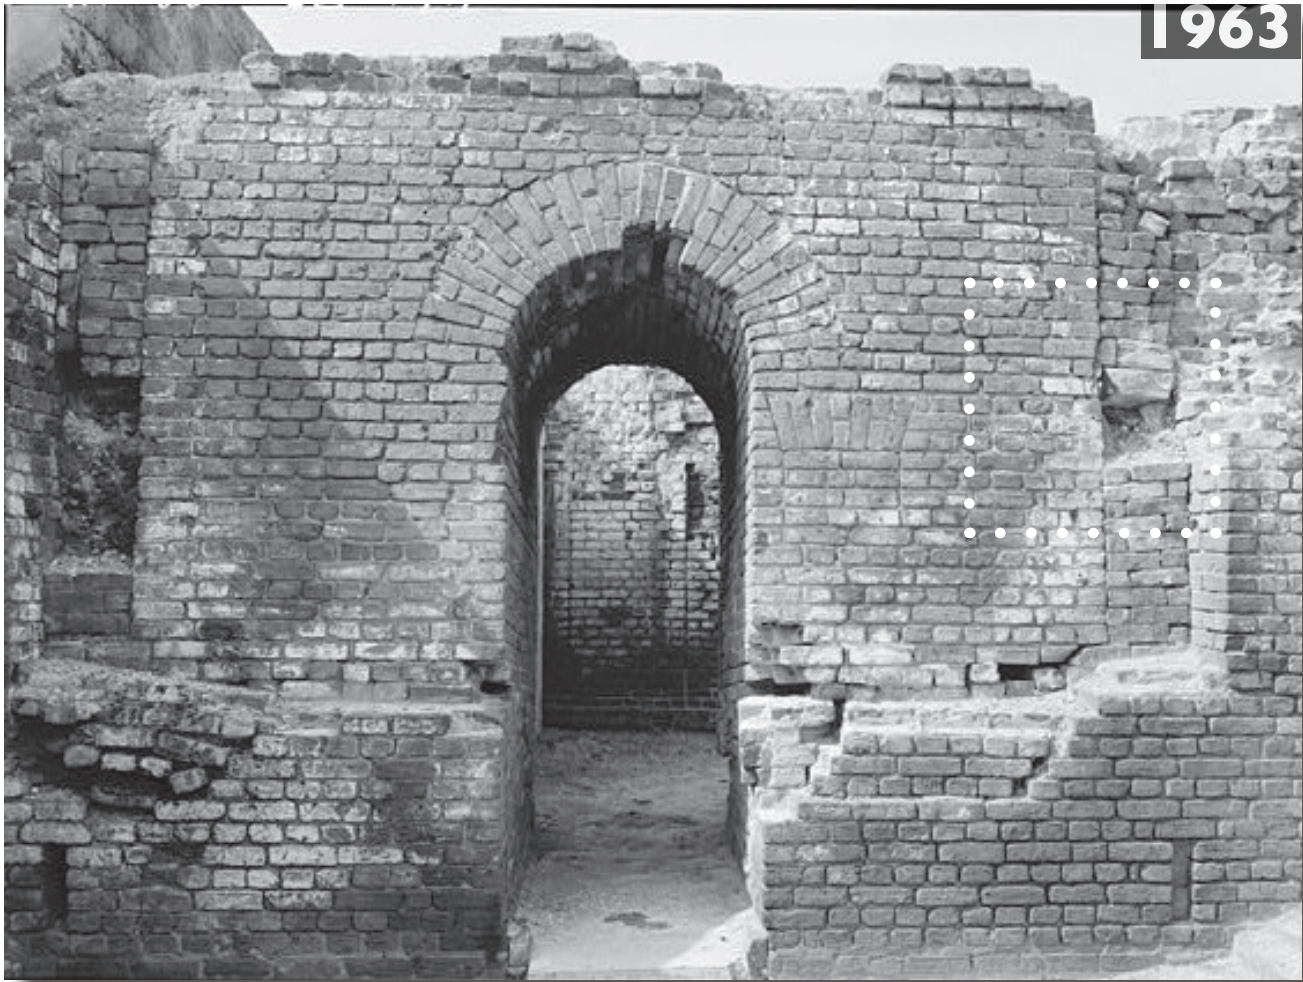
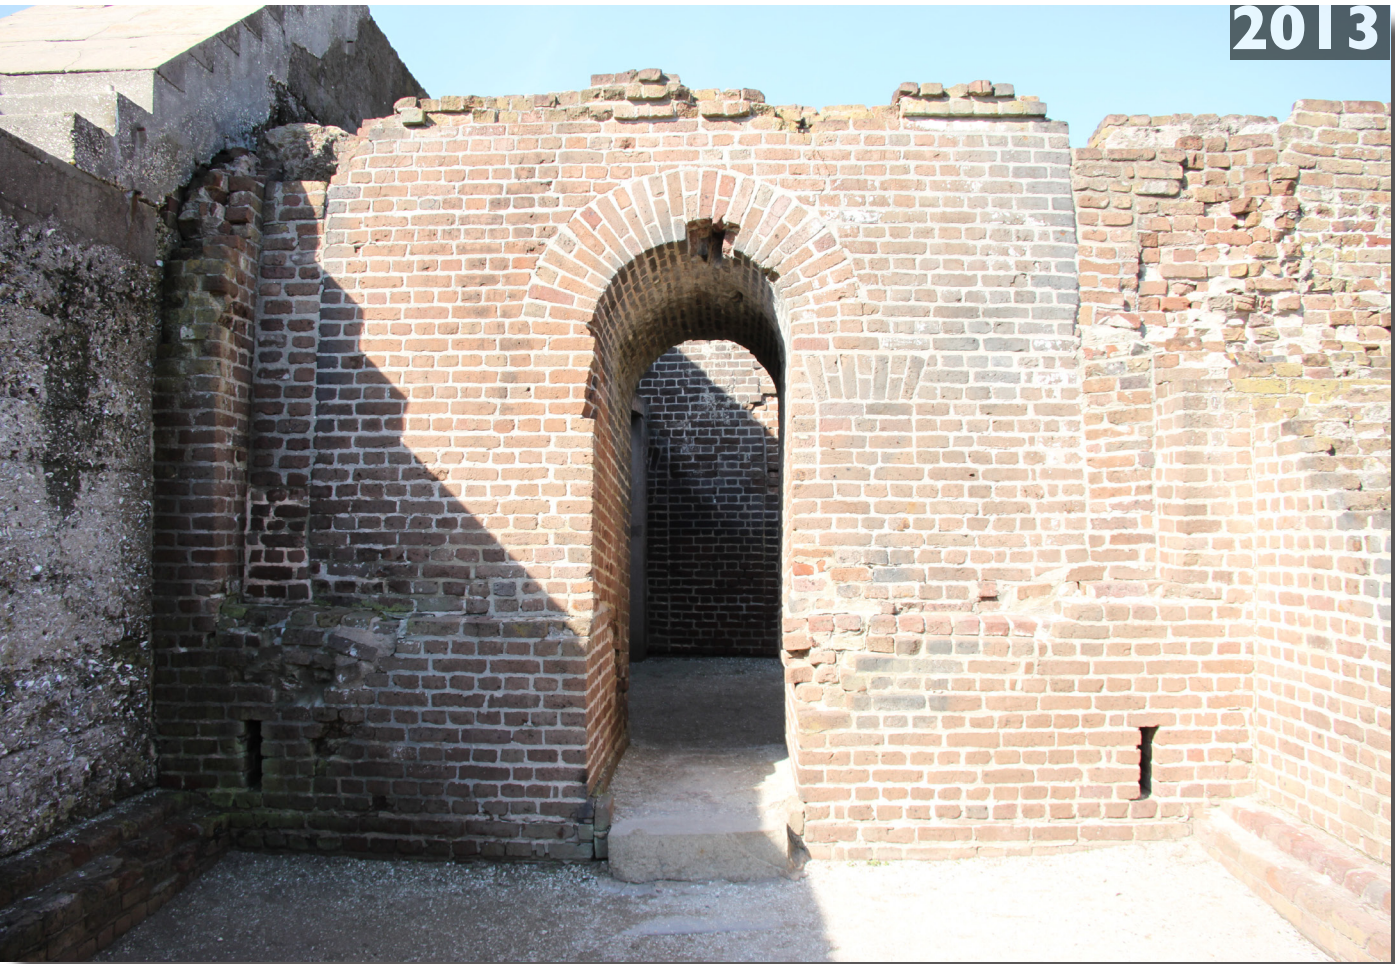
LOCATION

Gorge wall archeological ruins. The remains of Magazine East, looking west. [Credit: Jack Boucher]

- The horizontal cracking on the northside of the vaulted hallway into Magazine West appears to have been stabilized and filled with patching mortar.
- Many of the open mortar joints that were visible in 1963 have since been re-pointed.
- Brick has been infilled in the vertical spaces on the northern and southern-most portions of the wall.

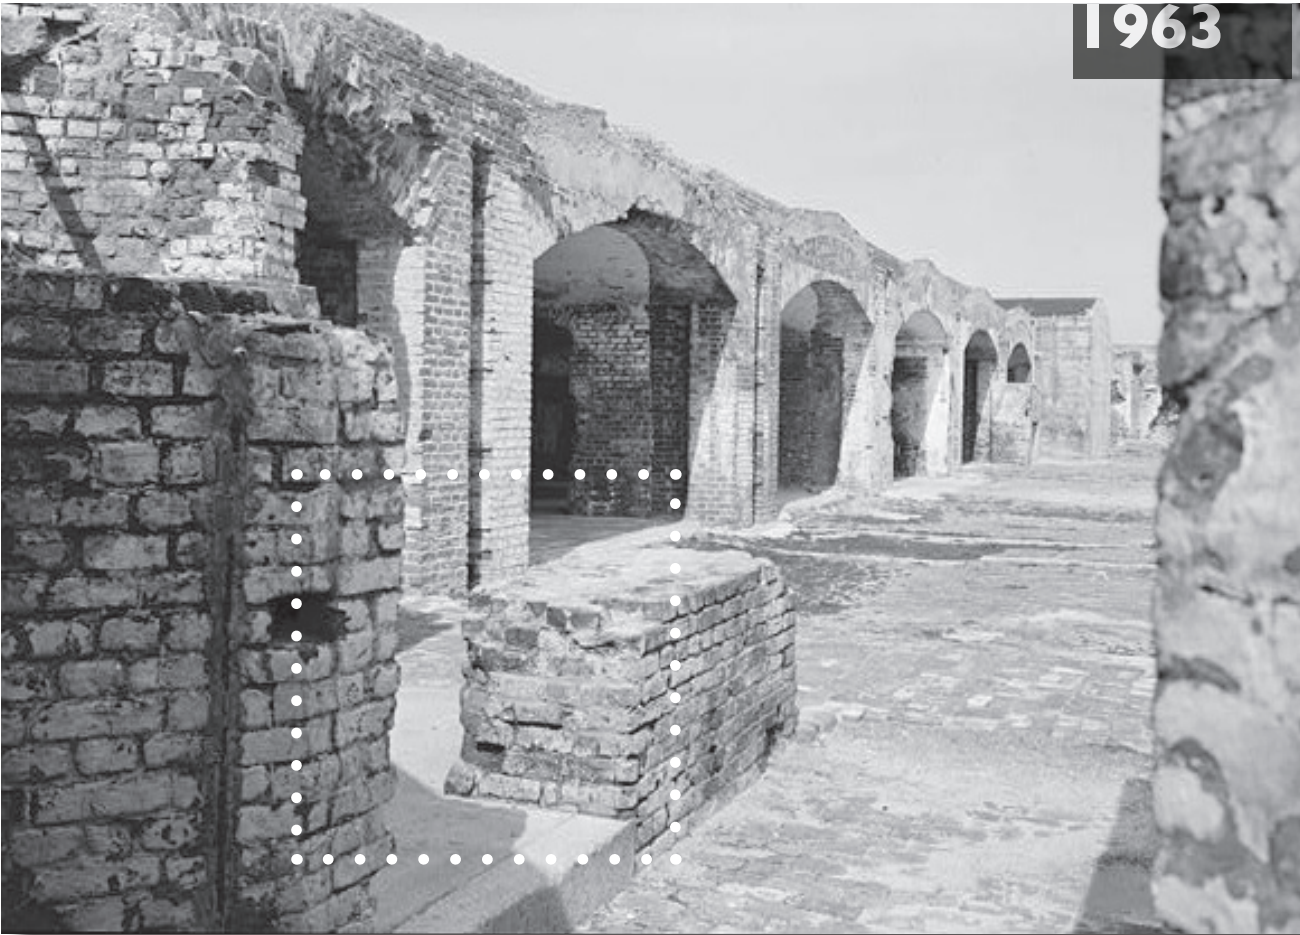
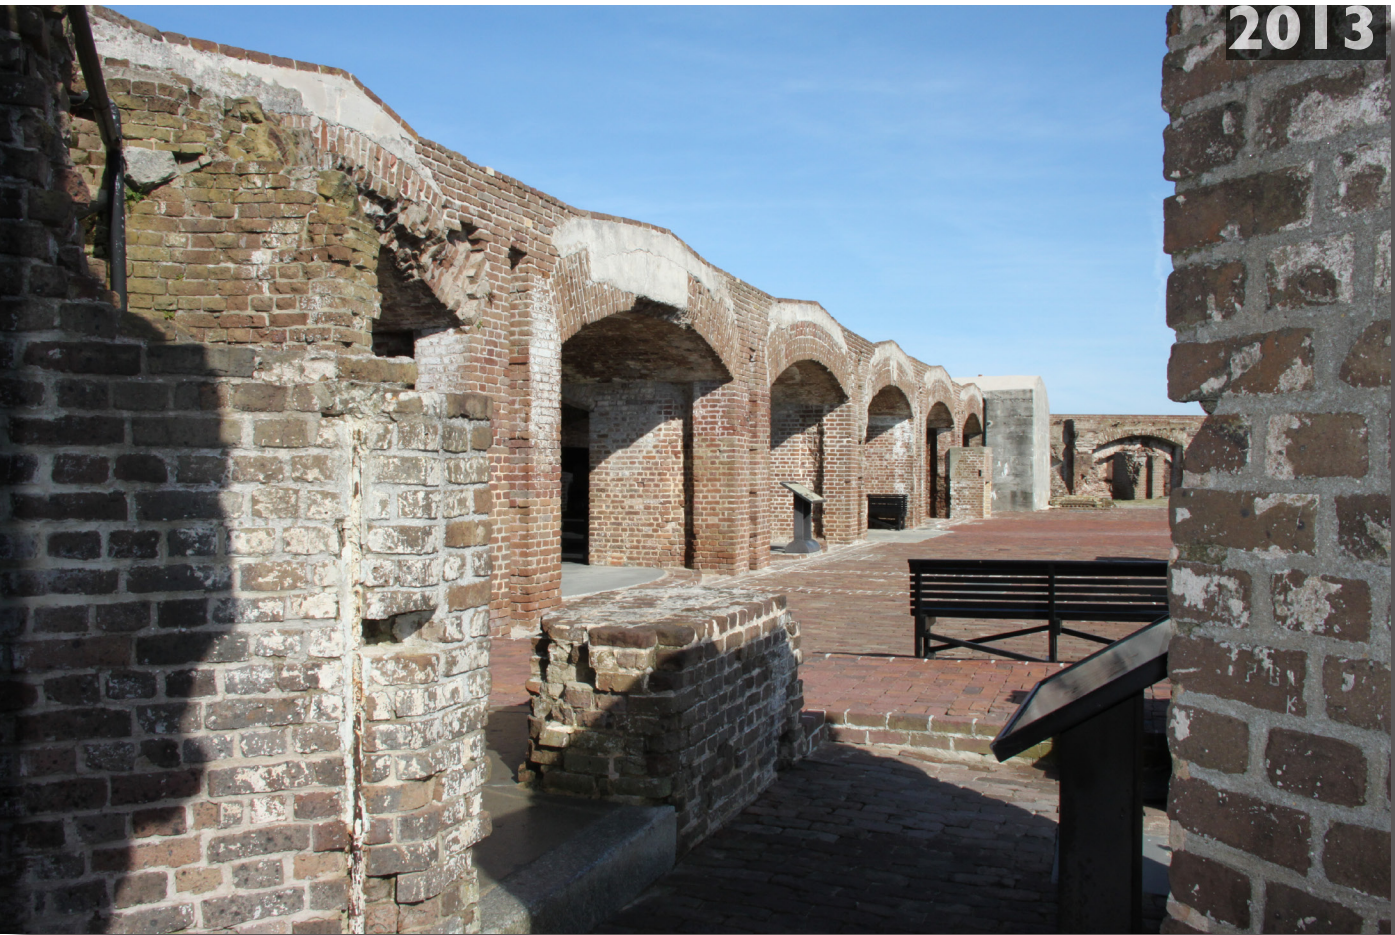
LOCATION

Left Flank Casemates, looking north from the Gorge Wall Archeological Ruins.
[Credit: Jack Boucher]

- The flooring at the rear of the Left Flank Casemates has been repaved.
- There has been an overall loss of white finishes on the brick masonry since 1963.

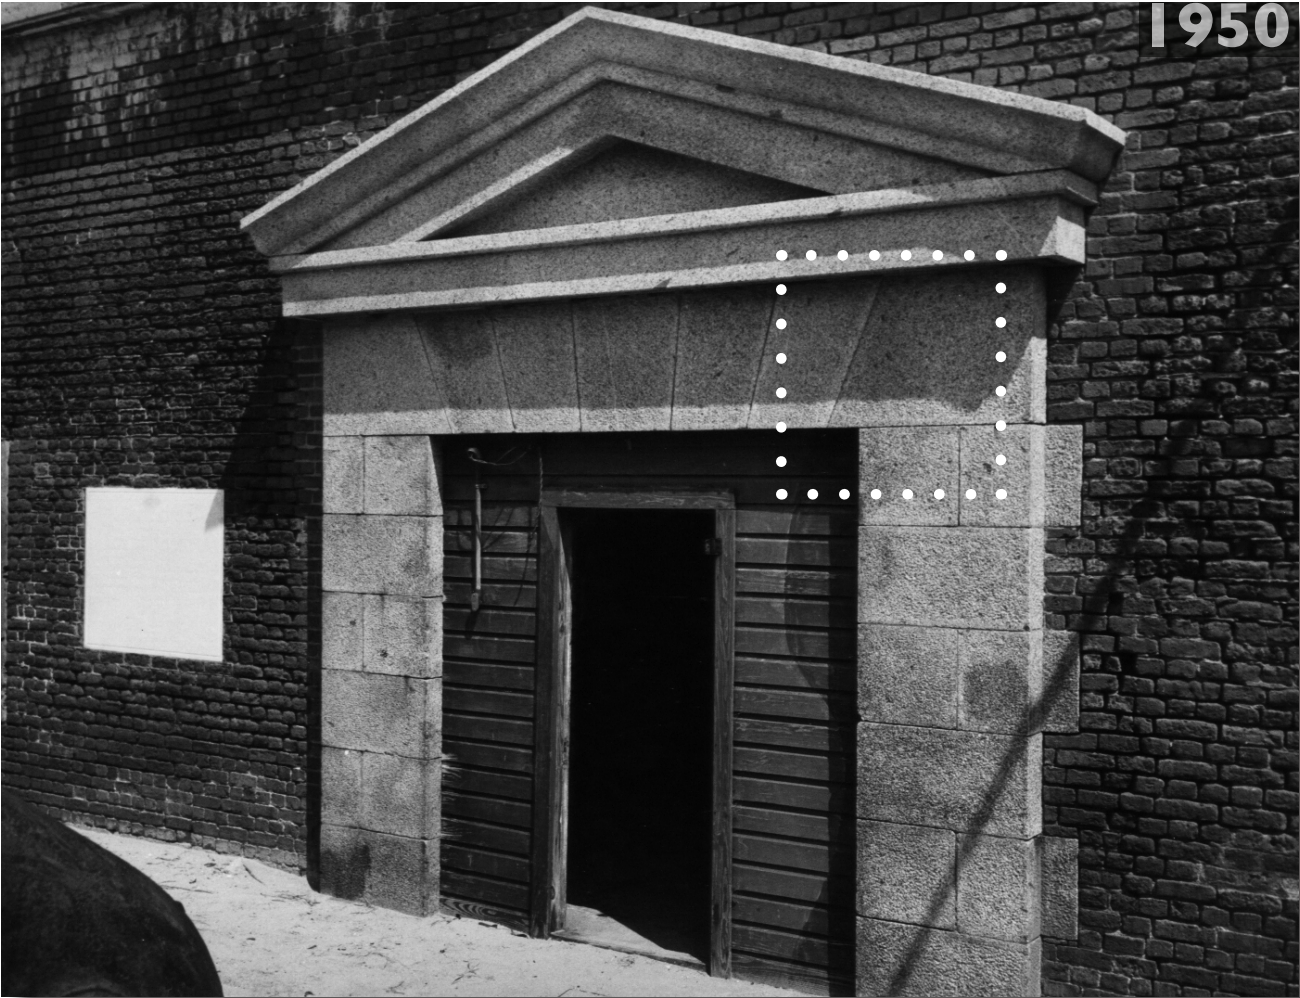
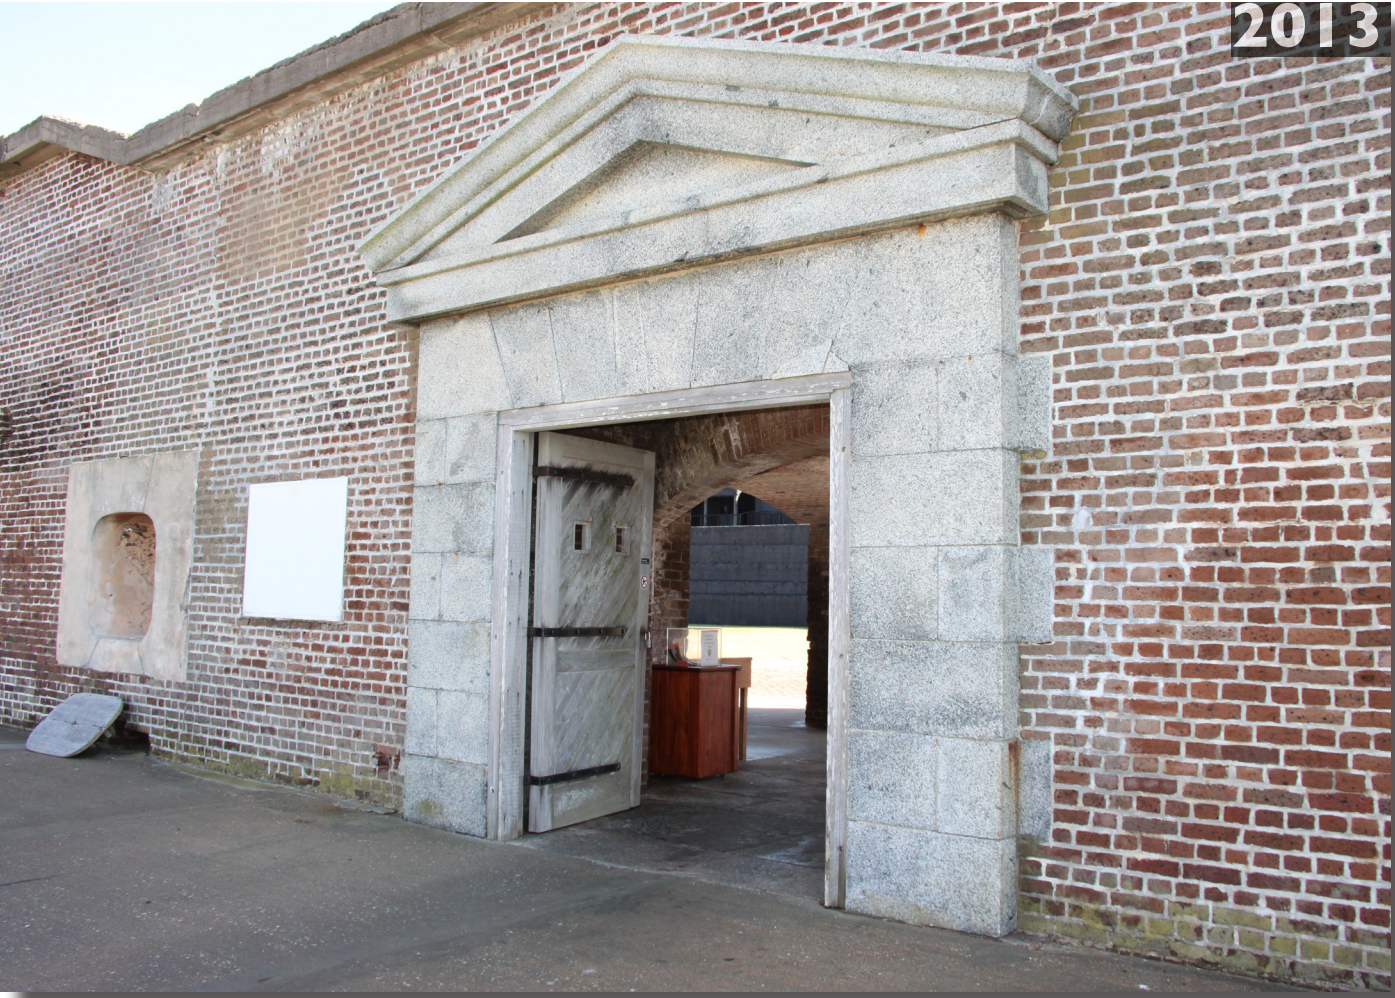
LOCATION

Left Flank Casemates, exterior Sallyport entrance. [Credit: Fort Sumter Archives]

- The single door entrance in 1950 was replaced with a two-door entrance that was meant to reproduce the appearance of the mid-nineteenth century sallyport door opening.
- A portion of the granite lintel (shown in the detail) has cracked and is about to spall.

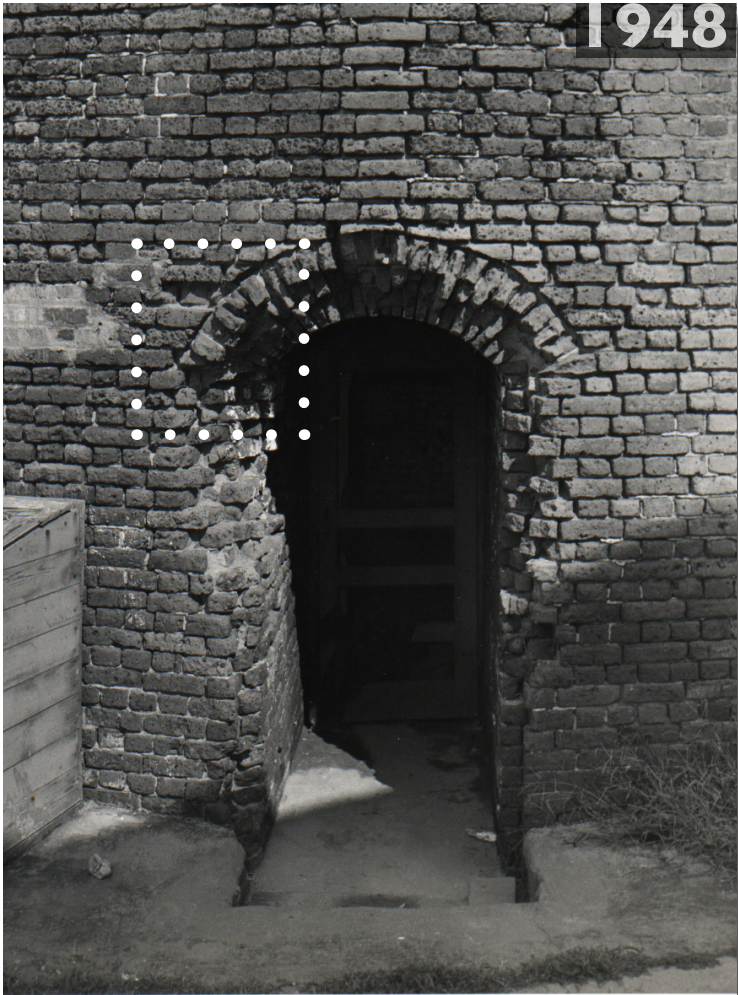
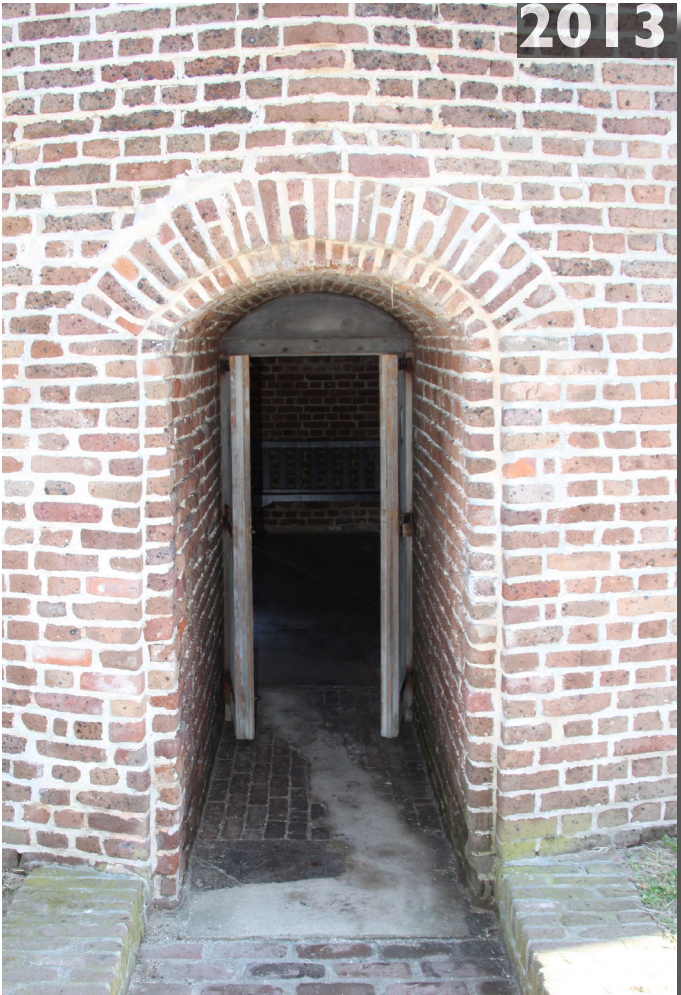
LOCATION

Left Flank Casemates, exterior southwest corner entrance. [Credit: Fort Sumter Archives]

- The brick masonry surrounding this door opening has been replaced and repointed since 1948.

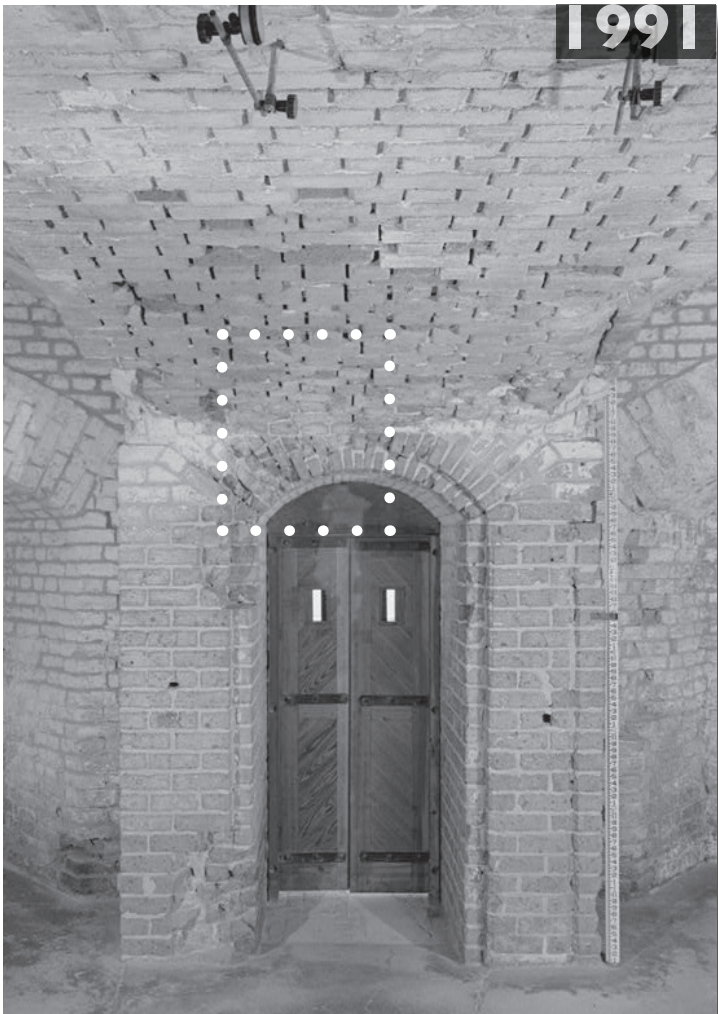
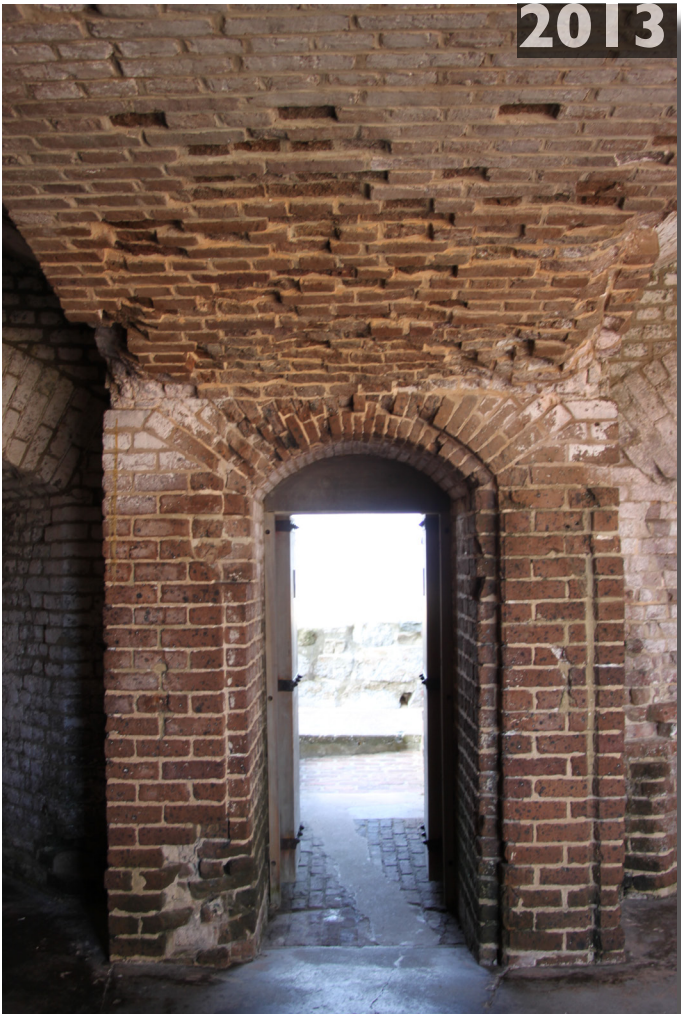
LOCATION

Left Flank Casemates, looking southwest from in the interior of the southwest corner door opening. [Credit: Historic American Buildings Survey]

- The brick surface appears to be consistent from 1991 to 2013.
- The door installation is also consistent.

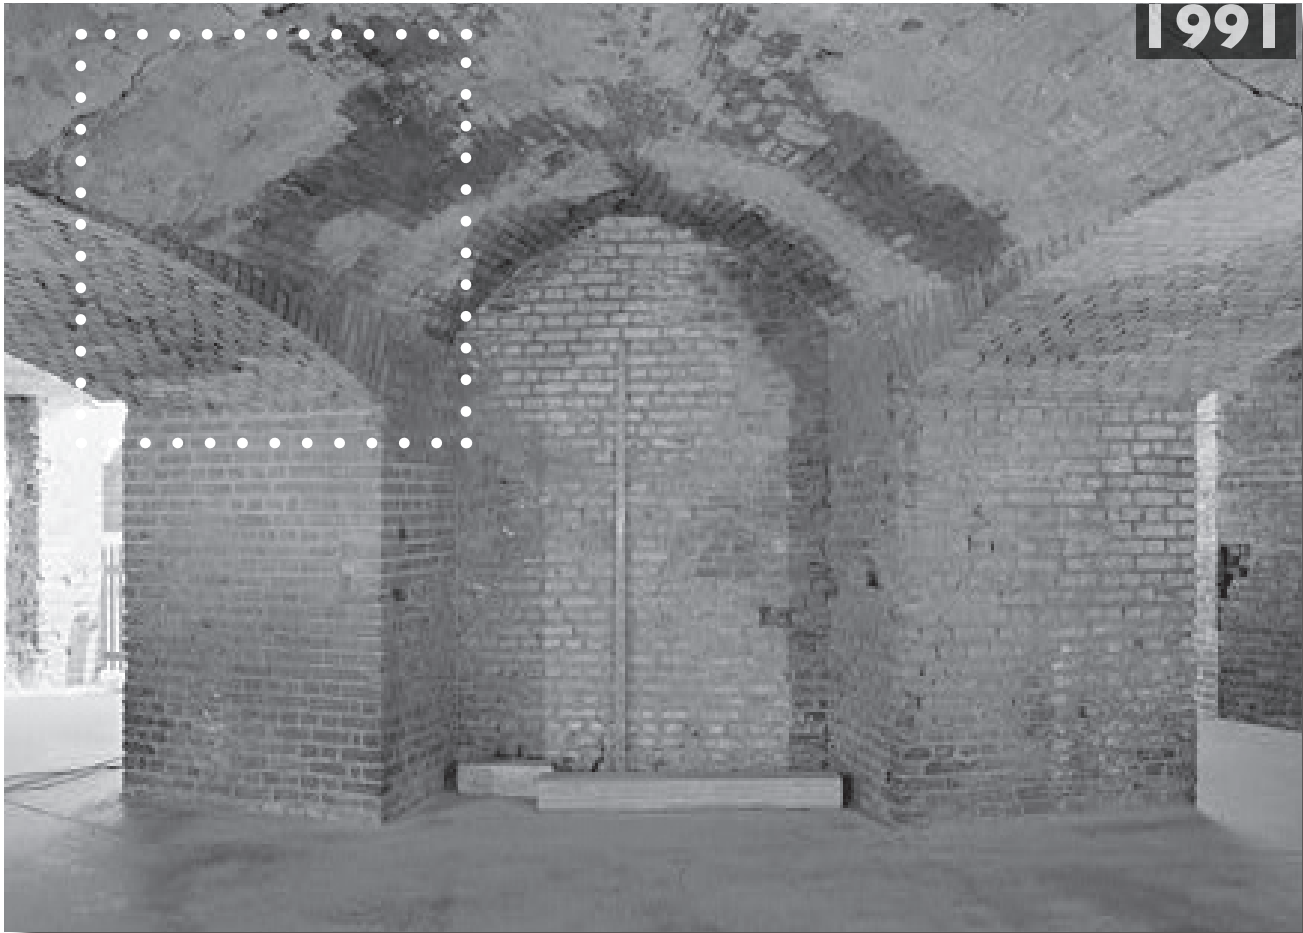
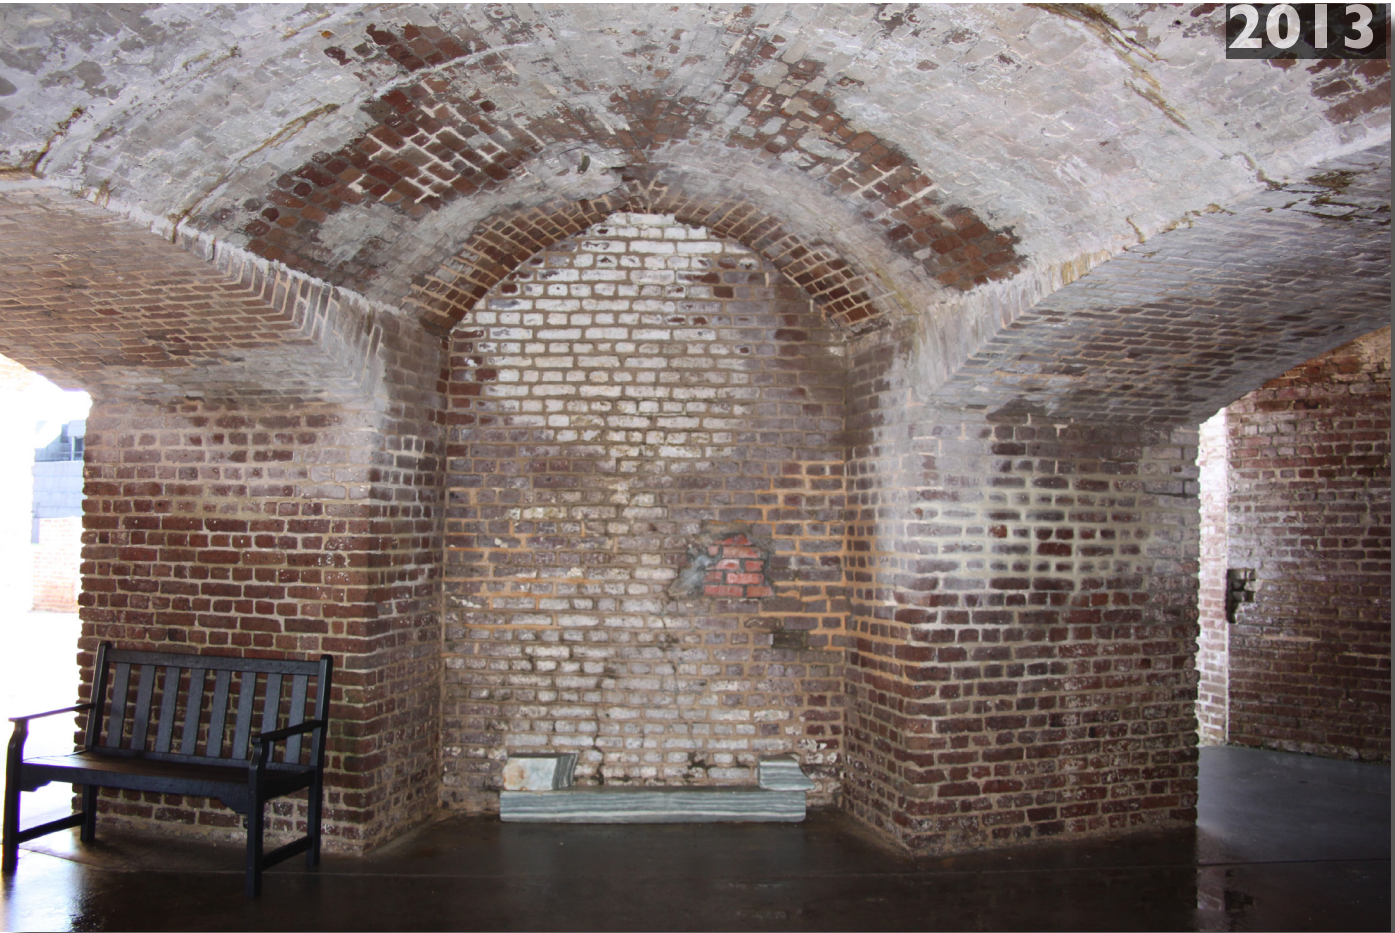
LOCATION

Left Flank Casemates, rear wall of Casemate C-2. [Credit: Historic American Buildings Survey]

- The cracks in the upper left and right corners present in 1991 appear to have been treated, as the cracks are no longer as prominent.

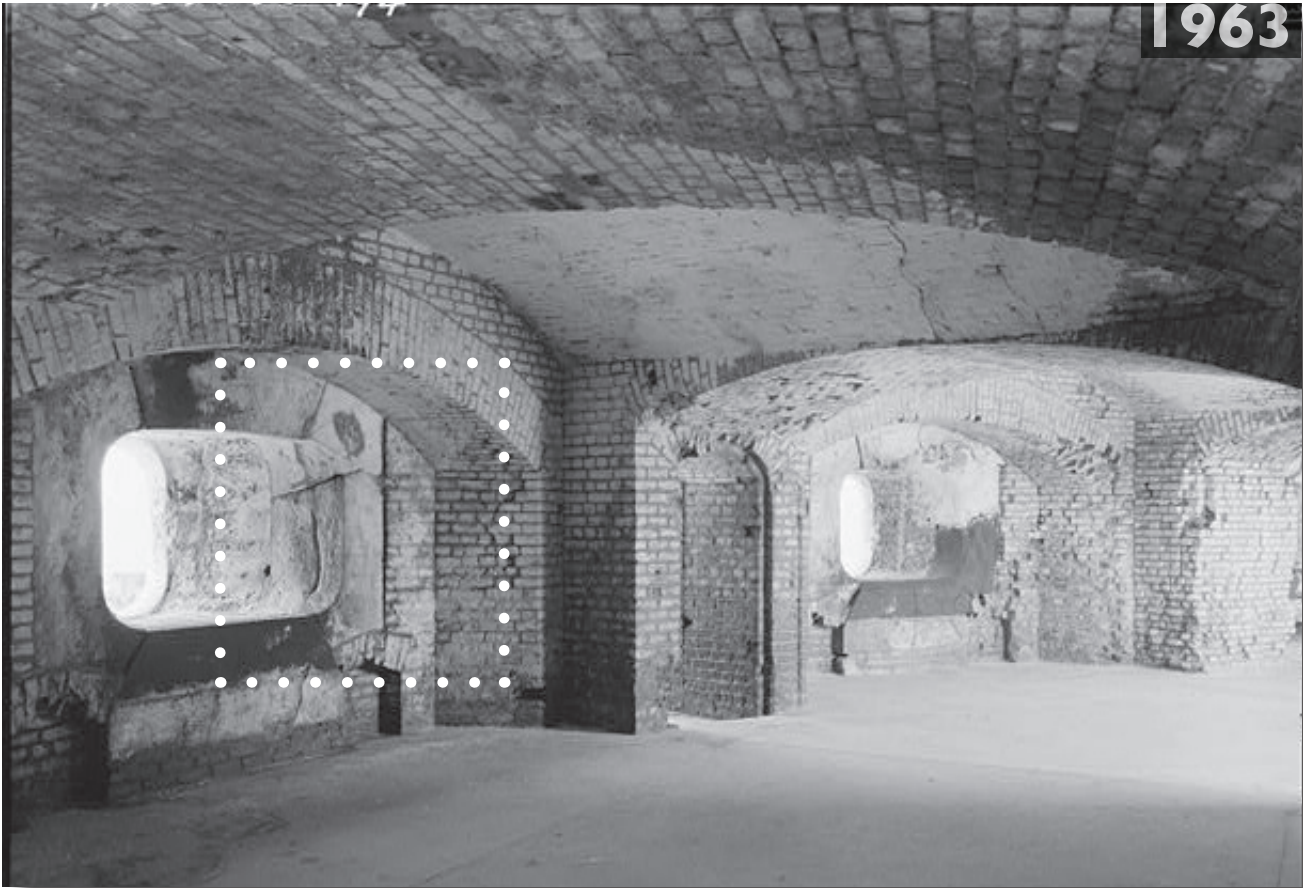
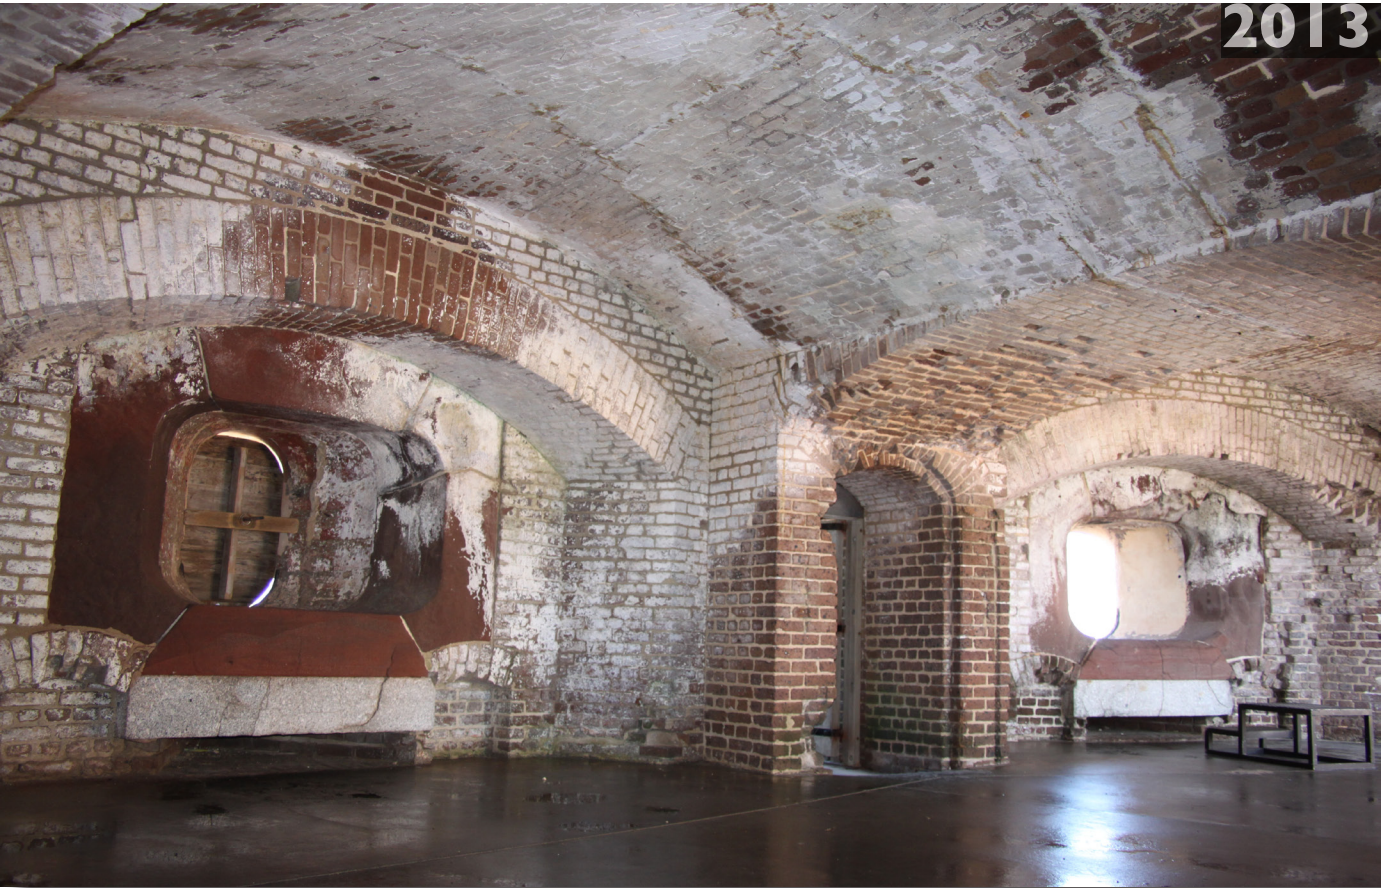
LOCATION

Left Flank Casemates, looking north with Casemate C2 in the forefront. [Credit: Jack Boucher]

- Many of the white finishes are no longer intact on the brick and brownstone masonry.
- The crack through the granite lintel in Casemate C2 was visible in 1963, though it appears the crack has since spread into the brownstone.

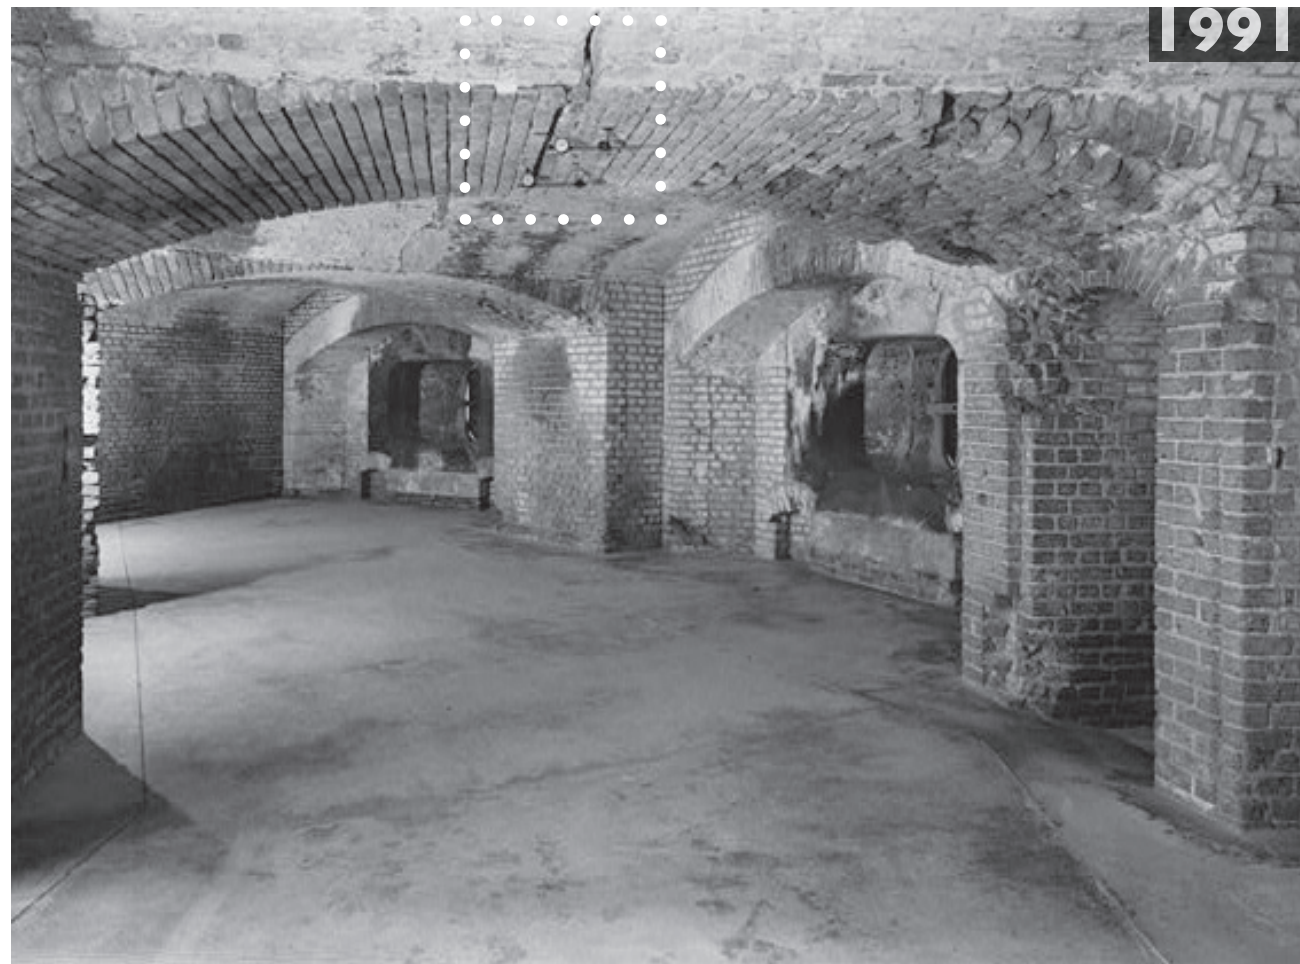
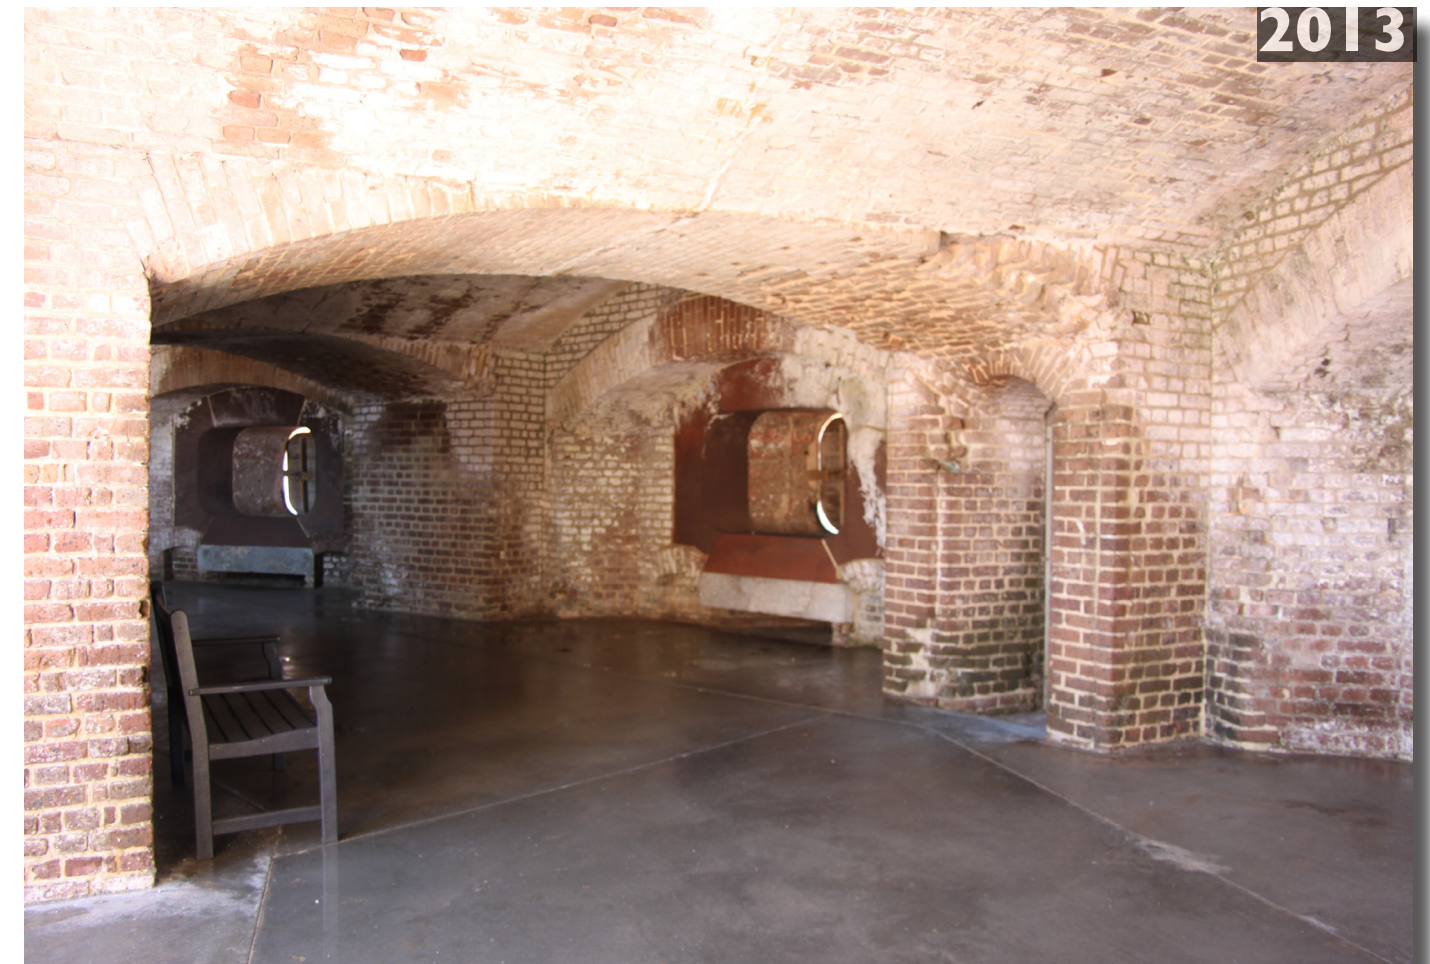
LOCATION

Left Flank Casemates, from Casemate B-I looking into Casemates C-2 and C-I. [Credit: Historic American Buildings Survey]

- The cracks in the ceiling have been treated since 1991, though the treatment repairs have since opened.
- Losses on the south corner of southwest corner doorway to the exterior have been filled with patching mortar.
- There has been loss of the white finishes on the brownstone embrasure.

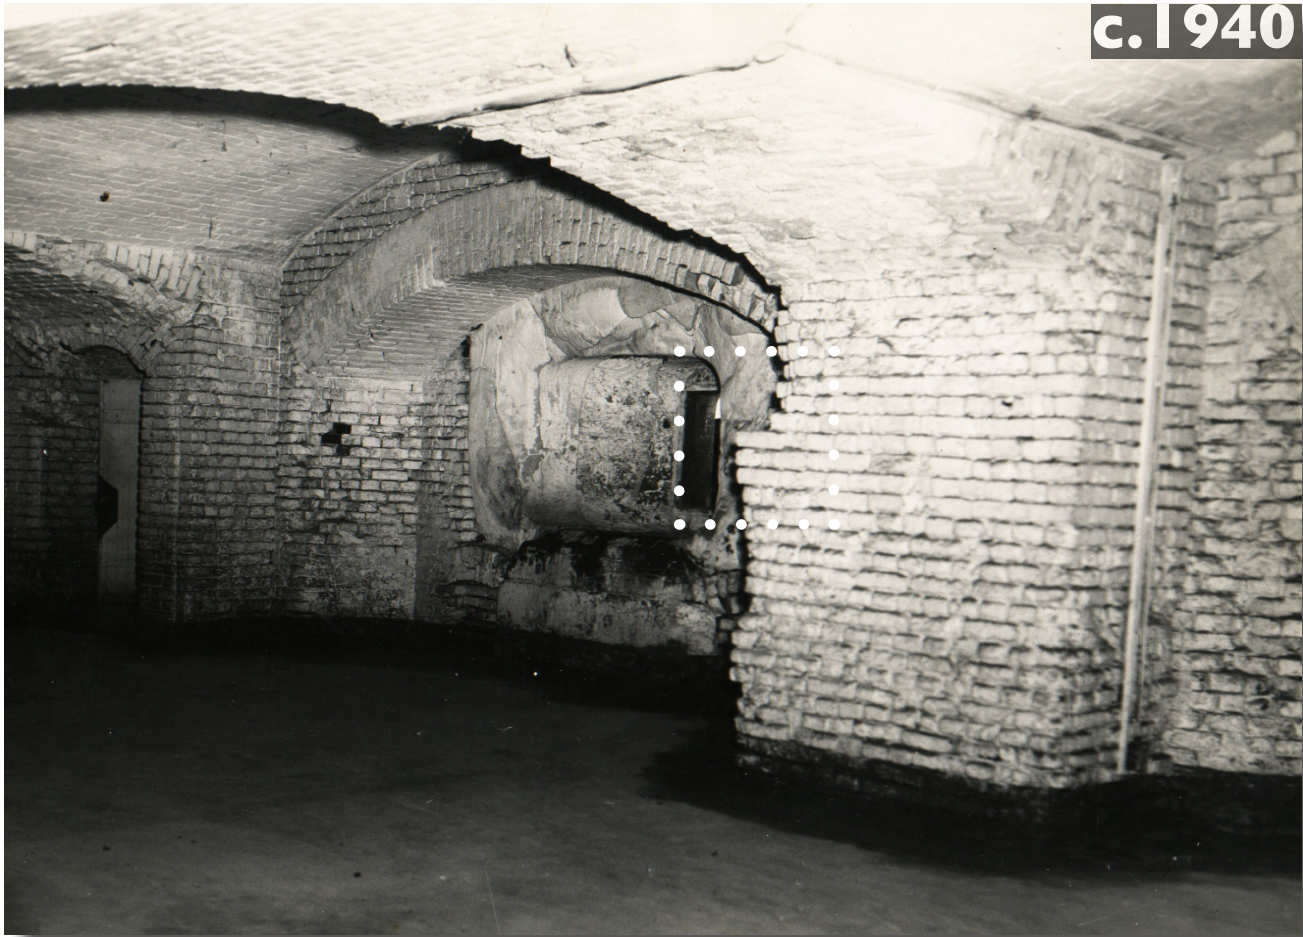
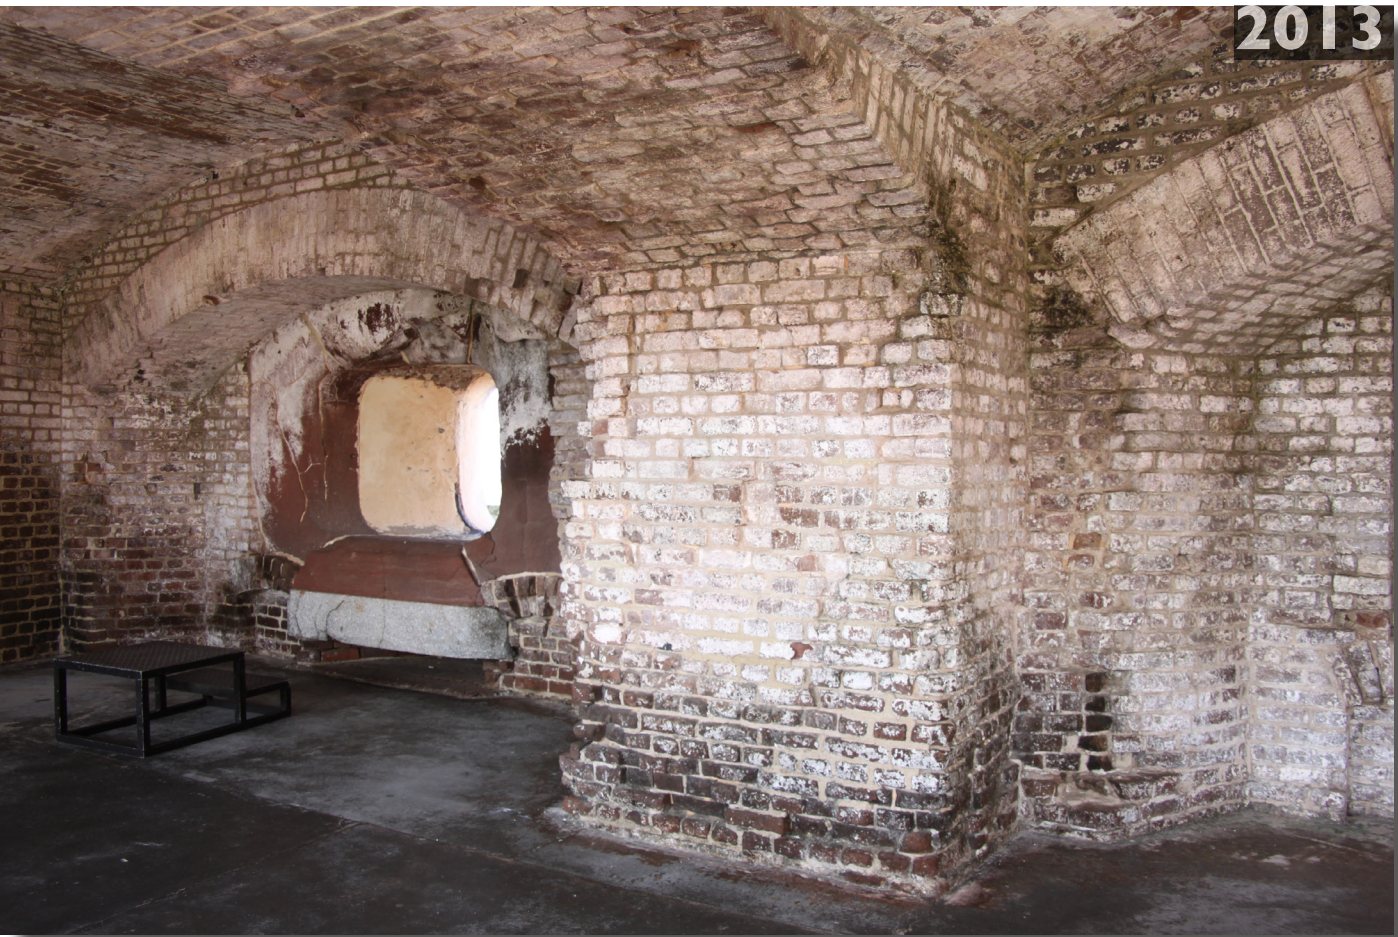
LOCATION

Left Flank Casemates, Casemate B1, c. 1940s [Credit: Fort Sumter Archives]

- There has been a loss of white finishes on the brick and brownstone masonry from the 1940s to 2013.
