Fort Sumter
Fort Sumter National Monument
Historic Structure Report

Volume II
APPENDICES A-F

2015

JOSEPH K. OPPERMANN – ARCHITECT, P.A.

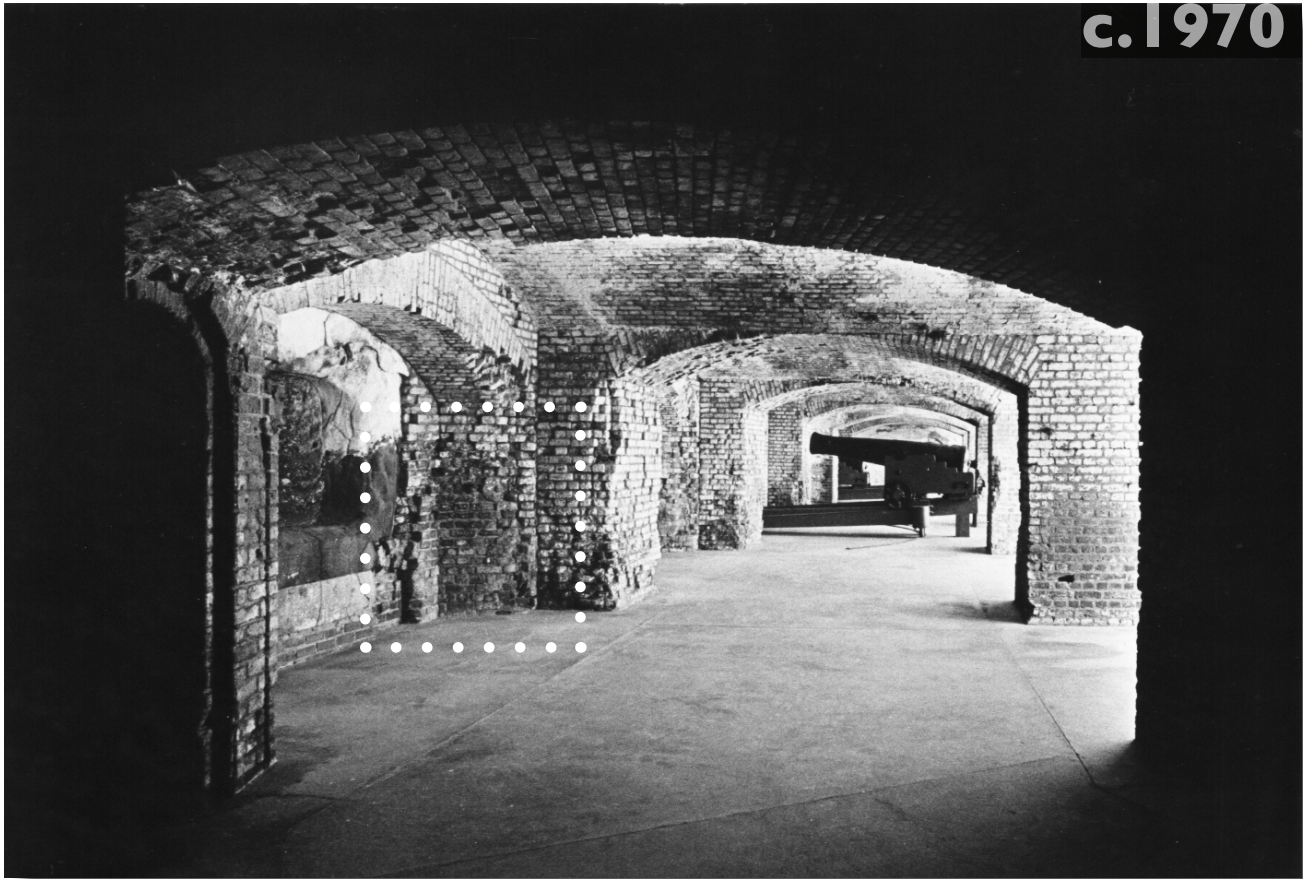
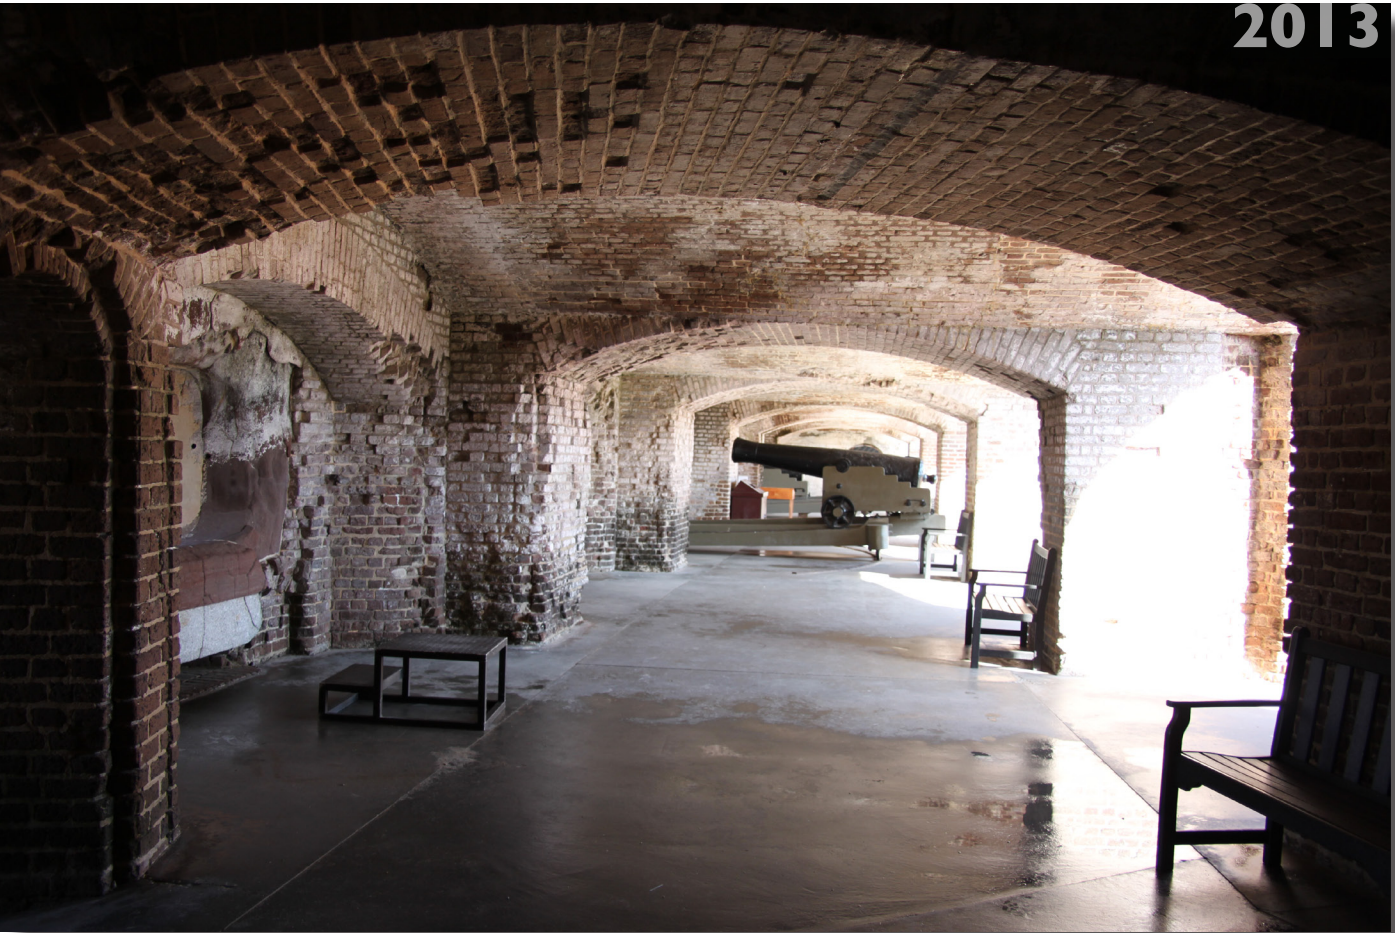
LOCATION

Left Flank Casemates, view from Casemate C2 looking north. [Credit: Fort Sumter Archives]

- There has been a loss of white finishes on the brick and brownstone masonry from the 1970s to 2013.
- The benches have been added since the 1970s.
- The temporary pedestal in Casemate B1 has been added for the park rangers, to add in the interpretation of the site.

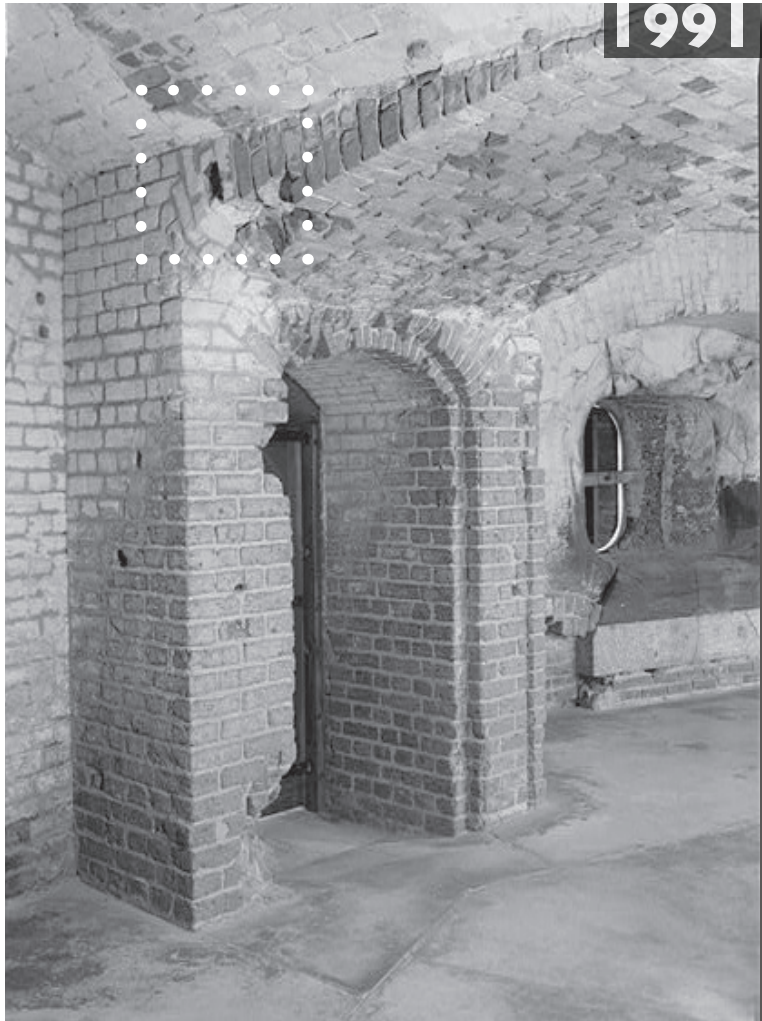
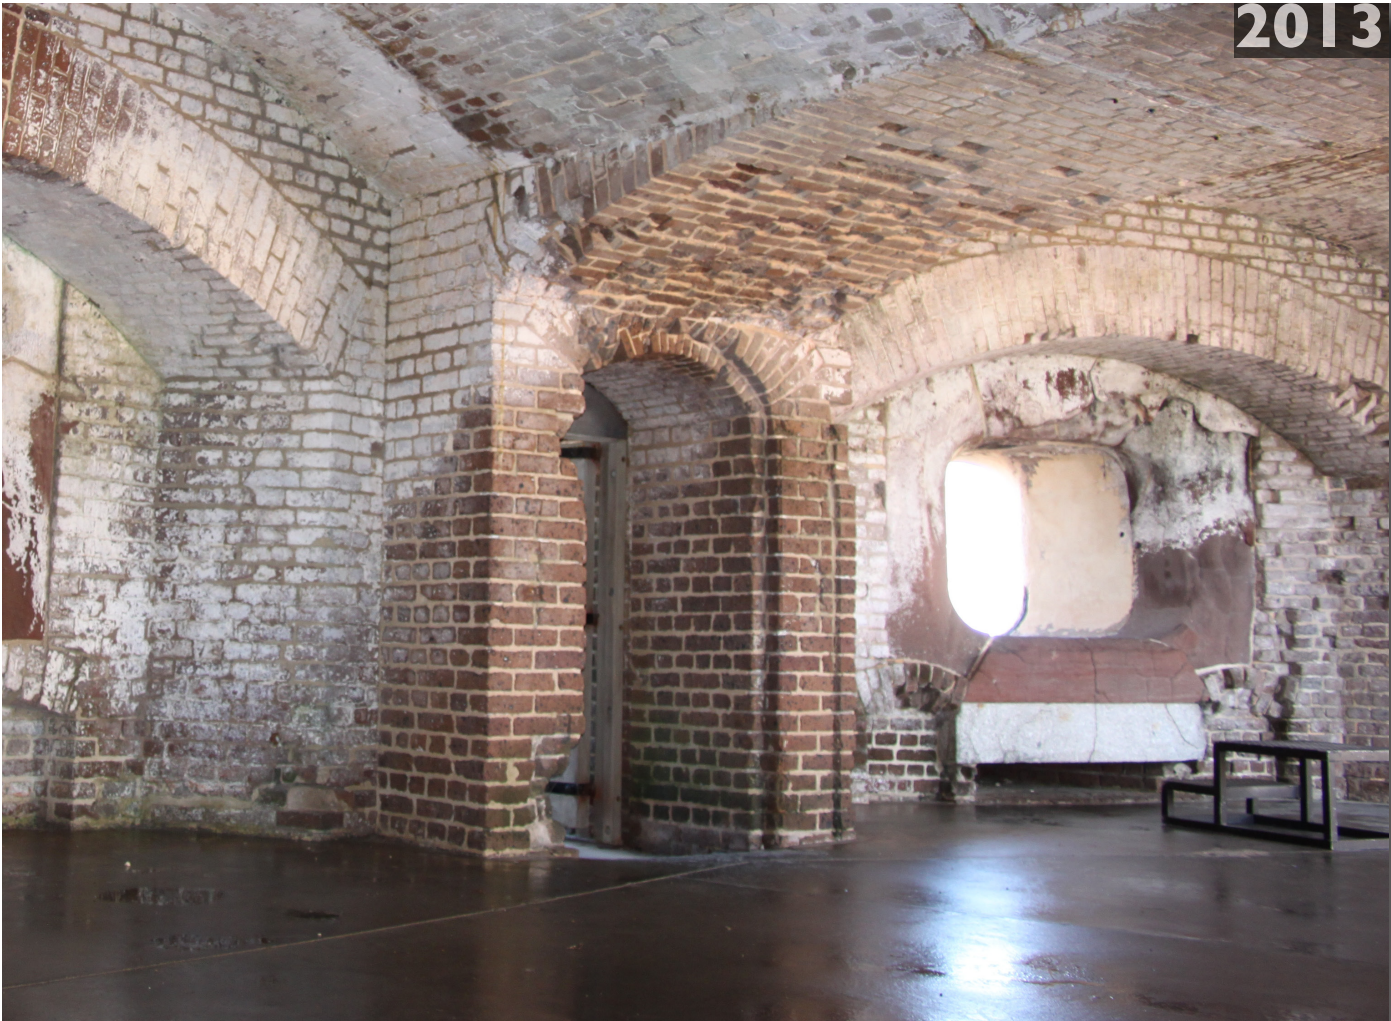
LOCATION

Left Flank Casemates, from Casemate C2 into Passage of B1, located in the Southwest Quadrant.
[Credit: Historic American Buildings Survey]

- The brick loss on the underside of the separation arch appears consistent from 1991 to 2013, with continued erosion of the brick's surface.

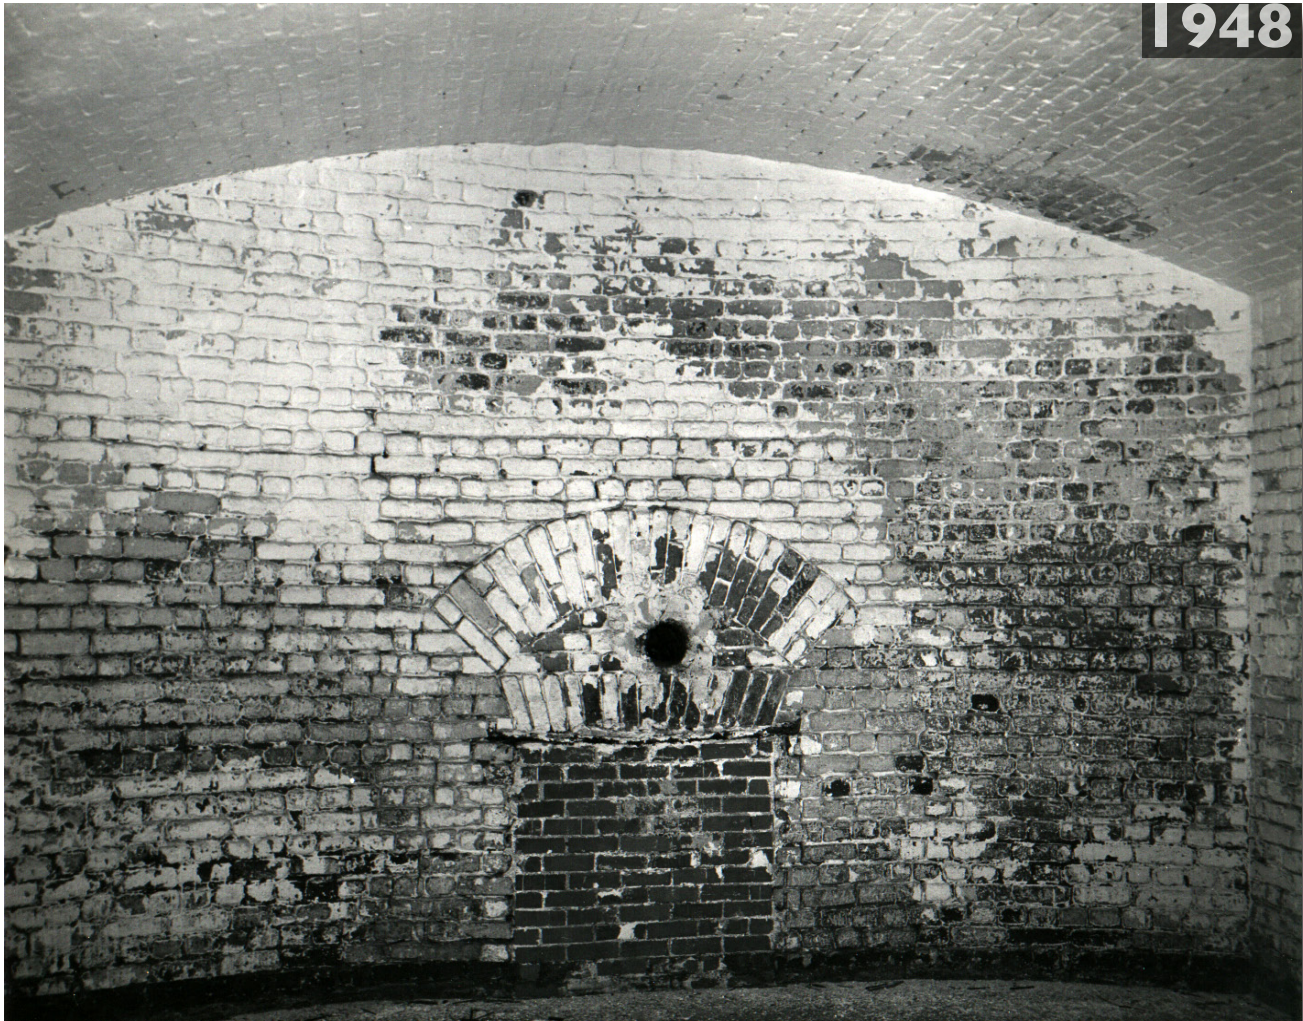
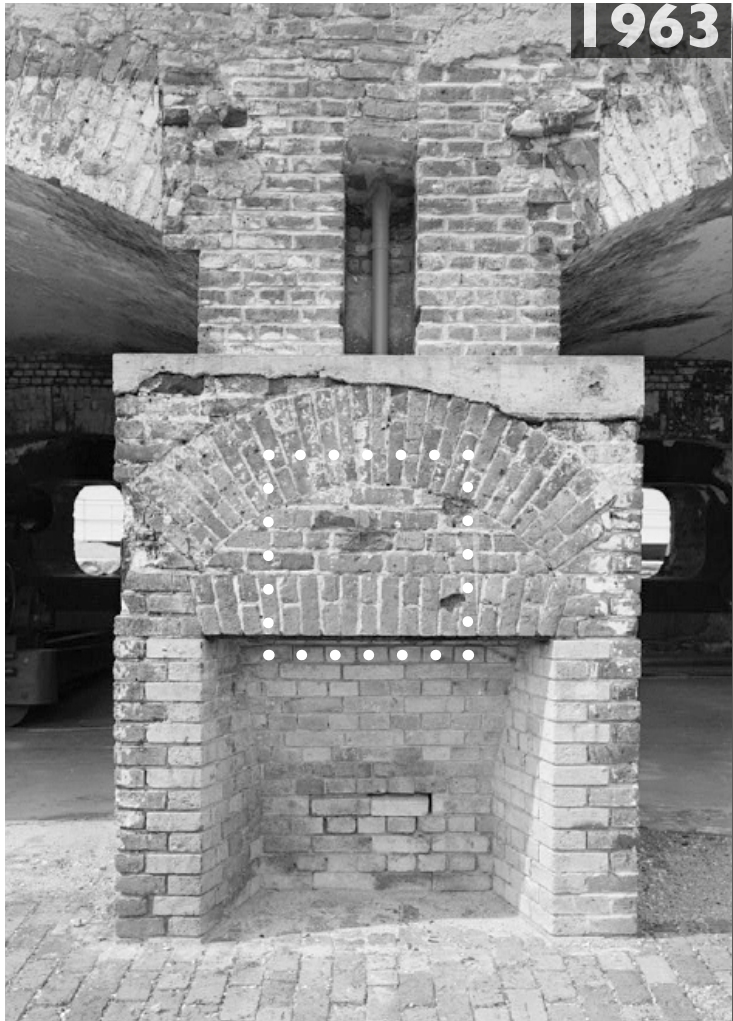
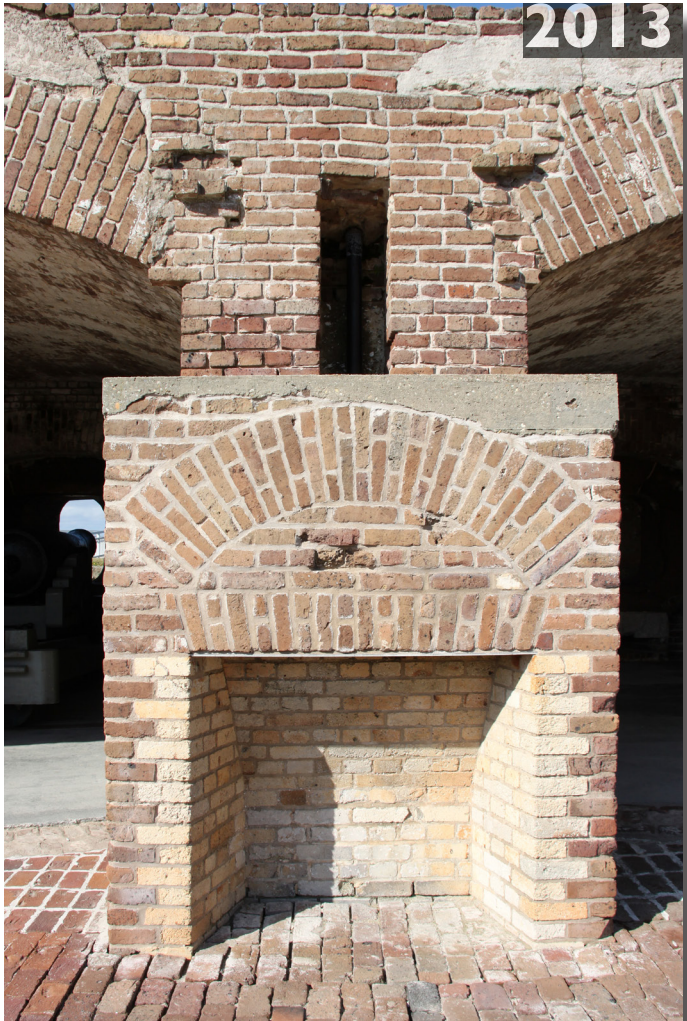
LOCATION

Left Flank Casemates, Left: The rear east wall of Casemate A5, in the Enlisted Men's Barracks [Credit: Fort Sumter] Middle: The fireplace installation at the rear parade ground pier between Casemates A4 and A5. [Credit: Jack Boucher]

- The fireplace was originally installed in the rear wall of Casemate A5, when the area was used as the Enlisted Men's Barracks. When the wall was demolished, the fireplace was re-installed at the rear parade ground pier between Casemates A4 and A5.
- The fireplace and surrounding masonry has lost a significant amount of white finishes from 1963 to 2013.

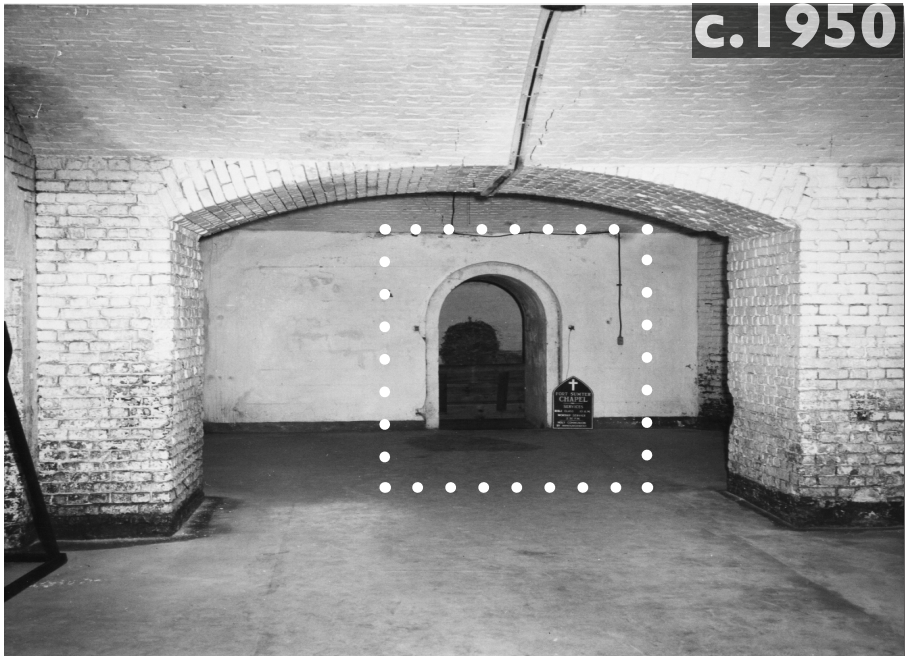
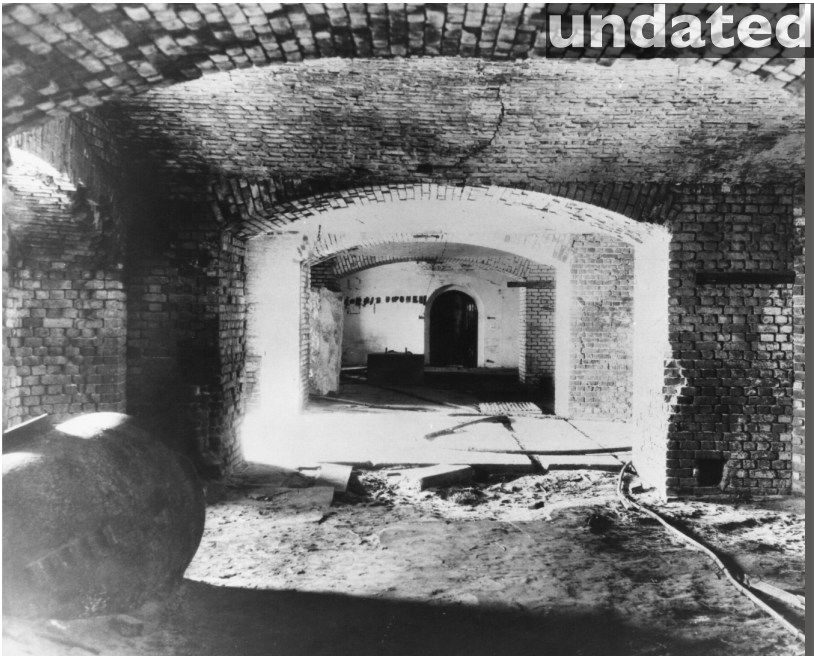
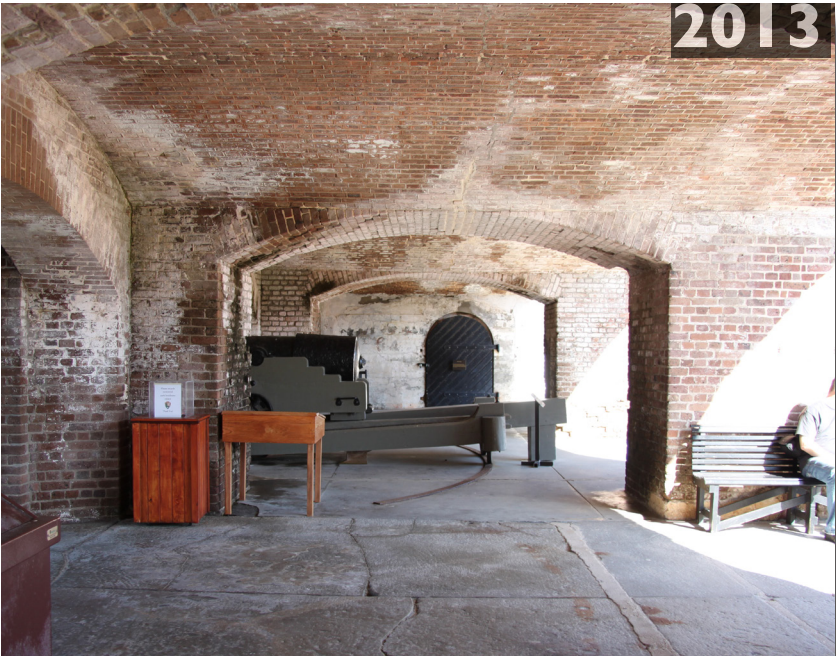
LOCATION

Left Flank Casemates, looking towards Mining Casemate (A6). [Credit: Fort Sumter Archives]

- A door was not installed on the opening to Casemate A6 in the left flank in c. 1950, and two different doors have been installed since that date.
- Fragments of the “undated” paint scheme are still intact on the north wall of Casemate A5, to the left of the door opening.
- The ceiling strip used for the installation of utilities in c. 1950 was later removed and replaced by an underground trench dug in Casemate A3, shown in the “undated” photo and currently visible as the vertical patch in the flooring of Casemate A3.

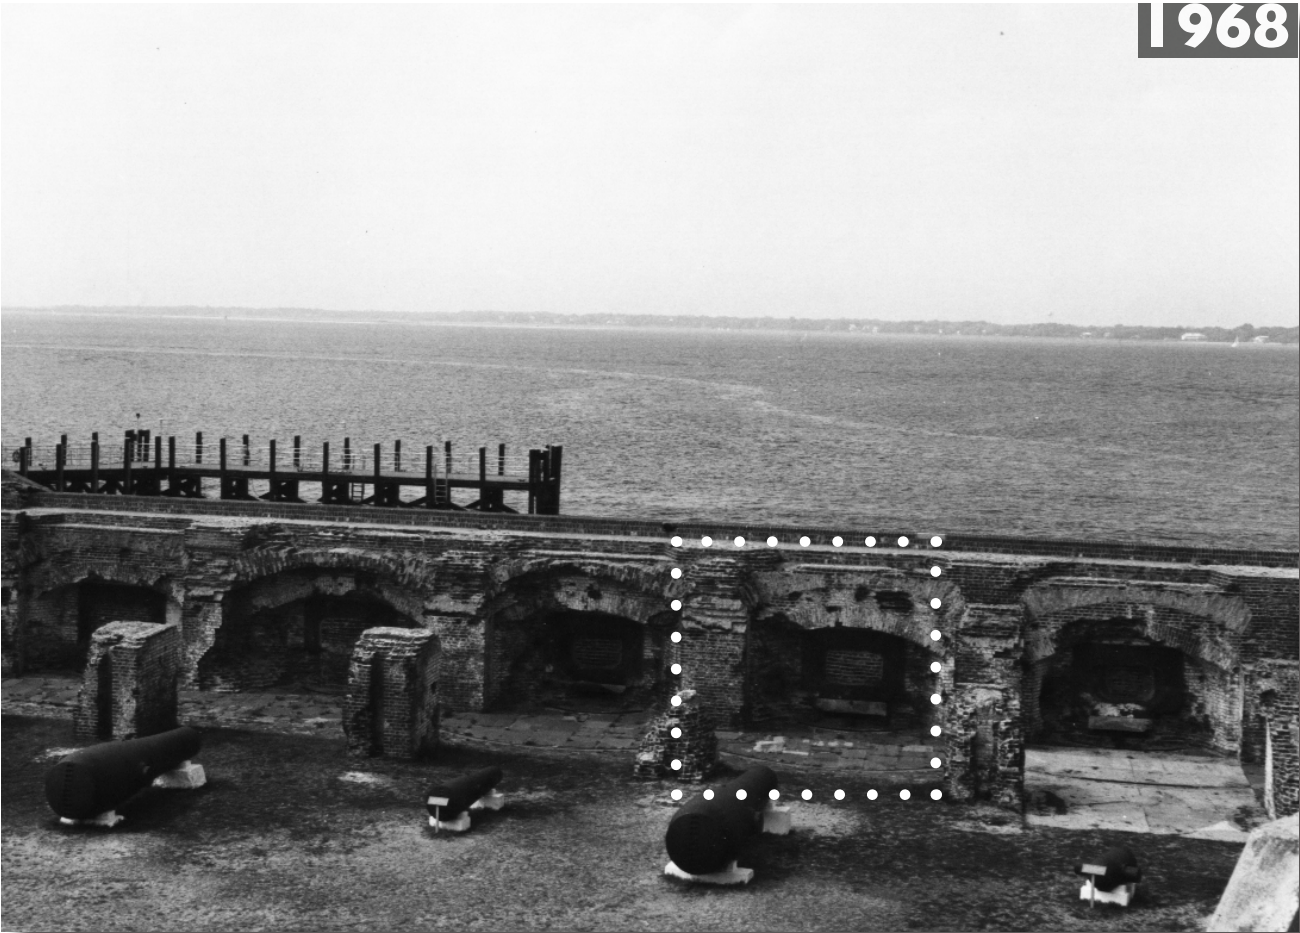
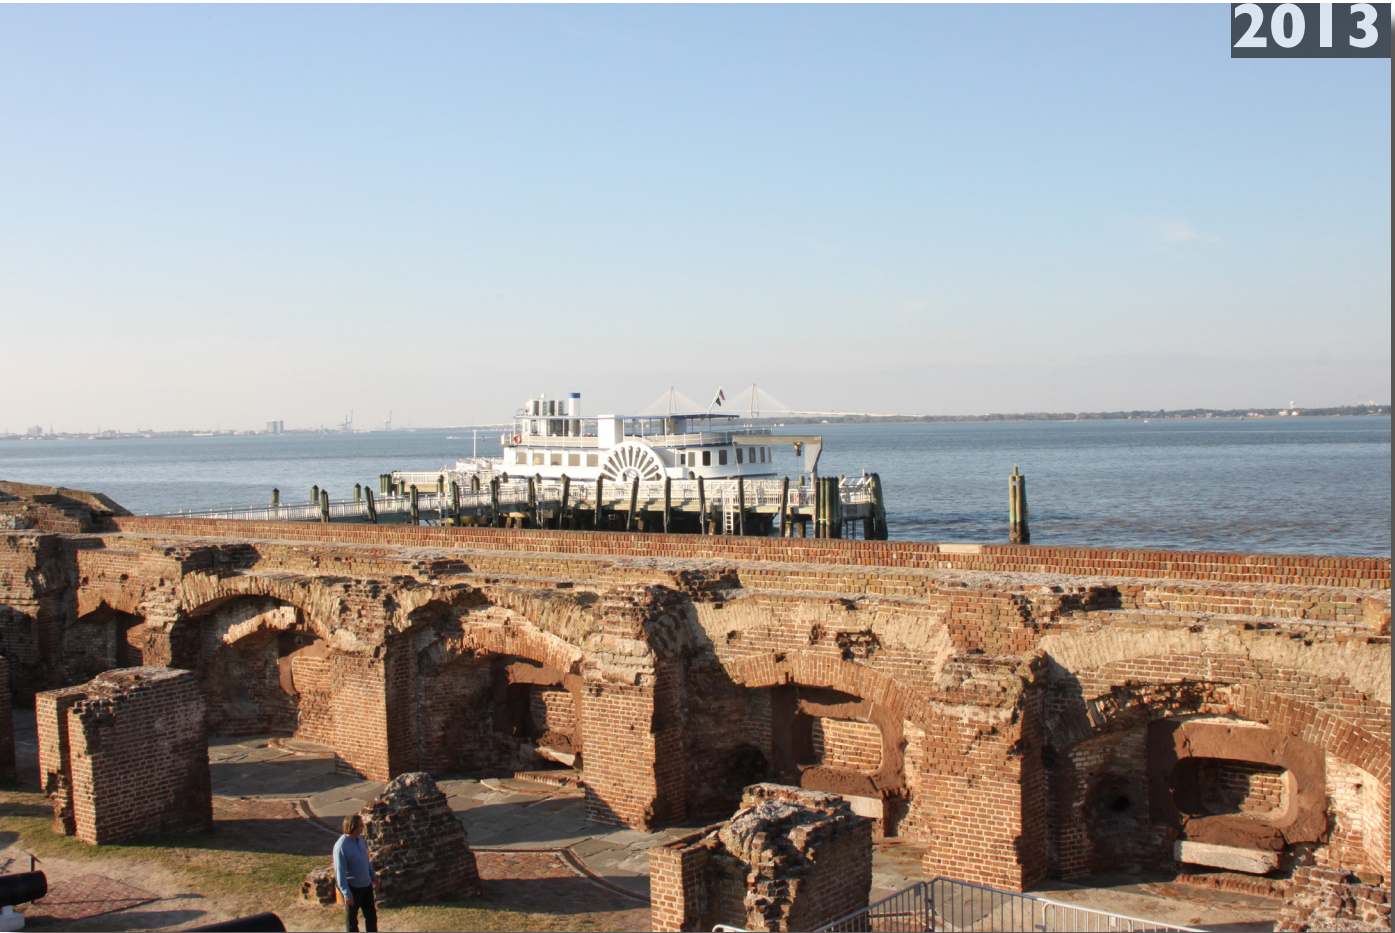
Left Face Casemates, with Casemate A10 (noted by its granite paving) visible at the far right. [Credit: Fort Sumter Archives]

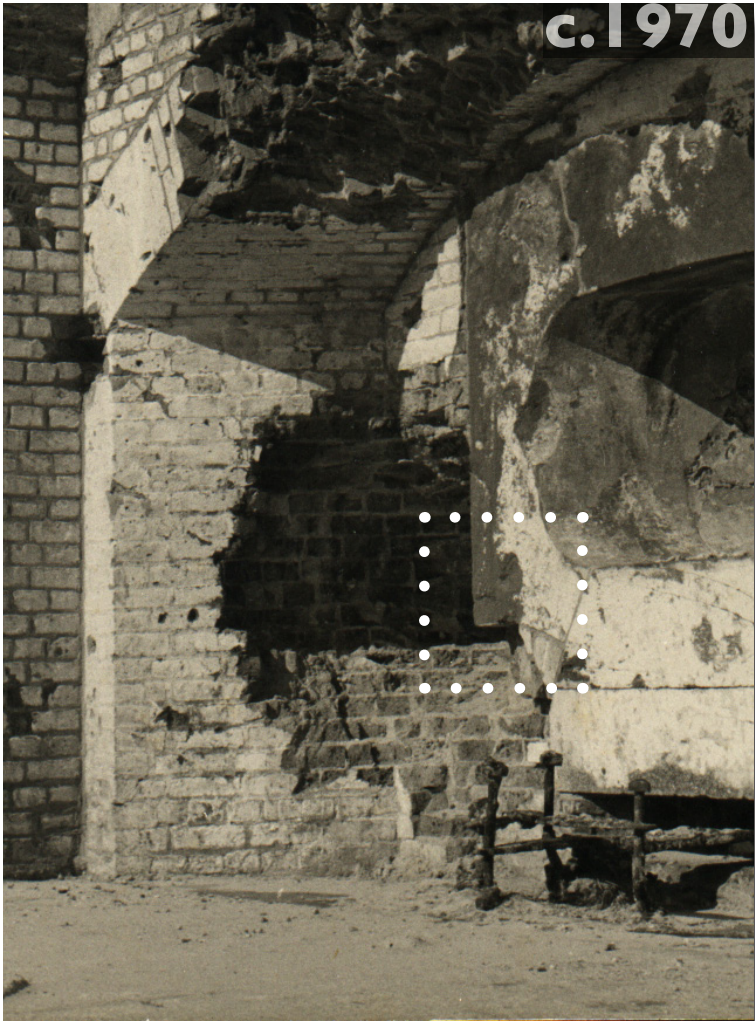
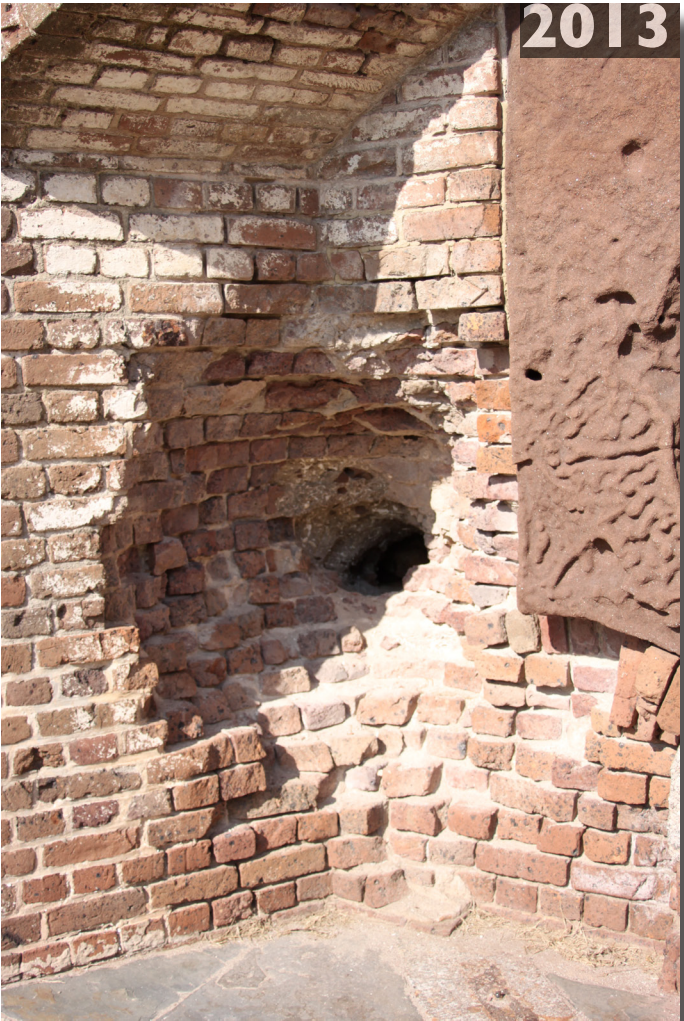
Left Face Casemates, western angled wall of Casemate A10. [Credit: Fort Sumter Archives]

- There has been a loss of white finishes on the brick and brownstone masonry from 1991 to 2013.
- The previously installed metal elements (in the lower right portion of the photograph from c. 1970) are no longer extant.

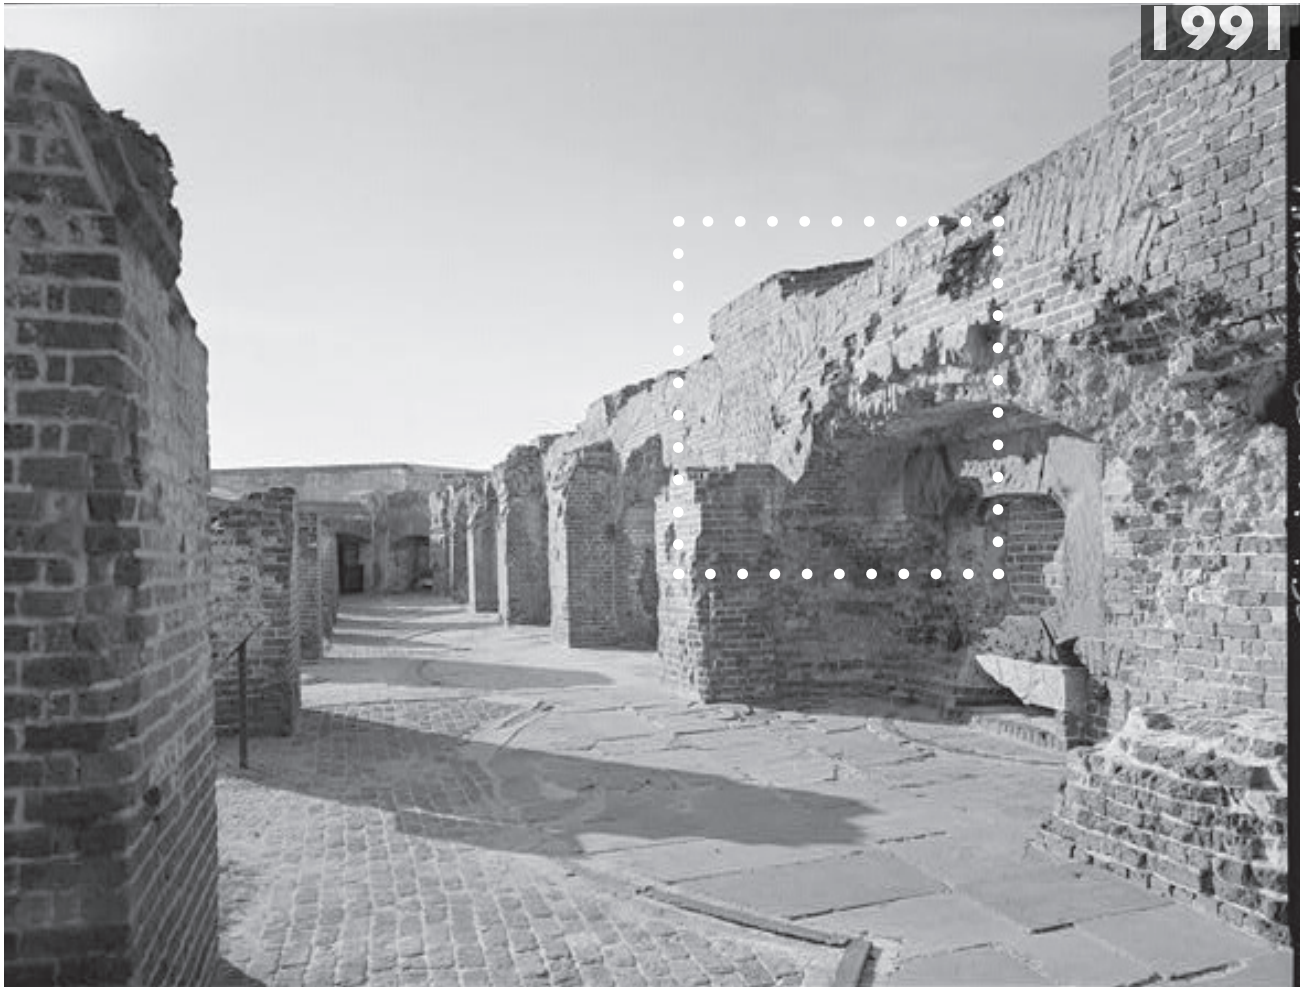
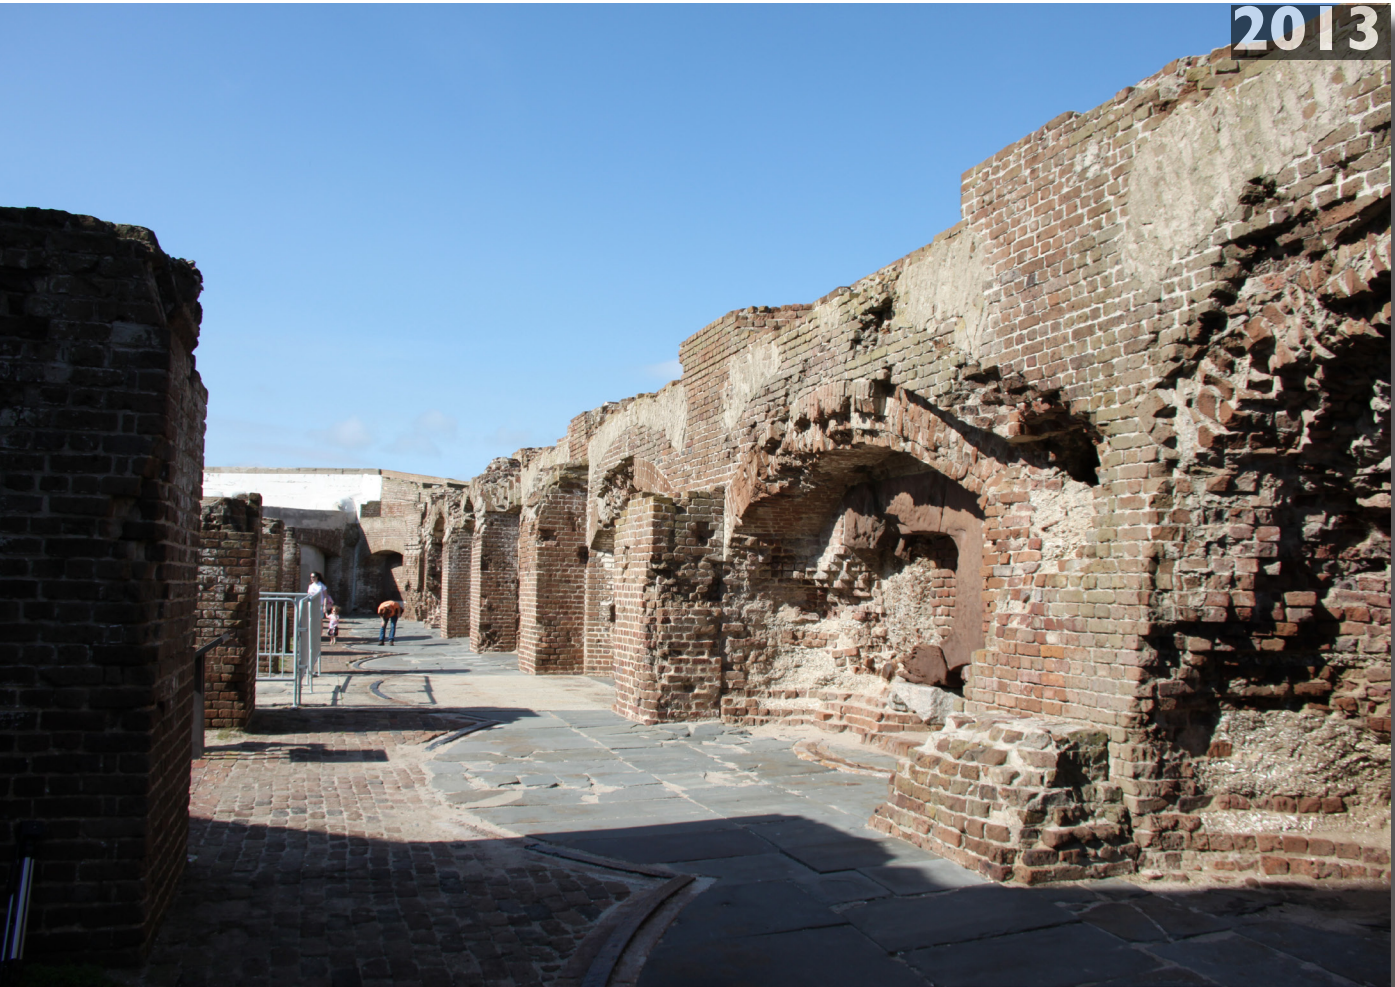
Left Face Casemates, looking down the corridor from Casemate A-9 through to C-3. [Credit: Historic American Buildings Survey]

- Many of the mortar joints have deteriorated significantly since 1991.

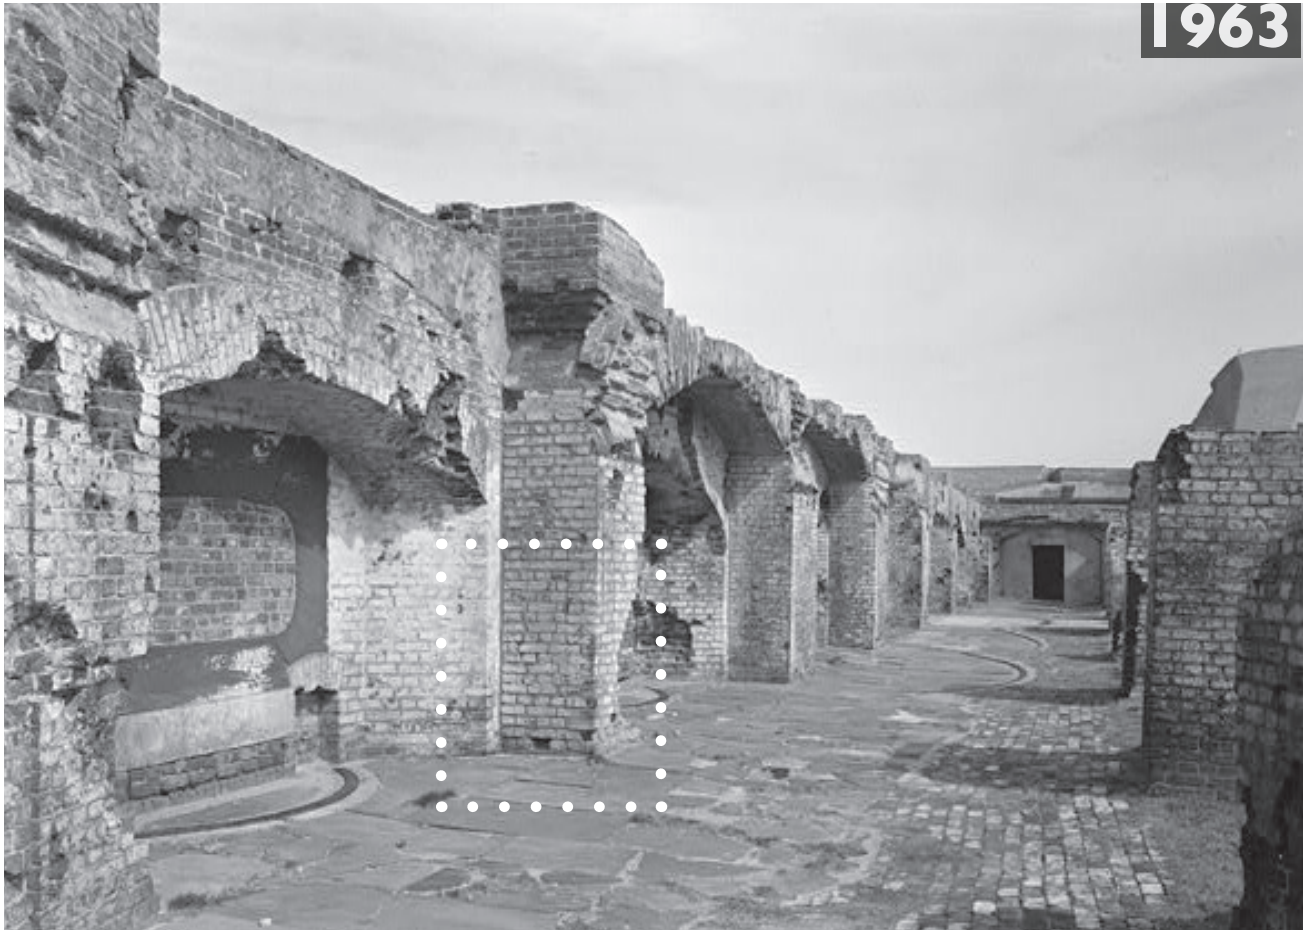
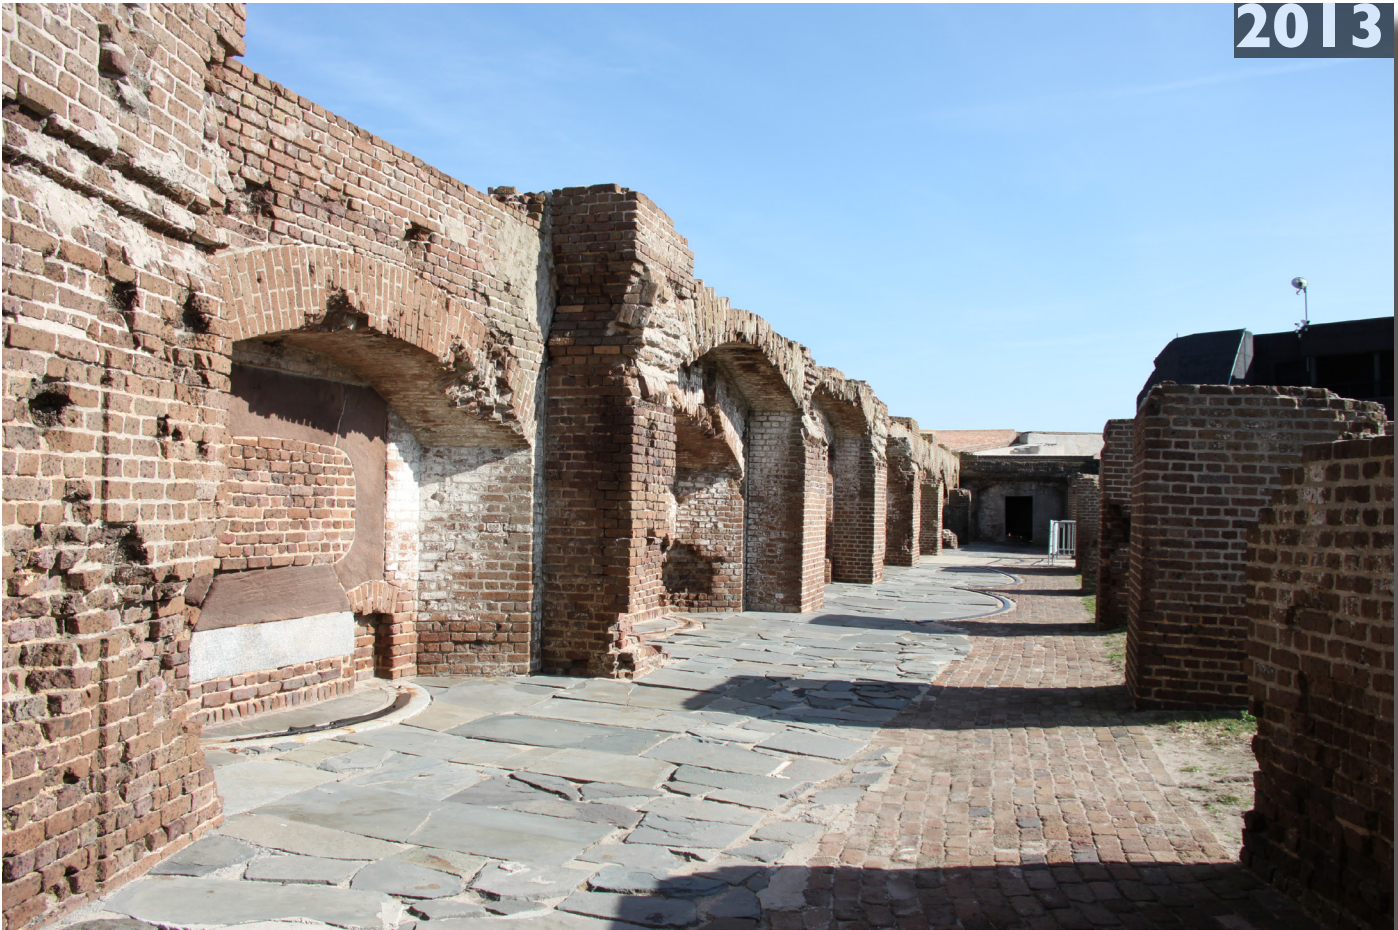
Left Face Casemates, looking towards the Salient Angle. [Credit: Jack Boucher]

- Many of the white finishes on the brick masonry and brownstone are no longer intact.
- The pavement appears consistent from 1963 to 1991.

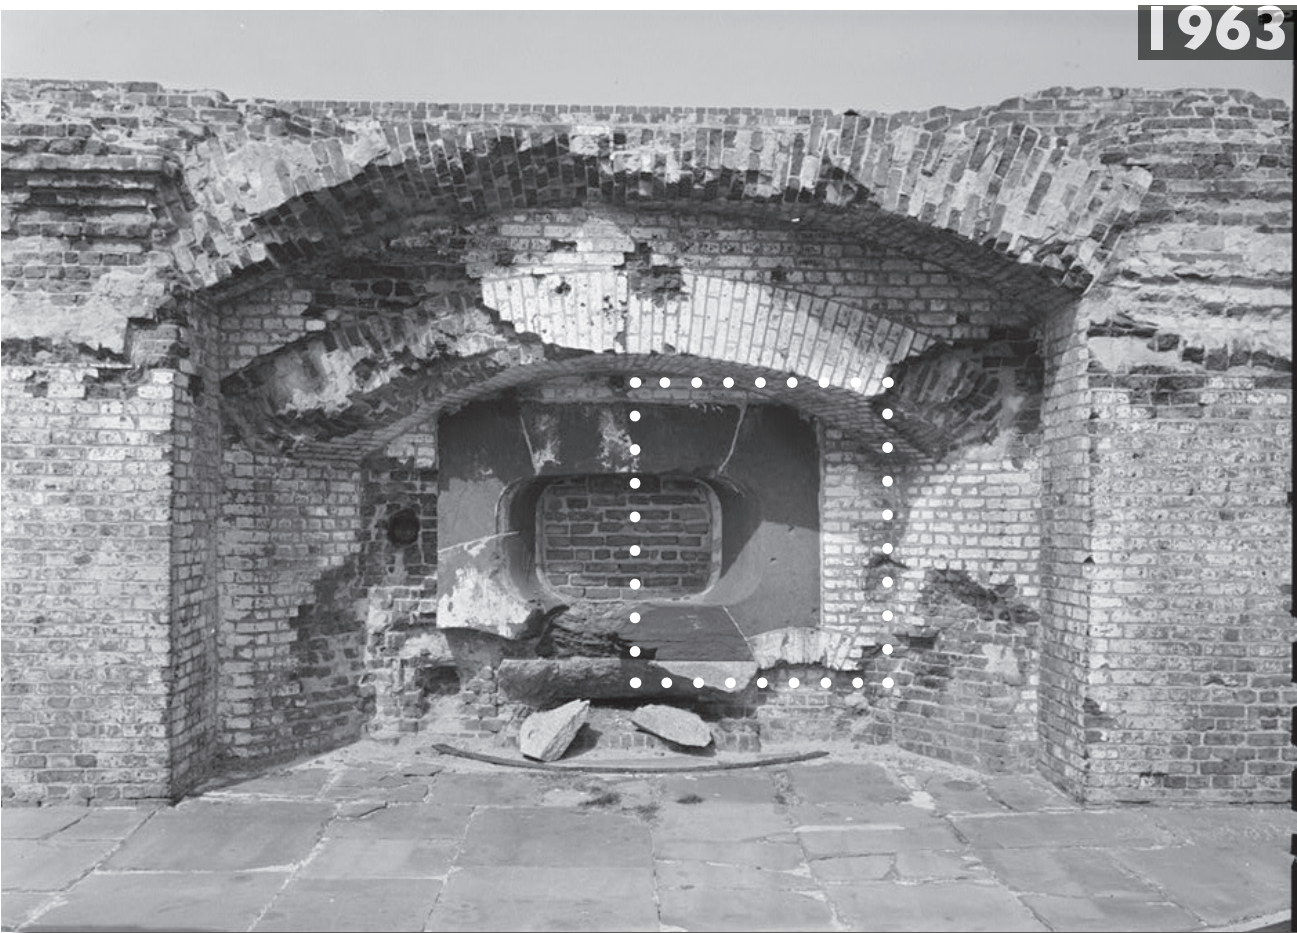
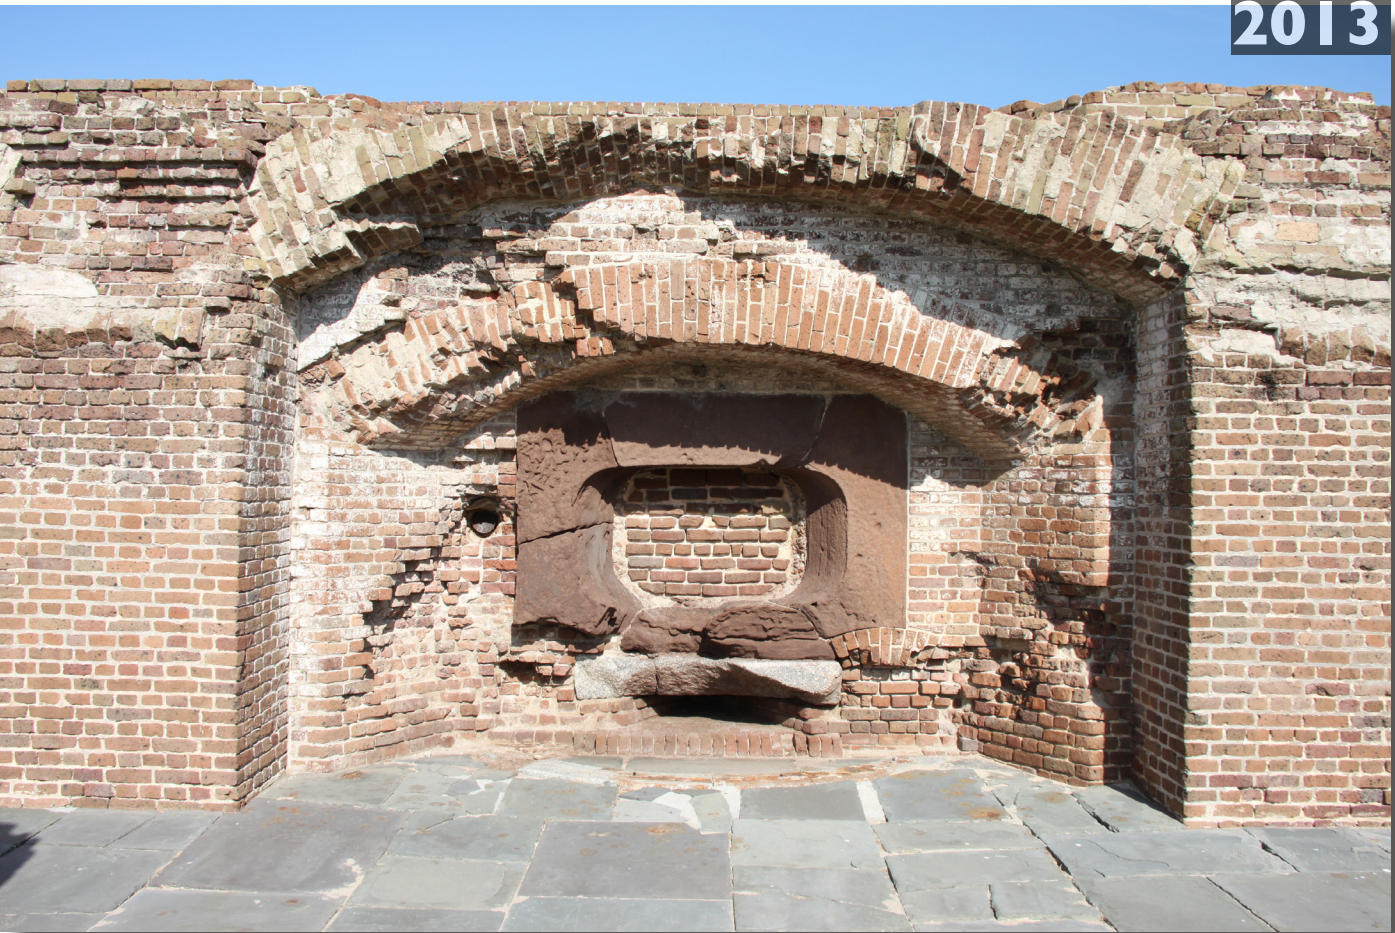
Left Face Casemates, the north wall of Casemate A8 [Credit: Jack Boucher]

- The inner canon traverse track has been removed since 1968.
- The surface of the brownstone has deteriorated significantly since 1968, fracturing in many places, with visible alveolar erosion throughout its surface.
- Many of the white finishes on the brick masonry and brownstone are no longer intact.
