Fort Sumter
Fort Sumter National Monument
Historic Structure Report

Volume II
APPENDICES A-F

2015

JOSEPH K. OPPERMANN – ARCHITECT, P.A.

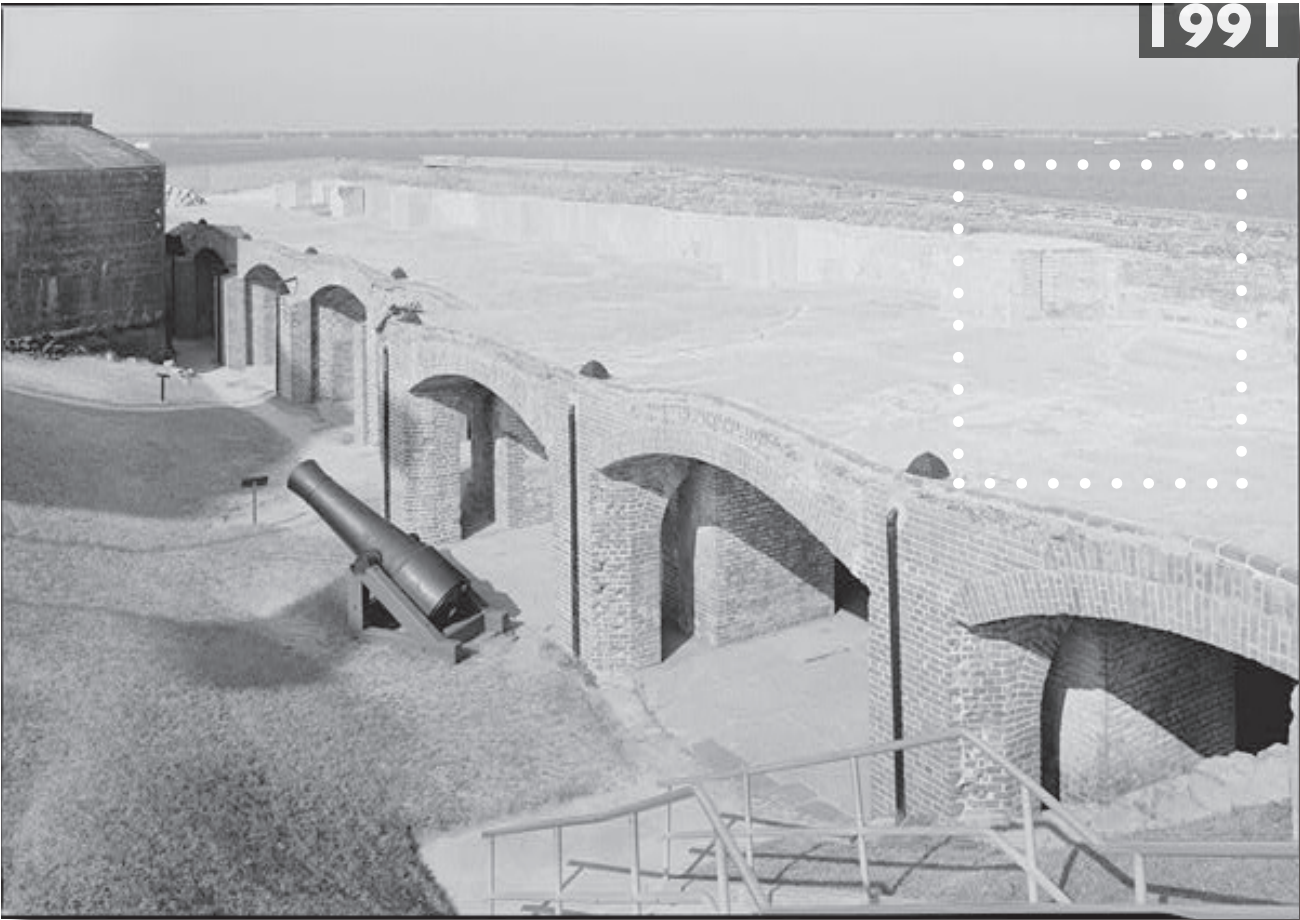
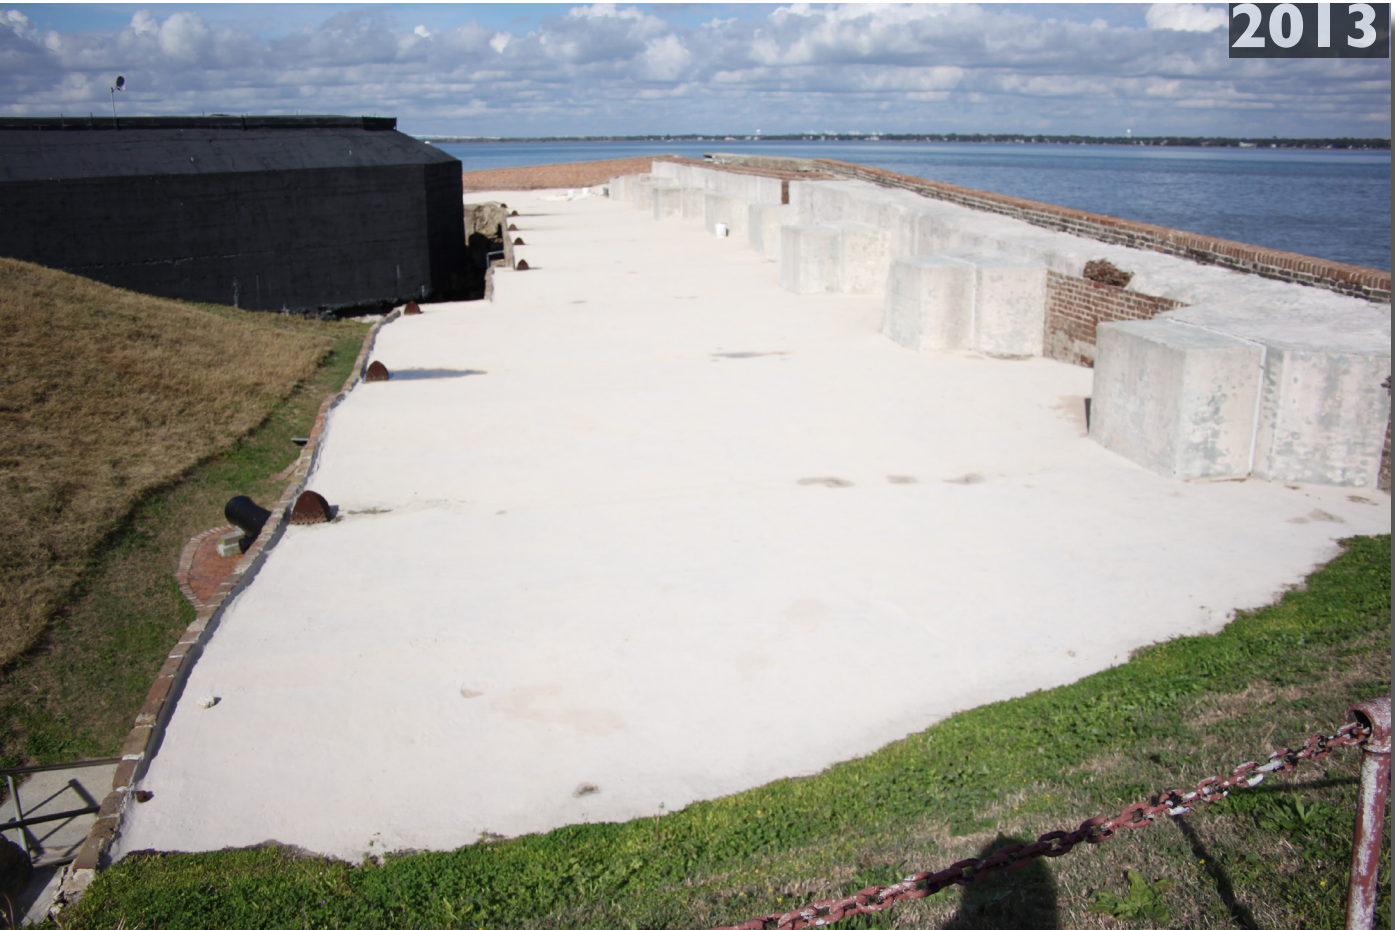
Right Face Casemates, Casemate A-18 in the forefront, looking north. [Credit: Historic American Buildings Survey]

- The roofing material appears to be consistent from 1991 to 2013.

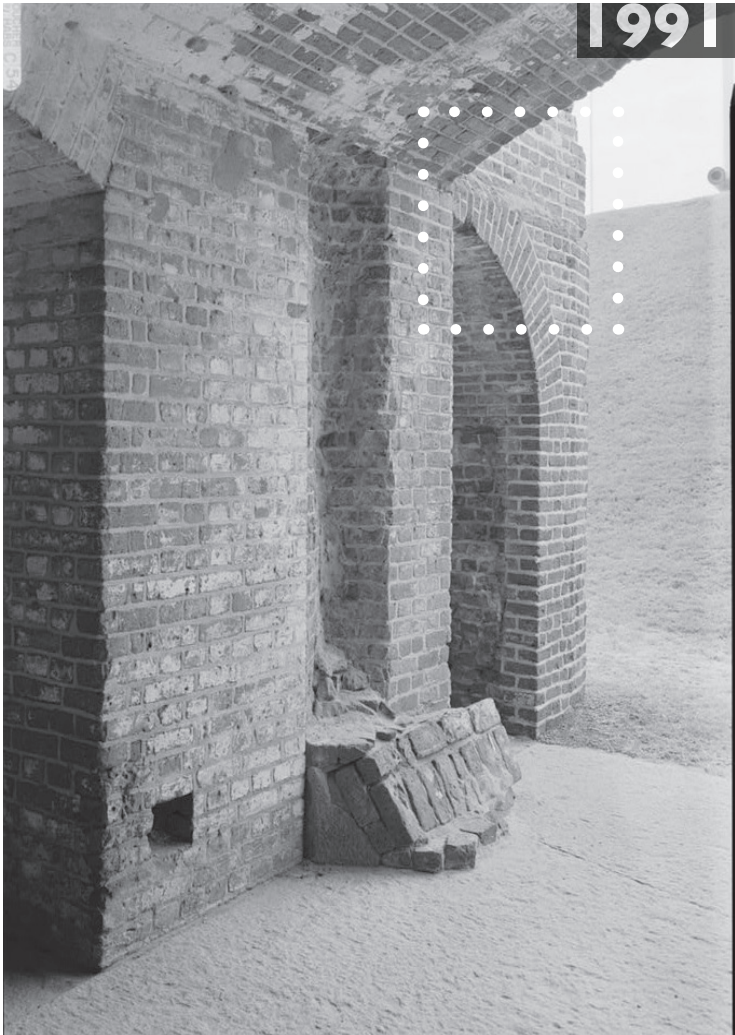
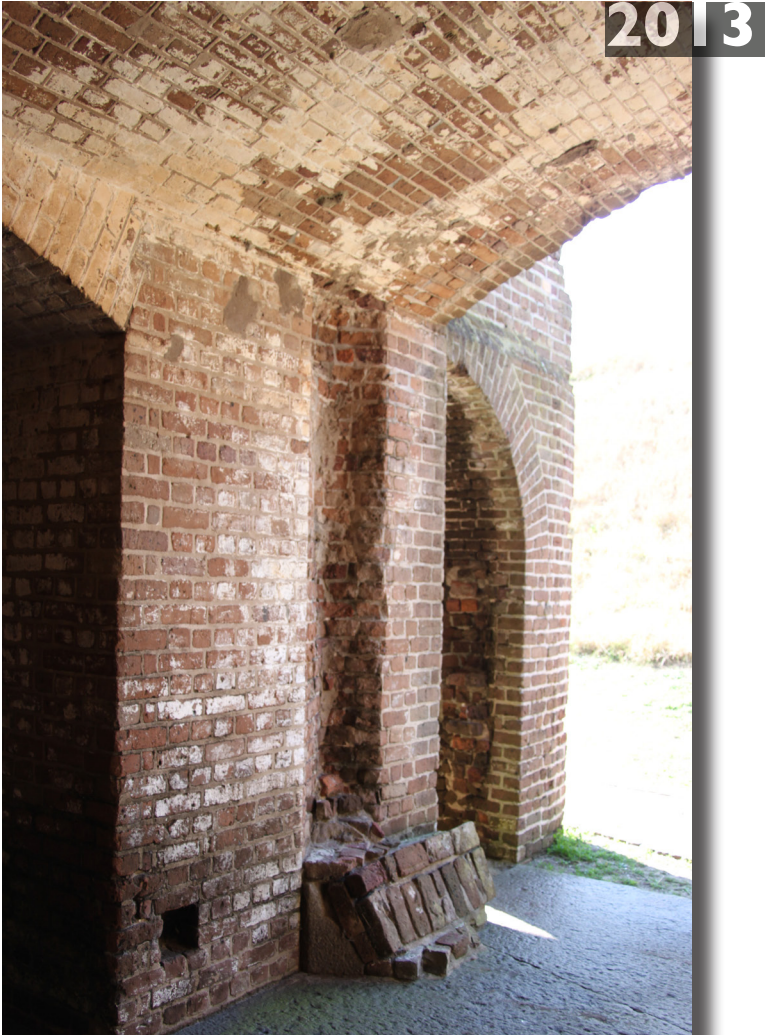
Right Face Casemates, detail view of the southeast wall leading out of Casemate A-17. [Credit: Historic American Buildings Survey]

- Many of the white finishes on the brick masonry have remained predominantly intact since 1991.

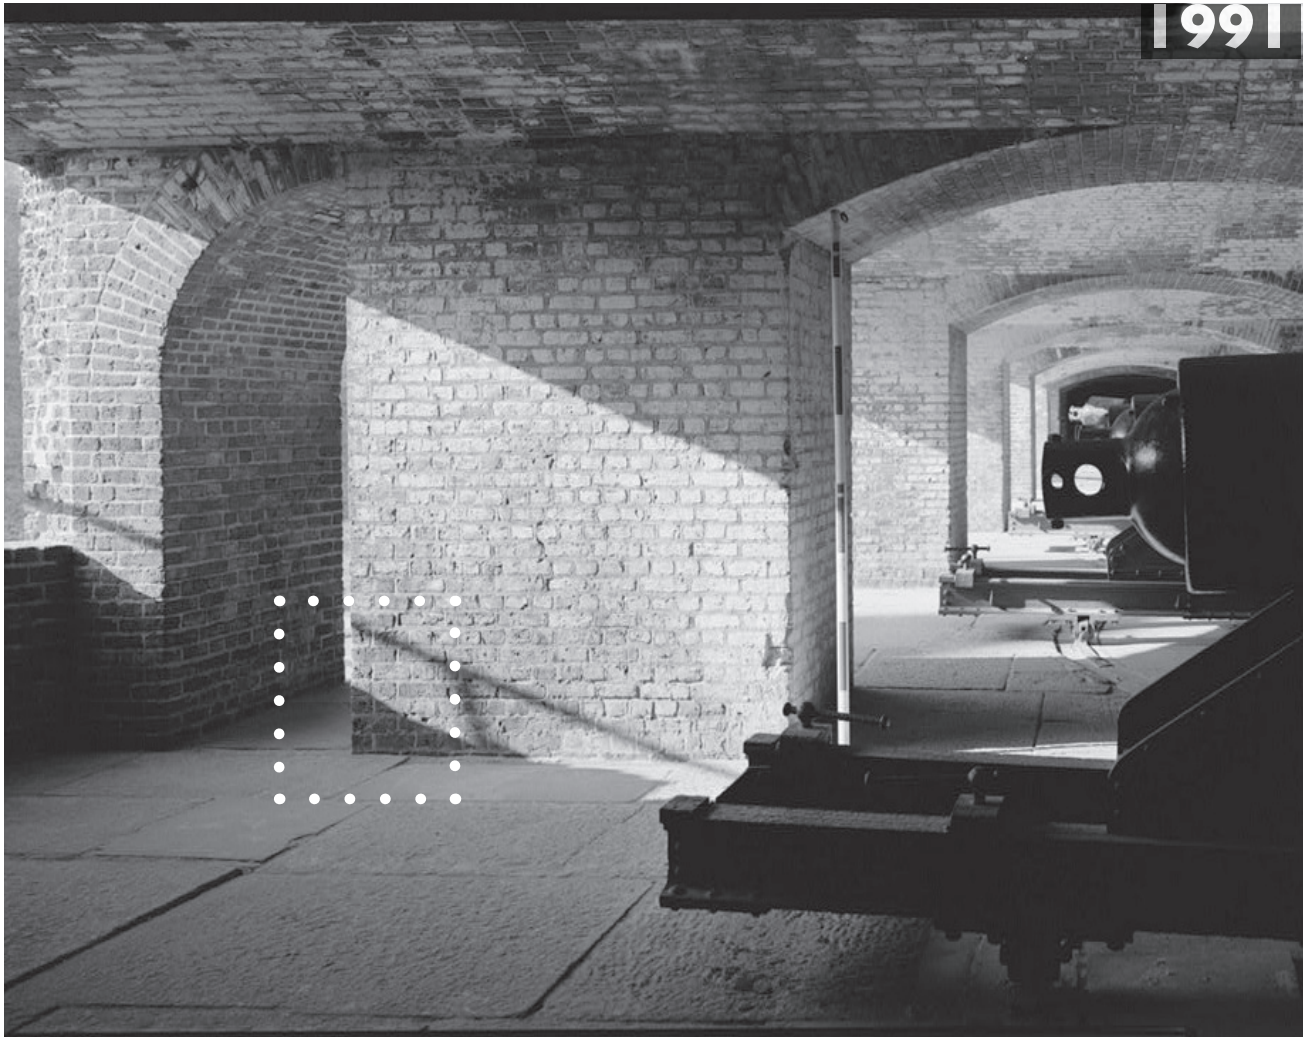
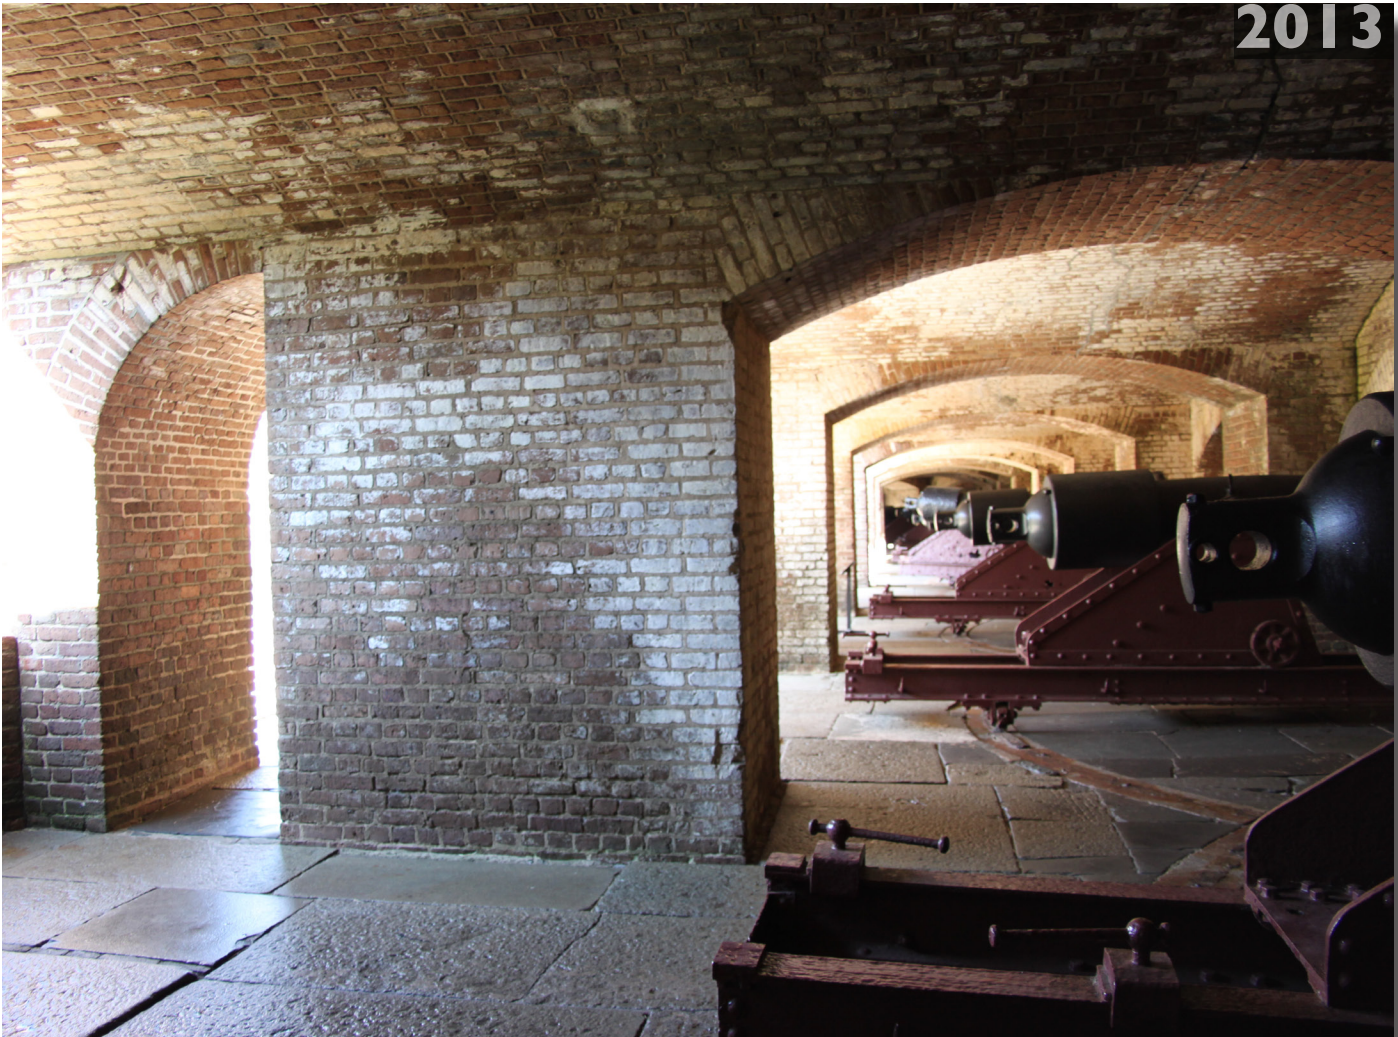
Right Face Casemates, from Casemate B'3 looking towards the salient angle through the casemates.
[Credit: Historic American Buildings Survey]

- Many of the white finishes on the brick masonry have remained predominantly intact since 1991.
