# **Lagoon Island Cabin**

## **Glacier Bay National Park & Preserve**

### **Historic Structure Report | 2025**

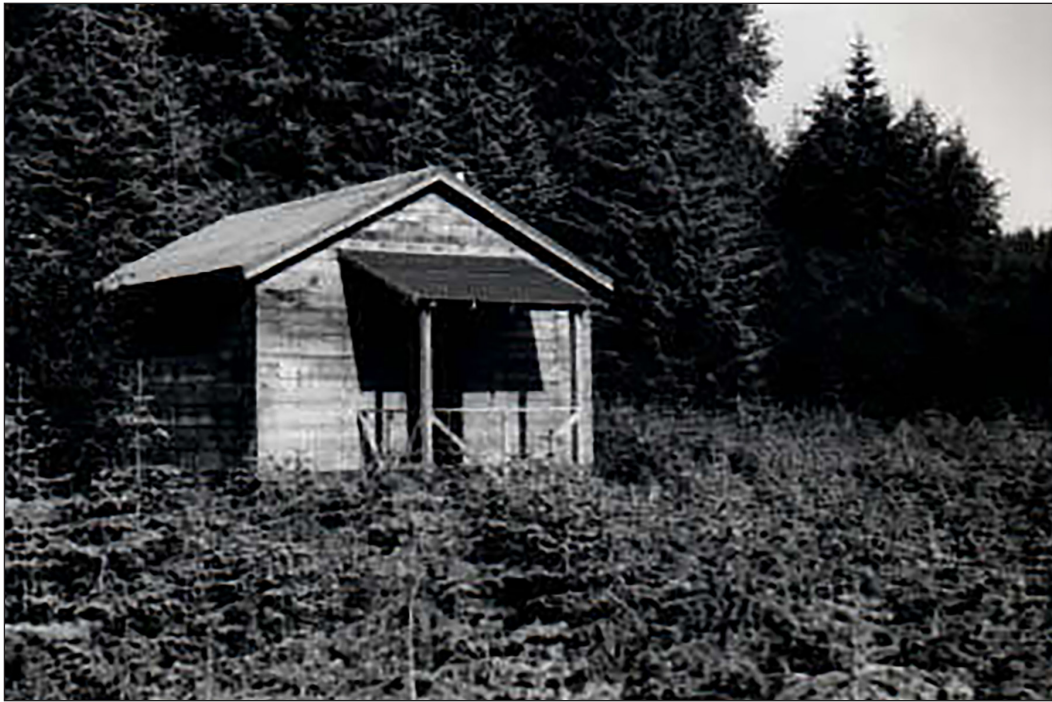
**Figure 3.1:** View of the Lagoon Island Cabin in August 1951. The majority of exterior Character Defining Features remain intact contributing to the cabin's high degree of integrity. Note the five-panel wood door which is likely original and the foundation lacking a skirting. GLBA Archives, Accession # 00491, Box 6, Folder 6 GLBA 10885.

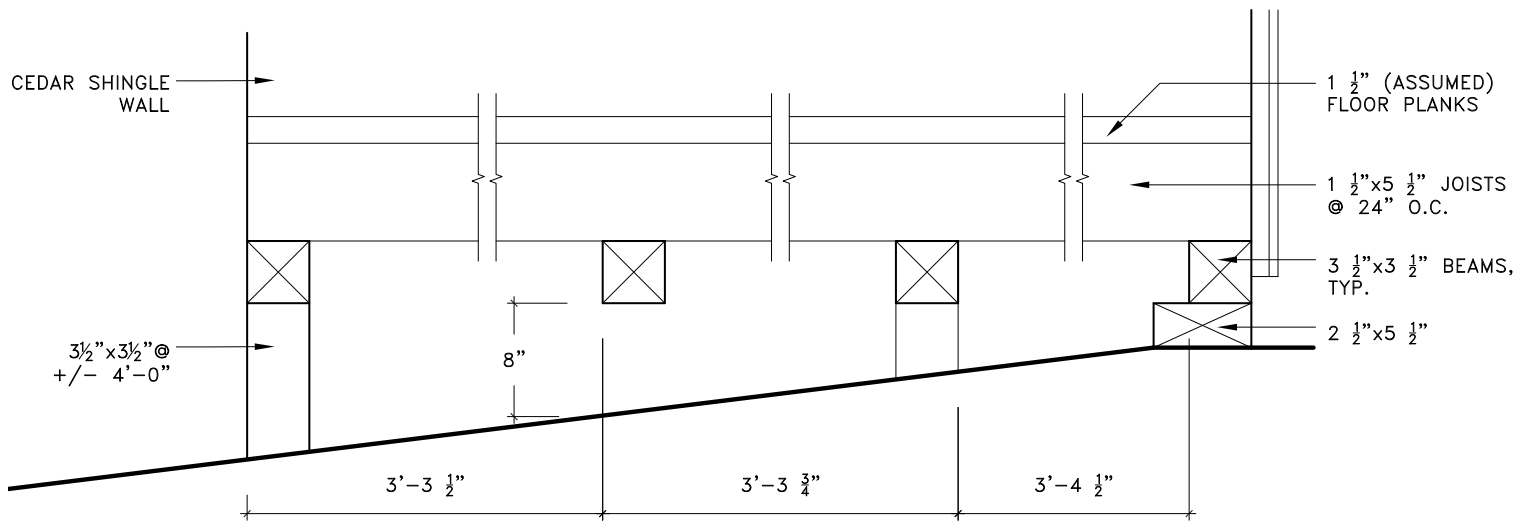
**Figure 5.4:** Section detail of the original cabin's east elevation illustrating the cantilevered perimeter. The reason for this detail is unknown but may be attributed to the cabin's original foundation or the relocation effort.

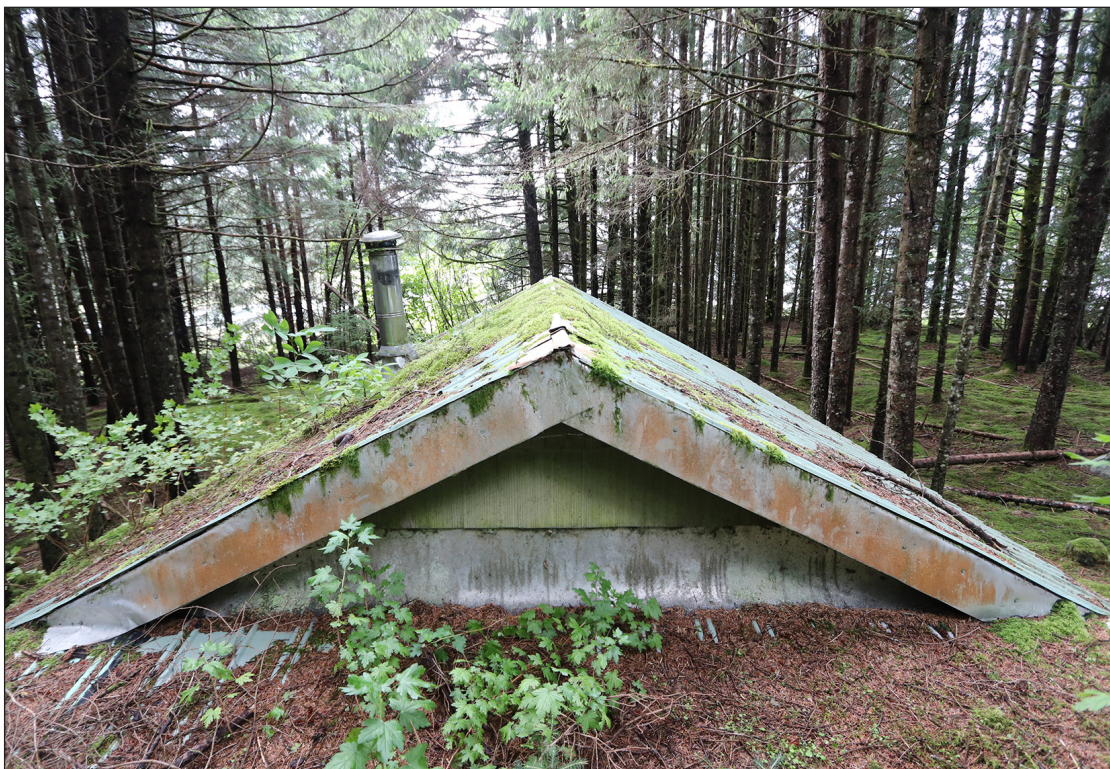
**Figure 5.8:** View looking south where the addition's shed roof joins the main gable roof. Note the metal fascia flashing on the gable end of the cabin roof. The roof was covered in vegetation and duff during the 2018 inspection. The park cleaned the roof off in the fall of 2018.

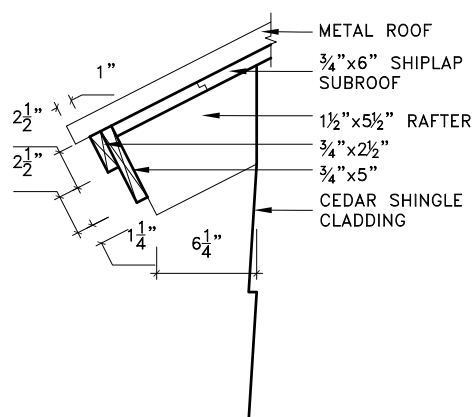
Figure 5.9: Eave detail of the cabin's primary roof. NPS AKRO 2018.

ends have a  $\frac{3}{4}$ " x 5  $\frac{1}{2}$ " fascia and the eave has exposed square cut rafter tails with  $\frac{3}{4}$ " x 5" fascia and 2  $\frac{1}{2}$ " trim.

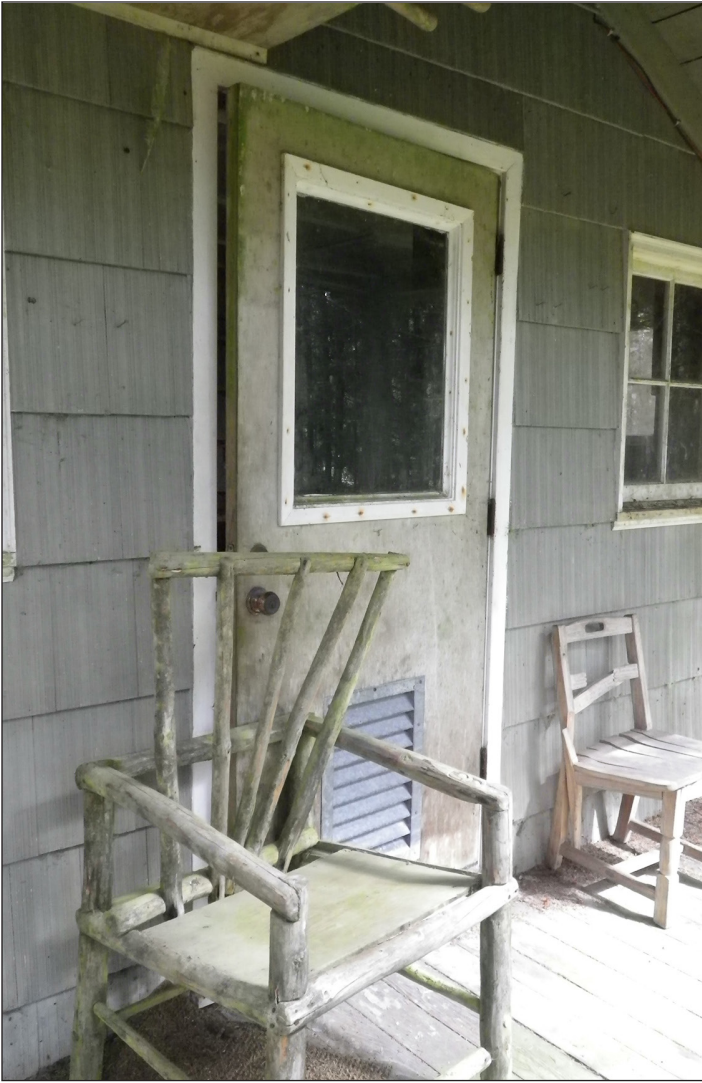
**Figure 5.10:** The door serving the primary entry to the cabin on the south elevation was a half-lite, solid core door. The door was vandalized in 2018. Following the vandalism incident, the park installed plywood until the final preservation treatment is realized. NPS Photo, 2013.

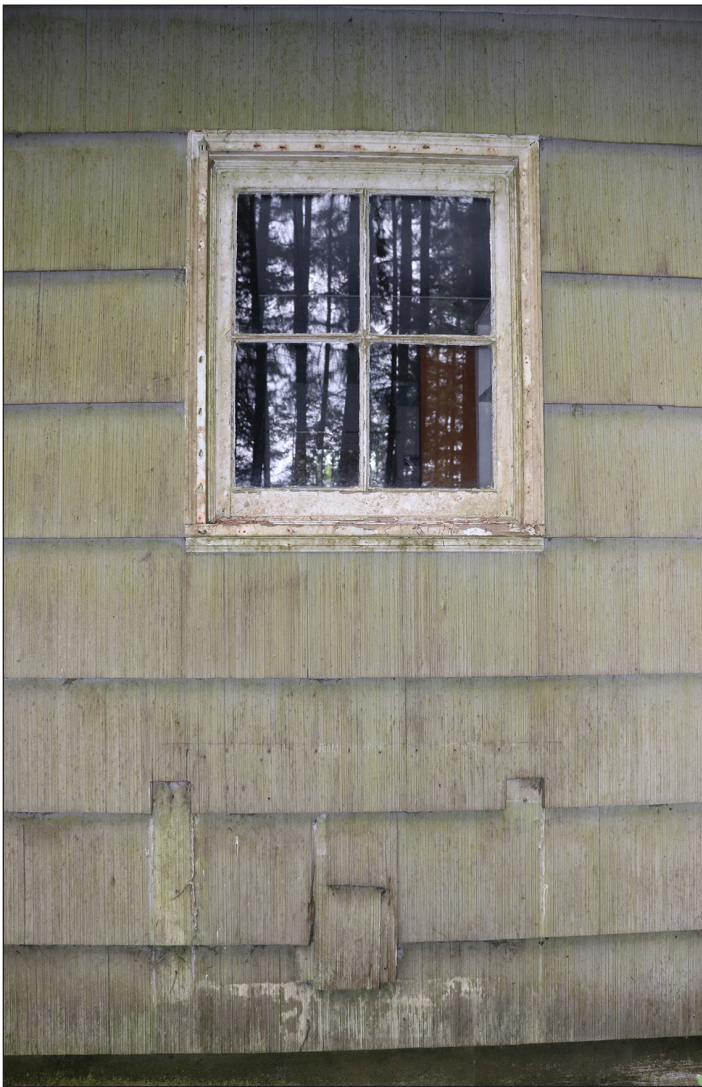
**Figure 5.13:** The cabin includes six 4-lite, fixed, wood sash window and one 8-lite fixed, wood sash window. The windows remain intact, are well placed and proportional to the small cabin.

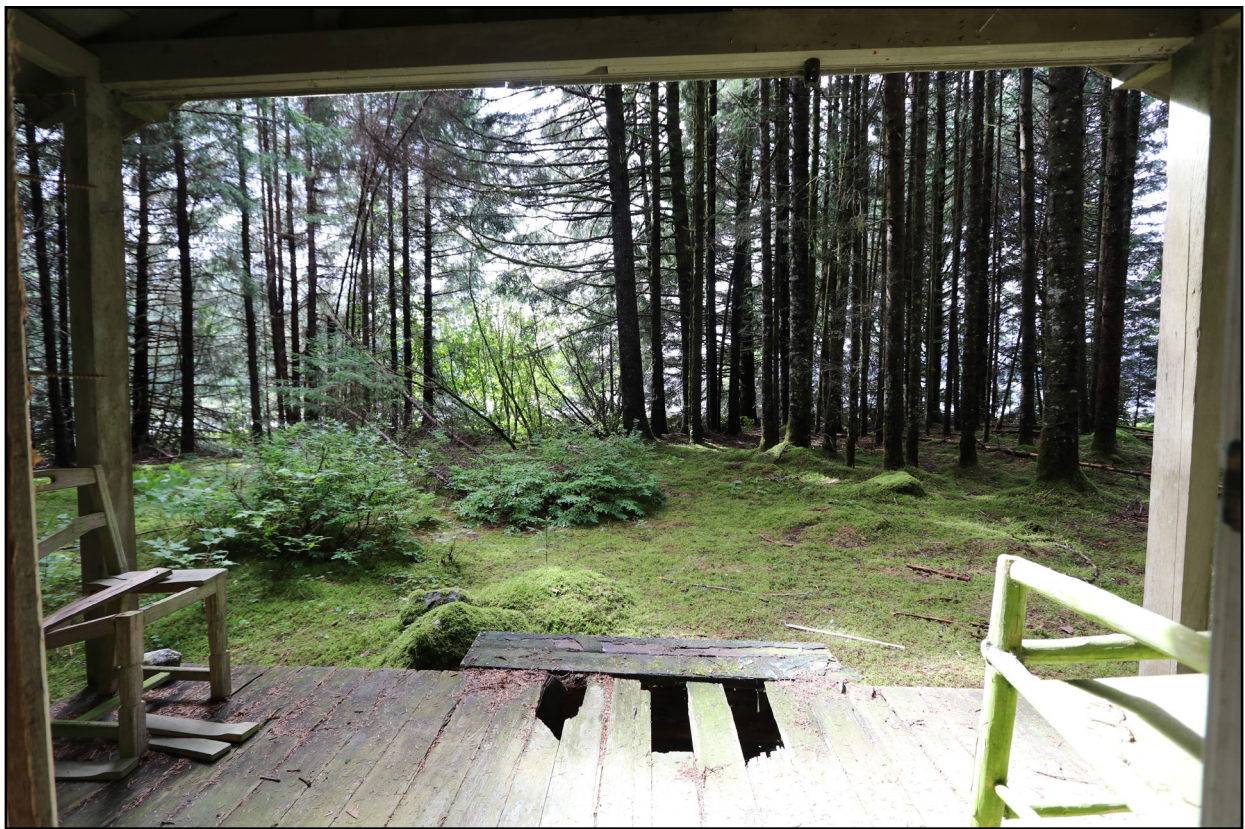
**Figure 5.17:** View south from the primary entry of the Lagoon Island Cabin. During the Period of Significance, the view would not have been obstructed by any vegetation. Natural reforestation conceals the cabin from Bartlett Cove. Selective vegetation removal is included in the cultural landscape recommendations.

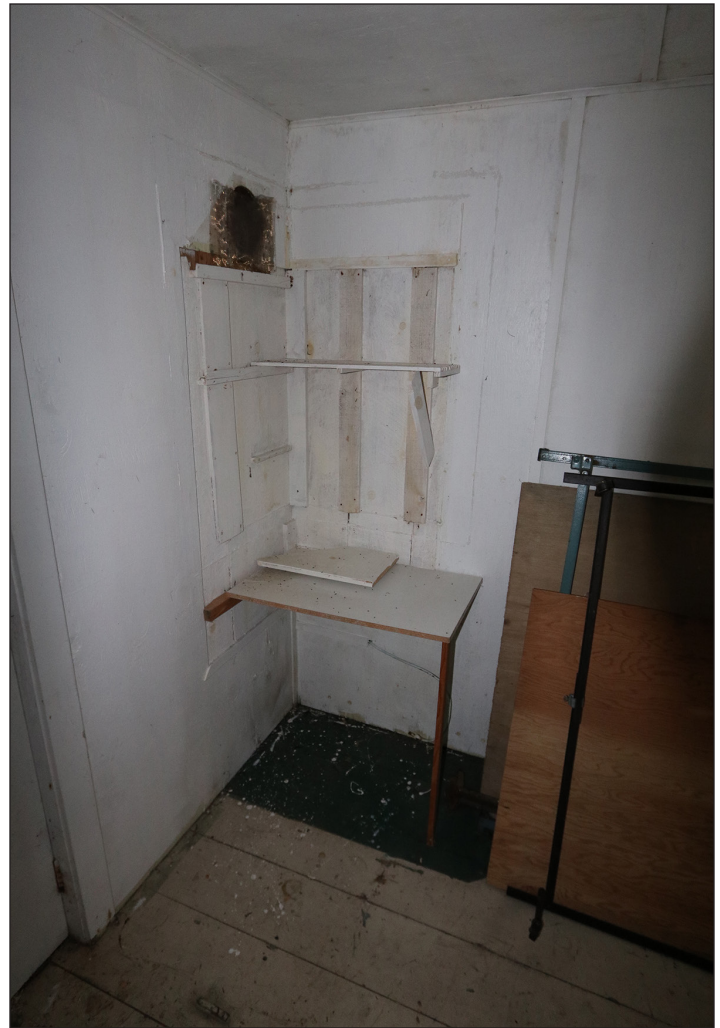
**Figure 5.27:** Detail of the northeast corner of Room Three.

In the northwest corner of Room Three, evidence of a wood stove with a 6" diameter stove pipe exists although a shelf was constructed following its removal. A heat shield on the floor measures 3'-5 3/4" east to west and 1'-11 1/2" north to south. The former stove pipe penetration through the west wall is clad with screen but has not been patched with wood siding.

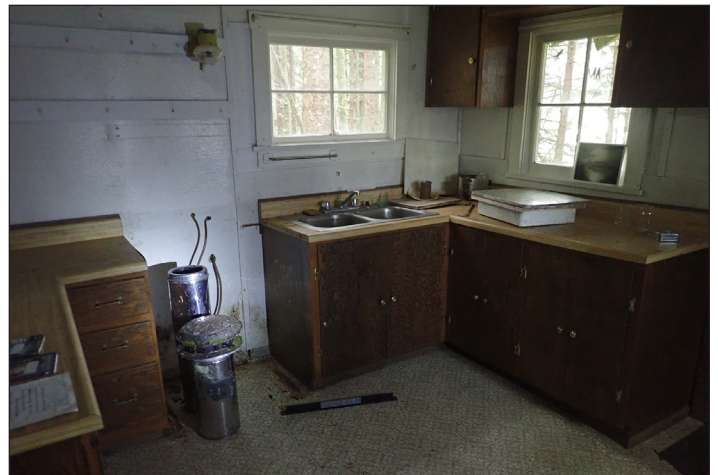
**Figure 5.31:** The kitchen casework including a vacant space for a stove and the double-basin kitchen sink. The casework likely dates to the 1980s but is still serviceable.

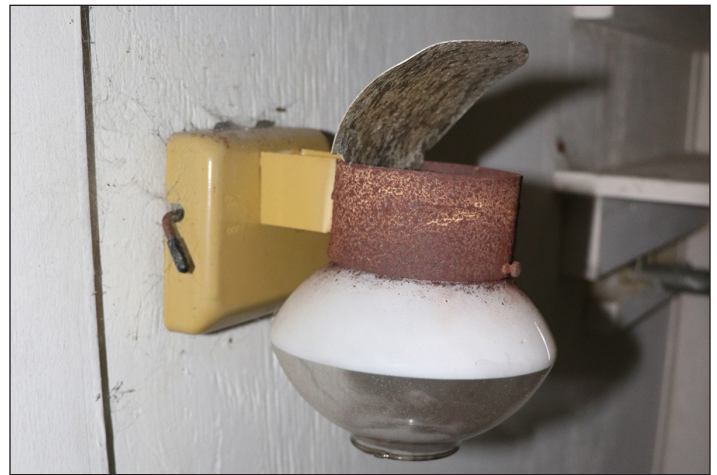
**Figure 5.34:** The interior was most recently illuminated by wall mounted propane lights. Rehabilitation efforts may include an electrical system powered by intermittent use of a generator or a power source from the mainland. The system is yet to be determined.

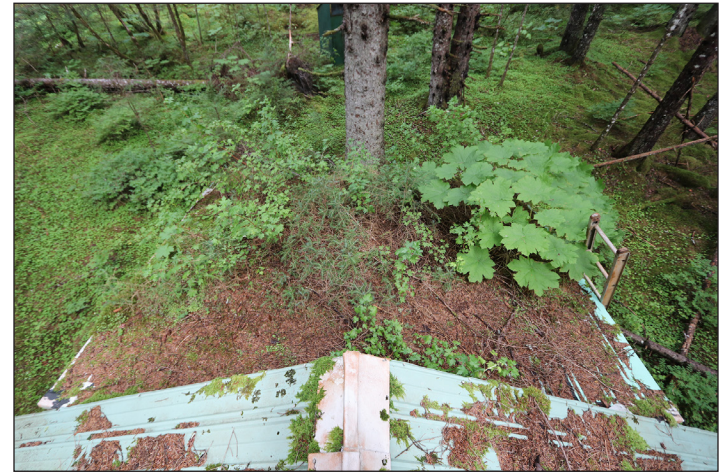
**Figure 8.9:** View to the east from atop the primary roof. The shed roof addition is completely covered with duff and actively supports vegetation.

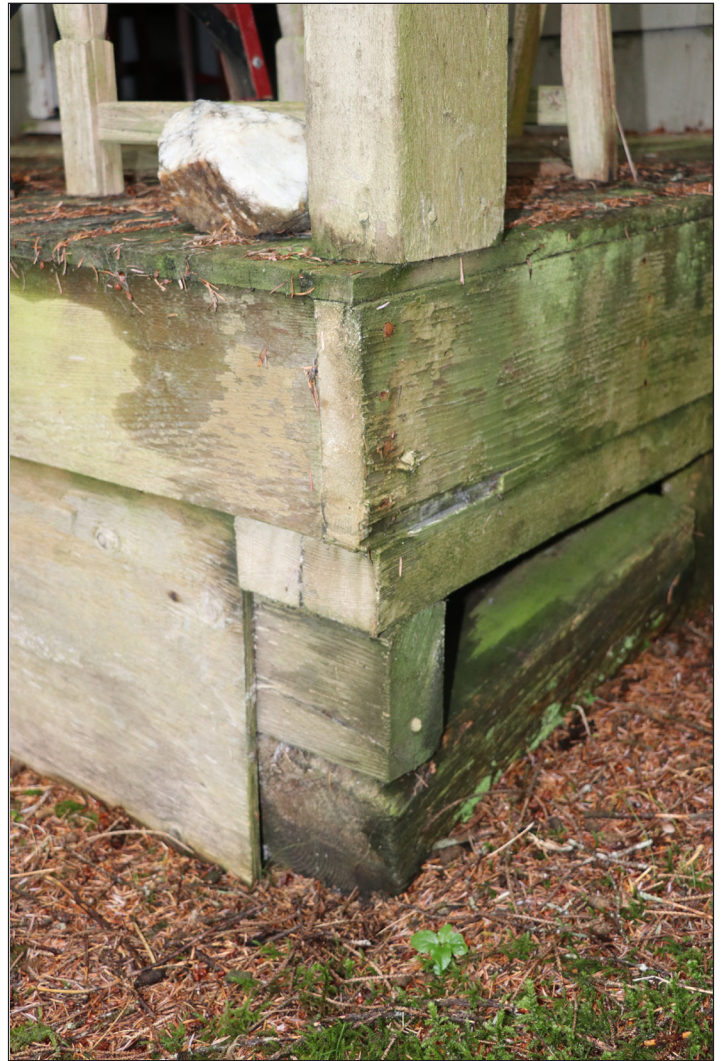
The porch foundation pads are also in contact with the soil and have likely rotted.

**Figure 8.16:** Detail view of the cabin's porch foundation at the southwest corner.

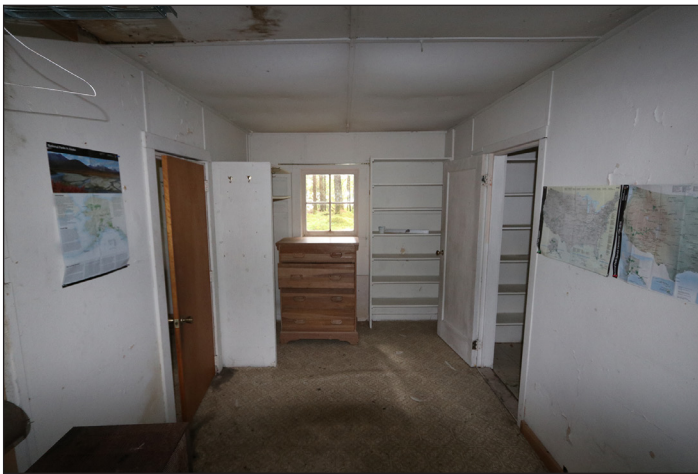
**Figure 8.19:** Each of the rooms have built-in shelving which likely dates to the early NPS era of the cabin.

Some of the built in casework may be original to the cabin's use associated with Glacier Bay National Park & Preserve, however it is likely the movable furniture is an amalgamation of pieces brought to the cabin over the years. The built in casework is in a serviceable condition.

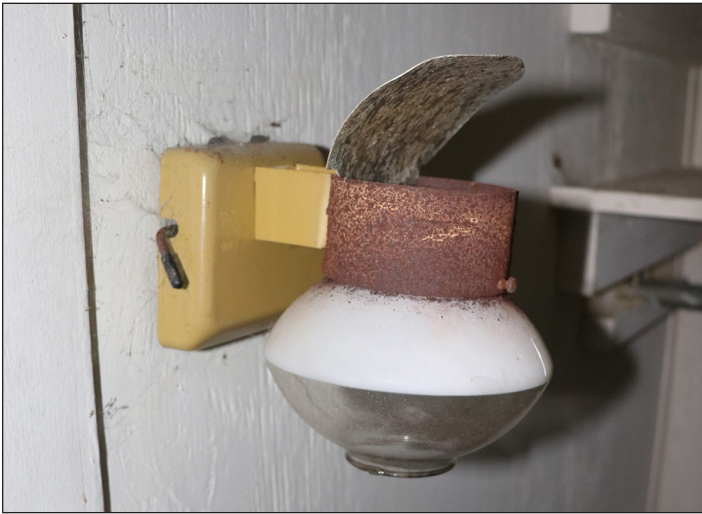
**Figure 8.21:** The interior was most recently illuminated by wall mounted propane lights. Rehabilitation efforts may include an electrical system powered by intermittent use of a generator or a power source from the mainland. The system is yet to be determined.

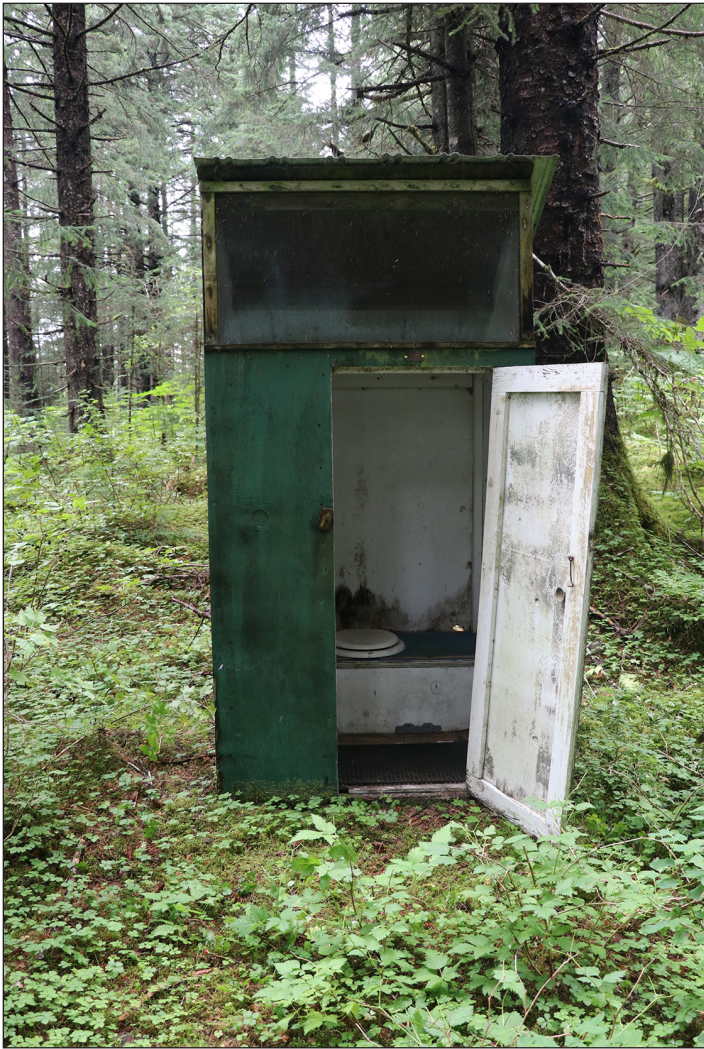
**Figure 8.24:** South elevation of the existing outhouse which is no longer in use.

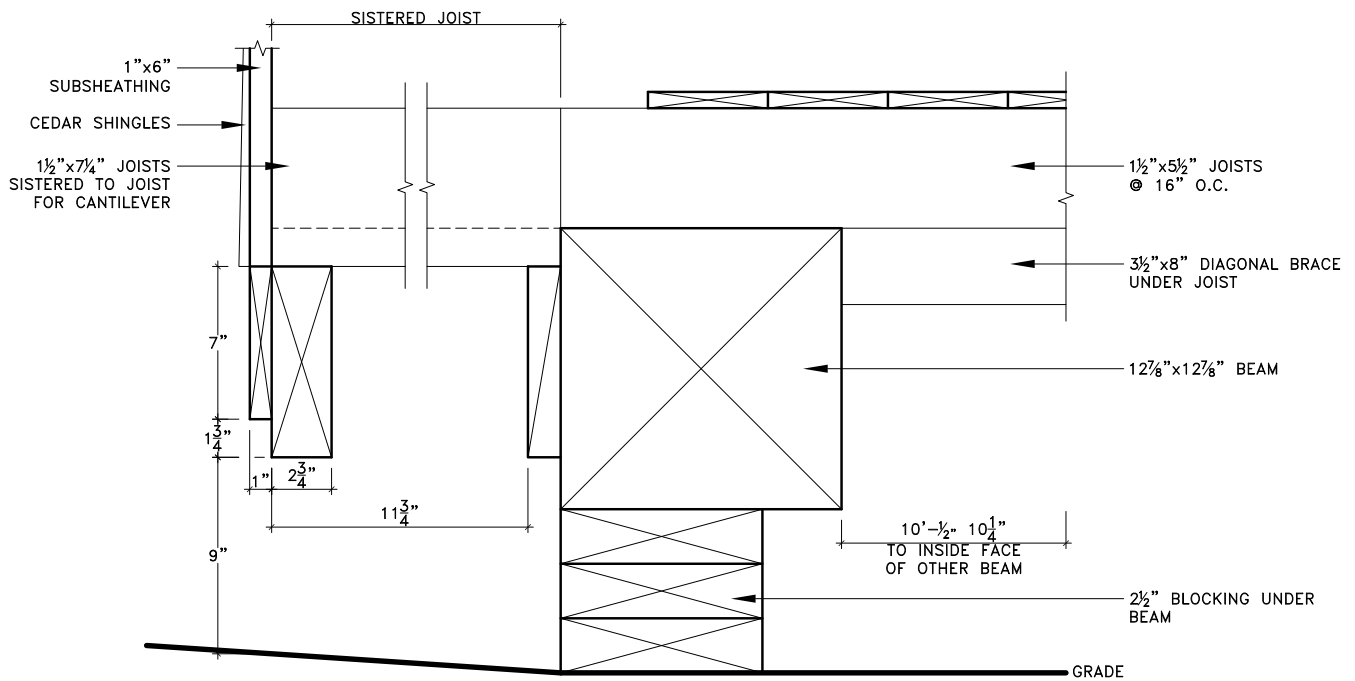
1 FOUNDATION DETAIL  
1 1/2"=1'-0"

Park staff also observed some of the joists that are cantilevered past the 12"x12" beams are deflecting and

Lifting and leveling the foundation is recommended to establish new, regularly spaced foundation piers and pads of either concrete or green treated material. Ideally the elevation of the cabin's finish floor would increase only 7" to maintain a railing free porch. A height of 30" will require a handrail on the porch.

are cracked. Following a review by Denali National Park and Preserve's engineer (architectural engineer), the recommendation is to sister additional 2"x6" to each joist to carry the load. A perimeter post and beam configuration may also support the load from the wall and eave. Additional design details can be found in Appendix B.
