Cain Cabin
Elkmont Historic District
Great Smoky Mountains National Park
Historic Structure Report

September 2014

Historic Structure Report

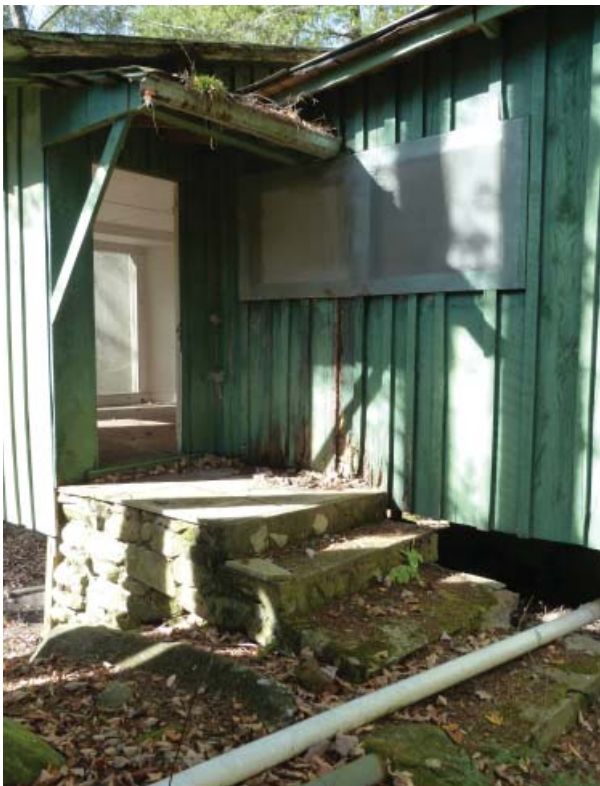
Figure 30. South patio and entrance to Room 111.

On the south side of the cabin, at the entrance to a back room addition is a small patio paved with one-inch-thick flagstone set in mortar; the flagstone is supported by stacked fieldstone. The patio measures 5'-0" deep by 4'-4" wide. Three fieldstone steps squared off with mortar lead down from the patio to the south side yard (Fig. 30).

The only gutter is at the entry to the southwest addition (*Fig. 30*). The modern aluminum gutter has no end cap or downspout and is approximately four feet long.

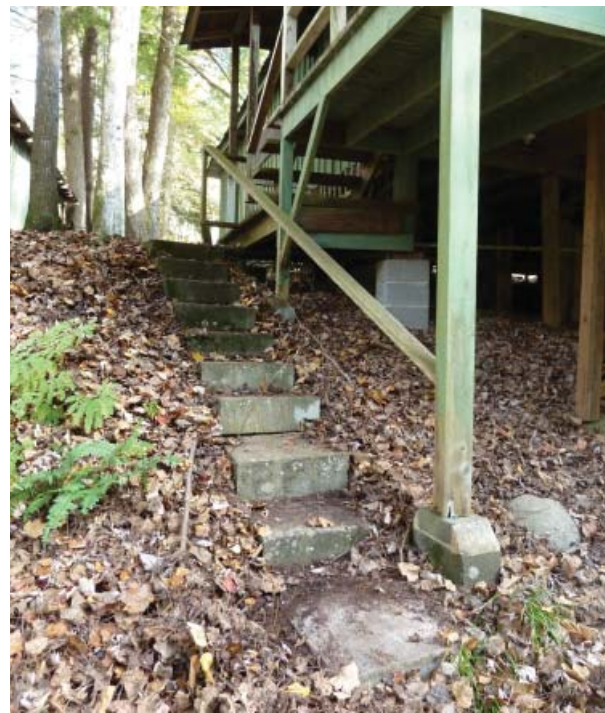
Figure 31. View of north steps from the back yard looking east.

On the north side of Cain Cabin, adjacent to the wood porch, are eight CMU (concrete masonry unit) steps filled with cement (Fig. 31). They connect the north side yard to the back yard, where there is a mortared flagstone patio and walkway. Today, the patio and walkway are almost completely obscured by moss and fallen tree branches. The top landing of the steps is a concrete slab measuring 3'-0" wide by 3'-8" deep (Fig. 45).

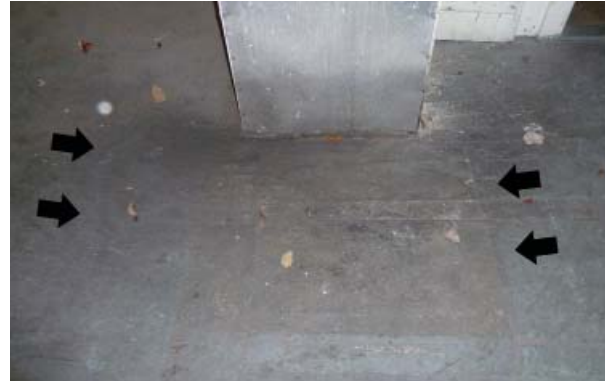
A wood-burning stove was once used for heating. A patched flue opening on the north wall of the main block living space connects to the chimney in the adjoining room. At the base of the chimney, discolored flooring in a square shape that measures 2’-10” in the north-south direction and 2’-6” in the east-west direction indicates where the stove once sat.

Figure 39. Discoloration of flooring indicating the location of a wood-burning stove, Room 104.

The tongue-and-groove wood floor boards measure 2¼” in width and are laid north-south. The flooring is continuous from Room 101a. There is a 1½” seam board in the floor where the north wall has been removed. At the base of the chimney in the northwest corner, straddling both Room 102 and Room 104, there is discoloration in the flooring where a stove once sat (Fig. 39).

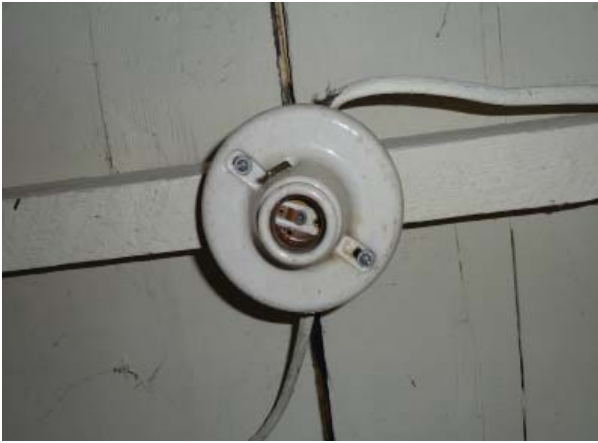
Figure 41. Typical ceiling-mounted ceramic lamp holder used in most rooms of the cabin.

The present electrical distribution system is a mix of vintage mid-twentieth century non-grounded, cloth-wrapped insulated cable together with late-twentieth-century vinyl-wrapped cable. Elsewhere is a mix of mid- and late-twentieth century in-wall and surface-mounted receptacles and switches. Ceiling-mounted ceramic lamp holders are used in nearly every room of the cabin (*Fig. 41*).

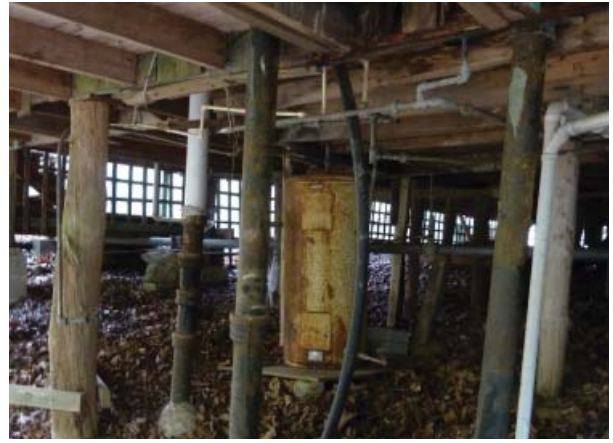
Figure 42. Inoperable electric hot water heater in the crawl space.

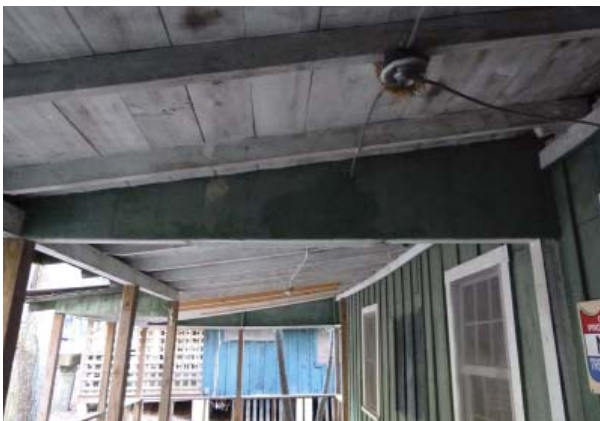
The wood porch posts measure 3½" by 3½". A 1½" by 3½" wood handrail is supported by vertical 1½" by 3½" boards spaced approximately 1'-8" on center. The remains of an east-west dividing wall for a screened porch stand seven feet from the north end of the porch; there is a 1½" by 3½" post against the east wall of the house and the upper portion of a board wall. At the remaining wall header, paint markings indicate that a 2'-8" wide (screen) door was once at this location. The porch has two ceiling-mounted ceramic lamp holders.

Figure 44. Remains of a dividing wall at the front porch.

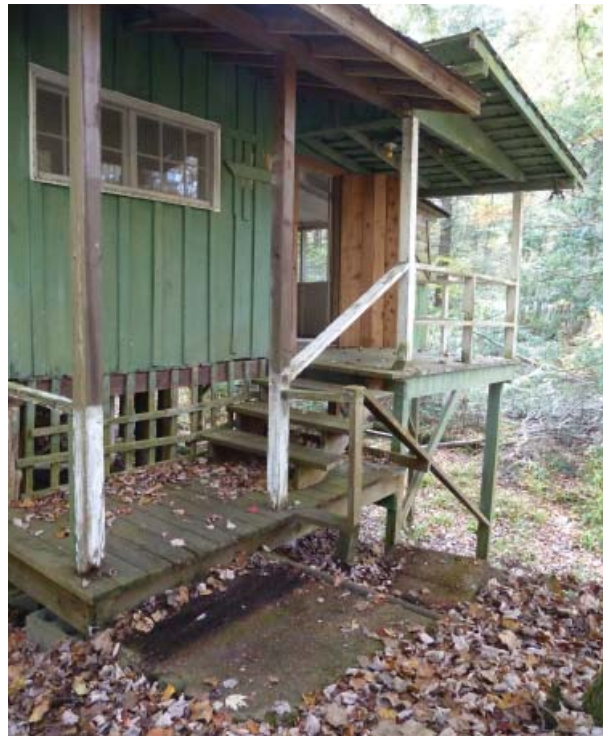
The north porch provides access to the enclosed northwest porch and kitchen from the side yard. It has two levels connected by three wood steps. The lower level is 3'-11" deep and the upper level is 5'-8" deep. The steps are made up of two boards each, measuring 1½" by 5½", and are supported by

Figure 45. Two levels of the north porch.

The west window of the north elevation is Type A six-over-six-light double-hung sash set on its side as a sliding window. The window opening measures 1'-10" tall by 4'-6" wide. The casing is made of wooden plank boards. The lintel and west jamb casing measure $\frac{3}{4}$ " by $2\frac{3}{4}$ " and the east jamb casing measures $\frac{3}{4}$ " by $1\frac{1}{2}$ "; they are lintel cut without ears. Remnants of trim pieces on the exterior and ghost marks on the interior of the window, on the west side, suggest that the opening may have been previously wider (Fig. 45).

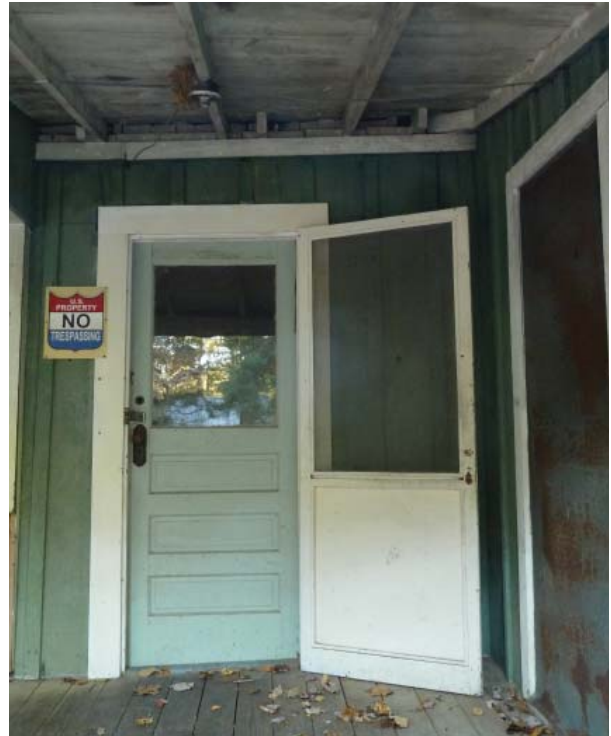
The front (east) door to the cabin has three raised horizontal panels with a glass sash. It measures 2'-8" wide by 6'-7" tall, and is attached with three original 3½" by 3½" five-knuckle steel ball-pin hinges. There is a steel mortise lock between early-twentieth-century embossed escutcheon plates that measure 2½" by 7½", as well as original 2¼" diameter embossed metal doorknobs and an original brass key escutcheon. Outside the door is a single-panel-below-screen door that measures 2'-8" wide by 6'-7½" tall. Its two late-nineteenth or early-twentieth century embossed spring hinges measure 3" by 3". A 4" wire handle is ⅛" in diameter.

Figure 47. Front door with screen door at the east elevation.

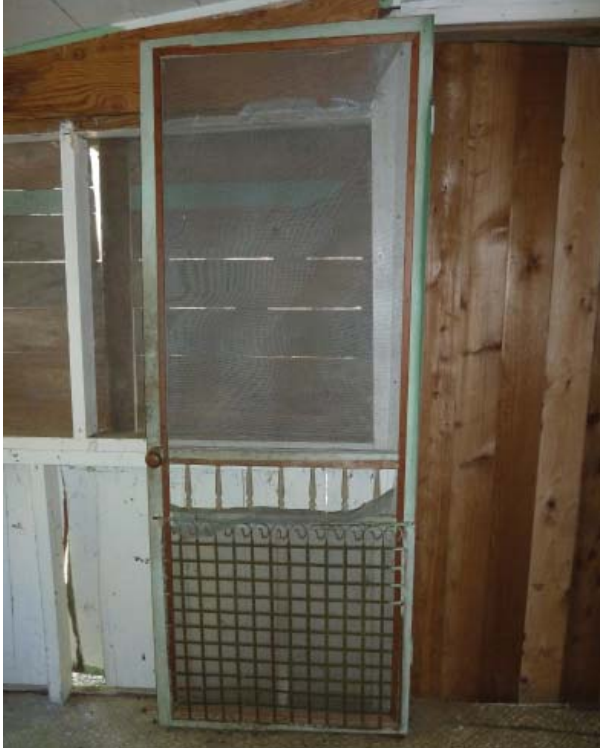
Figure 49. Screened door of Enclosed Porch (Room 106).

spindles separating the upper and lower panels (Fig. 49). The bottom panel has a metal dog guard grille. The door hardware includes two 3" spring hinges, an original $1\frac{3}{4}$ " brass doorknob and an original 2" brass handle on the inside. There is no threshold at this doorway.

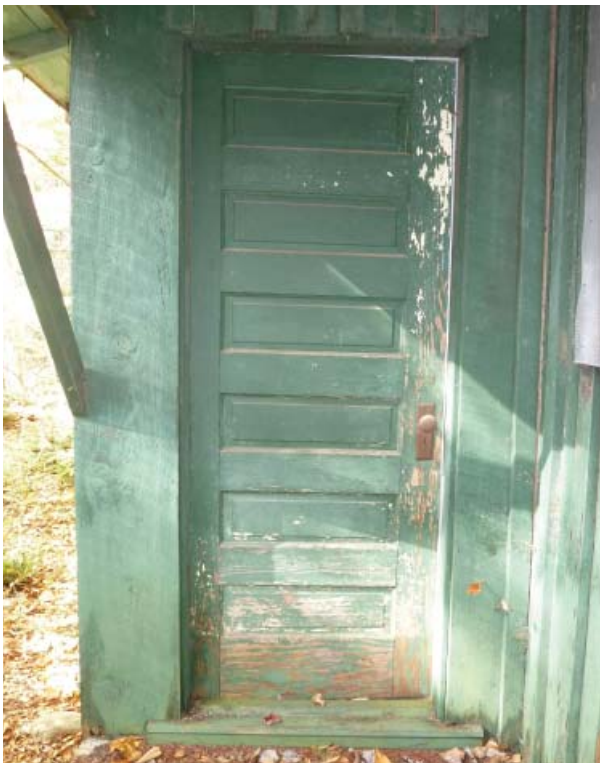
Figure 50. Entrance door, southwest addition, Room 111.

The southwest addition has an exterior entrance from the south side yard. The six-horizontal-panel door measures 2'-6 $\frac{3}{4}$ " wide by 6'-6" tall and has two 3 $\frac{1}{2}$ " by 3 $\frac{1}{2}$ " five-knuckle steel butt hinges, a mortise lock, and a 2" galvanized modern barrel bolt (Fig. 50). There is no casing on the exterior side of this door. The door sill is 3" above the top of the entrance landing.

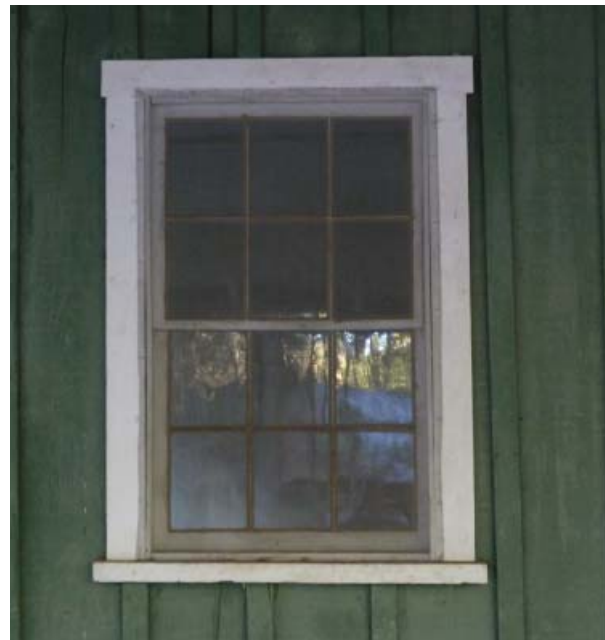
The south window on the east elevation of the main block is a Type B six-over-six-light double-hung sash window that measures 2'-4" wide by 3'-9" tall. The north window on the east elevation is a Type A six-over-six-light double-hung sash window

Figure 51. Original south window on the east elevation with Type B sash, Room 101a.

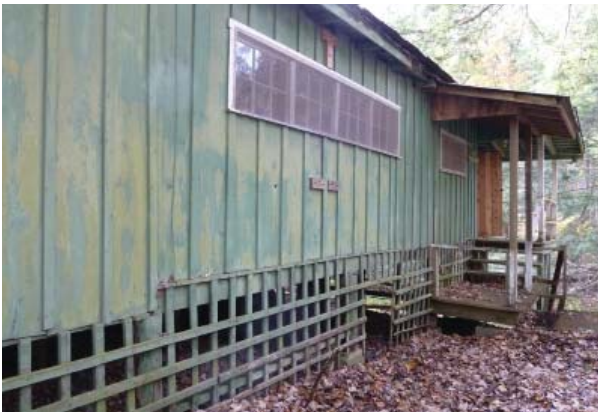
Figure 52. Four early window sash reused on the north elevation.

In the middle of the north elevation are four Type A six-light sash windows fixed side-by-side. They are early window sash that have been reused; all have been recently repaired. Some of the replacement stiles and rails lack the profile of the Type A sash (Fig. 53). The window opening measures 1'-9 $\frac{1}{2}$ " tall by 9'-4" wide. Casings are wooden plank boards that measure $\frac{3}{4}$ " by $2\frac{3}{4}$ " and are lintel cut with 1" ears.

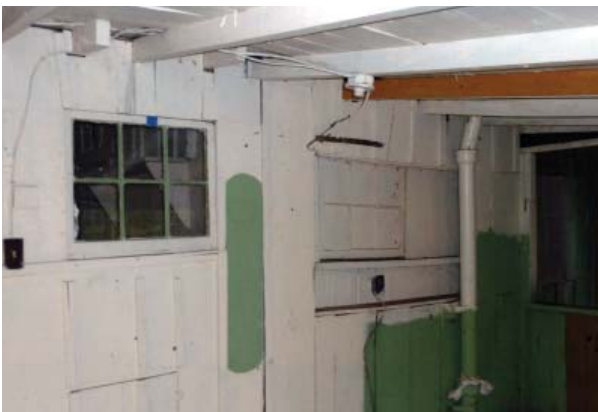
Figure 54. Casement window (left) and sliding window (right) of the enclosed porch.

The opening measures 2'-0" tall by 2'-4" wide and there is no casing. The window has been recently repaired (Fig. 54).

South of the casement window is another Type A sash window cut into the wall and set in tracks to slide horizontally. The opening measures 1'-11" tall by 2'-3½" wide and there is no casing (Fig. 54).

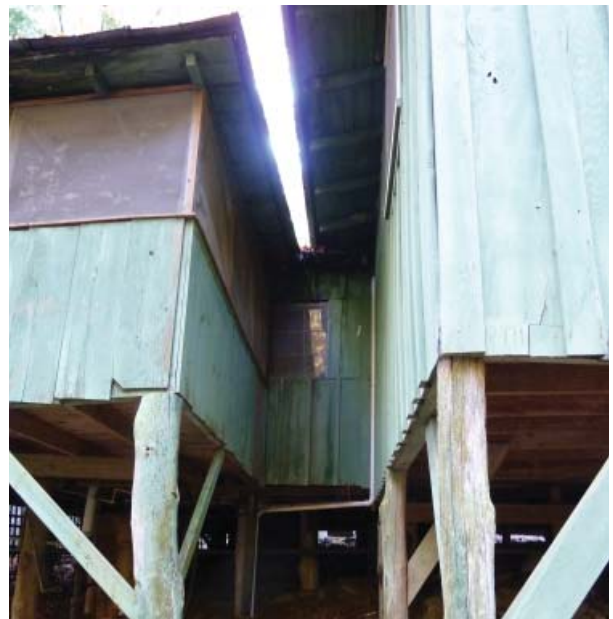
Figure 55. Six-light sash window between the two back additions.

A Type A six-light sash window is set vertically between the two back additions; its opening measures 2'-4" tall by 2'-0" wide and has no casing (Fig. 55).

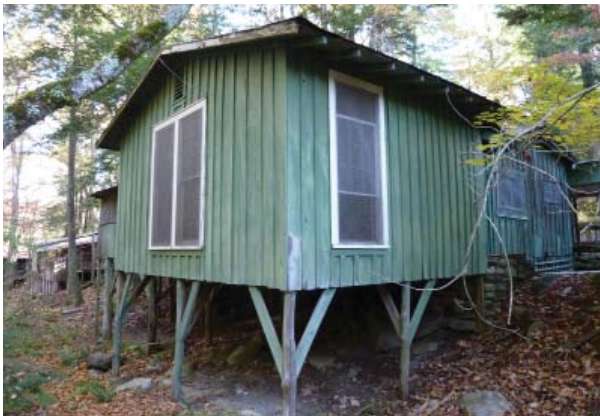
Figure 56. Nine-over-nine-light windows of the southwest addition.

addition are lintel cut without ears and measure 5/4" by 4½" with a 7/8" by 3½" weatherboard above the lintel (Fig. 56).

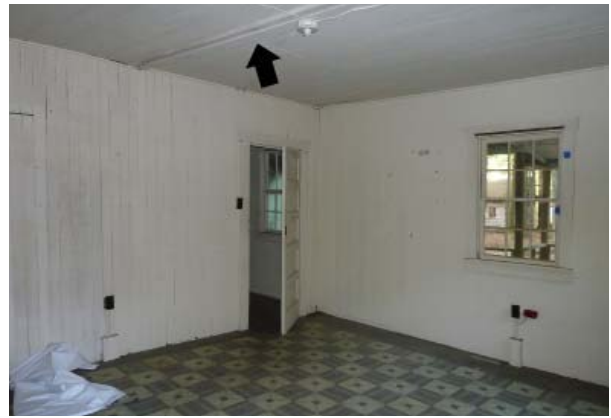
Figure 59. Southeast Bedroom (Rooms 101a & 101b) looking northeast. Only the header of the north-south dividing wall remains.

run north-south. The header from the north-south dividing wall remains on the ceiling, but the ceiling sags in the location that the wall was removed.

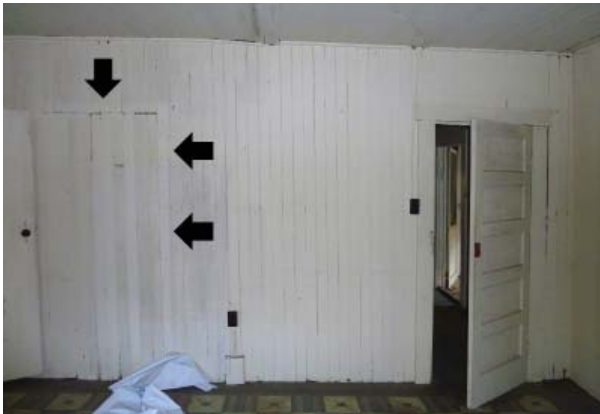
The south, east and west walls are finished in $\frac{7}{8}$ " by 3½" vertical wood boards. There is a remnant divider board at the middle of the south wall, where a north-south wall once stood separating the space in two. The north wall has an infilled door patch on the west side that mirrors the door opening on the east side; it measures 2'-5" wide by 6'-5" tall (Fig. 61). A combination of $\frac{7}{8}$ " by 3½" vertical boards and 3¼" tongue-and-groove vertical boards with a ¼" edge bead are used as finish material on the north wall. There are vertical pieces of 1" quarter round in the southwest, northwest, and southeast corners of the room.

Figure 61. Rooms 101a & 101b looking north. Infilled door patch (left) mirrors door opening (right).

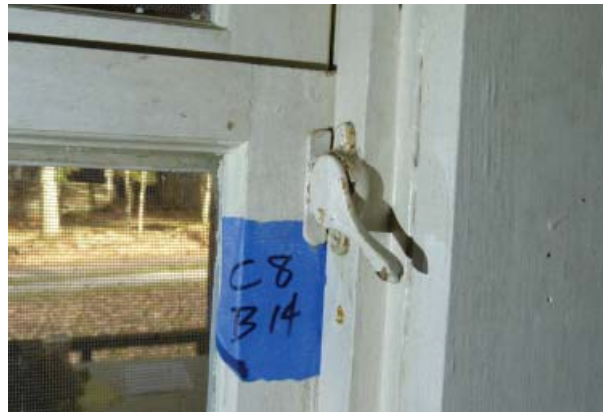
Figure 63. Jamb-mounted compression latch on the window.

There are three windows in this space and though each is unique they have all been recently repaired. The east elevation window is an original Type B six-over-six-light double hung sash window. The casing at the jambs is made up of plank boards measuring $\frac{7}{8}$ " by $3\frac{1}{2}$ " and the casing at the header measures $\frac{7}{8}$ " by 4". The apron is a $\frac{7}{8}$ " by $3\frac{1}{2}$ " plank board. The casing is lintel cut with 1" ears that project beyond the jambs. The only hardware is a jamb-mounted compression latch (Fig. 63).

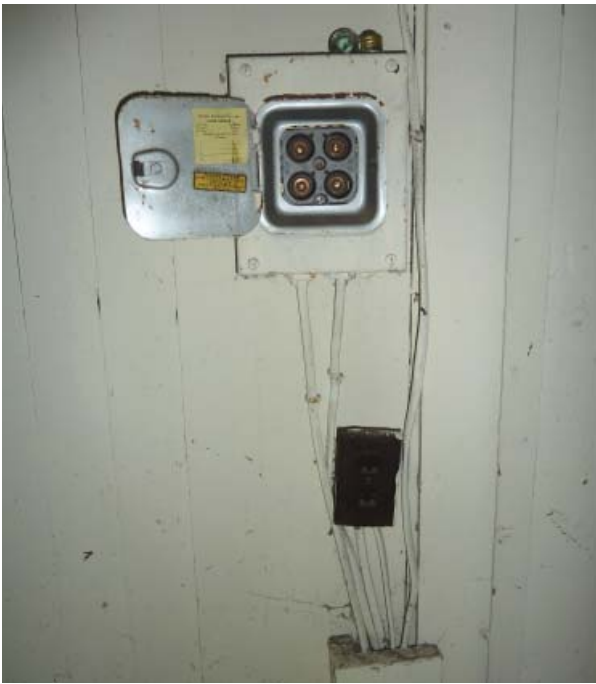
Figure 64. Fuse box and duplex outlet on the south wall.

Electricity is supplied to this space from the west. Cloth-wrapped wiring is exposed on the ceiling and connects to a 4½” ceramic lamp holder that is surface-mounted to the north-south wall header. Evidence of old knob and tube wiring is visible; two knobs and tubes on the east wall connect through to the front porch. On the north wall there are two ceramic tubes over the door and two east of the door. An additional two holes, for missing tubes, are found over the infilled door opening of the north wall.

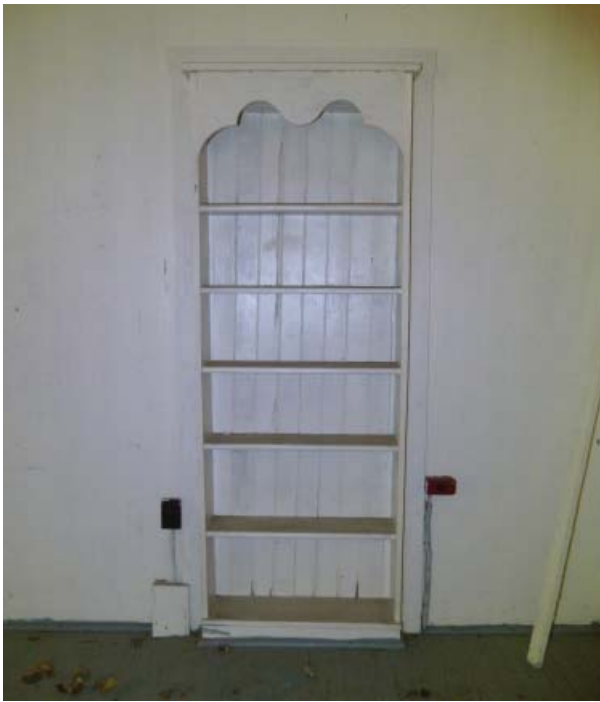
The walls are finished in 7/8” by 3½” vertical wood boards. There is a bookshelf on the south wall where a doorway has been patched (Fig. 67). The size and location mirror the doorway at the

Figure 67. South wall bookshelf in Room 102 covers original doorway to Room 101b.

The bookshelf on the south wall sits in front of a patched doorway to the Southeast Bedroom (Room 101b); the door casing remains intact and is visible around the perimeter of the shelving (*Fig. 67*). The casing is made of wood plank boards that measure $\frac{7}{8}$ " by $4\frac{3}{4}$ " and are lintel cut with 1" ears. The bookshelf is wood with six shelves and measures 2'-5" wide by 6'-5" tall.

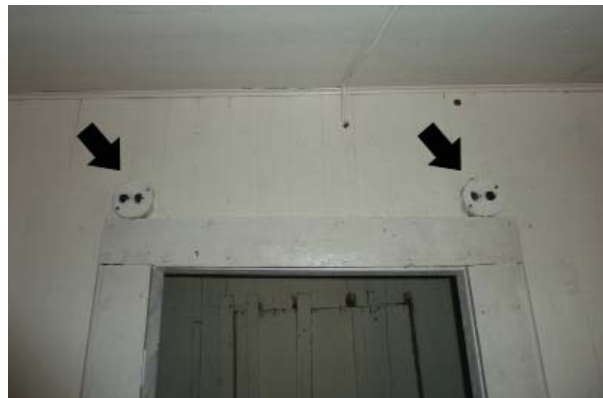
Figure 69. Duplex outlets mounted above the doorway on the west elevation, Room 102.

Above the west doorway are two surface-mounted duplex outlets with 4" diameter metal covers; they are fed with vinyl-wrapped wire (*Fig. 69*). There is a 250 volt three-prong outlet on the south wall with in a red box and a phone jack on the west wall. On the east wall near the doorway is a surge protector for telephone equipment.

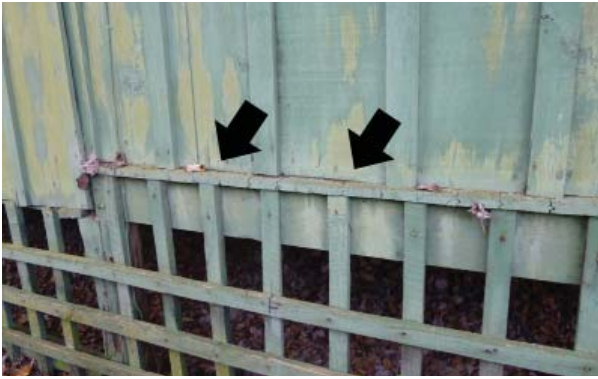
This space began as a porch at the north elevation of the main cabin block. When later enclosed to increase interior living space the siding of the original north wall of the main block was relocated to the north end of the porch. The porch flooring remains exposed on the exterior north elevation below the board-and-batten siding (Fig. 74). This room is open to the Living Room (Room 102) to

Figure 74. Early porch flooring extends beyond north wall of Room 104.

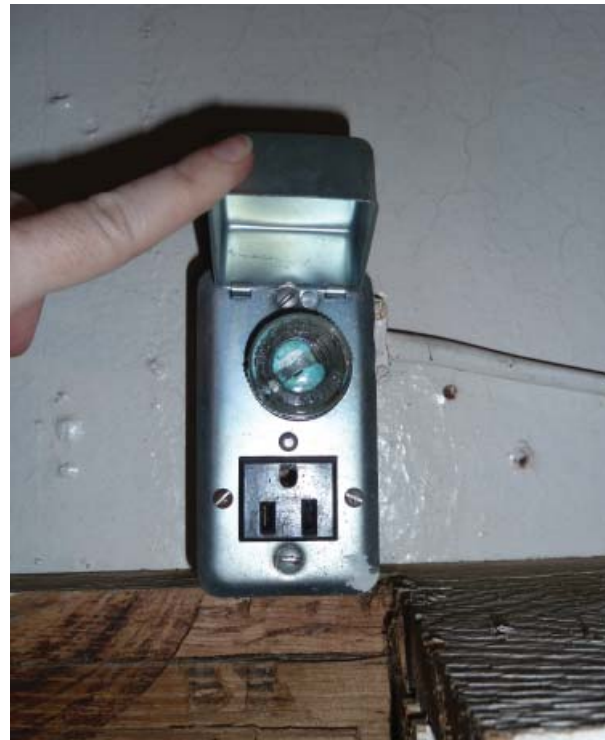
On the north wall, east of the sink, there is a surface-mounted duplex outlet with a brown molded plastic cover plate. Higher up on the north wall, west of the sink, there is a surface-mounted three-prong outlet with a fuse above (*Fig. 82*). It has vinyl-wrapped wire.

Figure 82. A three-prong outlet with fuse on north wall of Room 105.

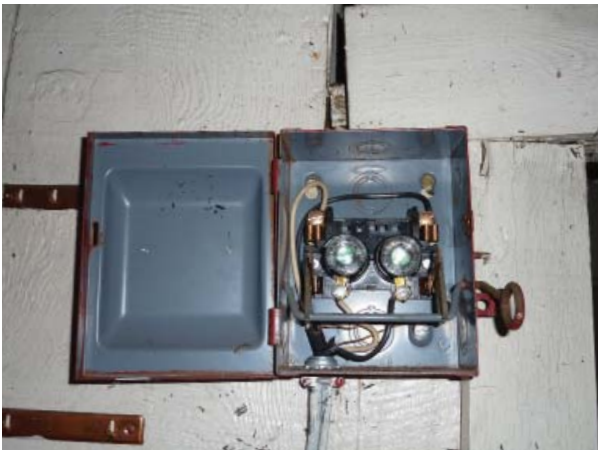
Figure 83. Fuse box on the south wall of Room 105.

manufacturer's name is Leviton. It has black vinyl-wrapped non-metallic sheathed cable that is labeled Type NM 600V. East of the doorway on the south wall is a three-prong outlet that is 20 amps/ 250 volts, manufactured by PNS. It has a metal box. West of the doorway on the south wall is another three-prong outlet that is 50 amps/ 250 volts, manufactured by Knox. It has a plastic box. There is a 30 amp/ 125-250 volt fuse box, manufactured by Wadsworth, located higher up on the south wall east of the doorway (*Fig. 83*).

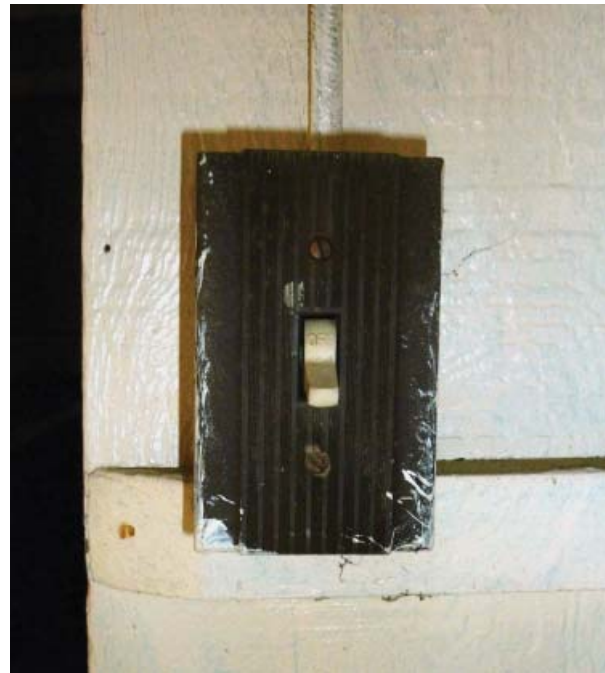
Figure 87. Light switch with mid-twentieth century brown plastic plate on the east wall of Room 106.

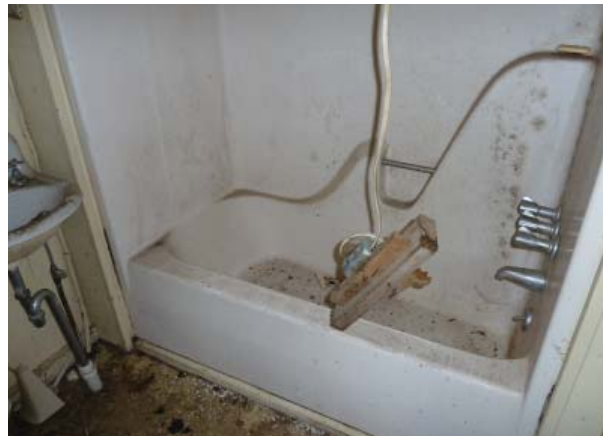
This room was likely enclosed early, at the same time as the Half-Bathroom (Room 107). It has recently been updated with the addition of a modern molded plastic shower unit. Rectilinear in plan, the room measures about 6’-4” by 6’-0”.

Figure 96. Modern molded plastic shower unit of Room 108.

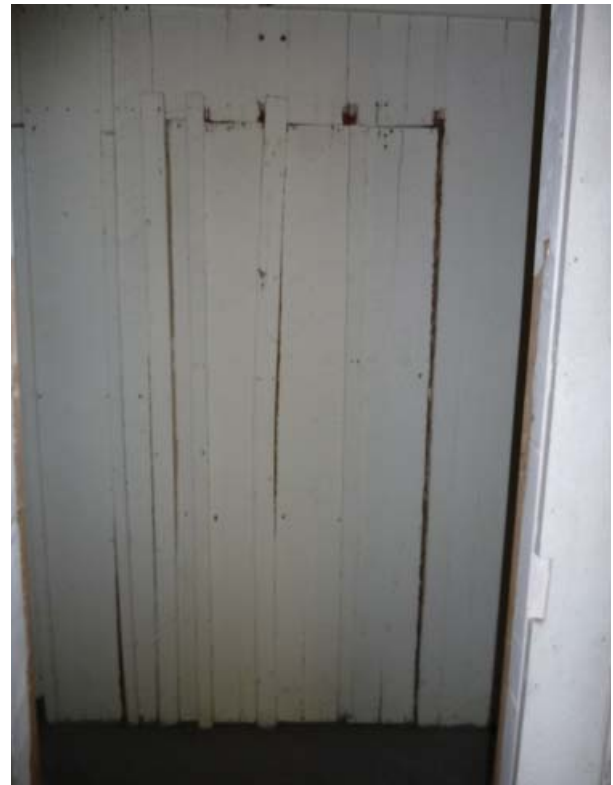
There are seams in the west wall where it was cut open to allow for the installation of the molded

Figure 98. West wall of Room 109a with seams for an opening to allow for installation of the tub in Room 108.

plastic shower unit (*Fig. 98*). The filled-in opening measures 2'-10" wide by 6'-7" tall.

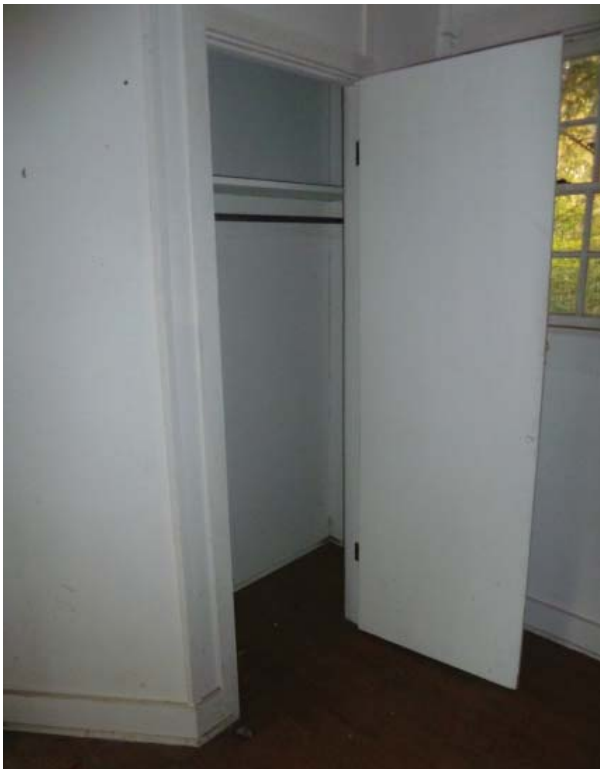
Figure 106. North closet of Room 111.

forming what feels like a central bay window. Each closet has two shelves along the diagonal wall that are 1'-7½" deep, a ¾" diameter steel pipe clothing bar set 5'-1" above the finished floor, and a 12" deep top shelf that is set 5'-6" above the finished floor (Fig. 106).

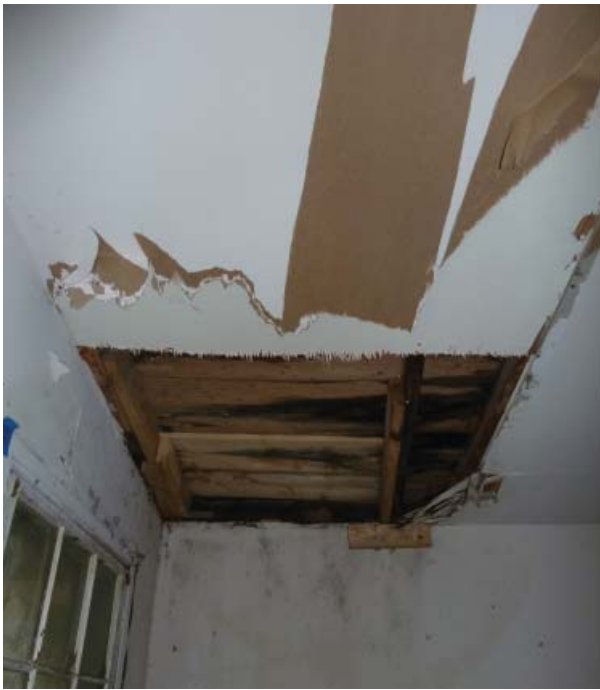
The ceiling is finished in 3/8" gypsum board that has been installed over ¼" plywood. The ceiling is in poor condition and the roof rafters are exposed in the southwest corner of the room. The rafters and

Figure 112. Exposed roof rafters and decking in the ceiling of Room 112.

decking are modern; the rafters measure 1½” by 3½” and the decking is made of 5¼” tongue-and-groove boards.
