National Park Service
U.S. Department of the Interior

Harry S Truman National Historic Site
Missouri

Truman Home

Cultural Landscapes Inventory

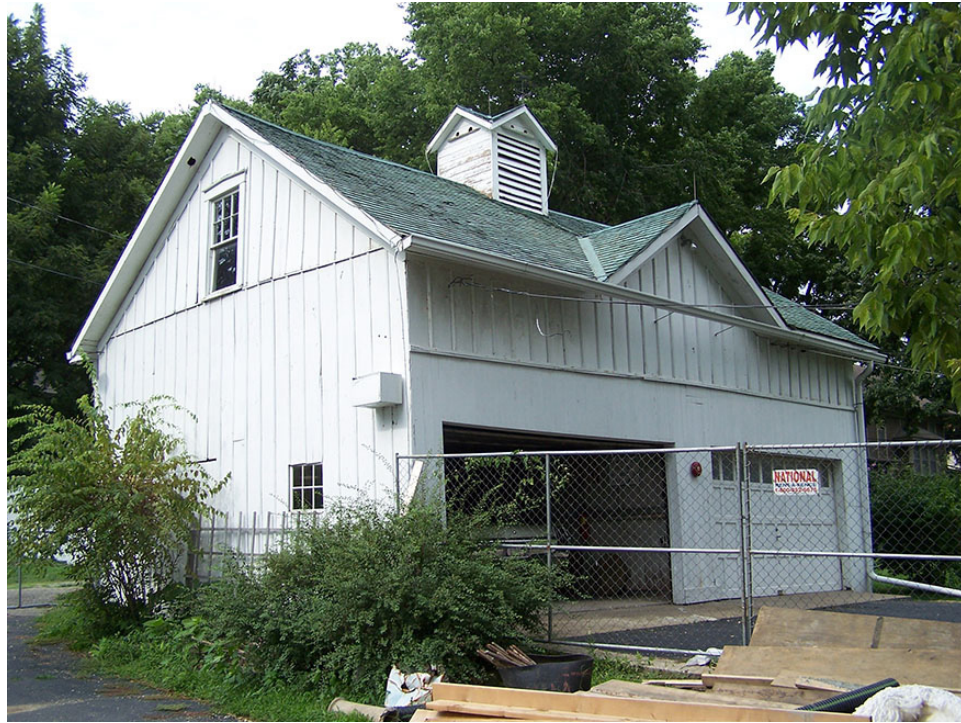
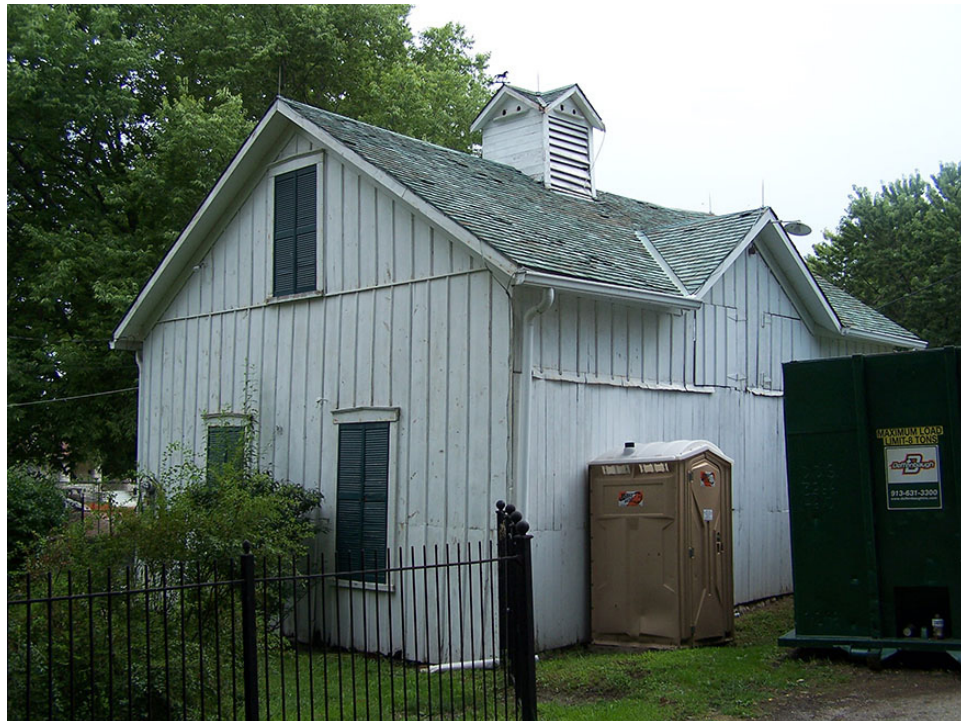
Carriage House: The carriage house behind the Truman home served as Mr. Truman's garage. His last car, a 1972 Chrysler, is housed in it currently. At one time, the Secret Service used the building for security purposes. Built in 1868, and altered in 1875, it is approximately 24 feet by 32 feet. It is a one and one-half story timber framed, two-bay carriage house with white vertical sheathing. It has a poured concrete slab floor. The gable roof is sheathed in wood shingles, and there is a square cupola centered at the ridge. There is also a bronze weathervane perched on top. There are overhead rolling garage doors, with loft doors at the main gable ends. Two six-pane windows with shutters are in the east and west facades. Structural problems currently include shifting of the building, and as a result it is pulling itself apart. The columns in the east end are dropping and putting stress on the garage. It is currently in fair condition (LCS records, 2004).

Truman Carriage House, looking southwest (LCS 2013)

Truman Carriage House, looking northeast (LCS 2013)

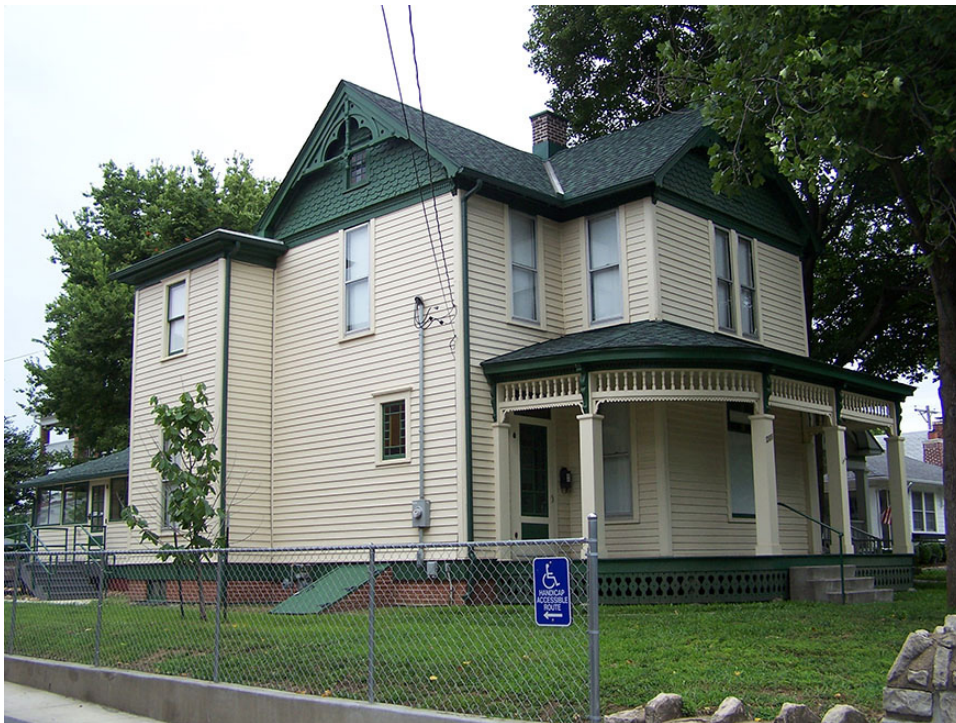
Noland House, looking northwest (LCS 2013)

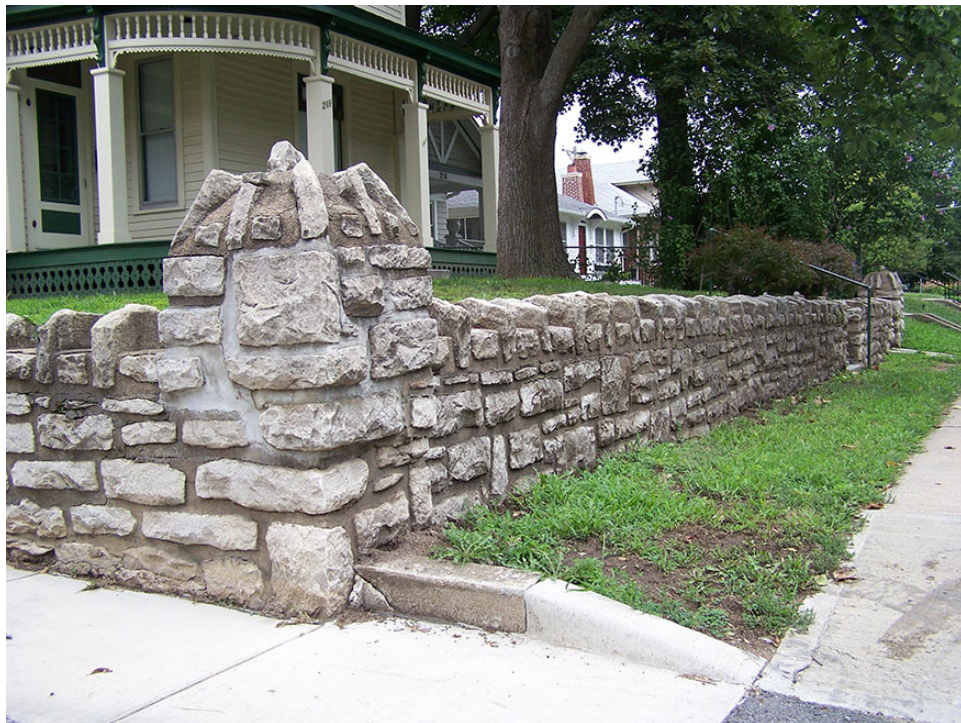
Retaining Wall: The fieldstone wall along the east sidewalk of the Noland lot is two feet six inches high, and 56 linear feet long. The stone is laid with mortar and has four piers with tapered tops at the corners. The top course has regularly spaced alternating horizontal and vertical stones. The south corner post was repaired in September 1992. It is in good condition (LCS records, 2004).

Noland House Retaining Wall, looking northwest (LCS 2013)

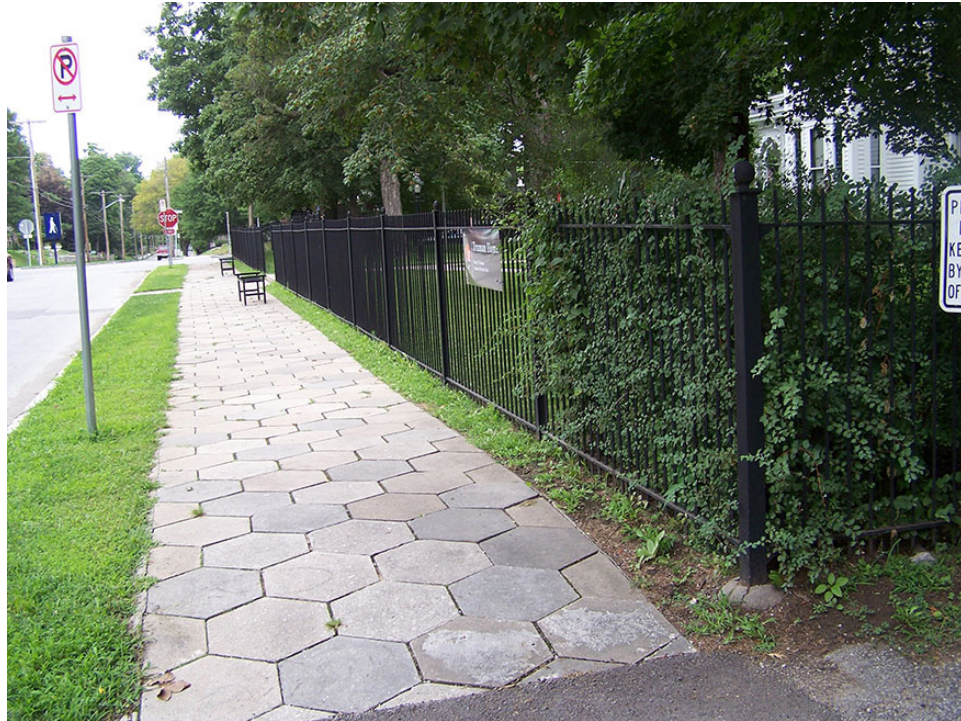
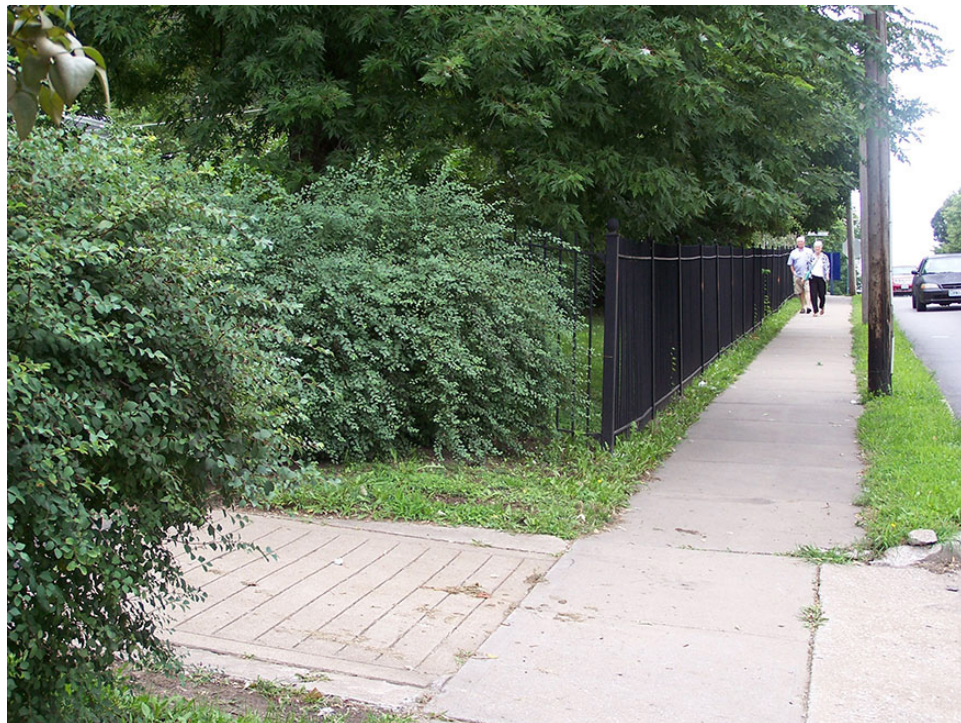
Fence: The wrought iron and steel fence was installed by the Secret Service in 1949 to provide protection for the Truman family. The original cost was \$5400. It surrounds the Truman home on the north, south, and west sides. The fence is in good condition (LCS records, 2004).

Truman fence, looking north (LCS 2013)

Truman fence, looking west (LCS 2013)

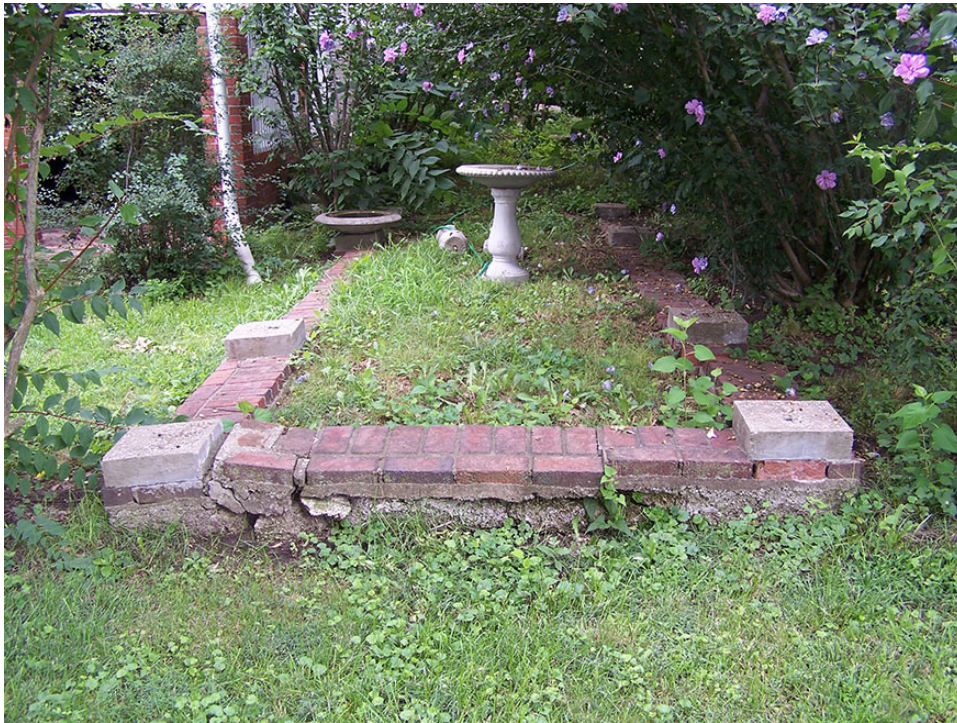
Pergola foundation: The pergola was built around 1924 to accent the rose garden planted by Mr. Truman's mother-in-law, Madge Wallace. There remains a rectangular stone base with brick edging. The pergola originally had eight Doric hollow wood columns. Some of the brick pavers are missing. It is in good condition (LCS records, 2004).

Truman House Pergola Foundation looking West (LCS 2013)

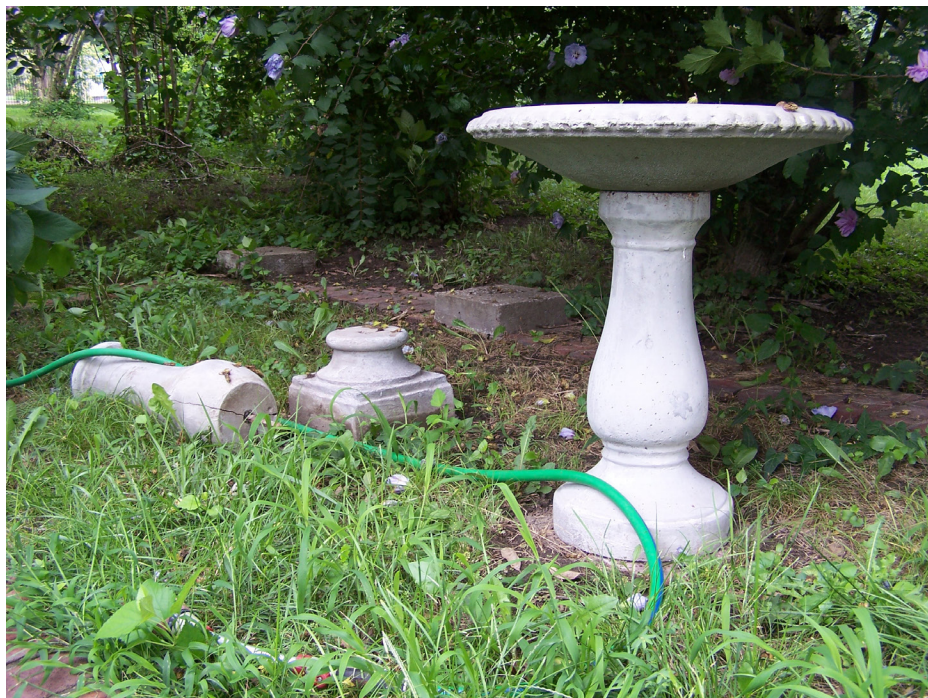
Birdbath: The birdbath was installed in 1920, and had a limestone circular base. In 1994, it was repaired and replaced in the original location. It is in good condition (LCS records, 2004).

Truman Home Birdbath, looking Northwest (LCS 2013)

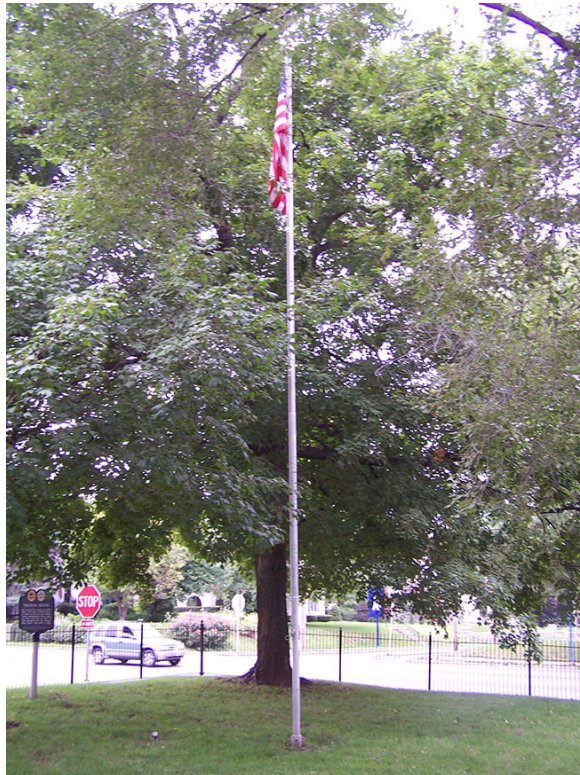
Flagpole: The flagpole was installed in 1945 by the City of Independence to commemorate President Truman's first homecoming as president in June 1945. It is in the northwest corner of the front yard, standing 35 ½ feet tall, set in cement. It is in good condition (LCS records, 2004).

Truman Home Flagpole, looking North (LCS 2013)

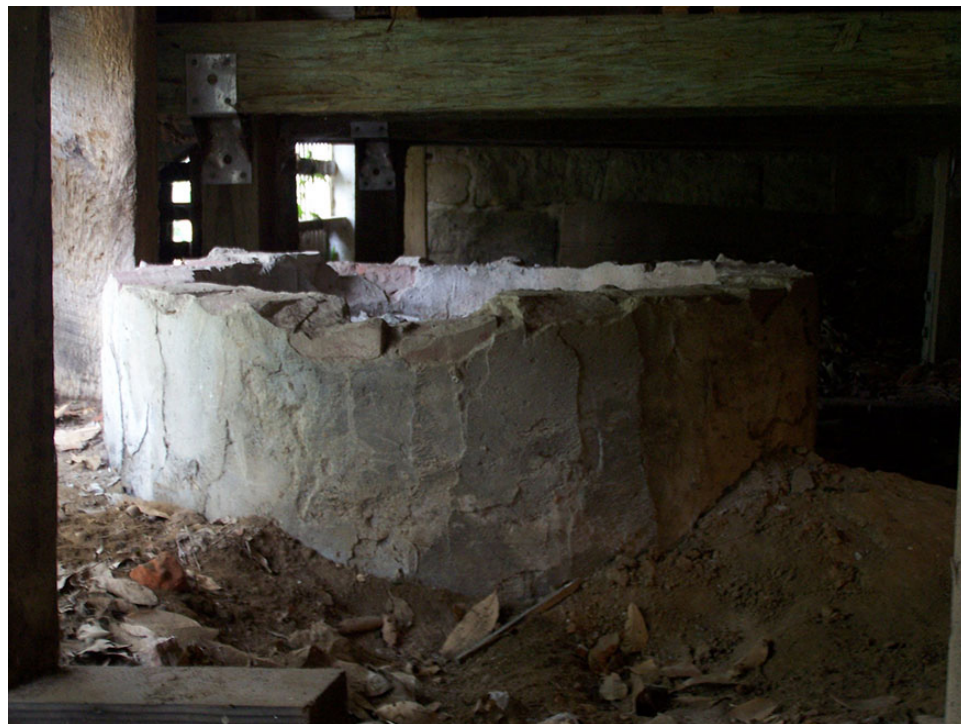
Cistern: The cistern was installed in 1850 to serve as the family's first water supply. It is a subgrade brick cistern beneath the kitchen porch. It was capped with concrete in 1926 due to fear of contamination. It is in good condition (LCS records, 2004).

Truman Home Cistern, looking West (LCS 2013)
