KALAUPAPA BUILDING INVENTORY

KALAUPAPA - HAWAII

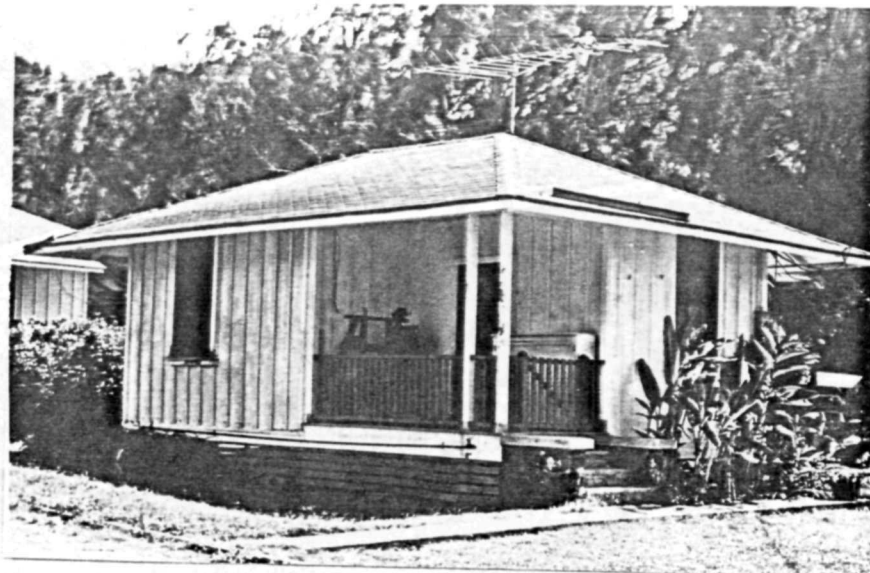
STRUCTURE: Building 1

DESCRIPTION: The structure is a one-story building of single wall construction (board and batten), with a concrete pad and post foundation. The hip roof is finished with composition shingles. Concrete and stone steps provide access to the recessed corner porch which is incorporated under the hip roof. The wood window frames of the 12-light double hung windows project several inches from the exterior wall. A wash house section, constructed on a concrete slab and with a shed roof, is located at the rear of the T-shaped structure. The building is occupied, and is in good condition, although in need of painting (particularly window sills)

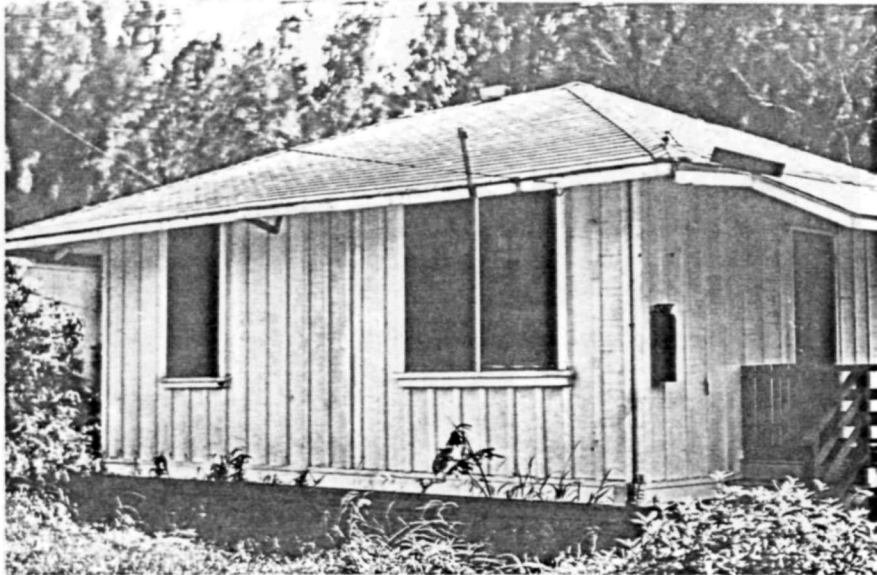
STRUCTURE: Building 2

DESCRIPTION: The one-bedroom structure is a one-story building of single wall construction (board and batten), with a concrete pad and post foundation. The hip roof is finished with composition shingles. A small wooden porch with a shed roof is located at the west side of the building. The wood window frames of the 12-light double-hung windows project several inches from the exterior wall. A wash house area, constructed on a concrete slab and with a shed roof, is located at the rear of the T-shaped structure. The building is assigned to a patient, but is presently unoccupied. The structure is in poor condition. Vegetation should be cleared from the base of the structure. The building should be fumigated, boards deteriorated by termites should be replaced, and the structure painted.

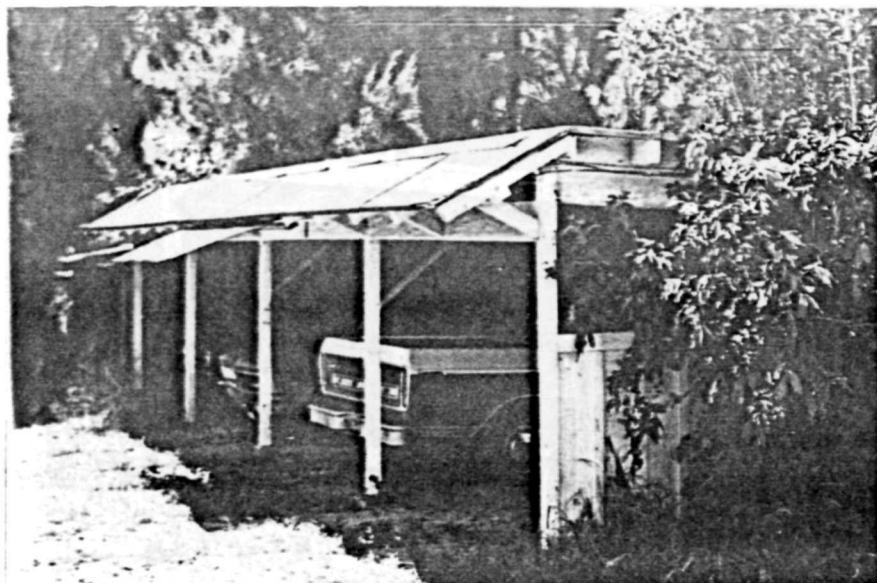
STRUCTURE: Building 3

DESCRIPTION: The structure is a one story garage, of single wall construction. The foundation is concrete; the floor is dirt. The shed roof is finished with rolled composition roofing. The building has a private one room addition which has been constructed at the southeast corner. The building is in poor condition, but should be maintained until it is no longer needed or until it becomes a hazard, at which time it should be removed.

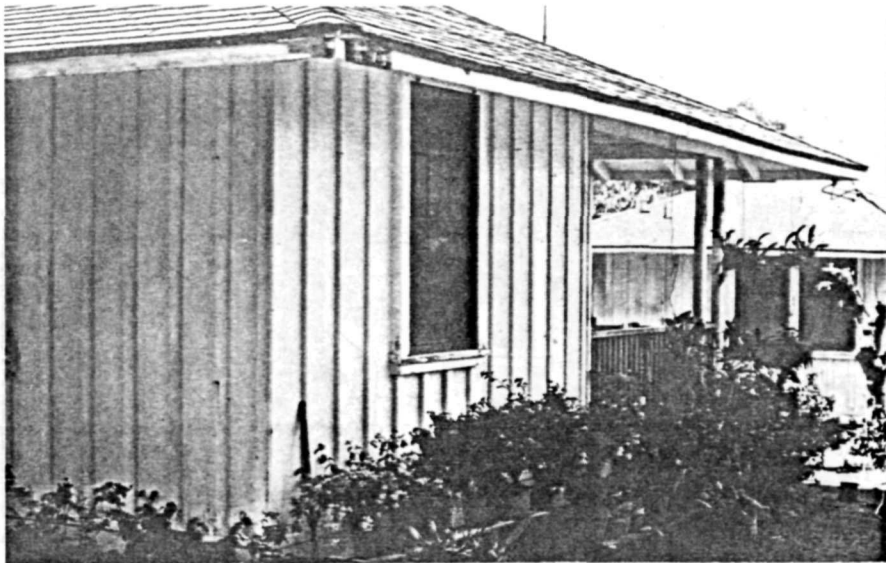
STRUCTURE: Building 6

DESCRIPTION: The structure is a one-story building of single wall construction (board and batten), with a concrete pad and post foundation. The hip roof is finished with green composition shingles. Steps on the west side of the structure provide access to the recessed corner porch which is incorporated under the hip roof. The wood frames of the 12-light double hung windows project several inches from the exterior wall. An exterior washroom, constructed on a concrete slab and with a shed roof, is located at the rear of the T-shaped structure. The building is occupied, and in fair condition. The structure is in need of painting, fumigation and minor board replacement. Vegetation should be cleared from the base of the structure to discourage further rot and termite damage.

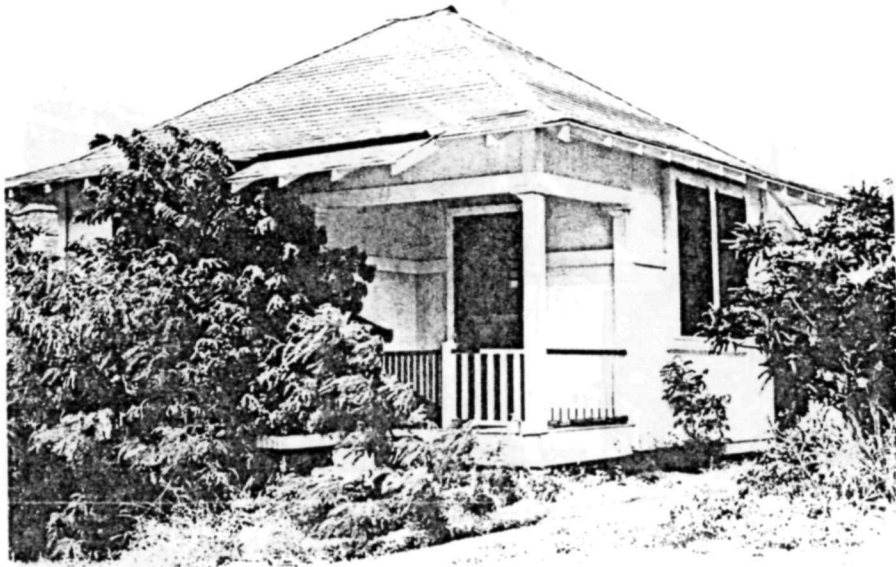
STRUCTURE: Building 11

DESCRIPTION: The structure is a one-story building of single wall construction, with a pad and post foundation. The hip roof is finished with red composition shingles. Concrete and stone steps provide access to the recessed corner porch which is incorporated under the hip roof. The post and pilasters articulating the porch corners are chamfered. Other corners of the structure are finished with cornerboards. The wood frames of the 12-light double-hung windows project several inches from the exterior wall. A broken girt encircles the exterior. A partially enclosed exterior washroom, constructed on a concrete slab and with a shed roof, is located at the rear of the rectangular structure. The structure is assigned to a patient, but presently is vacant. The building is in good condition, although in need of some foundation work, minor board replacement, fumigation and touch-up painting.

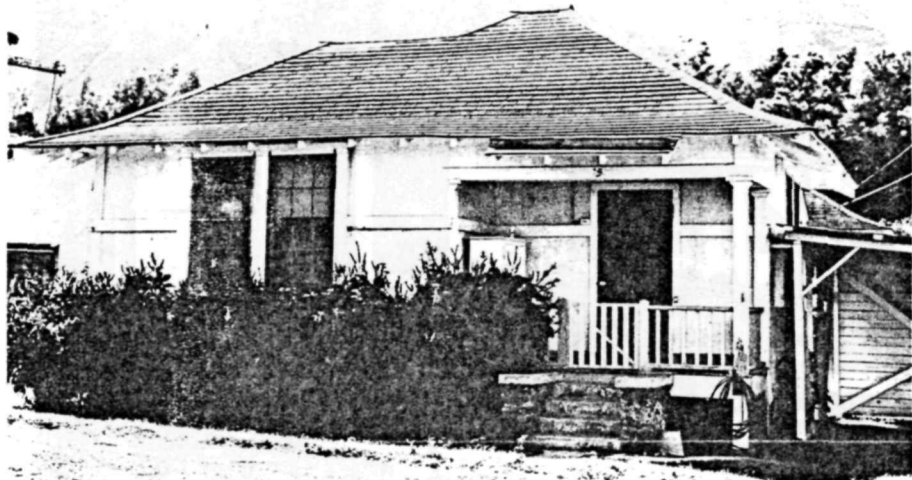
STRUCTURE: Building 15

DESCRIPTION: The structure is a one-story building of single wall construction, with a concrete pad and post foundation. The irregularly-shaped hip roof has a broken pitch, and is finished with composition shingles. Concrete and stone steps provide access to the recessed corner porch which is incorporated under the hip roof. A post and two pilasters articulate the edges of the porch. Other corners of the structure are finished with cornerboards. The wood frames of the 12-light double-hung windows project several inches from the exterior wall. A broken girt encircles the exterior. A frame carport with a shed roof has been added to the west side of the structure. The building is in fair condition, although in need of lumber replacement particularly in the foundation, painting and fumigation. The structure is occupied.

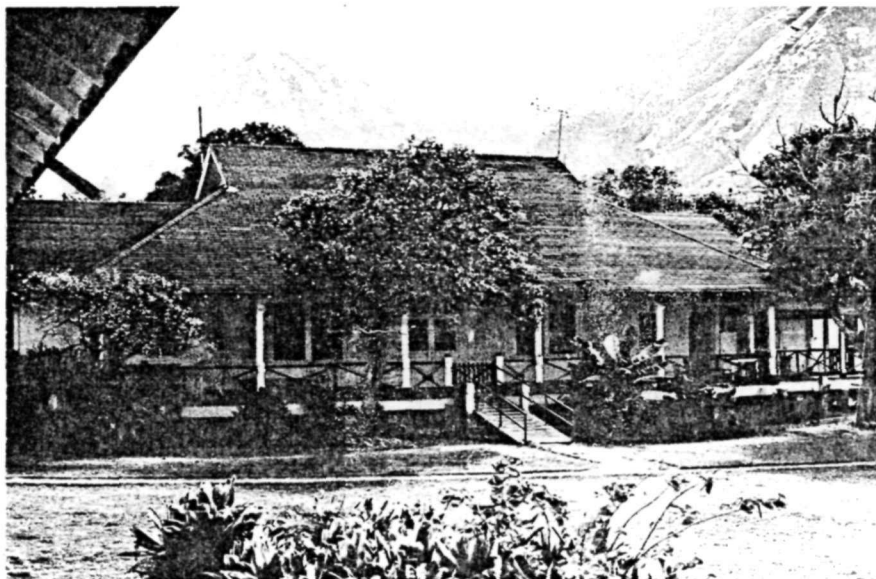
STRUCTURE: Building 2

The plan is generally symmetrical: a main section with a veranda is flanked by two smaller wings to the north and south, and a third wing to the east (rear). The dominant architectural feature of the building is the combination of intersecting hip roofs, all with louvered gables for ridges. Another louvered gable projects from the roof directly above the main entrance to the building. The veranda which is recessed under the main roof is bordered by a diamond-patterned railing and chamfered posts - some with jigsaw bracketing. The foundations consist of concrete piers. The main set of concrete steps (edged with concrete posts) have been covered with a ramp to make access to the building easier for some patients. The walls consist of vertical plank siding. Windows are usually double-hung, twelve light. The building is connected to Building 5 and 3 by a covered walkway which was constructed attaching the verandas. The walkway probably dates from the 1930's. The structure is in poor condition. The building should be fumigated, and termite damage repaired. The foundation should be rebuilt. The structure should be painted, and the building should be re-roofed eventually with the original shingles. For more detailed description of the work, see construction estimate sheets.

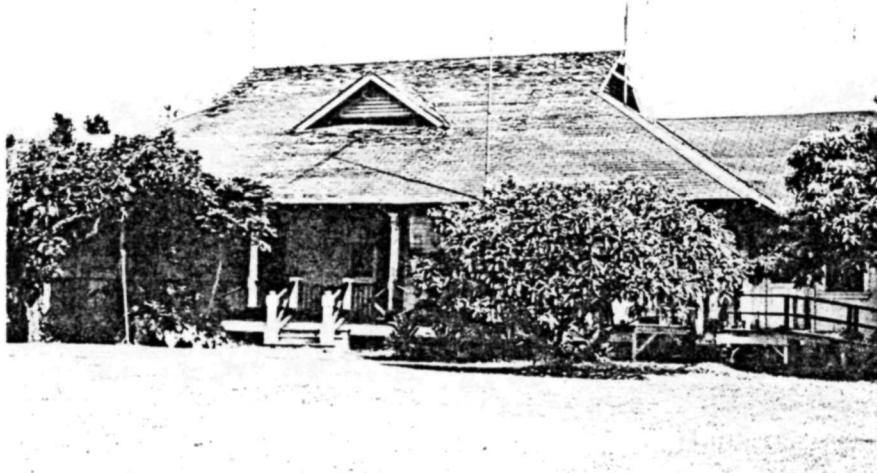
STRUCTURE: Building 3

Another louvered gable projects from the roof directly above the main entrance to the building. The veranda which is recessed under the main roof is bordered by a diamond-patterned railing and chamfered posts with jigsaw bracketing. The foundation consists of concrete piers. Concrete steps with concrete and wood railings serve as the major entrance to the building. A wood ramp replacing the concrete steps on the south side of the structure has made access to the building easier. The walls consist of vertical plank siding. Windows are usually double hung, twelve light. The building is connected to Building 2 and 5 by a covered walkway which is an extension of the veranda. The structure is in poor condition. The building should be fumigated, and termite and rot damage repaired. The foundations should be rebuilt. The structure should be painted, and eventually re-roofed with the original wood shingles. For more detailed description of work needed, see cost estimated sheets.

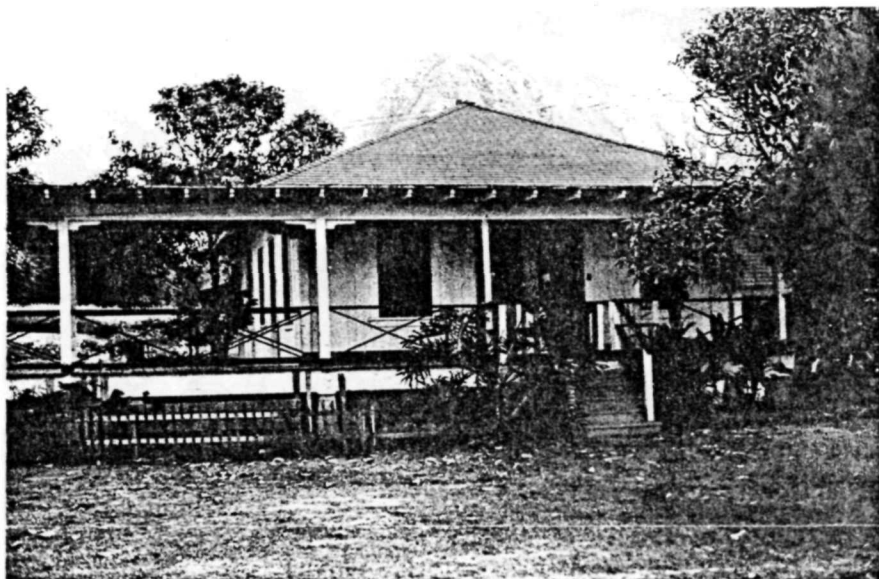
STRUCTURE: Building 5

DESCRIPTION: The structure is a frame building of single wall construction. The foundation consists of concrete piers. Walls are vertical plank siding, with corners finished with cornerboards. The hip roof is finished with composition shingles. The wood frame windows are double hung, usually twelve-light. A water table encircles the sole plate of the building. A covered walkway which connects this building with the verandas of Buildings 2 and 3 runs across the front of the structure with a diamond-patterned railing. At the rear of the building (east) is a recessed corner porch with a concrete slab floor. The building is used daily, and is in fair condition. Termite damaged areas should be repaired. The building should be fumigated and grade cleared.

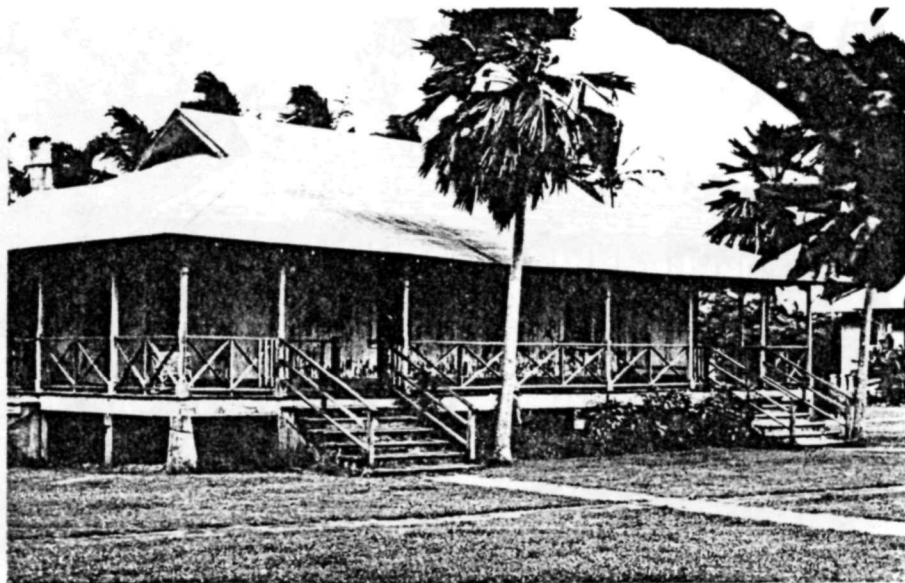
STRUCTURE: Building 6

DESCRIPTION: The structure is a frame building of single wall construction. The foundation consists of concrete piers. The symmetrical structure has a main section, with one wing nearly as large at the rear (west). The dominant architectural feature of the building is the combination of the intersecting hip roofs, with louvered gables at the ridges. The veranda wraps around three sides of the main building section is bordered by a diamond-patterned railing and chamfered posts with jigsaw brackets. The wing at the west side of the building (partially or all an addition?) is constructed on poured concrete and smaller concrete footings. Four sets of steps provide access to the veranda for the north (1), east (2) and south (1). The walls are vertical plank siding. Windows are usually double hung (twelve light). The building is in poor condition. The foundation, siding, roof, chimney, as well as other major parts need repair. The building should be painted, interior and exterior. When the structure needs re-roofing again, the original material should be replaced (wood shingles). The building should be fumigated. For further details, see cost estimate sheets.

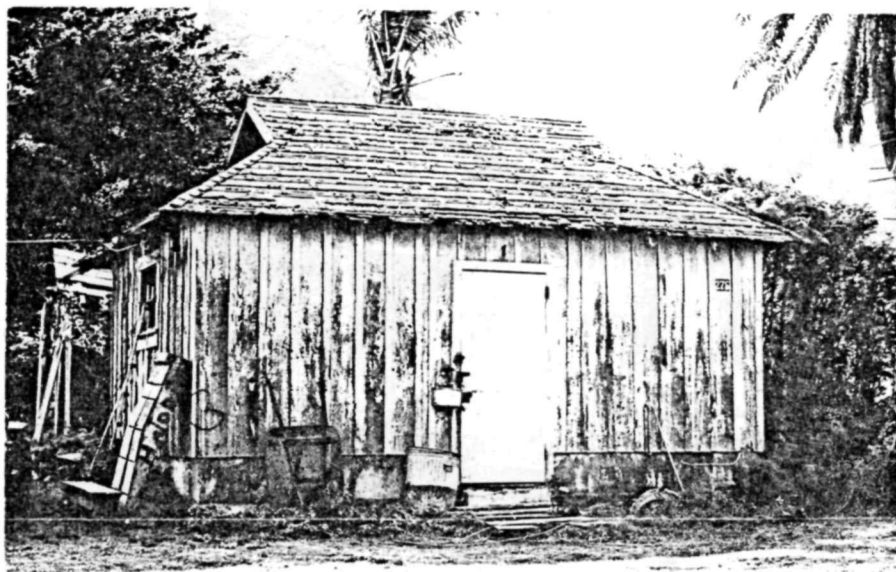
STRUCTURE: Building 7

DESCRIPTION: The structure is a frame building of single wall construction, with a board and batten exterior finish. The foundation is a concrete slab. The hip roof has lowered gables at the ridge lines. The roof is finished with wood shingles. The building is in very deteriorated condition.

SIGNIFICANCE: Good small scale and combination of architectural elements. However, the building is beyond repair. According to one patient, the structure was a store at one time, where "you could get good deals." Another patient stated that the building was the washhouse for Bay View. The numbers "278" appear on one wall, as well as "7" above the door.

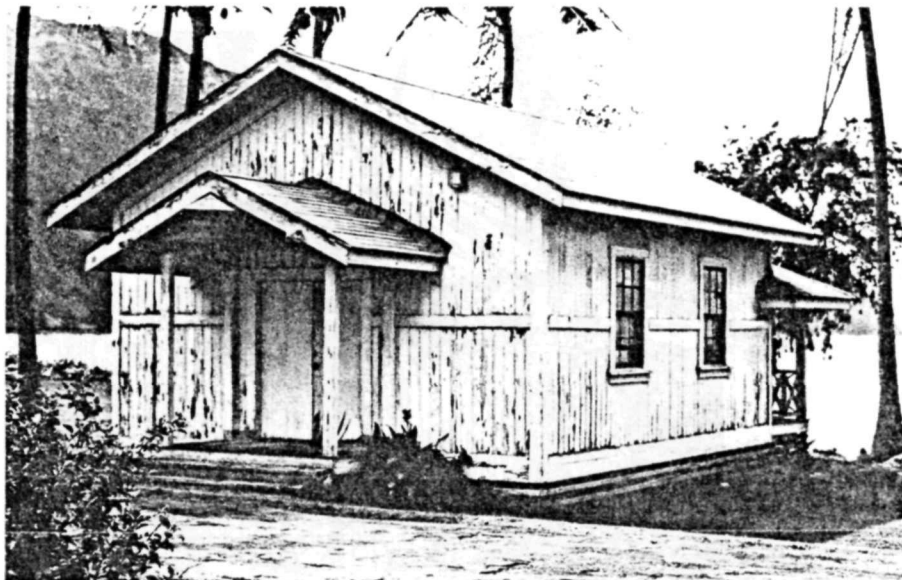
STRUCTURE: Building 8

DESCRIPTION: The structure is a frame building of single wall construction. The foundation is mainly stone footings and wood posts. The gable roof is finished with composition shingles. A portico sheltered by a small gable roof is located at the front (east) of the building. A corner porch and an enclosed addition (?) are covered by a hip roof at the rear (west of the building). The porch is bordered by a diamond-patterned railing and chamfered posts and pilasters. The addition is constructed on a concrete slab. A girt, broken by the wood frame of the twelve-light double hung windows and by the door frames, encircles the structure. A water table surrounds the sole plate. The corners of the building are finished with cornerboards. The building is in fair to poor condition, and is used for storage. Some wood needs replacement due to rot and termite damage. The building should be painted. Vegetation should be cleared from the base of the structure. The building should be fumigated.

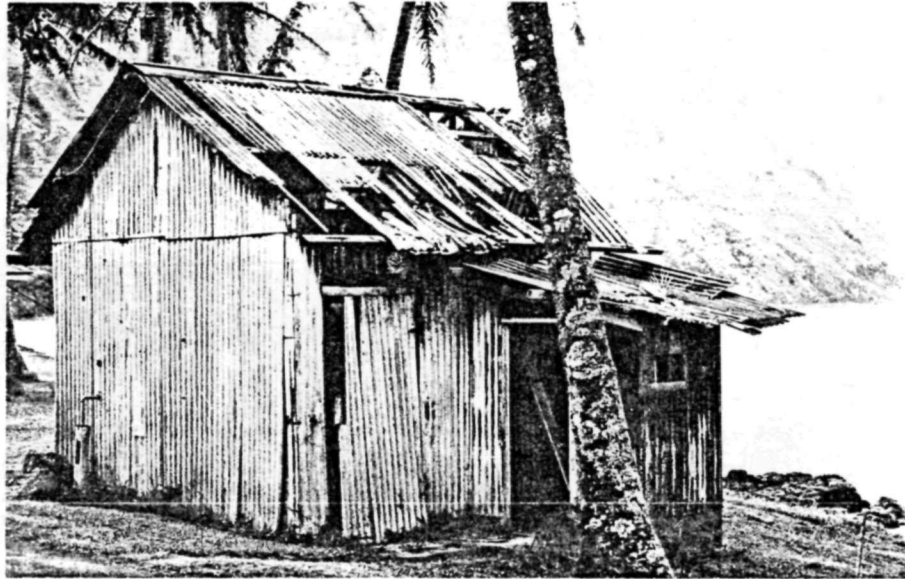
STRUCTURE: Building 9

DESCRIPTION: The structure is a frame building of single wall construction, with a concrete foundation. The walls and gable roof are covered with corrugated metal. The building is in very deteriorated condition, and immediate removal is recommended.

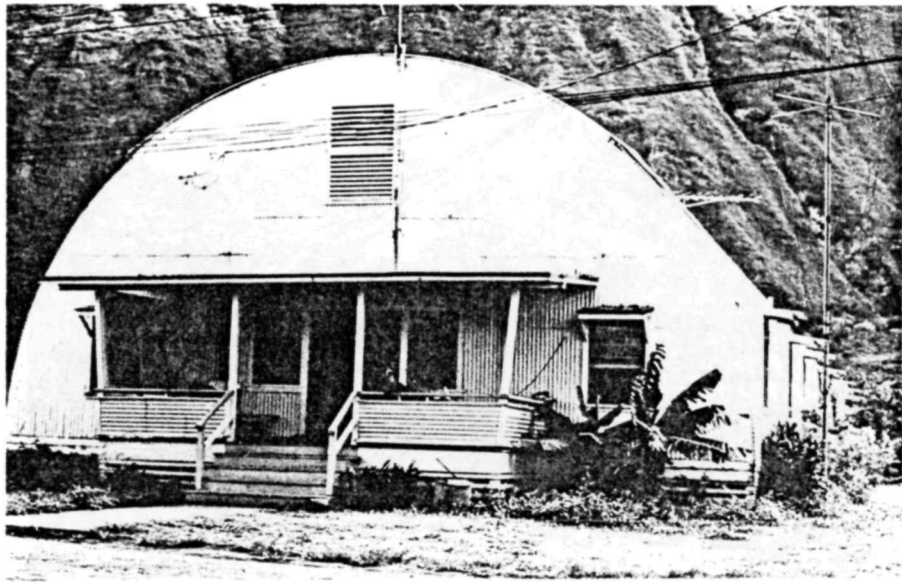
STRUCTURE: Building 10

DESCRIPTION: The structure is a large quonset hut constructed on a foundation of concrete footings and wood posts. The semi-cylindrical structure is covered with corrugated metal. Double hung windows, all sheltered by small shed roofs are evenly spaced along the long sides of the building. A frame porch with a shed roof is located on the north side of the structure. Metal ventilation louvers are located near the roofline at the east and west sides of the building. The structure is occupied, and in poor condition. To keep the building habitable, it should be fumigated for termites. Termite damage affecting the structure should be repaired. Vegetation should be cleared from the base of the building. The interior and exterior should be painted.

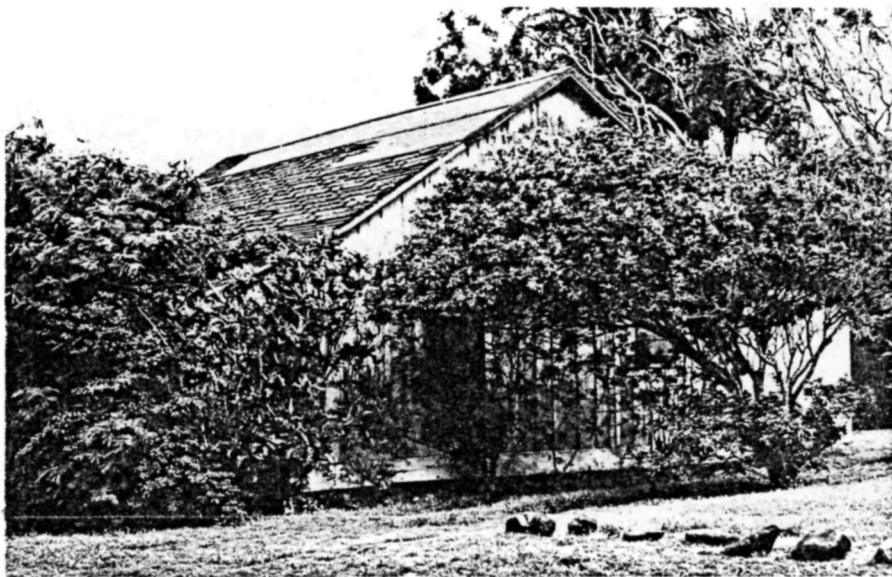
STRUCTURE: Building 10

DESCRIPTION: The structure is a frame building of single wall construction, with a board and batten exterior finish. The gable roof and shed roof extension are finished with the remains of rolled roofing material which had been applied over the original wood shingles. A recessed veranda, with a diamond-patterned railing runs one third of the length of the front of the structure. A partially enclosed washroom on a concrete floor is located at the rear of the building. The foundations for the rest of the structure consist of stone footings and wood posts. Rectangular louvers are located at the gable ends. The building is unoccupied, and in very deteriorated condition. Practically board-by-board reconstruction would be necessary to rehabilitate the building.

SIGNIFICANCE: This building could be one of the structures (whose location was inadequately pinpointed in the State Register) which dates back to the old Kalaupapa Settlement, before the official arrival of the patients to that side of the peninsula. The structure is an example of a simple, Hawaiian vernacular building type, although not an outstanding one. More research is warranted before demolition of the building, and before its eventual demise by termites and rot.

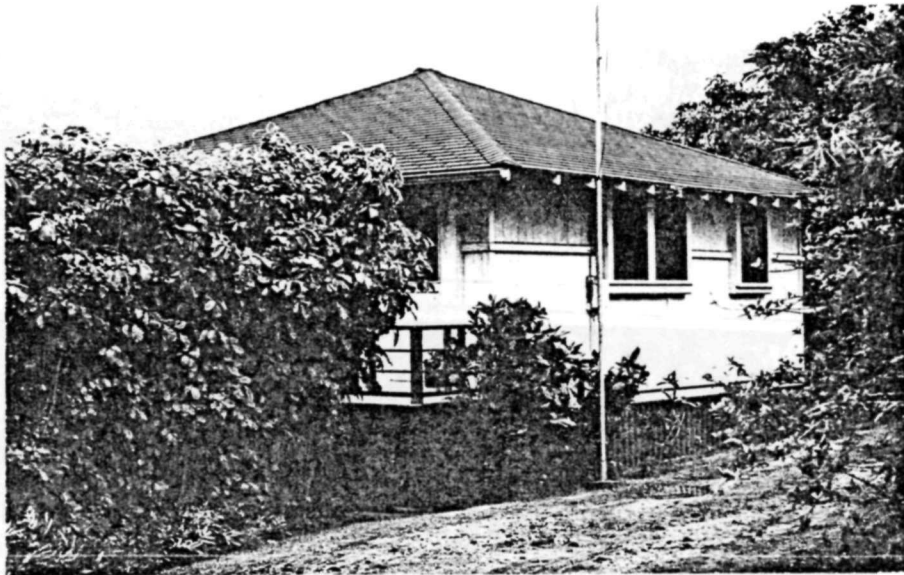
STRUCTURE: Building 11

DESCRIPTION: The structure is a frame building of single wall construction, with a concrete foundation. A recessed corner porch is incorporated under the hip roof in the southwest corner of the building. The corners of the building are finished with cornerboards. A girt encircles the structure, and is broken by the wood frame of the doors and the double-hung windows which project several inches from the exterior of the vertical plank wall. The hip roof is finished with composition shingles. A water table surrounds the sole plate. The concrete footing-and-wood posts foundation is camouflaged by a vertical wood strip skirting. (The poured concrete foundation of the basement washroom is not camouflaged). The building is occupied and in fair condition. Termite damage should be repaired. The building should be fumigated and painted. Vegetation should be cleared from the base of the building.

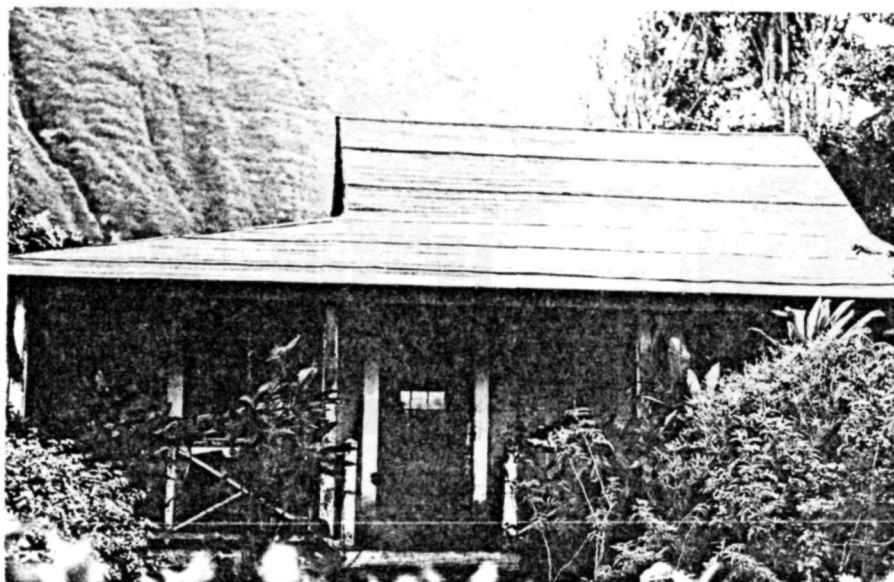
STRUCTURE: Building 63

DESCRIPTION: The structure is a frame building of single wall construction, with a board and batten exterior finish. The hip roof (with very large gablets) is finished with rolled roofing material, which has been applied over wood shingles. A veranda with a diamond-patterned railing runs the length of the front of the structure. The wood frame windows are double hung (twelve-light). The structure is occupied, and in deteriorated condition. To keep the building habitable some termite and rot damaged wood should be replaced. The building should be fumigated and painted.

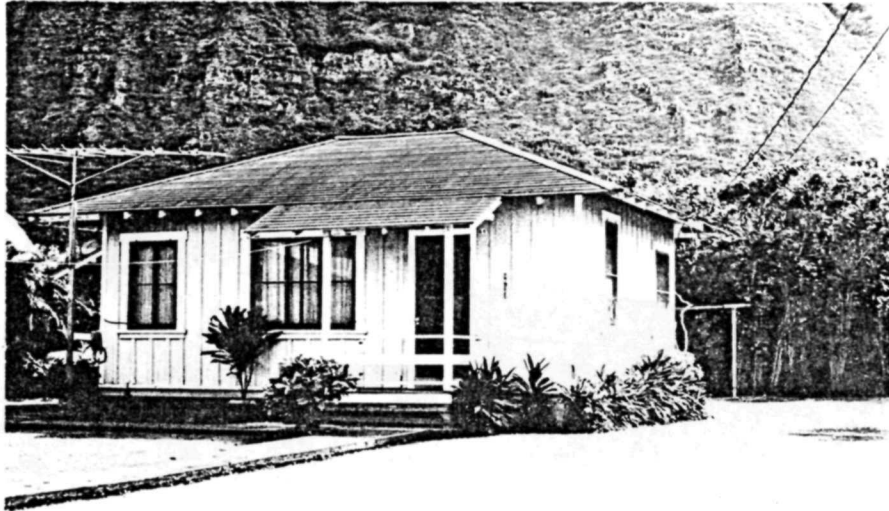
STRUCTURE: Building 64

DESCRIPTION: The structure is a frame building of single wall construction, with a board and batten exterior finish. The foundation is made up of stone and concrete footings and wood posts. The foundation is camouflaged by horizontal wood strips. The hip roof is finished with composition shingles. A partially enclosed wash room with a shed roof, is constructed on a concrete pad at the rear of the building. The building is occupied and seems to be in fair condition. The structure should be fumigated. Termite damaged wood should be replaced. Vegetation should be cleared from the base. The building should be painted.

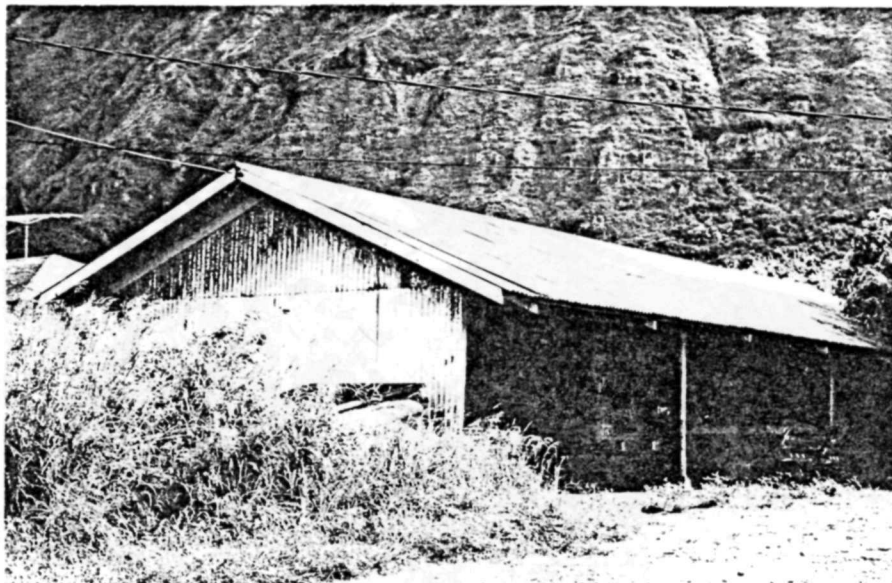
STRUCTURE: Building 512

DESCRIPTION: The structure is a frame and pole building, with a corrugated metal gable roof and corrugated metal walls. The floor is dirt. The foundation is concrete. The building houses 6 cars. The structure seems to be in fair condition.

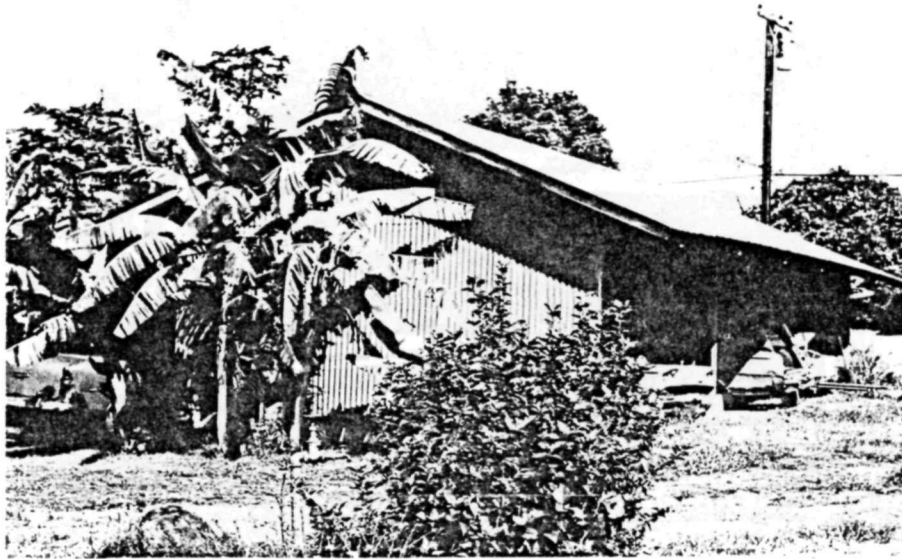
STRUCTURE: Building 513

DESCRIPTION: The structure is a frame and pole building, with a corrugated metal gable roof and corrugated metal walls. The floor is dirt. The foundation is concrete. The building houses 6 cars. A frame shed with a corrugated metal roof is attached to the rear of the building. The structure is used, and in poor condition. Termites have debilitated the structural wood so that the building is leaning.

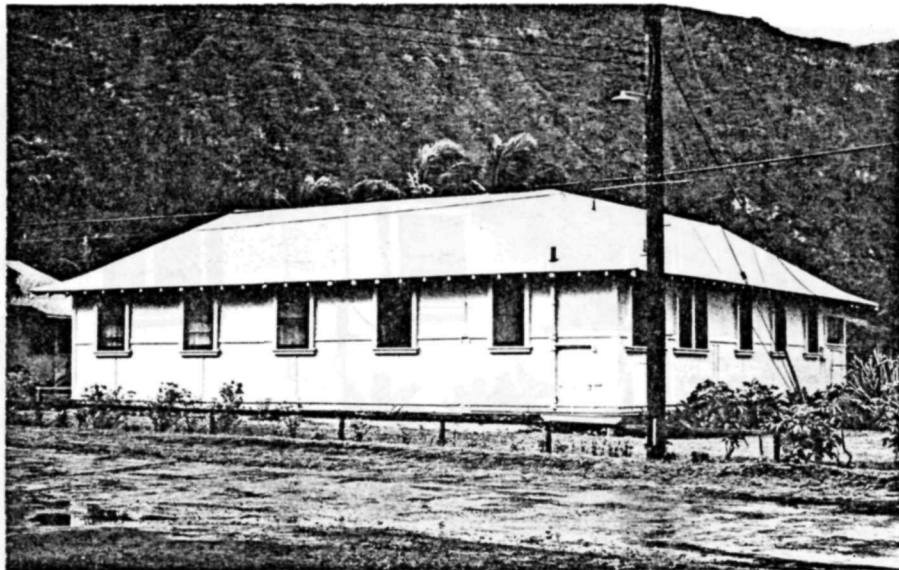
STRUCTURE: Building 274

DESCRIPTION: The structure is a frame building of single wall construction. The foundations consist of concrete footings and wood posts under most of the structure, and a concrete floor under the restroom areas. The hip roof of the L-shaped building is finished with composition shingles. A girt encircles the exterior of the structure is broken by the wood frames of the double hung windows, which project several inches from the exterior of the structure. A water table runs along the sole plate. A recessed screened veranda runs the length of the L-shaped building on the makai side. The building houses seven bedrooms for visitors. The structure was recently painted, and is in good condition. The building should be fumigated. Vegetation should be cleared from the base of the building. Any termite damage revealed in subsequent inspections should be repaired.

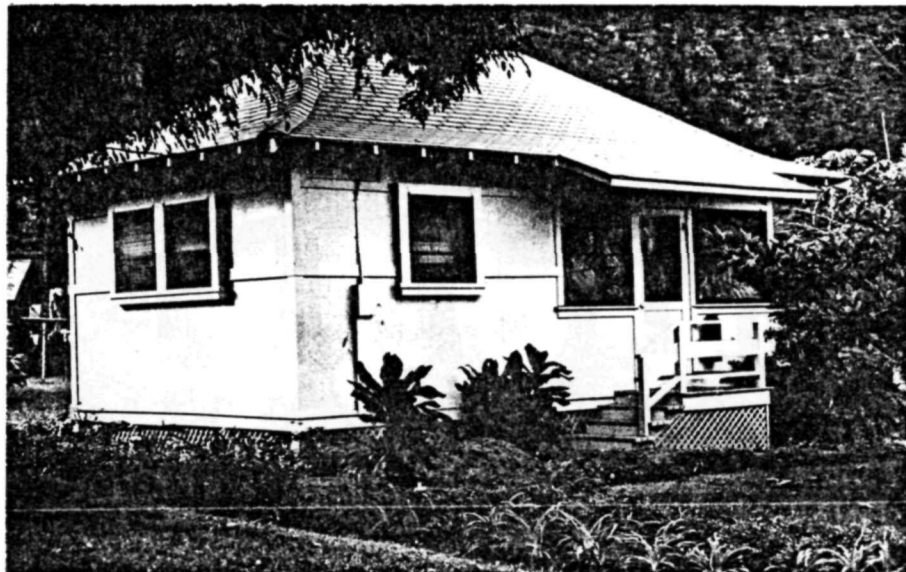
STRUCTURE: Building 275

DESCRIPTION: The structure is a frame building of single wall construction. Foundations consist of concrete pads and wood posts, separated by termite shields and camouflaged by a latticework skirting. The hip roof of the rectangular building is finished with composition shingles. The walls are vertical plank siding. The building is divided into two areas - an enclosed kitchen area, and a screened eating area. Two girts, broken by the wood frames of the double hung windows, encircle the exterior of the enclosed (kitchen) area. The corners of the building are finished with cornerboards. The sole plate is surrounded by a water table. The structure is used frequently, and is in good condition. Any termite damage should be repaired, and the building should be fumigated.

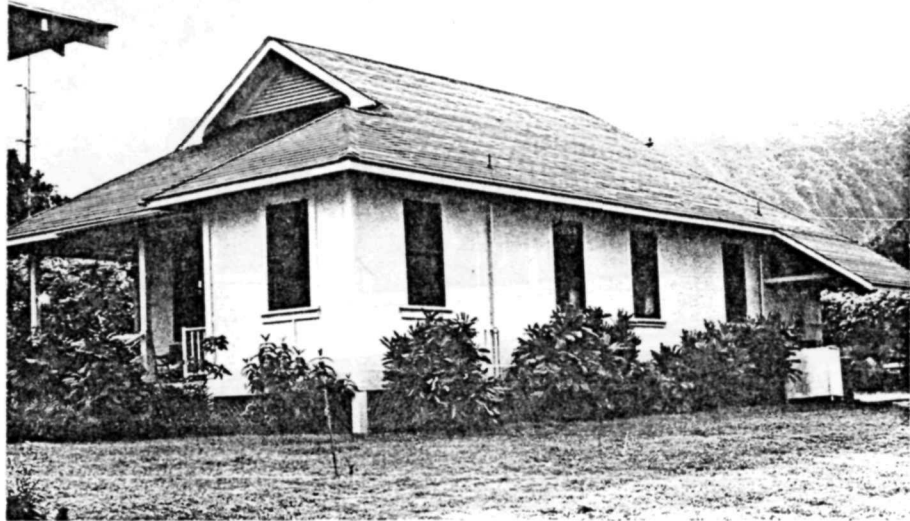
STRUCTURE: Building 277 (Wilcox Memorial Building)

DESCRIPTION: The structure is a frame building of single wall construction. The foundation consists of concrete and stone footings, and wood posts camouflaged by a latticework skirting. The walls are vertical plank siding. Corners of the structure are finished with cornerboards. A recessed corner porch with chamfered posts and diamond-patterned railing is incorporated under the hip roof in the northeast corner of the building. The hip roof has a louvered gablet for ventilation. A smaller hip roof which covered an addition to the building intersects the main roof in the west corner of the building. The wood frame windows are double hung (twelve-light). A shed roof extension in the south corner of the building shelters an open washing area. A small recessed porch is located at the rear (southeast) of the building. The structure is used and in good condition. The building should be fumigated, and any termite damage should be repaired. When a new roof is needed (the present roof seems to be in good condition), the original fabric (wood shingles) should replace the present fabric.

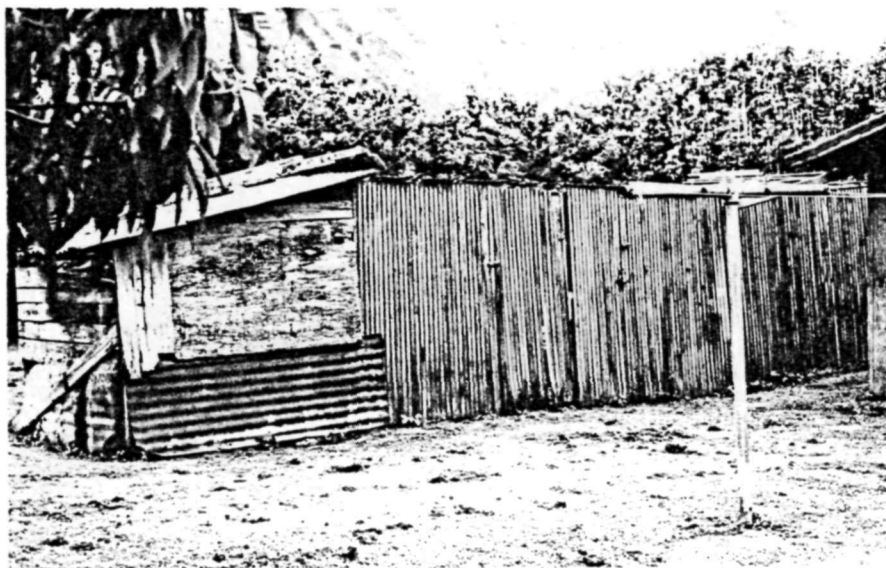
STRUCTURE: Building 543

DESCRIPTION: The structure is a frame building, on an uncertain foundation.

Other wall areas are finished with corrugated metal, horizontal planks, and plywood sheets. The shed roof are covered with the lath-size wood strips or corrugated metal. The structure is in poor condition.

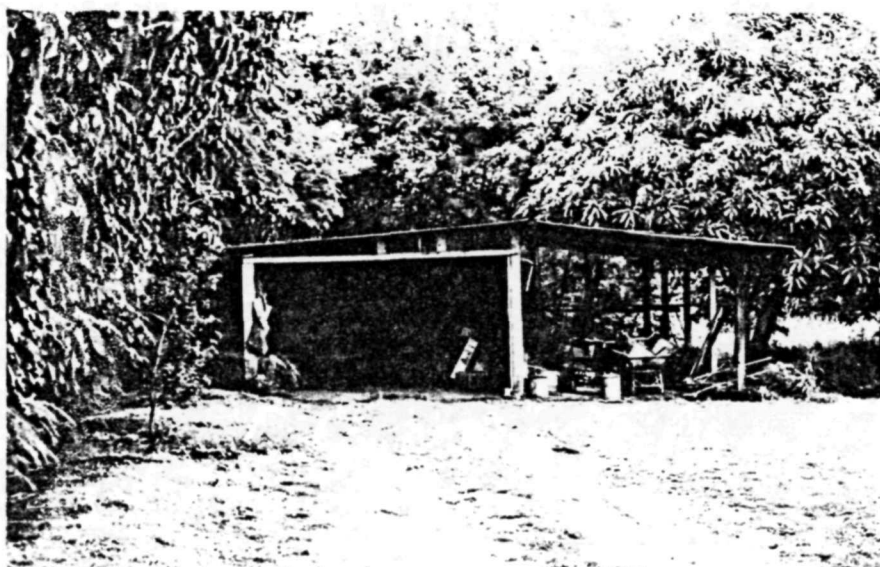
STRUCTURE: Building 544

DESCRIPTION: The structure is a frame building of single wall construction with a partial concrete foundation. The building is divided into two sections - an open section for storage and partially enclosed section for a garage. Any exterior walls have vertical plank siding. The low gable roof is covered with corrugated metal. The structure is used, and is in fair to poor condition.

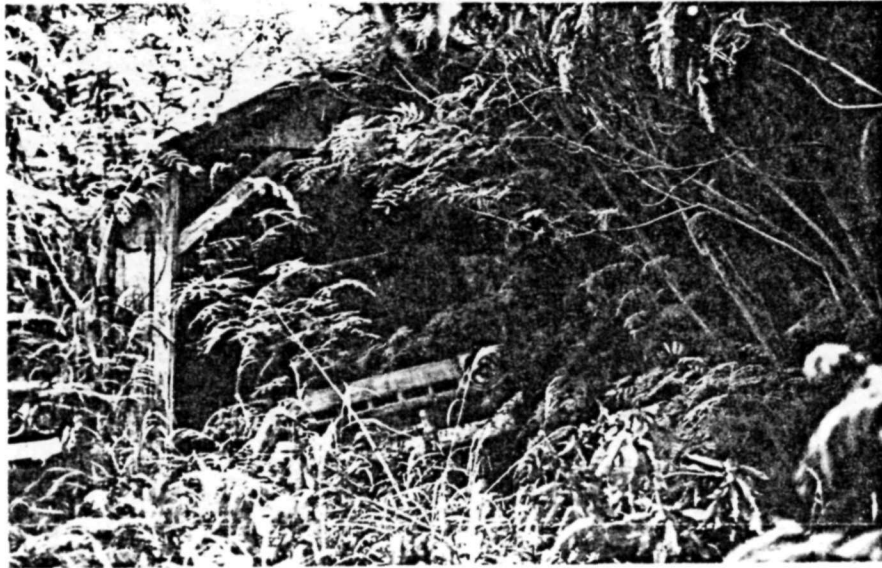
STRUCTURE: Building 545

DESCRIPTION: The structure is a frame building of single wall construction. The exterior finish is board and batten. The gable roof is finished with rolled composition roofing material. The structure is in deteriorated condition, and is overgrown by koa.

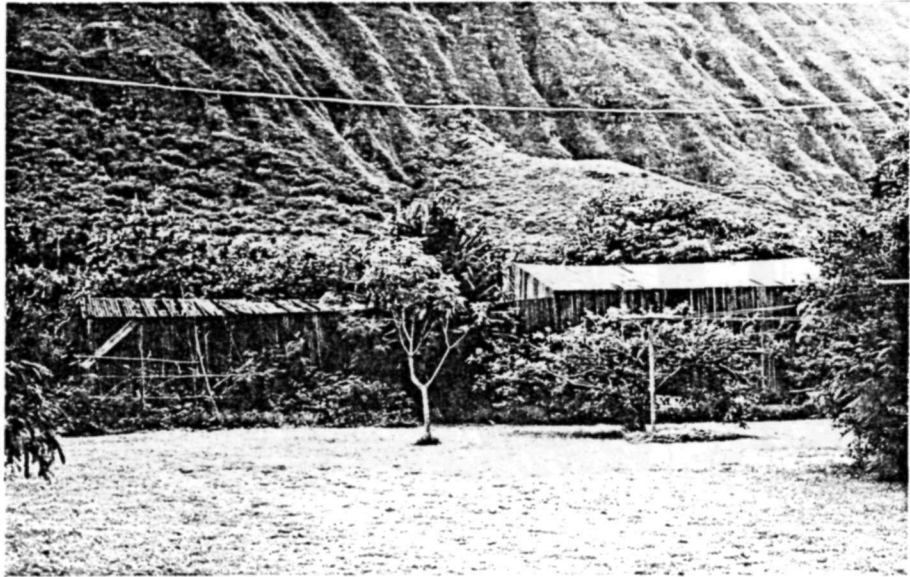
STRUCTURE: Building 546

DESCRIPTION: The structures (two which nearly run together) are frame buildings, with perforated walls and roofs which are sheathed with lath-size wood strips. The easternmost structure is in poor condition. The one to the west is in fair condition.

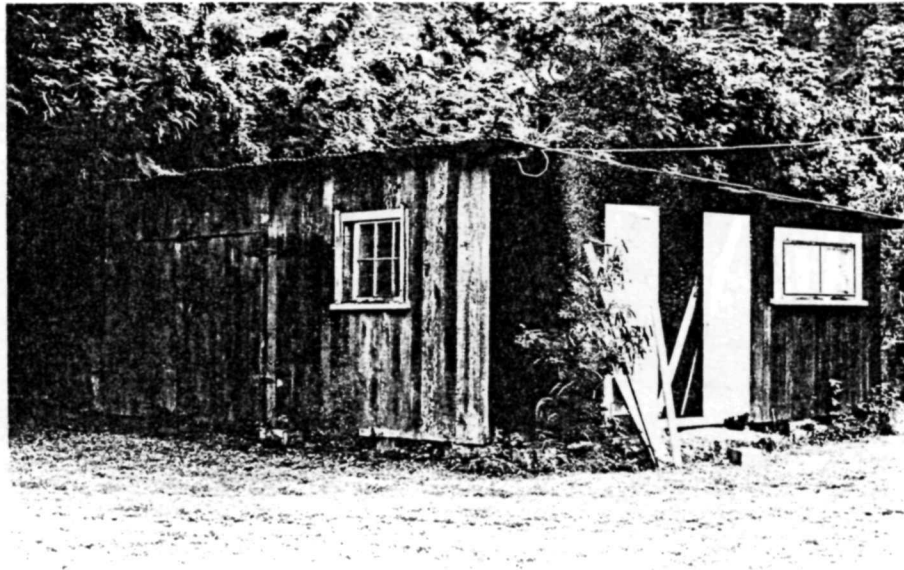
STRUCTURE: Building 547

DESCRIPTION: The structure is a frame building of single wall construction. The walls are vertical plank siding. The foundations consist of stone and concrete footings. The shed roof is covered with corrugated metal. The building is used, and in fair to poor condition. The structure seems to have been built of recycled materials.

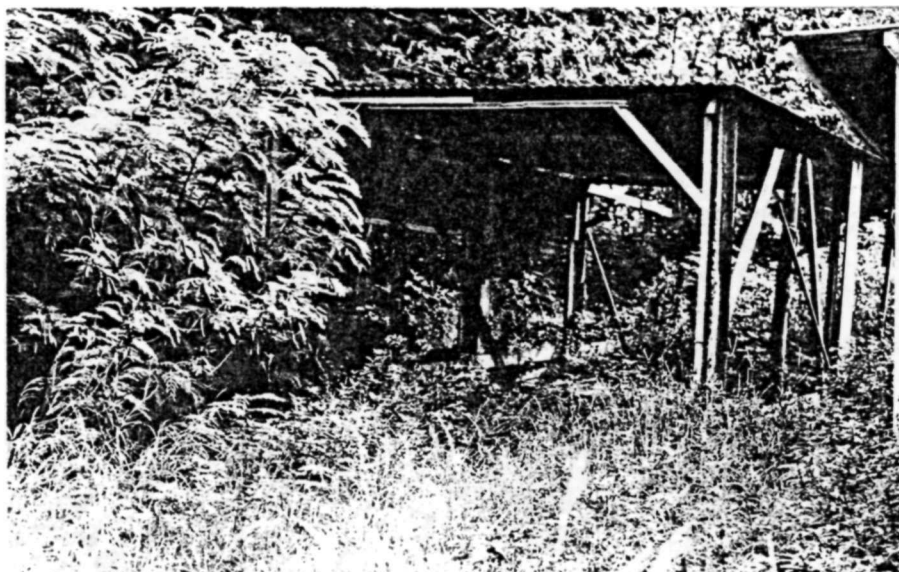
STRUCTURE: Building 548

DESCRIPTION: The structure is a wood frame, with a corrugated metal shed roof. The structure is in deteriorated condition, and has not been used recently.

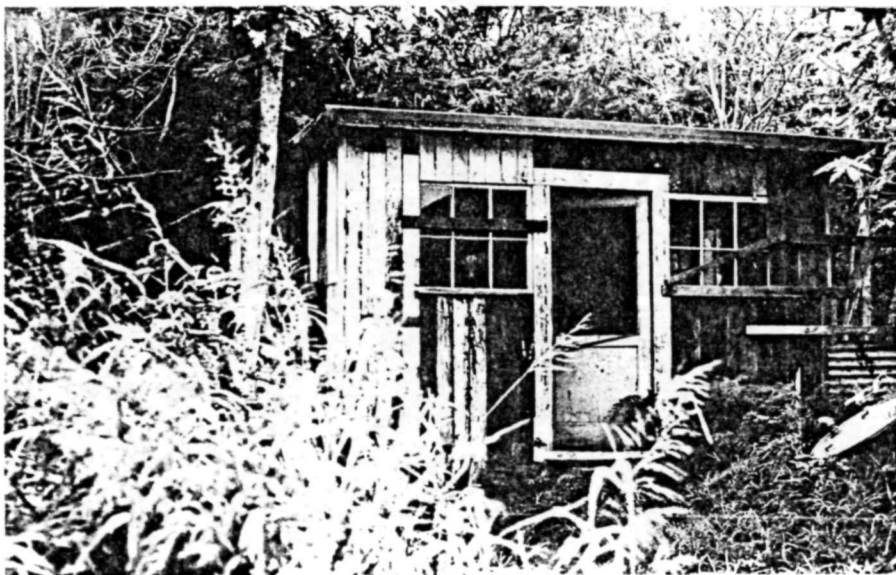
STRUCTURE: Building 576

DESCRIPTION: The structure is a frame building of single wall construction. The shed roof is finished with rolled composition roofing material. The exterior walls are vertical plank siding, which seems to have been recycled from other structures. The structure is used intermittently and is in poor condition.

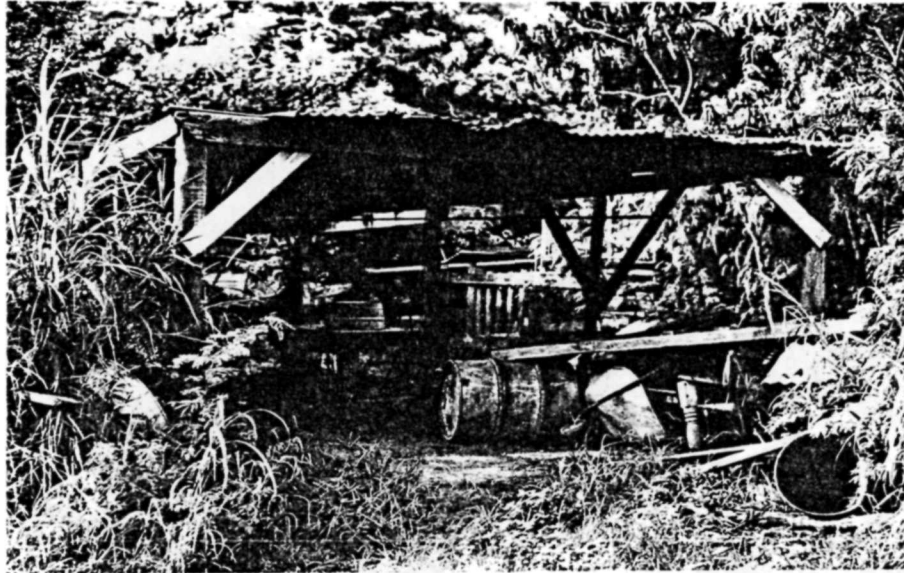
STRUCTURE: Building 577

DESCRIPTION: The structure is a wood frame with a corrugated metal shed roof. It is used as the shelter for the slop preparation. The structure is in poor condition.

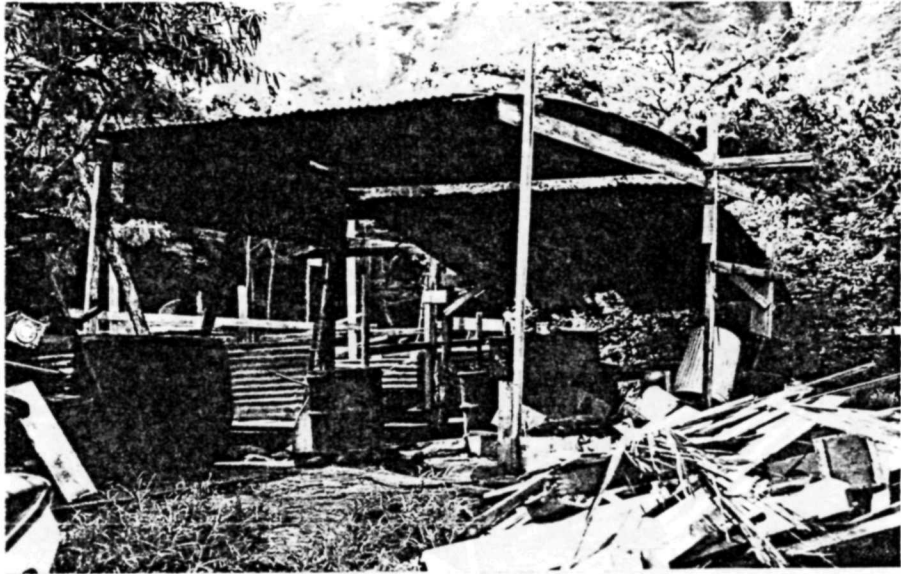
STRUCTURE: Building 578

DESCRIPTION: The structure is a frame, covered with a corrugated metal roof. The structure is very deteriorated.

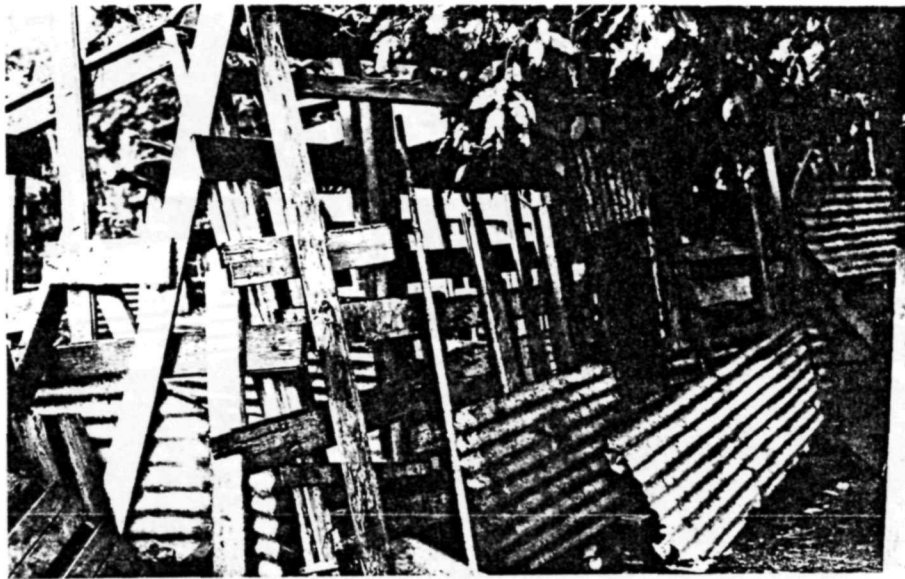
STRUCTURE: Building 579

DESCRIPTION: The structure is a wood frame shed for pigs, with the remains of a shed roof finished with rolled composition roofing. Small sections of wall are covered with corrugated metal. The structure is in very deteriorated condition.
