KALAUPAPA BUILDING INVENTORY

KALAUPAPA - HAWAII

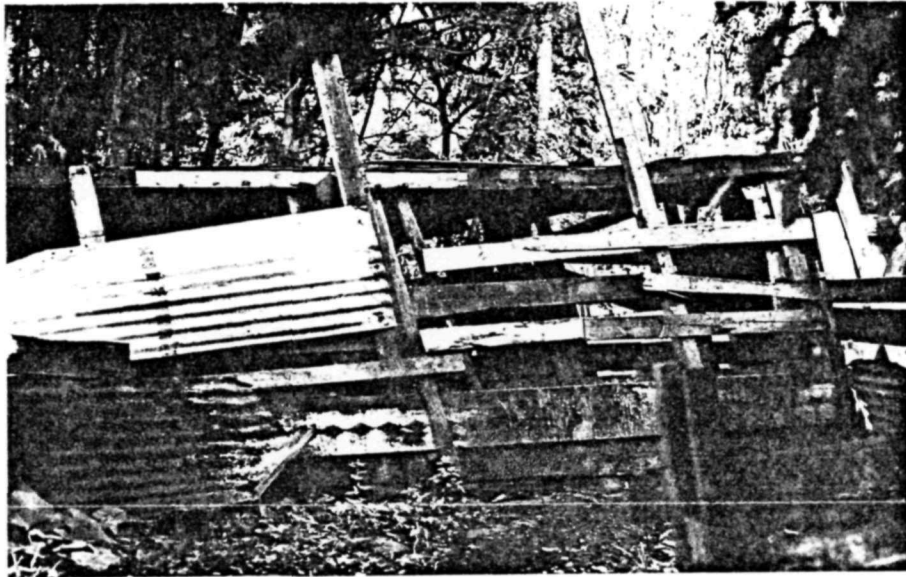
STRUCTURE: Building 580

DESCRIPTION: The structure is a frame with a shed roof finished with
rolled composition roofing material. The structure is in deteriorated
condition, and is surrounded by wood fences and pens for the pigs. The
structure was built of recycled materials.

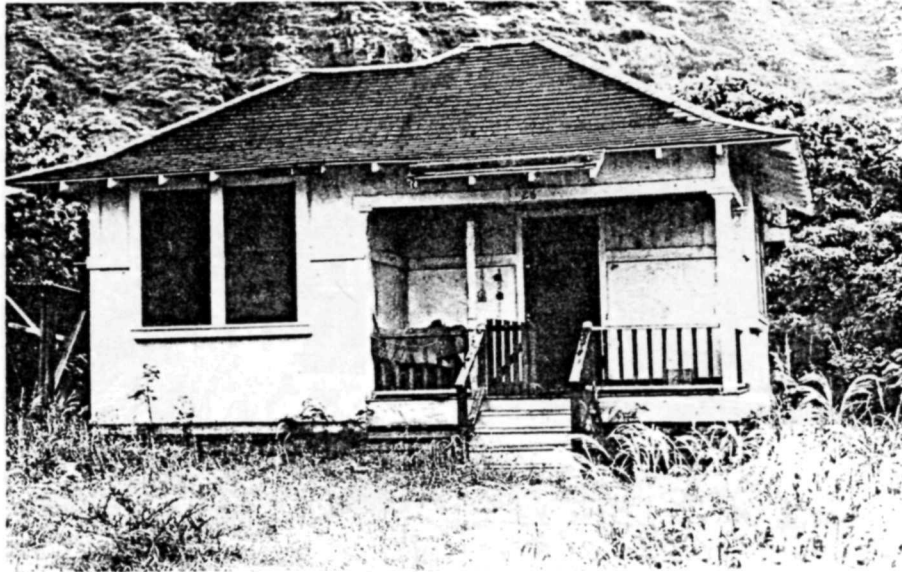
STRUCTURE: Residence 26

DESCRIPTION: The structure is a one-story building of single wall construction, with a concrete pad and post foundation. The irregularly shaped hip roof has a broken pitch, and is finished with composition shingles. Wooden steps provide access to the recessed corner porch which is incorporated under the hip roof. The wood frames of the twelve-light double hung windows project several inches from the exterior wall. A post and two pilasters articulate the edges of the porch. Other corners of the structure are finished with cornerboards. A broken girt encircles the exterior. A partially enclosed porch with a shed roof, is located at the rear of the rectangular structure. The building is not occupied, and in poor condition. The yard, and particularly the vegetation at the base of the structure should be cleared. Boards severely damaged by termites should be replaced. The structure should be fumigated, cleaned and painted, and re-roofed.

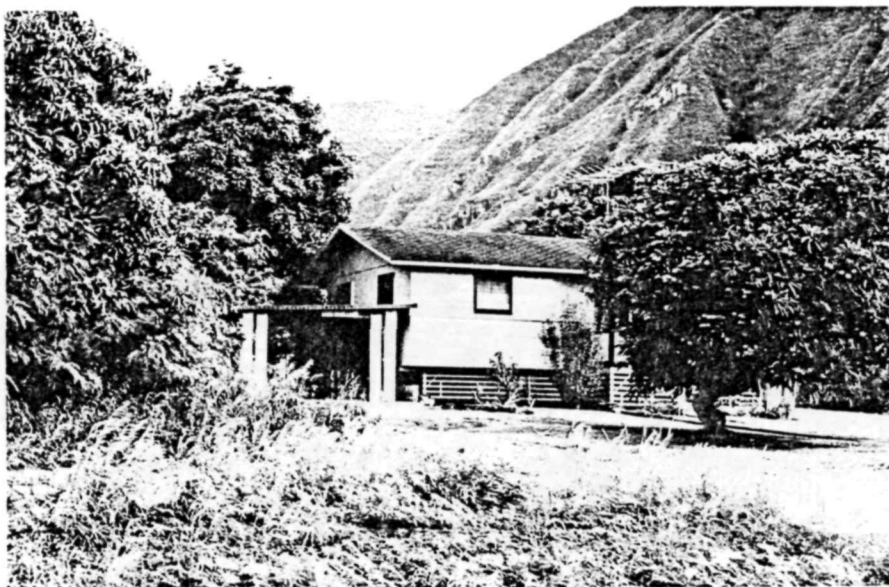
STRUCTURE: Building 62-101

DESCRIPTION: The structure is a one-story building of single wall construction, with a concrete pad and post foundation. A small wood porch, sheltered by an extension of the gable roof, provides access to the front door. The gable roof finished with composition shingles. The wood frames of the jalousie windows project from the exterior walls. A continuous girt encircles most of the exterior of the structure. The girt is broken at the southwest corner by two two-sash jalousie and fixed windows, divided vertically. A carport with a flat roof and a concrete slab foundation is located at the southeast corner of the structure. A second, smaller carport constructed mainly of recycled materials is located at the north side of the building. The structure is occupied, and in good condition. The building should undergo routine termite fumigation, and a small section of roof needs patching.

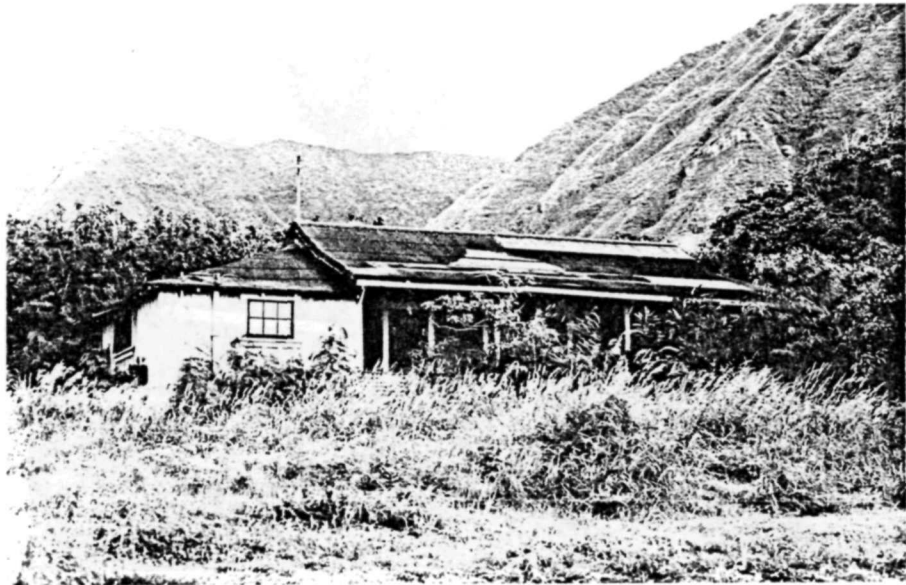
STRUCTURE: Building 102

DESCRIPTION: The structure is a one story building of single wall construction, with a stone pad and concrete foundation. The exterior finish is board and batten. The building was formerly a duplex residence, but is currently unoccupied (used for storage?). The front of the structure is symmetrical (the rear was inaccessible due to vegetation). The main section of the building has a gable roof with a shed extension which covers the veranda running the length of that section. On the north and south side are wings with hip roofs. All roofs are finished with rolled composition roofing, which has been placed over wood shingles. The building has minor details such as jigsaw brackets which contribute to its architectural character. The roof is sagging and the structure is in such deteriorated condition that preservation costs would be prohibitive, considering the relative significance of the structure.

SIGNIFICANCE: Of local architectural significance with good detailing, but these elements are repeated in other structures of the same vintage which are in better condition (single family as opposed to duplex). Preservation of a representative example in better condition is recommended.

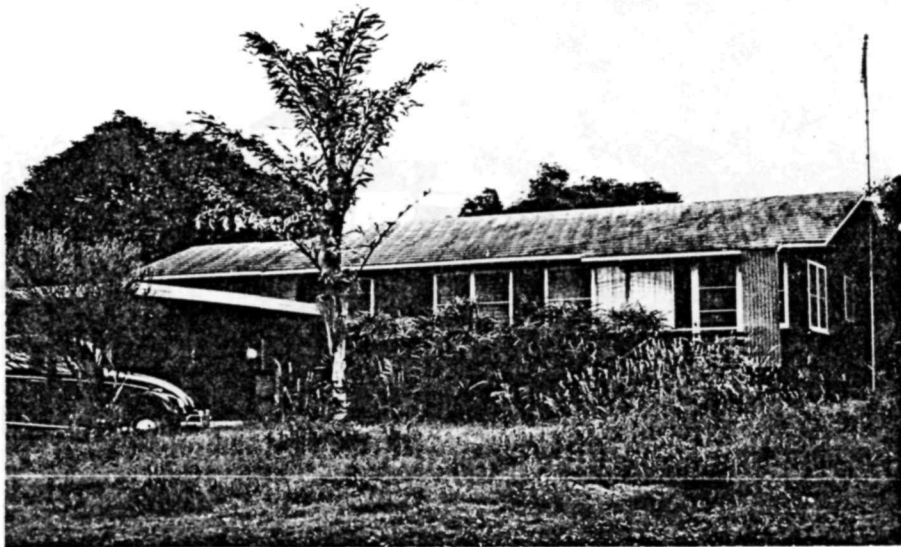
STRUCTURE: Building 64-103

DESCRIPTION: The structure is a one-story building of single wall construction, with a concrete pad and post foundation. A termite shield is located between the concrete pad and wood post. The gable roof is finished with grey composition shingles. A small wooden front provides access to the front door, and it is sheltered by an extension of the gable roof. The wood frames of the jalousie windows project several inches from the exterior wall. A broken girt encircles the exterior of the structure. A carport, with a flat roof and concrete slab foundation protrudes from the north side of the structure. The building is occupied and in good condition. Vegetation should be cleared from the base, and the structure should be fumigated.

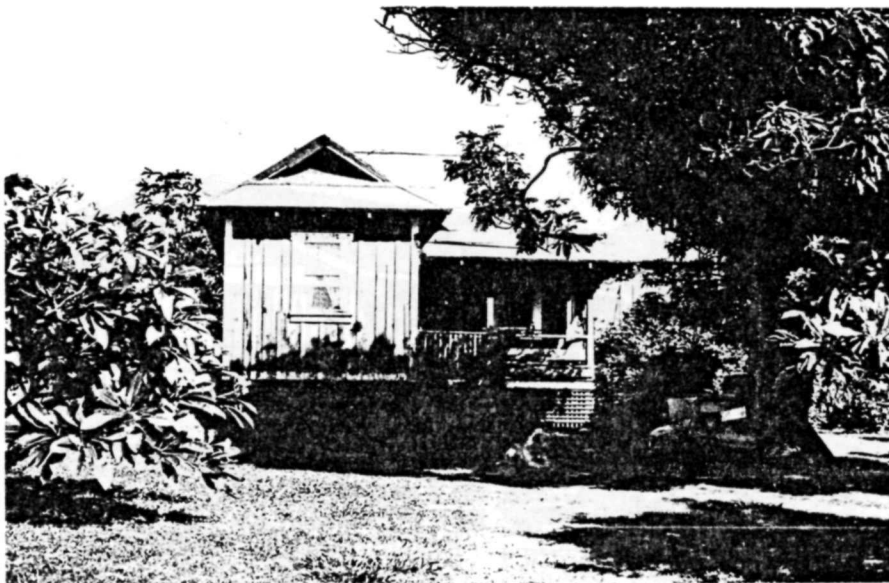
STRUCTURE: Building 104

DESCRIPTION: The structure is a one-story building of single wall construction (board and batten), with a stone and post foundation. The gable roof with gables is finished with green rolled composition roofing. The structure seems to have been built in several stages. The exterior of the building is board and batten. The windows are twelve-light double hung. A latticework skirting is located around the base of the structure. A recessed wood porch is located under the main roof section. The structure is occupied, but in deteriorated condition. Much of the siding needs replacement, as do some of the roof members and footings. The structure should be fumigated, re-roofed and painted.

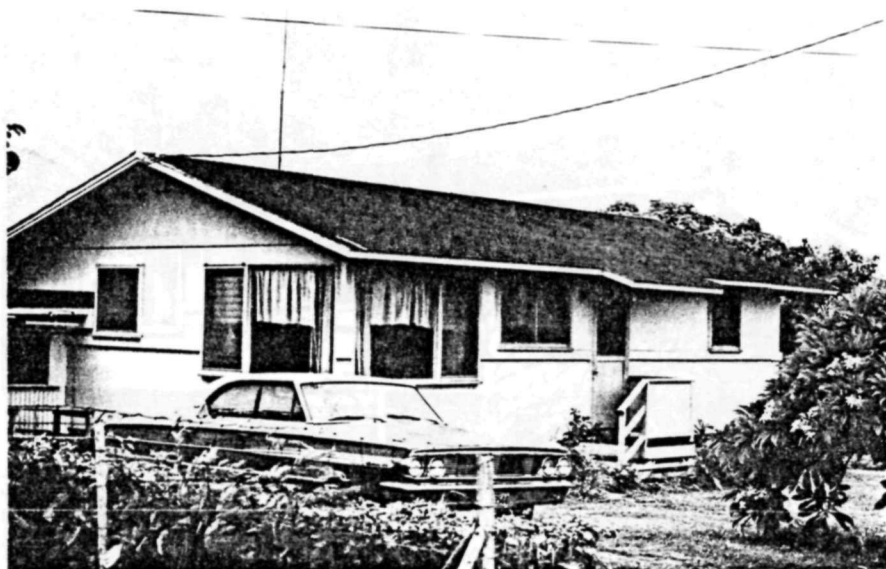
STRUCTURE: Building 62-105

DESCRIPTION: The structure is a one-story building of single wall construction, with a concrete pad and post foundation. A small wood porch, sheltered by an extension of the gable roof, provides access to the front door. The gable roof is finished with composition shingles. The wood frames of the jalousie windows project from the exterior walls. A continuous girt encircles most of the exterior of the structure. The girt is broken at the east corner by two two-sash jalousie and fixed windows, divided vertically. A carport with a shed roof and a concrete slab foundation is located at the southeast corner of the structure. The structure is occupied and in good condition, although in need of minor board replacement, painting and fumigation.
