KALAUPAPA BUILDING INVENTORY

KALAUPAPA - HAWAII

RESIDENTIAL AREA - PRIVATE OWNED STRUCTURES

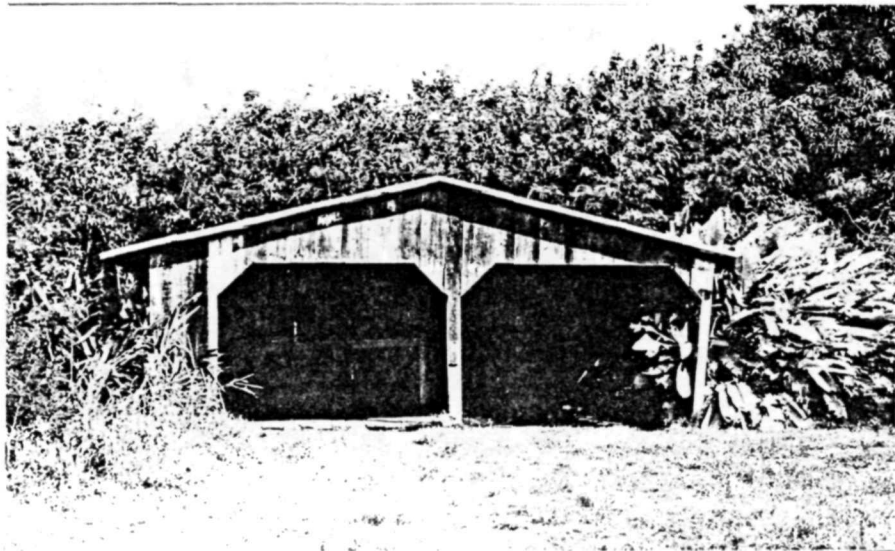
STRUCTURE: Building 556

DESCRIPTION: The structure is a frame building of single wall construction.
The gable roof is finished with green rolled composition roofing material.
The structure is divided into two stalls. The floor is wood, which is
riddled with termites and rot. The structure is leaning, and in poor
condition, although in use.

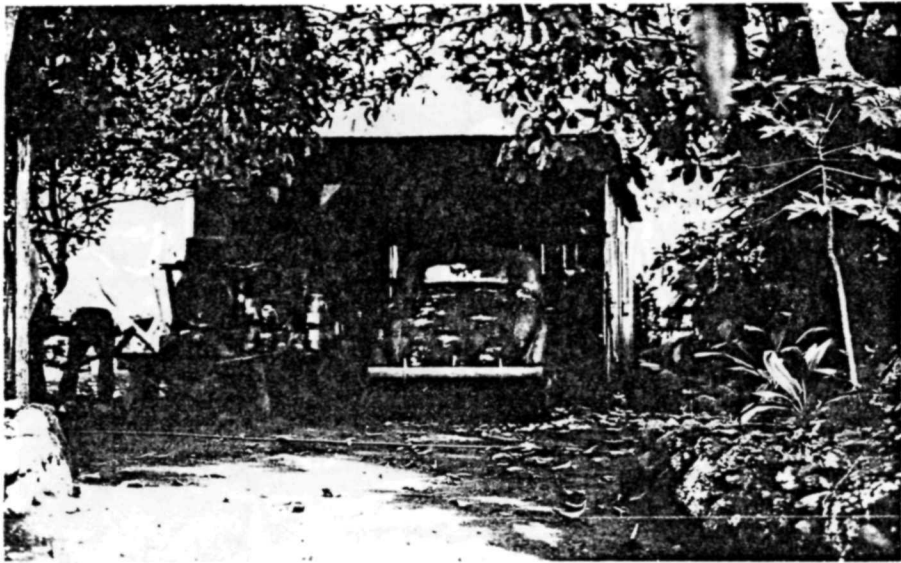
STRUCTURE: Building 558

DESCRIPTION: The structure is a frame building of single wall construction. The exterior finish is board and batten. The structure has a shed roof. Although the structure is very well-kept, the wood is deteriorating due to rot and termites. The structure is in poor condition. The building was probably constructed of recycled materials.

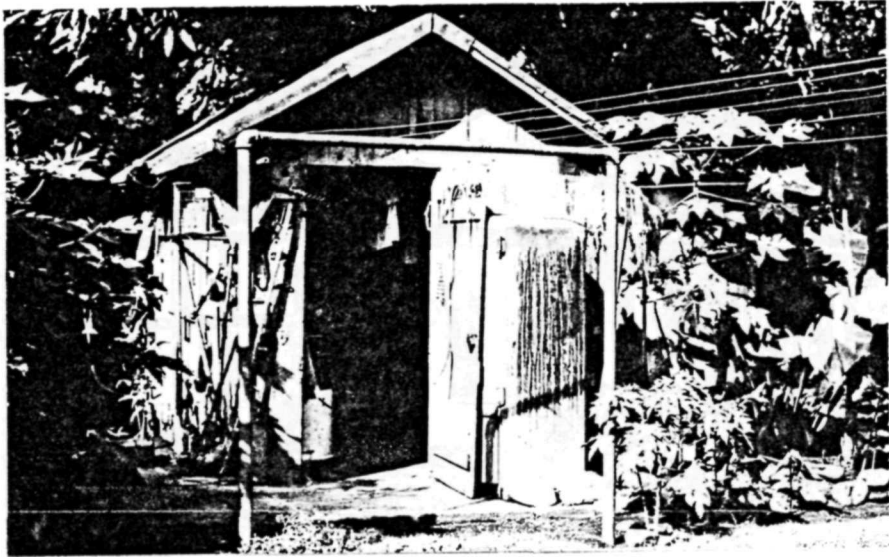
STRUCTURE: Building 559

DESCRIPTION: The structure is a frame building of single wall construction. The gable roof is finished with rolled composition roofing material. The building is in fair to poor condition, and has termites. The structure still is in use.

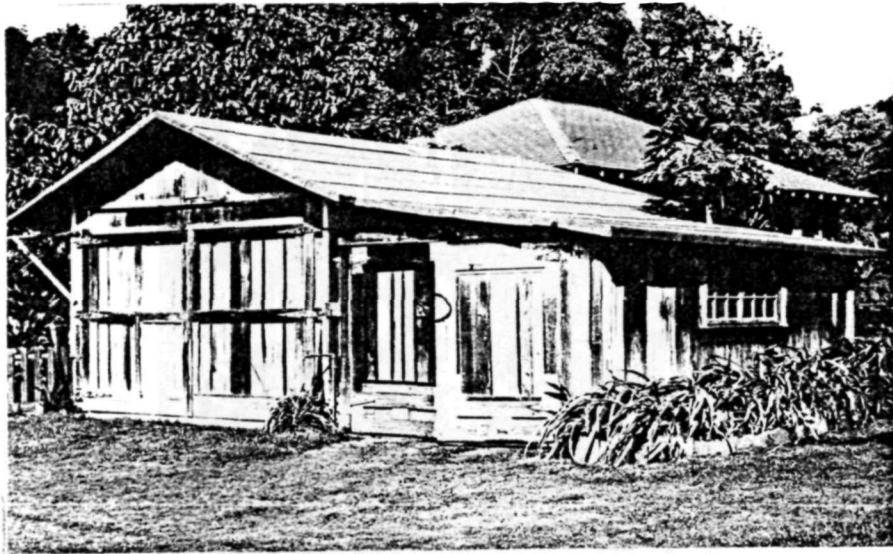
STRUCTURE: Building 560

The foundation is concrete. The gable and shed roofs are finished with rolled composition roofing material. The walls are board and batten and vertical plank siding. The structure is in fair condition, considering all the rot and termites. The building was constructed of recycled materials.

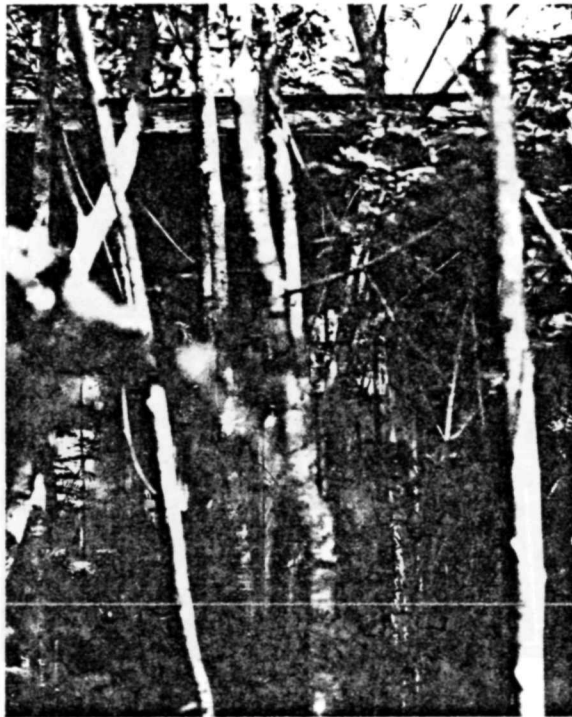
STRUCTURE: Building 561

DESCRIPTION: The structure is a frame building with a shed roof and vertical plank siding, and a double door. The structure is so overgrown that it is barely visible. Presumed condition is deteriorated.

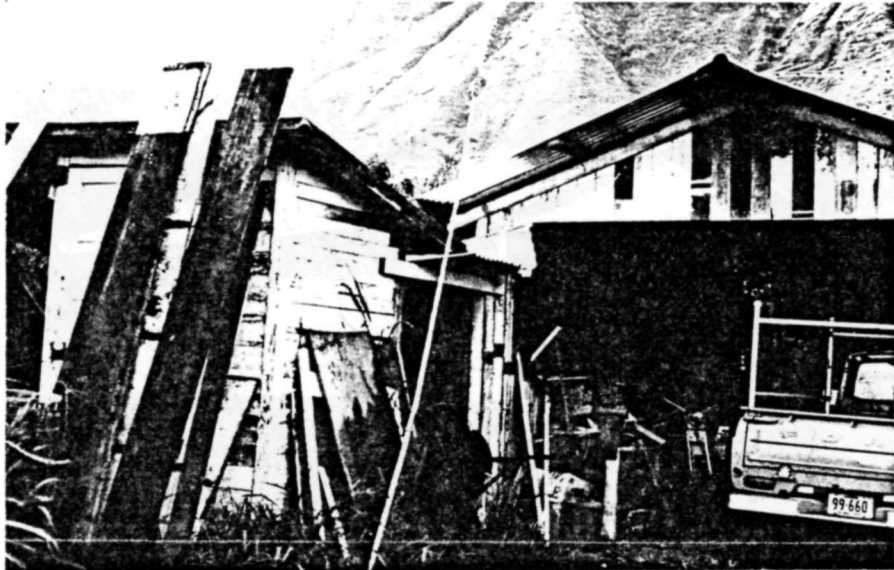
STRUCTURE: Building 563

DESCRIPTION: The structure is a frame building of single wall construction, with a concrete foundation. The structure is actually four separate shed, each with a distinct roof, but all inter-connected. The main section has a gable roof covered with corrugated metal. The other shed roofs are covered with corrugated metal and rolled composition roofing material. The walls are horizontal and vertical plank siding, with sections of plywood sheets. The structure is in poor condition, and is in use.

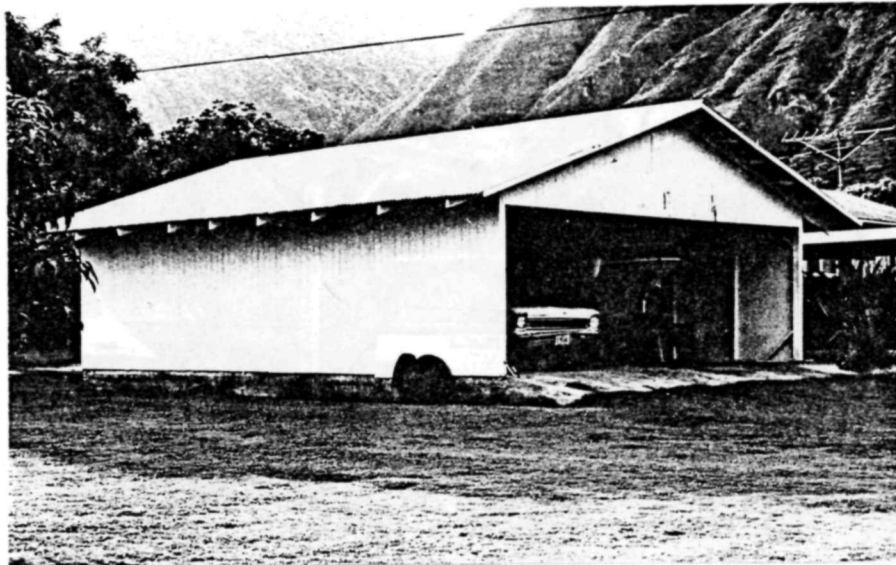
STRUCTURE: Building 564

DESCRIPTION: The structure is a wood frame building of single wall construction, with a concrete slab foundation. The walls are covered with vertical plank siding. The gable roof is covered with corrugated metal. The structure seems to be in good condition, and is in use.

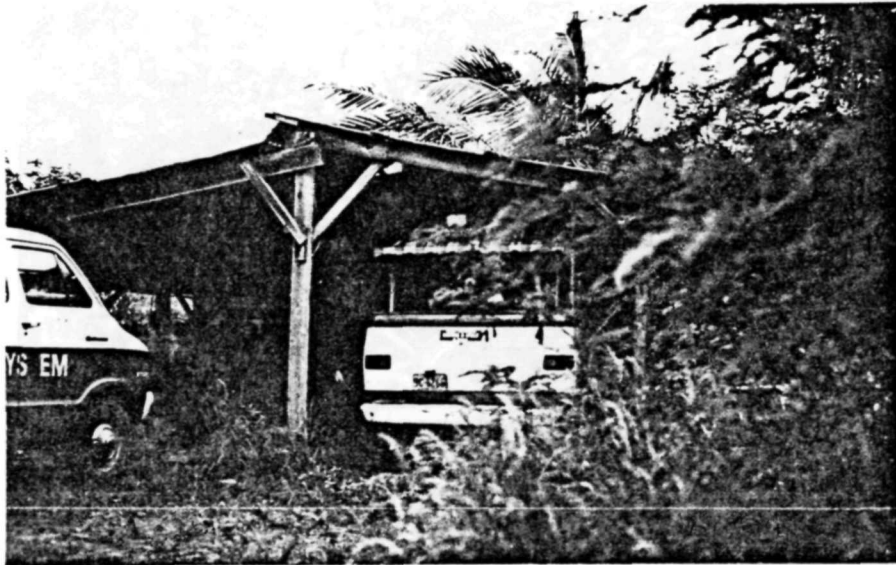
STRUCTURE: Building 565

DESCRIPTION: The structure is a frame building constructed on stone foot-
ings. The structure has five vehicle stall, and extra space for storage.
The low gable roof is covered with corrugated metal. The structure is in
very deteriorated condition, and is in use.

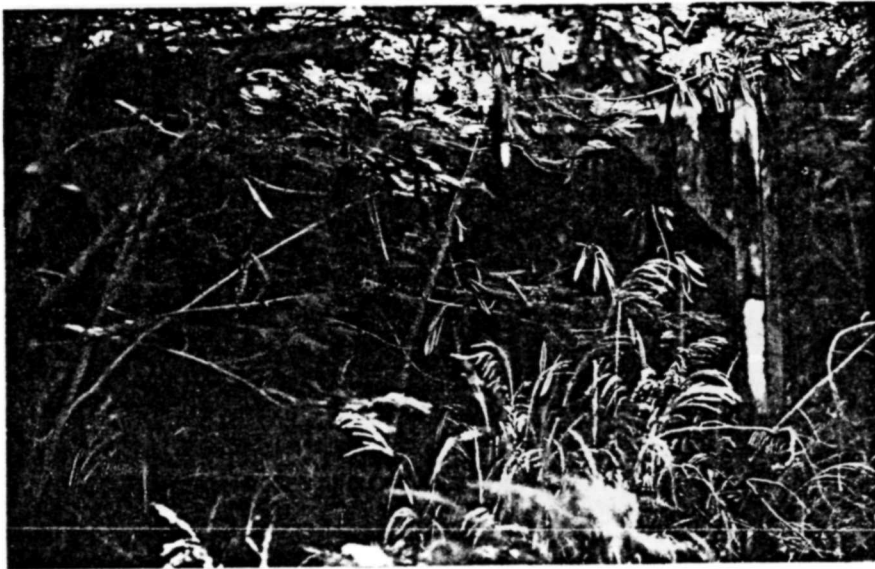
STRUCTURE: Building 567

DESCRIPTION: The structure is a frame building of single wall construction.
The exterior is vertical plank siding. The gable roof is finished with
rolled composition roofing material. The structure is overgrown, and in
deteriorated condition.

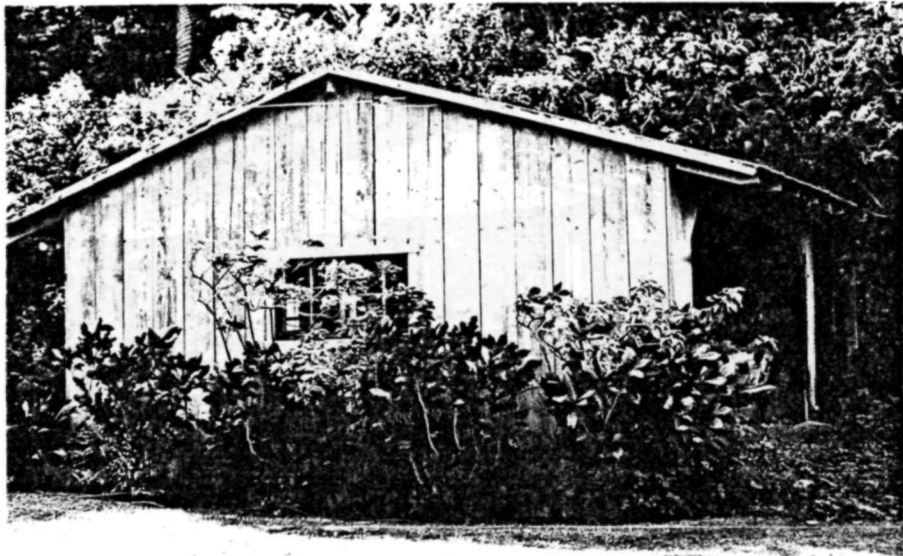
STRUCTURE: Building 568

DESCRIPTION: The structure is a frame building of single wall construction. Walls are vertical plank siding. The gable roof is covered with corrugated metal. An addition, with a shed roof also covered with corrugated metal, is located on the south side of the structure. The building shows signs of rot and termites, but is in use and in fair condition.

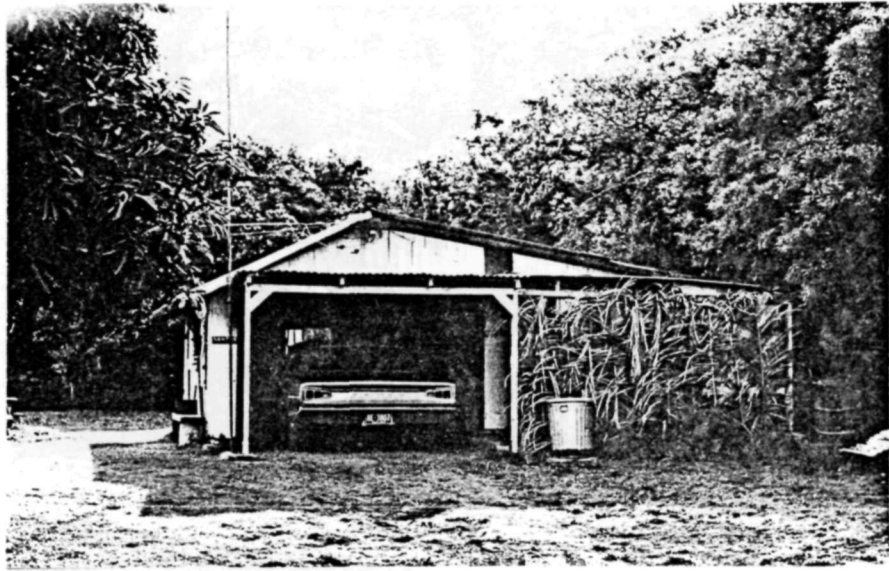
STRUCTURE: Building 570

The foundation consists of concrete footings. The gable roof, and shed
roof extension are finished with a combination of rolled composition
roofing in material and corrugated metal. The structure is in fair to
poor condition, and still is in use.

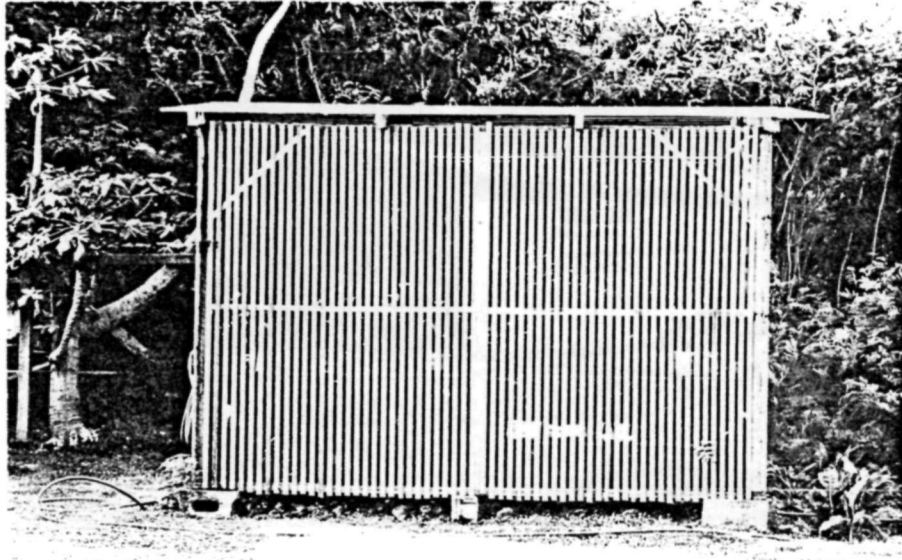
STRUCTURE: Building 575

DESCRIPTION: The structure is a frame with walls and roof covered with lath-
size wood strips. The foundation consists of concrete footings. The
structure is in use, and seems to be in good condition.

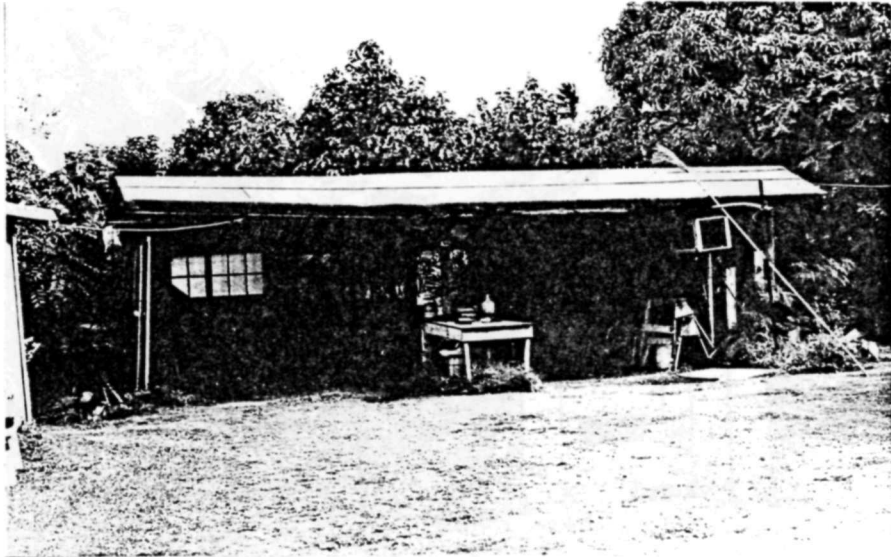
STRUCTURE: Building 582

DESCRIPTION: The structure is a frame building of single wall construction. The walls are vertical plank siding which seems to have been recycled from another structure. The building is divided into two large vehicle stalls (without doors). The roof is finished with rolled composition roofing material. The wood frame structure is sagging, and in deteriorated condition. The structure is still in use.

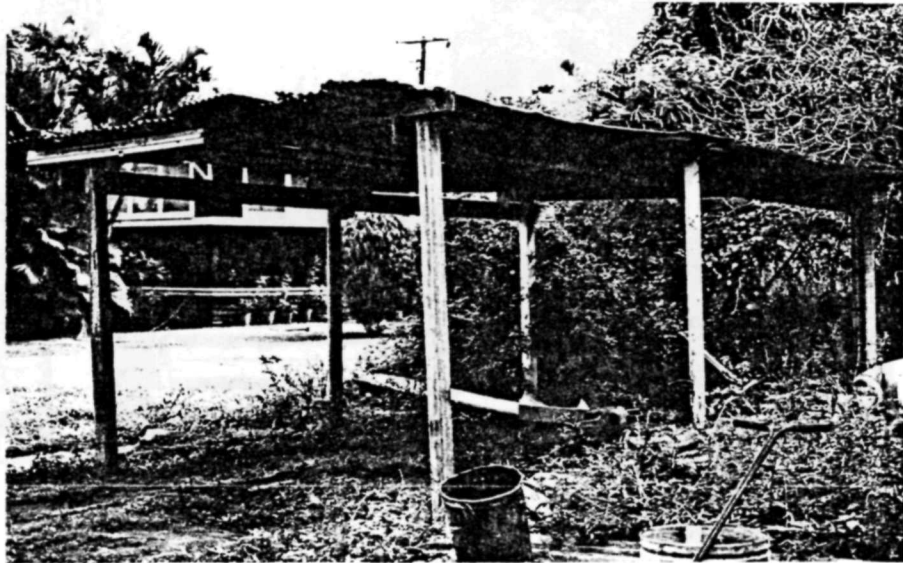
STRUCTURE: Building 586

DESCRIPTION: The structure is a wood frame, with a corrugated metal roof.
The structure is used, but in poor condition.

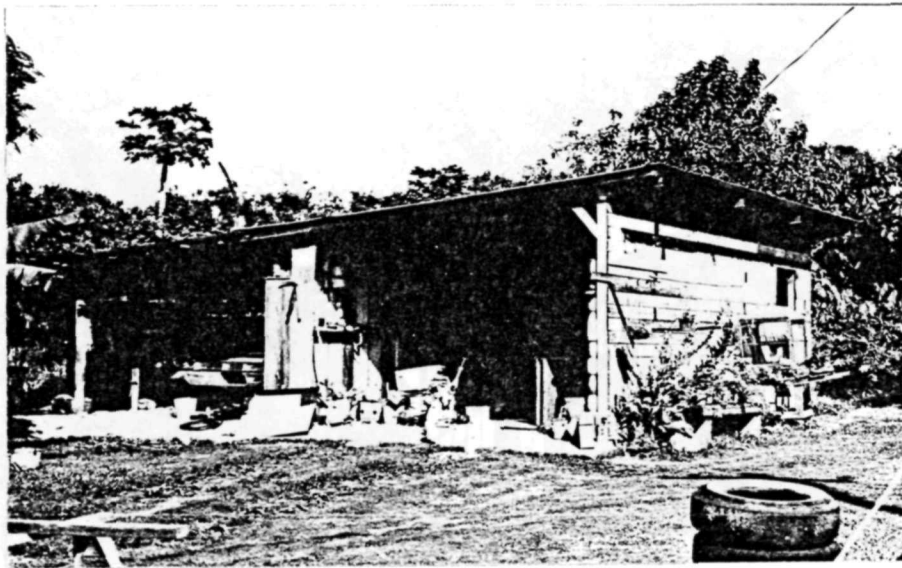
STRUCTURE: Building 621

DESCRIPTION: The structure is a frame building of single wall construction, with a concrete slab foundation. The shed roof is finished with corrugated metal. The horizontal plank siding of the structure seems to have been recycled from other buildings. The structure is used, and is in fair condition.

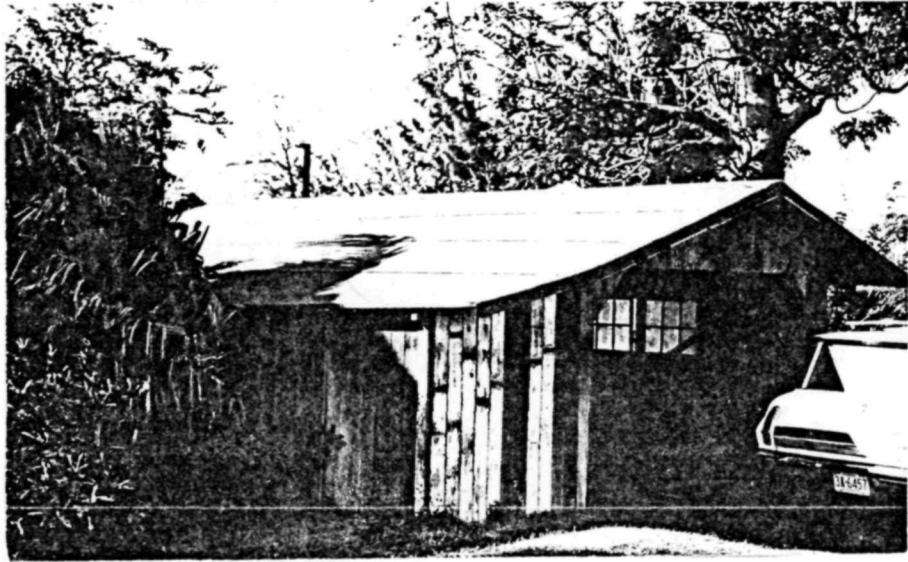
STRUCTURE: Building 622

The exterior vertical plank walls are probably recycled material from another structure. The gable roof is finished with rolled composition roofing material. The structure is still in use, and is in fair condition.

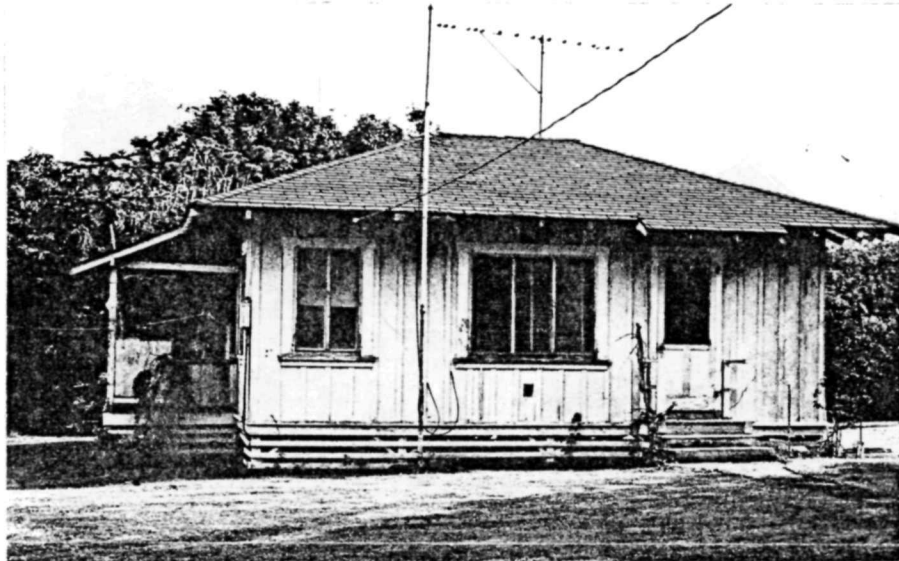
STRUCTURE: Building 161

DESCRIPTION: The structure is a one-story building of single wall construction, with a board and batten exterior finish. The foundation is made up of concrete pads and posts. The hip roof is finished with green composition shingles. A small wood porch, sheltered by an extension of the hip roof provides access to the front door. Two other partially enclosed porches, also sheltered by roofs, are located in the north and northwest section of the house. The structure is occupied and in poor condition. Termite damage should be repaired. The structure should be painted, re-roofed and fumigated.

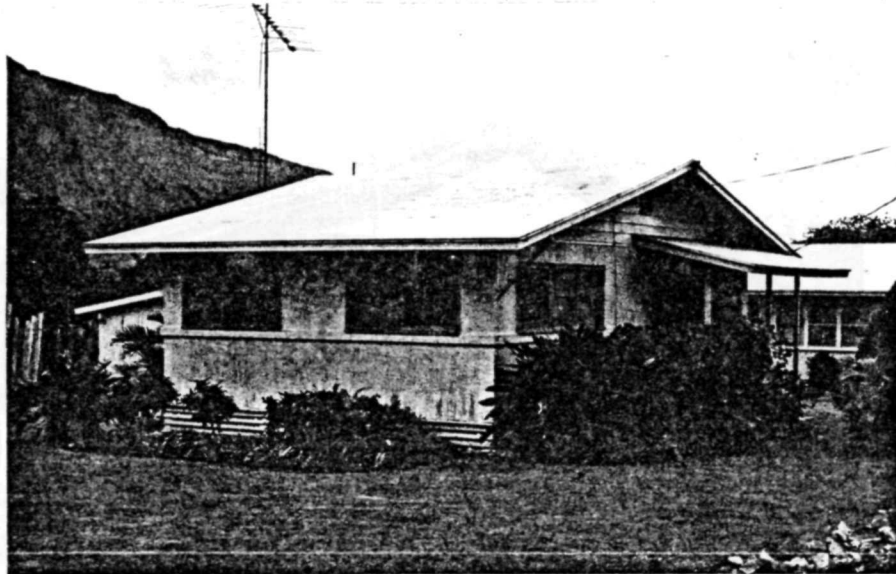
STRUCTURE: Building 56-112

DESCRIPTION: The structure is a one-story building of single wall construction, with a concrete pad and post foundation. The gable roof is finished with metal roofing. A small wood porch with a shed roof provides access to the front entrance to the dwelling. The wood frames of the two-sash double hung windows project several inches from the exterior walls. A continuous girt surrounds most of the structure, except at the west corner, where it is broken by the front door and a series of windows. A carport with a concrete slab foundation is located at the rear of the structure (southwest corner). The building is occupied, and in good condition. The structure should be fumigated.

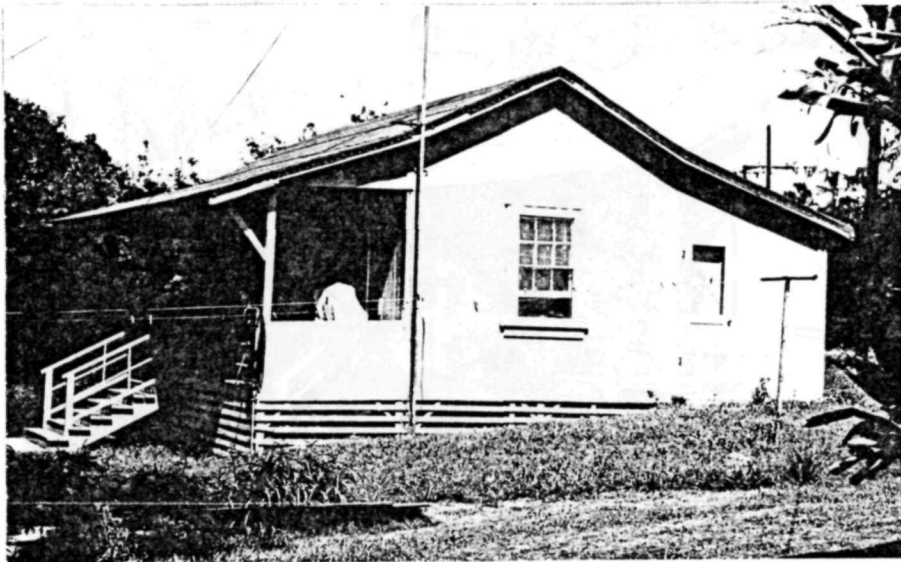
STRUCTURE: Building 114

DESCRIPTION: The structure is a one-story building of single wall construction, with a stone pad and post foundation. The gable roof extends into shed roofs at the front and rear of the house. The roof is finished with rolled composition roofing material. A veranda runs the entire length of the building on the west side of the structure. The exterior finish is simply vertical plank siding. Wood steps and railings led up to the veranda. A skirting of horizontal wood strips surrounds the foundations. The structure is occupied, and seems to be in fair condition. The building should be fumigated, and termite damage repaired. Roofing should be removed and replaced. Grade should be cleared.

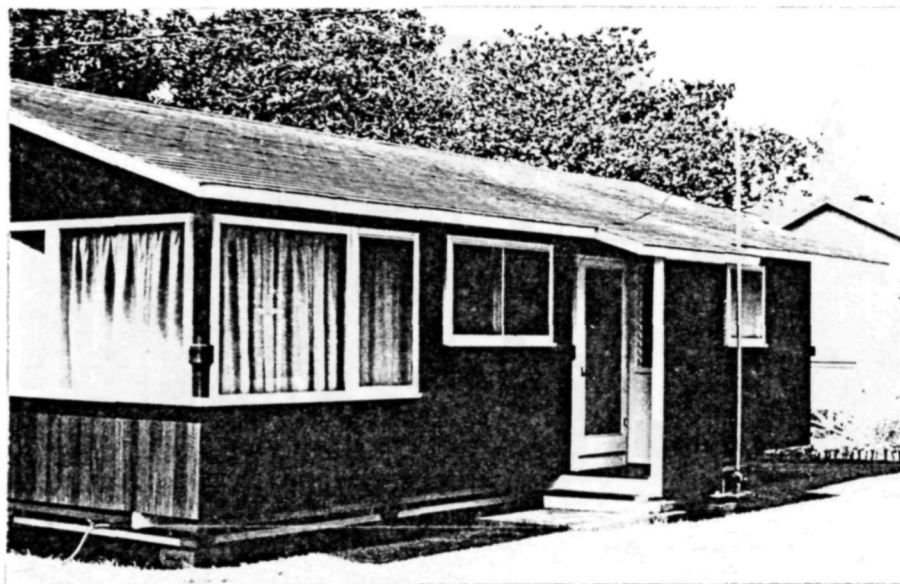
STRUCTURE: Building 62-117

DESCRIPTION: The structure is a one-story building of single wall construction, with a concrete pad and post foundation. A small wood porch, sheltered by an extension of the gable roof, provides access to the front door. The gable roof is finished with composition shingles. The wood frames of the jalousie windows project several inches from the exterior walls. A continuous girt surrounds most of the exterior of the structure. The girt is broken at the south east corner by two-sash windows, divided vertically. A carport with a shed roof and a concrete slab foundation is located at the southwest corner of the structure. The structure is occupied and seems to be in good condition. The eaves should be painted, to protect them from weather and termites, and the structure should be fumigated.

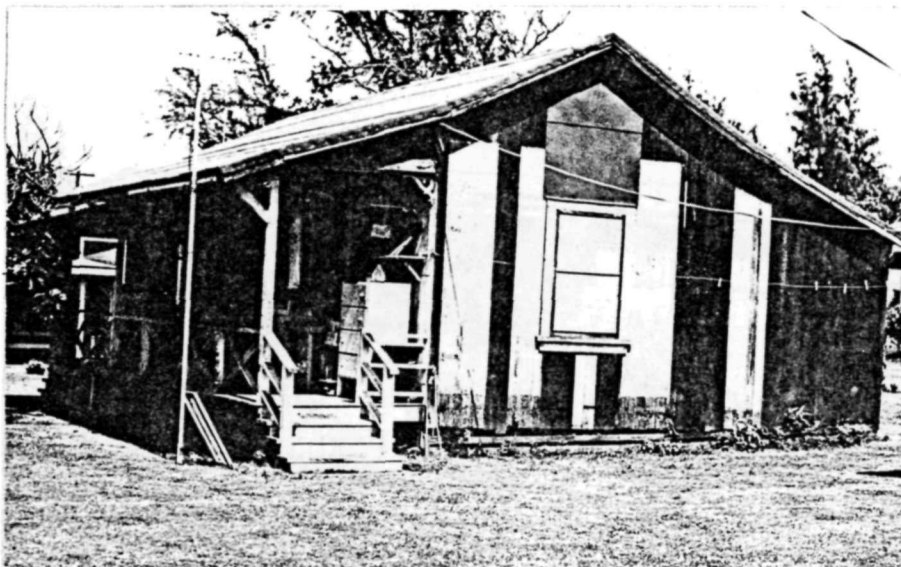
STRUCTURE: Building 118

DESCRIPTION: The structure is a one-story building of single wall construction, with a stone pad and post foundation. The building has a saltbox roof, with another extension at the front of the structure which shelters the recessed veranda. The veranda, which runs the length of the front of the building still has some of the original details - chamfered posts, jigsaw work, diamond-patterned railing. The exterior finish is vertical plank. The structure is in deteriorated condition, but should be preserved because it is occupied, and because it is an example of a type. The building should be fumigated. Termite damage (floor, footings, walls, siding) should be repaired. The building should be re-roofed with original material, and the structure should be painted.

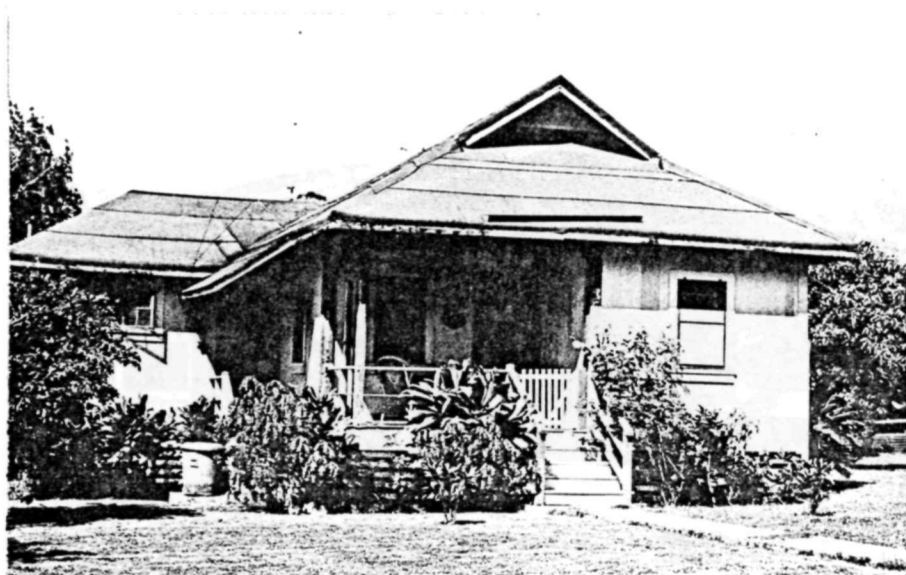
STRUCTURE: Building 6OR-119

DESCRIPTION: The structure is a one-story building of single wall construction with a concrete pad and post foundation. A recessed porch is located under the southwest corner of the gable (with gablet) roof. The roof is finished with rolled composition roofing paper. At the rear of the irregularly shaped structure (northeast corner) is a washing area with a concrete slab foundation. The structure is in poor condition. The building is in need of re-roofing, board replacement, fumigation and painting.

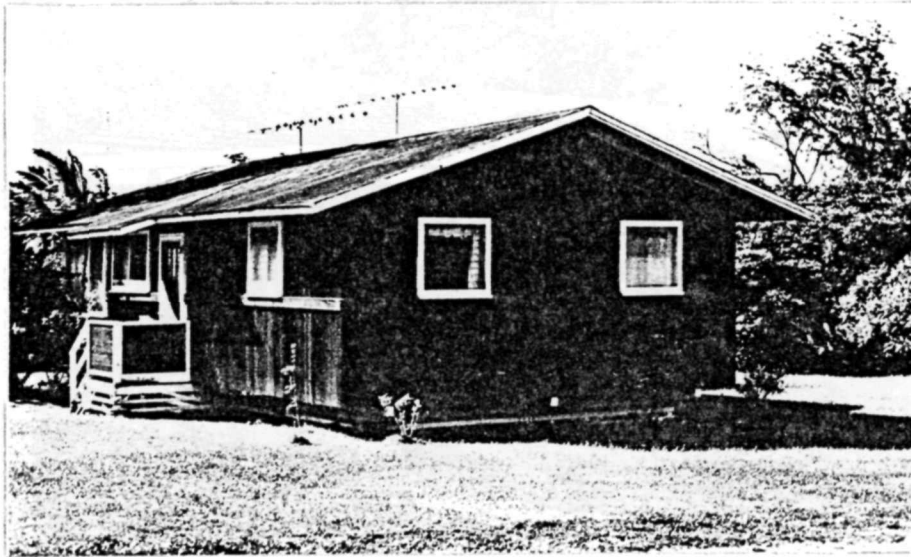
STRUCTURE: Building 62-120

DESCRIPTION: The structure is a one-story building of single wall construction with a concrete pad and post foundation. The pads and wood posts are separated by termite shields. A small wood porch, sheltered by an extension of the gable roof, provides access to the front door. The gable roof is finished with composition shingles. The wood frames of the jalousie windows project several inches from the exterior walls. A continuous girt encircles most of the exterior of the structure. The girt is broken at the southwest corner of the structure by two-two-sash windows, divided vertically. A carport with a shed roof and a concrete slab foundation is located at the northwest corner of the structure. The building is occupied and in fair to good condition. Some wood damaged by water (plumbing leak) and by termites should be replaced. The structure should be fumigated and painted.

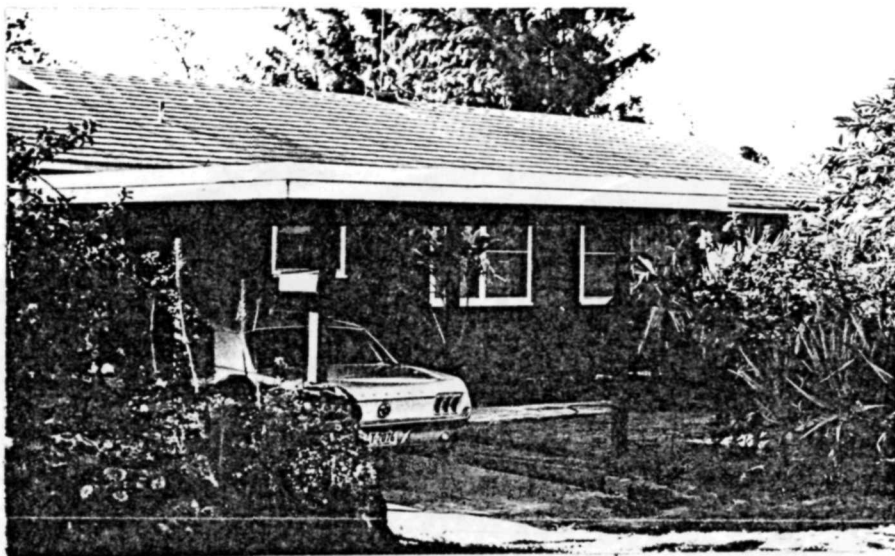
STRUCTURE: Building 64-121

DESCRIPTION: The structure is a one-story building of single wall construction, with a concrete pad and post foundation. The gable roof is finished with composition shingles. A small wooden front porch provides access to the front door. The wood frames of the jalousie windows project several inches from the exterior wall. A fixed sash picture window is also located at the front of the structure. A broken girt encircles the exterior of the structure. A carport, with a shed roof and concrete slab foundation protrudes from the east side of the structure. The building is occupied and in good condition. The structure should be routinely fumigated for termites.

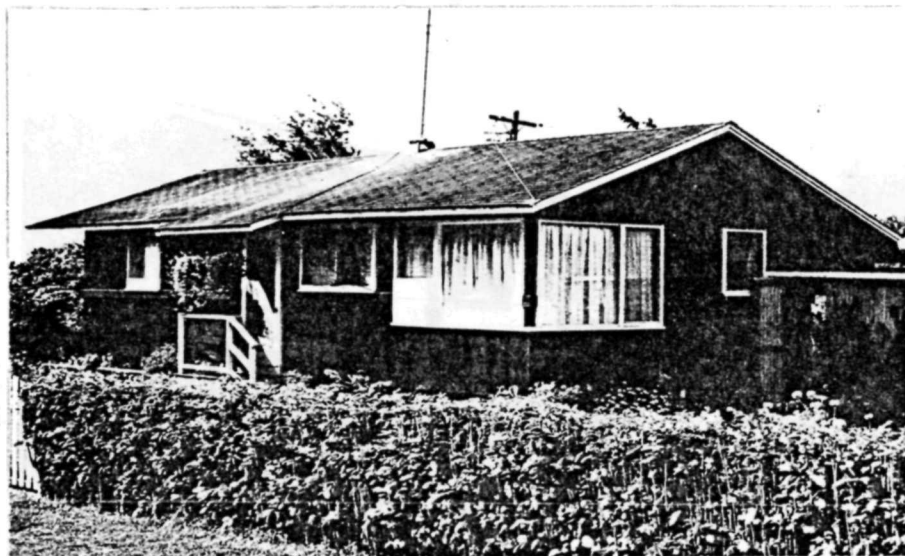
STRUCTURE: Building 62-122

DESCRIPTION: The structure is a one-story building of single wall construction, with a concrete pad and post foundation. The pads and wood posts are separated by termite shields. A small wood porch, sheltered by an extension of the gable roof, provides access to the front door. The gable roof is finished with composition shingles. The wood frames of the jalousie windows project several inches from the exterior walls. A continuous girt encircles most of the exterior of the structure. The girt is broken at the southeast corner of the structure by two two-sash windows, divided vertically. A carport with a flat roof and a concrete slab foundation is located at the northeast corner of the structure. The building seems to be in very good condition, but should undergo termite fumigation.

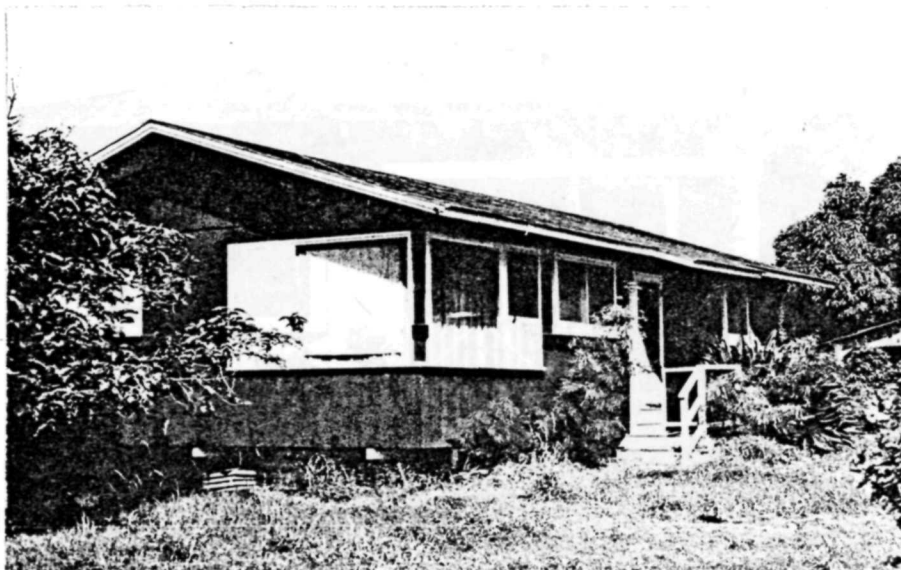
STRUCTURE: Building 62-123

DESCRIPTION: The structure is a one-story building of single wall construction, with a concrete pad and post foundation. A small wood porch, sheltered by an extension of the gable roof, provides access to the front door. The gable roof is finished with composition shingles. The wood frames of the jalousie windows project several inches from the exterior walls. A continuous girt encircles most of the exterior of the structure. The girt is broken at the south corner by two two-sash windows, divided vertically. A carport with a shed roof and a concrete slab foundation is located at the northwest corner of the structure. The structure was vacant for a period of time, but is now being rehabilitated for occupancy. The building should be routinely fumigated for termites.

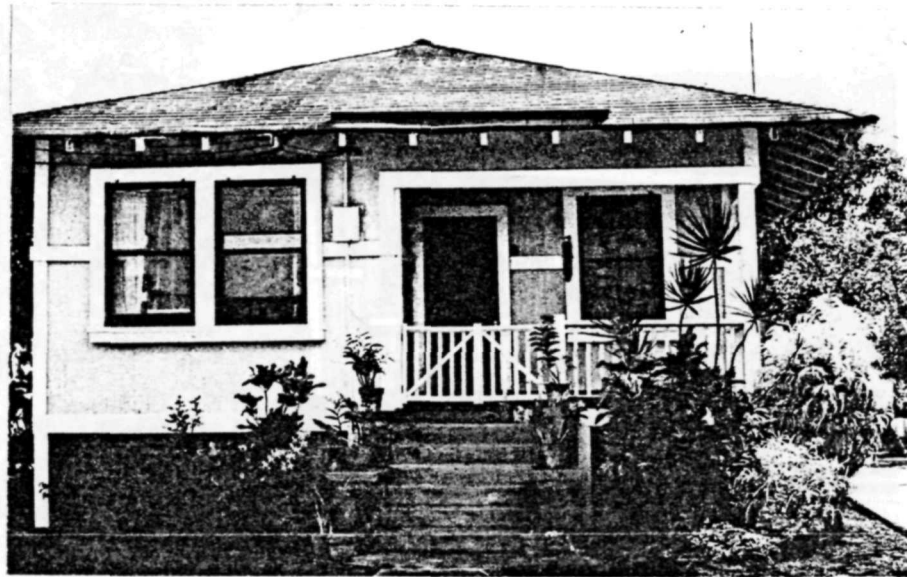
STRUCTURE: Building 151

DESCRIPTION: The structure is a one-story building of single wall construction, with a stone pad and post foundation. Stone and concrete steps provide access to the recessed corner porch which is incorporated under the hip roof. One chamfered post and two chamfered pilasters articulate the edges of the porch. The corners of the building are finished with corner boards. A girt encircles the structure, and is broken by the wood frames of the double-hung windows which project several inches from the exterior of the verticle plank wall. The hip roof is finished with composition shingles. A partially enclosed washhouse, with a shed roof is located at the rear of the rectangular structure. The building is occupied and in fair condition. Termite damage should be repaired. The structure should be fumigated and painted.

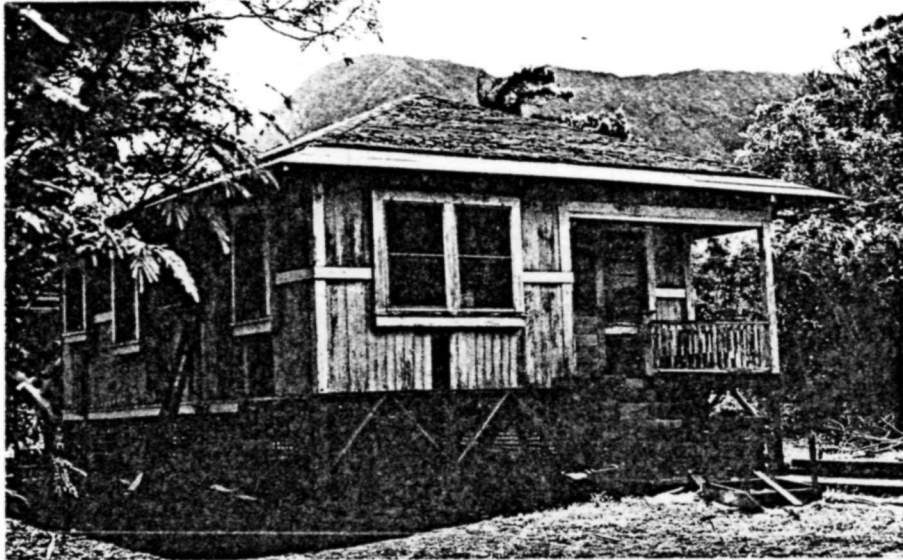
STRUCTURE: Building 152

DESCRIPTION: The structure is a one-story building of single wall construction, with a stone pad and post foundation. Stone and concrete steps provide access to the recessed corner porch which is incorporated under the hip roof. One chamfered post and two chamfered pilasters articulate the edges of the porch. The corners of the building are finished with cornerboards. A girt encircles the structure, and is broken by the wood frames of the double-hung windows which project several inches from the exterior of the vertical plank wall. The hip roof is finished with composition shingles. The wash house, attached to the rear of the structure, and built on a concrete slab, has been screened in. Refurbishing work on this structure is underway. The structure is not occupied presently.

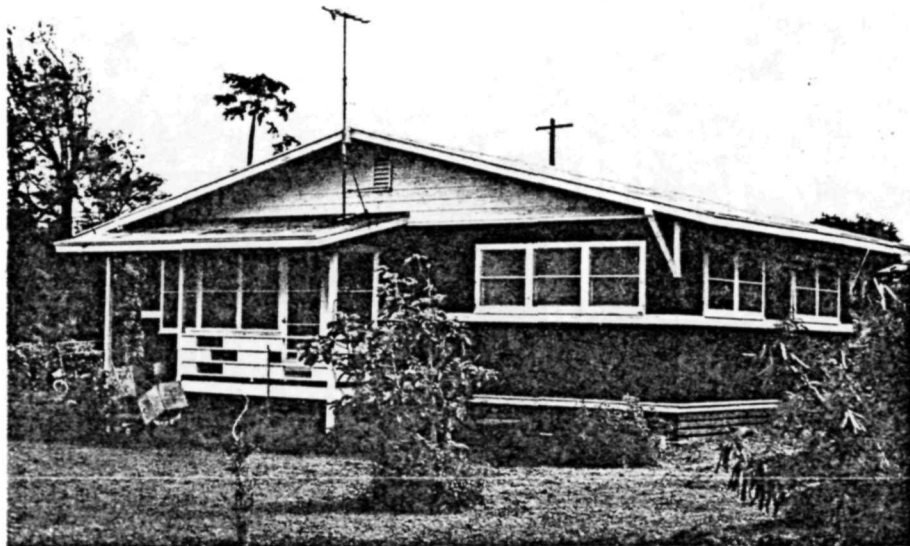
STRUCTURE: Building 56-153

DESCRIPTION: The structure is a one-story building of single wall construction, with a concrete pad and post foundation. Termite shields are located between the pads and wood posts. The gable roof is finished with metal roofing. A small wood porch with a shed roof provides access to the front entrance to the dwelling. The wood frames of the two-sash double hung windows project several inches from the exterior walls. A continuous girt surrounds most of the structure, except at the northwest corner, where it is broken by the front door and a series of windows. A carport with a concrete slab foundation and a shed roof is located at the rear (east) of the structure. The building is occupied and in fair to poor condition. Termite and other damage to the wood should be repaired. The structure should be fumigated, and painted (including roof). Vegetation should be cleared away from the base, to discourage further termite damage and rot.

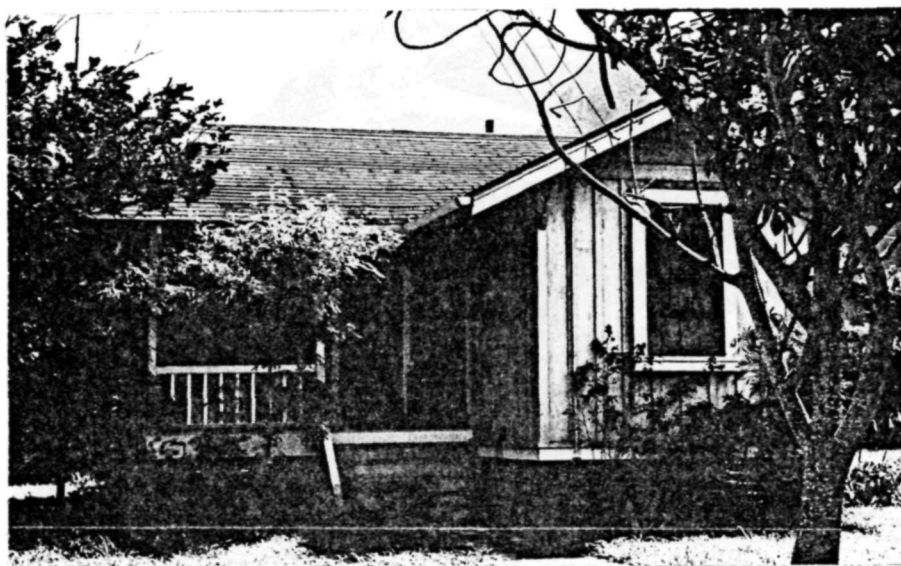
STRUCTURE: Building 154

DESCRIPTION: The structure is a one-story building of single wall construction. The exterior finish is board and batten. The irregularly-shaped building has intersecting gable roofs finished with composition shingles. A water table encircles the base of the structure proper. The wood frames of the double hung twelve-light windows project several inches from the exterior wall. A recessed porch is located under the main gable. The building is in poor condition. The structure should be fumigated for termites, and all termite damage repaired. Rot and termites have destroyed major sections of the front porch, railing and steps. This damage should be repaired. The structure should be re-roofed and painted. A partially enclosed wash house, constructed on a concrete slab, is located at the rear of the structure.

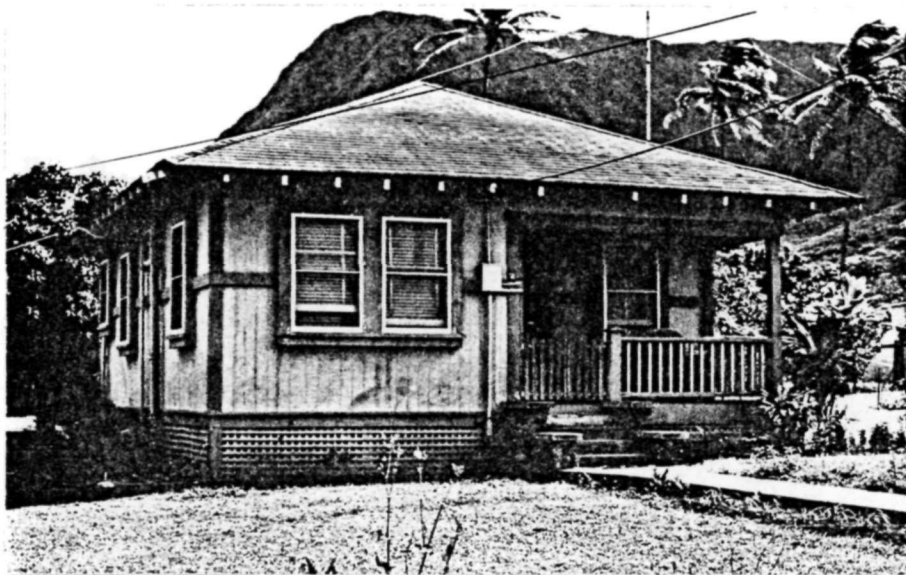
STRUCTURE: Building 155

DESCRIPTION: The structure is a one-story building of single wall construction, with a stone pad and post foundation. Stone and concrete steps provide access to the recessed corner porch which is incorporated under the hip roof. One chamfered post and two chamfered pilasters articulate the edges of the porch. The corners of the building are finished with cornerboards. A girt encircles the structure, and is broken by the wood frames of the double-hung windows which project several inches from the exterior of the vertical plank wall. The hip roof is finished with composition shingles. A partially enclosed wash house, with a concrete foundation and a shed roof is located at the rear of the rectangular structure. The building is occupied and in fair condition. The foundations should be stabilized, and termite damage should be repaired. The building should be fumigated.

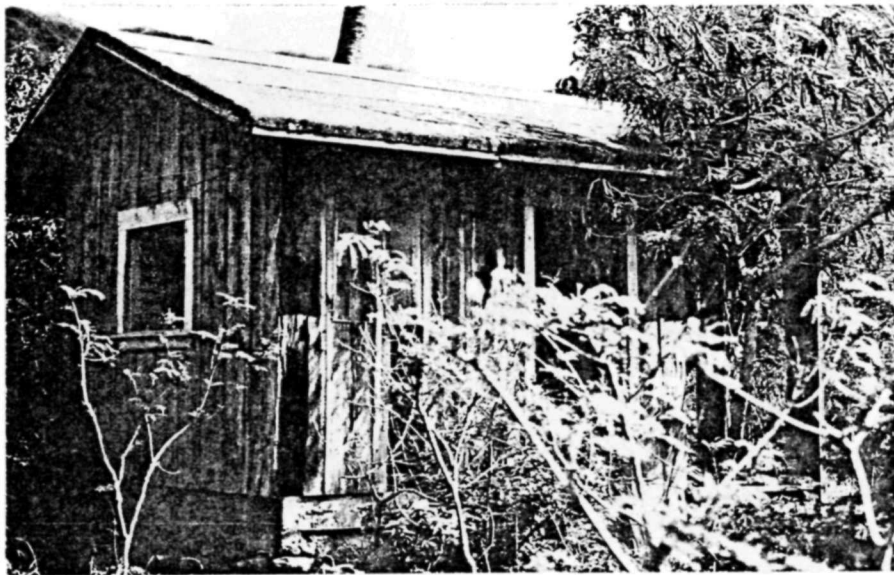
STRUCTURE: Building 549

SIGNIFICANCE: None. Removal is recommended.

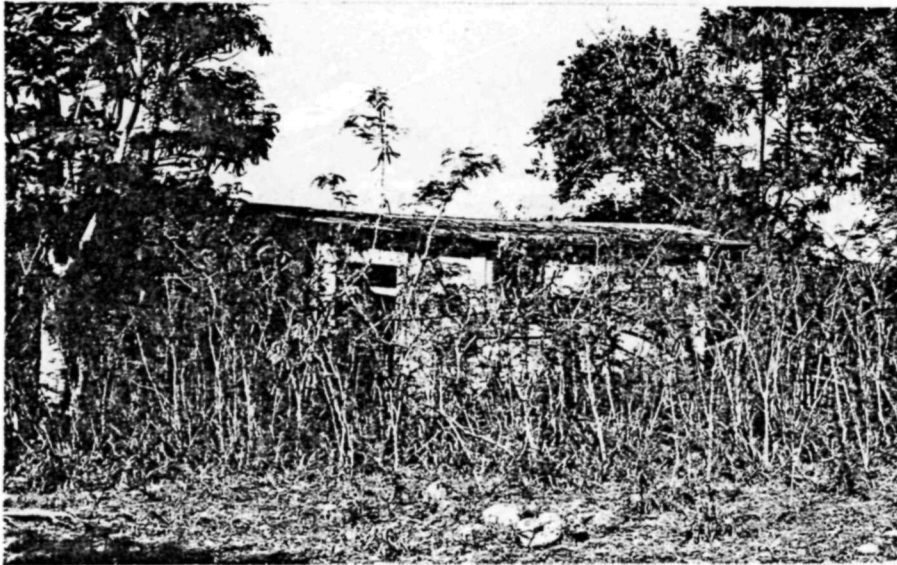
STRUCTURE: Building 551

DESCRIPTION: The structure is a one-story building of single wall construction. The gable roof of the structure is finished with the remains of rolled composition roofing material. The structure is in very deteriorated condition, and about to collapse.

SIGNIFICANCE: None - removal is recommended.

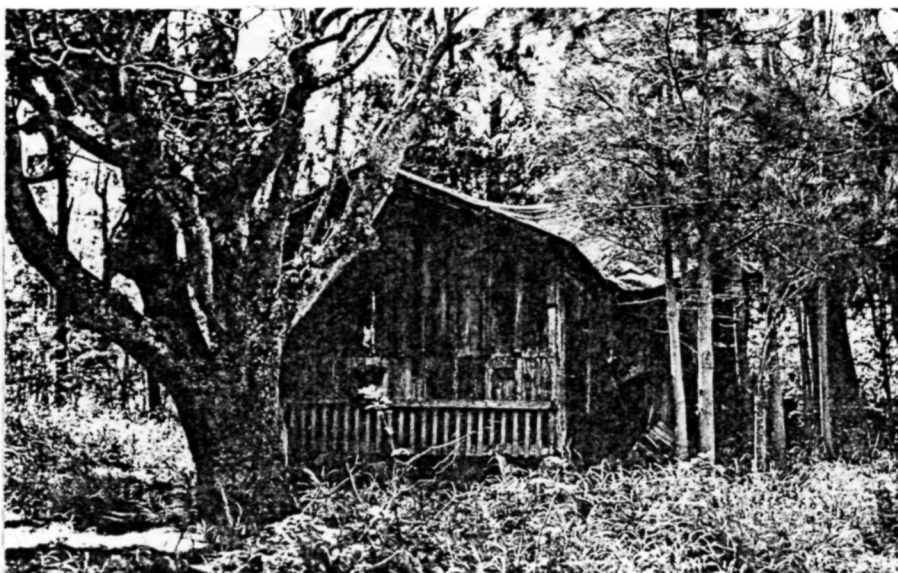
STRUCTURE: Building 554

DESCRIPTION: The structure is a frame building of single wall construction, with an exterior finish of board and batten. The building seems to have been divided into stalls at one time. The gable roof is sagging and about to collapse. The structure is in very deteriorated condition.

SIGNIFICANCE: None. Removal is recommended.

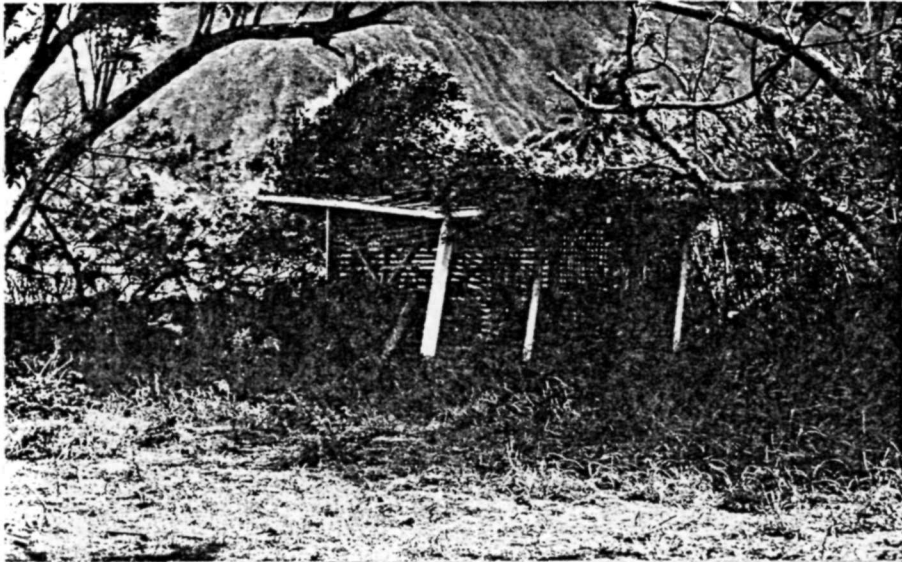
STRUCTURE: Building 555

DESCRIPTION: The structure is a frame building of posts, with latticework walls and shed roof. The structure probably was a hothouse. The structure is in deteriorated condition and is collapsing.

SIGNIFICANCE: None - removal is recommended.
