KALAUPAPA BUILDING INVENTORY

KALAUPAPA - HAWAII

RESIDENTIAL AREA - PRIVATE OWNED STRUCTURES

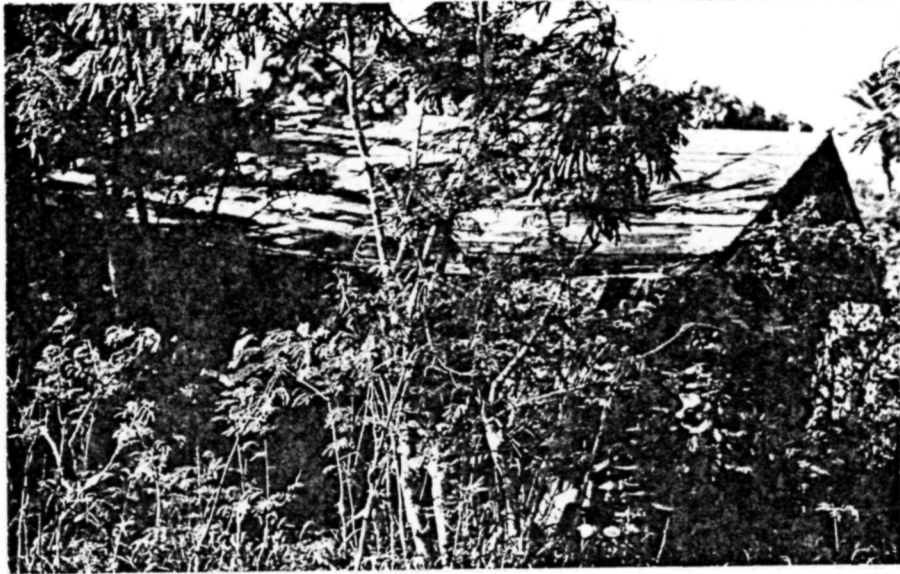
STRUCTURE: Building 556

DESCRIPTION: The structure is a frame building of single wall construction, with a gable roof finished with rolled composition roofing material. The structure is in very deteriorated condition is leaning and about to collapse. The building is being overgrown by koa.

SIGNIFICANCE: None - removal is recommended.

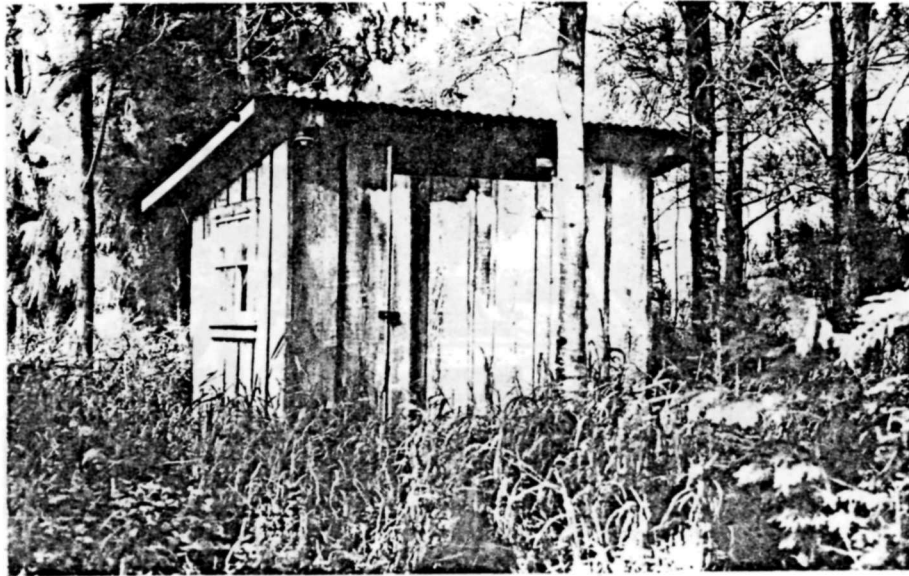
STRUCTURE: Building 617

DESCRIPTION: The structure is a frame building of single wall construction.
The exterior finish is board and batten. The shed roof is finished with
corrugated metal. The structure is in fair to poor condition.

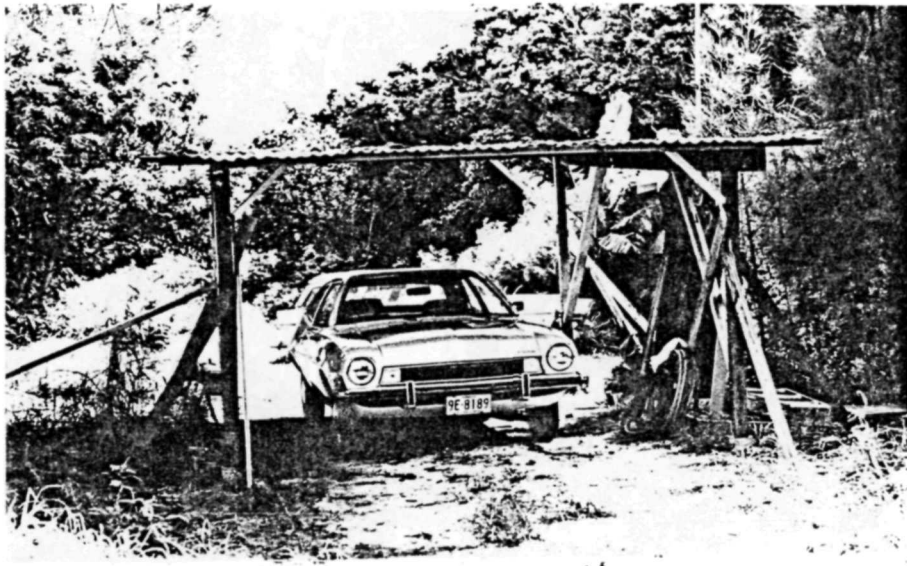
STRUCTURE: Building 618

DESCRIPTION: The structure is a wood frame, with a shed roof finished with corrugated metal. The posts rest in cans of poured concrete. The structure is in deteriorated condition.

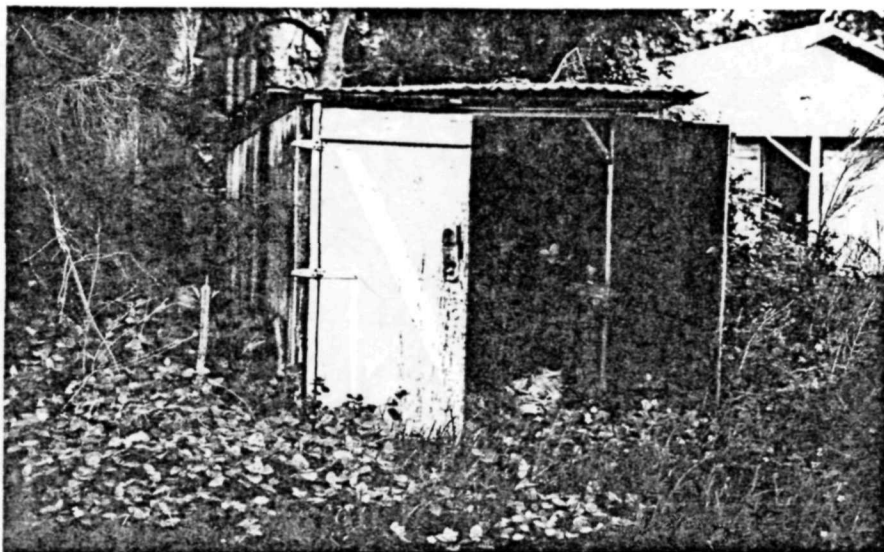
STRUCTURE: Building 625

DESCRIPTION: The structure is a single wall frame building with a shed roof. The roof is finished with corrugated metal. The foundation is overgrown with vegetation, and is rotting and riddled with termites. The front wall of the building is made up of double doors. The structure is in deteriorated condition.

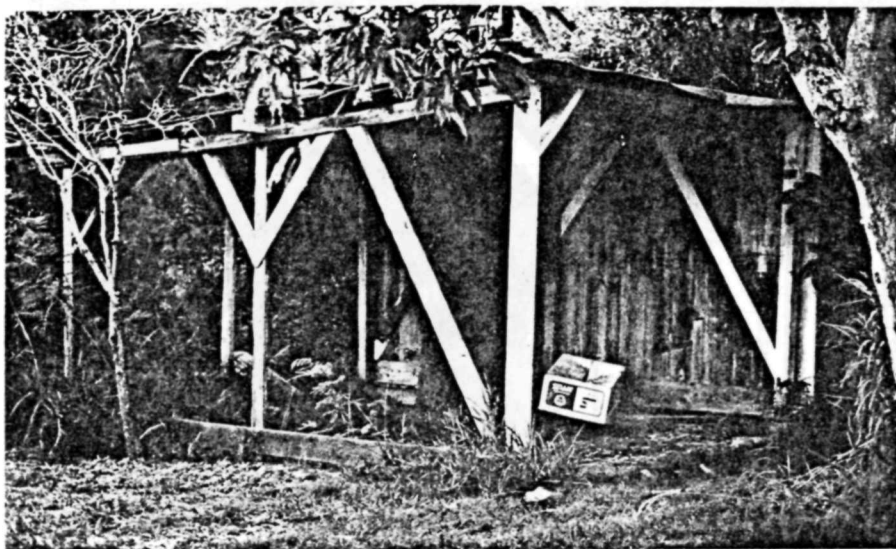
STRUCTURE: Building 626

DESCRIPTION: The structure is built of frame construction, with a shed roof finished with rolled composition roofing. The structure has a concrete pad foundation. Only one wall is finished with wood siding. The other three sides are open. The structure seems to have been built of recycled materials, and is in deteriorated condition.

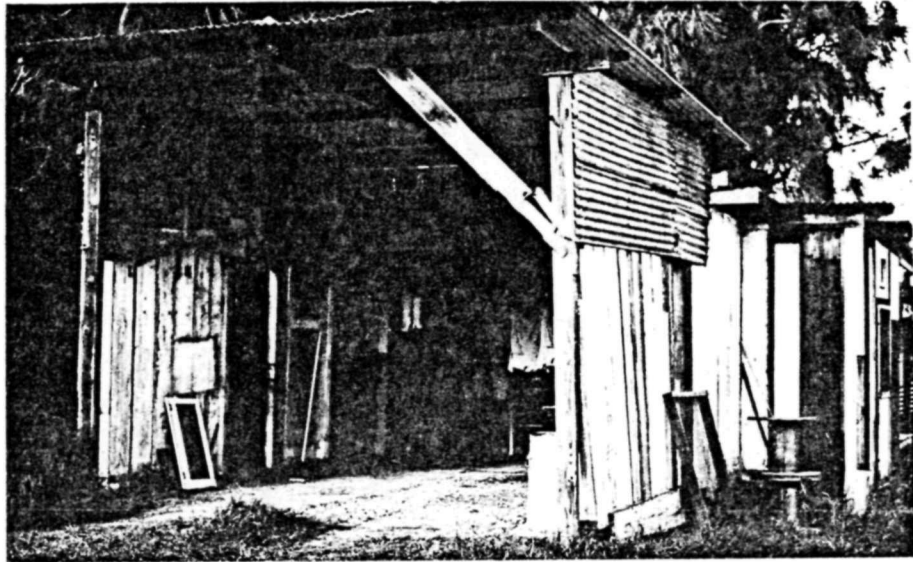
STRUCTURE: Building 629

DESCRIPTION: The structure is a one story building of single wall construction. The intersecting shed roofs of this rectangular structure are finished with corrugated metal. Wall finish is corrugated metal and board and batten. The structure, which seems to have been built of recycled materials, is in poor condition.

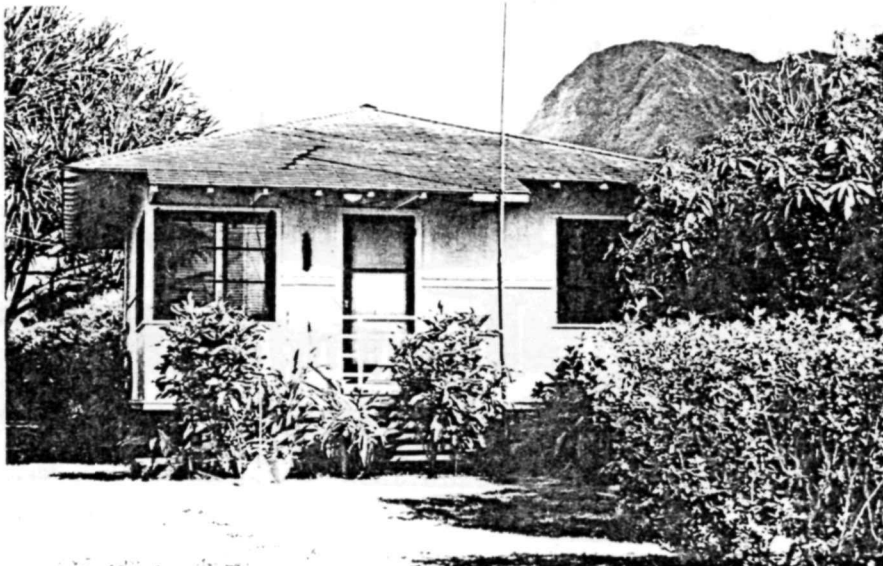
STRUCTURE: Building SR-1-A

DESCRIPTION: The structure is a one-story building of single wall construction. The hip roof is finished with red composition shingles. The foundation consists of concrete pads and posts. A broken girt encircles the exterior of the structure. A shed roof, which extends from the west side of the structure, shelters a small wood porch which provides access to the front door. A water table finishes the lower edge of the structure. The structure is used intermittently as a guest house for non-patient guests, and living quarters for visiting outside staff members on duty tours. The structure is in fair to good condition, and in need of fumigation and painting.

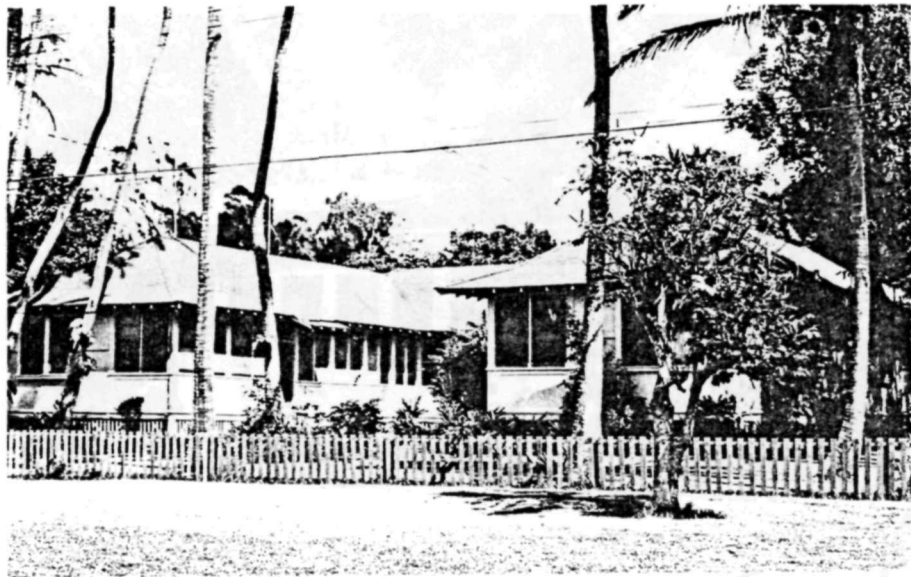
STRUCTURE: Building 1

DESCRIPTION: The structure is a one-story building of single wall construction, with a concrete pad and post foundation. The broken pitch hip roof of the U-shaped structure is finished with composition shingles. The wood frames of the twelve-light double hung windows project several inches from the exterior wall. The structure is divided into separate bedrooms and community living spaces. Concrete steps with solid stone railings provide access to the three main entrances in the front courtyard on the wet side of the structure. The building is occupied, and seems to be in good condition. Some vegetation should be cleared from the base of the structure, and the termite-eaten boards which are no longer structurally sound should be replaced. The building should be fumigated.

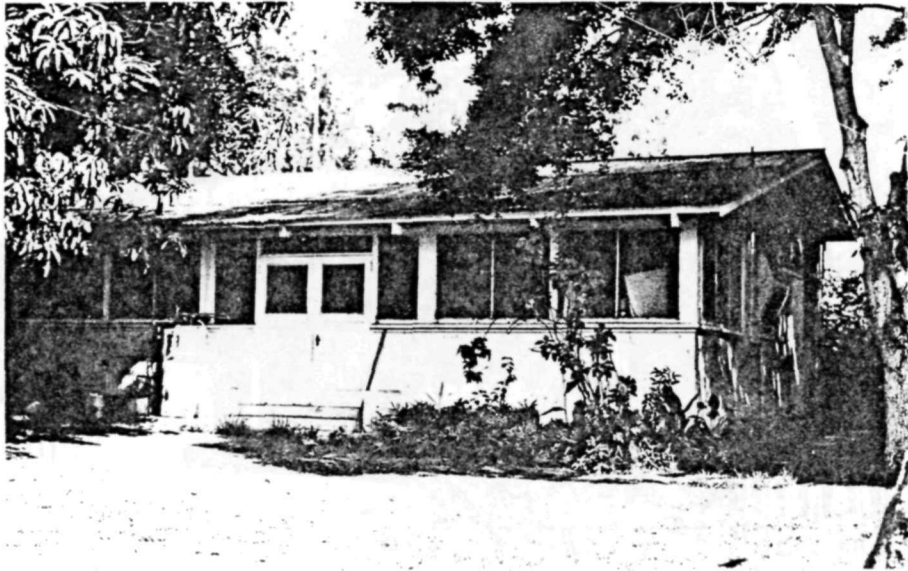
STRUCTURE: Building 3

DESCRIPTION: The structure is a single story building constructed of concrete block finished with cement stucco. Parts of the upper section of the building, and the roof are of wood frame construction. The gable roof is finished with corrugated metal. The foundation is concrete. The structure is used, and serves as living quarters for two non-patient employees, and a staff laundry room. The structure is in fair condition, but should be fumigated and painted, and termite damage repaired. Vegetation should be cleared from the base of the structure.

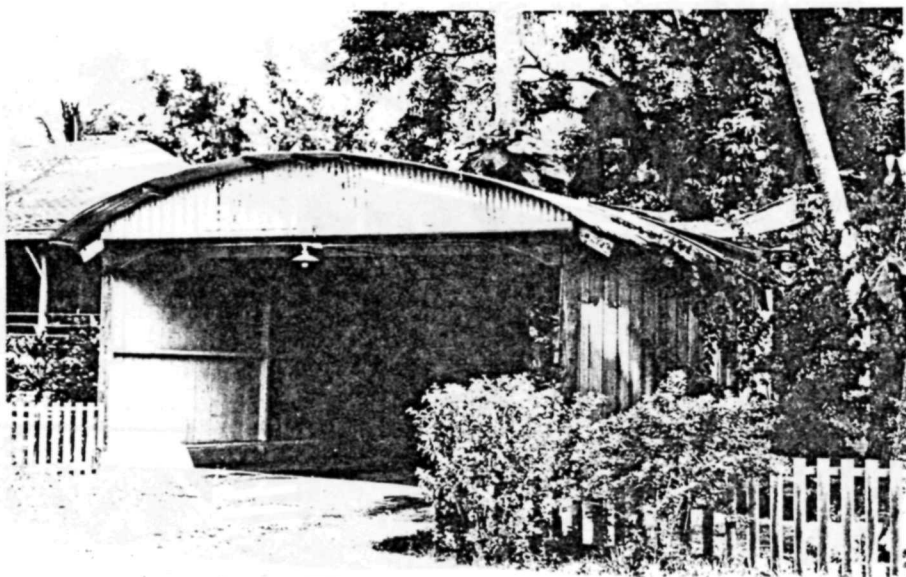
STRUCTURE: Building 4

DESCRIPTION: The structure is a single wall frame building (board and batten) with a corrugated metal quonset roof-constructed on metal framing members. The structure has a concrete foundation. The wood portions of the building are deteriorating due to rot and termites, and the metal roof and framing members are rusting. The structure is in poor condition. No estimate was done, due to its condition and lack of significance.

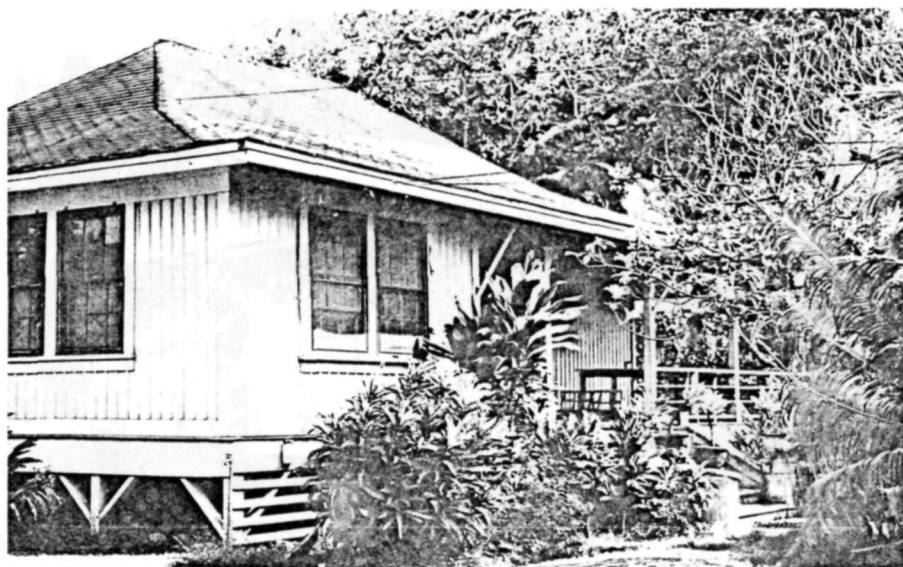
STRUCTURE: Building 5

DESCRIPTION: The structure is a one-story building of single wall construction, with a stone pad and post foundation. The generally rectangular building has a broken-pitch hip roof, with a recessed porch at the southwest corner. Concrete steps, bordered by two planters (as in the Administrator's Residence) lead to the front porch and two entrance doors. The wooden posts of the porch have jigsaw decorative brackets. The porch ceiling is plasterboard or "Celotex". Most of the windows are paired, and are wood frame, double hung (twelve-light). The exterior finish is board and batten. The corners of the structure are finished with endboards. The structure has been altered-the south wall includes a wall section of concrete block. The building is used daily, and is in fair condition. The structure should be fumigated and painted, re-roofed with original material, and termite damage repaired.

SIGNIFICANCE: Probably the earliest structure on staff row, originally the Administrator's Residence. Architectural significance has been marred by the alterations. Eventually should be restored to its original condition.

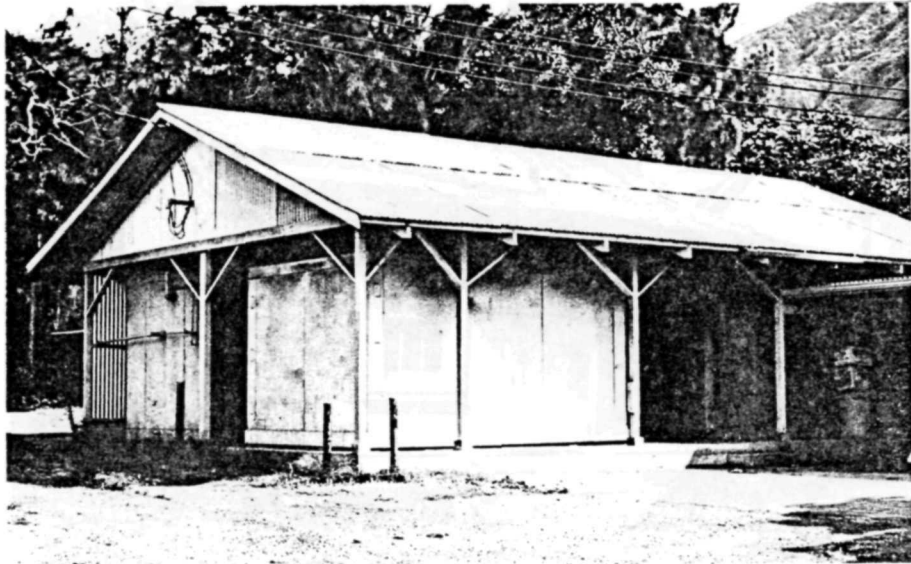
STRUCTURE: Building 6

DESCRIPTION: The structure is a frame building with a gable roof and a concrete slab foundation. The roof, gable ends, and the east side are finished with corrugated metal. The building is connected to the dining hall (Building 5) immediately to the west of it by a walkway covered with a corrugated metal roof. The structure houses the freezers for the dining hall. The building is in good condition. Ferns growing from the base of the freezer should be removed.
