# KALAUPAPA BUILDING INVENTORY

## KALAUPAPA - HAWAII

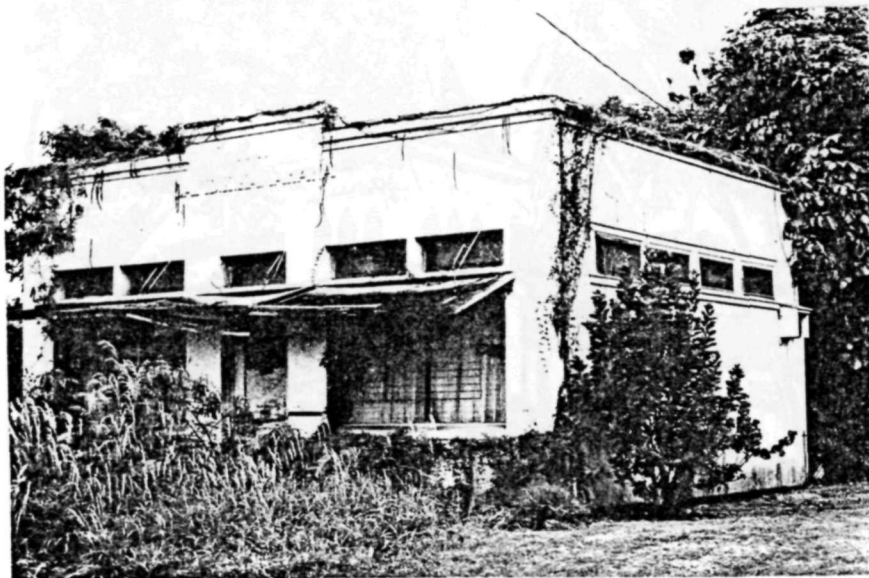
STRUCTURE: Building 260

DESCRIPTION: The structure is a frame building. The front section of the building has an exterior finish of stucco. The rear (storage) section is vertical plank siding, and is probably of single wall construction. The building has a symmetrical facade, with a door flanked by two picture windows. A series of five windows is located above the door and main windows. A small shed roof runs the length of the front of the structure. A parapet which runs along the roofline is broken, and raised several inches to articulate the front entrance. The structure is used for storage at this time, although a resident plans to turn the building into a museum. The structure is overgrown, and seems to be in fair to poor condition.

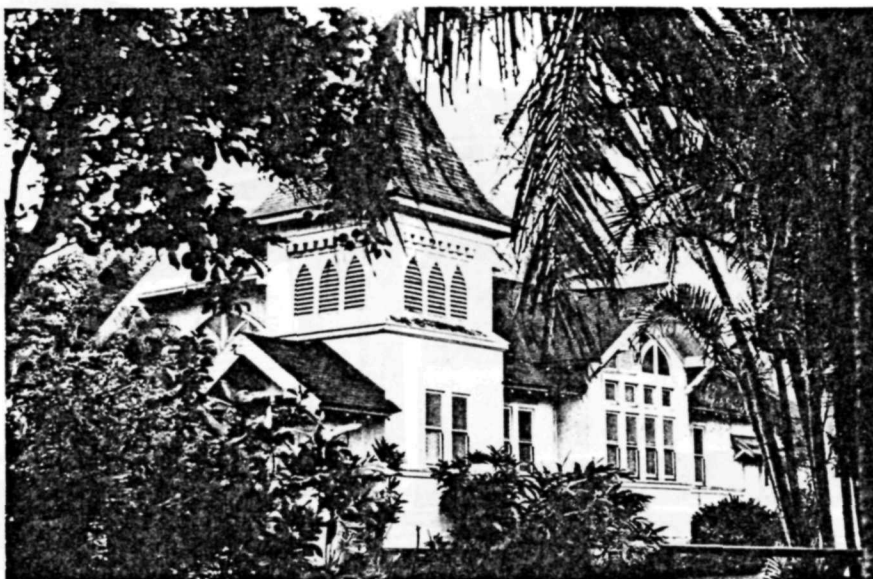
STRUCTURE: Building 286

DESCRIPTION: The structure is a frame building of single wall construction, with a foundation consisting of stone footings and wood posts, and concrete. The main gable roof is transected by two smaller gables which cover the windows projecting from the middle sections of the east and west walls. These gables are approximately two feet lower than the main gable. A tower which designates the main entrance to the building is located in the northwest corner of the structure. The tower has a hip roof finished with wood shingles, and ventilating louvers in the shapes of pointed arches on all four sides. Walls consist of vertical plank siding, surrounded by a continuous girt just below window level, and a water table at the sole plate. The large window areas - one at each gable end and each wing - are broad, pointed arches filled with fixed sash and double hung windows. Structural outlookers project beyond the roof-lines at the gable ends. The interior space is articulated with wood barrel vaults and exposed trusses. The building is in very deteriorated condition, and is in need of virtual board-by-board reconstruction.

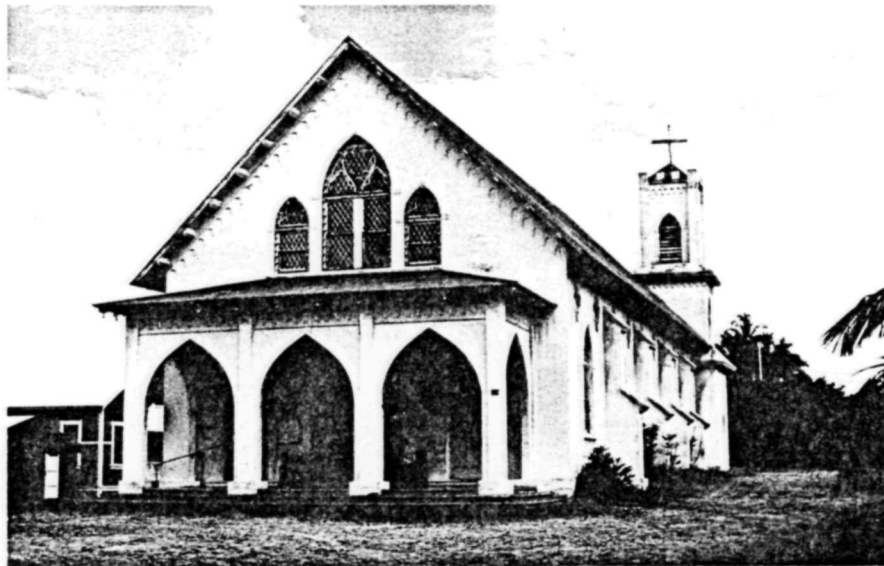
STRUCTURE: Building 291

DESCRIPTION: The building is a reinforced concrete structure with a concrete foundation. The rectangular building has an arched portico at the west side sheltered by a hip roof, a large nave with a gable roof, and a sacristy at the east end with a shed roof. A three-tiered steeple with a pyramidal roof is located in the southeast corner of the structure. All roofs are covered with corrugated metal. The hooded gothic windows are interspersed with reinforced concrete buttresses on the north and south walls. Other windows throughout the structure, as well as the louvers in the steeple are also of the hooded gothic type. Flanking the tops of the windows on the north and south are quatrefoils which have been filled in with masonite (replacing the original glass?). Corinthian columns on the interior help support the gothic vaults. The interior floor is scored concrete. The structure is used daily, and is in poor condition. Any termite damage should be repaired (windows, roof structure.) The stained glass windows should be stabilized. The structure should be re-roofed. The interior and exterior should be painted.

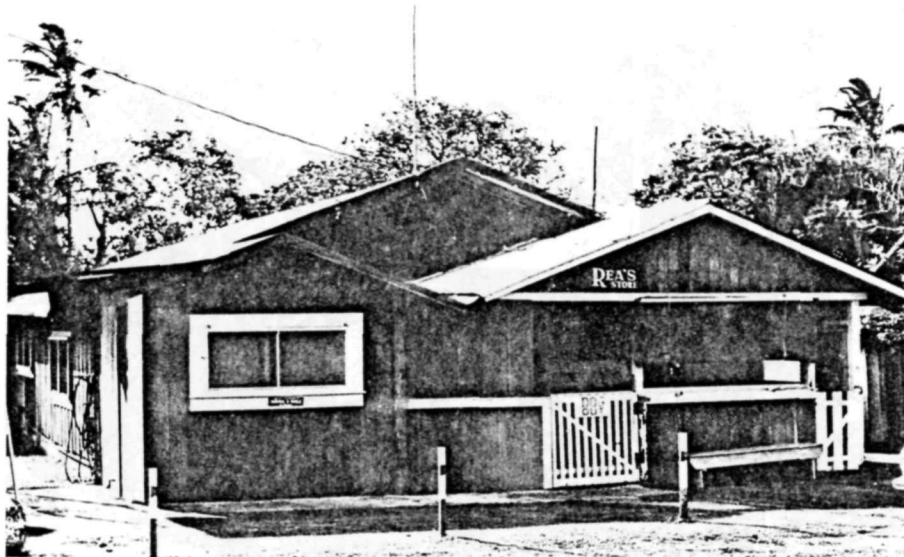
STRUCTURE: Building 298-A

DESCRIPTION: The structure is a frame building of single wall construction, with exterior walls of board and batten and vertical plank siding. The multiple gable roofs are finished with rolled composition roofing material and corrugated metal. The building is constructed on a concrete slab. A recessed porch, incorporated under the gable roof, is located at the east end of the structure. The building is used daily (except Sunday) and is in fair to poor condition (termites and the usual problems).

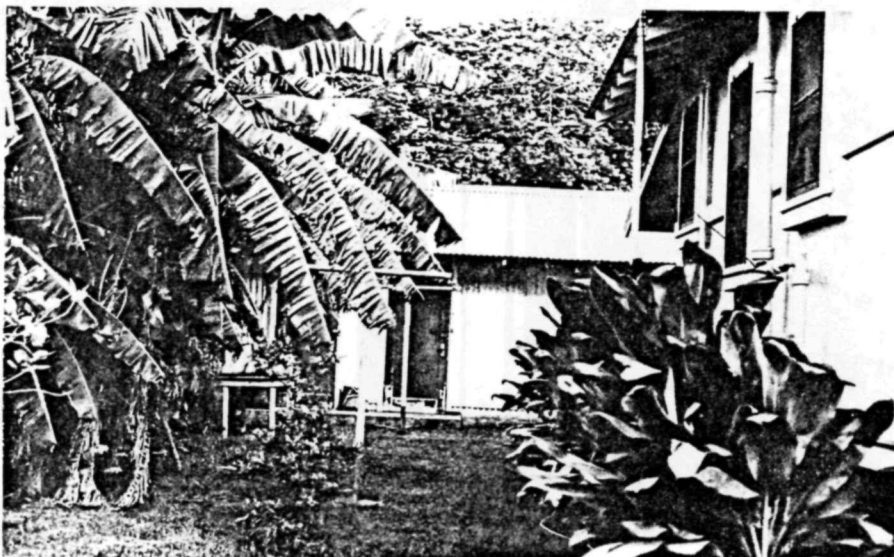
STRUCTURE: Building 623

The foundation is concrete. The structure is used, and seems to be in good condition.

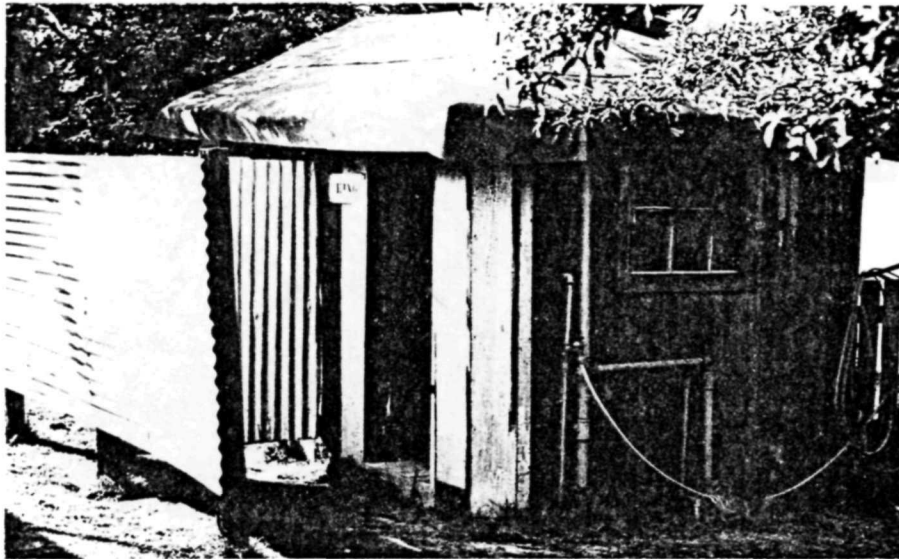
STRUCTURE: Building 624

DESCRIPTION: The structure is a frame building of single wall construction, with an exterior finish of board and batten. The hip roof is finished with rolled composition roofing material. The foundations consists of footings (stone or concrete?) which are obscured by vegetation. The building is divided into two sections ("Kings" and "Queens"). A baffle consisting of a wood frame and corrugated metal sheets discreetly shelters both entrances. The building is in poor condition (rot and termites). The structure like the bar, is used daily, except Sunday.

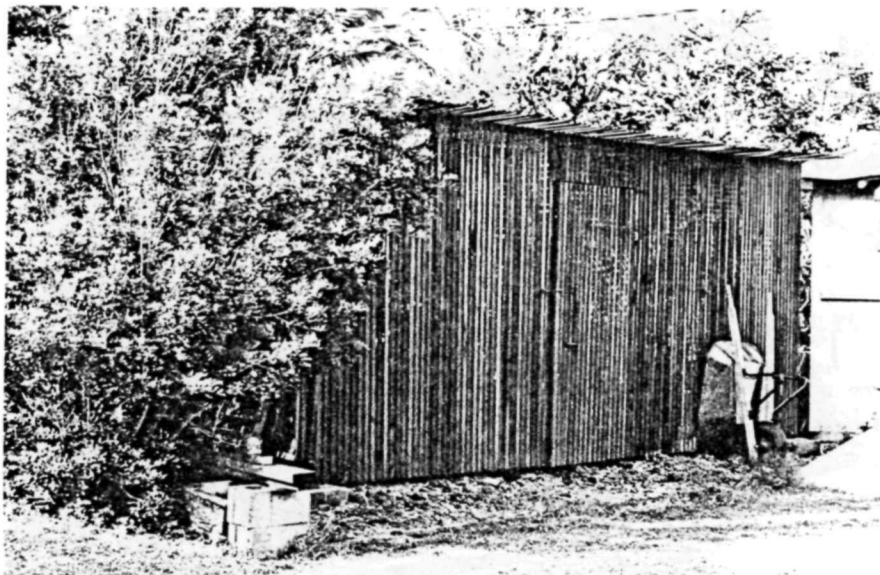
STRUCTURE: Building 636

DESCRIPTION: The structure is a wood frame, with walls and shed roof covered with lath-size wood strips. The foundation consists of concrete pads. The building is in use, and seems to be in fair condition.

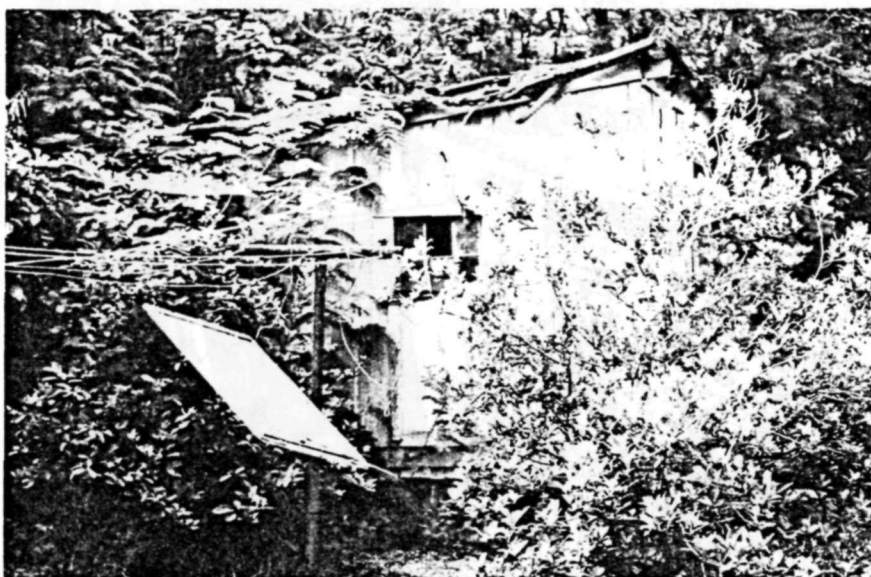
STRUCTURE: Building 641

DESCRIPTION: The structure is a frame building of single wall construction, with an exterior finish of board and batten siding. The foundation consists of stone pads and wood posts. The shed roof is finished with rolled composition roofing material. The structure is being overgrown. The building is abandoned, and seems to be in poor condition.

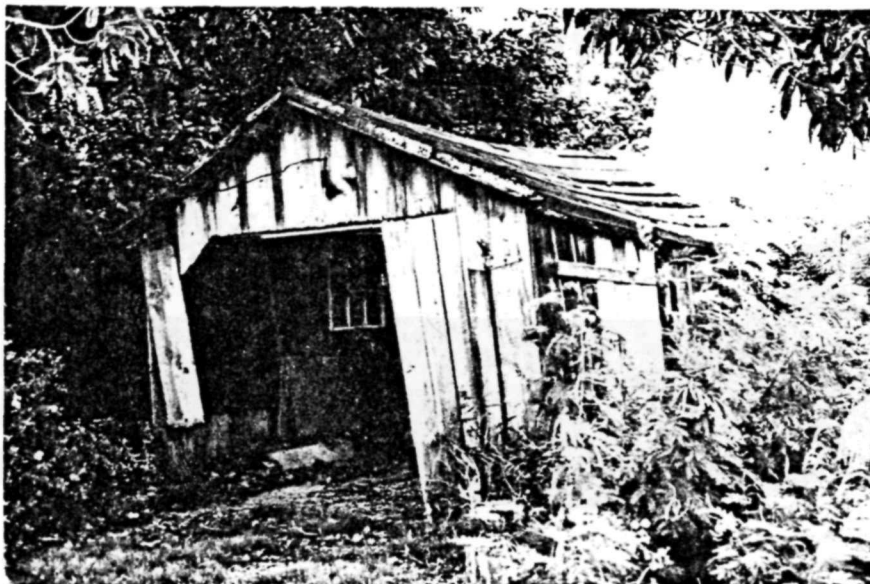
STRUCTURE: Building 642

The walls consist of vertical plank and board and batten siding. The gable roof is finished with rolled composition roofing material. The structure has no visible foundation. The building is sagging, and is about to collapse.

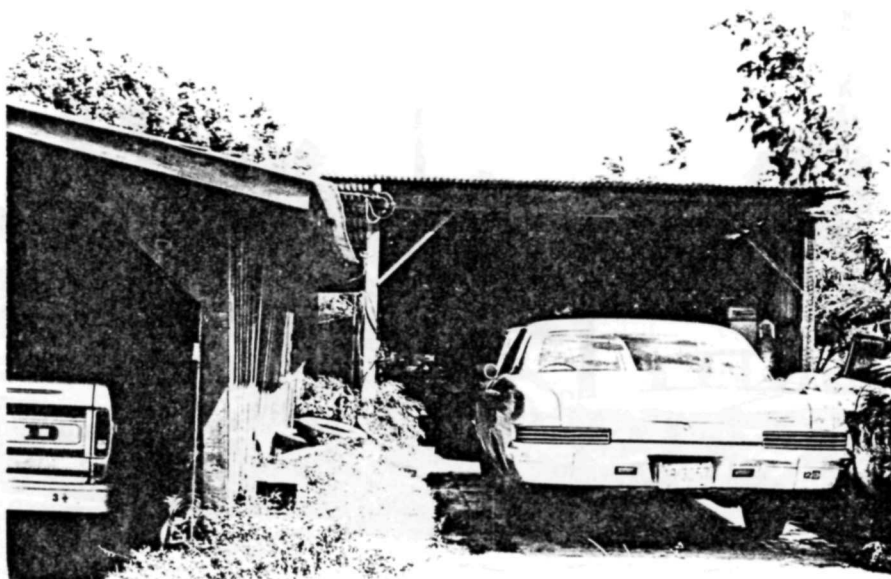
STRUCTURE: Building 645

DESCRIPTION: The structure is a frame building, with corrugated metal for three walls and roof. The fourth wall is completely open. The structure is used, and shows the usual signs of deterioration.

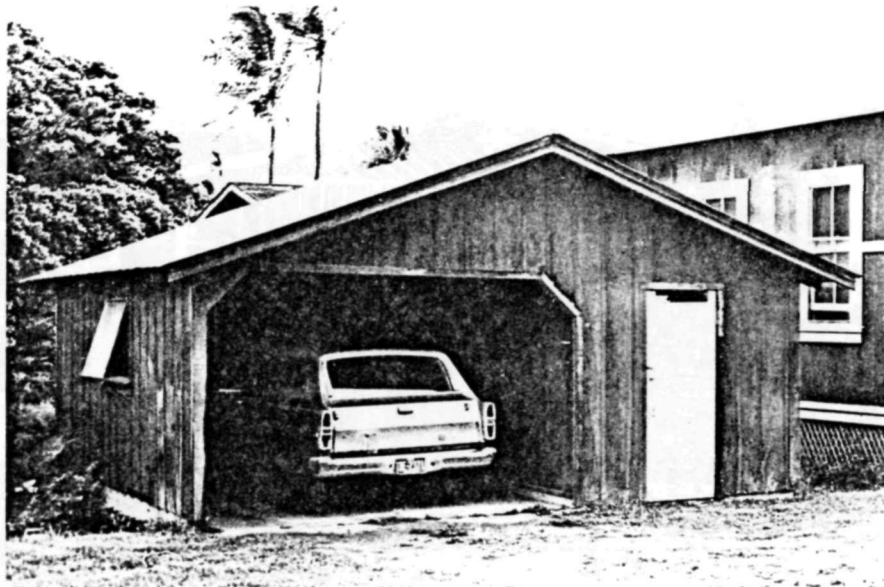
STRUCTURE: Building 647

DESCRIPTION: The structure is a frame building of single wall construction, with a board and batten exterior finish. The foundation is a concrete slab. The gable roof is finished with corrugated metal. The building is divided into two sections an open carport area, and enclosed storage area. The building is used, and is in fair to poor condition.

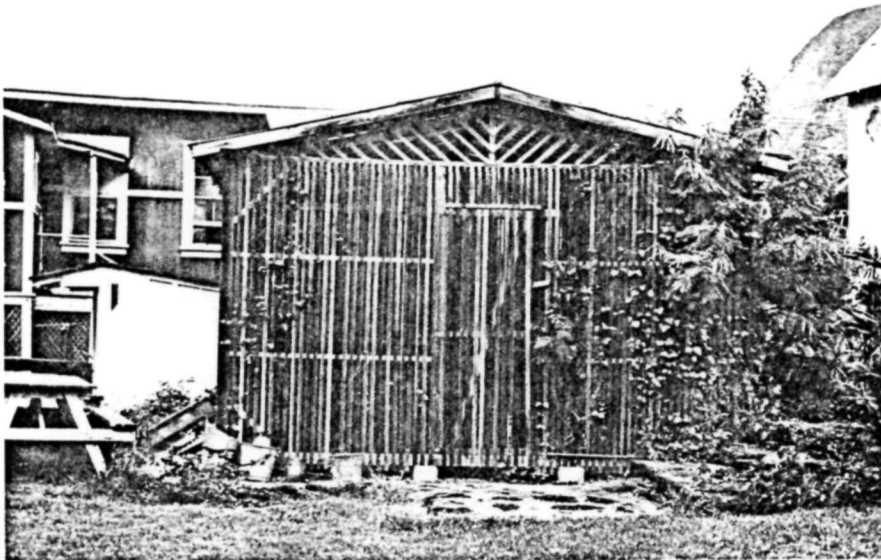
STRUCTURE: Building 648

DESCRIPTION: The structure is a wood frame, with perforated walls and roof  
of lath-size wood strips. The gable ends are finished in a decorative  
herringbone pattern. The foundations consist of concrete blocks. The  
structure is used, and seems to be in fair condition.

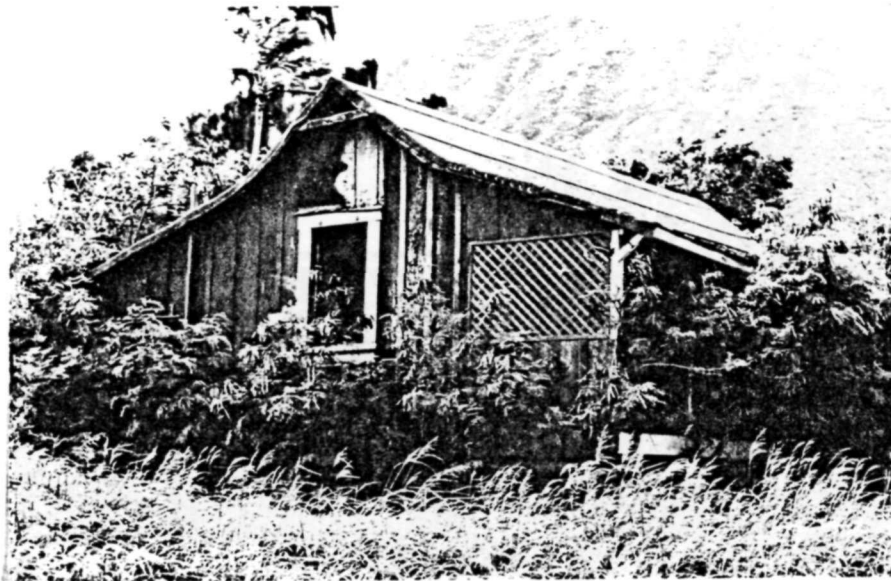
STRUCTURE: Building 29

DESCRIPTION: The structure is a frame building of single wall construction, with a board and batten exterior finish. The combination of gable and shed roofs is covered with rolled composition roofing material which has been applied over wood shingles. The foundation consists of stone footings and wood posts. A recessed porch is incorporated under the roof in the northwest corner of the structure. The structure is so deteriorated that it essentially is beyond repair.

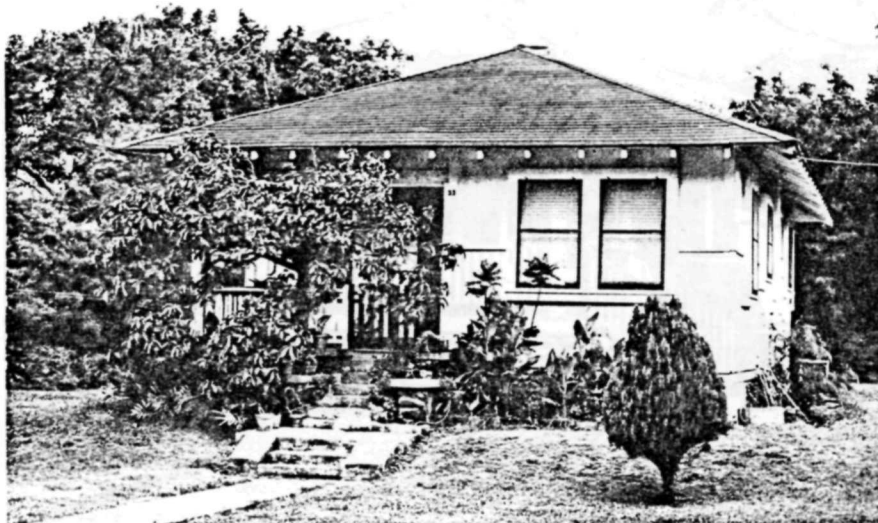
STRUCTURE: Building 53

DESCRIPTION: The structure is a one-story frame building of single wall construction, with a stone pad and post foundation. Stone and concrete steps provide access to the recessed corner porch which is incorporated under the hip roof. One chamfered post and two chamfered pilasters articulate the edges of the porch. The corners of the building are finished with cornerboards. A girt encircles the structure, and is broken by the wood frames of the double hung windows which project several inches from the exterior of the vertical plank wall. An enclosed wash room, with a shed roof and a stone pad foundation, is located at the rear of the building. The structure is in poor condition. Termite damage should be repaired and vegetation should be fumigated, re-roofed and painted.

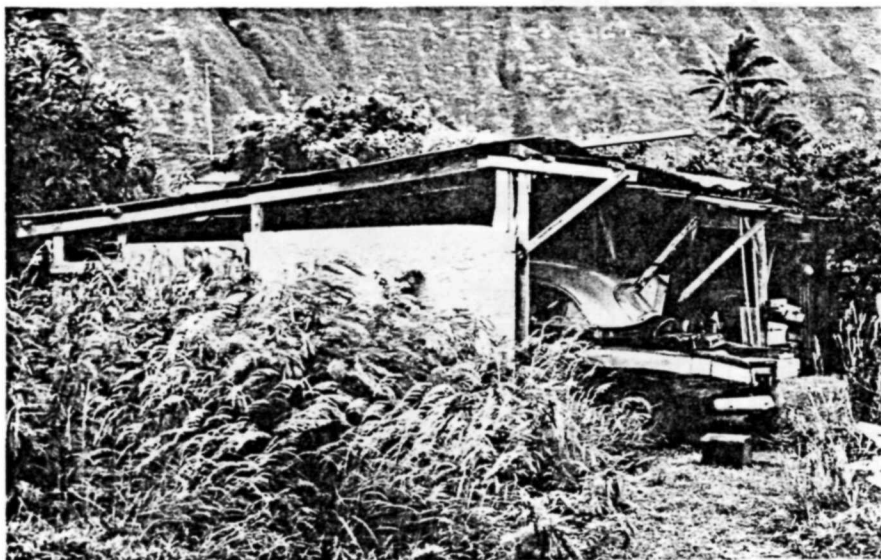
STRUCTURE: Building 660

DESCRIPTION: The structure is a woodframe, with a shed roof covered with corrugated metal. The building is divided into four garage spaces for cars. One side of the building is completely open. The other three sides are covered haphazardly with plywood and corrugated metal. The structure is still in use, and is in deteriorated condition.

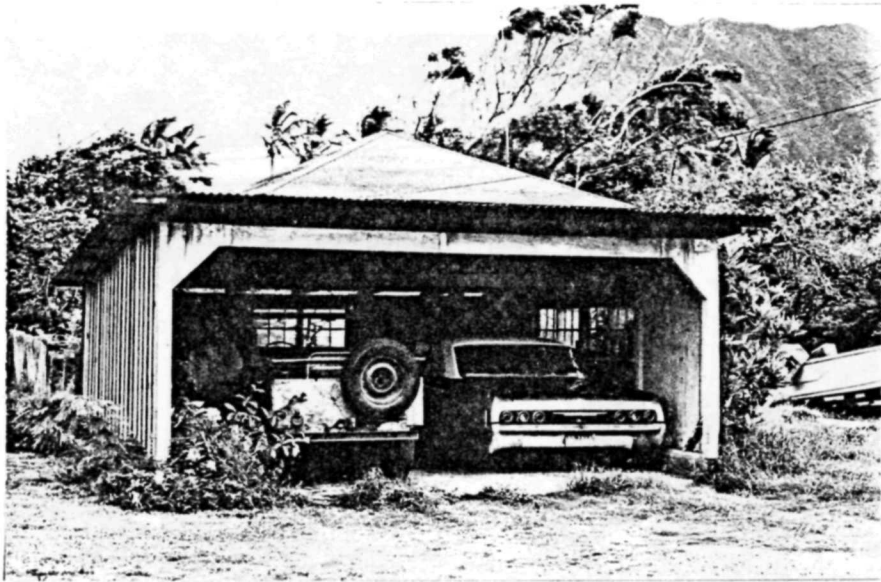
STRUCTURE: Building 662

DESCRIPTION: The structure is a frame building of single wall construction, with a board and batten exterior finish. The shed roof is covered with corrugated metal. The foundation is concrete. The west side of the structure which has no wall is open and serves as the entrance to the garage. The structure is used, and is in fair to poor condition.

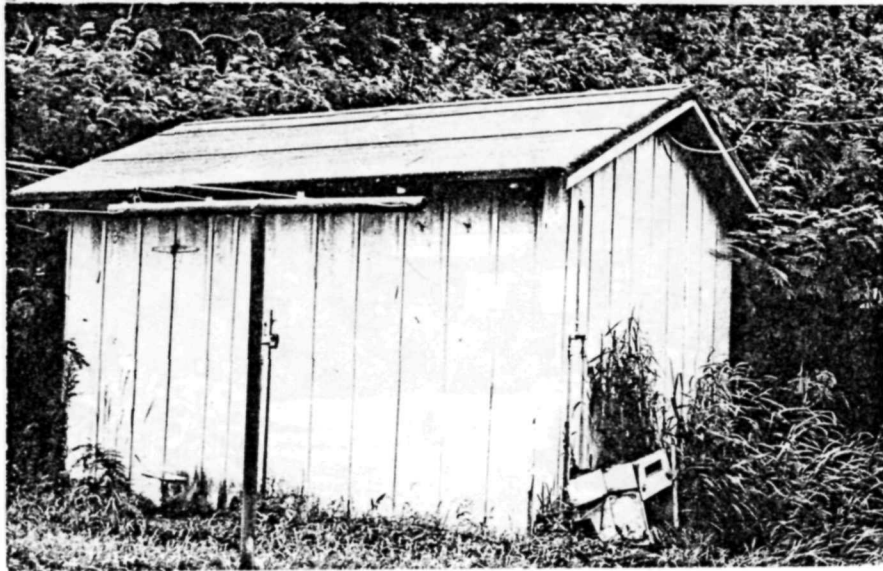
STRUCTURE: Building 663

DESCRIPTION: The structure is a frame building of single wall construction, with a board and batten exterior finish. The gable roof is finished with green rolled composition roofing material. The structure is a concrete slab foundation. The building is used, and in fair to poor condition.

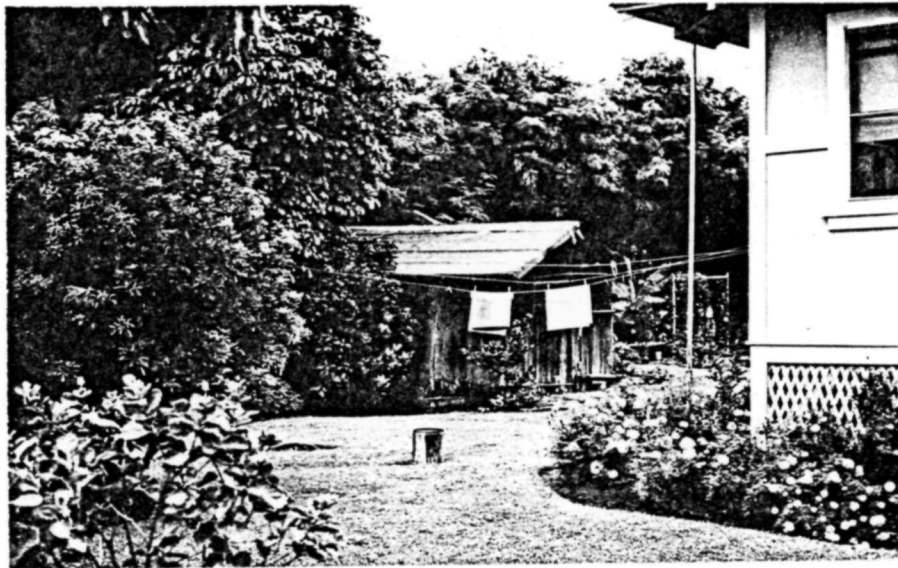
STRUCTURE: Building 664

DESCRIPTION: The structure is a frame building of single wall construction,  
with an exterior finish of board and batten. The gable roof is finished  
with rolled composition roofing material. The structure is still in use,  
but in very deteriorated condition.

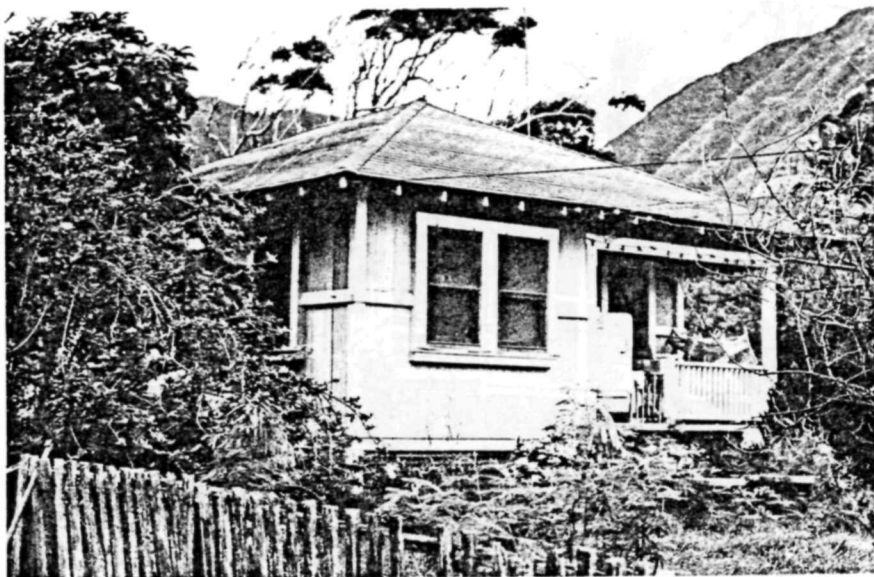
STRUCTURE: Building 55

DESCRIPTION: The structure is a frame building of single wall construction, with a stone pad and post foundation. Stone and concrete steps provide access to the recessed corner porch which is incorporated under the hip roof. One chamfered post and two chamfered pilasters articulate the edges of the porch. The corners of the building are finished with cornerboards. A girt encircles the structure, and is broken by the wood frames of the double-hung windows which project several inches from the exterior of the vertical plank wall. The hip roof is finished with composition shingles. A porch with a shed roof is located at the rear of the rectangular structure. The building is occupied and in fair condition. Termite damage should be repaired. The structure should be fumigated and painted. Vegetation should be cleared from the base of the building to discourage further termite and rot deterioration.

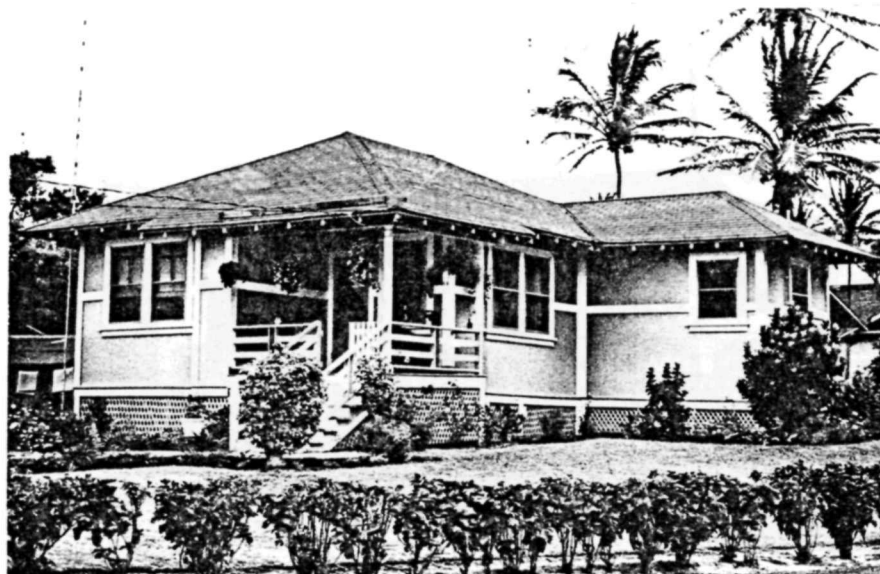
STRUCTURE: Building 56

DESCRIPTION: The structure is a frame building of single wall construction, with a concrete pad and post foundation. Wood steps provide access to the recessed corner porch which is incorporated under the hip roof. The corners of the building are finished with cornerboards. A girt encircles the structure, and is broken by the wood frames of the double-hung windows. The wall is composed of vertical plank siding. The hip roof is finished with composition shingles. A partially enclosed porch with a shed roof is located at the rear of the L-shaped structure. The building is occupied, and in good condition. Termite and rot damage (particularly to the roof, where the wood shingles were used as decking for the composition shingles) should be repaired. The building should be fumigated.

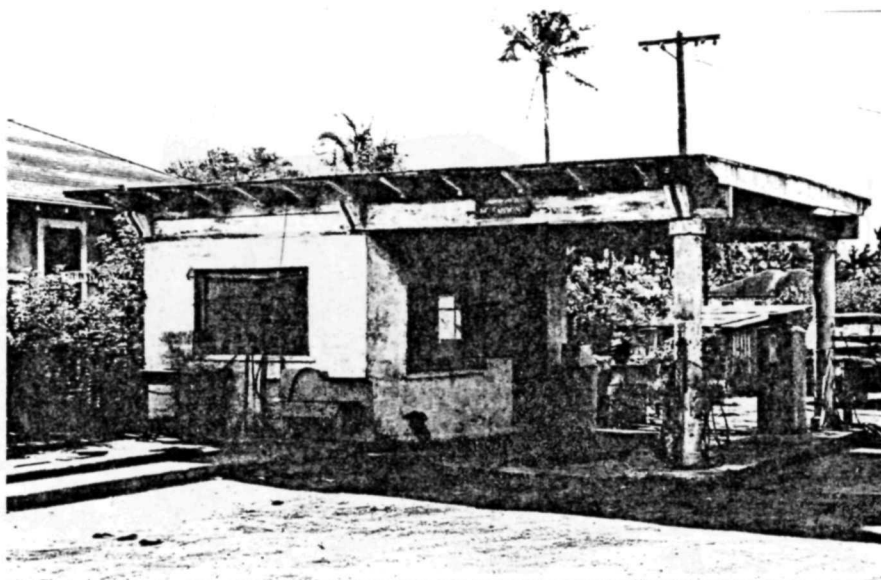
STRUCTURE: Building 258

The columns supporting the portico are simple, round pillars, with circular capitals. The windows are both metal and wood frame. The structure is rapidly deteriorating. The building houses the air compressor and other equipment. The building should be fumigated, re-roofed, cleaned and painted.

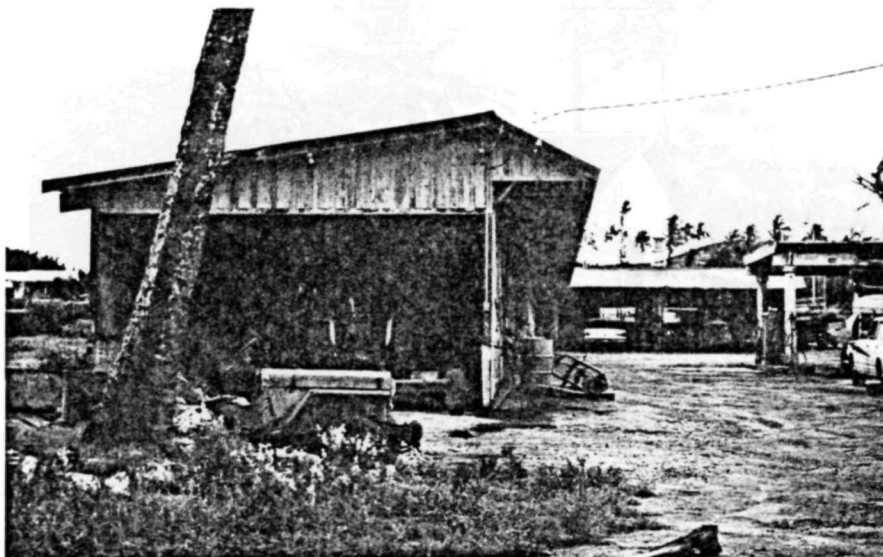
STRUCTURE: Building 259

DESCRIPTION: The structure is a frame building of single wall construction, with a board and batten exterior finish. The foundation is concrete. The shed roof is covered with corrugated metal. The building is divided into open stalls, most of which are twenty feet wide. The structure is in poor condition. One section of the north wall has been broken through (practically driven through) and should be repaired. Termite damage should be repaired. Vegetation should be cleared from around the structure to prevent further damage from termites and rot. The building should be painted and fumigated.

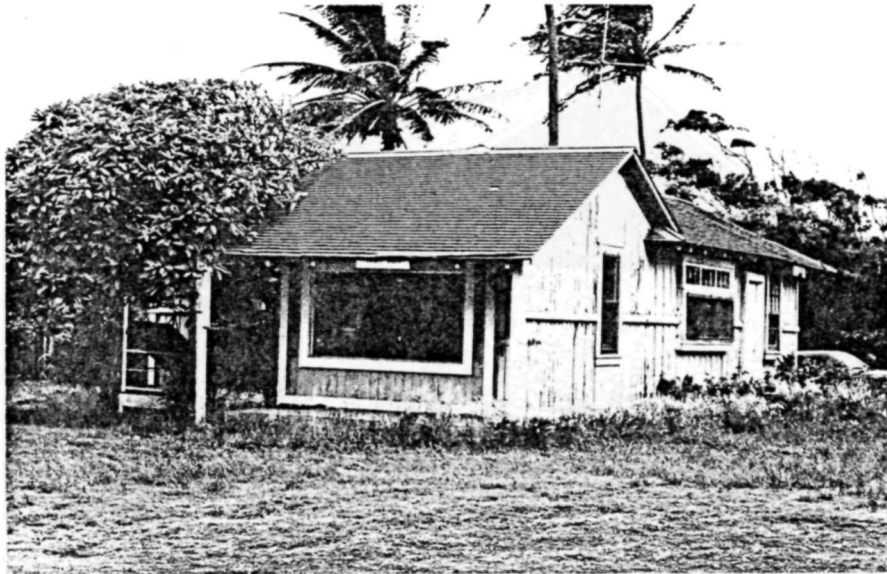
STRUCTURE: Building 300

Some of the siding is vertical plank, some is board and batten. The foundations vary from concrete slabs to stone or concrete footings and wood posts. The multiple roofs are predominantly gable, finished with wood shingles at the front of the structure and corrugated metal and rolled composition roofing at the rear. The building is irregularly shaped. Most of the structure is surrounded by a broken girt. Corners are finished with corner boards. The wood frame windows vary from double-hung twelve light to fixed sash picture windows. The structure receives intermittent use, and is in poor condition. The building could easily be made serviceable for many more years if termite damage were repaired and the structure was fumigated. Vegetation should be cleared from the base and the roof. The building should also be painted.

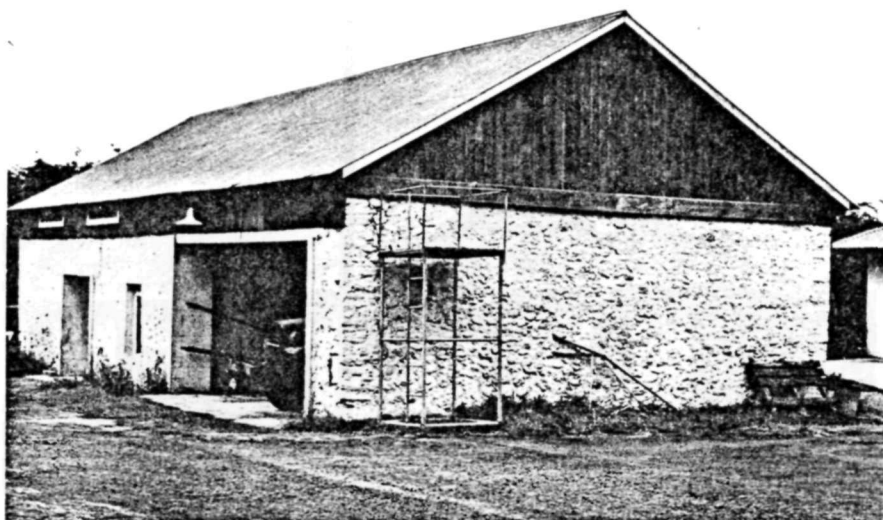
STRUCTURE: Building 301

DESCRIPTION: The building is a stone masonry structure (lime mortar) with a gable roof. The roof is finished with corrugated metal. The gable ends and a two-foot section at the top of the wall are finished with board and batten siding. A large open stall for vehicle storage, located at the southeast corner, has a concrete slab floor. A door in the west wall, and a window in the south wall are finished with old wood lintels. Quoins, visible through the paint, articulate the four corners of the rectangular structure. The building is in poor condition. The roof structure should be stabilized and the building should be fumigated to prevent further damage to wood. The structural cracks in the masonry of the southeast and southwest corners will eventually need stabilization. The building has been altered (interior has been divided, concrete openings framed openings have been made of the south wall. Probably an old doorway was located on the Maui side, but it has since been filled in).

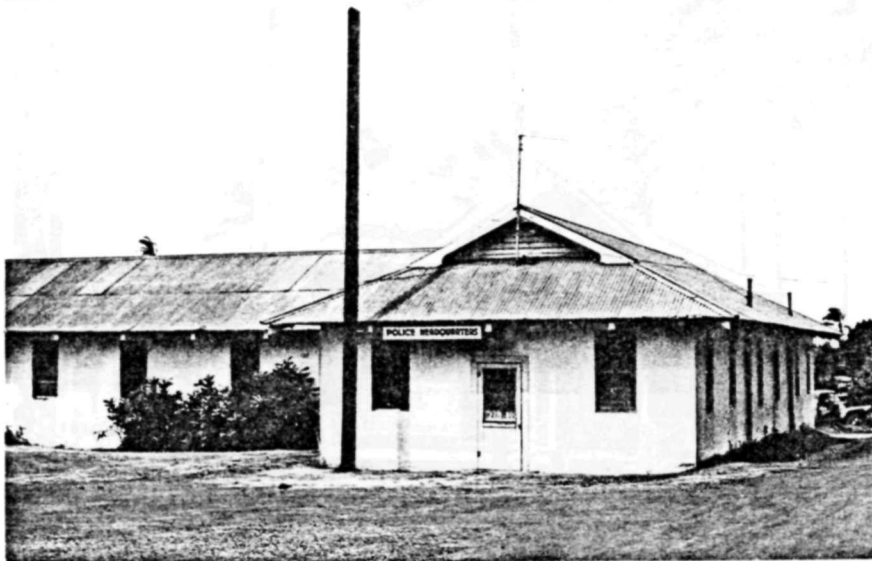
STRUCTURE: Building 302 and 303

DESCRIPTION: The two structures are joined together by an intersecting roof and a concrete slab breezeway. Both structures are concrete, with concrete foundations. The hip roofs (with gablets) are covered with corrugated metal. The buildings are connected in a T-shape. Building 303 to the east serves as police headquarters. Windows are wood frame double hung (twelve light). Building 302, the jail, is to the west. Metal bars are located on all the windows. Police headquarters is used daily. The jail has not been used for an extended period of time. The structures are in fair to poor condition. Any termite damage (window frames, roof structure, etc.) should be repaired, as should the spalling concrete. The roofs and exterior walls should be painted. The buildings should be fumigated. Vegetation should be cleared.

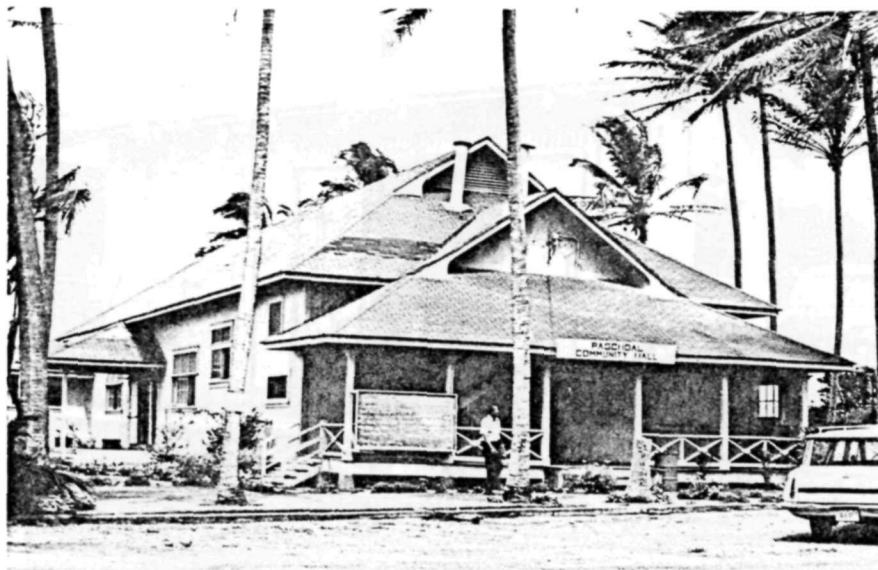
STRUCTURE: Building 304

DESCRIPTION: The structure is a 2 story building of single wall construction, with a foundation of concrete piers. The multiple roofs, finished with green composition shingles, are hip roofs usually with gables. The facade of the structure is symmetrical. The east and west sides differ slightly (additions and alterations?) although the windows are of the same type, size and spacing on each of those walls. A veranda, sheltered by a hip roof which intersects the main roof, runs the length of the front (south) of the structure and serves as the main entrance. A diamond-patterned railing and chamfered posts and pilasters articulate the edges of the veranda. Other entrances are located at the middle of the east and west sides. The interior consists of a large portion of empty floor space, several storage rooms, and an auditorium with tiers of seating which rise up to the balcony. The audience area was originally separated so that kokua sat in the balcony, separated from the patients by a railing. Access to the balcony is by means of an exterior stairway from the front porch (or now through the tiers of seating). The structure is in fair to poor condition. Termite damage should be repaired. The building should be re-roofed, fumigated and painted (interior and exterior). SIGNIFICANCE: Architecturally, the building seems to have been slightly modified since its construction (stairways, minor addition, etc.); a formal, symmetrical building which has been slightly adapted to fit needs better. Warrants preservation.

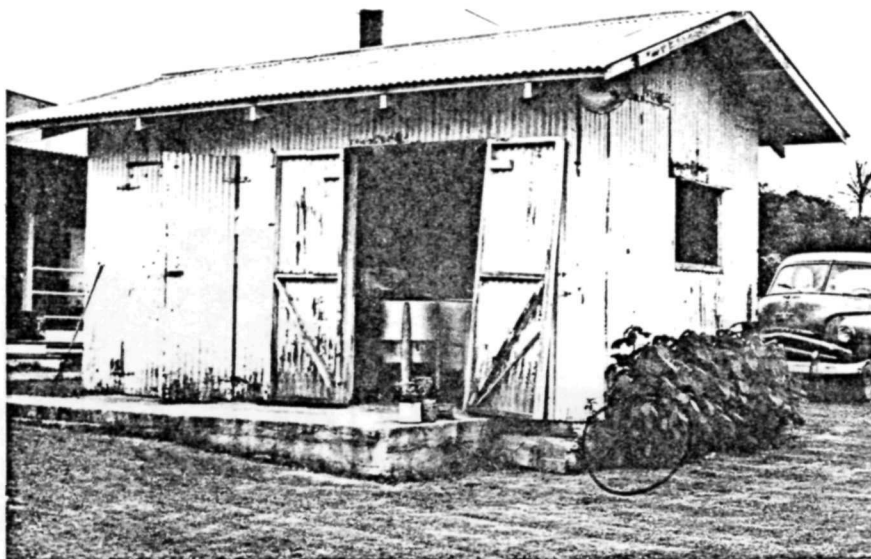
STRUCTURE: Building 656

DESCRIPTION: The structure is a frame building of single wall construction. Walls and gable roof are covered with corrugated metal. The foundation is a concrete slab. The building has two double doors, which open out to the south. The structure is in very deteriorated condition. The roof is rusted and leaking. The doors are off their hinges. The pipes have rusted. The building is still in use.

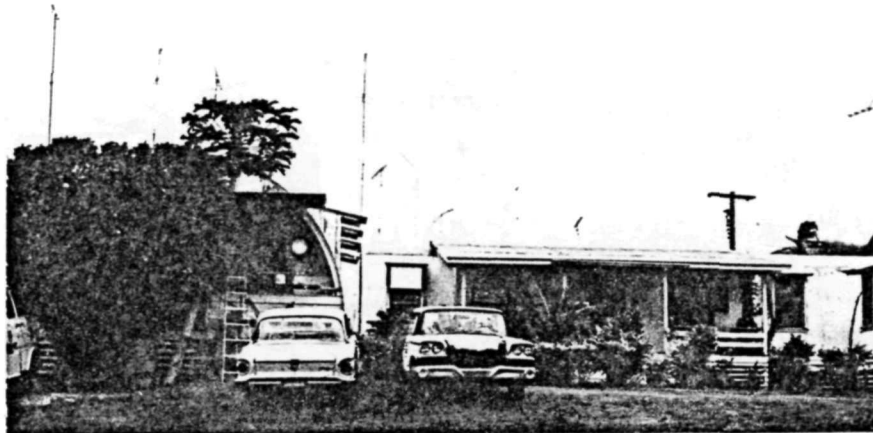
STRUCTURE: Building 657

DESCRIPTION: The structure consists of three quonset huts which have been joined together in an H-shape. The quonsets' foundations are concrete footings and wood posts. Some of the posts have been eaten away by termites, so the remainders dangle in the air a foot above the concrete pads. Covered porches with shed roofs are located on both sides of the central quonset. Dormer window with shed roofs extend from the long sides of all the quonsets. The buildings are in very deteriorated condition and should be demolished.

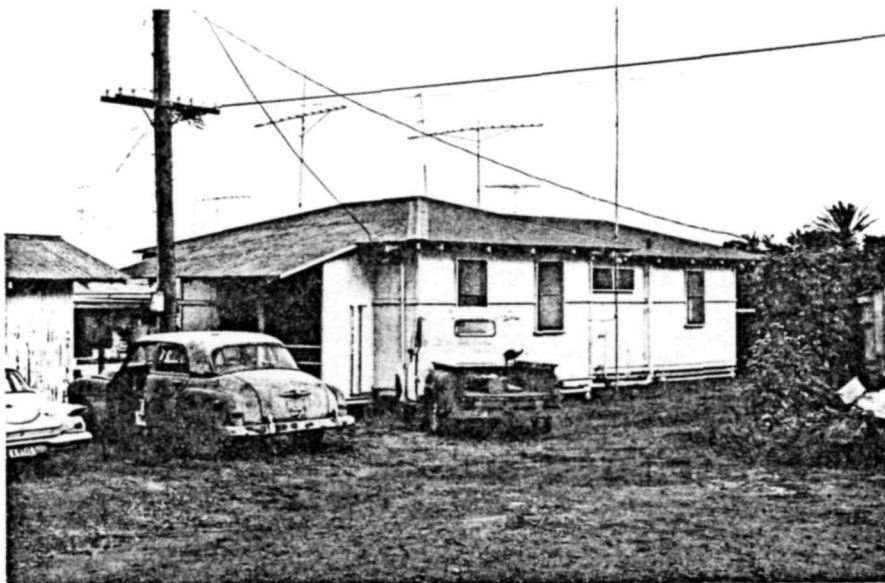
STRUCTURE: Building 657-A

DESCRIPTION: The structure is a frame building of single wall construction. The foundation is a series of concrete footings. The intersecting hip roofs of the L-shaped structure are finished with corrugated metal. A broken girt encircles the structure. The corners are finished with cornerboards. A shed roof (extension of the hip) covers a porch located on the south side of the building. The structure is occupied, and in fair to poor condition.

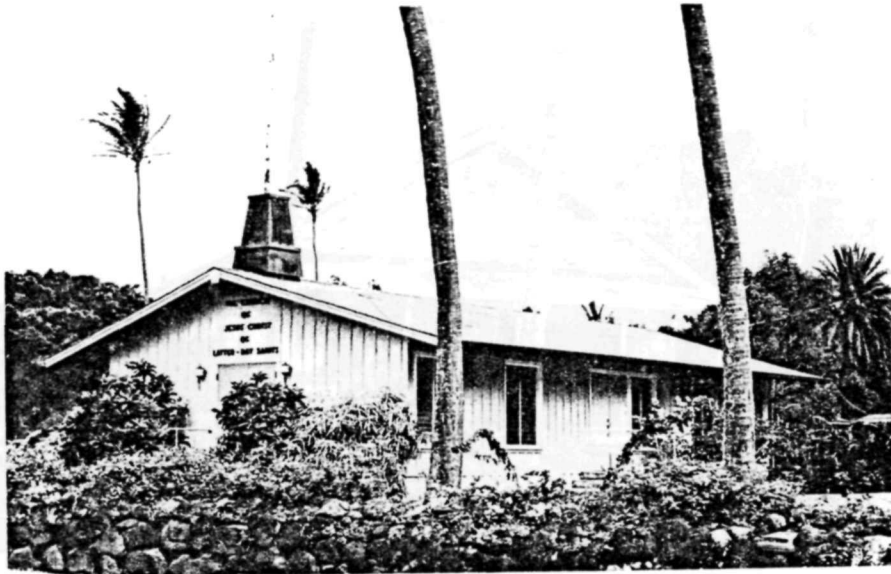
STRUCTURE: Building 257

DESCRIPTION: The structure is a frame building (plywood and batten exterior finish?) with a concrete foundation. The gable roof is finished with grey composition shingles. The structure is used intermittently, and seems to be in good condition.

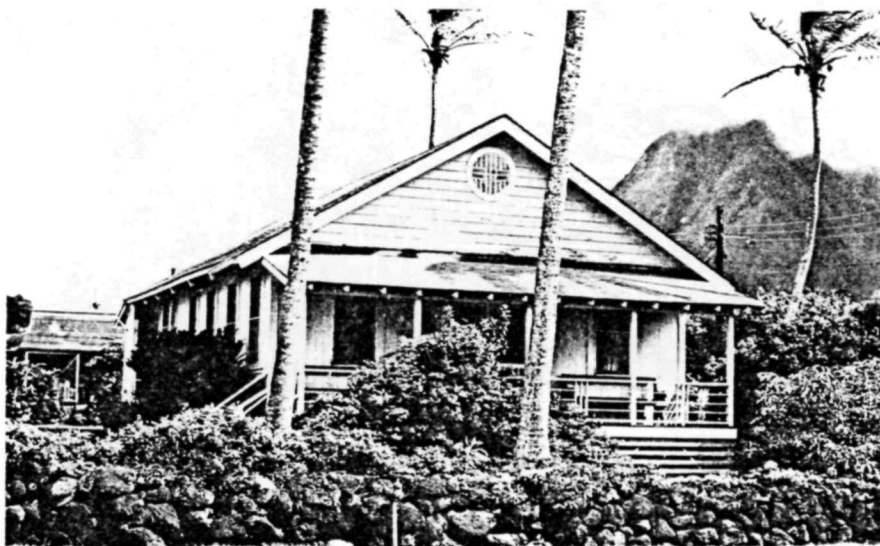
STRUCTURE: Building 257-A

DESCRIPTION: The structure is a frame building of single wall construction, with a foundation consisting of concrete pads. The gable roof is finished with grey composition shingles. A shed roof shelters a veranda at the west gable end of the building. The shed roof is also covered with composition shingles. The walls are vertical wood siding, with horizontal siding filling in the gable ends. A round window in the west gable end is divided by horizontal and vertical glazing bars in a decorative pattern (Japanese?). The horizontal and vertical interplay is enclosed in the porch railing. The structure is in fair condition, and is used intermittently.

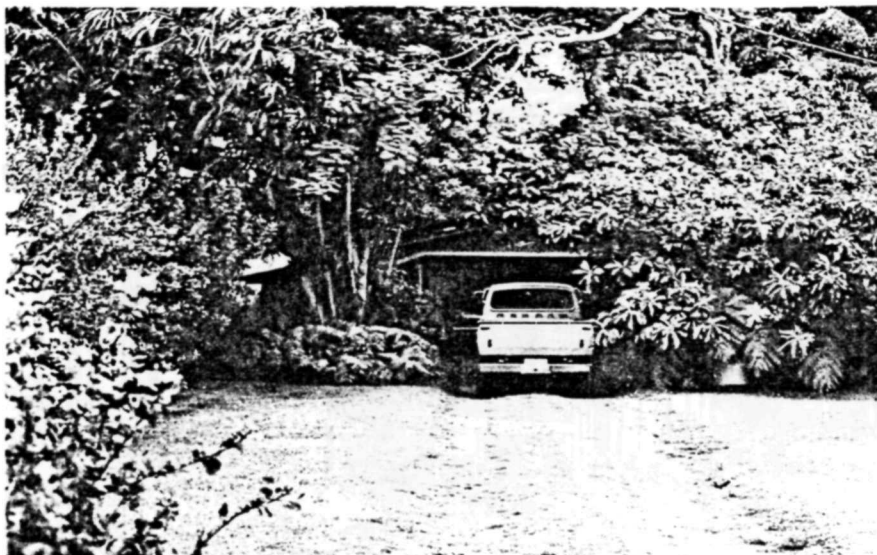
STRUCTURE: Building 661

DESCRIPTION: The structure is a frame building of single wall construction, with vertical plank siding (part board and batten). The building is used, and is in fair condition.

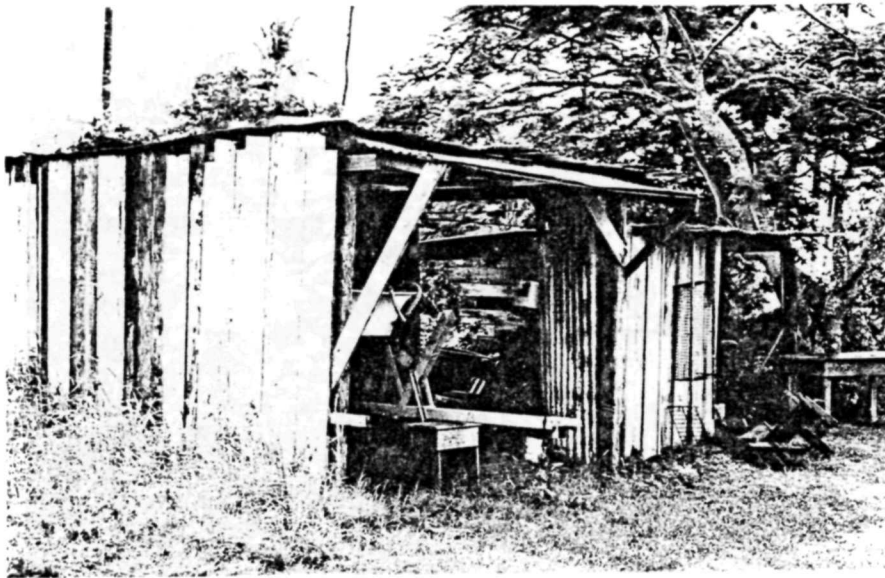
STRUCTURE: Building 665

DESCRIPTION: The structure built of recycled materials, consists of several  
sheds constructed one against the other. The shed roofs are covered with  
corrugated metal. The foundations are inadequate - is used, and is in  
very deteriorated condition.

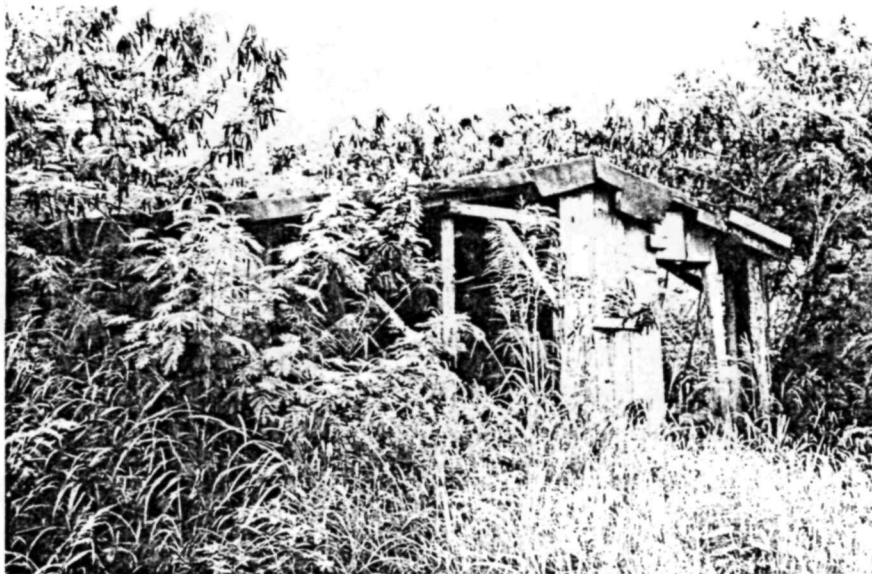
STRUCTURE: Building 666

DESCRIPTION: The structure is a frame building of single wall construction, with vertical plank siding. The gable roof is finished with the remains of some rolled composition roofing material. The structure is overgrown and very deteriorated.

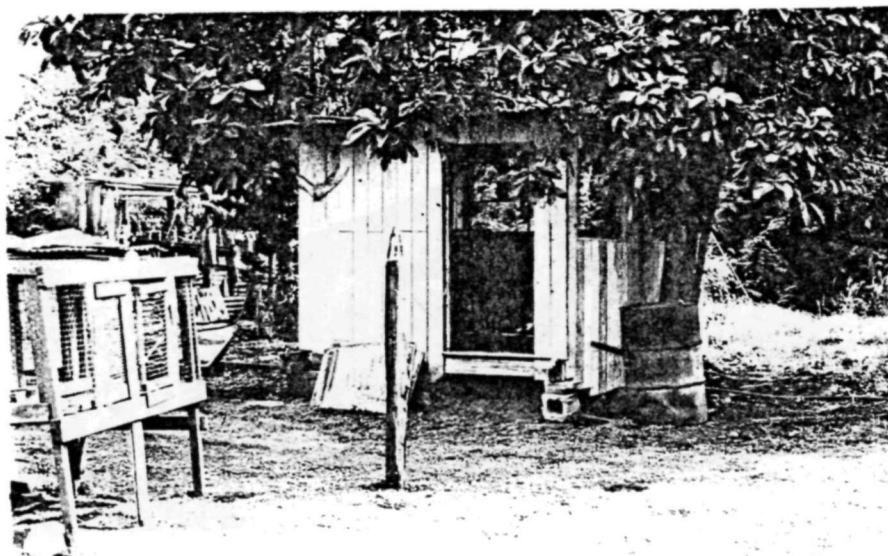
STRUCTURE: Building 667

DESCRIPTION: The structure is a frame building of single wall construction. The foundation consists of concrete blocks. The walls are vertical plank siding. The shed roof is covered with corrugated metal. The structure is frequently occupied by chickens, and is in deteriorated condition.
