# KALAUPAPA BUILDING INVENTORY

## KALAUPAPA - HAWAII

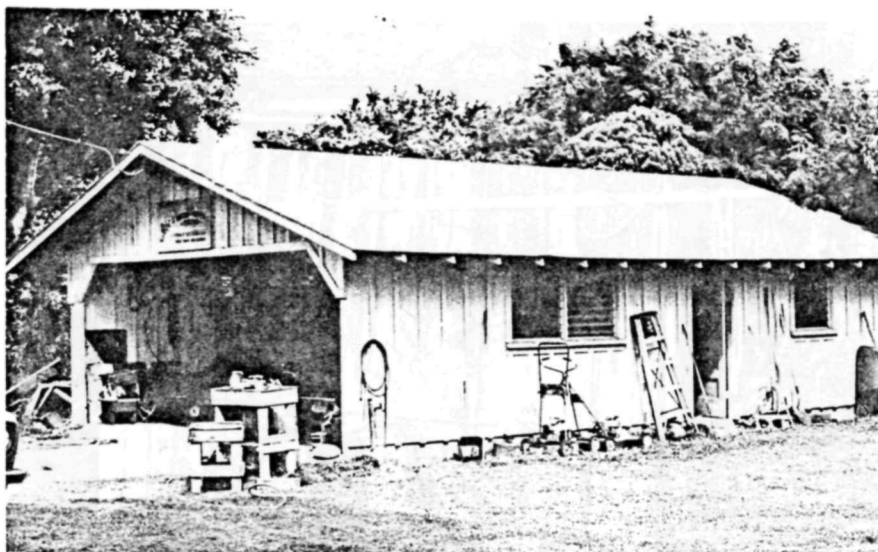
STRUCTURE: Building 672  
LOCATION: Kamehameha Street  
USE: Garage  
SIZE: Approx. 20 x 40 OWNERSHIP: Private  
DATE OF STRUCTURE: Unknown  
DESCRIPTION: The structure is a frame building of single wall construction (board and batten). The foundation is concrete. The gable roof is finished with grey composition shingles. The west facade is completely open. The building has jalousie windows. The structure is in use ("Ike's Auto - Tune-up - Repair Service"), and in good condition.

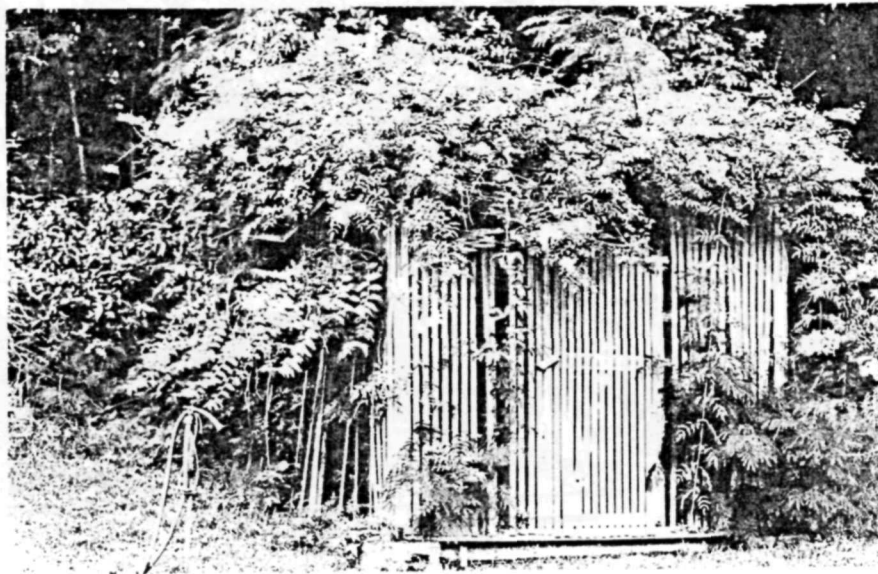
STRUCTURE: Building 674

DESCRIPTION: The structure is a frame, with perforated walls and roof of  
lath-size wood strips. The foundation is wood planks and concrete blocks.  
The structure has been completely taken over by plants, and is in very  
deteriorated condition.

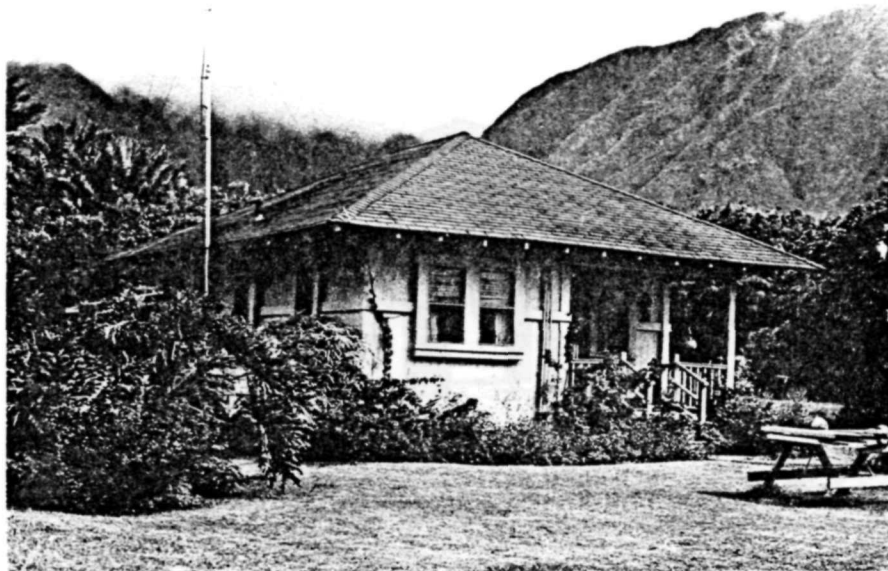
STRUCTURE: Building 9

DESCRIPTION: The structure is a one-story frame building of single wall construction, with foundations consisting of stone footings and posts. Wood steps with railings provide access to the recessed corner porch which is incorporated under the hip roof. One chamfered post and two chamfered pilasters articulate the edges of the porch. The corners of the building are finished with corner boards. A girt encircles the structure, and is broken by the wood frames of the double hung plank wall. The hip roof is finished with composition shingles. A partially enclosed wash house with a shed roof, and constructed on a concrete slab is located at the rear of the structure. The building is occupied and in fair condition. Termite damage should be repaired, and the settling footings should be stabilized. Vegetation should be cleared out from the base to discourage further termite activity and rot. The building should be fumigated and painted.

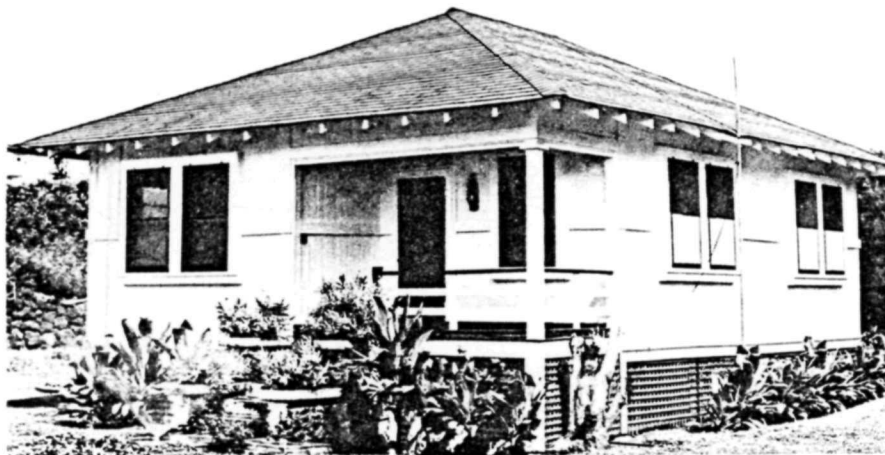
STRUCTURE: Building 15

DESCRIPTION: The structure is a one-story frame building of single wall construction, with foundations consisting of stone footings and posts. Stone and concrete steps provide access to the recessed corner porch which is incorporated under the hip roof. One post with a simple capital, and two chamfered pilasters articulate the edges of the porch. The corners of the building are finished with cornerboards. A girt encircles the structure, and is broken by the wood frames of the double hung windows which project several inches from the exterior of the vertical plank wall. The hip roof is finished with composition shingles. A partially enclosed wood porch with a shed roof is located at the rear of the structure. The building is occupied and in good condition. Termite damage should be repaired, as well as the settling footings. The building should be fumigated.

SIGNIFICANCE: None - removal is recommended

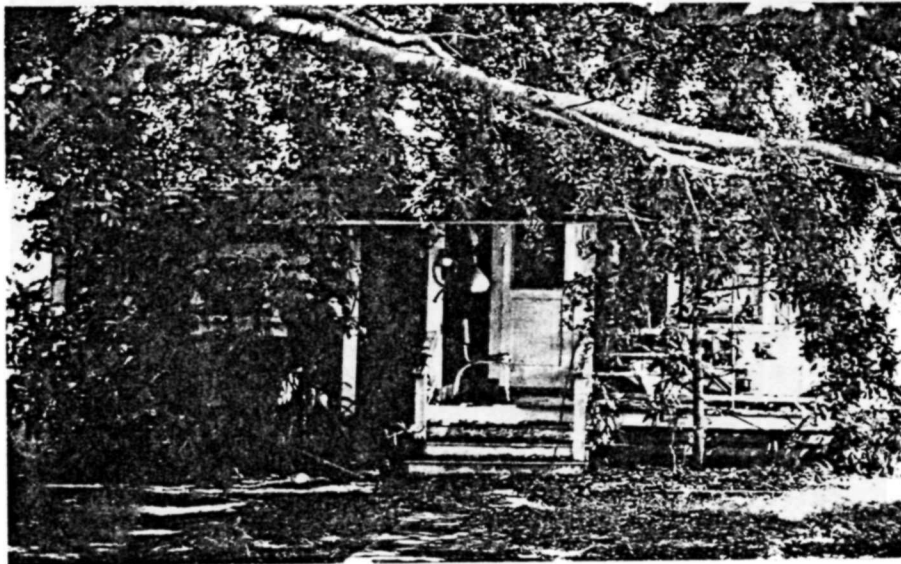
STRUCTURE: Building 20

DESCRIPTION: The structure is a frame building of single wall construction, with a board and batten exterior finish. The foundations consist of stone footings. The structure has a main gable roof, with shed roof extensions. The roofing finish is rolled composition roofing material, which has been applied over wood shingles. The wood frame windows are double hung (twelve-light). A recessed porch is located on the west side of the building. The corners of the structure are finished with cornerboards. The north wall of the building is finished with wood shingles (unusual). The structure is in fair to poor condition, and has not been occupied for several months. Vegetation should be cleared from the base, termite damage should be repaired and the roof should be resingled. The building should be painted and fumigated.

SIGNIFICANCE: Good example of an old type, and in salvagable condition. Rehabilitation is recommended.

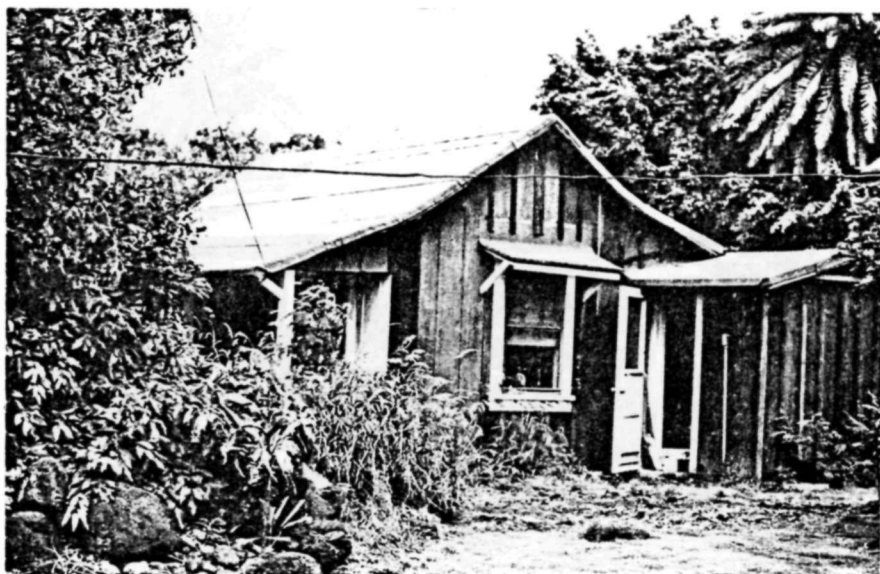
STRUCTURE: Building 21

DESCRIPTION: The structure is a frame building of single wall construction. The exterior finish is board and batten. The foundation consists of stone pads. The gable and shed roofs are finished with rolled composition roofing material. A veranda runs the length of the front of the building. A small addition with a gable roof is attached to the southeast corner of the building. The structure is in very deteriorated condition, and is occupied. Fumigation and minimal maintenance is recommended until the structure is no longer occupied.

SIGNIFICANCE: The date should be checked, just in case the building dates back much further than suspected. In any case, it is not one of the key buildings of the settlement, and preservation is not recommended.

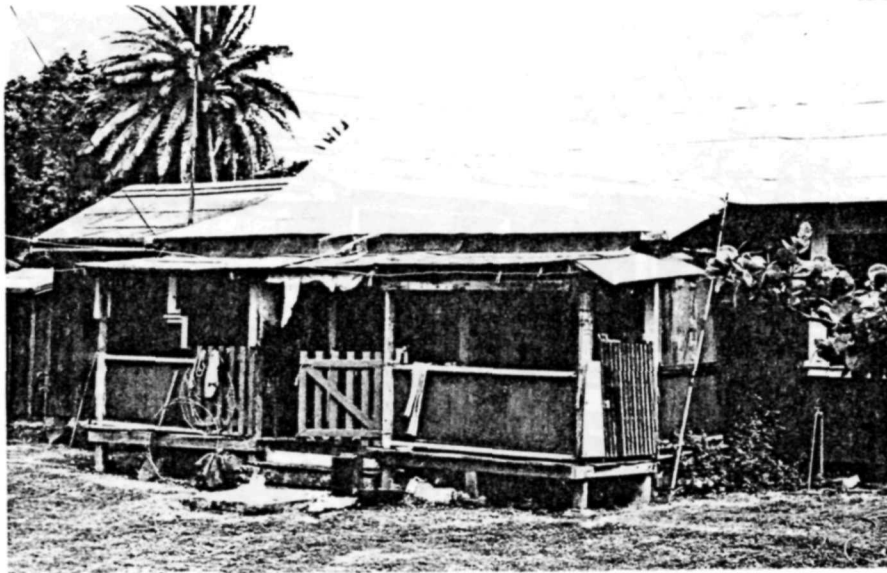
STRUCTURE: Building 22

DESCRIPTION: The structure is a one-story building of single wall construction. The exterior finish is board and batten. The multiple gable and shed roofs of the structure are finished with rolled composition roofing material. The foundation consists of stone and concrete footings. The building is in a cruciform shape. The main section of the building has a recessed veranda at the west side. The wood frame windows are double hung (twelve-light). The structure is occupied, and in poor condition. The structure seems to be riddled with termites. Minimal maintenance, such as painting, fumigation and re-roofing would be done as long as the structure is occupied.

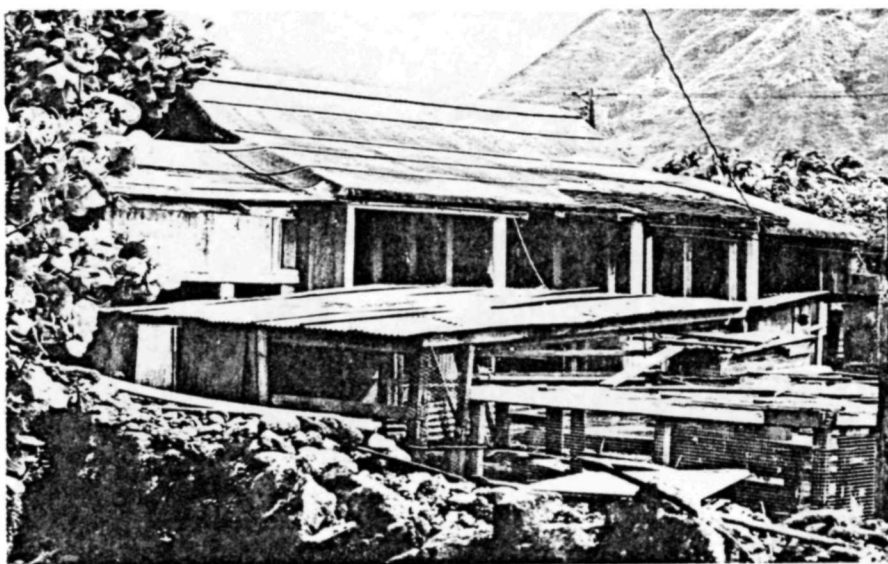
STRUCTURE: Building 23

DESCRIPTION: The structure is a frame building of single wall construction, with a board and batten exterior. The multiple gable and shed roofs are finished with rolled composition roofing material, which has been applied over wood shingles. The foundations consist of stone footings. The wood frame windows are double hung (twelve-light). A recessed porch is located on the west side of the structure. The structure is in very deteriorated condition, and is used as a chicken coop. Removal is recommended when the building becomes a safety hazard.

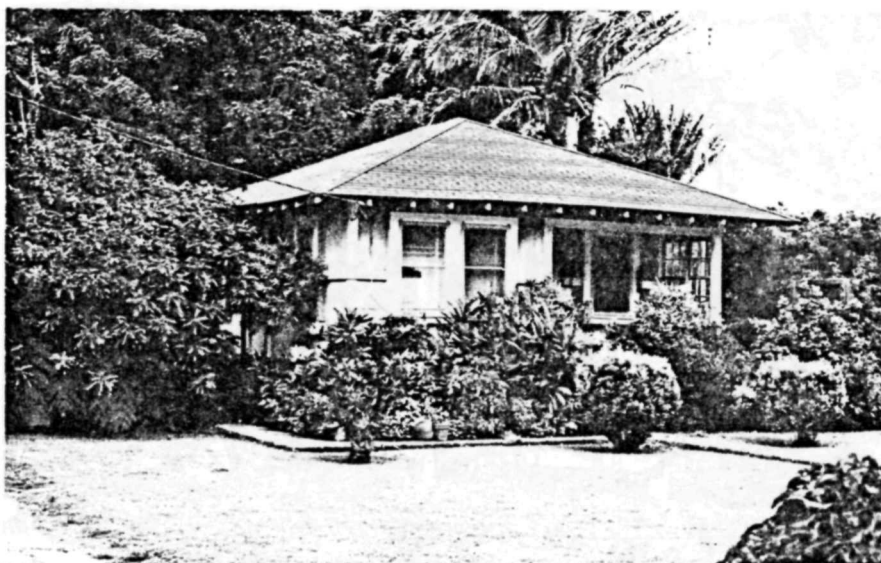
STRUCTURE: Building 25

DESCRIPTION: The structure is a one-story building of single wall construction, with a pad and post foundation. Stone and concrete steps provide access to the recessed corner porch which is incorporated under the hip roof. One chamfered post and one chamfered pilaster finish the open edges of the porch. The southeast side of the porch is walled with wood frame windows. The corners of the building are finished with corner-boards. A girt encircles the structure, and is broken by the wood frames of the double hung windows which project several inches from the exterior of the vertical plank wall. The hip roof is finished with composition shingles. A partially enclosed porch is located at the rear of the structure. The steps up to the porch is located at the rear of the structure. The steps up the porch have recently been replaced. The building seems to be in fair condition, although it is settling. The structure should be stabilized, fumigated. Termite damage should be repaired, and the building should be painted.

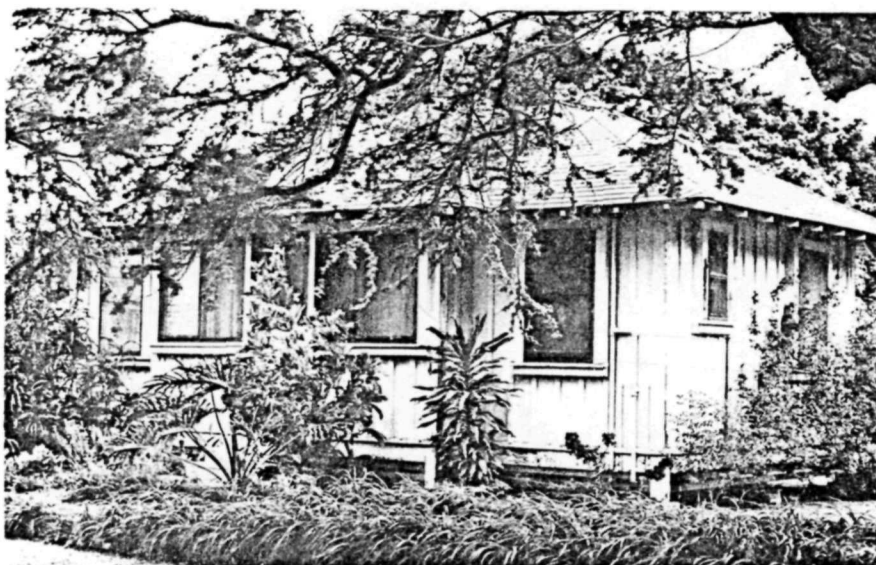
STRUCTURE: Building 256

DESCRIPTION: The structure is a frame building of single wall construction, with a board and batten exterior finish. The foundation consists of concrete footings and posts. The hip roof is finished with red composition shingles. The wood frames of the double hung twelve-light windows projects several inches from the exterior of the structure. An enclosed porch is incorporated into the west side of the building under the hip roof. The corners of the structure are finished with cornerboards. The structure is unoccupied most of the time, and is in fair to poor condition. Termite damage should be repaired; the building should be fumigated and painted.

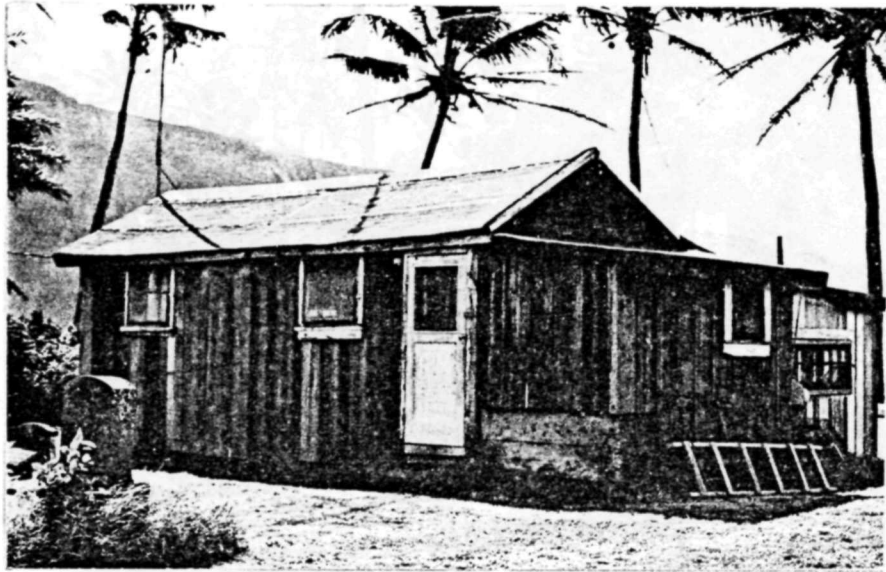
STRUCTURE: Building 671

DESCRIPTION: The structure is a frame building of single wall construction, with walls of board and batten or vertical plank siding. The foundation consists of poured concrete, and stone footings and wood posts. The gable and shed roofs are finished with rolled composition roofing material. The wood frame windows are mainly pivoting, six-light. The structure is used frequently, and is in fair to poor condition.

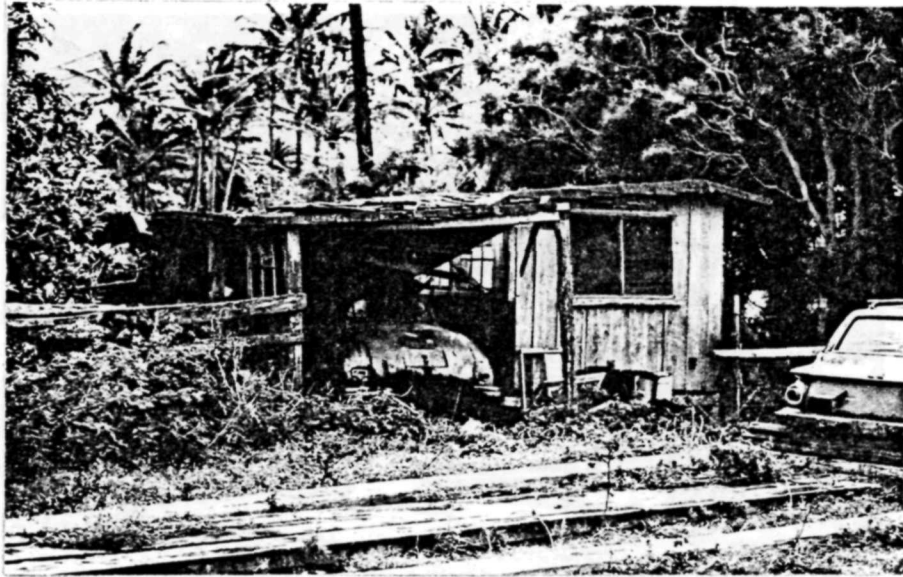
STRUCTURE: Building 682

DESCRIPTION: The structure is a frame building of single wall construction, with board and batten and vertical plank siding. The foundations consist of stone and concrete footings. The building is divided into two sections- one garage and one general storage area. The shed roofs are finished with the remains of rolled composition roofing material. The building is in very deteriorated condition, and seems to have been abandoned.

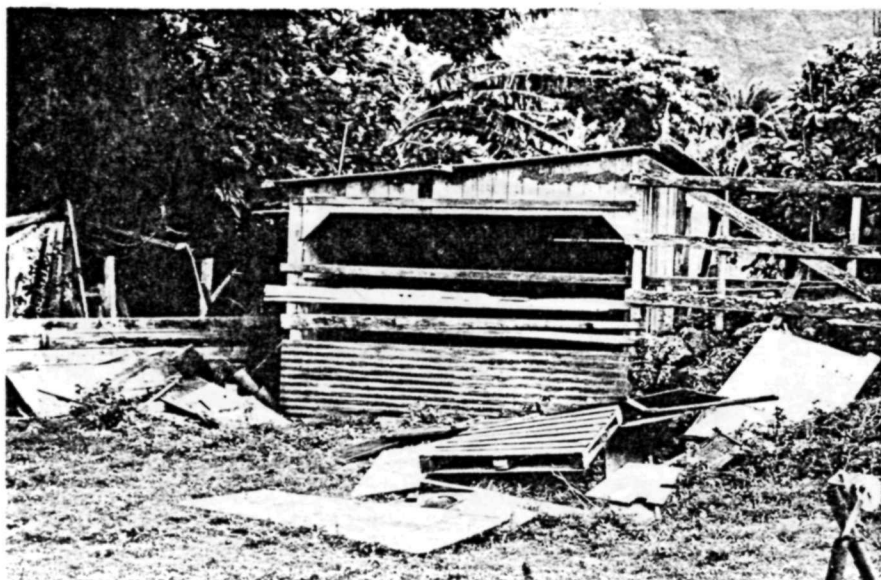
STRUCTURE: Building 683

DESCRIPTION: The structure is a frame building os single wall construction, with vertical plank siding. The shed roof is covered with corrugated metal. The previously open (garage) entrance has been boarded up with planks and corrugated metal sheets, presumably to keep out the cattle which graze next to the building. The structure is in deteriorated condition.

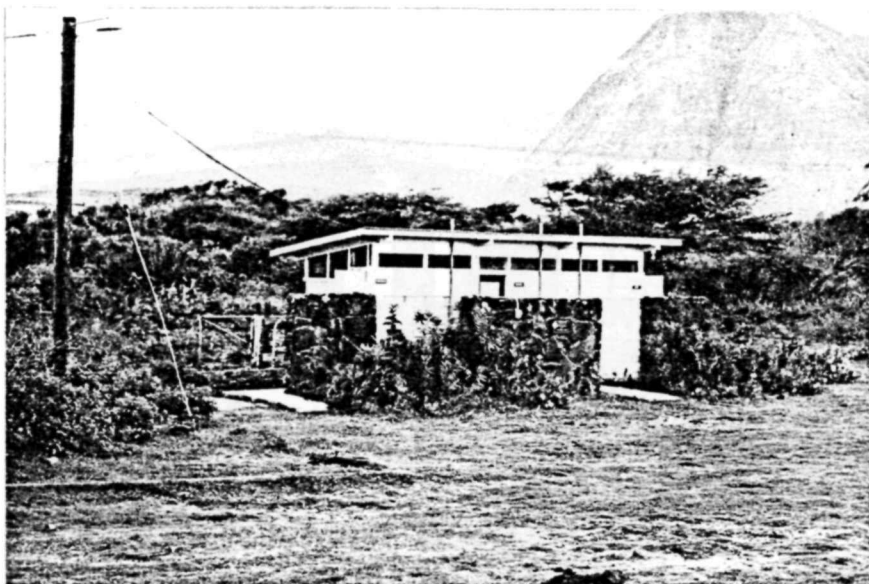
STRUCTURE: Building 687

DESCRIPTION: The structure is built of stone and concrete blocks with a shed roof covered with corrugated metal. The foundation is concrete. Masonry (lava-rock) baffles shelter the three entrances to the restroom areas--men, women, and visitors. The structure is in fair to poor condition.

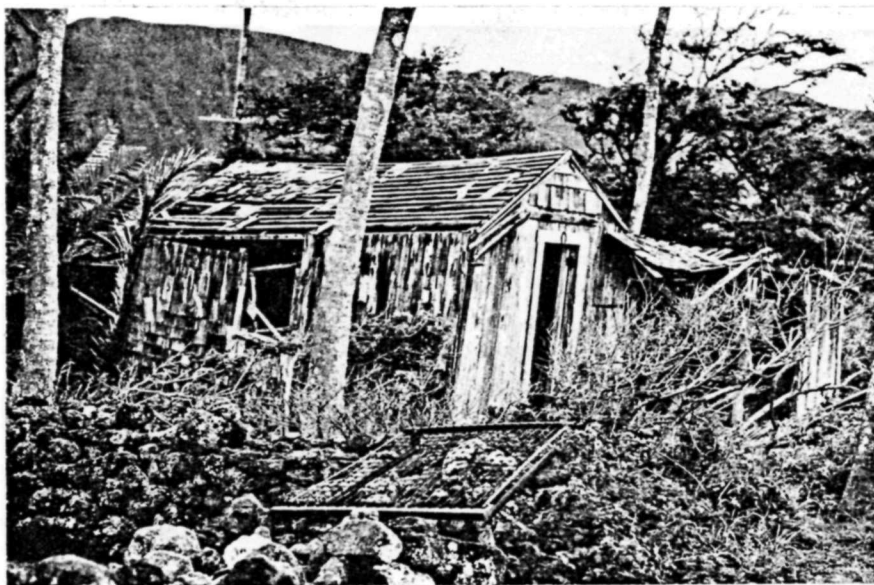
STRUCTURE: Building 689

DESCRIPTION: The structure is a frame building of single wall construction, with walls of vertical plank siding, some finished with wood shingles. The gable and shed roofs, once covered with wood shingles, are nearly completely bare of shingles. Only furring strips remain. The structure is very deteriorated and about to collapse.

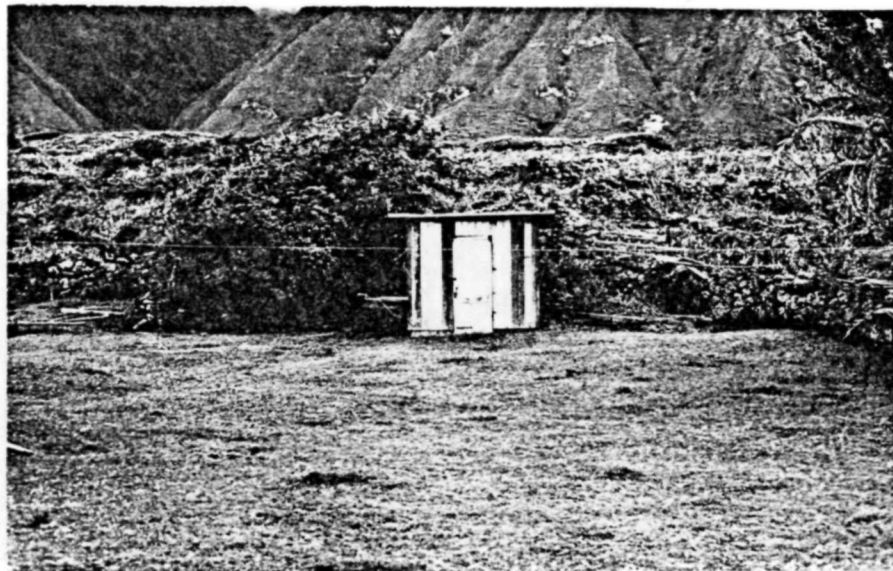
STRUCTURE: Building 690

DESCRIPTION: The structure is a frame building os single wall construction,  
with walls of recycled vertical plank siding. The shed roof is finished  
with rolled composition roofing material. The foundation is a concrete  
slab. The structure is in fair to poor condition.

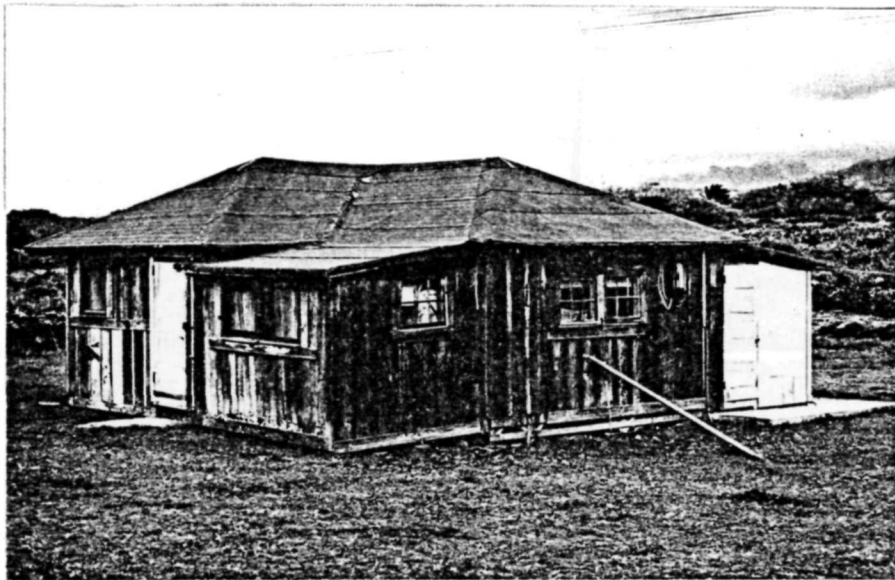
STRUCTURE: Building 691

DESCRIPTION: The structure is a frame building of single wall construction, with a board and batten exterior finish, with board and batten and vertical plank siding. A water table at the sole plate encircles the structure. The intersecting hip and shed roofs are finished with rolled composition roofing material. The foundations consists of stone footings, and a small concrete slab under one section of the building. The structure is used intermittently, and in poor condition.

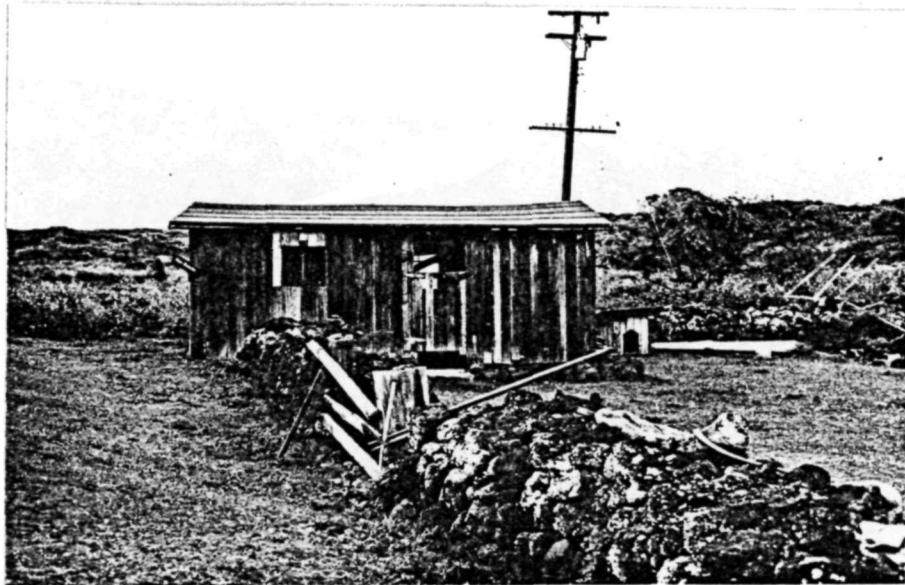
STRUCTURE: Building 692

DESCRIPTION: The structure is a frame building of single wall construction, with foundations consisting of concrete footings. The gable roof is finished with rolled composition roofing material. The northwest end of the building is an open wall. The structure received very little use, and is in poor condition.

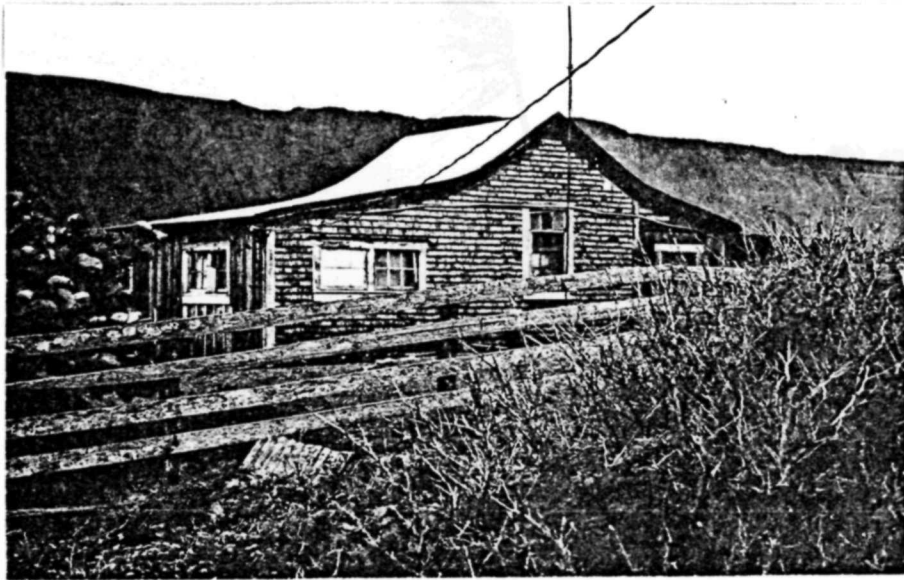
STRUCTURE: Building 693

DESCRIPTION: The structure is a frame building of single wall construction, with exterior wall sections varying from board and batten to vertical plank siding to wood shingle finishes. The foundation consists of stone footings and wood posts. The gable and shed roofs are finished with composition shingles. The structure receives intermittent use, and in poor condition.

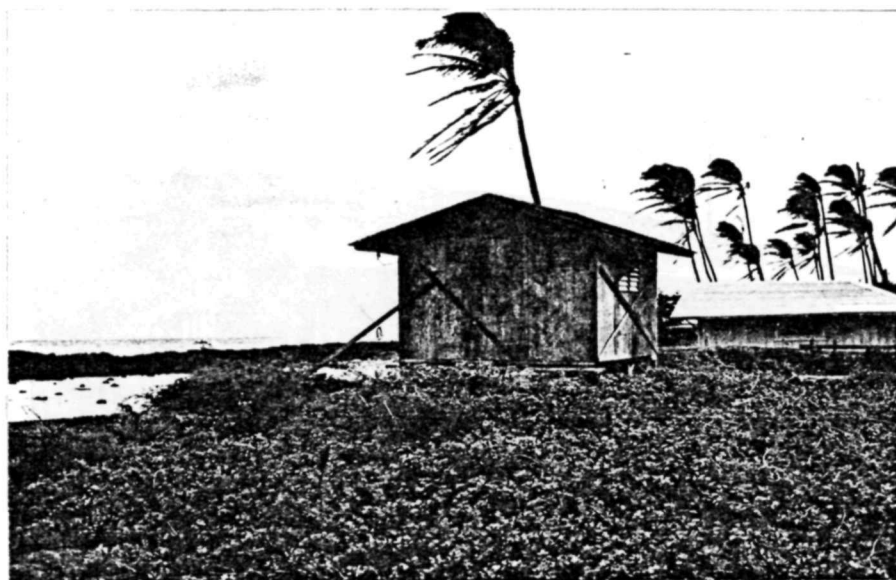
STRUCTURE: Building 694

located at the gable ends. The foundations consist of concrete pads

and wood posts, and some temporary wood foundations. The structure seems

to be in fair condition, and perhaps is still under construction.

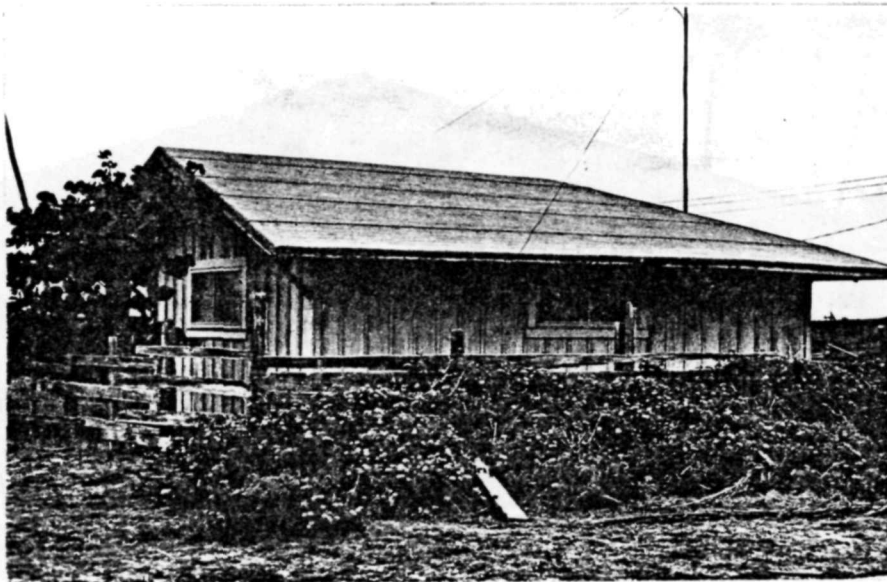
STRUCTURE: Building 695

DESCRIPTION: The structure is a frame building of single wall construction, with a board and batten exterior finish. The combination gable-hip roof is finished with rolled composition roofing material. The building receives intermittent use, and seems to be in fair condition.

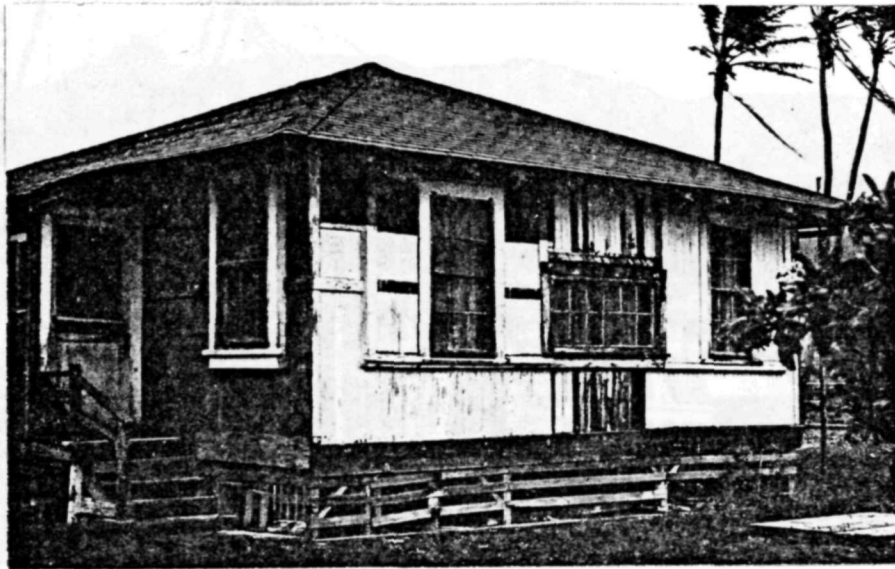
STRUCTURE: Building 696

DESCRIPTION: The structure is a frame building of single wall construction, with a hip roof finished with composition shingles. The sole plate of the building is surrounded by a water table. A broken girt encircles part of the building. The structure seems to have been recycled in several ways - the building proper is very similar to one of the types of residences in the settlement (cf. Building 11, Bay View), so that it probably was moved from there when it was scrapped, sheds have been attached in at least two places, and wall sections have been replaced with other recycled materials. The building is in fair to poor condition, and received intermittent use.

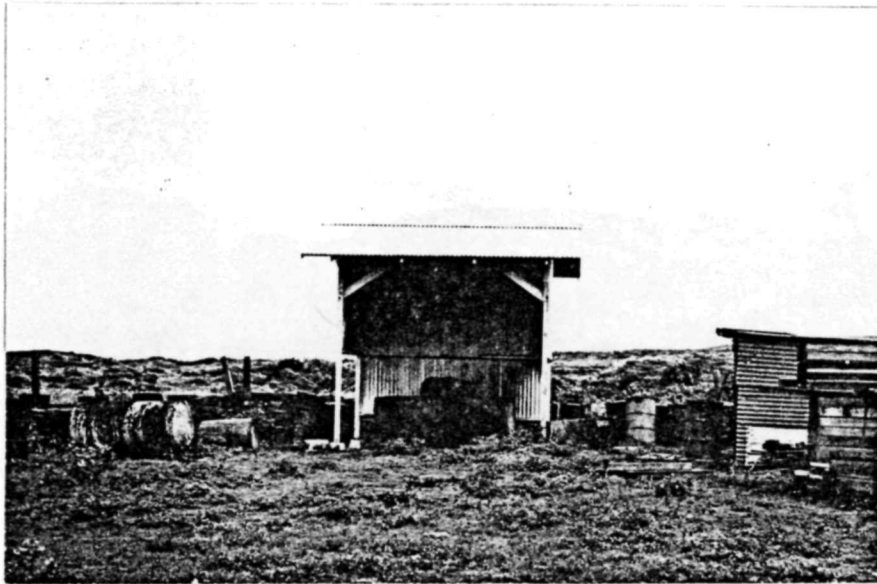
STRUCTURE: Building 684  
LOCATION: Old landing field  
USE: Storage  
SIZE: Approx. 7 x 10 OWNERSHIP: State  
DATE OF STRUCTURE: Unknown  
DESCRIPTION: The structure is a wood frame with corrugated metal walls and gable roof. One side of the structure is completely open to the elements. The building is still in use and houses a watering trough for the cattle which graze there. The structure seems to be in good condition.

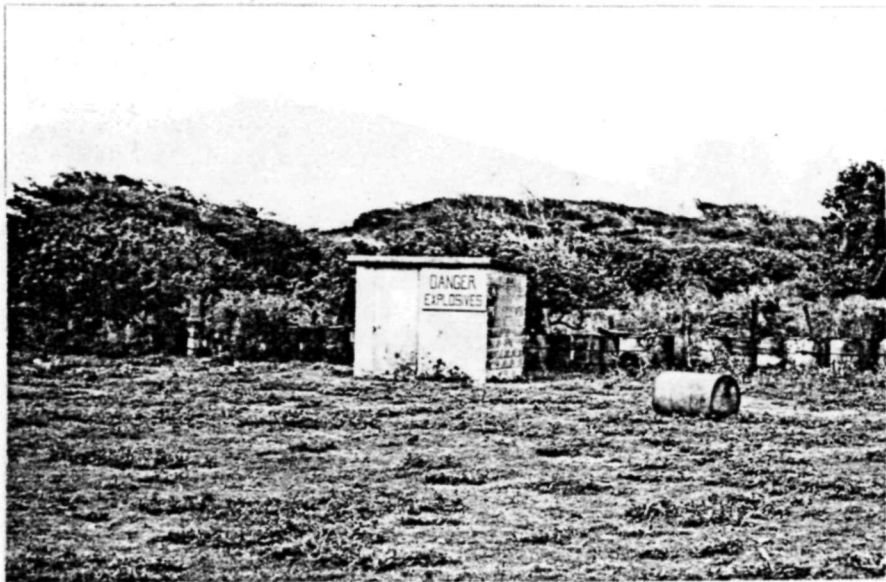
STRUCTURE: Building 686  
LOCATION: Old landing field  
USE: Storage for explosive material  
SIZE: Approx. 5 x 7 OWNERSHIP: State  
DATE OF STRUCTURE: Unknown  
DESCRIPTION: The structure is built of concrete block with a metal door and metal shed roof. The building is still used and seems to be in fair condition for its use.
