Kalaupapa and Kalawao Settlements Cultural Landscape Report

VOLUME II OF II
APPENDIX A - INVENTORY TABLE AND MAPS
APPENDIX B - CEMETERY MANAGEMENT PLAN
JUNE 2020

Appendix A: Inventory Tables and Maps

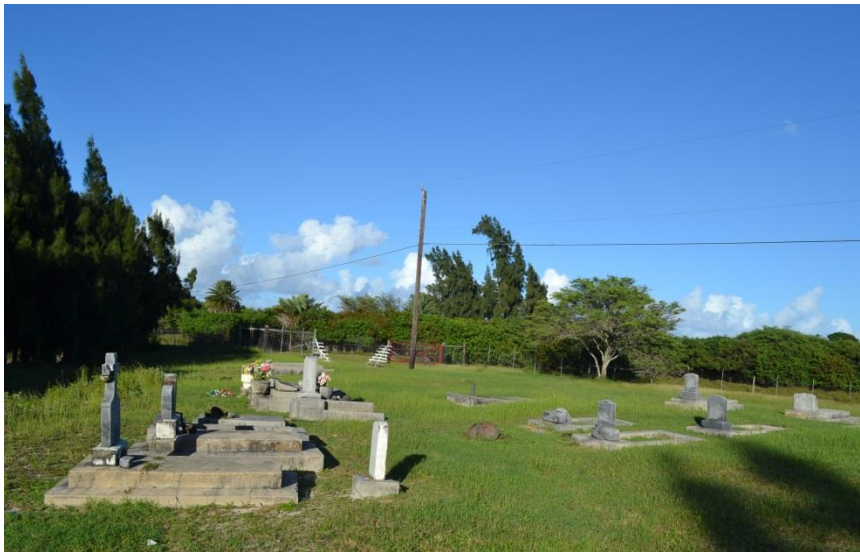
Figure B-24. View of Cemetery A looking north.

Grave markers within Cemetery A exhibit several issues of concern regarding their conditions. These include cracking of the concrete, partial collapse of grave markers, leaning, settling, and chipping. Some of the markers have become dislodged and are now propped against other burial marker elements. Inscriptions on many of the markers has become obscured by biological growth and weathering.

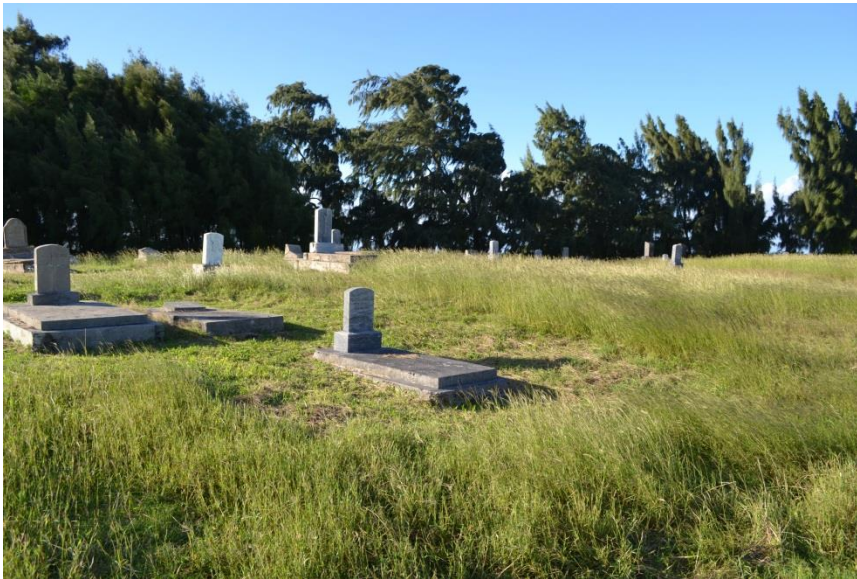
Figure B-26. General view of Cemetery B.

Grave markers within Cemetery B exhibit several condition issues of concern. Primary among them is cracking of concrete and weathered limewash. Erosion of the ground and settling has caused some markers to lean. Others are on the cusp of falling over. Chipping of monuments by mowing equipment is apparent on several markers, particularly those that are low to the ground.

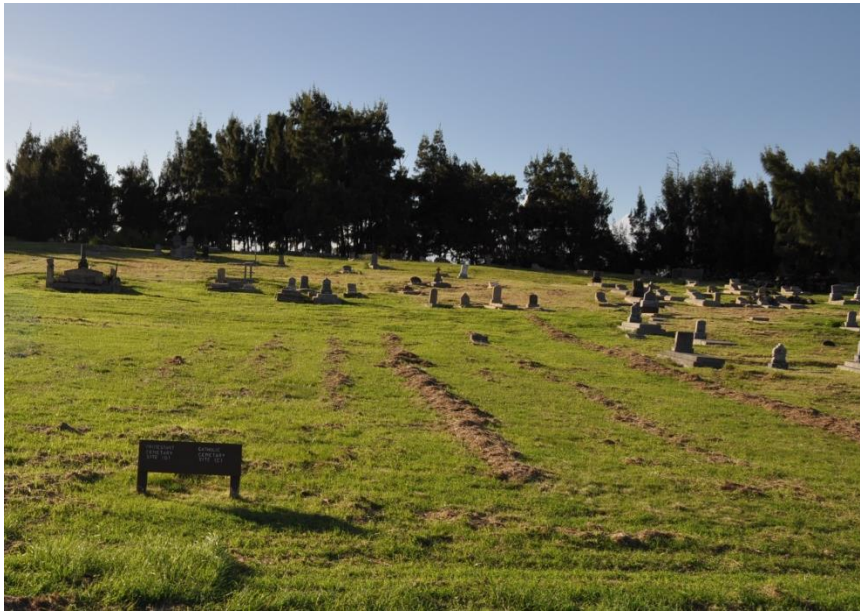
Figure B-29. View west toward Cemetery C, right.

Conditions identified in association with Cemetery C relate include soil erosion and settling that has caused markers to lean or to become unstable. Others exhibit damage from mowing equipment or cracking of concrete and render and erosion of limewash.

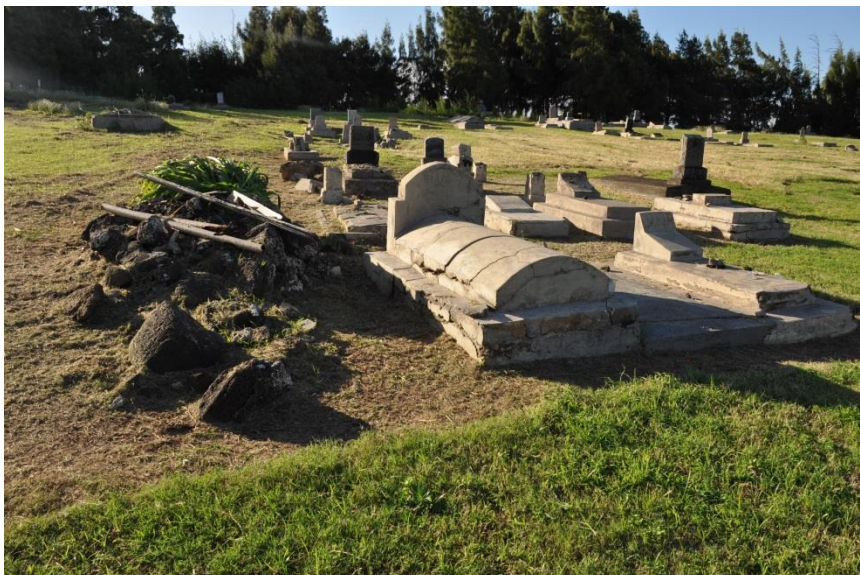
Figure B-30. View northwest across Cemetery D.

Condition issues of concern include a low point within the cemetery that contains several graves and may be subject to ponding.

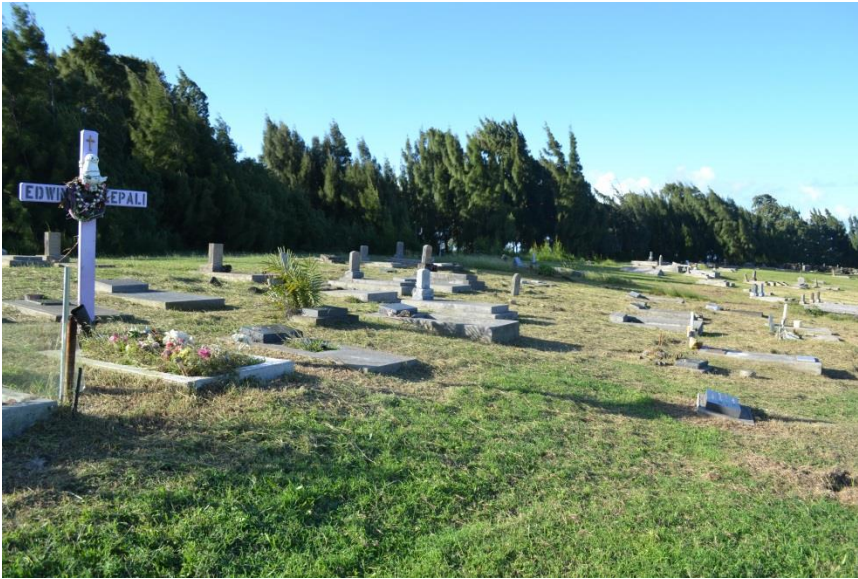
Figure B-31. View northwest across Cemetery E.

Condition issues include the fact that many of the ledger-type vaults have significant cracks down the center, are leaning, and appear to be collapsing. Markers extending only a few inches off the ground have been subject to mowing-related damage.

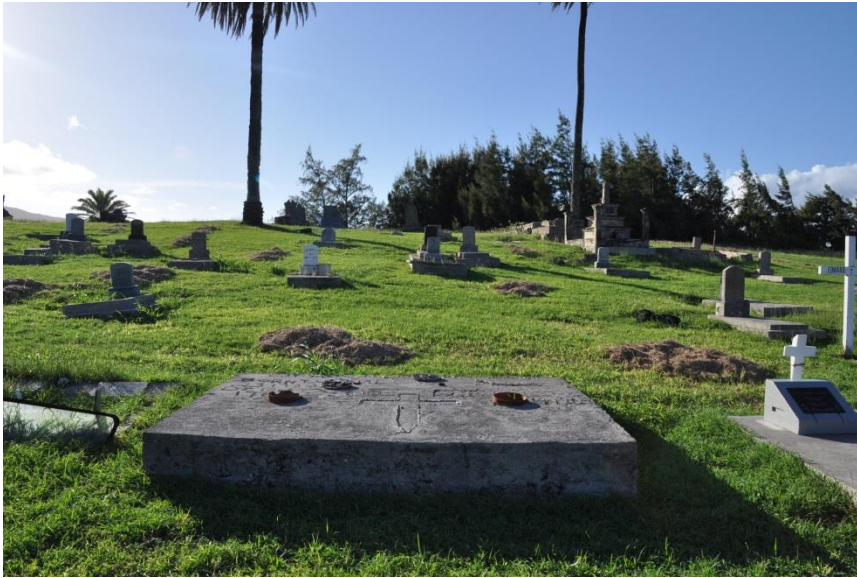
Figure B-32. View west across Cemetery F.

Maintenance issues of concern relate to the erosion of the sloping topography, which has buried the uphill side of several markers at the western end of the burial ground. Eroding soil has also caused several markers to lean. Elsewhere, many of the flush markers have become partially to completely overgrown and obscured by grass and soil. Offerings left on these markers, such as shells, rope, vases, figurines, necklaces, and artificial flowers, are similarly hidden by the grass and at risk of damage from maintenance equipment. Wooden crosses are subject to leaning and deterioration of the wood. Several have been propped against markers until they can be reset.

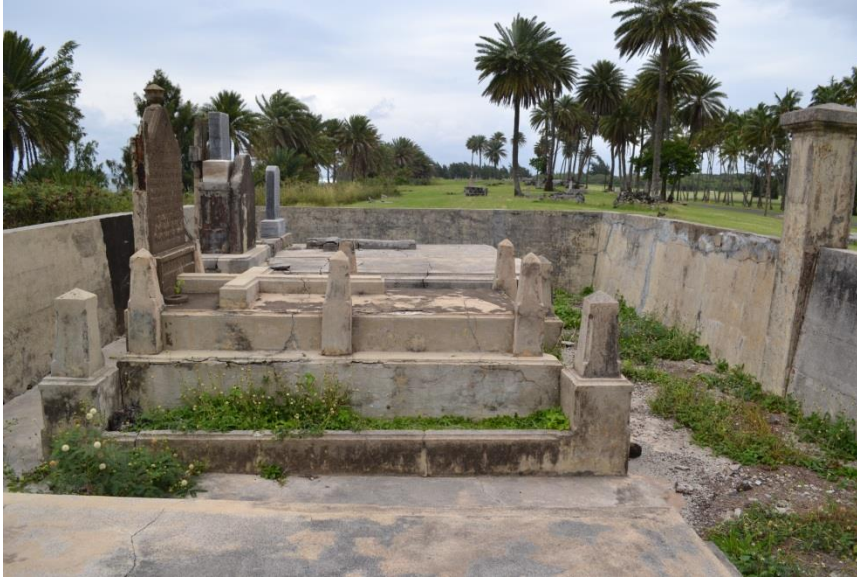
Figure B-34. Group of grave markers set within a walled enclosure within Cemetery G.

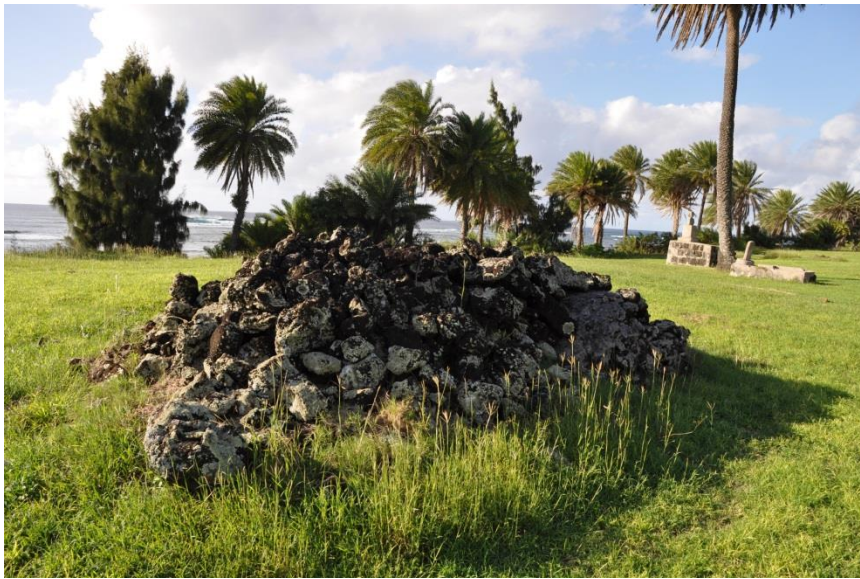
Figure B-35. Materials used to fashion grave markers in Cemetery G include concrete, marble, granite, as well as lava rock arranged in Traditional Hawaiian fashion as shown.

Several of the flush markers in Cemetery G have been damaged by maintenance equipment. Some of the grave markers are so badly damaged that their original forms are difficult to discern. Others are broken into small pieces and only slightly resemble their original forms. Graves located near coconut palm trees are frequently split or have been uplifted by the trees. Many of the arched vaults are in poor condition and are cracking, breaking apart, and collapsing. Some of the vaults appear to have settled over time or been buried by soil.

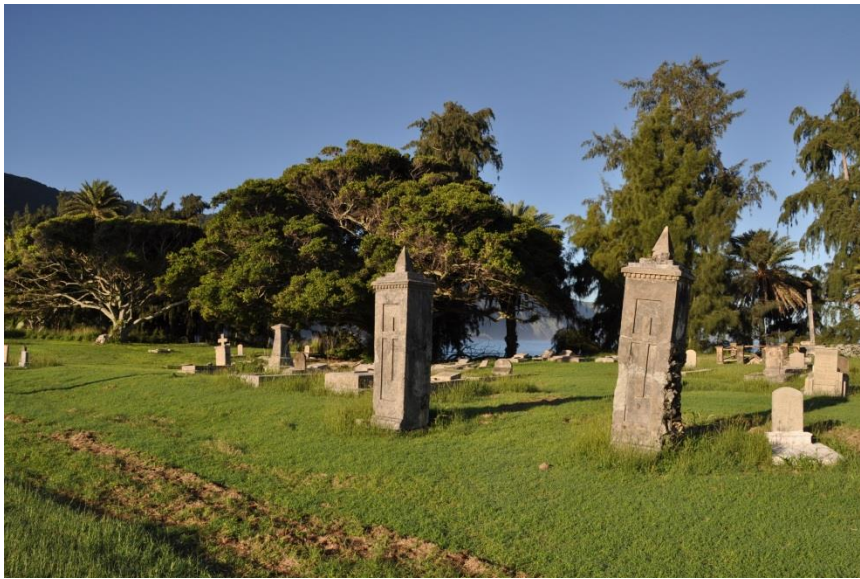
Figure B-37. Concrete or rendered lava rock piers located within Cemetery H.

Many of the headstones in Cemetery H are leaning sufficiently to be unstable. Some are cracked with vegetation growing between the ledger and the headstone. Grave markers that are set low to the ground have been damaged by maintenance equipment.

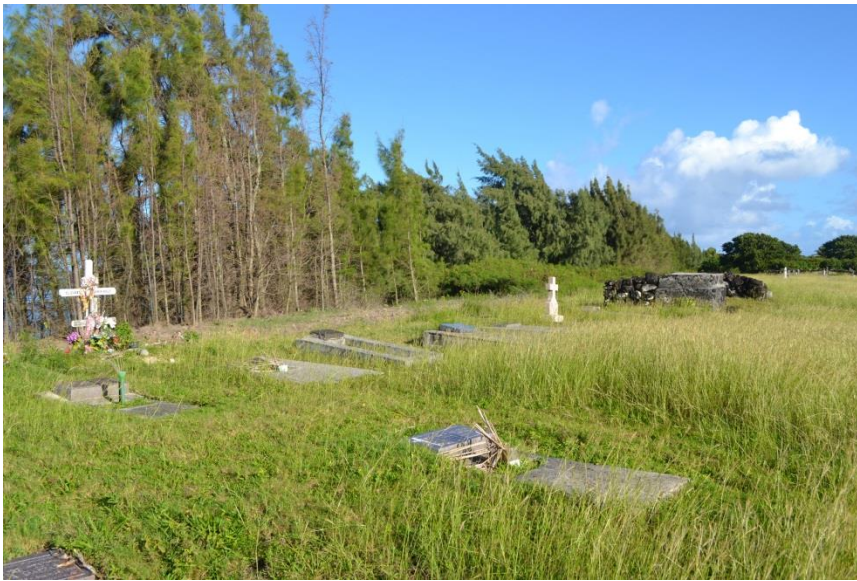
Figure B-42. View northwest across Cemetery J.

The primary condition issues identified in association with Cemetery J include the vulnerability of wooden crosses, some of which are leaning, or have decayed at the base and are now propped on stone or concrete markers. The wooden crosses are also difficult to see when the grass is allowed to grow taller than a foot in

height, as are other markers that are low to the ground. This potentially subjects the markers to damage by mowing equipment.

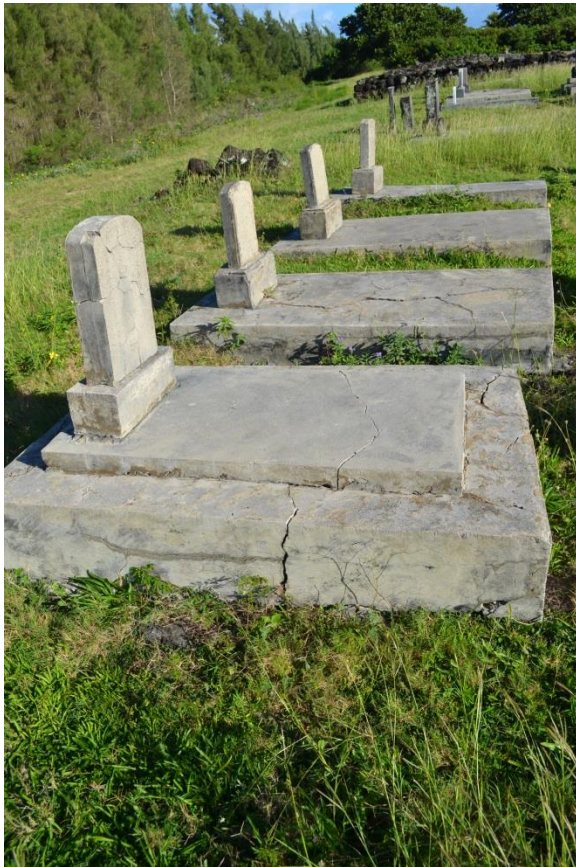
Figure B-43. View north across Cemetery K.

Most of the graves within Cemetery K are in poor condition. Condition issues of concern include cracking of both headstones and ledger bases, as well as leaning. Many also appear to be leaning and in danger of falling over.

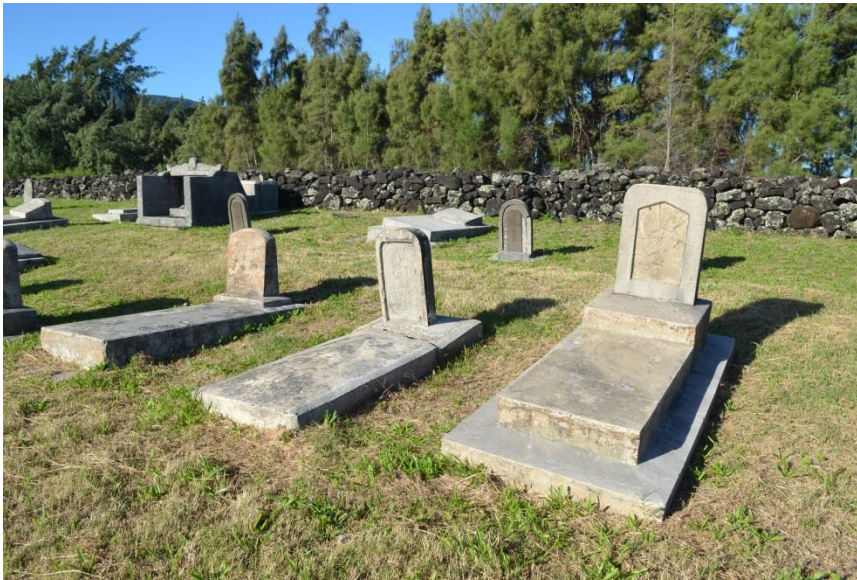
Figure B-44. View west across Cemetery L to the perimeter rock wall with several ledger style markers shown.

Grave markers within Cemetery L display damage similar to other cemeteries along the western shoreline. Some of the ledger markers are not plumb and are either settling or have become partially buried by soil from erosion of the ground above to the west. Maintenance equipment appears to have chipped some of the lower-lying markers. One large ledger marker is cracked into two pieces. Evidence of coconut palm trees that may once been present exists in the form of trunks within the cemetery.

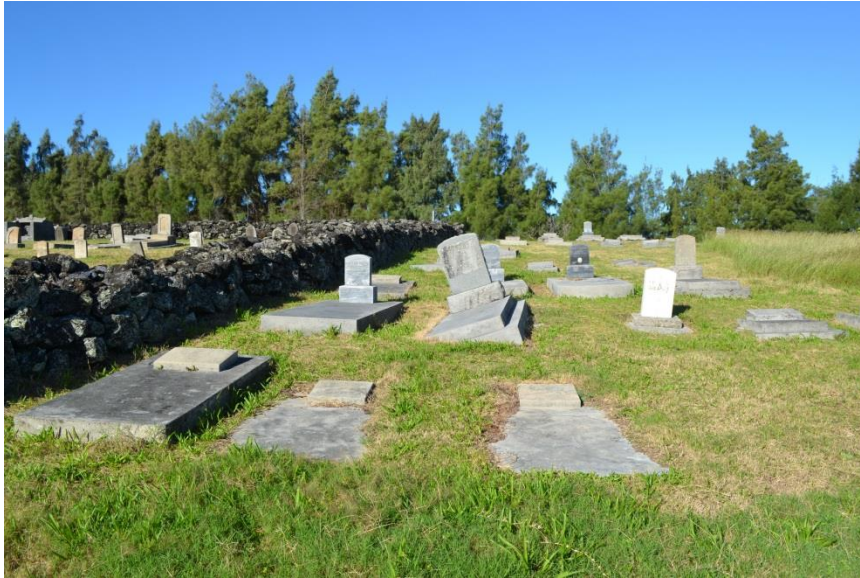
Figure B-45. View west across Cemetery M.

Condition issues include subsidence that has resulted in ledger and upright headstones being partially sunk into the ground throughout the cemetery. Stumps are present, suggesting that trees were formerly present but have been removed. The bases of many grave markers are cracked and spalling.

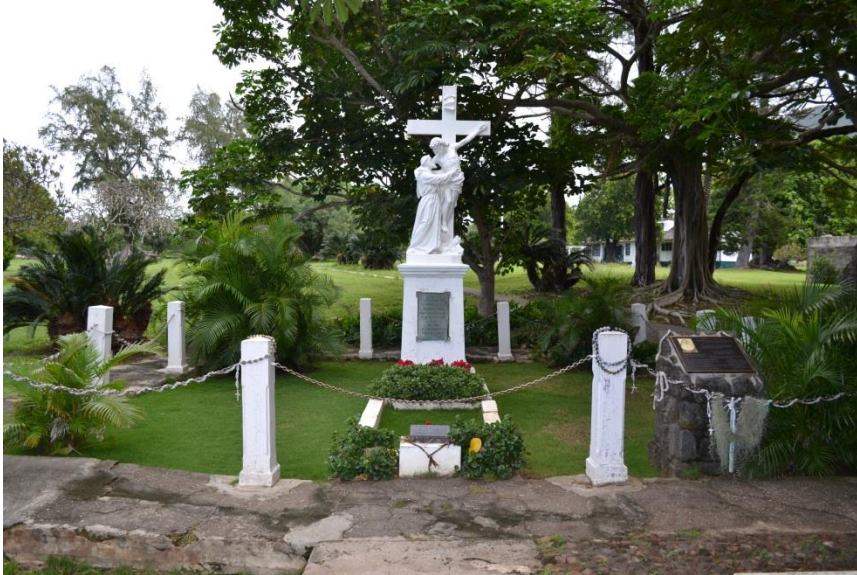
Figure B-46. View west toward features associated with Cemetery I.

The primary condition issues of concern associated with the Saint Marianne Cope Grave include the cracked and uneven nature of the surrounding concrete sidewalk and the walk that connects to Bishop Road, and the need for paint at the base of the statue and the posts that support the chain that surrounds the monument.

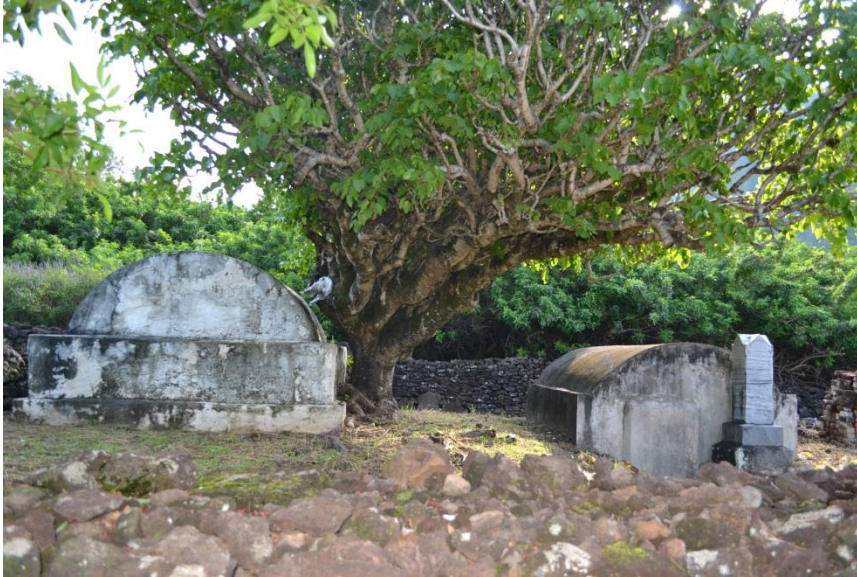
Figure B-50. View of one of the enclosed burial grounds on the western slopes and rim of Kauhakō Crater that are part of Cemetery N.

The principal condition issue of concern at Kauhakō Crater Cemetery is the expanding colony of ironwood pine trees located near the graves located near the rim of the crater, and other invasive species located near the walled cemeteries further to the south. The NPS repaired many of the walls associated with Cemetery N in 2014.

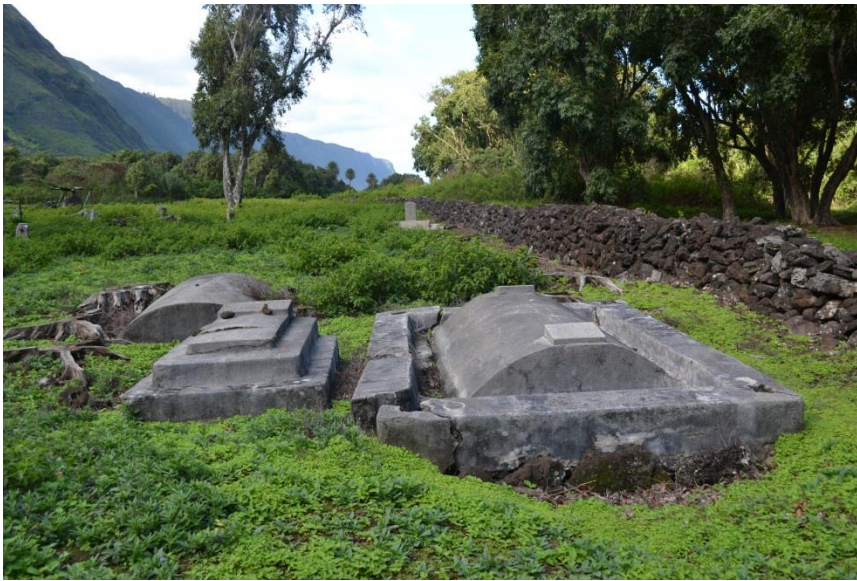
Figure B-54. View west of Kahaloko Cemetery (Cemetery O), with barrel vault grave markers and the perimeter rock wall.

Kahaloko Cemetery exhibits several condition issues of concern. Java plum trees remain within the cemetery that are causing stress to the grave markers, with branches and trunks sometimes falling on the markers and damaging them. Rooting feral pigs have rooted within the cemetery and damaged the grave markers by dislodging stones and cracking render. Pipe scaffolding is currently present in an effort to protect some of the grave markers from further damage associated with tree fall.

An undated document titled “Mortarless Wall Repair and Reconstruction Kahaloko Cemetery” provides detailed documentation for work done to address various condition issues of concern within the cemetery. Photographs and a sketch map indicate where specific repairs have occurred.

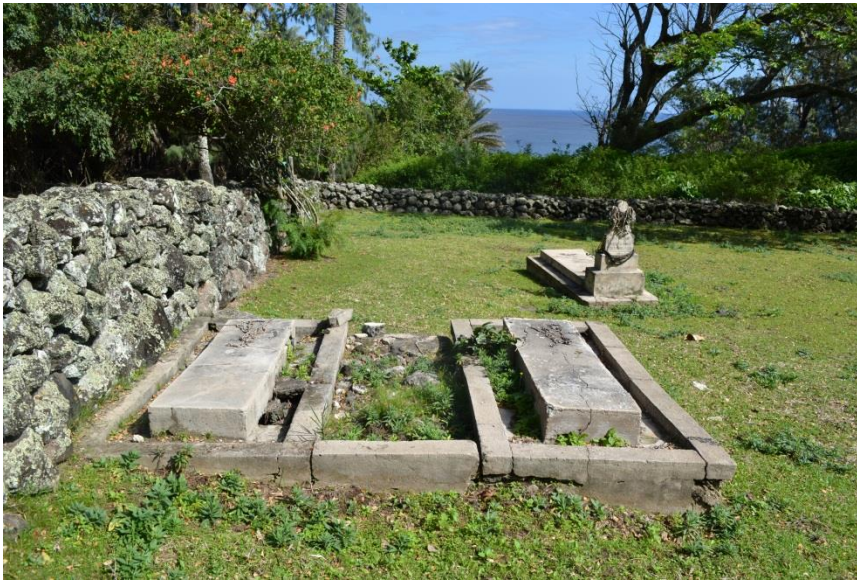
Figure B-59. View north across Cemetery P toward the perimeter rock wall.

The graves located in the southeastern portion of the churchyard are largely shaded by trees that have grown along the lava rock wall. Many of the gravestones are covered in biological growth, presumably fostered by shady conditions.

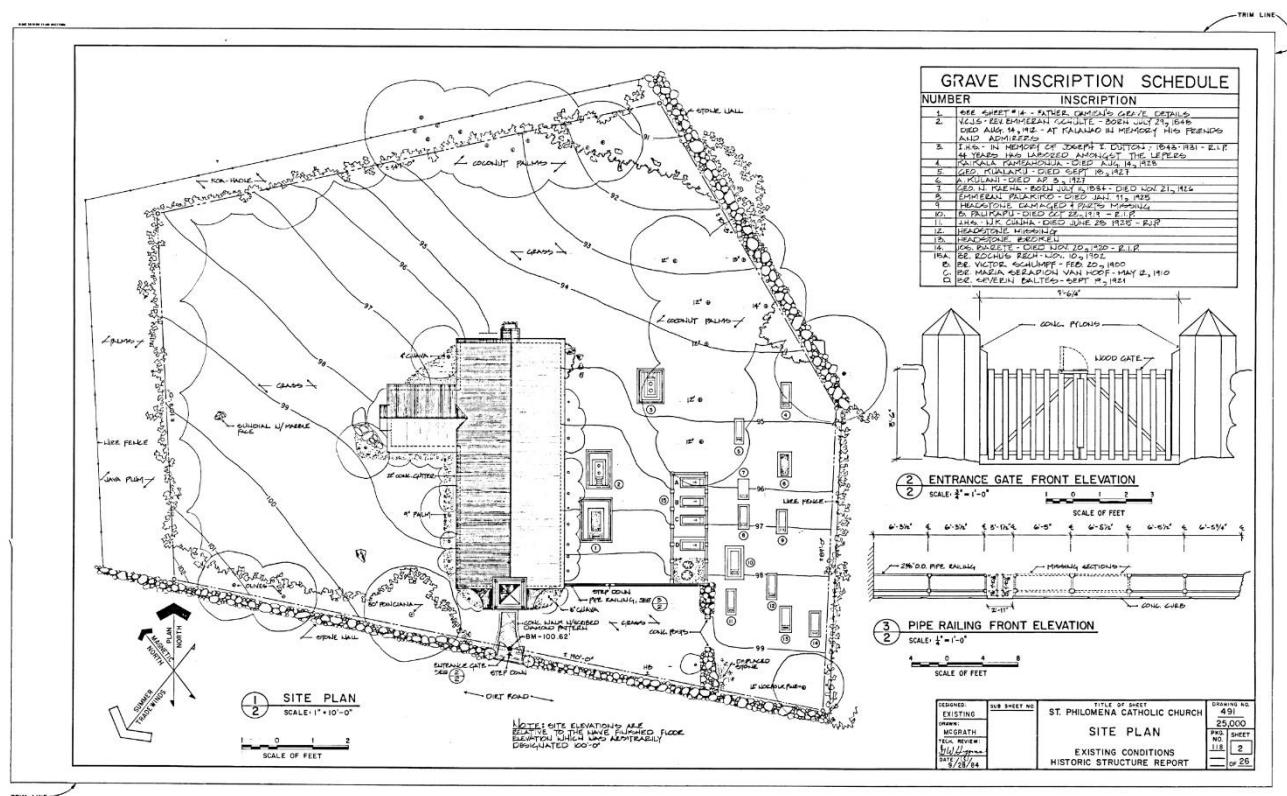
is painted gold. The grave marker is surrounded by a 3-foot-tall, black painted iron fence fashioned from vertical rails with spike-shaped finials.⁸⁸ The fence appears in historic photographs by the early twentieth century but appears to have deteriorated and been lost at some point during the mid-twentieth century. Marines from Kaneohe Marine Corps Air Station restored the fence around Saint Damien's grave in 1969.⁸⁹ By 1983, a Collections Preservation Guide prepared by the National Park Service indicated that the wrought iron fence was severely corroded with flaking and pitting. A Historic Structure Report prepared in 1985 included construction documentation for replacing the fence in kind that appears to have been implemented (refer to Figure B-63).

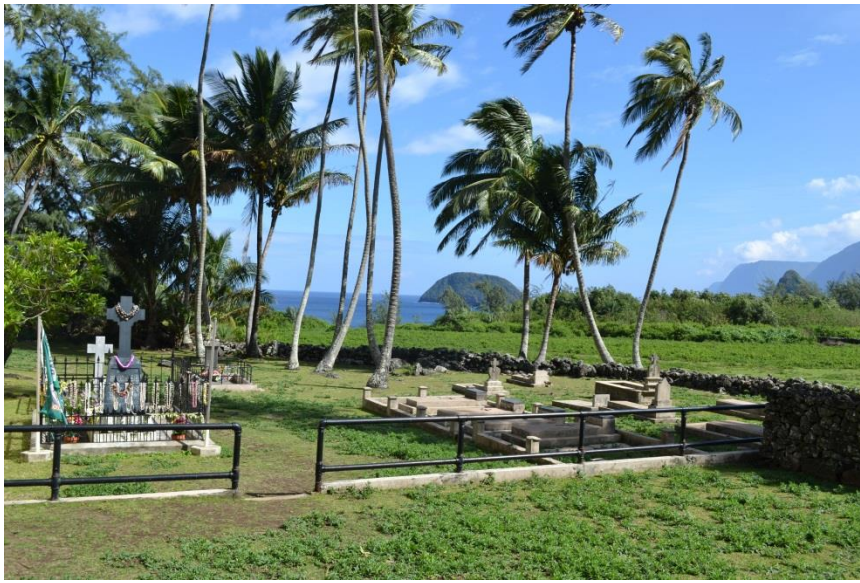
Figure B-64. View north of Cemetery Q including Saint Damien's grave marker.

Condition issues of concern associated with Cemetery Q include subsidence of grave markers and biological growth on markers.

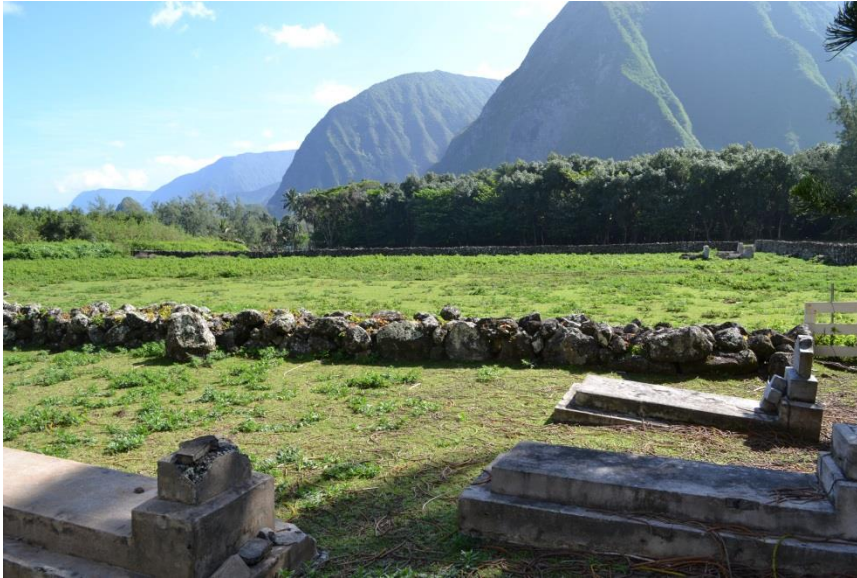
Figure B-65. View east toward and across Cemetery R.

Condition issues of concern associated with the cemetery include cracked, broken, and leaning grave markers.

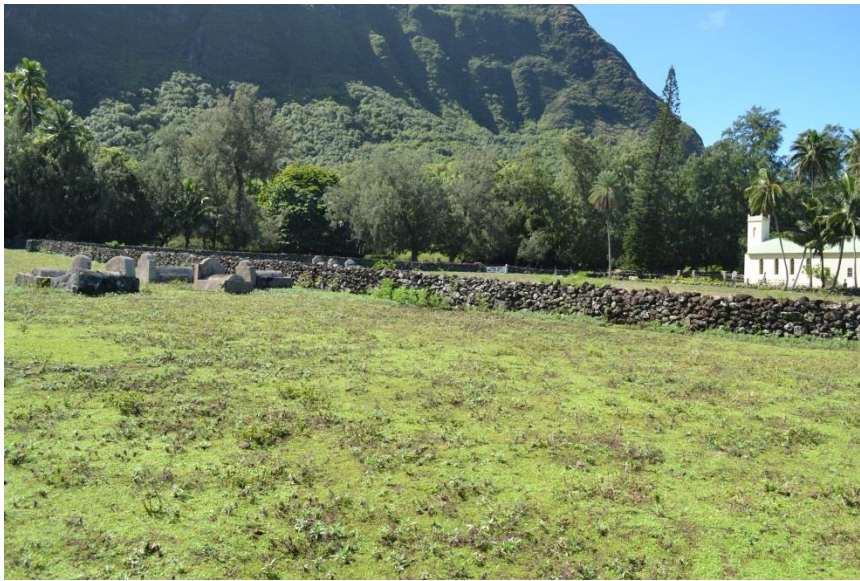
Figure B-66. View north of Cemetery S, which contains only a few grave markers in close proximity to the rock wall that surrounds Cemetery R, and many unmarked burials.

Condition issues of concern associated with the cemetery include cracked markers due to settling and the loss of legibility of some text on grave markers.
