HISTORIC STRUCTURE REPORT

ST. PHILOMENA CATHOLIC CHURCH

KALAUPAPA NATIONAL HISTORICAL PARK  
Molokai, Hawaii

January 1985

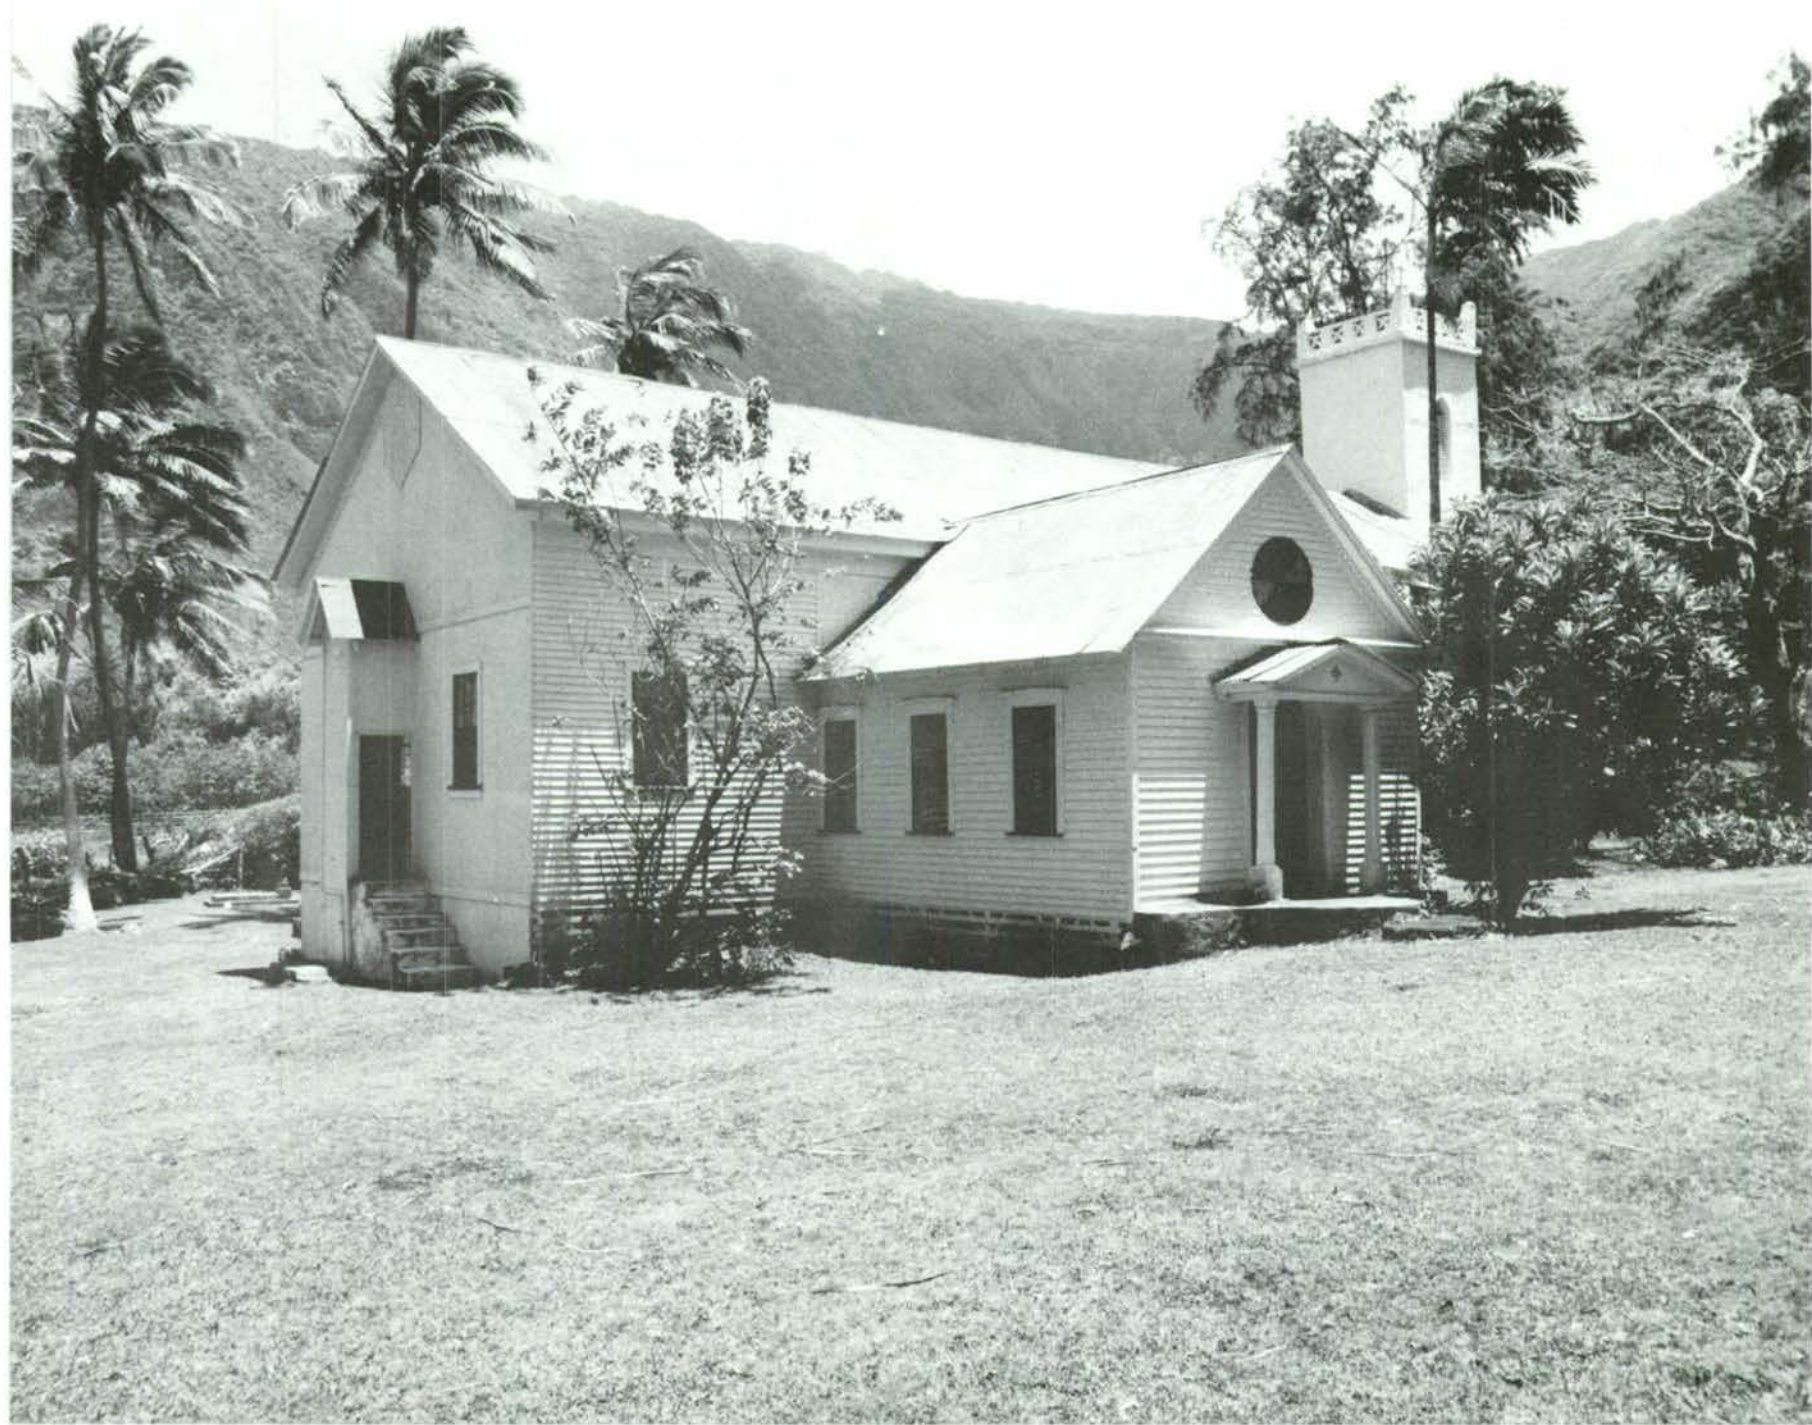
Illustration A3.

View from 'northwest.' The projecting wing was constructed in 1876 by Fr. Damien, an addition to the first building built by Brother Bertrand in 1872, which was within the 1888 portion and removed after the later section was built. The projecting wing is referred to in this report as the 1876 nave. The roofing was originally wood shingle. The date of conversion to corrugated metal is not known. The porch and round window are later period modifications, dates unknown. The rear entry enclosure was recently rebuilt. The former enclosure was larger and had another doorway to the cellar. Compare these details with historic photos. 6/84. R.L.C.

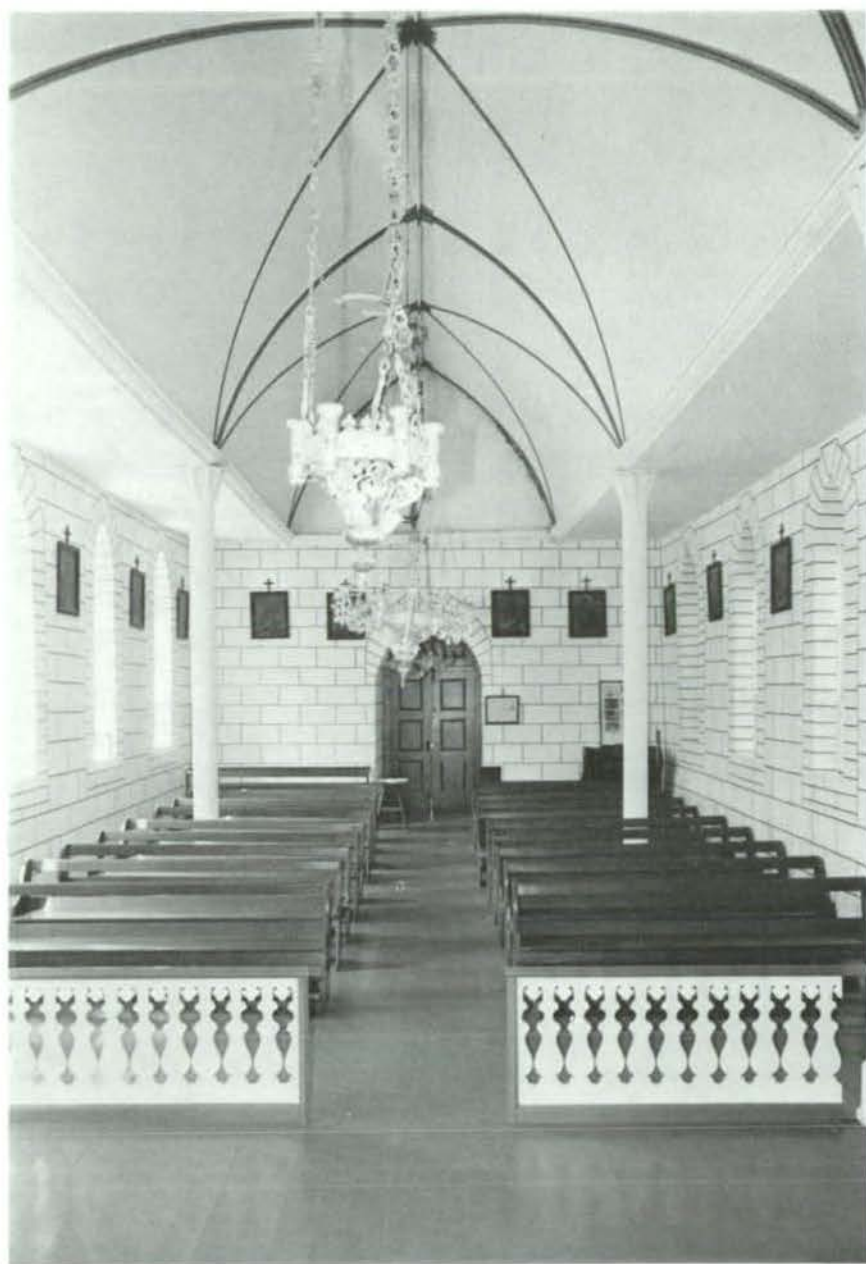
Illustration A6.

The 1888 nave as viewed from the crossing. The plastered masonry walls are painted white with the stone block pattern painted on in red. The flat 'side-aisle' ceilings and vault are of wood boarding and painted light blue. Columns and cornices are white. Water and dirt stains at the junction of the vault and wall are due to leakage at the roof to tower flashing. This leakage has damaged the stations of the cross on the south wall. 8/84. P.C.C.

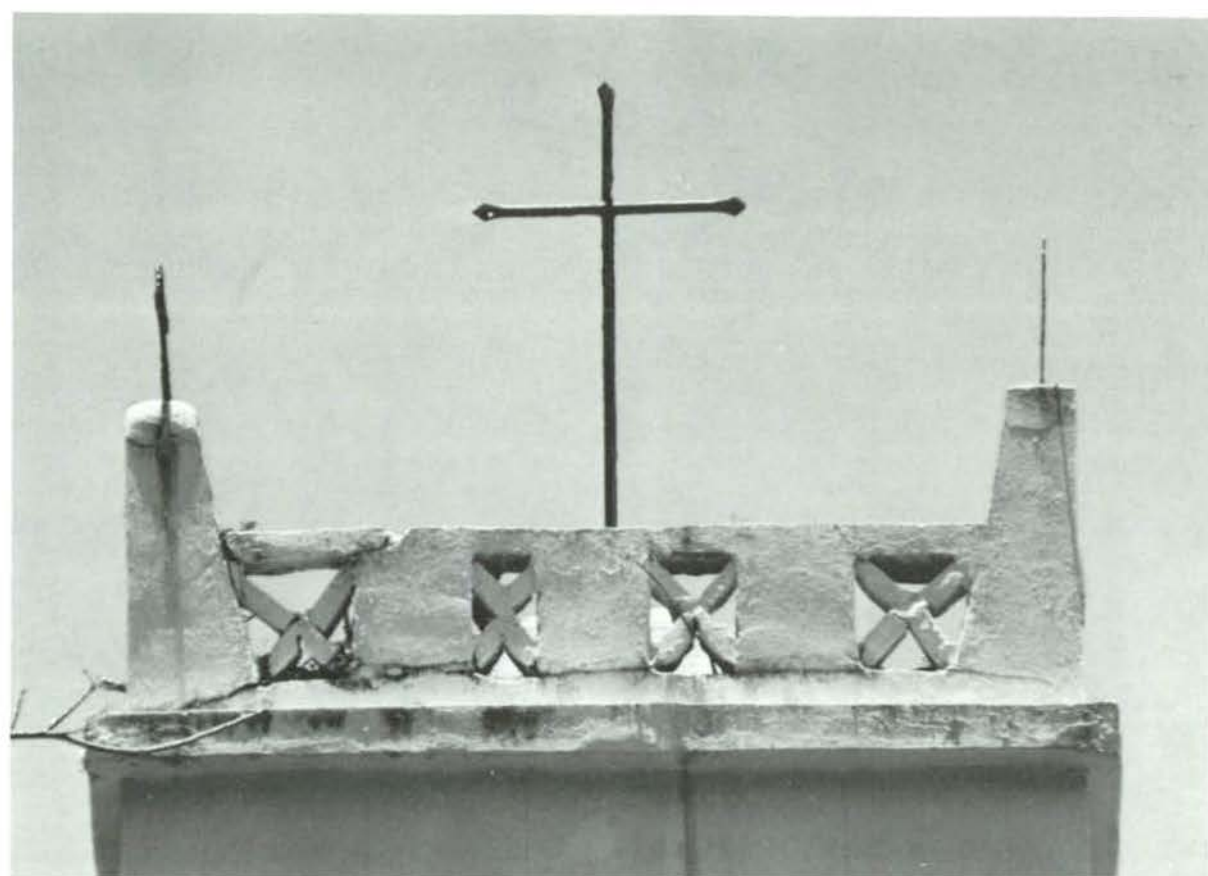
Illustration A22.

'South' parapet of bell tower. Note especially the crack along the base of the parapet and pinnacles. The 'southwest' pinnacle and cross (at left) appears to be the only original material and form of the four. 6/84. R.L.C.

4. Masonry						
Tower parapet, dismantle, remove all vegetation and remove all non-historic materials. Reconstruct with reinforcement to resist wind and seismic loads. Reshape pinnacles to match southwest pinnacle. Reshape gutter and install new scuppers.	stone to match historic corrosion resistant reinforcing	1.00	lumpsum	10000.00	10000.00	3
Dry laid stone fences to be relaid where collapsed.	10'-0"x3"-0" area of fence	10.00	lin.ft.	120.00	1200.00	10
Remove vegetation from stone fence.	80 lin.ft. of fence	80.00	lin.ft.	15.00	1200.00	10
Mortar and plaster analysis		1.00	lumpsum	5000.00	5000.00	2

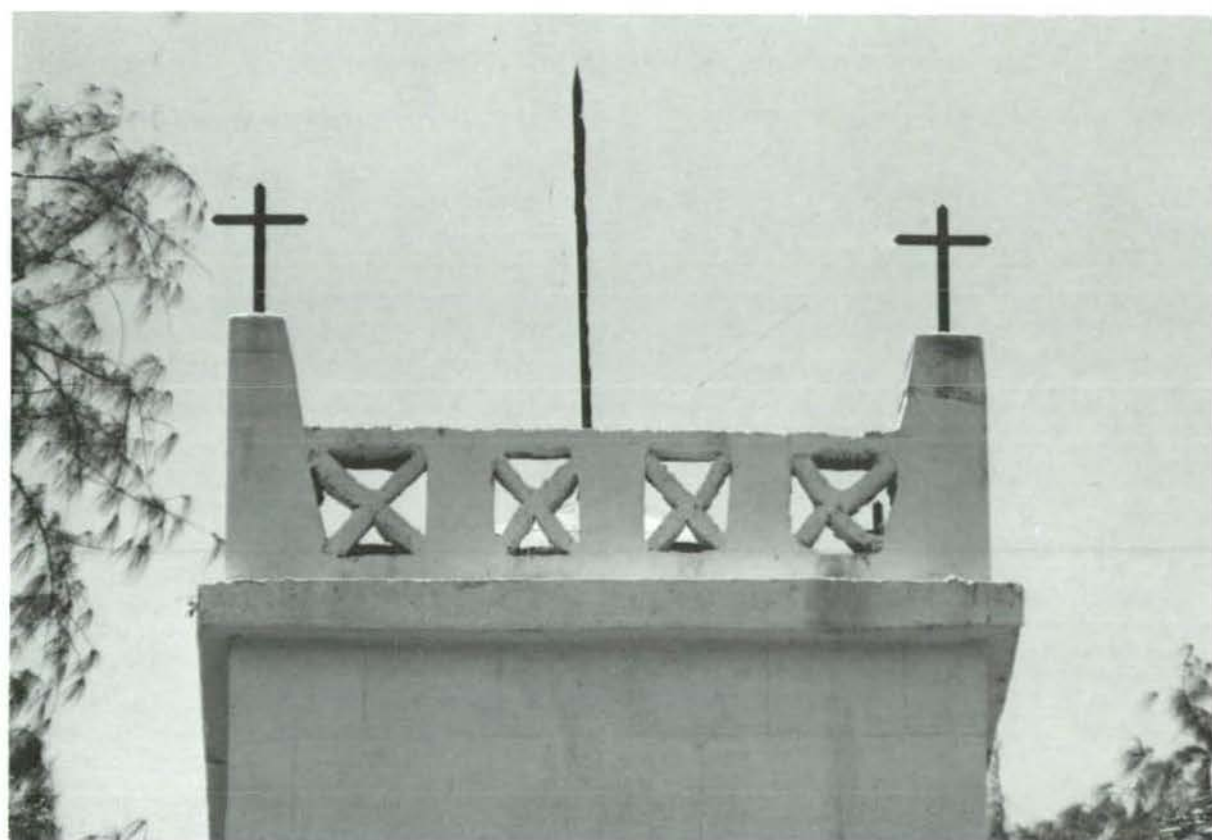
Illustration A23.

'East' parapet of bell tower. 6/84. R.L.C.

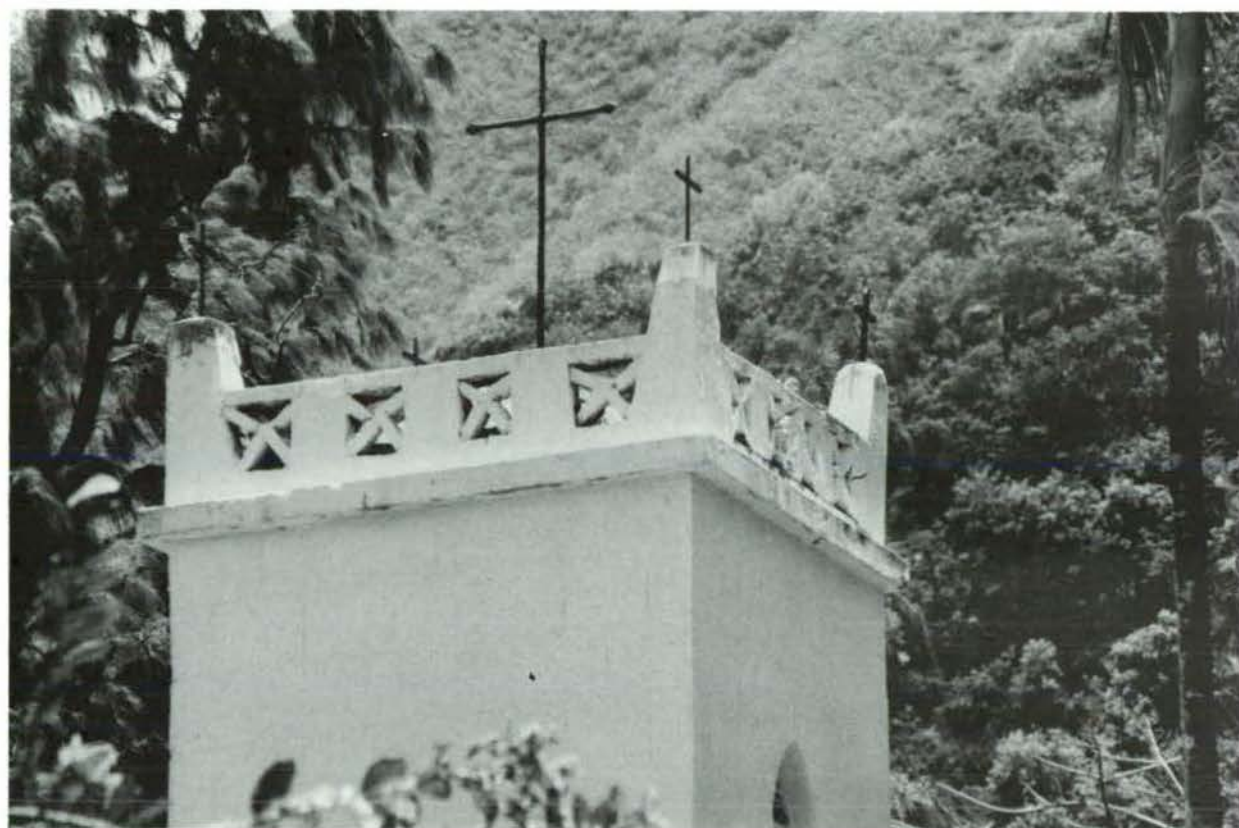
Illustration A24.

'North' and 'west' parapets of bell tower. Note repair caps on pinnacles resulting from replacement of crosses. 6/84. R.L.C.

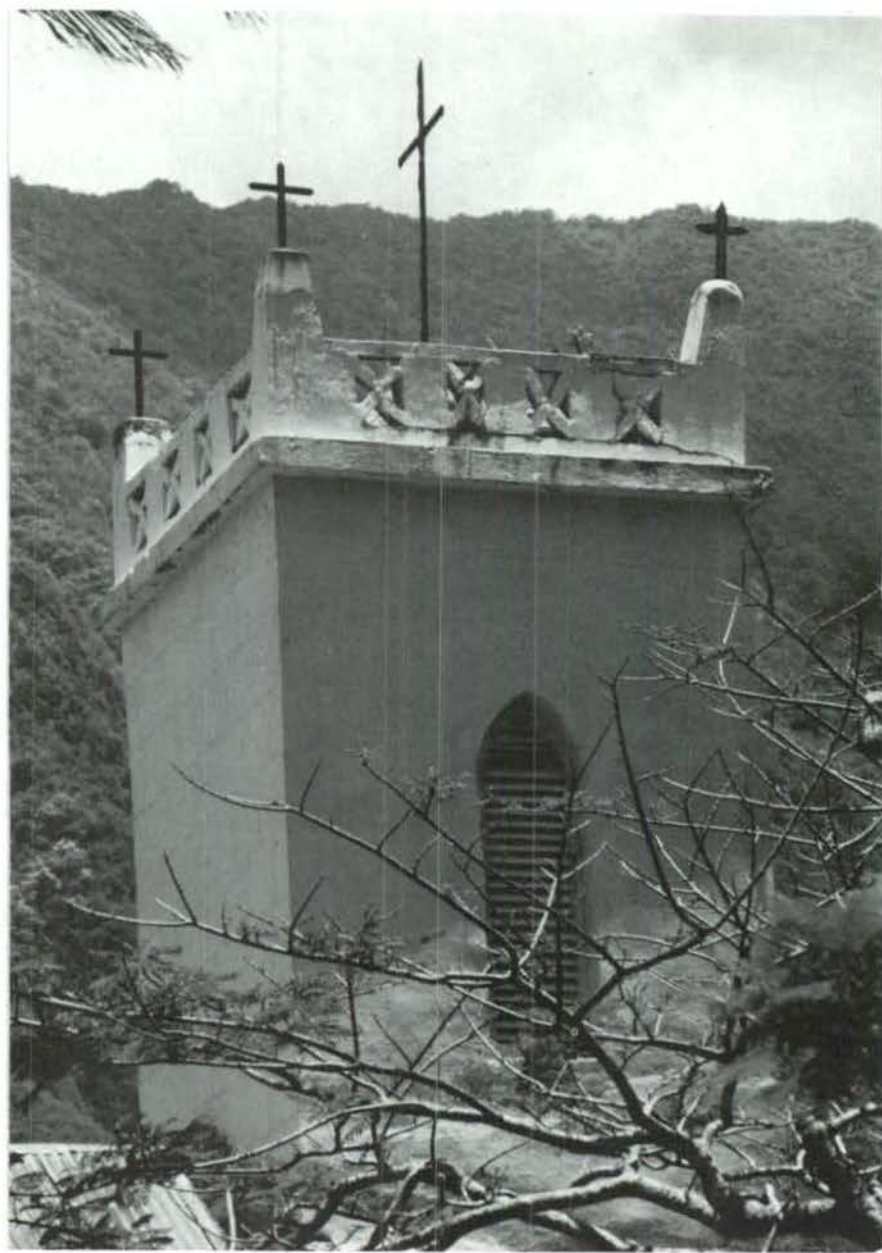
Illustration A25.

View of parapet of 'west' elevation of bell tower. Note base crack here also. The 'southwest' pinnacle is not secure. 6/84. R.L.C.

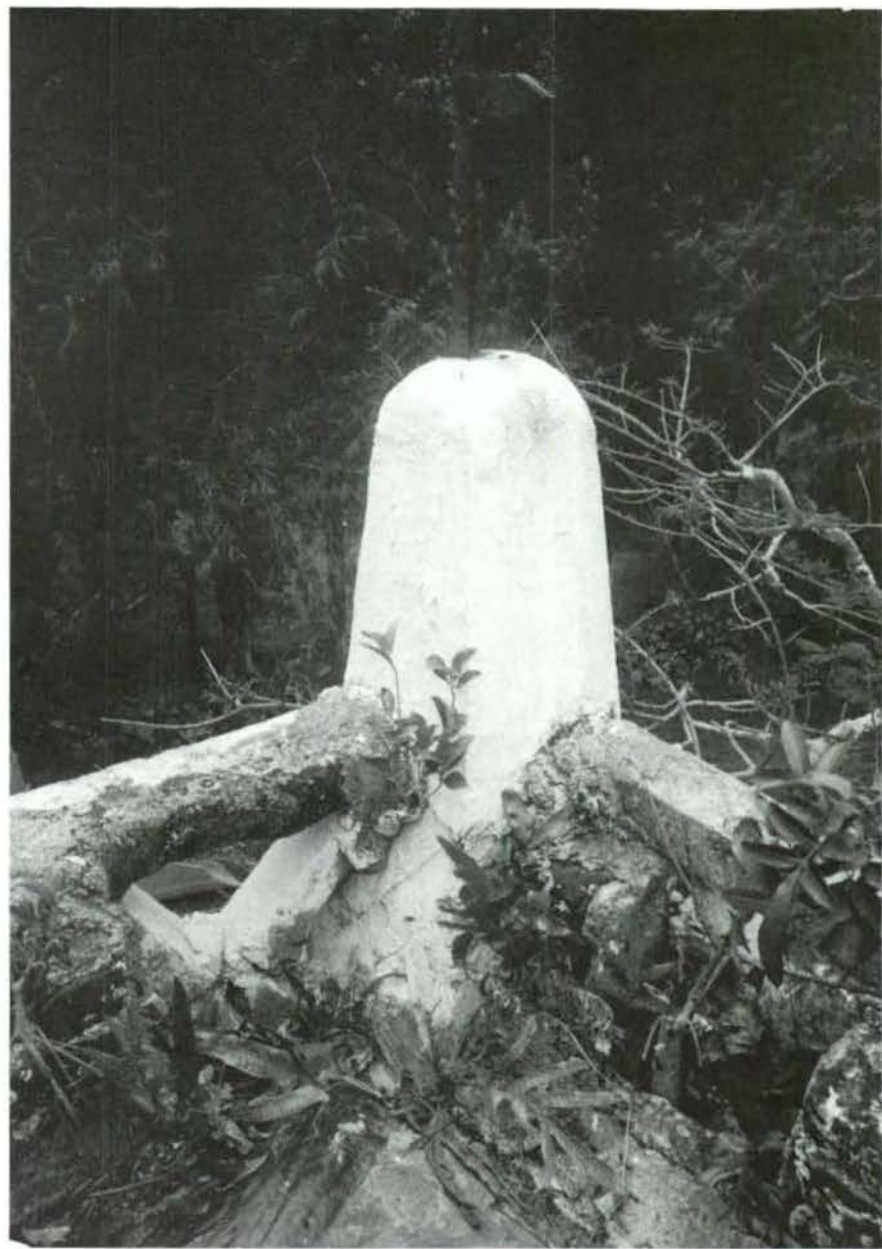
Illustration A26.

'Southwest' pinnalce showing vegetation growth in masonry which forces masonry work apart and allows water intrusion. 5/84. H.G.L.

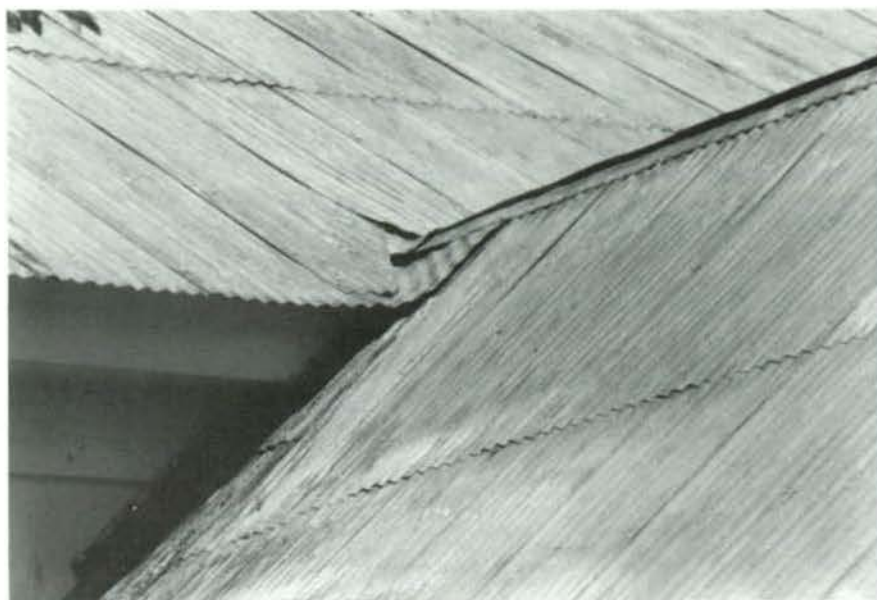
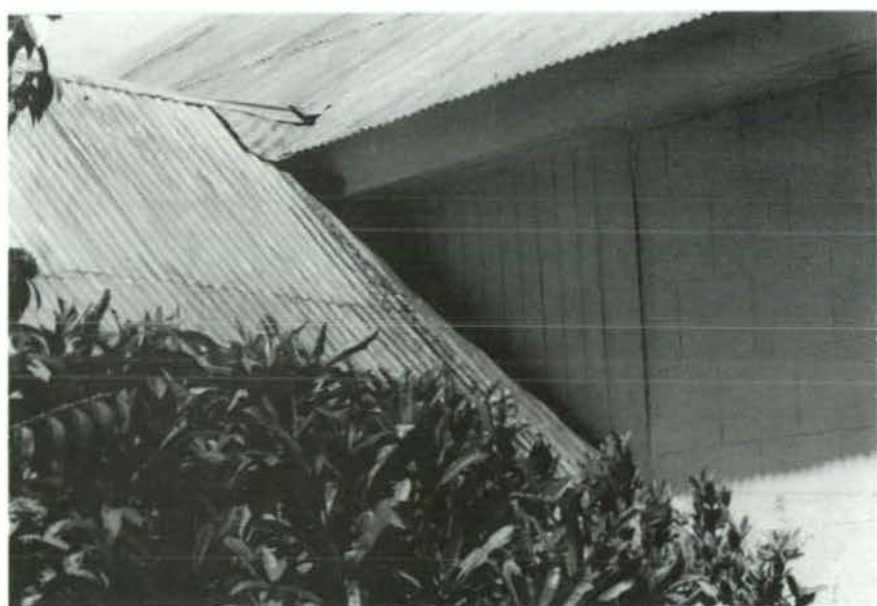
Illustrations A39 and A40.

Details of flashing at juncture of 1876 and 1889 roofs. Also note the vertical siding which is at both sides of the 1876 roof. 6/84. R.L.C.

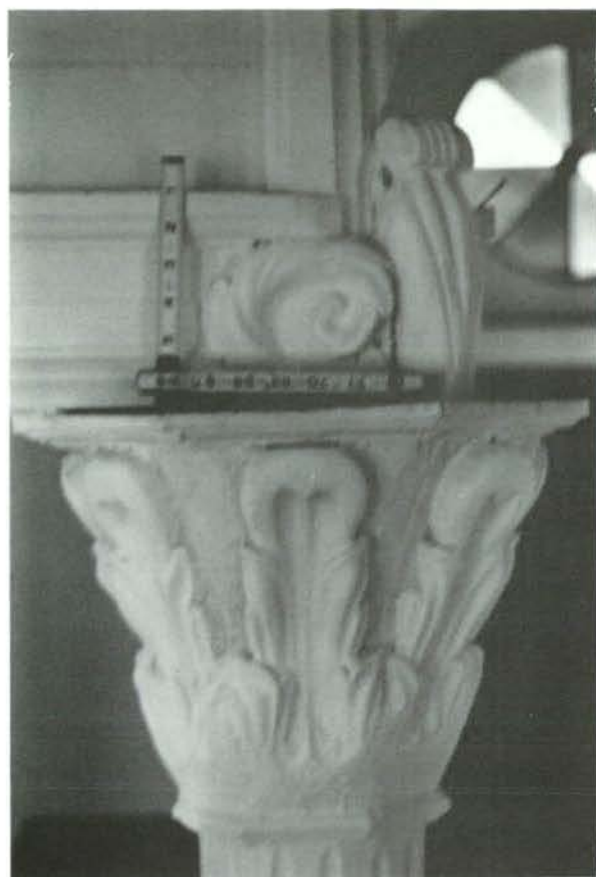
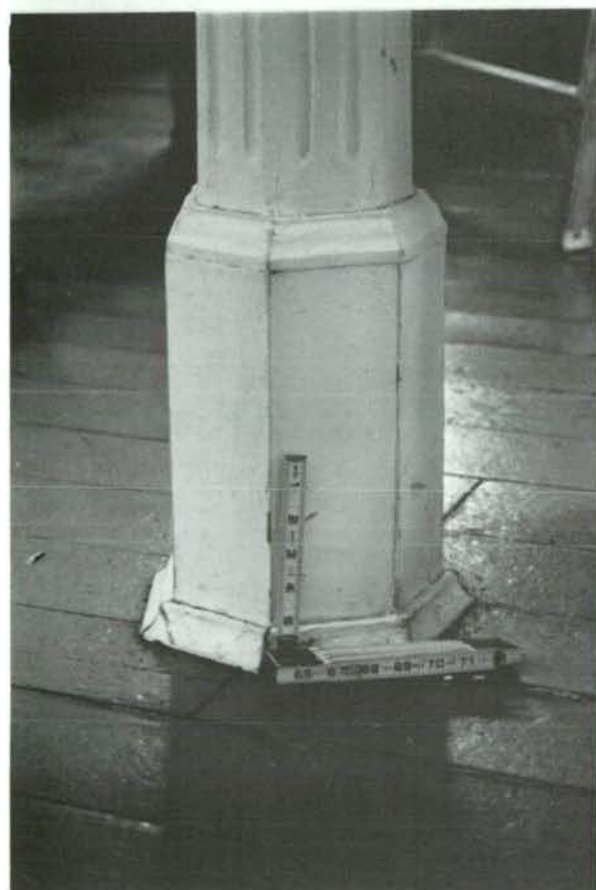
Illustrations A44 and A45.

Details of capital and base of column at intersection of 1876 nave with crossing. The two columns at this intersection are seven-sided, whereas the larger columns of the 1888 nave are octagonal. Some column capitals have been repaired with a fiberglass filler. 8/84. P.C.C.

1876 portion, replace siding and trim when required	bevel siding	420.00	sq.ft.	25.00	10500.00	11	
Column capitals, repair	consolidate or replace	1.00	lumpsum	6000.00	6000.00	9	
Cornice, south interior wall, remove existing nailer/replace. Reinstall cornice into historic position as indicated by plaster and paint lines.	2"x4"x14'-0"	1.00	lumpsum	850.00	850.00	1	
Bell tower roof framing, replace	treated Douglas Fir	1.00	lumpsum	750.00	750.00	3	
Bell tower, wood louvers	repair/replace as required	1.00	lumpsum	1500.00	1500.00	12

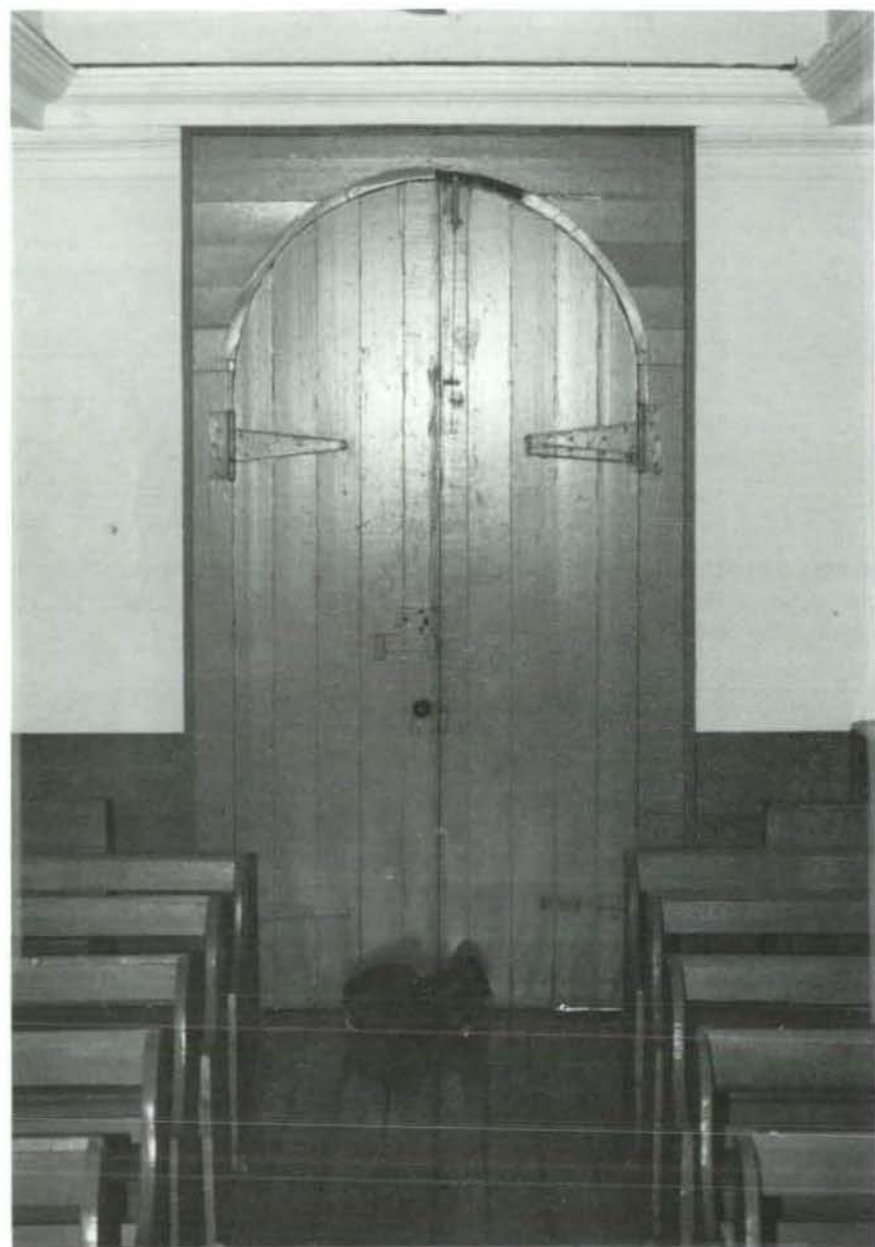
Illustration A56.

Interior of 'west' entry door, 1876 nave. The door is built-up of two layers of one-inch thick tongue-and-groove boarding. Note the repositioned and replacement hinges. 6/84. R.L.C.

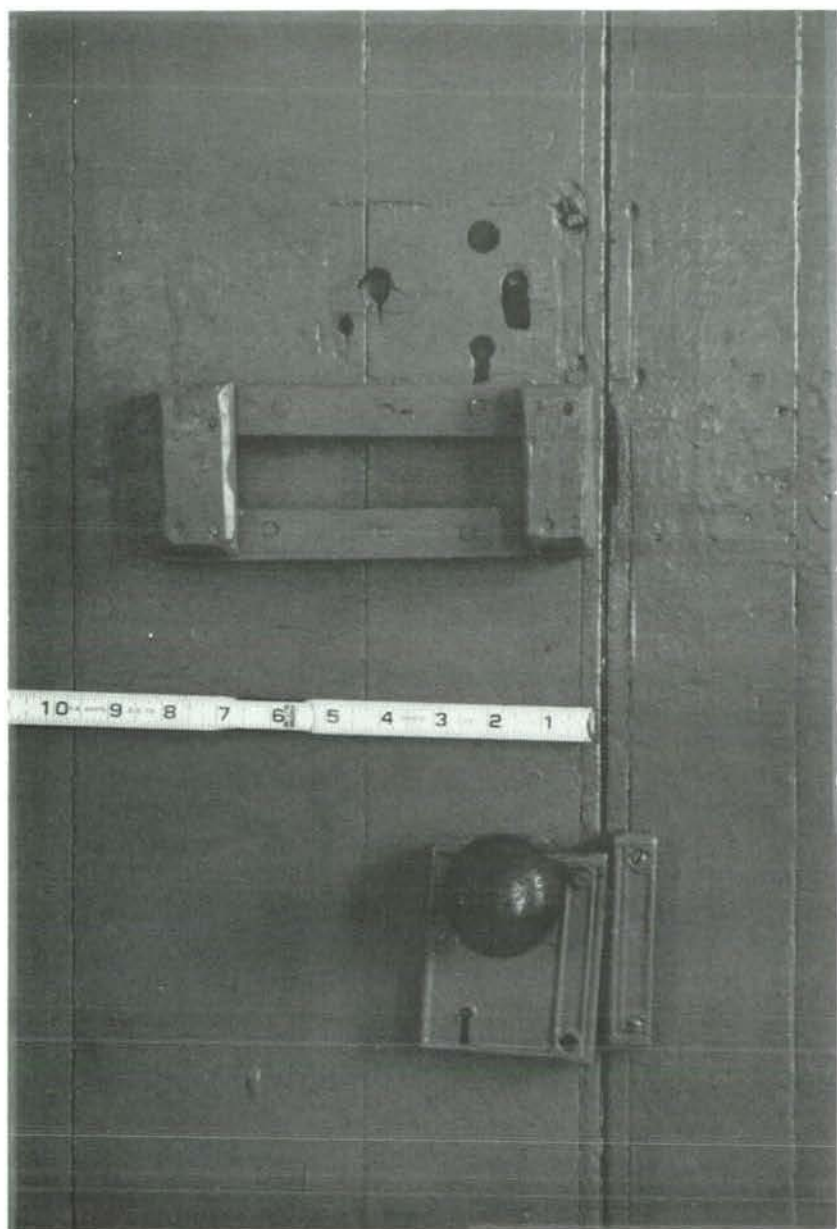
Illustration A57.

Hardware detail, interior of 'west' entry door, 1876 nave. Three periods of hardware are evident, the missing rim lock probably the intermediate set. Part of the wood slide-latch is obviously missing. 8/84. P.C.C.

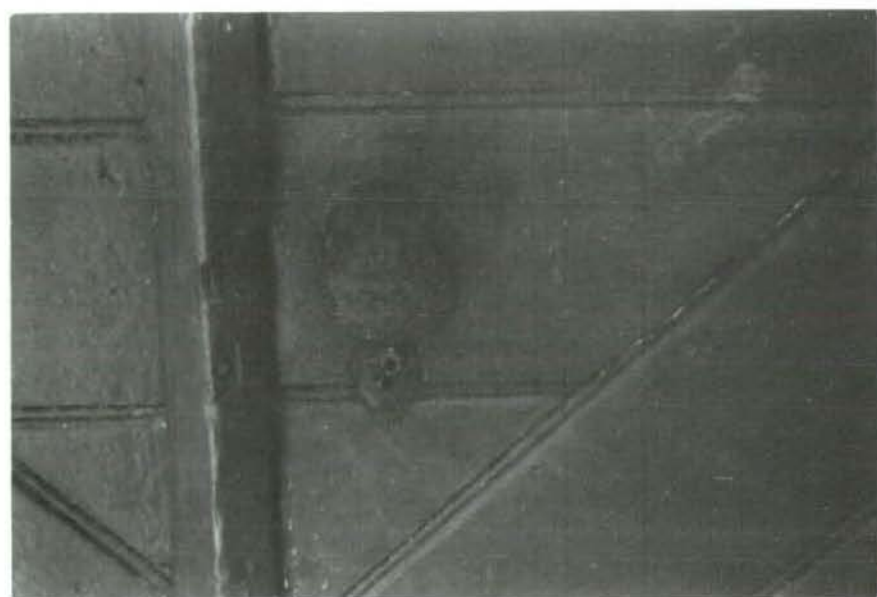
Illustration A58.

Hardware detail, exterior, 'west' entry door, 1876 nave. This lockset is inoperable. 8/84. P.C.C.

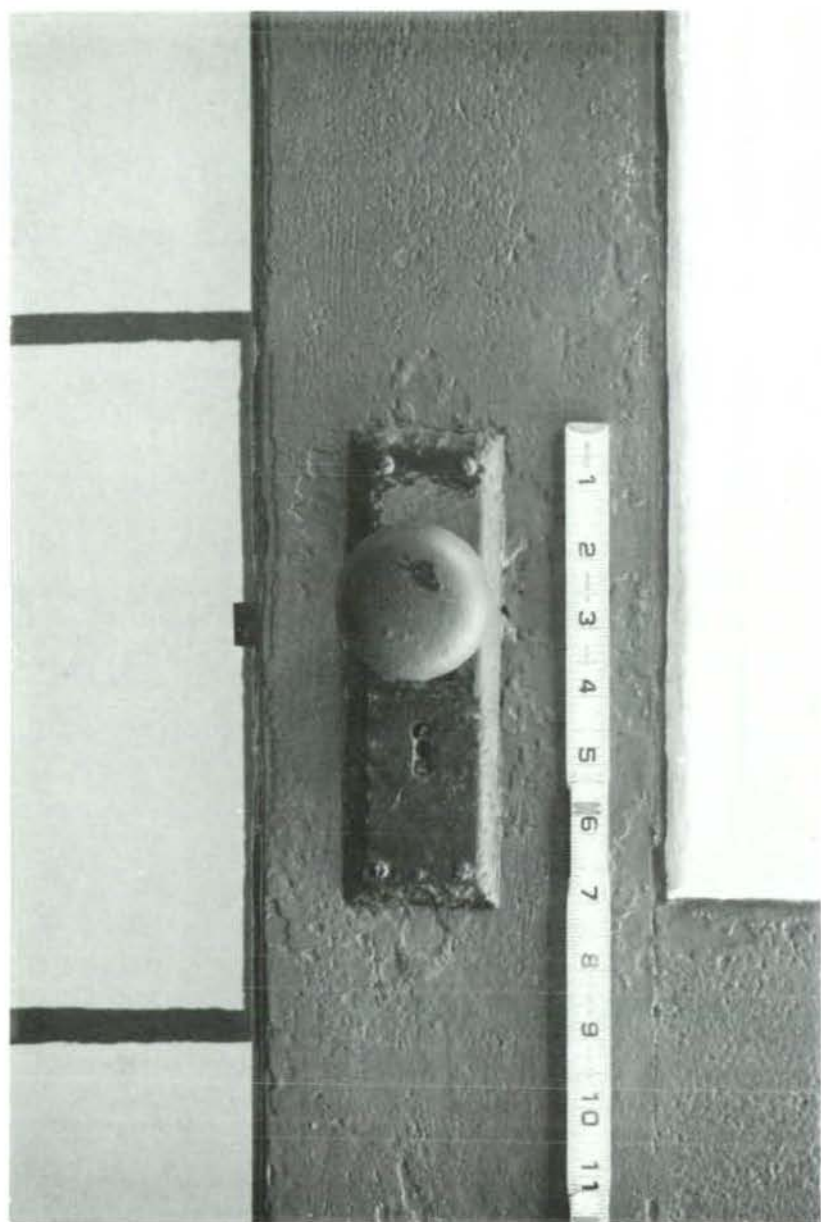
Illustration A59.

Hardware detail, 'south' entry, 1888 nave. This lockset is only partially operable. 8/84. P.C.C.

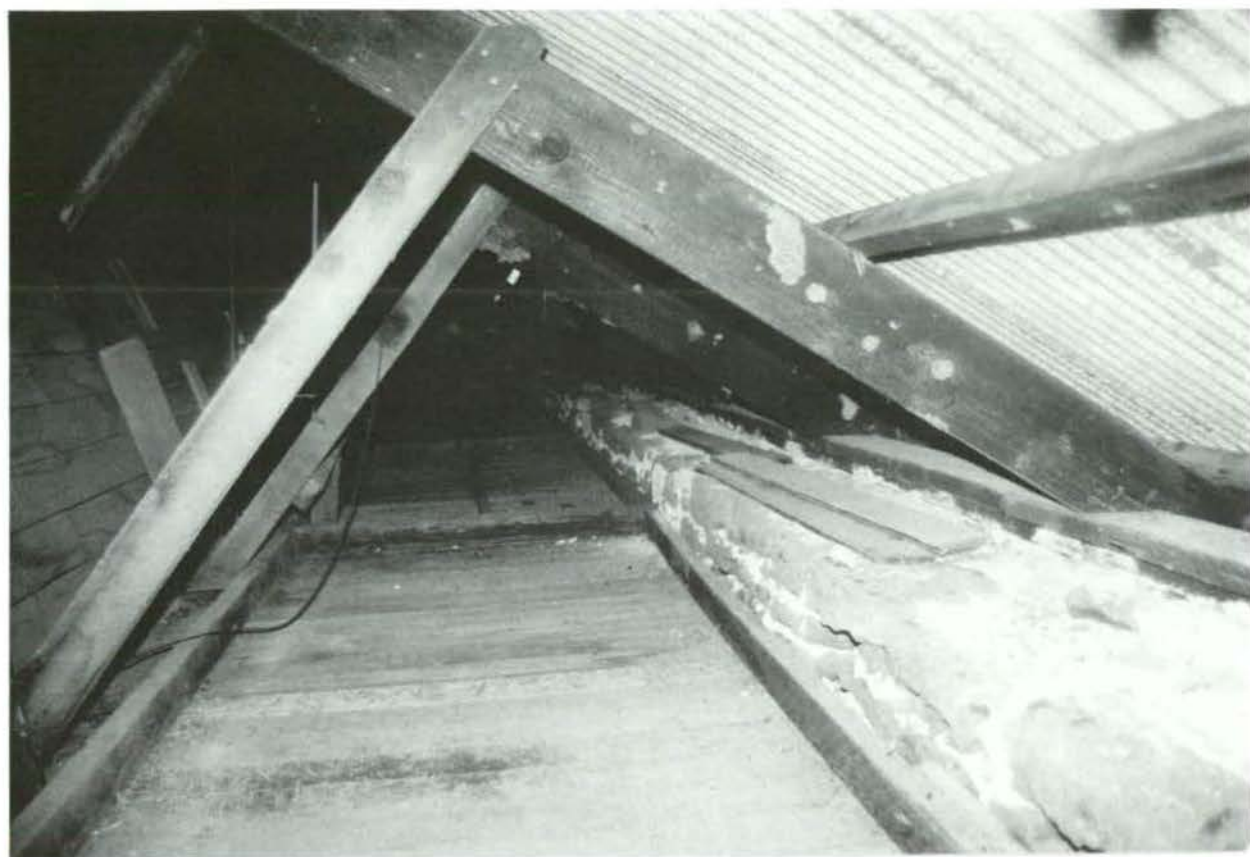
Illustration A61.

Attic along 'west' side of 1888 nave vault, view toward south. Part of the flat 'side-aisle' ceiling boarding has been replaced, probably ca. 1969. There are no visible anchors securing the double 2x8 rafter bearing plate to the stone wall. 8/84. P.C.C.

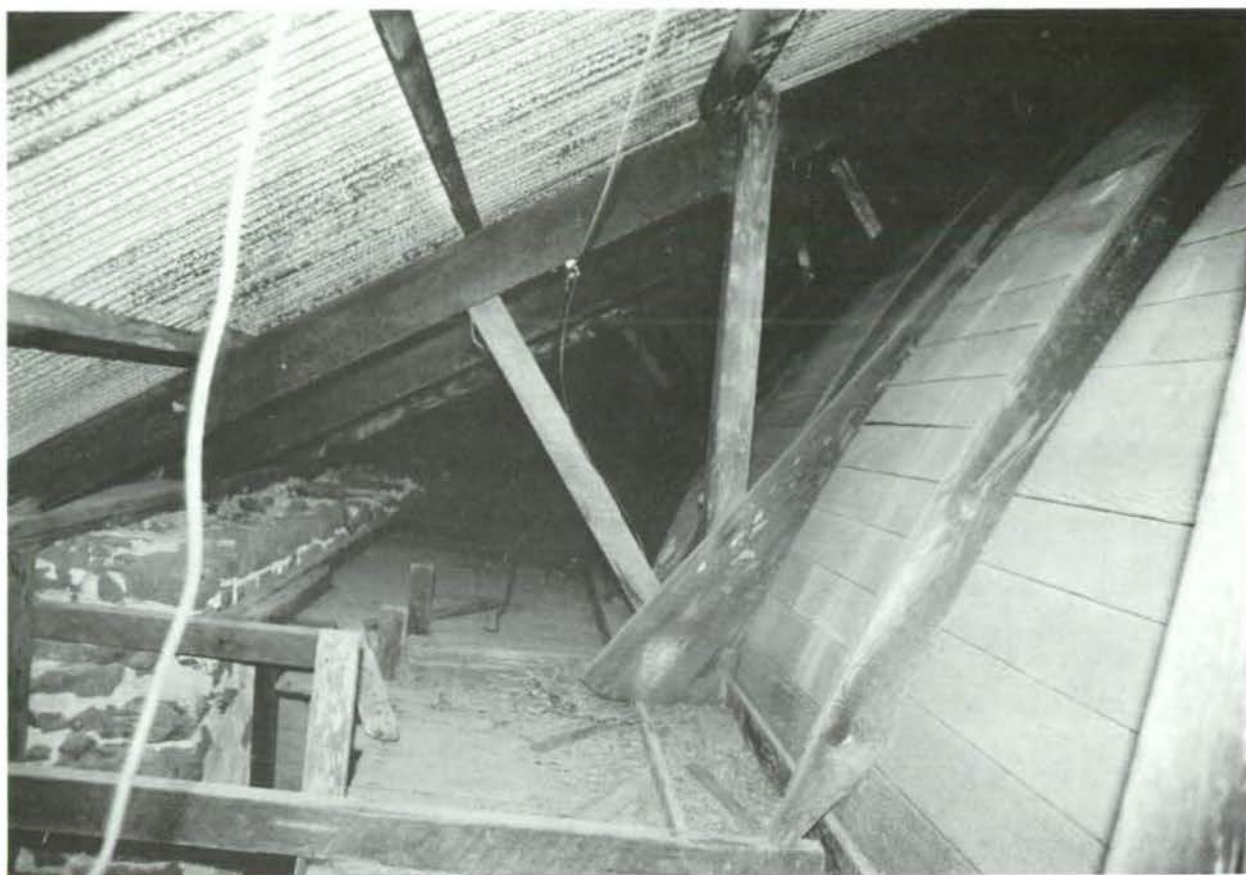
Illustration A63.

Attic along 'east' side of 1888 nave vault, view toward south. Most rafters and vault ribs are sound, but the vault base plates, a flat 2 inch by 10½ inch member on this side (lower center of photo), are extremely deteriorated from air-borne termite infestations. Most of the weight of the vault is probably carried in suspension from the rafters. The end of the stone wall is also visible in this photo. 8/84. P.C.C.

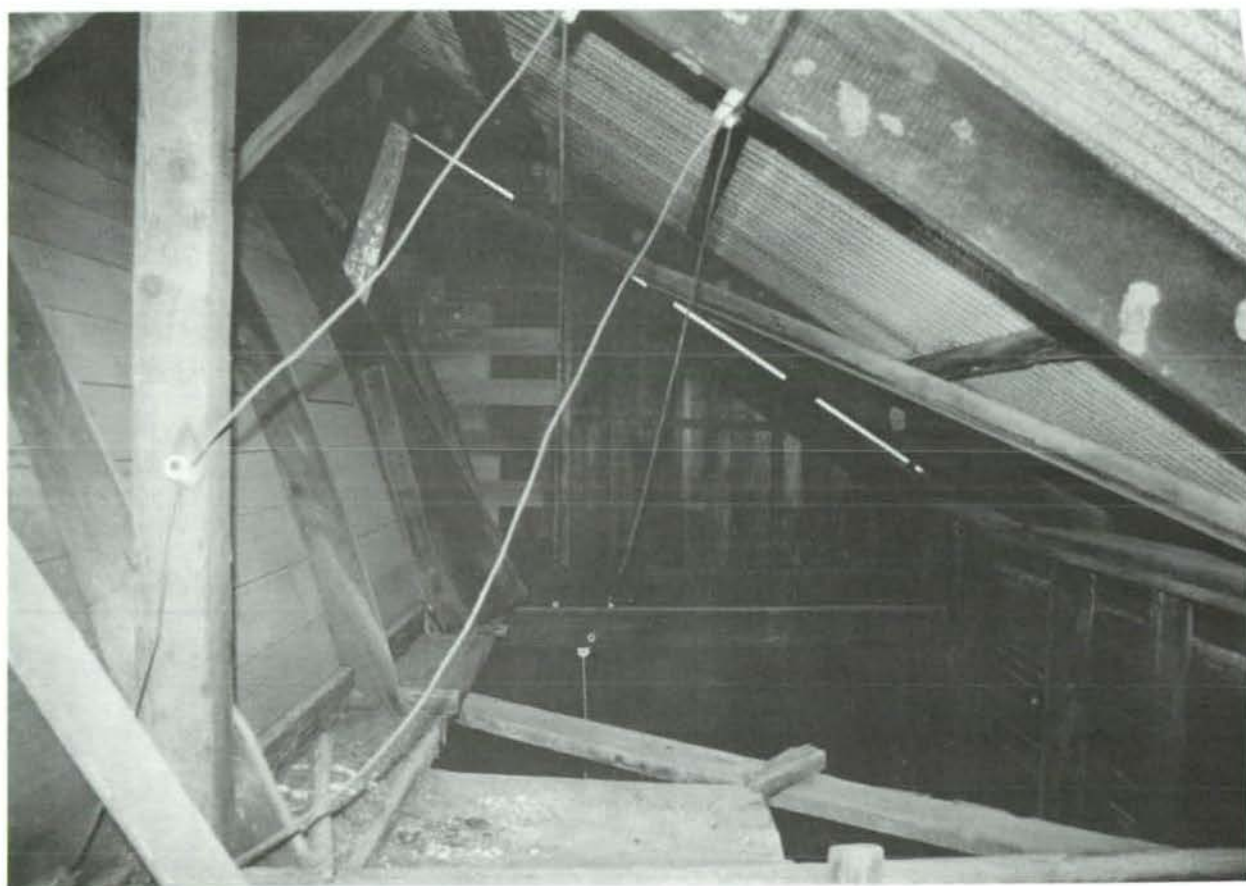
Illustration A64.

Attic along 'east' side of 1888 nave vault, view toward 'north', showing wood frame portion of building, open to the east sacristy below. The deteriorated vault base plate is at lower left. 8/84. P.C.C.

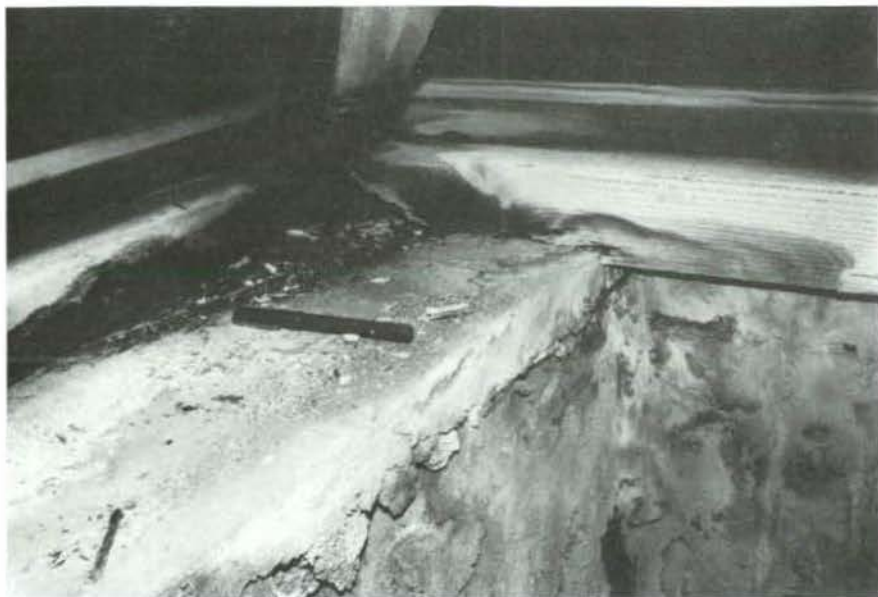
Illustration A66.

Detail of deteriorated base plate of bell tower roof at 'southeast' corner.  
8/84. P.C.C.

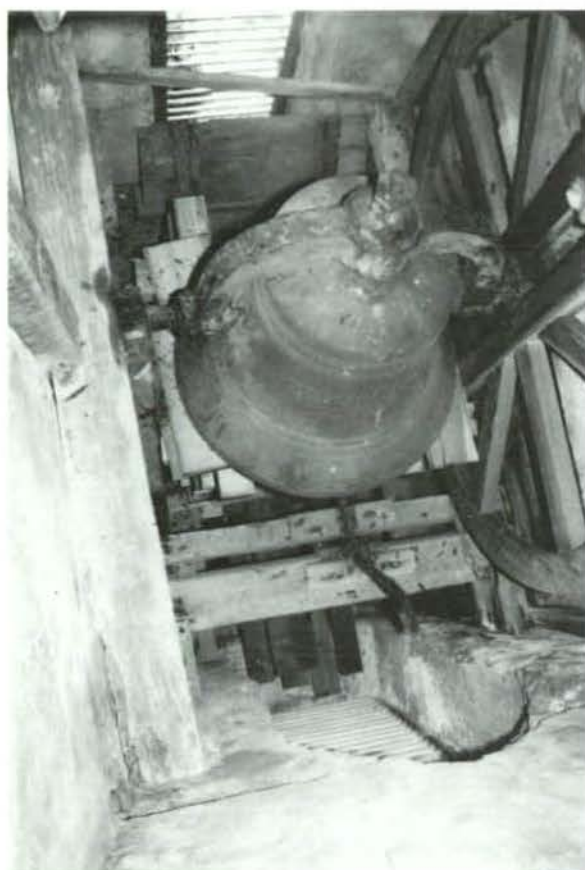
Illustration A73.

View of bell from above after temporary cribbing was installed. Cribbing is supported on sills of louvered openings. 8/84. P.C.C.

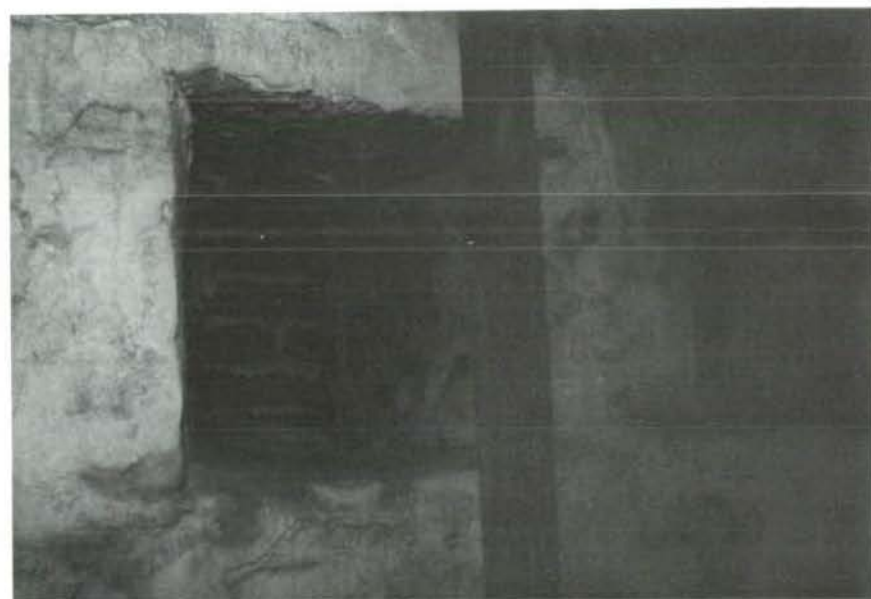
Illustration A75.

Opening in wall between bell tower and main nave, partially closed with brick. 6/84. R.L.C.

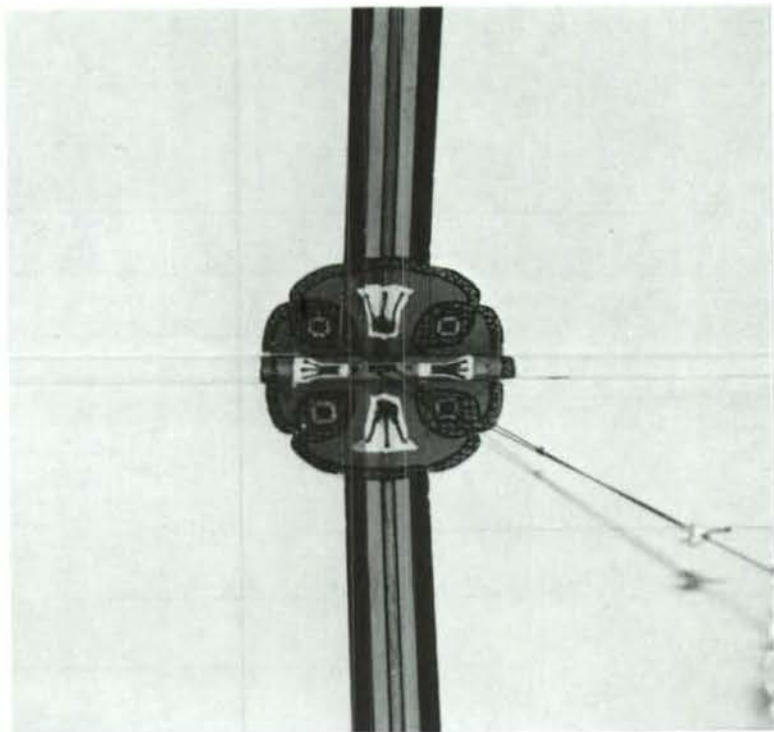
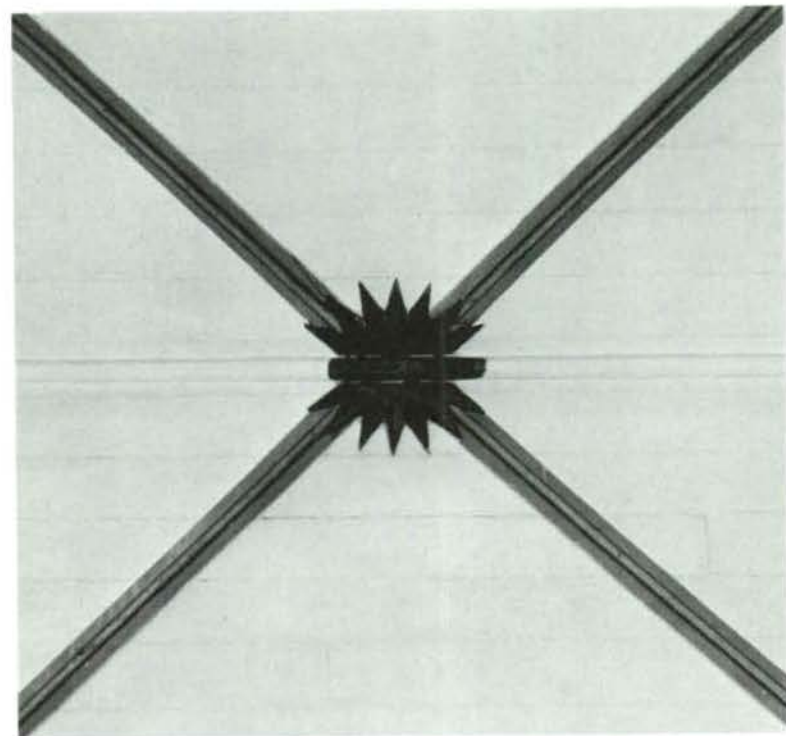
Illustrations A99 and A100.

Ceiling medallions. 8/84. P.C.C.
