HISTORIC STRUCTURE REPORT

ST. PHILOMENA CATHOLIC CHURCH

KALAUPAPA NATIONAL HISTORICAL PARK  
Molokai, Hawaii

January 1985

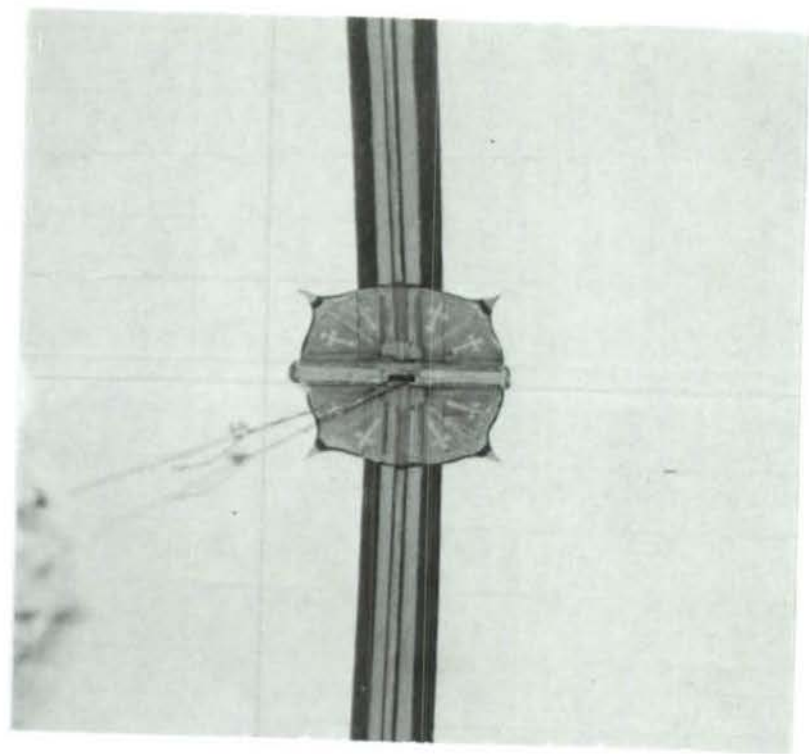
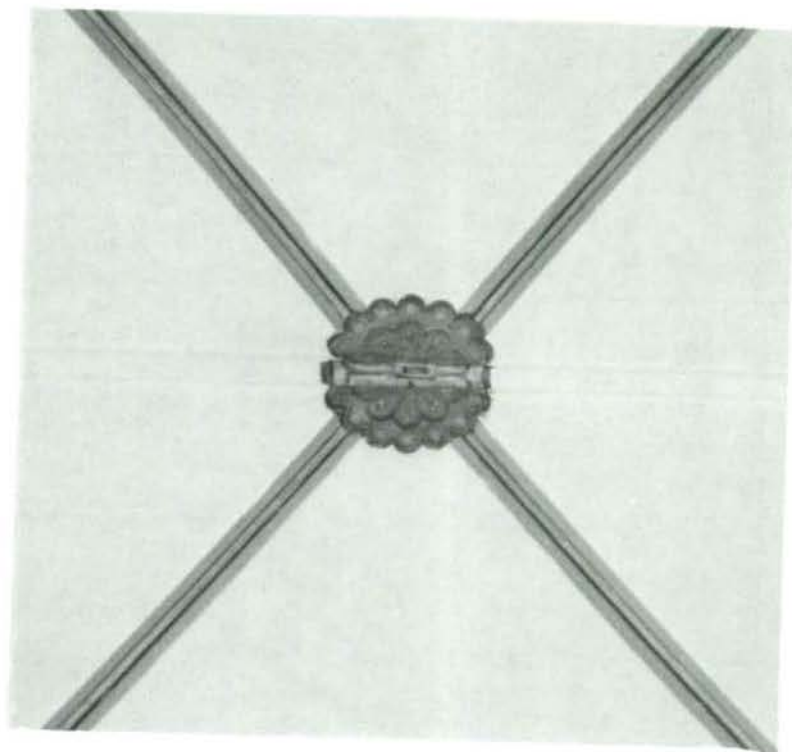
Illustrations A101 and A102.

Ceiling medallions. 8/84. P.C.C.

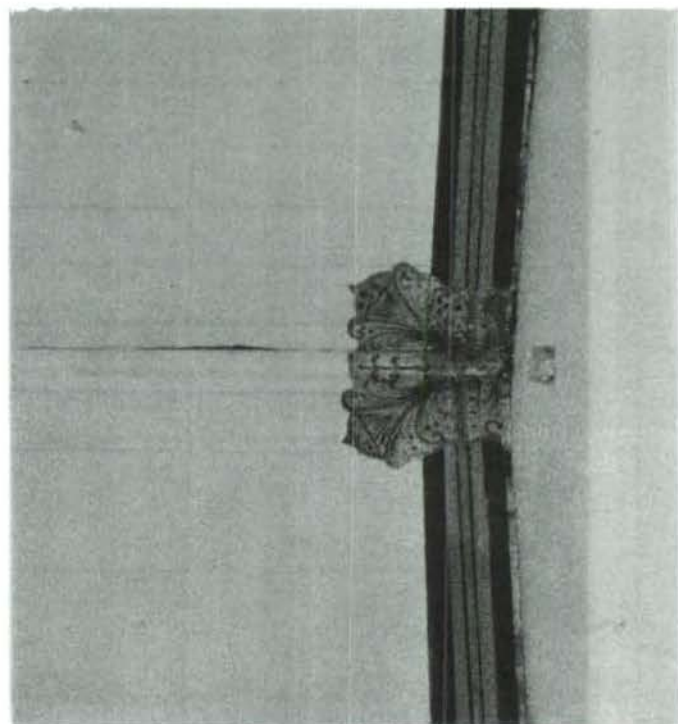
Illustration A103.

Ceiling medallion at 'south' wall, 1888 nave. 8/84. P.C.C.

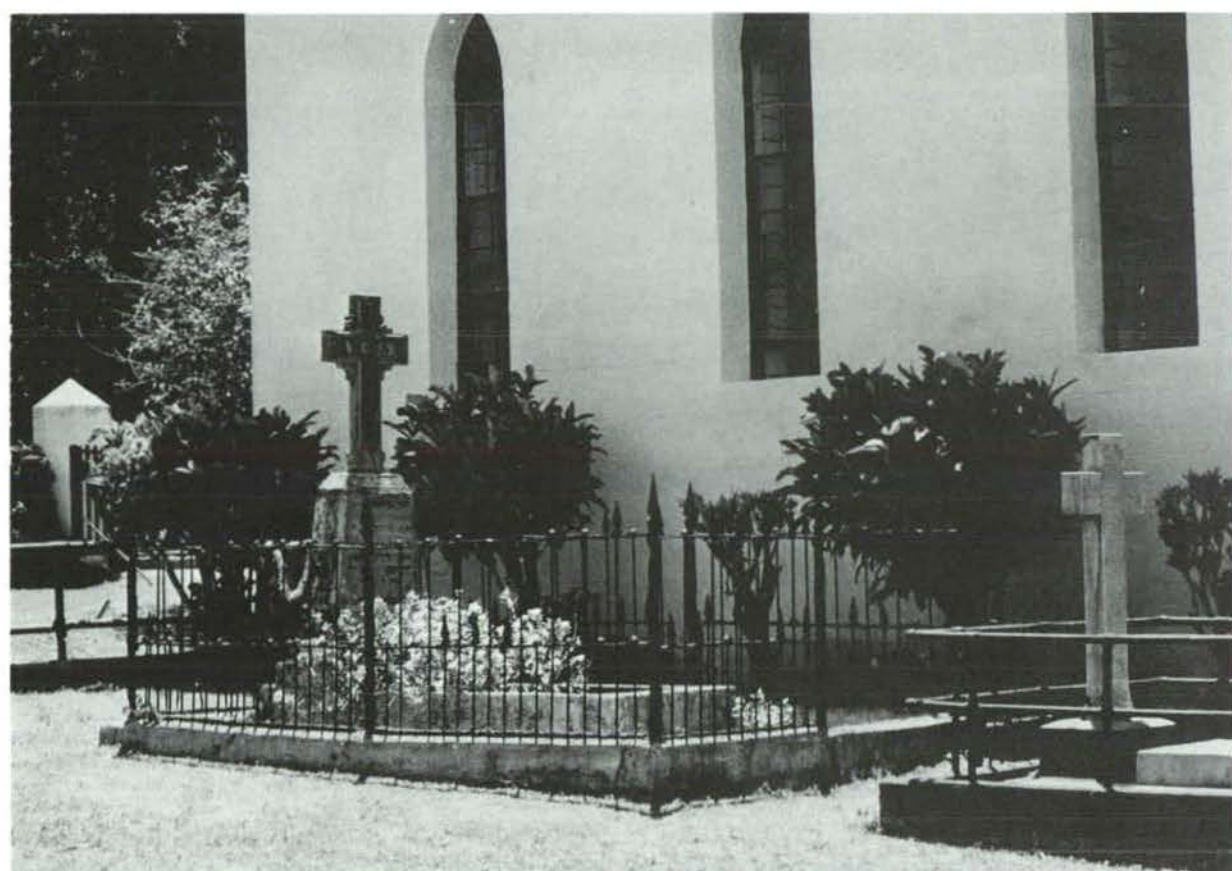
Illustration A108.

Fr. Damien's grave. 6/84. R.L.C.

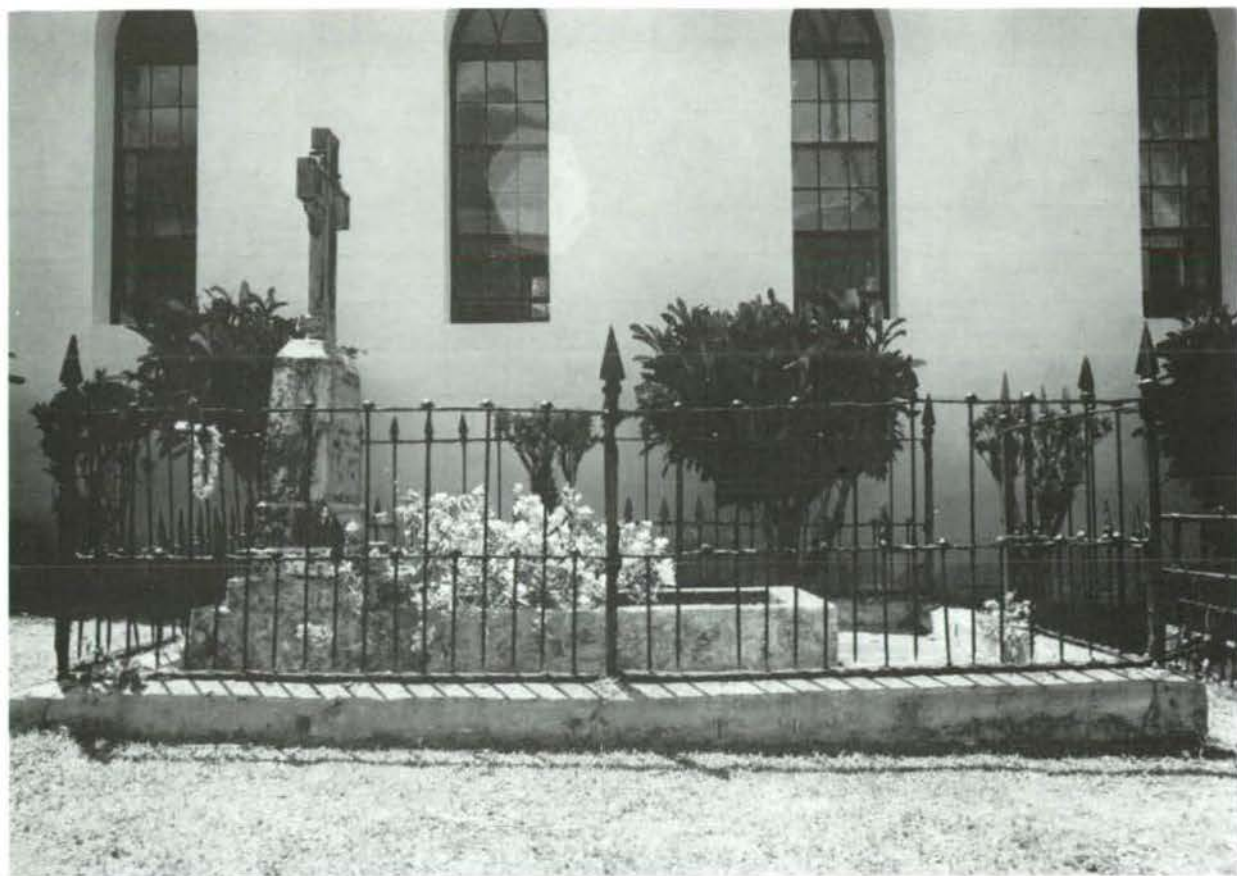
Illustration A109.

Fr. Damien's grave, from 'east'. 6/84. R.L.C.

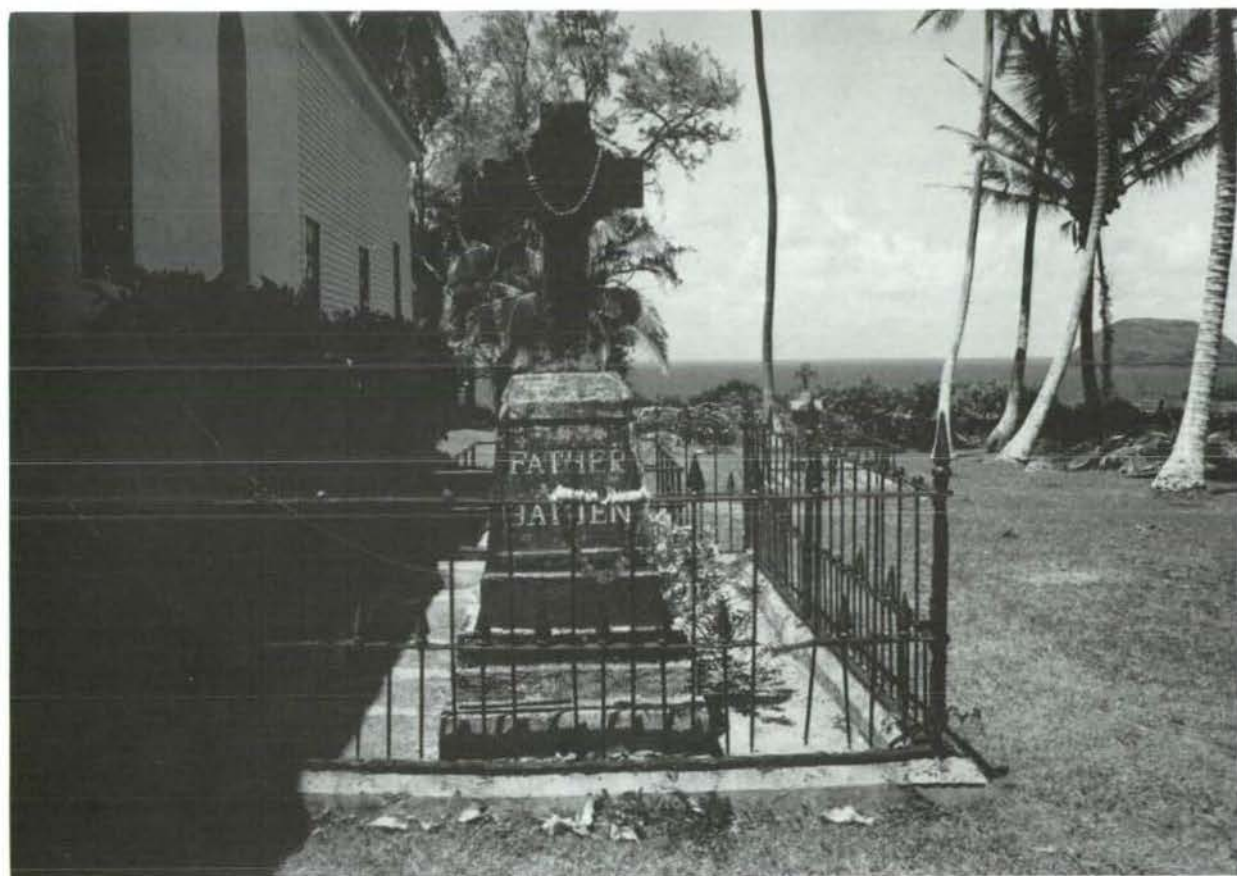
Illustration A110.

Fr. Damien's grave, from 'south'. 6/84. R.L.C.

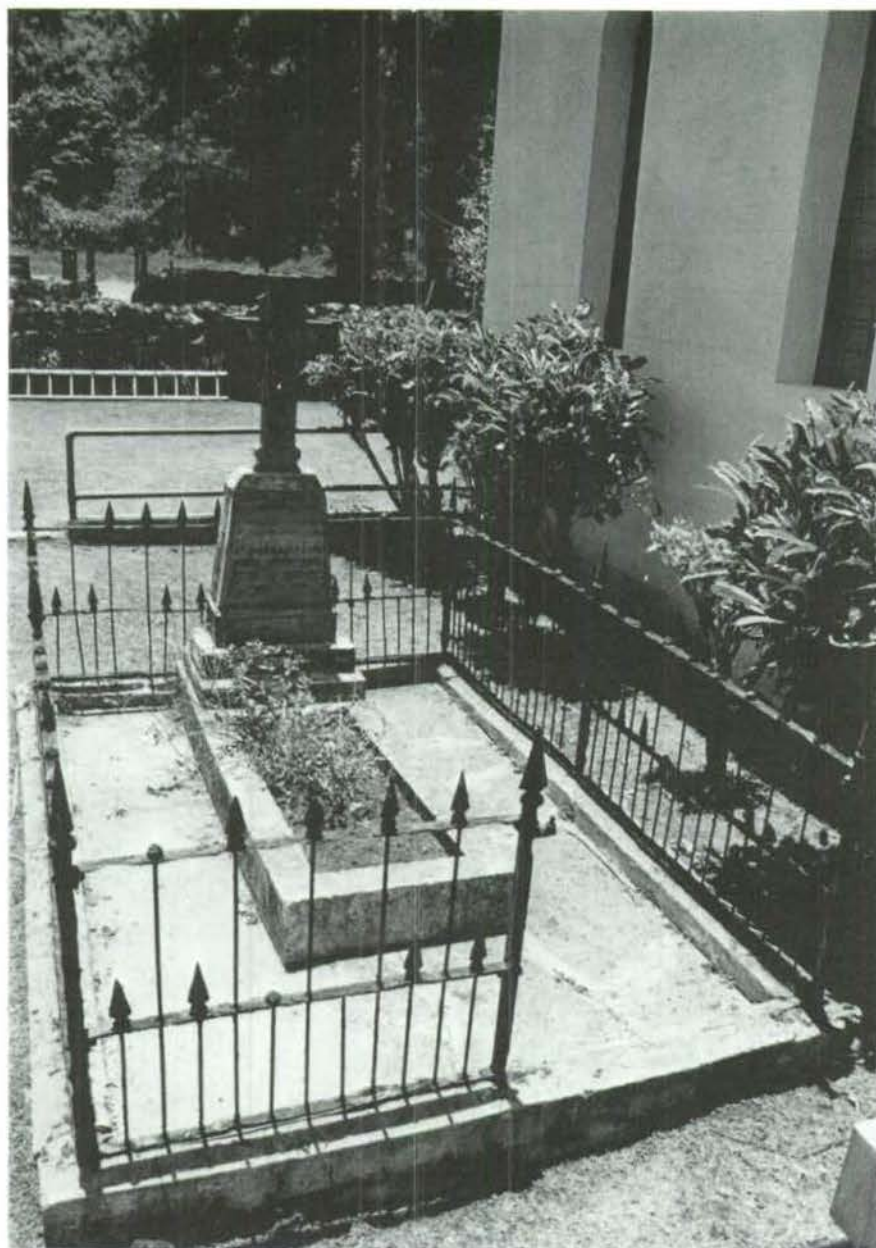
Illustration A111.

Fr. Damien's grave. Note deterioration of decorative railing and missing elements. Part of gate still exists. 8/84. P.C.C.

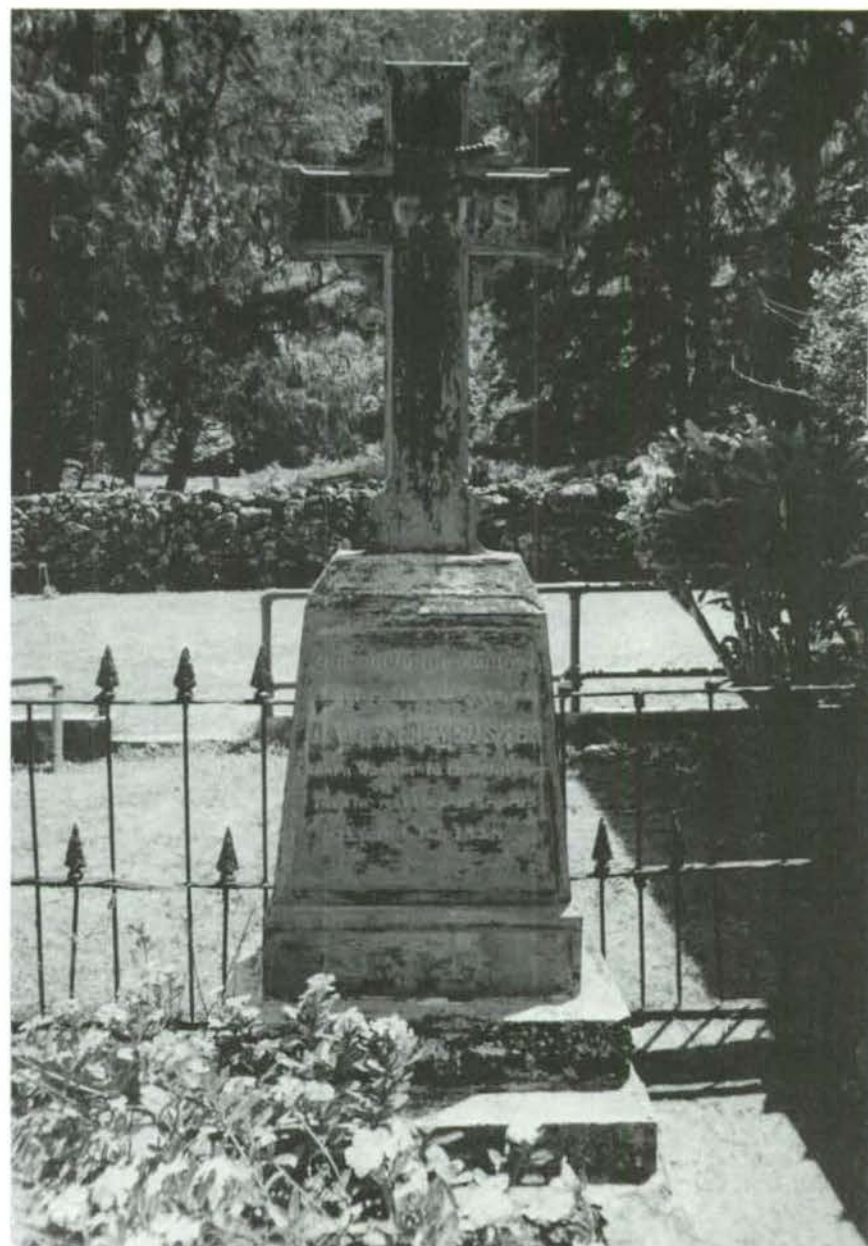
Illustration A112.

Fr. Damien's grave. Although some stone was used, concrete was used extensively for the grave markers at St. Philomena. 6/84. R.L.C.

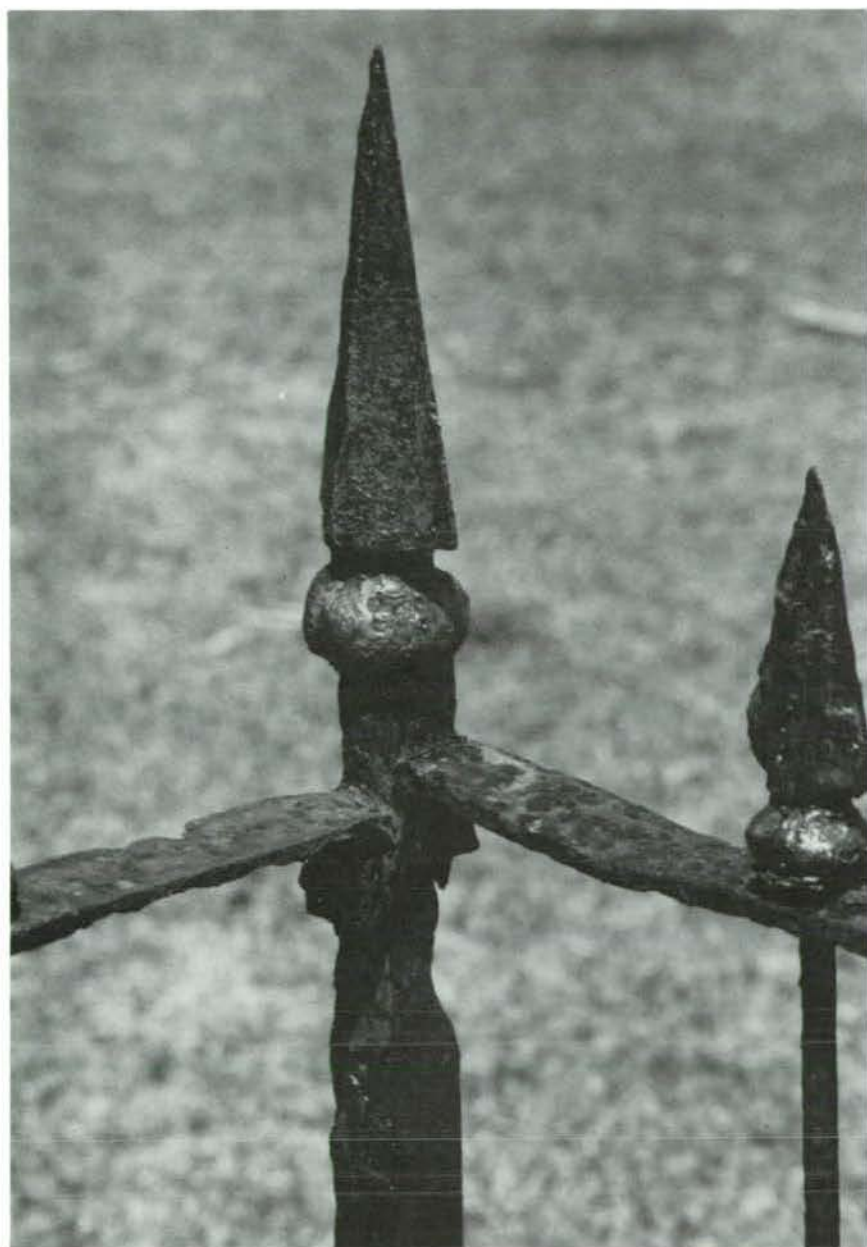
Illustration A113.

Corner post of railing, Fr. Damien's grave. 6/84. R.L.C.

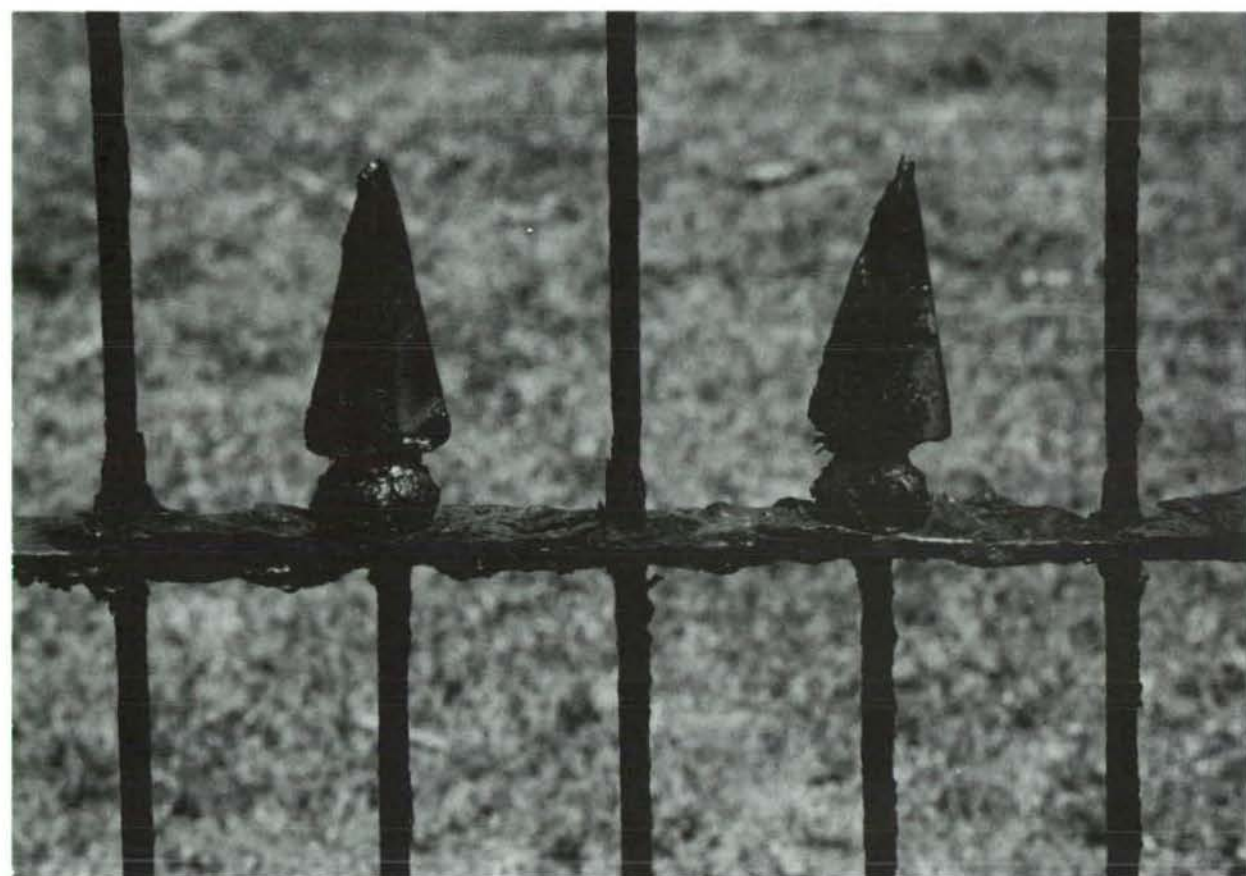
Illustration A114.

Detail at center rail, Fr. Damien's grave. 6/84. R.L.C.

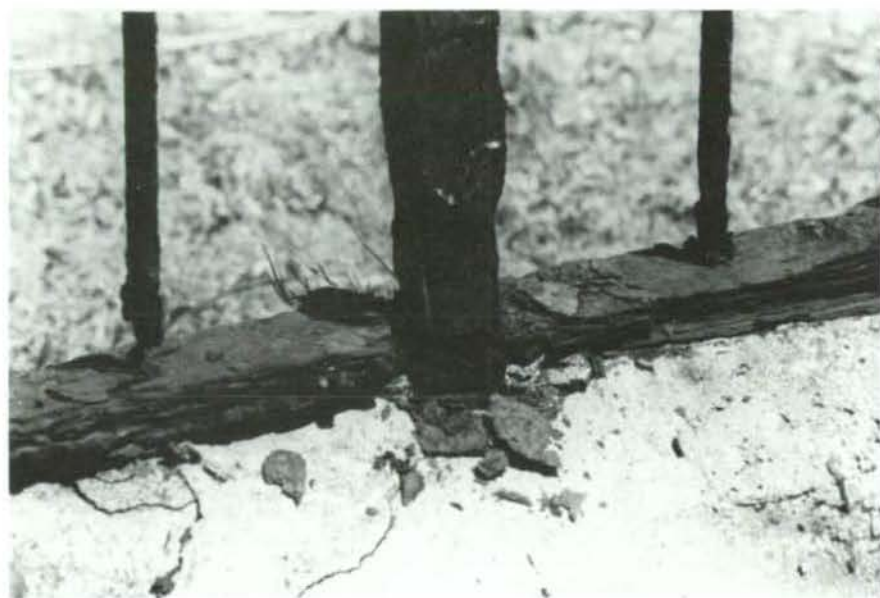
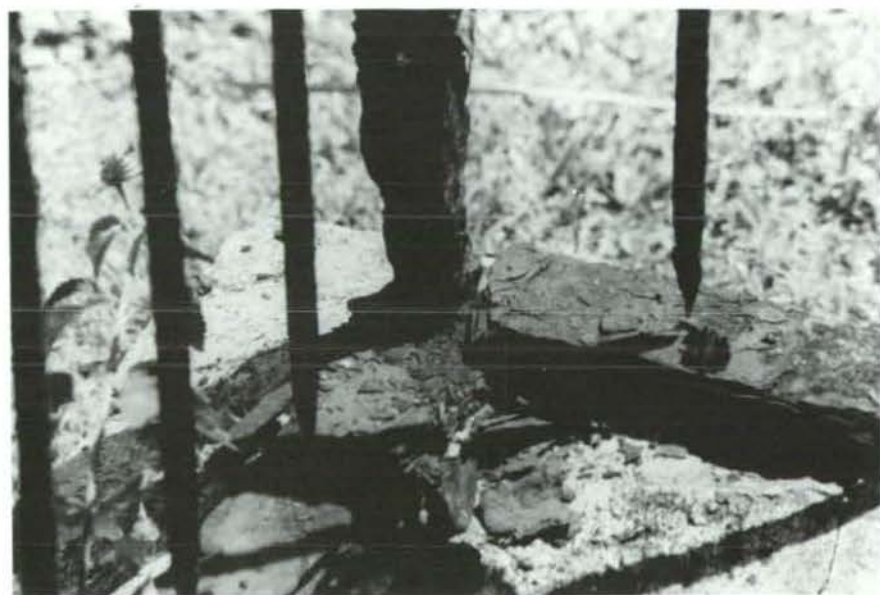
Illustrations A117 and A118.

Details of intermediate and corner post at bottom rail, Fr. Damien's grave. 6/84. R.L.C.

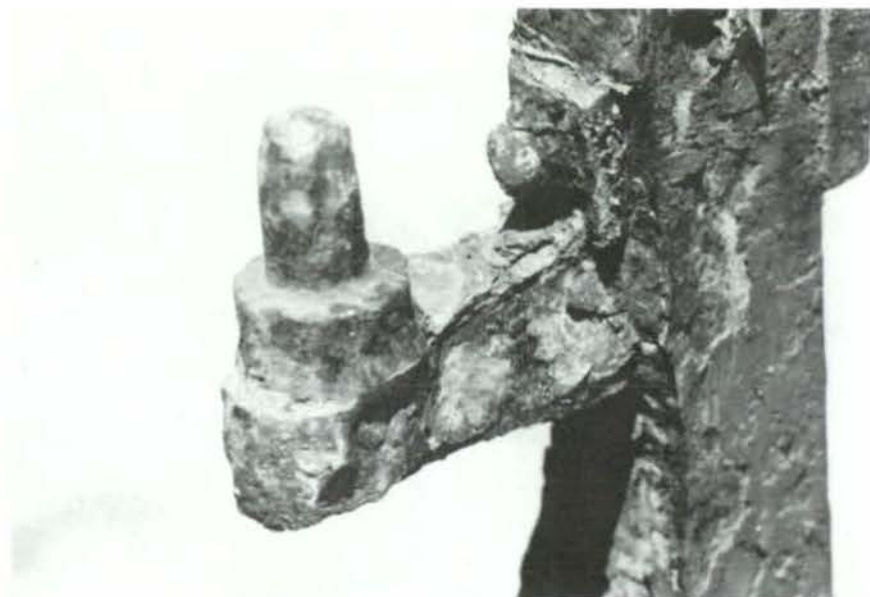
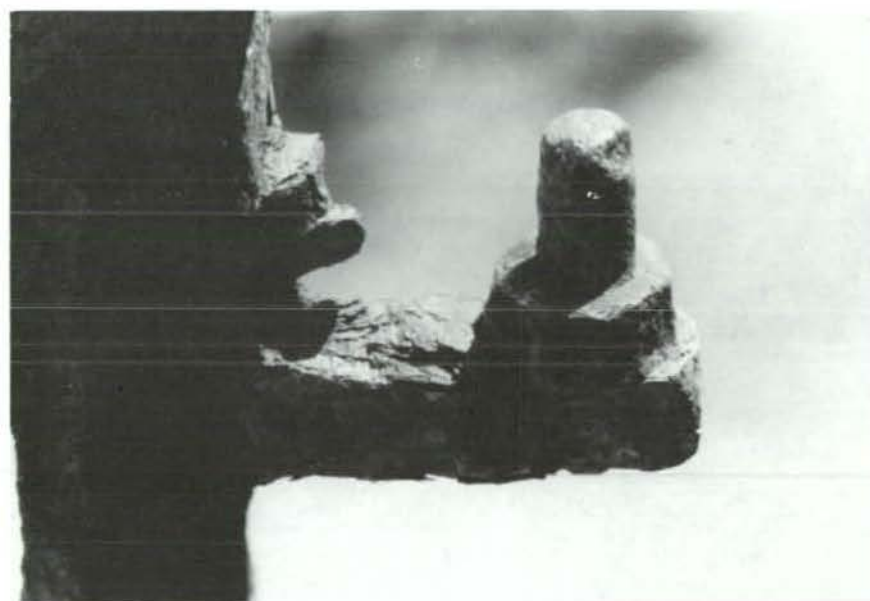
Illustrations A119 and A120.

Gate pintle details, railing of Fr. Damien's grave. 6/84. R.L.C.

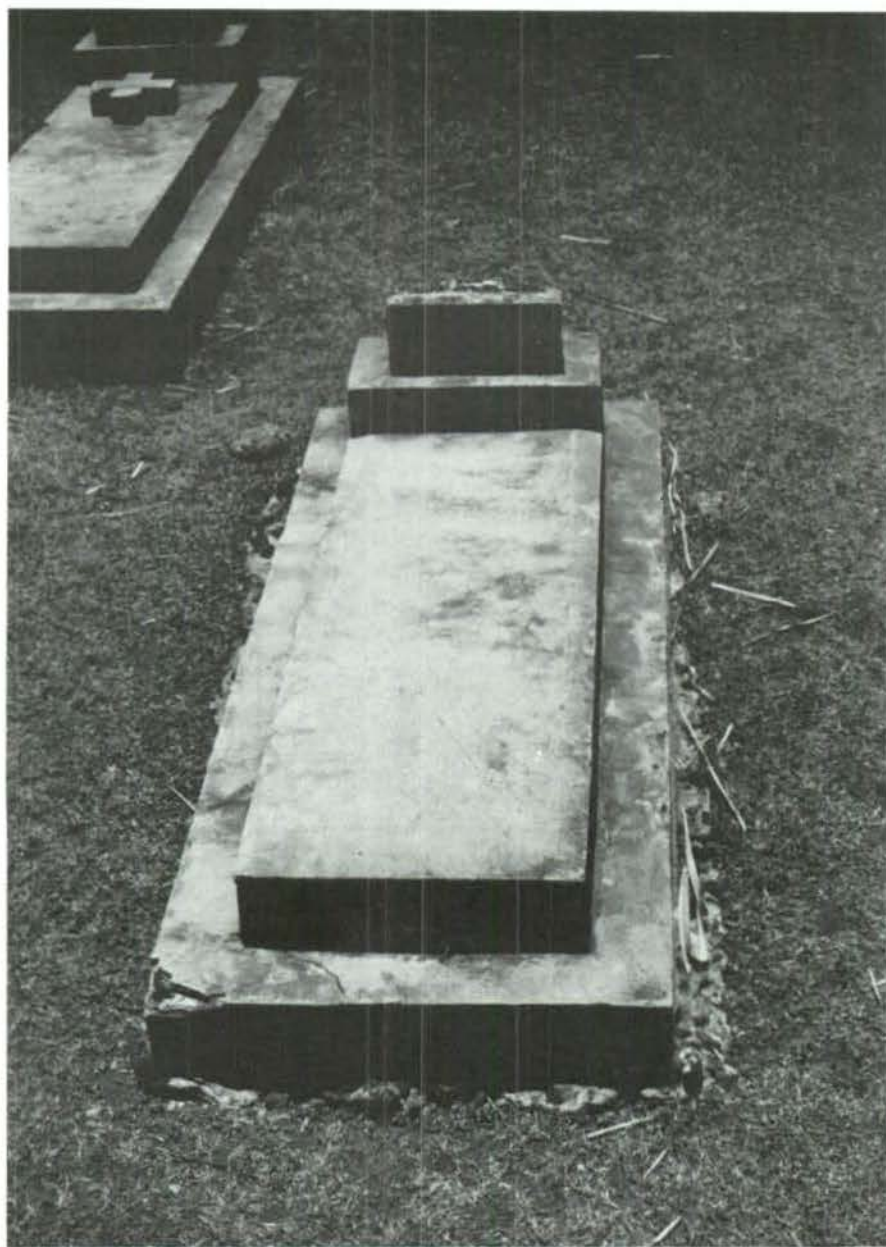
Illustration A132.

The person buried here was unidentified as the headstone is missing (grave No. 12 on Site Plan drawing). 8/84. P.C.C.

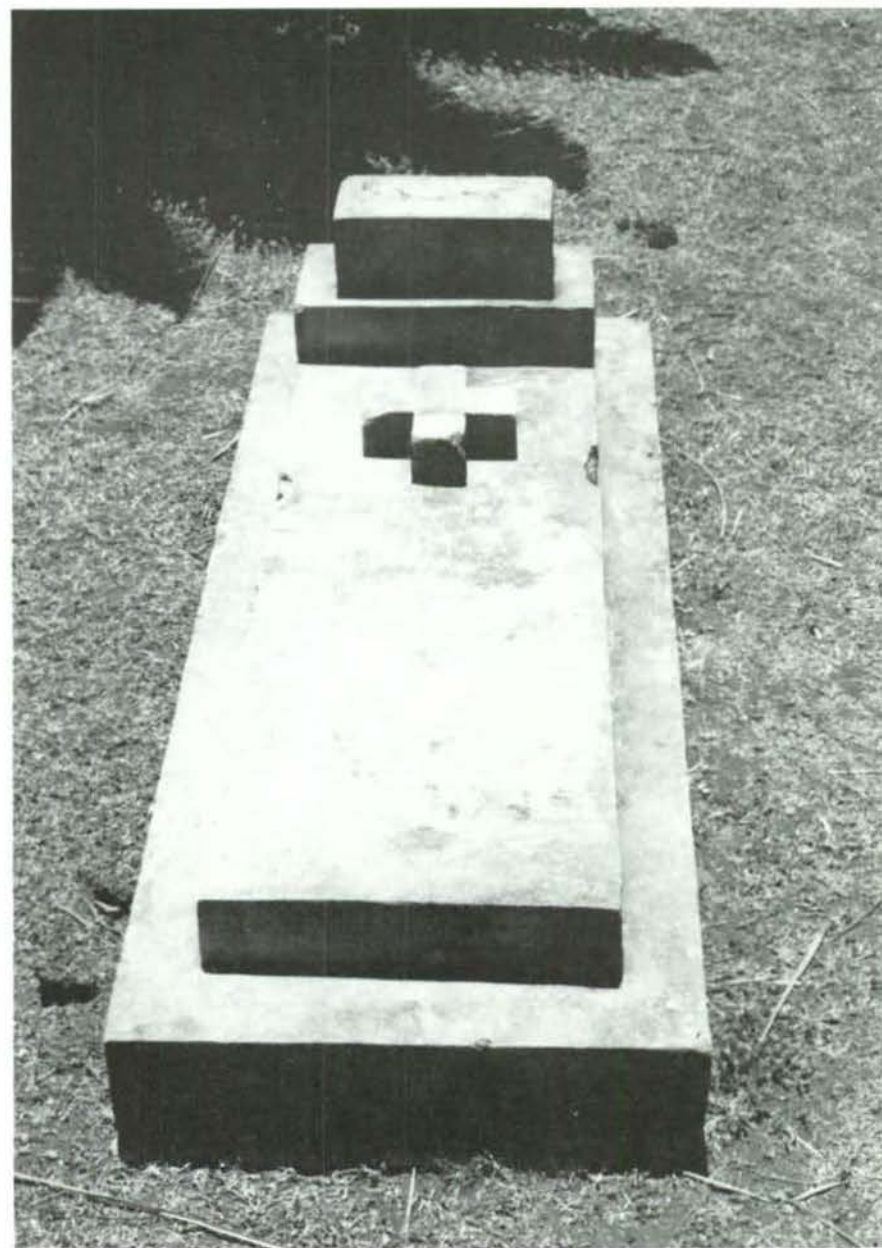
Illustration A133.

Also unidentified as headstone is broken (No. 13 on Site Plan drawing). 8/84. P.C.C.
